# **Fluvial Geomorphology Study of the Turners Falls Pool on the Connecticut River Between Turners Falls, MA and Vernon, VT**

Northfield Mountain Pumped Storage Project  
FERC License No. 2485  
Northfield, Massachusetts

Field Geology Services  
Farmington, ME

November 2007

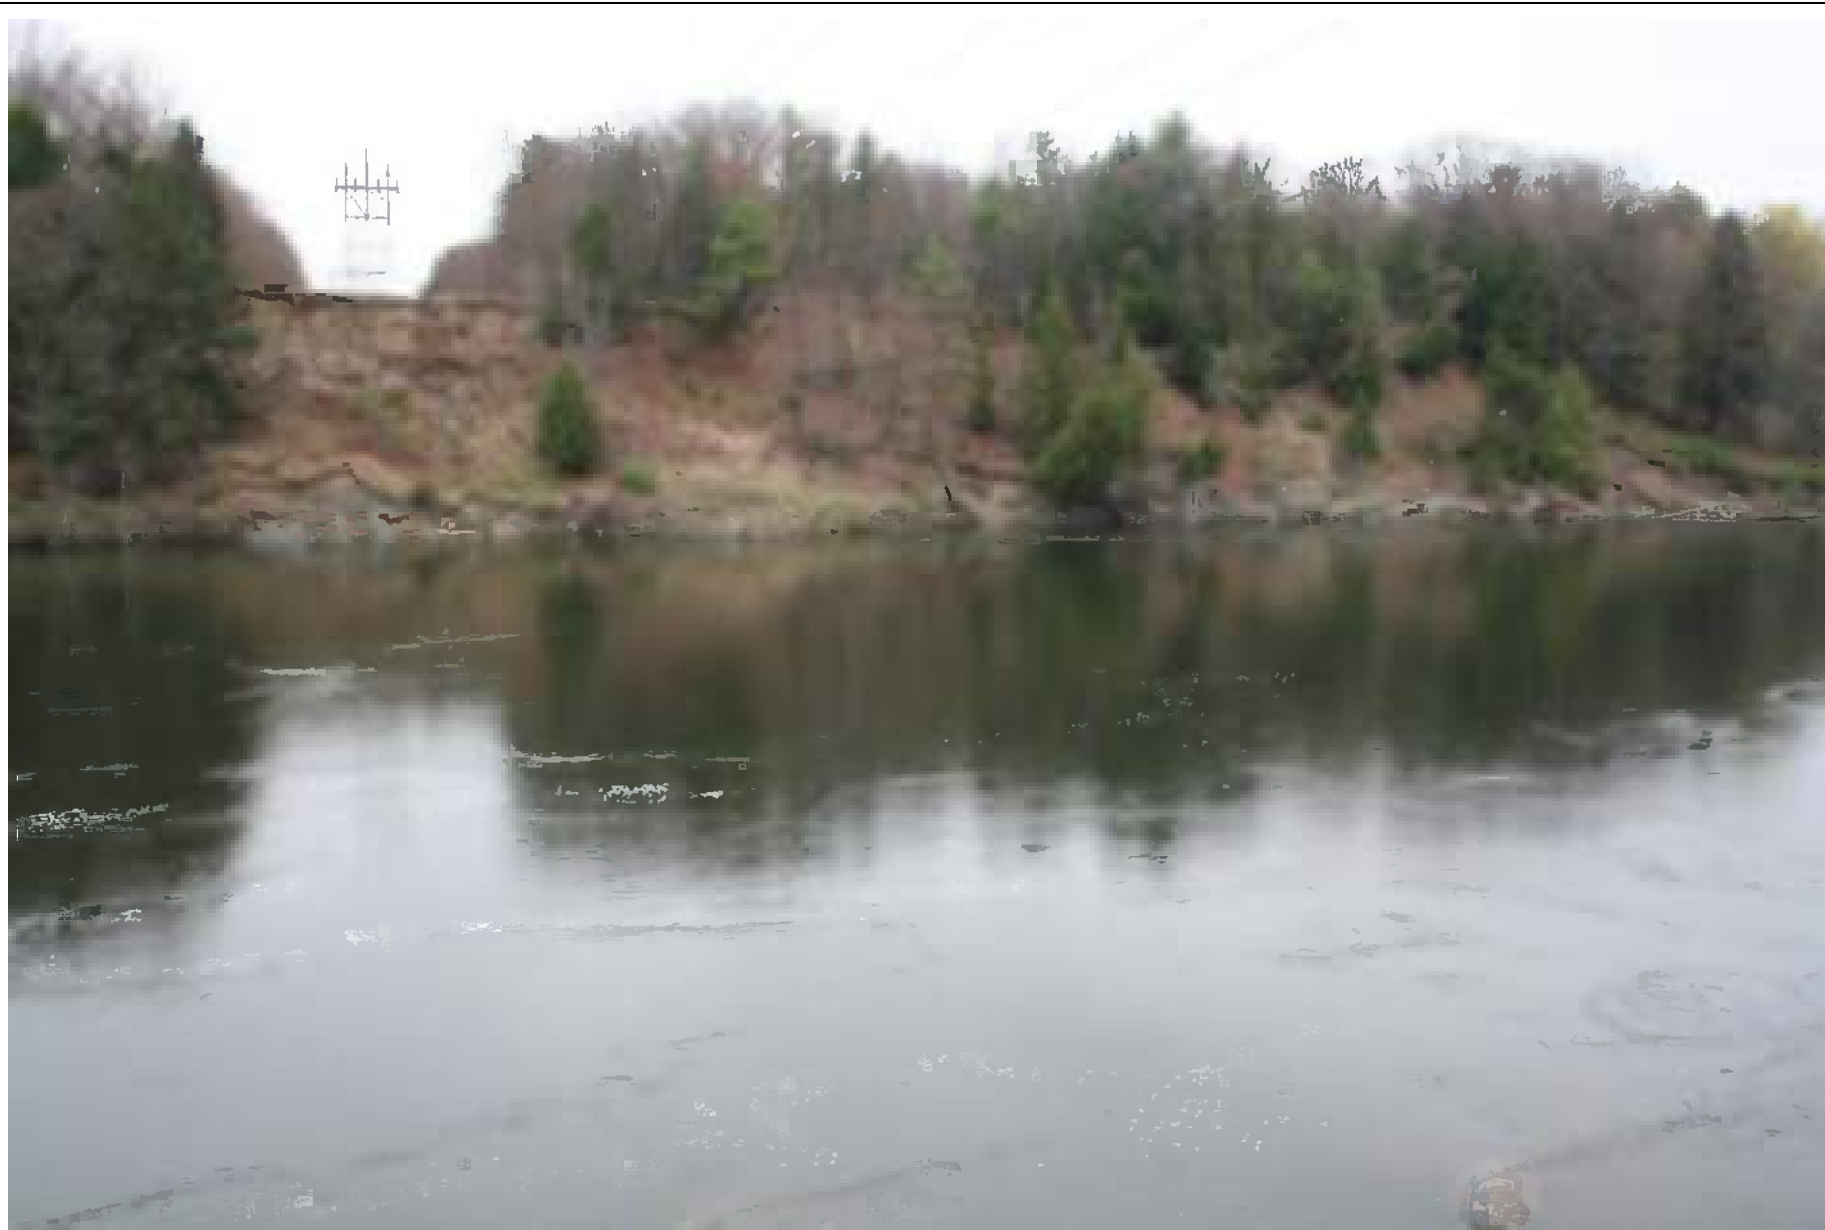
The channel's position relative to the various terraces determines the bank heights along the length of the river with higher banks encountered where the river flows against older terraces (Figures 5 and 9). At several locations, high banks are found on both sides of the river as can be seen on topographic maps (Appendix 1), thereby creating natural constrictions along the river relative to areas immediately upstream where low meadows (i.e., floodplain surfaces) are present. An artificial constriction was created when the railroad grade was built in 1847 across Moose Plain (Deborah Noble Associates, written communication, 2006). Artificial fill was added to keep the railroad and bridge at the same height as Second Moose Plain and an equivalent terrace of the same height on the east side of the river (Figures 5a and 10).

Figure 9: Higher bank developed where the river intersects older terrace surface.

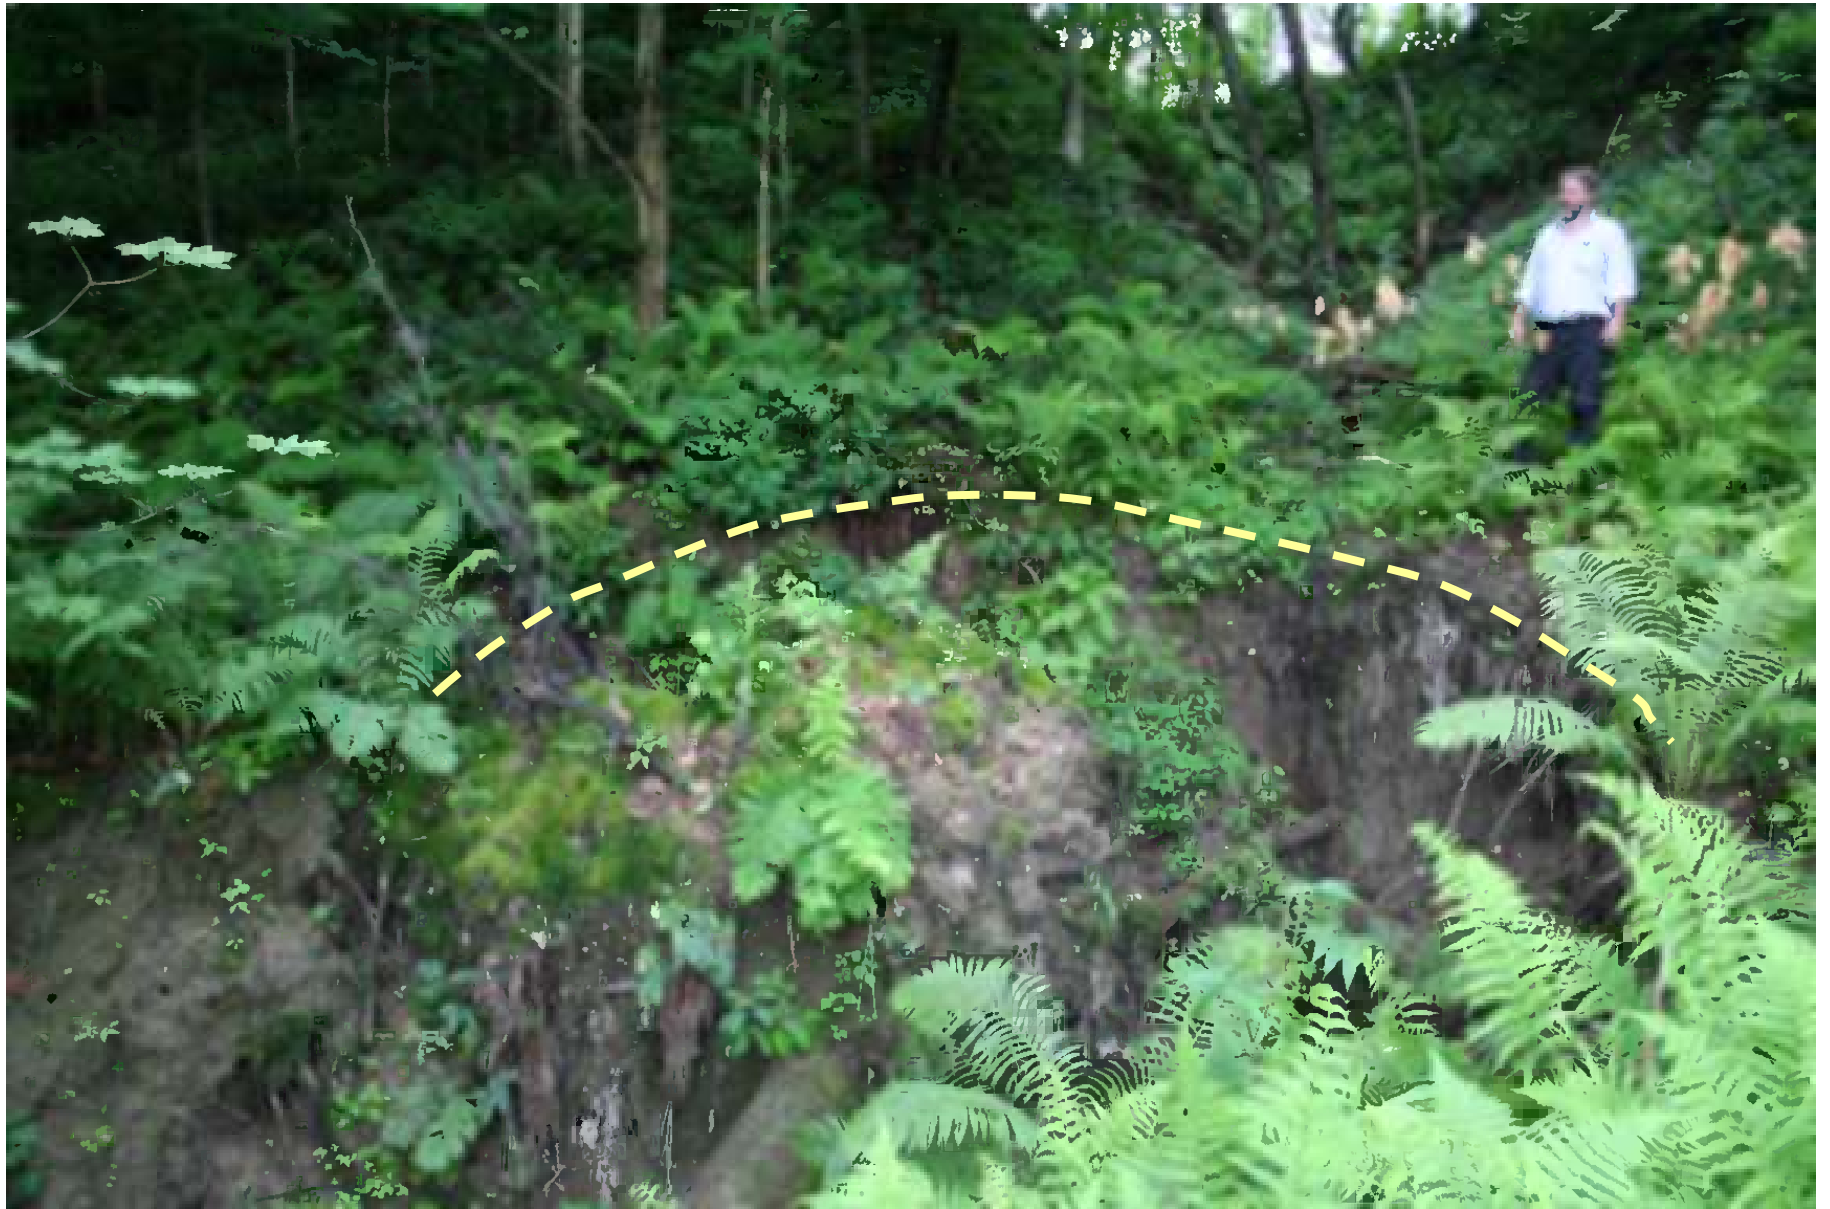
bank has been removed (see Section 8.0). Gullies are more common on high banks but the steep side slopes are generally well forested and stable (Figure 20b), although exceptions are infrequently observed (Figure 15). The largest gullies are up to 600 ft long and are found incised into higher terrace surfaces (Figure 20b). Gullies on high banks are most likely the result of groundwater springs emanating from the banks. While the springs are still present today, the gullies have stabilized as they have achieved an equilibrium slope consistent with the discharge from the spring. Consequently, larger springs typically lead to the formation of longer gully systems.

Figure 15: Active headcut on a small gully incised into a high bank downstream of Dry Brook. Note top of headcut is delineated by dashed yellow line.

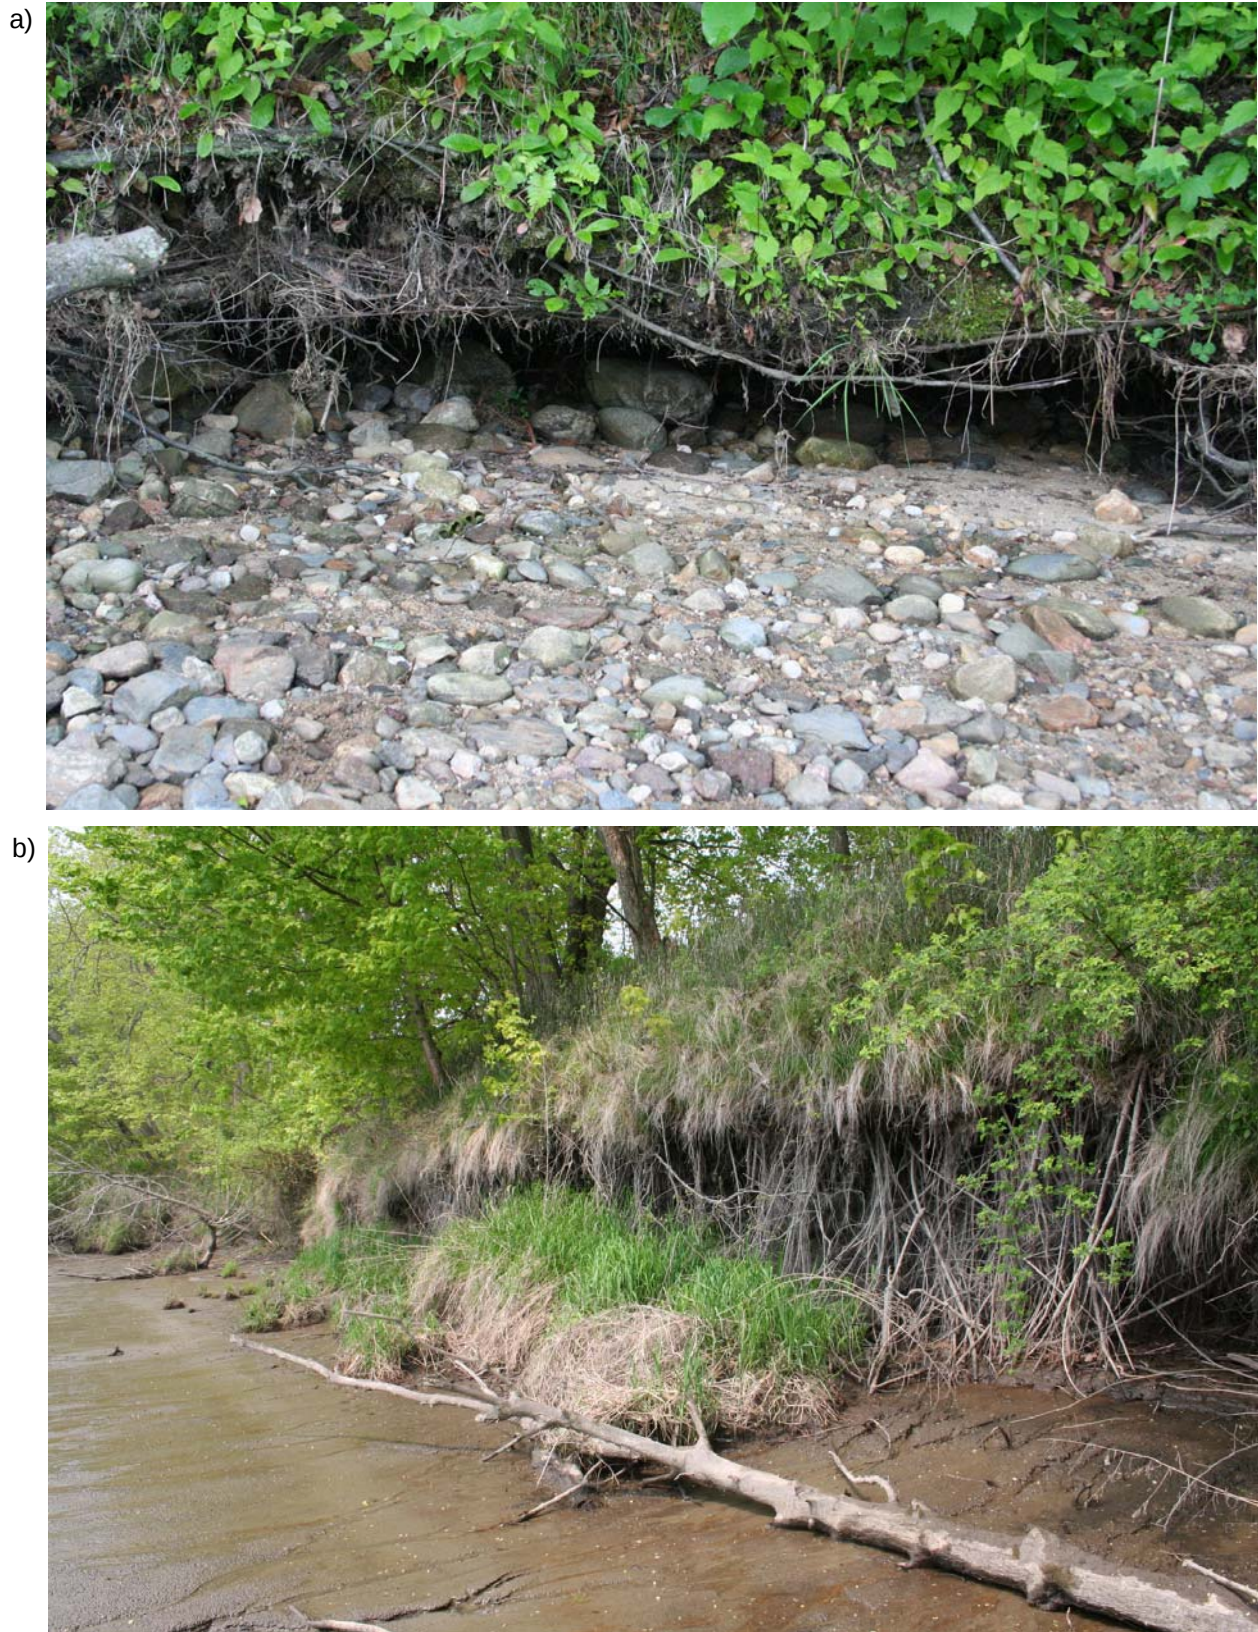
Figure 19: Undercut bank with a) narrow notch at base of bank and b) cavity extending higher up the bank.

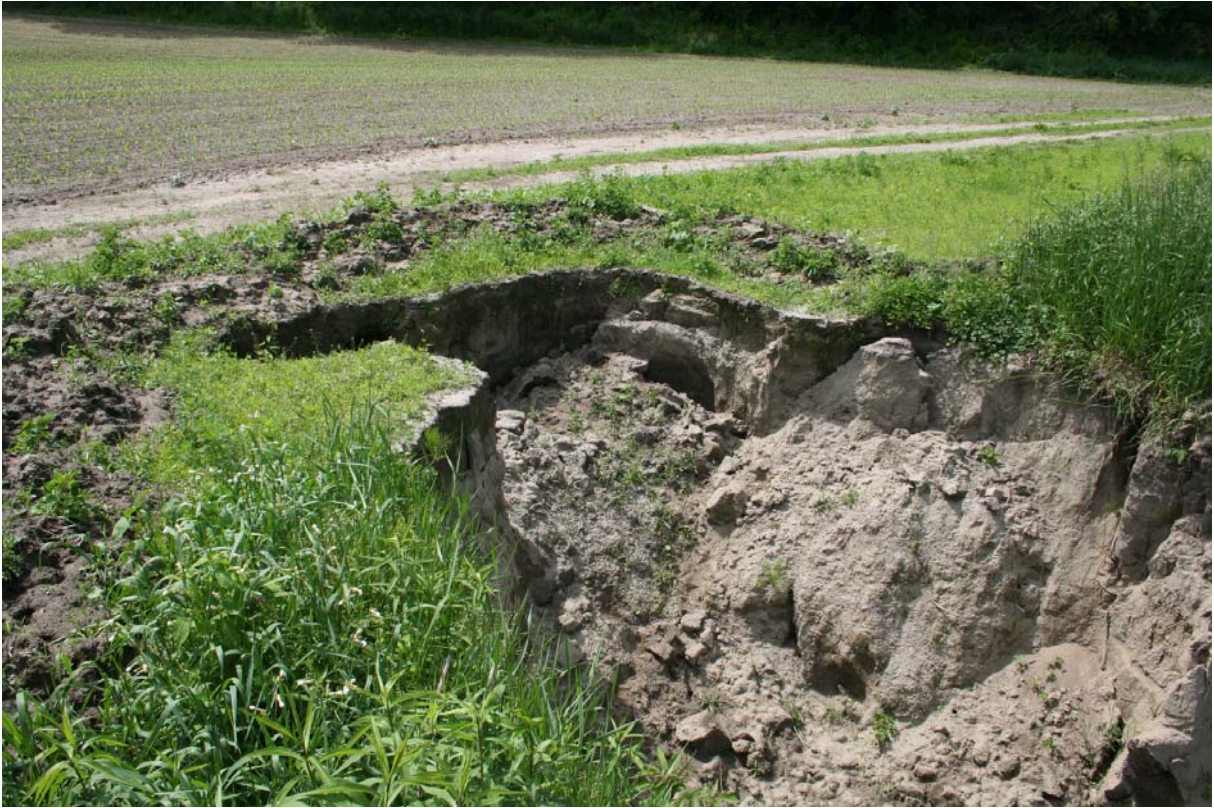
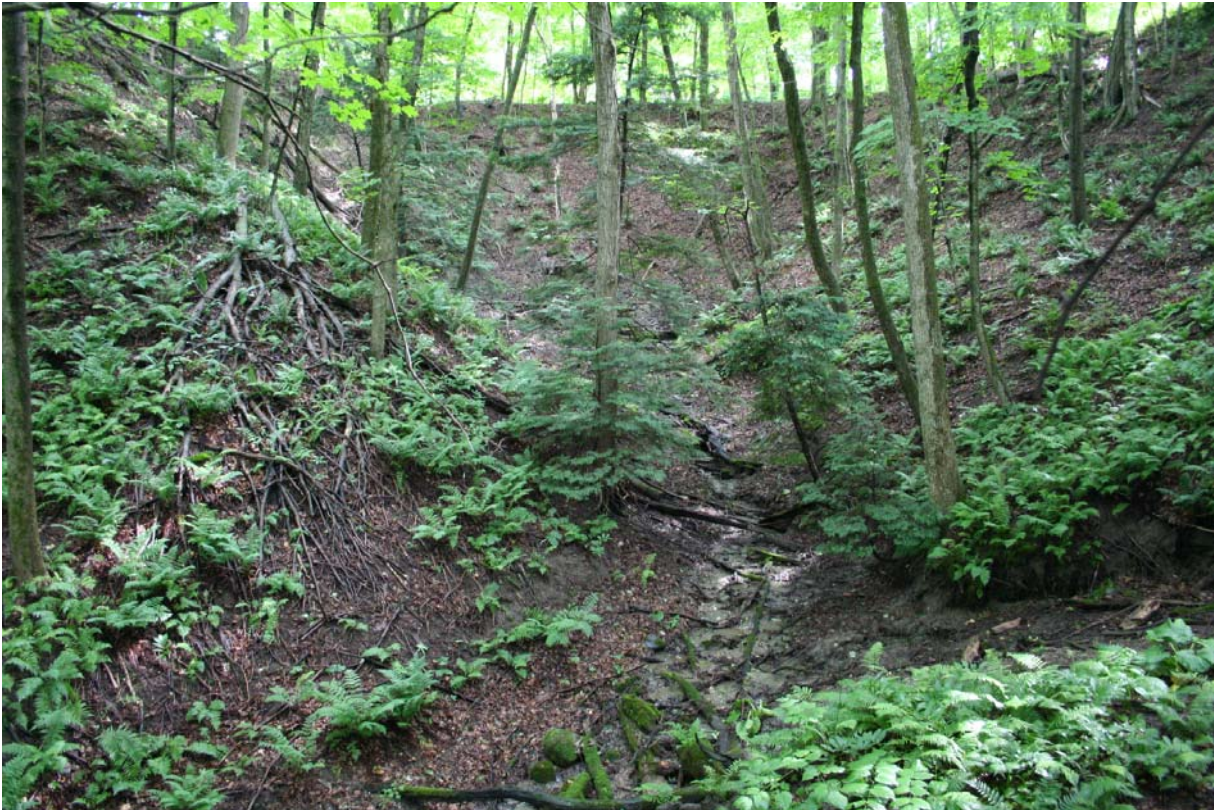
Figure 20: Gully formed by a) overland flow and b) groundwater seeps. Note berm in a) built to prevent additional overland flow from enlarging gully.

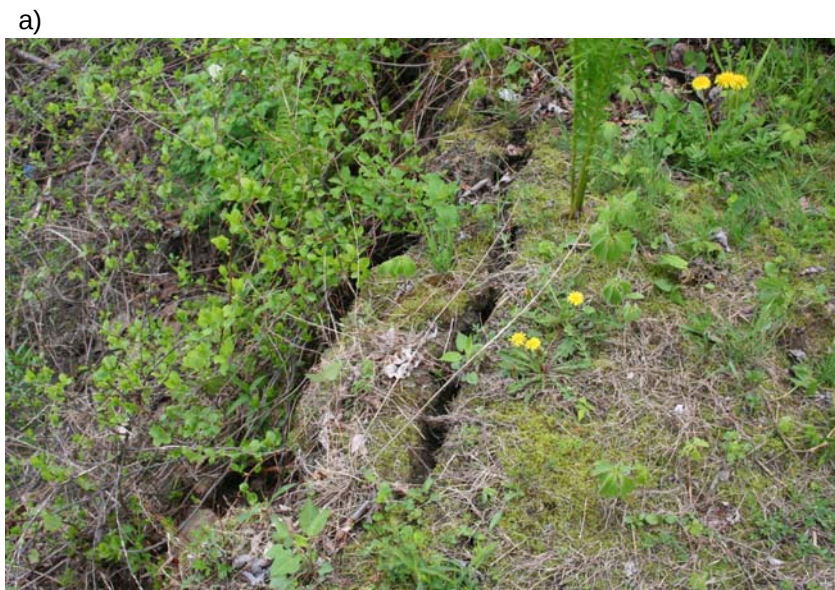
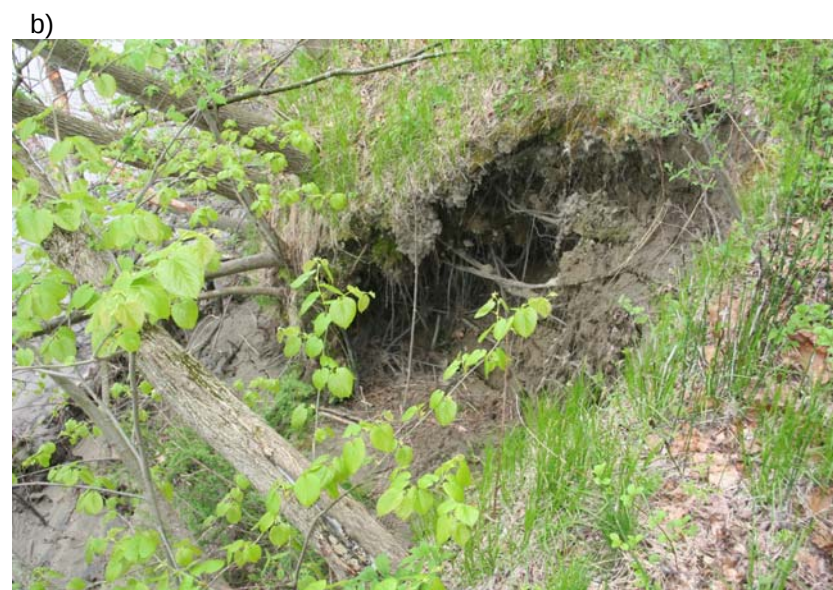
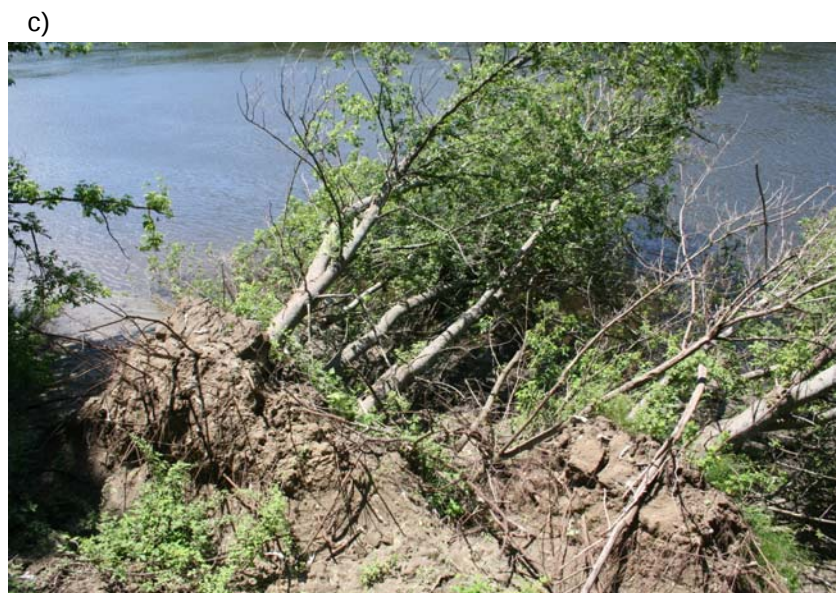
Topples occur when vertical tension cracks (Figure 21a) forming at the top edge of the bank widen to the point where the top portion of cohesive masses of soil rotate forward about a pivot point near the base of the soil mass. Topples are typically enhanced when soil attached to a root mass of a severely undercut tree leans over and collapses over the bank (Figure 21b). Individual soil blocks involved in topples when no trees are incorporated are generally rectangular in shape with less than 2.0 ft of width between the tension crack and bank face and a length of up to 6.0 ft parallel to the bank. Once the support of the soil mass has been removed, new vertical tension cracks might form parallel to the bank and the process is able to repeat itself.

Figure 21: a) Vertical tension cracks lead to b) a topple blocks with tree attached and c) mounds of soil and roots at the base of the bank.

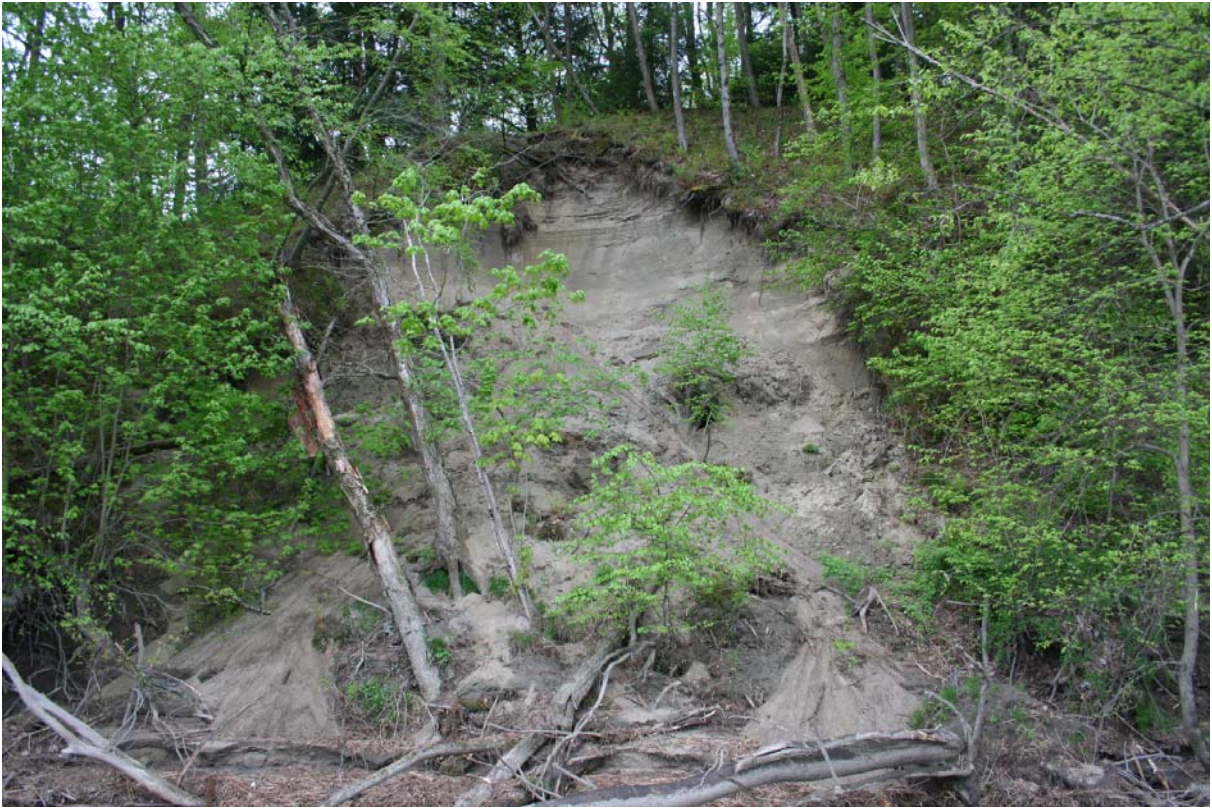
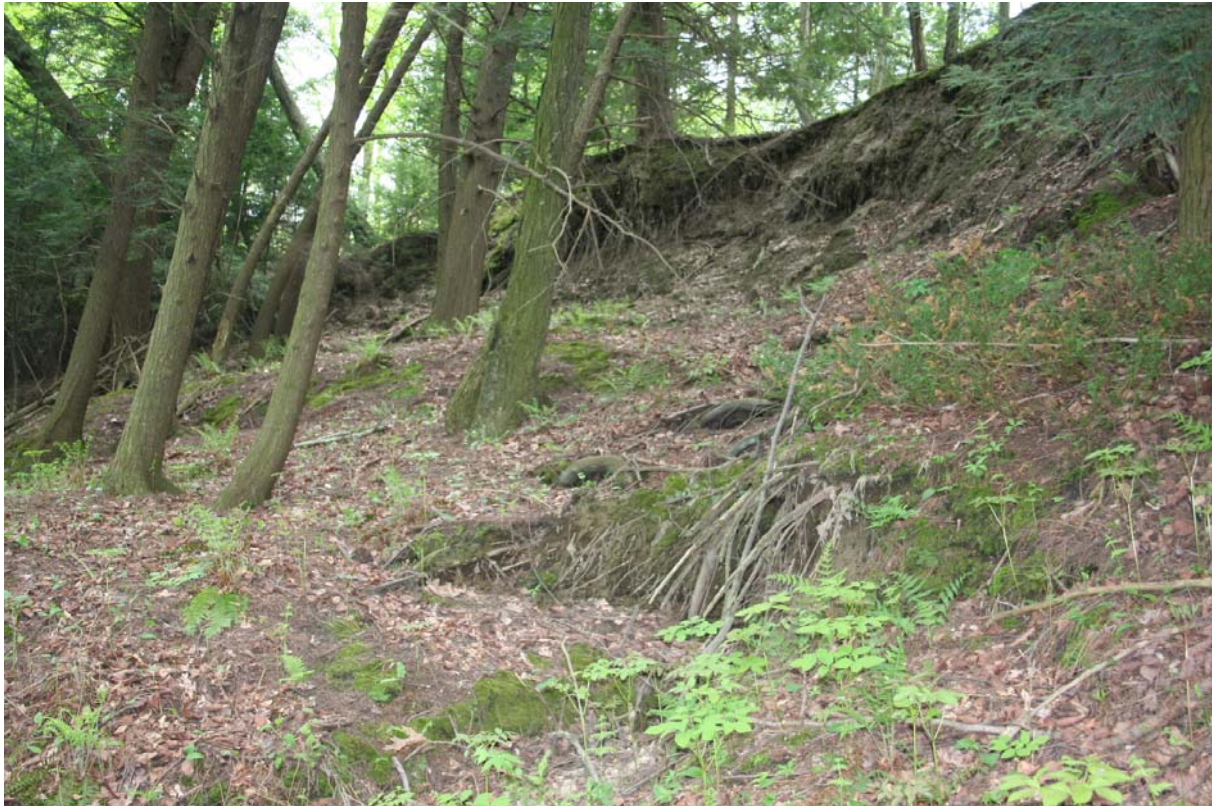
Both shallow planar slips (Figure 22a) and deep-seated rotational slumps (Figure 22b) occur in the Turners Falls Pool with transitional forms present. These types of mass movements give rise to what have been described as sloughing banks by others (e.g., U.S. Army Corps 1979 and 1991). Planar slips can be over 200 ft in length as tension cracks develop on the upper slope or at the top of banks, creating a failure surface along which the slide occurs. A series of slips along the bank can result in hundreds of feet of nearly continuously eroding bank. The exposed failure surface, or scarp, is steep and planar. Where the slip mass does not slide all the way down the slope, a narrow bench develops

Rotational slumps are typically less than 30 ft wide with head scarps that are arcuate in plan view and, therefore, are similar in shape to topples caused by the collapse of undermined trees (Figure 22b and Table 2). One distinguishing feature is that trees within a slump block will generally be leaning back towards the bank as the result of block rotation (Table 2). In profile the failure surface is more concave than planar slips. Benches formed partially down the slope represent the top of the failed slump block and will typically be wider and slope back towards the bank in contrast to planar slips (Table 2). Slumps are less prevalent in the Turners Falls Pool than slips as a result of the preponderance of less cohesive sandy soils that favor shallower failure surfaces.

Figure 22: a) Planar slip and b) rotational slump.

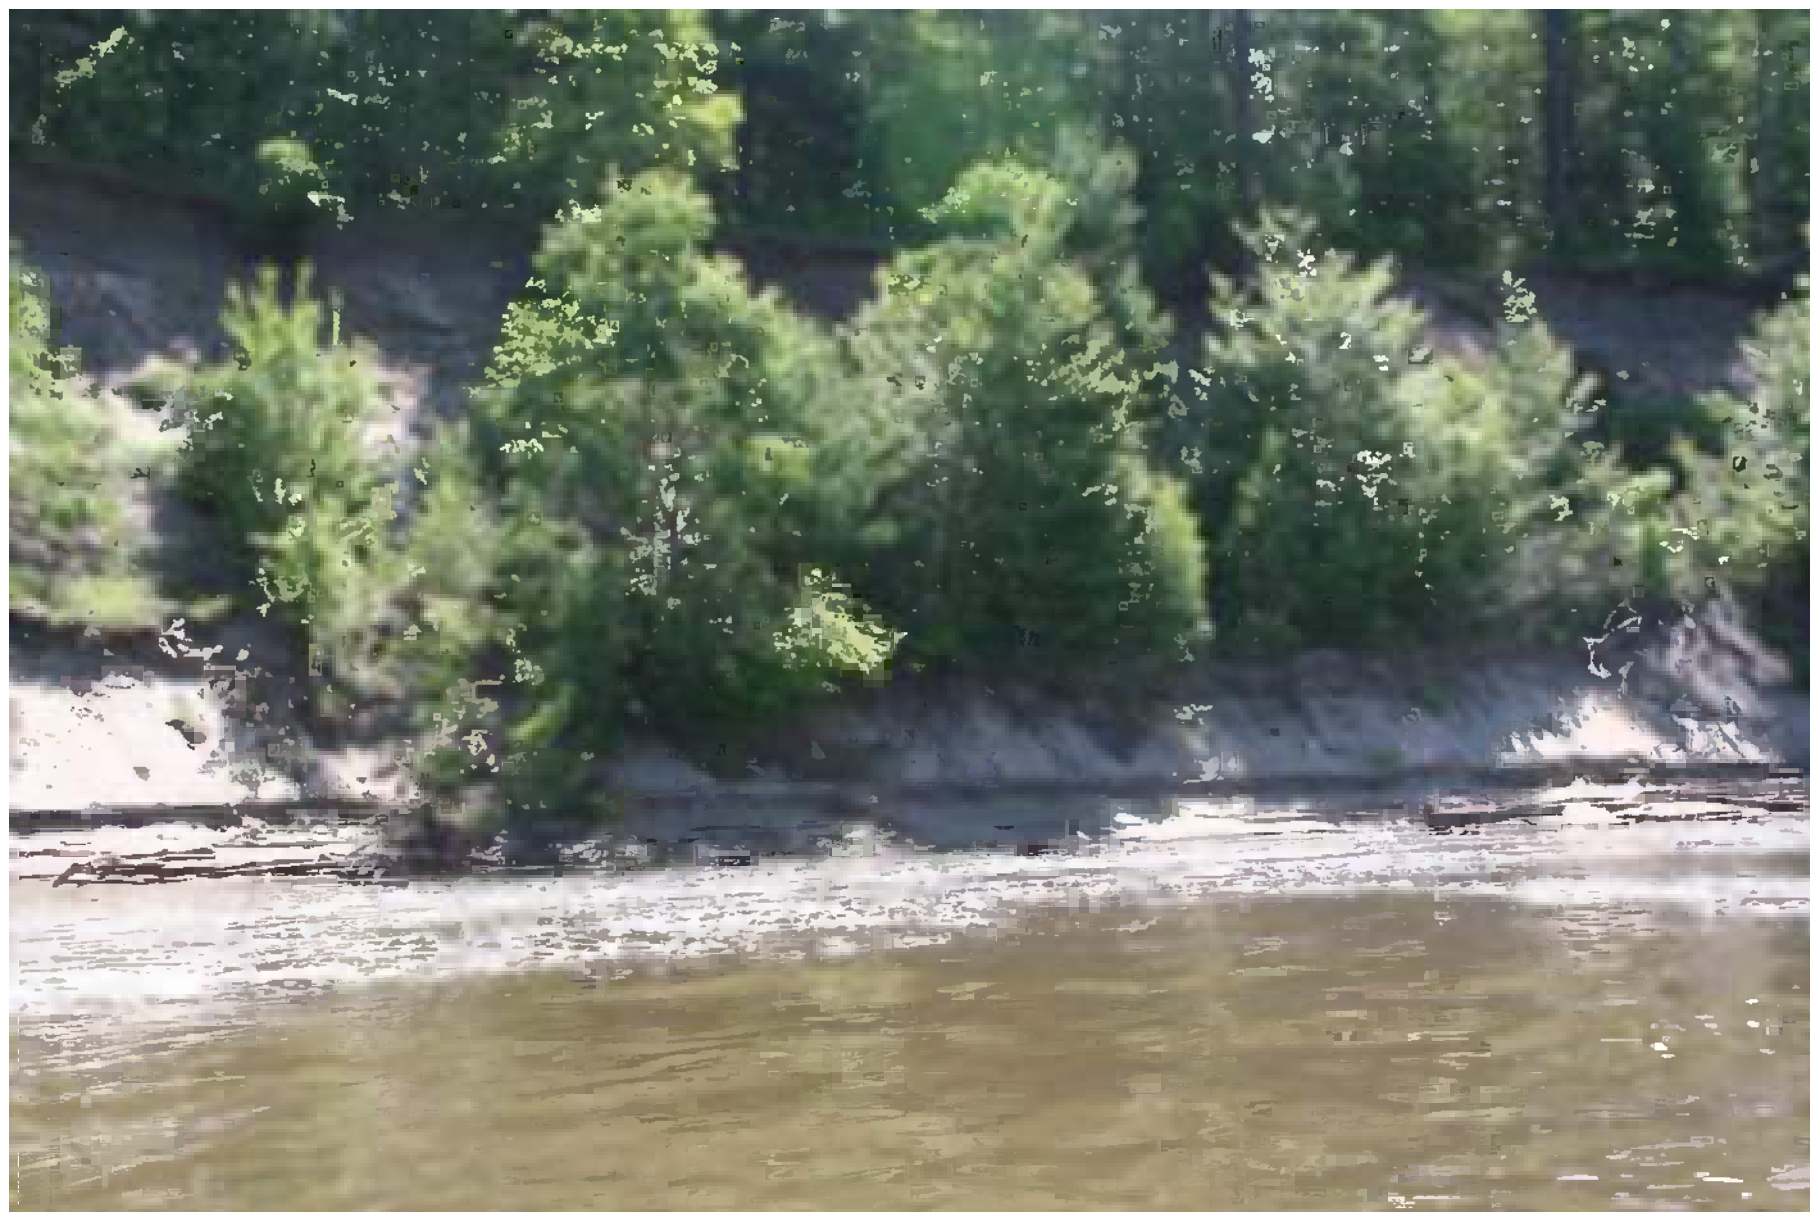
Flows generally occur in association with other mass failures (Figure 25). Long flows are unable to develop given the relatively short length of even the highest bank slopes, although some might continue below the water surface where the bank drops off steeply. Flows form at the base of planar slips and rotational slumps if the moving mass becomes disaggregated and liquefied with sufficient soil moisture. Dry grain flows can occur for sometime after an event if the material remains loose, especially on the oversteepened base of the slide masses (Tables 2). The characteristics of a flow transition from the intact slide mass above to a slope of colluvial deposits below. While individual flows are narrow (< 30 ft wide), a series of adjacent flows lead to the development of a colluvial apron potentially several hundred feet wide (Figure 23).

Colluvial aprons are well formed at the base of some high eroding banks, but also occur on lower banks (Figure 23). The colluvial deposits are typically restricted to the lower half of the bank where gentler slopes develop as the angle of repose is established in the loose sediments. The grade of the colluvial slopes is slightly concave upward, but not as dramatically as the failure surfaces of rotational slumps (Table 2).

Figure 23: High eroding bank downstream of Vernon Dam showing trees still growing on bench at top of a slip block. Note colluvial apron formed from flow deposits below bench

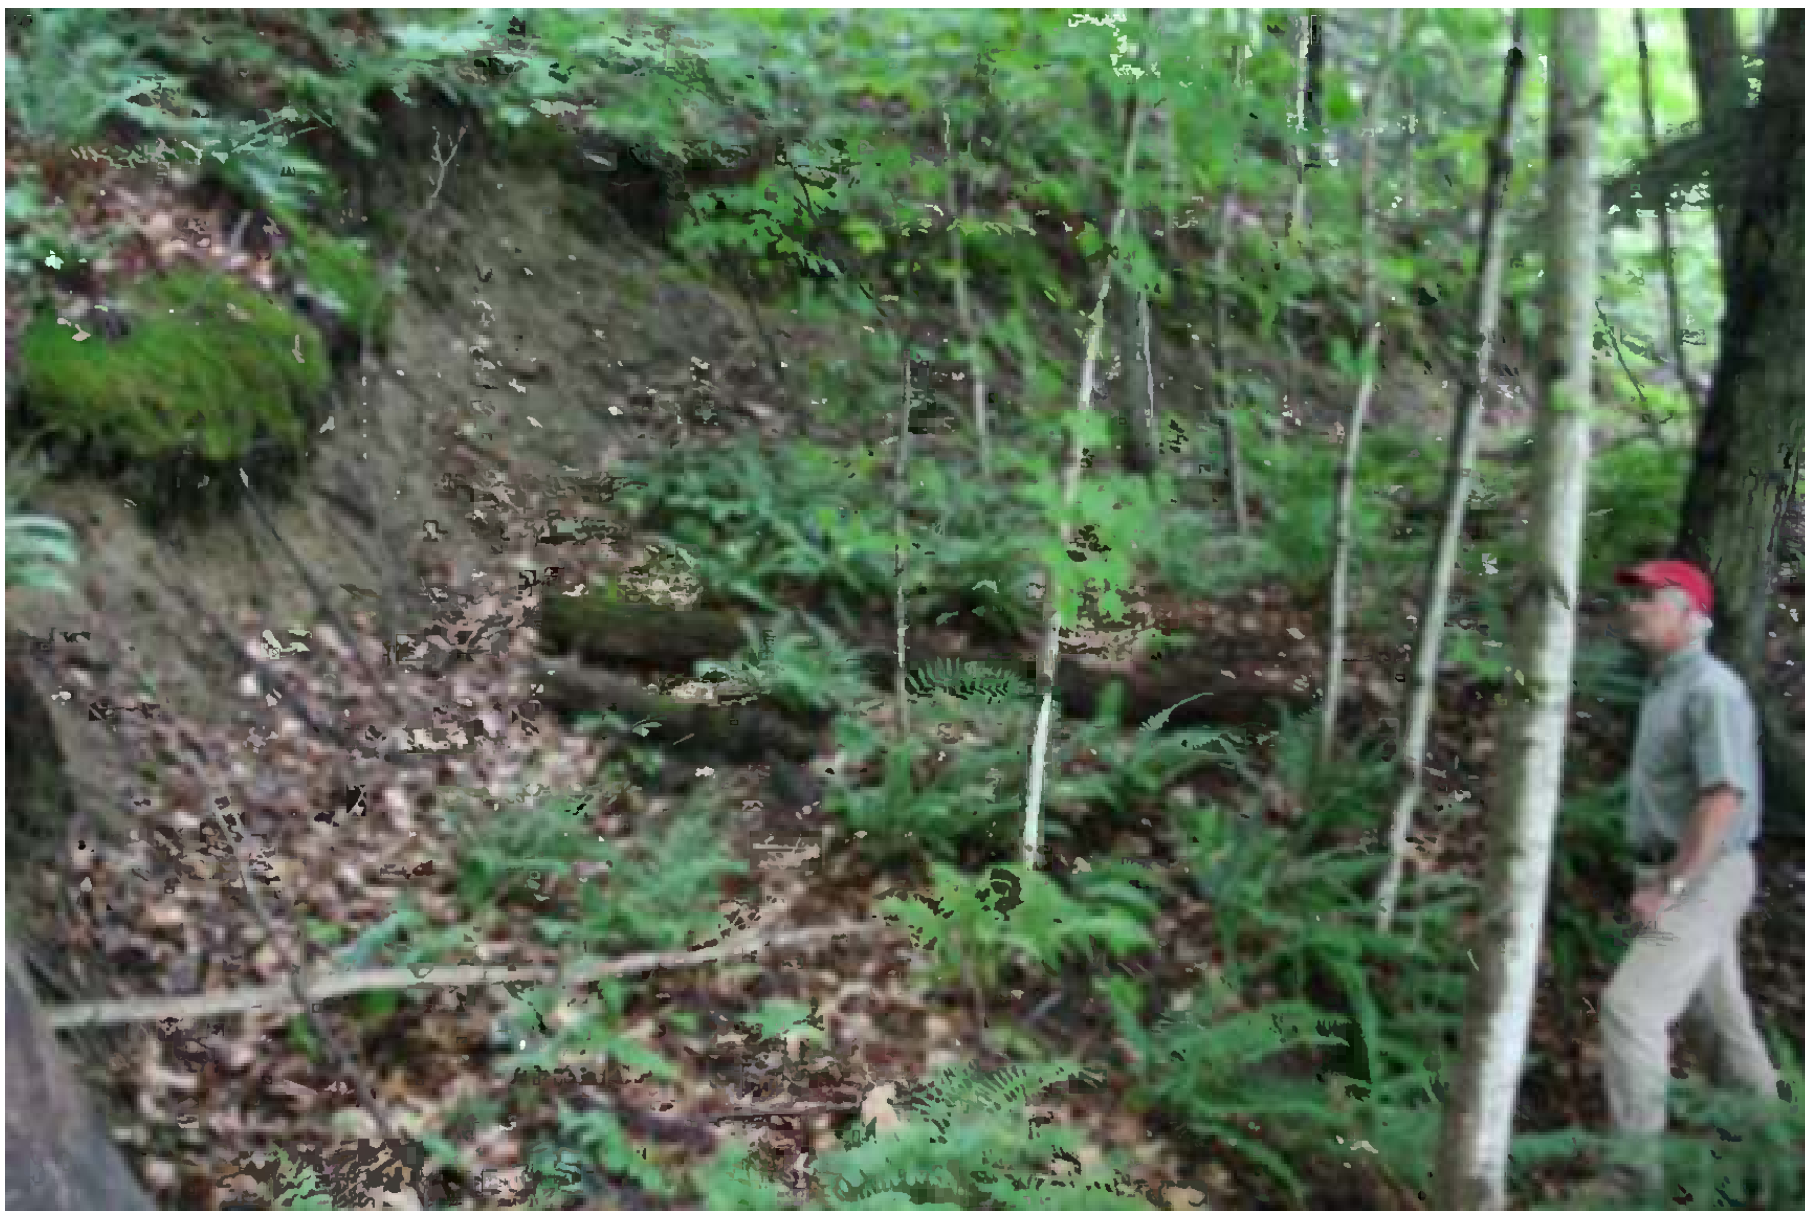
Figure 24: Long continuous planar slips on high bank downstream of Dry Brook.

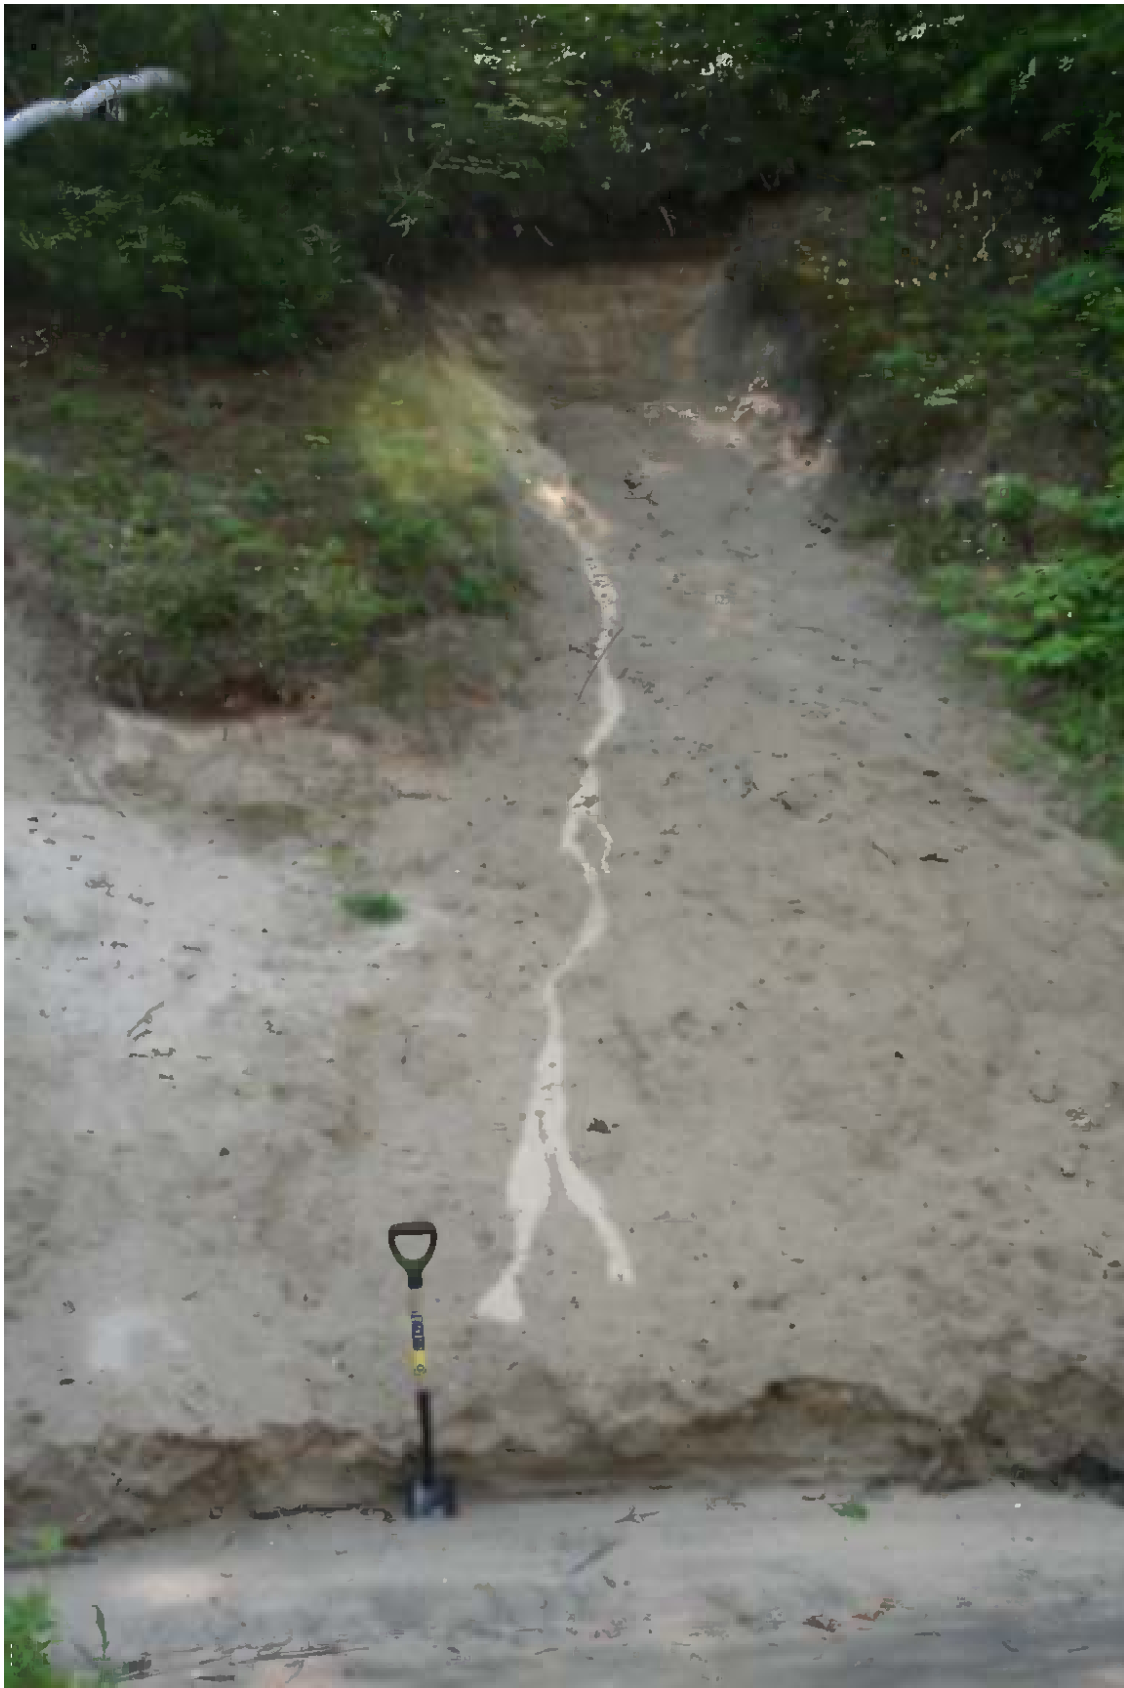
Figure 25: Flow formed at the base of a planar slip. Note colluvial deposits on lower slope are composed of individual flows such as visible on the surface.

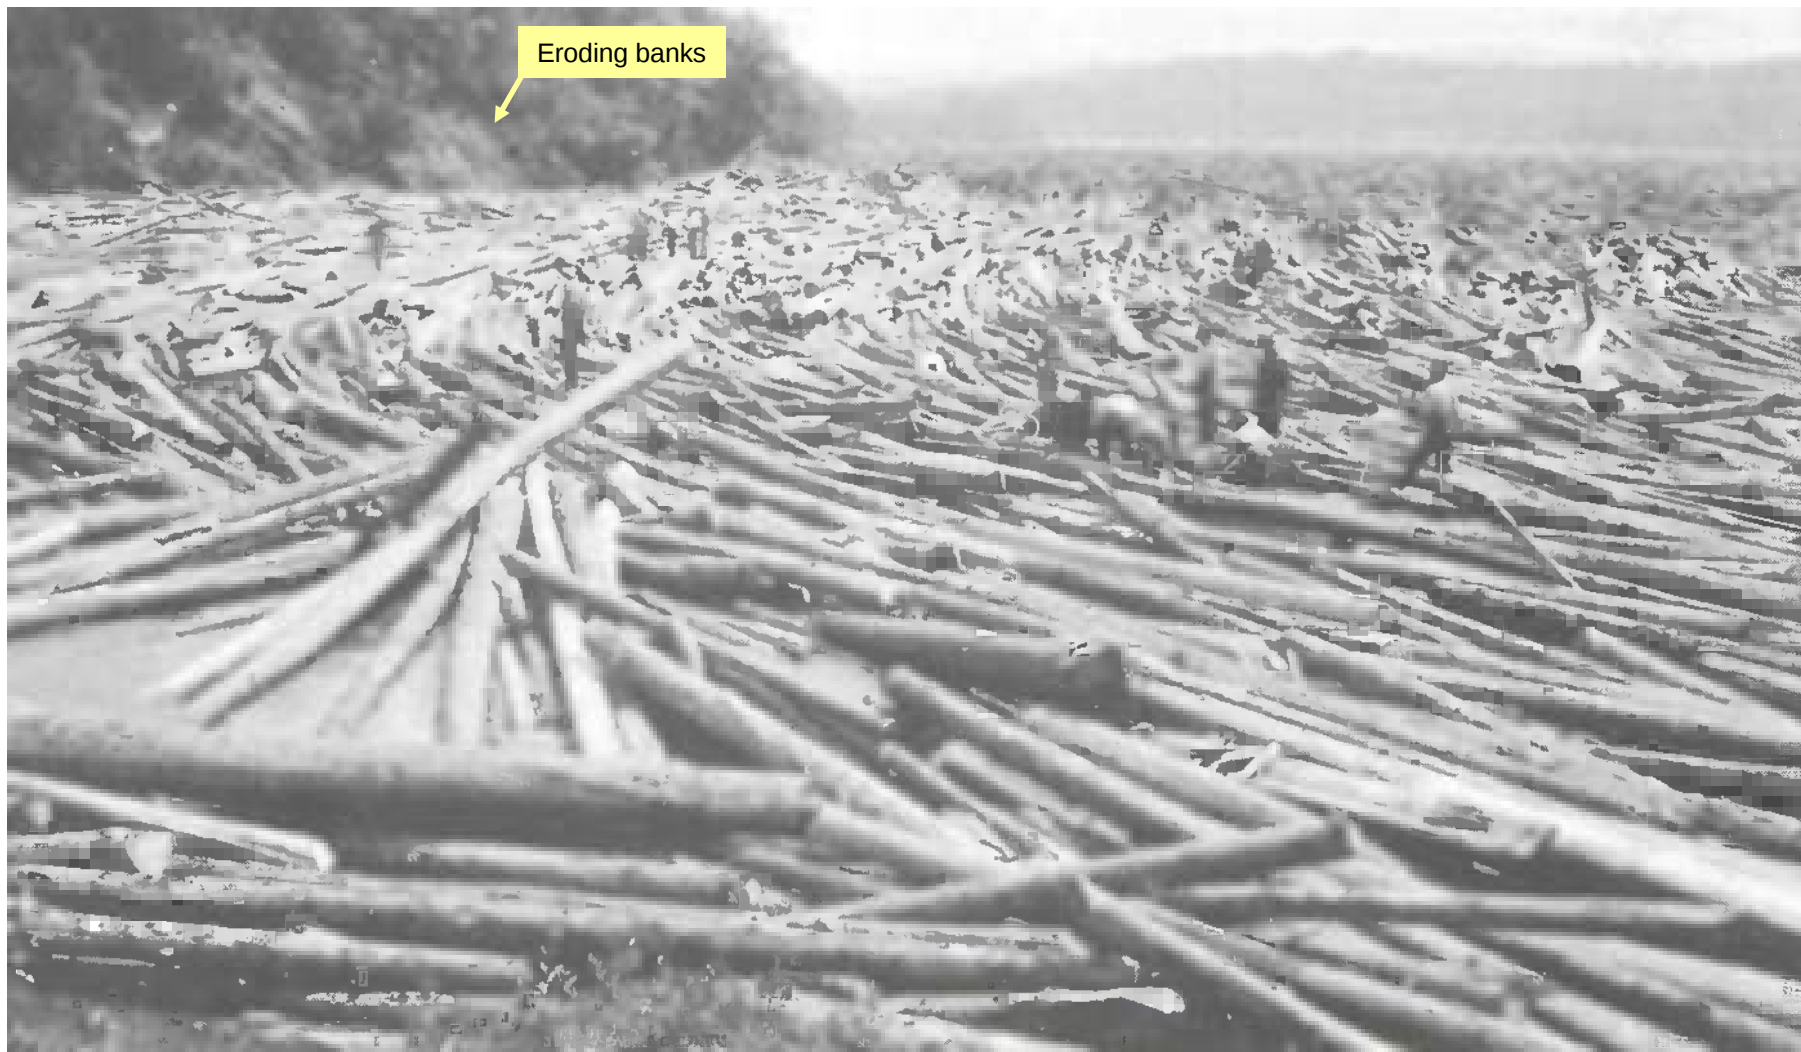
Figure 27: Eroding banks near the Narrows at a time of a log drive in the late 1800's or early 1900's before the opening of the Northfield Mountain Pumped Storage project. Modified from Northeast Utilities (1991, p. 133).
