# **Fluvial Geomorphology Study of the Turners Falls Pool on the Connecticut River Between Turners Falls, MA and Vernon, VT**

Northfield Mountain Pumped Storage Project  
FERC License No. 2485  
Northfield, Massachusetts

Field Geology Services  
Farmington, ME

November 2007

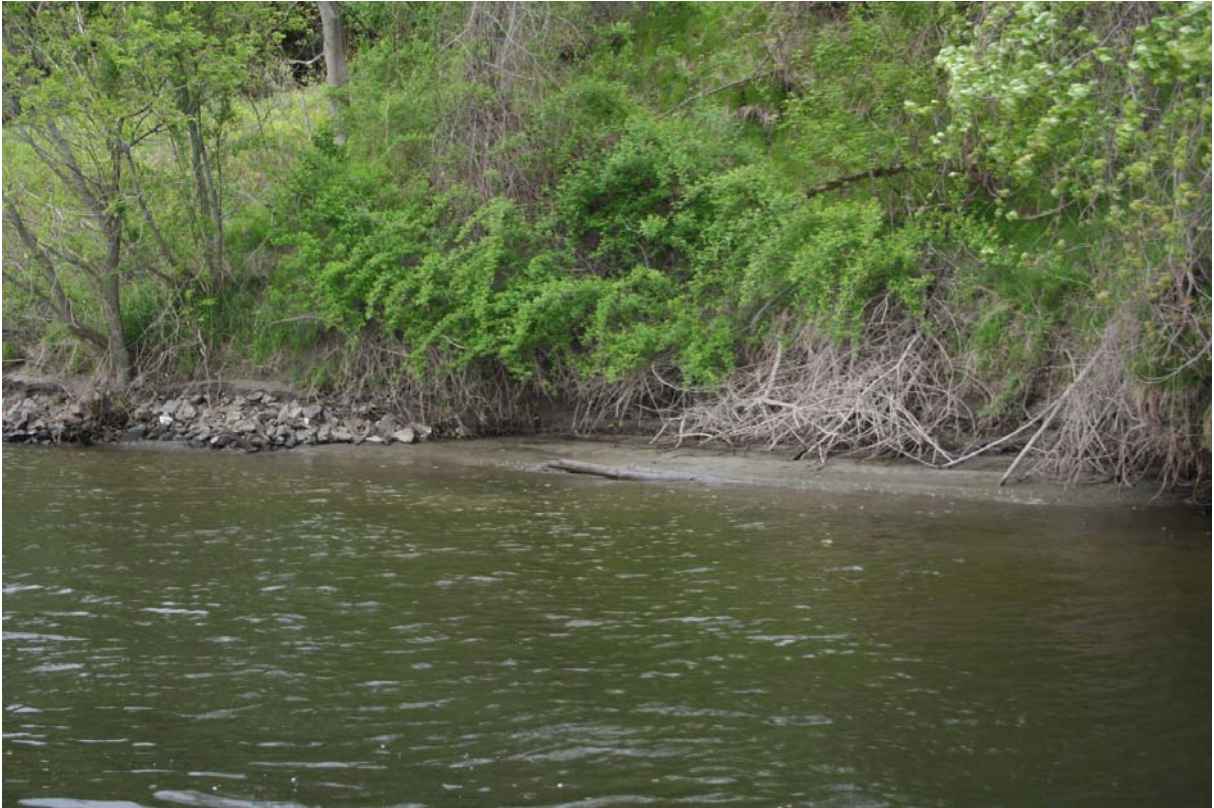
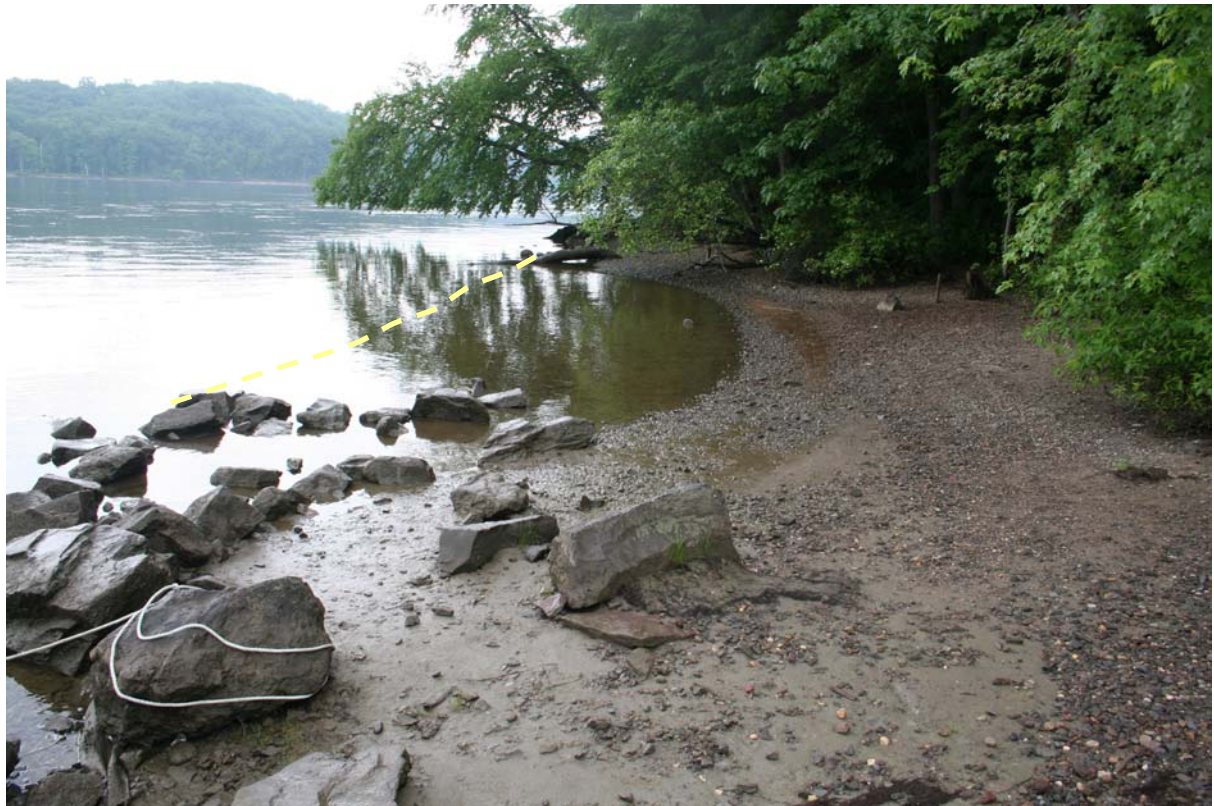
In many locations in the Turners Falls Pool, the riverbank has been protected from erosion with large rock (i.e., riprap). The bank protection is not continuous, so the bank has continued to recede adjacent to the static bank positions protected by riprap (Figure 29a). At one location in Barton Cove recession has occurred within the riprapped area where the rock protection has failed (Figure 29b). Assuming the receding banks were originally flush with the riprap when first installed, the average bank recession rate can be calculated if the date of riprap installment and total amount of bank recession is known. The location and age of various bank protection efforts were mapped and tabulated by NDT (1991). Surveys of the bank line from areas of riprap to adjacent sections without protection were conducted at either the base of the bank or top of the bank depending on access, visibility, and water levels (Appendix 9). Data were compiled for seven sites where the age of the bank protection was known and measurable bank recession was observed. Measurements of the total recession were not taken immediately adjacent to the terminus of the riprap as bank recession is sometimes greater just upstream or downstream of the riprap due to hydraulic effects caused by the bank armor itself (Appendix 9). Since other locations showed minimal bank recession around riprap, the results of these surveys are indicative of conditions at the survey locations only and cannot be generally applied to the Turners Falls Pool as a whole. However, the results do provide a general understanding of recession rates in the area.

Figure 29: a) Bank recession continuing beyond riprap and b) failed section of riprap in Barton Cove (dashed line indicates former position of riprap).

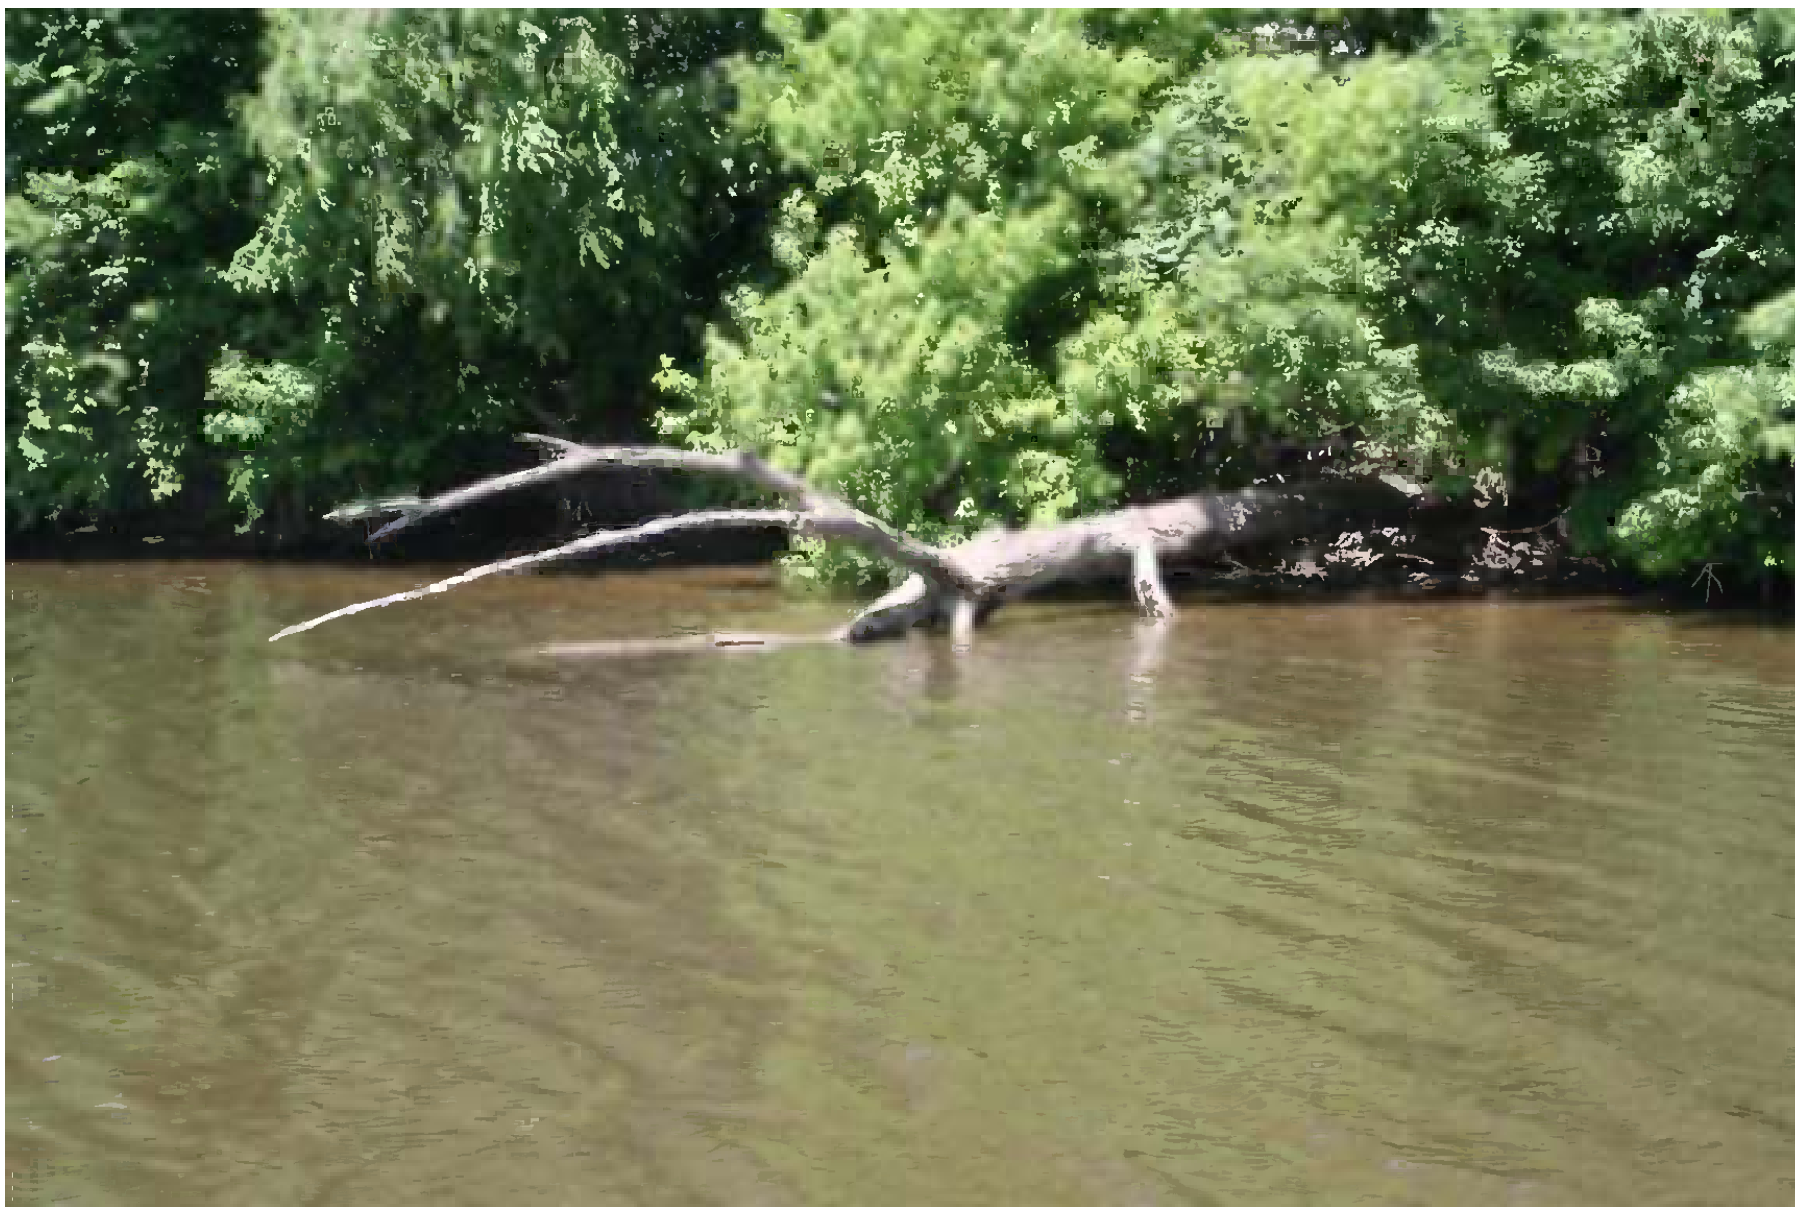
Figure 31: Decaying tree still attached to the bank and providing bank protection.

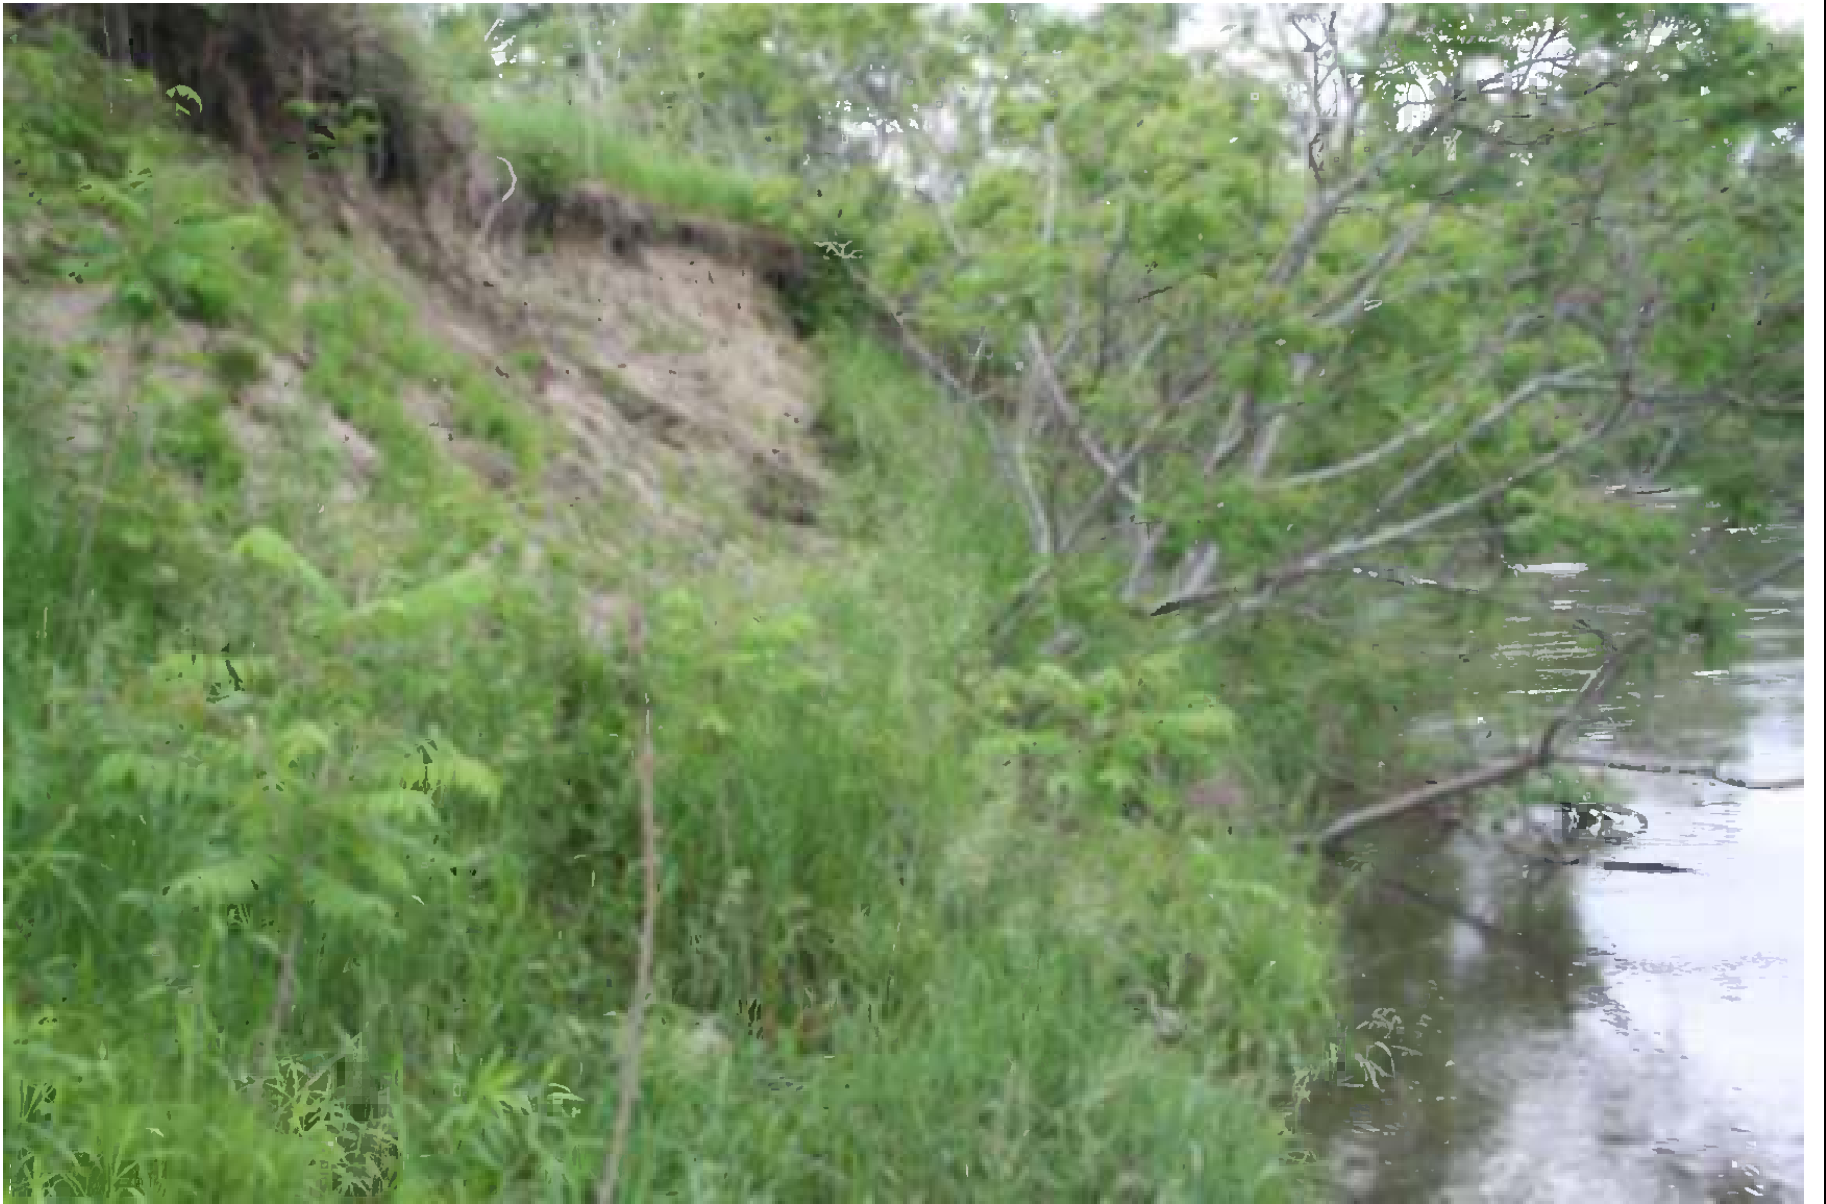
Figure 32: Active planar slip with vegetation growing on the surface.

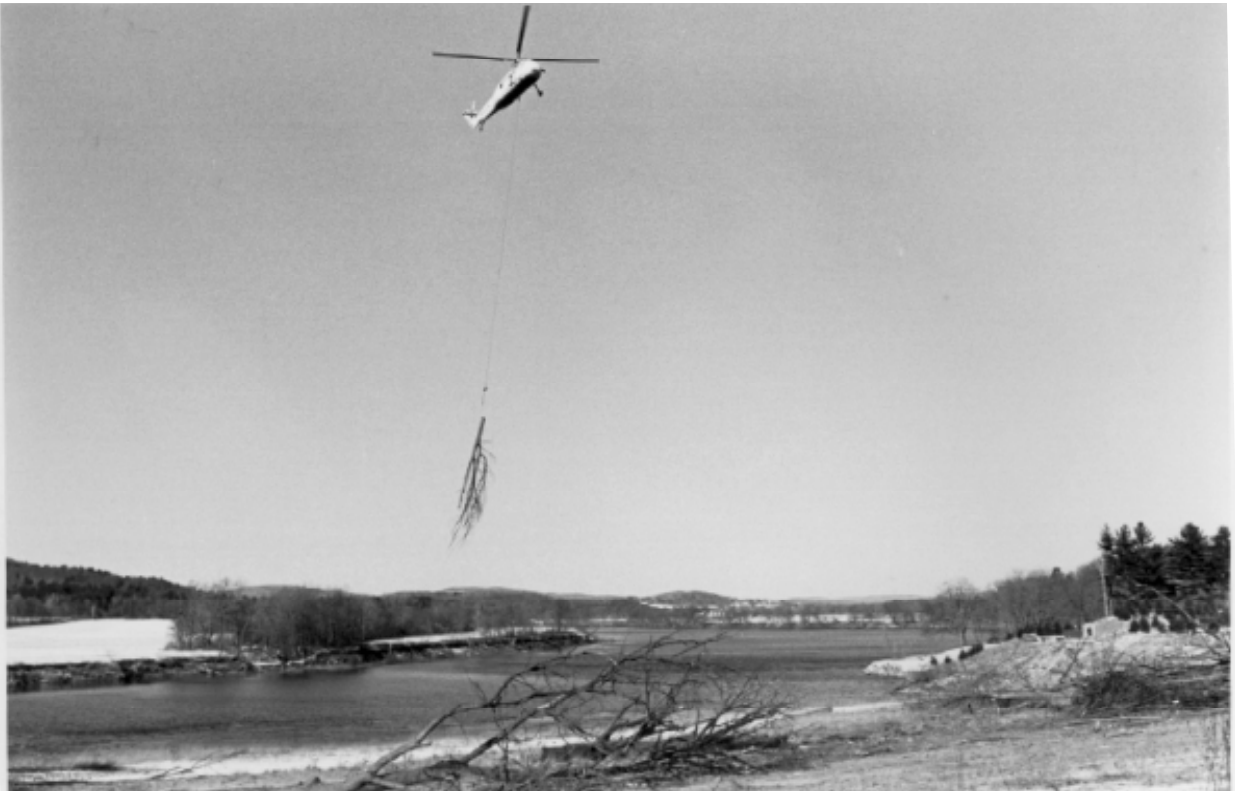
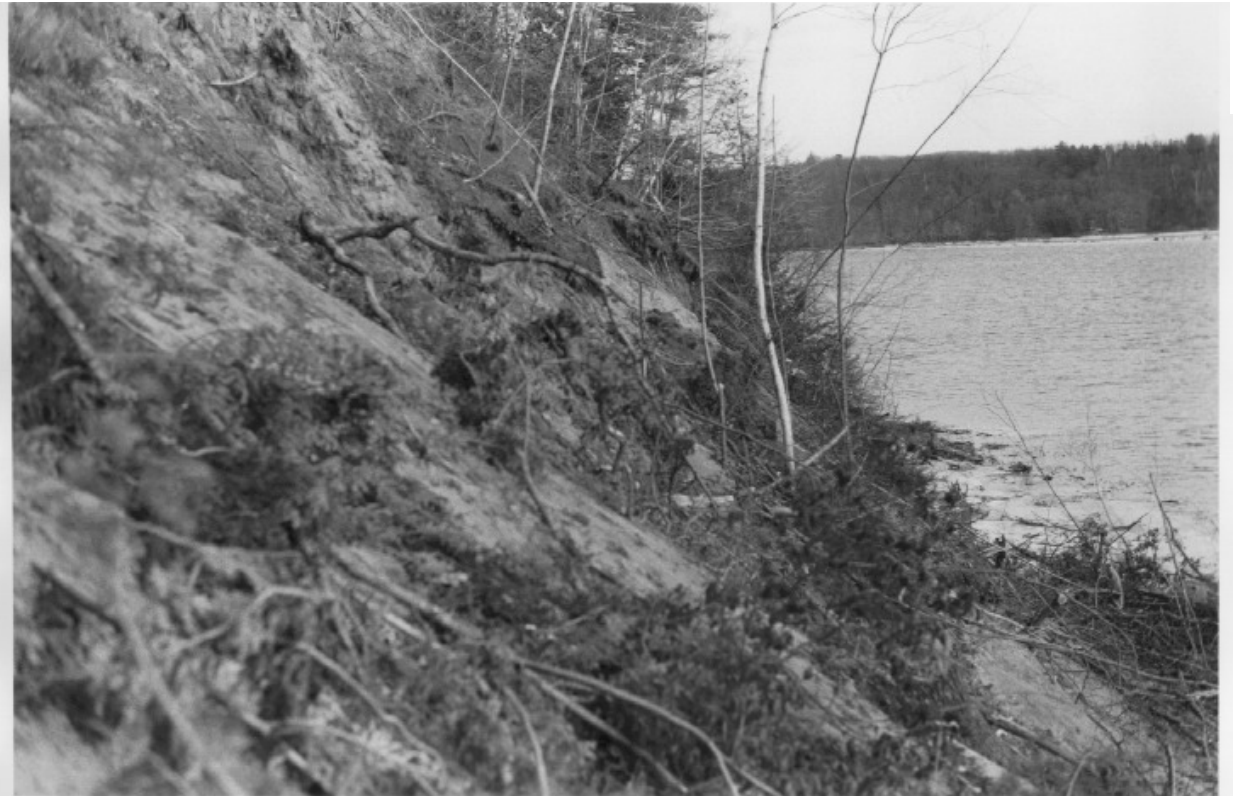
Figure 34: a) Log being removed by helicopter and b) erosion in area of helicopter logging.

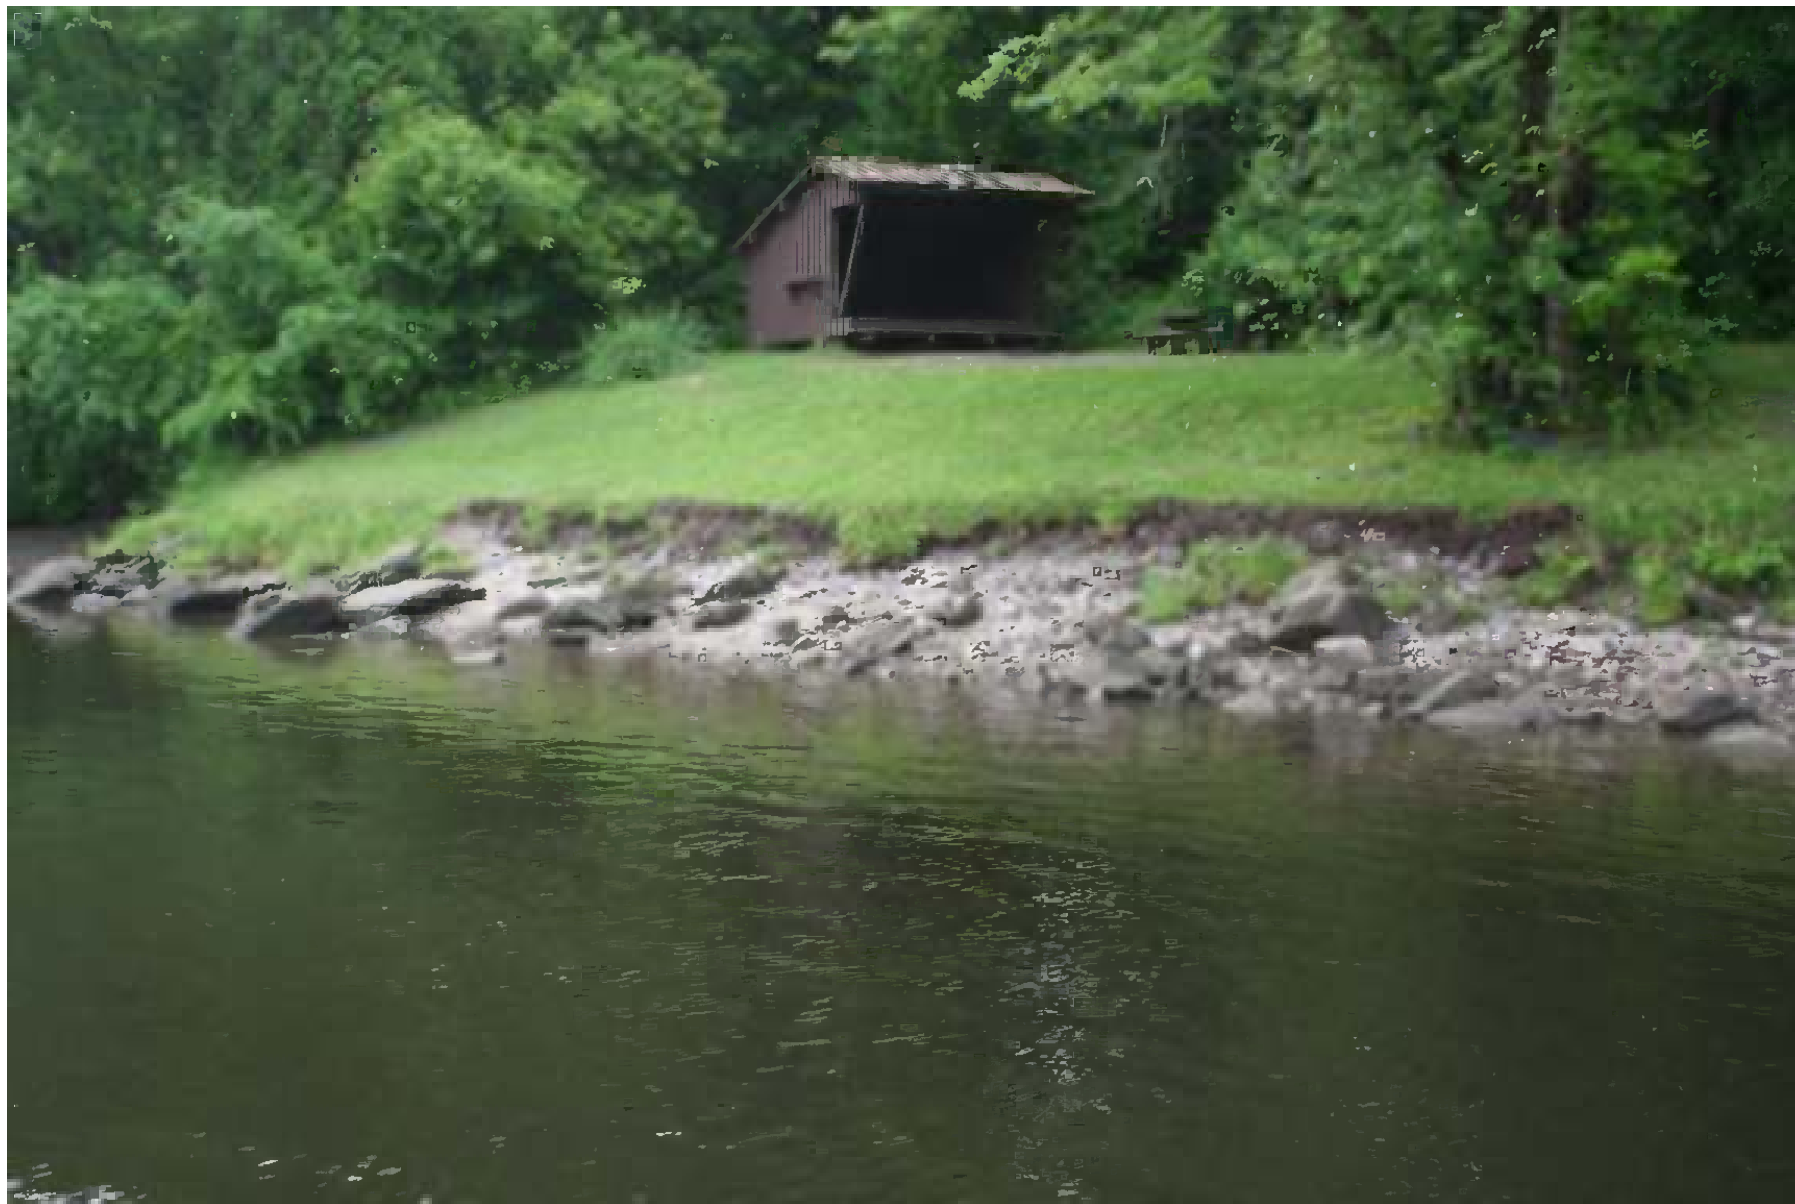
The maximum amount of bank recession is 41 ft at Site 4 (picnic ground across from Munns Ferry Road) where the riprap was installed in 1977 for an average recession rate of 1.4 ft/yr (Table 6 and Appendix 9). Recession of only 9 ft is observed at Site 1 (Wickey Site). This is at a bioengineering project installed in 1998, so the average recession rate is still 0.8 ft/yr, higher than at other locations with more total recession (e.g., Site 6). The overall average recession rate for all seven sites is 0.9 ft/yr with a maximum rate of 1.7 ft/yr at Site 5 (L'etoile Farm) and a minimum of 0.4 ft/yr at Site 2 (Route 10 Bridge)(Table 6 and Appendix 9). Site 6 is the only location where the riprap appears to wrap around the bank (Appendix 9). This may indicate that additional riprap was added after the bank began to recede. If so, the results at Site 6 would represent a minimum rate of recession. The range of calculated recession rates is in general accordance with those measured from the full river cross sections and suggests, at some locations at least, the average recession rates measured have held steady since the 1970's. Bank recession at Site 3 (Munns Ferry Road) and Site 4 directly across the river reveals that erosion has apparently occurred on both banks simultaneously for an extended period of time. Comparisons of bank recession rates longitudinally (i.e., progressing downstream) were not made given the relatively few sites available for such an analysis.

Figure 35: Failing rock armor at Munn's Ferry picnic area.

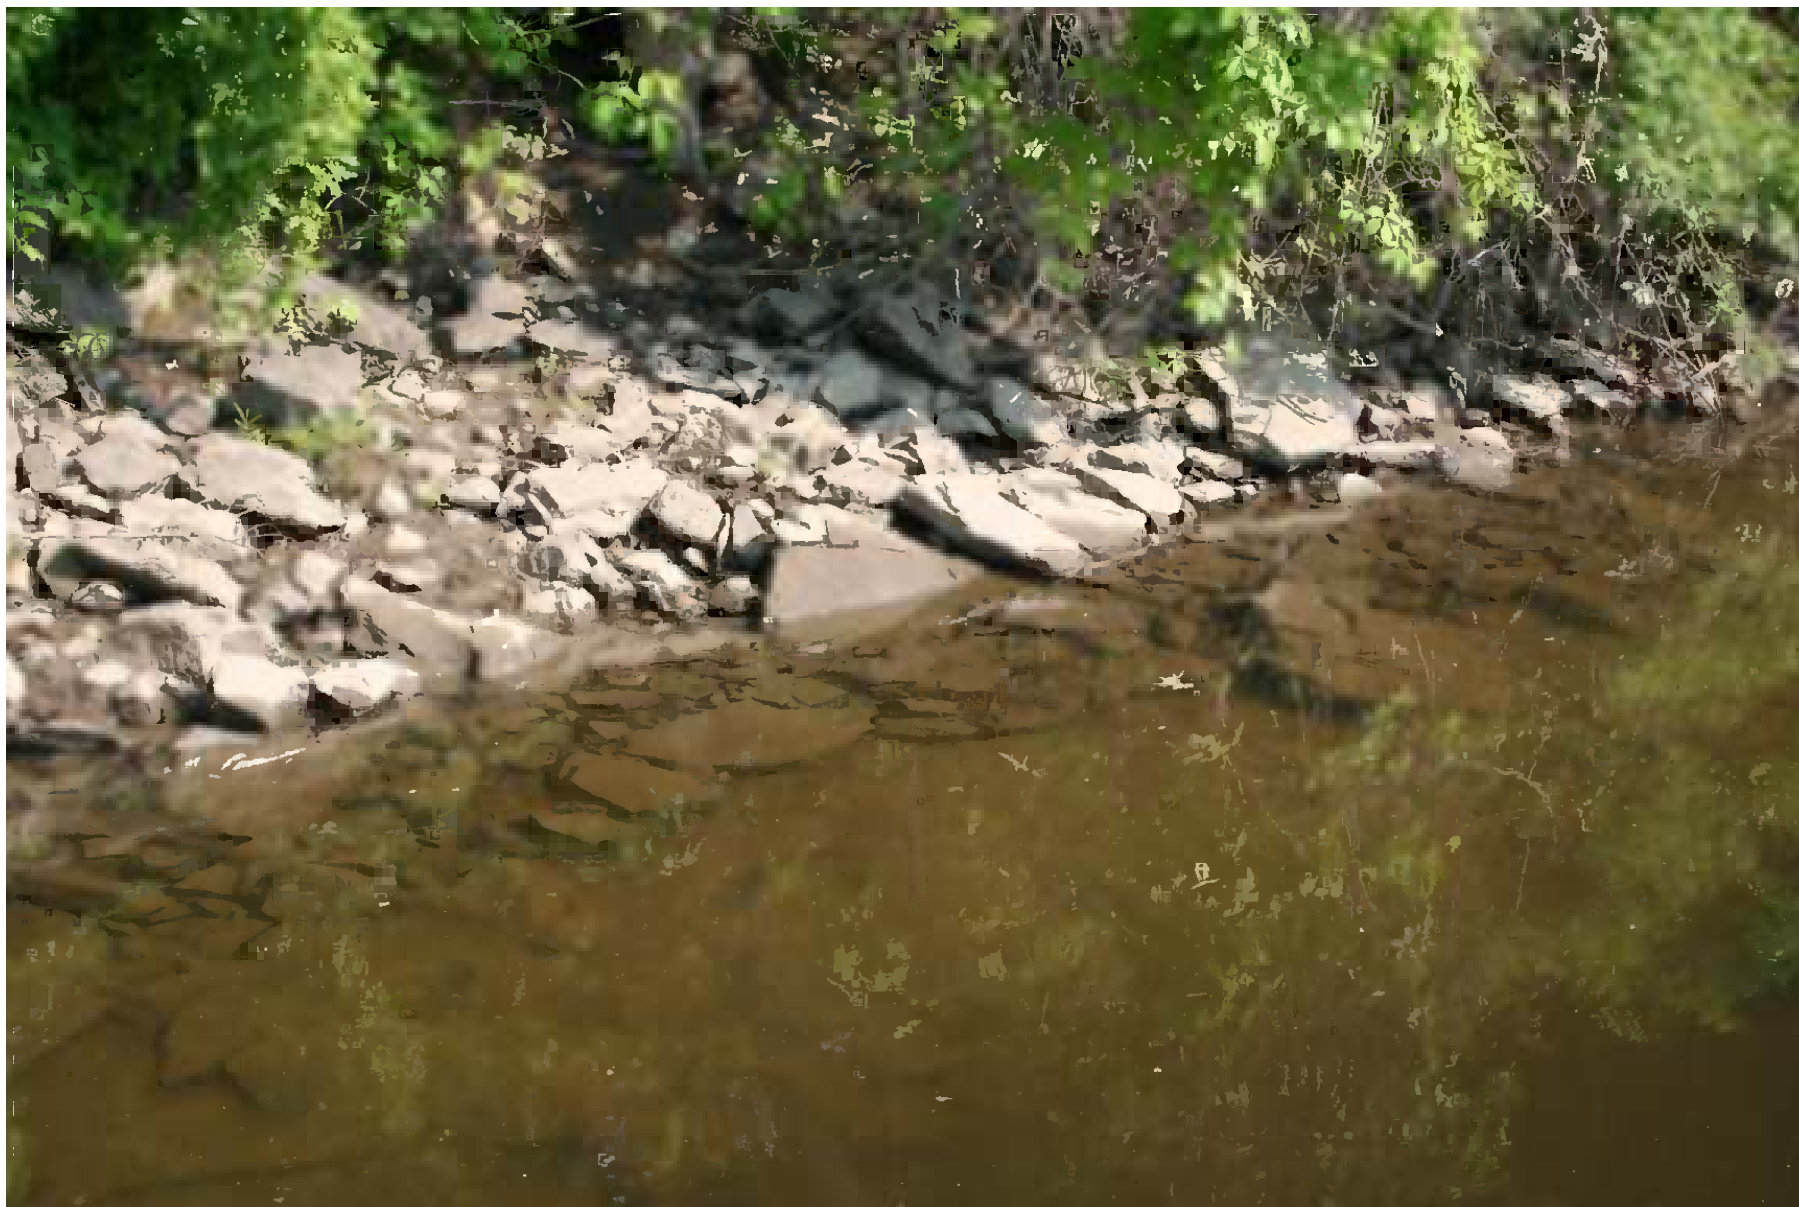
Figure 36: Notching above rock armoring with resulting minor erosion across from the Northfield Mountain Pumped Storage Project tailrace.

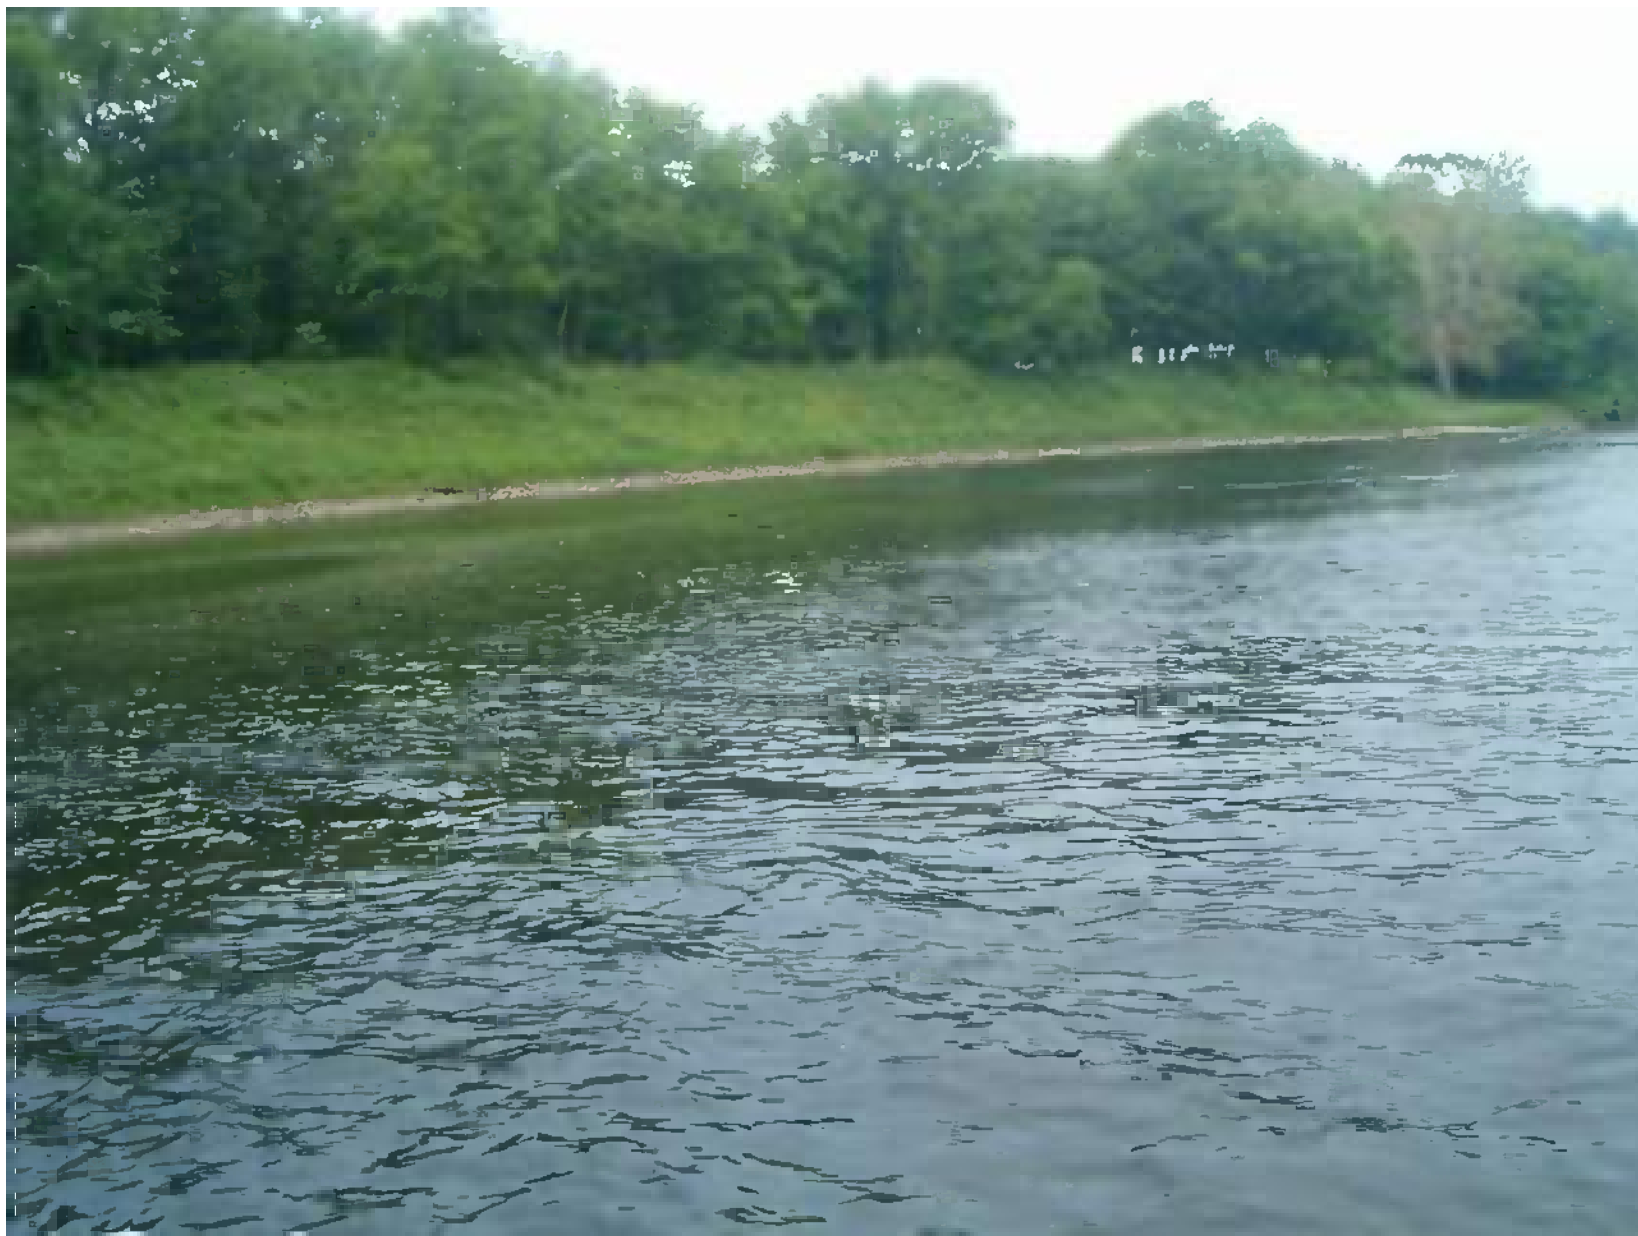
Figure 40: Crooker Road Site with growth of herbaceous vegetation but limited tree growth.

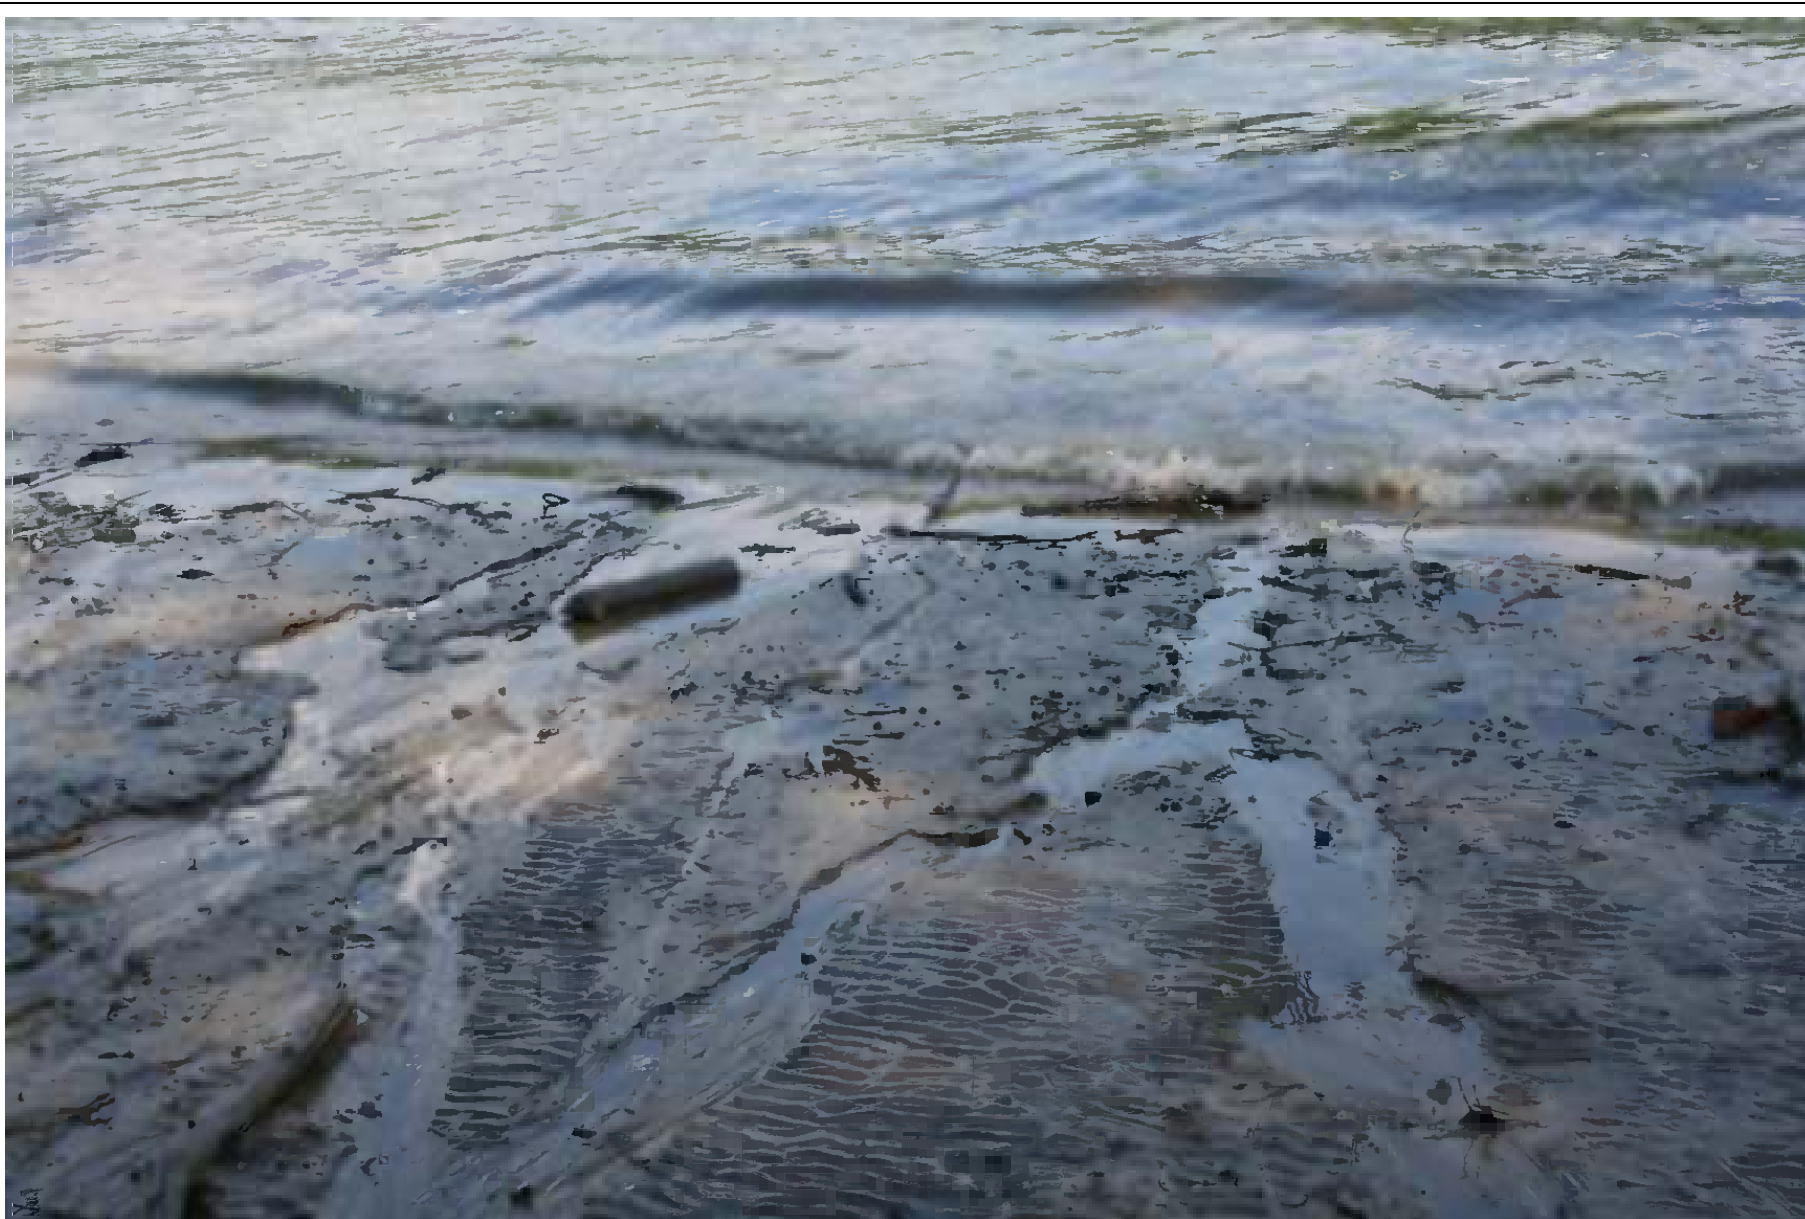
Figure 43: Seepage channels forming across a beach face.

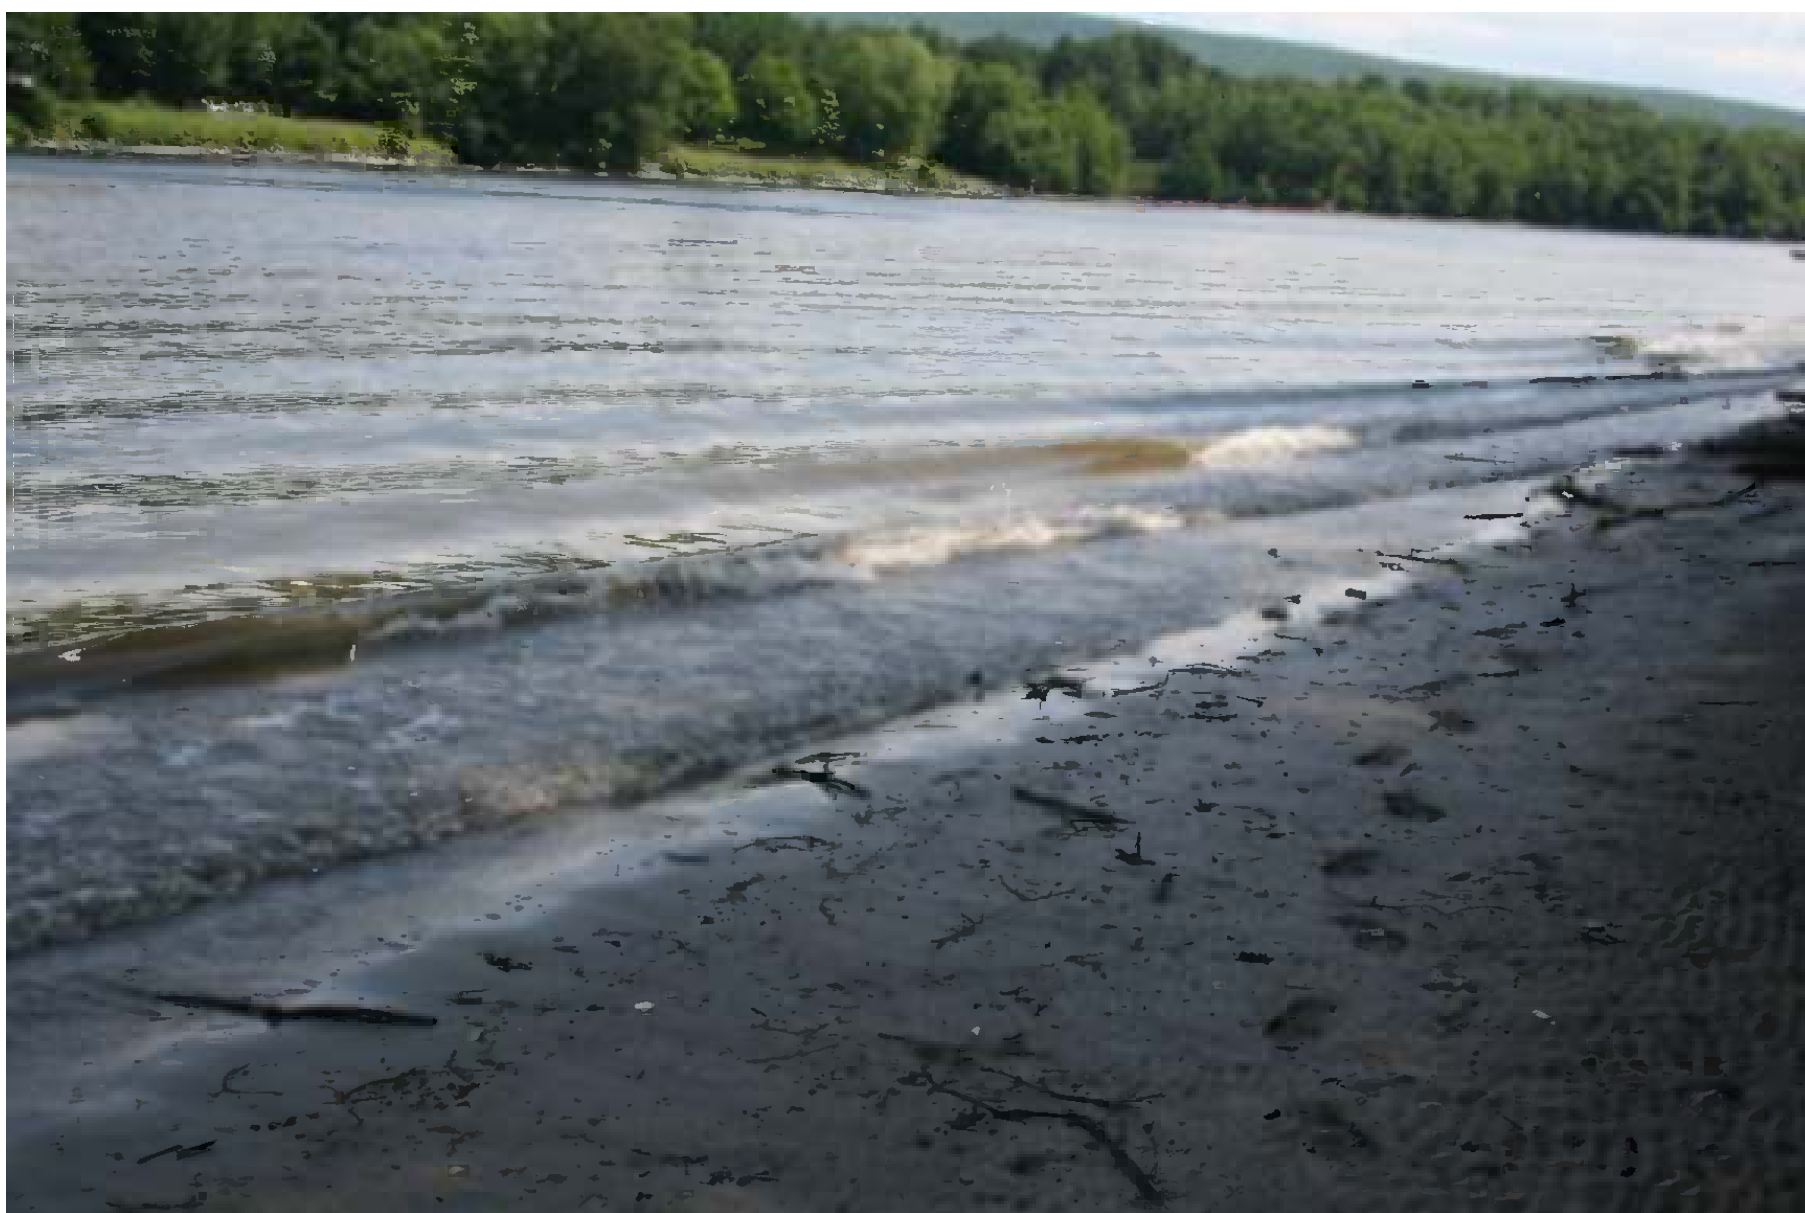
Figure 44: Boat waves breaking on a beach face.
