Northfield Mountain Project - FERC No. 2485 MA

Re: FERC letter, received Nov 17, 2009,  
Erosion Control Plan - Status and Update of Activities

FirstLight Power Resource Services, LLC, (FirstLight), on behalf of FirstLight Hydro Generating Company, licensee, submits a summary report on erosion control measures pertaining to the Northfield Mountain Project. Northfield Mountain's Erosion Control Plan requires monitoring, maintenance and construction of erosion control project in the Turners Falls Impoundment section of the Connecticut River. FirstLight hereby submits a mid-year status and update of its erosion control work.

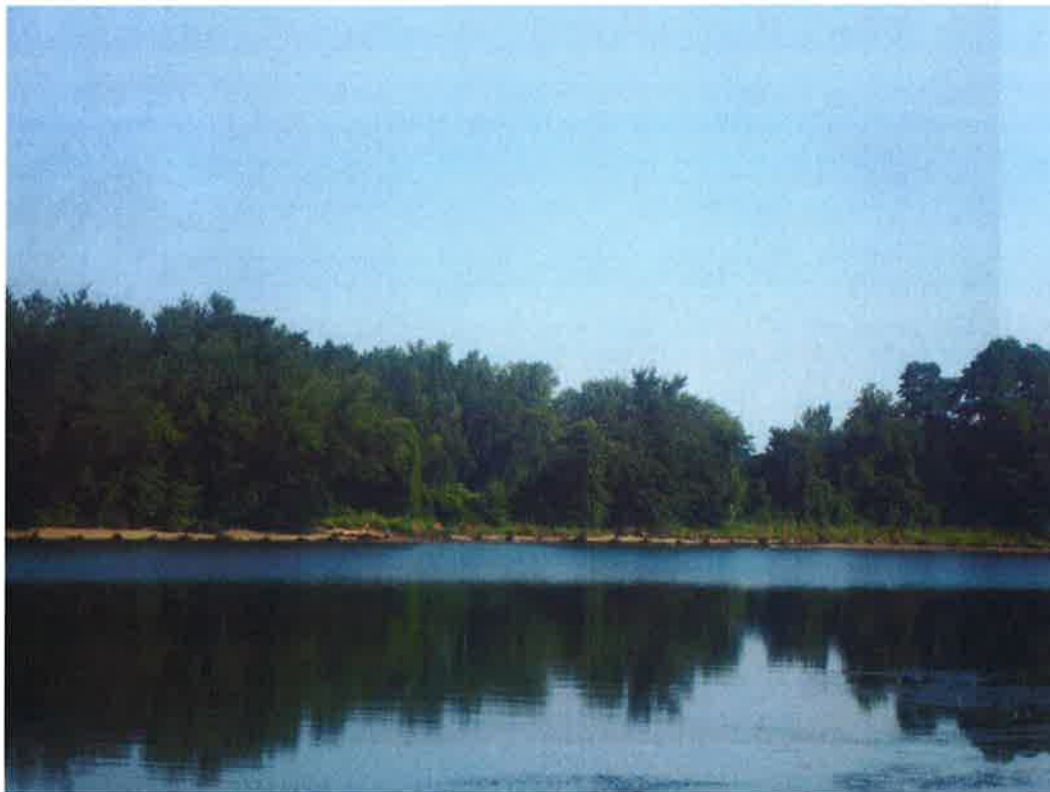
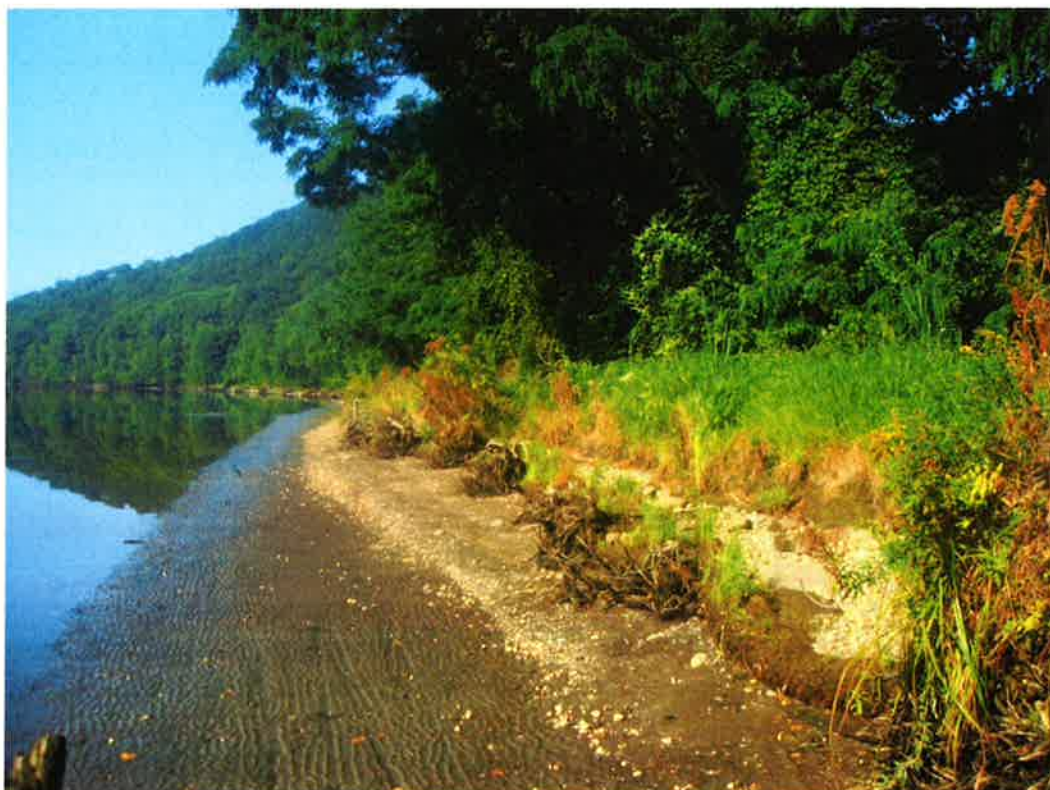
Approximately 1700 ft. of initial riverbank stabilization was completed in the fall of 2009, with the vegetative plantings occurring in the spring of 2010. To date, the structural component of the restoration is in very good condition and no new lower bank erosion has occurred. The woody debris structures are stable and appear to be trapping sediment. In June, 2011, additional vegetation was planted and appears successful to date. Several inches of sediment has settled on the lower bank and beach area. (Pictures # 1 and 2)

Picture # 1 - Split River Farm 8/21/13

Picture # 2 - Split River Farm 8/21/13

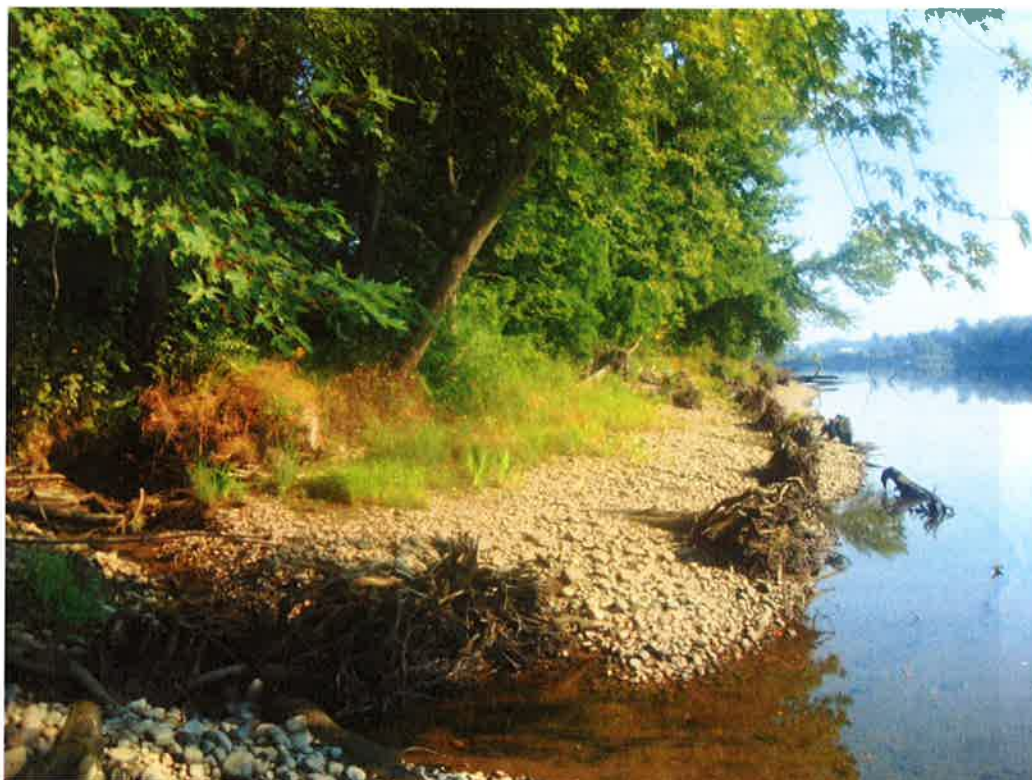
Approximately 1000 ft. of riverbank stabilization was completed in October, 2010, with the vegetative plantings occurring in the spring of 2011. The structural component of the restoration is in very good condition and no lower bank erosion has occurred to date. Several inches of new sediment have been deposited on the site during the spring, 2011 freshet and it appears stable. (Pictures # 3)

Picture # 3 - Split River Lower 8/21/13

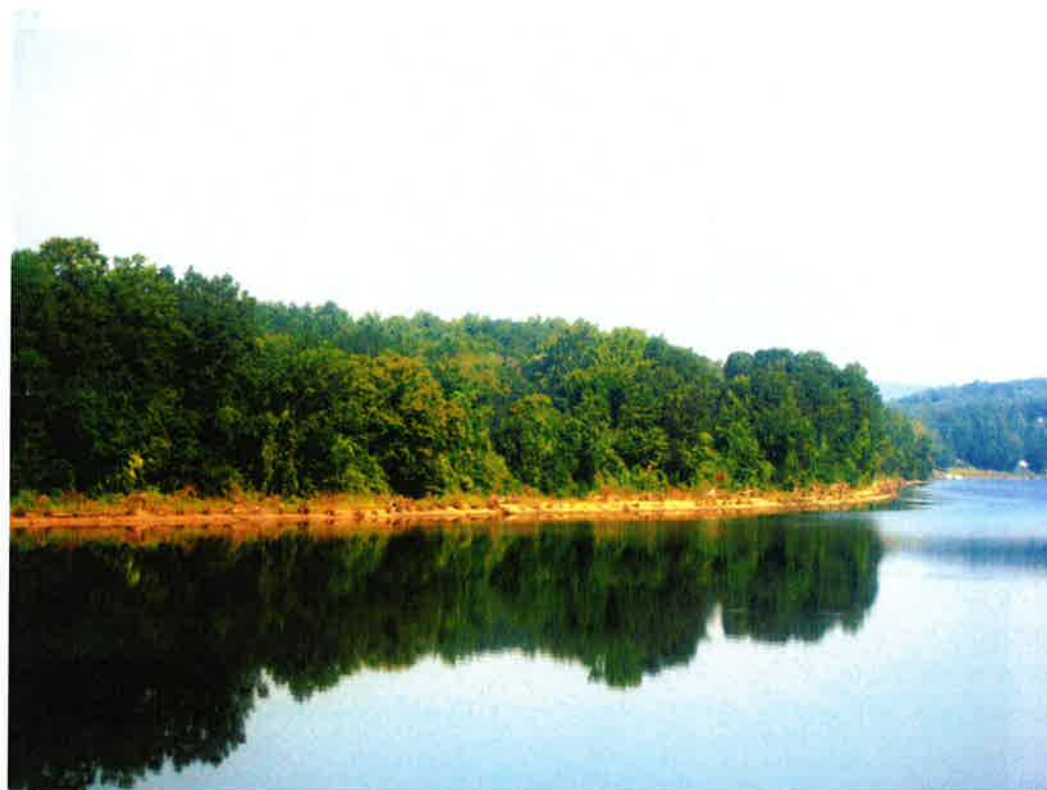
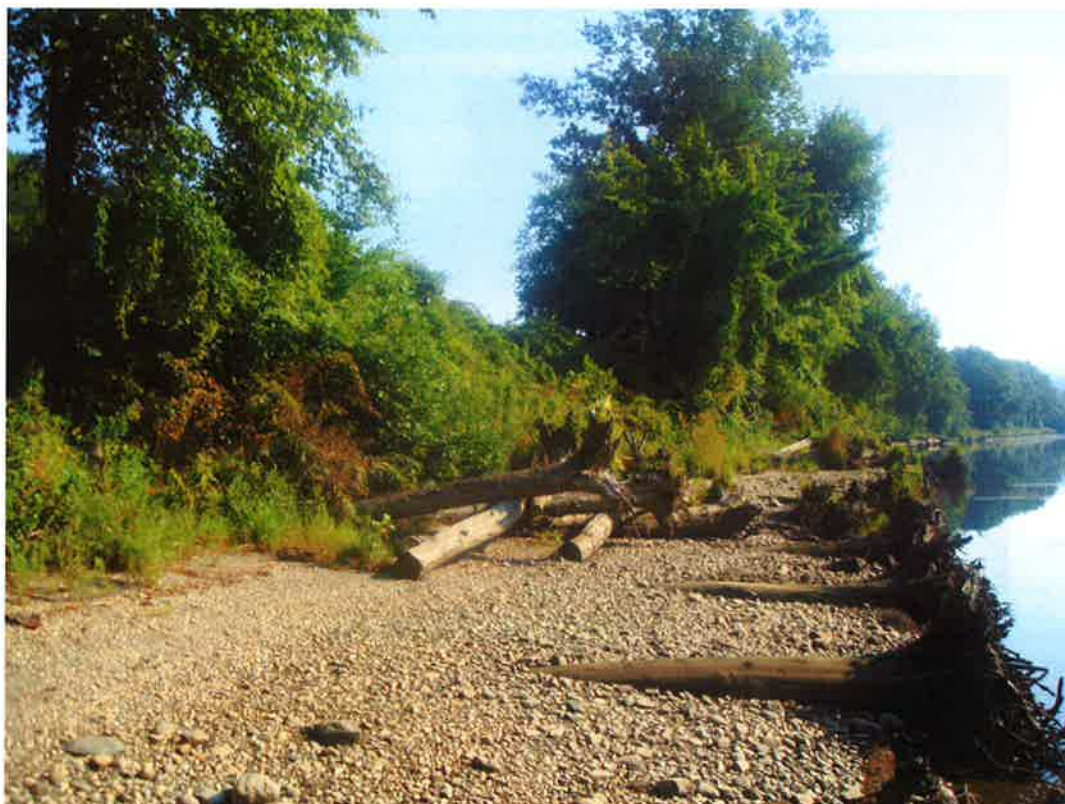
Approximately 1000 ft. of riverbank stabilization work was completed in October, 2011. The vegetative plantings work was not completed in the spring of 2012, as there was an extremely low flowing spring freshet with virtually no soil deposition taking place. Planting work has resumed this summer and should be completed this fall. (Pictures # 4, and 5)

Picture # 4 - Split River Upper 8/21/13

Picture # 5 - Split River Upper 8/21/13

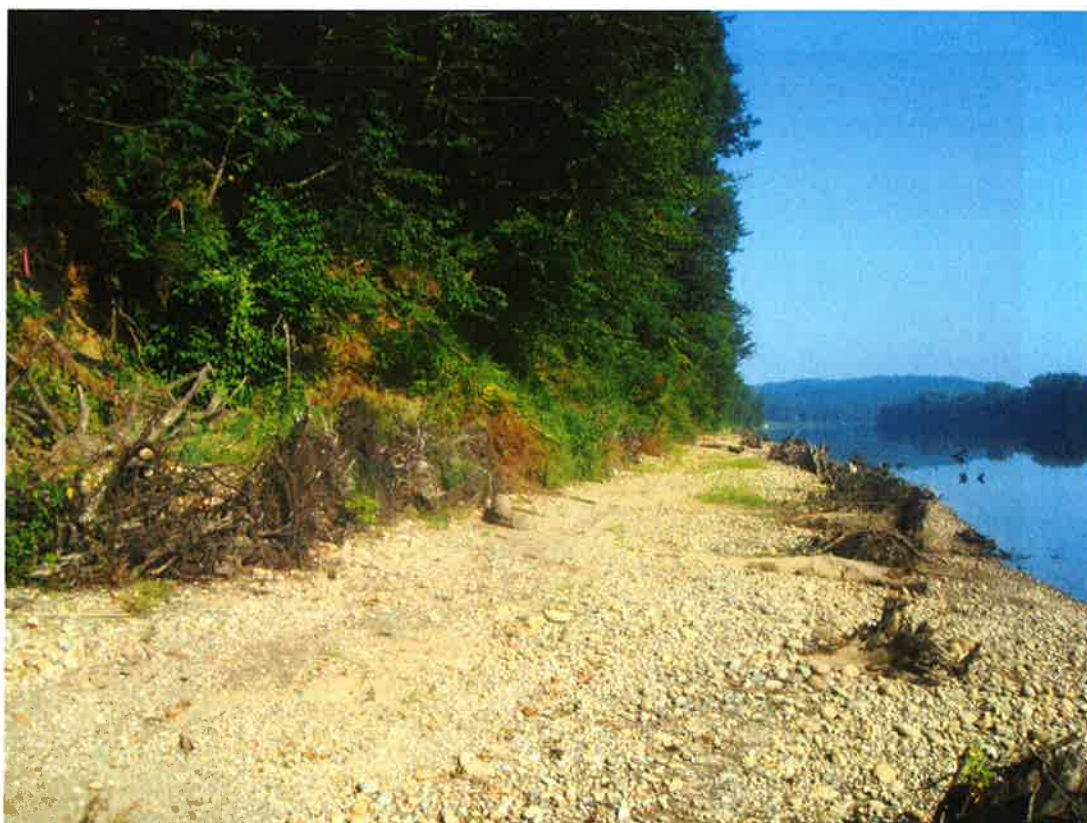
FirstLight completed portions of both the Bathory-Gallagher and Wallace-Watson sites in the fall of 2012. FirstLight's intent is to complete the major portions of construction later this year with plantings to occur in the spring of 2014. The total length of repair is approximately 2300 ft. (Pictures # 6, 7 and 8)

Picture # 6 – Bathory-Gallagher 8/21/13

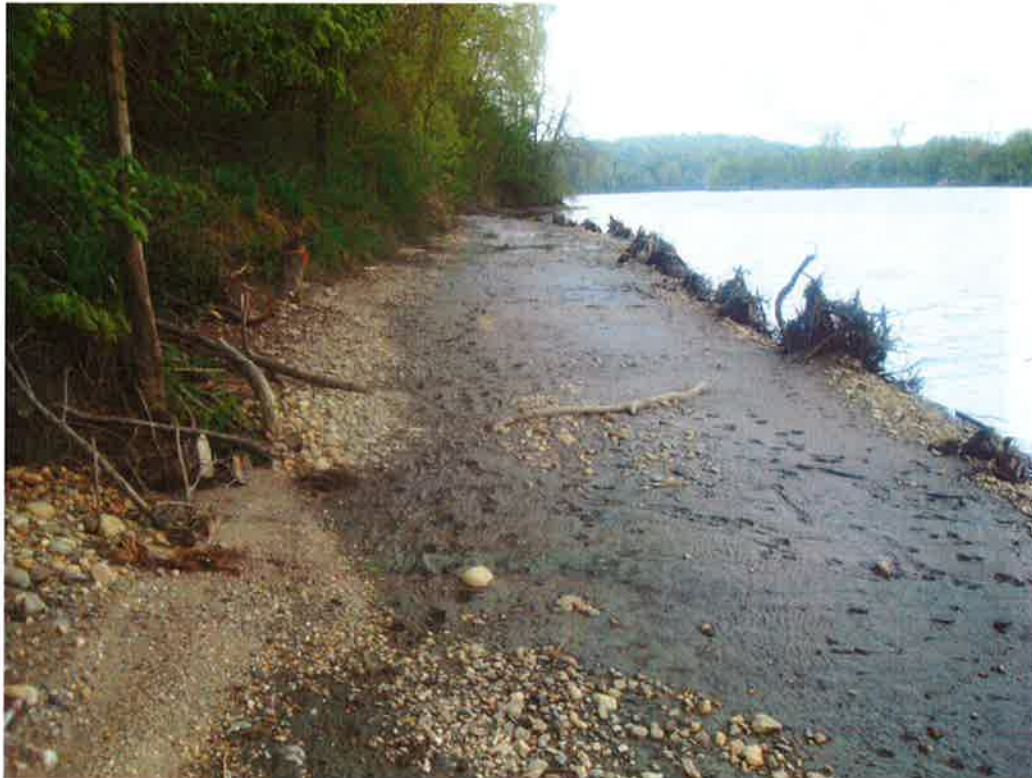
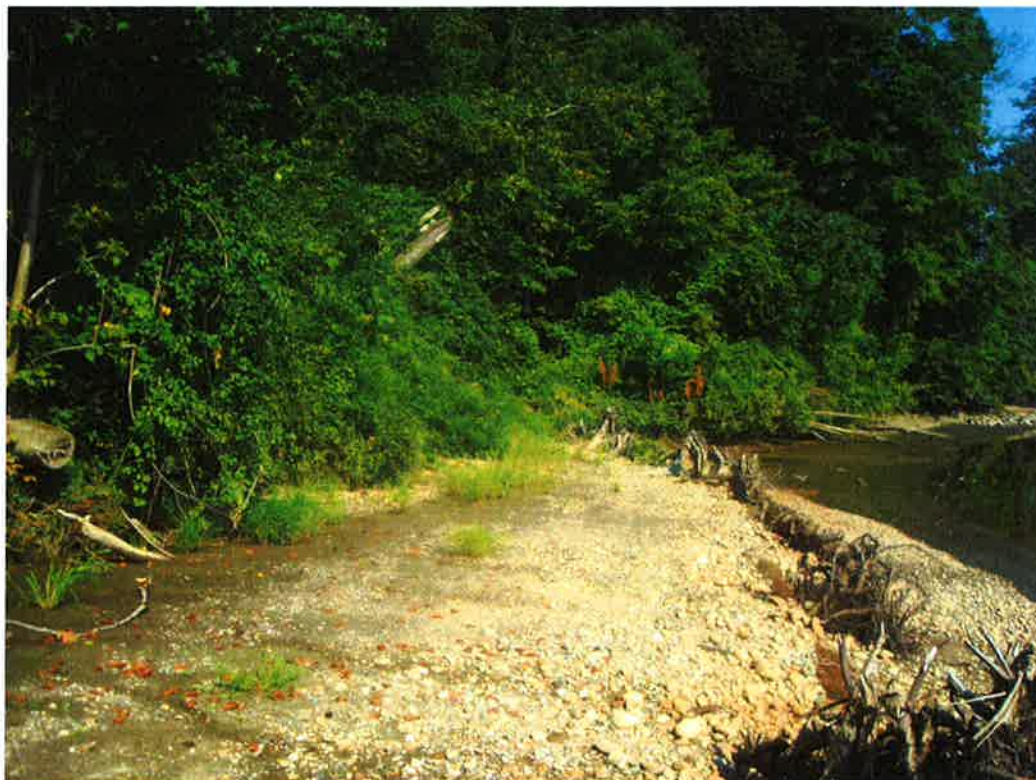
Picture # 7 – Wallace Watson 6/13

Picture # 8 – Wallace Watson 8/21/13
