P-1889

FEDERAL ENERGY REGULATORY COMMISSION
Office of Energy Projects
Division of Dam Safety and Inspections - New York Regional Office
19 West 34th Street, Suite 400
New York, NY 10001

In reply refer to:
11-13 Power Street
Montague MA

October 3, 2013

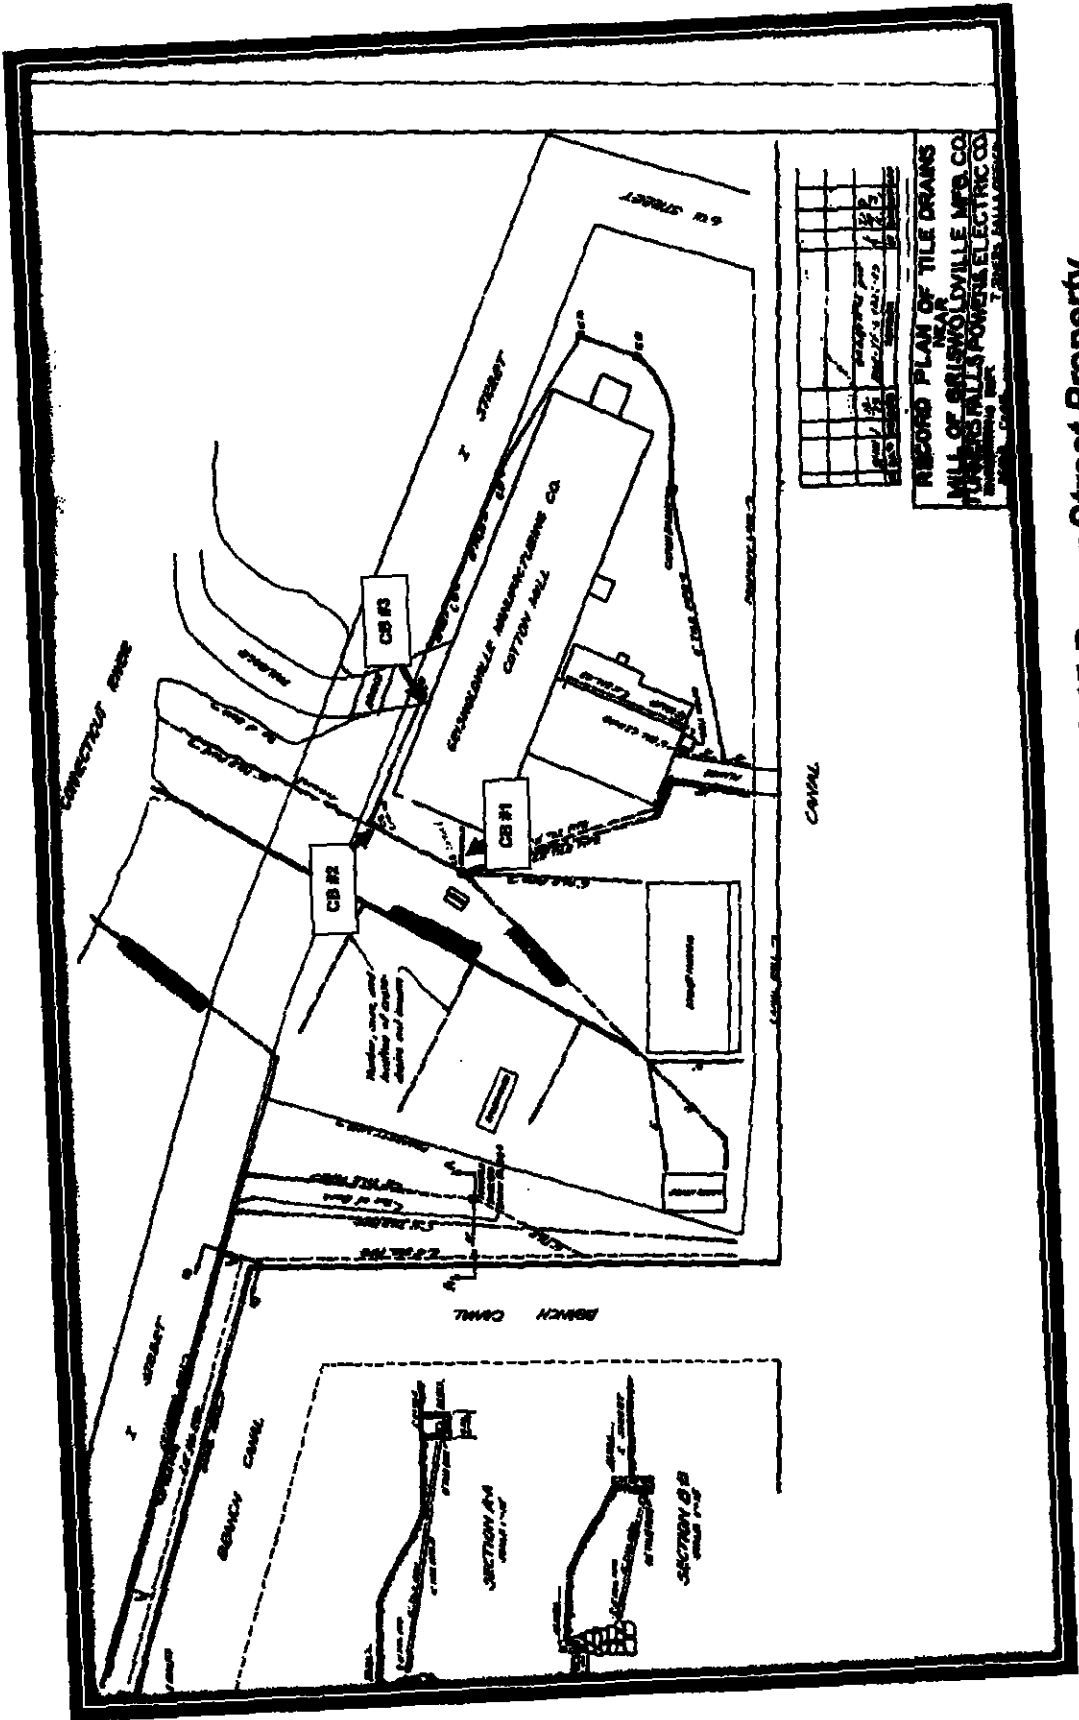
At the paved parking lot, we observed a catch basin that connected underground drain pipes on the northwesterly side of the old Cotton Mill building. A review of the drawing, "Record Plan of Tile Drains near Mill of Griswoldville Mfg. Engineering Office, File No. 11347; Drg. No. H861", dated Nov. 26, 1924 (Figure 1) found that four drain pipes, three 6-inch and one 10-inch, outlet into Catch Basin #1 (covered with inlet grate). The outflow from Catch Basin #1 is through a 16-inch tile drain pipe that connects to two other catch basins (Catch Basin #2 & #3).

You claimed that *"the flow of canal water is now in sufficient quantities to render a significant portion, if not all, of the parcel unsuitable for development. Indeed, there is a legitimate concern that the seepage is of such a permanent nature now that portions of the parcel could be deemed to be wetlands; thus, further eroding the parcel's development value"*. This cannot be substantiated. The drainage system shown on Figure 1, appears to be in need of maintenance.

Figure 1 – Plan of Tile Drains at 11-15 Power Street Property
(Also, showing the catch basins (CB#1, #2 & #3))

1. You or your successors should maintain or replace the 1924 underground drain pipes within the 11-15 Power Street property to allow seepage or percolation of canal water to drain freely through the underground drain pipes as stipulated in the 1952 indenture.
2. FirstLight should inspect the bulkhead to the old and abandoned Cotton Mill intake flume during their annual drawdown and make any repairs necessary.
3. FirstLight should continue to monitor the drainage weir installed on the swale downstream of the 42-inch culvert pipe outlet on a monthly basis and record flows. The monthly flow records will be submitted to us as part of FirstLight annual reporting to D2SI-NYRO.

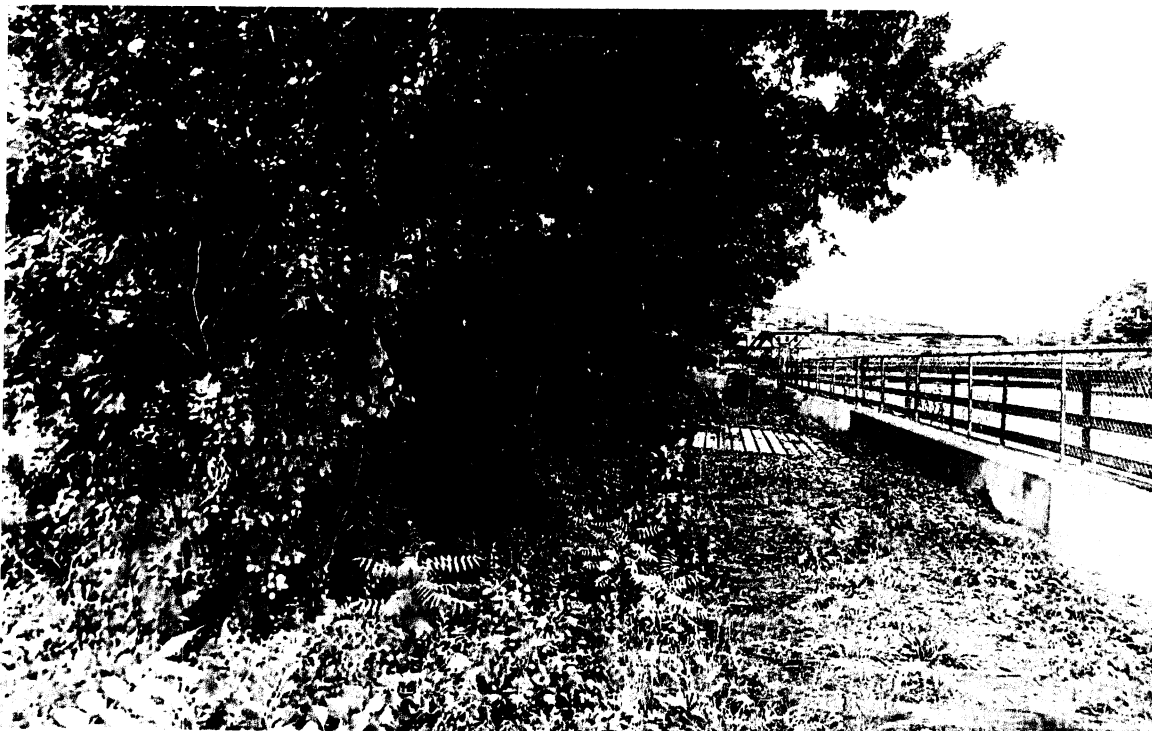
Photo No. 1 -- View of the power canal right of way and the old Mill Intake Flume

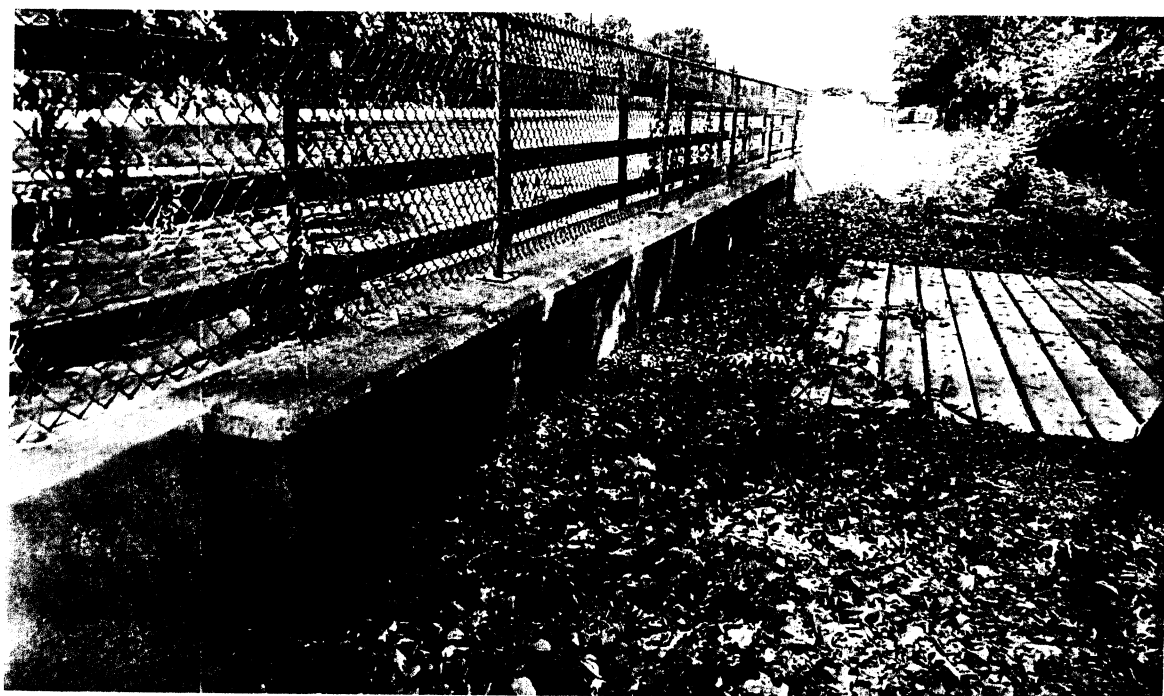
Photo No. 2 -- A close-up view of the sealed old Mill intake flume and ROW looking towards the No. 1 Powerhouse intake

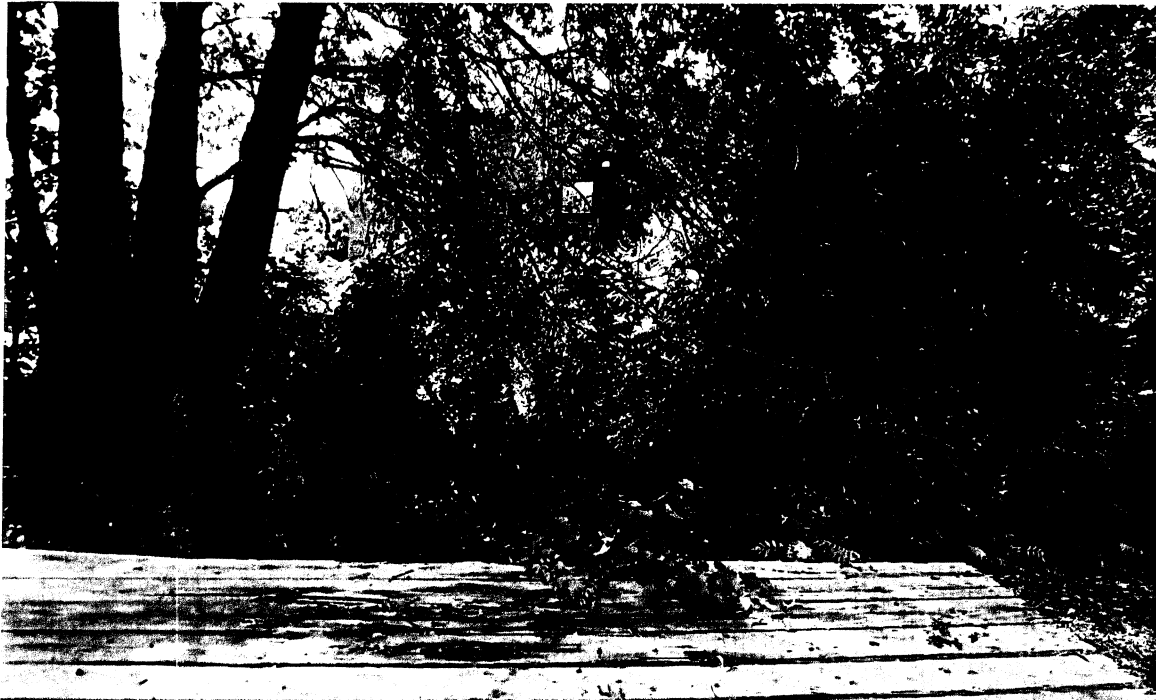
Photo No. 3 – A view of the old Mill intake flume looking towards the abandoned Griswoldville Manufacturing Co. Cotton Mill building.

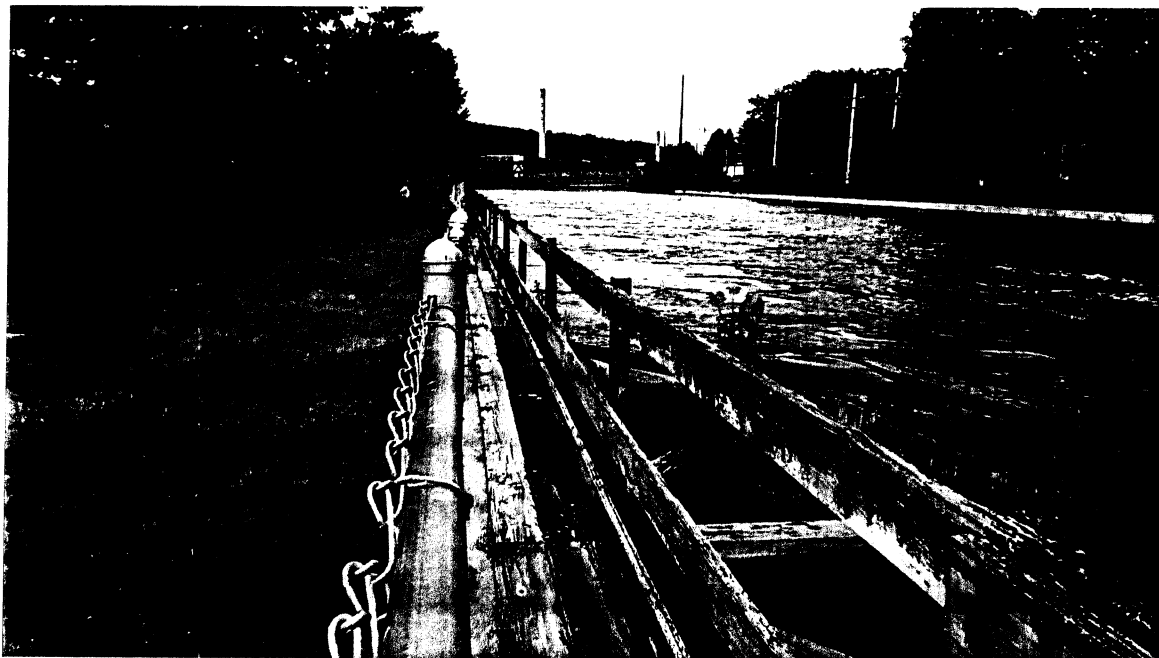
Photo No. 4 -- View of the Power Canal right-of-way looking from the No. 1 Powerhouse intake structure towards the 11- 15 Power Street property

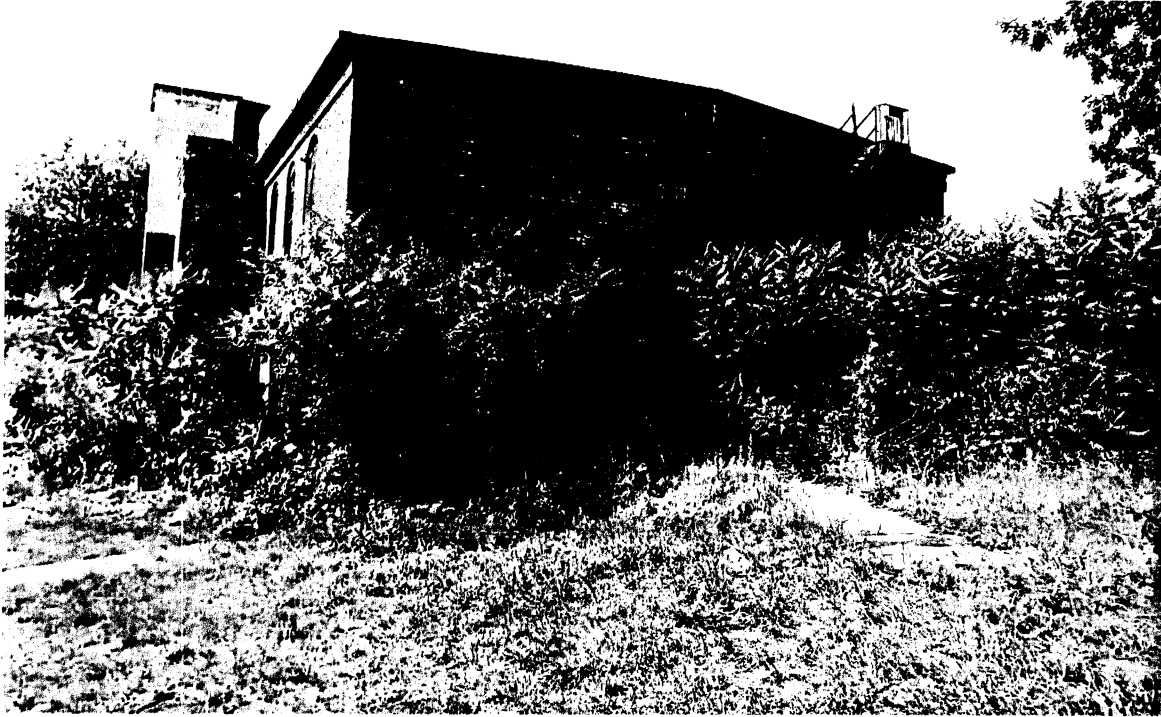
We observed that all land abutting the power canal was dry. FirstLight mowed the land within their canal's ROW, which enabled a close visual inspection of the entire length of the canal wall including the ROW parallel to the property. There was dense vegetation around both buildings on the 11-15 Power Street property (Photo Nos. 5 and 6). However, we were unable to confirm the presence of wetland vegetation on your property.

Photo No. 5 – A view of the “Store House” located in the rear of the Cotton Mill building. This lot has been recently subdivided and is now Lot 2 and has been sold separately.

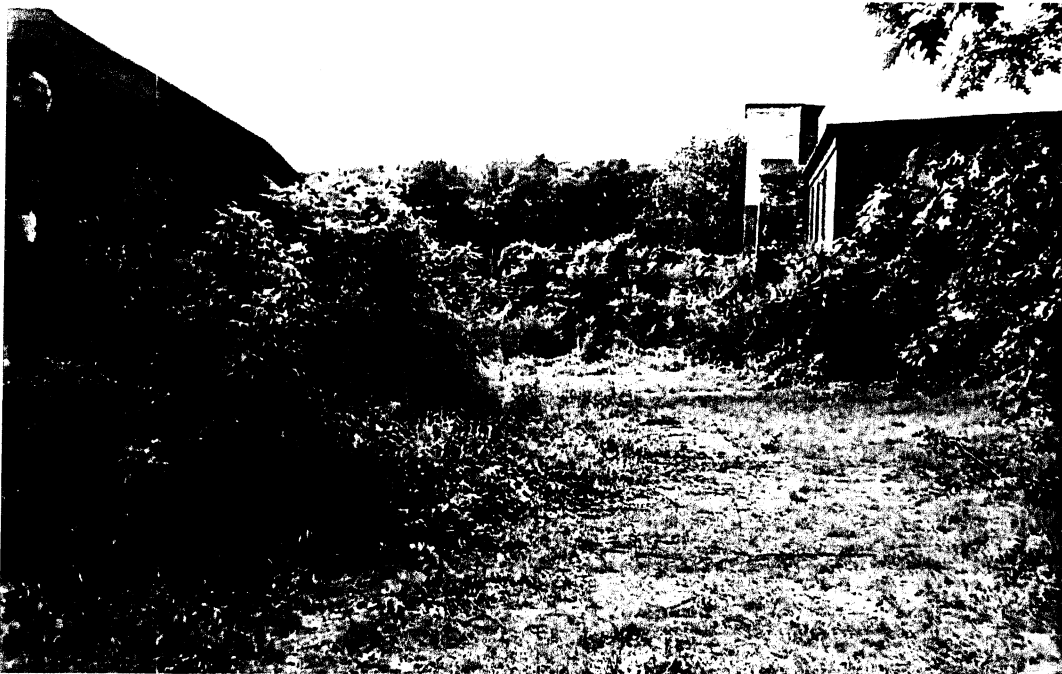
Photo No. 6 – View of the grounds between the “Store House and the Old and abandoned Cotton Mill Building.

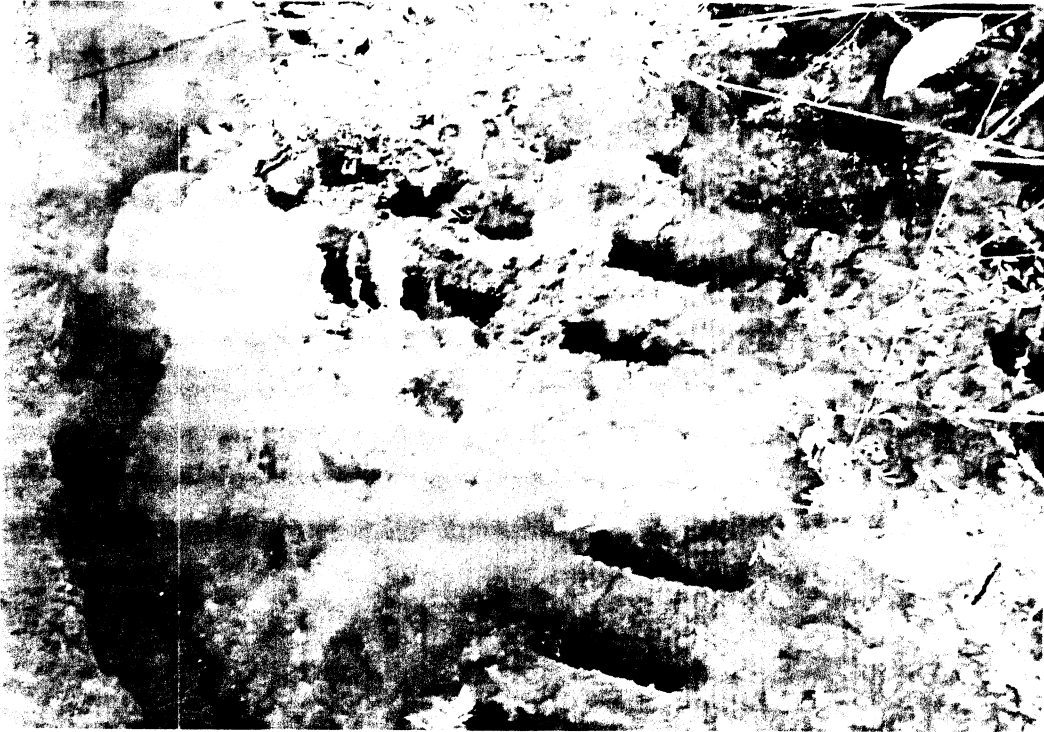
Seepage from these underground drain pipes was flowing out from the top of Catch Basin #1 (Photo No. 7) and over the paved parking lot. The surface drainage from the 11-15 Power Street parking lot area and any percolation or seepage from the old

Photo No. 7 -- Close-up view of the source of seepage flows on the property. Flows were coming out from a drainage catch basin (see inlet grates), suggesting clogged drainage pipes.

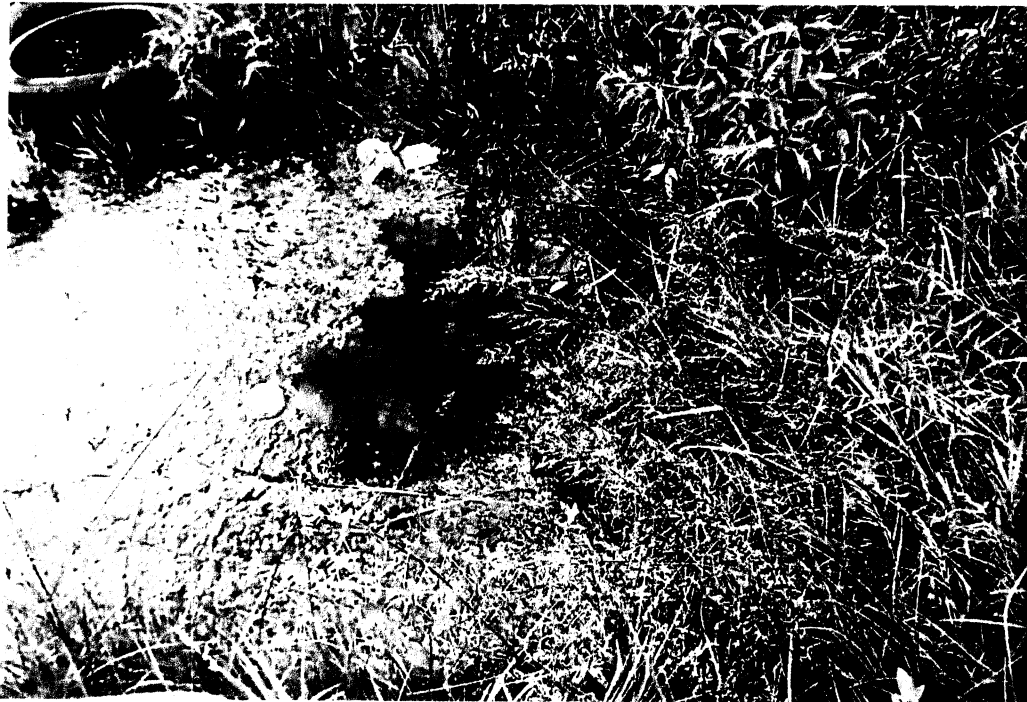
Photo No.8 -- Vegetation around the seepage path from the catch basin towards Power Street

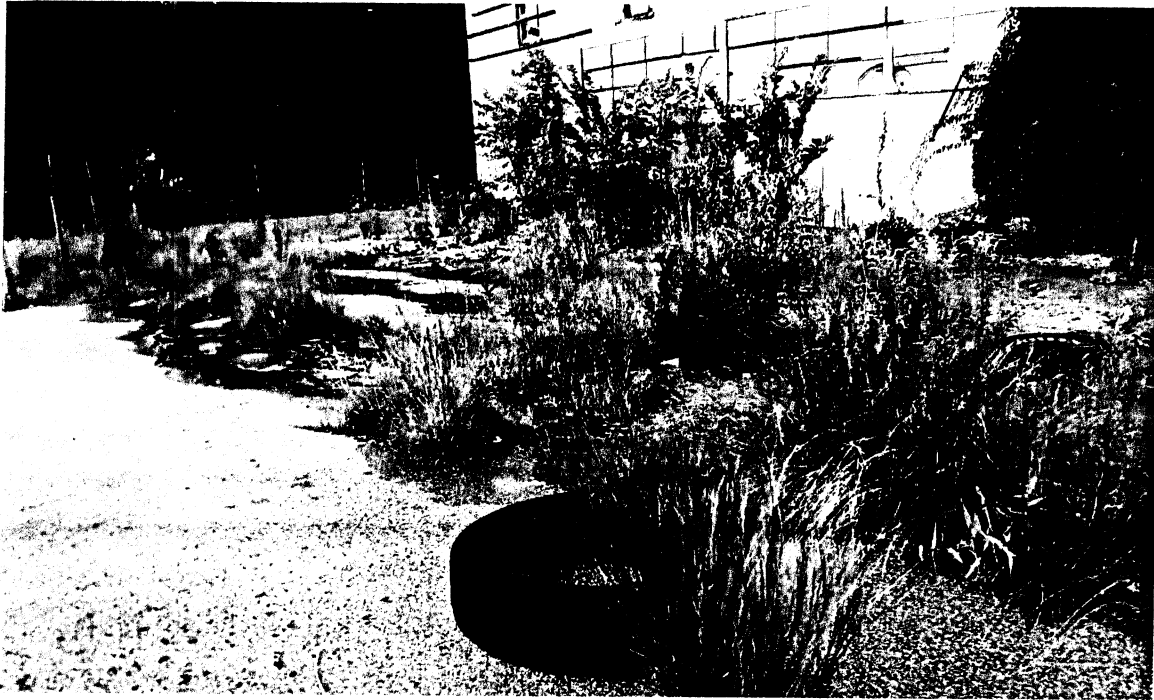
Photo No. 9 – The wet area of the parking lot looking towards Power Street

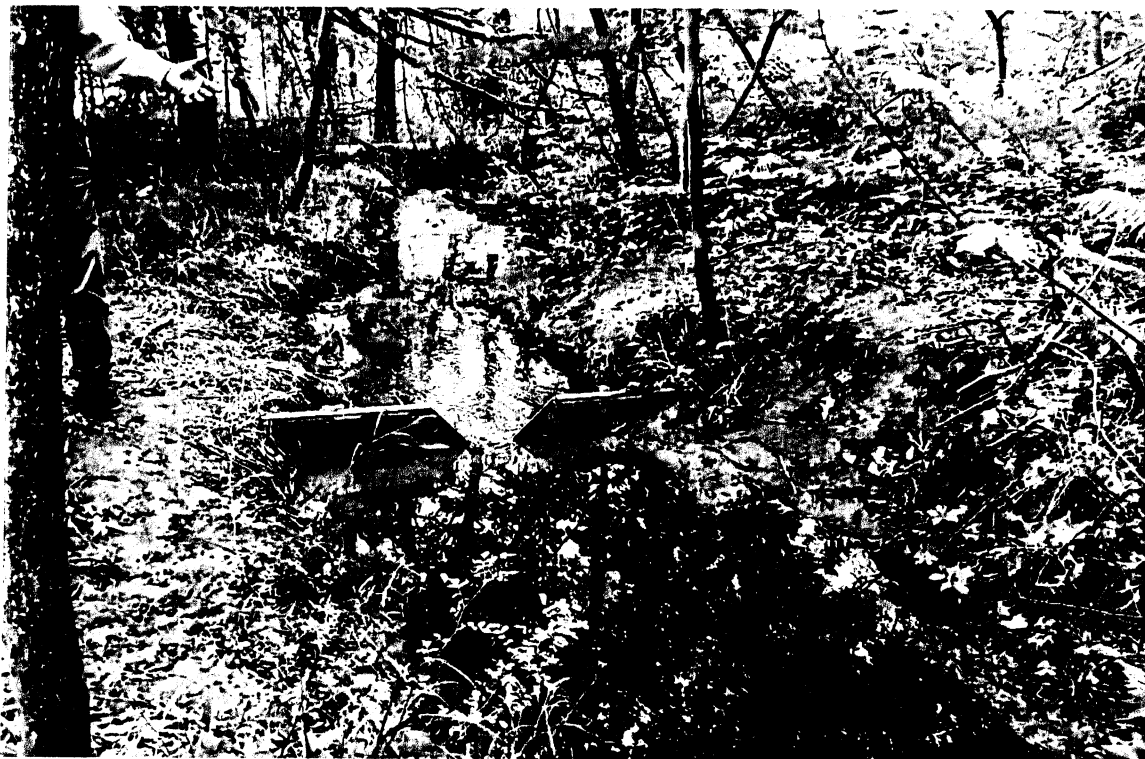
Cotton Mill intake bulkhead flows through the pipes and empties into an existing 42-inch culvert that replaced the old Cotton Mill tailrace under Power Street (see Figure 1). The flows discharge into a swale on the FirstLight property between Power Street and the Connecticut River (Photo No. 10). FirstLight installed and monitors a weir (Photo Nos. 11-12) located downstream of the outflow of the 42-inch culvert to evaluate the rate of seepage.

Photo No. 11 – FirstLight installed a weir on the outflow drainage channel to the Connecticut River to measure the seepage from 11 Power Street property
