Northfield Mountain Project - FERC No. 2485-MA
Erosion Control Plan - 2013 Construction Report

Construction Progress Report

Northfield Mountain Pumped Storage Project

Riverbank Restoration

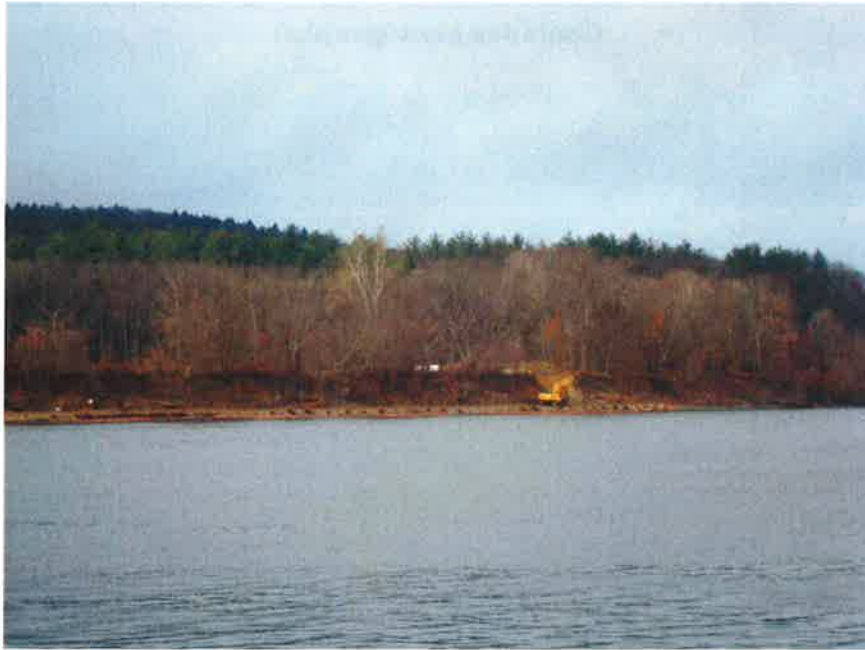
Showing construction from across river 11/13

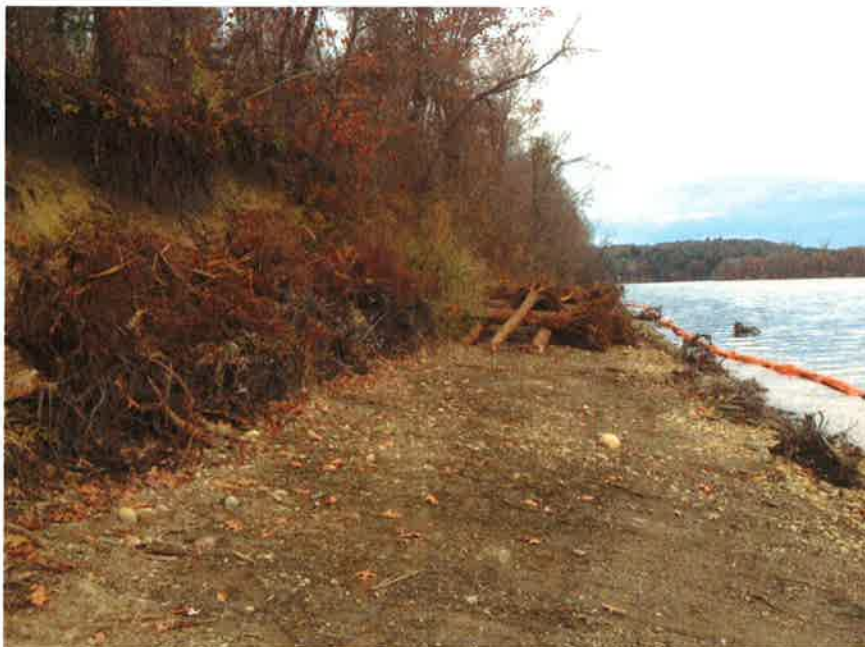
Looking North at Woody debris structure and root wads
11/18/13

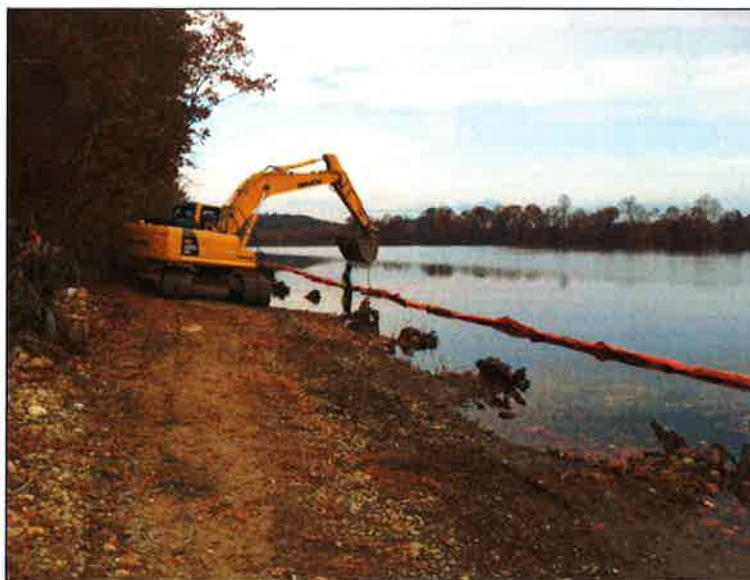
Photo 1:

A view of the turbidity curtain
being installed.
(October 28-31, 2013)

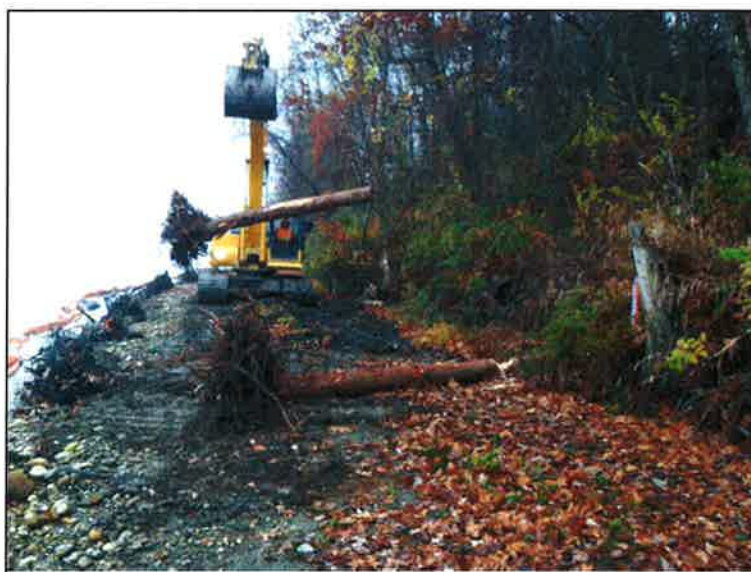
Photo 2:

The first woody debris structure
being installed.
(October 28-31, 2013)

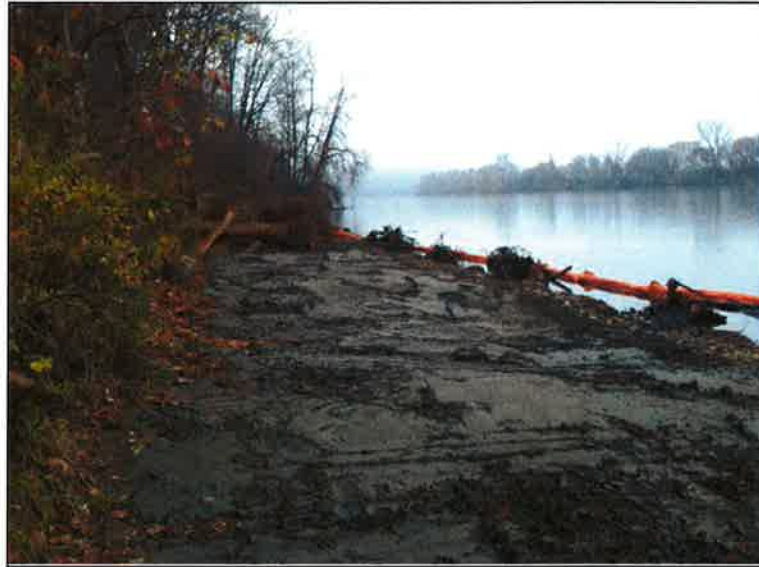
Photo 3:

A view looking up river at the first structure. (October, 2013)

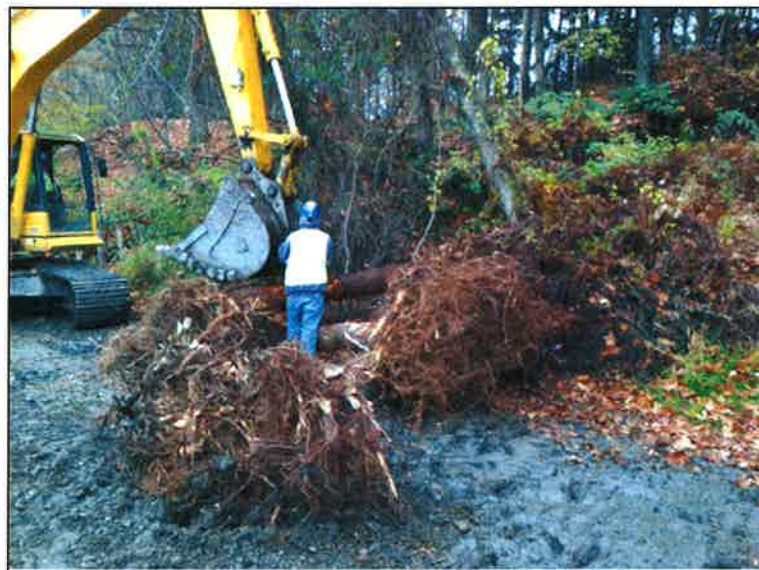
Photo 4:

A view of a woody debris structure being constructed. (October, 2013)

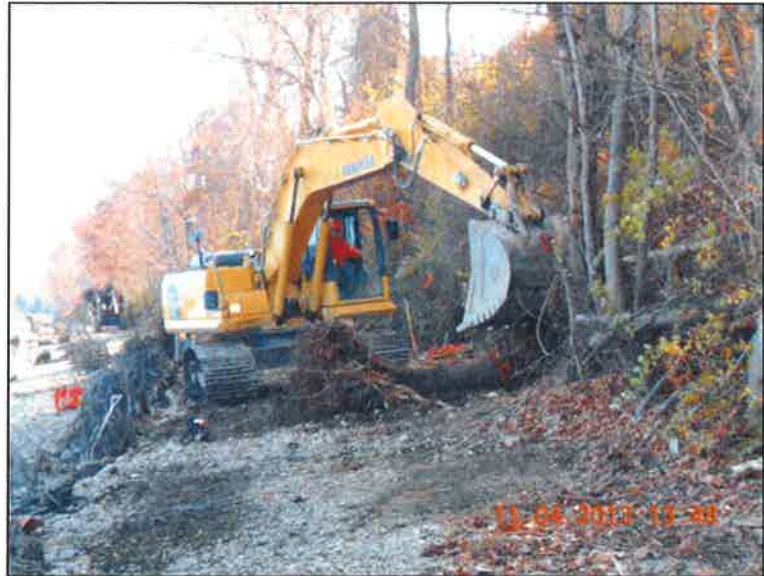
Photo 1:

A view of a woody debris structure being installed.
(November 4-8, 2013)

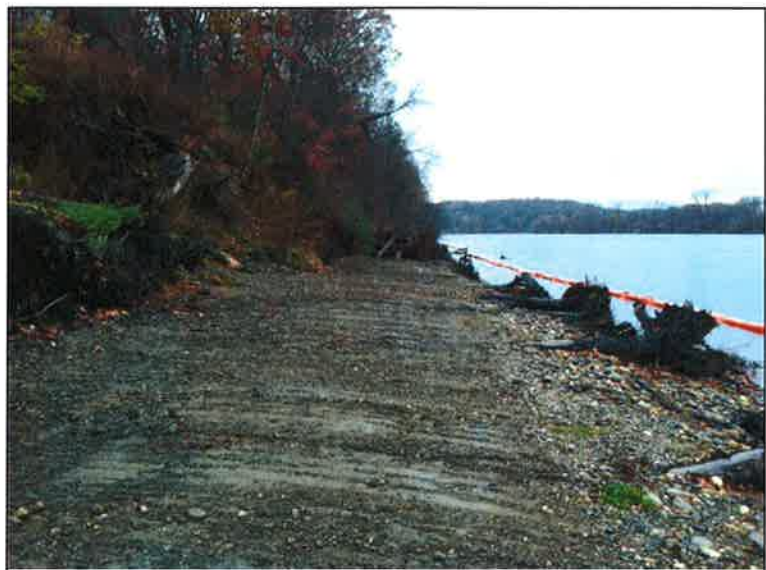
Photo 2:

A view between structures of the
“dressed out” bench.
(November 4-8, 2013)

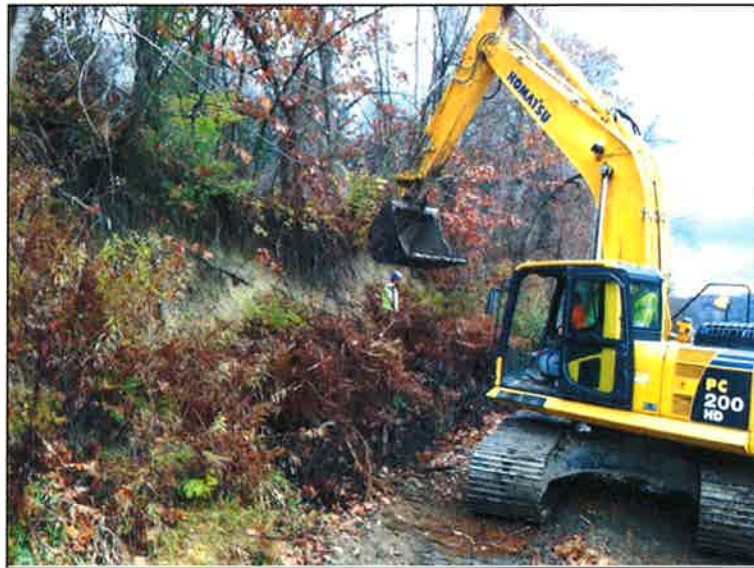
Photo 3:

A view of a bank treatment being installed.
(November 4-8, 2013)

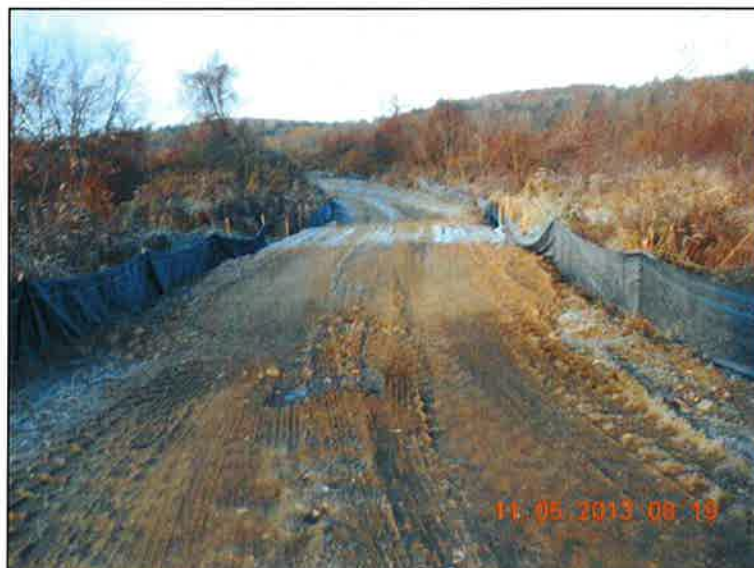
Photo 4:

A view of the farm road crossing.
(November 4-8, 2013)

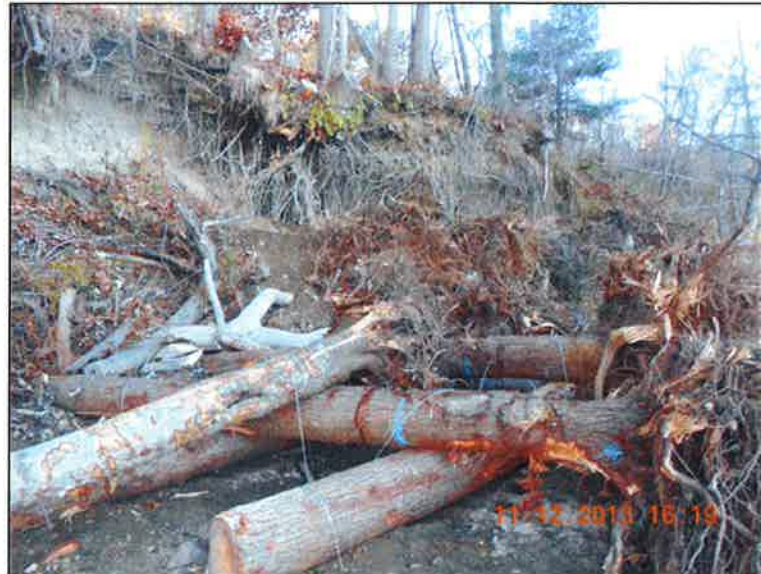
Photo 1:

A view of a woody debris structure.
(November 11 – 15, 2013)

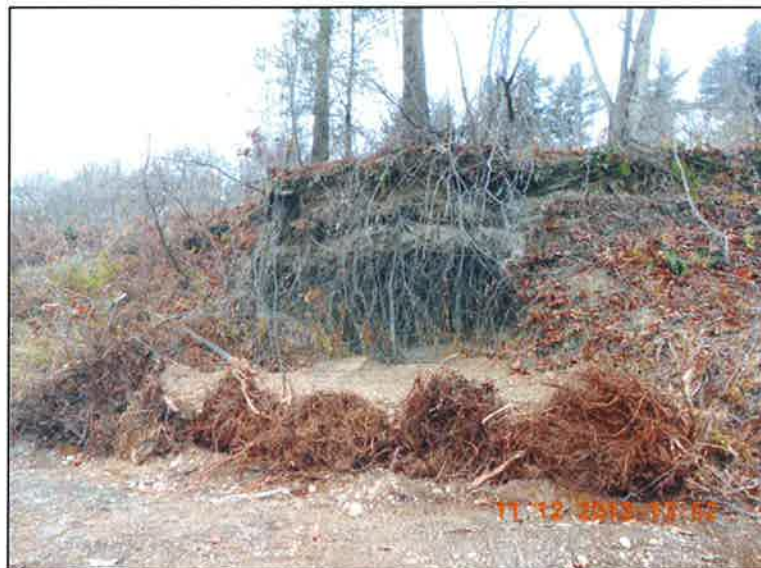
Photo 2:

A view of a bank treatment.
(November 11 – 15, 2013)

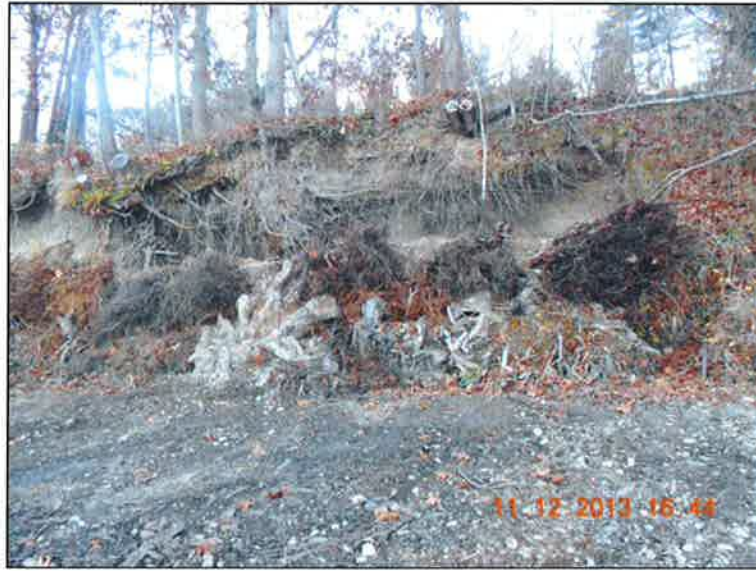
Photo 3:

A view of a bank treatment.
(November 11 – 15, 2013)

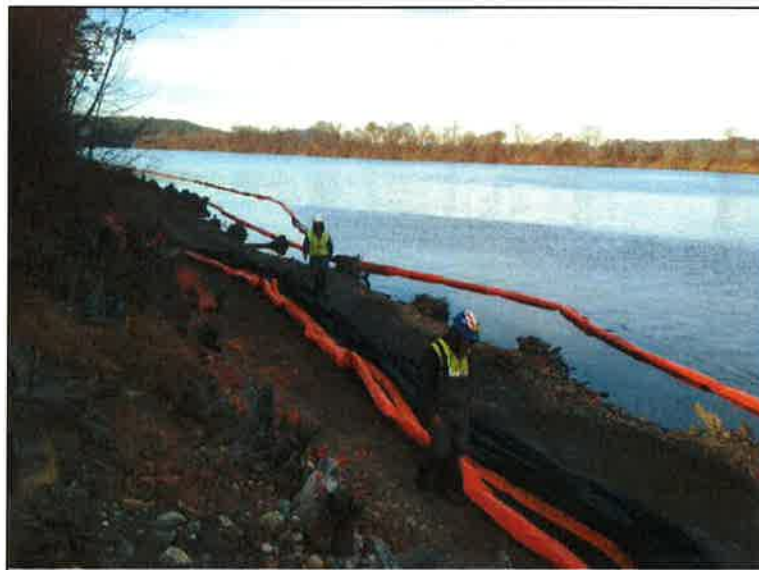
Photo 4:

A view of the turbidity curtain
removal.
(November 11 – 15, 2013)

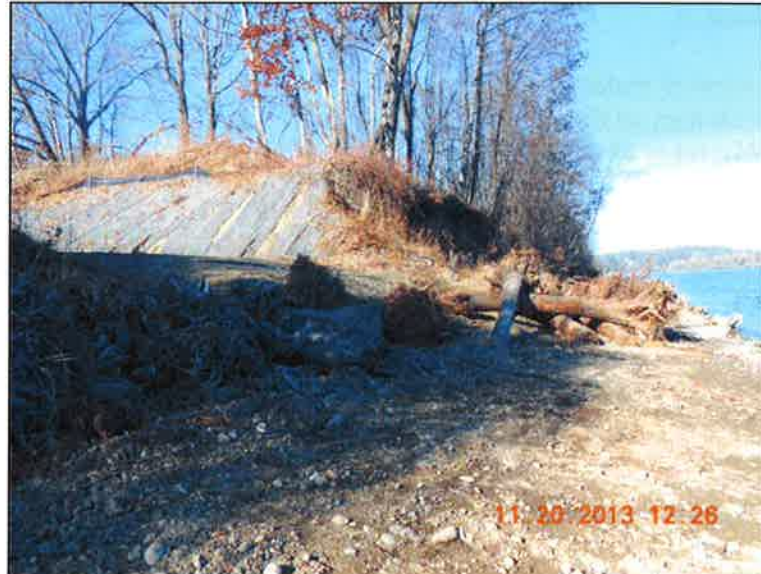
Photo 1:

A view of the last woody debris structure, bench and the construction access ramp.
(November 18 – 20, 2013)

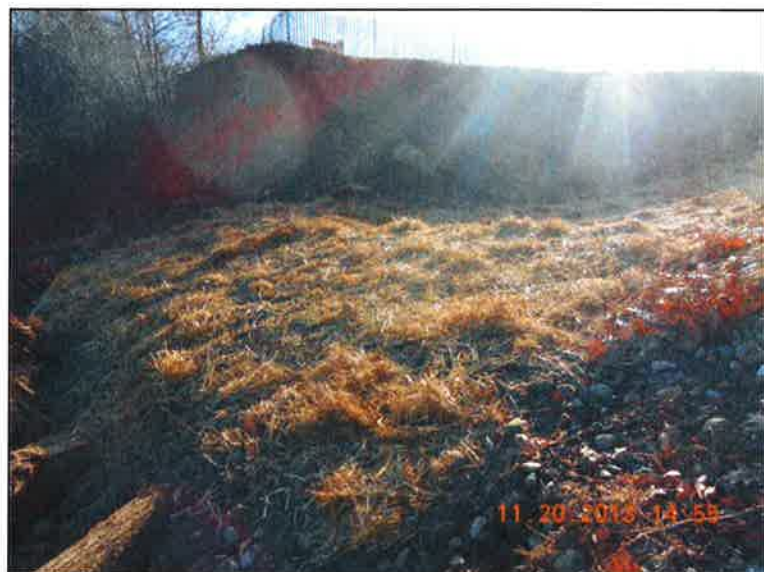
Photo 2:

A view of the stabilization to the end of the construction access.
(November 18 – 20, 2013)

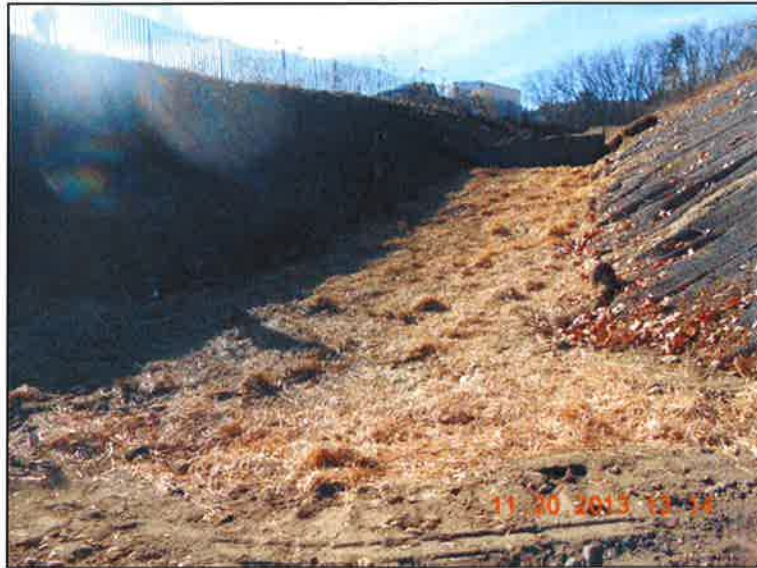
Photo 3:

A view of mulch and silt fence
check dam on the access.
(November 18 – 20, 2013)

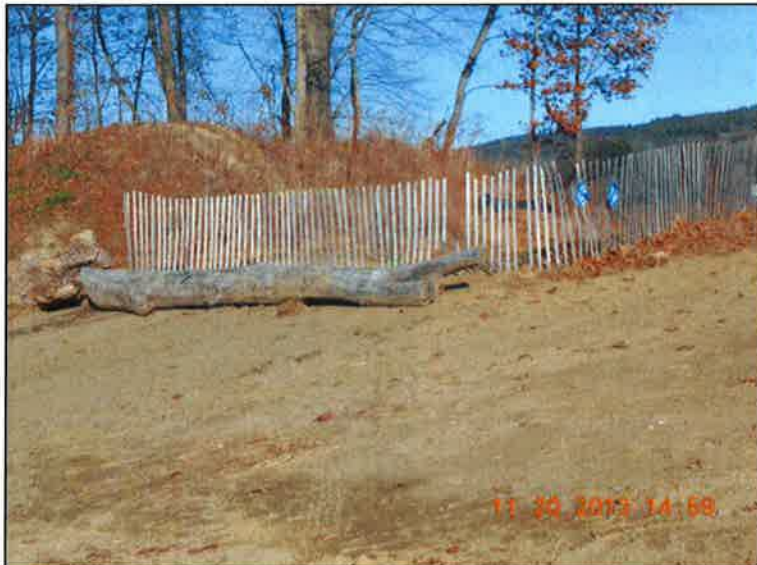
Photo 4:

A view of the closed off access
ramp.
(November 18 – 20, 2013)
