Relicensing Study 3.1.2

**Northfield Mountain / Turners Falls
Operations Impact on Existing Erosion and
Potential Bank Instability
Study Report**

**Northfield Mountain Pumped Storage Project (No. 2485) and
Turners Falls Hydroelectric Project (No. 1889)**

SEPTEMBER 2016

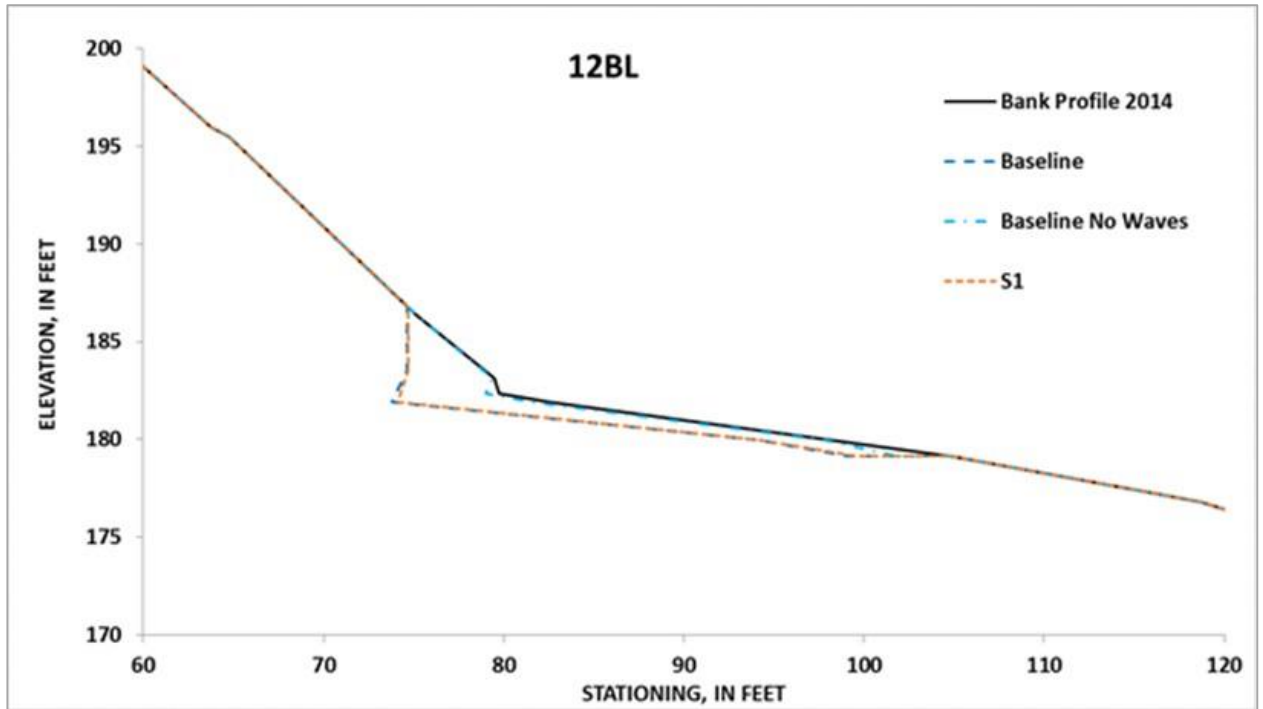
Figure 5.4.2.2-2: Example of the Important Effect of Boat Waves in the Lower TFI (Reach 1) showing the Greater amount of Hydraulic Erosion (Undercutting) between the Baseline Condition with Waves as Compared to the Baseline Condition Without Waves at Site 12BL

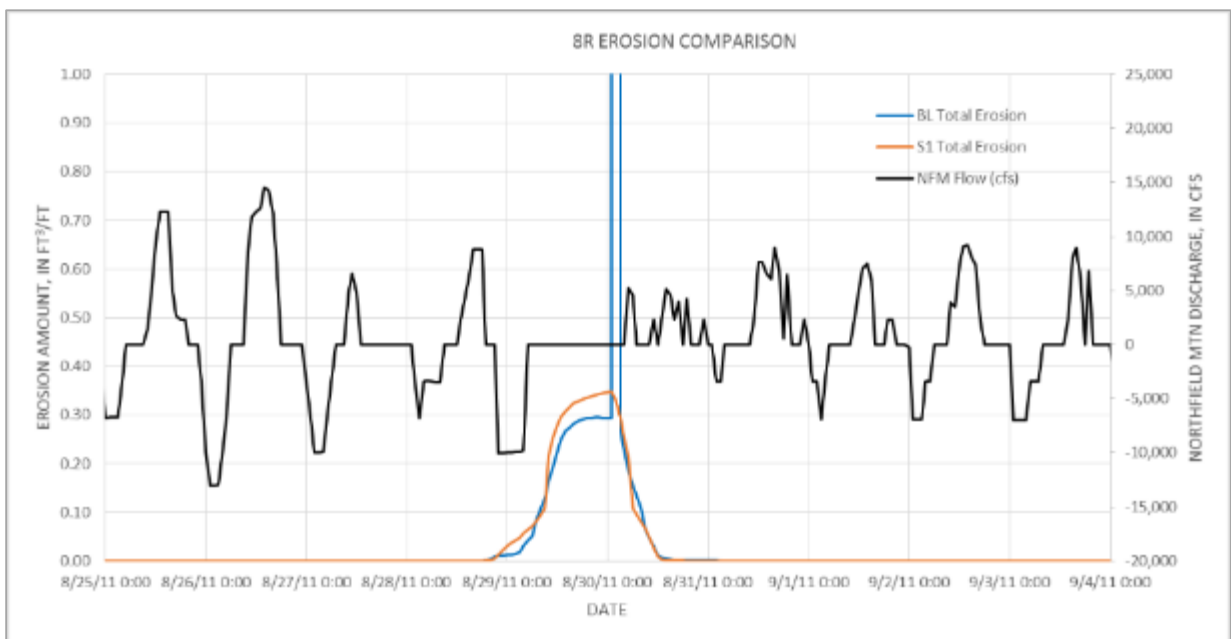
Figure 5.7.23-4 – Timing of large, geotechnical failure during Hurricane Irene for the Baseline Condition but not during Scenario 1 when NFM is idle.

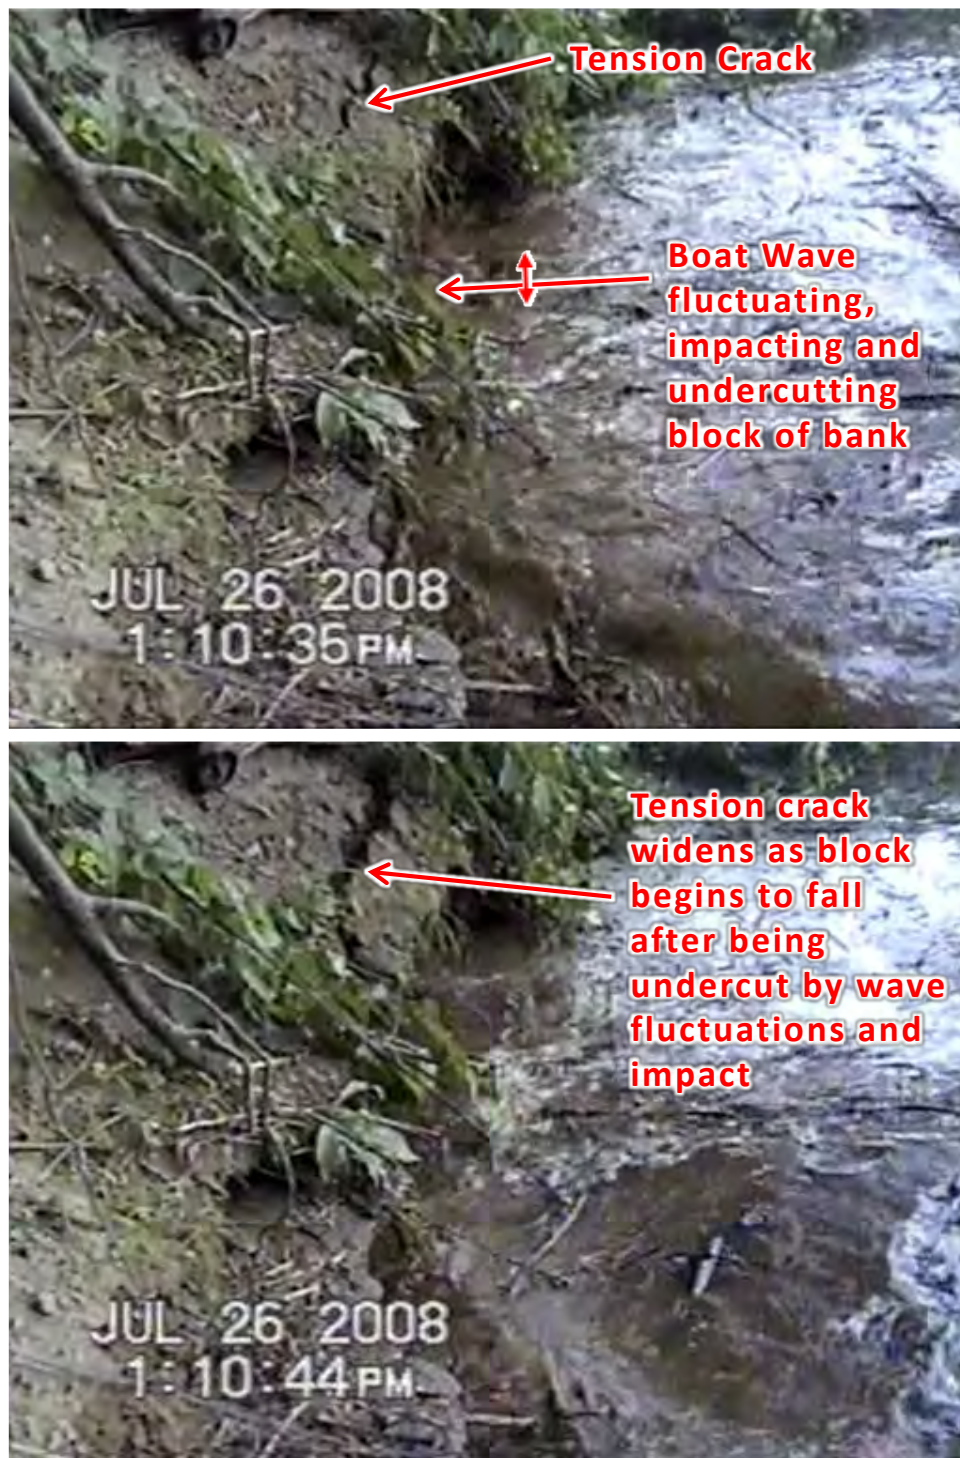
Figure 5.5.3-6a: Boat Wave Erosion Sequence

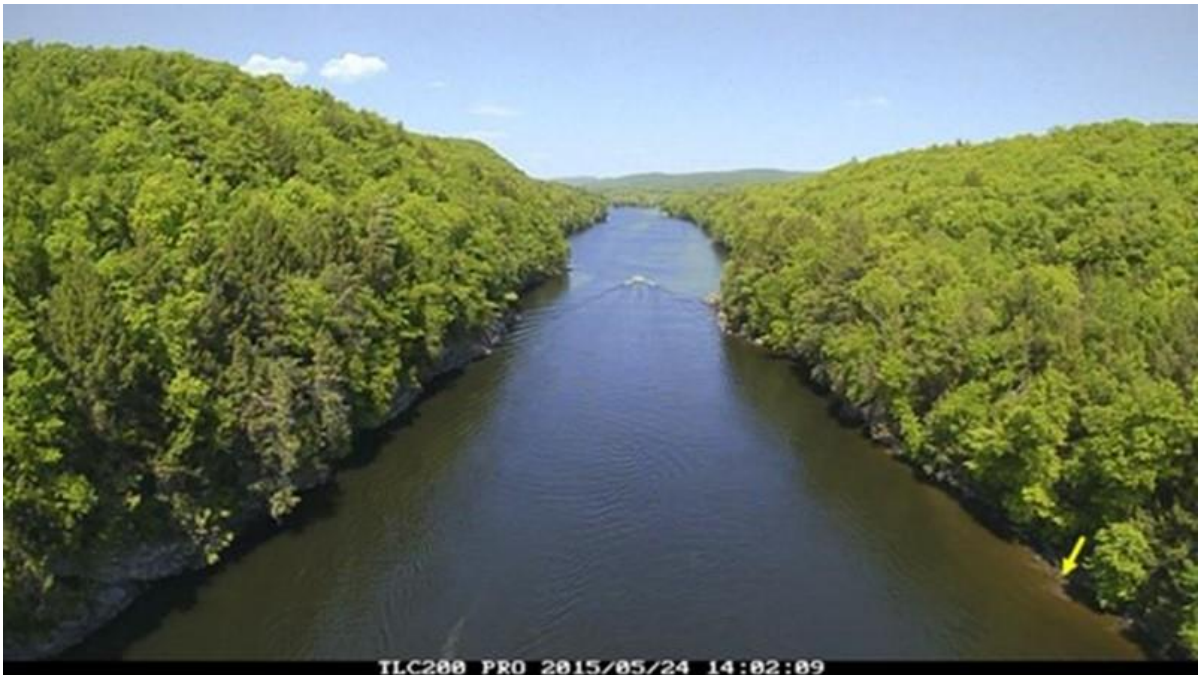
Figure 5.5.3-9: Plume of Suspended Sediment Begins from Bank Erosion Induced by Waves

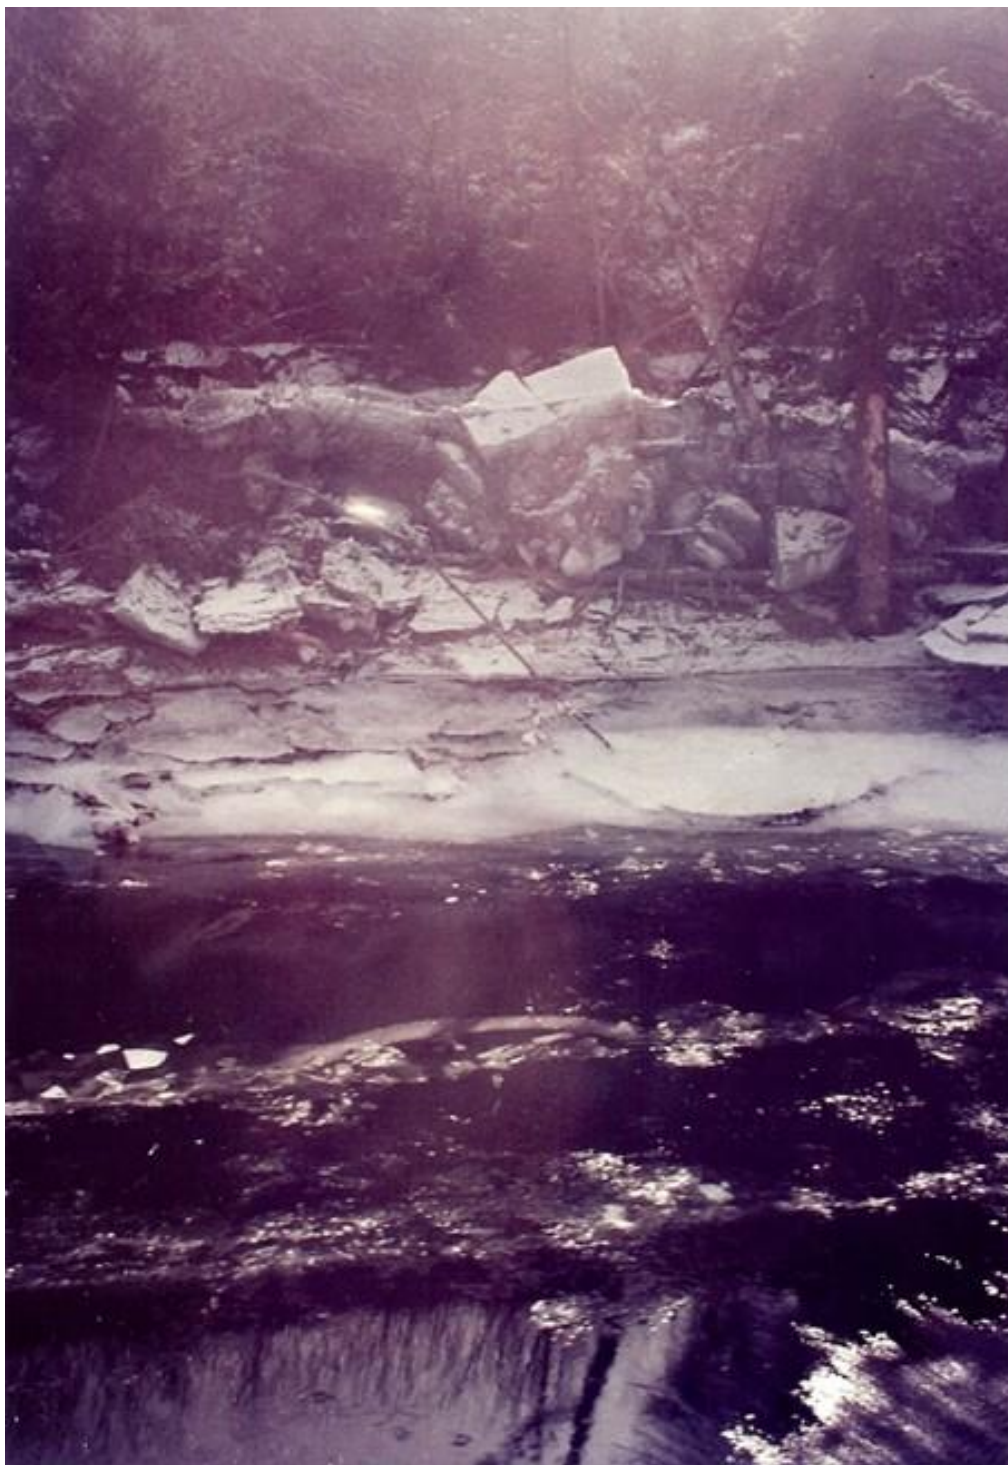
Figure 5.5.5.3-3 Ice Damage to Riparian Vegetation in the Bellows Falls Impoundment – 1992
