Relicensing Study 3.1.2

**Northfield Mountain / Turners Falls
Operations Impact on Existing Erosion and
Potential Bank Instability
Study Report**

Volume II – Main Report

**Northfield Mountain Pumped Storage Project (No. 2485) and
Turners Falls Hydroelectric Project (No. 1889)**

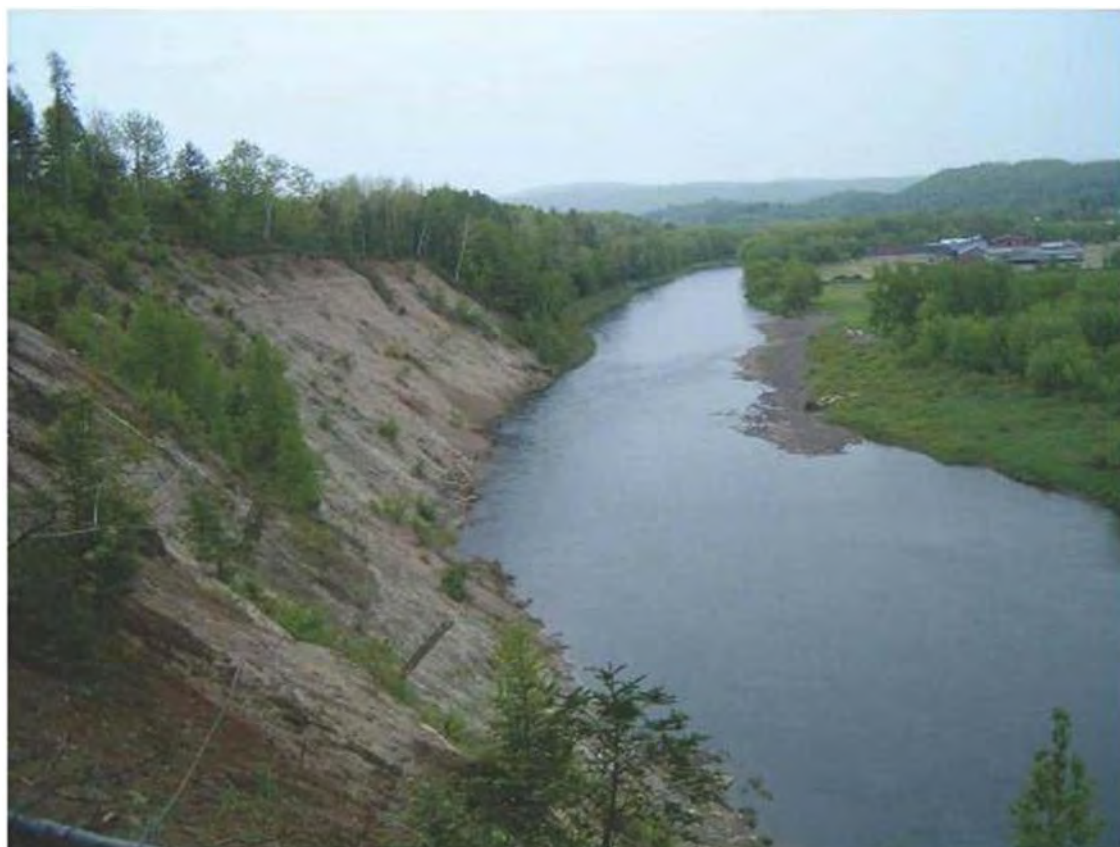
The erosion sites identified in 1997 were revisited in 2008 to photographically document any changes that might have occurred since 1997. Sets of photographs showing 1997 and 2008 images at the same sites are presented in [Figures 2.5-5](#) and [2.5-6](#) for the Bellows Falls Impoundment; Vernon – [Figures 2.5-7](#) and [2.5-8](#); and Holyoke – [Figures 2.5-9](#) and [2.5-10](#). For these three impoundments, erosion sites in 1997 were observed to be in the same eroding condition in 2008.

Note: Near Brunswick Springs, VT

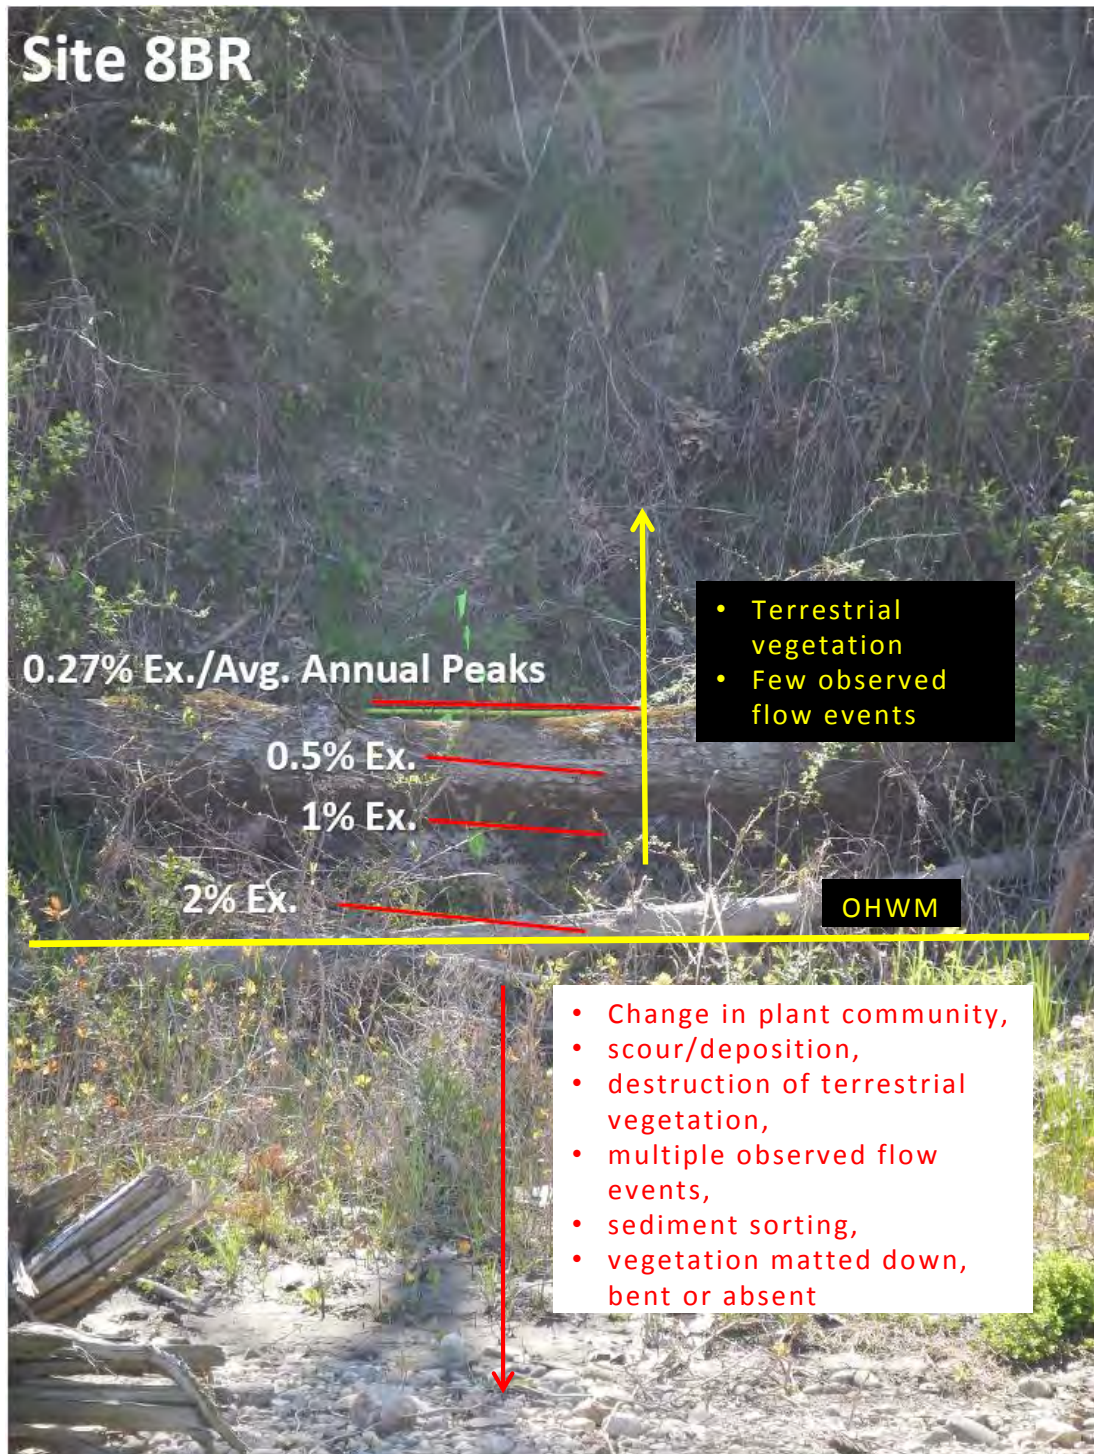
Figure 4.2.4.1-2. Physical characteristics of OHWM at Site 8BR

Photographs of the riverbanks at a number of sites along the TFI were then labeled with observed physical characteristics as well as a range of water levels from the water level-duration analysis to help determine which statistical measure should be used to define an appropriate water level to represent the ordinary high water mark ([Figures 4.2.4.1-2](#) through [4.2.4.1-8](#)). These figures show the OHWM which is marked as a horizontal yellow line, with physical characteristics labeled above and below the OHWM as observed at each site. At many of these sites there are multiple physical characteristics that identify the OHWM, while at some there are none visible since they are below water.

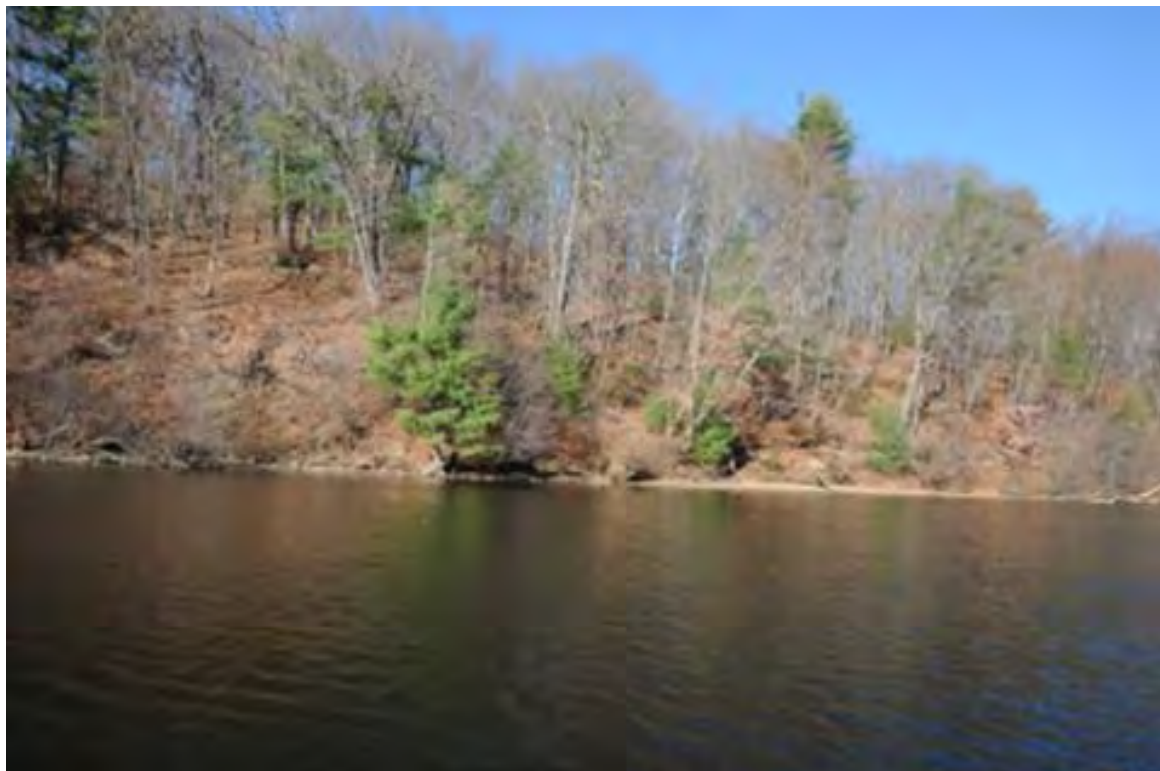
Figure 5.4.3.27-1 Photos at site 9R Pre Restoration (Photo from 2013 FRR)

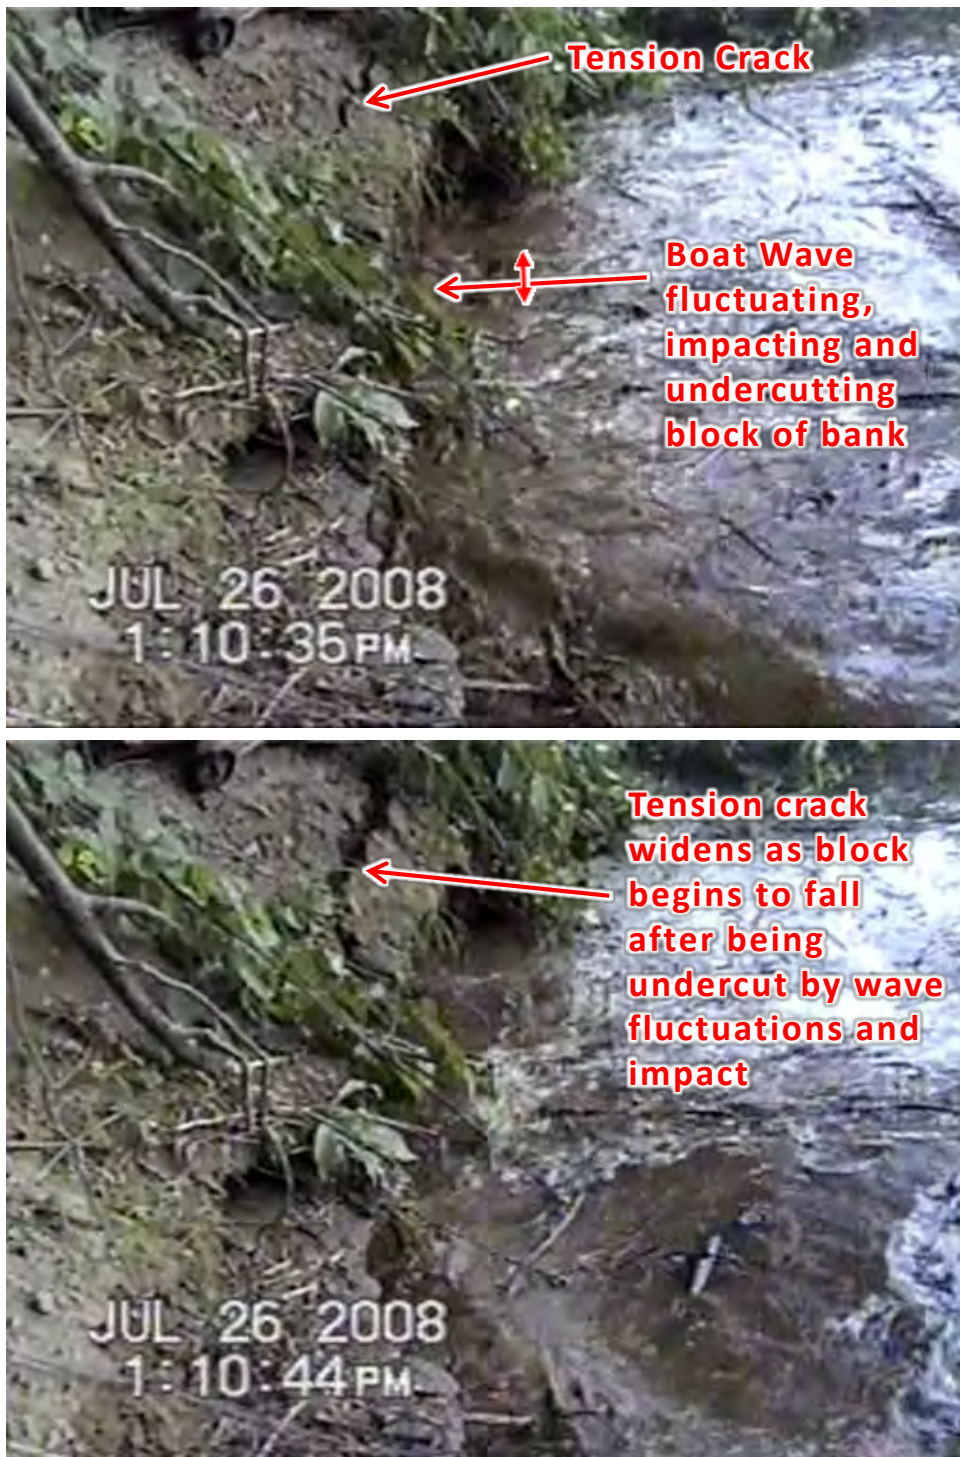
Figure 5.5.3-6a: Boat Wave Erosion Sequence

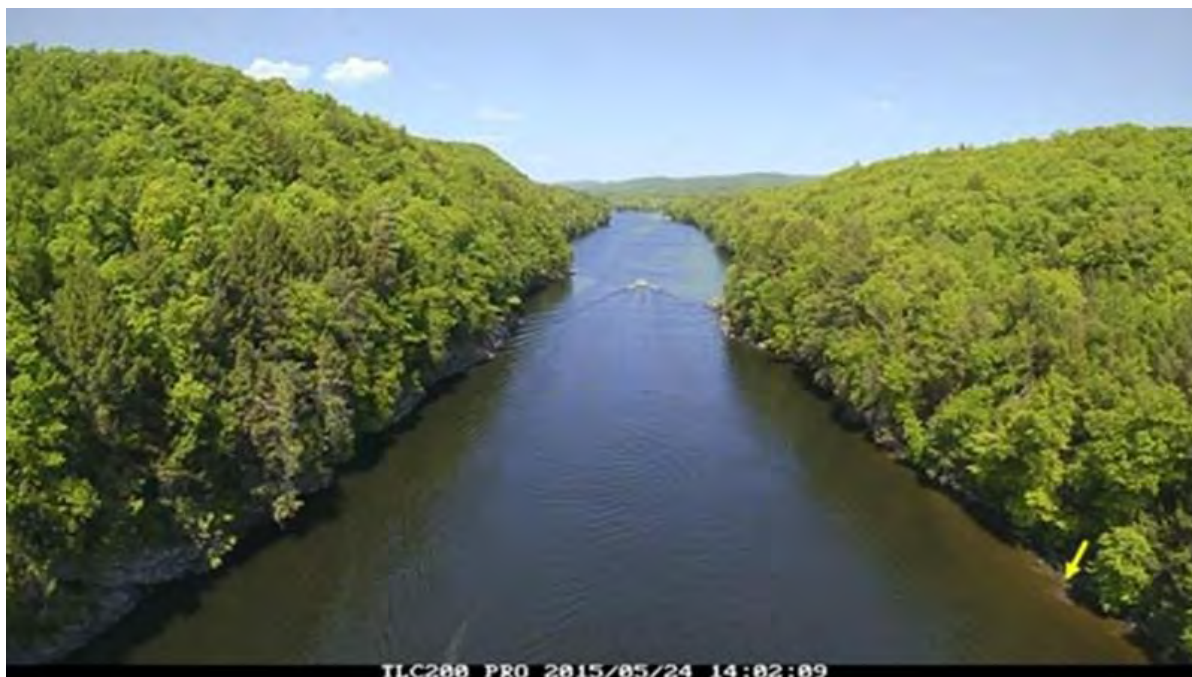
Figure 5.5.3-9: Plume of Suspended Sediment Begins from Bank Erosion Induced by Waves

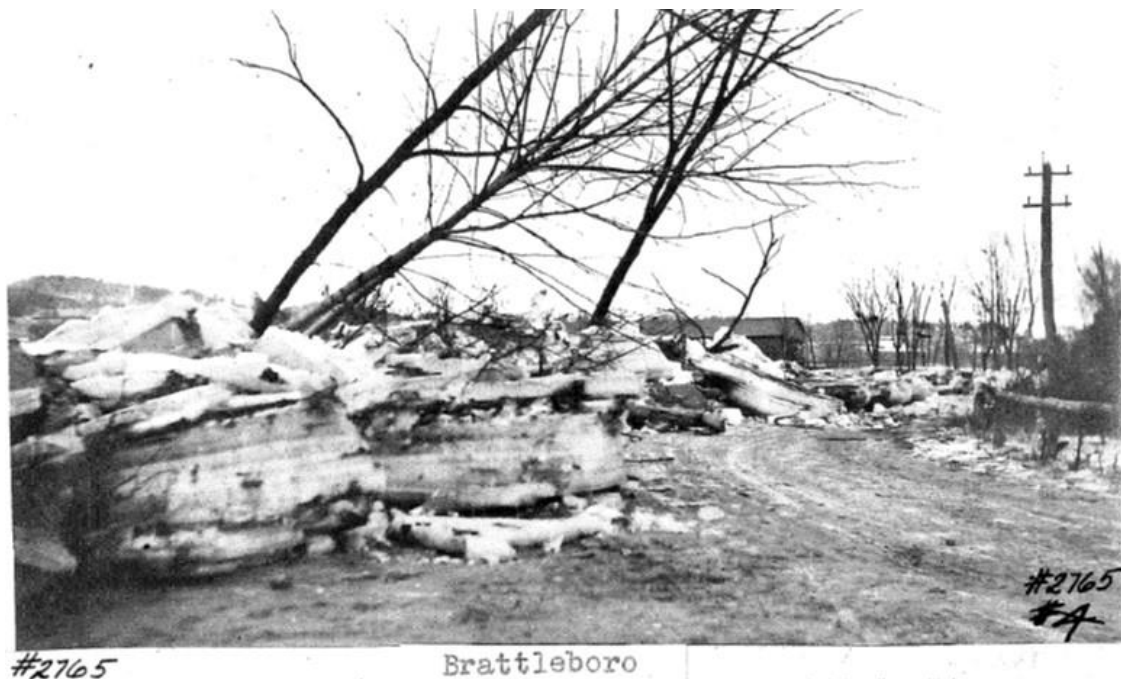
Figure 5.5.5.2-3 Ice along riverbanks showing damage to trees, 1915 (after TransCanada)

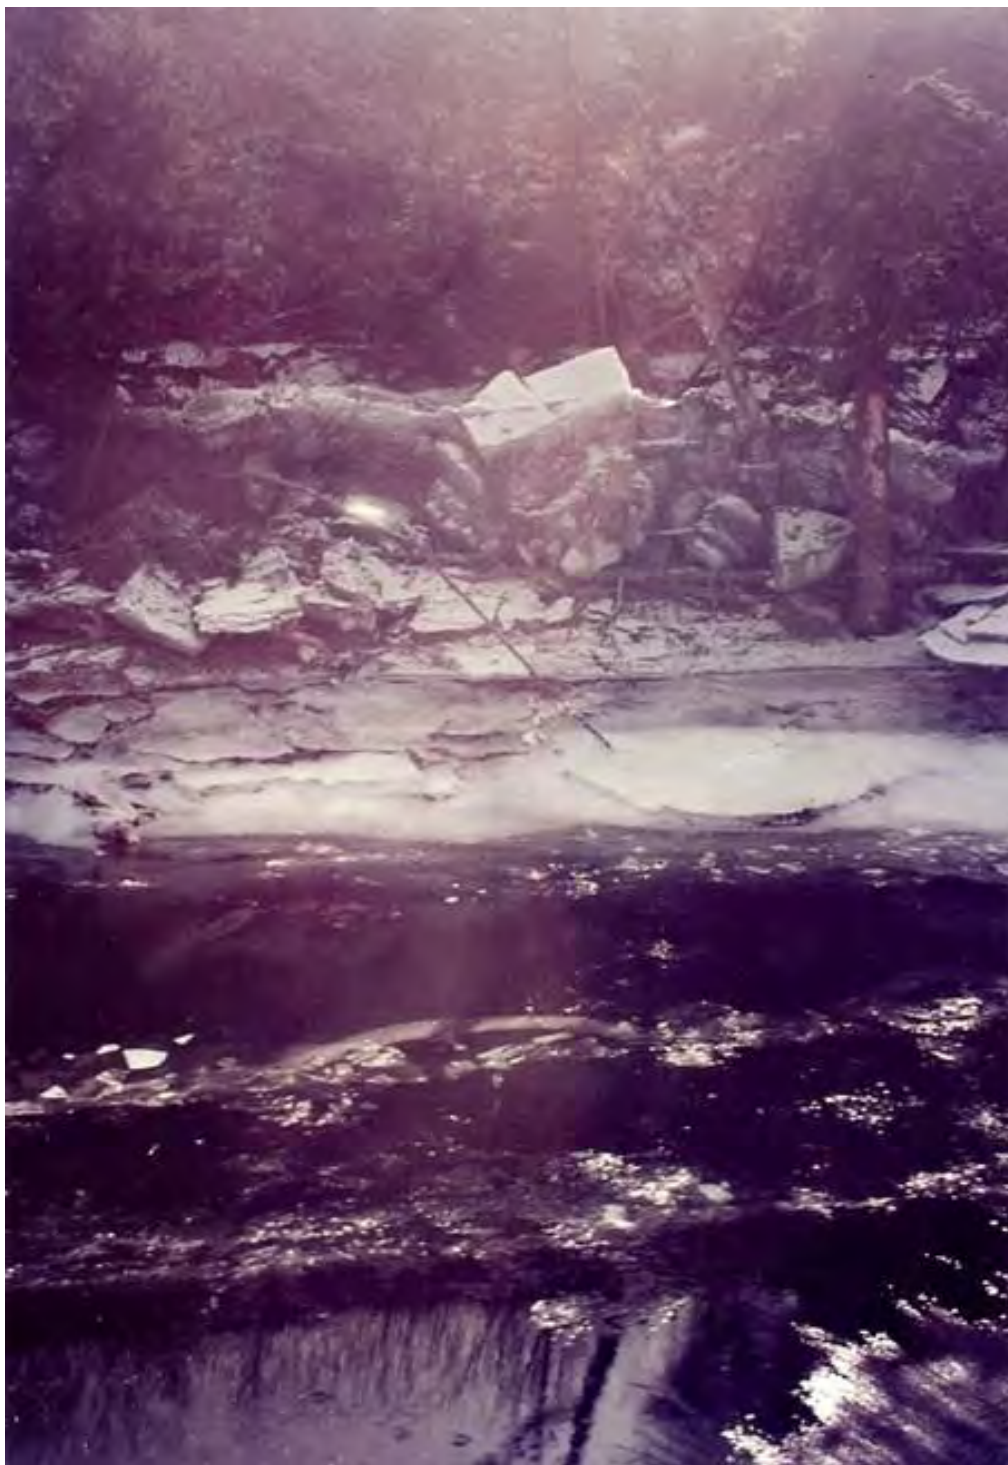
Figure 5.5.5.3-3 Ice Damage to Riparian Vegetation in the Bellows Falls Impoundment – 1992

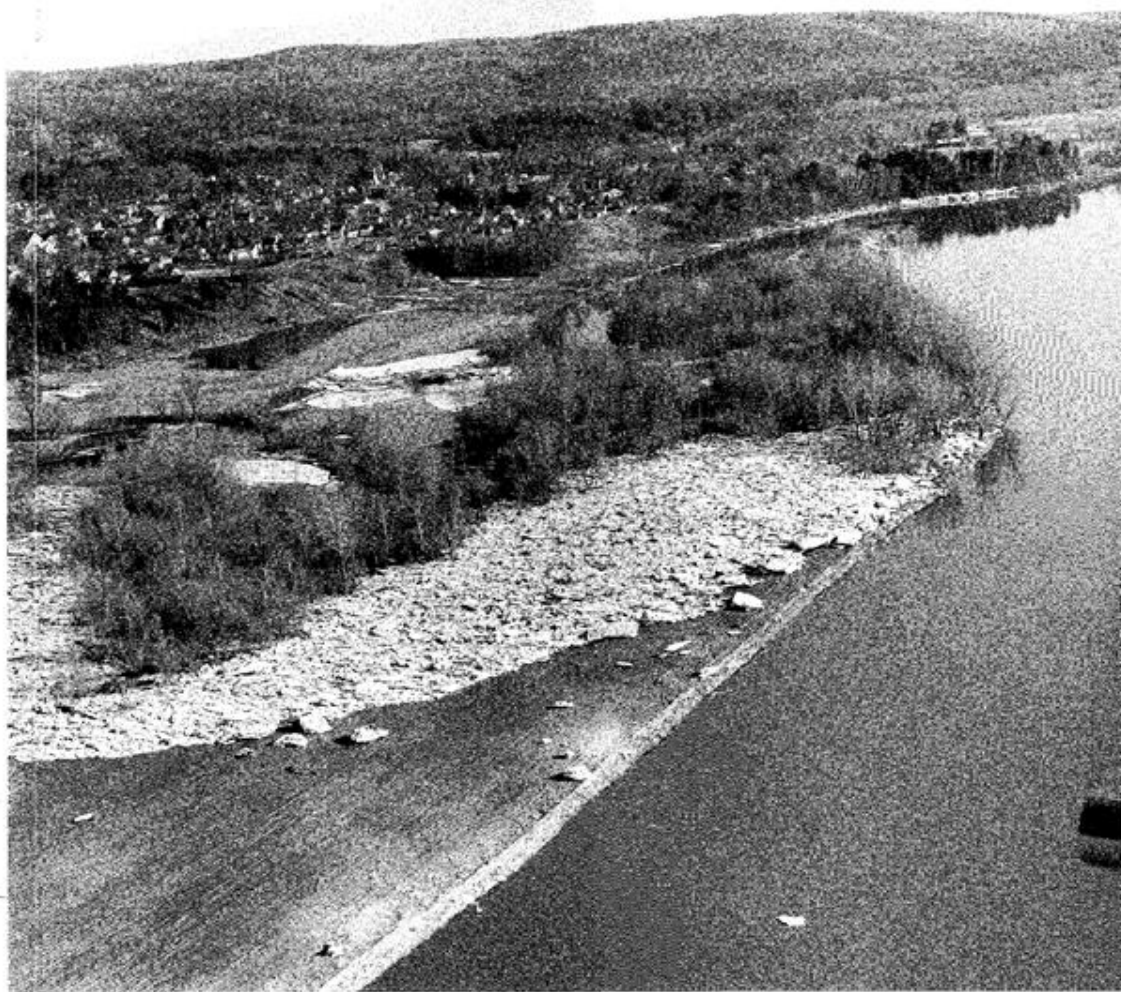
Figure 5.5.5.5-24 Ice and erosion damage, 1968
