Riverbank Erosion Comparison along the Connecticut River

October 2012

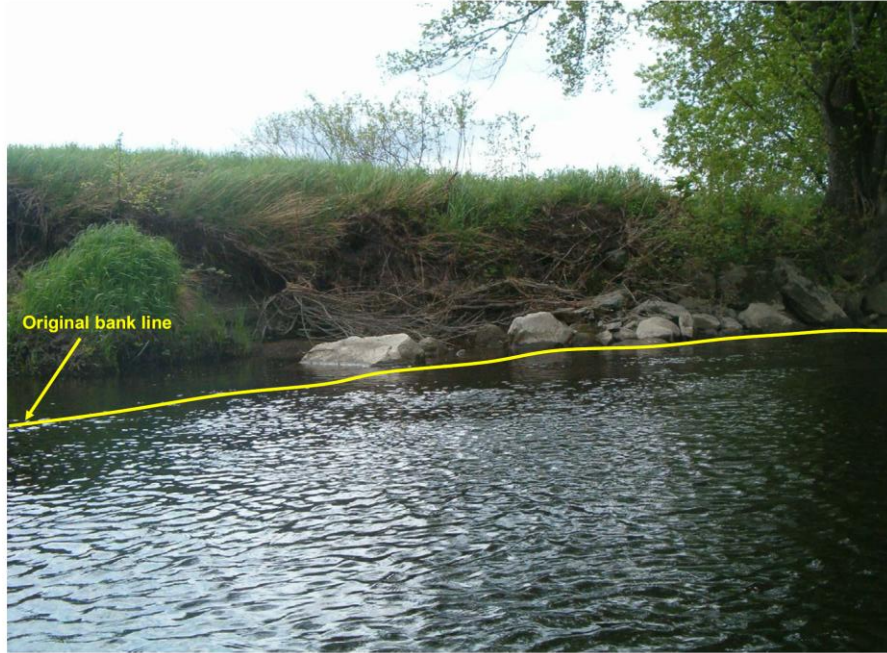
Old Riprap Failing Along Straightened Channel

Note: In Reach 14

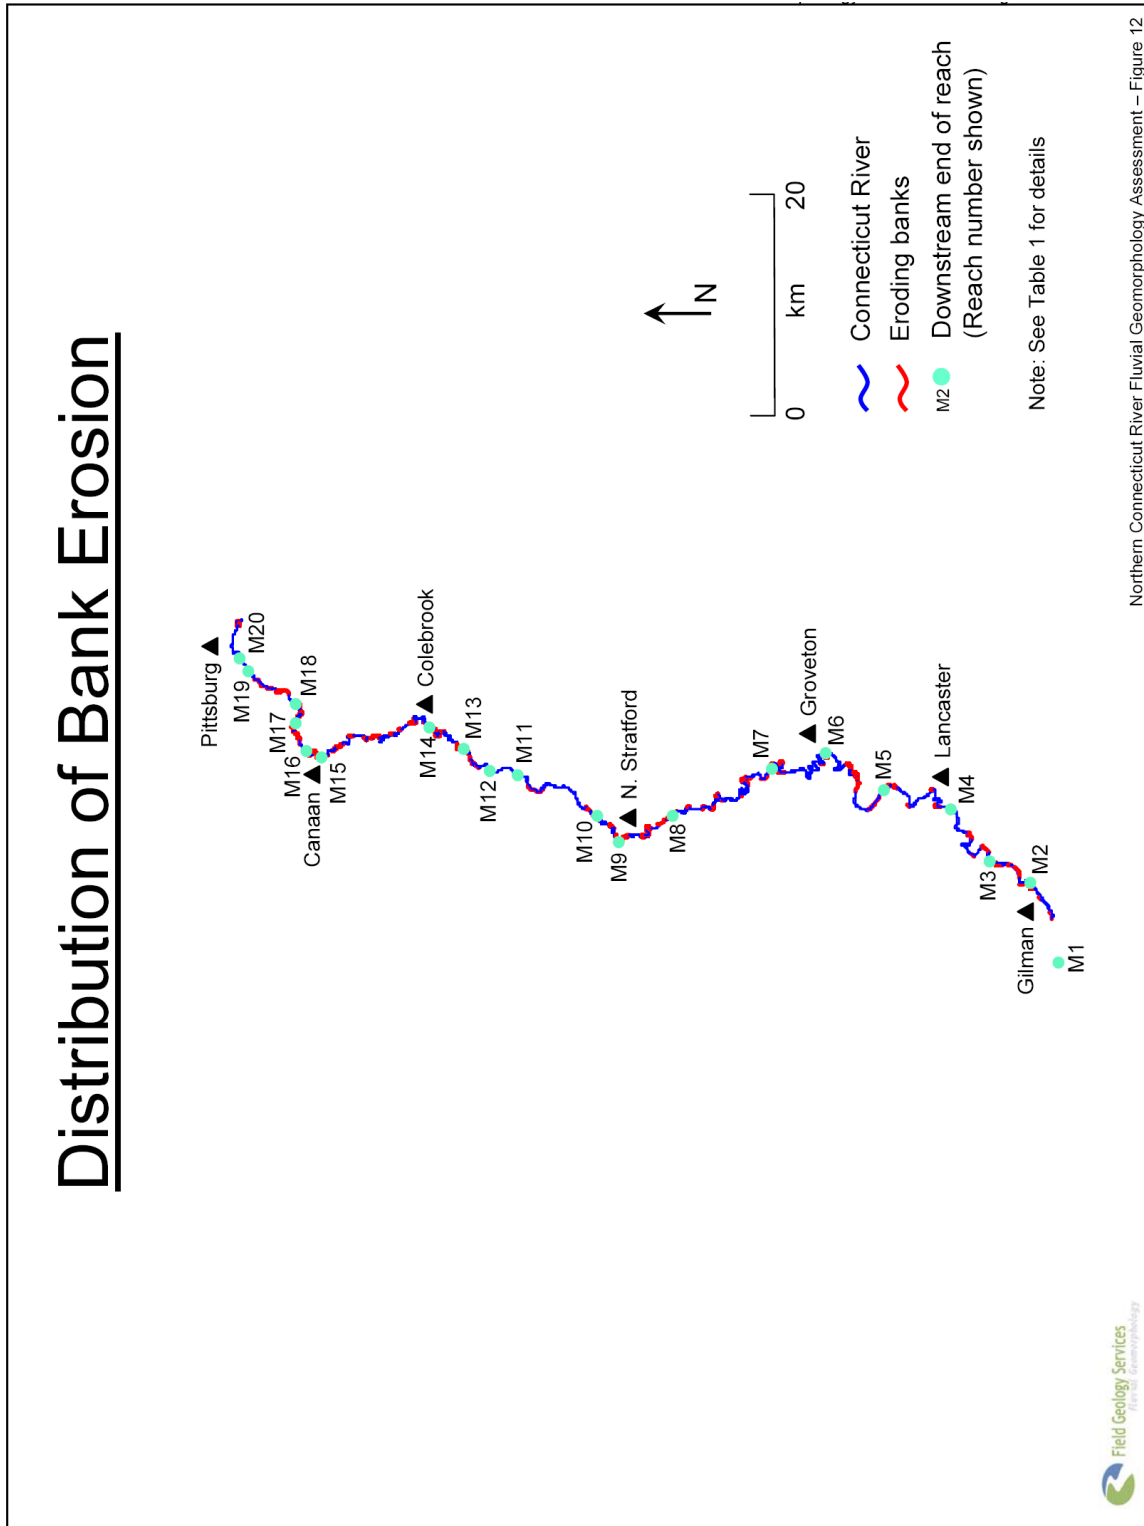
Figure 9. Riverbank erosion – Pittsburg to Gilman (after Field, 2004)

The distribution of riverbank erosion through this reach was summarized by Field as shown in Figure 9; eroding banks are shown in red.

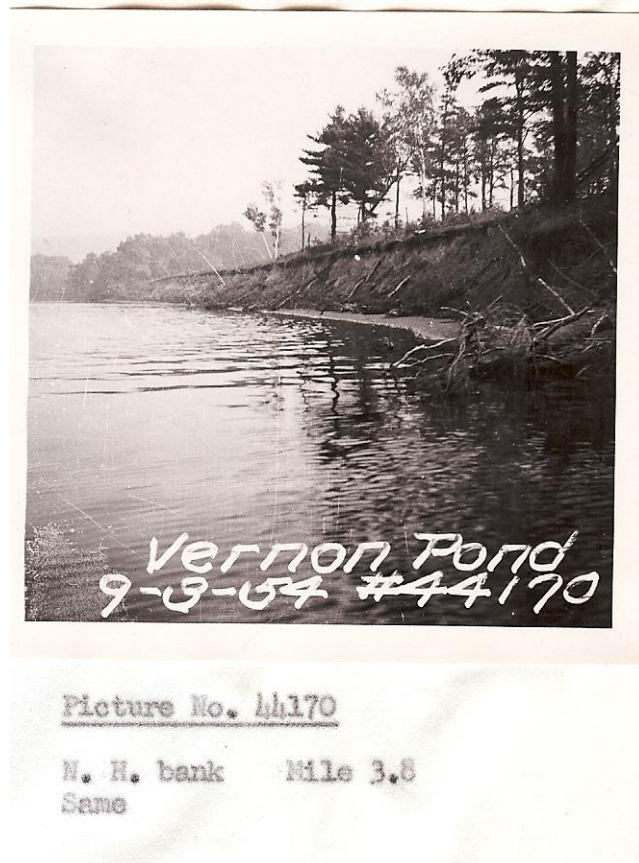
Figure 15. Erosion in Vernon Pool, 1954

As listed in available references, the power company that was operating the Vernon Station during the 1950s documented erosion in the Vernon Impoundment on a periodic basis. The 1954 document discusses and shows about 50 erosion sites that were photographed. Apparently, they were monitoring erosion sites along the Vernon Impoundment over time and documenting them by noting changes and taking photographs. Figure 15 presents an example of an erosion site taken by the Connecticut River Power Company in 1954. Other examples are found in Appendix F. The existence of this document shows that erosion has been an issue of concern for over half a century.

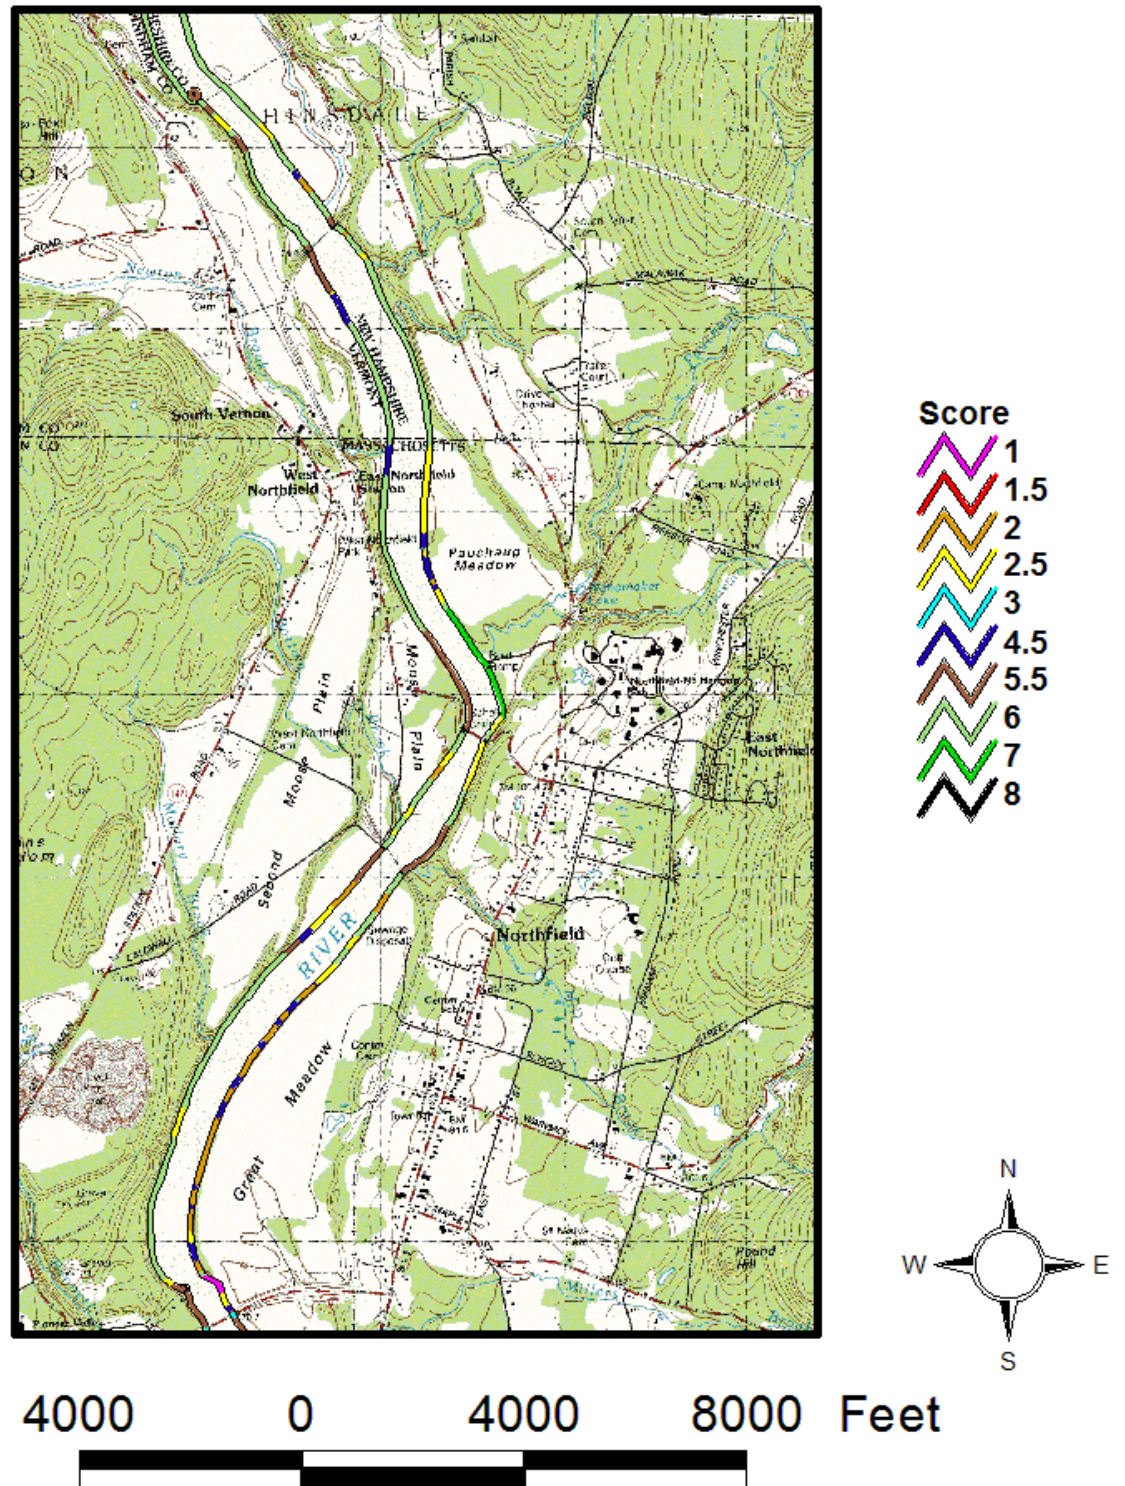
Figure 16. Example of Full River Reconnaissance Map – Turners Falls Impoundment

Results of the 2008 FRR showed that 83.3% of the riverbanks showed little to no erosion, while some erosion was found for 16.1% of the reach and extensive erosion was found in 0.6% of the Turners Falls Impoundment.

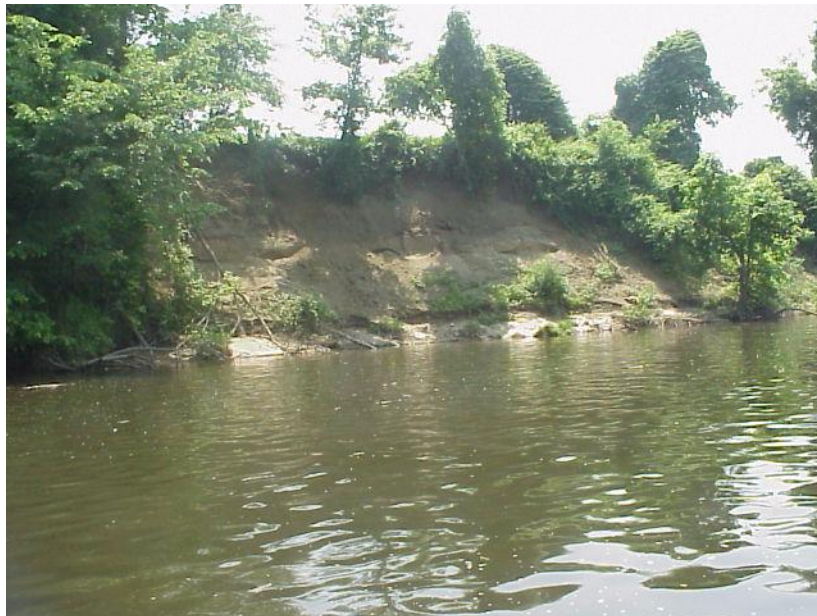
Site 6 – Skalski, prior to 2004

Photographs are available at several erosion sites in the Turners Falls Impoundment taken before and after riverbank stabilization projects that have occurred with implementation of the ECP. Many of the erosion sites identified in the ECP have been stabilized by a range of measures including placement of rock at the toe of the slope, coir logs, placement of large woody debris, various fabrics, and planting of vegetation including riparian and aquatic. Some re-shaping of riverbanks has also been conducted at some sites. An example of the transformation from an unstable, eroding riverbank to a stabilized riverbank is shown in Figure 17. As shown by this comparison of photos from before 2004 to 2008, the eroding bank has been stabilized by placing relatively small rock at the toe of the slope and planting vegetation above the rock on the formerly eroded bank. The 2008 photo shows the transformation from erosion to stability accomplished by this effort. Appendix H provides other examples of riverbank stabilization efforts in the Turners Falls Impoundment. From the commencement of implementation of the ECP to the present, approximately 14,000 feet of riverbank have been stabilized in the Turners Falls Impoundment.

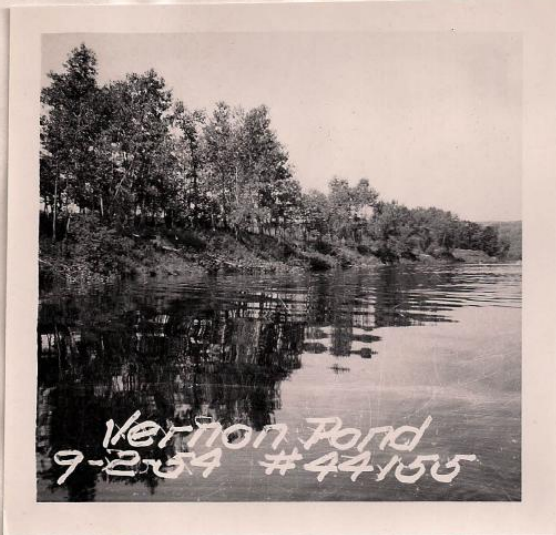
Vernon Pond
9-2-54 #44155

Vt. bank Mile 22.4
Same
Looking at bank below mouth to
gully caused by swirl pool

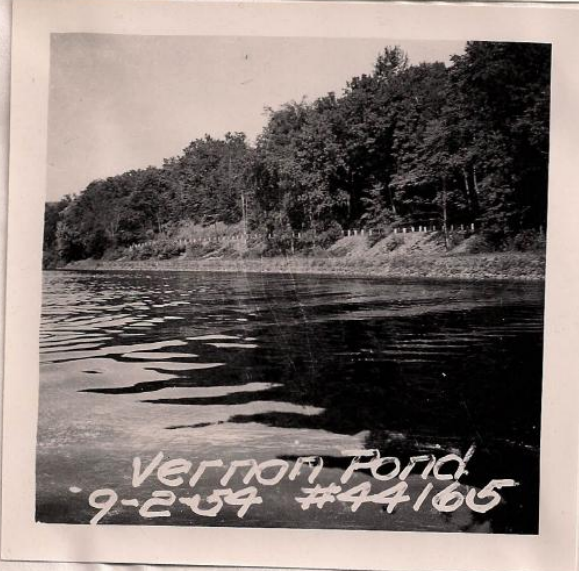
Picture No. 44165

N. H. bank
Mile 11.8
West Chesterfield Road
Repairs
V-192

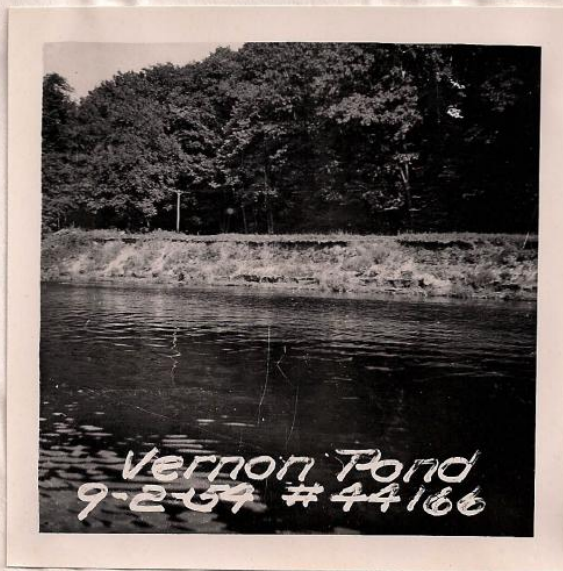
Picture No. 44166

N. H. bank
Mile 11.6
C. T. Chase
V-191
