Re: Filing of Addendum to Study No. 3.1.1- 2013 Full River Reconnaissance  
Turners Falls Hydroelectric Project (FERC No. 1889) and Northfield Mountain Pumped Storage  
Project (FERC No. 2485)

## **ATTACHMENT A: 2013 Full River Reconnaissance – 2015 Addendum: Riverbank Segment QA Comparison**

2015 FRR Addendum  
 Selected Riverbank Segments for QA  
 Map 1

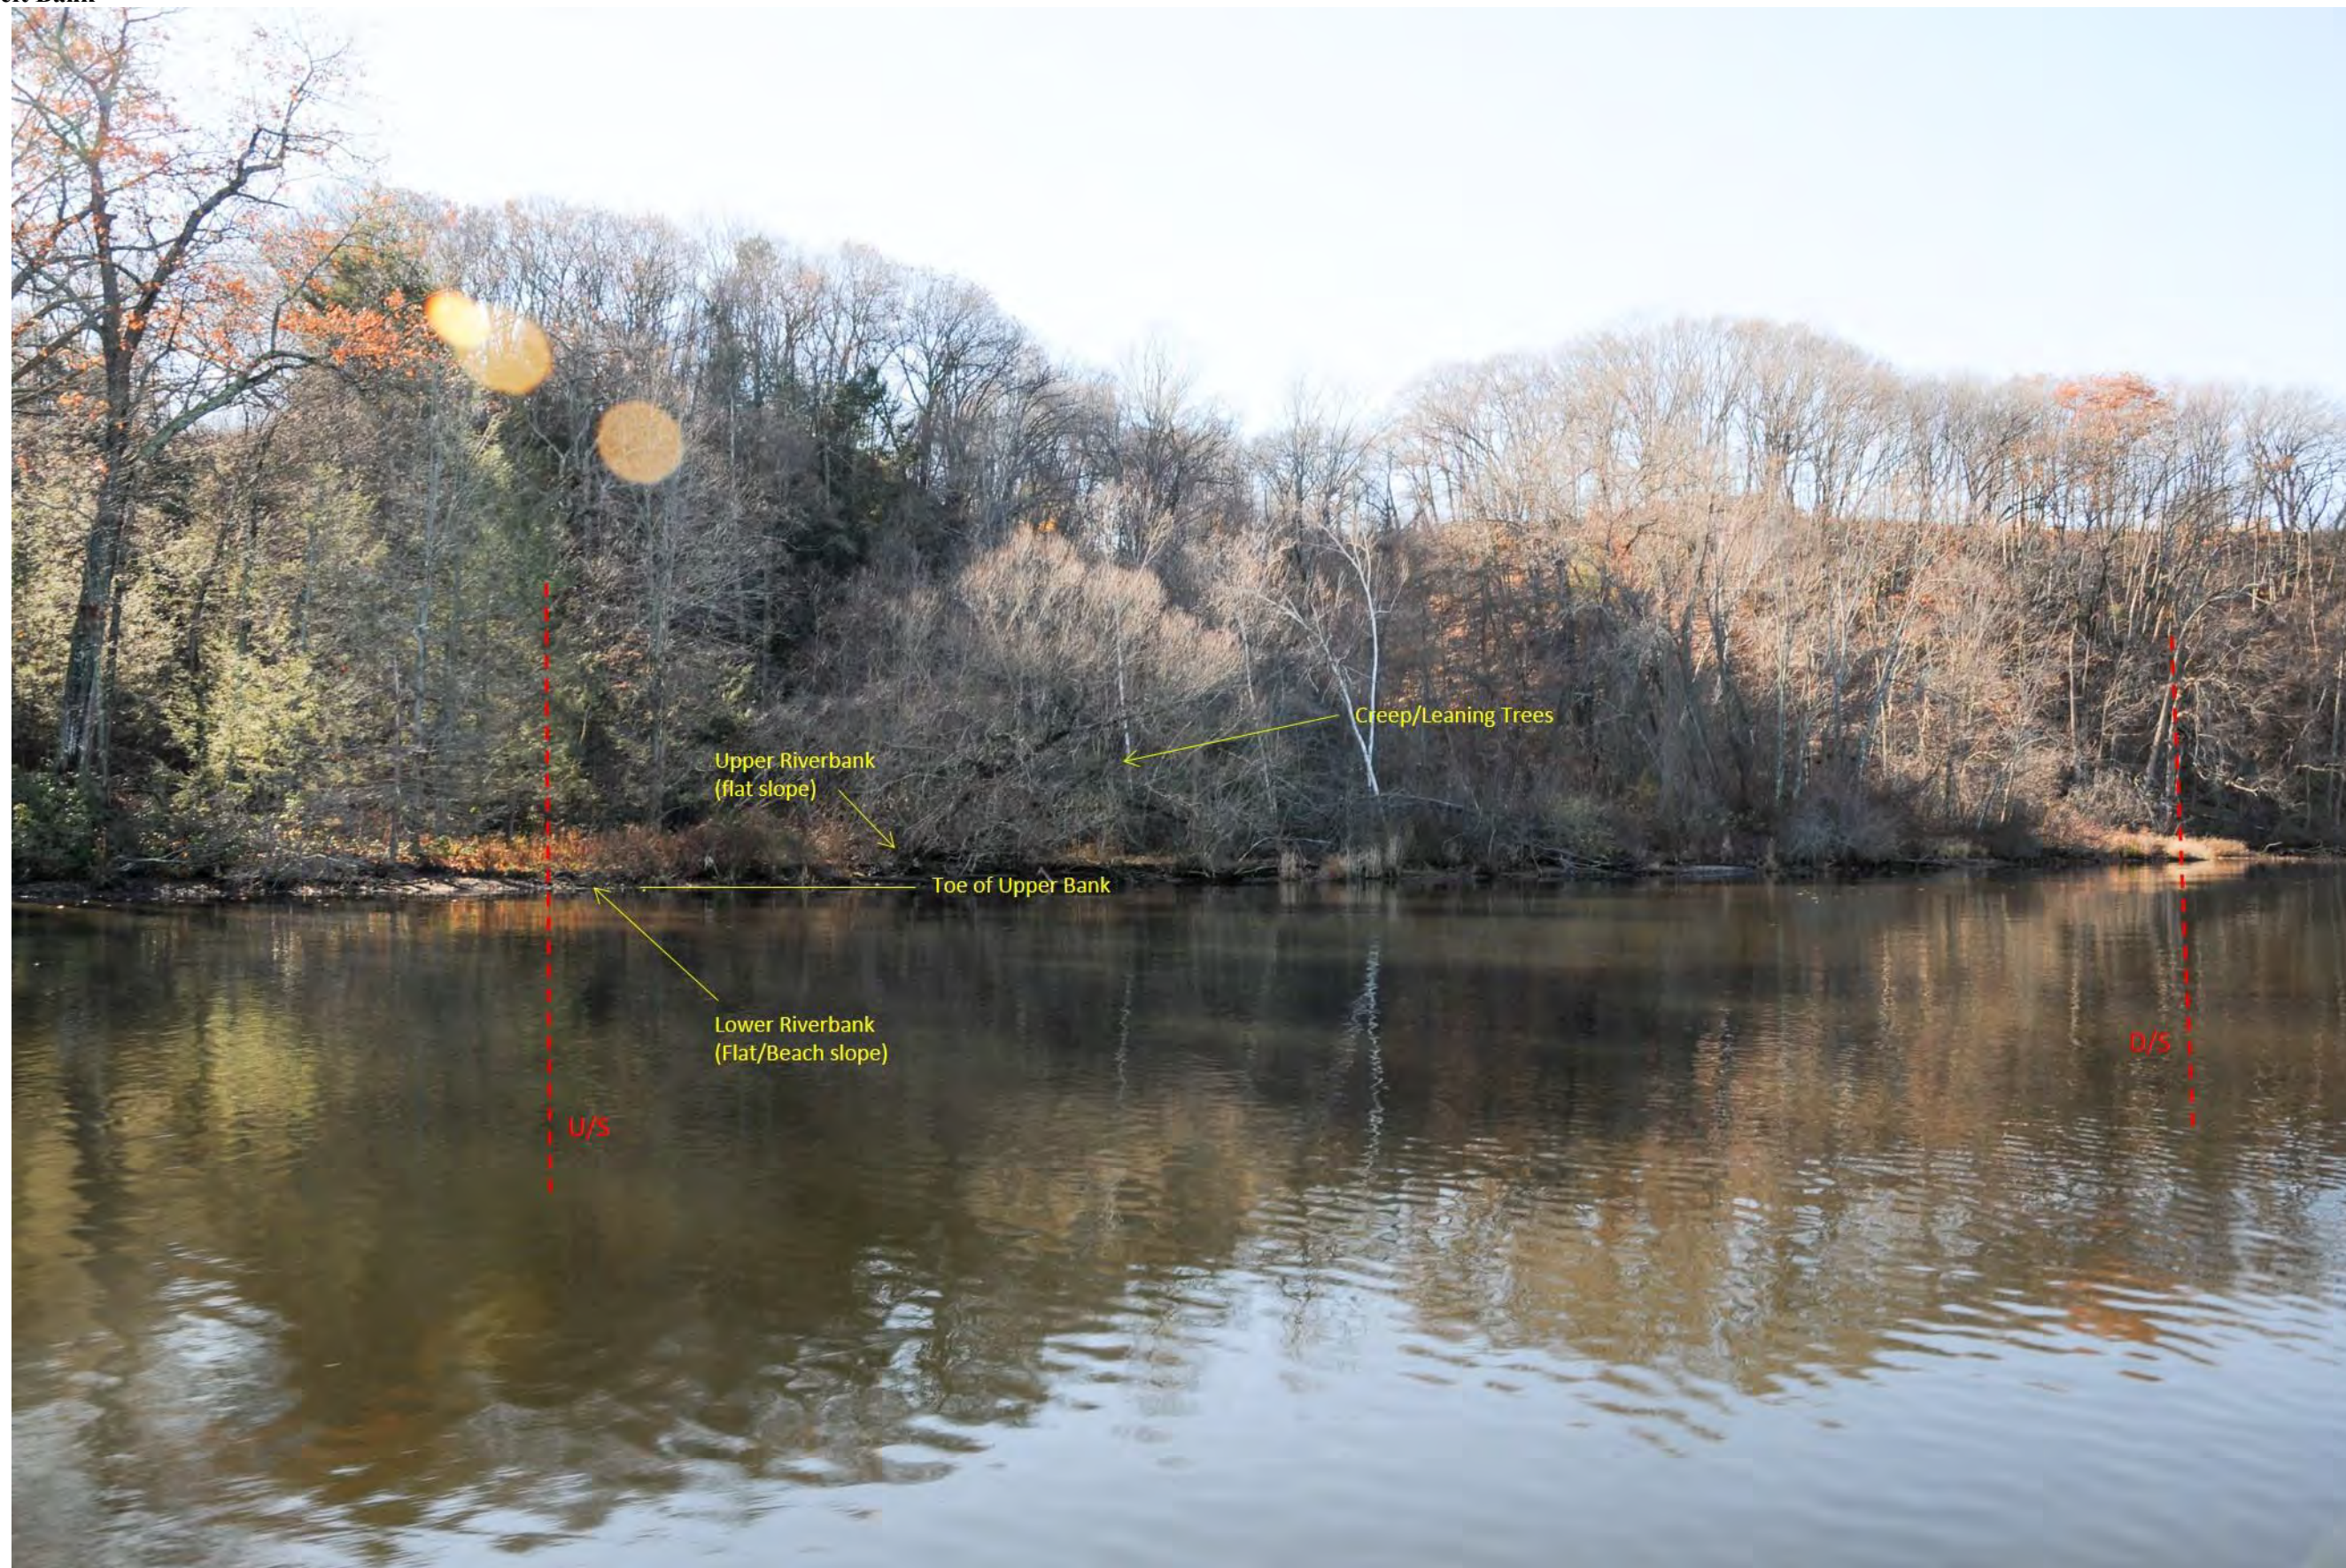
Photo ID 259 (photo covers segment)

**QA Observations:** Upon review of the photos for this segment, classification made in the field was confirmed.

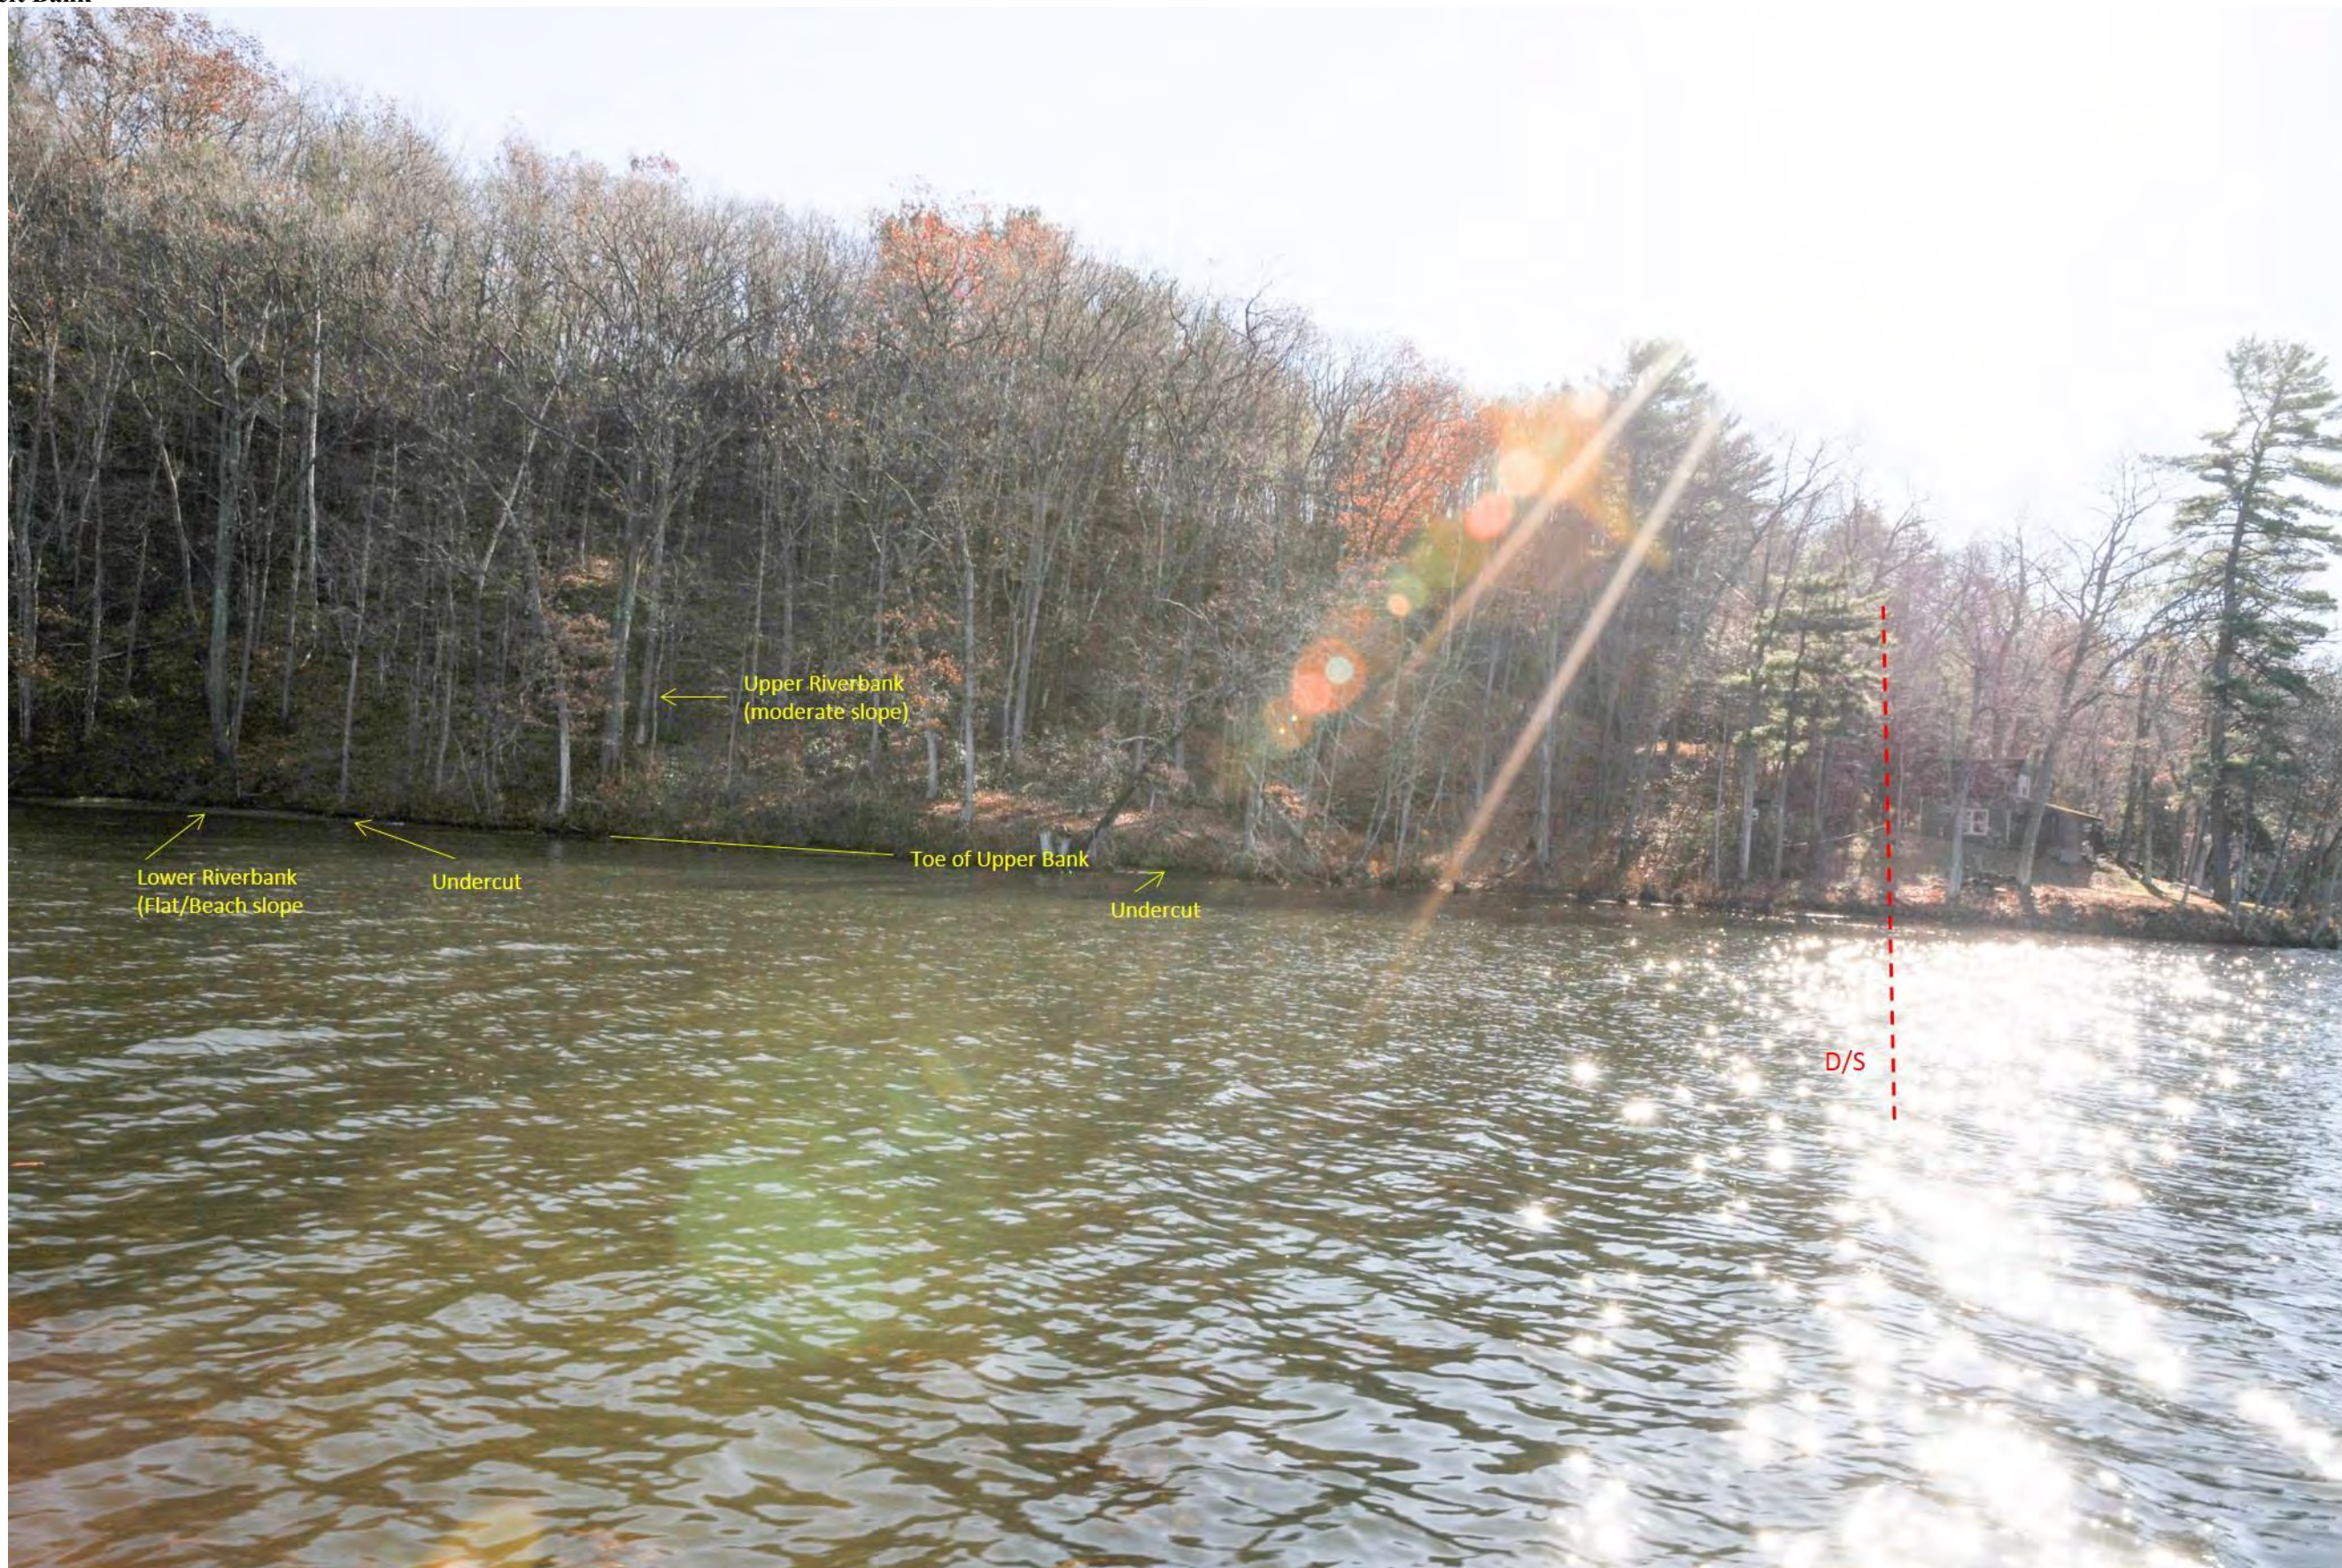
Photo ID 231 (D/S, left of line)

**QA Observations:** Upon review of the photos for this segment, classification made in the field was confirmed.

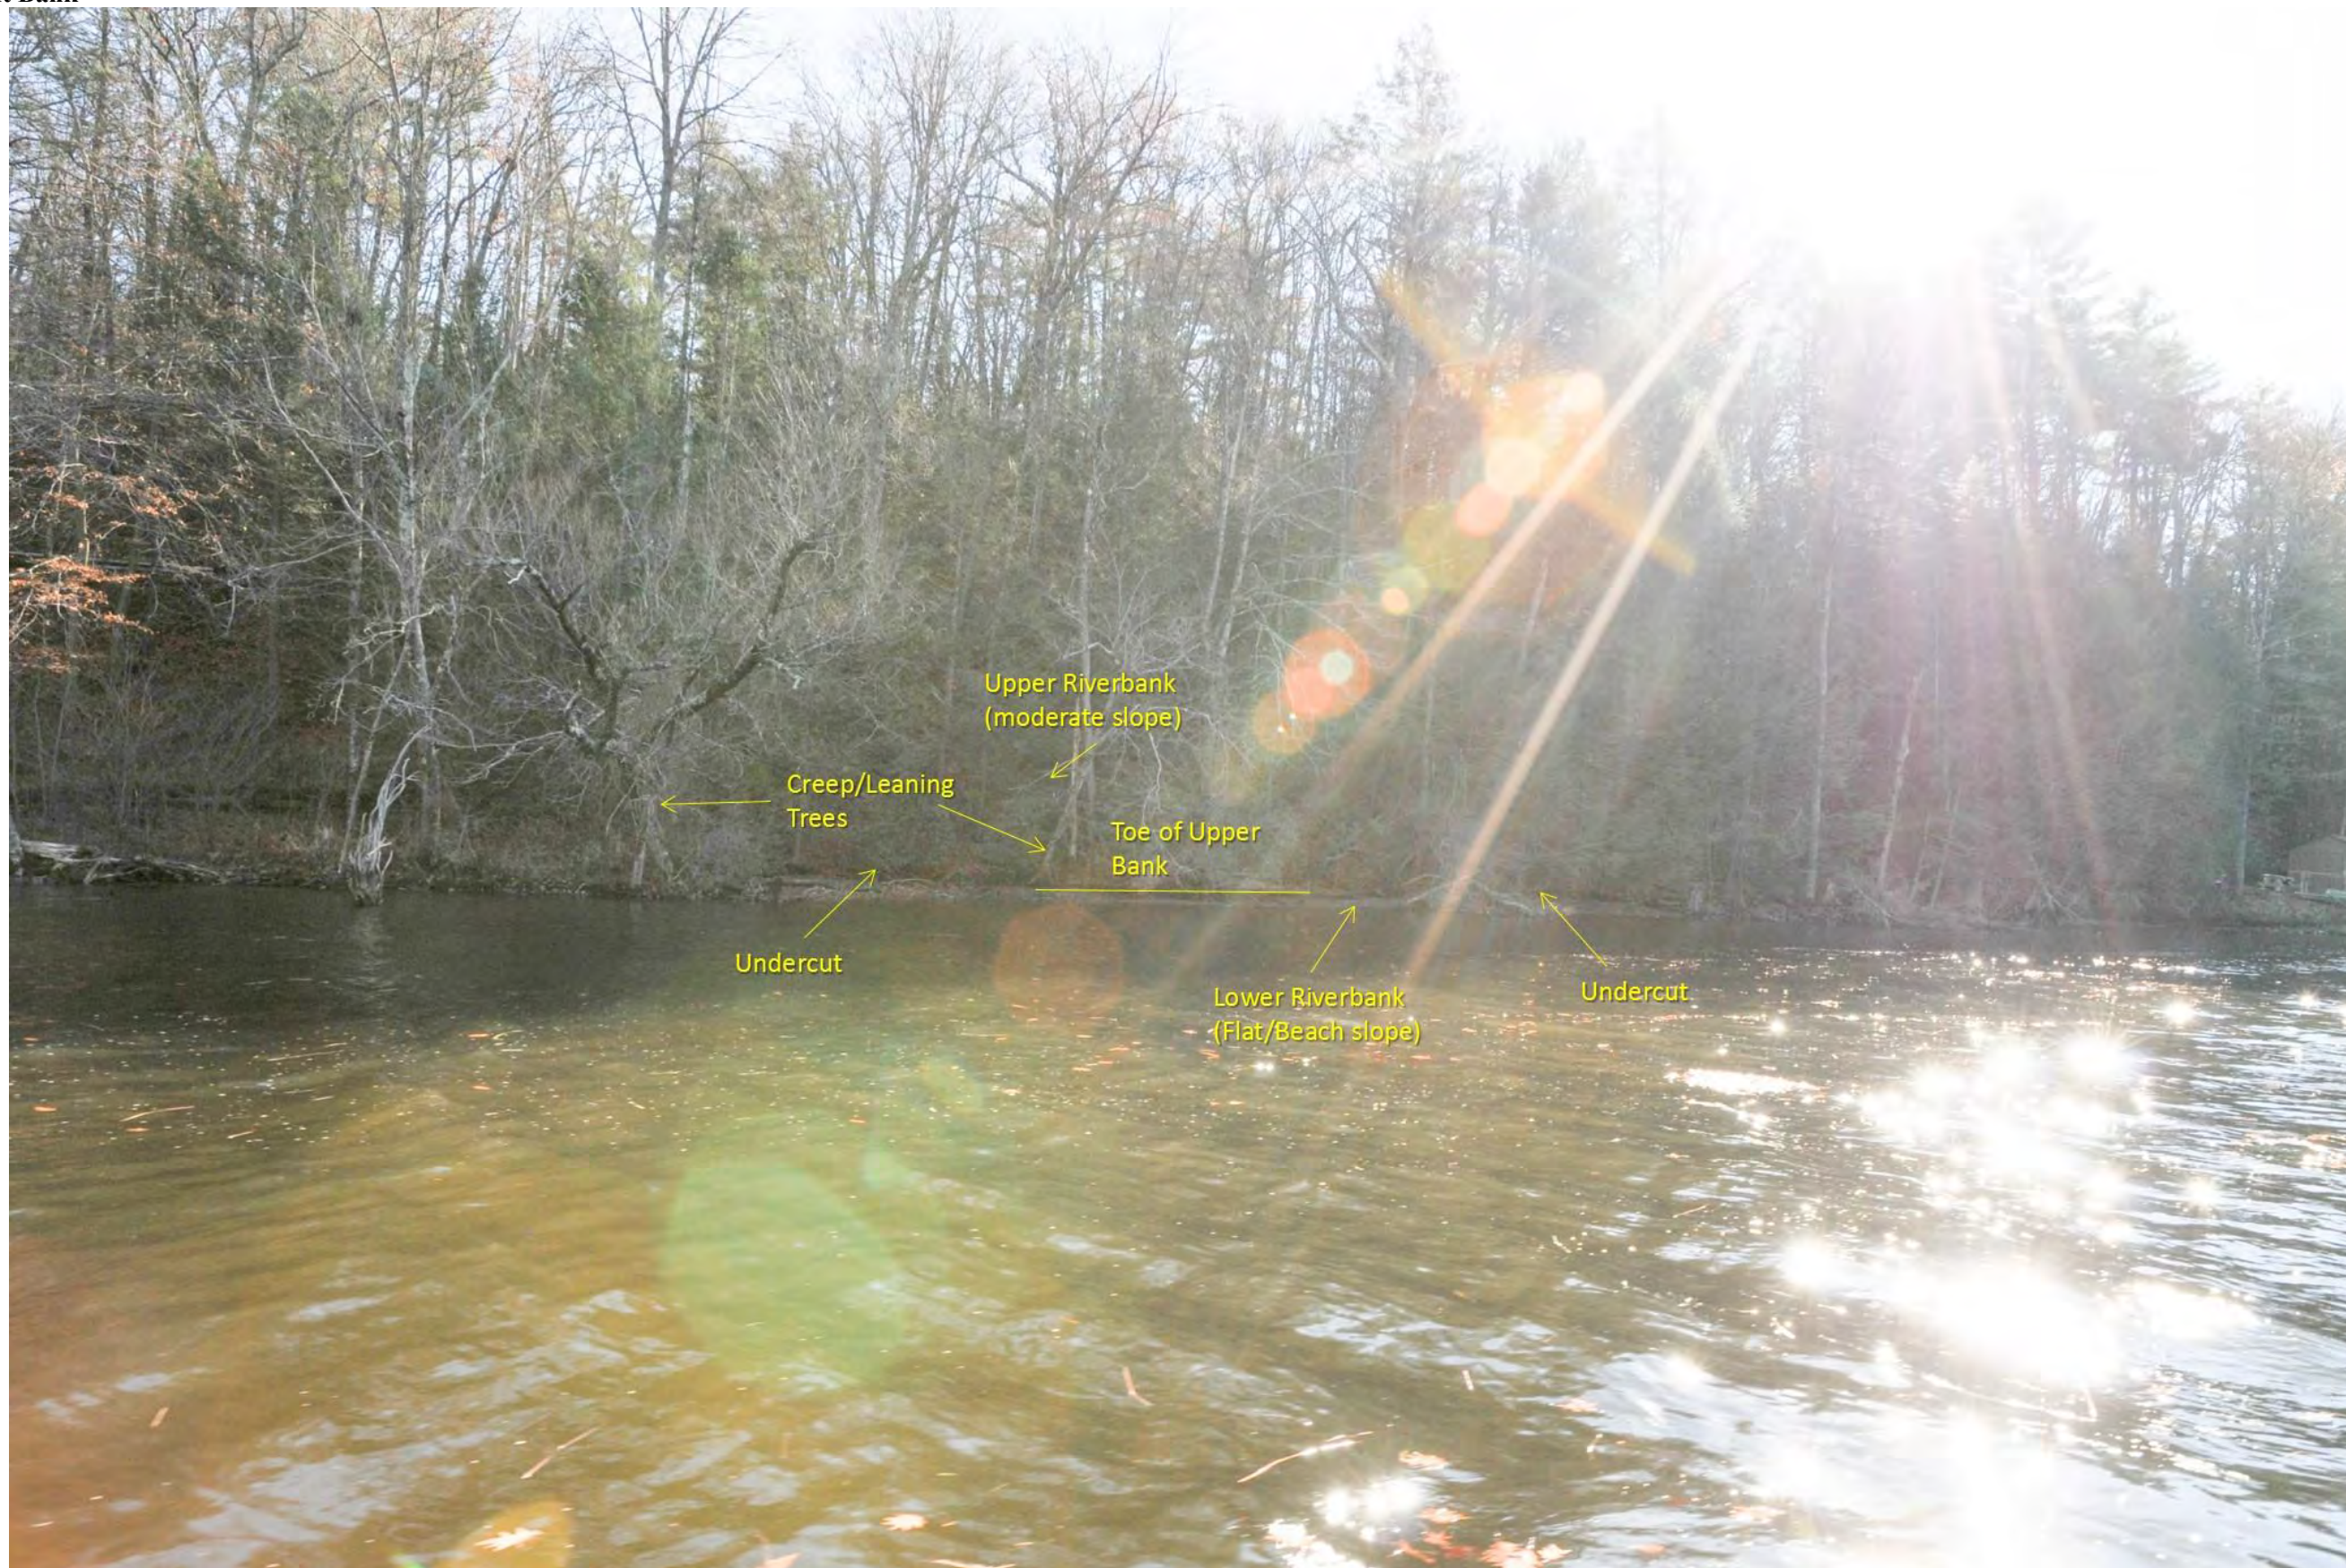
Photo ID 208 (mid-segment)

**QA Observations:** Upon review of the photos for this segment, classification made in the field was confirmed.

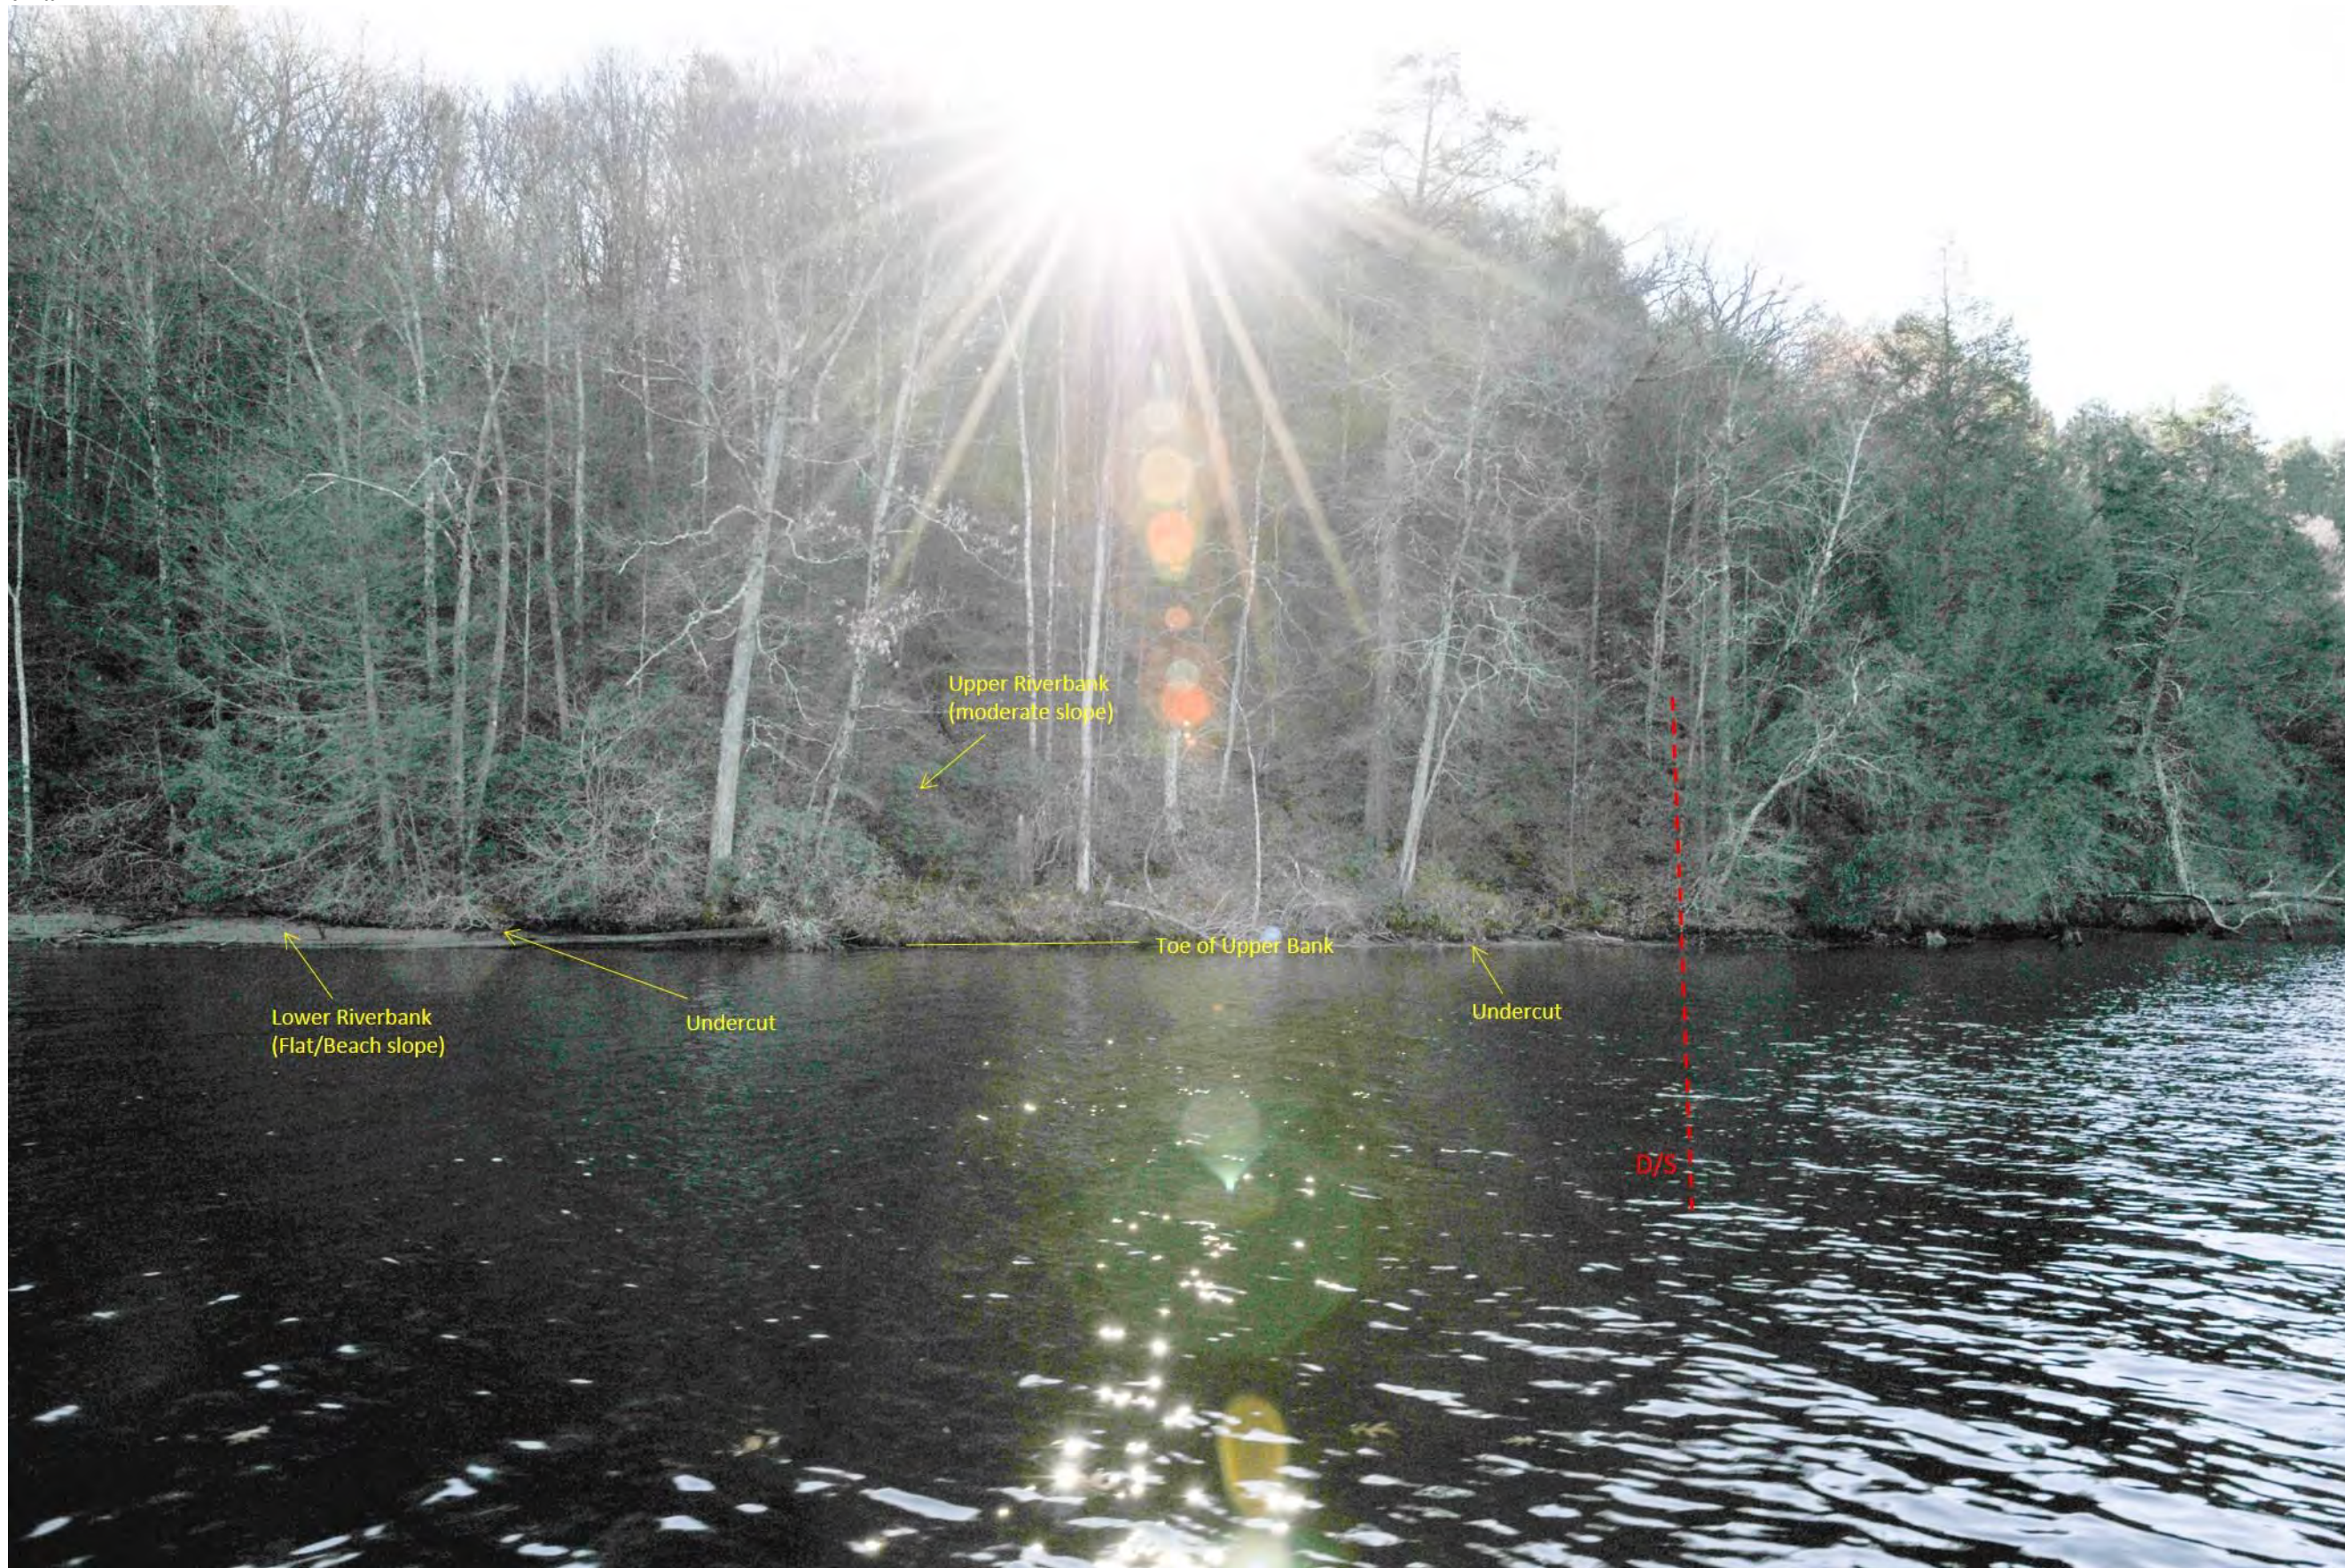
Photo ID 193 (mid-segment to D/S)

**QA Observations:** Upon review of the photos for this segment, classification made in the field was confirmed.

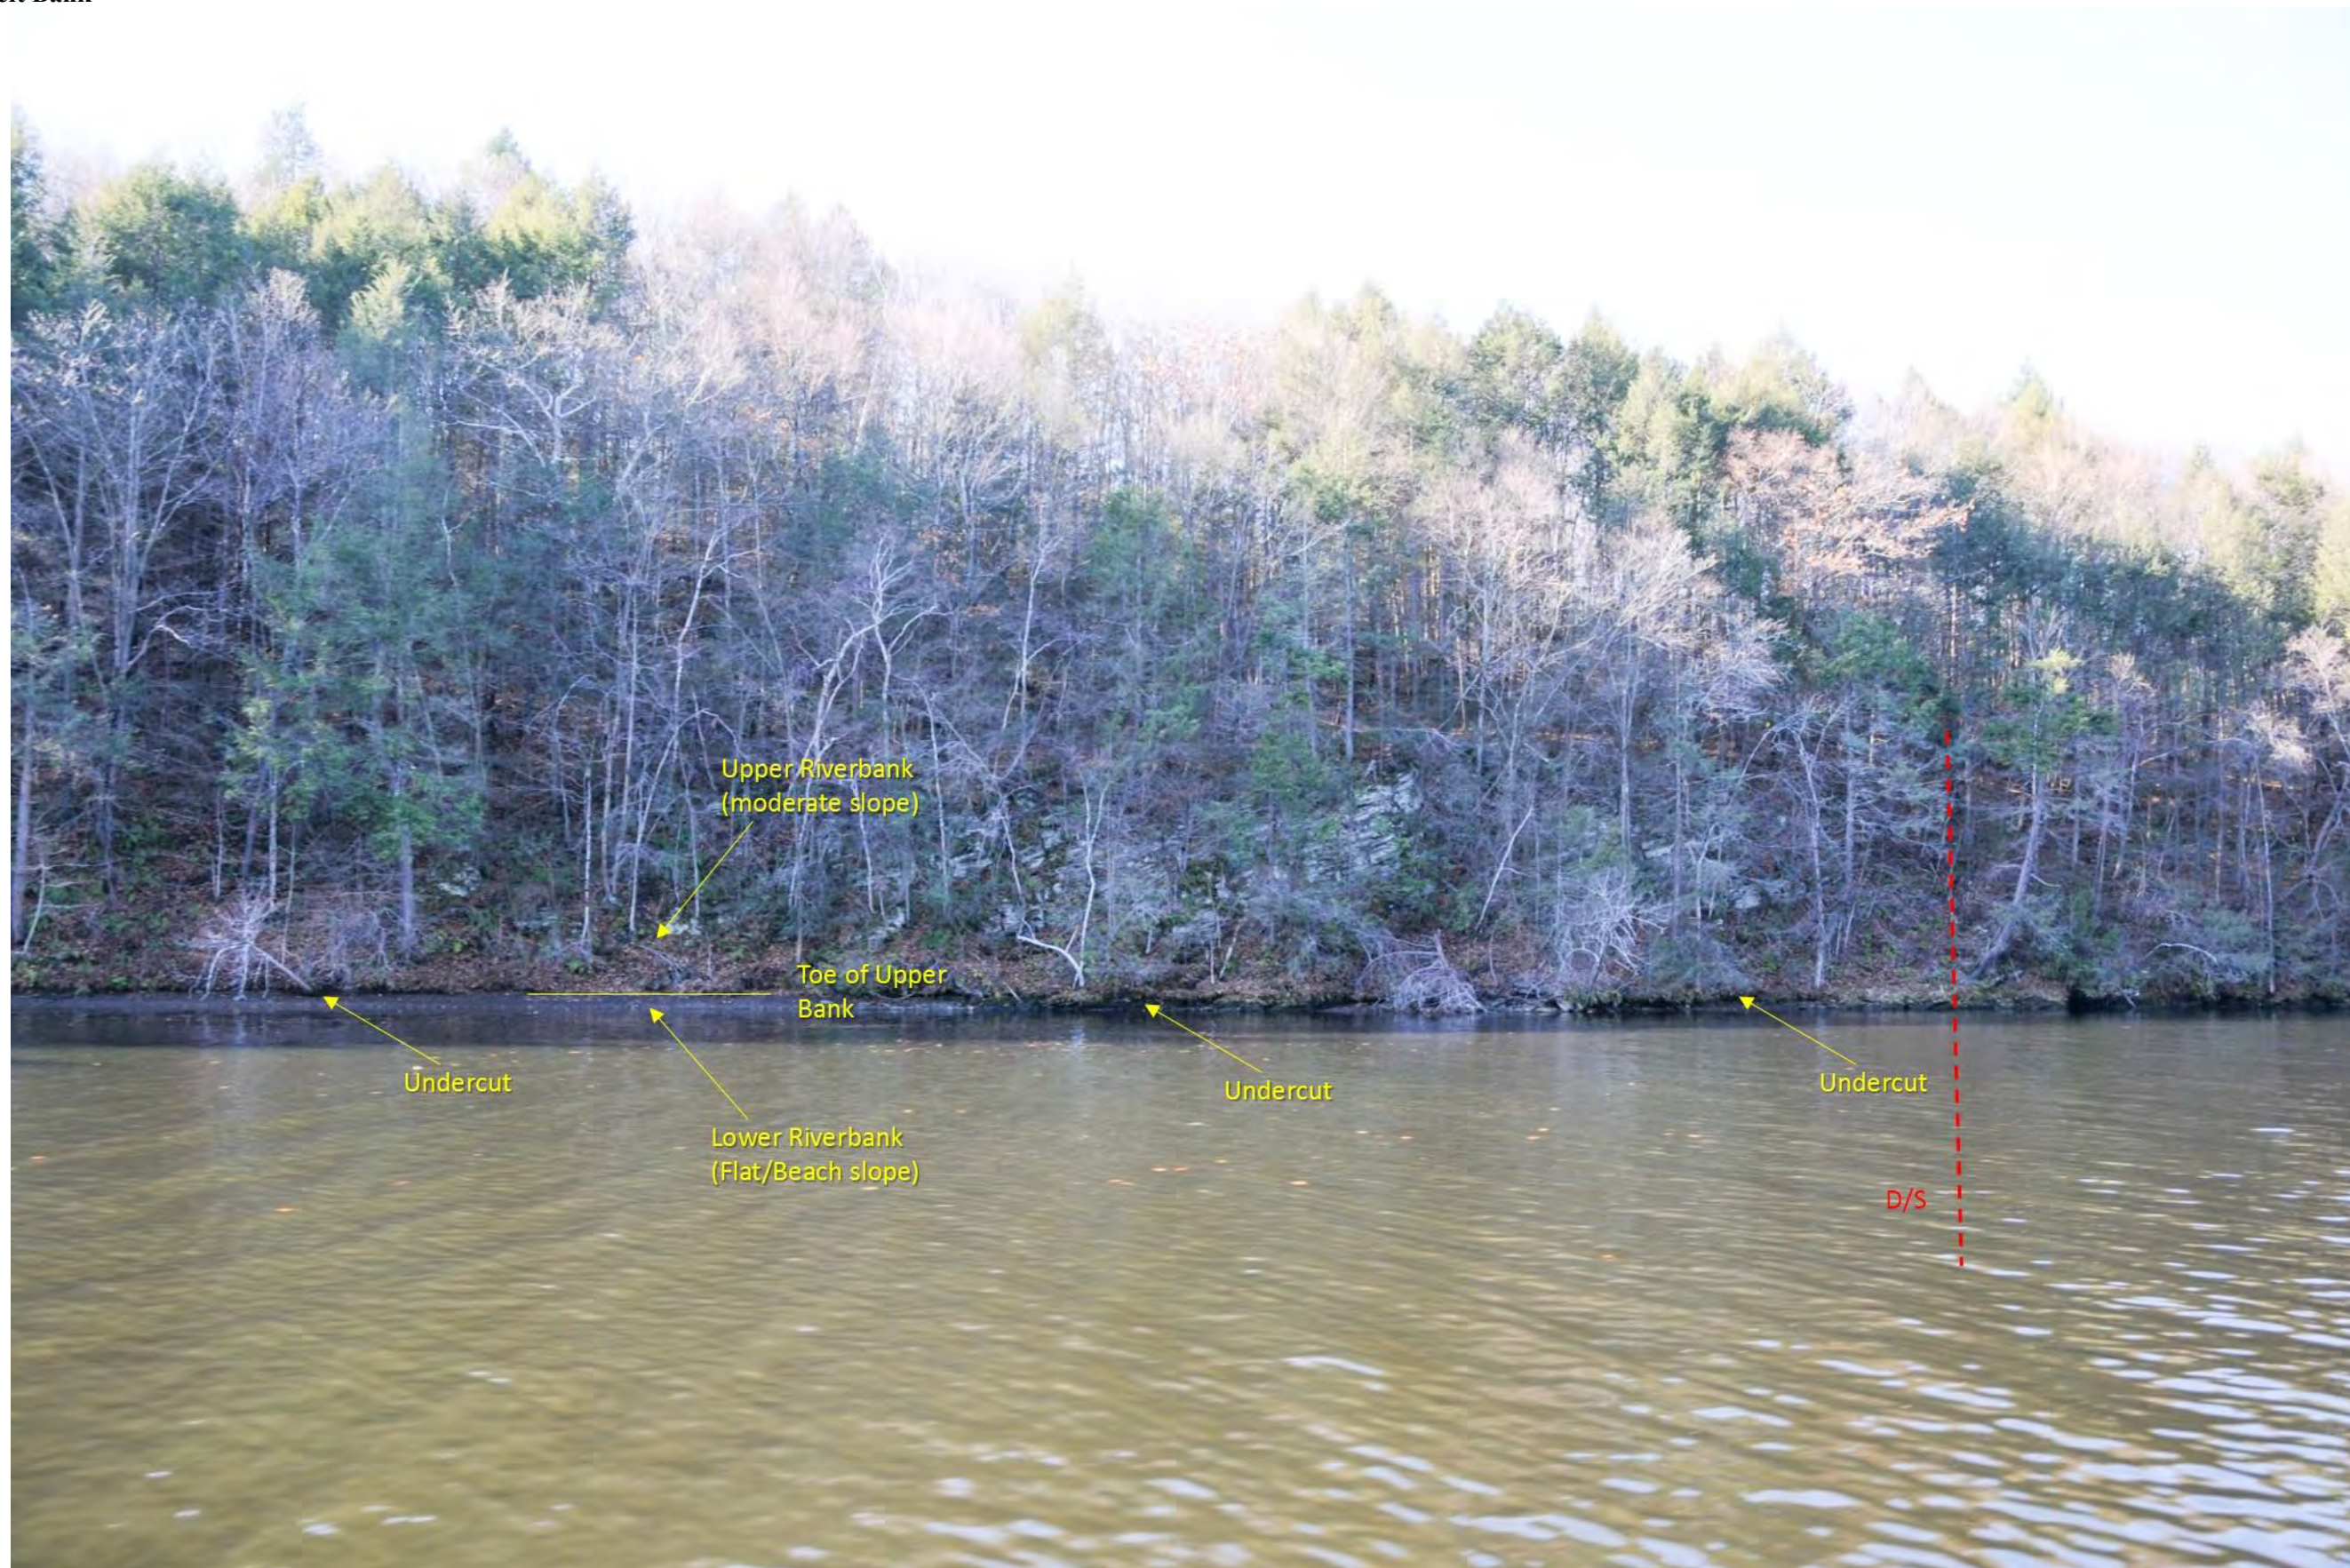
Photo ID 170 (mid-segment to D/S)

**QA Observations:** Upon review of the photos for this segment, classification made in the field was confirmed.

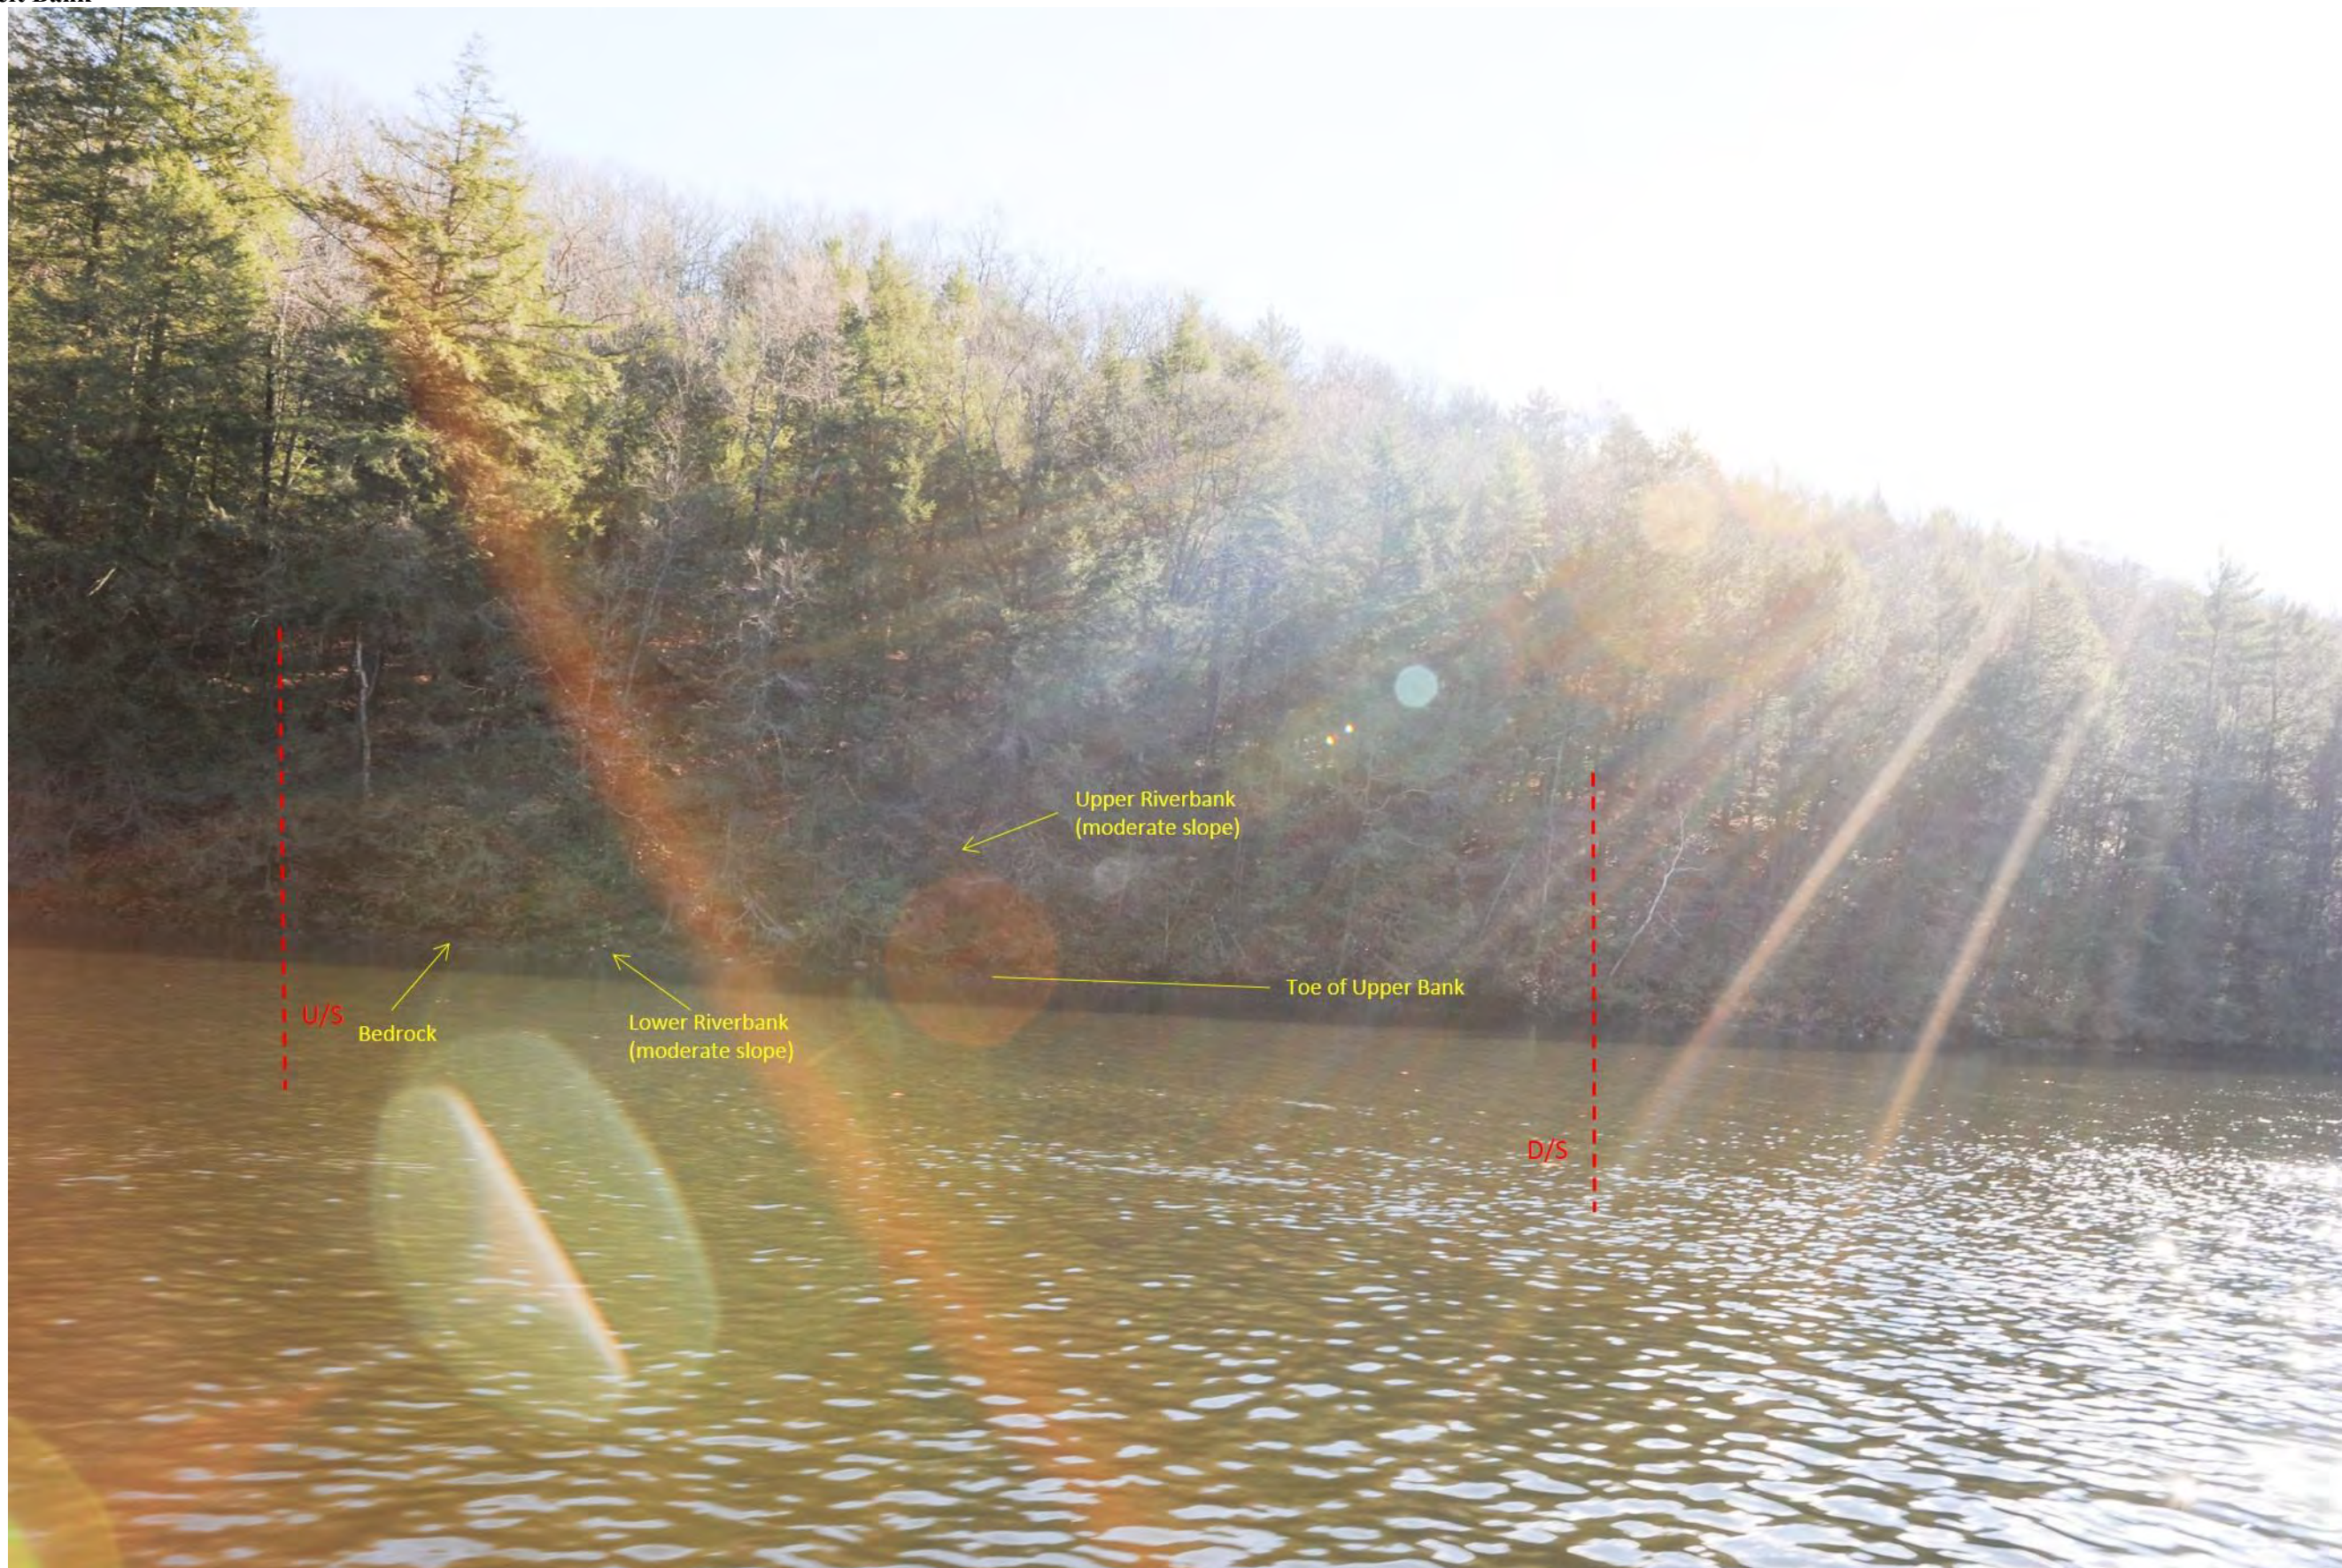
Photo ID 144 (photo covers segment)

**QA Observations:** Upon review of the photos for this segment, classification made in the field was confirmed.
