Re: Filing of Addendum to Study No. 3.1.1- 2013 Full River Reconnaissance  
Turners Falls Hydroelectric Project (FERC No. 1889) and Northfield Mountain Pumped Storage  
Project (FERC No. 2485)

## **ATTACHMENT A: 2013 Full River Reconnaissance – 2015 Addendum: Riverbank Segment QA Comparison**

2015 FRR Addendum  
 Selected Riverbank Segments for QA  
 Map 1

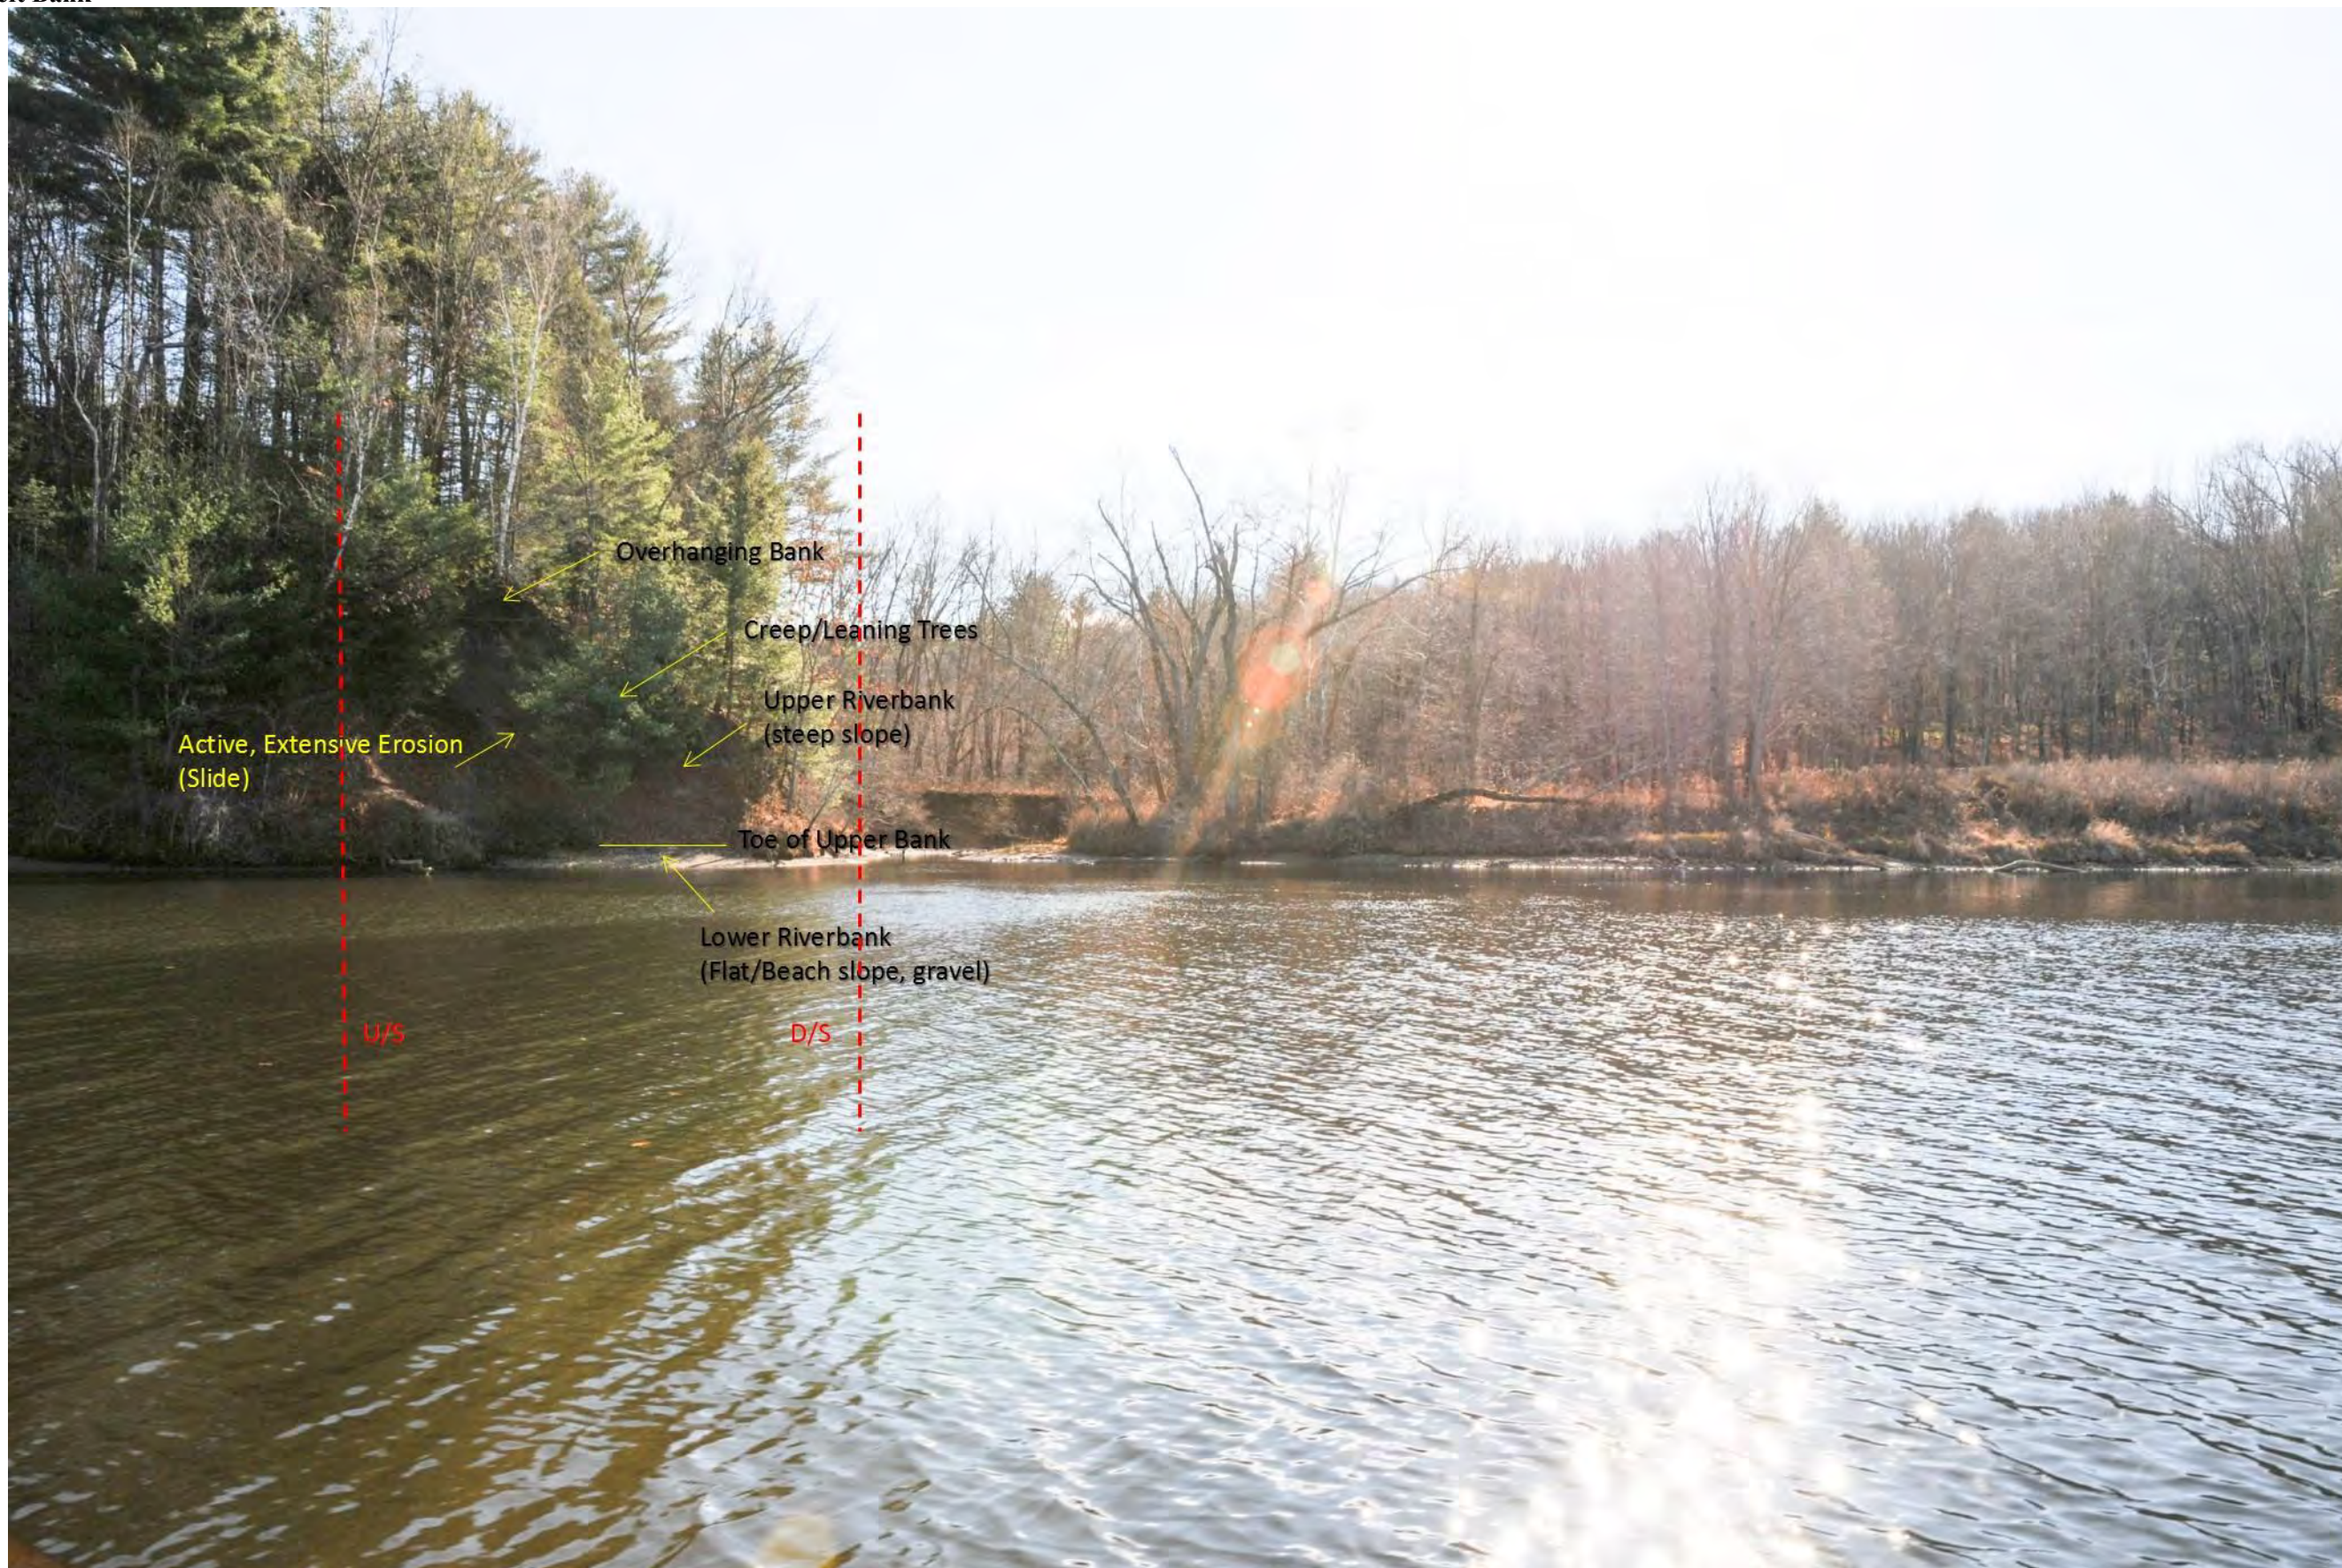
Photo ID 122 (photo covers segment)

Riverbank Features	Characteristics
Upper Riverbank Slope	Steep
Upper Riverbank Height	High
Upper Riverbank Sediment	Silt/Sand
Upper Riverbank Vegetation	Sparse
Lower Riverbank Slope	Flat/Beach
Lower Riverbank Sediment	Gravel
Lower Riverbank Vegetation	None to very sparse
Type of Erosion	Slide
Potential Erosion Indicators	Creep/leaning trees, Overhanging bank, Exposed roots
Stage of Erosion	Active Erosion
Extent of Erosion	Extensive

**QA Observations:** Upon review of the photos for this segment, classification made in the field was confirmed and additional indicators of potential future erosion were included.

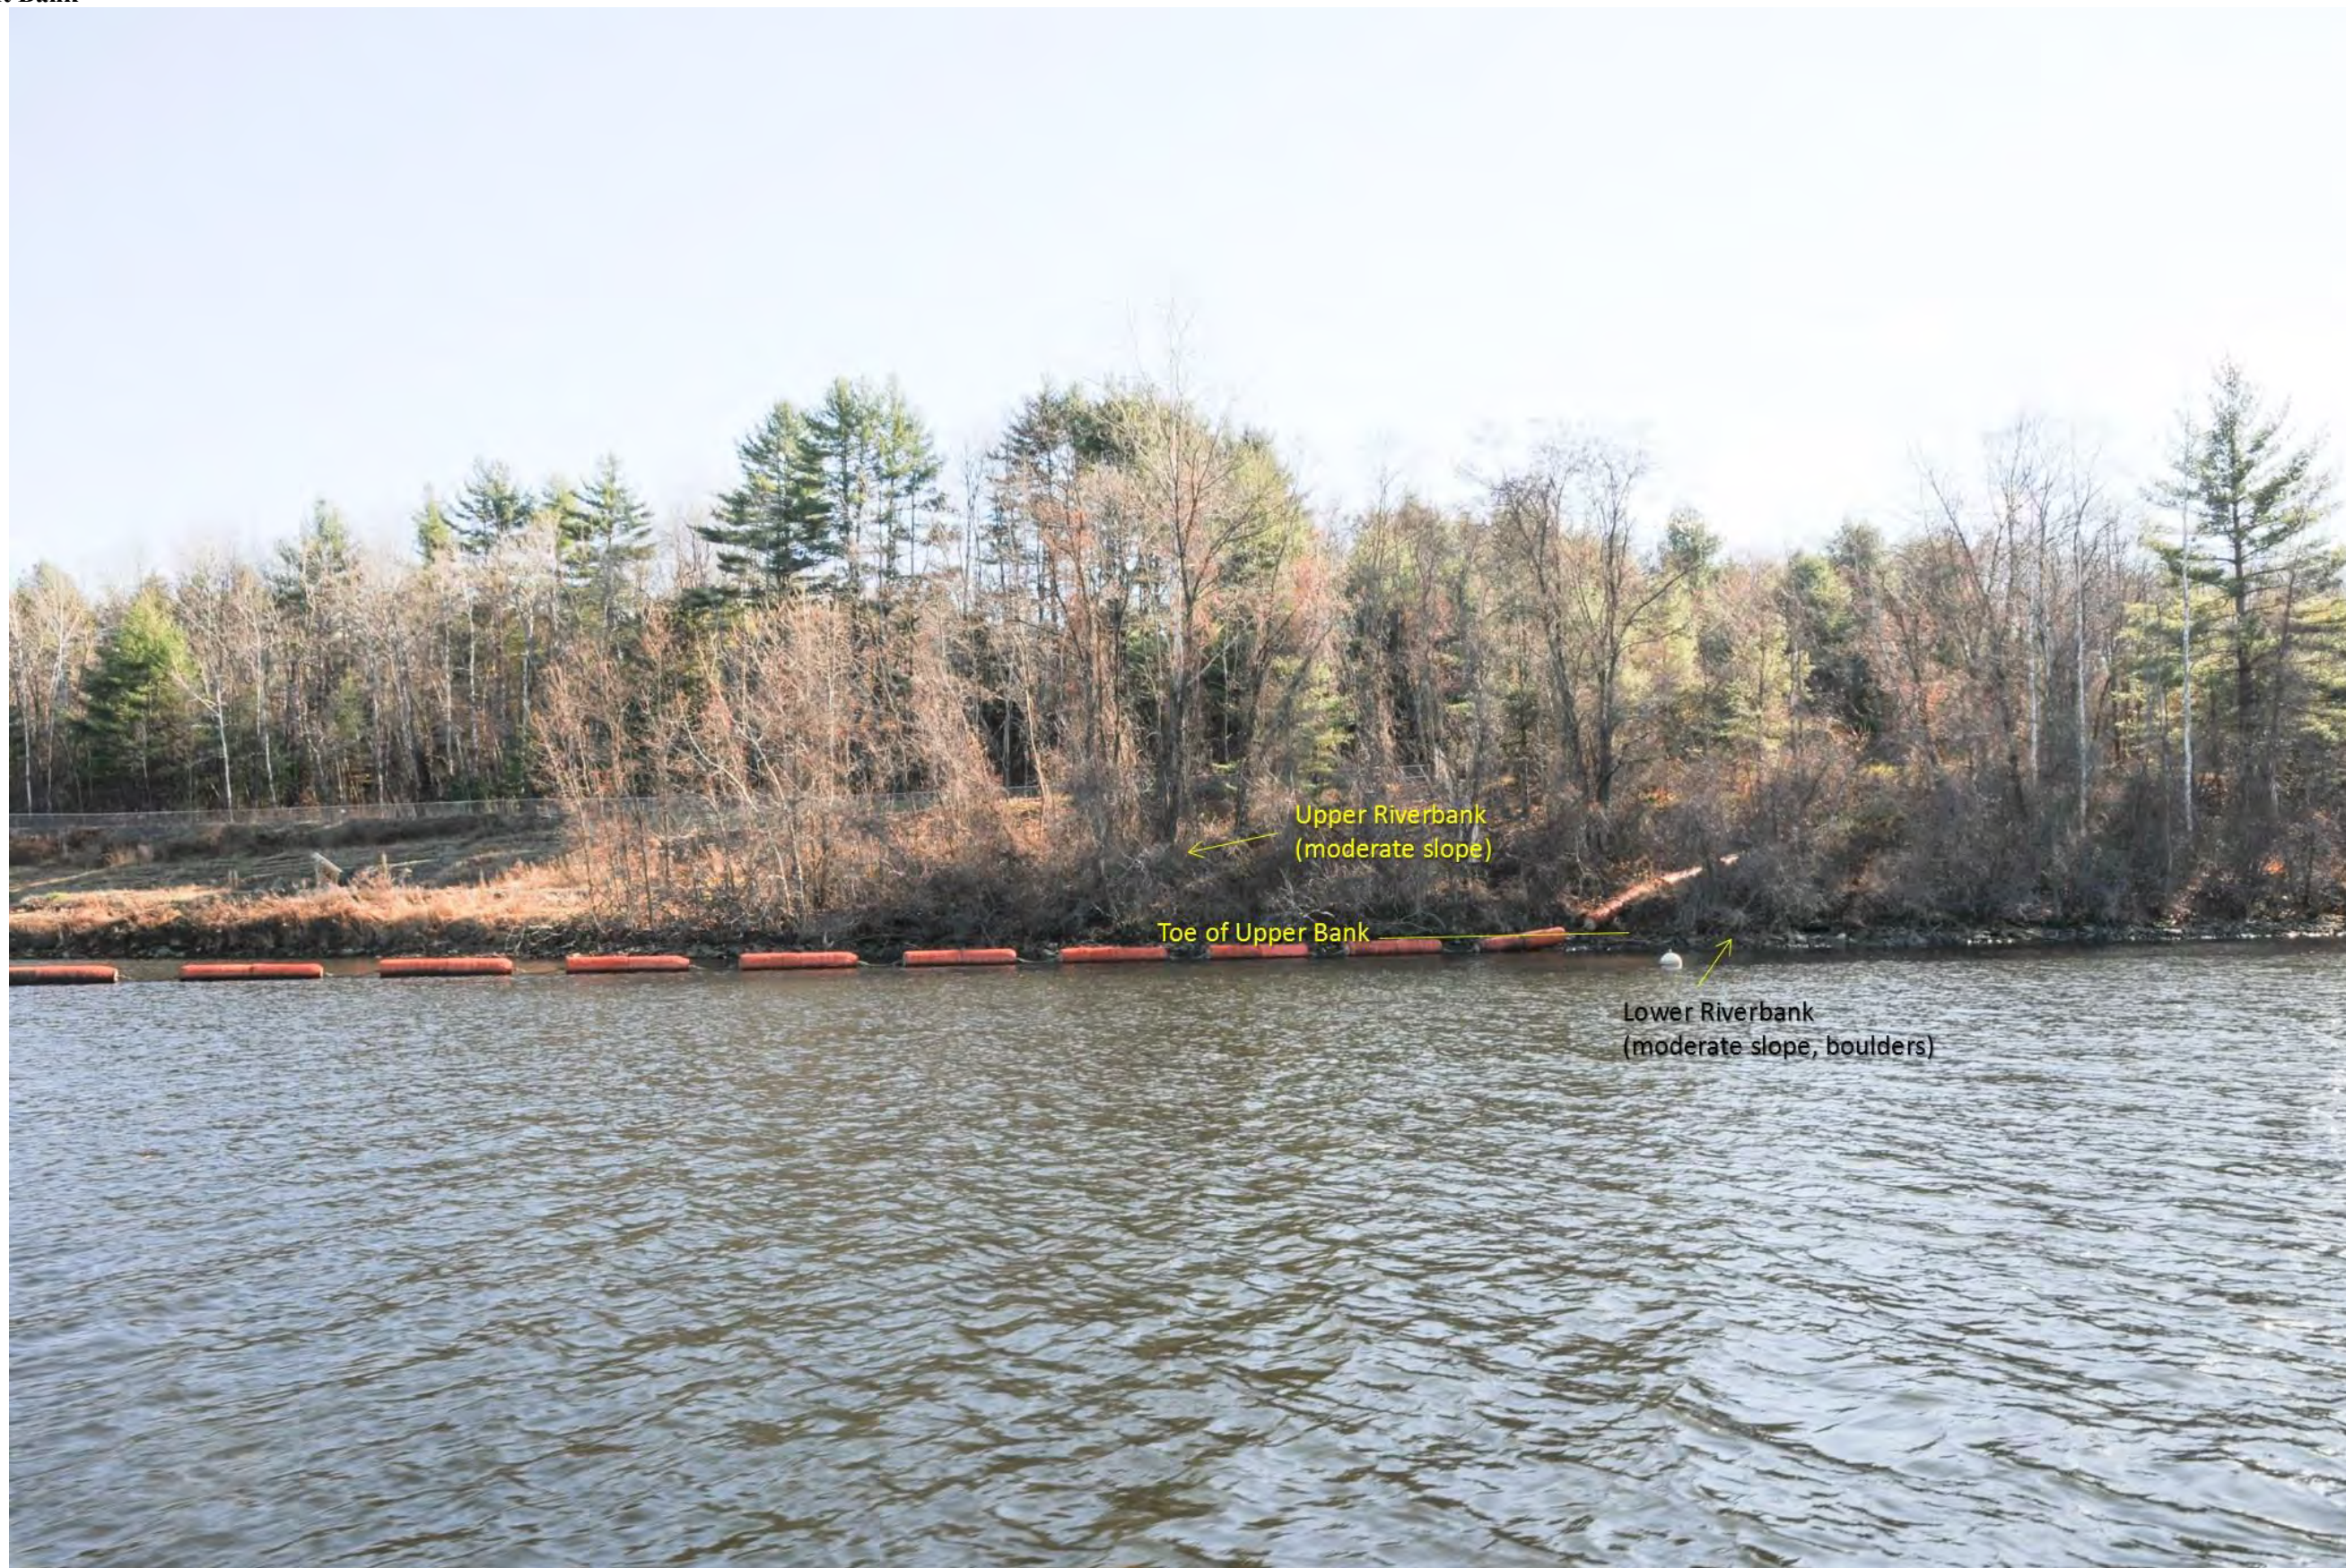
Photo ID 112 (mid-segment)

**QA Observations:** Upon review of the photos for this segment, classification made in the field was confirmed.

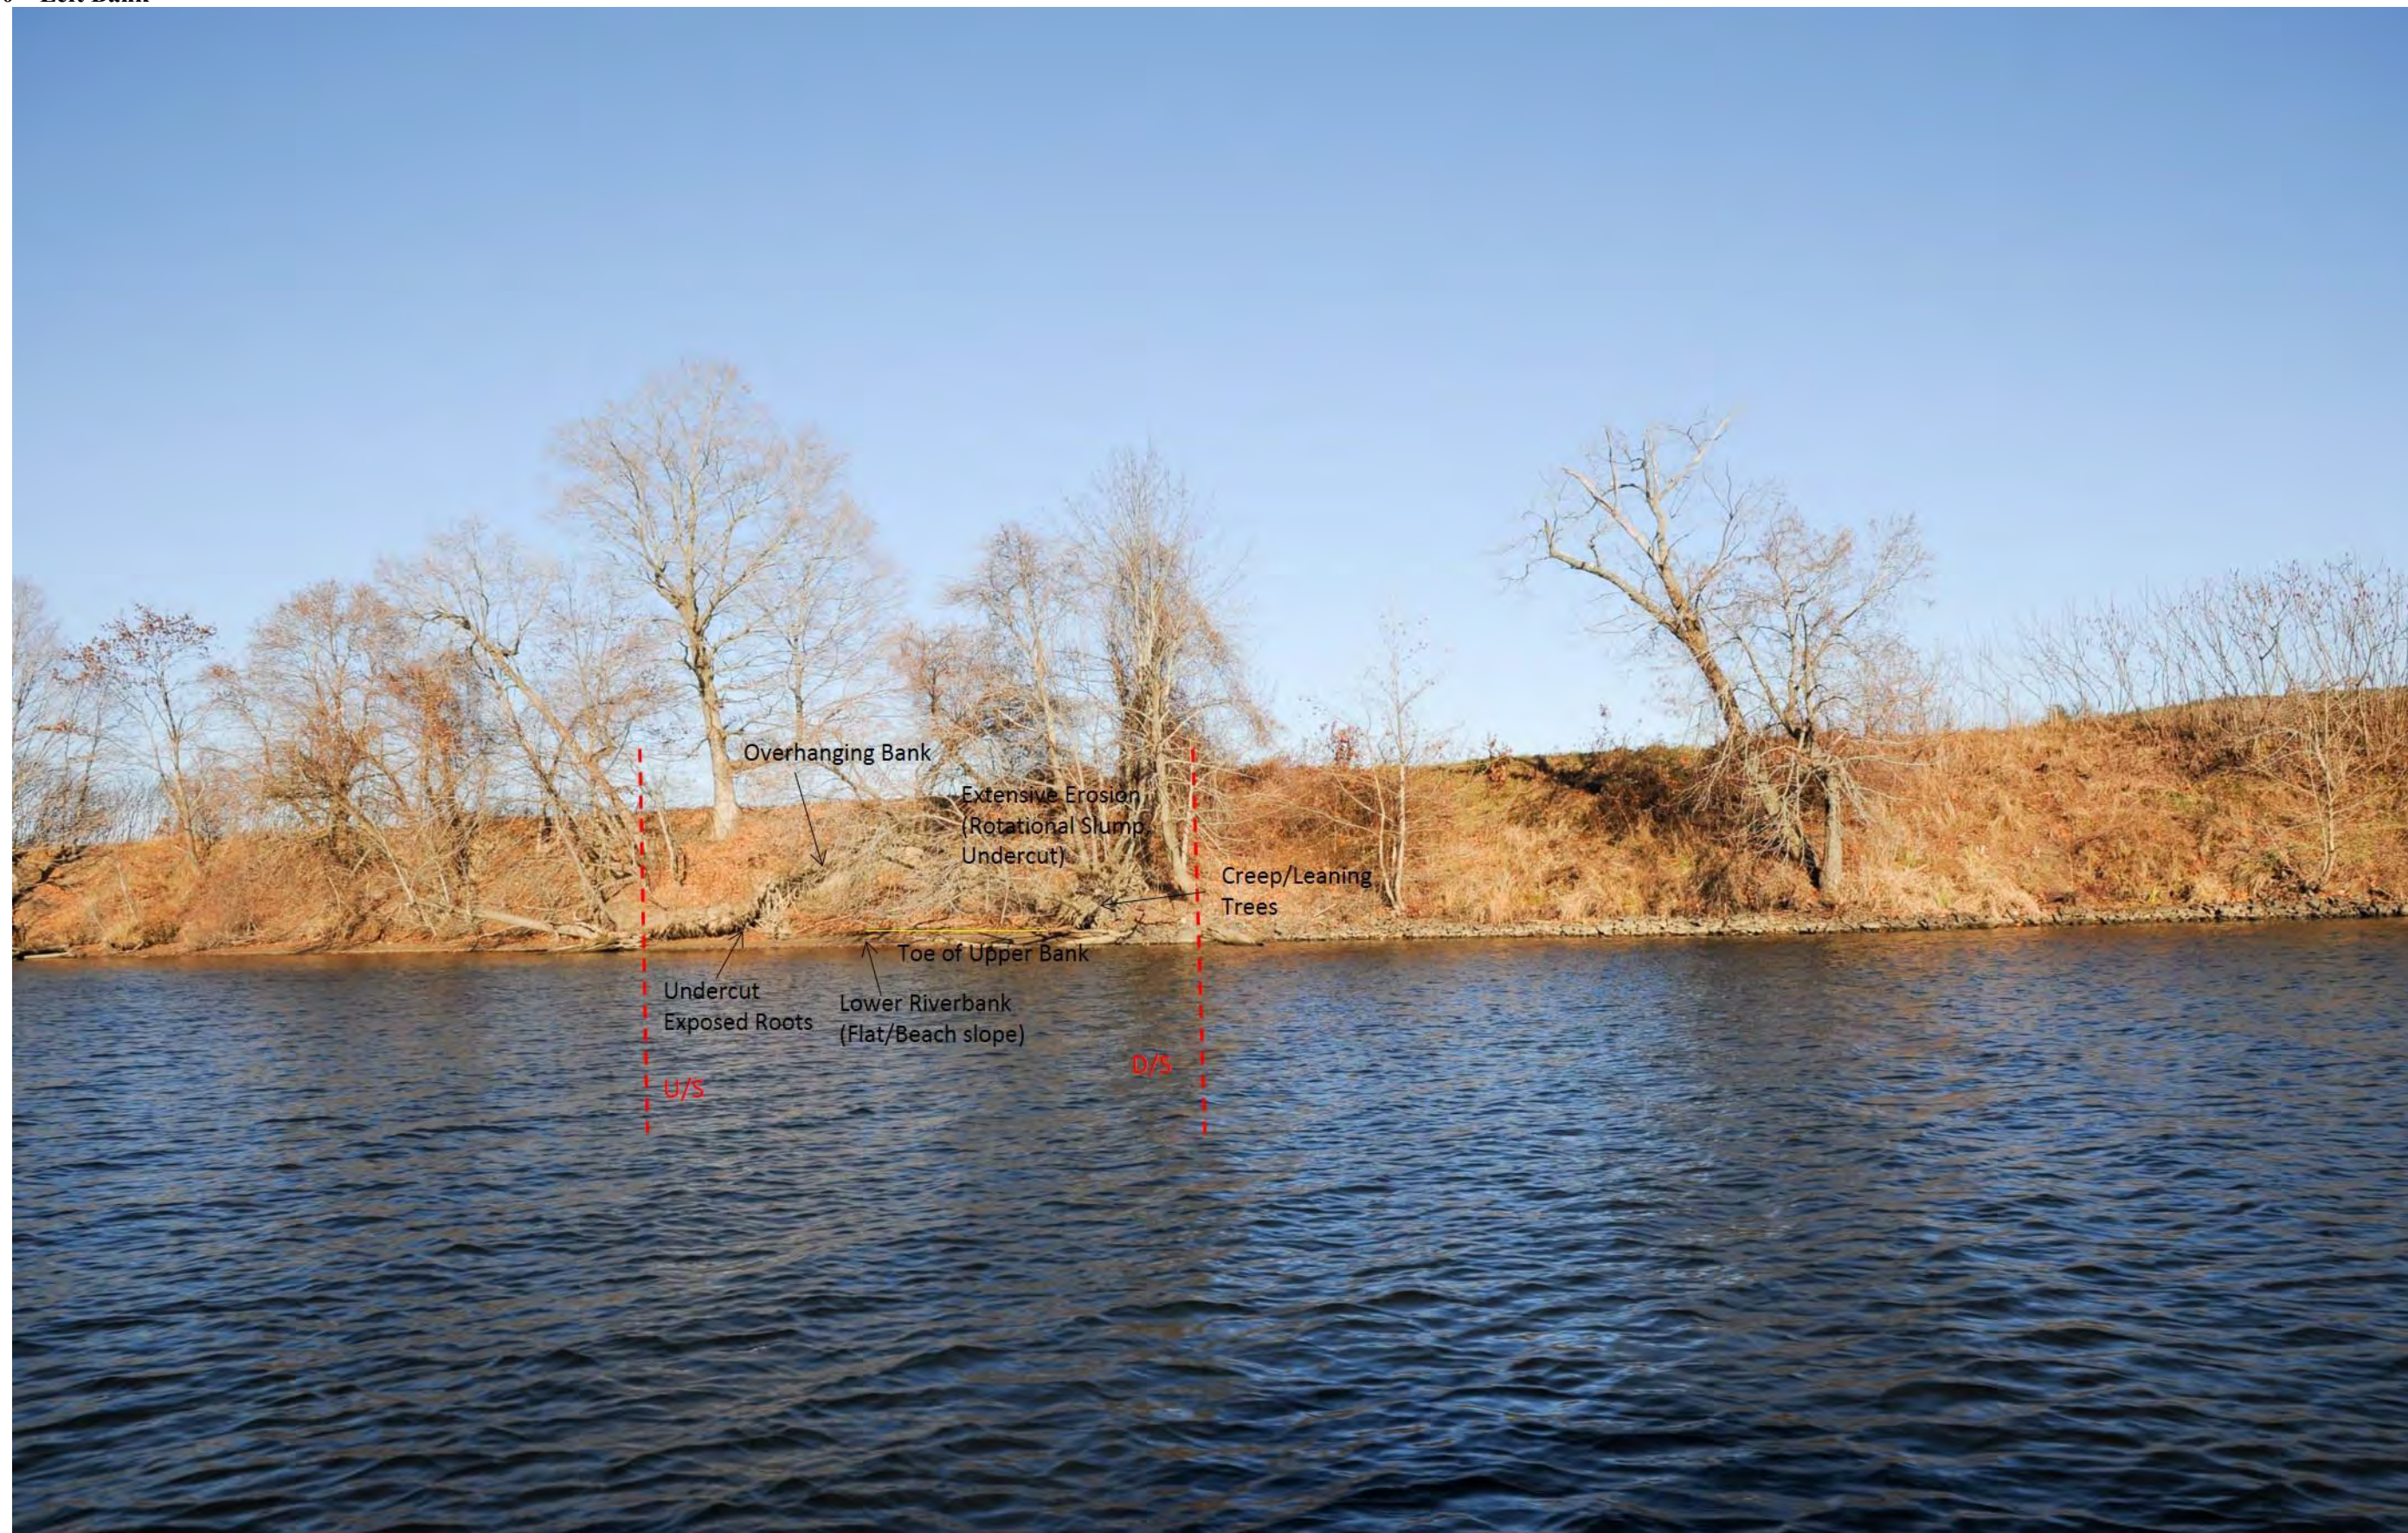
Photo ID 613 (photo covers segment)

Riverbank Features	Characteristics
Upper Riverbank Slope	Steep
Upper Riverbank Height	High
Upper Riverbank Sediment	Silt/Sand
Upper Riverbank Vegetation	Moderate
Lower Riverbank Slope	Flat/Beach
Lower Riverbank Sediment	Silt/Sand
Lower Riverbank Vegetation	None to very sparse
Type of Erosion	Rotational Slump, Undercut
Potential Erosion Indicators	Overhanging bank, Exposed roots, Creep/leaning trees
Stage of Erosion	Eroded
Extent of Erosion	Extensive

**QA Observations:** Upon review of the photos for this segment, classification made in the field was confirmed and additional indicators of potential future erosion were included.

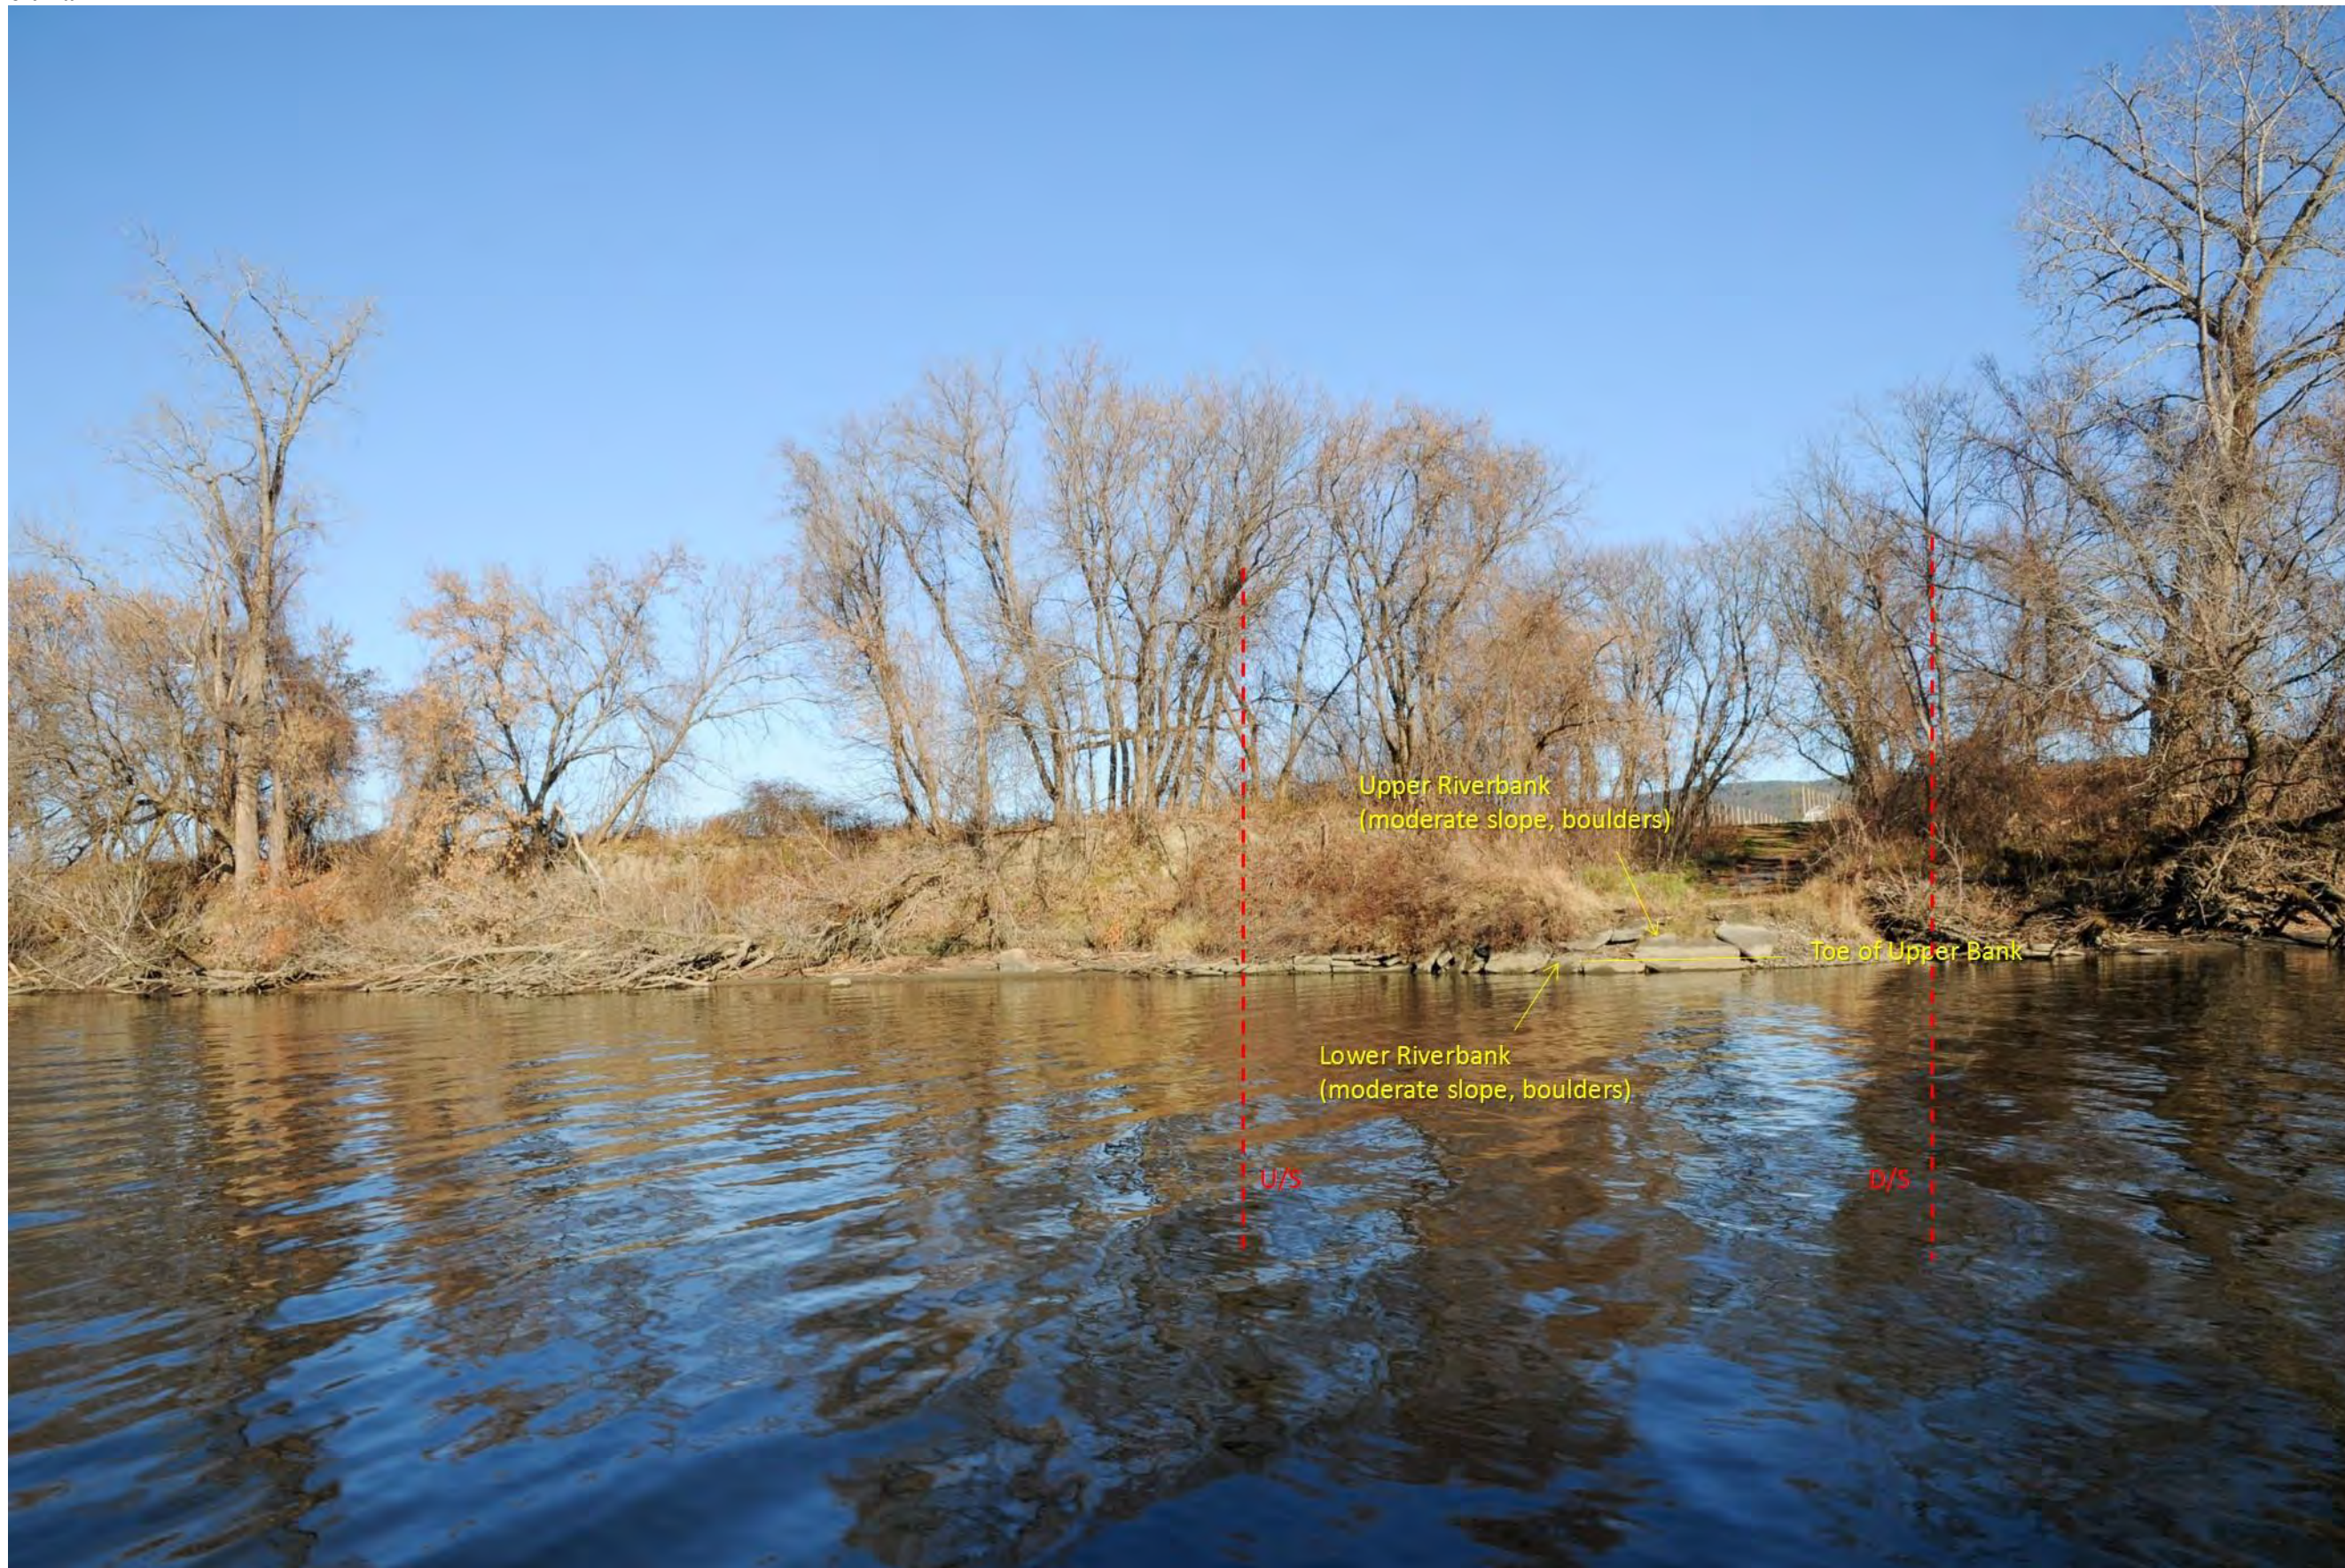
Photo ID 632 (photo covers segment)

**QA Observations:** Upon review of the photos for this segment, classification made in the field was confirmed.

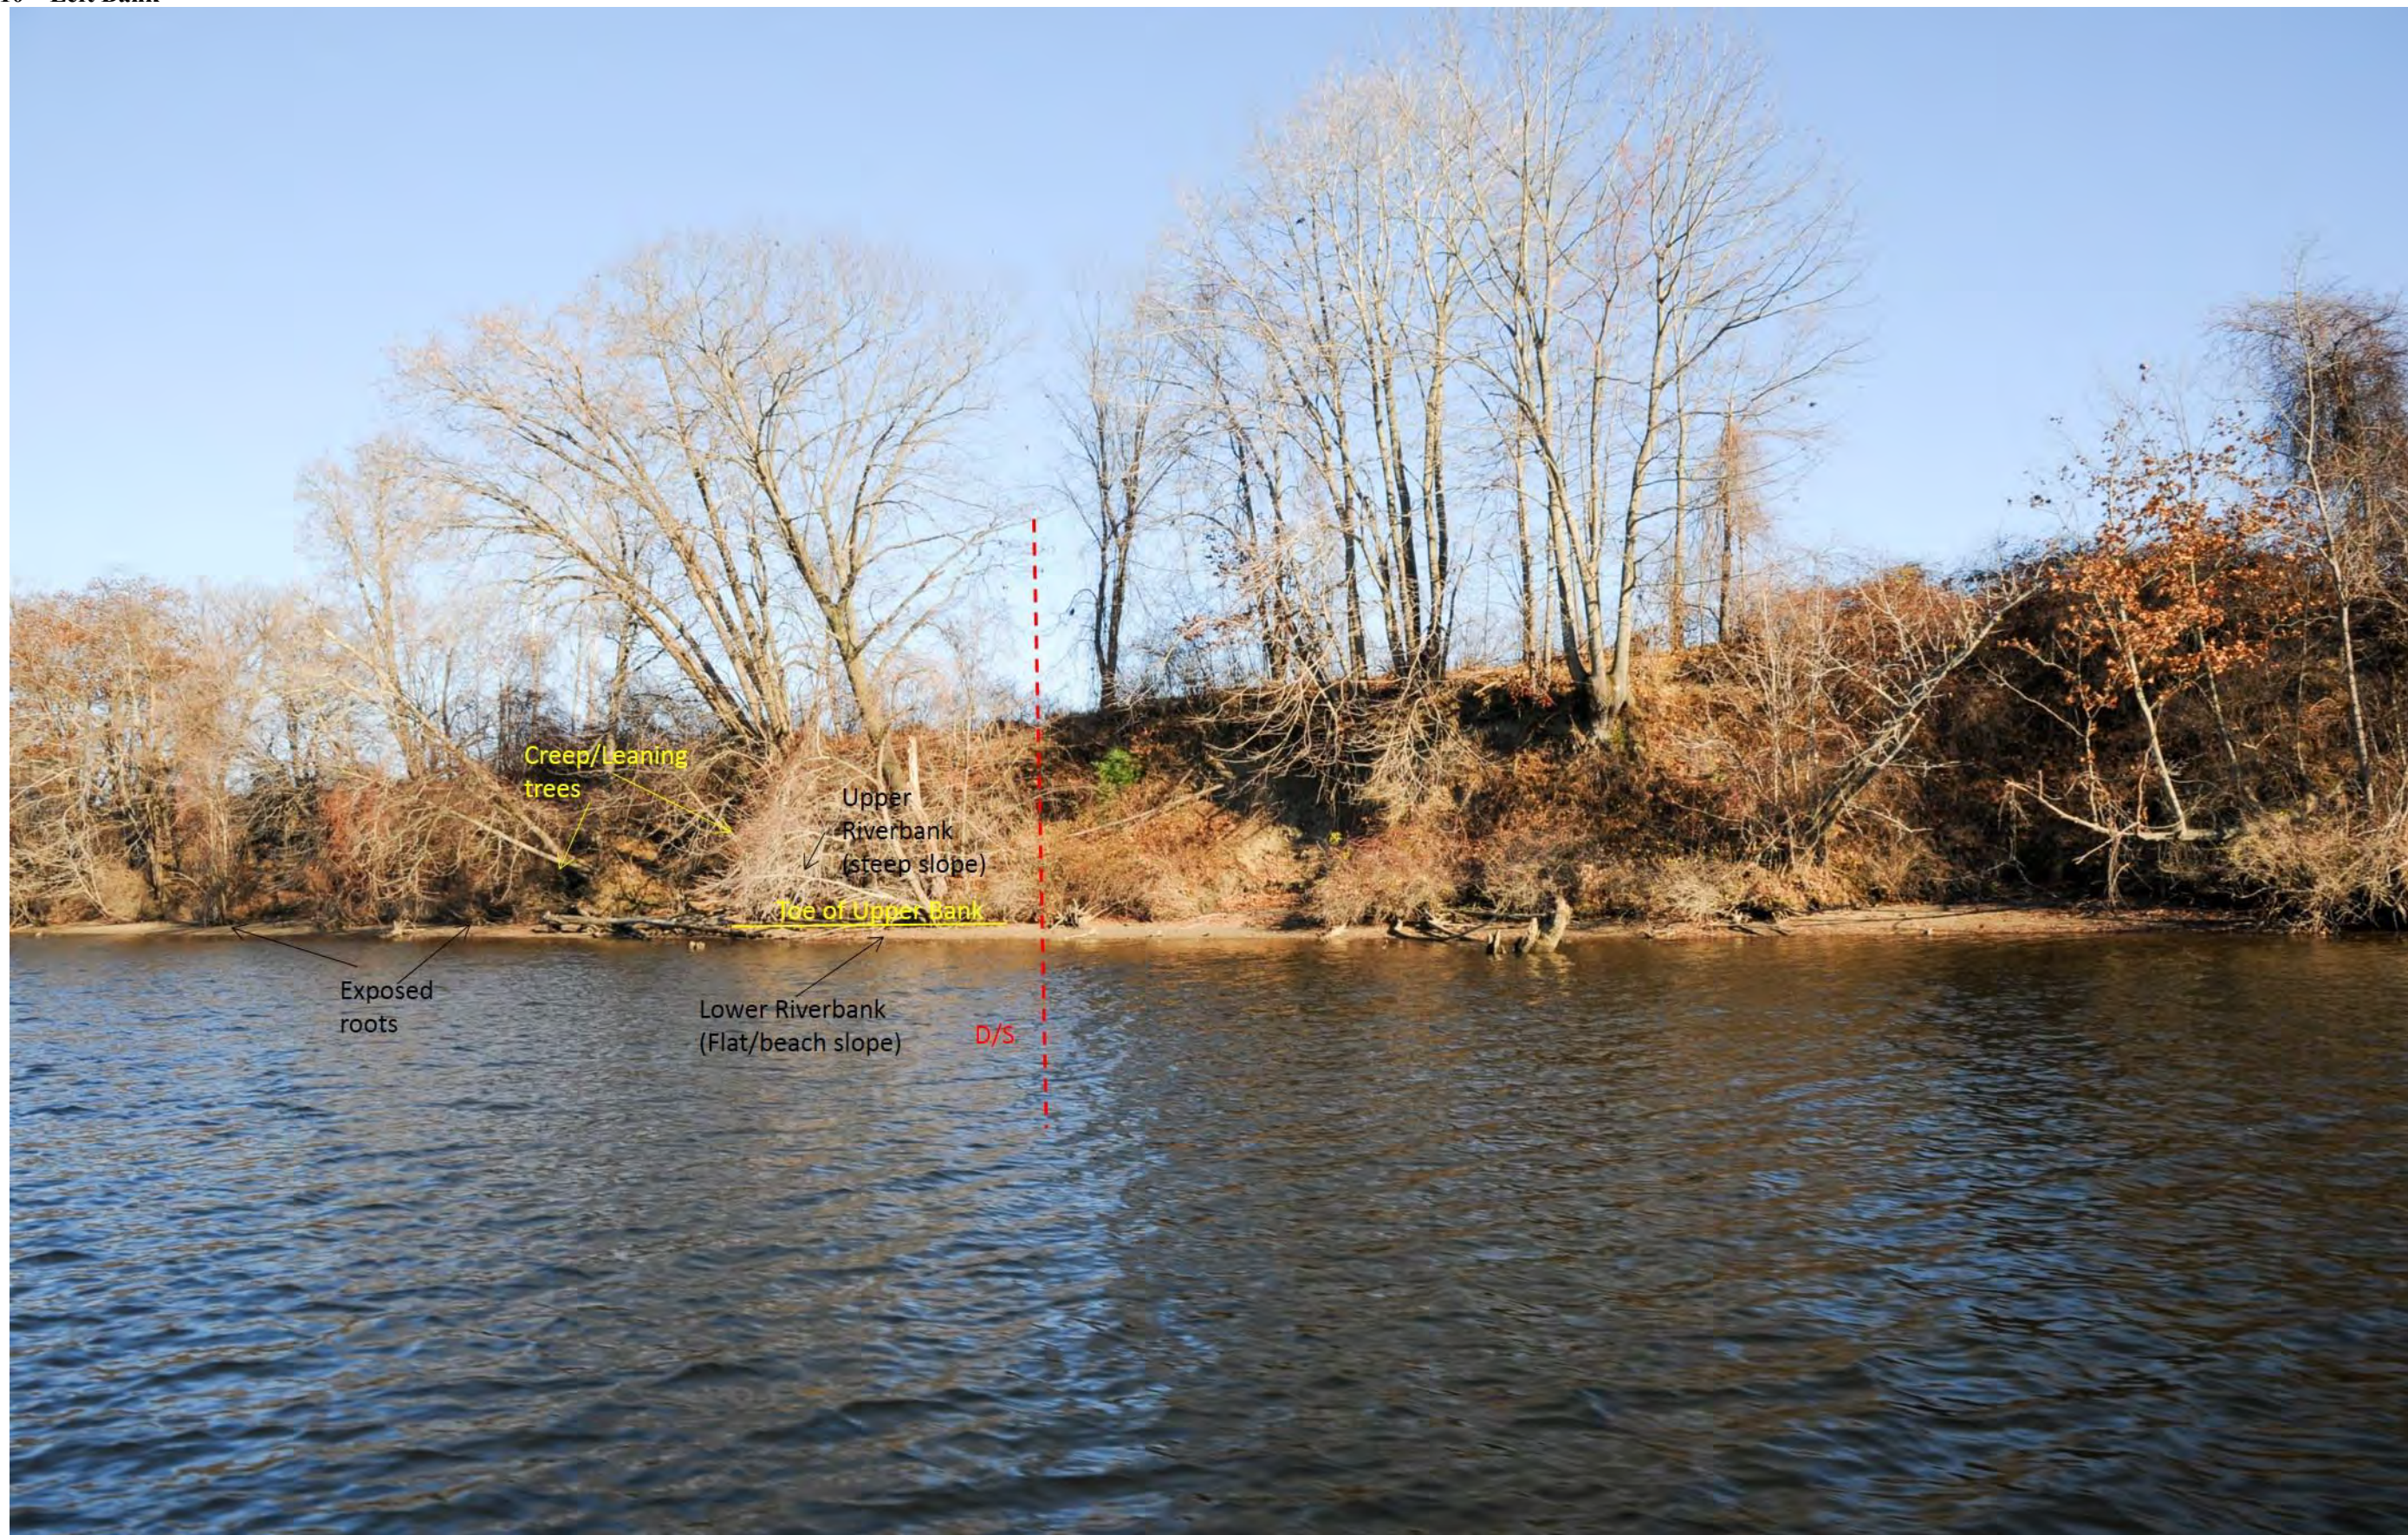
Photo ID 649 (D/S, left of line)

**QA Observations:** Upon review of the photos for this segment, classification made in the field was confirmed and additional indicators of potential future erosion were included.
