Re: Filing of Addendum to Study No. 3.1.1- 2013 Full River Reconnaissance  
Turners Falls Hydroelectric Project (FERC No. 1889) and Northfield Mountain Pumped Storage  
Project (FERC No. 2485)

## **ATTACHMENT A: 2013 Full River Reconnaissance – 2015 Addendum: Riverbank Segment QA Comparison**

2015 FRR Addendum  
 Selected Riverbank Segments for QA  
 Map 1

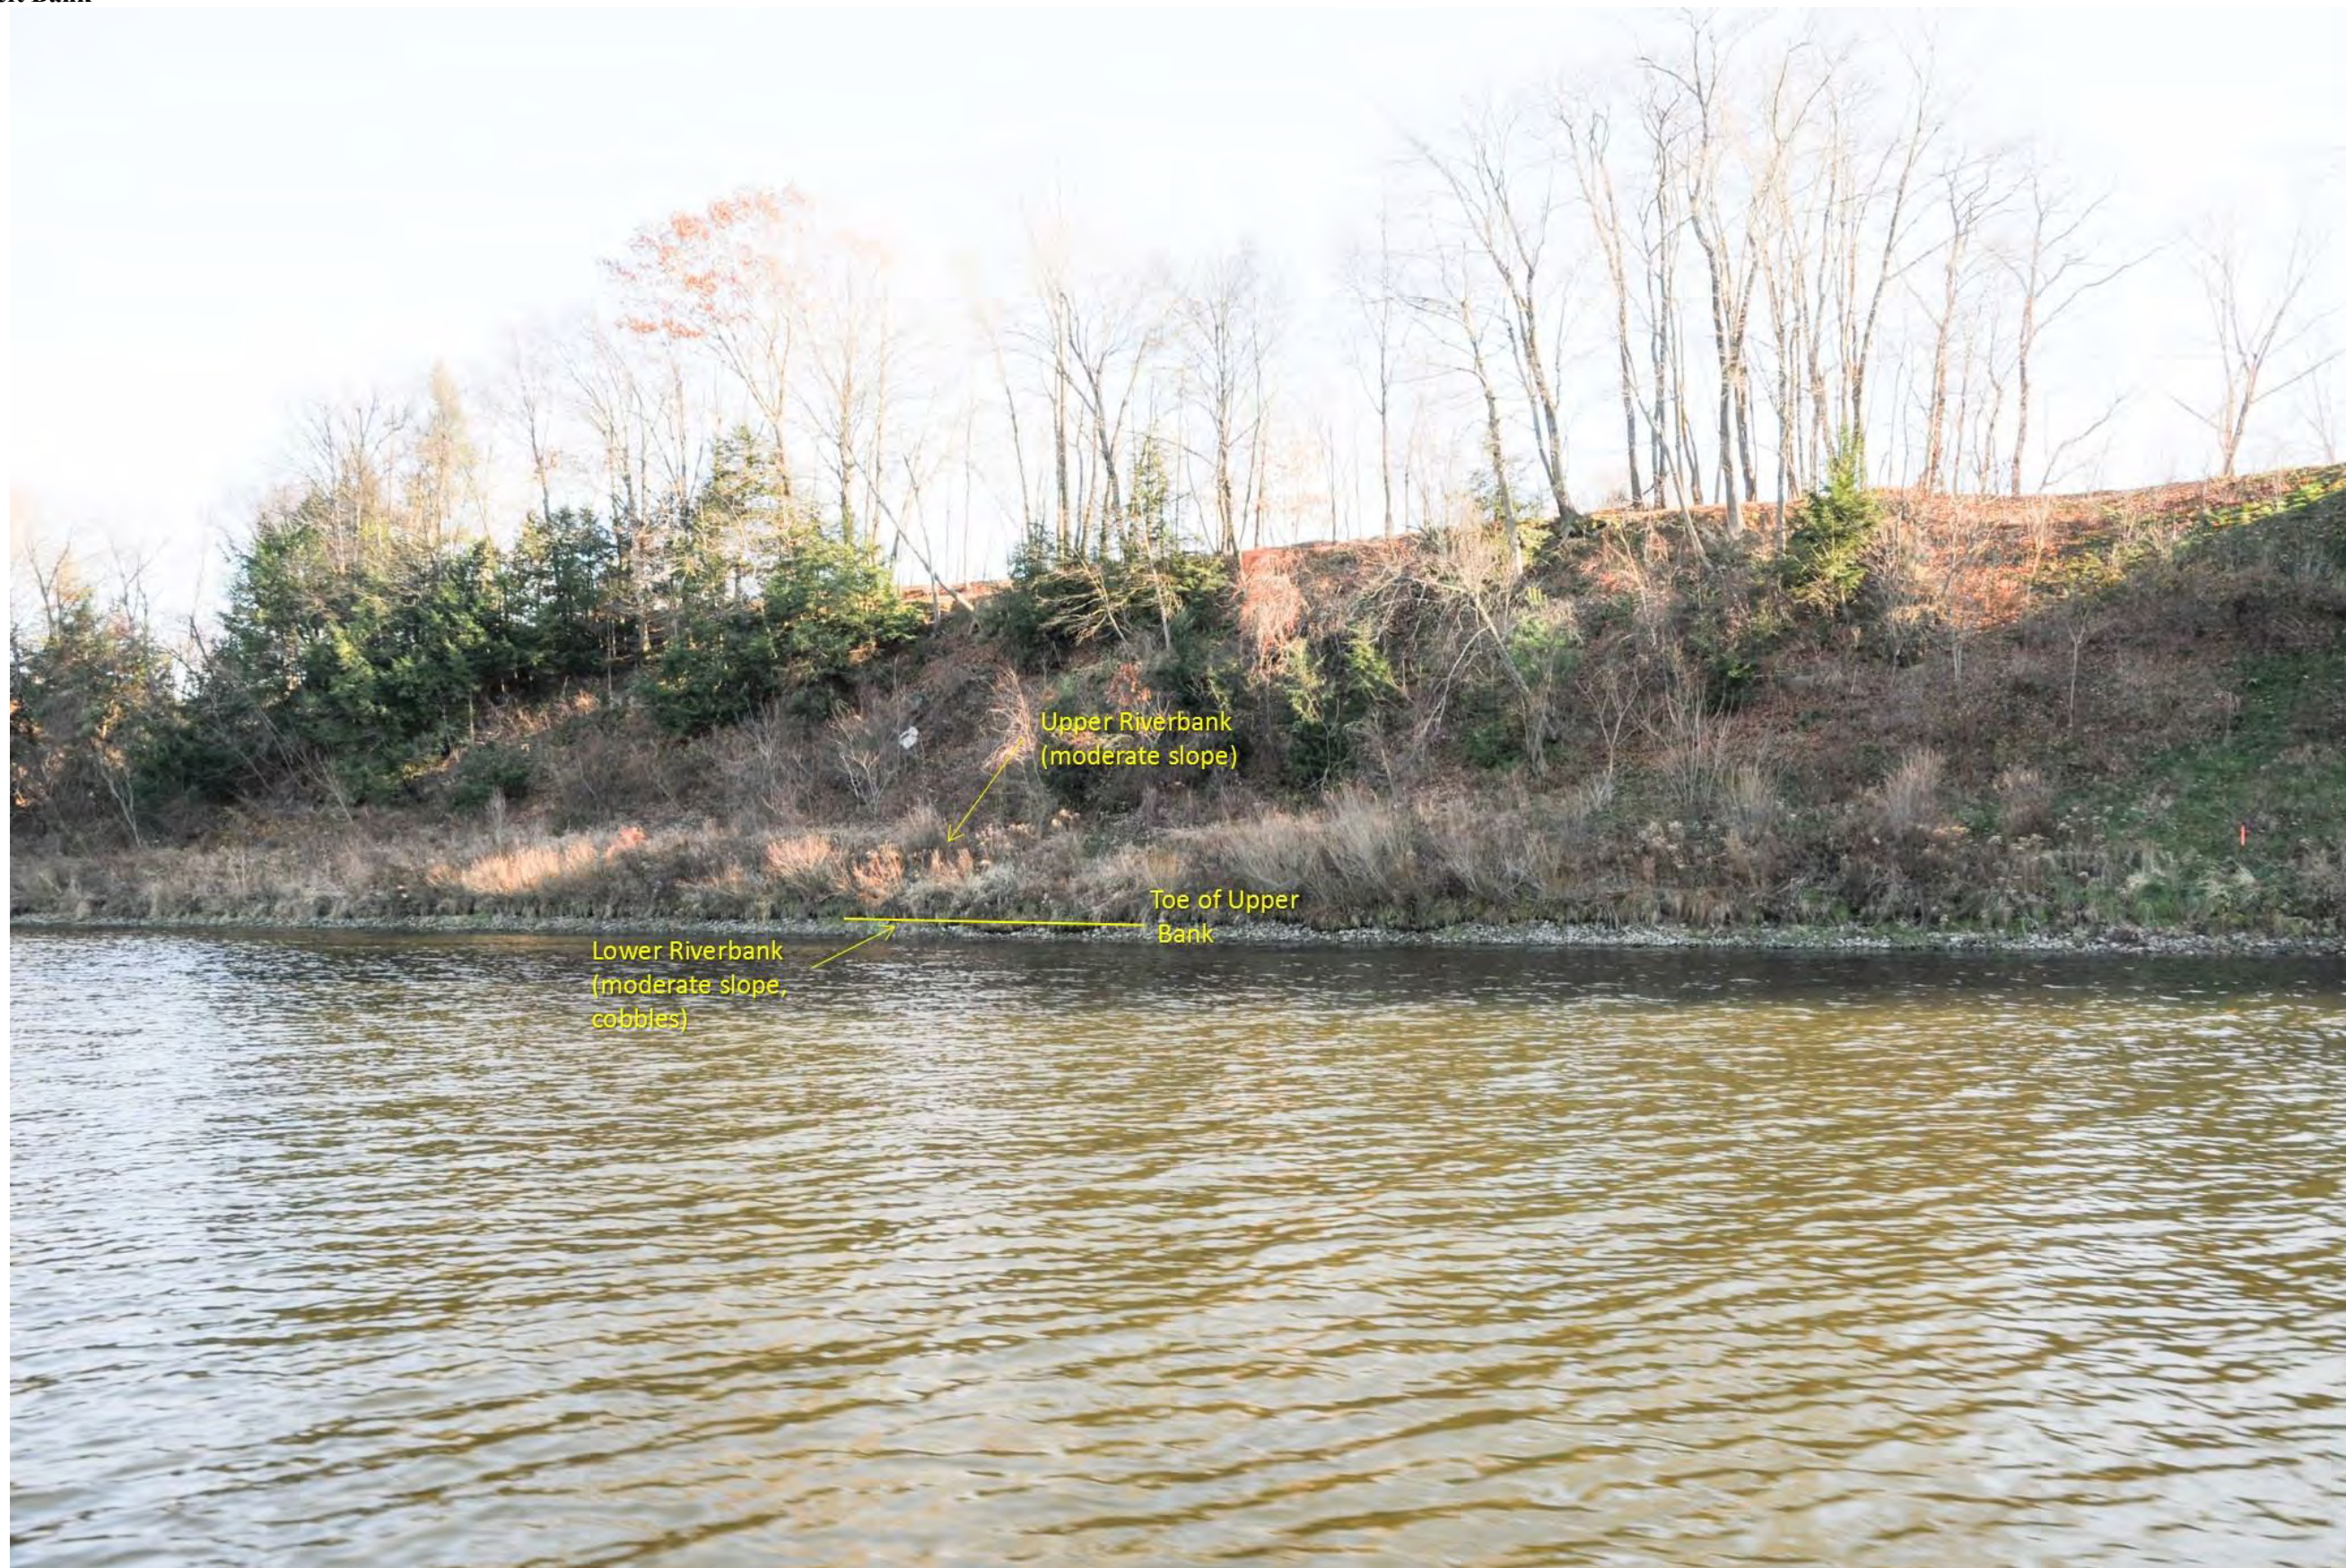
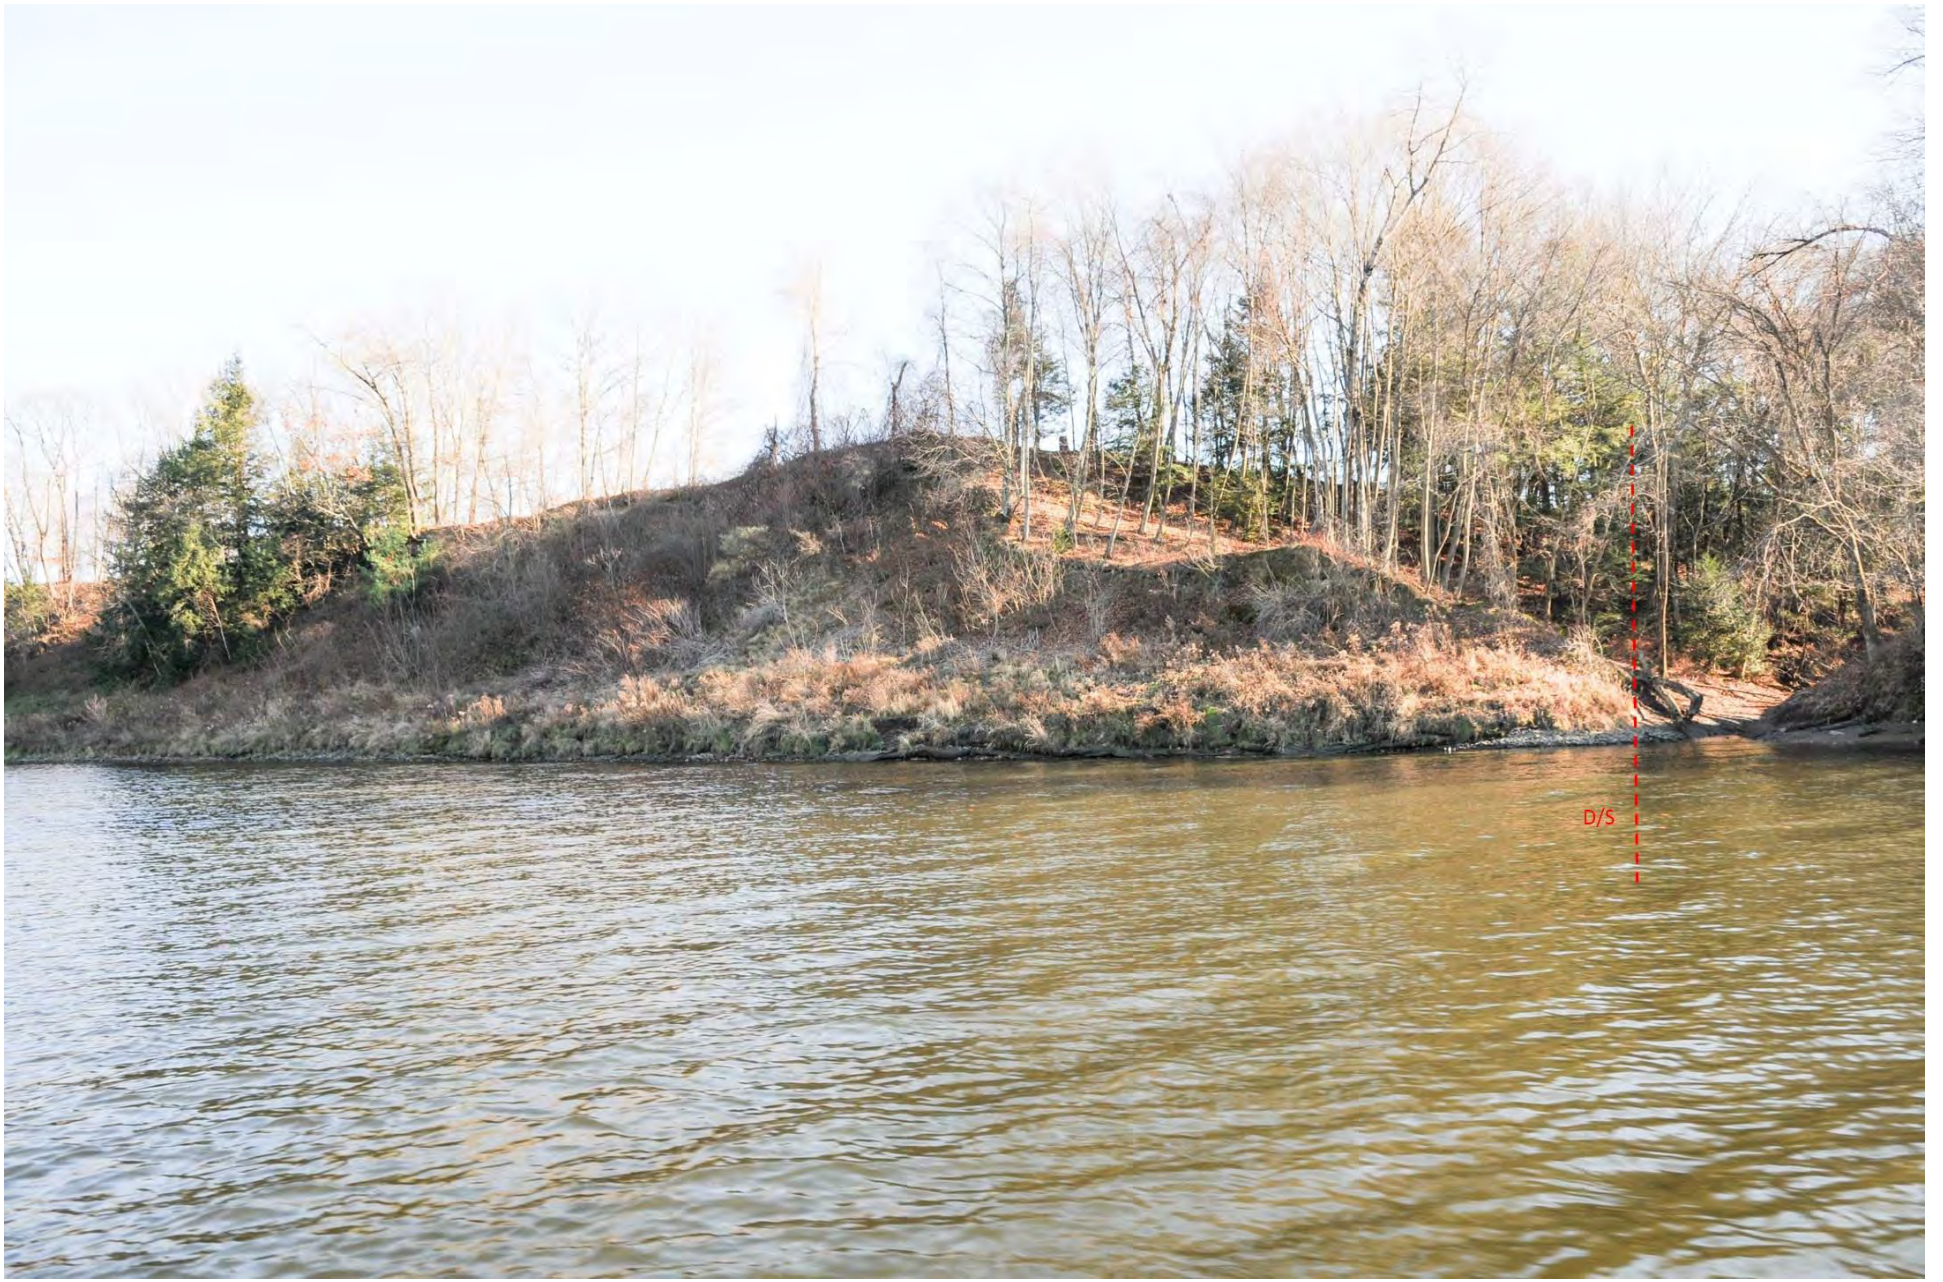
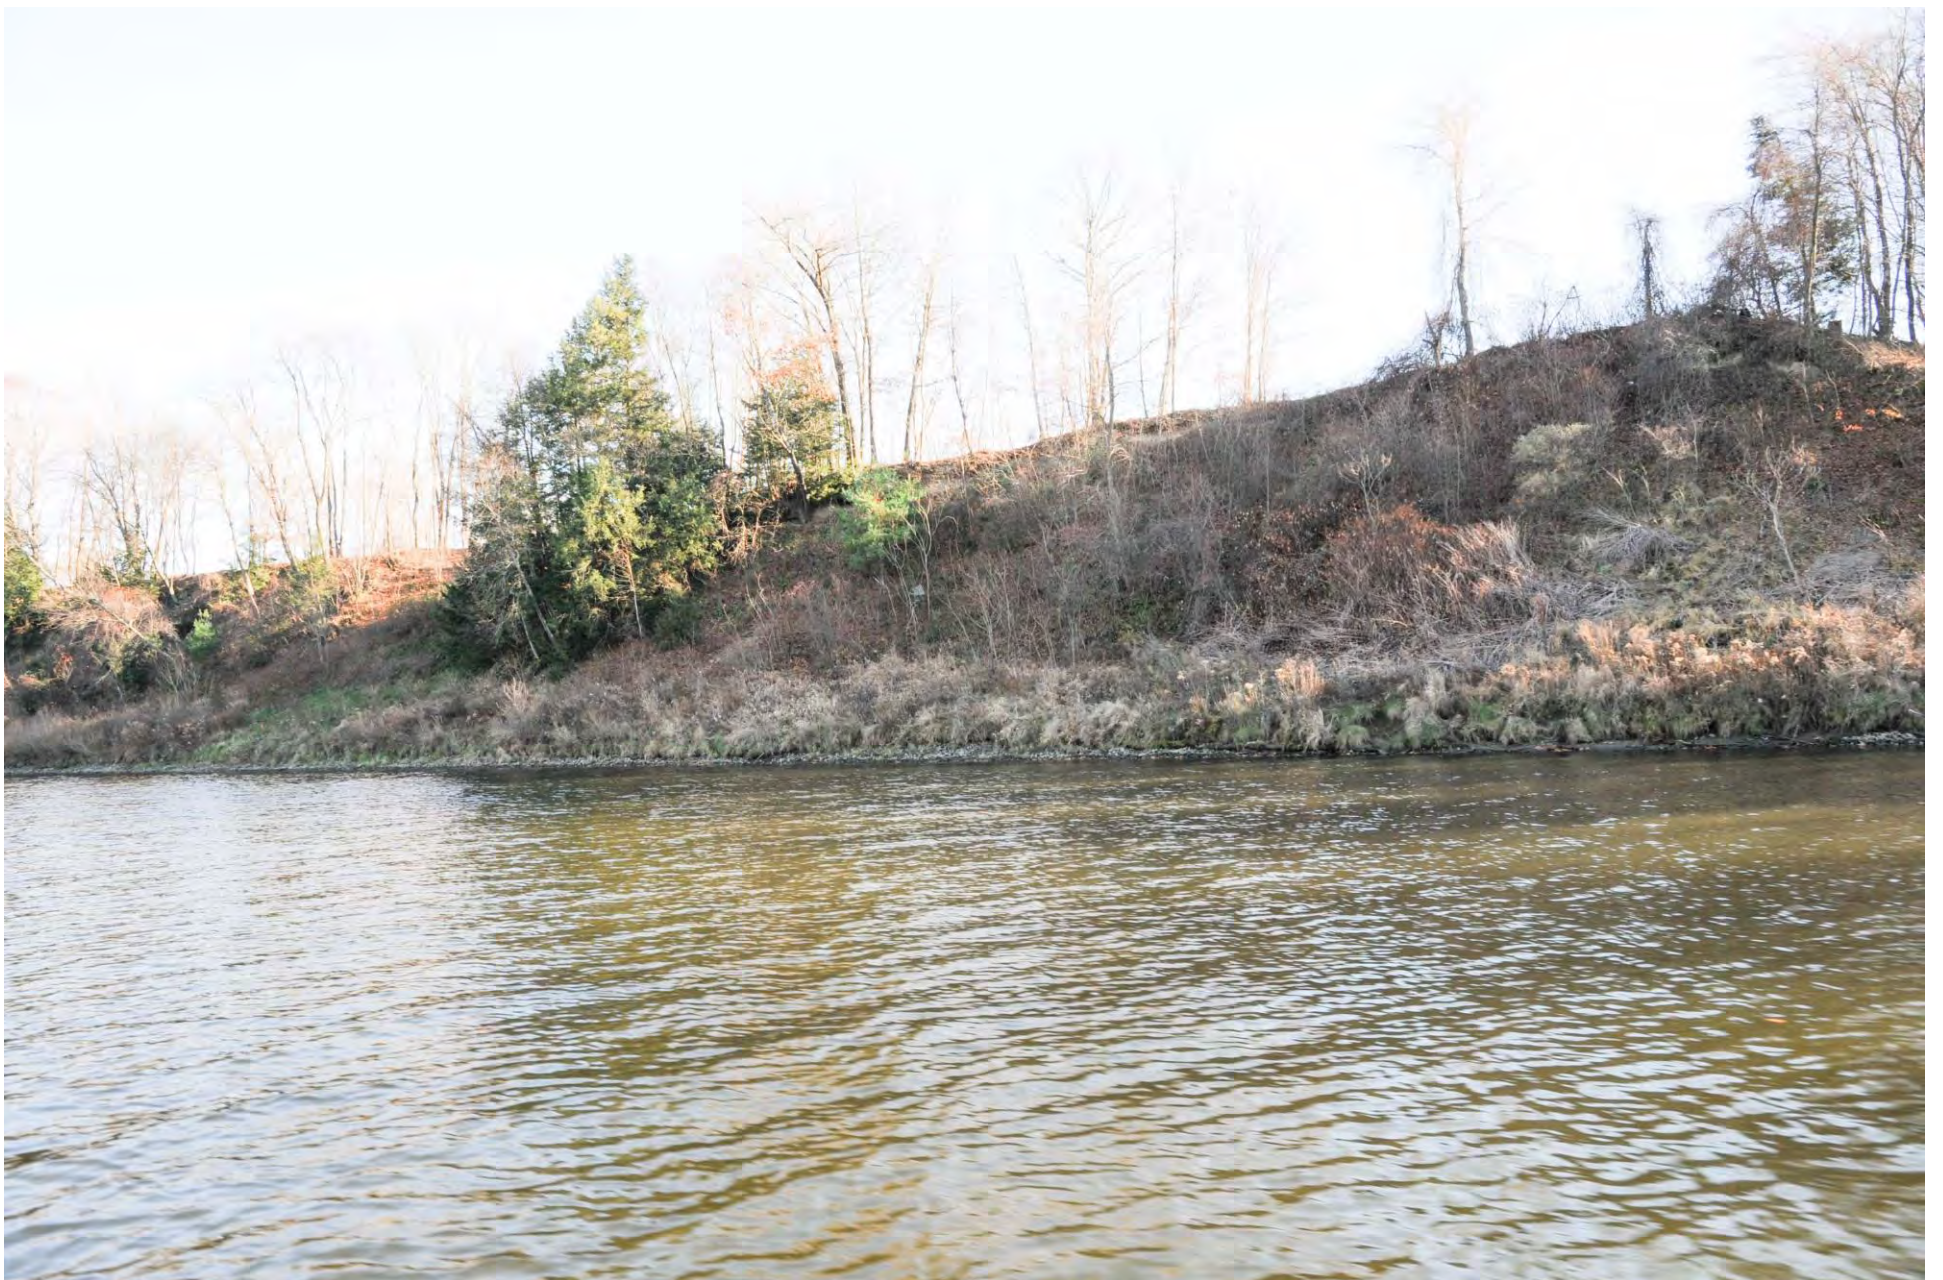
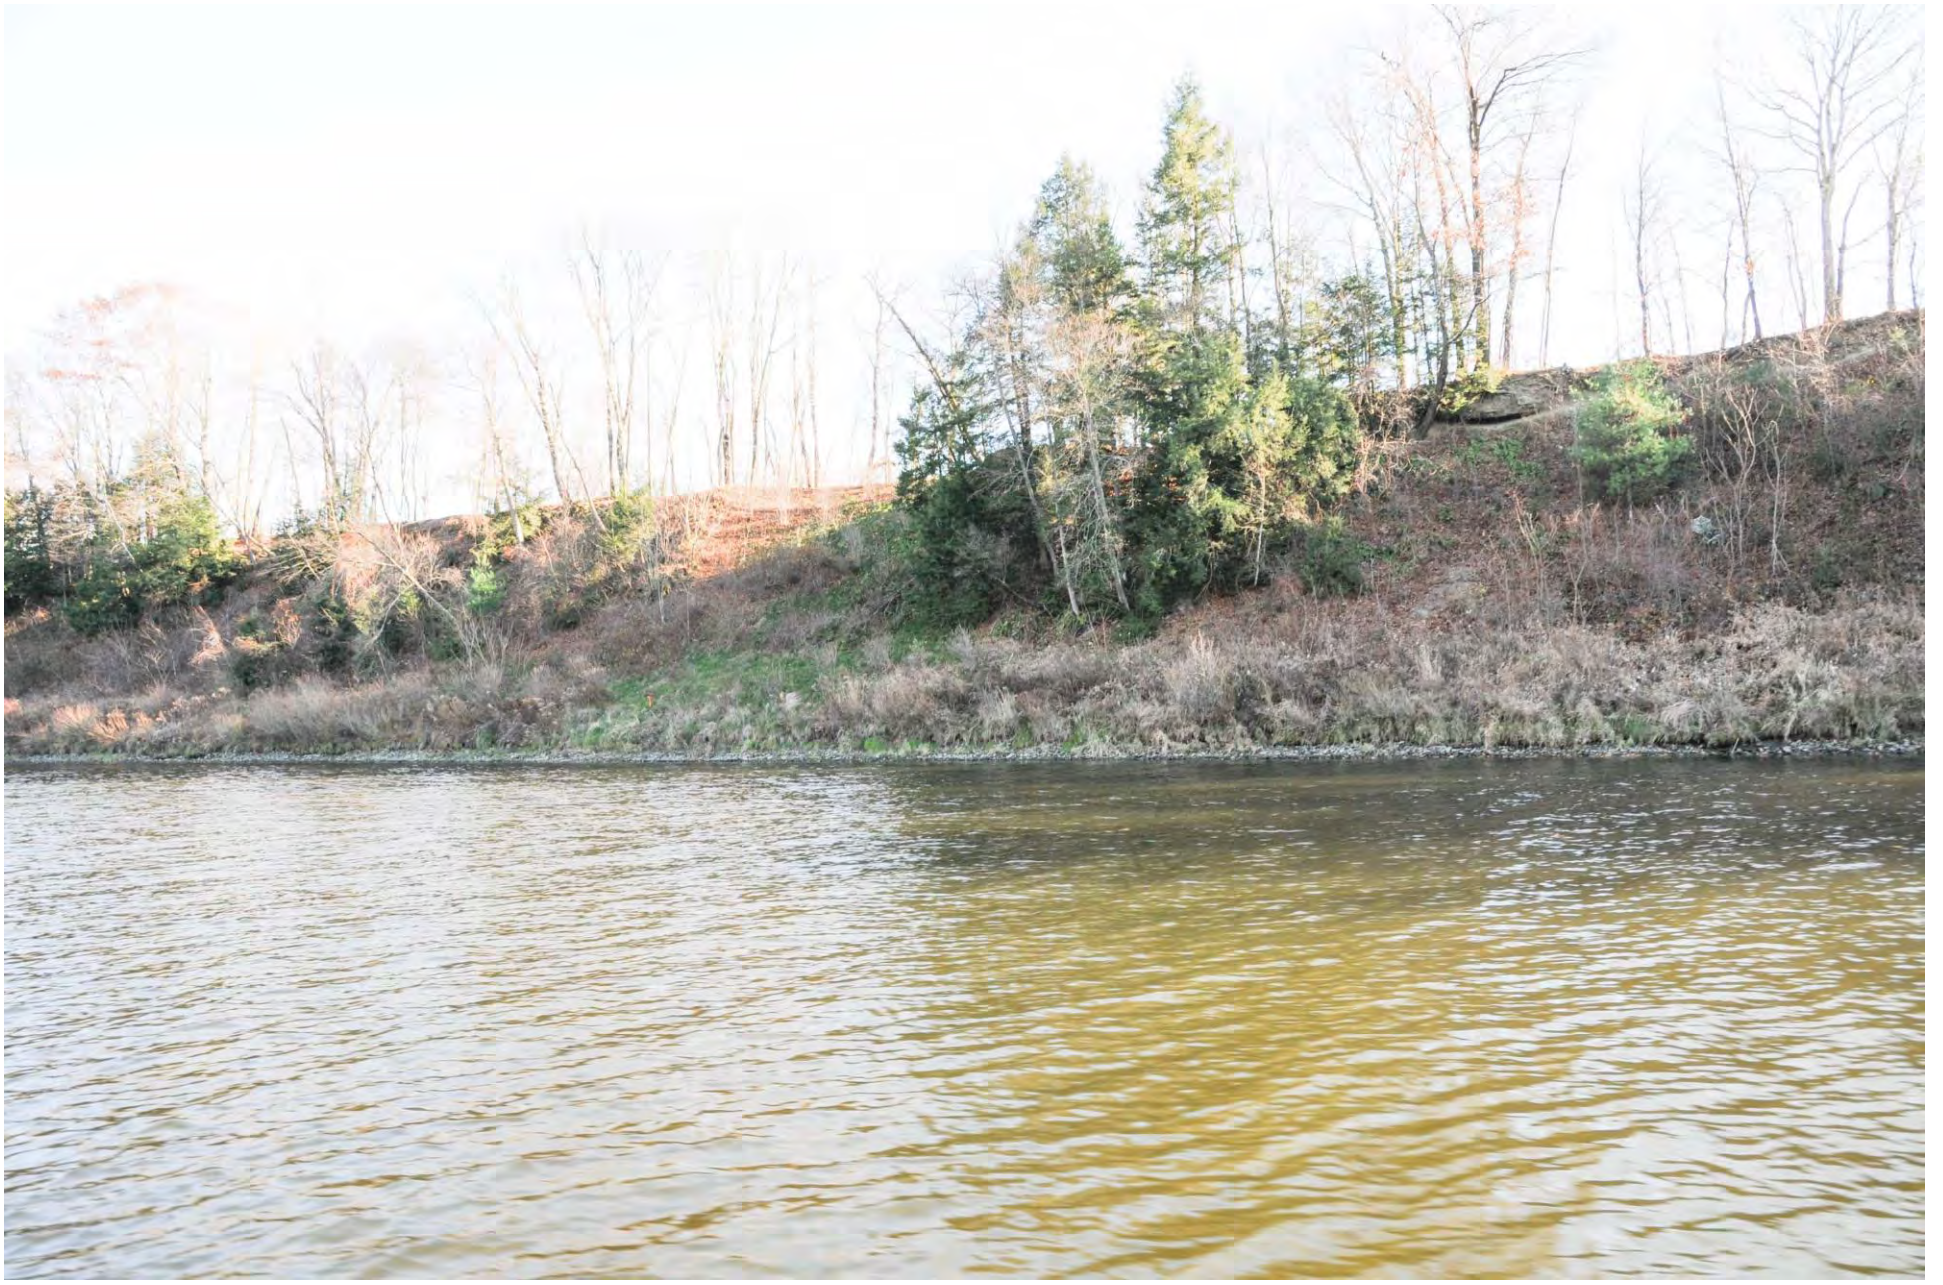
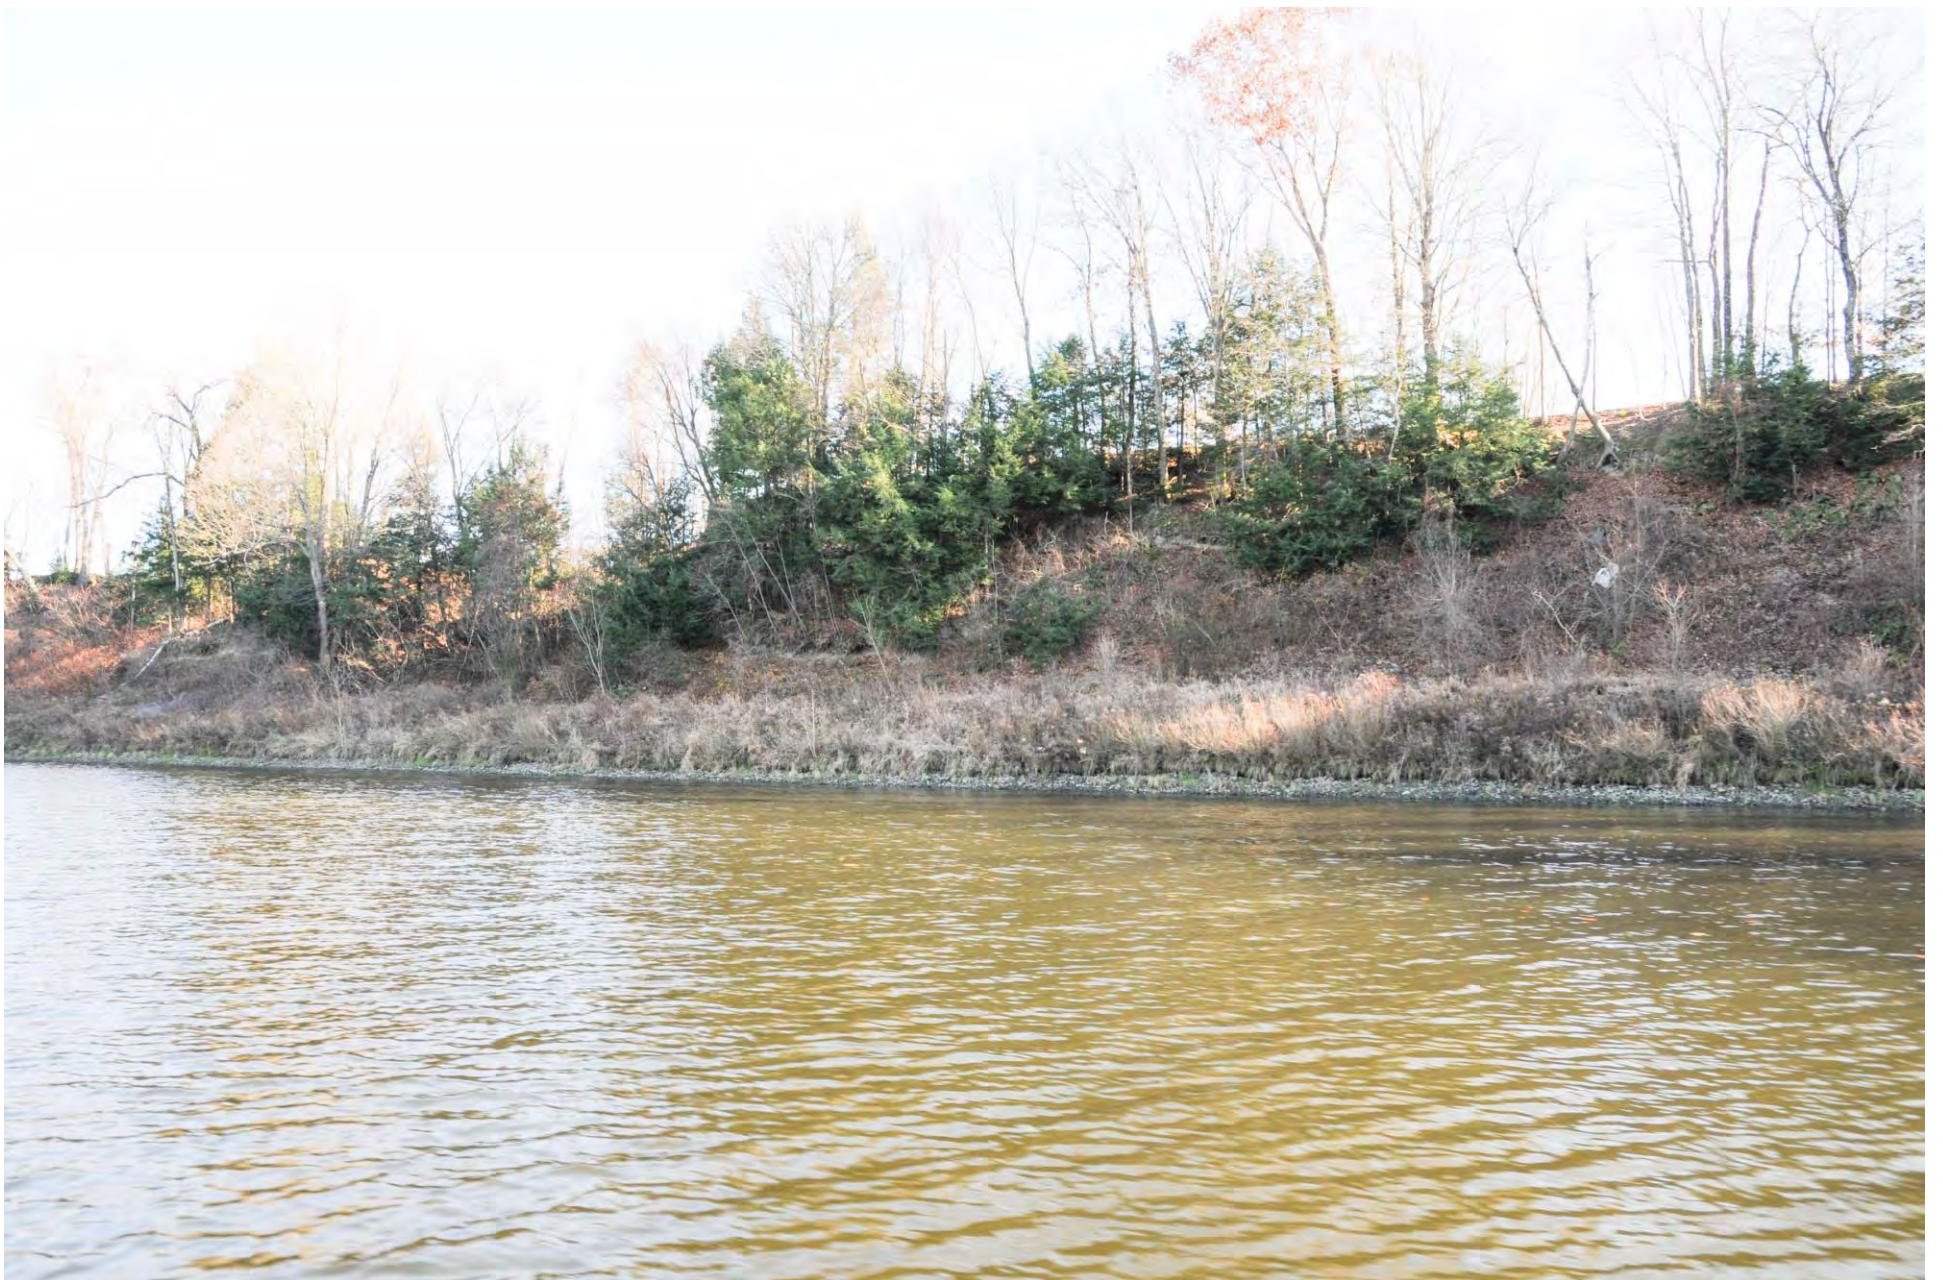
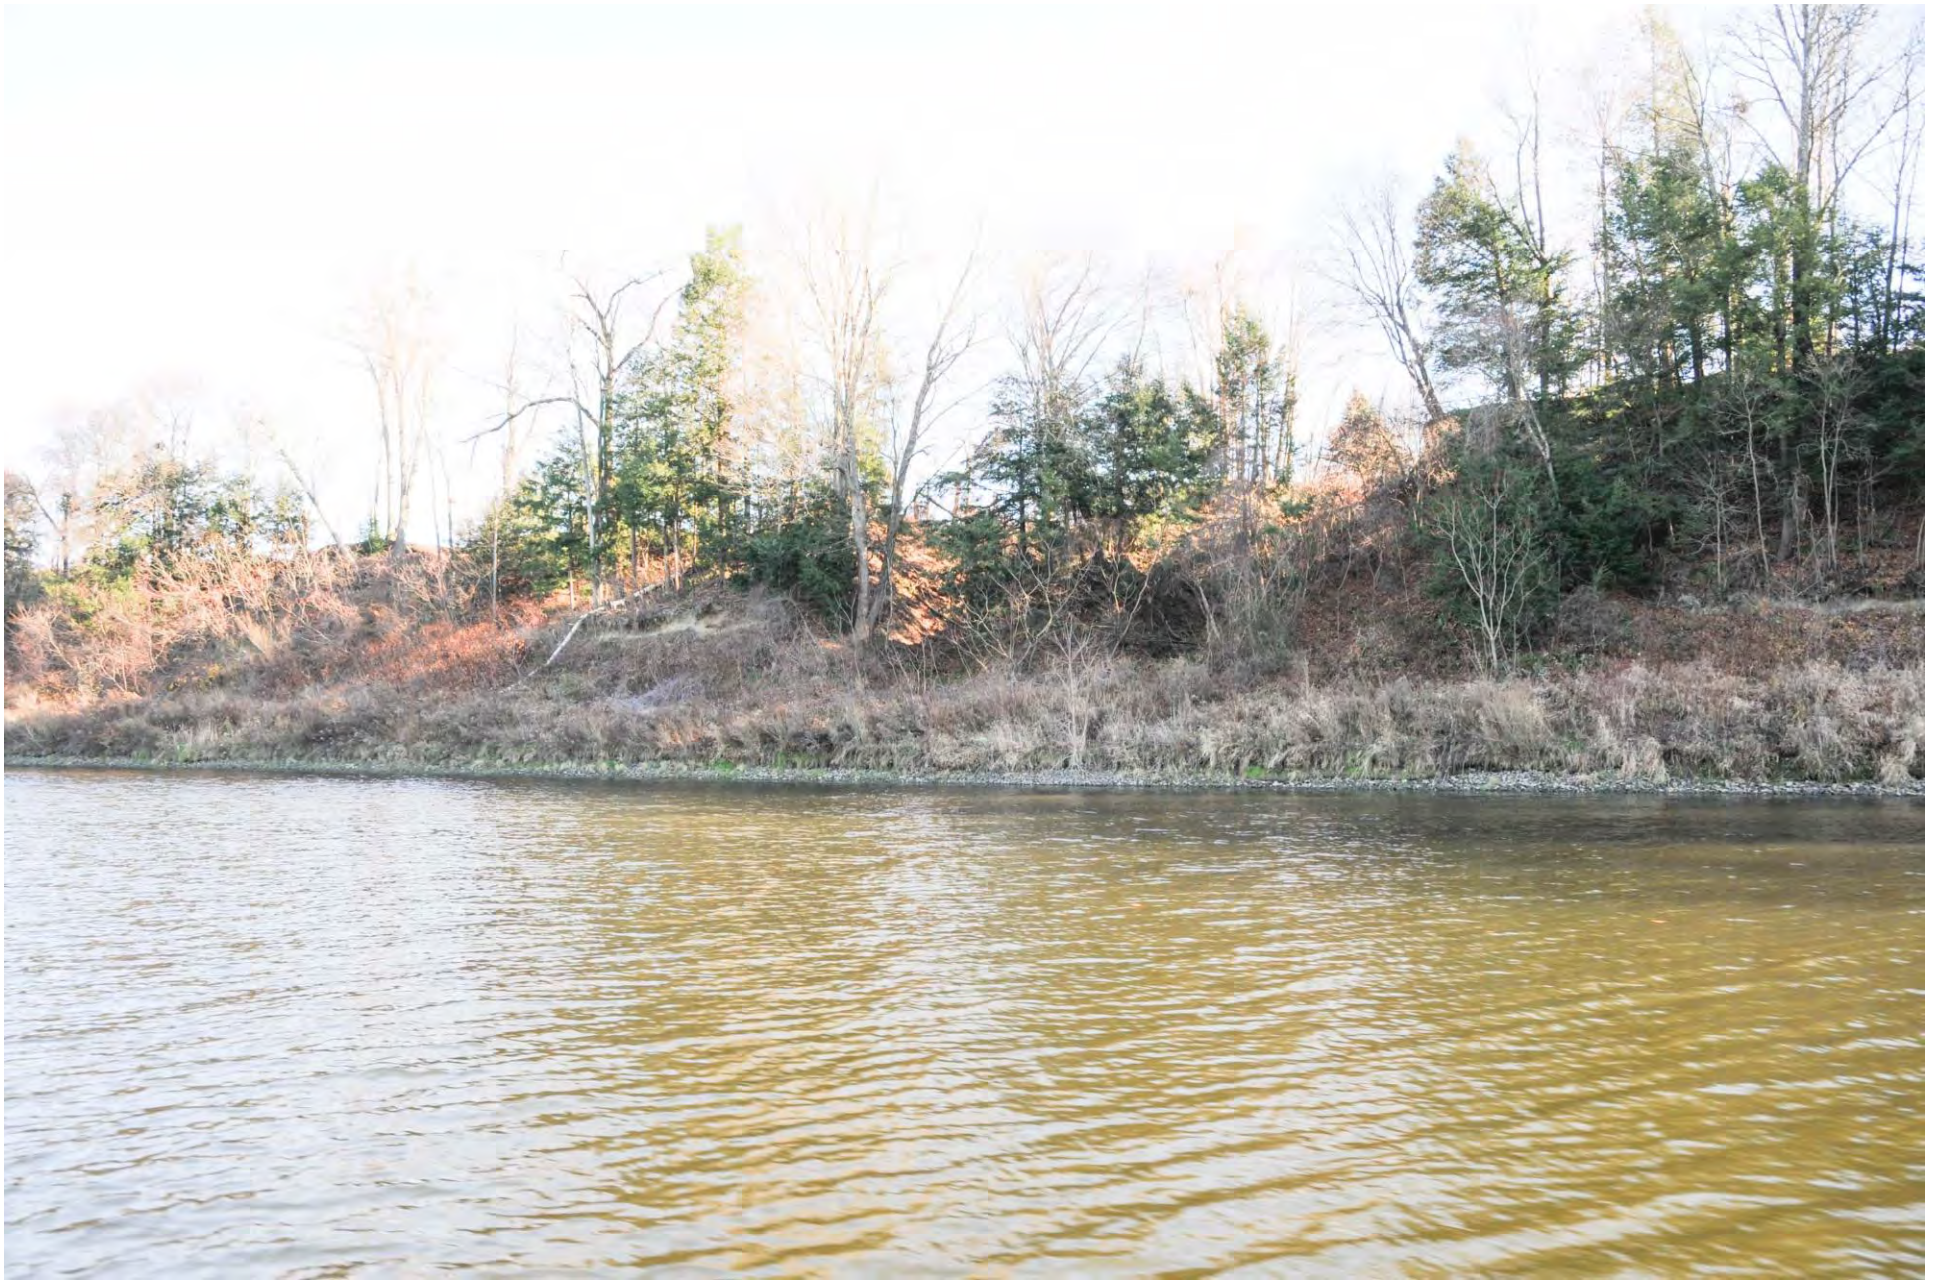
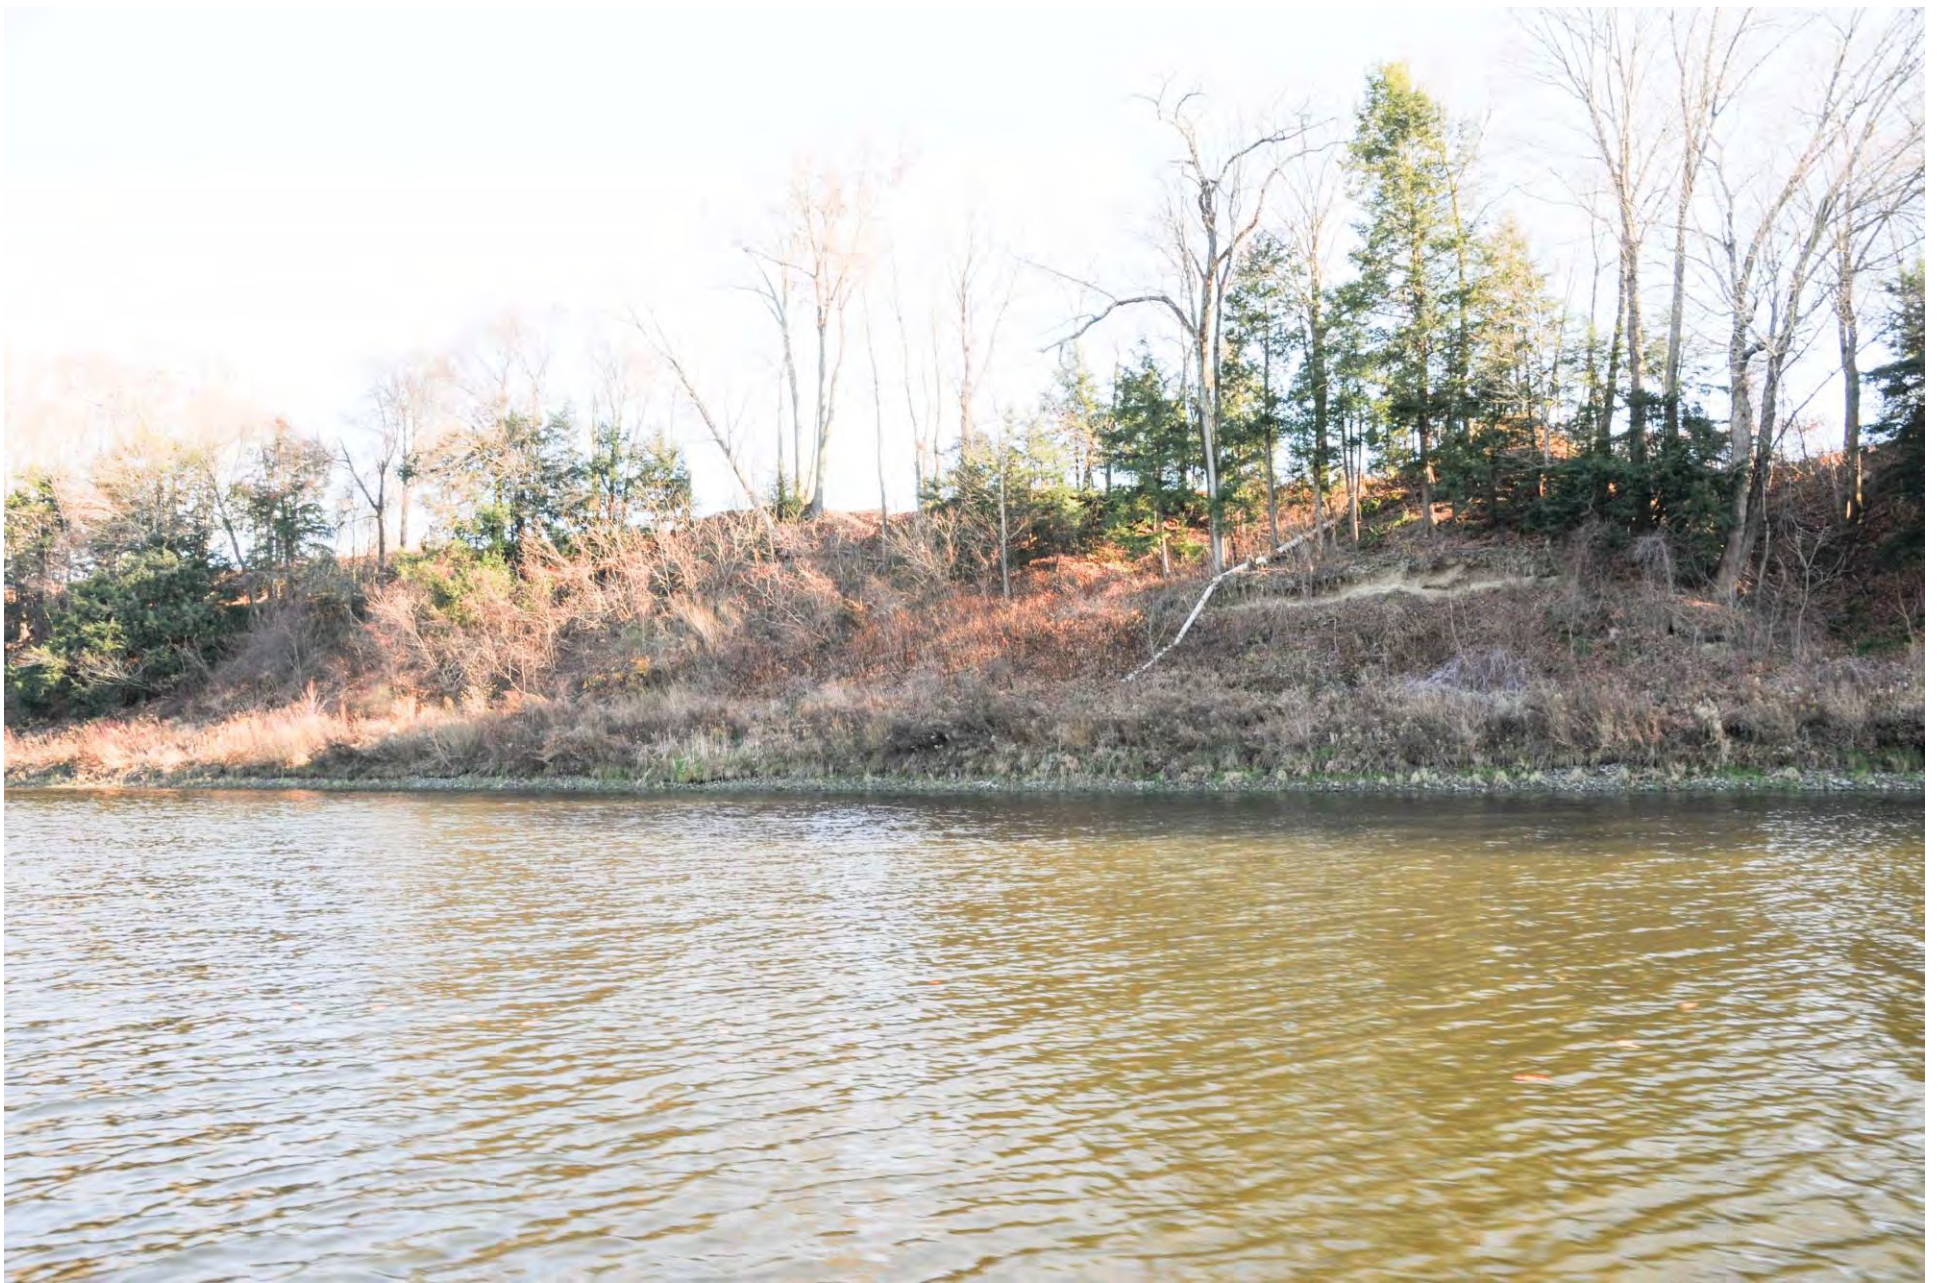
**QA Observations:** Upon review of the photos for this segment, classification made in the field was confirmed.

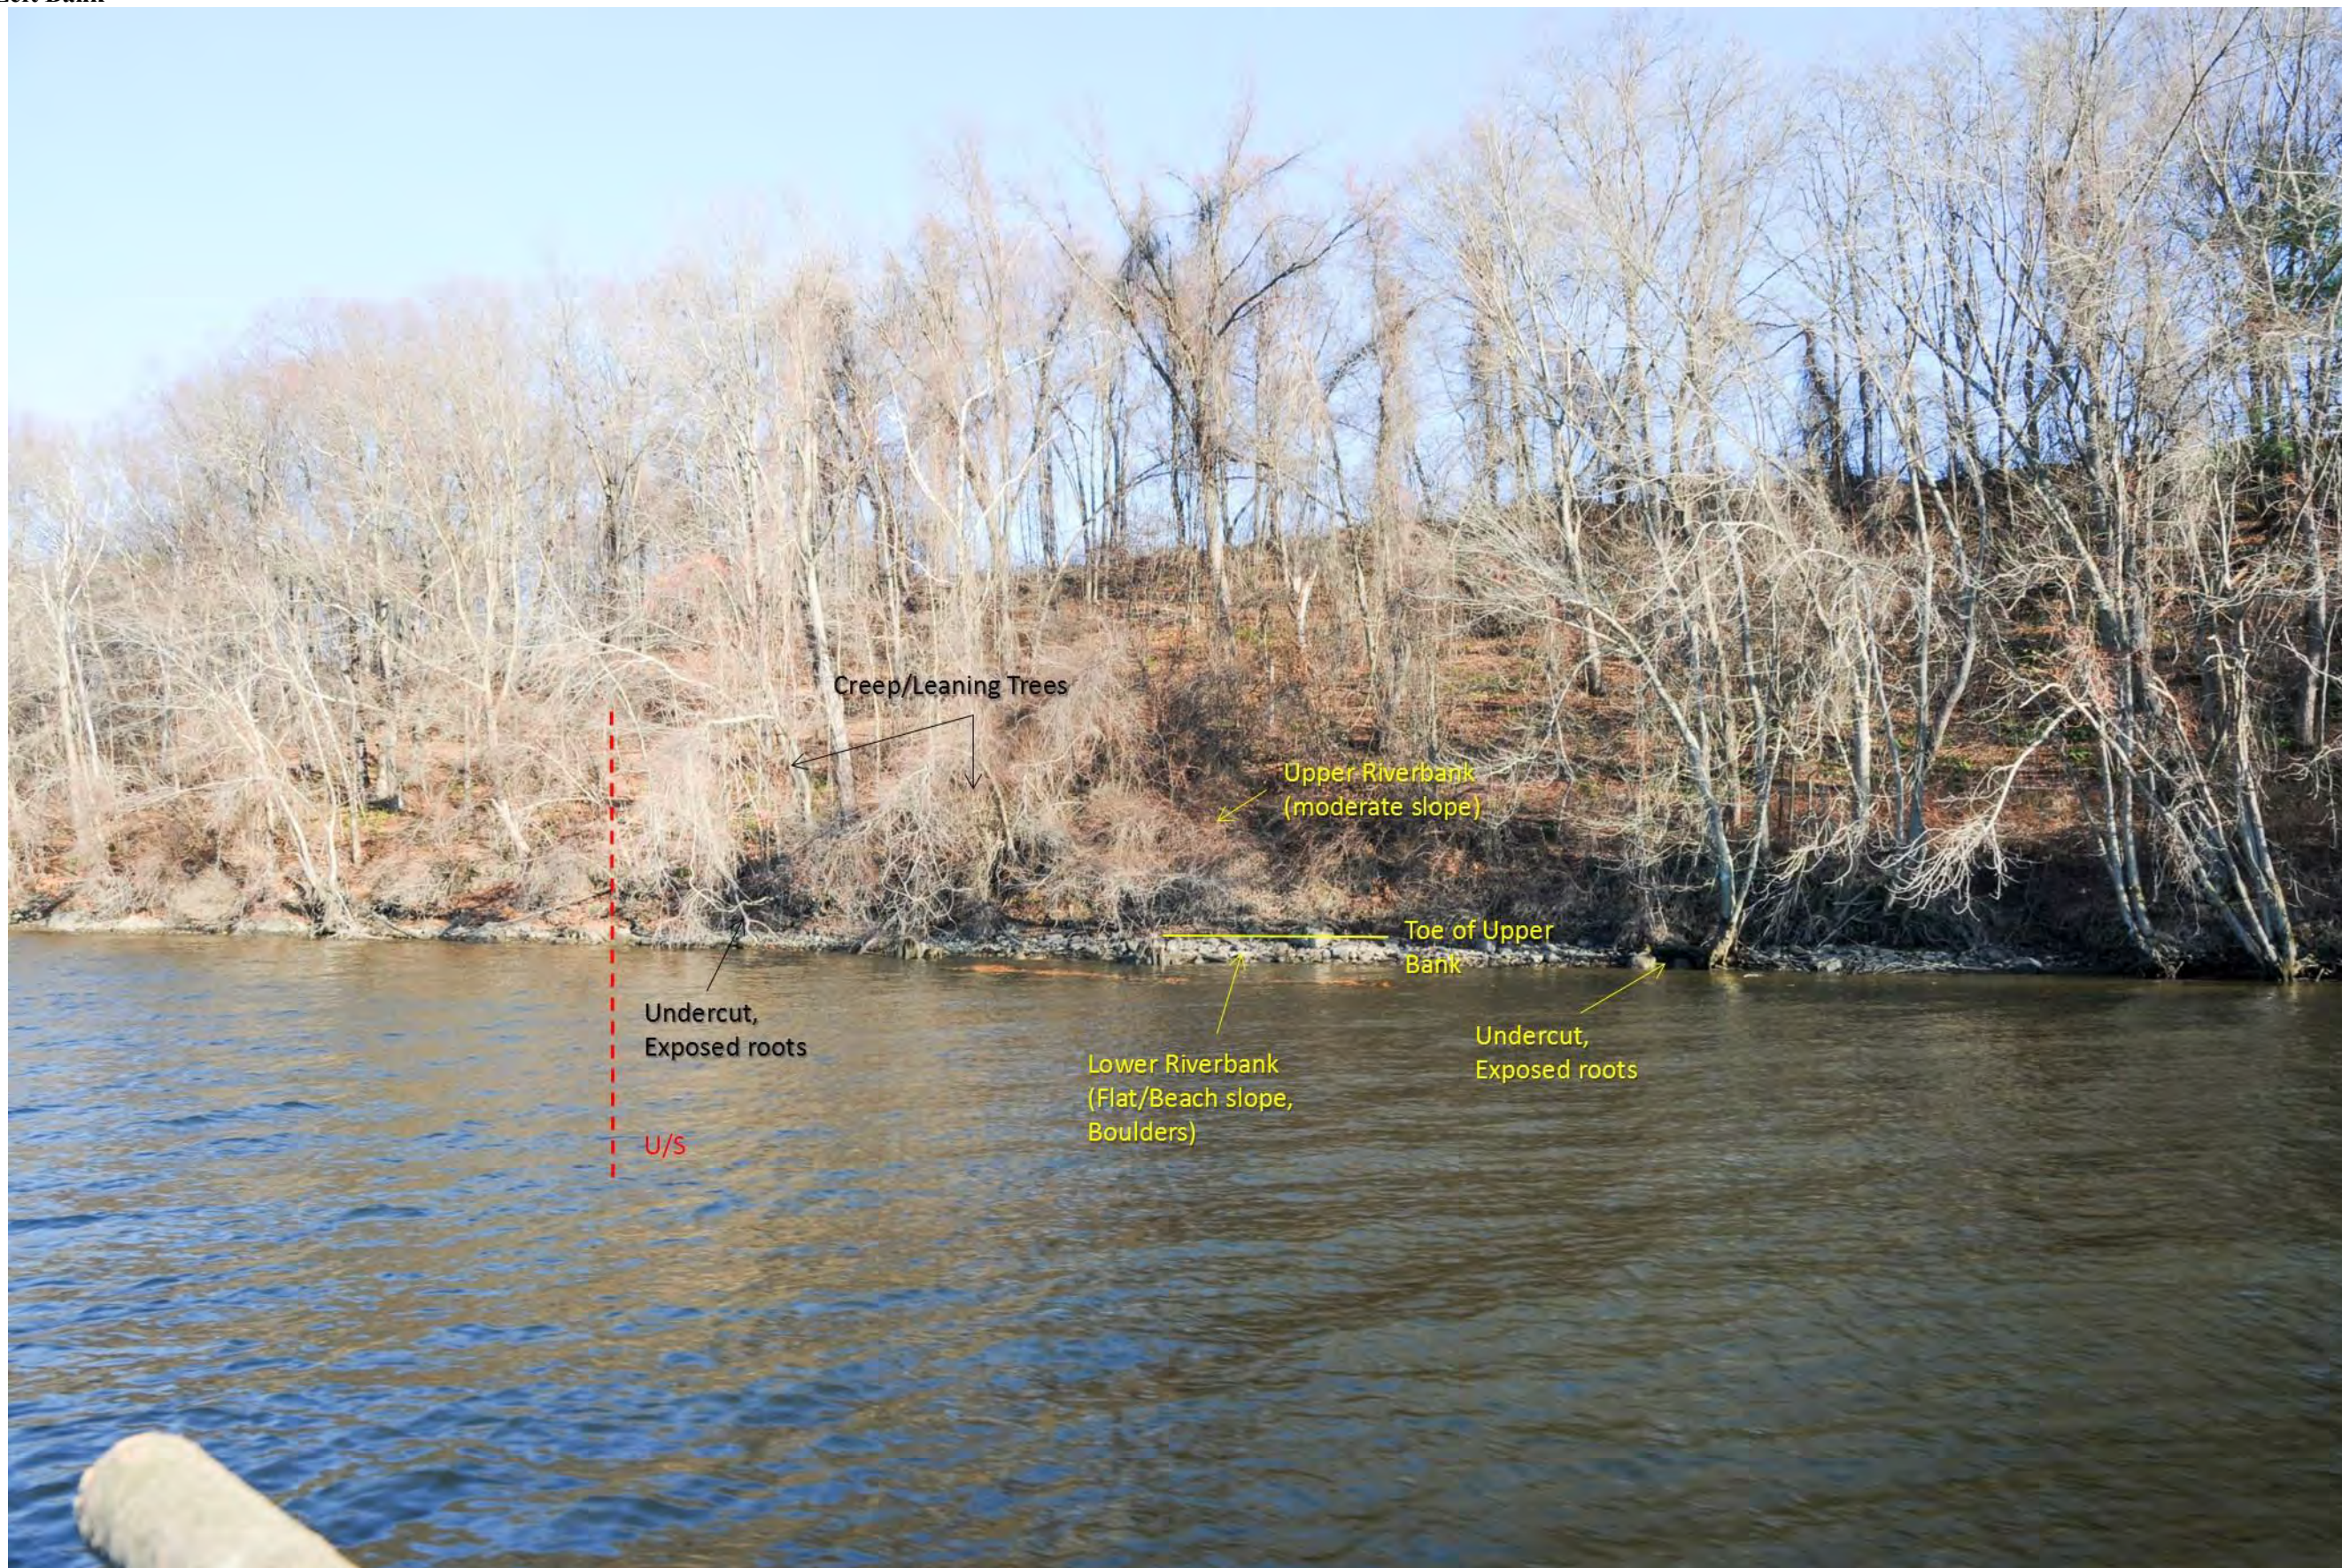
Photo ID 717 (U/S)

**QA Observations:** Upon review of the photos for this segment, classification made in the field was confirmed and additional indicators of potential future erosion were included.
