Re: Filing of Addendum to Study No. 3.1.1- 2013 Full River Reconnaissance  
Turners Falls Hydroelectric Project (FERC No. 1889) and Northfield Mountain Pumped Storage  
Project (FERC No. 2485)

## **ATTACHMENT A: 2013 Full River Reconnaissance – 2015 Addendum: Riverbank Segment QA Comparison**

2015 FRR Addendum  
 Selected Riverbank Segments for QA  
 Map 1

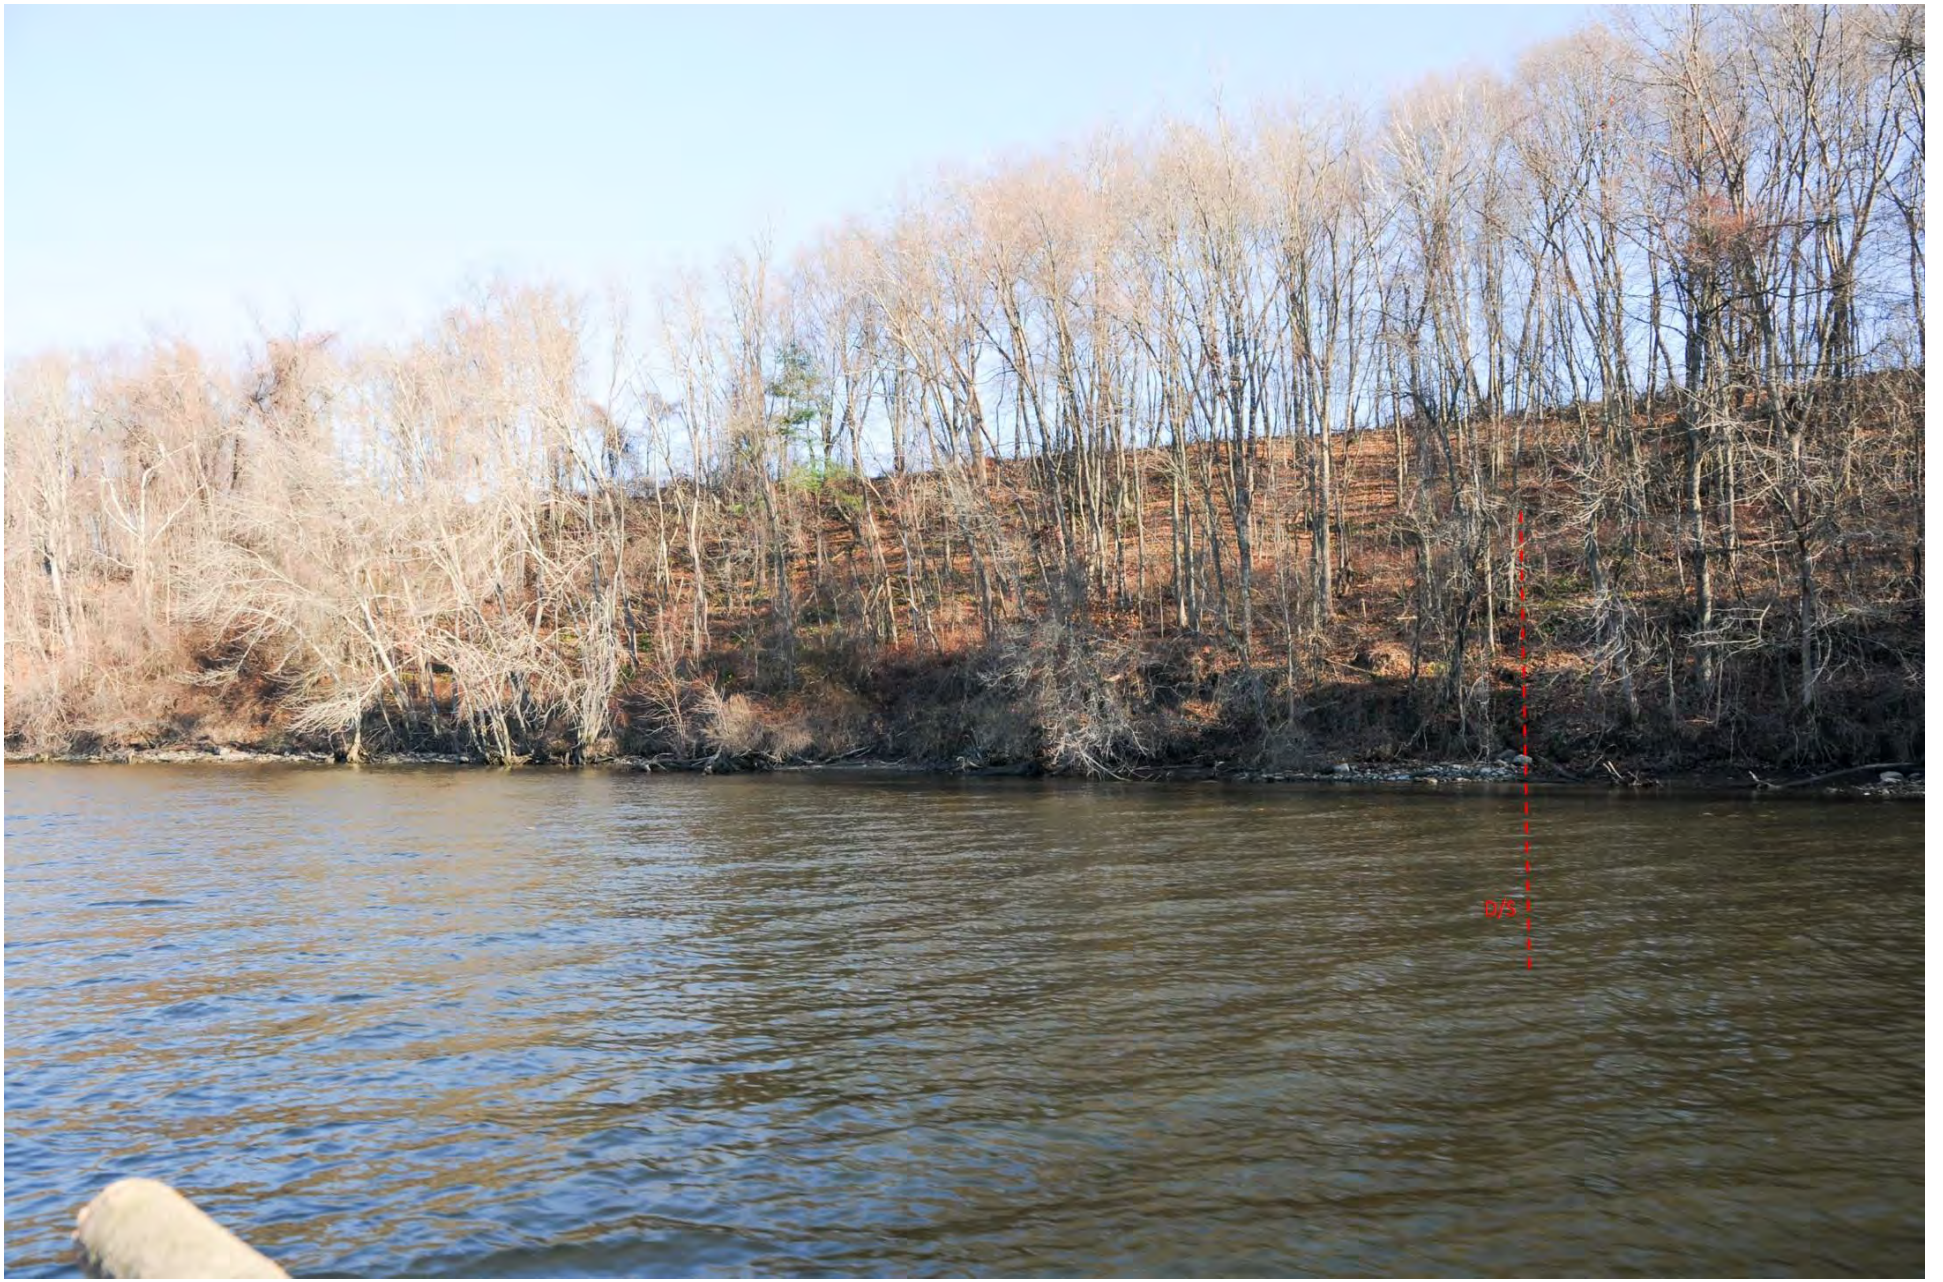
**Photo ID 716** (D/S, left of line)

**QA Observations:** Upon review of the photos for this segment, classification made in the field was confirmed and additional indicators of potential future erosion were included.
