**FIRSTLIGHT POWER RESOURCES**  
 RELICENSING STUDY 3.1.1  
 2013 FULL RIVER RECONNAISSANCE  
 TURNERS FALLS IMPOUNDMENT

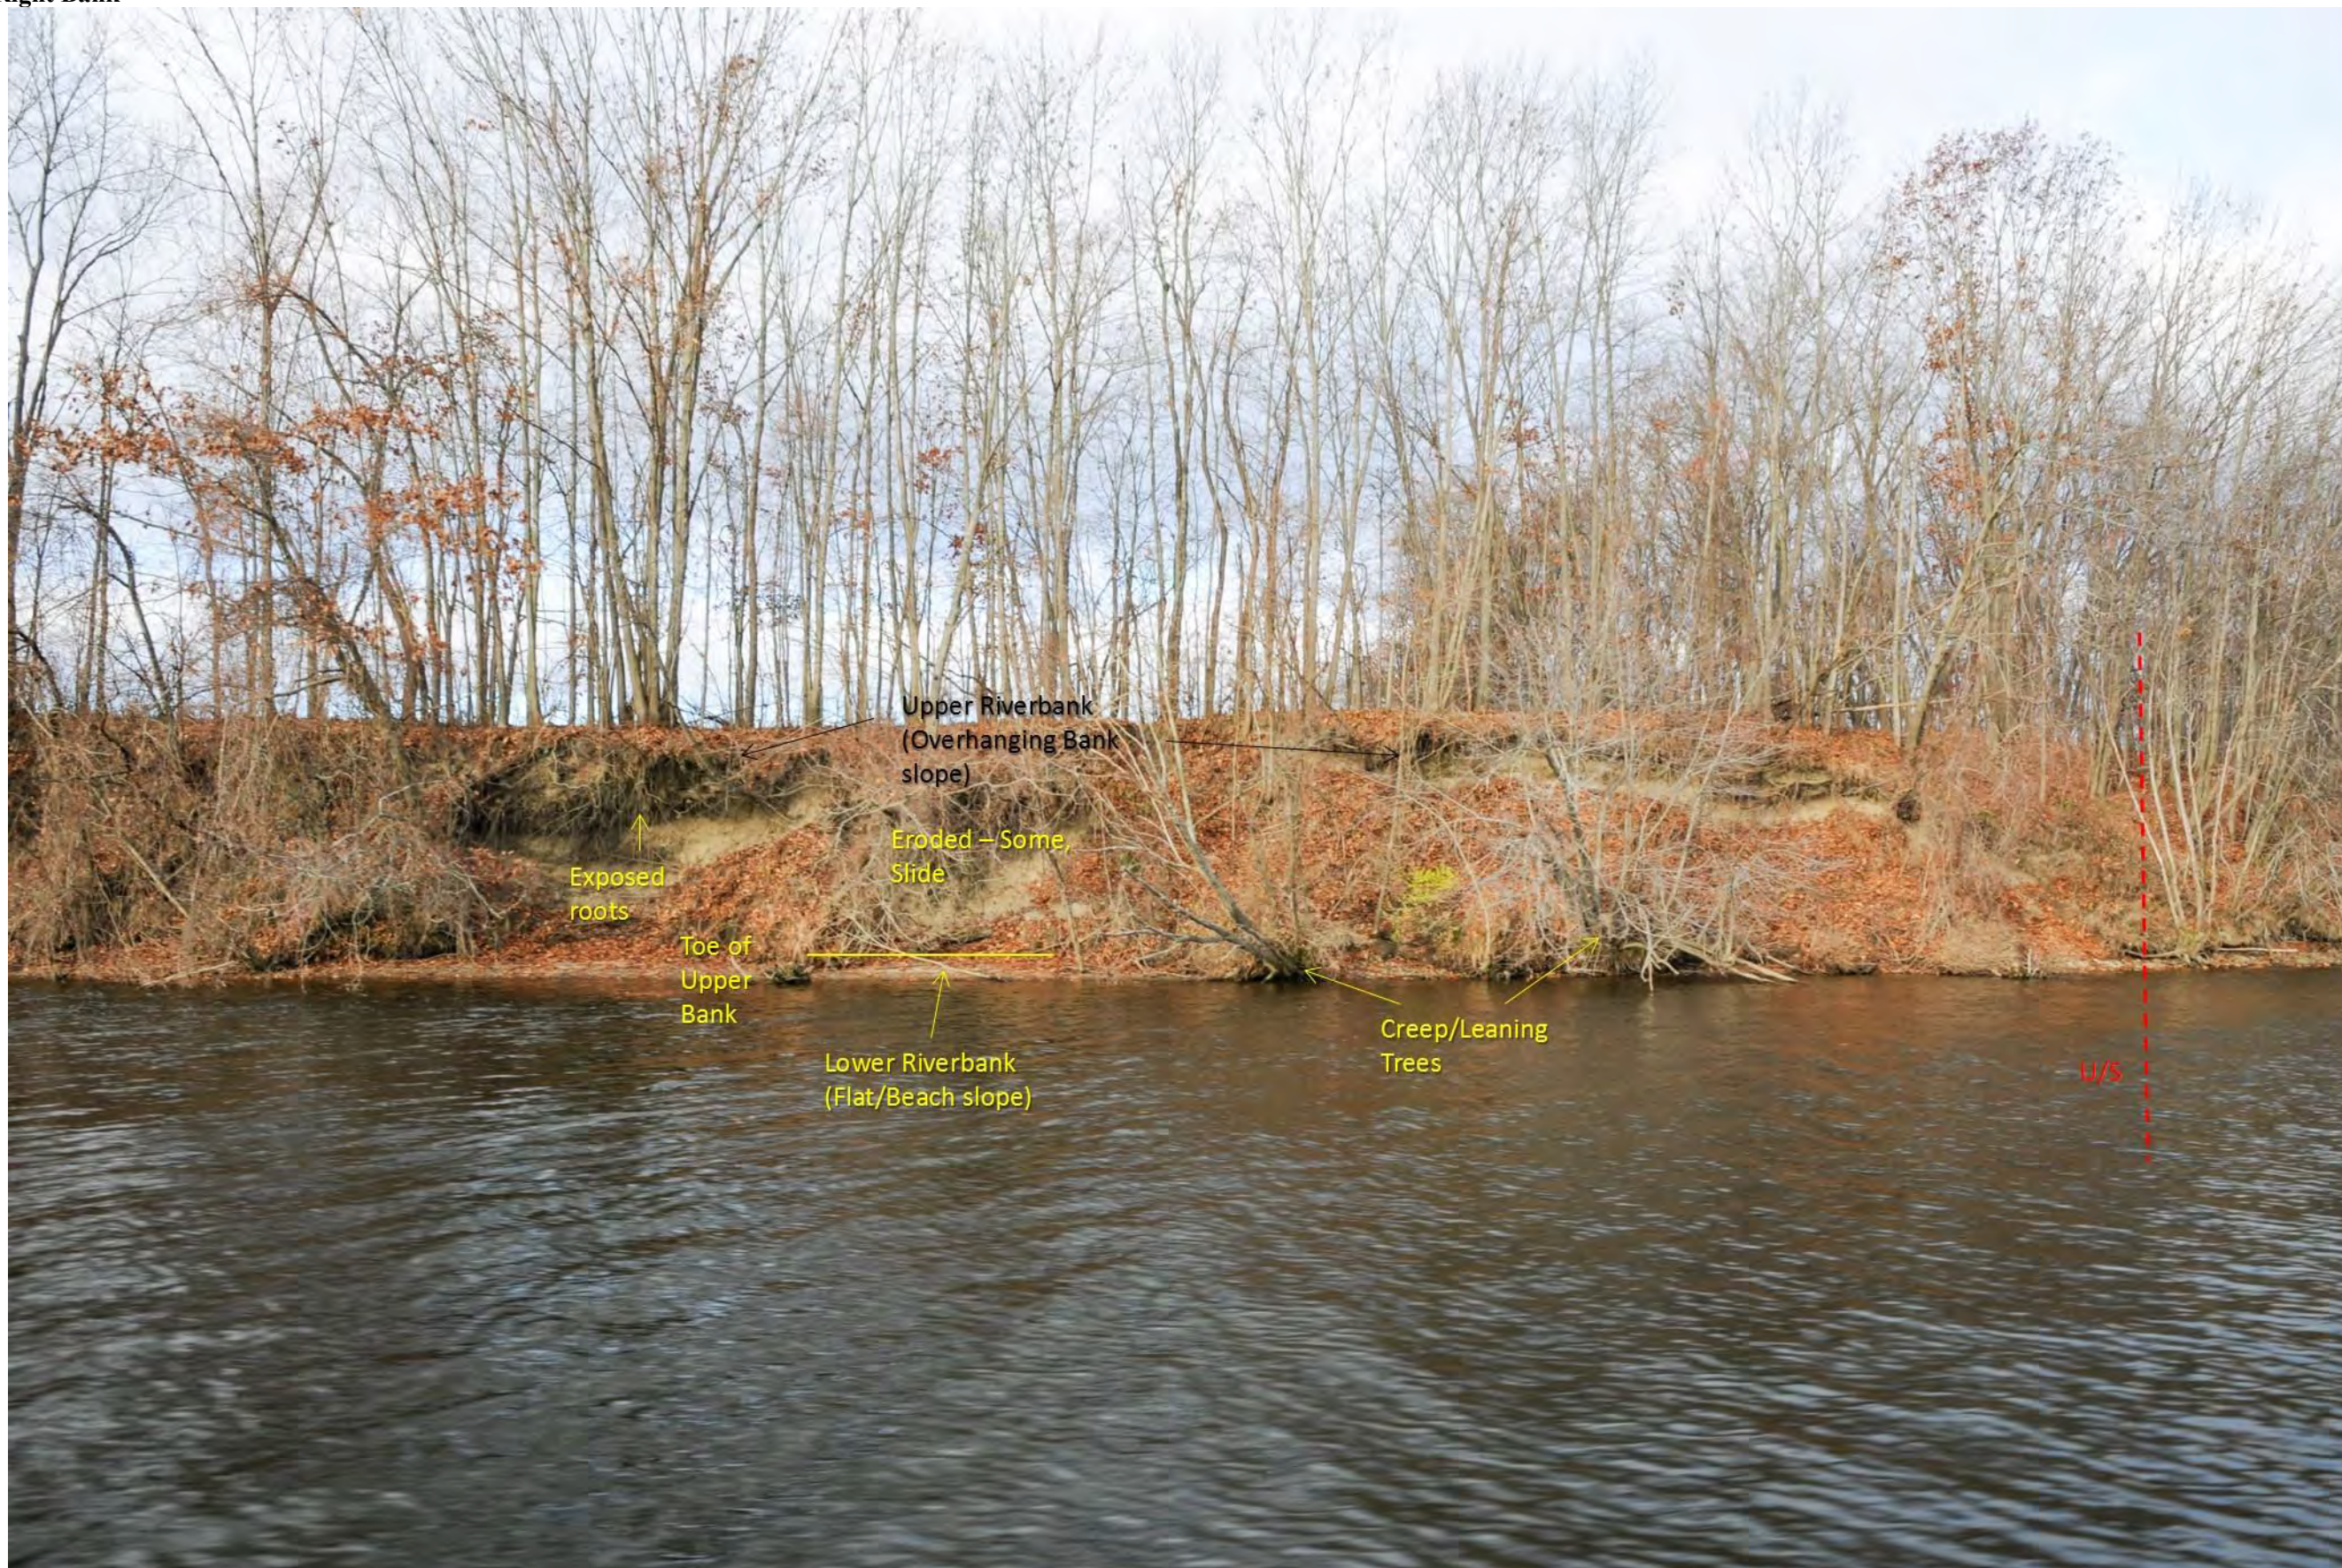
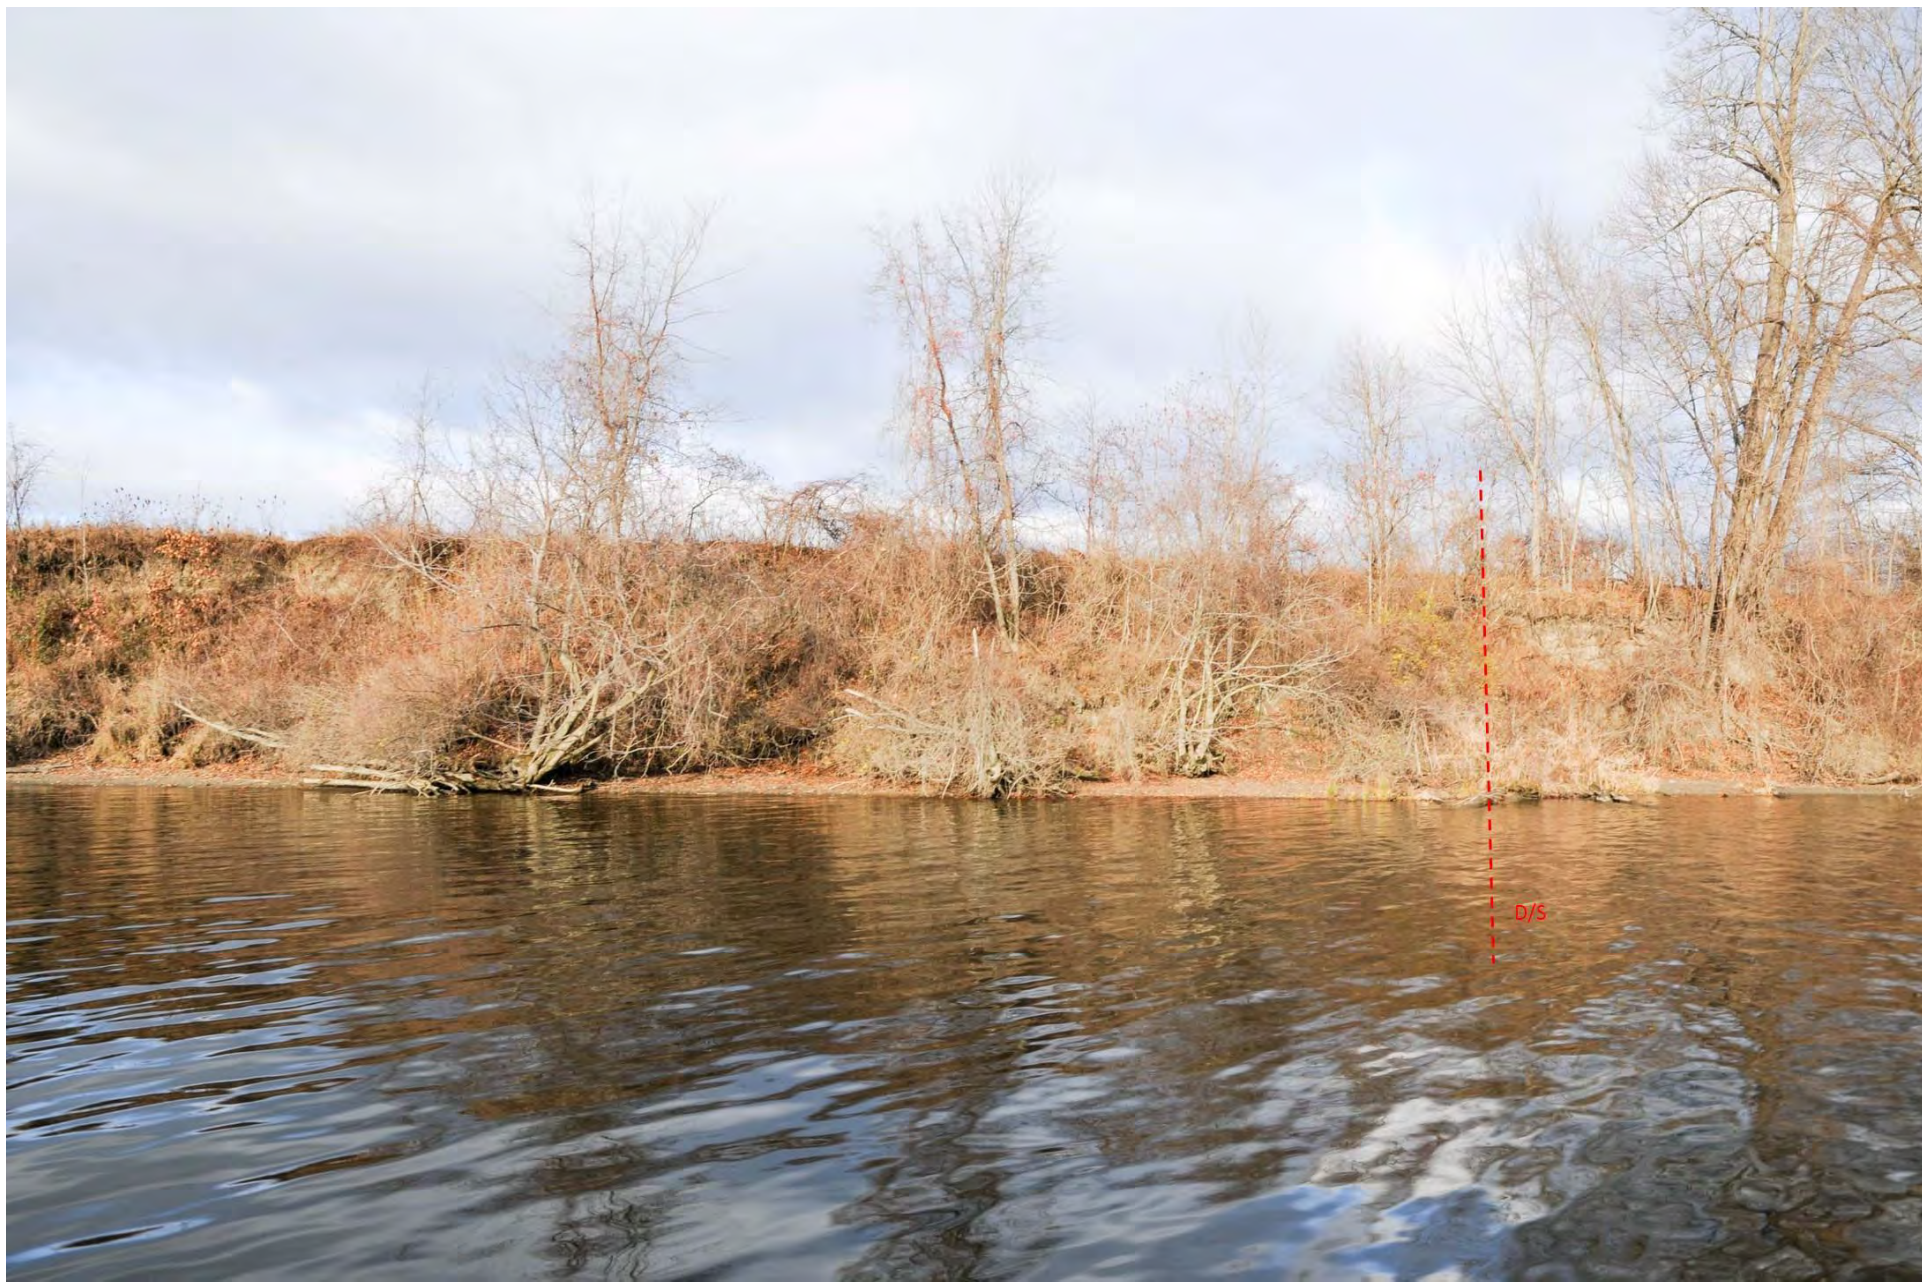
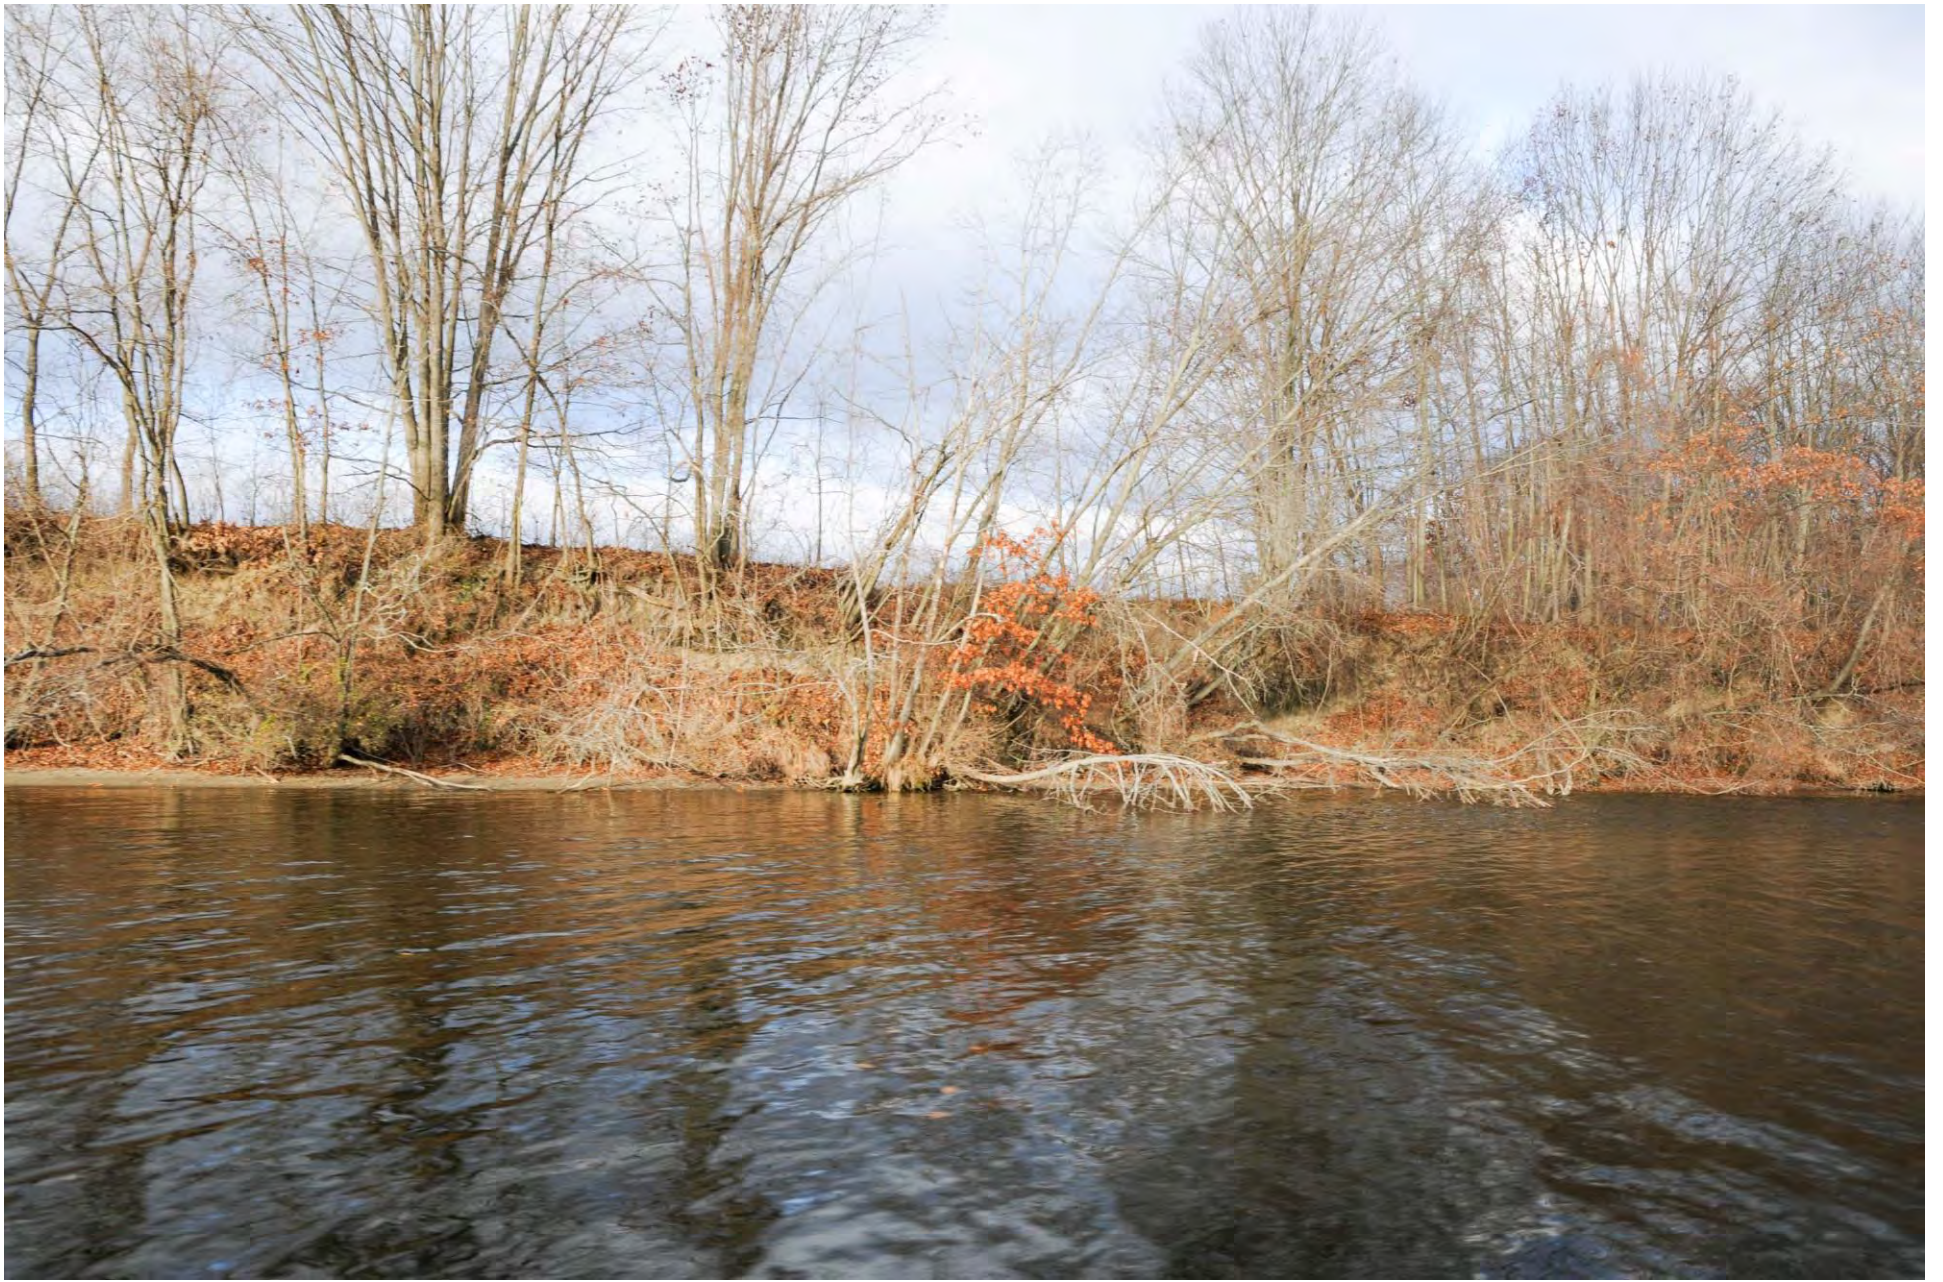
Riverbank Features	Characteristics
Upper Riverbank Slope	Overhanging
Upper Riverbank Height	High
Upper Riverbank Sediment	Silt/Sand
Upper Riverbank Vegetation	Heavy
Lower Riverbank Slope	Flat/Beach
Lower Riverbank Sediment	Silt/Sand
Lower Riverbank Vegetation	None to very sparse
Type of Erosion	Slide
Potential Erosion Indicators	Overhanging bank, Exposed roots, Creep/leaning trees
Stage of Erosion	Eroded
Extent of Erosion	Some

**QA Observations:** Upon review of the photos for this segment, classification made in the field was confirmed and additional indicators of potential future erosion were included.

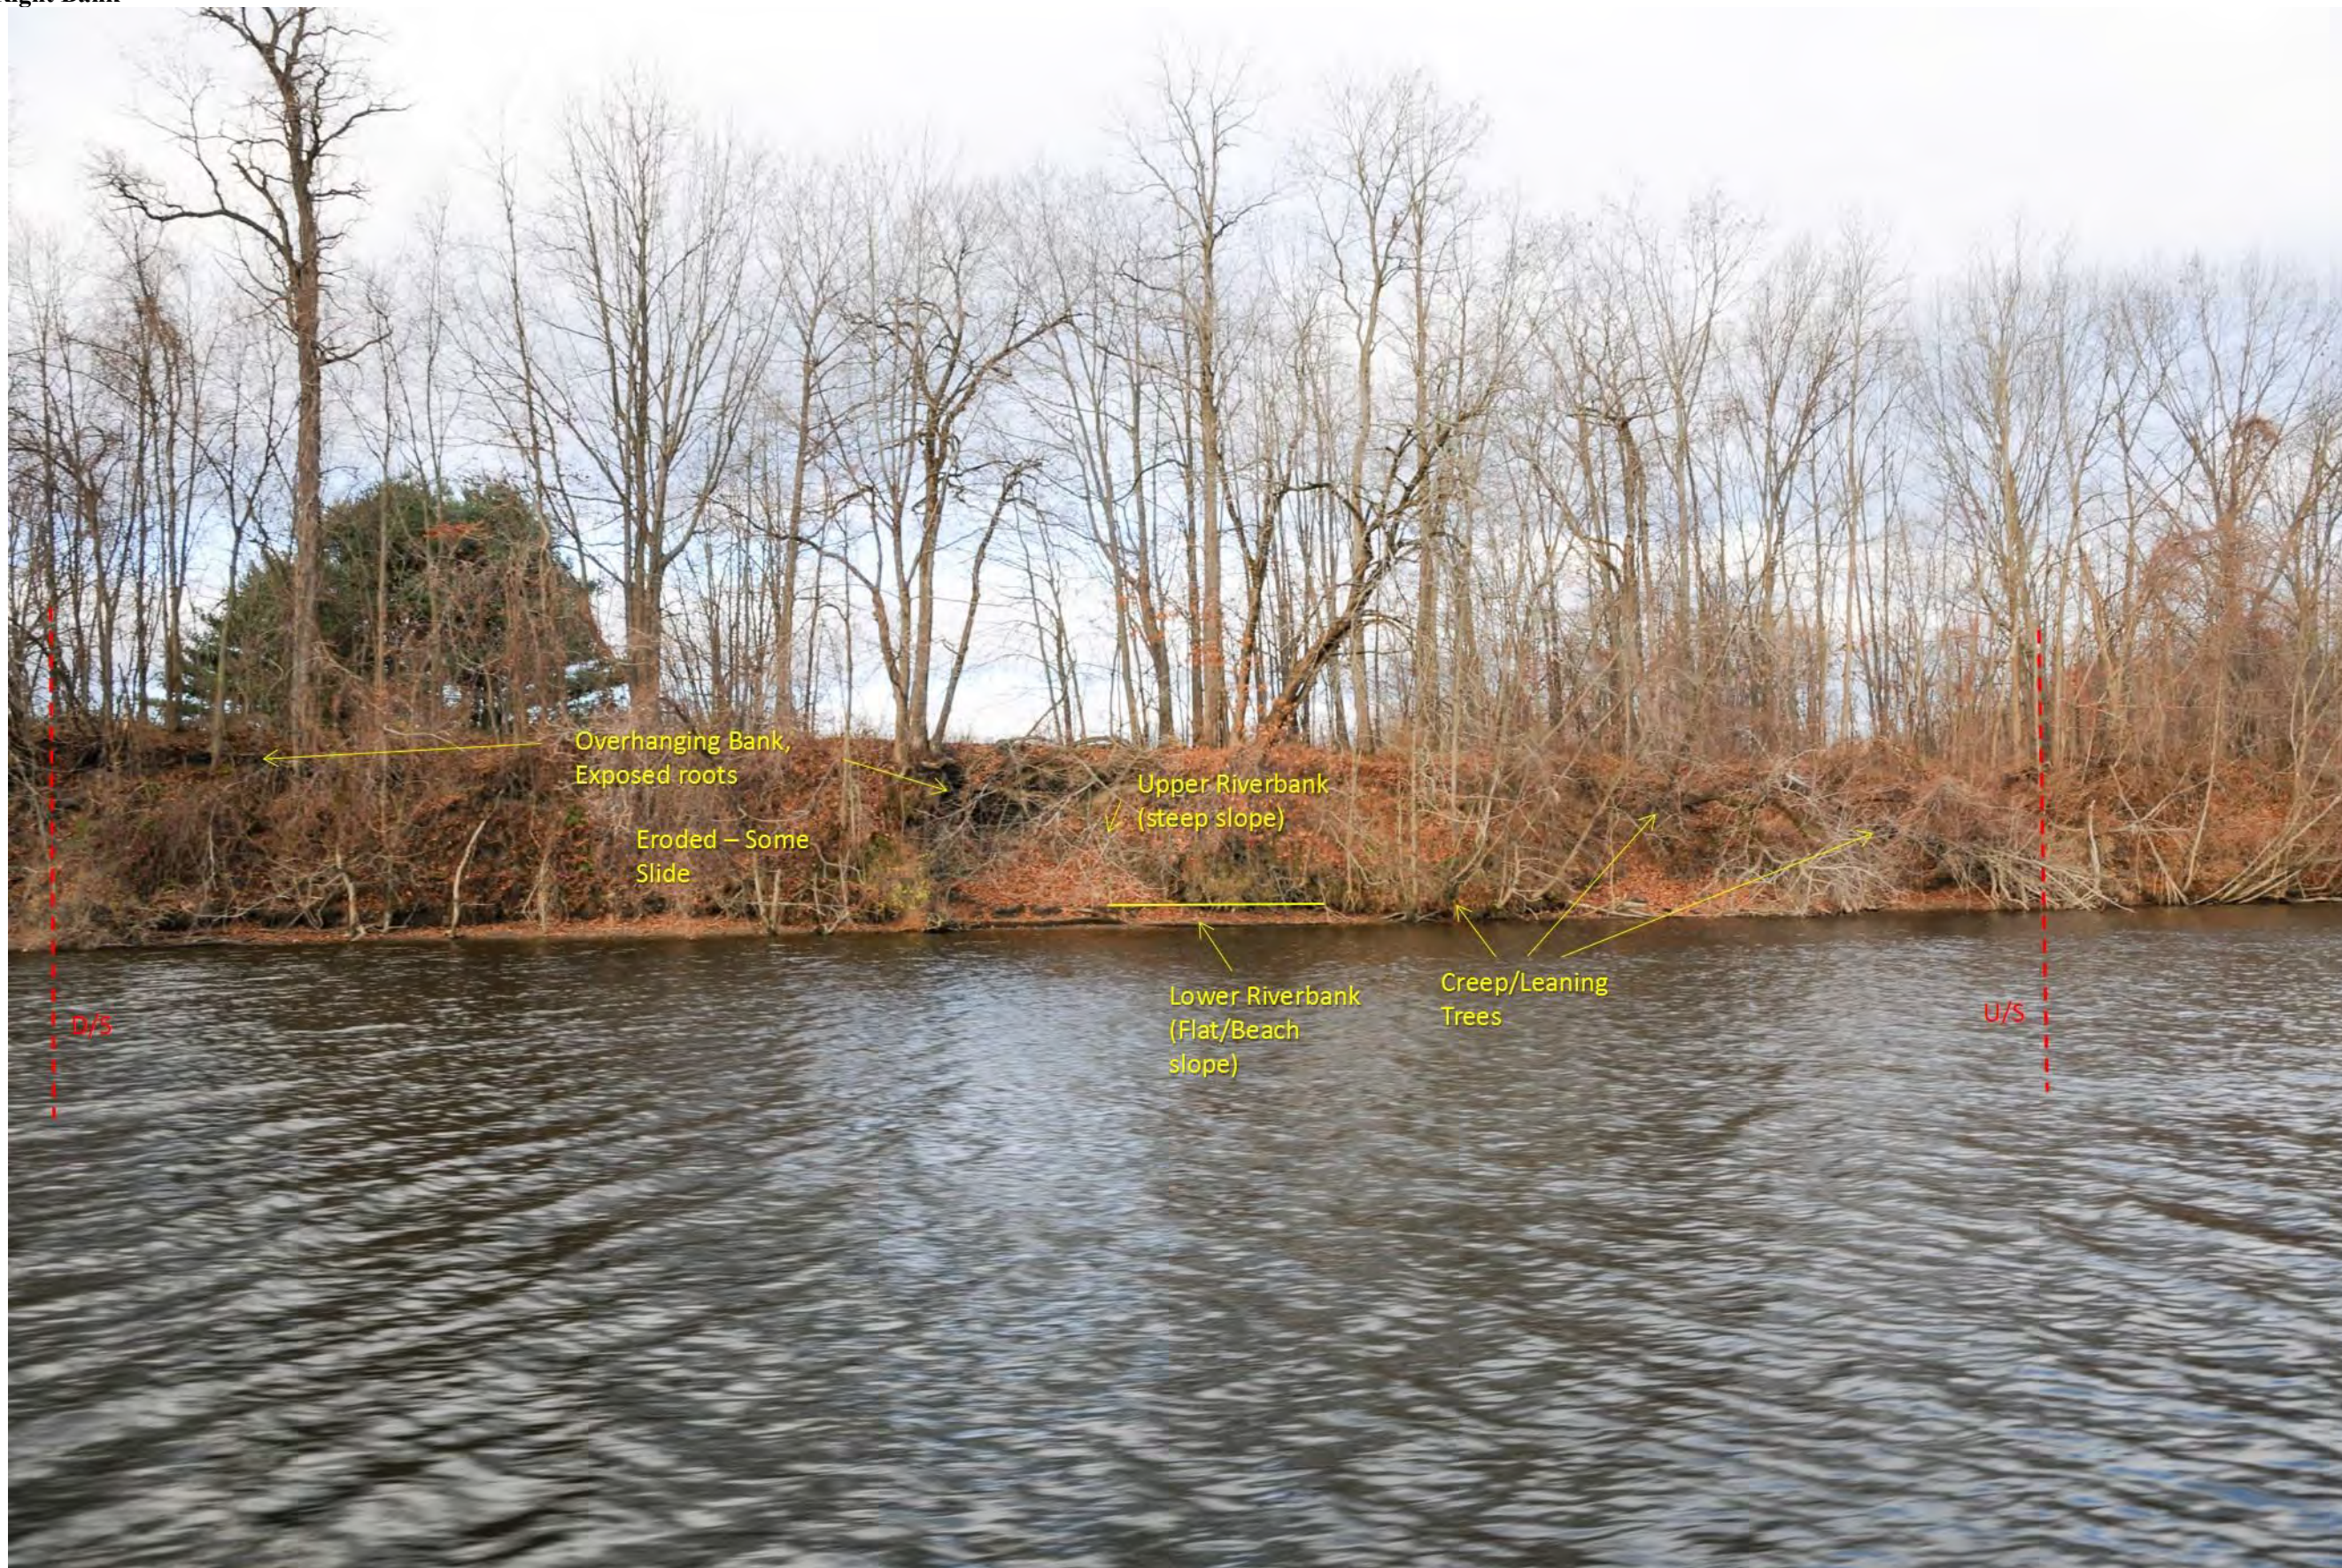
Photo ID 1104 (photo covers segment)

Riverbank Features	Characteristics
Upper Riverbank Slope	Steep
Upper Riverbank Height	High
Upper Riverbank Sediment	Silt/Sand
Upper Riverbank Vegetation	Moderate
Lower Riverbank Slope	Flat/Beach
Lower Riverbank Sediment	Silt/Sand
Lower Riverbank Vegetation	None to very sparse
Type of Erosion	Slide
Potential Erosion Indicators	Exposed roots, Overhanging bank, Creep/leaning trees
Stage of Erosion	Eroded
Extent of Erosion	Some

**QA Observations:** Upon review of the photos for this segment, classification made in the field was confirmed and additional indicators of potential future erosion were included.
