**FIRSTLIGHT POWER RESOURCES**  
 RELICENSING STUDY 3.1.1  
 2013 FULL RIVER RECONNAISSANCE  
 TURNERS FALLS IMPOUNDMENT

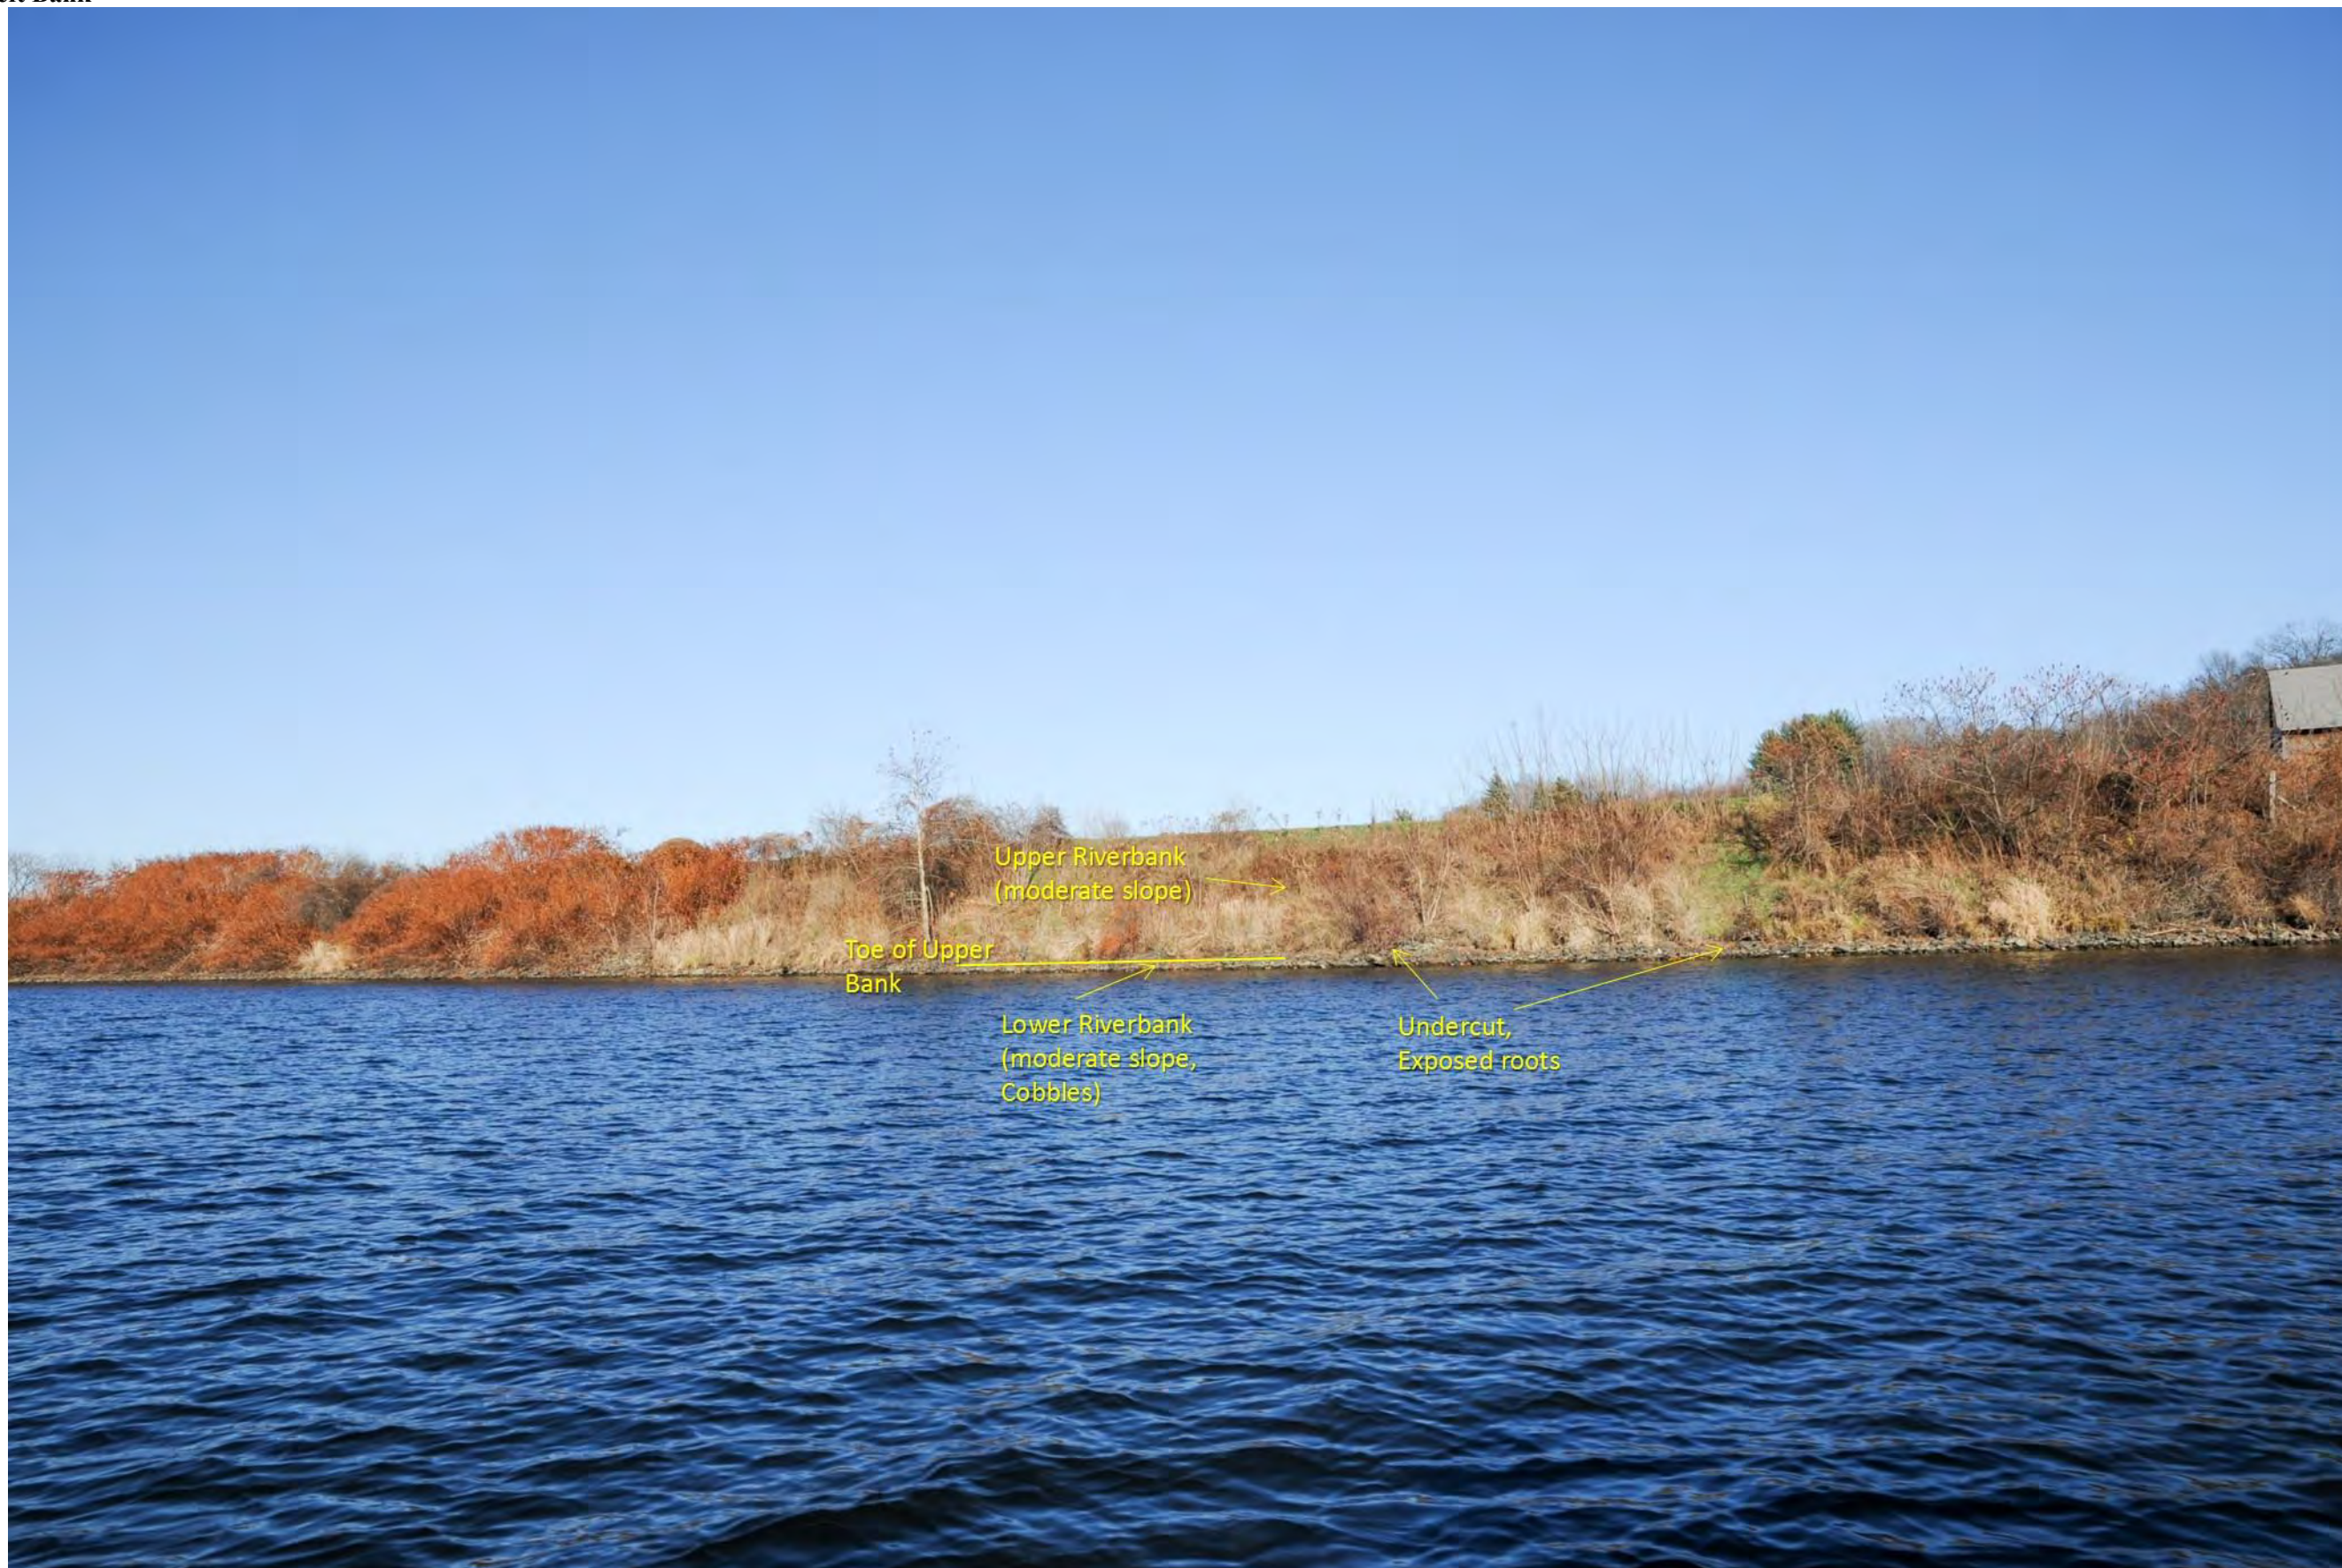
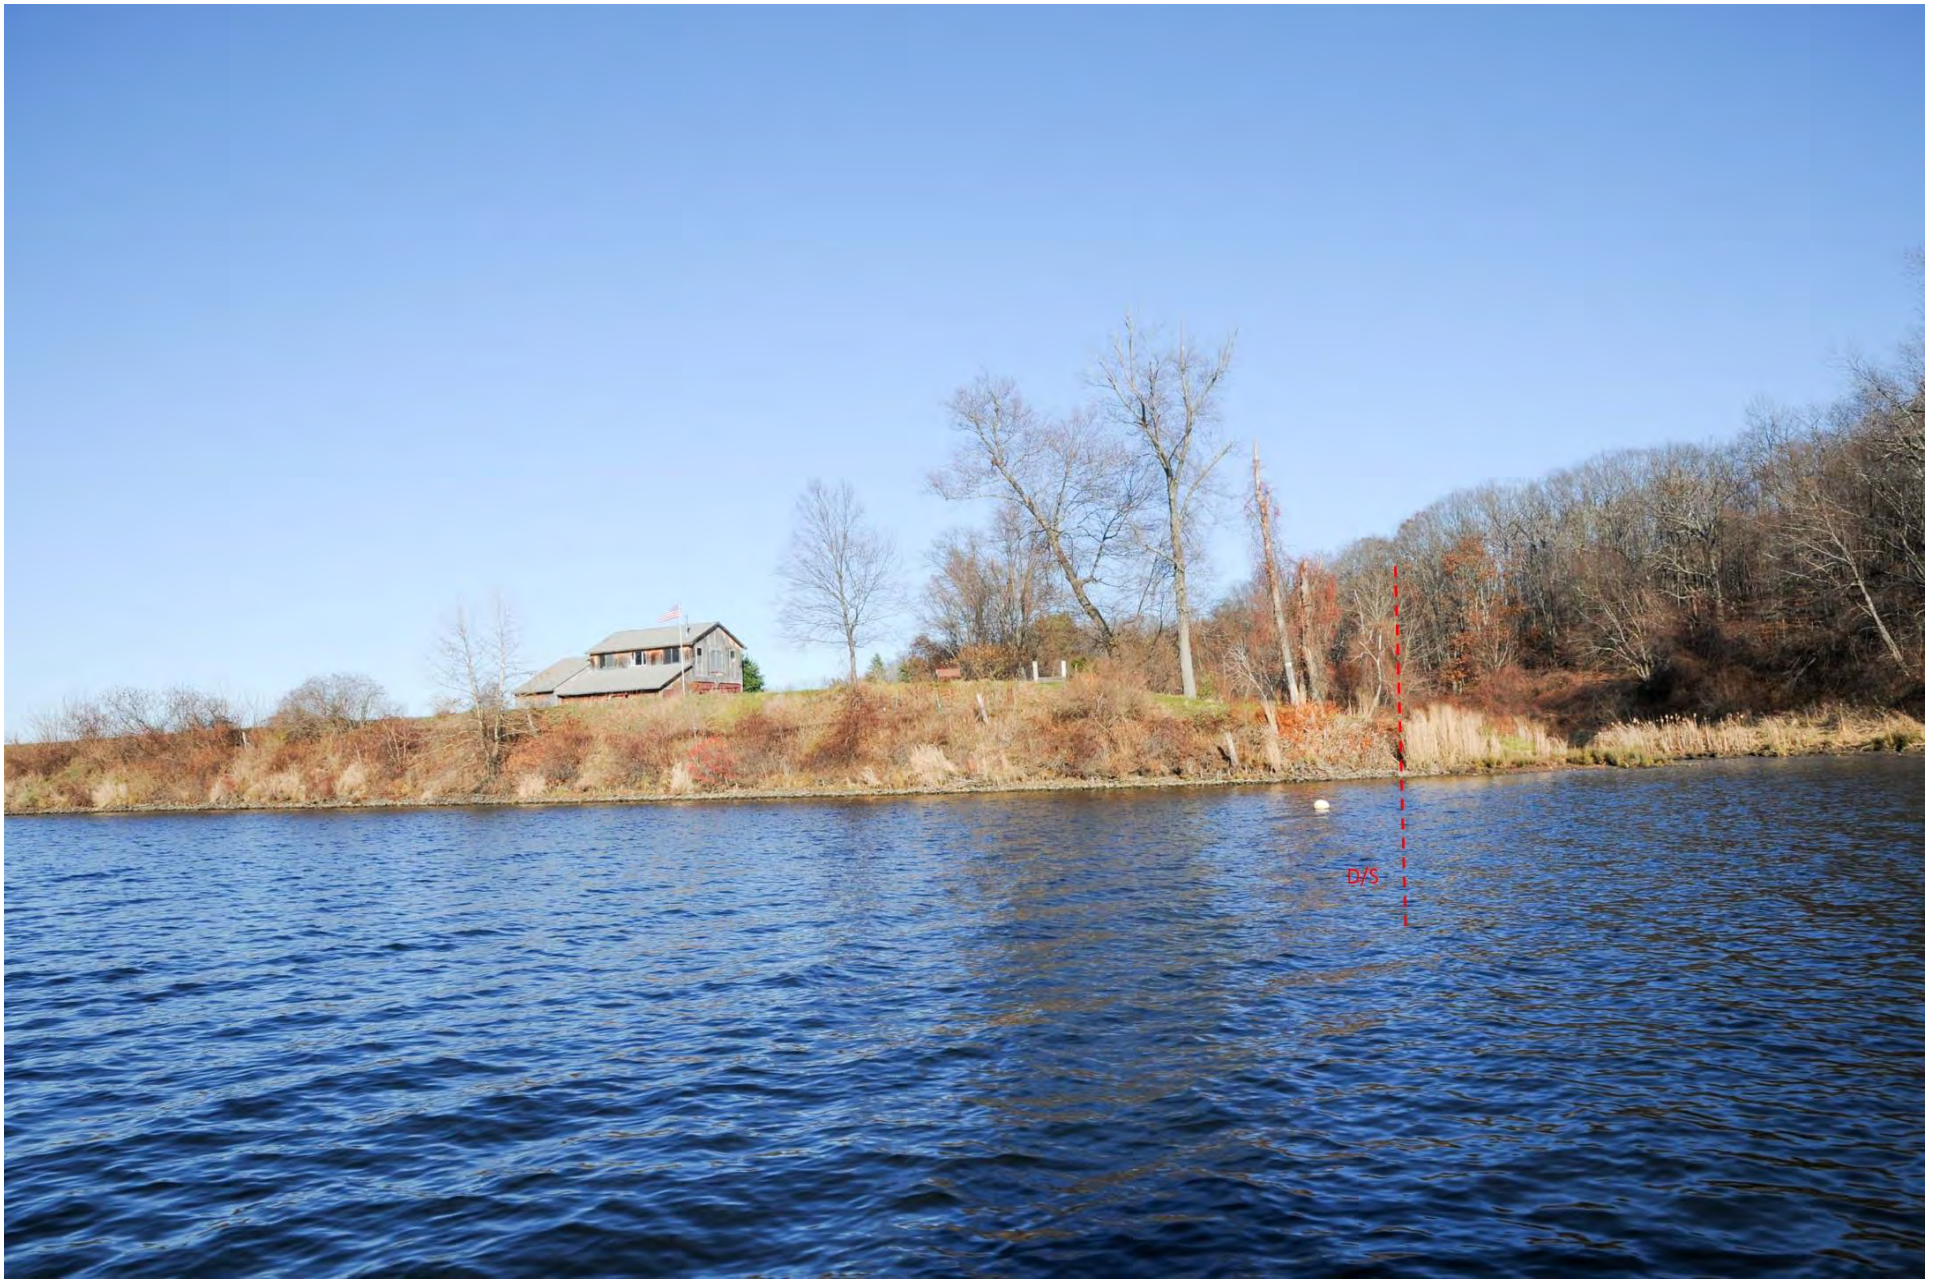
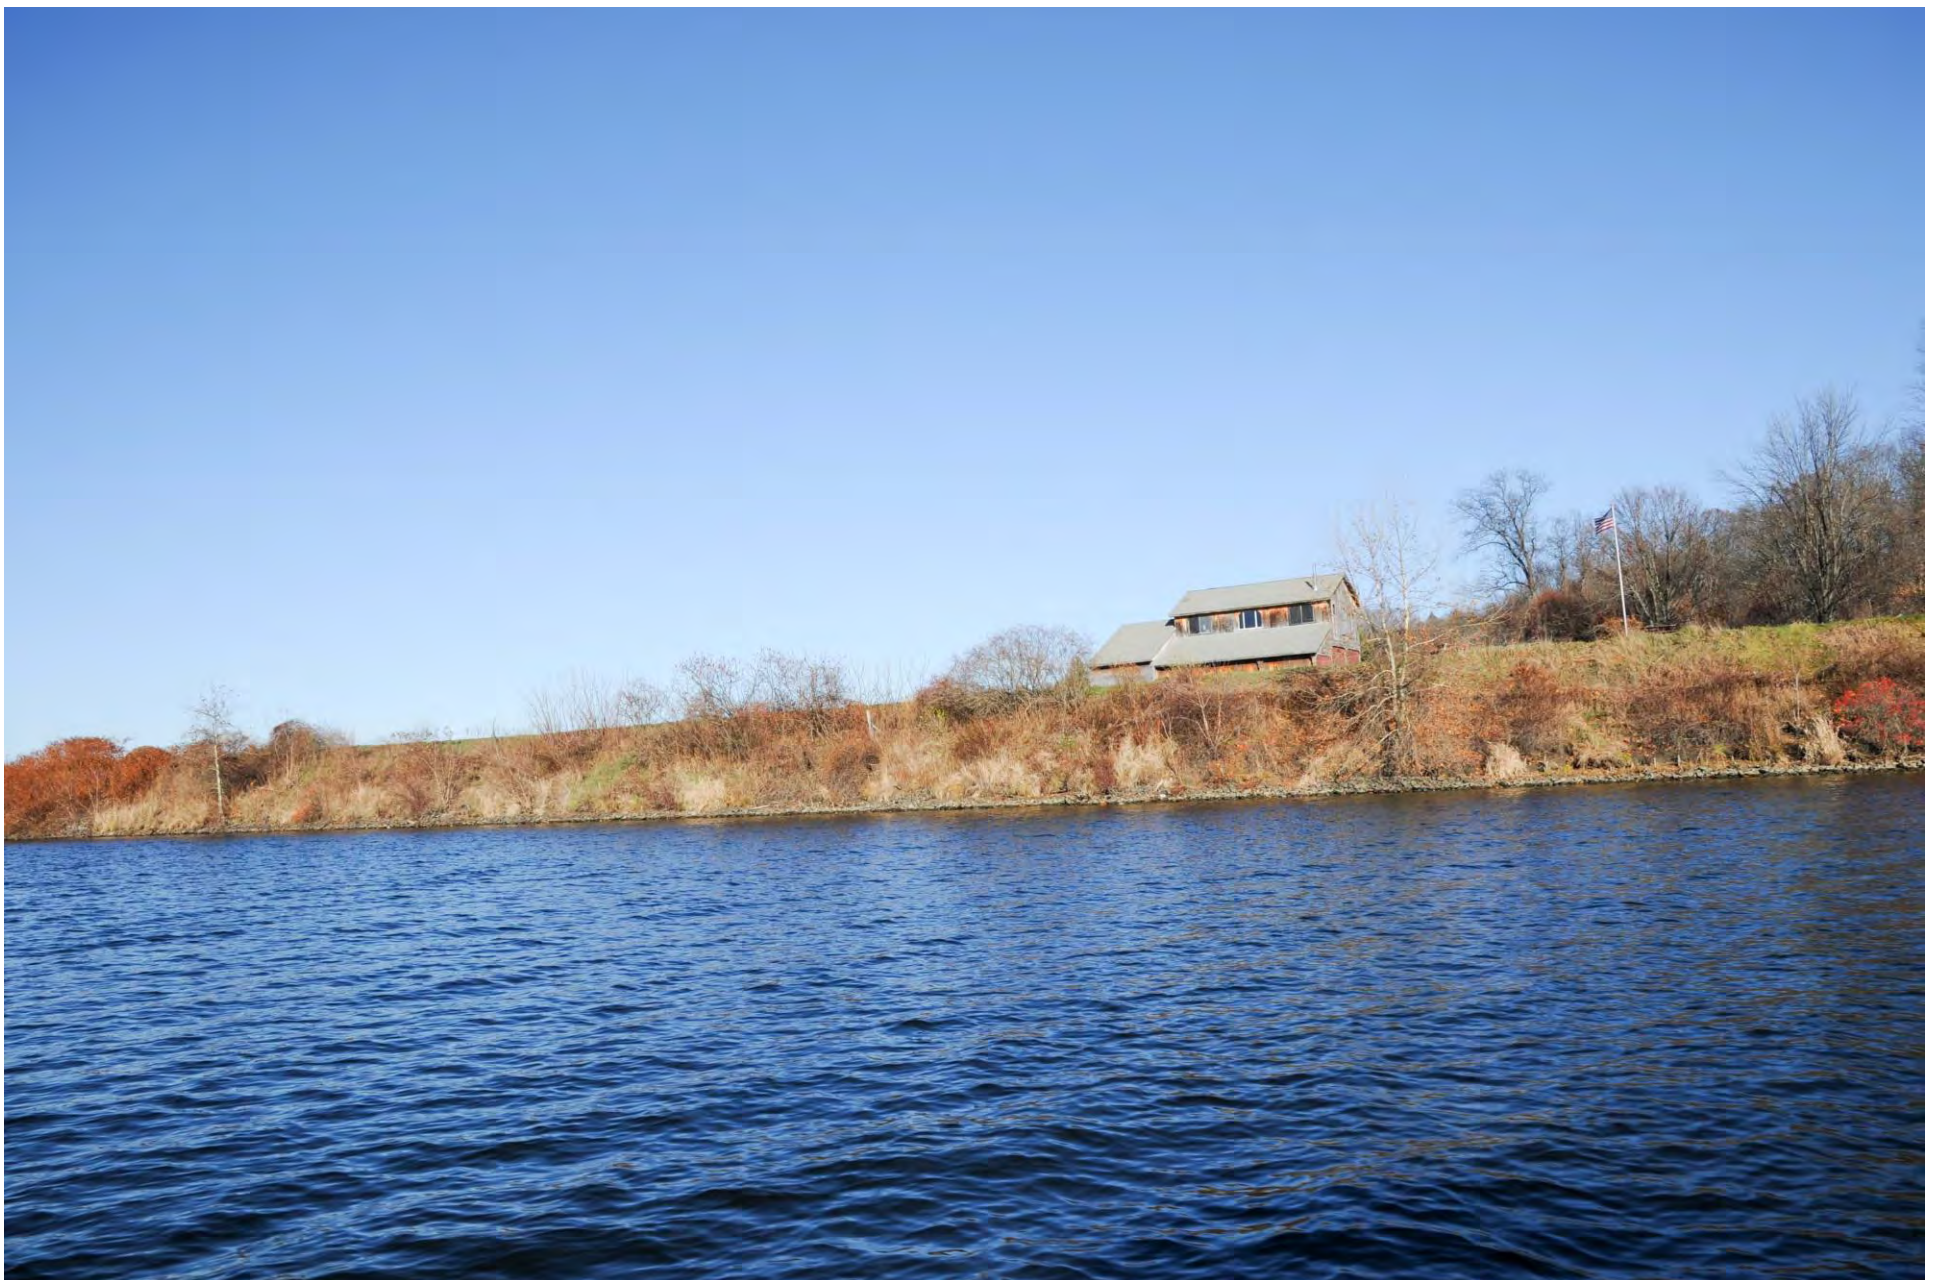
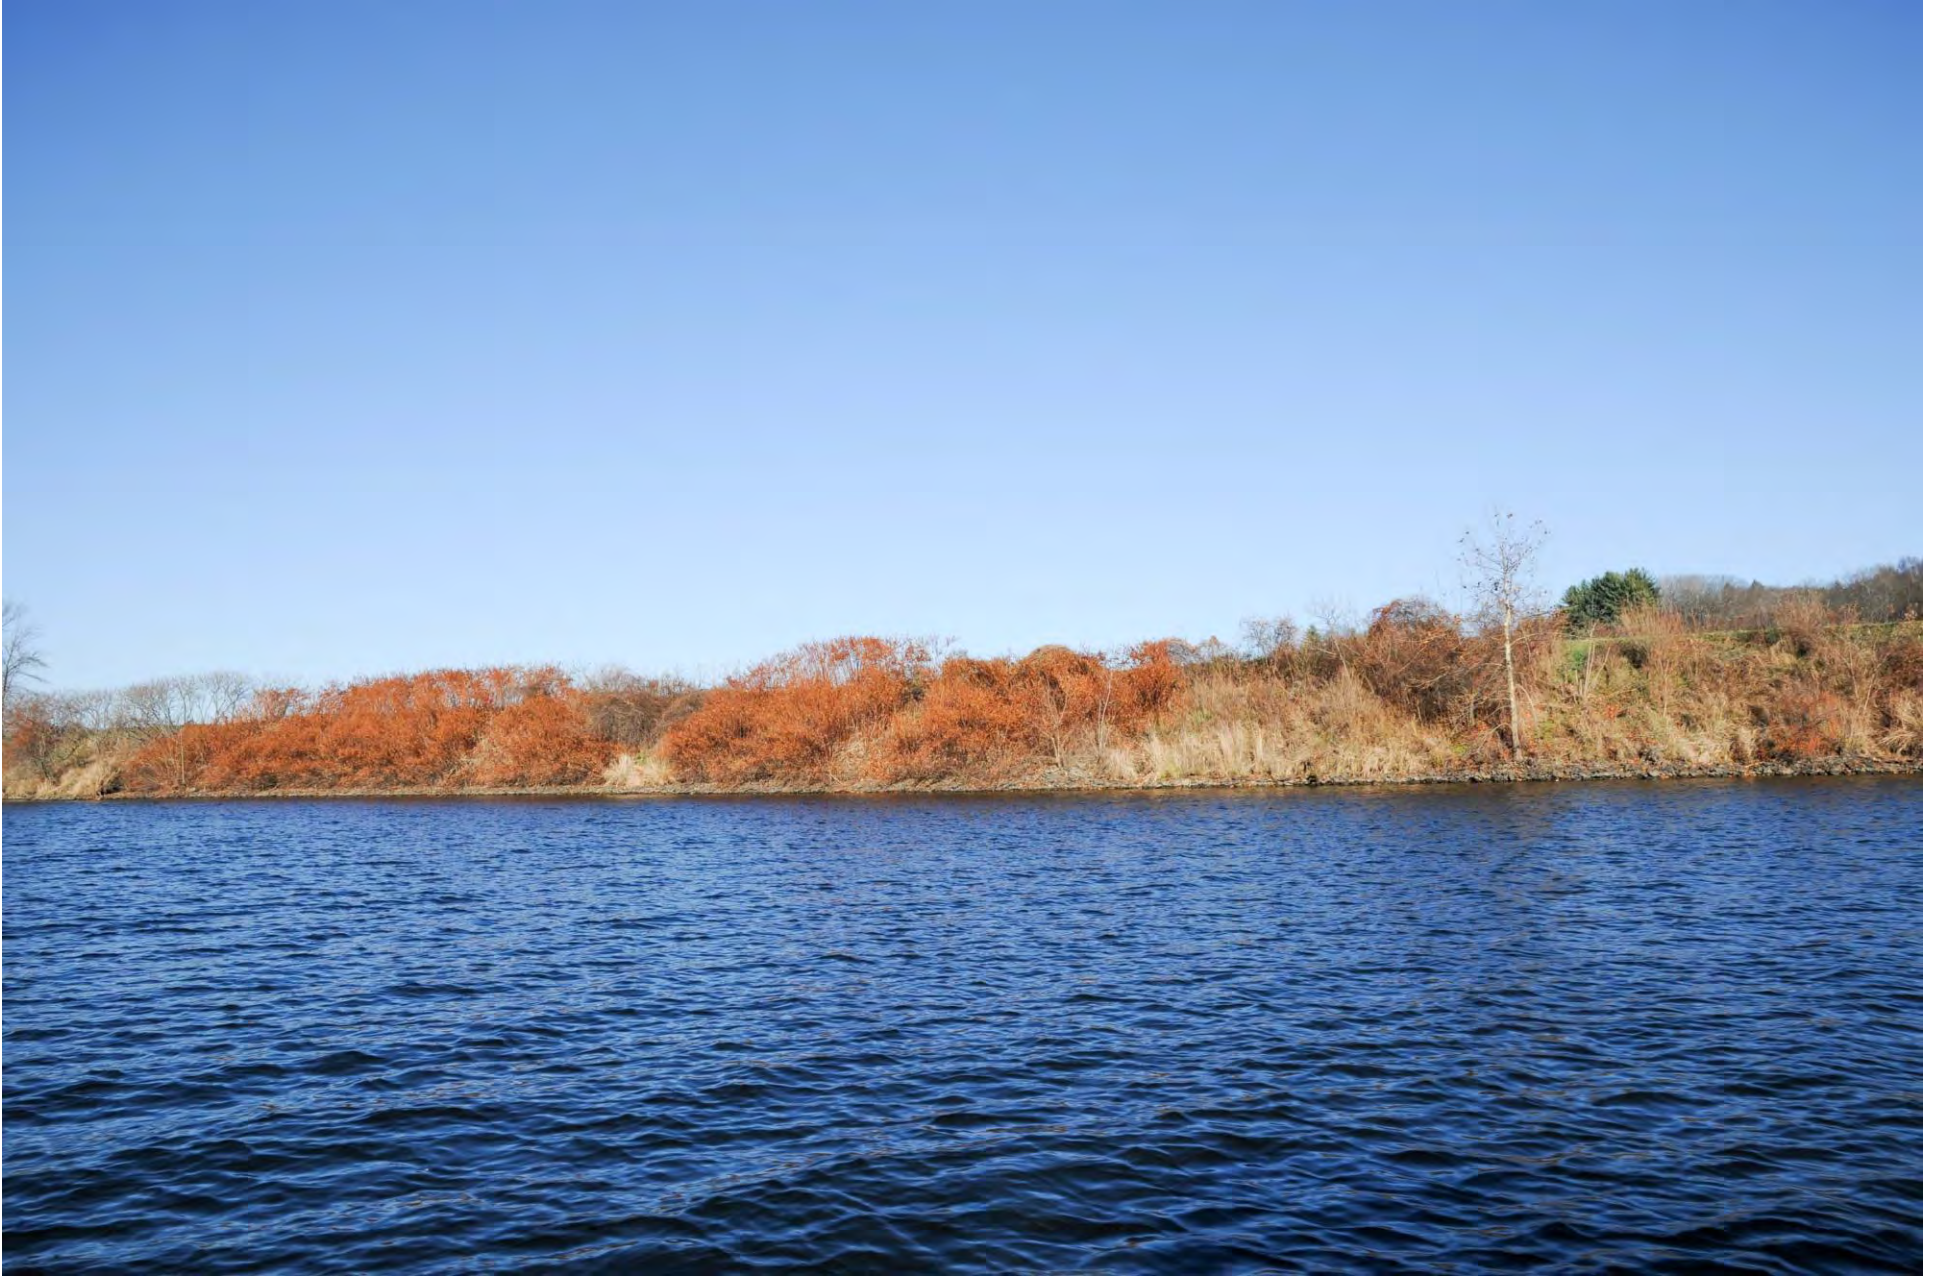
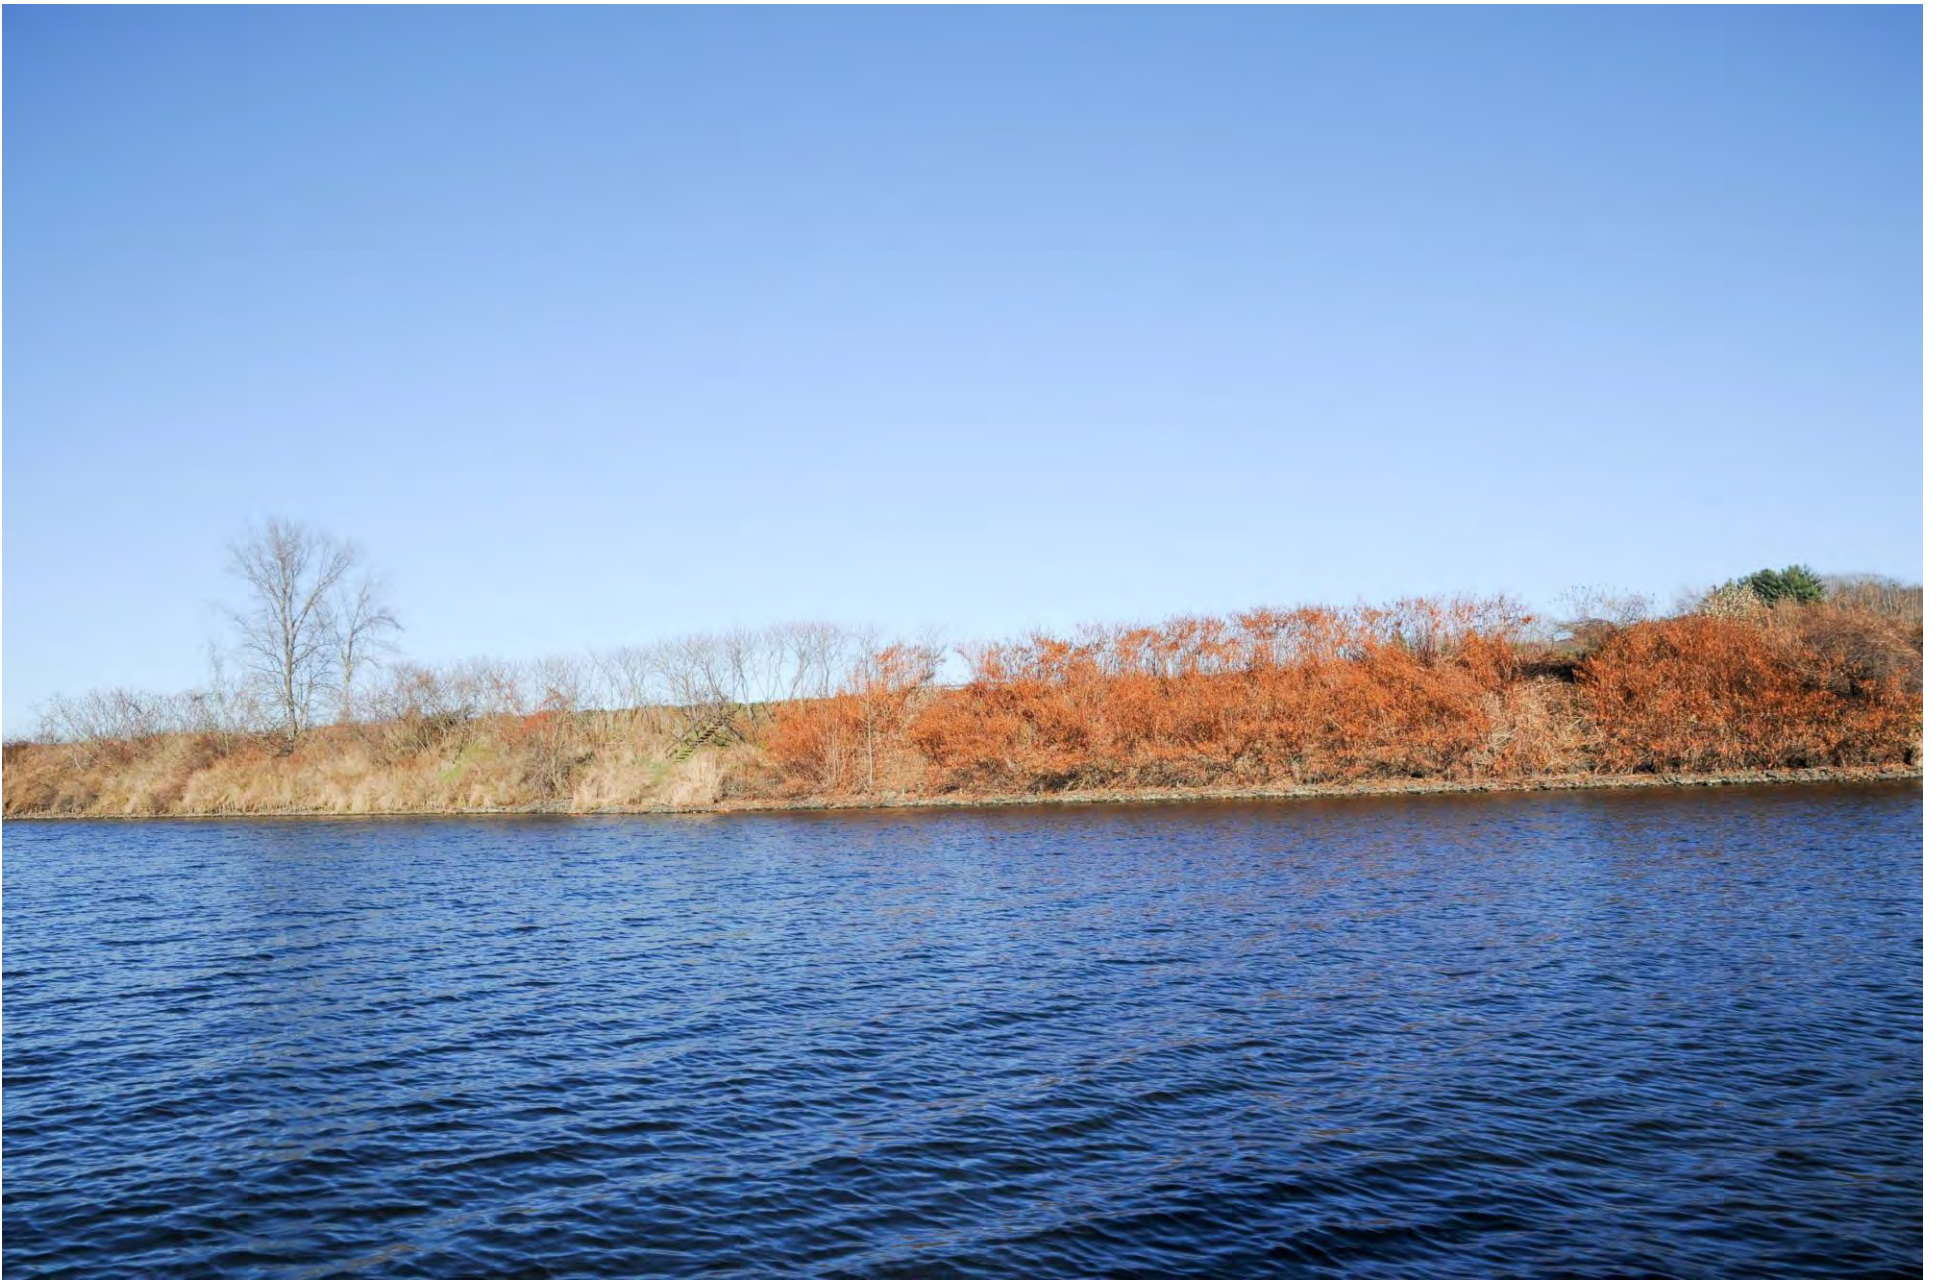
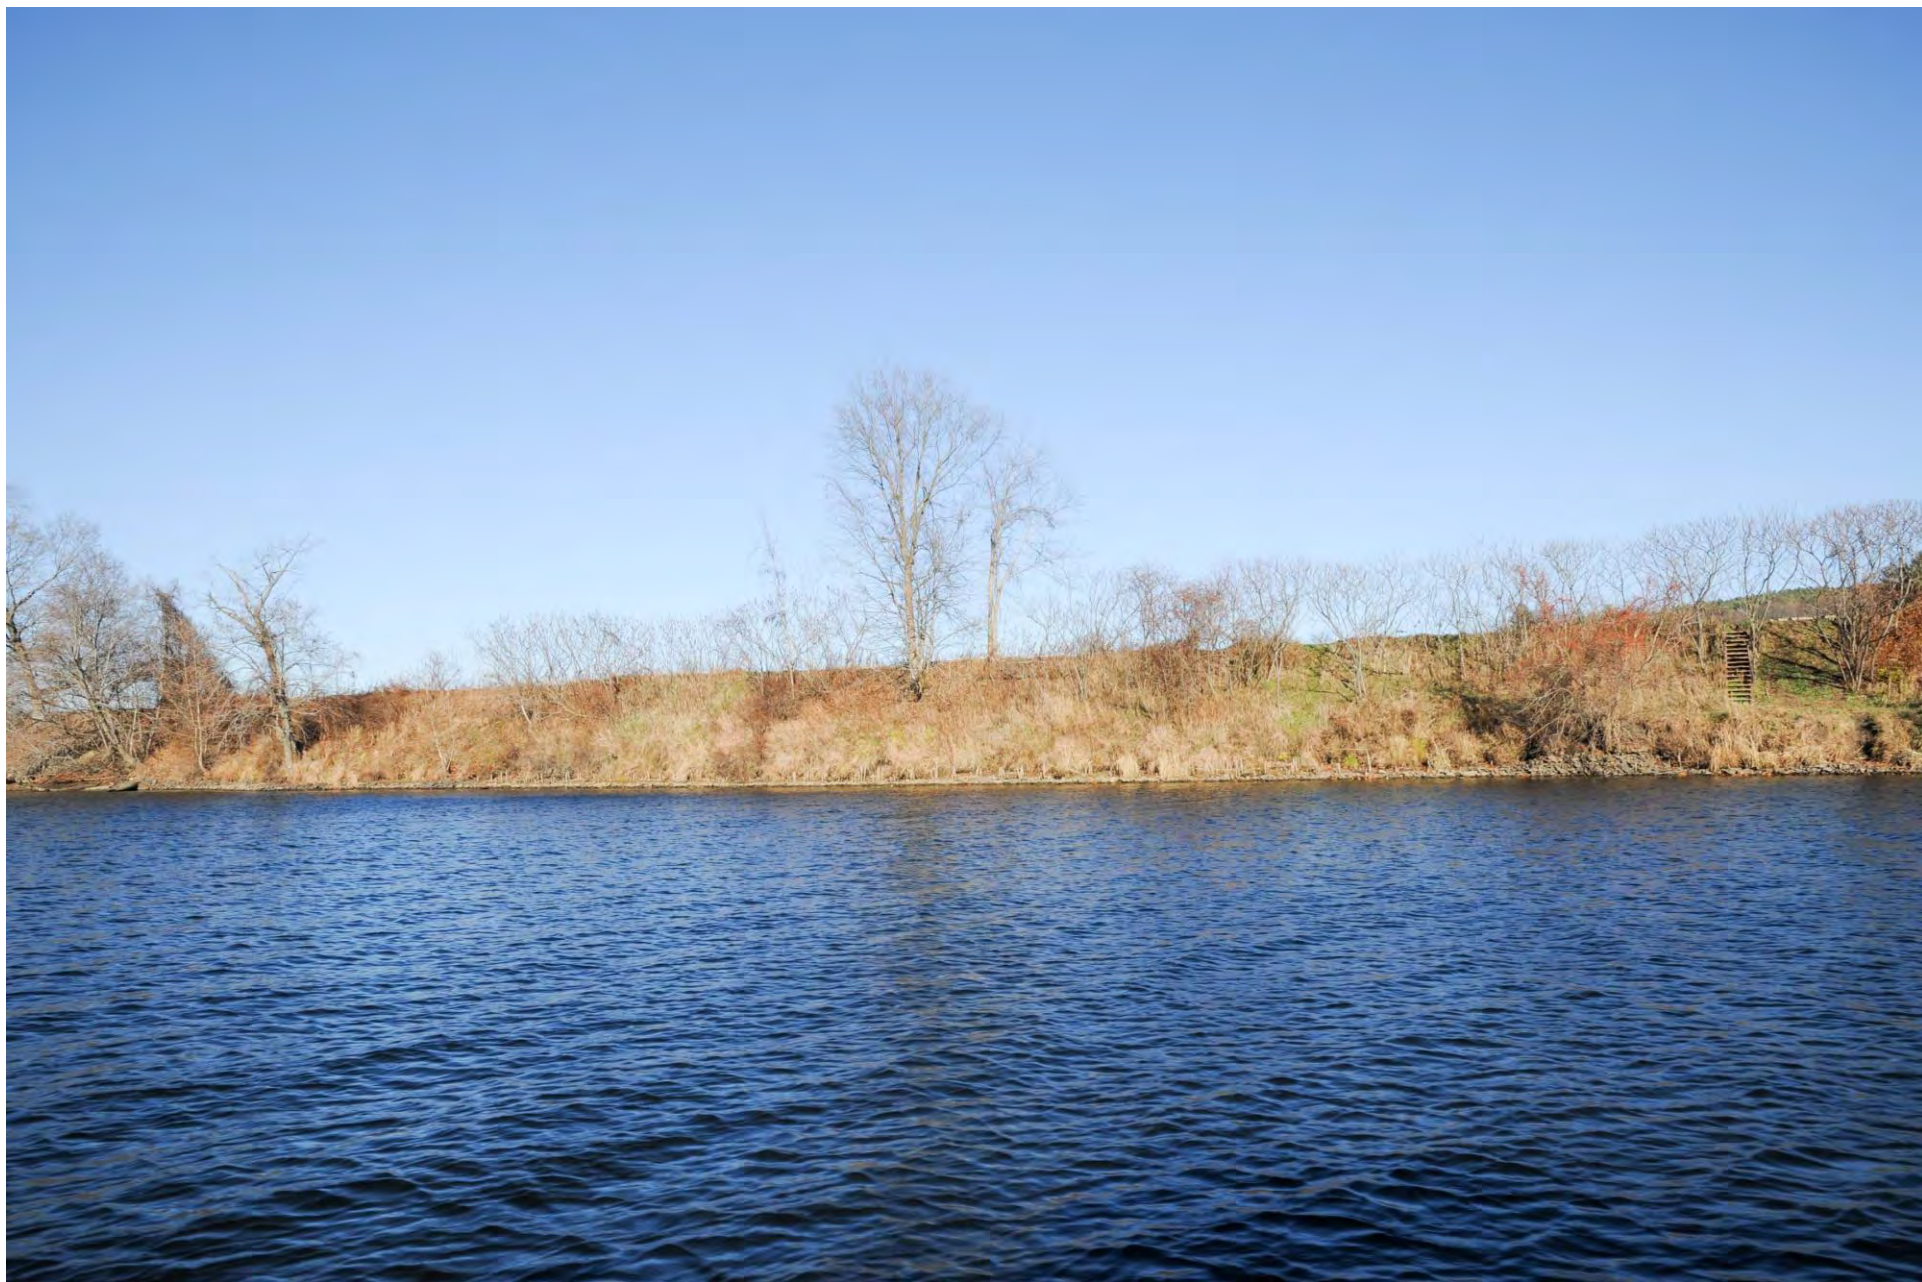
<b>Riverbank Features</b>	<b>Characteristics</b>
<b>Upper Riverbank Slope</b>	Moderate
<b>Upper Riverbank Height</b>	High
<b>Upper Riverbank Sediment</b>	Silt/Sand
<b>Upper Riverbank Vegetation</b>	Heavy
<b>Lower Riverbank Slope</b>	Moderate
<b>Lower Riverbank Sediment</b>	Cobbles
<b>Lower Riverbank Vegetation</b>	None to very sparse
<b>Type of Erosion</b>	Undercut
<b>Potential Erosion Indicators</b>	Exposed roots
<b>Stage of Erosion</b>	Stable
<b>Extent of Erosion</b>	None/Little

**QA Observations:** Upon review of the photos for this segment, classification made in the field was confirmed. Segment added as a site of interest due to planned repair to existing restoration to deal with undercut and exposed roots.

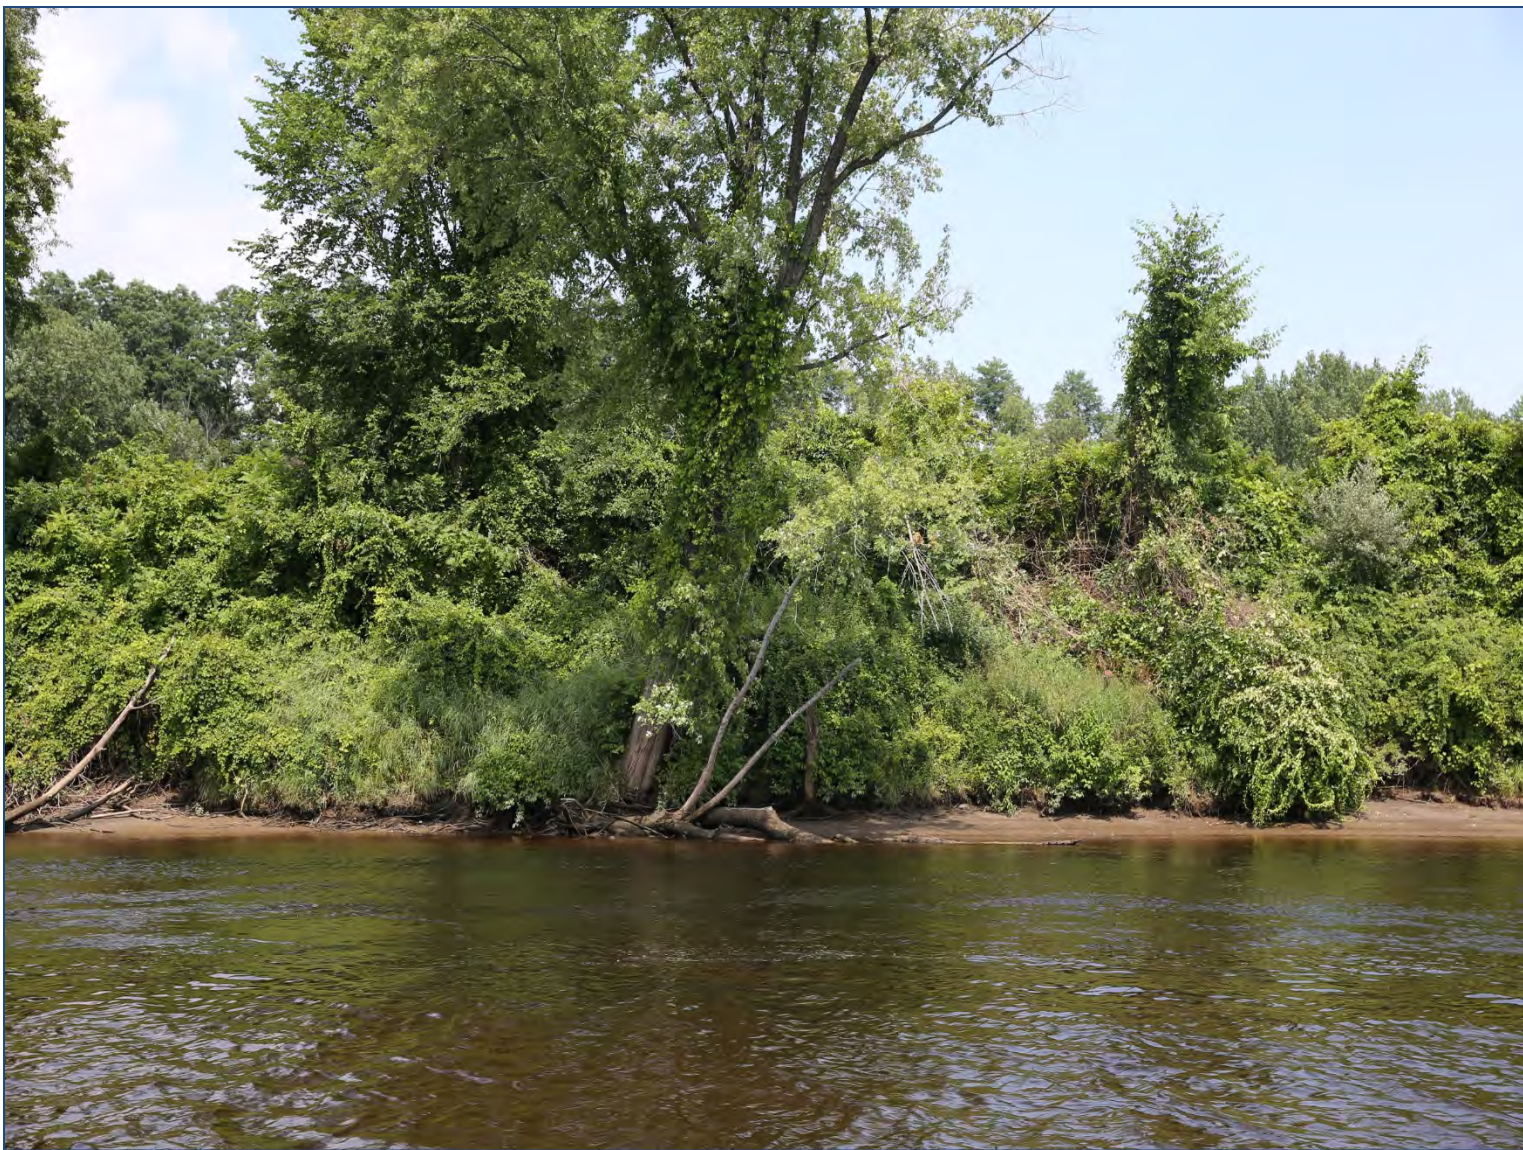
**2014 Photo:** Bonnette Farm

**Observations:** Dense and well established vegetation are observed in both photographs, indicative of relative stability. Since the 2007 photograph, the bank has become more vegetated due to the planting of hundreds of shrubs on the bank. Oriental bittersweet vines are common. There were sensitive receptor sites (kingfisher next cavity) present in 2007 and in 2014.

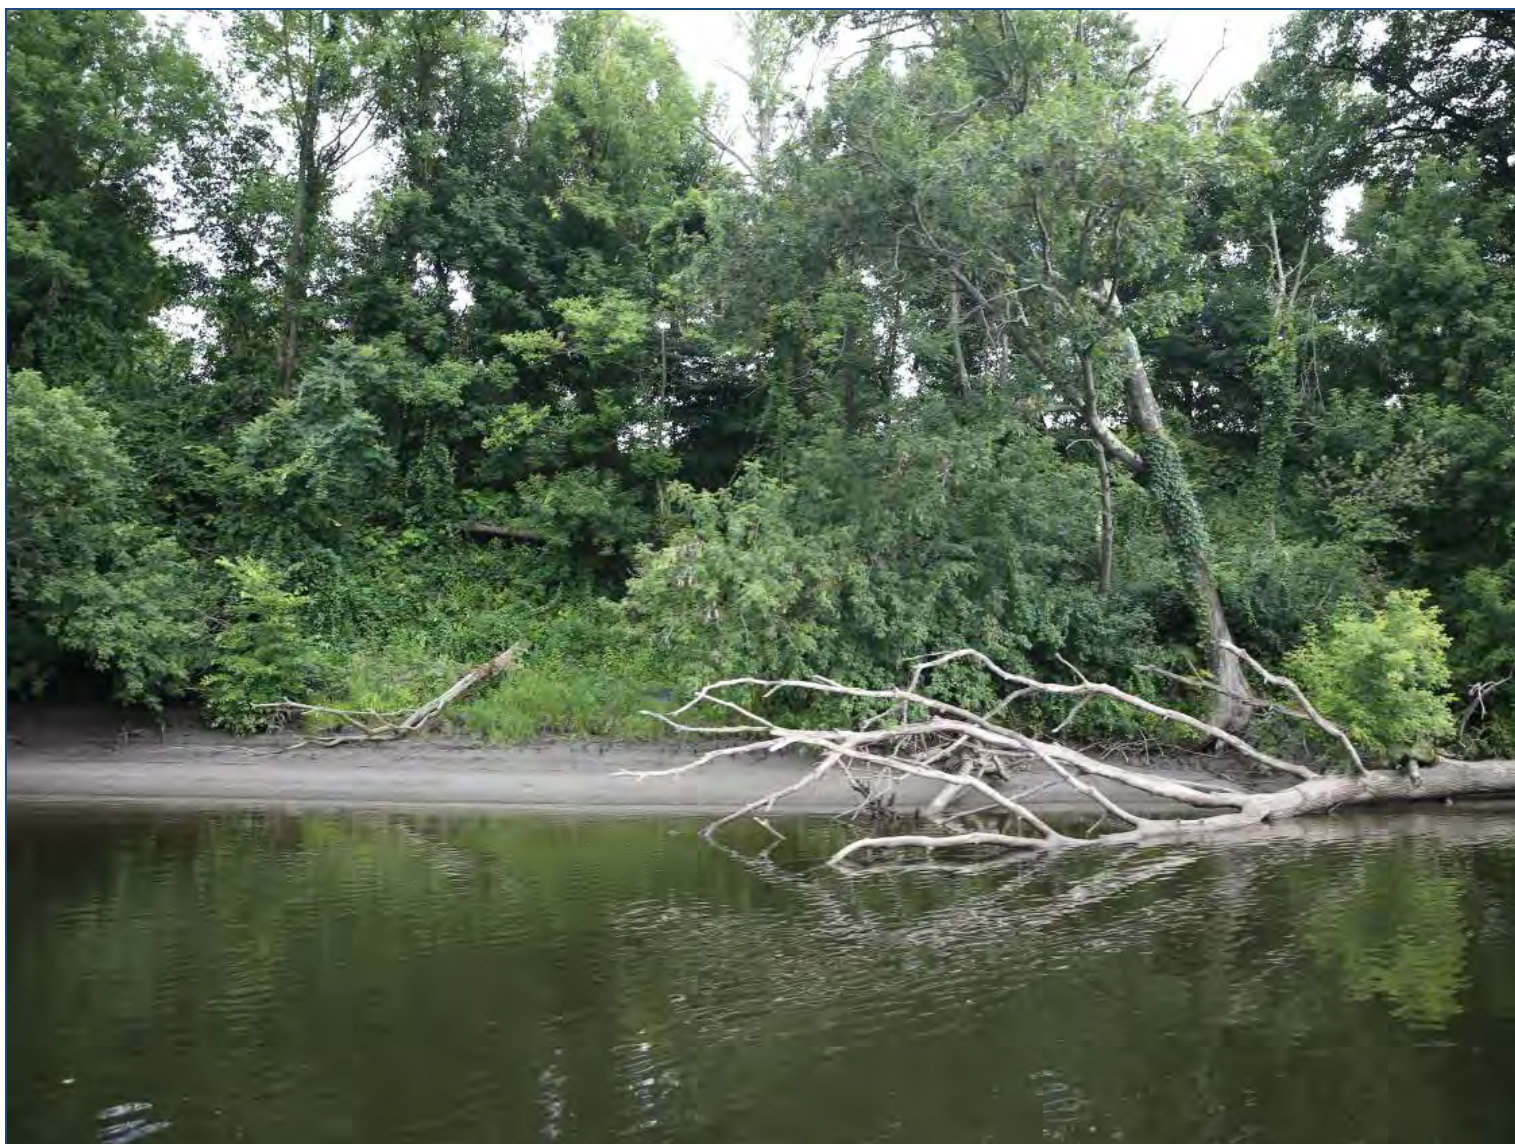
**2014 Photo:** Vermont Farm

**Observations:** Banks in both photos support a significant density of trees. An increase in lower level vegetative growth, including a patch of emergent vegetation on the bench which was not observed in the 2007 photo, can be observed in the 2014 photo.

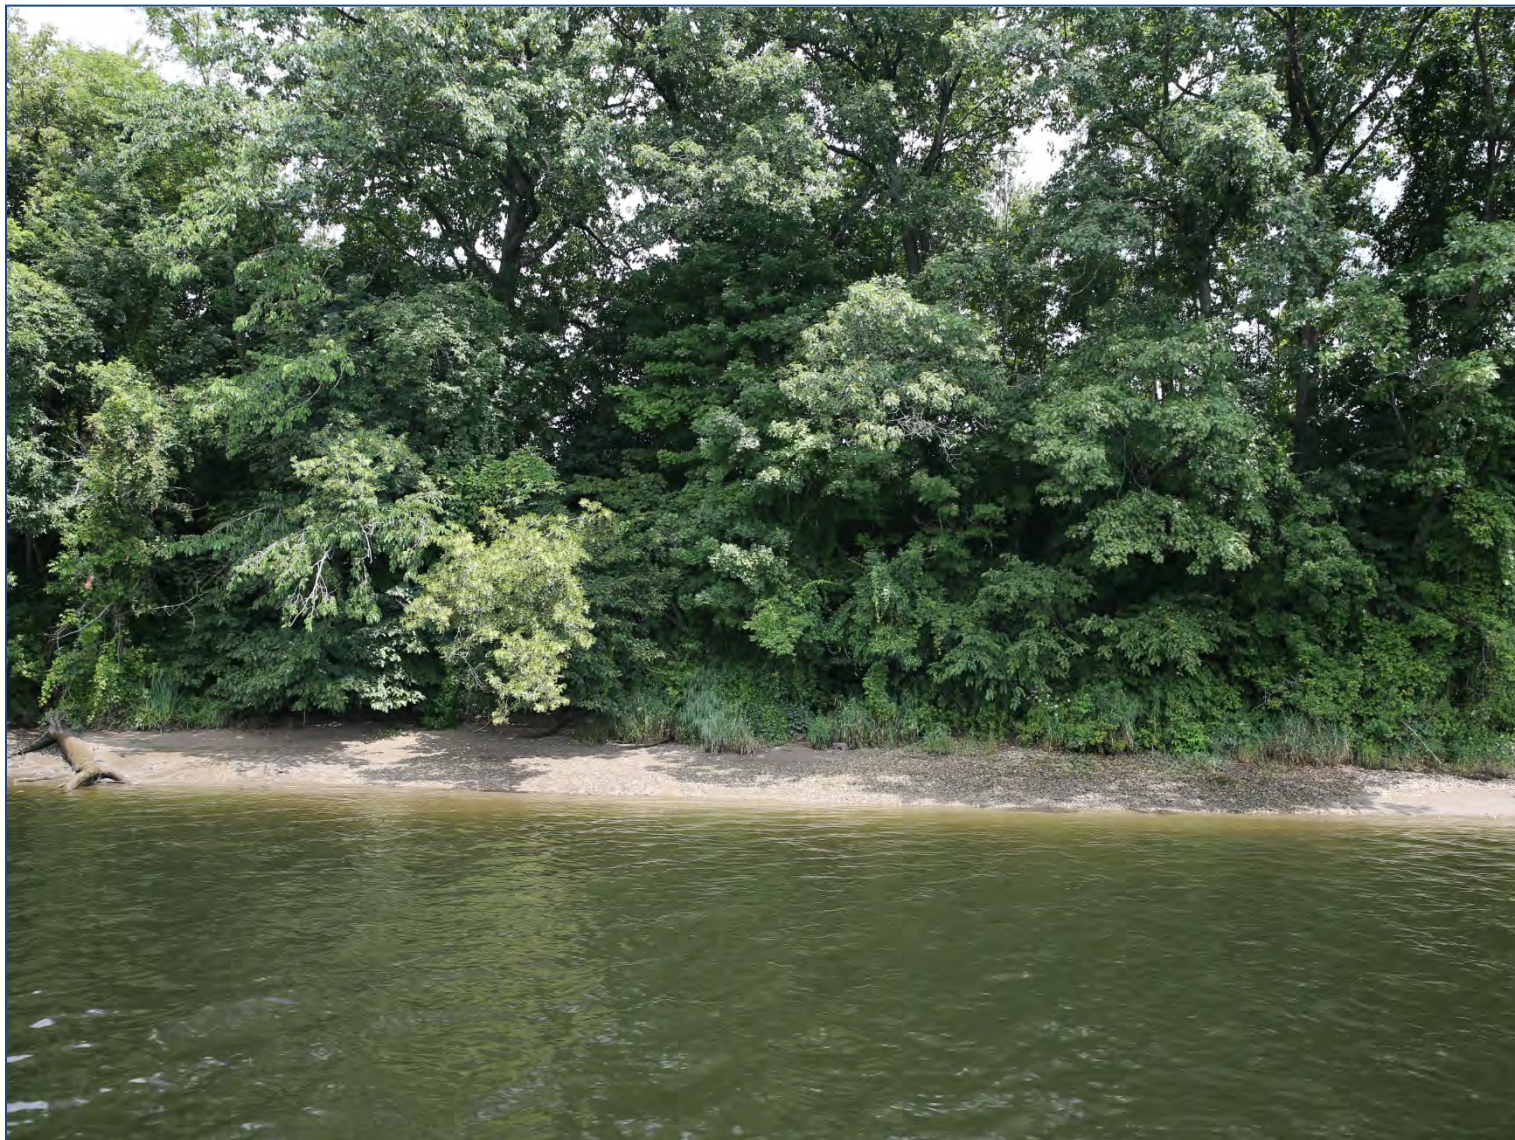
**2014 Photo:** New Hampshire Site

**Observations:** No significant changes in the bank at this location are observed.
