**FIRSTLIGHT POWER RESOURCES**  
 RELICENSING STUDY 3.1.1  
 2013 FULL RIVER RECONNAISSANCE  
 TURNERS FALLS IMPOUNDMENT

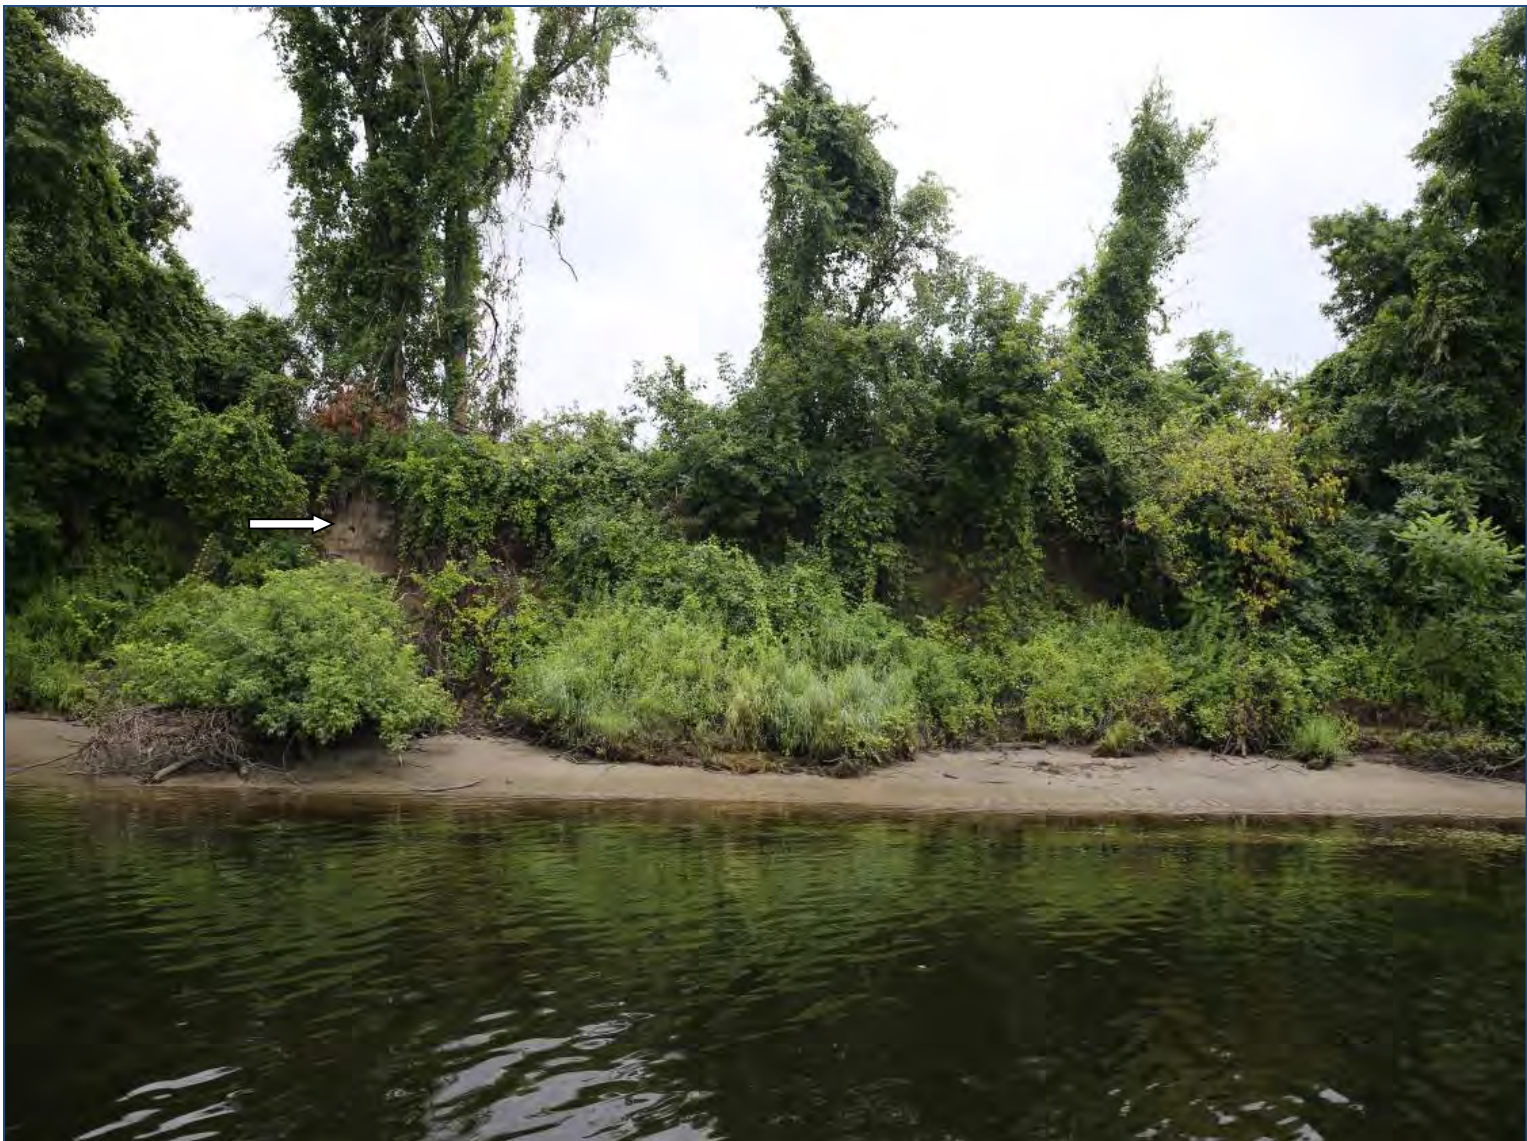
**2014 Photo:** Downstream from the old Railroad Bridge

**Observations:** Bank conditions appear similar in both sets of photographs but oriental bittersweet has become more established since 2007 at this location. There is a kingfisher nest cavity in the 2014 photograph (white arrow).

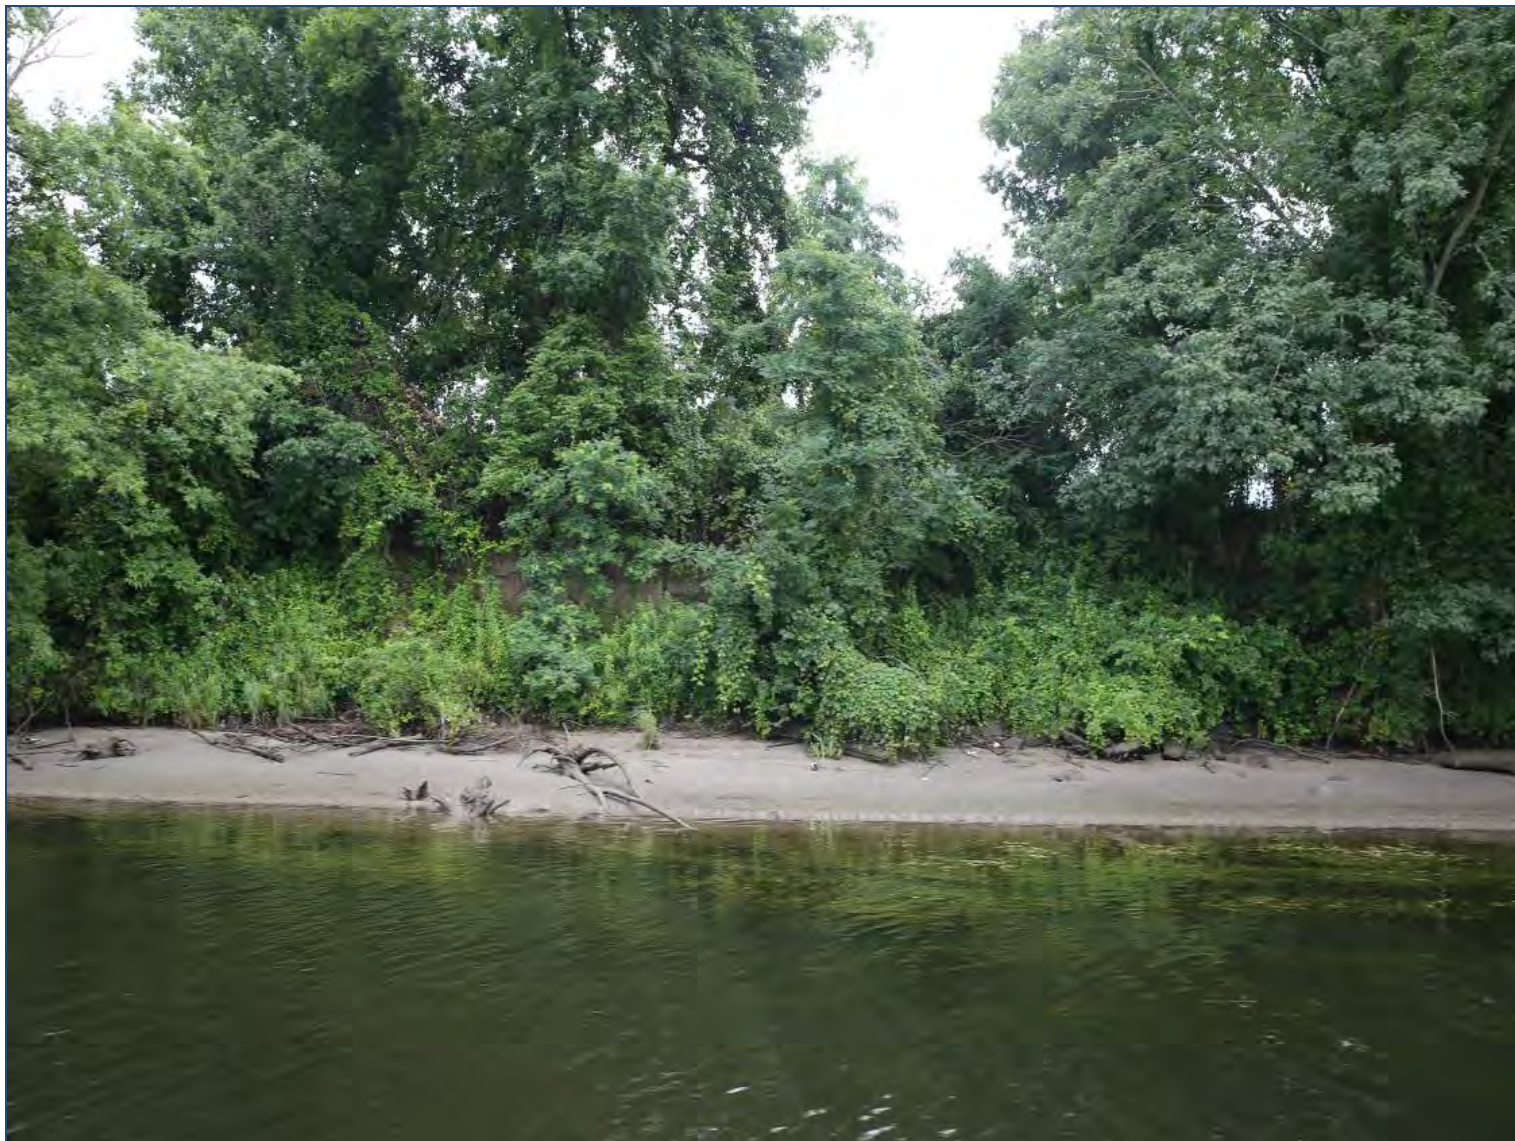
**2014 Photo:** Northfield Farm

**Observations:** Bank conditions do not appear to have changed significantly from 2007 to 2014. The vegetated riparian buffer along this farm field is narrow, and has not changed since 2007.

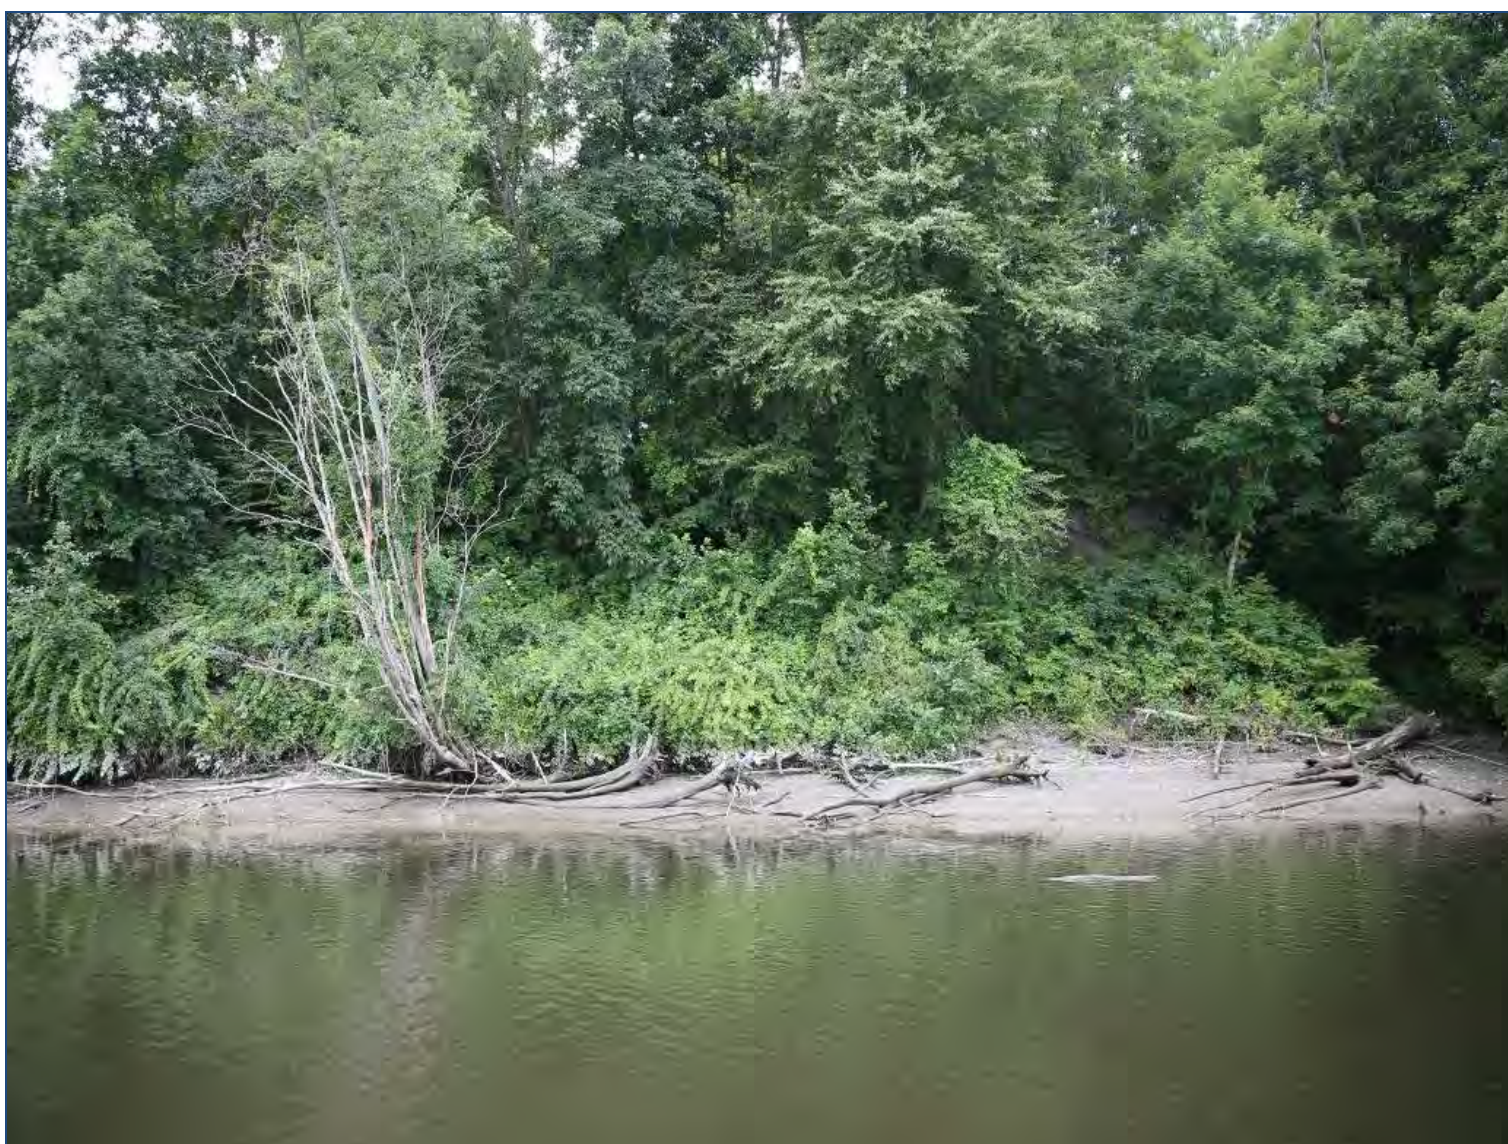
**2014 Photo:** Upstream from Urgiel Upstream restoration site

**Observations:** Bank conditions appear to be similar in both photographs. This photograph shows the location of a linear erosion feature with a vertical exposed face ranging from 1 to 2 feet high that extends longitudinally through part of the repaired segment (Urgiel) as well as farther upstream even crossing through a small drainage feature.

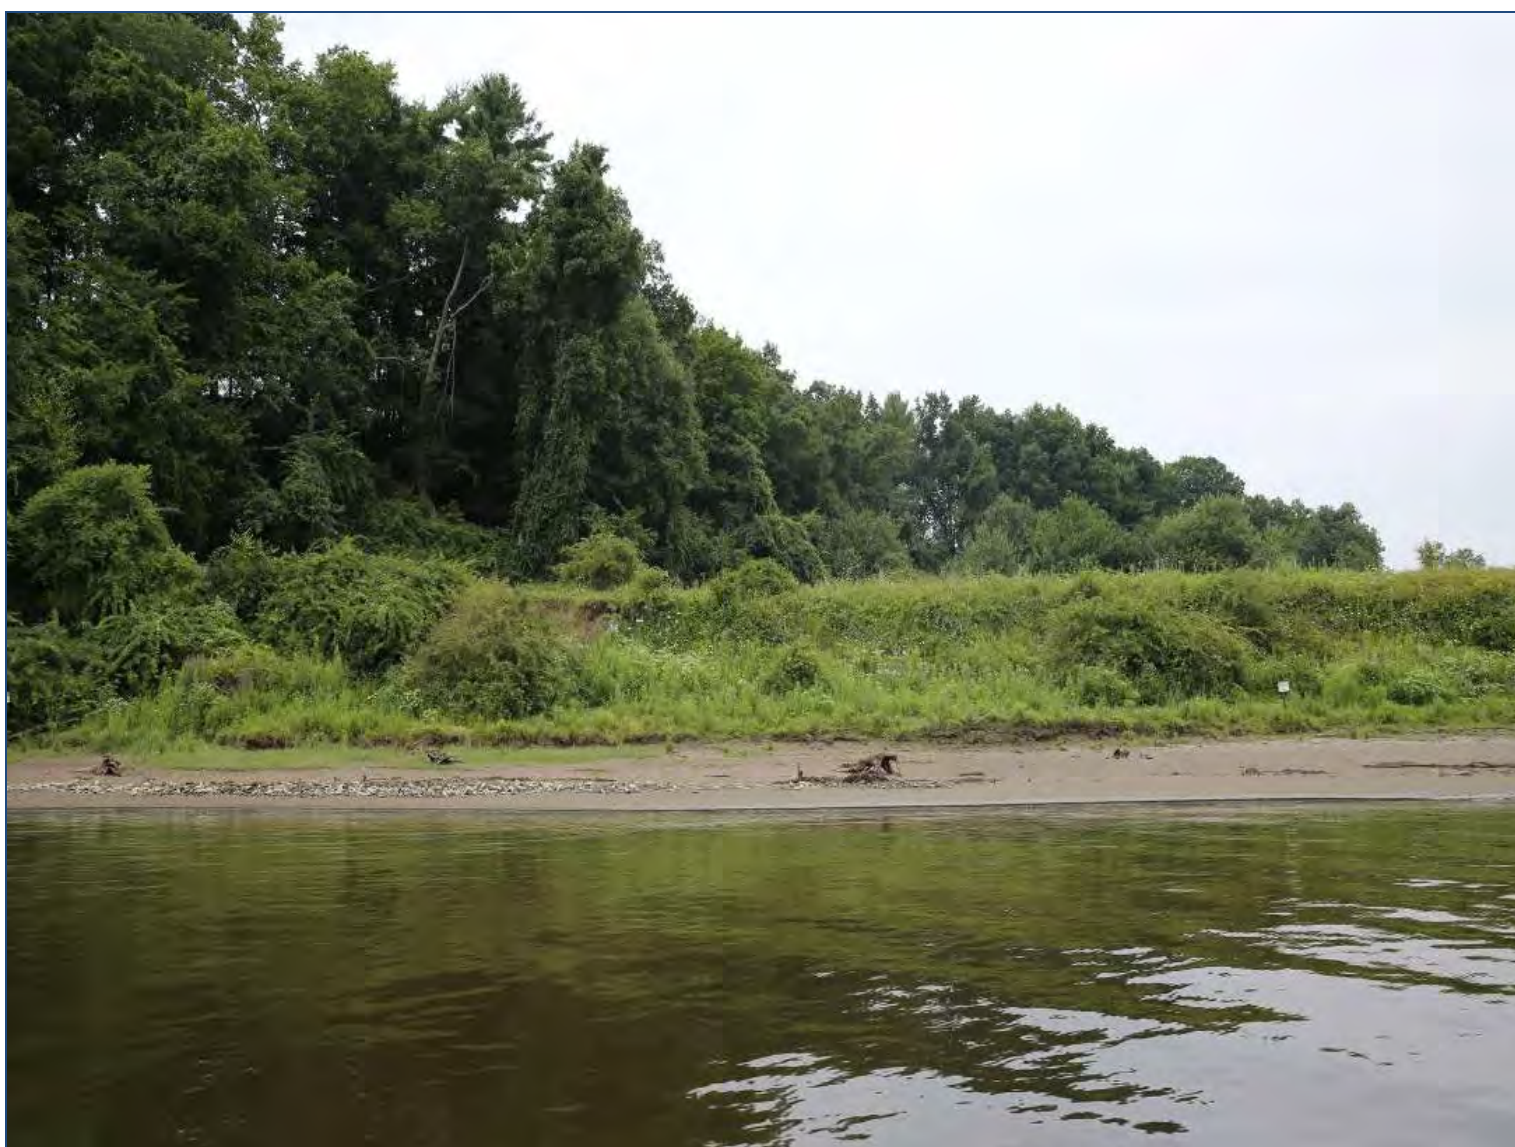
**2014 Photo:** Flagg Farm

**Observations:** Since the 2007 photograph the bank face has become more vegetated and recovering from past grazing activity by cattle since this site was restored in 1999. Sediment has deposited on the lower bank and emergent vegetation is becoming established and growing. Close observation of this site during field data collection for the erosion causation study showed that a number of cottonwood seedlings have become established on this lower bank. There were several bank swallow nest cavities observed at this site in 2007, but there were none observed in 2014.

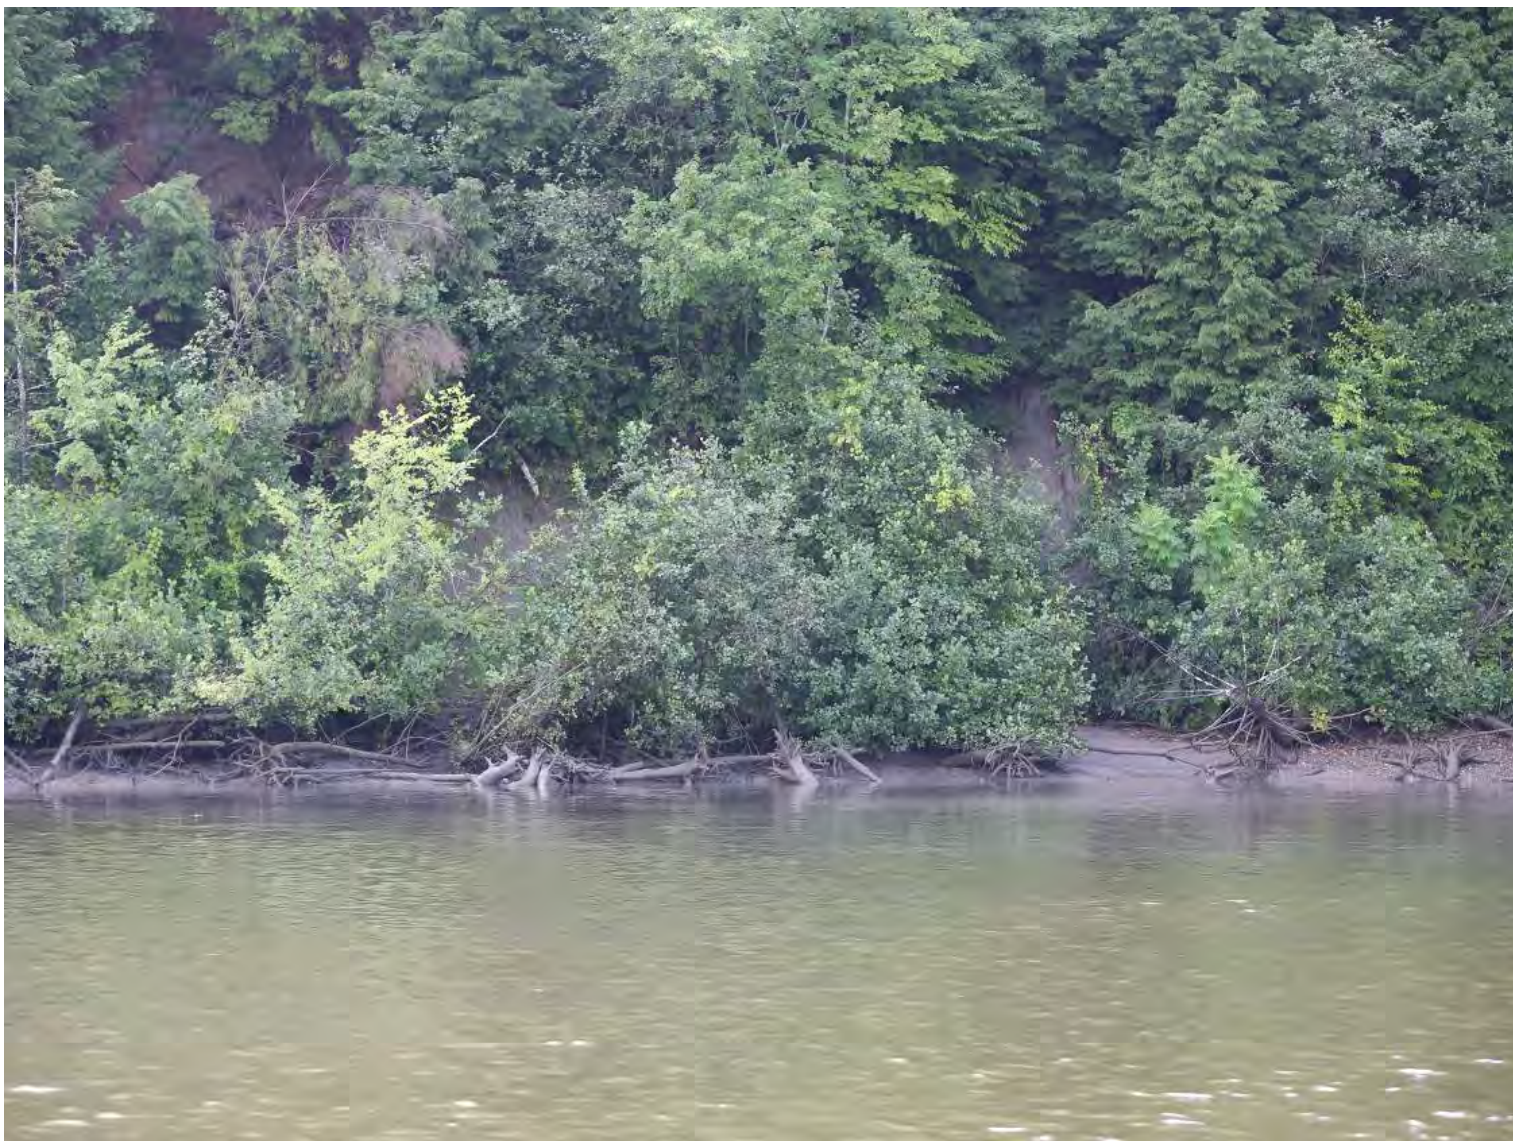
**2014 Photo:** Downstream from the tailrace

**Observations:** Erosion is occurring at this site and has been recommended for preventative maintenance and/or bank stabilization work in the 2013 FRR report.

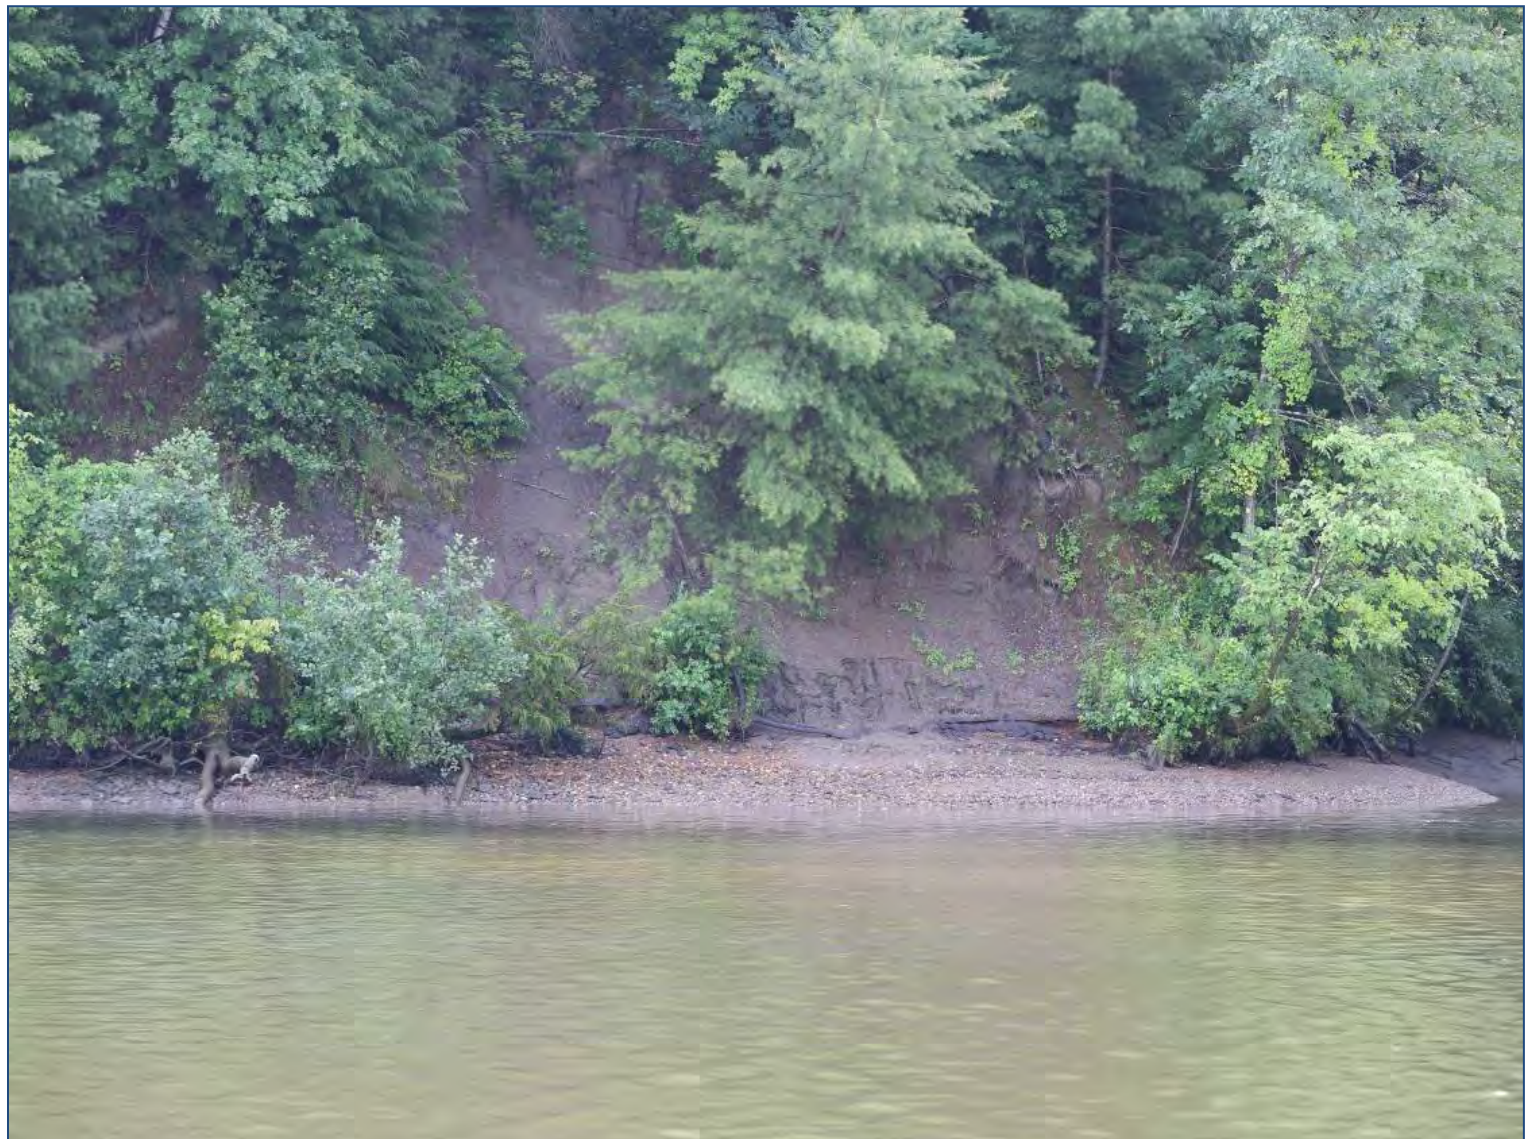
**2014 Photo:** Downstream from Tailrace at Unnamed Brook Inlet - This photo is a close-up of the area shown in photo 17a (white arrow), which is at the mouth of an unnamed brook inlet.

**Observations:** This site has been eroded for some time and was recommended for preventative maintenance and/or bank stabilization work in the 2013 FRR report.

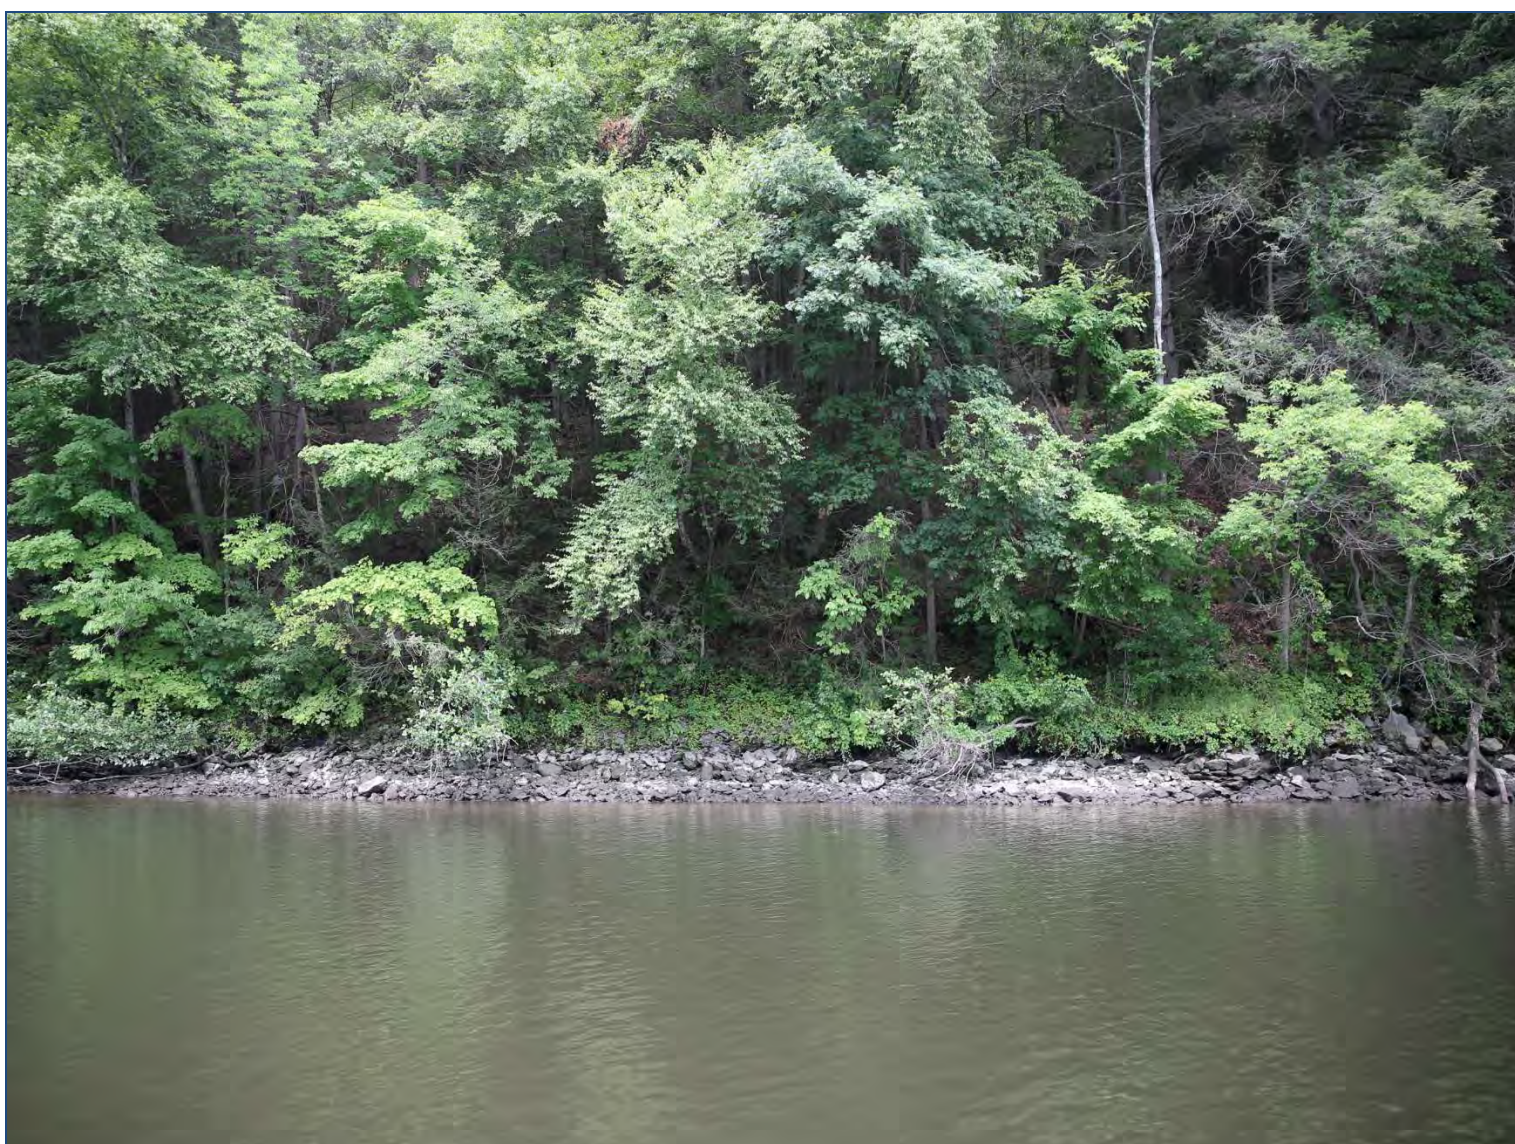
**2014 Photo:** Upstream from French King Bridge

**Observations:** This is a stable section of riverbank; no observable changes are noted between these photos.

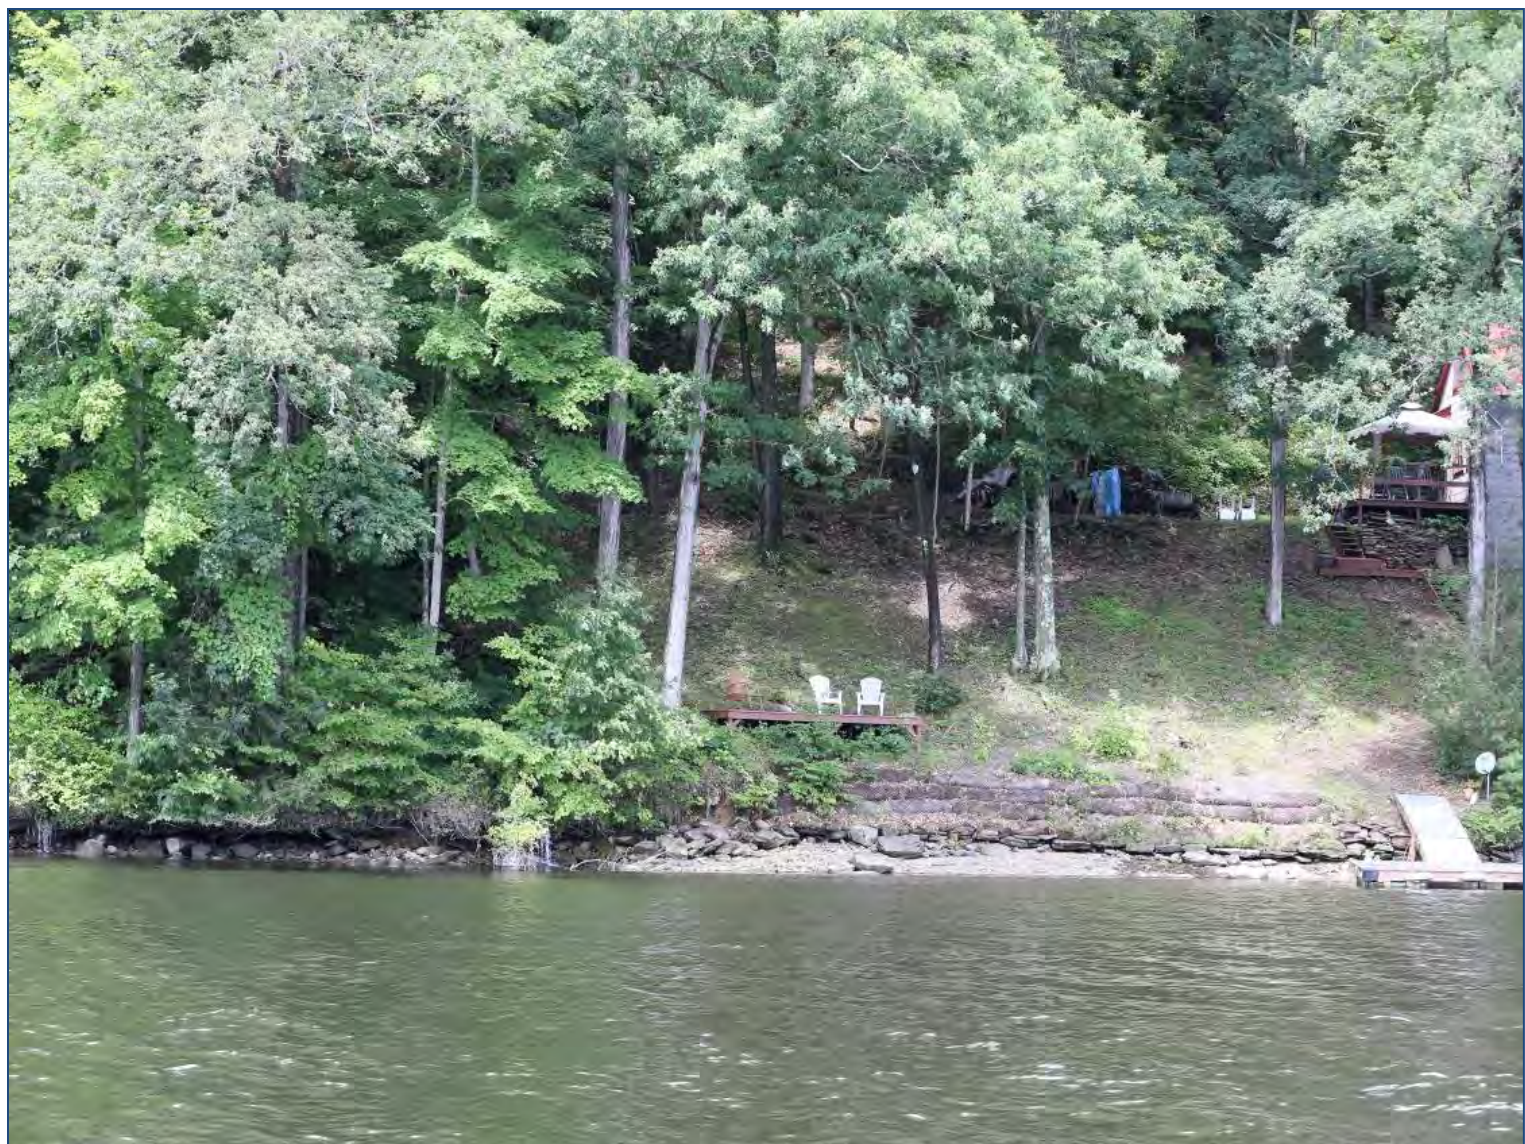
**2014 Photo:** Camp 2W

**Observations:** This site (see white arrow location in the 2007 photo) has been recommended for preventative maintenance and/or bank stabilization work in the 2013 FRR report.

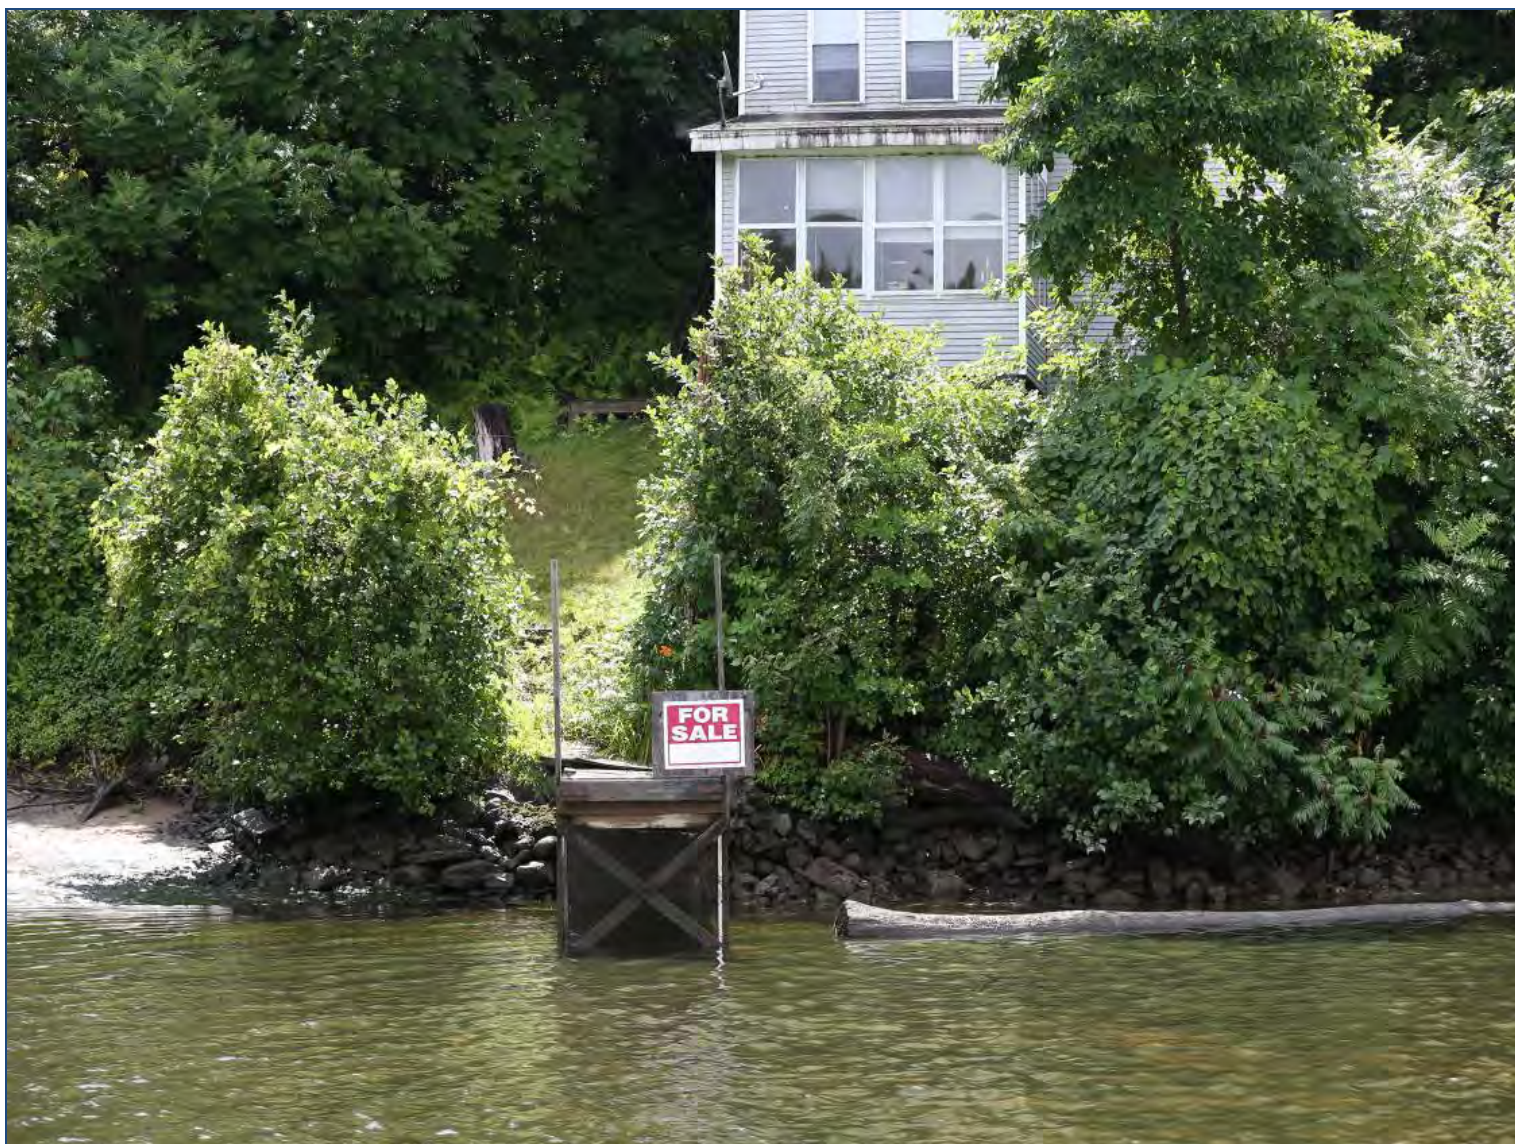
**2014 Photo:** Camp 4W

**Observations:** This camp site has been recommended for preventative maintenance and/or bank stabilization work in the 2013 FRR report.

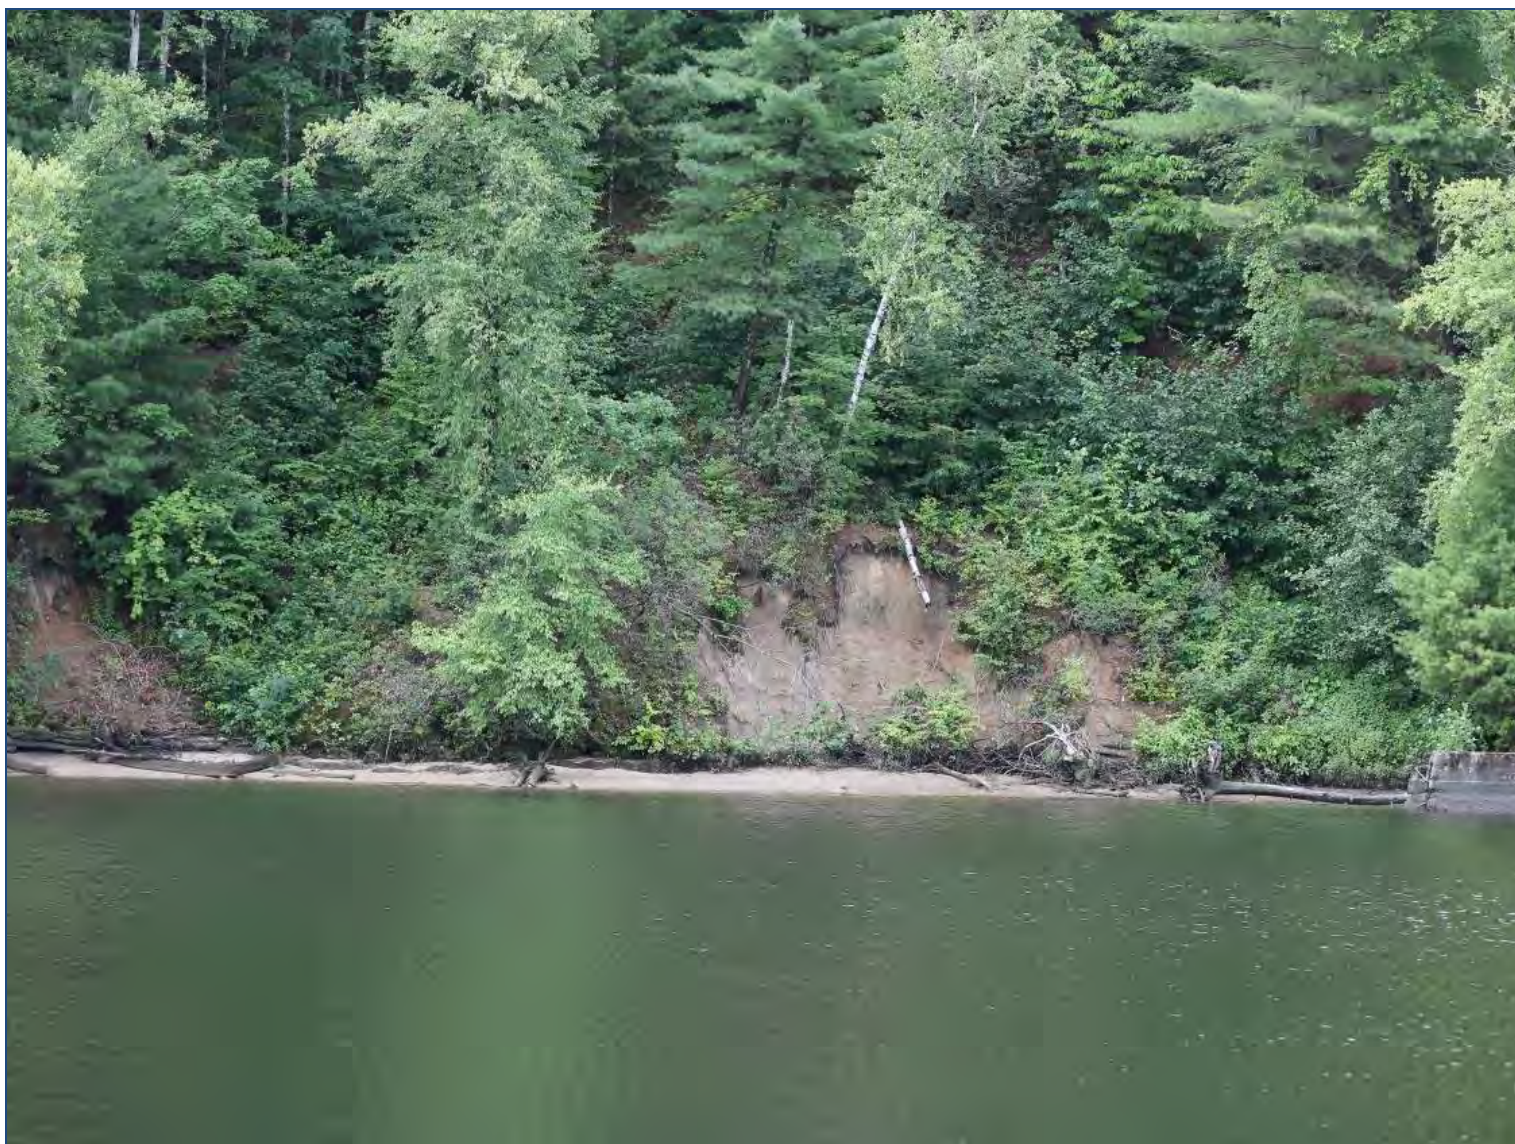
**2014 Photo:** Montague

**Observations:** Erosion has been ongoing at this site for quite some time and has been recommended for preventative maintenance and/or bank stabilization work in the 2013 FRR report.
