FIRSTLIGHT HYDRO GENERATING COMPANY  
 Northfield Mountain Pumped Storage Project No. 2485  
 Turners Falls Hydroelectric Project No. 1889  
 STUDY 3.1.2

*Northfield Mountain Pumped Storage Project (No. 2485) and Turners Falls Hydroelectric Project (No. 1889)*  
STUDY 3.1.2 NORTHFIELD MOUNTAIN / TURNERS FALLS OPERATIONS IMPACTS ON EXISTING  
EROSION AND POTENTIAL BANK INSTABILITY

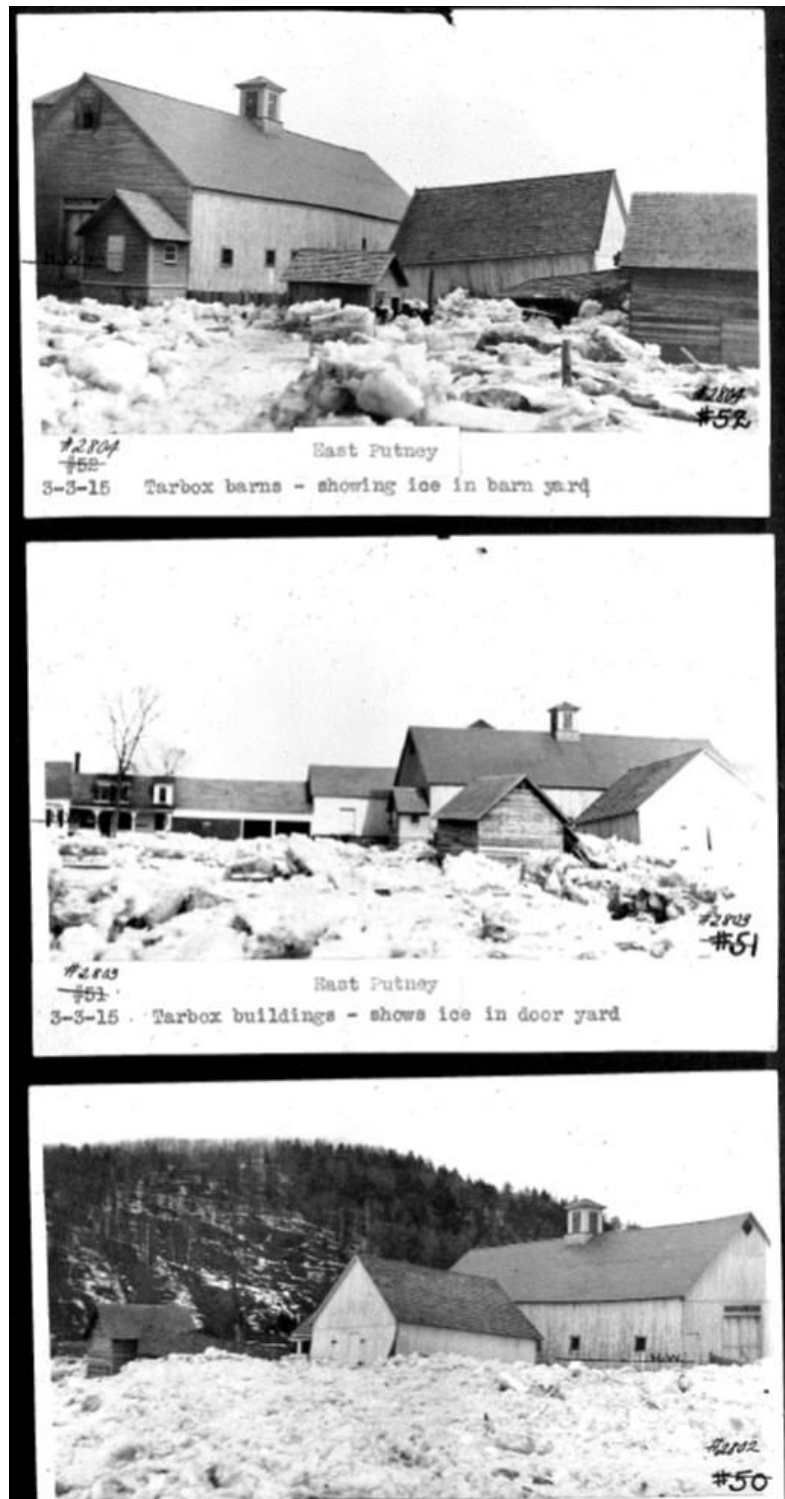
Sets of photographs showing ice found in the TransCanada files include the following years: 1915, 1935, 1940, 1941, 1942, 1943, 1945, 1946, 1959, 1968, 1989, 1992, and 1994. [Figure 5.5.5.2-4](#) provides an example of historic ice photos taken in 1915. In addition to a number of sets of photographs of ice, some data was also available in the TransCanada files including ice thickness at several locations along the river. An example of such data is shown in [Figure 5.5.5.2-5](#). Another example of the type of ice data that are available is found in [Figure 5.5.5.2-6](#). Similar types of data were found in the TransCanada files for the following years: 1940, 1944, 1945, 1946, 1948, 1951, 1952, 1953, 1955, 1956, 1957, and 1958. While some observations, are available before and after these years, actual measurements of ice in the available files were concentrated in the 1940s and 1950s. In addition, maps of the extent of ice were occasionally developed based on observations along the river ([Figure 5.5.5.2-7](#)). A review of the files also found that tributaries to the Connecticut River are a significant contributor of ice. When ice jams occur, they form as a result of constrictions or shallow areas associated with tributaries.

Figure 5.5.2-4 Ice at East Putney – 1915 (TransCanada)

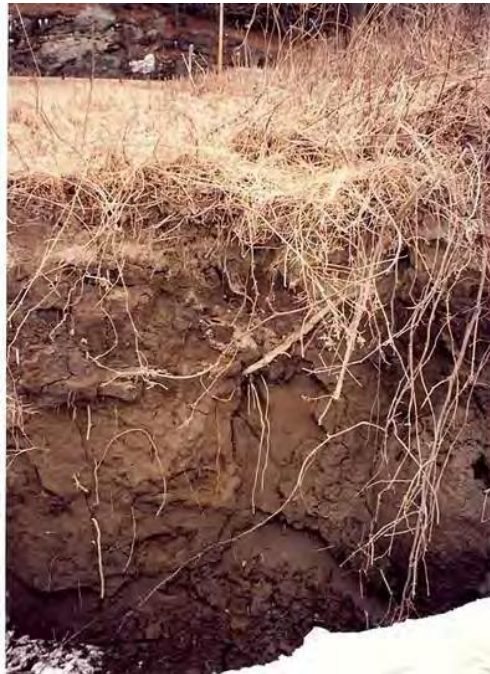
Inspection of riverbanks during winter conditions sometimes reveals cracks in the bank that may be related to freeze-thaw. Cracks that form as a result of this dynamic encourage more water to infiltrate into the crack because there is less resistance to flow than through the general soil matrix. As a result of subsequent freeze-thaw cycles, cracks in the soil may grow and eventually could lead to pieces of sediment breaking loose (spalling) and falling or sliding down the riverbank slope. [Figure 5.5.5.3-1](#) shows ice on the river as well as icicles hanging down the riverbank, which is indicative of water moving through the riverbank and freezing. [Figure 5.5.5.3-2](#) is an example of the small cracks forming in riverbanks that may be due to freeze-thaw. No actual data exist that allows quantification of the effect of freeze-thaw cycles on riverbank stability in the TFI. Freeze-thaw is a natural process that is primarily influenced by weather and climatic cycles and is not considered a primary factor in riverbank erosion processes in the TFI, nonetheless it is likely to contribute to riverbank instability to some lesser degree.

**Figure 5.5.5.3-2 Cracks in a Riverbank Potentially Associated with Freeze-Thaw**

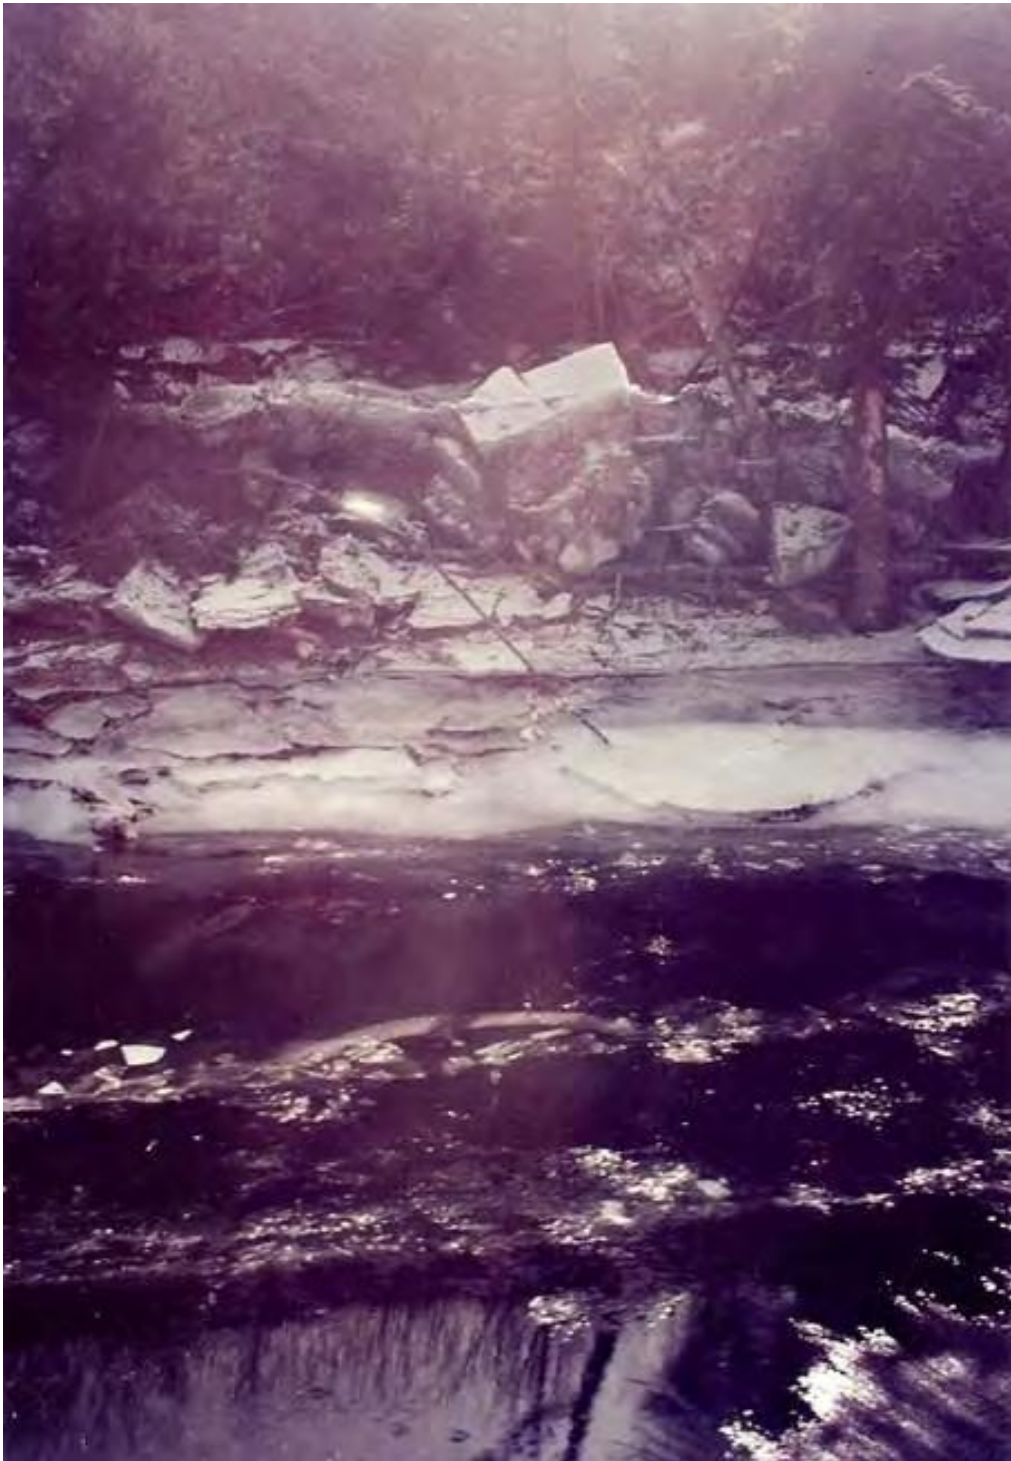
Damage to riverbanks near Cornish, NH in 1946 look very similar to what was observed farther downstream in the Bellows Falls Impoundment in the study conducted by Simons & Associates, [1992](#), "*Analysis of Bank Erosion at the Skitchwaug Site in the Bellows Falls Pool of the Connecticut River.*" The destruction of vegetation and the jagged nature of the top of bank in 1946 ([Figure 5.5.5.2-22](#)) following the ice event that year look similar to the lack of vegetation and ice pushed into the banks in 1992 ([Figure 5.5.5.2-23](#)). We believe the impacts at this location in 1992 were similar to that depicted in the 1946 photo.

**Figure 5.5.5.3-3 Ice Damage to Riparian Vegetation in the Bellows Falls Impoundment – 1992**

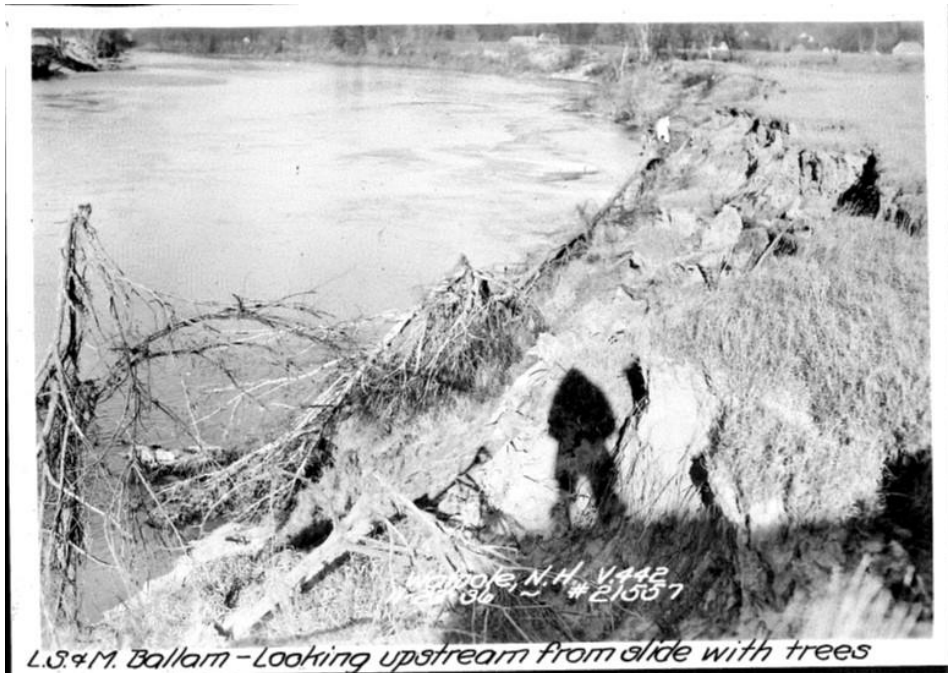
**Figure 5.5.5.5-1 Erosion Damage – 1936 Flood**

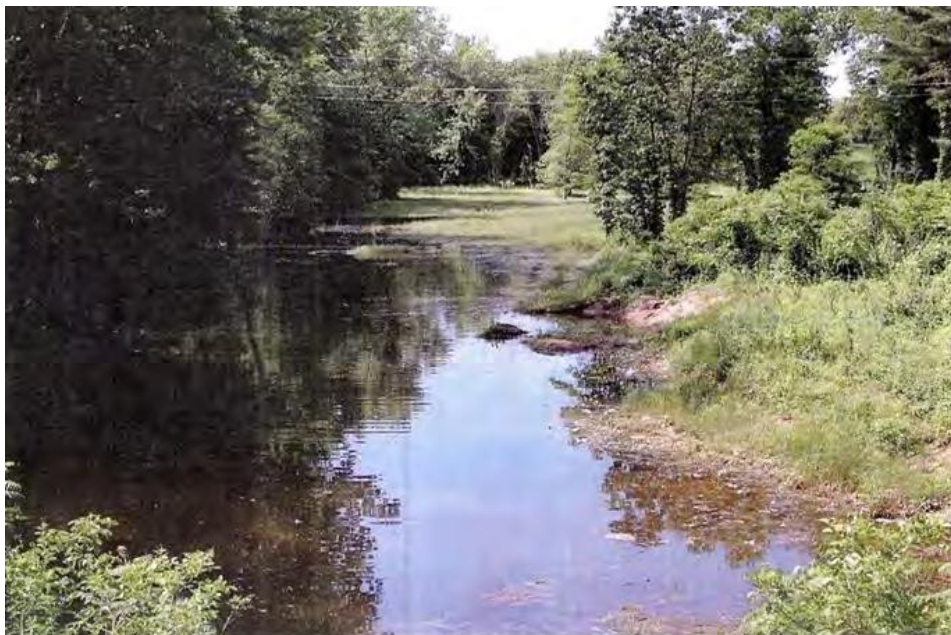
Figure 6: Abandoned avulsion channel formed across Moose Plain during the 1936 flood.

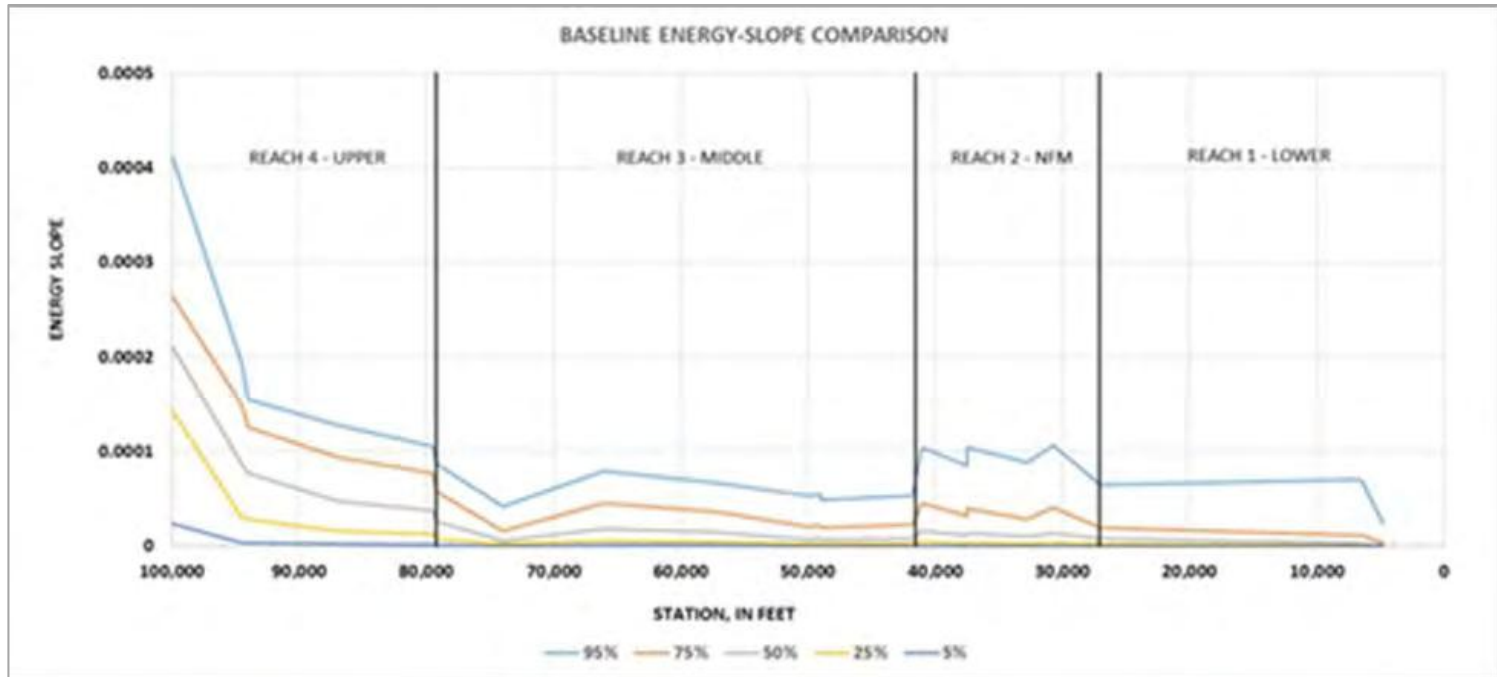
Figure 6.1.2.1-1: Energy slope trends through the Turners Falls Impoundment

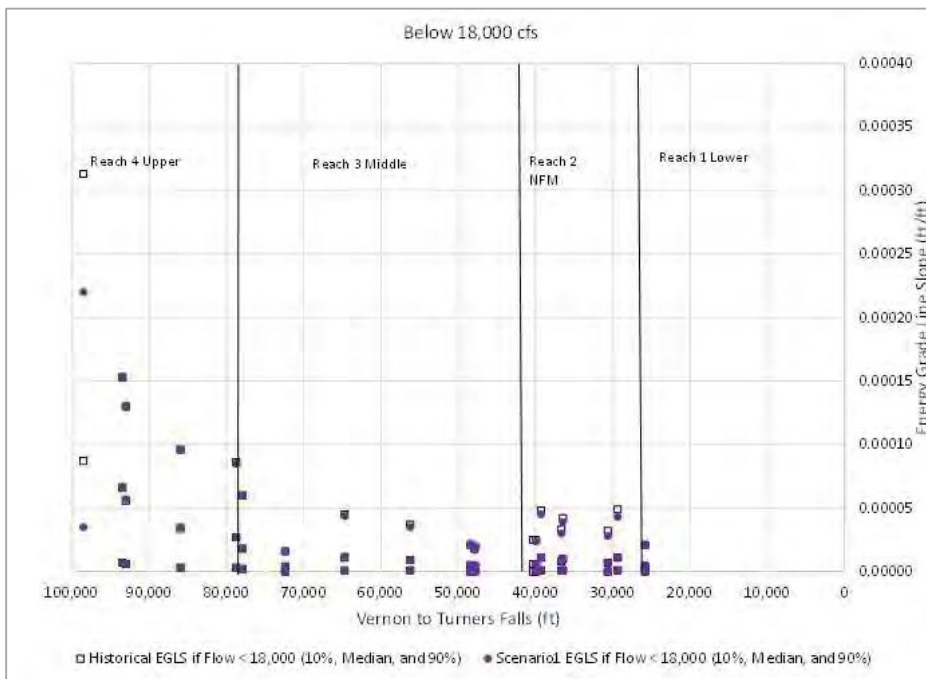
Figure 6.1.2.2-1: Energy slope trends through the Turners Falls Impoundment at flows less than 18,000 cfs

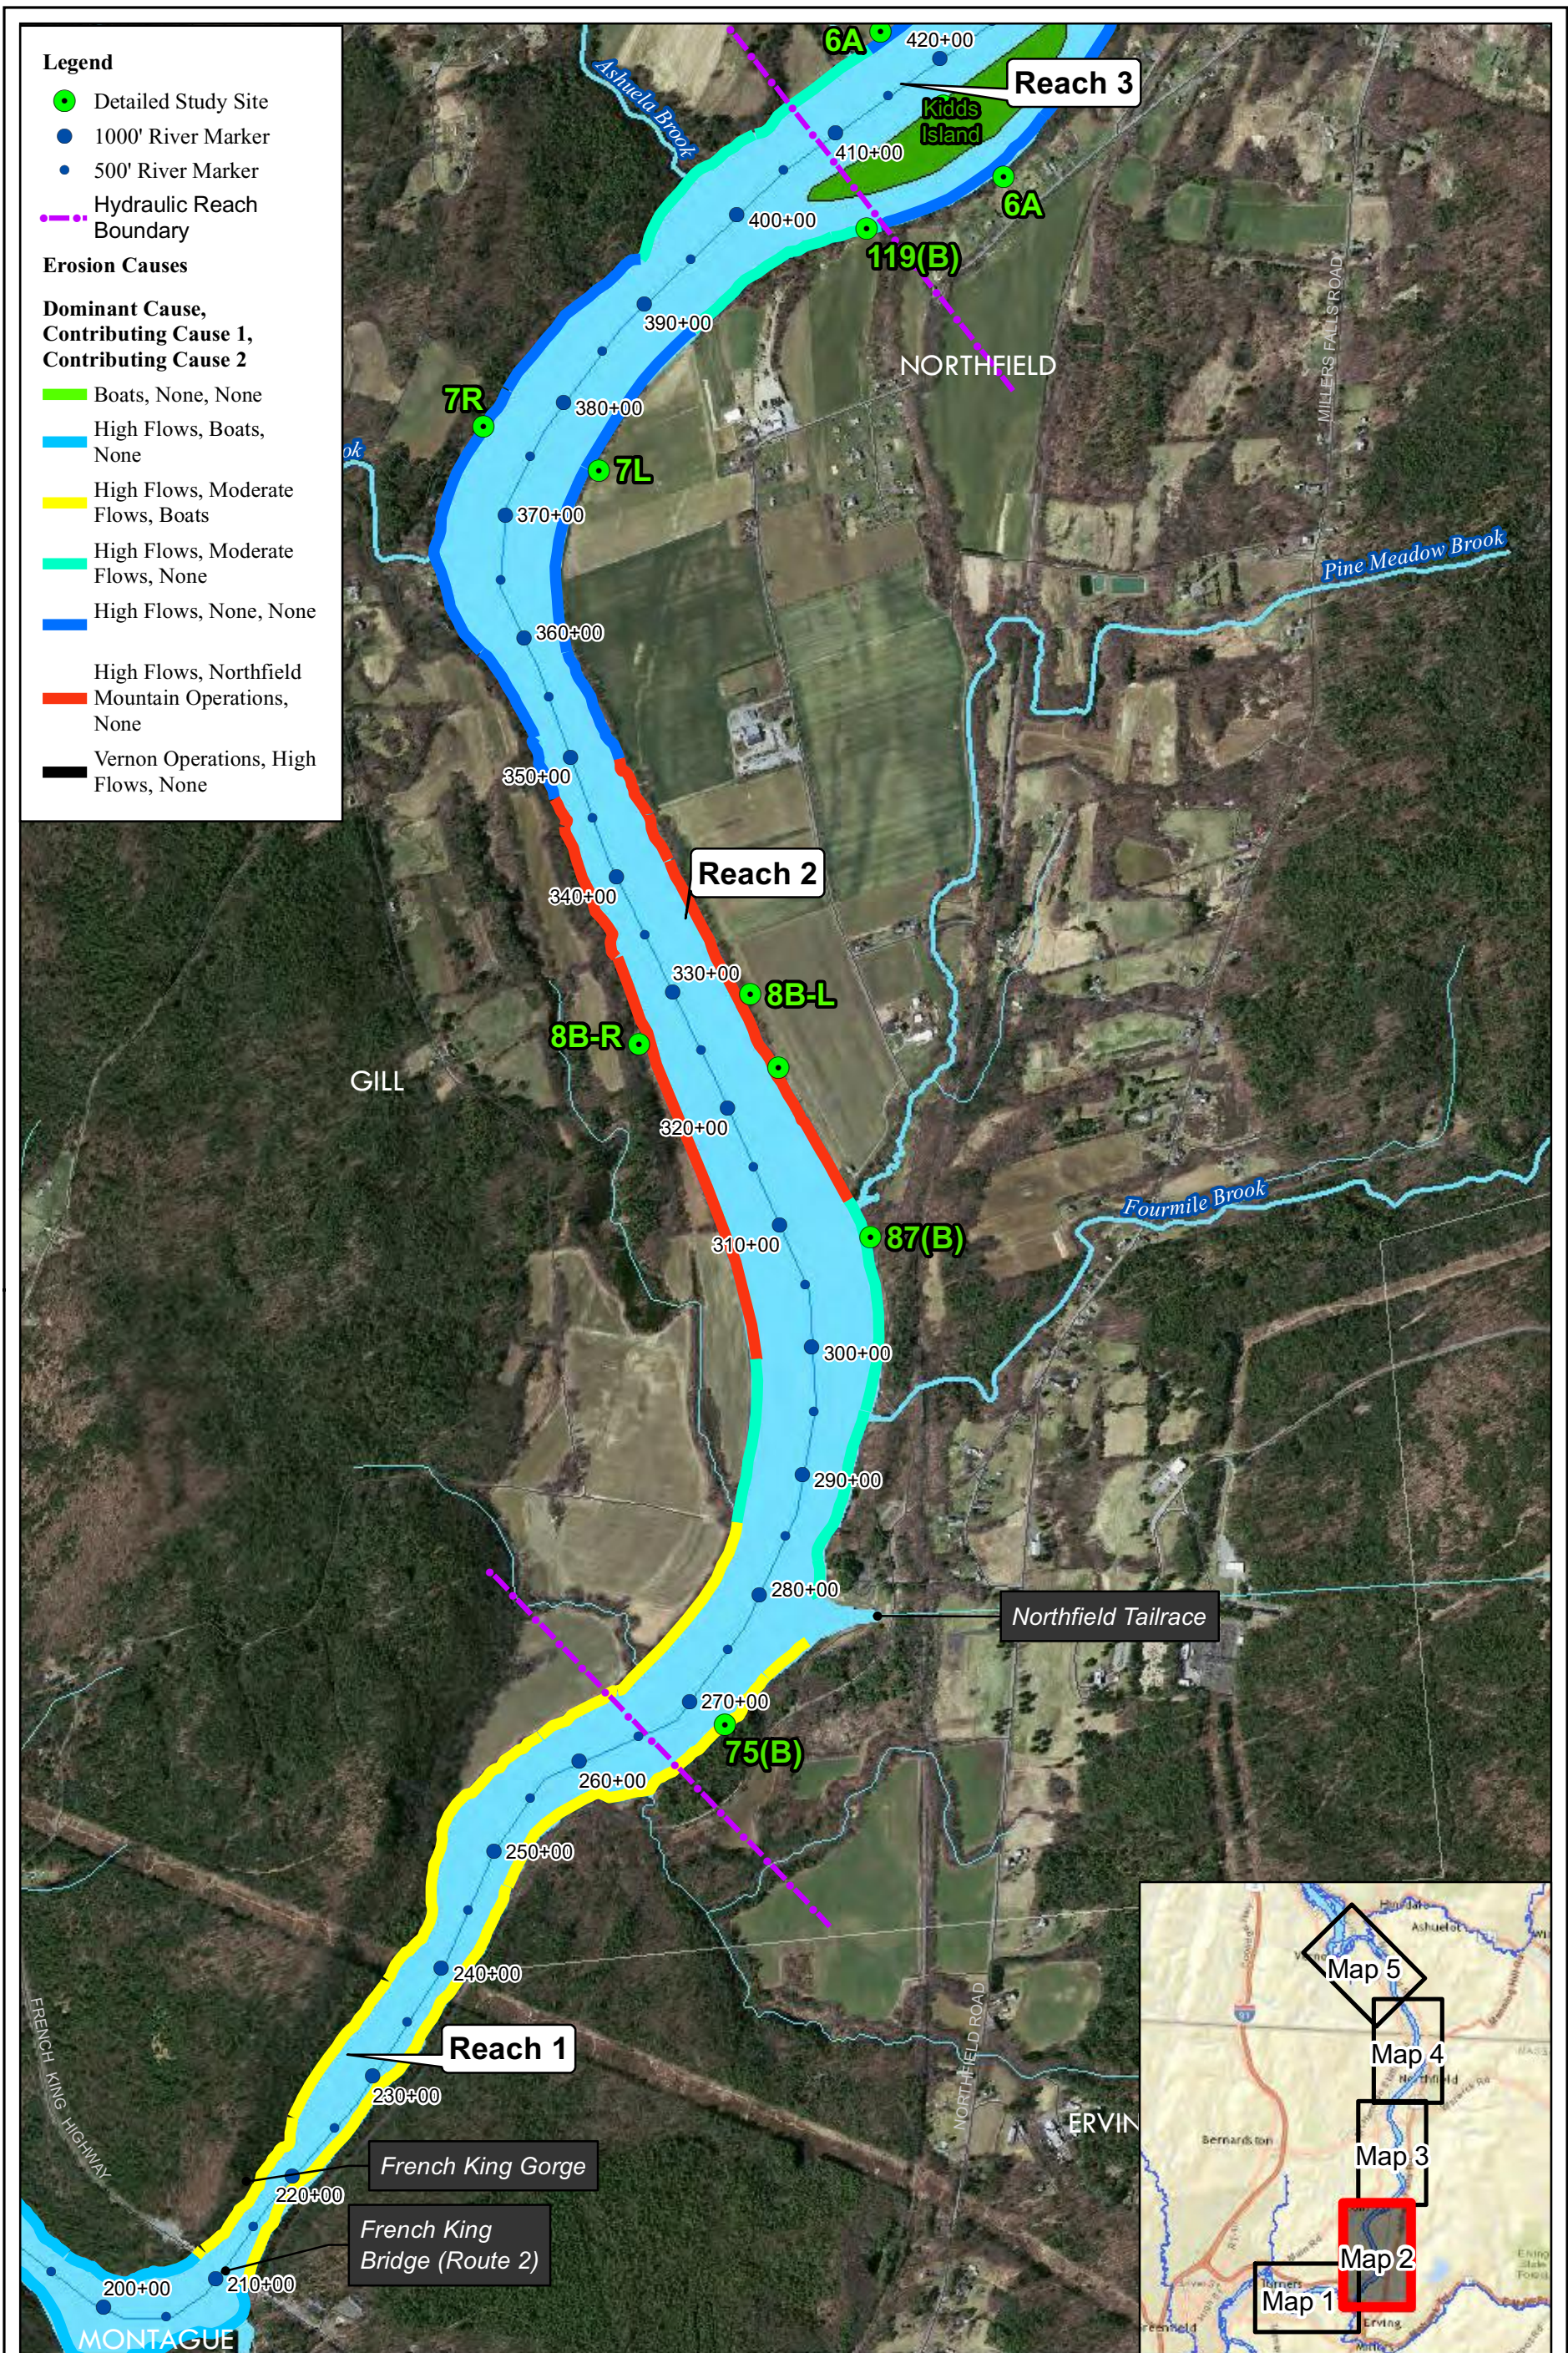
**Figure 6.1.2.2-6:**  
 Final Extrapolation of the Causes of Erosion  
 for each Riverbank Segment in  
 Turners Falls Impoundment  
 Map 1  
Service Layer Credits: Sources: Esri, HERE, DeLorme, USGS, Intermap, increment P Corp., NRCAN, Esri Japan, METI, Esri China (Hong Kong), Esri (Thailand), MapmyIndia, © OpenStreetMap contributors, and the GIS User Community

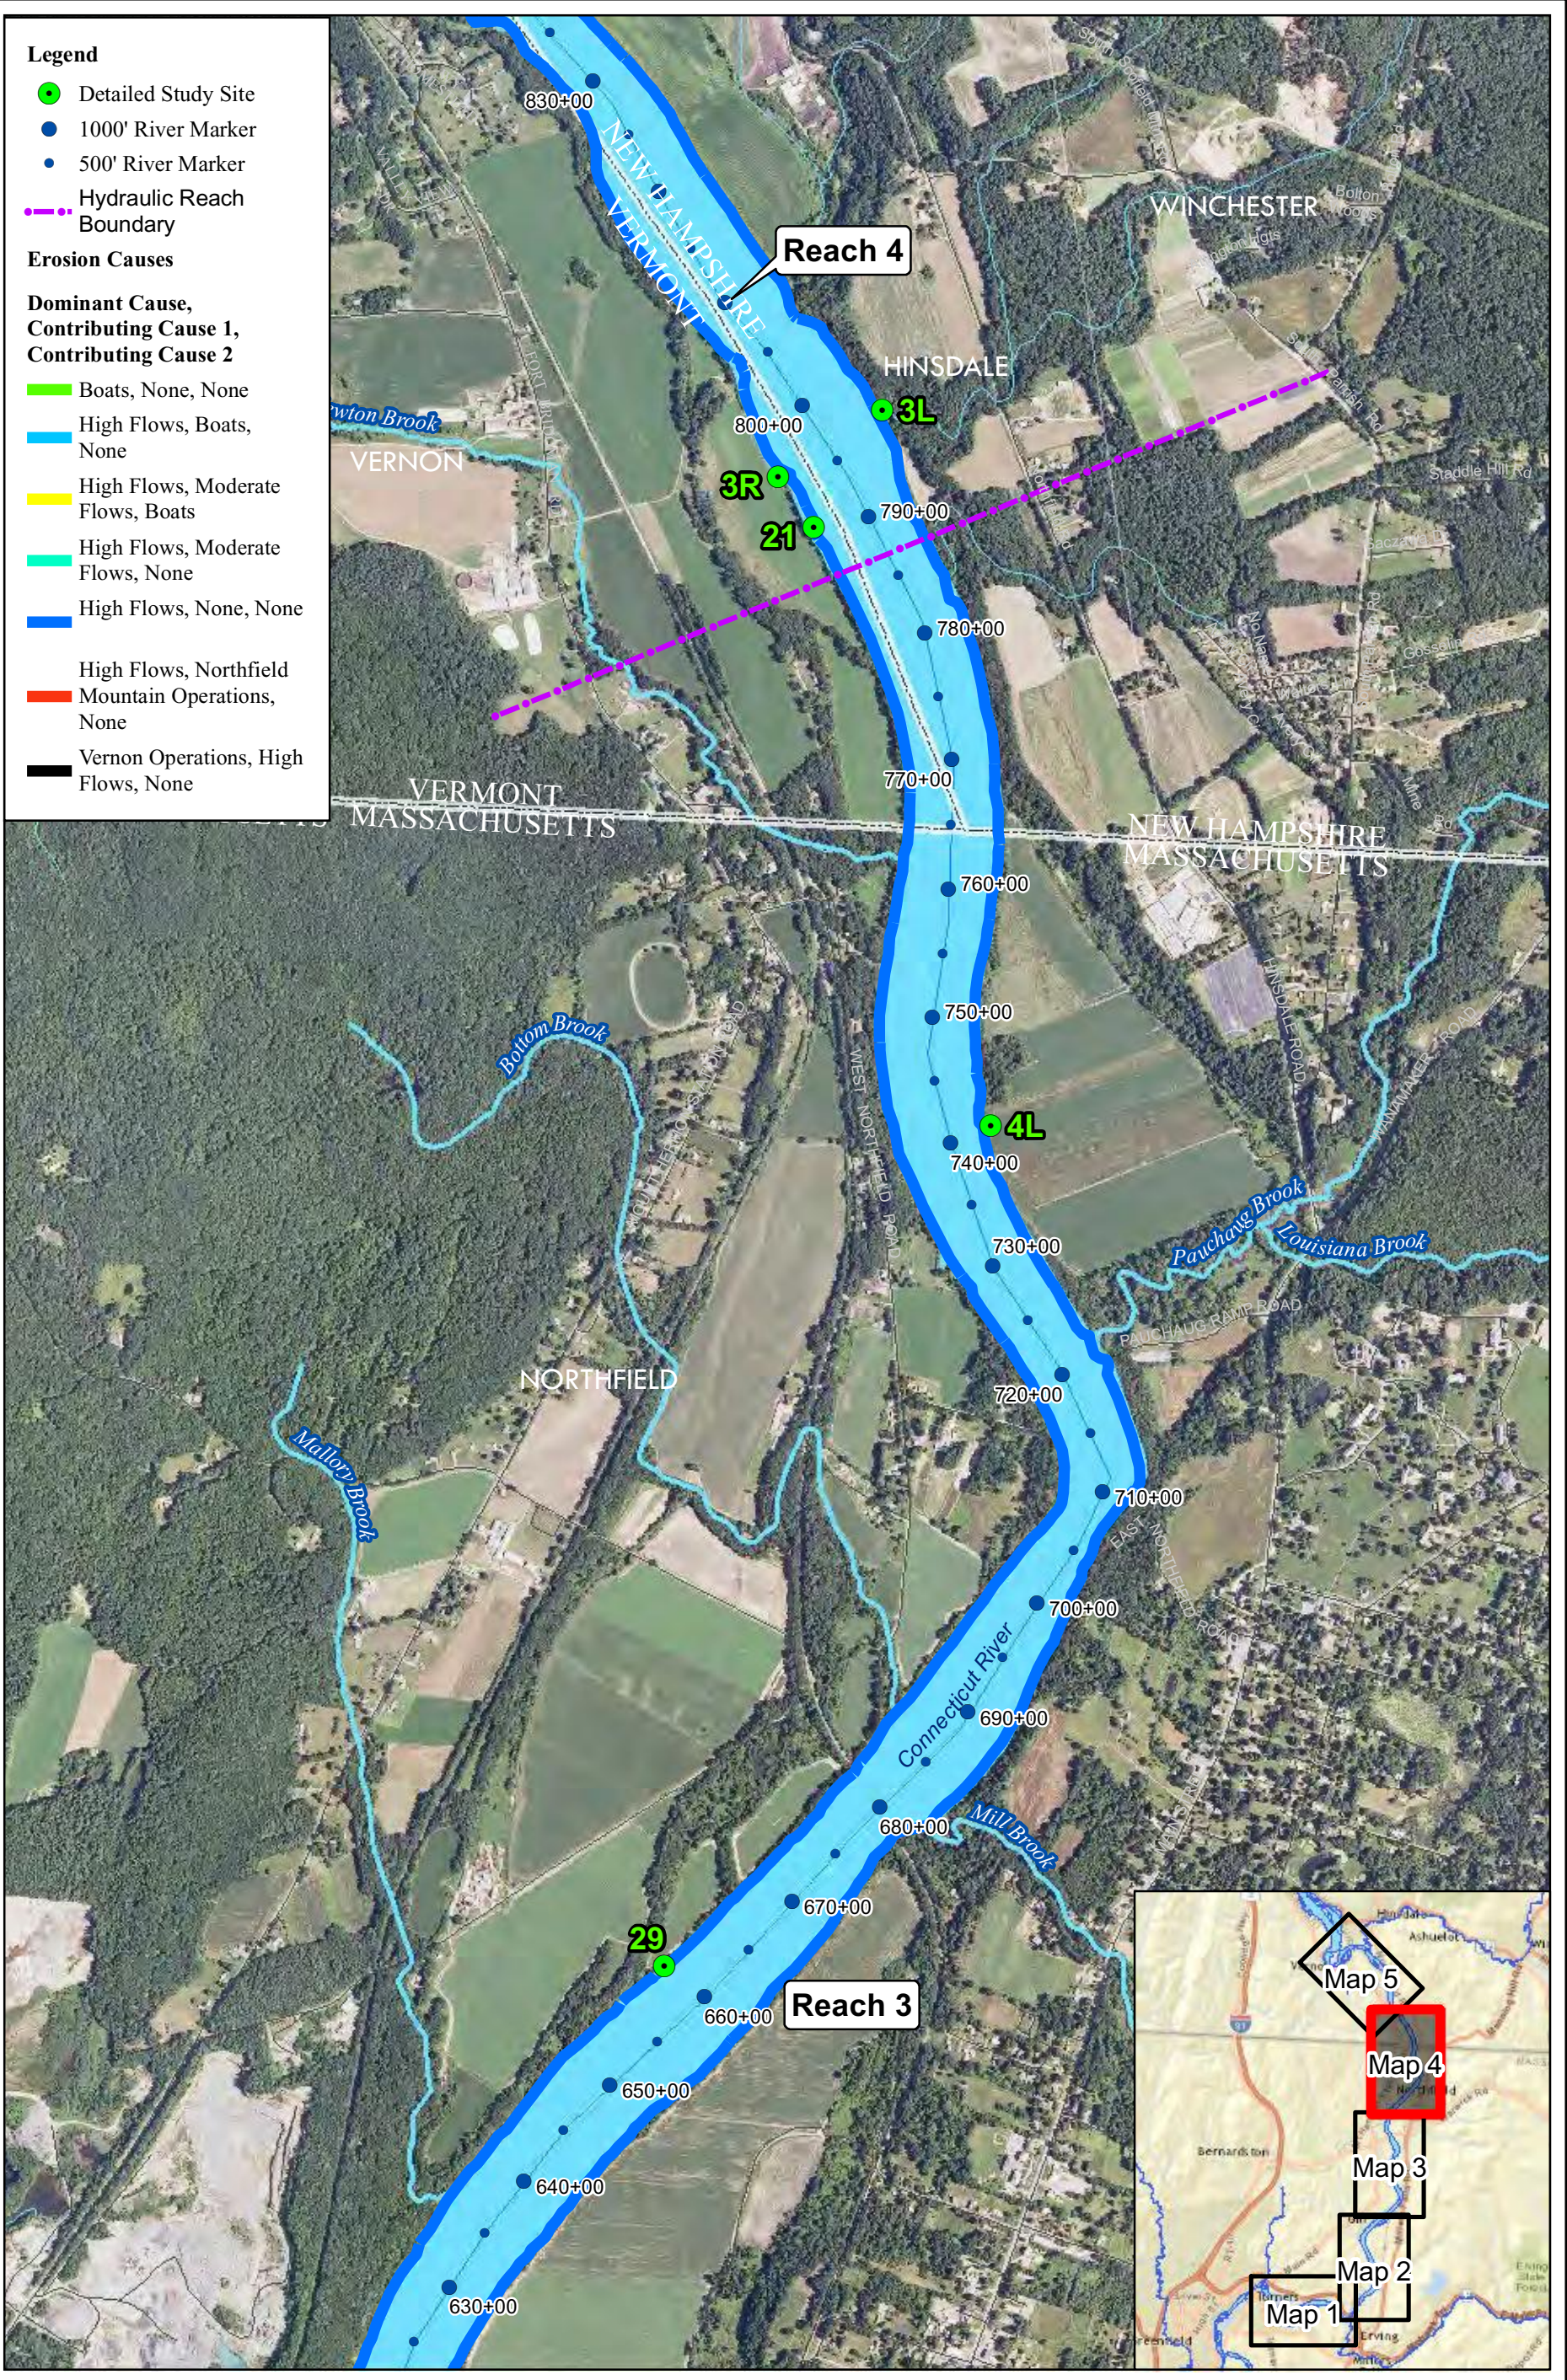
Figure 6.1.2.2-6:  
 Final Extrapolation of the Causes of Erosion  
 for each Riverbank Segment in  
 Turners Falls Impoundment  
 Map 4  
Service Layer Credits: Sources: Esri, HERE, DeLorme, USGS, Intermap, increment P Corp., NRCAN, Esri Japan, METI, Esri China (Hong Kong), Esri (Thailand), MapmyIndia, © OpenStreetMap contributors, and the GIS User Community
