**2014 Connecticut River Detailed Site Assessments
Land-Based Survey Photographs Reference No. 850 - 854
Location ID 10R – September 24, 2014**

Connecticut River – Turners Falls Impoundment Riverbank Detailed Site Assessments

STUDY 3.1.2 NORTHFIELD MOUNTAIN / TURNERS FALLS OPERATIONS IMPACTS ON EXISTING EROSION AND POTENTIAL BANK INSTABILITY

Northfield Mountain Pumped Storage Project (No. 2485) and Turners Falls Hydroelectric Project (No. 1889)

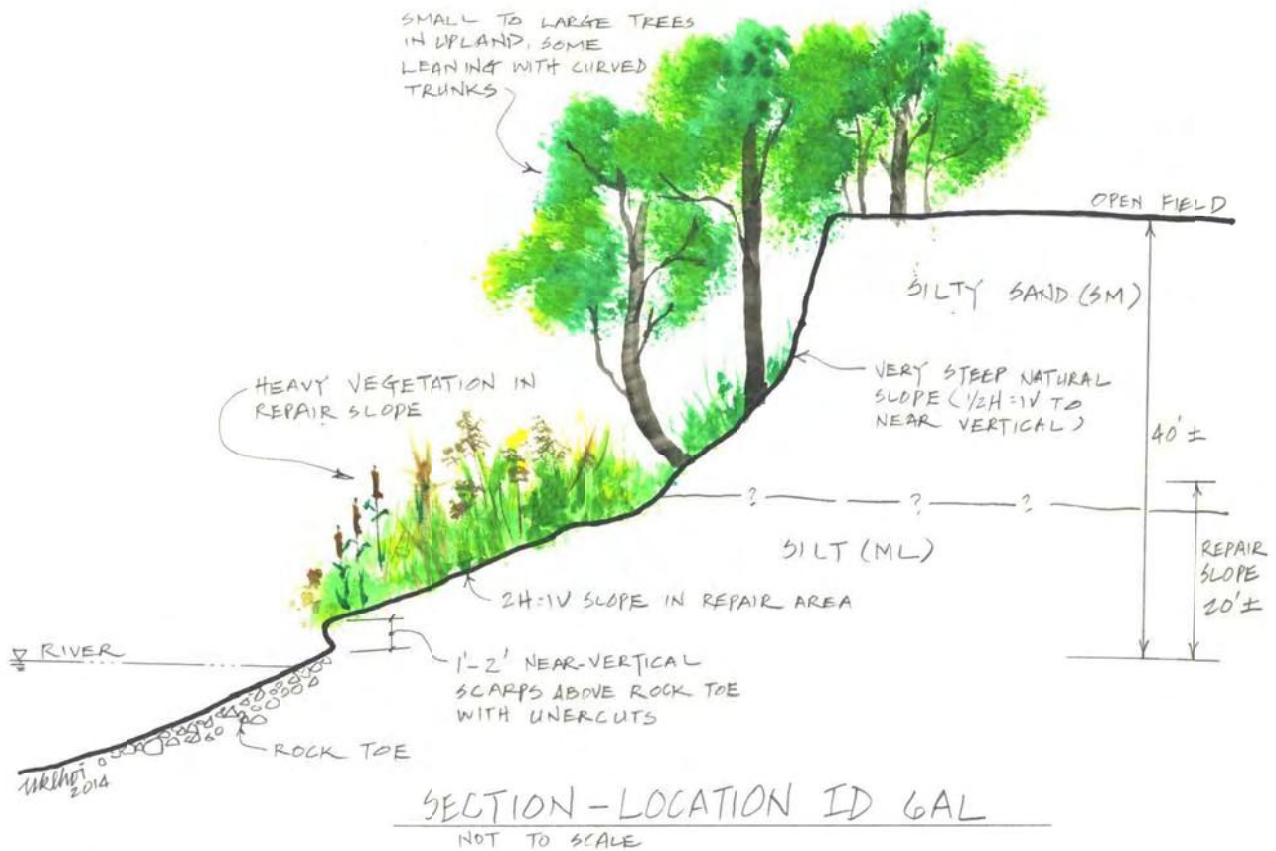
Site Sketch:

Upper Bank, Upper Layer: SILTY SAND (SM) – Fine to coarse sand, approx. 20% - 30% nonplastic fines, brown.

Upper Bank, Lower Layer: SILT (ML) – Slightly plastic, approx. 15% - 20% fine sand, gray.

Rock Toe – 1" to 4" riprap rock, angular, hard, minor deterioration.

- Little erosion at rock toe, with no depressions or movements observed.
- 1' – 2' high near-vertical scarps just above the rock toe, with minor undercuts.
- Very steep natural upland slope above repaired area.
- Some leaning trees in natural upland slope, some with curved trunks.

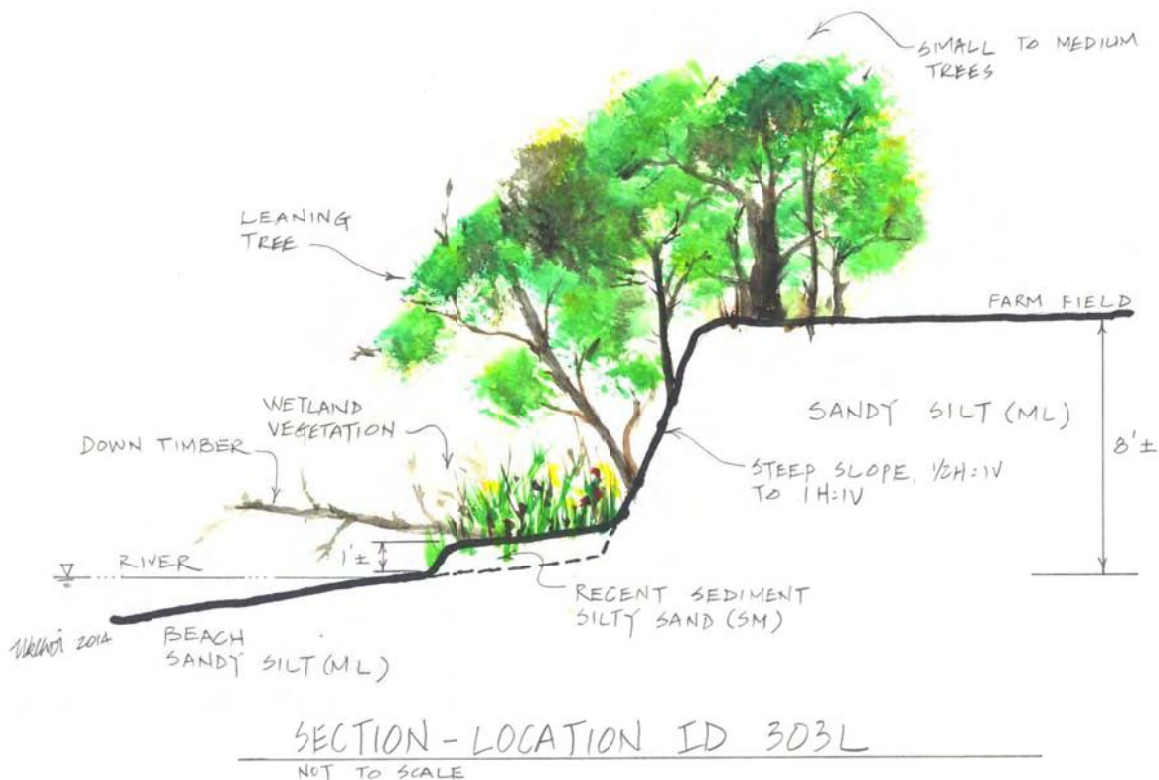
Site Sketch:

- No erosion observed on Lower Bank, the top of which was filled with recent sediments.
- Steep slopes, entire Upper Bank.
- Some undercuts with exposed roots.
- Leaning trees.
- Few down timber

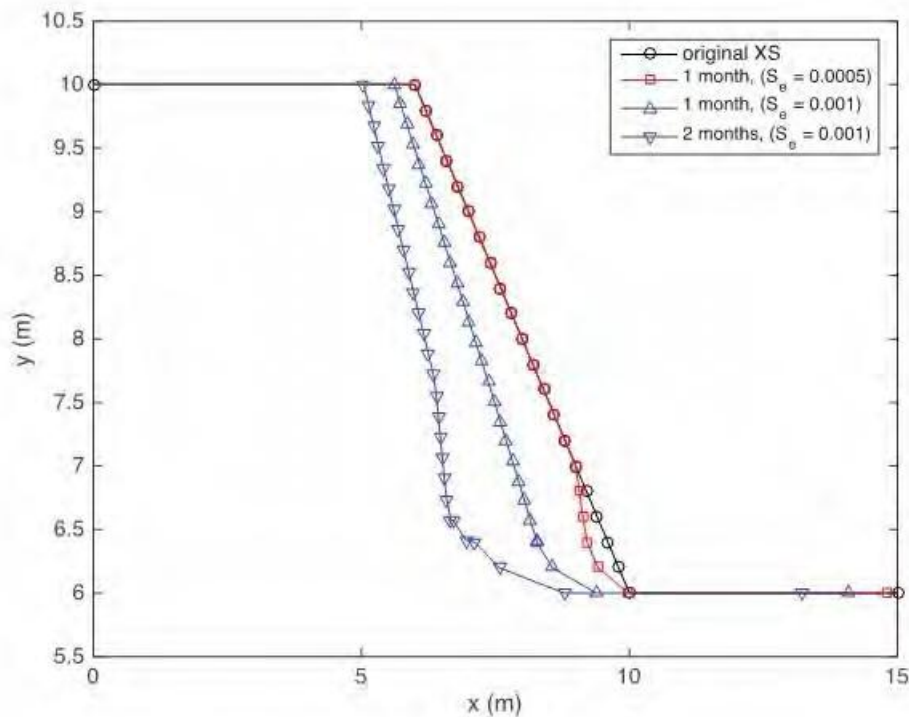
Figure 13. Eroded bank profile without boat waves.

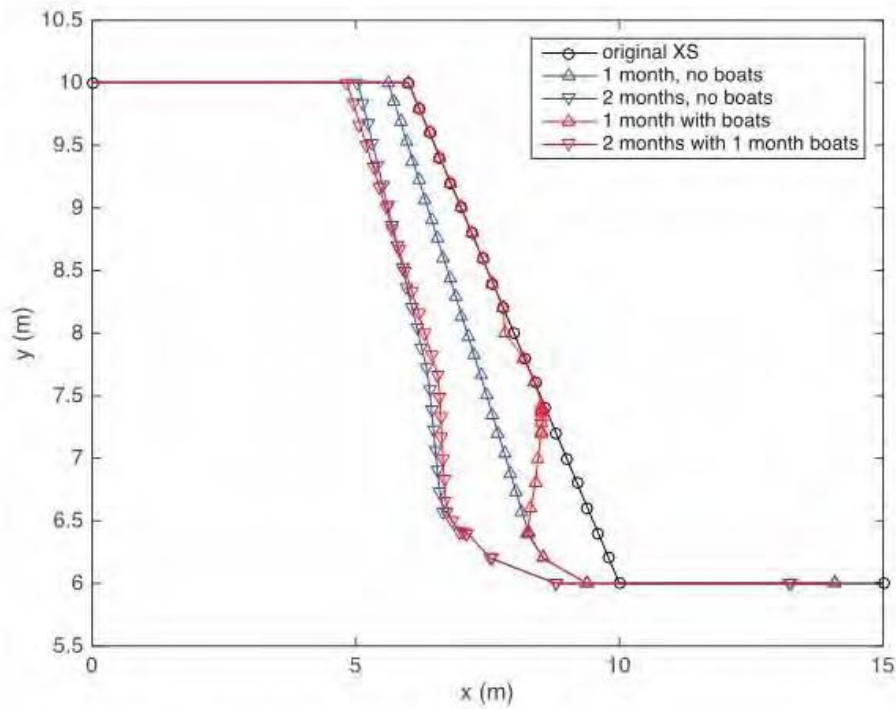
Figure 17. Comparison of failure profiles with and without boat waves.
