Analysis of Erosion in the Vicinity of the Route 10 Bridge Spanning the Connecticut River

October 2012

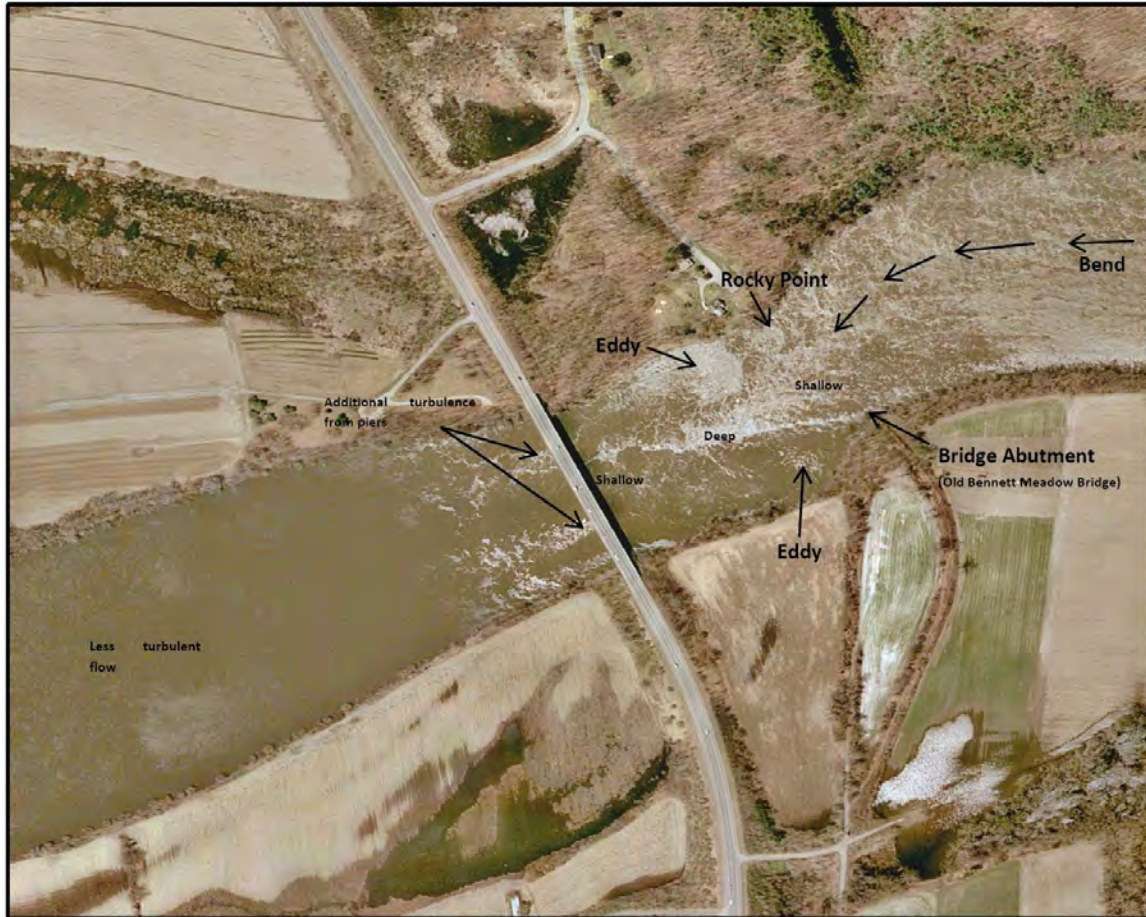
Figure 9. Flow characteristics in the vicinity of the Route 10 Bridge

As can be seen in Figure 9, a recent aerial photograph (MASSGIS, photo date April 2001) shows turbulence at the water surface in the reach of river upstream and through the Route 10 Bridge due to the bend, constriction and narrowing through the rock outcrop and old bridge abutment, acceleration of flow, extreme and rapid depth changes, separation zone and eddy, and the bridge piers. Once the flow has gone through these intense hydraulic changes, note that downstream of the Route 10 Bridge, the flow becomes much more tranquil as indicated by the much calmer water surface.

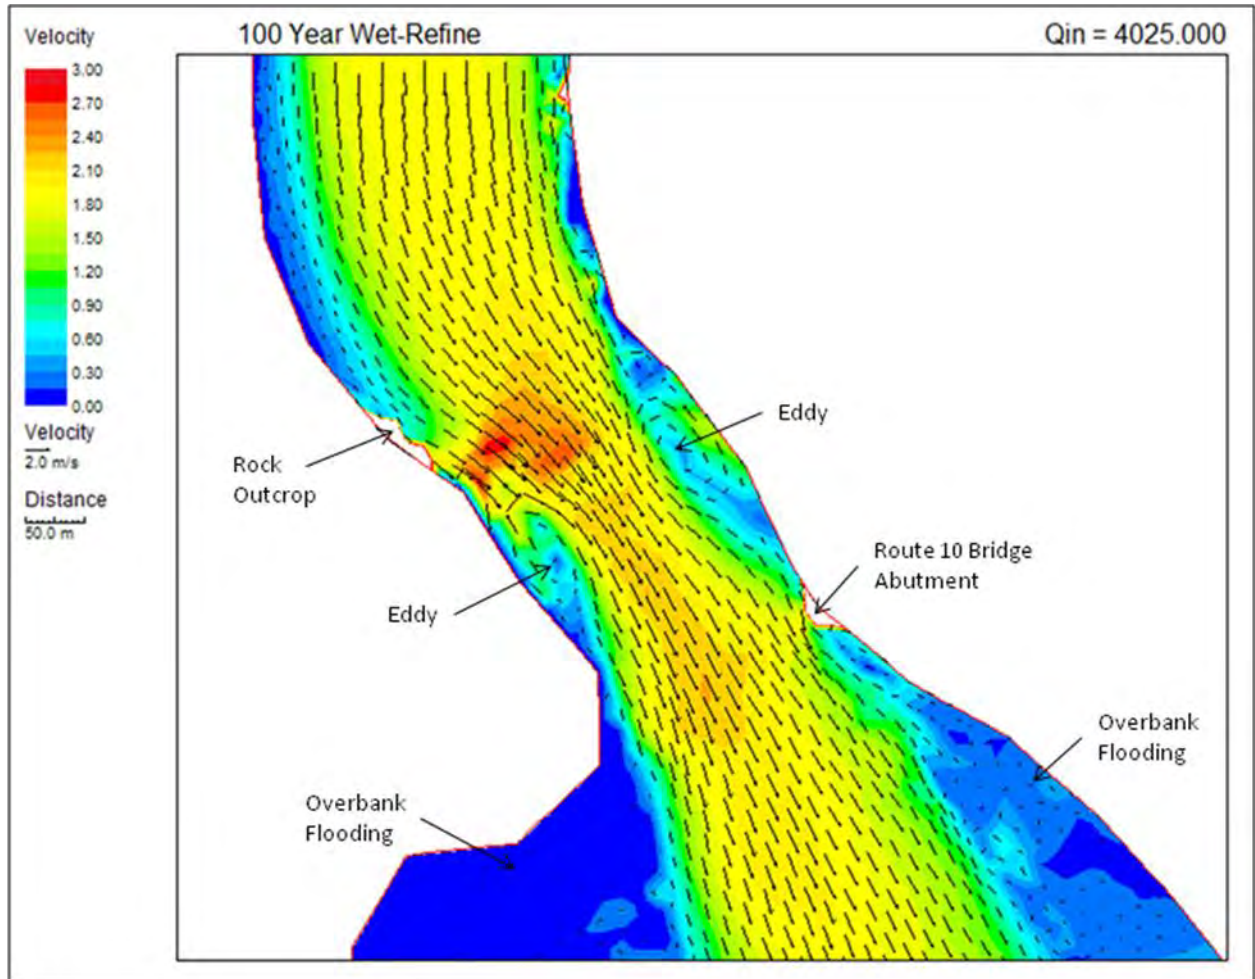
Figure 11. River-2D Results, 100-Year Flow

Figure 11 is an example of the velocity vectors computed by this model showing the formation of eddies in the vicinity of the Route 10 Bridge for the 100-year flow. The eddies are shown by the black velocity vectors showing a circular pattern near both riverbanks just downstream of the rocky point and between the old Bennett Meadow Bridge and the Route 10 Bridge. Appendix E presents the results of the River-2D model in this reach of interest for the 1.05 to 10-year events. The magnitudes of the velocities are shown by the length of the black velocity vectors and also by the colors. The blue color represents low velocities while the red color represents high velocities (ranging from 0-3 feet per second). Note on Figure 11 the small white area outlined in red representing the rock outcrop. The model shows that the rock outcrop accelerates the flow (as noted by the red shading and the longer arrows). Note the formation of eddies (circulatory pattern of velocity vectors) just downstream of the rock outcrop adjacent to both banks of the river. Acceleration of flow and the formation of eddies on one or both banks occurs for other flows (see Appendix E) and is consistent with flow patterns observed in this part of the river.

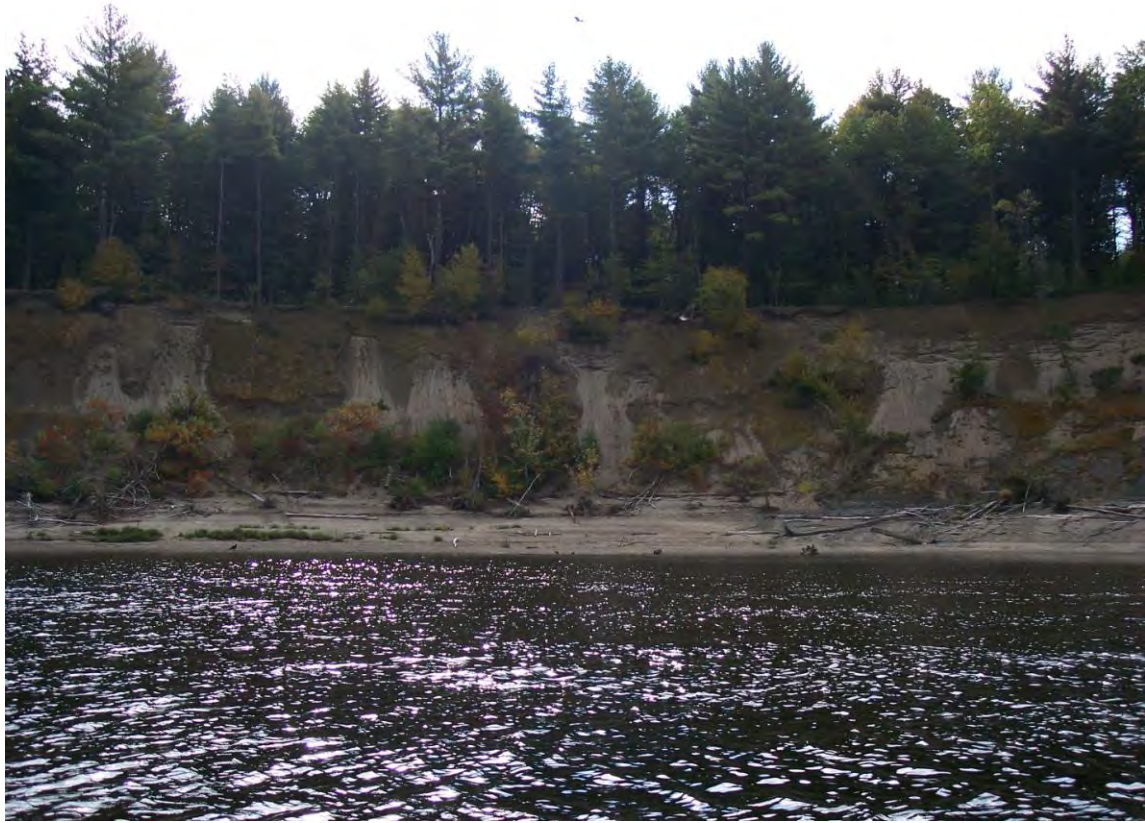
Figure 12. Riverbank Erosion downstream of Vernon Dam

Perhaps the area of most significant erosion along the Turners Falls Impoundment is located just downstream of the Vernon Dam on the left descending bank (east). Simons & Associates visited the site and conducted an evaluation of erosion at this location for New England Power in 1996. In this evaluation we stated, “*As water flows downstream of the dam along the left side (looking downstream) it forms a large eddy which circulates to the left in a counter clockwise direction into and around the eroded area.*” This large eddy has caused what is the most significant erosion of any part of the Turners Falls Impoundment. Figure 12 shows a water level view at relatively low flow and Figure 13 is an aerial view of the erosion caused by the eddy as high flows are discharged from the Vernon Dam spillway. As can be seen in Figure 13, a white-water jet is being discharged over the spillway at high velocity that induces a strong eddy and associated turbulence.

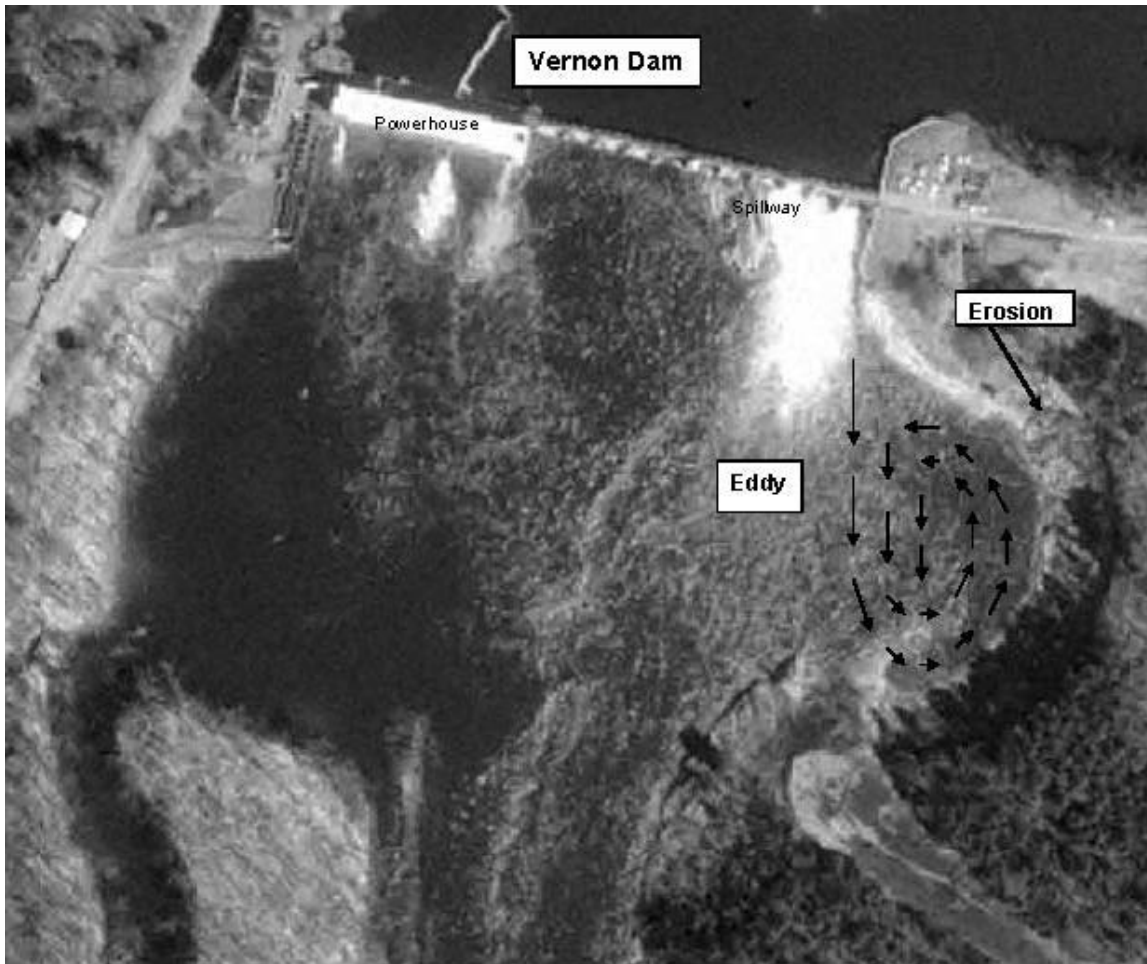
Figure 13. Eddy-induced erosion downstream of Vernon Dam

Appendix F presents additional photographs of this very significant eddy-induced erosion taken from boat and ground. Based on the aerial photo (April 2001 in the Massachusetts GIS), the toe of the eroded slope is about several hundred feet back from a straight line along the bank from the left abutment of the Vernon Dam (looking downstream) to the point on the bank downstream of the eddy-induced erosion where the power-line tower is located. The horizontal distance along this eroded slope from the toe to the top is about 150 feet. This eroded bank is about 90 feet high. This segment of eroded riverbank is larger than any other eroded bank in the Turners Falls Impoundment. These photos clearly show the erosive effect of such a large-scale eddy on the riverbanks in the Turners Falls Impoundment and confirm that significant erosion is occurring independent of Turners Falls and Northfield Mountain operations since this erosion is located far away from the effect of these projects where backwater and fluctuations due to these projects are not significant.

Field (“Fluvial Geomorphology Study of the Turners Falls Pool on the Connecticut River Between Turners Falls, MA and Vernon, VT,” 2007 discusses the erosive effect of eddies specifically on the Connecticut River at the Route 10 Bridge, “*Areas of intense erosion occur where eddies are well developed such as the Route 10 Bridge . . . as the eddy currents impinge directly on banks composed of floodplain sediments.*” The existence of large-scale eddies that circulate and intensify velocities against the riverbank at this location are a primary cause of erosion. The fact that very significant eddy-induced erosion is occurring in another segment of the Turners Falls Pool and the existence of eddies at the Route 10 Bridge suggests that these hydraulic conditions resulting in eddies are the primary and dominant cause of erosion at this location.

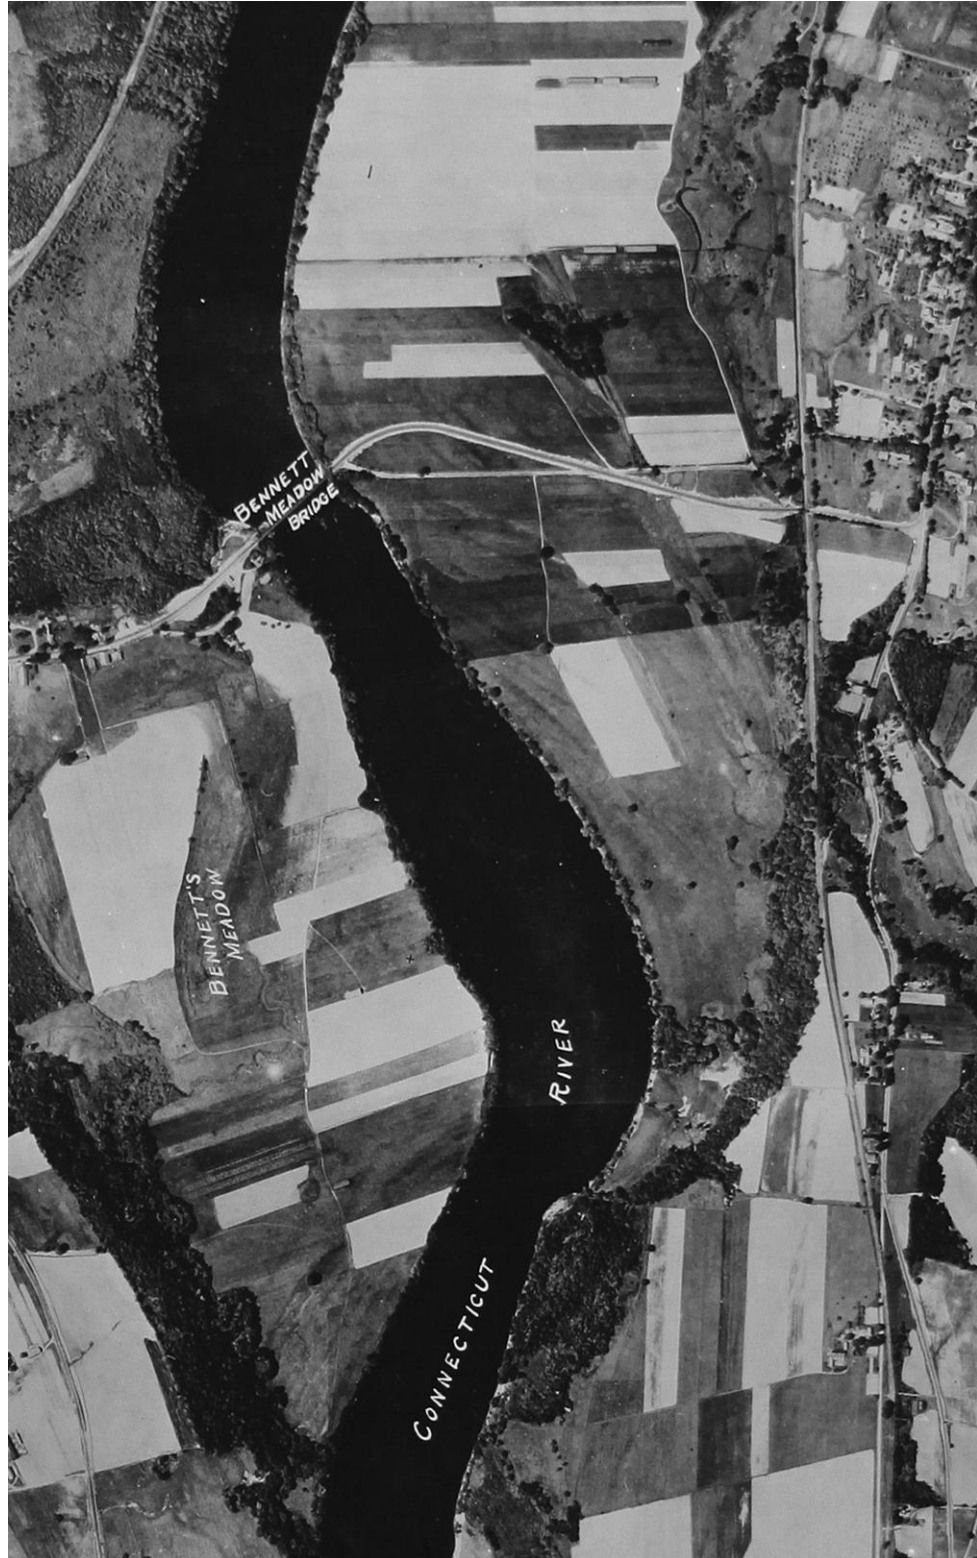
Connecticut River, Bennett Meadow Bridge – 1929

1929 – The 1929 photograph shows the old alignment of the Bennett Meadow Bridge as it crossed the river in basically a perpendicular direction from a rock point on the west bank (right descending bank – in the direction of flow). This bridge alignment took advantage of the rock point extending out into the river making this location as narrow as possible (to minimize the span and cost of the bridge). The bridge abutment on the east bank (left descending bank) was constructed on the bank itself and did not extend significantly out into the river channel. As the river flows downstream, it bends significantly to the left. Once the river passed the rocky point on the west bank, the bank developed a curved shape back in a westward direction as the river width expanded indicating that some erosion along the west bank was likely occurring beyond the normal width expansion from the narrow section where the bridge was located. On the east bank there is a small but abrupt change in the bank alignment that appears to indicate some local erosion is occurring. The east bank also exhibits some mild curvature indicative of a more general pattern of erosion as well.

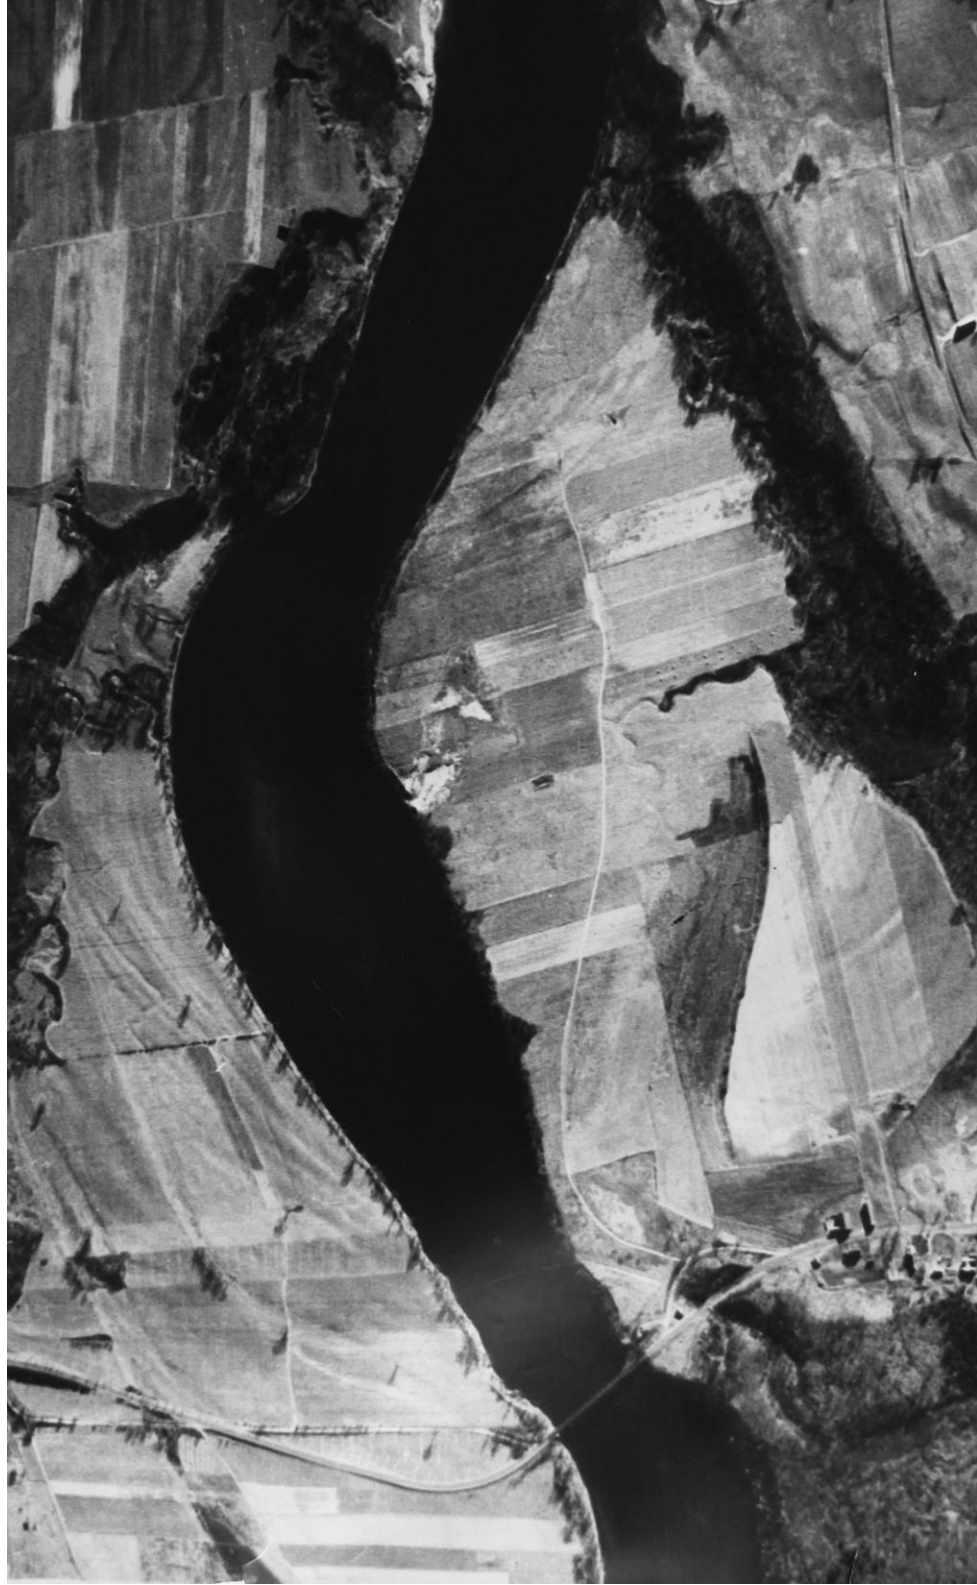
Connecticut River, Bennett Meadow Bridge - 1939

1939 – The river shows similar riverbank alignment and characteristics compared to the 1929 photograph. The area of localized but abrupt change in bank alignment on the east bank noted in 1929 has eroded more, and the curved area indicating more general erosion appears somewhat more pronounced.

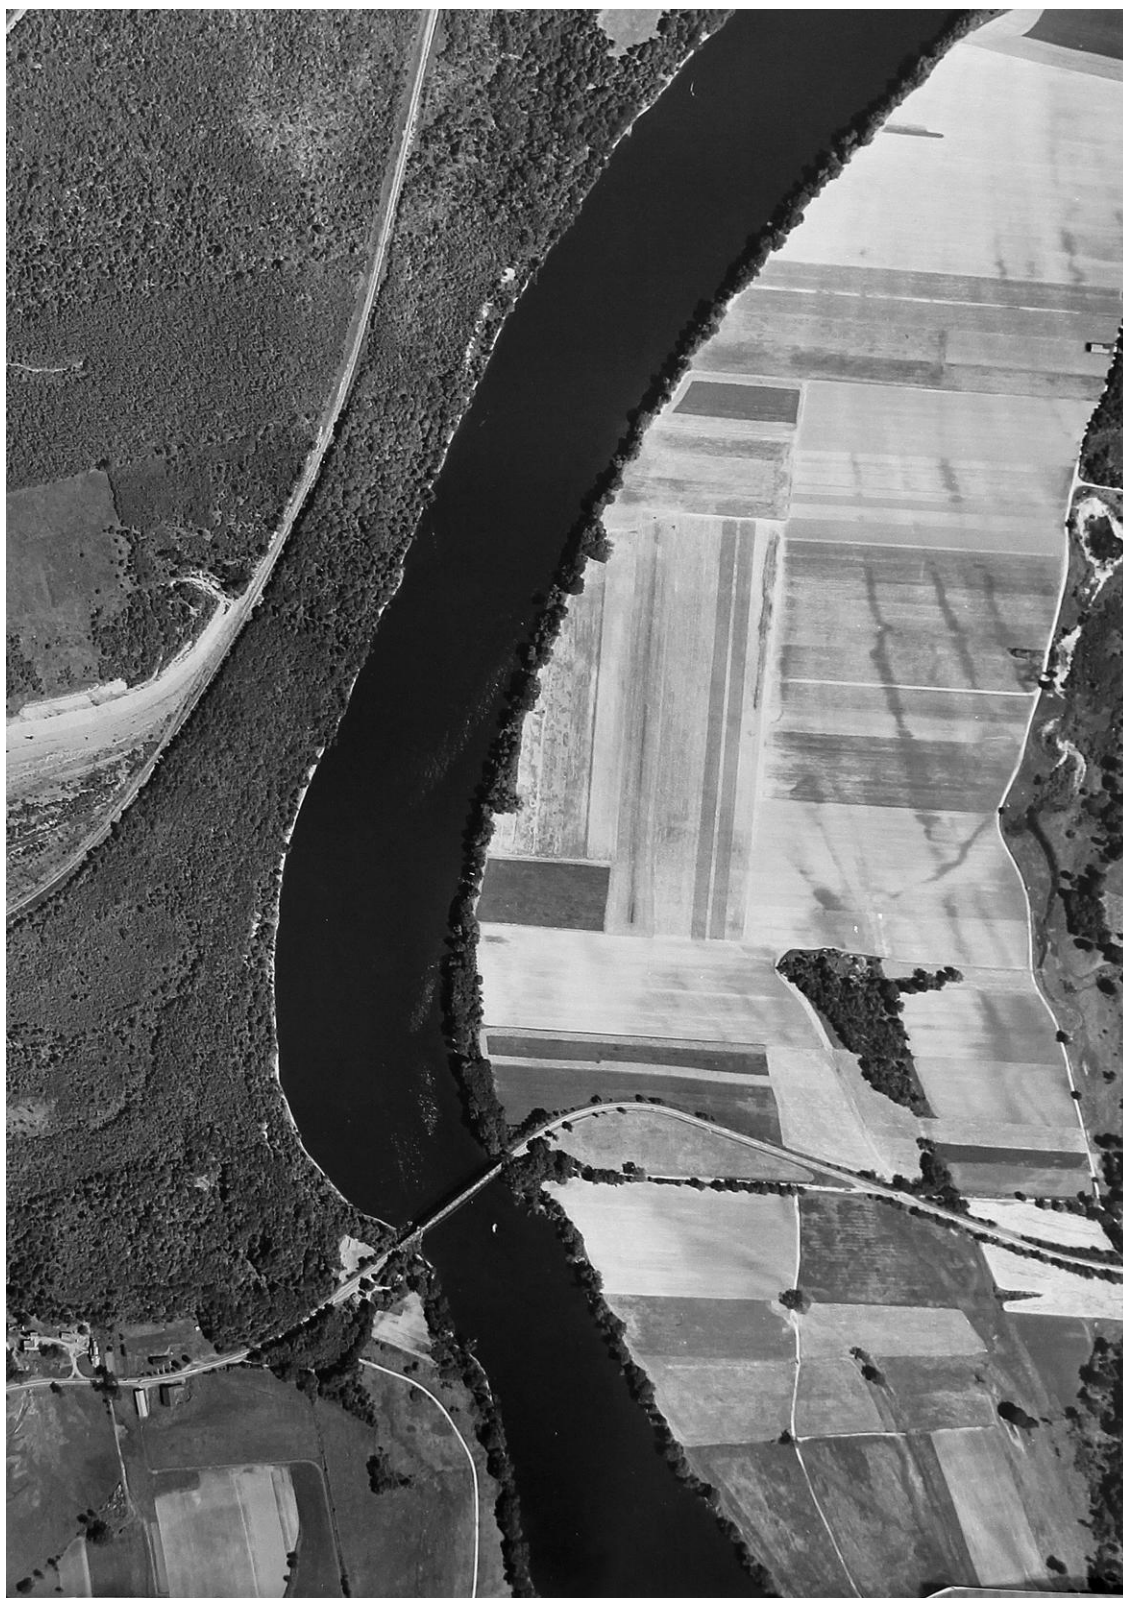
Connecticut River, Bennett Meadow Bridge – 1952

1952 – Again, the riverbank alignment appears similar to the previous photographs. There appears to be increased curvature of the riverbanks in the landward direction on both banks downstream of the bridge indicating ongoing erosion. There were several fallen trees on the east bank downstream of the bridge.

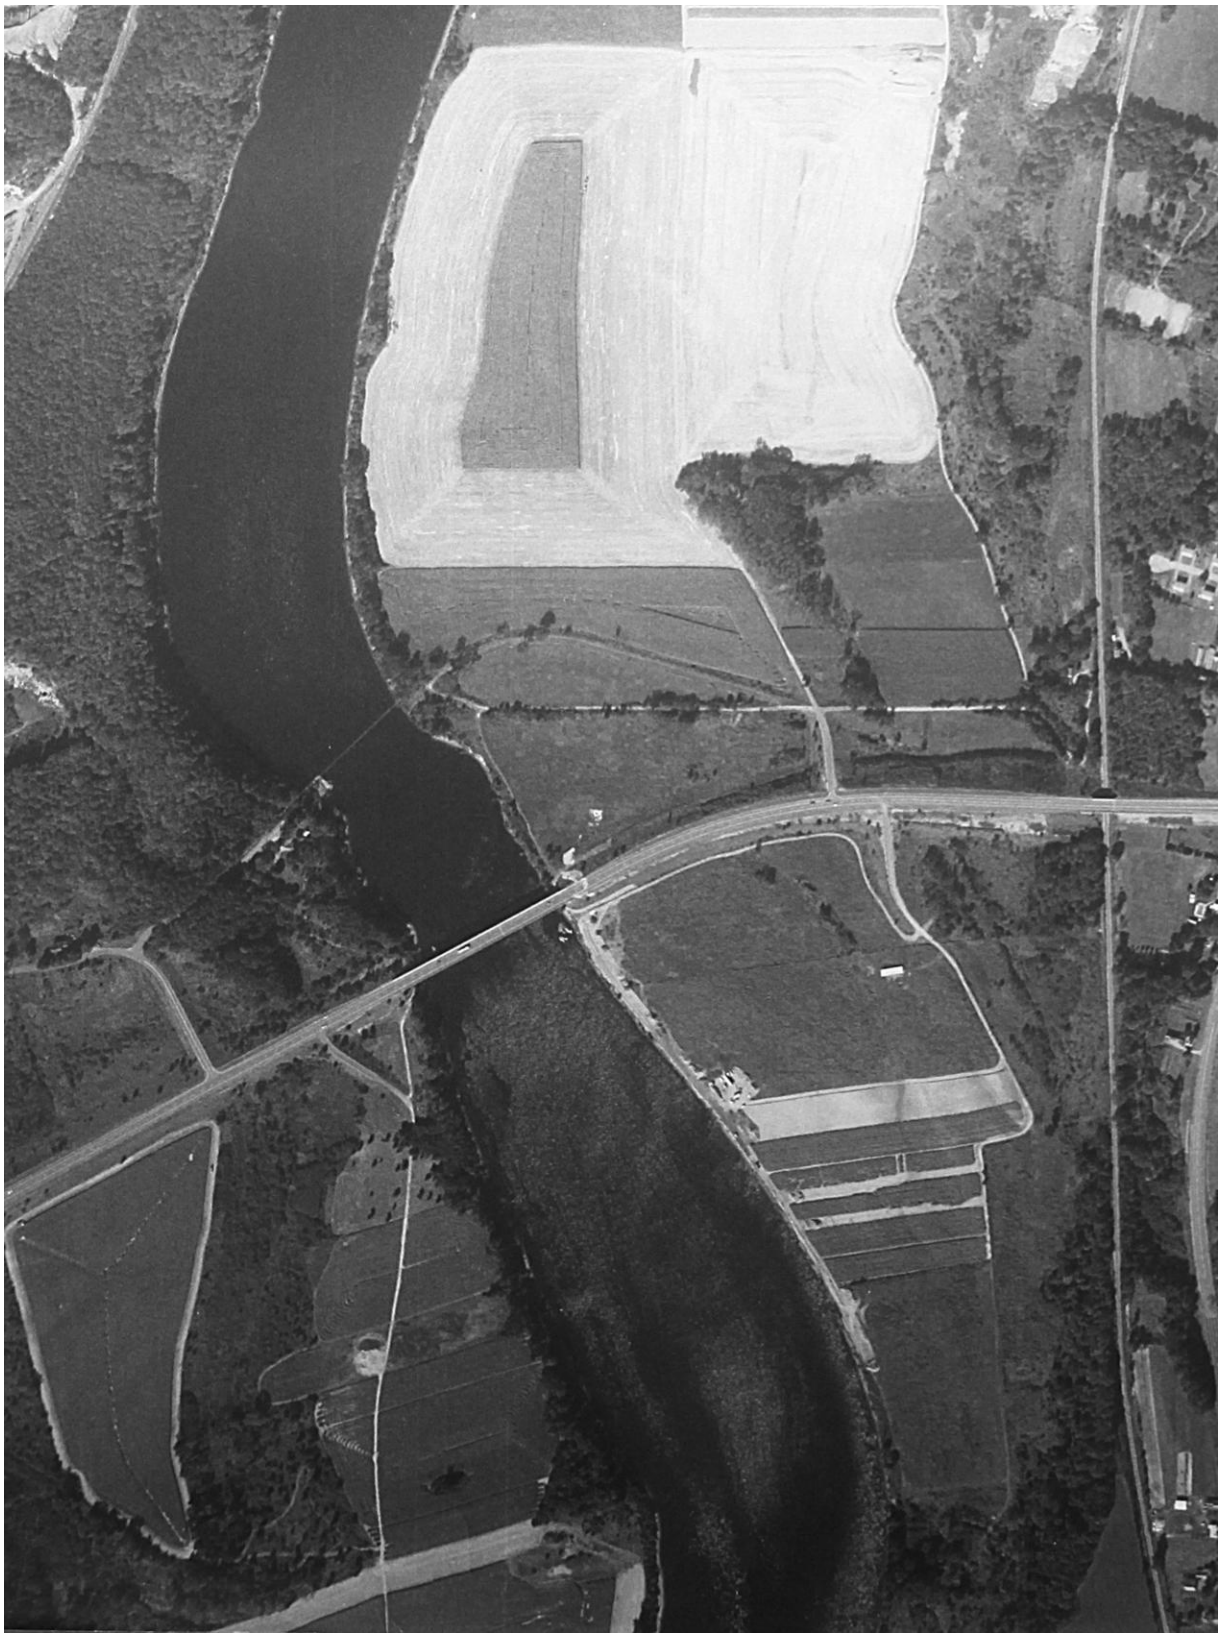
Connecticut River, Route 10 Bridge – 1980

1980 – This photograph shows that the old Bennett Meadow Bridge had been removed and the new Route 10 Bridge had been built (finished in 1969). The new bridge is located about 800 feet downstream of the old bridge. This photograph shows fewer trees along the east bank with a short distance showing no trees. There is more pronounced curvature indicating ongoing erosion of both banks in the same area where erosion had been occurring in the previous photographs (downstream of the old bridge location).

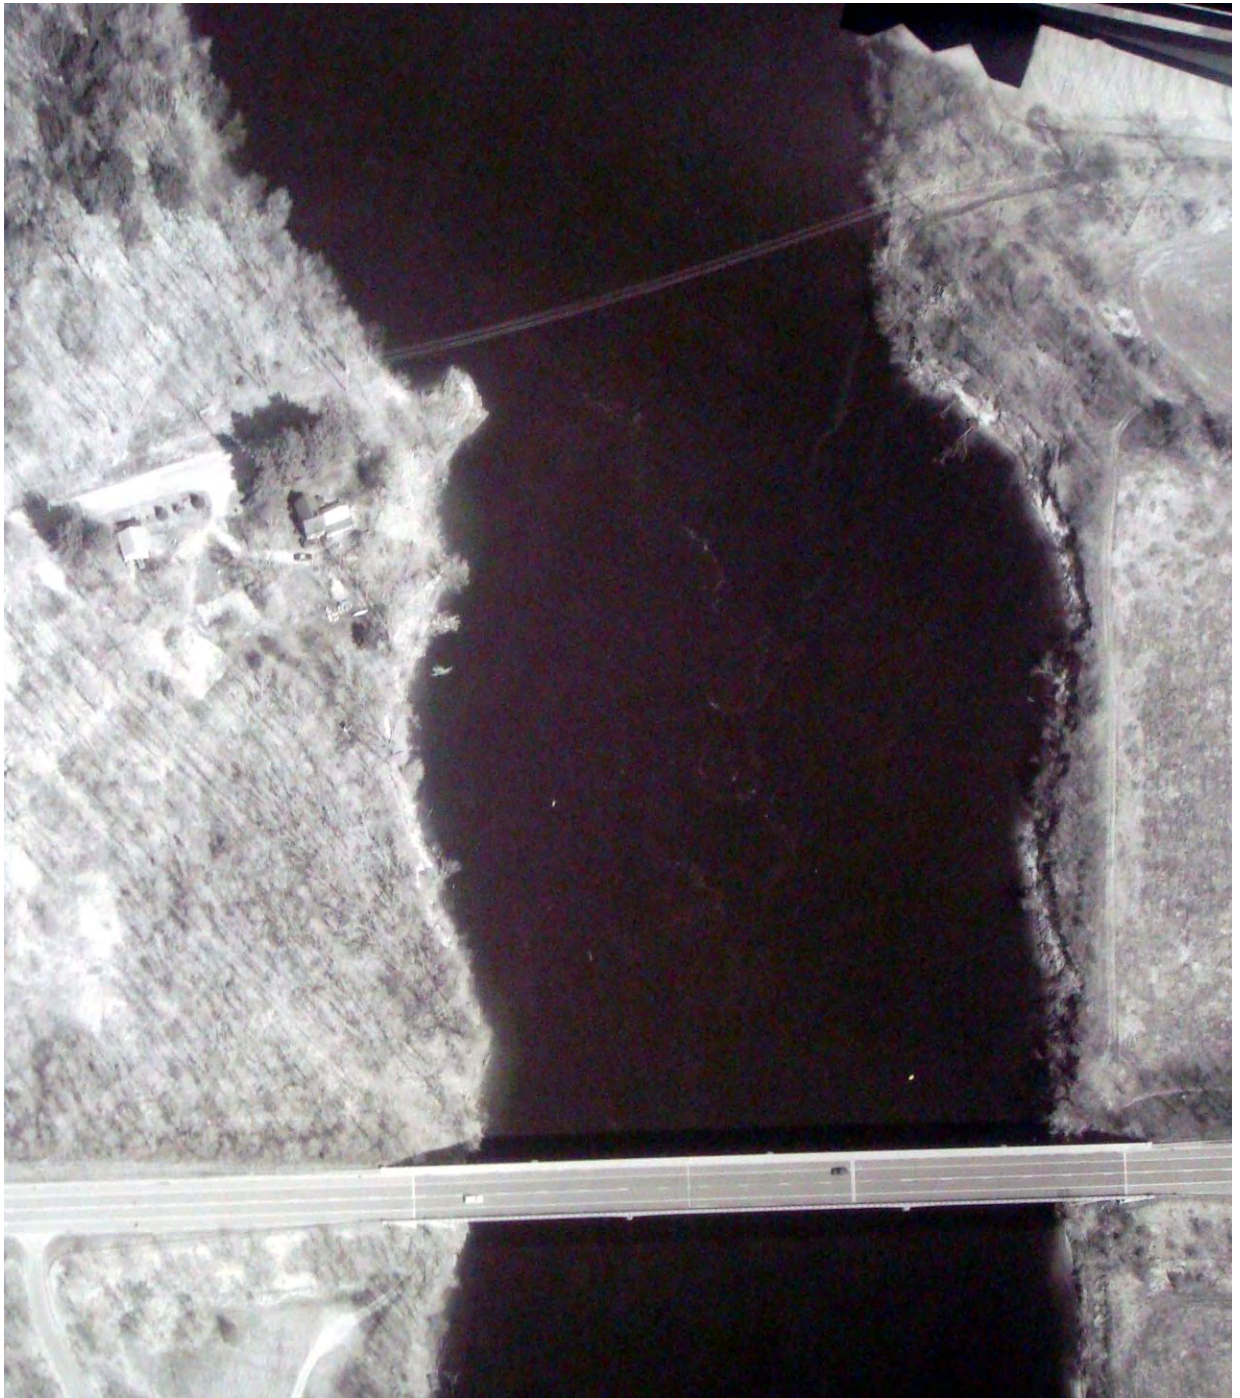
Connecticut River, Route 10 Bridge – 1990

1990 – The 1990 photograph shows three fallen trees on the east bank of the river and a wider band of no trees along this bank. There is again even more pronounced curvature in the landward direction, particularly on the east bank compared to 1980. This again indicates ongoing erosion. The area of landward curvature expanded farther downstream on the west bank.

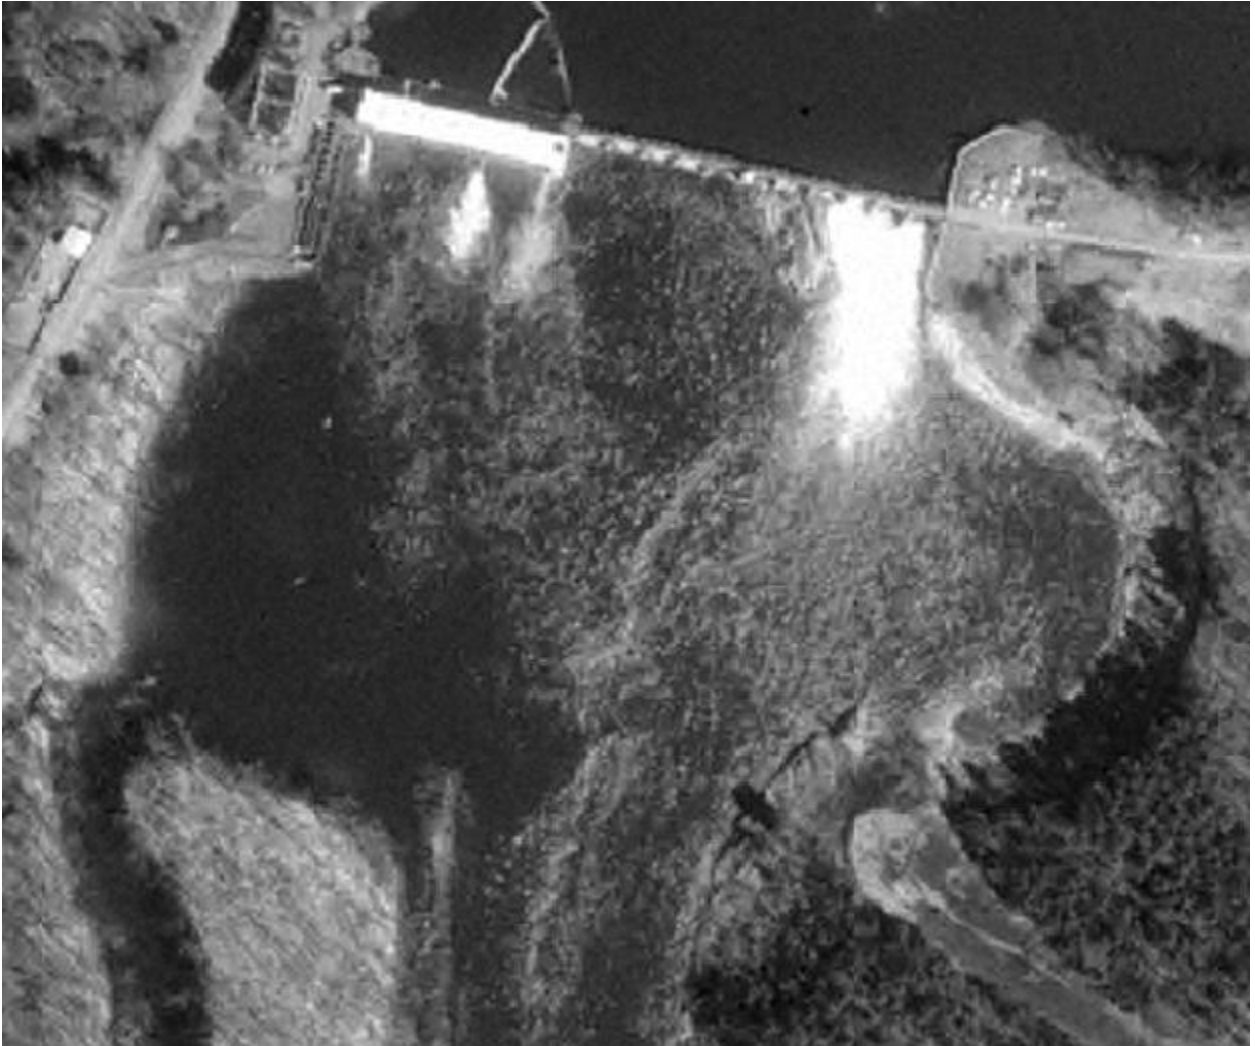
Note: Discharge from gates on left side of dam (looking downstream – right side of photo) has created a large eddy that has eroded into the hillside just downstream of the left abutment. The eddy has carved out a circular area consistent with the circulation pattern of the eddy.

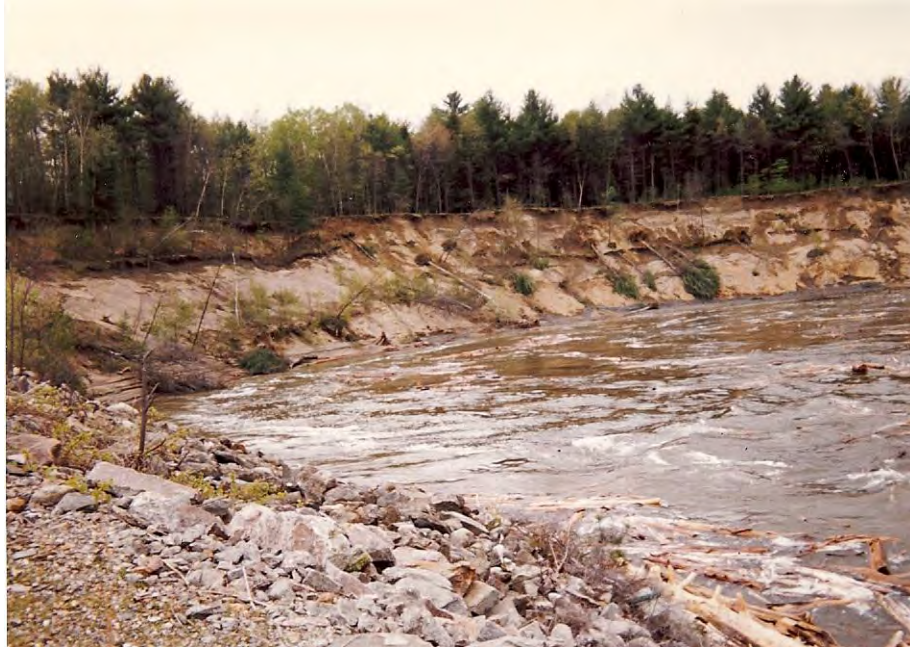
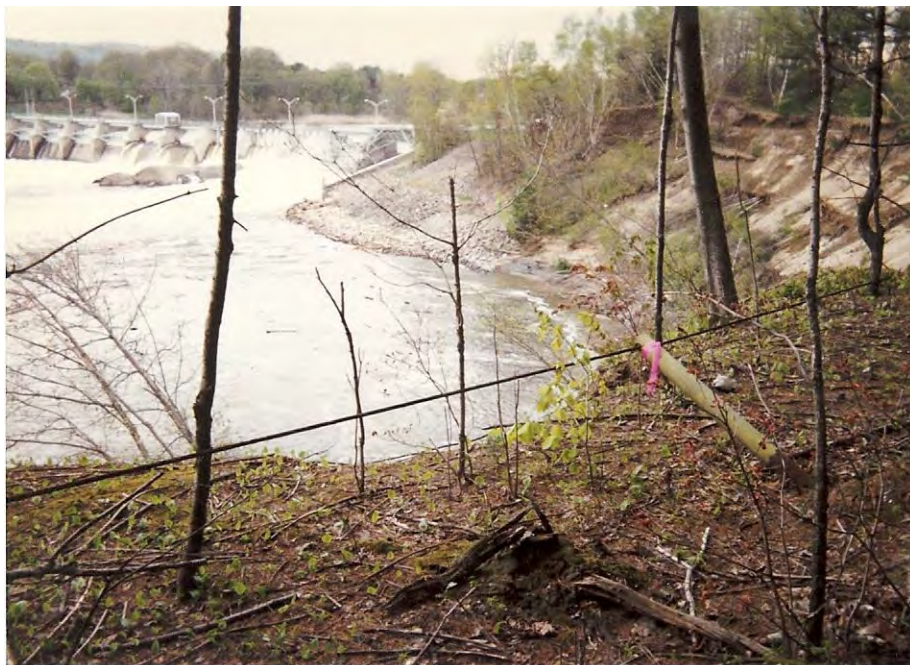
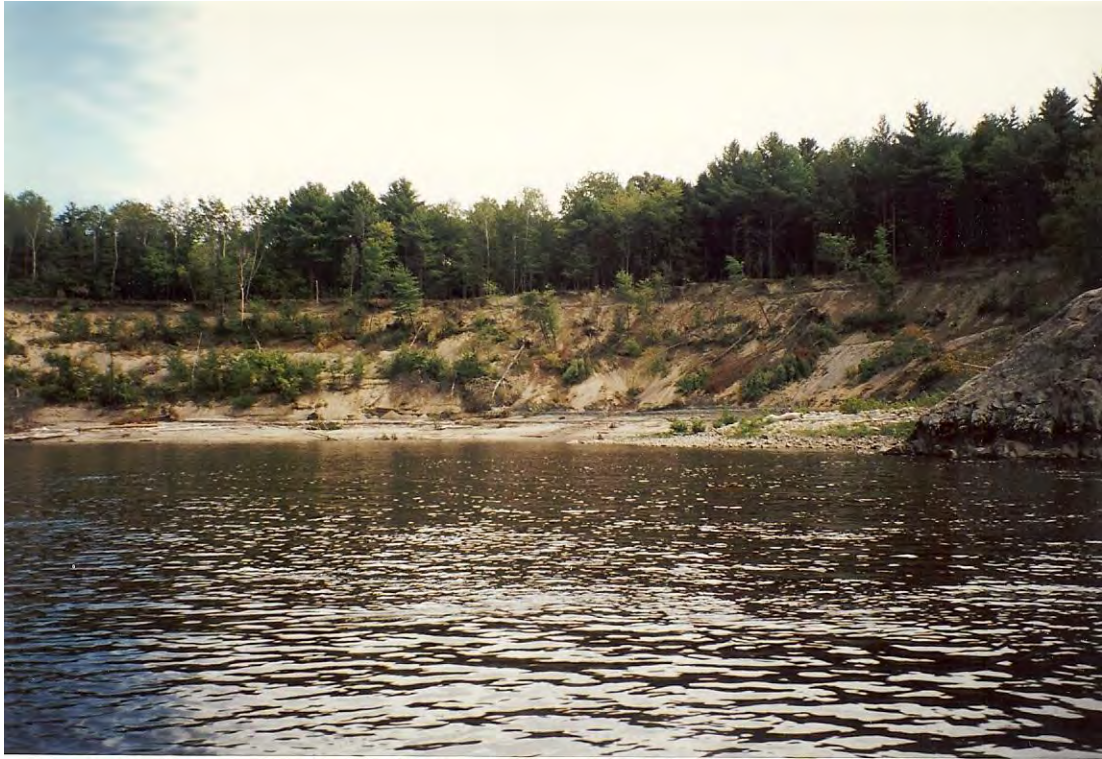
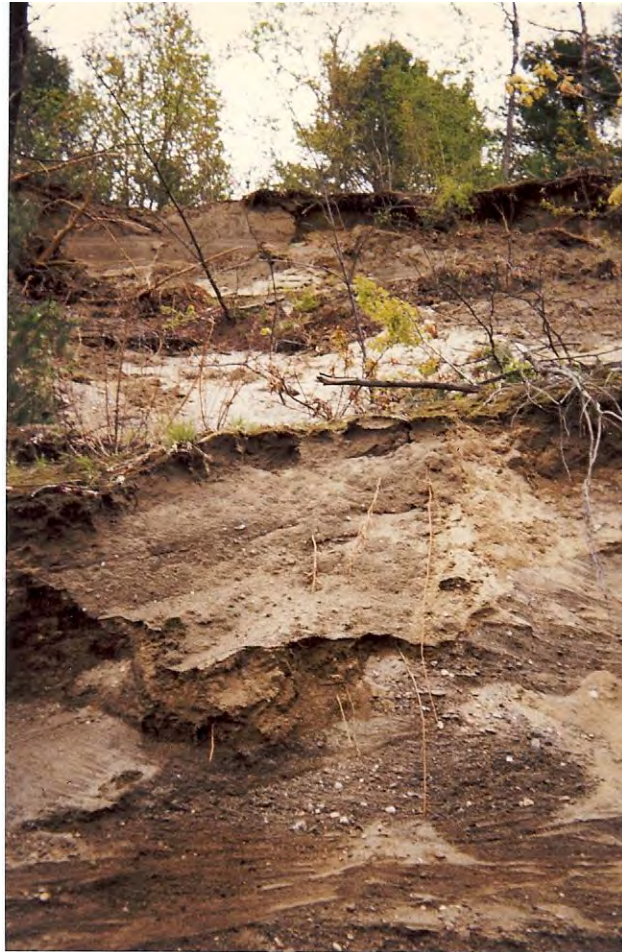
Photos of hillslope eroded by eddy just downstream of Vernon Dam – 1996

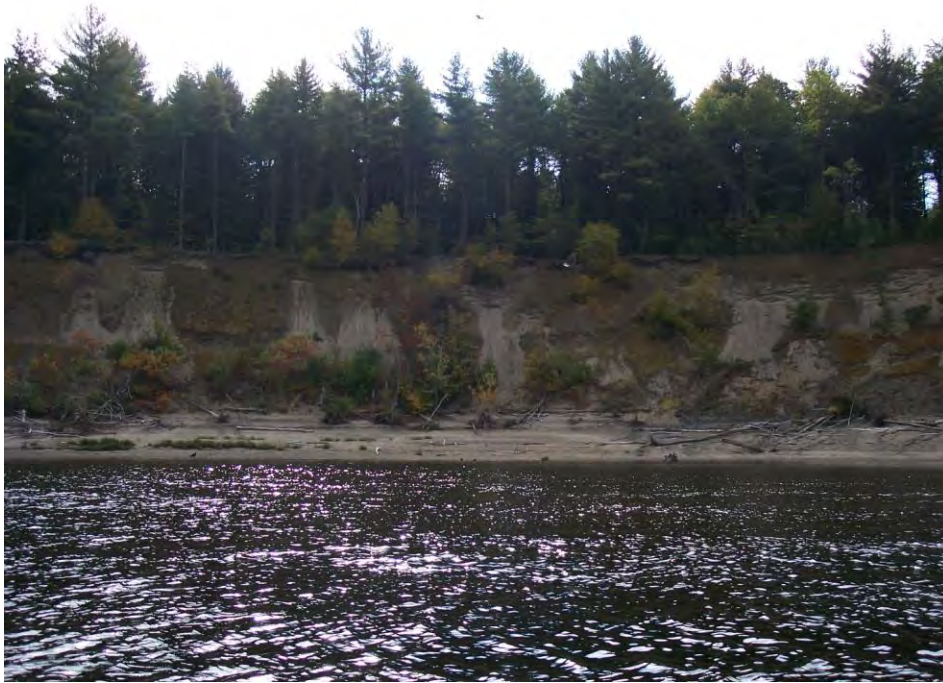
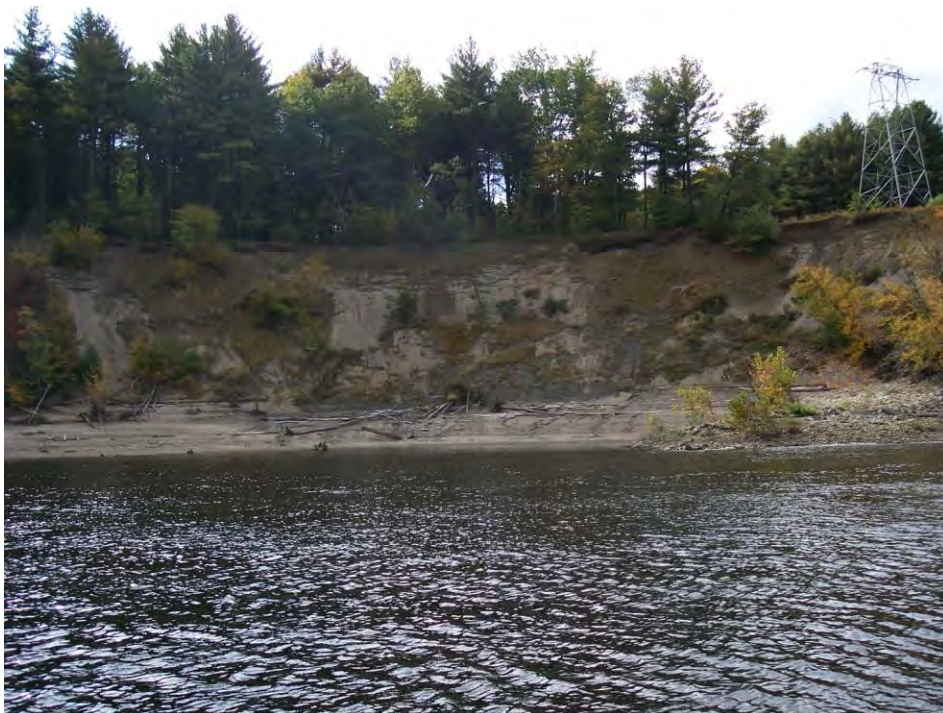
Photos of hillslope eroded by eddy just downstream of Vernon Dam – 2008

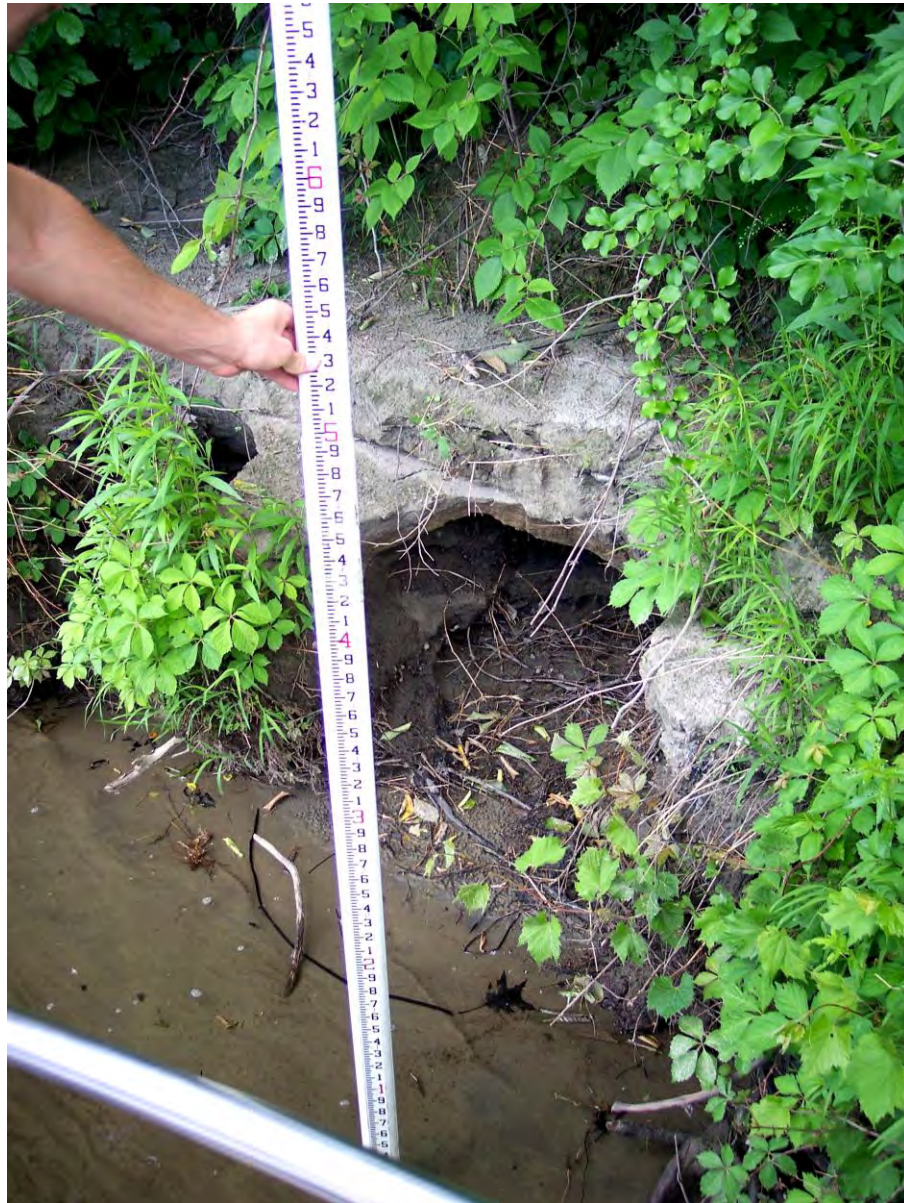
In observing the riverbanks at the Route 10 Bridge, we have seen boat waves cause erosion in Segment 5E). Waves impacted the toe of the slope and undercut small areas causing small blocks of sediment to collapse and fall and create other unstable blocks ready to fail (see Appendix G, images 138, 142, and 143 from Segment 5E). Thus; boat waves, in addition to eddies at this location, play a role in creating instability in this

Undercut bank (jpeg.138)

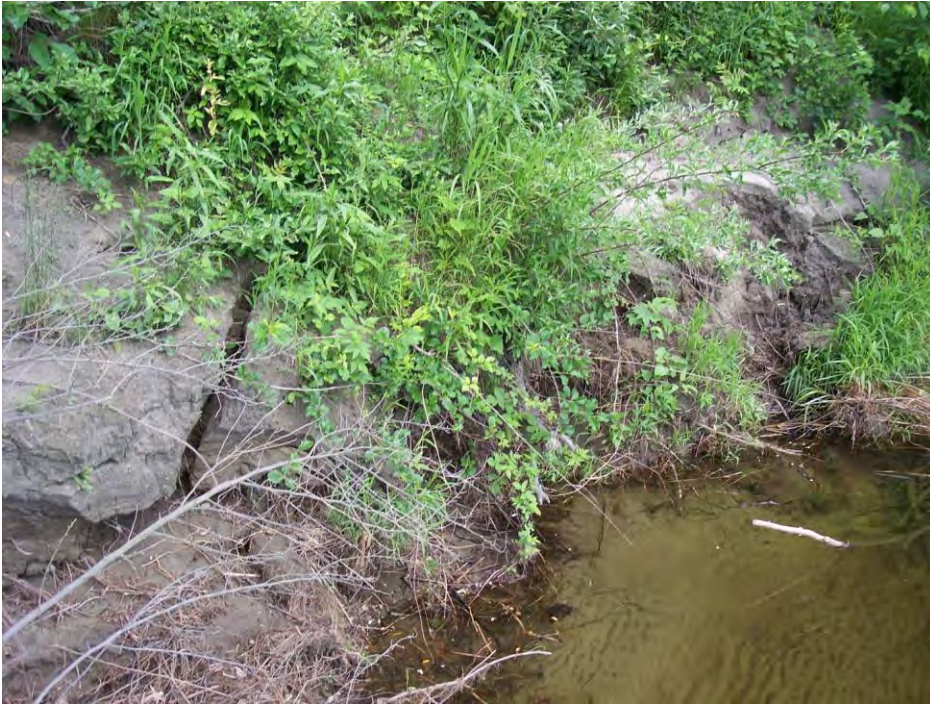
Erosion at toe of bank (jpeg.142)

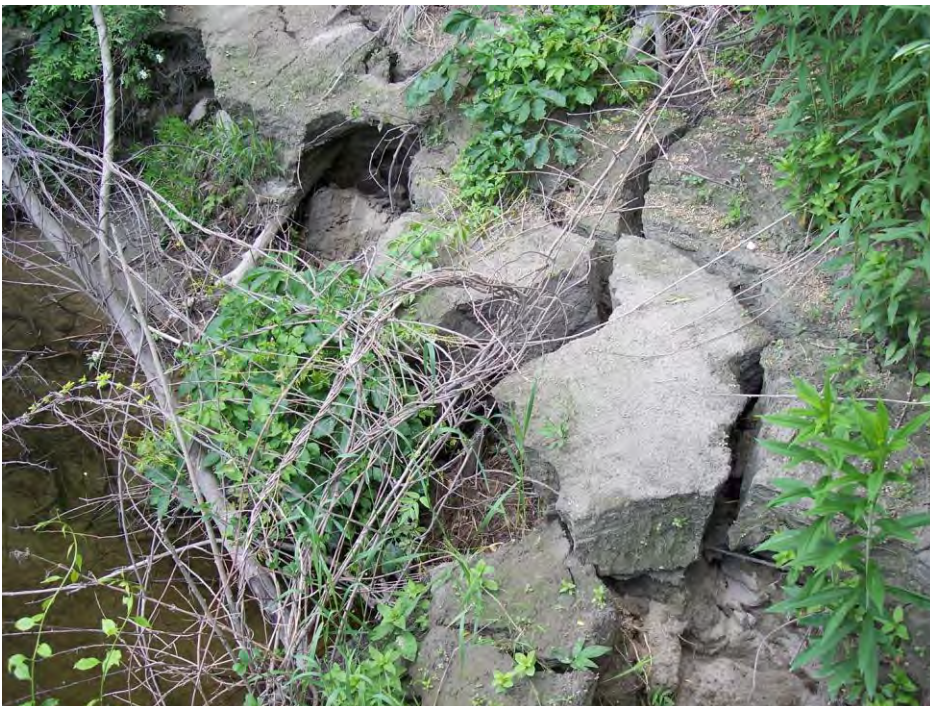
Erosion at toe of bank (jpeg.143)
