ATTACHMENT A: 2013 Full River Reconnaissance – 2015 Addendum: Riverbank Segment QA Comparison

FIRSTLIGHT POWER RESOURCES
RELICENSING STUDY 3.1.1
NORTHFIELD MOUNTAIN/TURNERS FALLS
2013 FULL RIVER RECONNAISSANCE

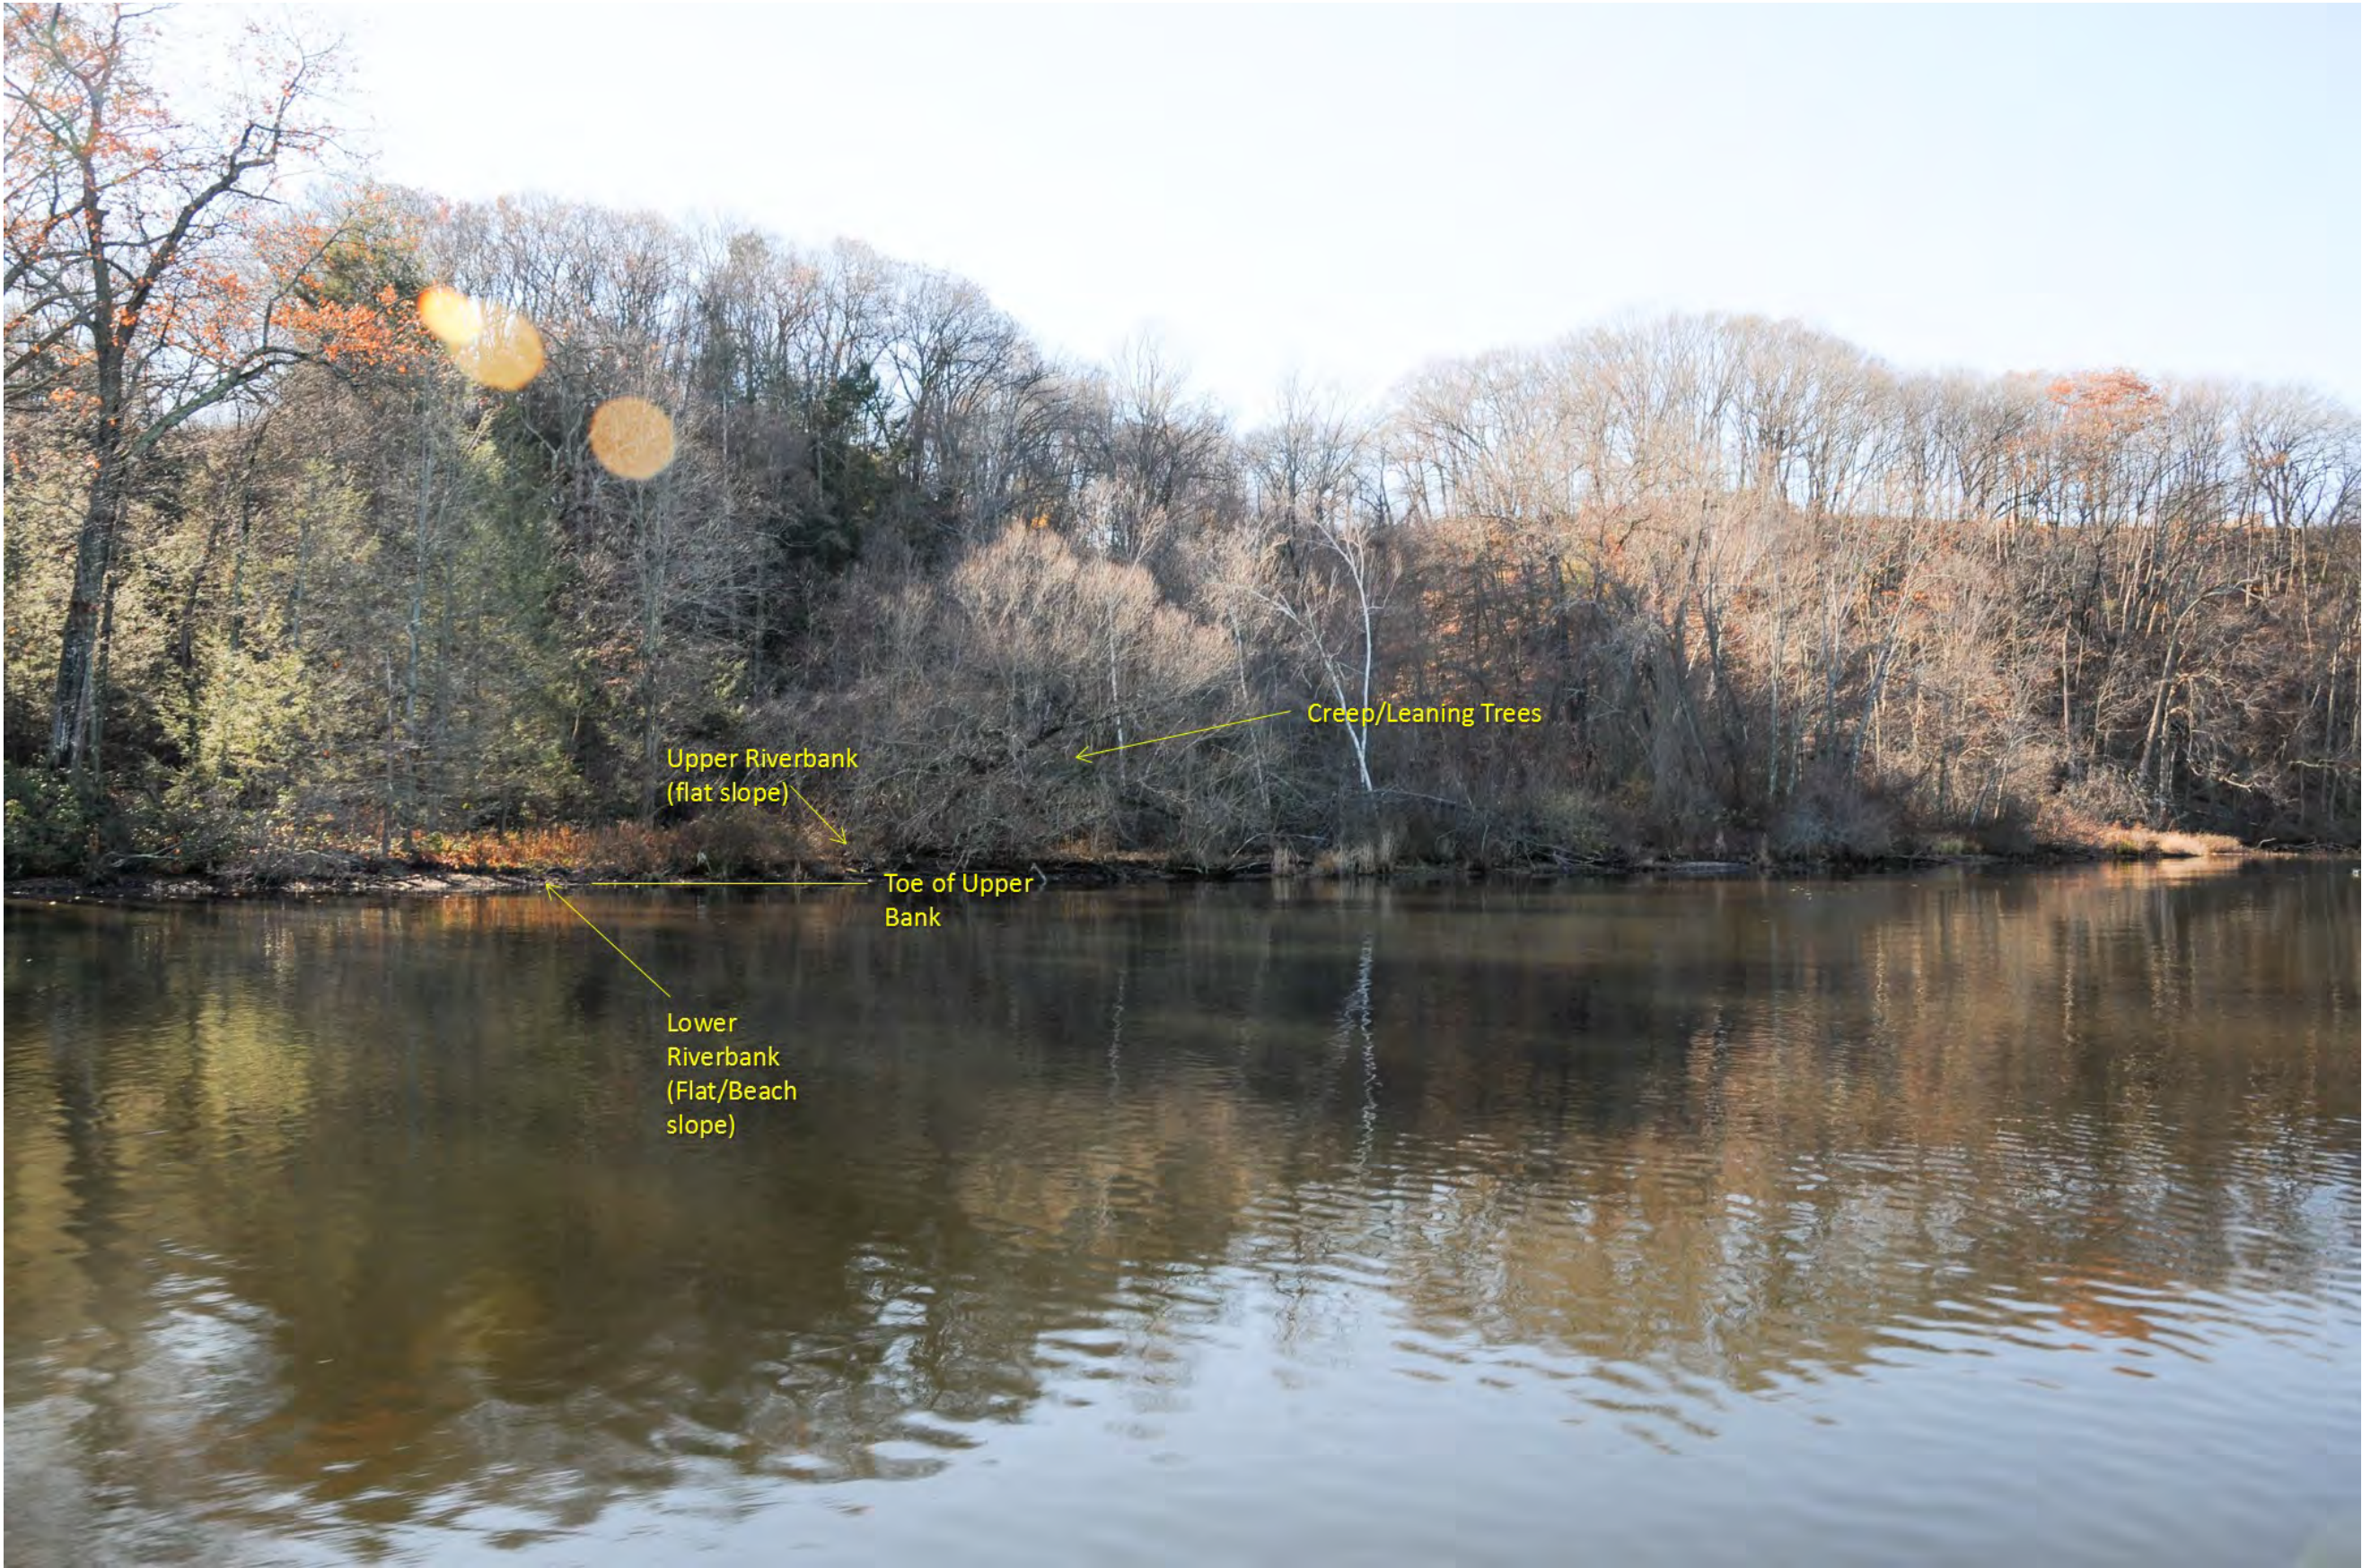
Photo ID 259 (right, D/S portion of segment)

Riverbank Features	Characteristics
Upper Riverbank Slope	Flat
Upper Riverbank Height	Low
Upper Riverbank Sediment	Silt/Sand
Upper Riverbank Vegetation	Heavy
Lower Riverbank Slope	Flat/Beach
Lower Riverbank Sediment	Silt/Sand
Lower Riverbank Vegetation	None to very sparse
Type of Erosion	
Potential Erosion Indicators	Creep/leaning trees
Stage of Erosion	Stable
Extent of Erosion	None/Little

QA Observations: Upon review of the photos for this segment, classification made in the field was confirmed.

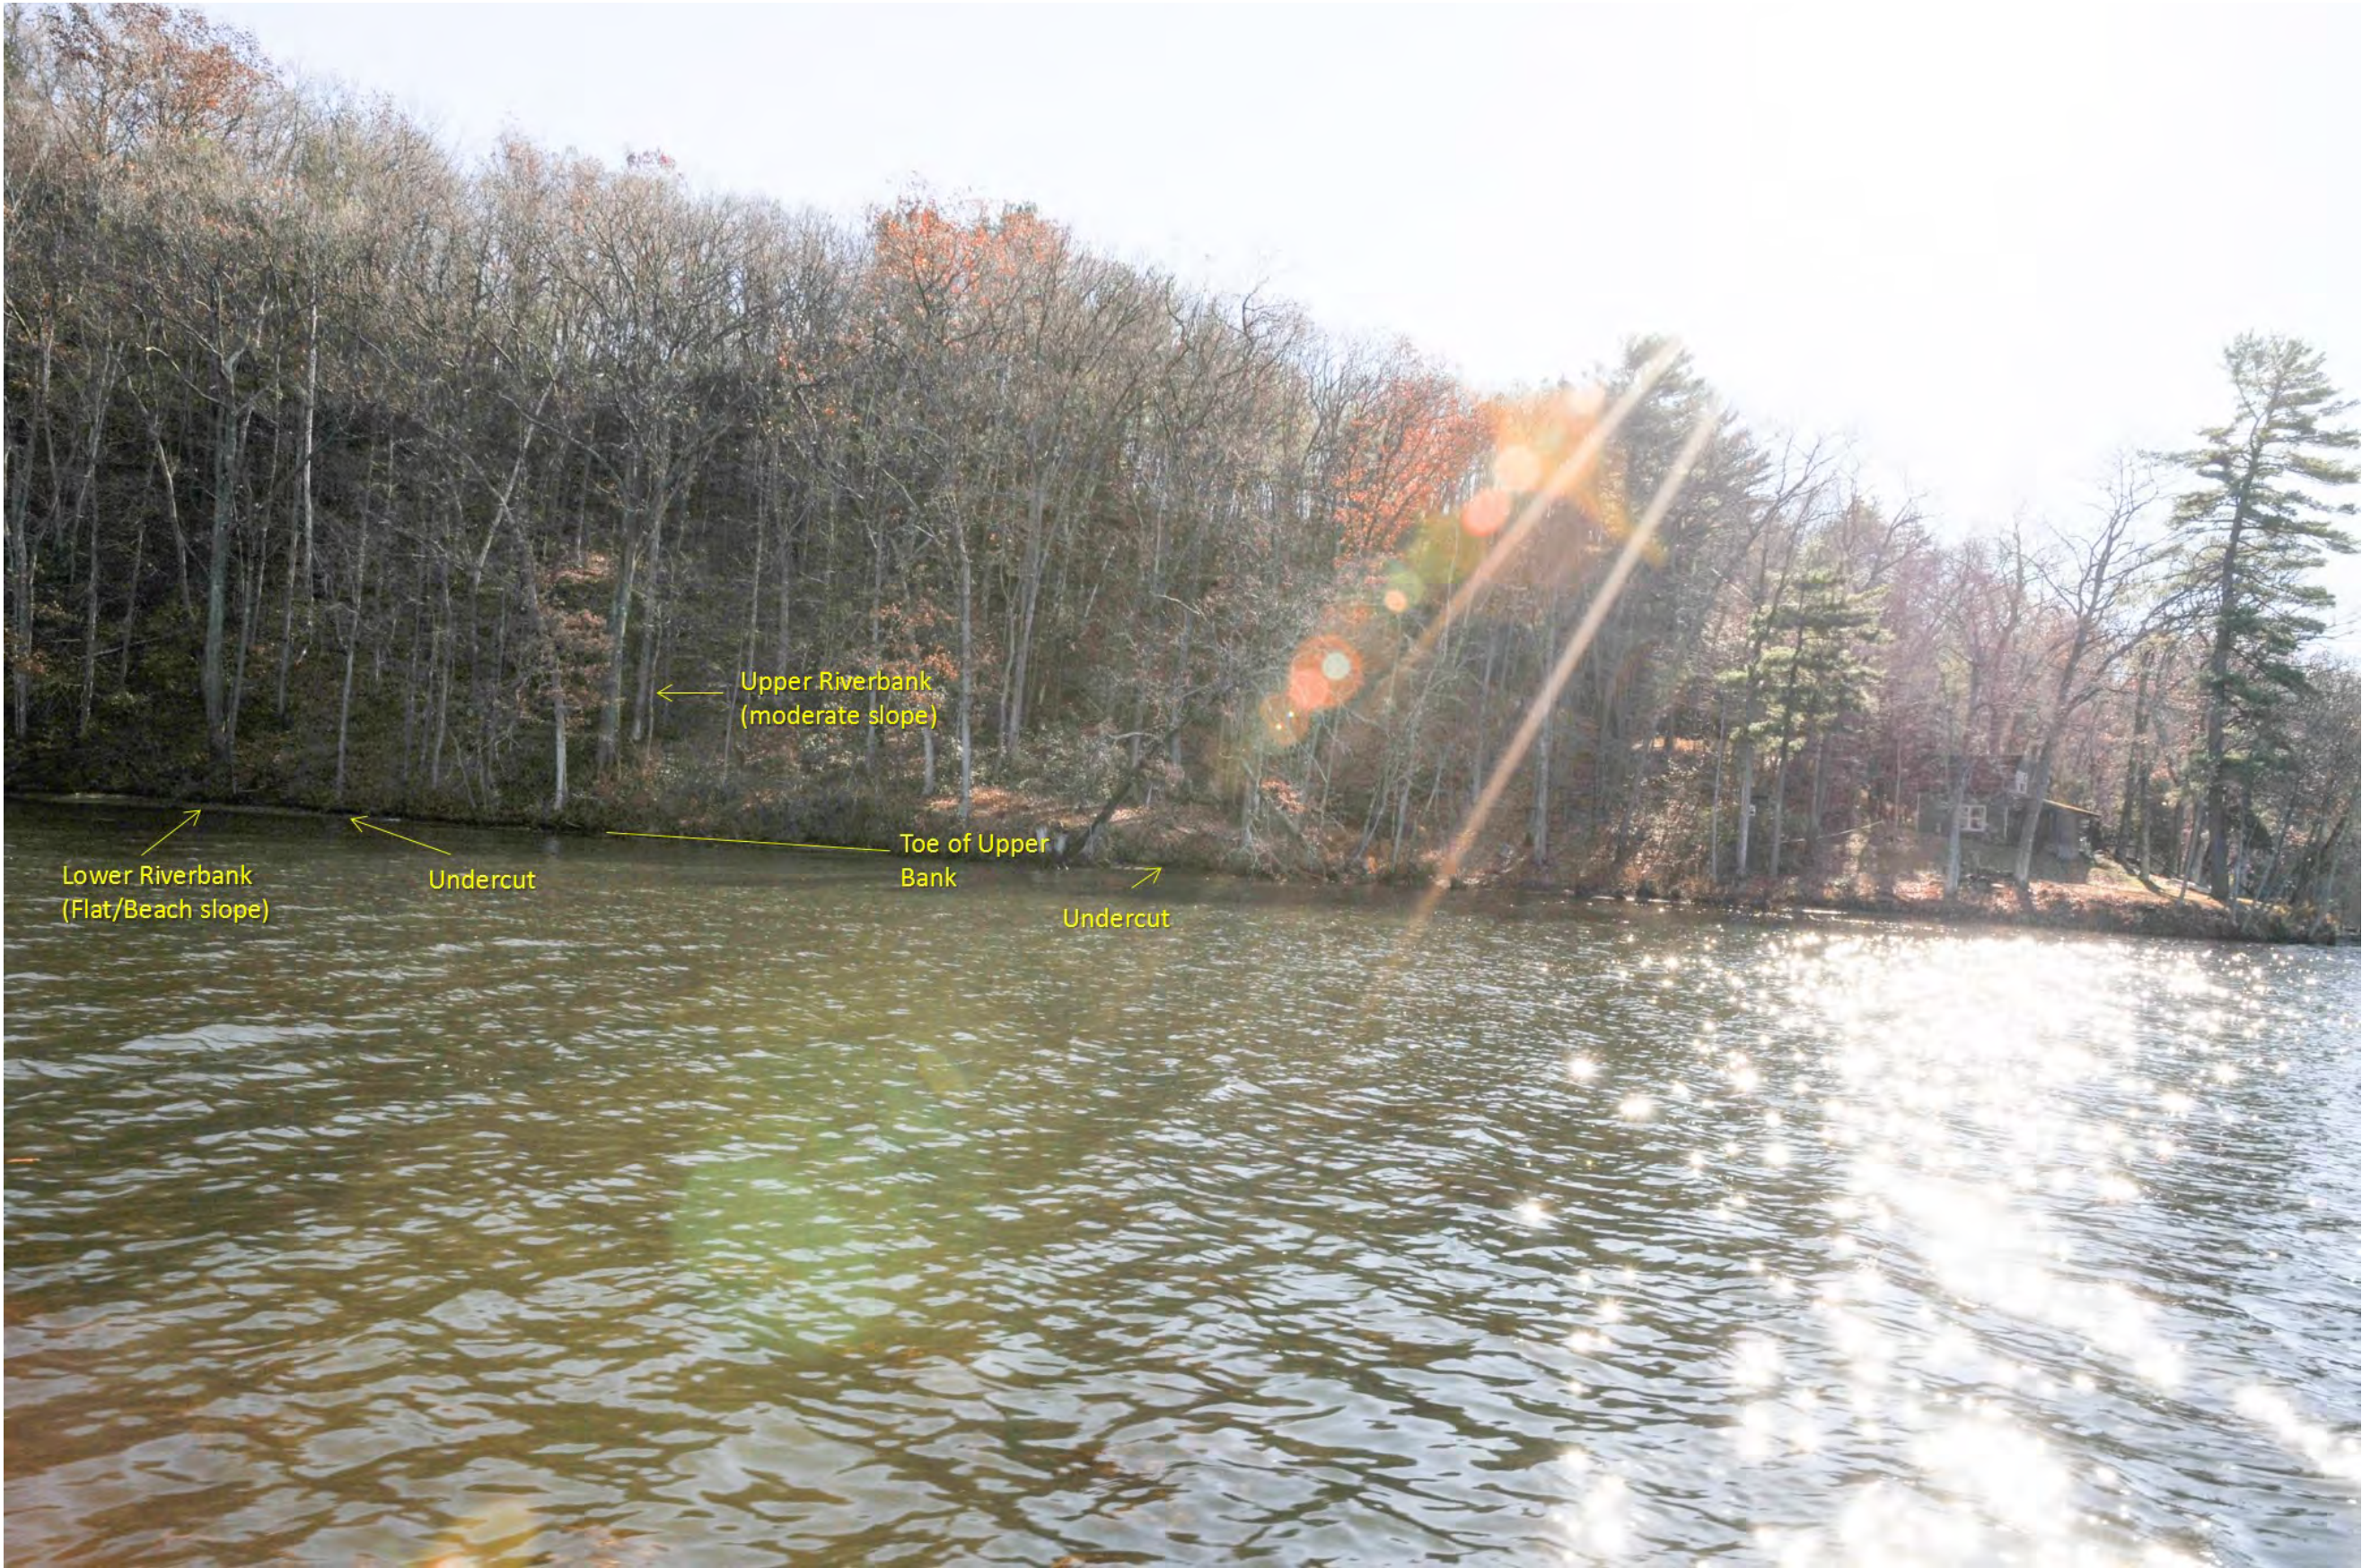
Photo ID 231 (right, D/S portion of segment)

Riverbank Features	Characteristics
Upper Riverbank Slope	Moderate
Upper Riverbank Height	Low
Upper Riverbank Sediment	Silt/Sand
Upper Riverbank Vegetation	Heavy
Lower Riverbank Slope	Flat/Beach
Lower Riverbank Sediment	Silt/Sand
Lower Riverbank Vegetation	None to very sparse
Type of Erosion	Undercut
Potential Erosion Indicators	None
Stage of Erosion	Stable
Extent of Erosion	None/Little

QA Observations: Upon review of the photos for this segment, classification made in the field was confirmed.

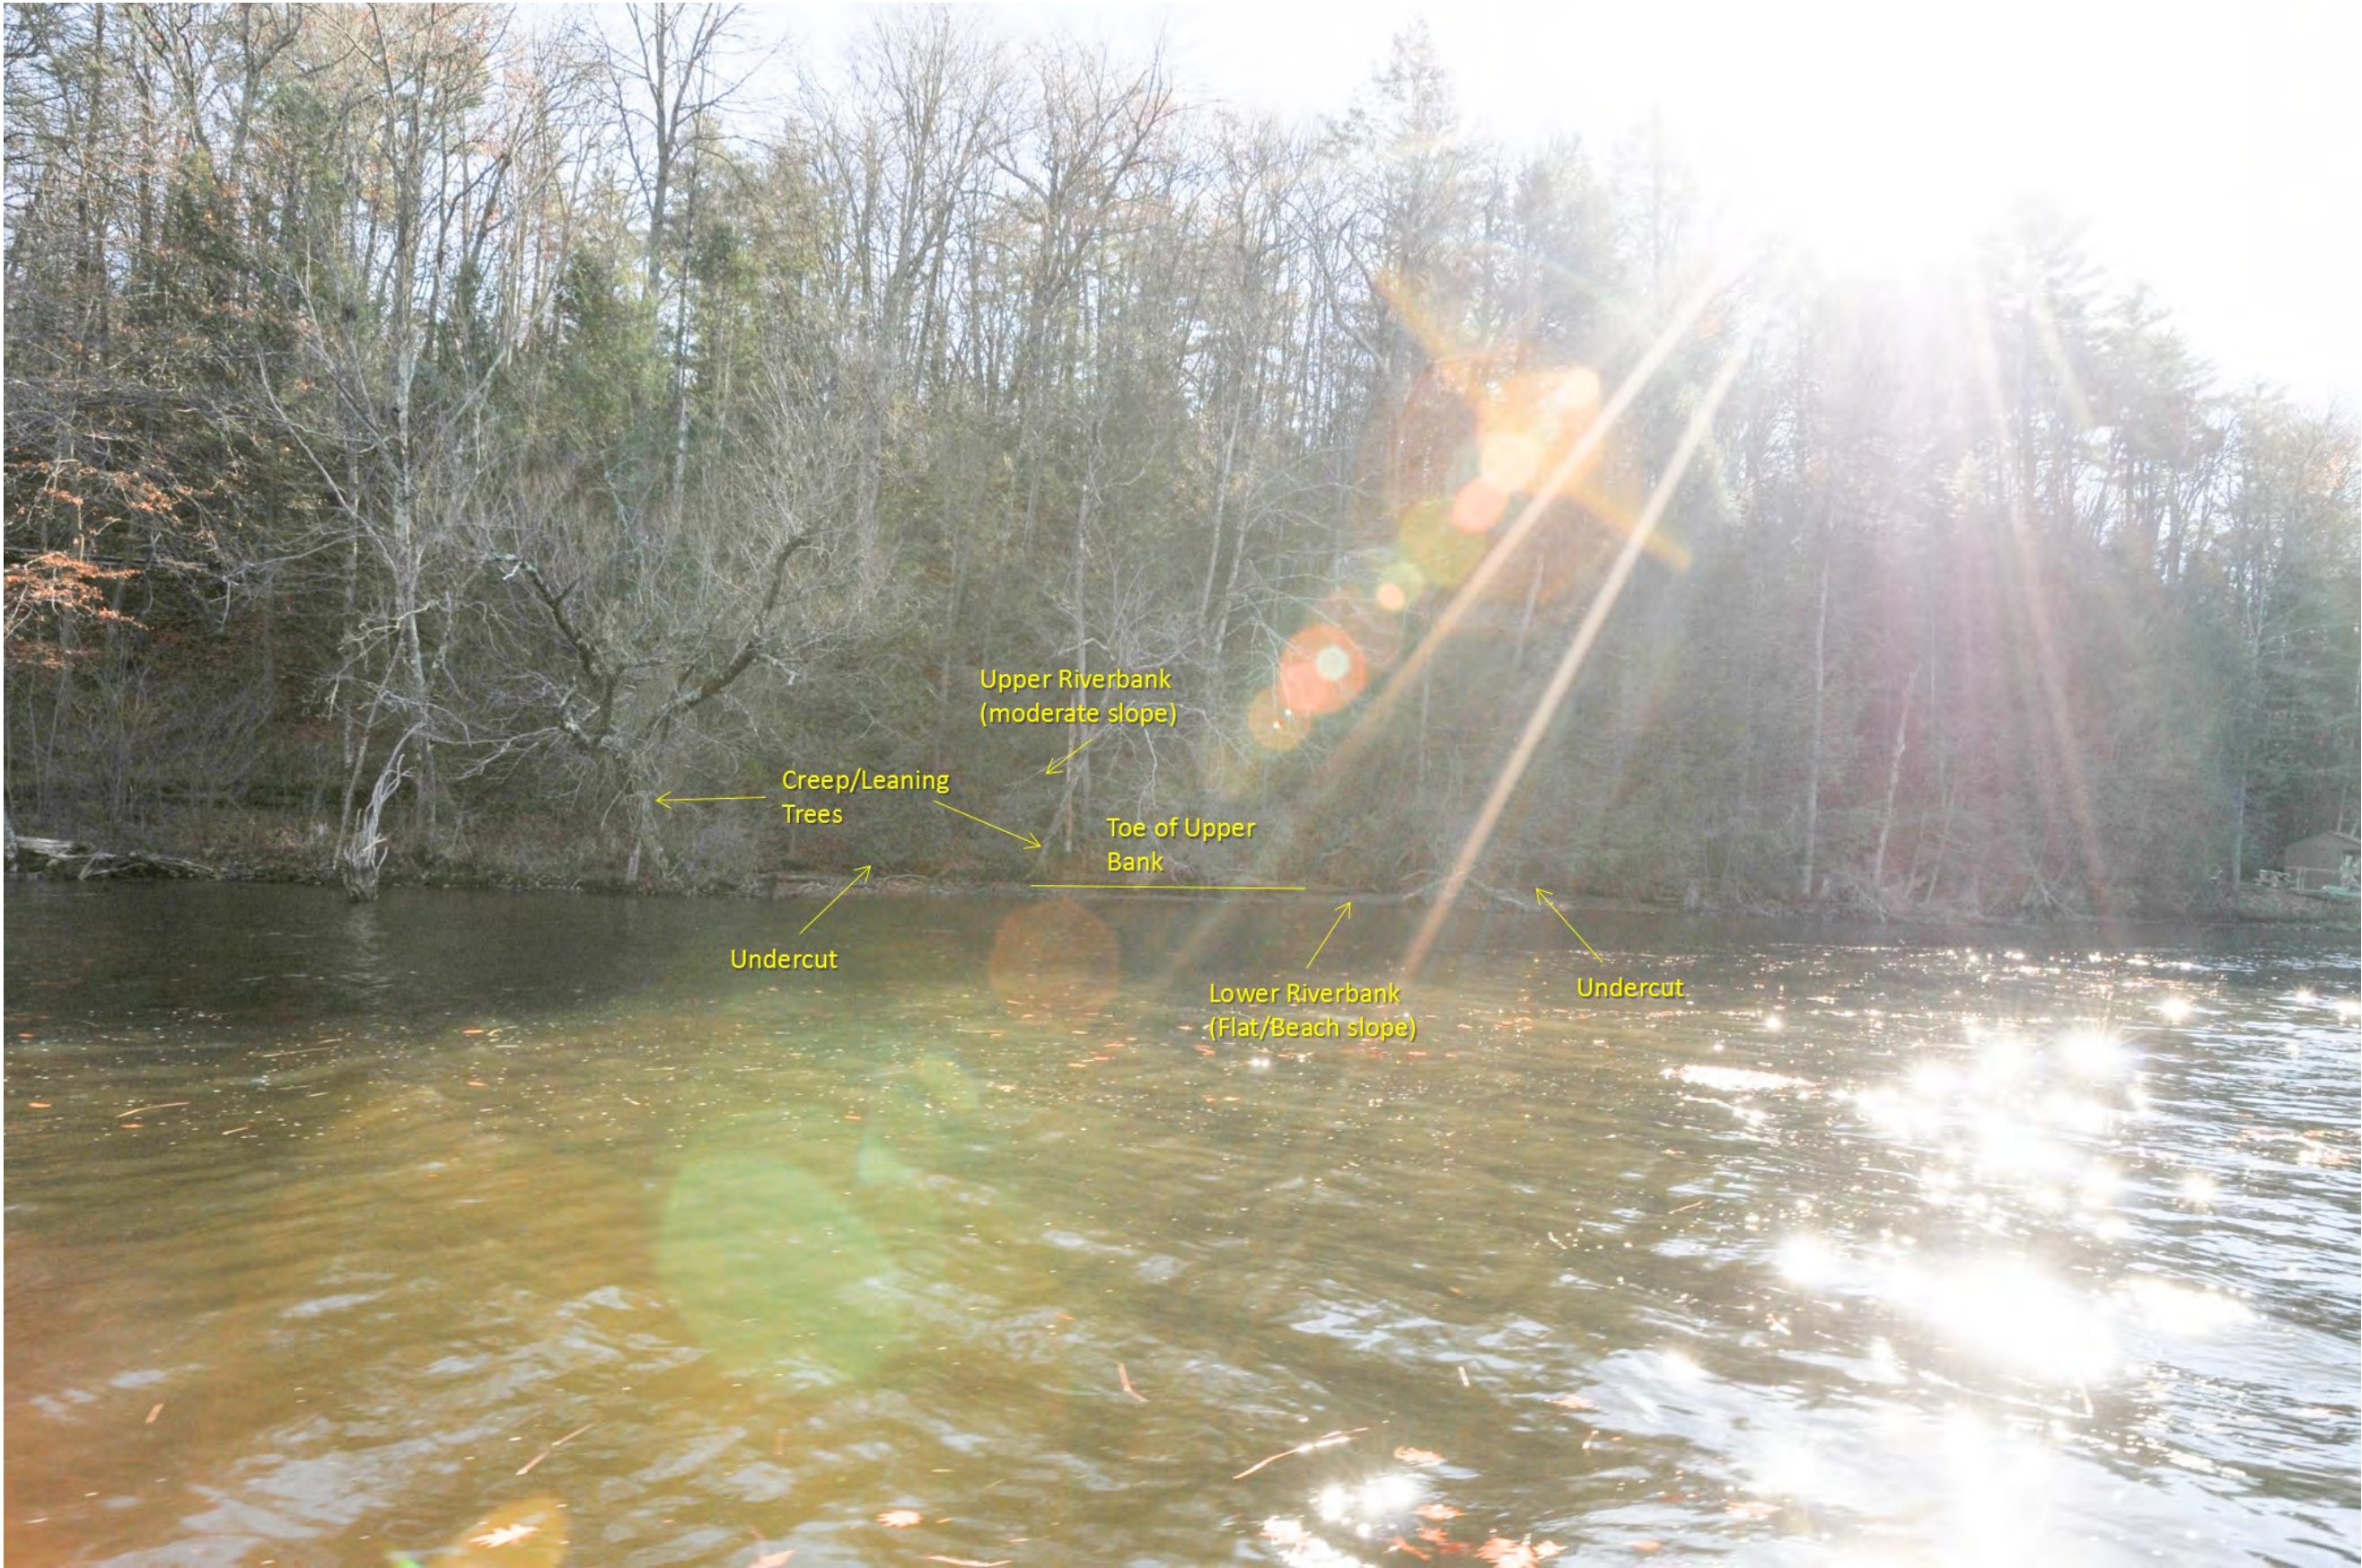
Photo ID 208 (mid-segment)

Riverbank Features	Characteristics
Upper Riverbank Slope	Moderate
Upper Riverbank Height	High
Upper Riverbank Sediment	Silt/Sand
Upper Riverbank Vegetation	Heavy
Lower Riverbank Slope	Flat/Beach
Lower Riverbank Sediment	Silt/Sand
Lower Riverbank Vegetation	None to very sparse
Type of Erosion	Undercut
Potential Erosion Indicators	Creep/leaning trees
Stage of Erosion	Stable
Extent of Erosion	None/Little

QA Observations: Upon review of the photos for this segment, classification made in the field was confirmed.

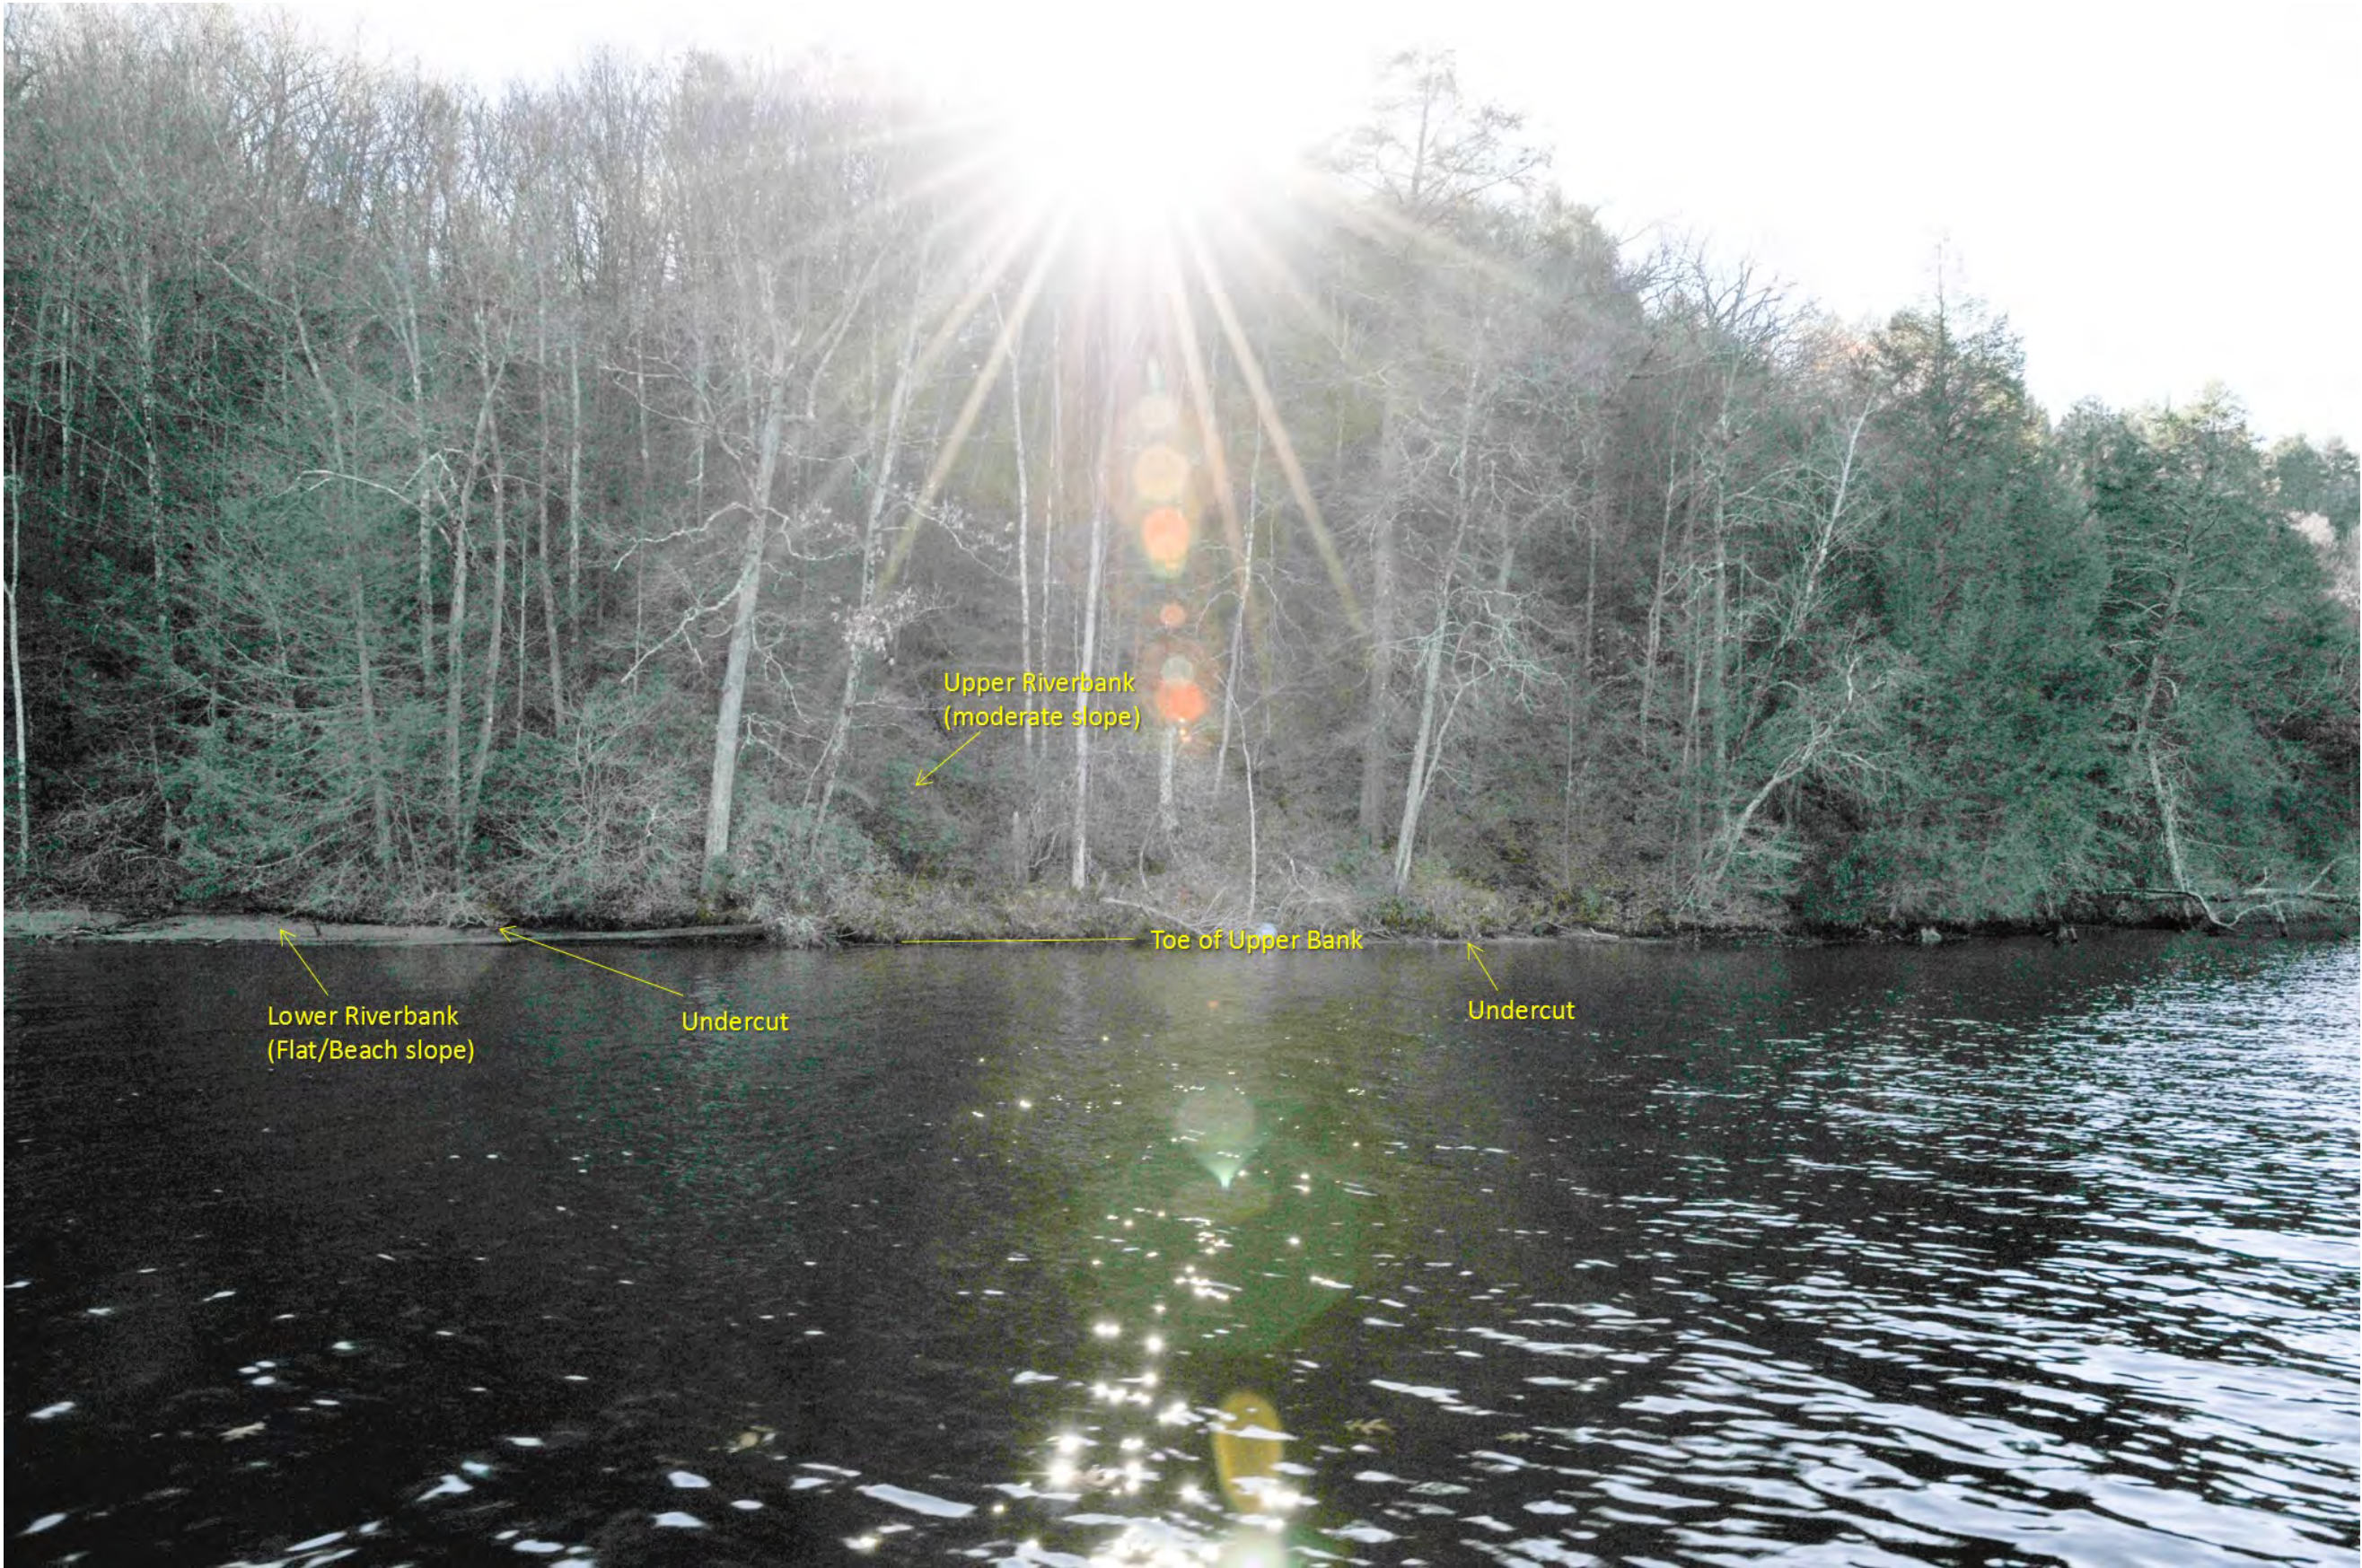
Photo ID 193 (mid-segment)

Riverbank Features	Characteristics
Upper Riverbank Slope	Moderate
Upper Riverbank Height	High
Upper Riverbank Sediment	Silt/Sand
Upper Riverbank Vegetation	Heavy
Lower Riverbank Slope	Flat/Beach
Lower Riverbank Sediment	Silt/Sand
Lower Riverbank Vegetation	None to very sparse
Type of Erosion	Undercut
Potential Erosion Indicators	None
Stage of Erosion	Stable
Extent of Erosion	None/Little

QA Observations: Upon review of the photos for this segment, classification made in the field was confirmed.

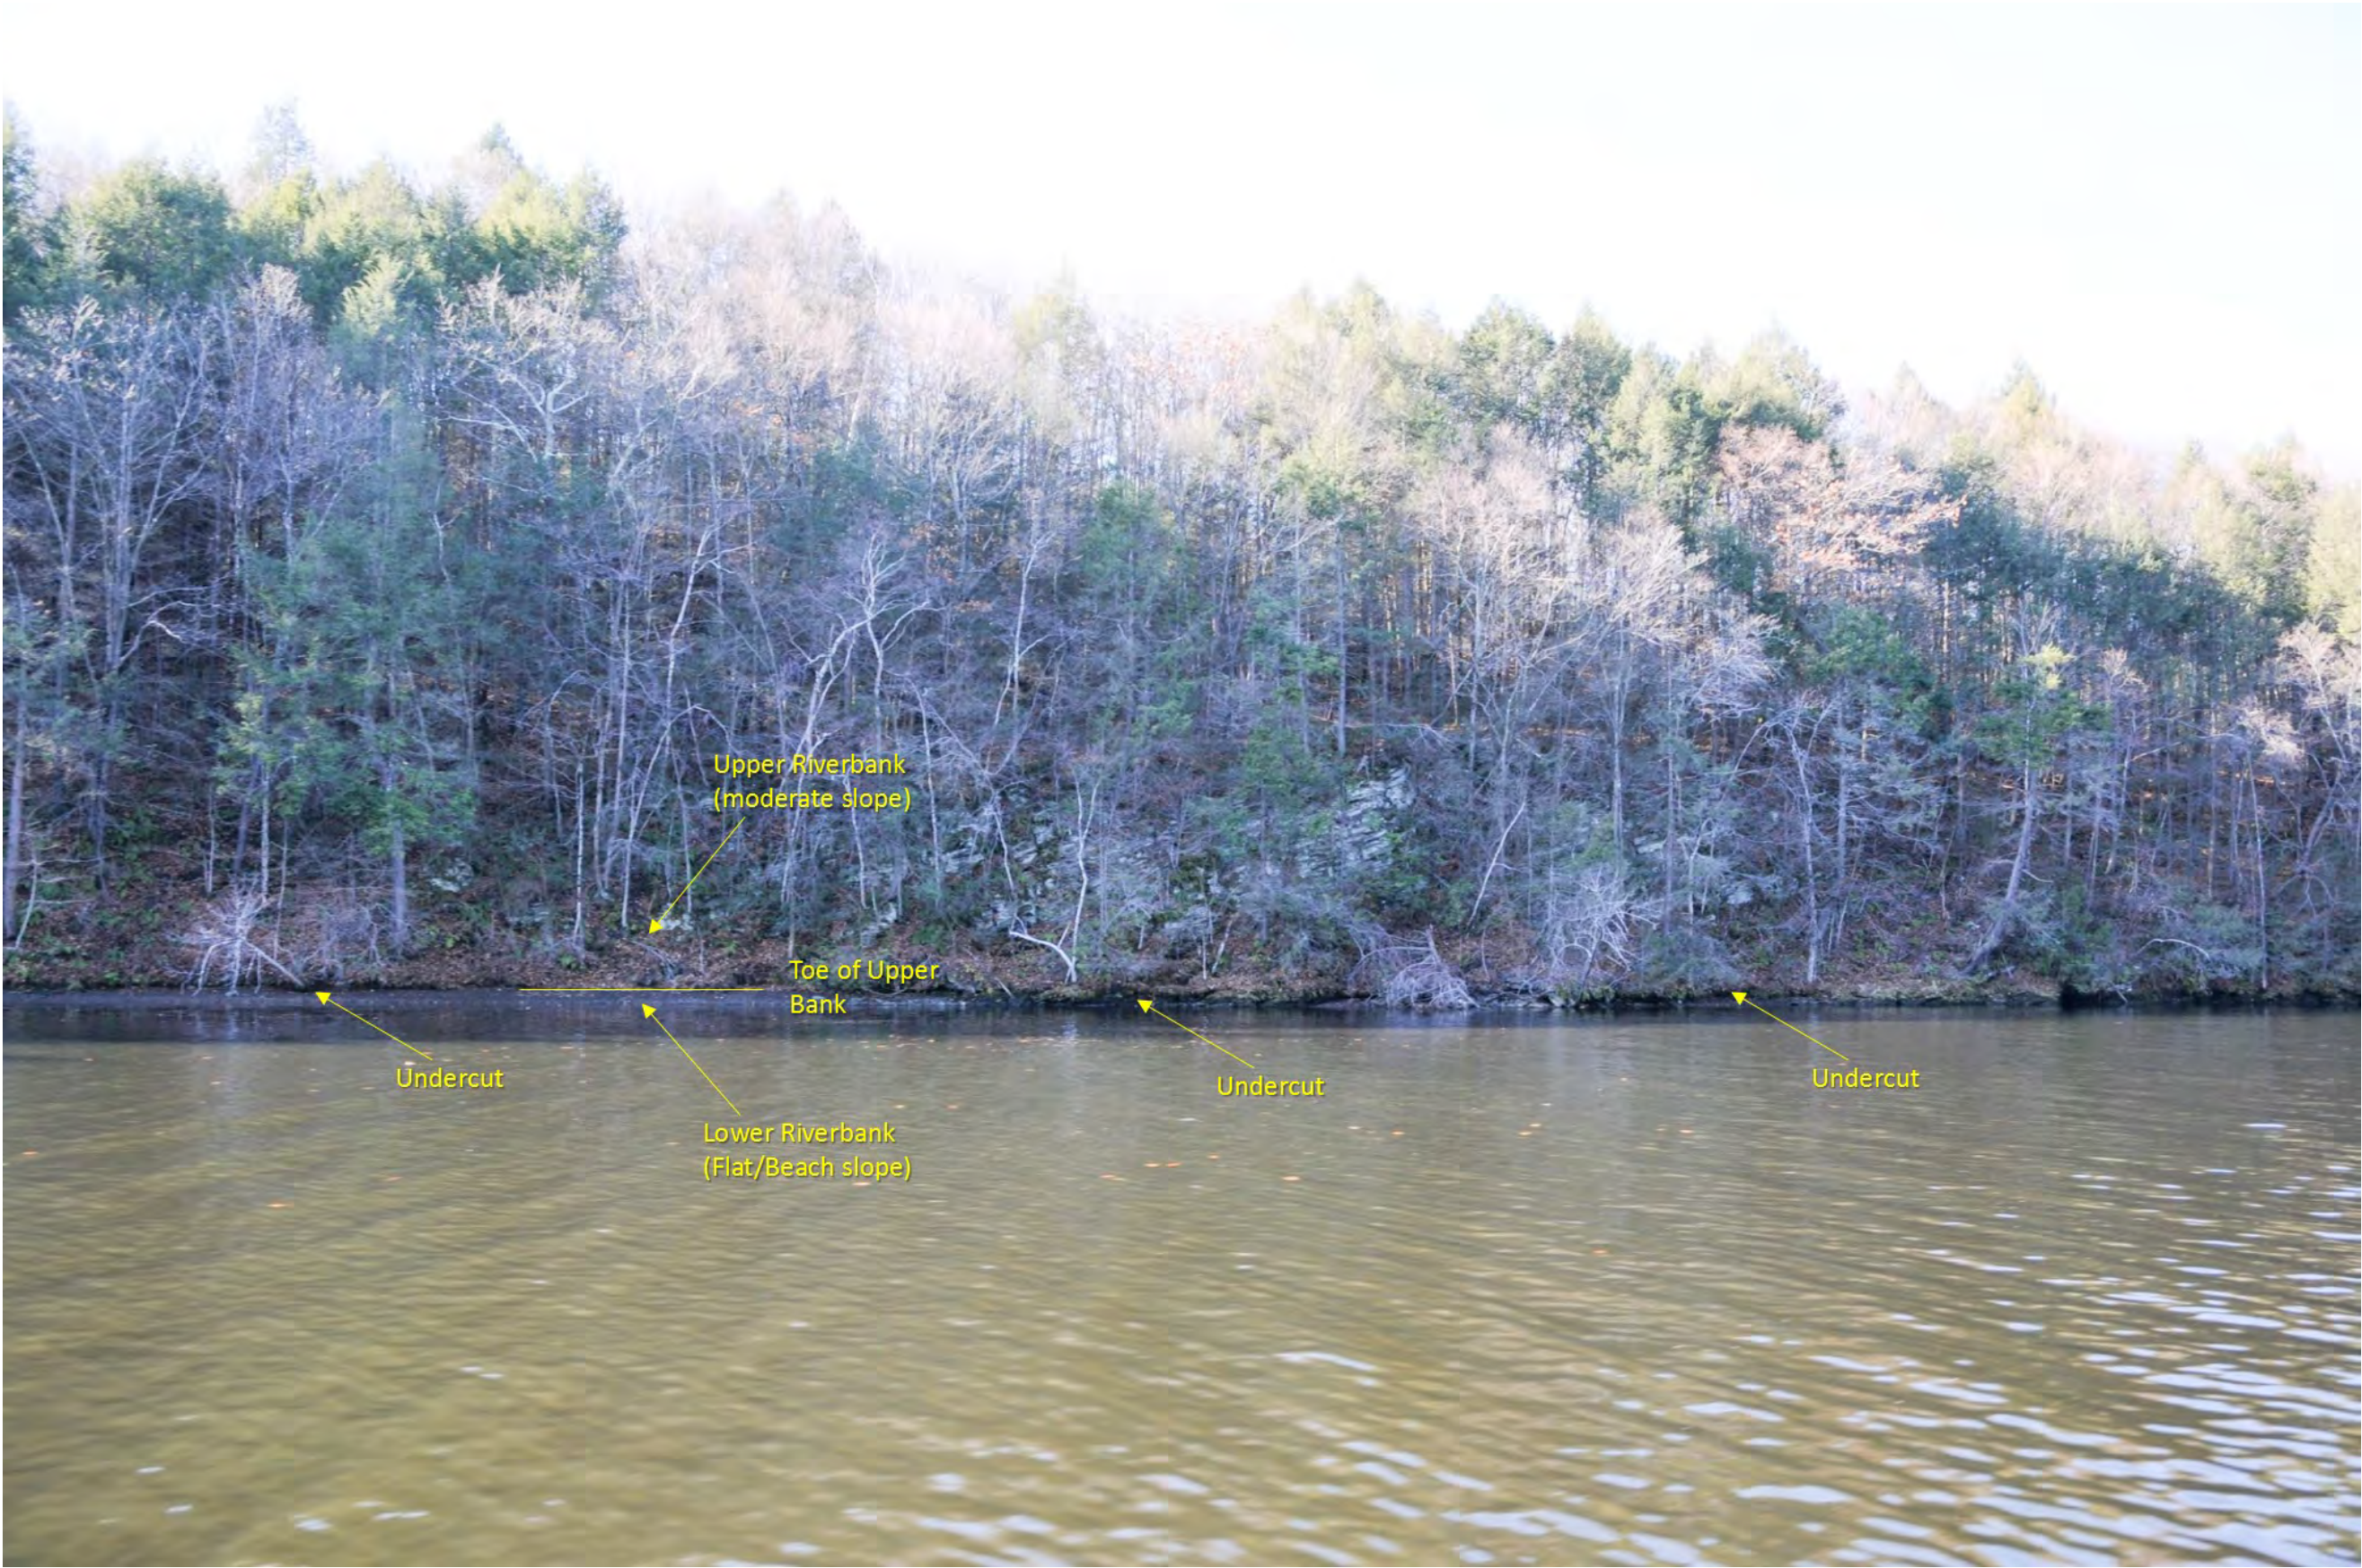
Photo ID 170 (mid-segment)

Riverbank Features	Characteristics
Upper Riverbank Slope	Moderate
Upper Riverbank Height	High
Upper Riverbank Sediment	Silt/Sand
Upper Riverbank Vegetation	Heavy
Lower Riverbank Slope	Flat/Beach
Lower Riverbank Sediment	Gravel
Lower Riverbank Vegetation	None to very sparse
Type of Erosion	Undercut
Potential Erosion Indicators	None
Stage of Erosion	Stable
Extent of Erosion	None/Little

QA Observations: Upon review of the photos for this segment, classification made in the field was confirmed.
