ATTACHMENT A: 2013 Full River Reconnaissance – 2015 Addendum: Riverbank Segment QA Comparison

FIRSTLIGHT POWER RESOURCES
RELICENSING STUDY 3.1.1
NORTHFIELD MOUNTAIN/TURNERS FALLS
2013 FULL RIVER RECONNAISSANCE

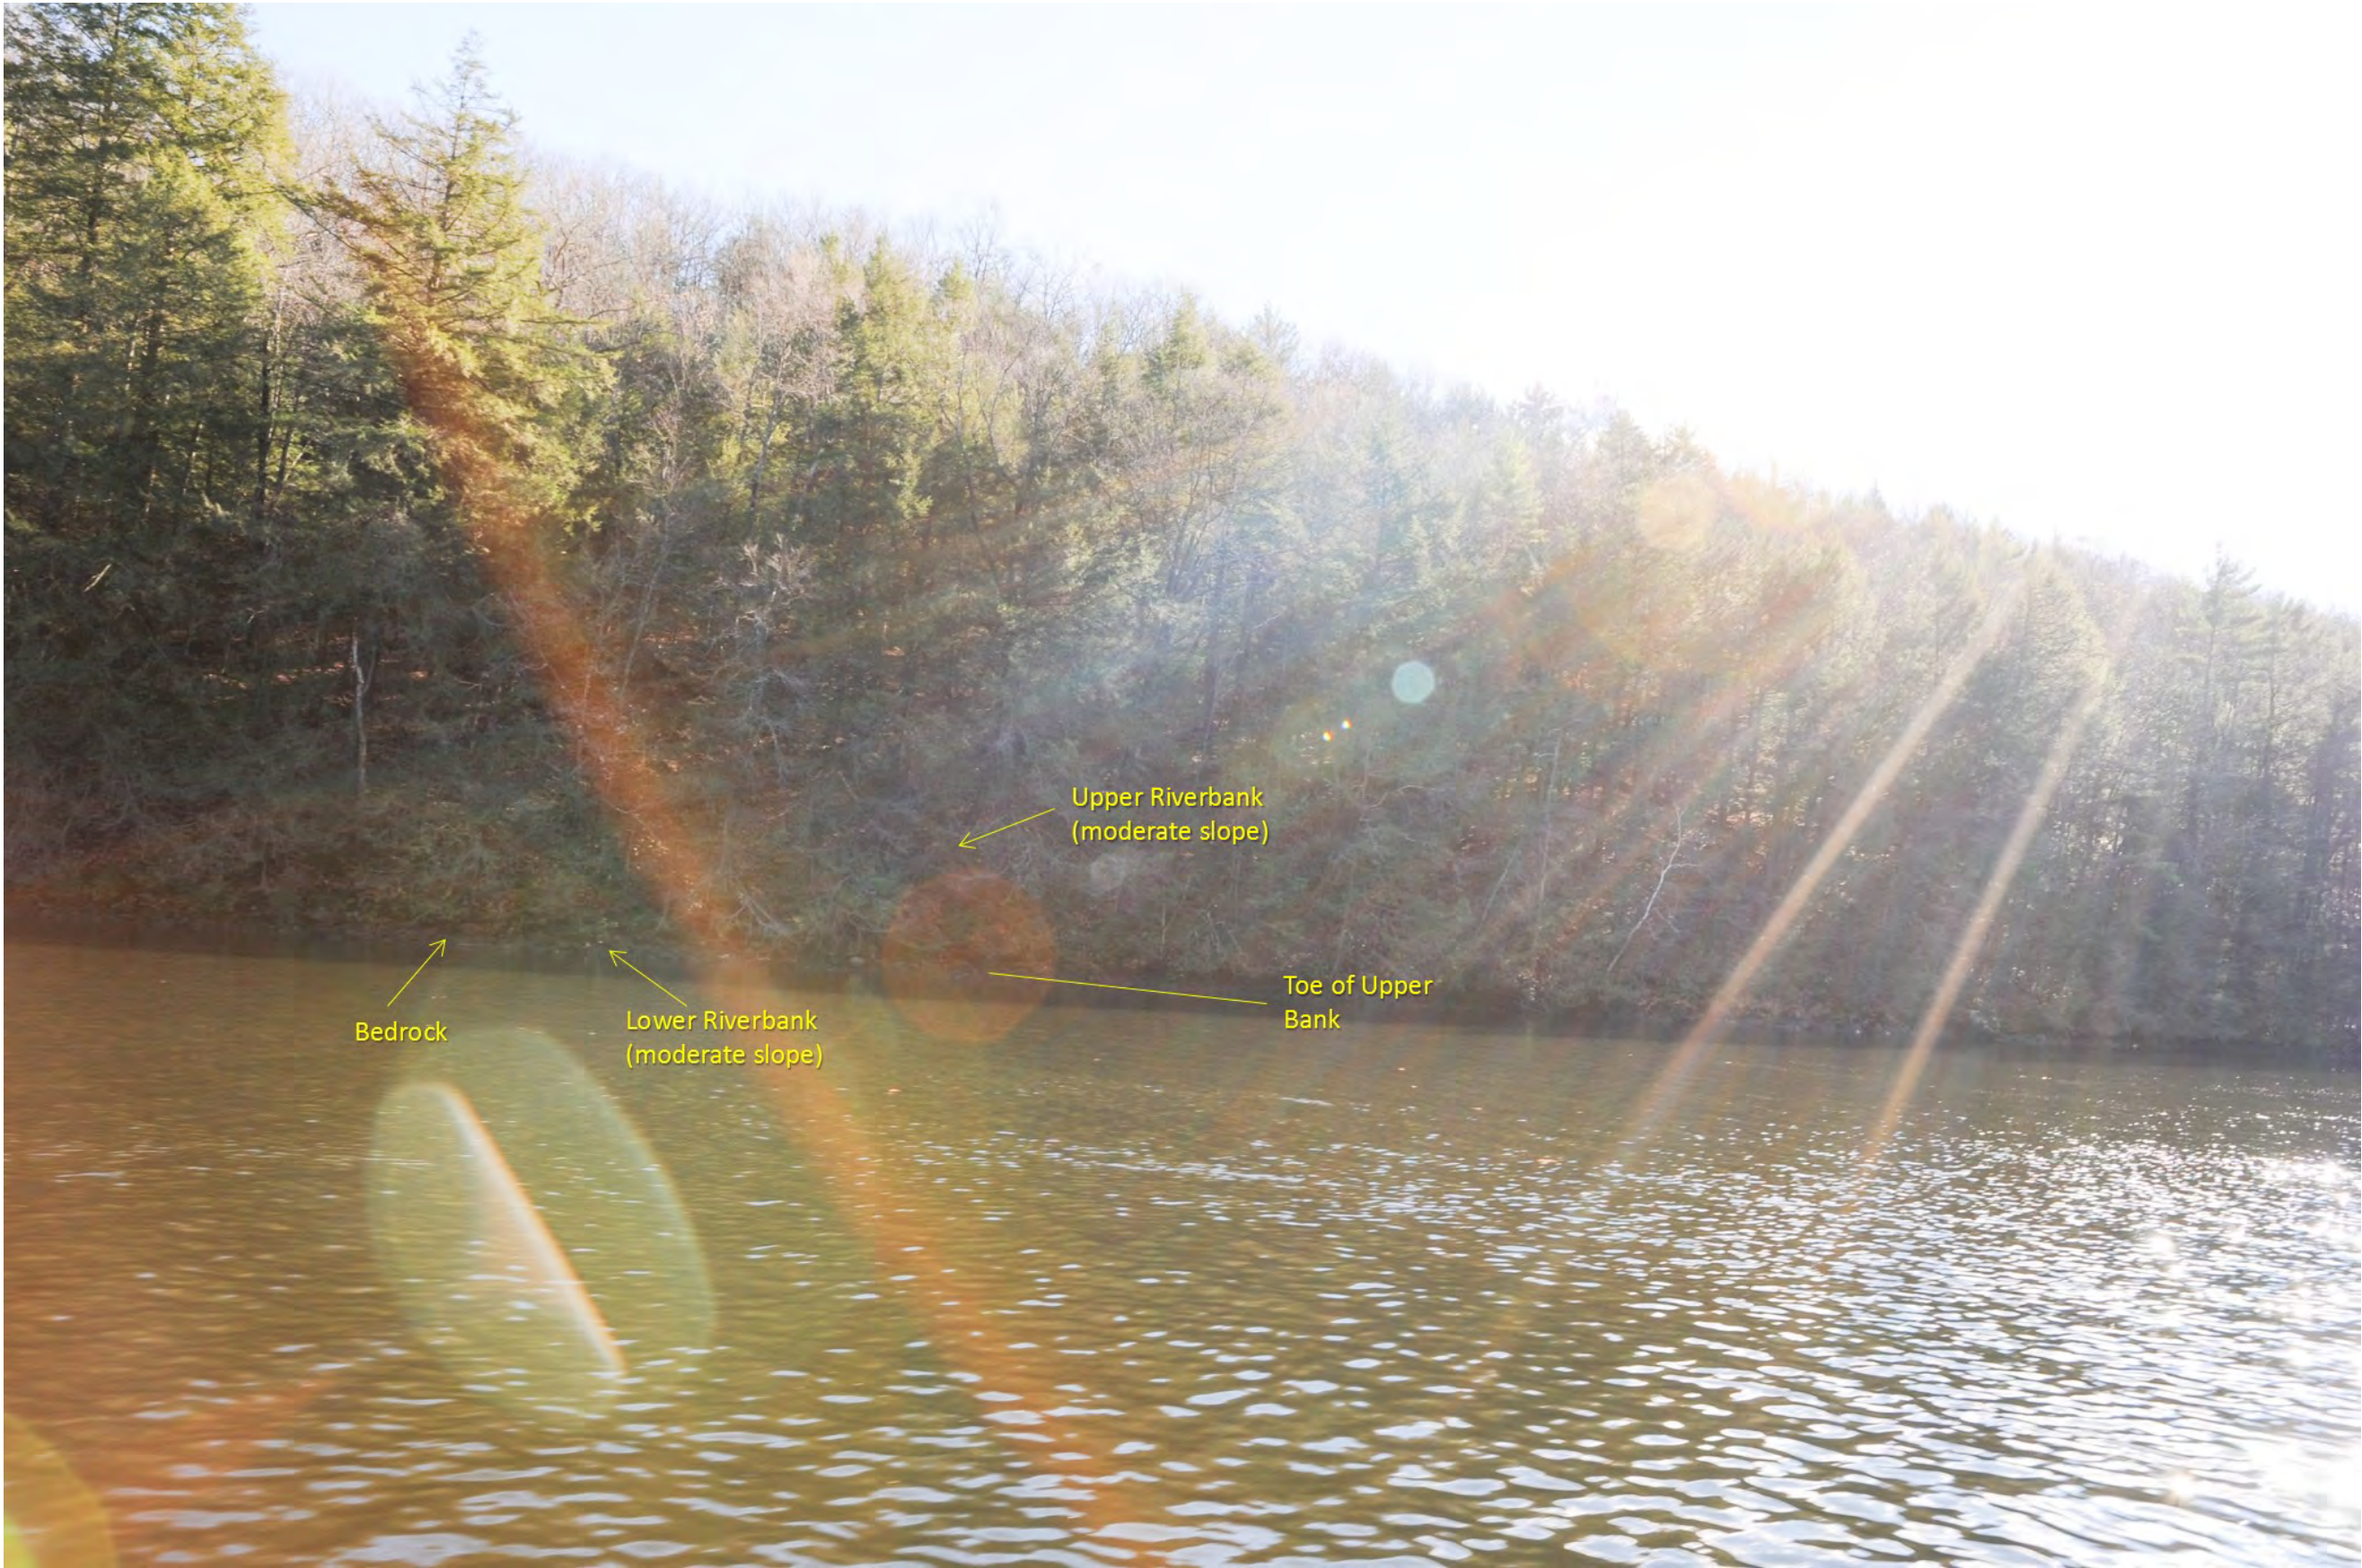
Photo ID 144 (includes entire segment)

Riverbank Features	Characteristics
Upper Riverbank Slope	Moderate
Upper Riverbank Height	High
Upper Riverbank Sediment	Silt/Sand
Upper Riverbank Vegetation	Heavy
Lower Riverbank Slope	Moderate
Lower Riverbank Sediment	Bedrock
Lower Riverbank Vegetation	None to very sparse
Type of Erosion	
Potential Erosion Indicators	None
Stage of Erosion	Stable
Extent of Erosion	None/Little

QA Observations: Upon review of the photos for this segment, classification made in the field was confirmed.

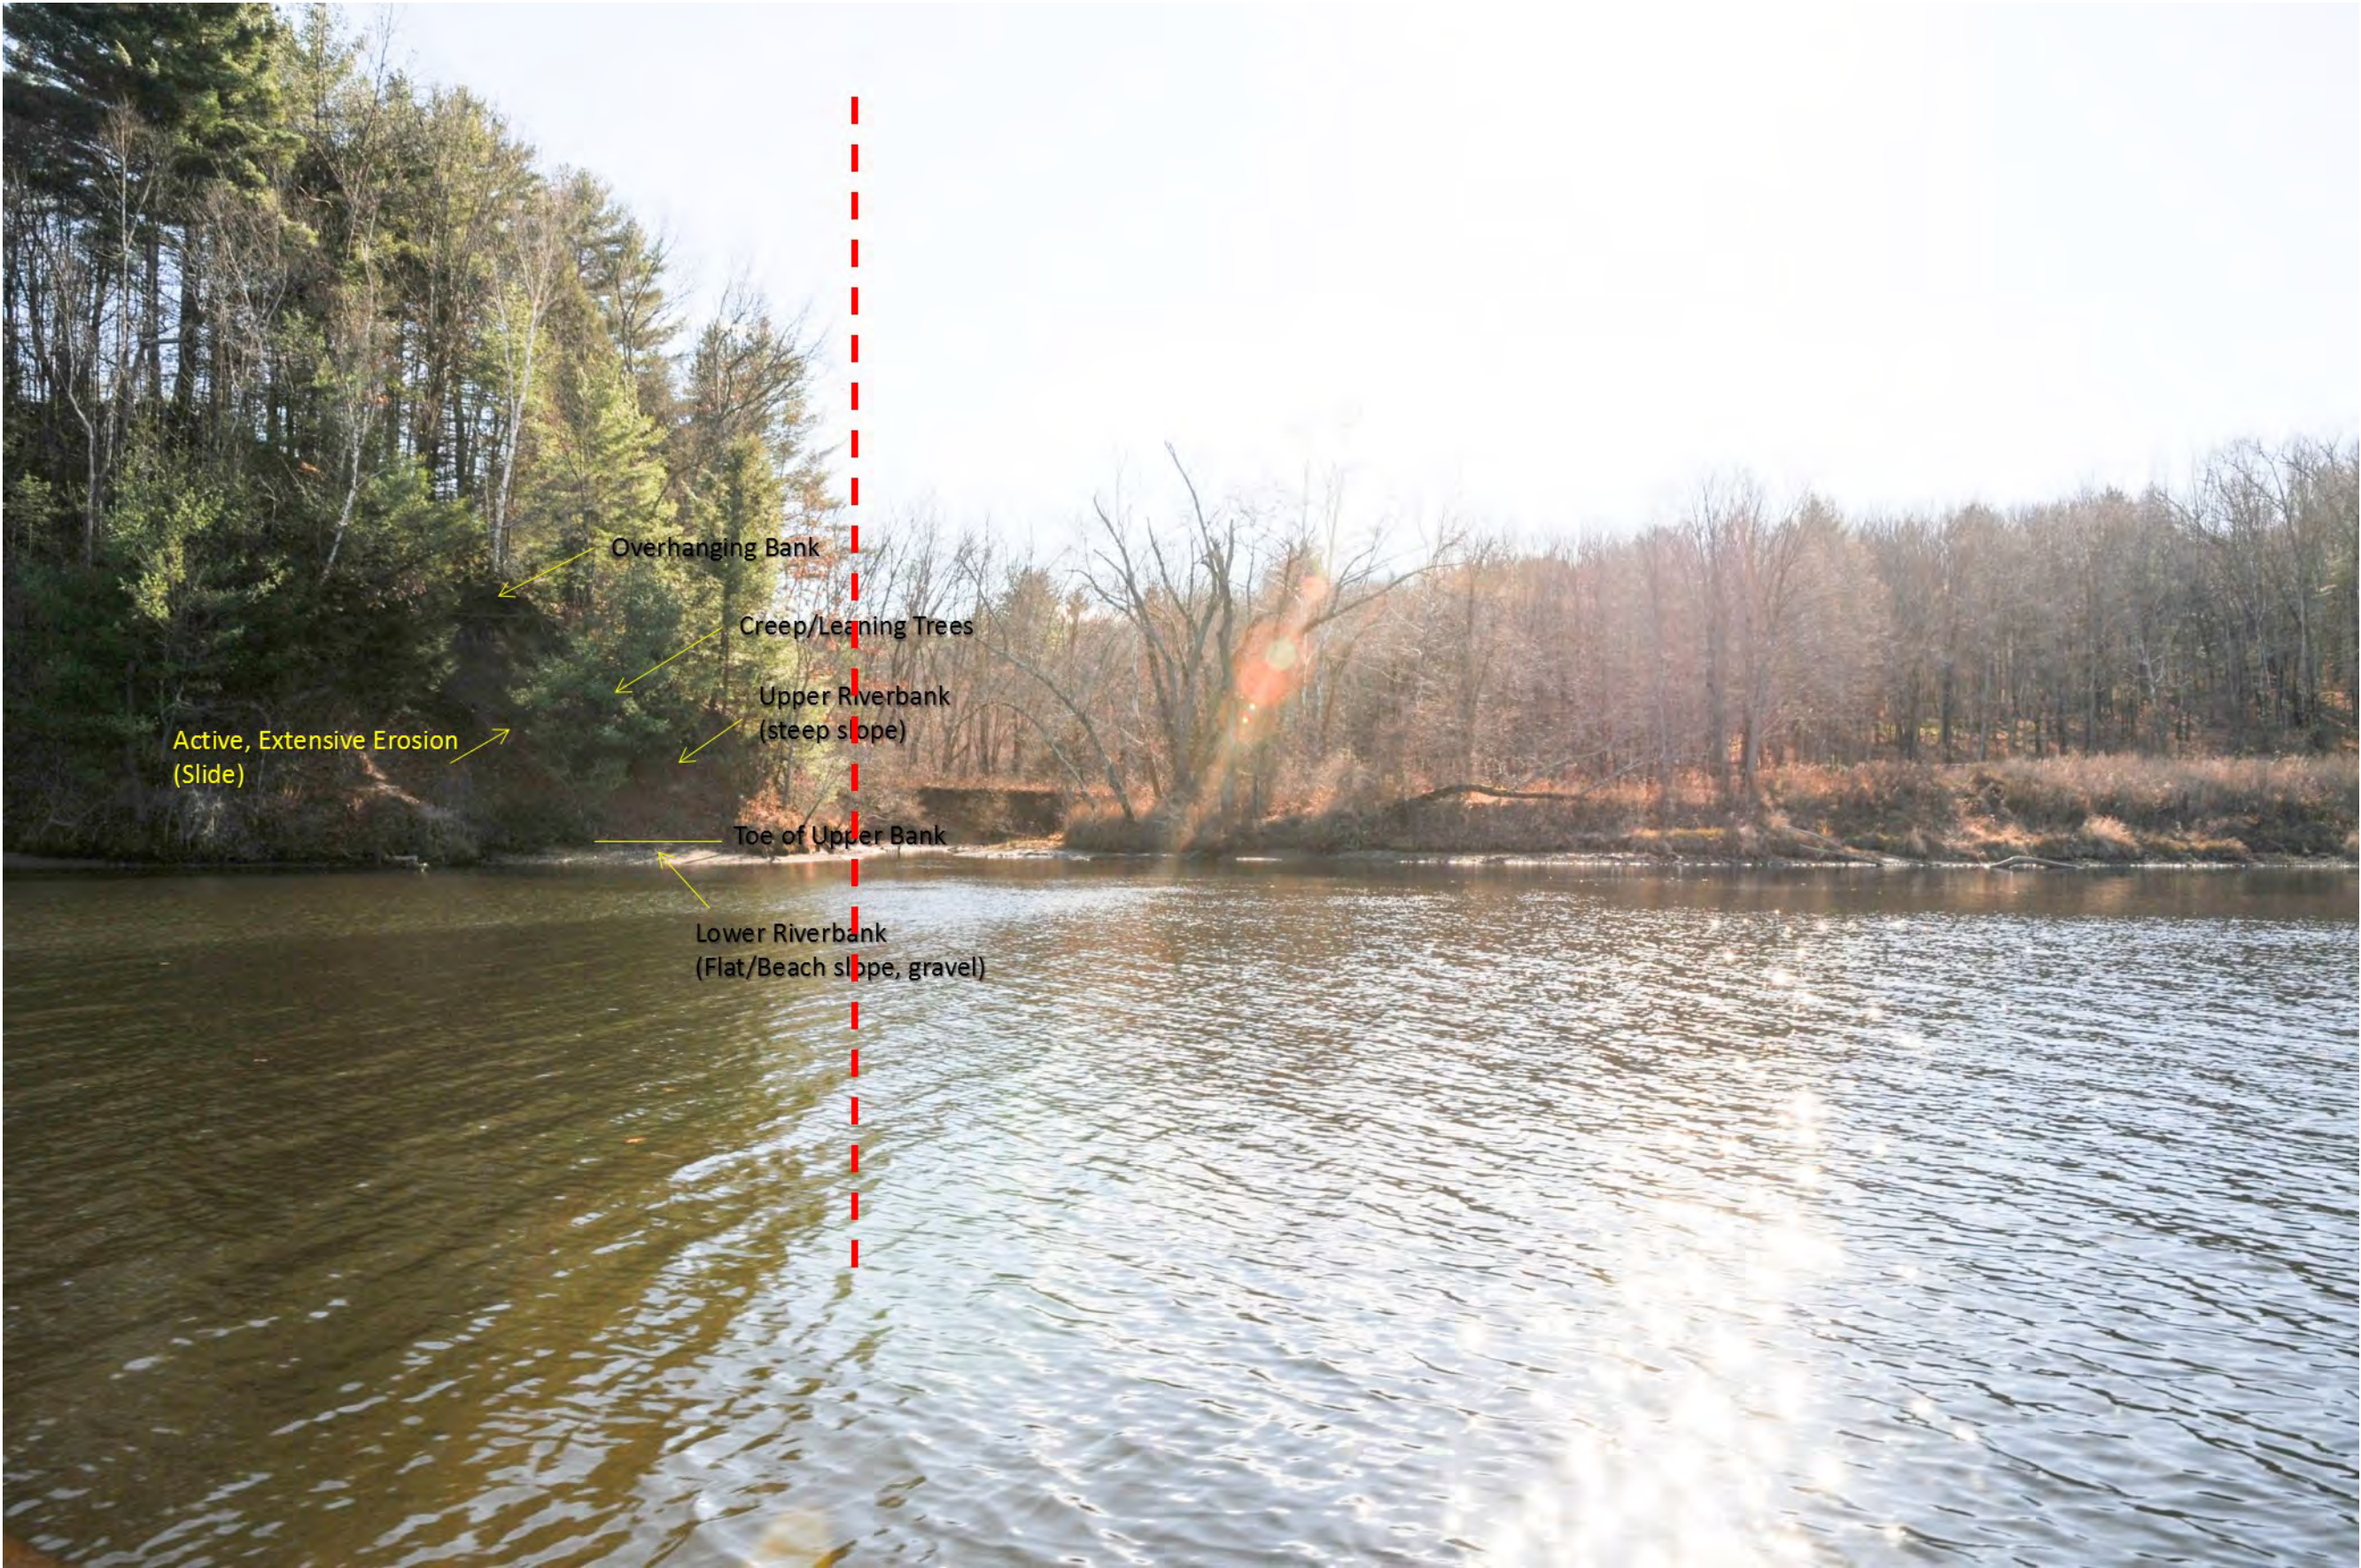
Photo ID 122 (segment is the high, eroded slope as indicated by the labels. Dashed line represents approximate end of segment)

Riverbank Features	Characteristics
Upper Riverbank Slope	Steep
Upper Riverbank Height	High
Upper Riverbank Sediment	Silt/Sand
Upper Riverbank Vegetation	Sparse
Lower Riverbank Slope	Flat/Beach
Lower Riverbank Sediment	Gravel
Lower Riverbank Vegetation	None to very sparse
Type of Erosion	Slide
Potential Erosion Indicators	Creep/leaning trees, Overhanging bank, Exposed roots
Stage of Erosion	Active Erosion
Extent of Erosion	Extensive

QA Observations: Upon review of the photos for this segment, classification made in the field was confirmed and additional indicators of potential future erosion were included.

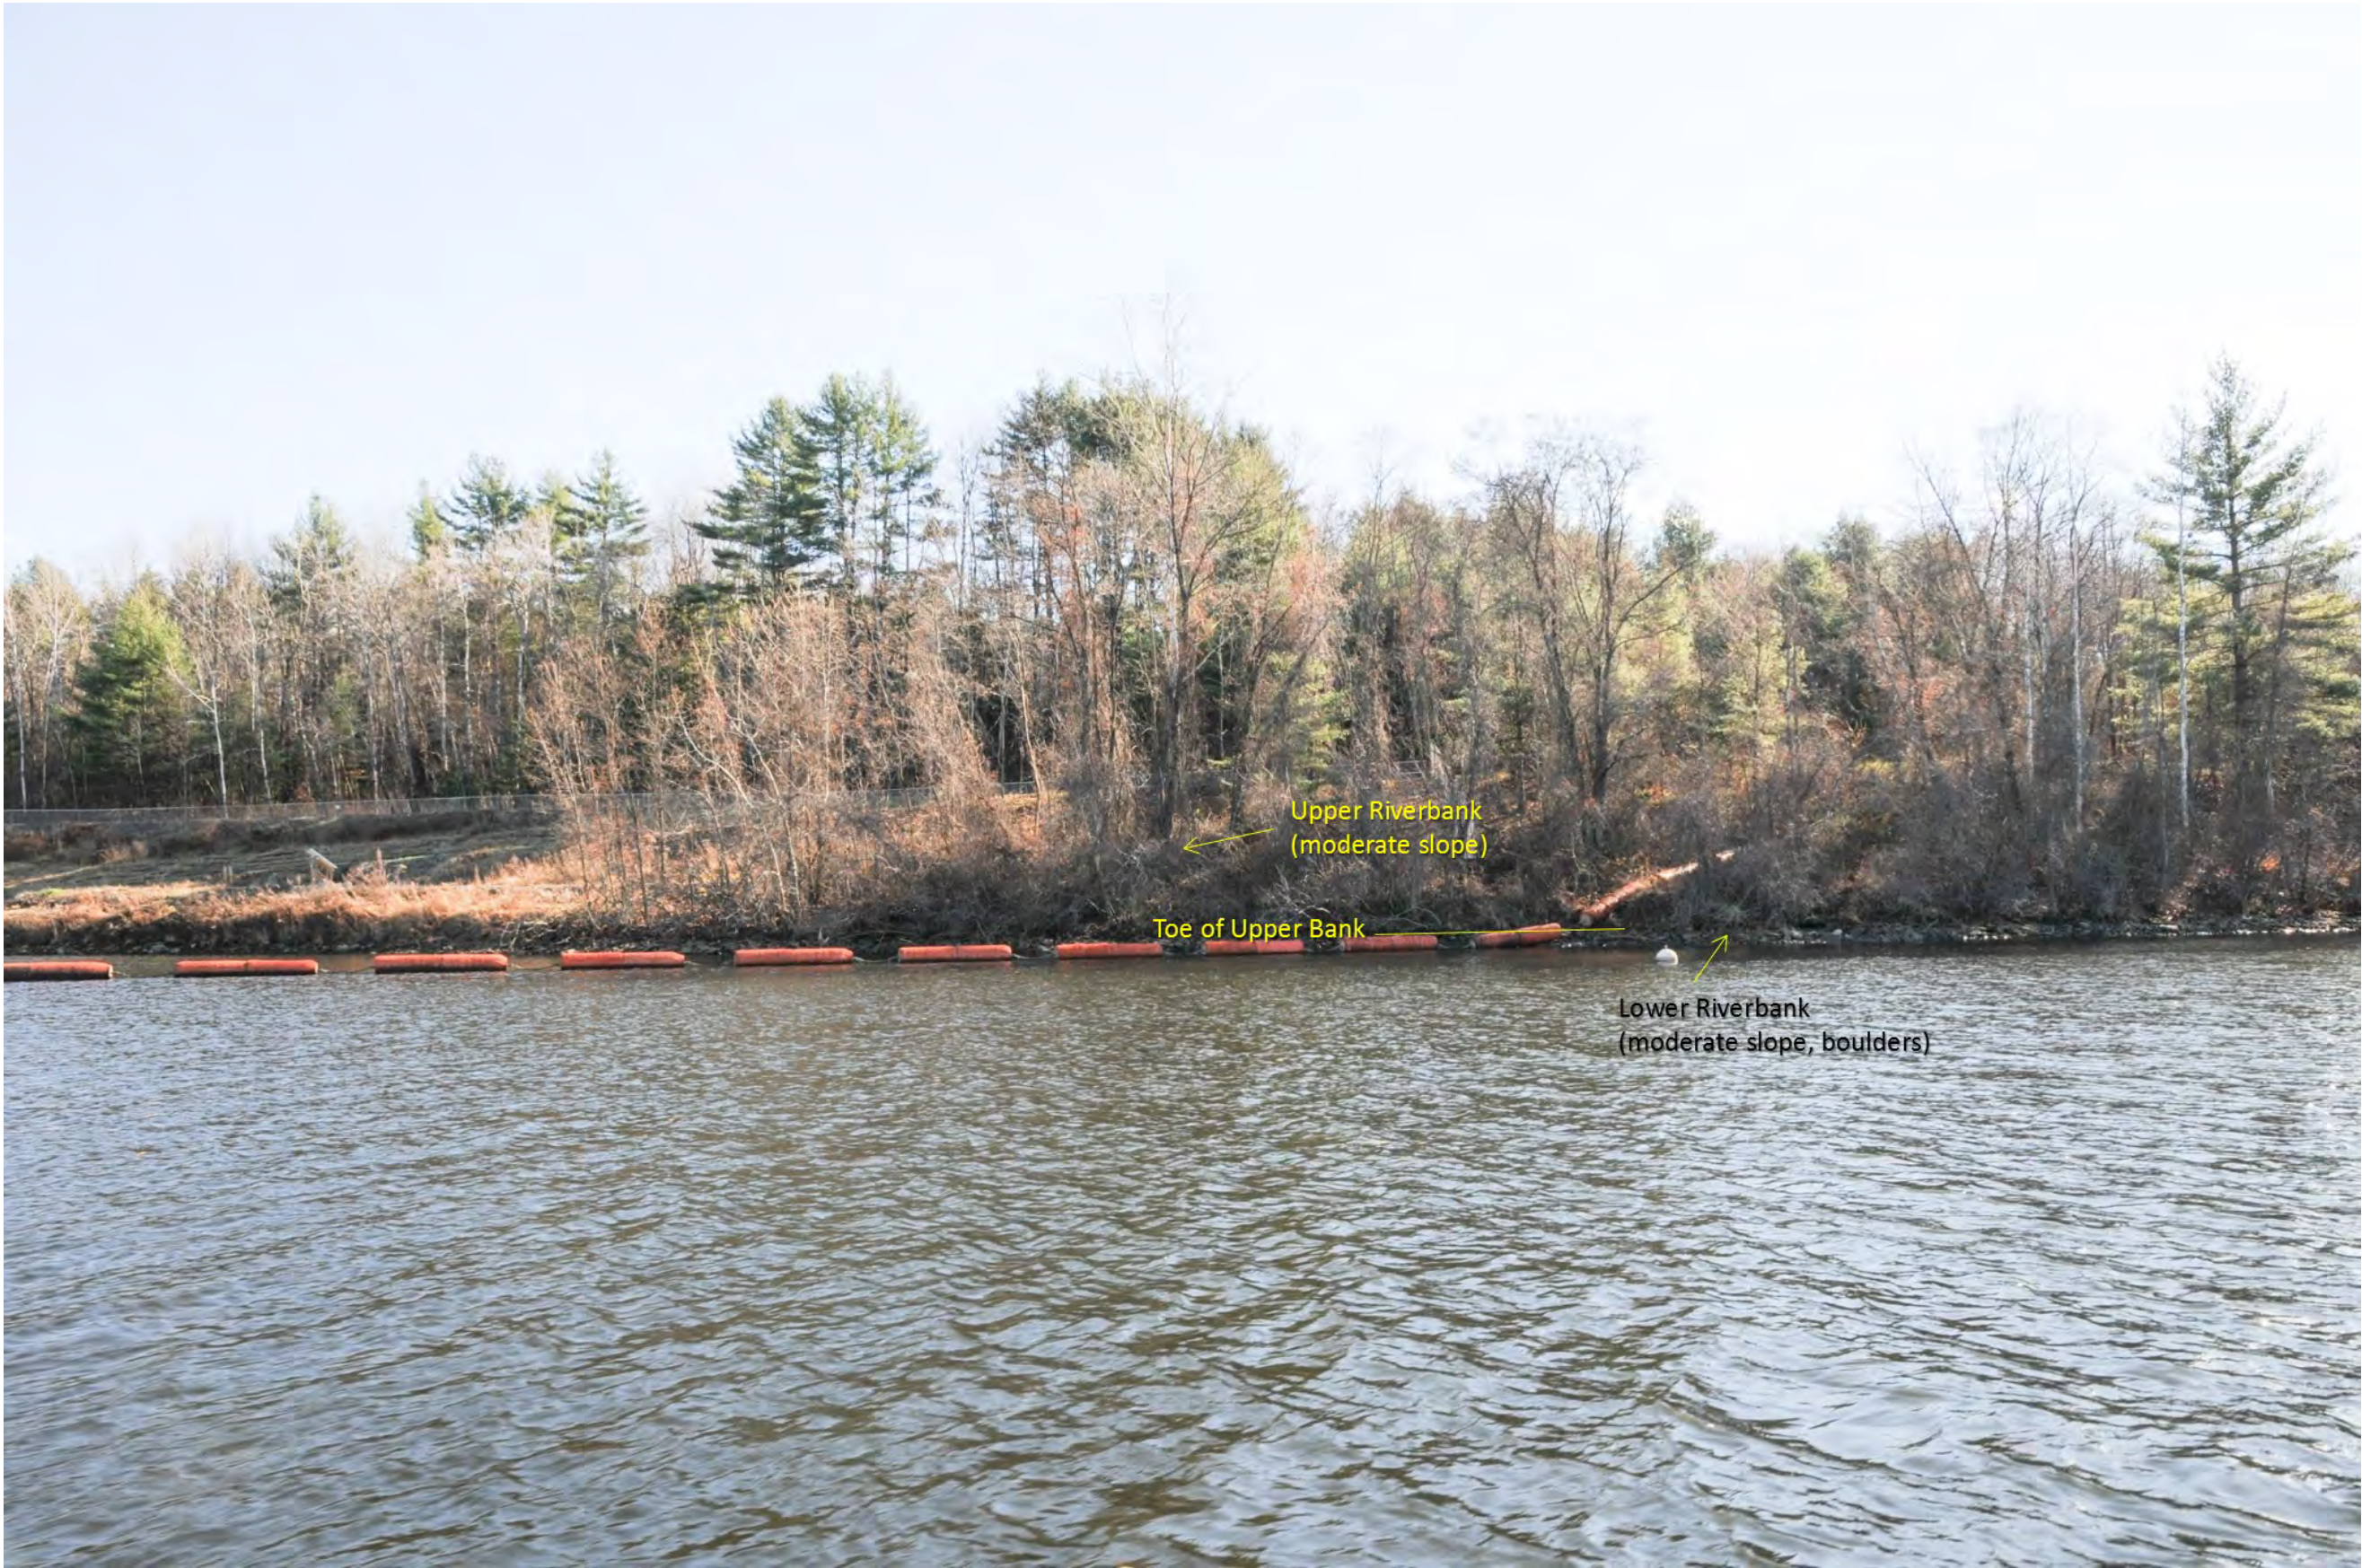
Photo ID 112 (mid-segment)

Riverbank Features	Characteristics
Upper Riverbank Slope	Moderate
Upper Riverbank Height	High
Upper Riverbank Sediment	Silt/Sand
Upper Riverbank Vegetation	Heavy
Lower Riverbank Slope	Moderate
Lower Riverbank Sediment	Boulders
Lower Riverbank Vegetation	None to very sparse
Type of Erosion	
Potential Erosion Indicators	None
Stage of Erosion	Stable
Extent of Erosion	None/Little

QA Observations: Upon review of the photos for this segment, classification made in the field was confirmed.
