Segment 90 – Left Bank

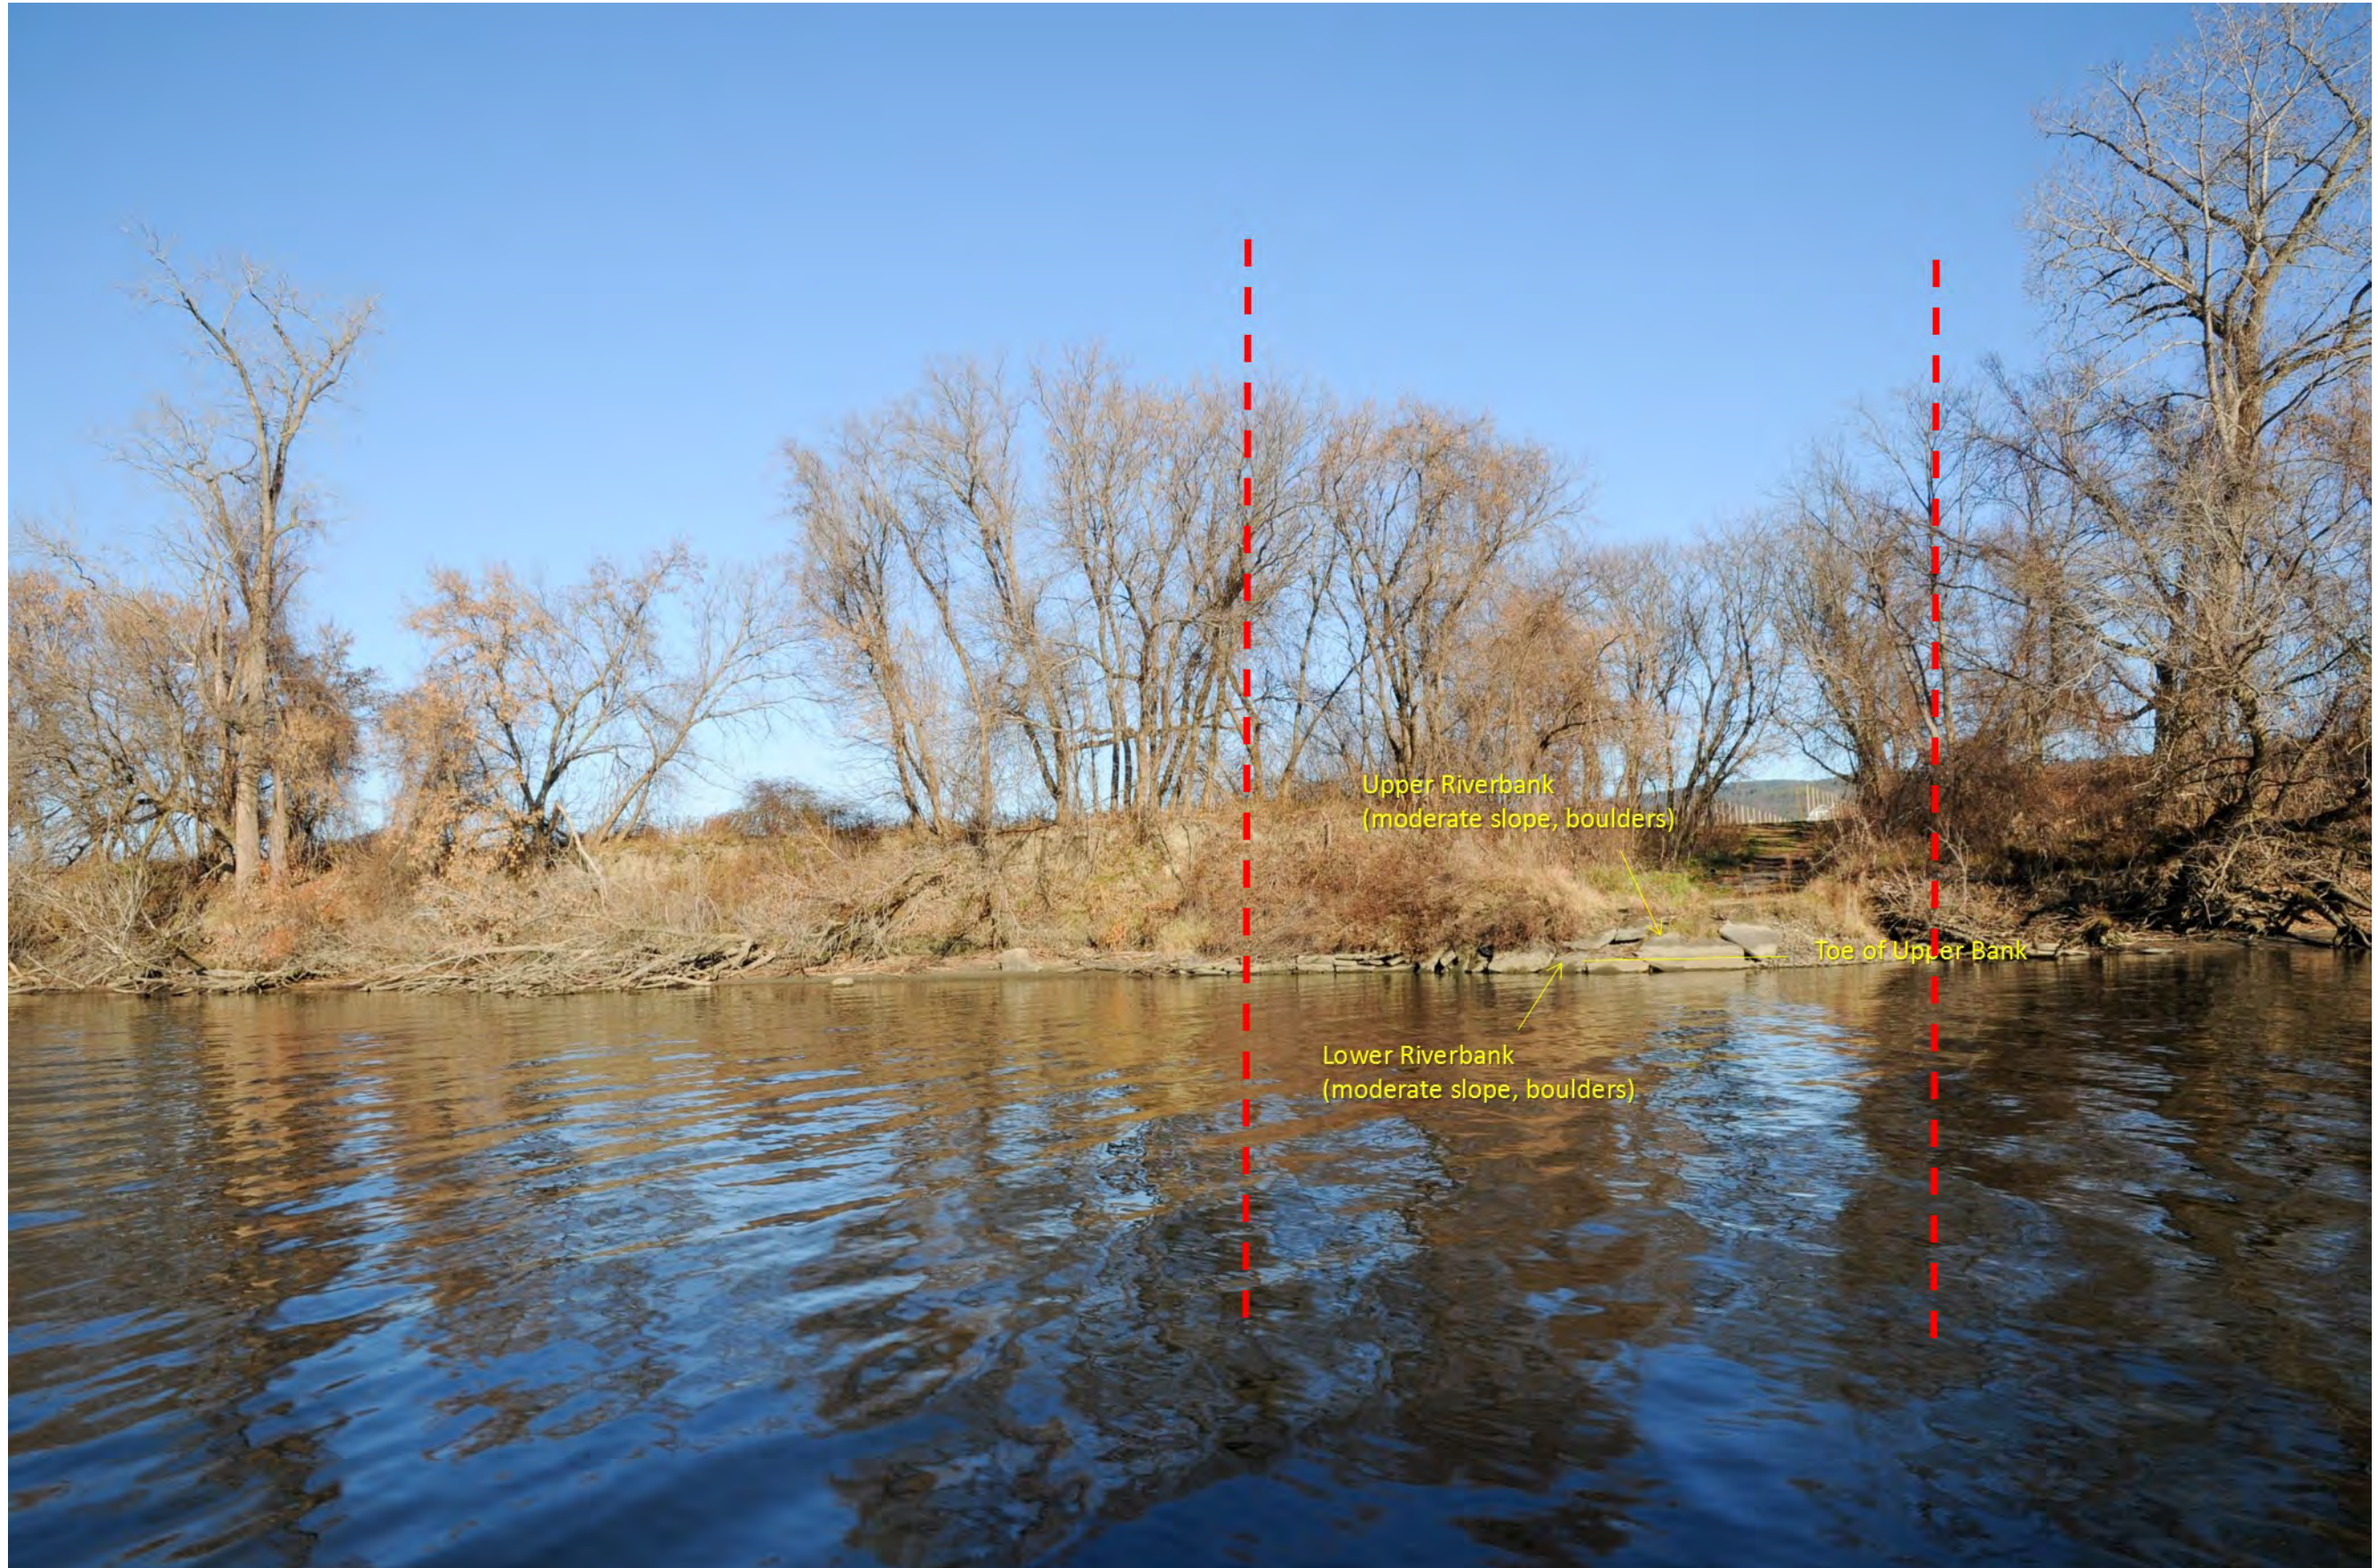
Photo ID 632 (segment is labeled portion of photograph. Dashed lines represent approximate ends of segment)

Riverbank Features	Characteristics
Upper Riverbank Slope	Moderate
Upper Riverbank Height	Low
Upper Riverbank Sediment	Boulders
Upper Riverbank Vegetation	Moderate
Lower Riverbank Slope	Moderate
Lower Riverbank Sediment	Boulders
Lower Riverbank Vegetation	None to very sparse
Type of Erosion	None
Potential Erosion Indicators	
Stage of Erosion	Stable
Extent of Erosion	None/Little

QA Observations: Upon review of the photos for this segment, classification made in the field was confirmed.

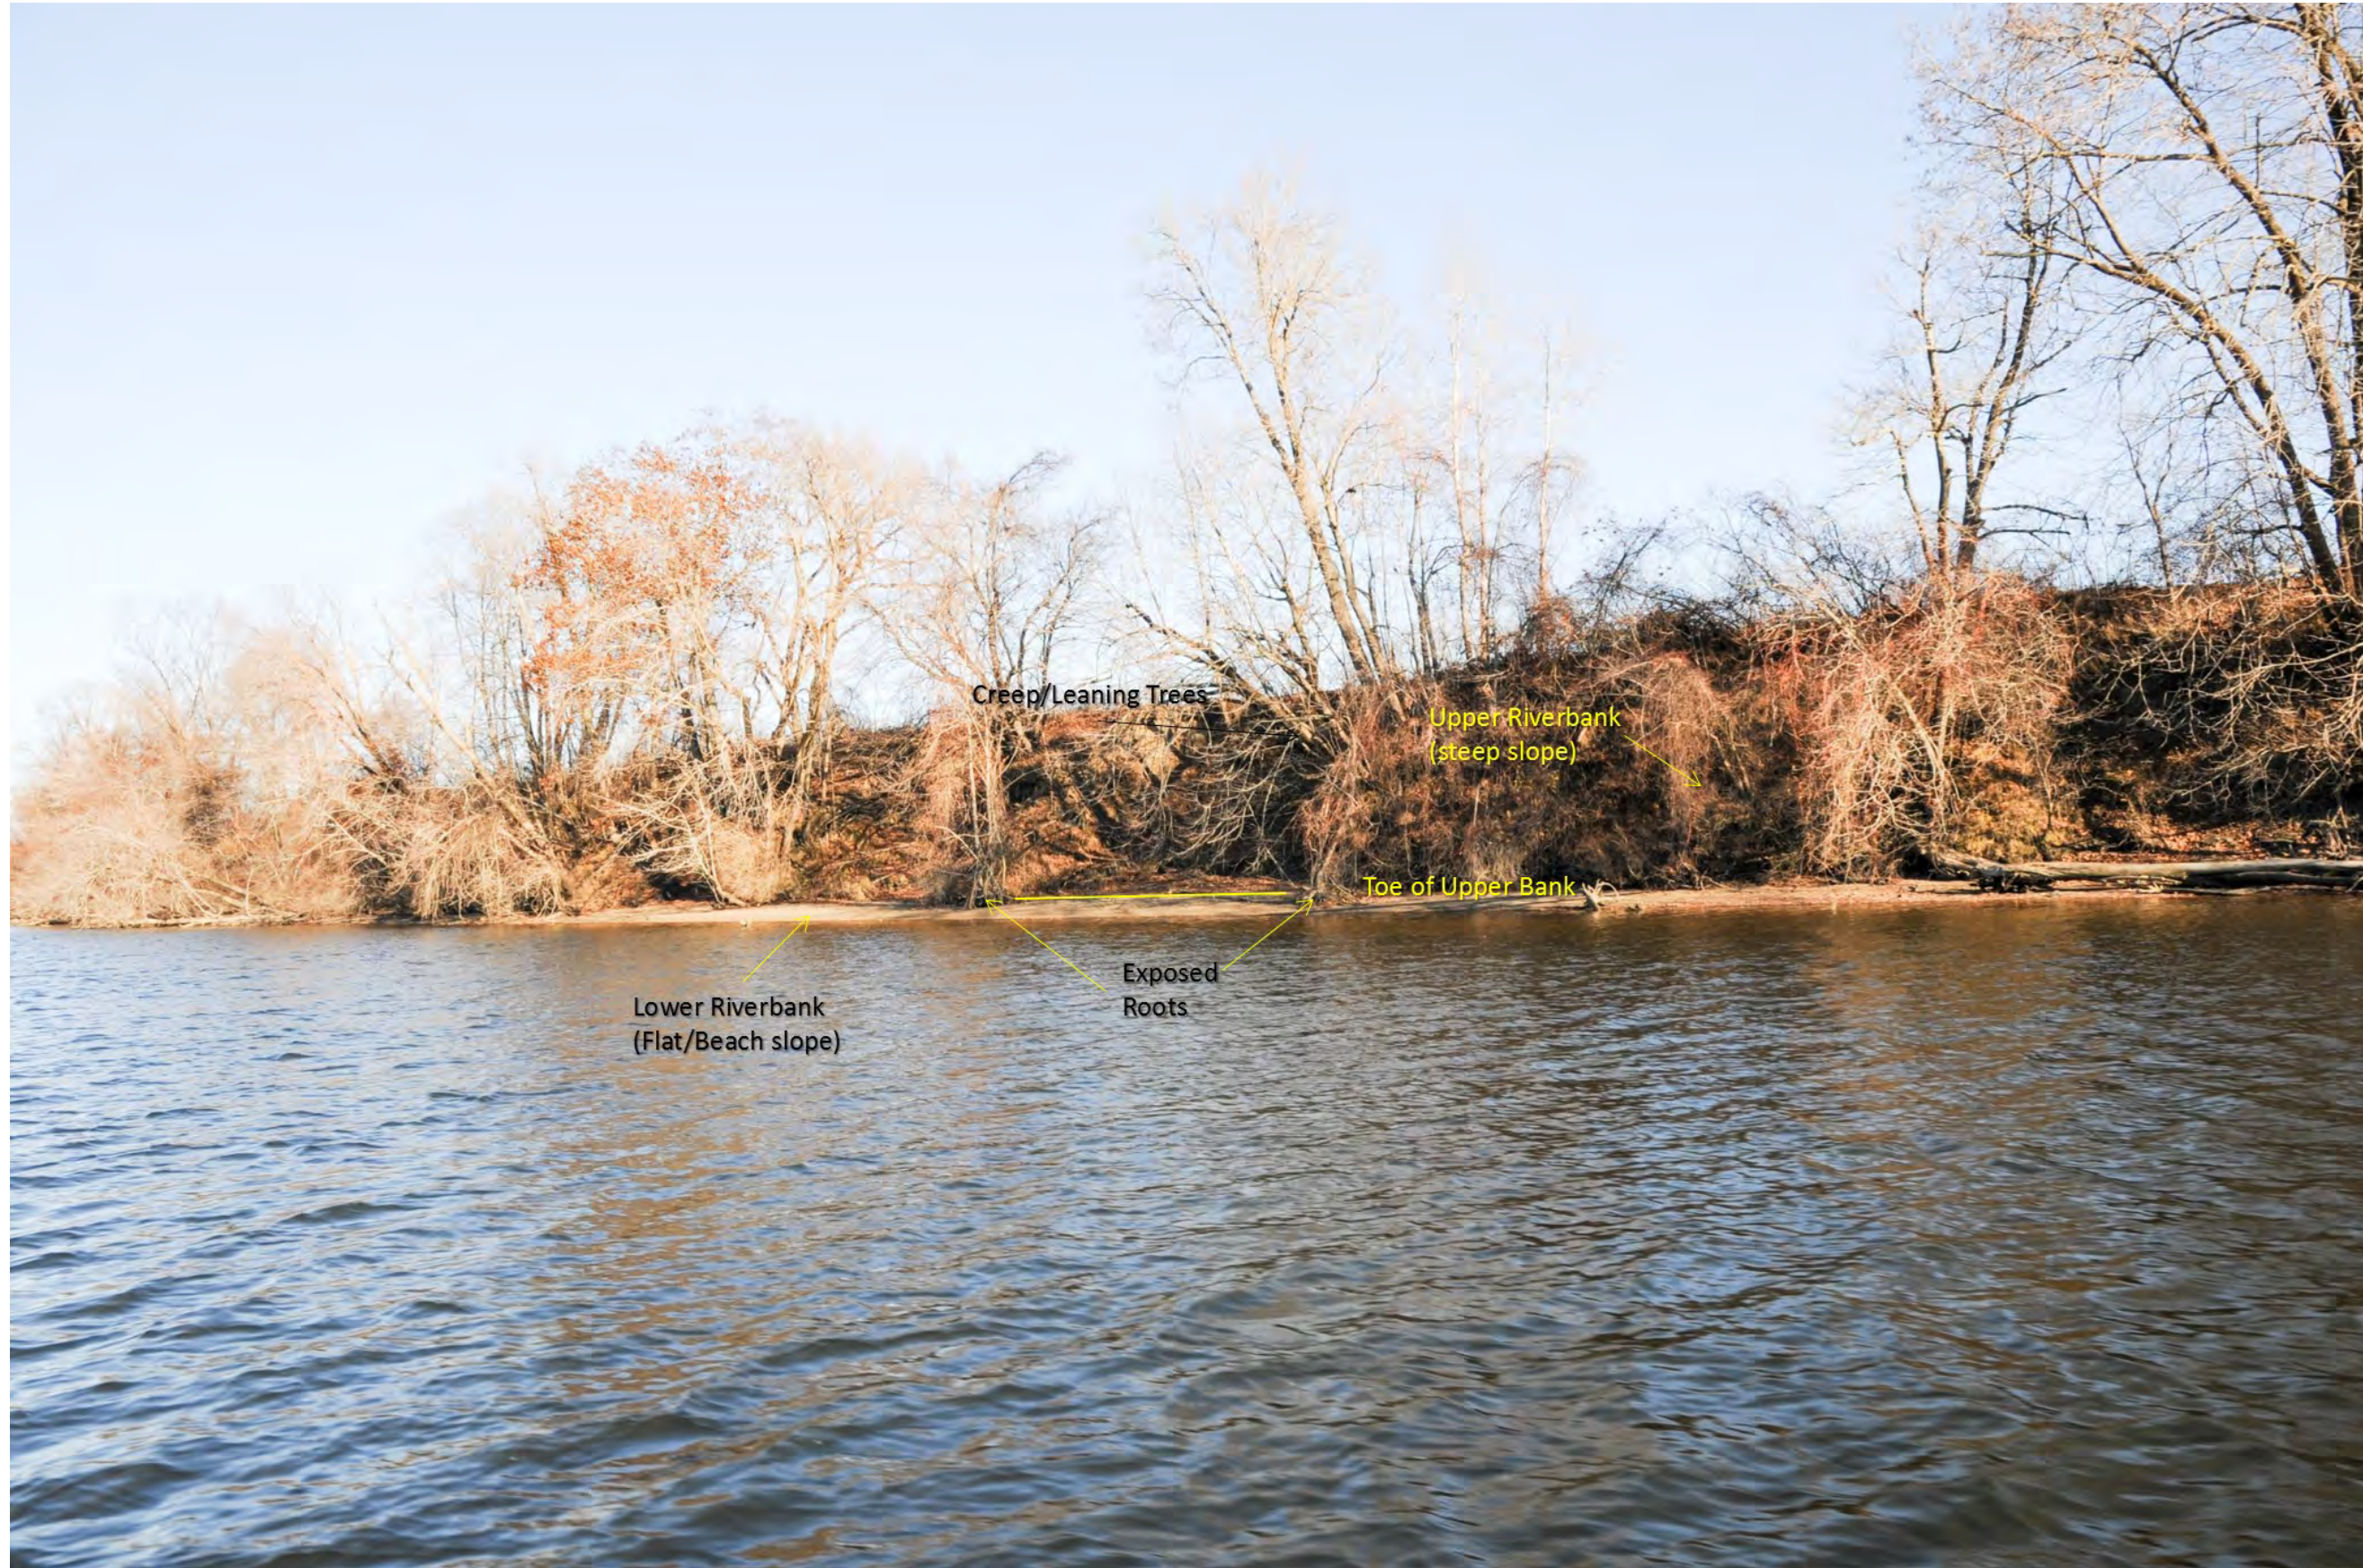
Photo ID 650 (left, U/S portion of segment)

Riverbank Features	Characteristics
Upper Riverbank Slope	Steep
Upper Riverbank Height	High
Upper Riverbank Sediment	Silt/Sand
Upper Riverbank Vegetation	Heavy
Lower Riverbank Slope	Flat/Beach
Lower Riverbank Sediment	Silt/Sand
Lower Riverbank Vegetation	None to very sparse
Type of Erosion	
Potential Erosion Indicators	Creep/leaning trees, Exposed roots
Stage of Erosion	Stable
Extent of Erosion	None/Little

QA Observations: Upon review of the photos for this segment, classification made in the field was confirmed and additional indicators of potential future erosion were included.
