Segment 90 – Left Bank

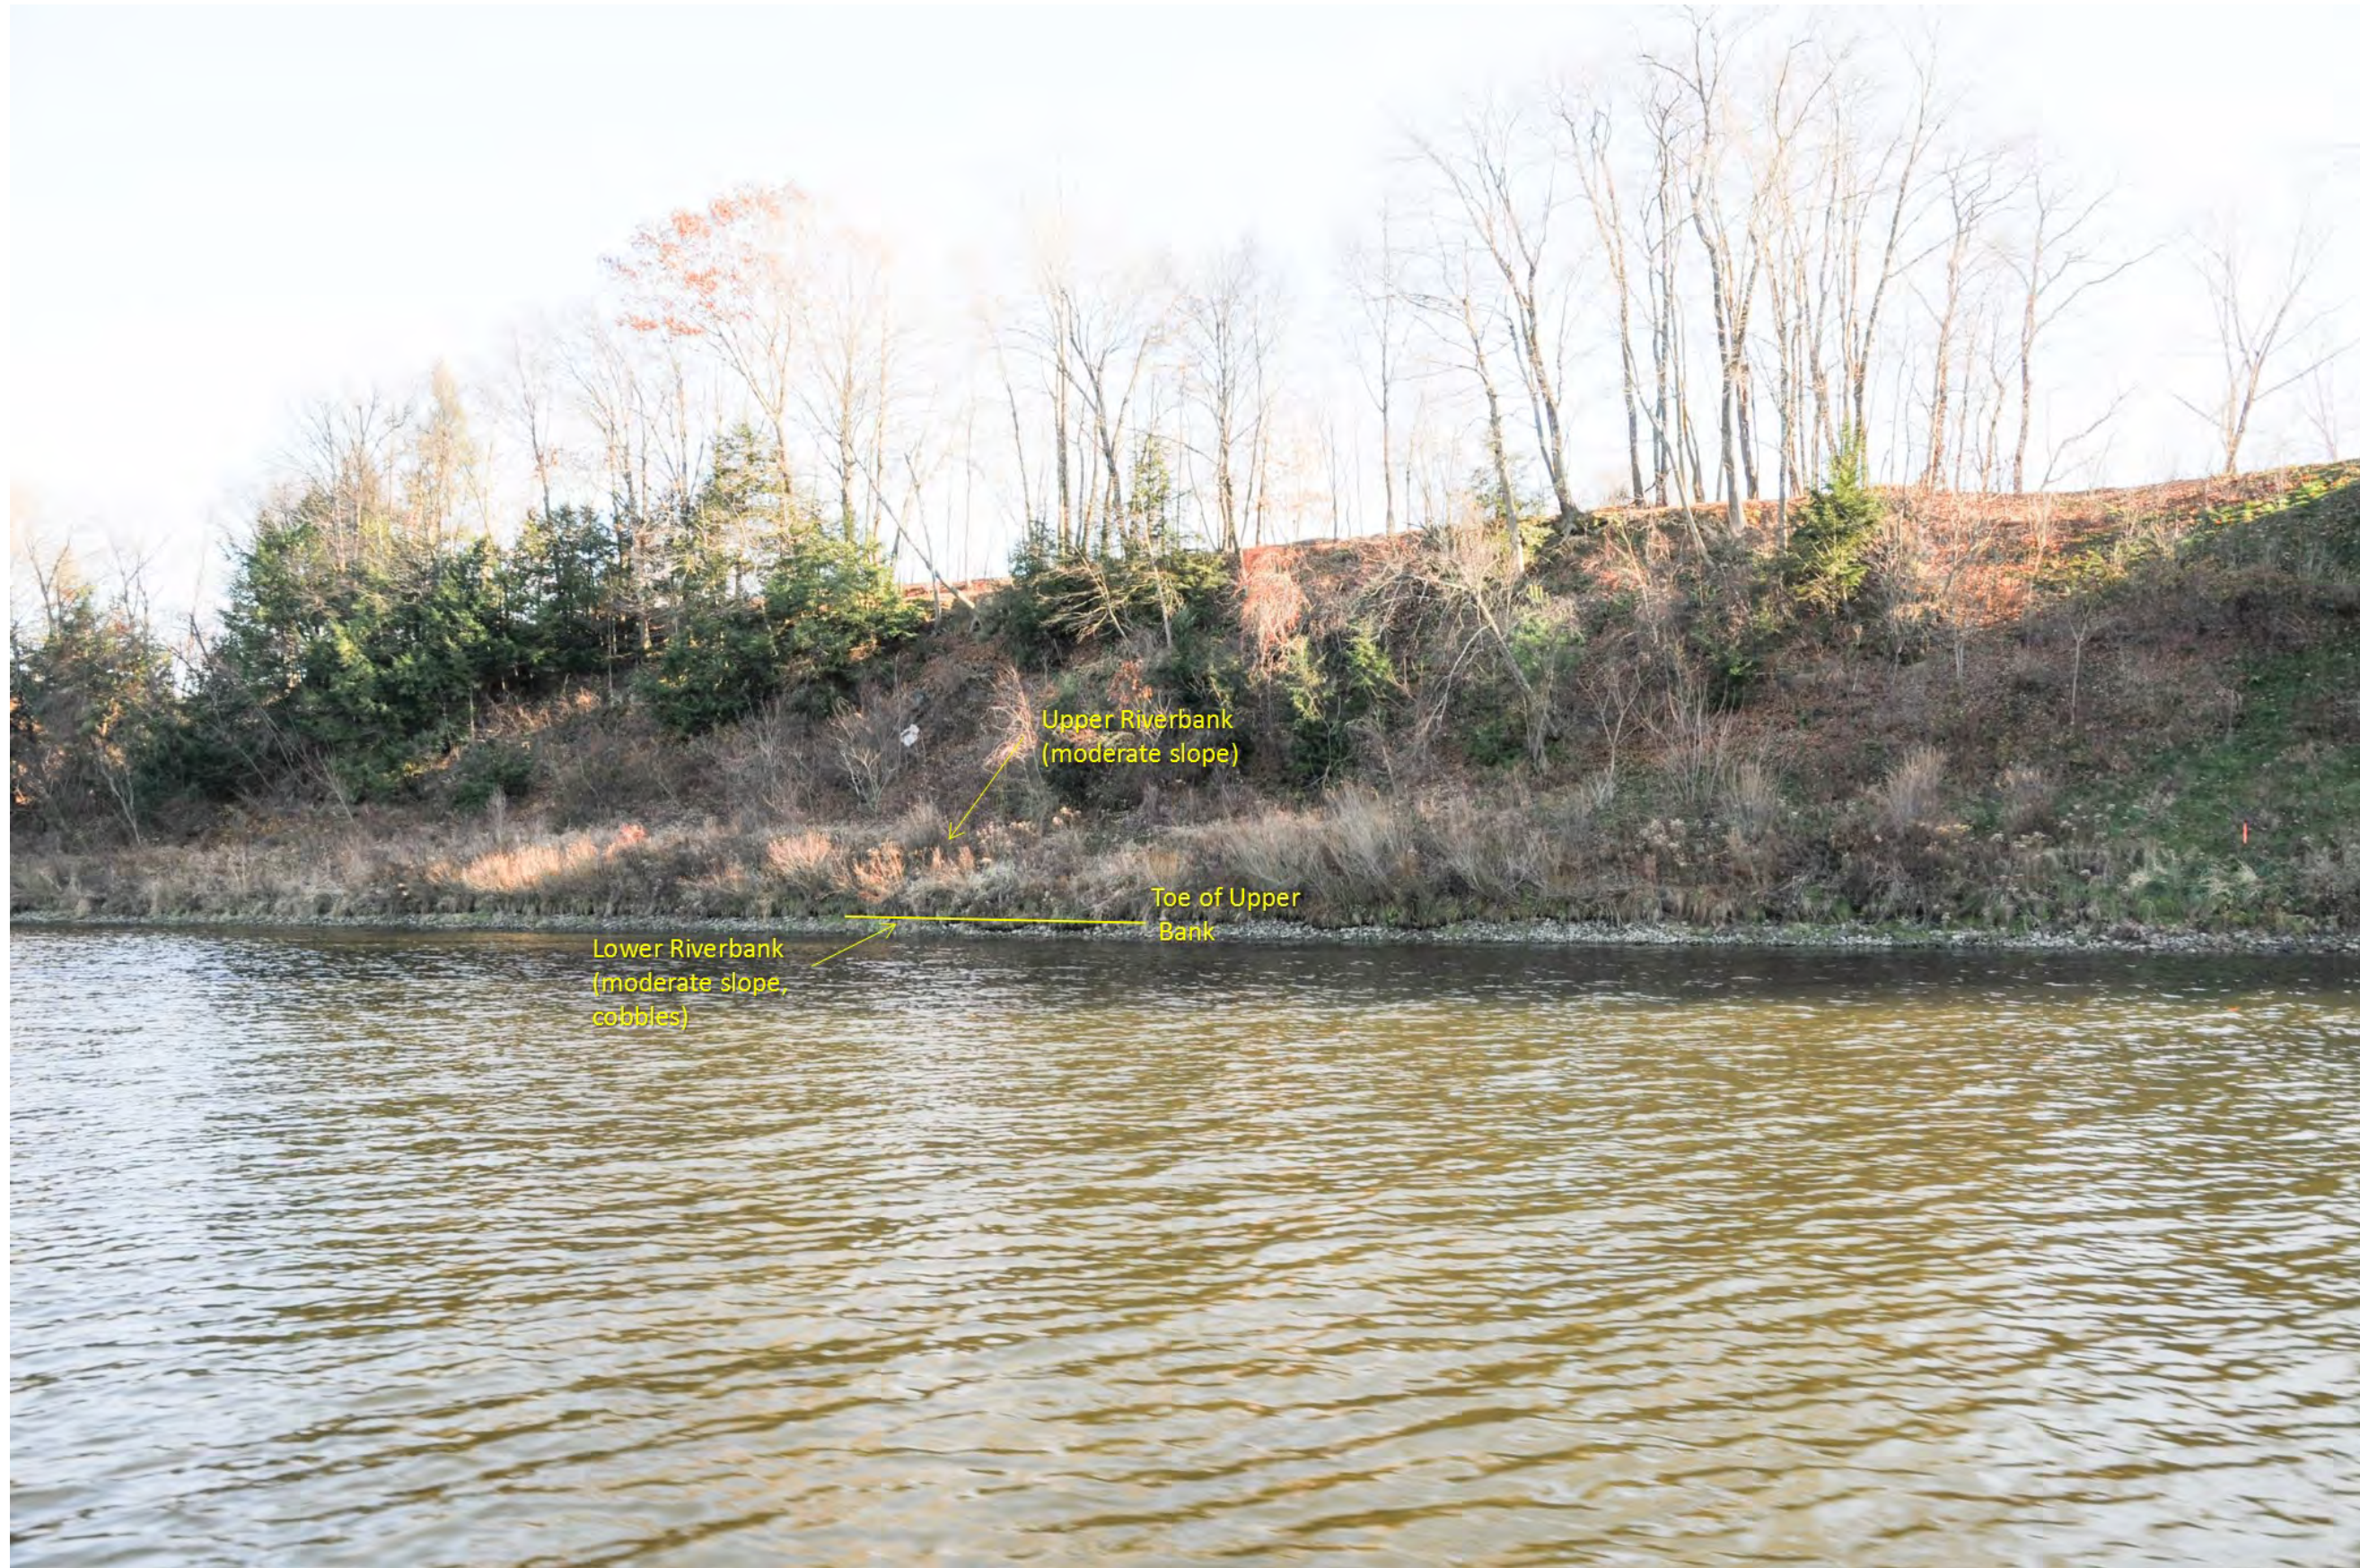
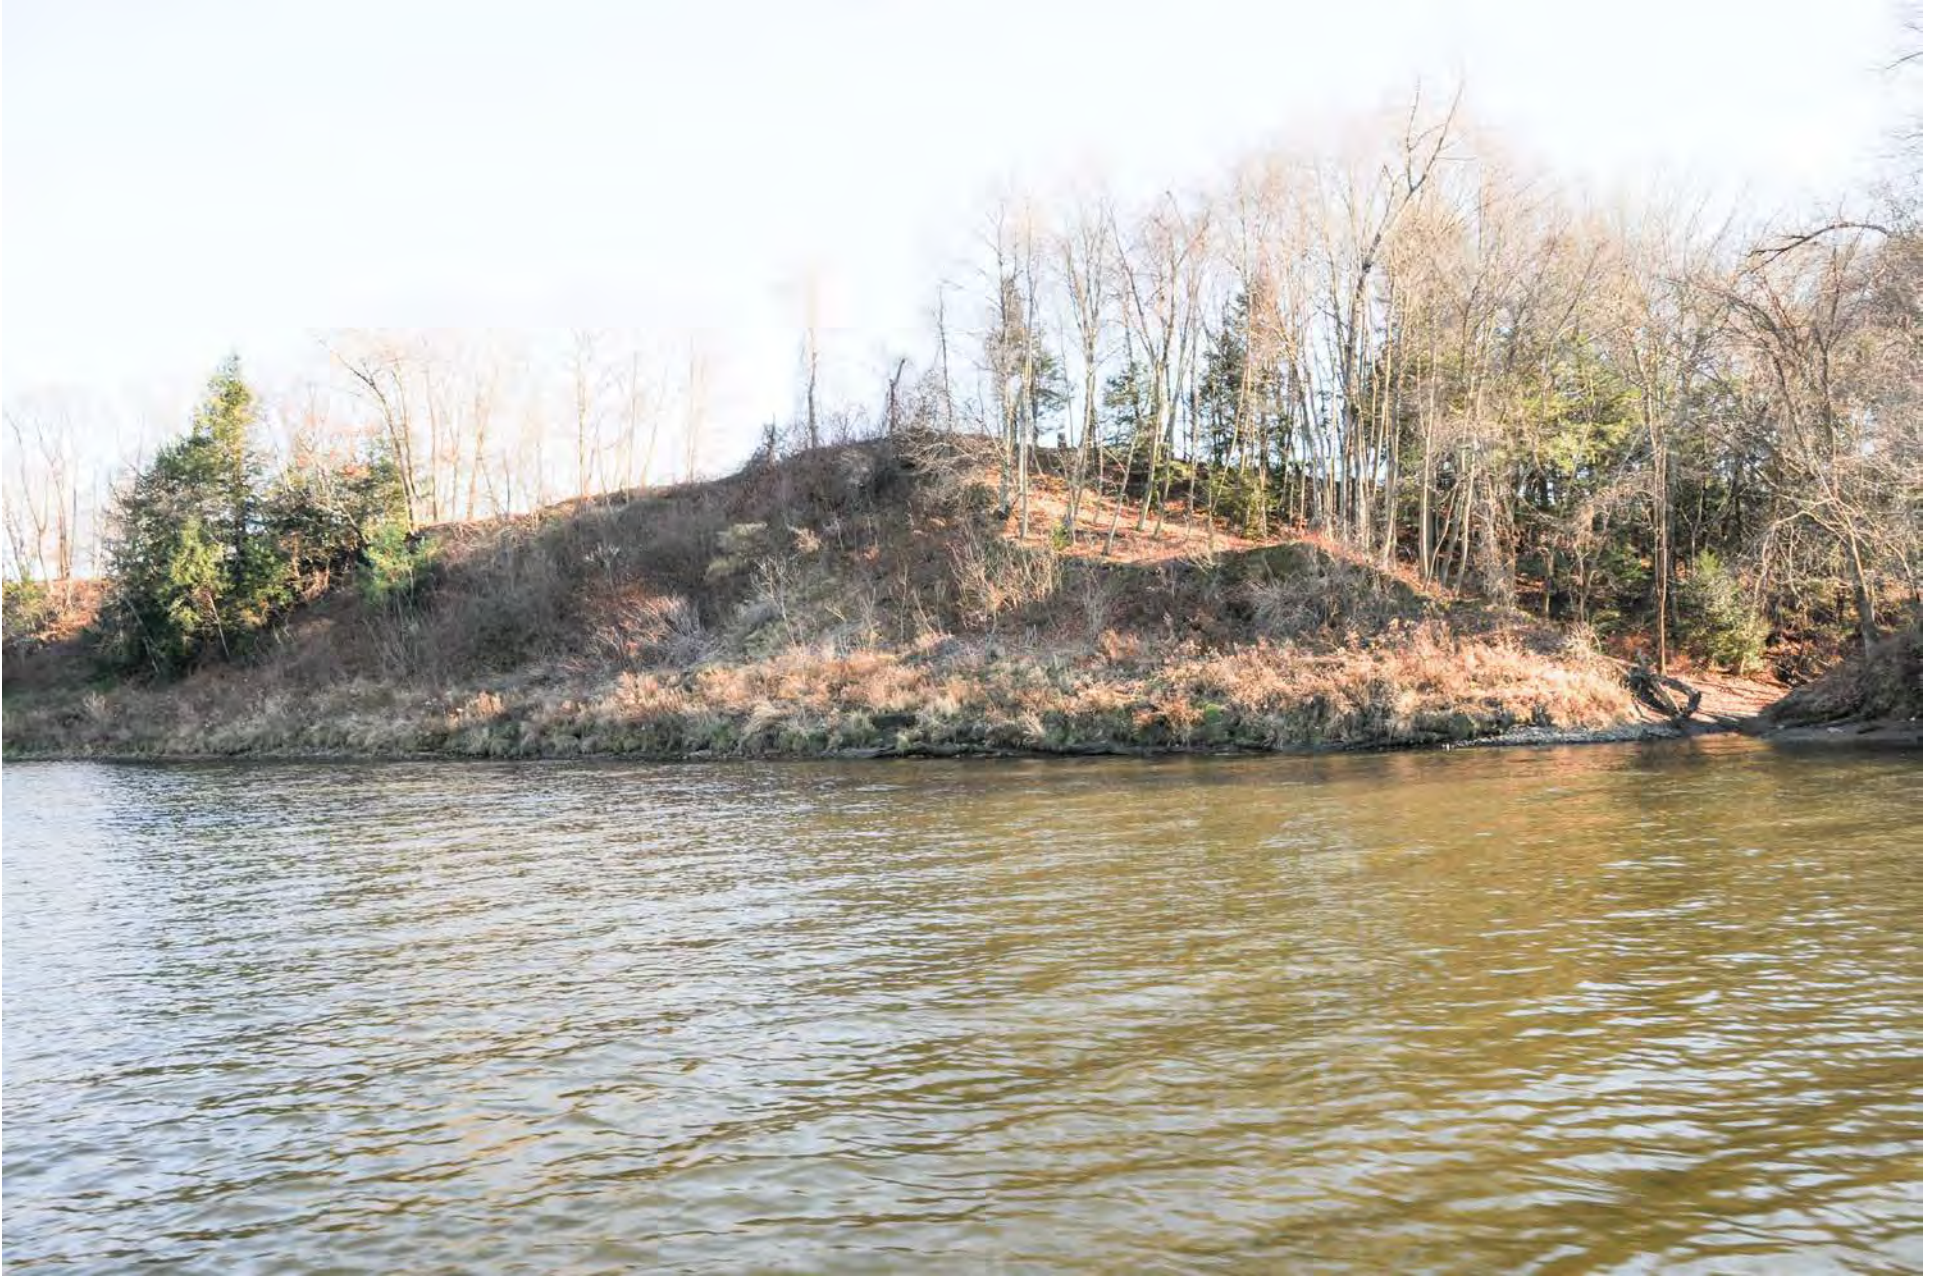
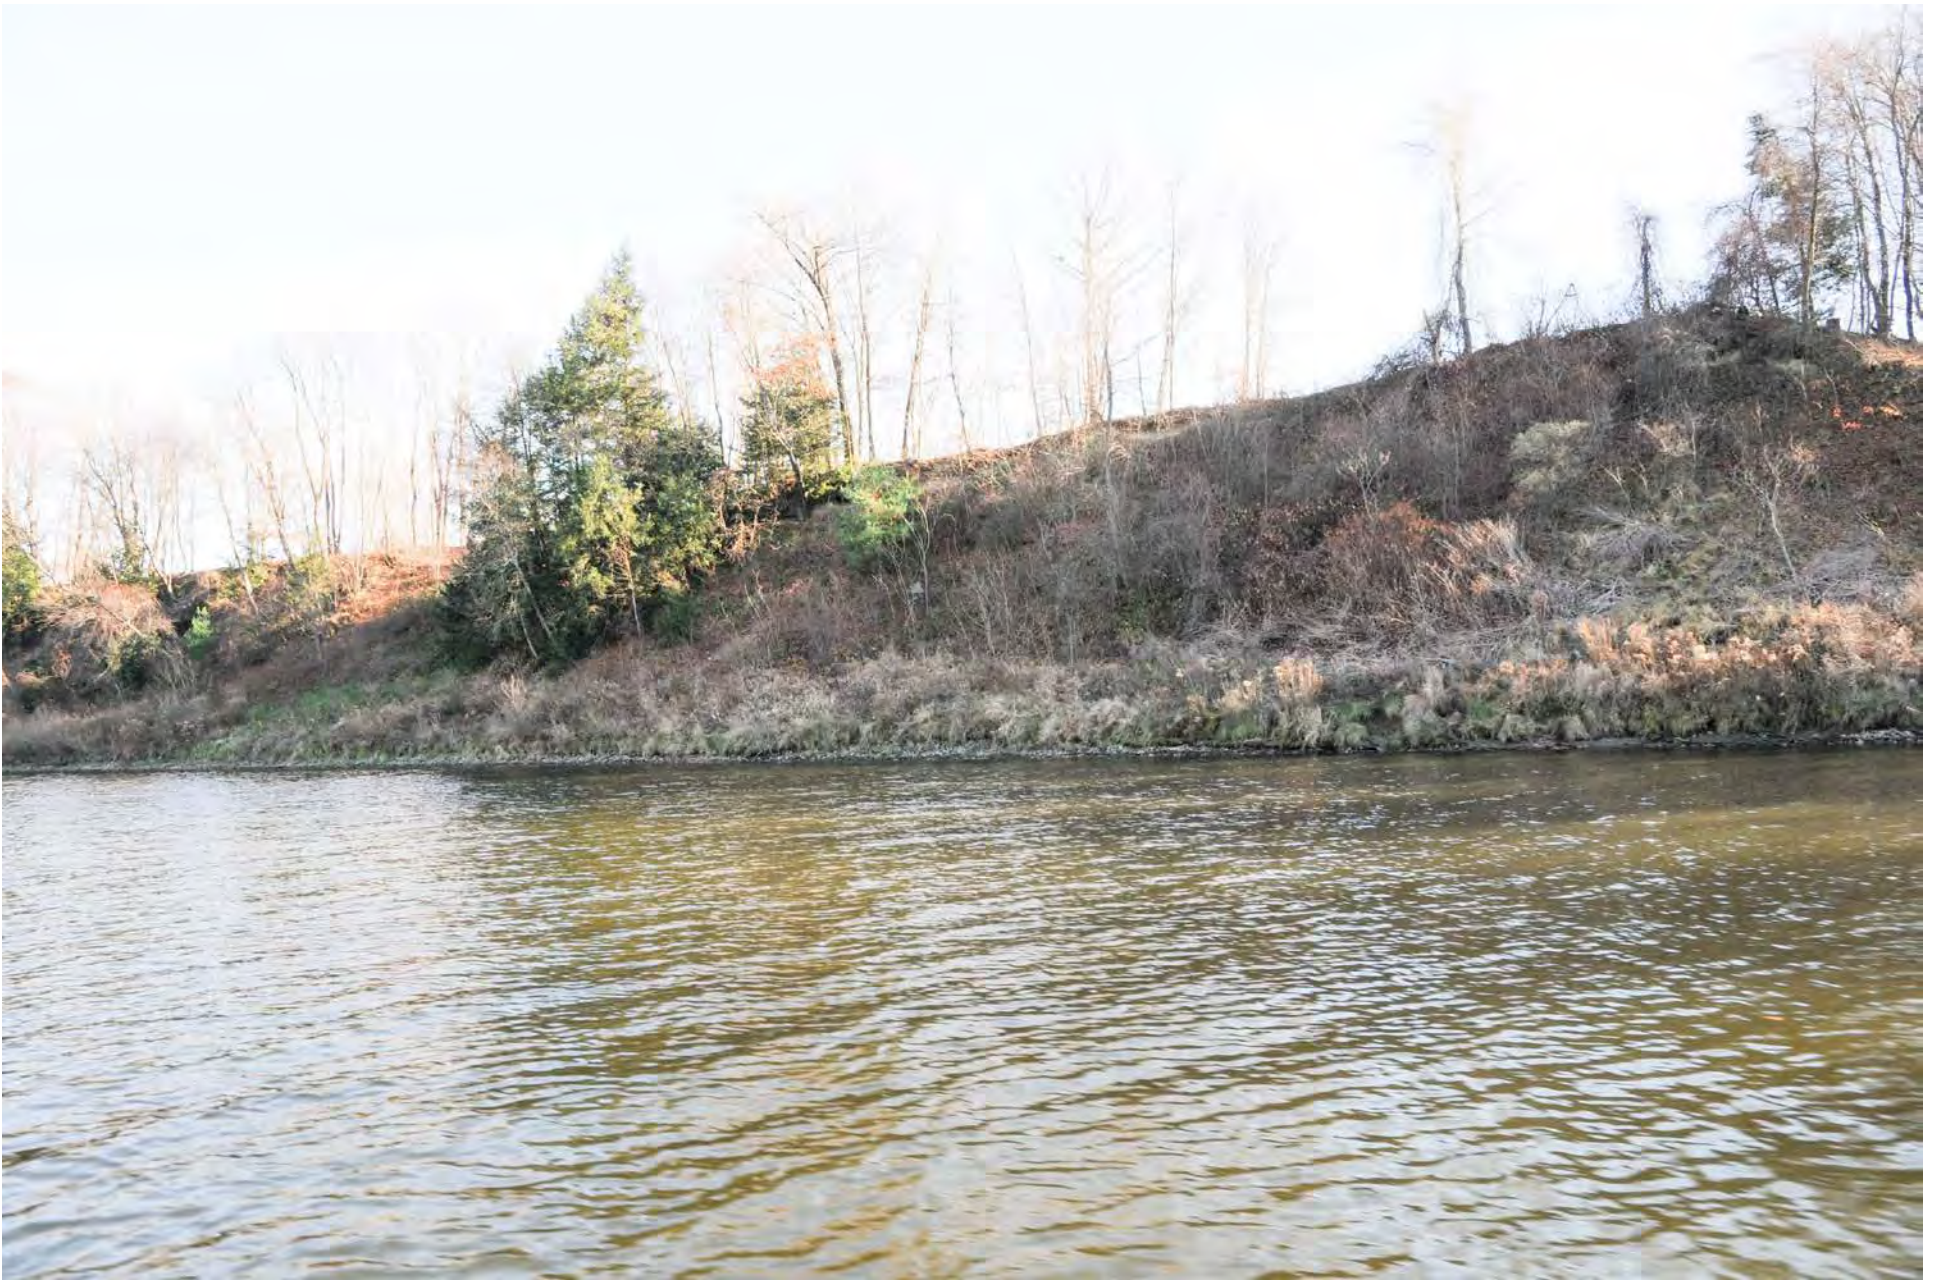
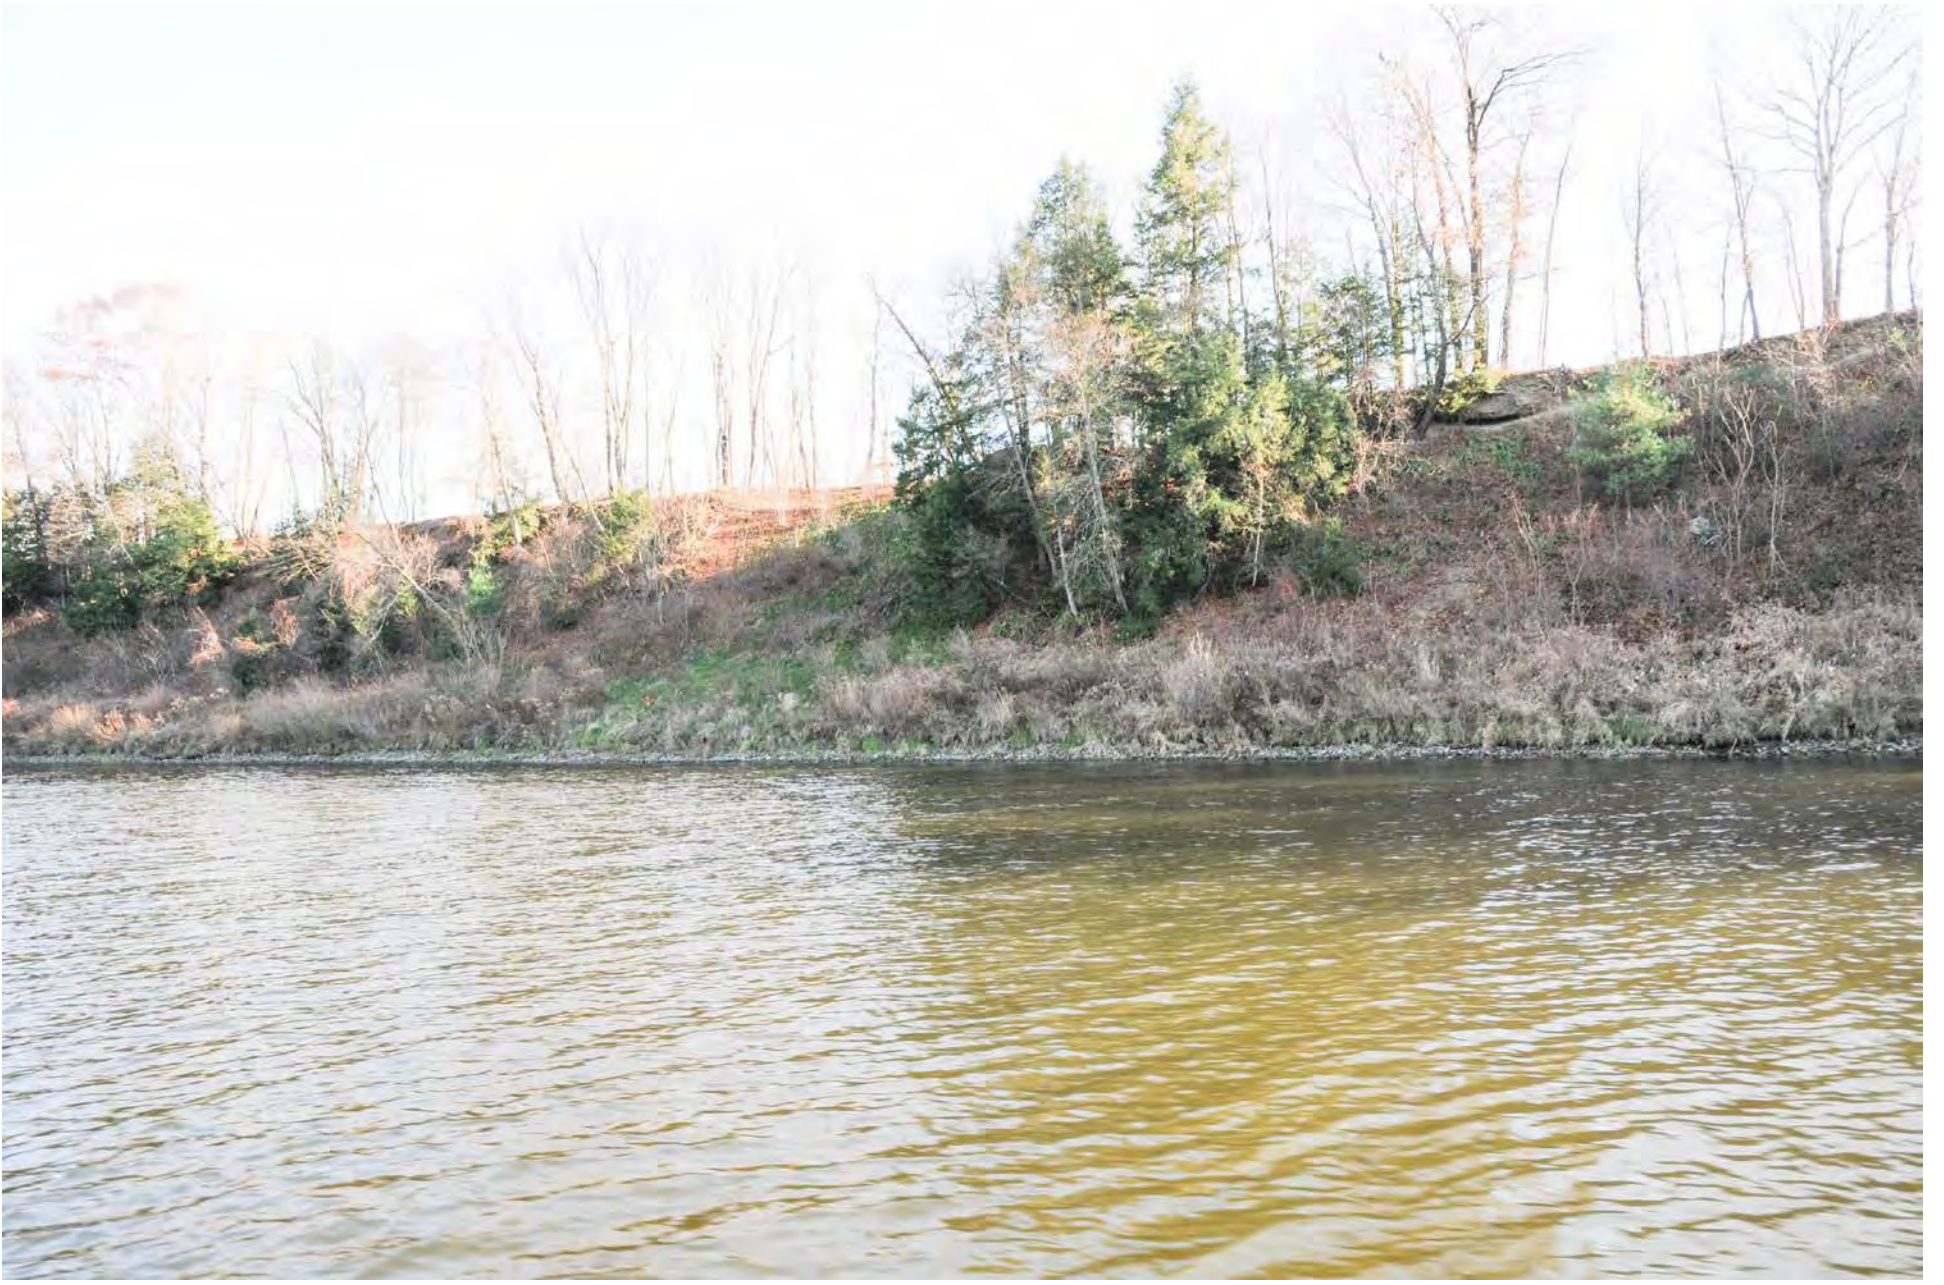
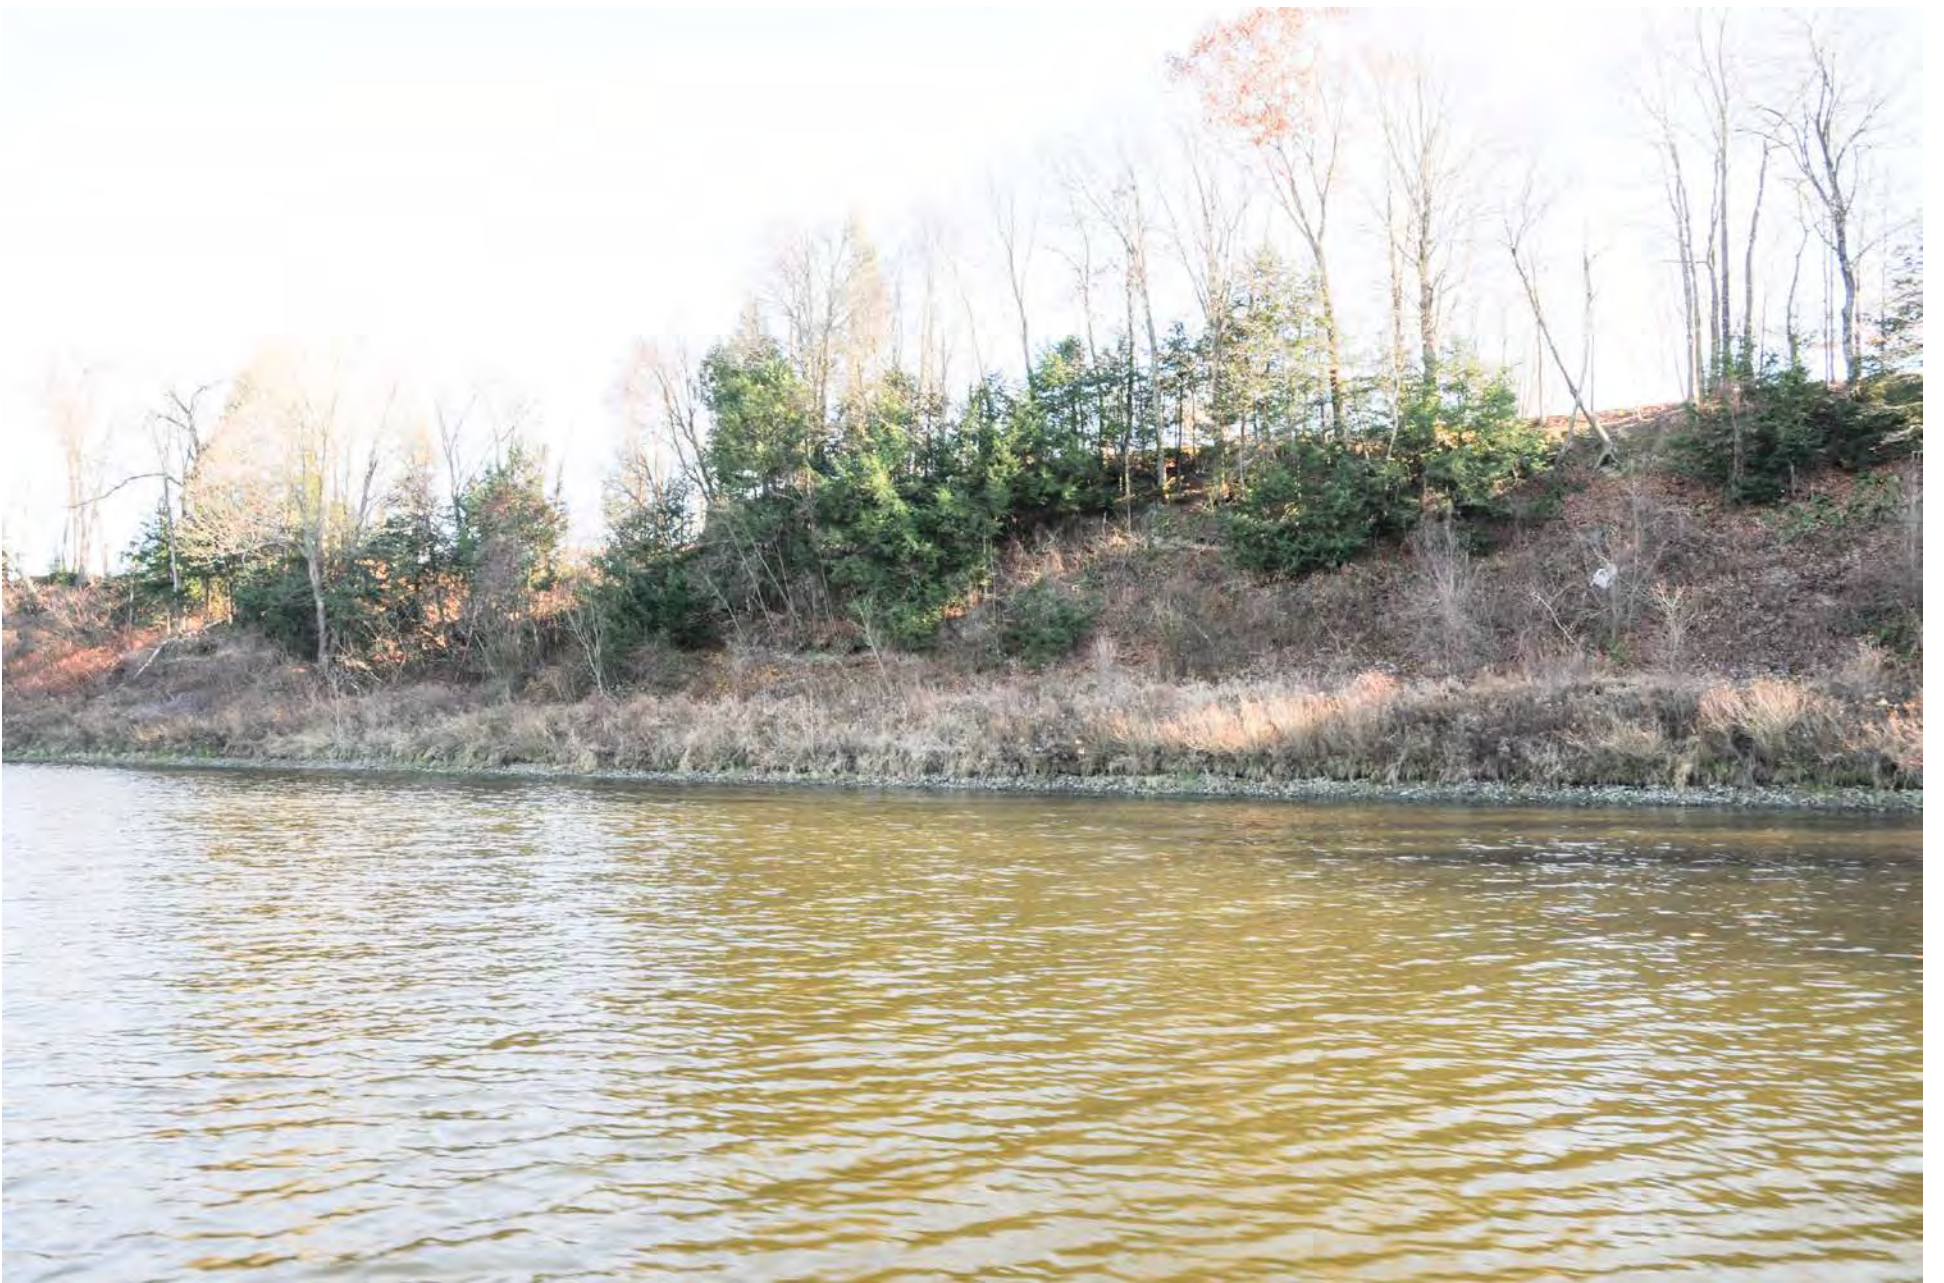
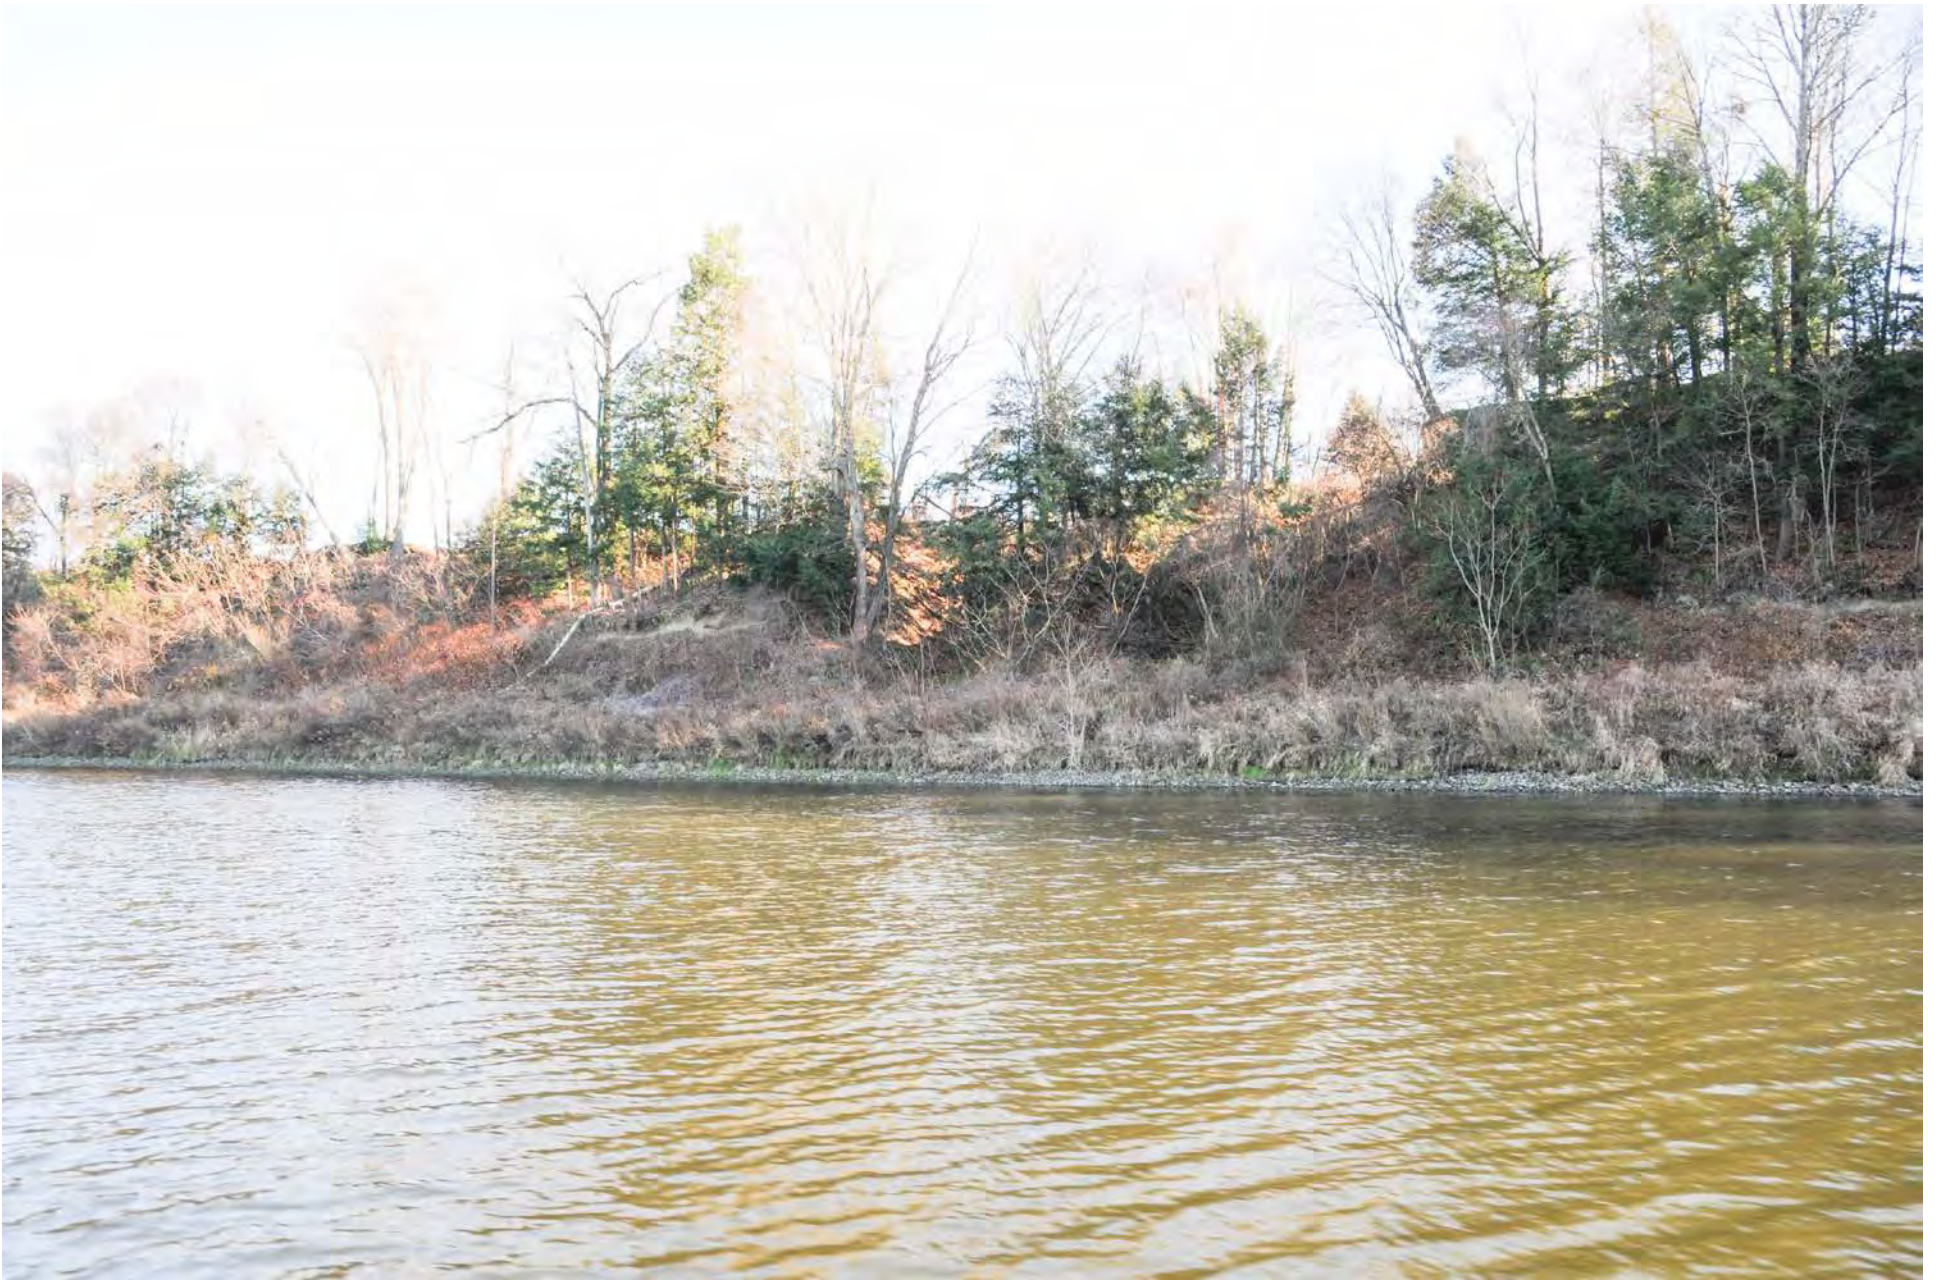
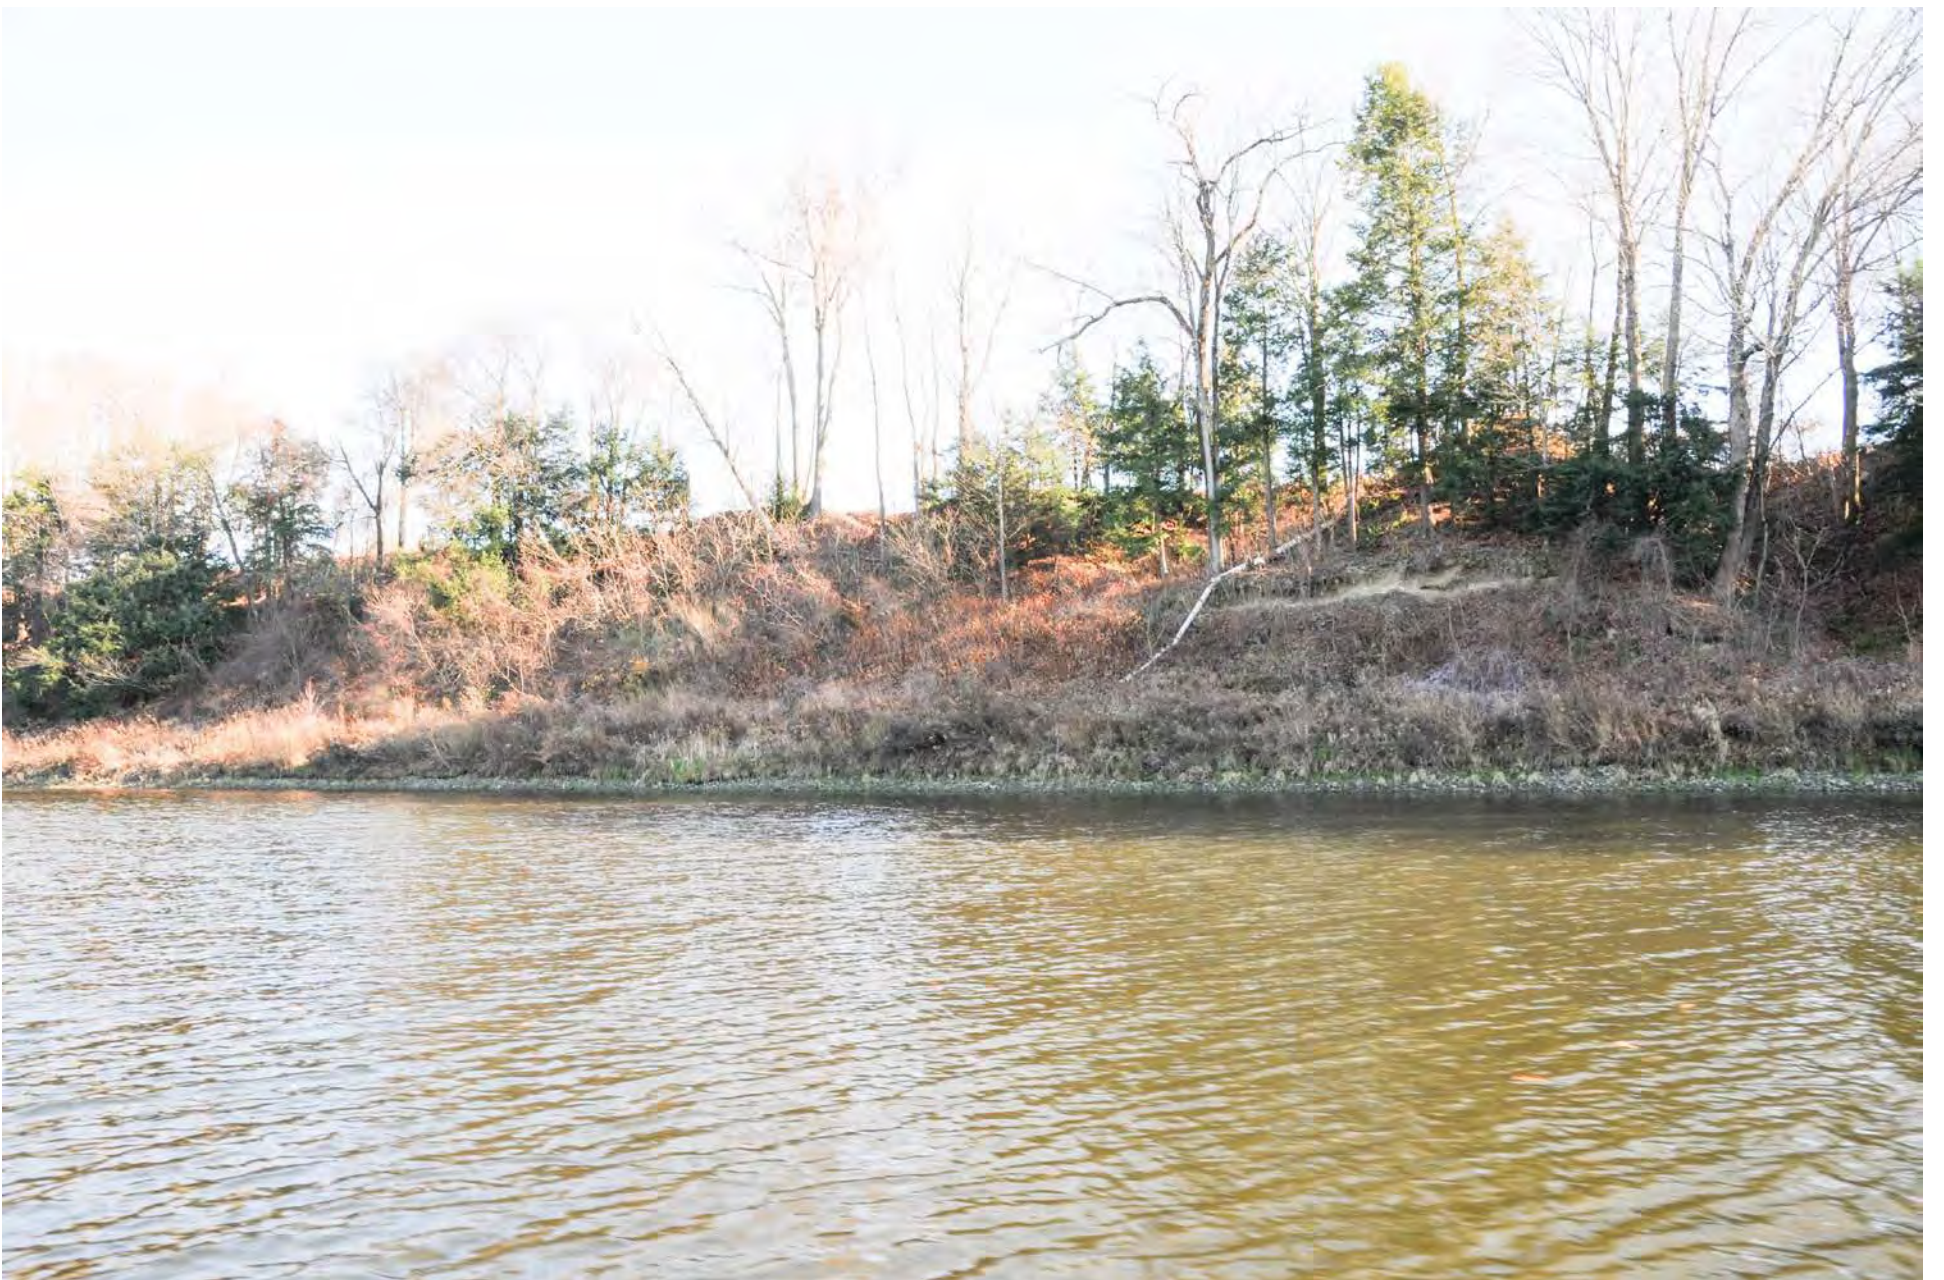
Riverbank Features	Characteristics
Upper Riverbank Slope	Moderate
Upper Riverbank Height	High
Upper Riverbank Sediment	Silt/Sand
Upper Riverbank Vegetation	Heavy
Lower Riverbank Slope	Moderate
Lower Riverbank Sediment	Cobbles
Lower Riverbank Vegetation	None to very sparse
Type of Erosion	
Potential Erosion Indicators	None
Stage of Erosion	Stable
Extent of Erosion	None/Little

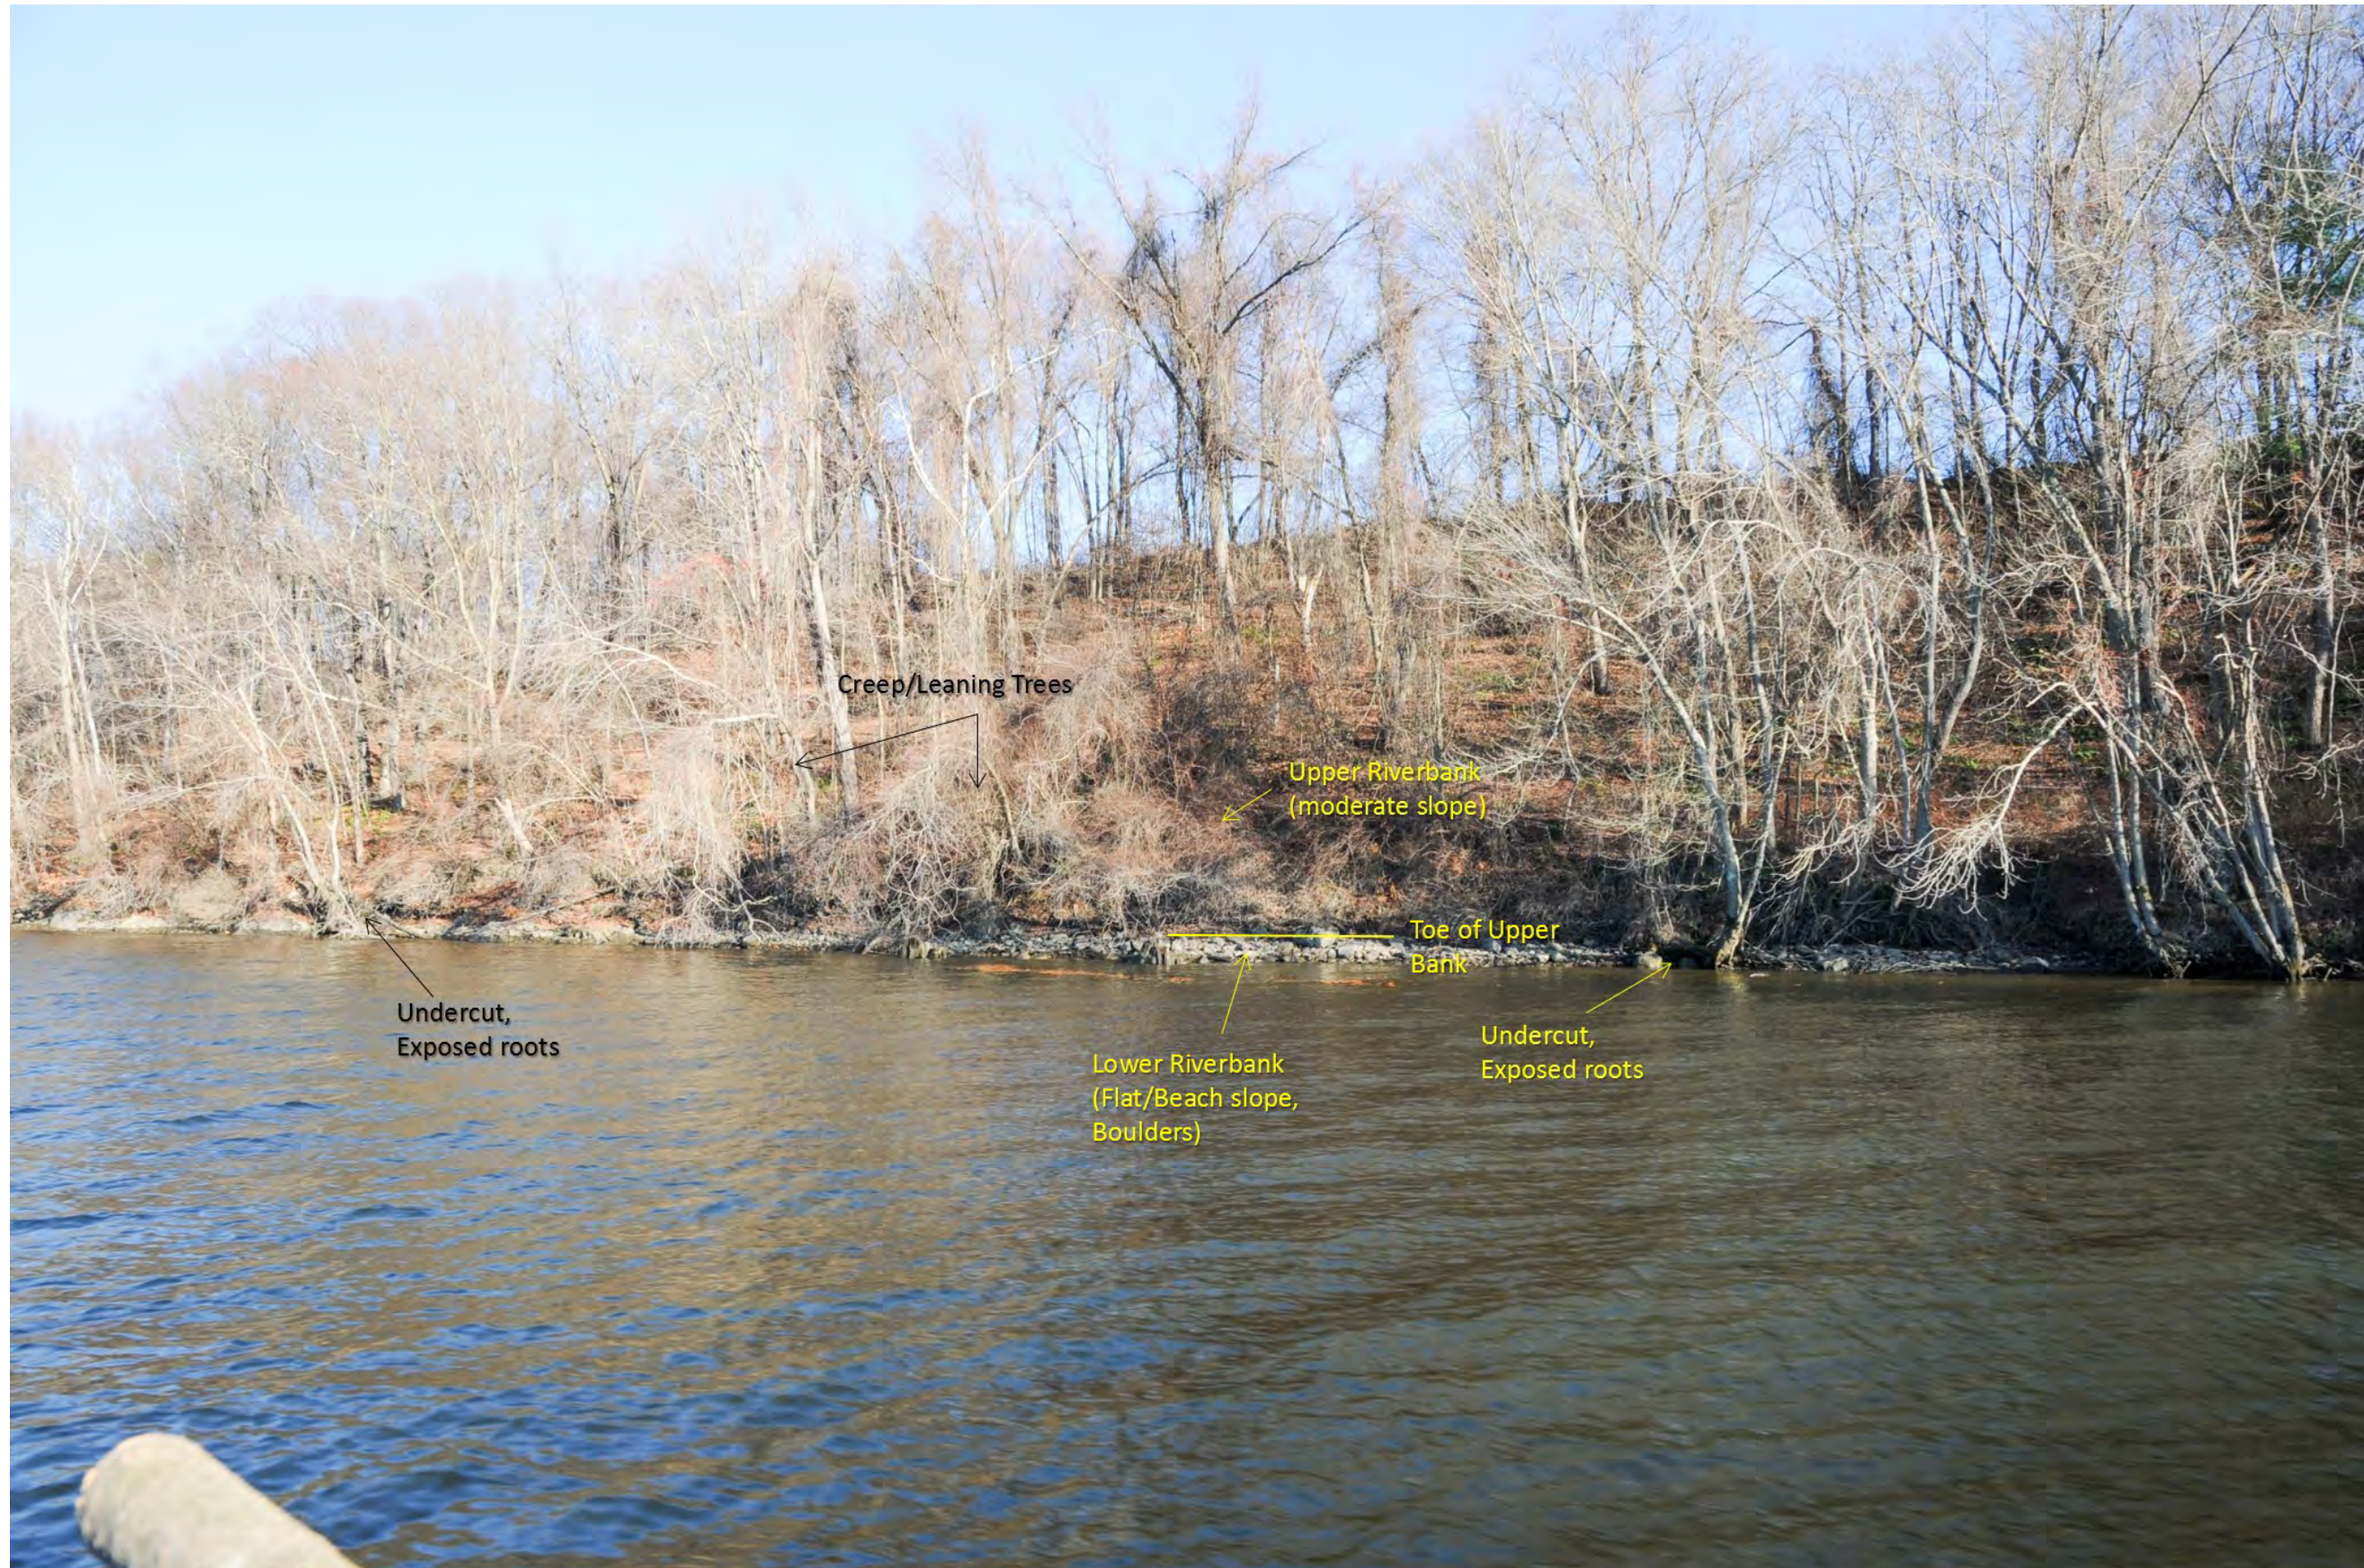
Photo ID 717 (covers segment)

Riverbank Features	Characteristics
Upper Riverbank Slope	Moderate
Upper Riverbank Height	High
Upper Riverbank Sediment	Silt/Sand
Upper Riverbank Vegetation	Heavy
Lower Riverbank Slope	Flat/Beach
Lower Riverbank Sediment	Boulders
Lower Riverbank Vegetation	None to very sparse
Type of Erosion	Undercut
Potential Erosion Indicators	Exposed roots, Creep/leaning trees
Stage of Erosion	Stable
Extent of Erosion	None/Little

QA Observations: Upon review of the photos for this segment, classification made in the field was confirmed and additional indicators of potential future erosion were included.
