Segment 90 – Left Bank

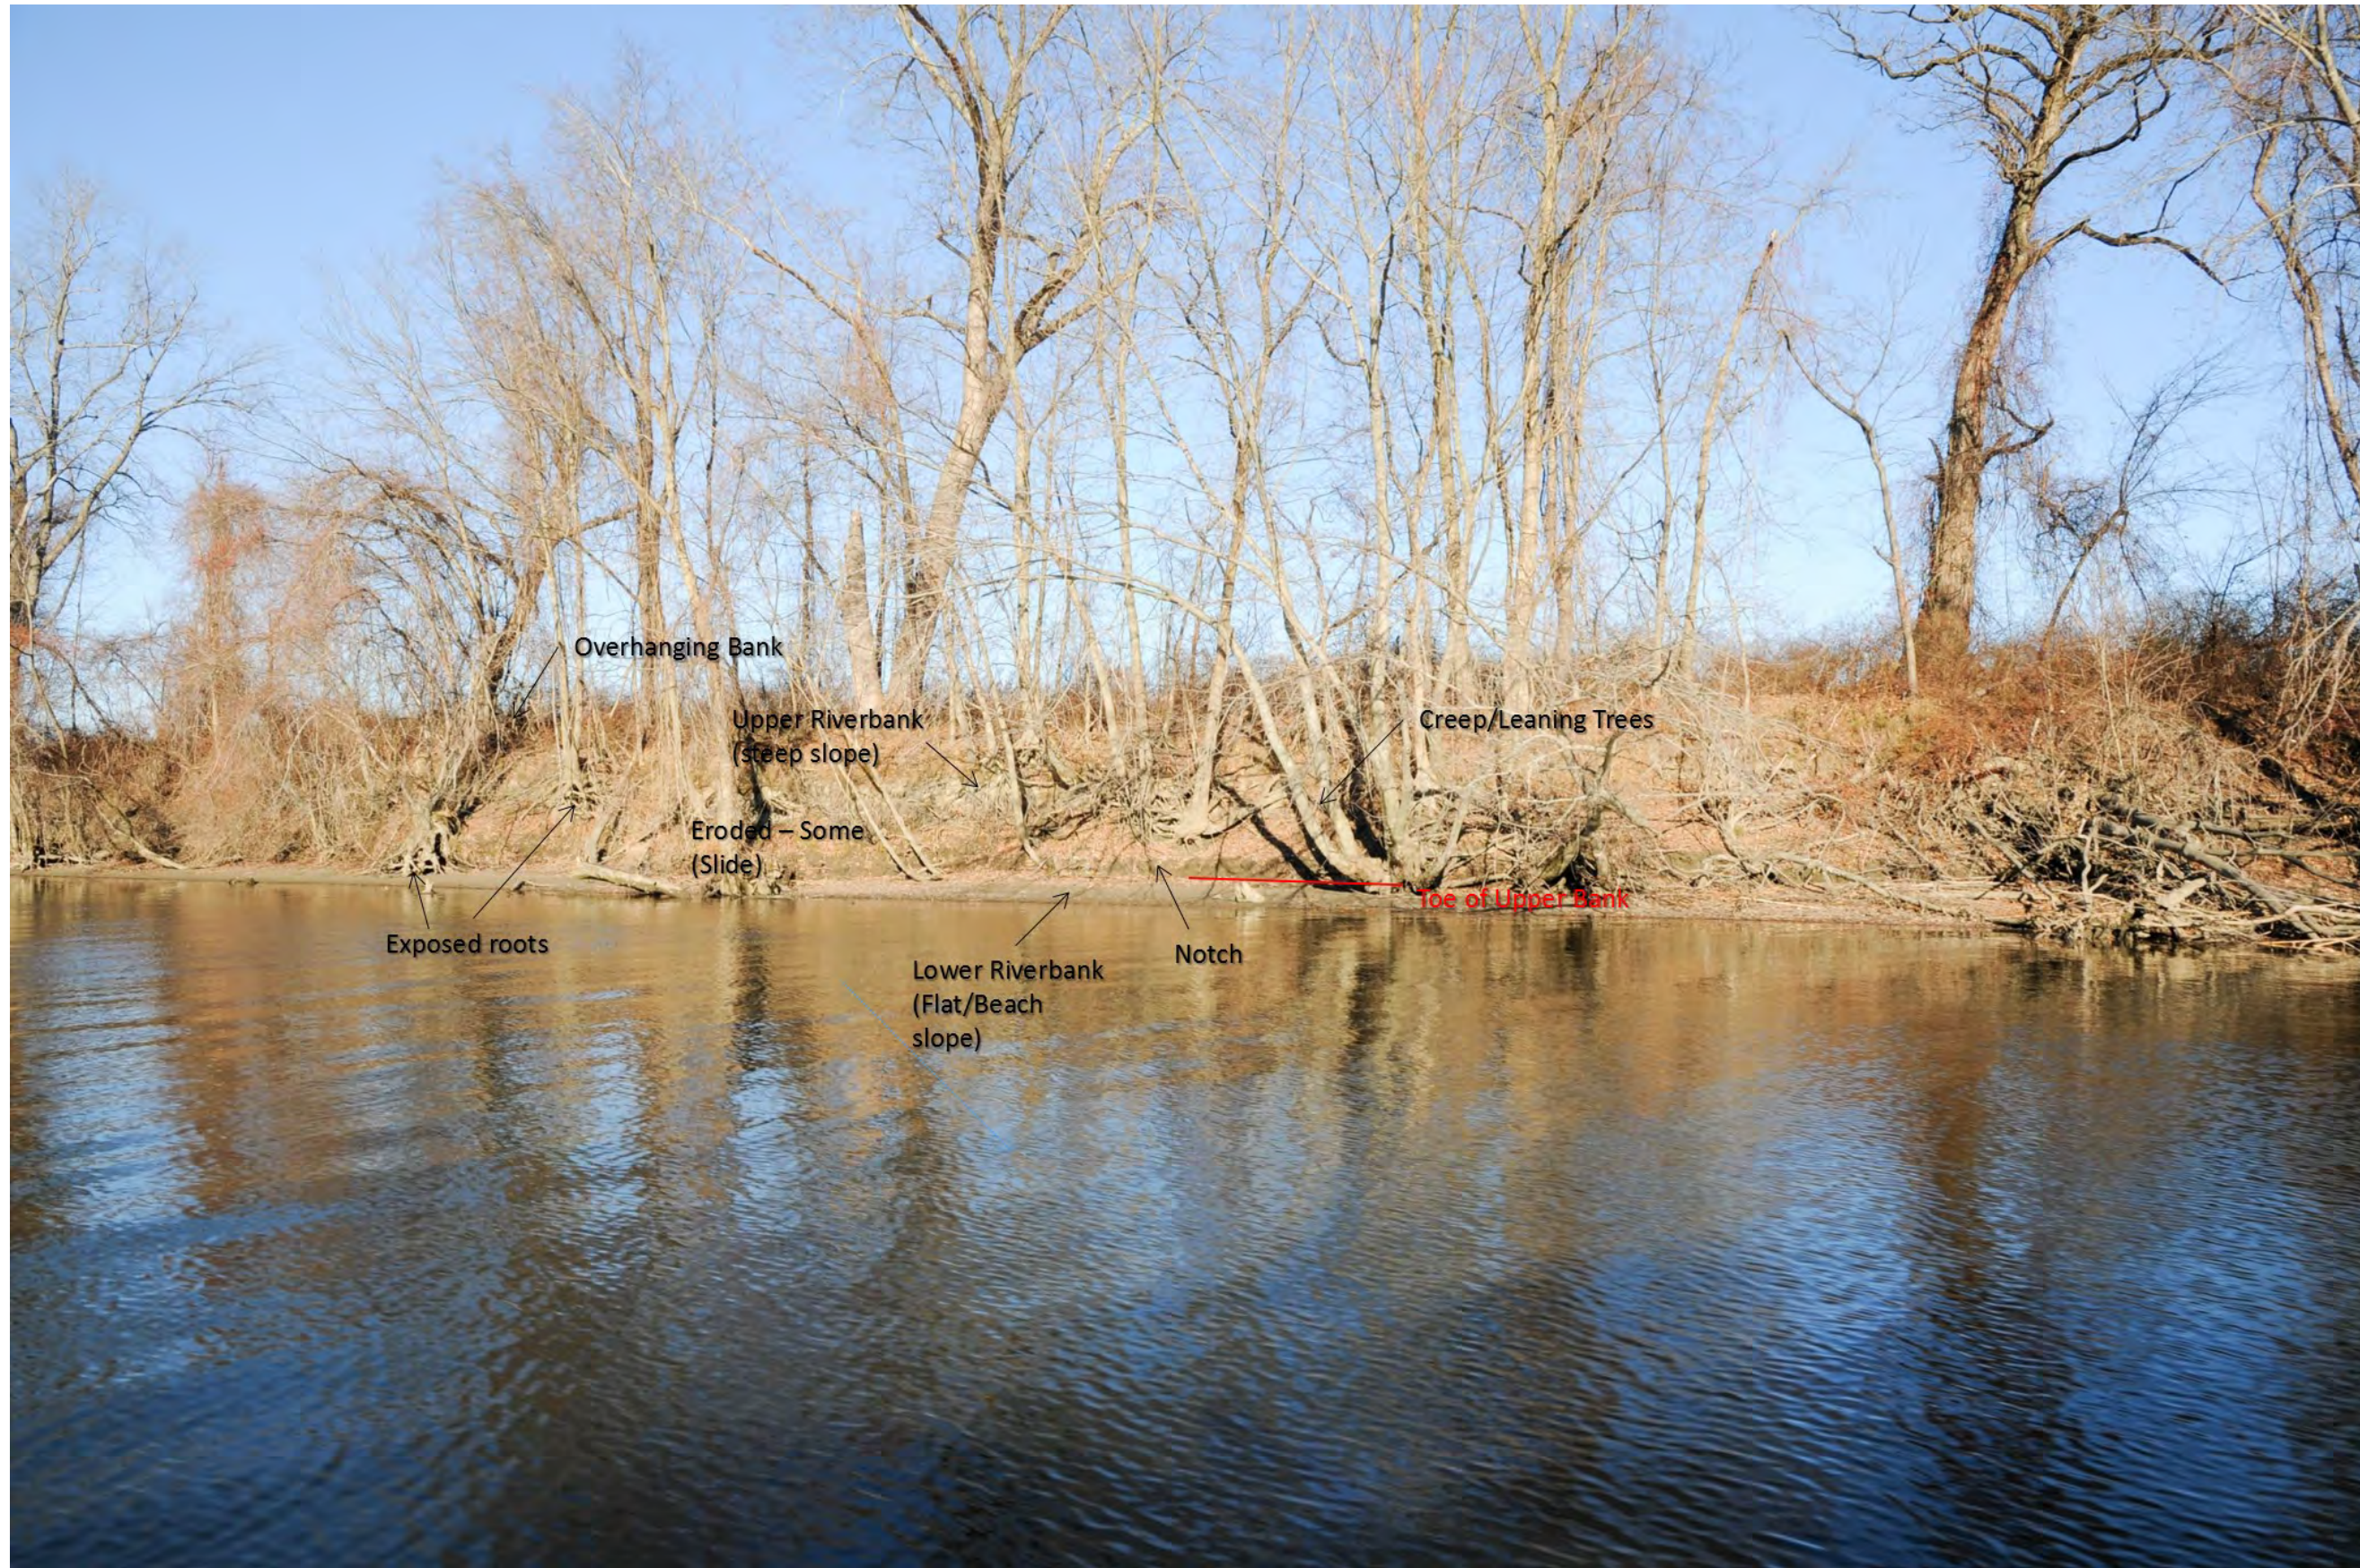
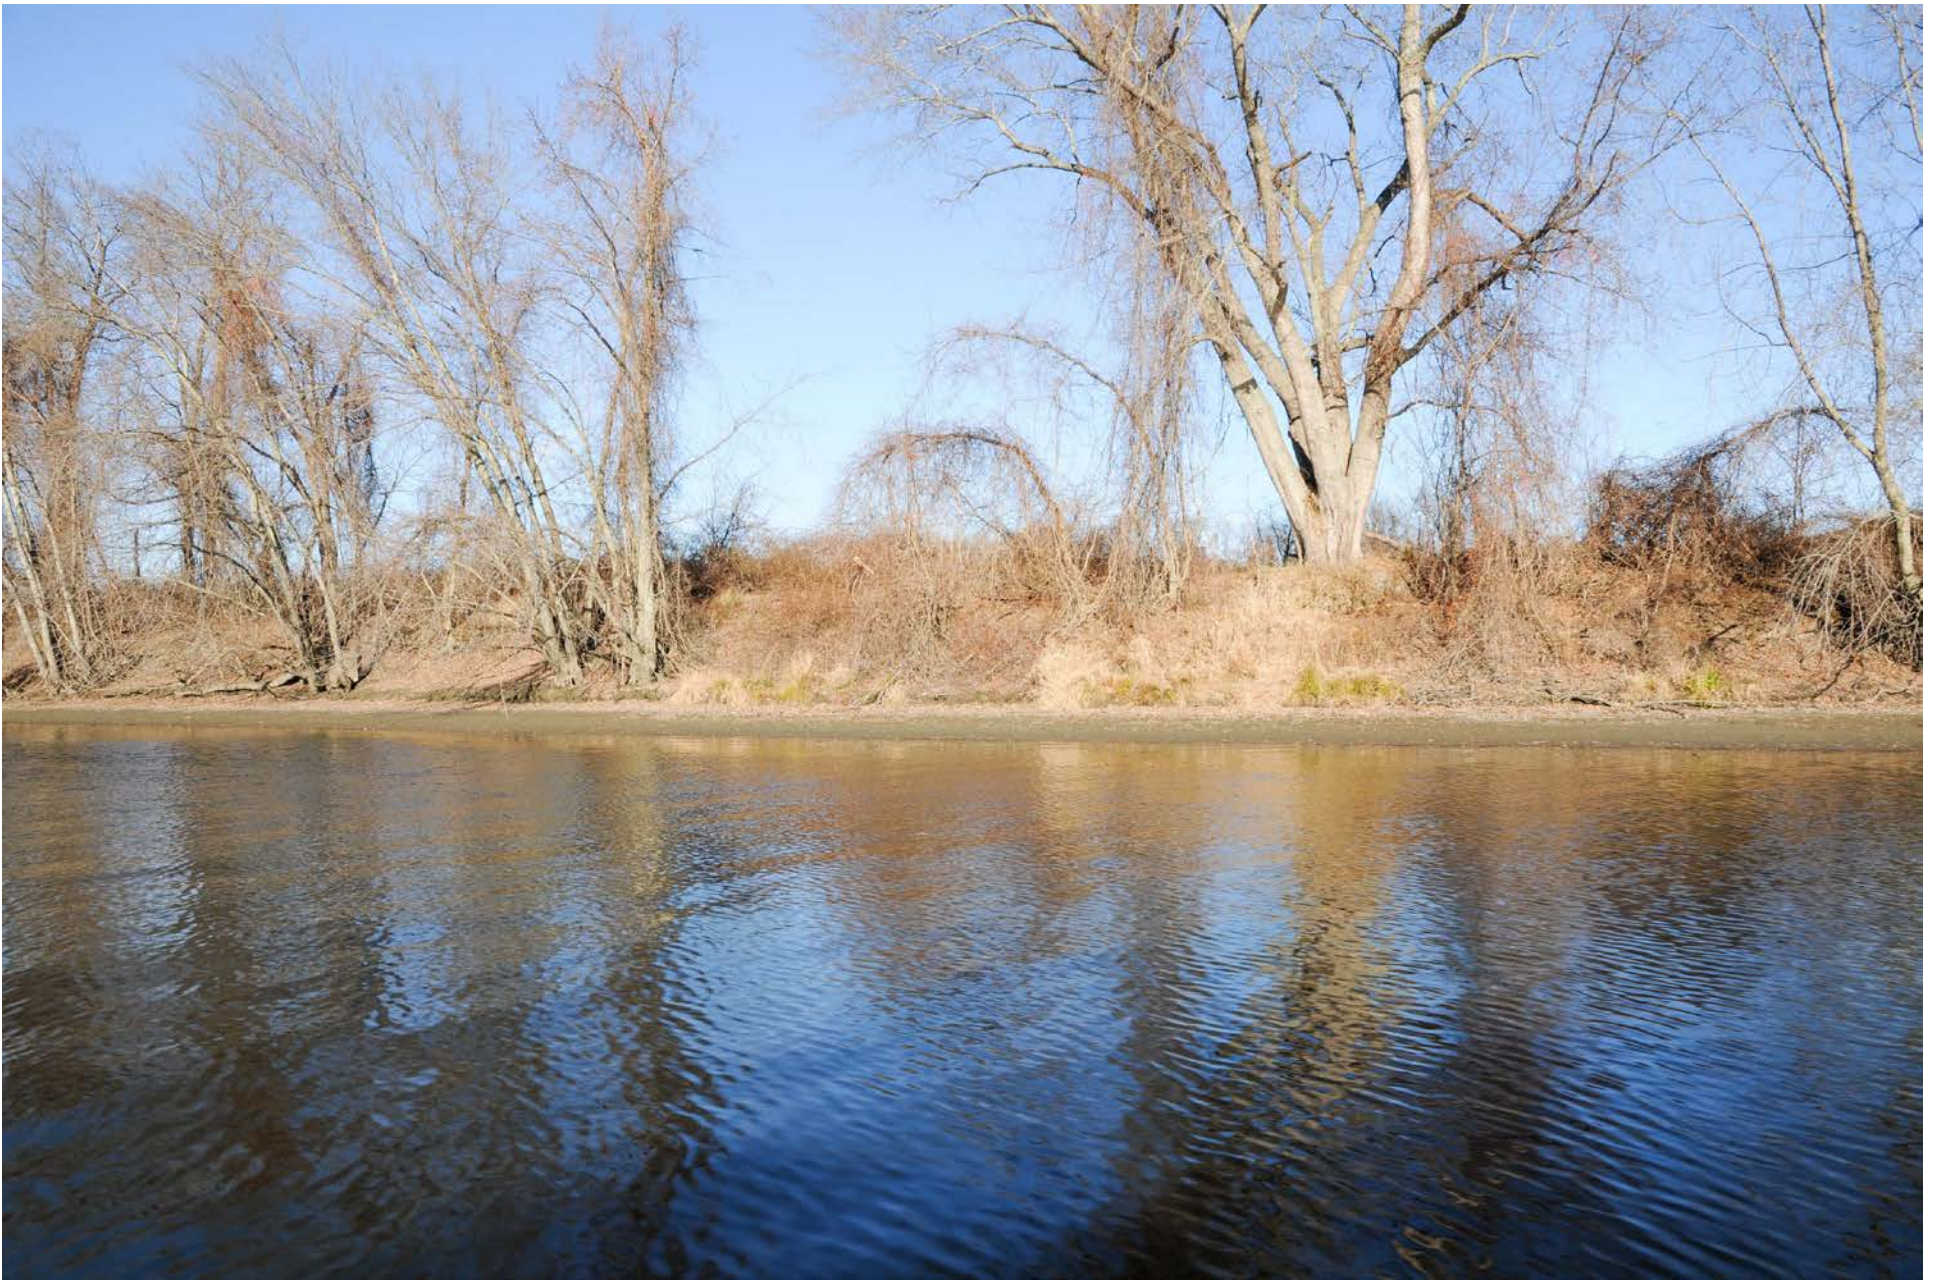
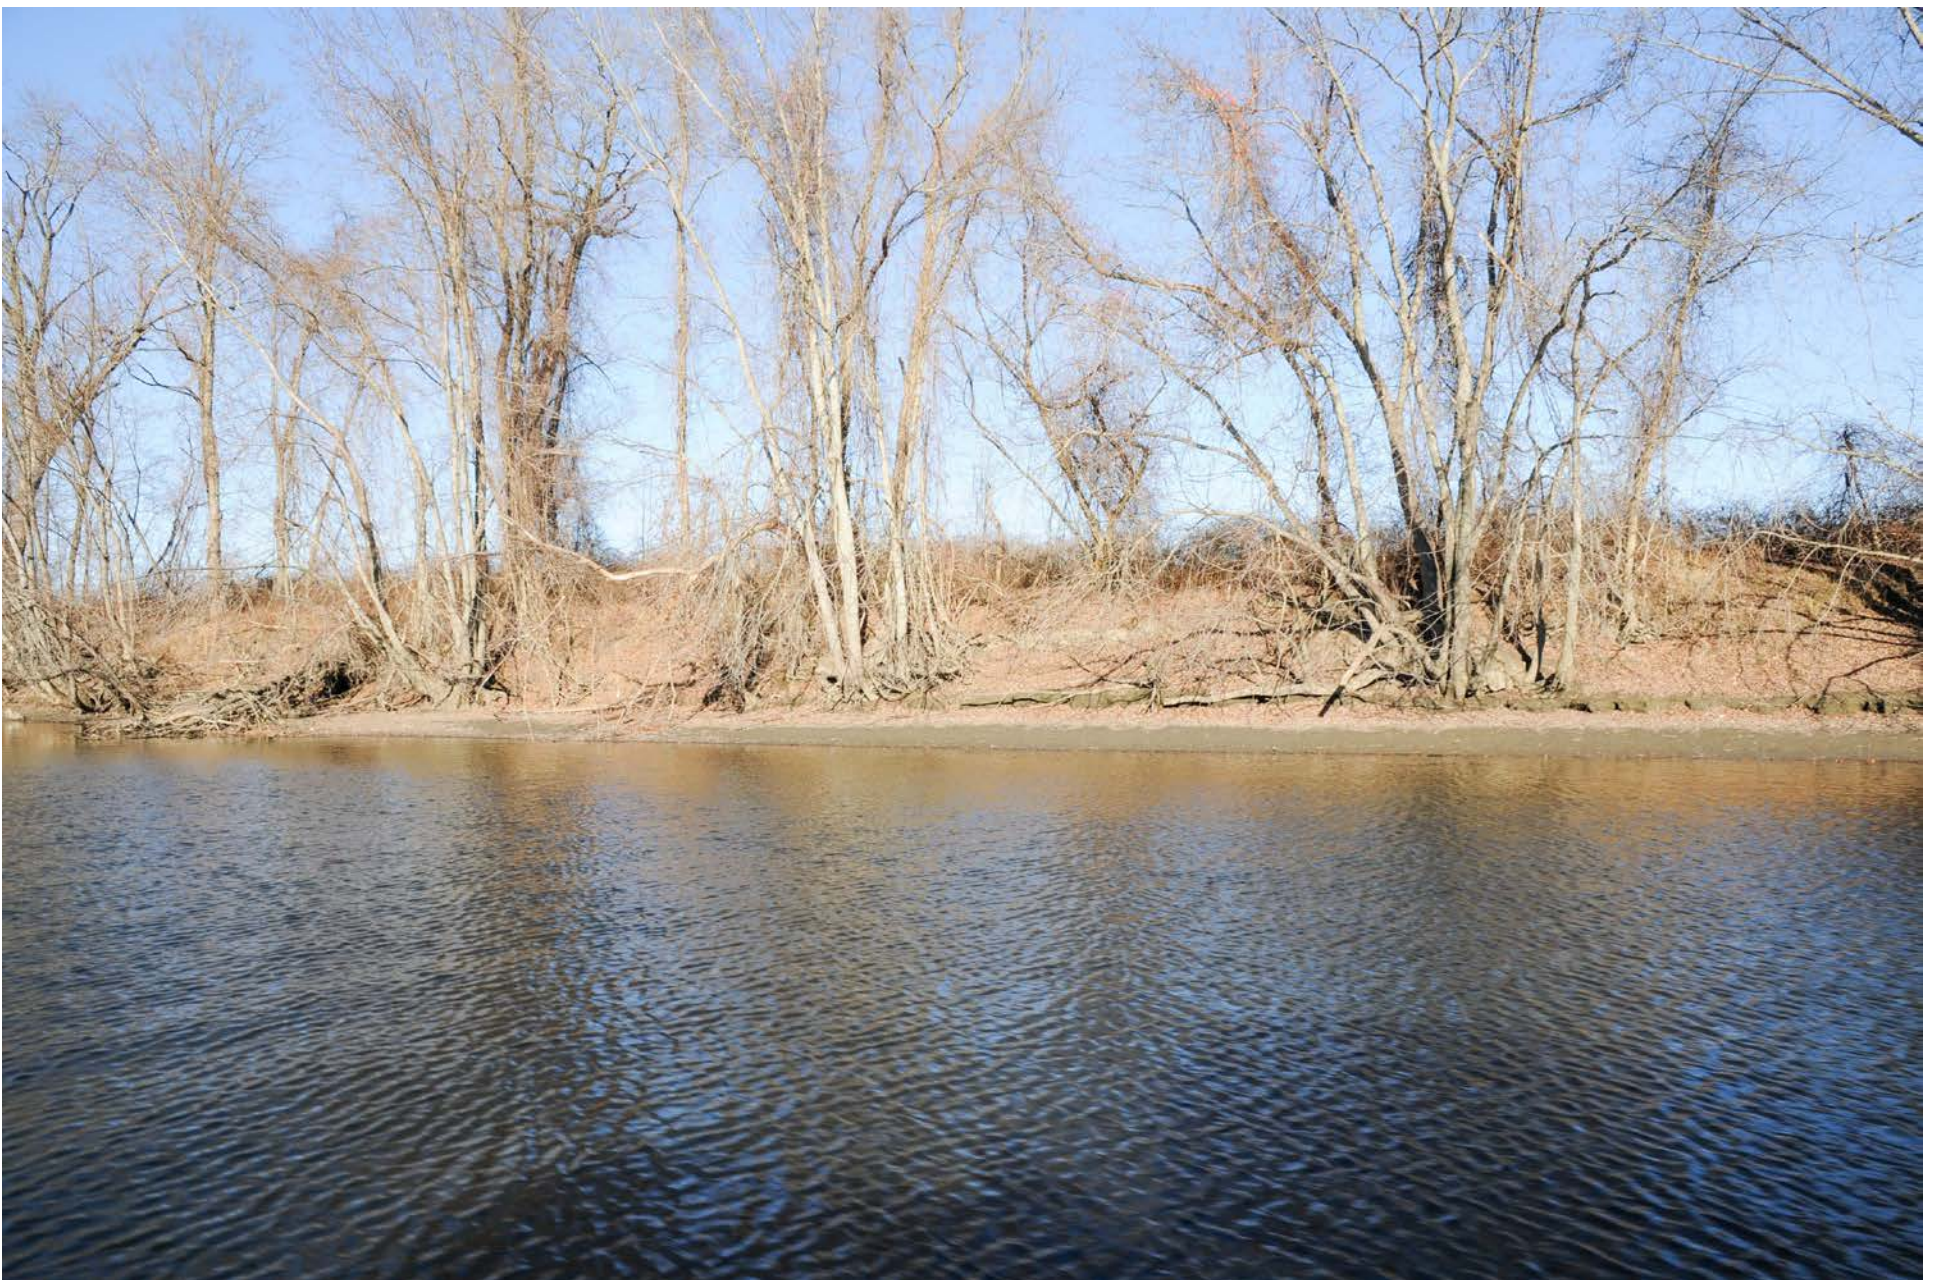
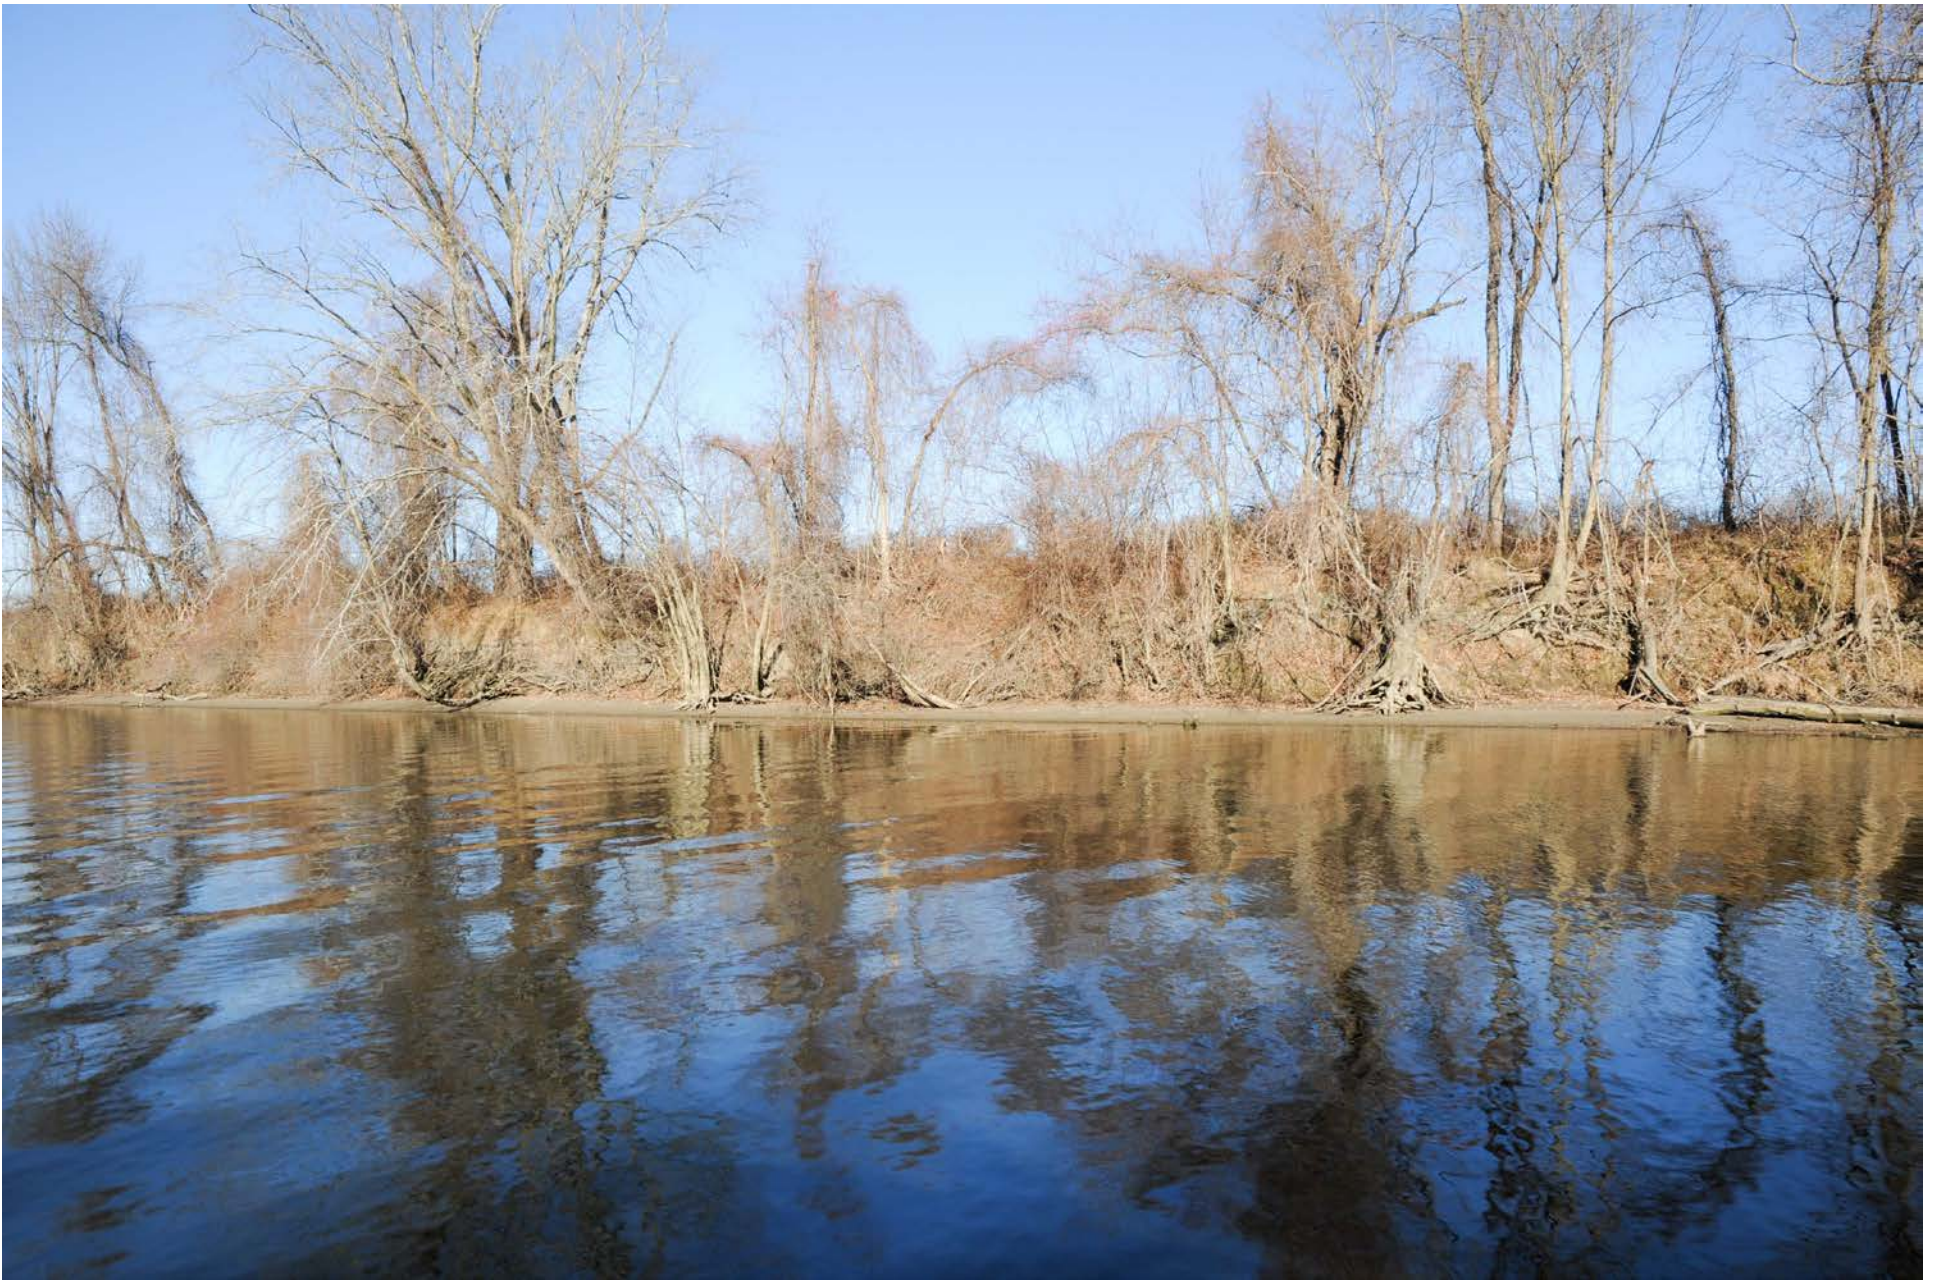
Riverbank Features	Characteristics
Upper Riverbank Slope	Steep
Upper Riverbank Height	High
Upper Riverbank Sediment	Silt/Sand
Upper Riverbank Vegetation	Heavy
Lower Riverbank Slope	Flat/Beach
Lower Riverbank Sediment	Silt/Sand
Lower Riverbank Vegetation	None to very sparse
Type of Erosion	Slide
Potential Erosion Indicators	Exposed roots, Creep/leaning trees, Overhanging bank, Notch
Stage of Erosion	Eroded
Extent of Erosion	Some

QA Observations: Upon review of the photos for this segment, classification made in the field was confirmed and additional indicators of potential future erosion were included.

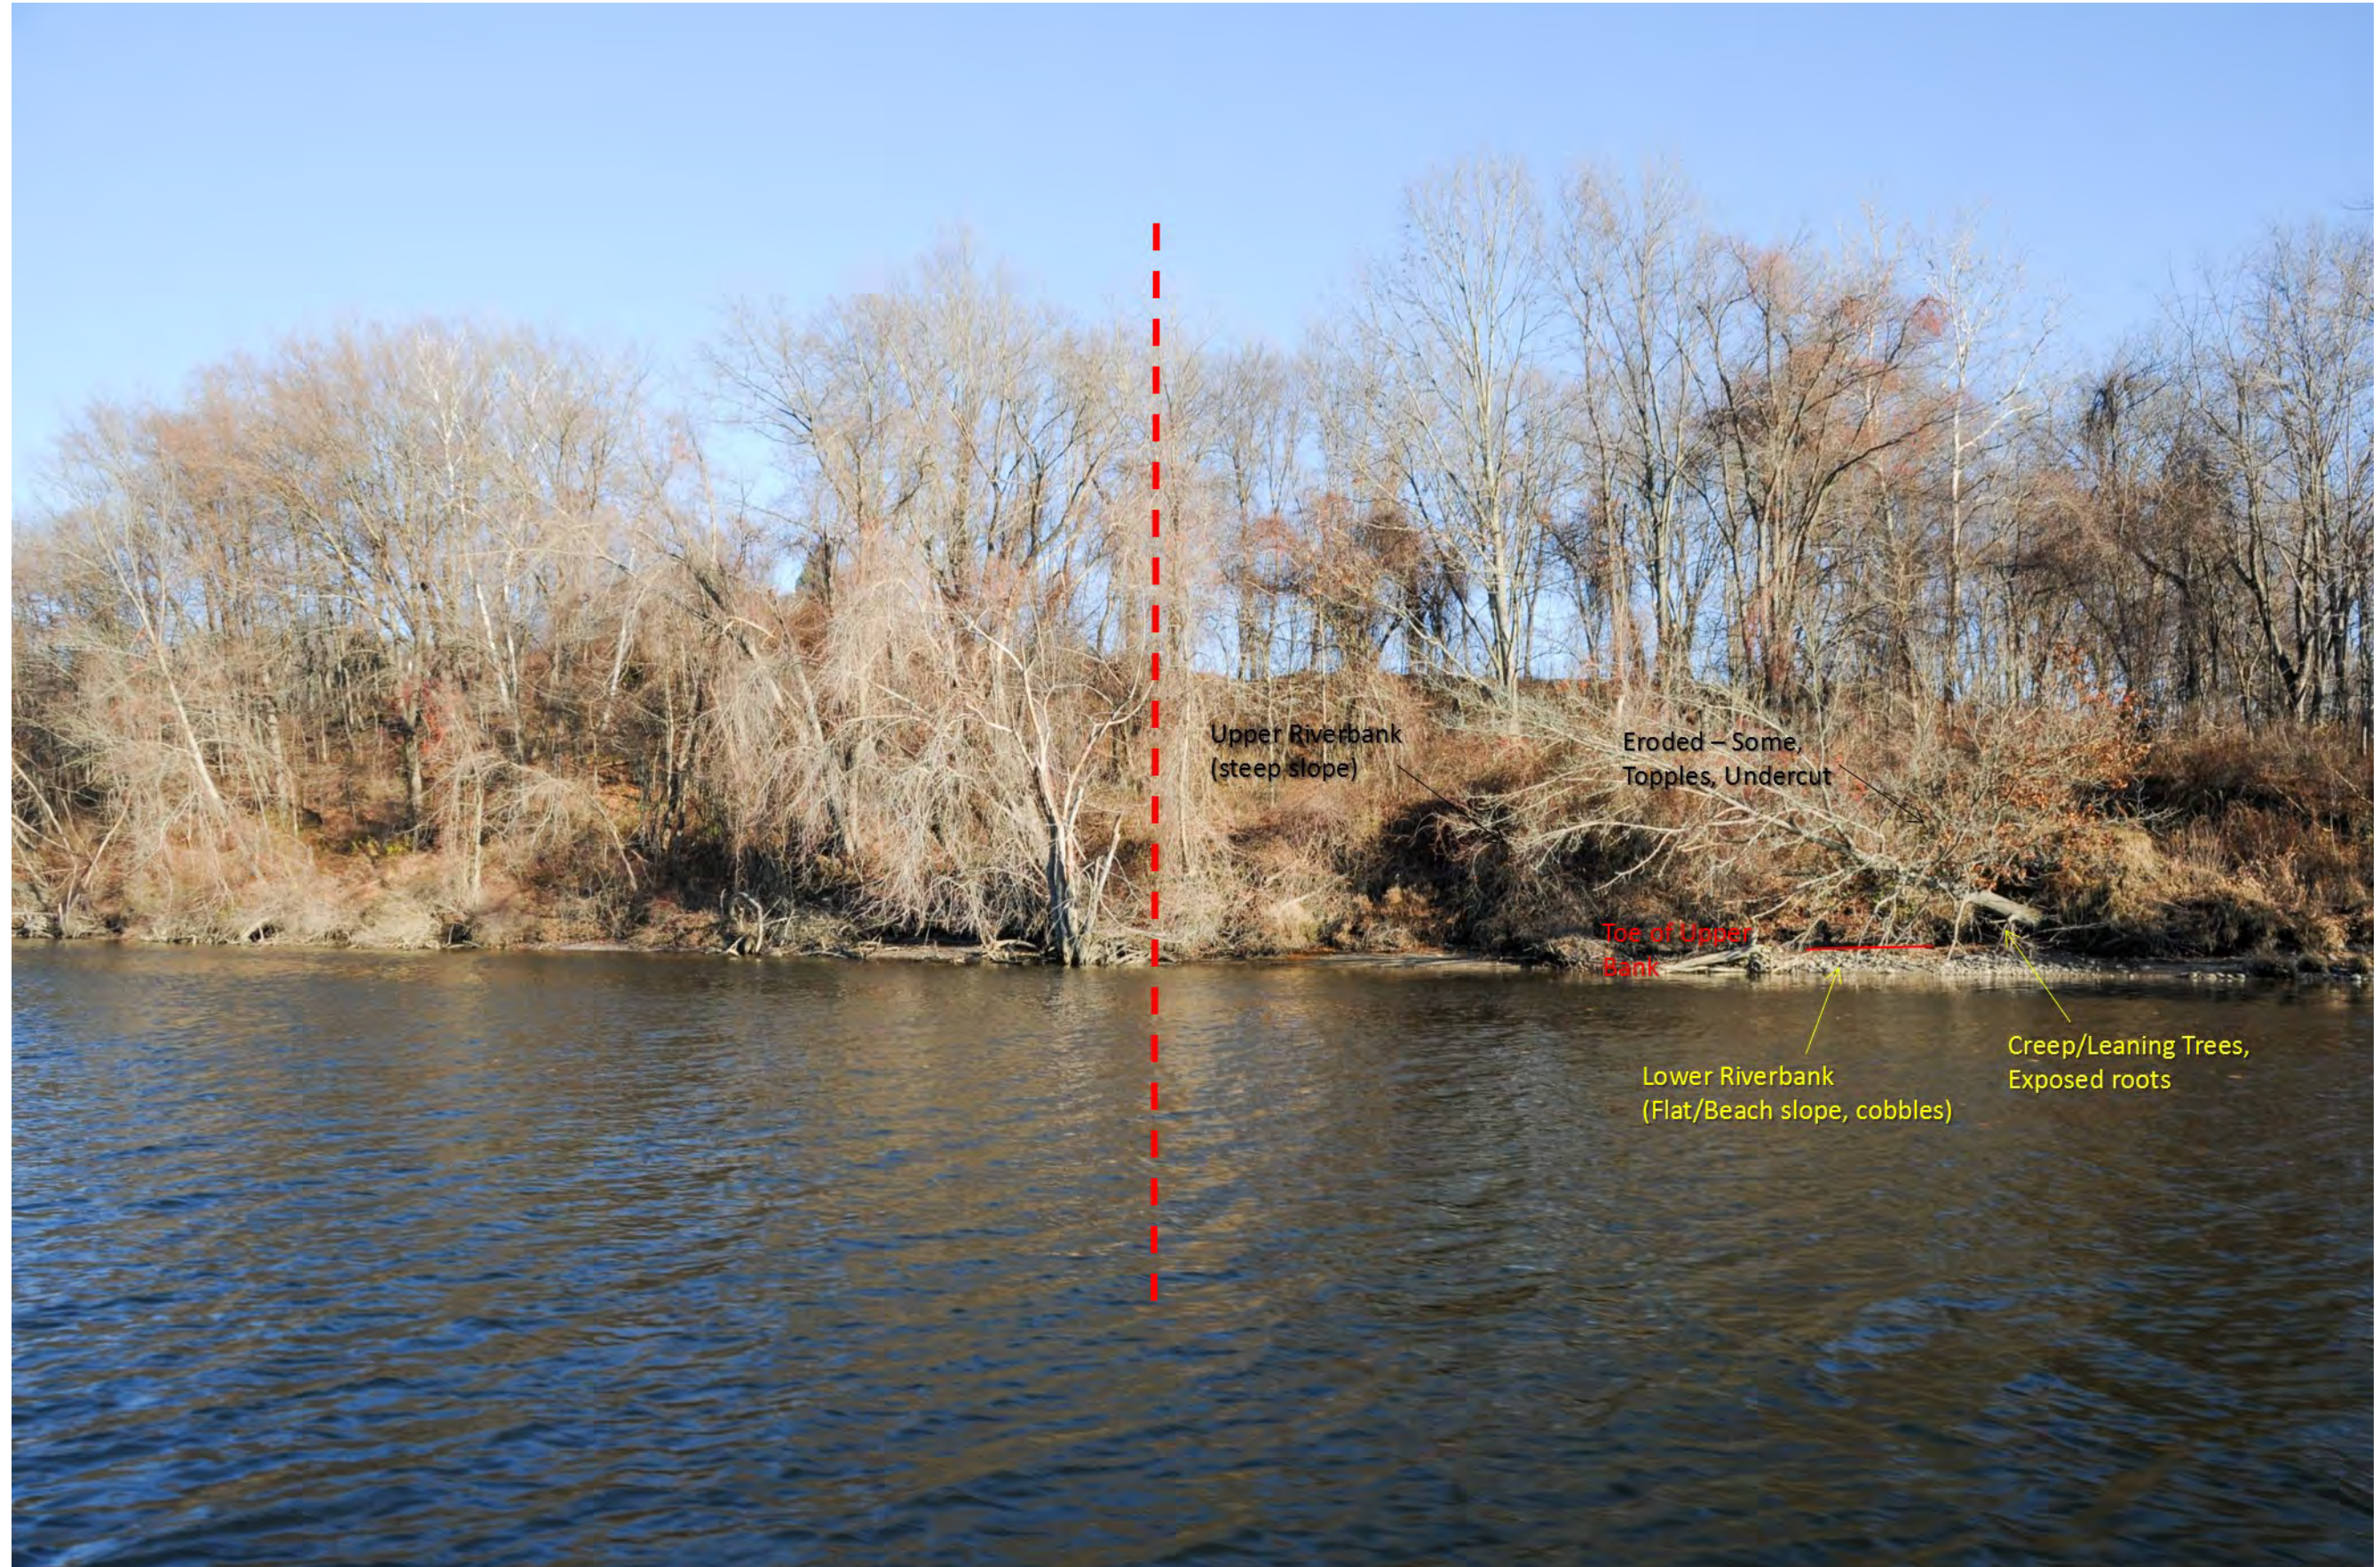
Photo ID 765 (segment is in right, D/S side of photograph. Dashed line represents approximate end of segment)

Riverbank Features	Characteristics
Upper Riverbank Slope	Steep
Upper Riverbank Height	High
Upper Riverbank Sediment	Silt/Sand
Upper Riverbank Vegetation	Heavy
Lower Riverbank Slope	Flat/Beach
Lower Riverbank Sediment	Cobbles
Lower Riverbank Vegetation	None to very sparse
Type of Erosion	Topples, Undercut
Potential Erosion Indicators	Creep/leaning trees, Exposed roots
Stage of Erosion	Eroded
Extent of Erosion	Some

QA Observations: Upon review of the photos for this segment, classification made in the field was confirmed and additional indicators of potential future erosion were included.

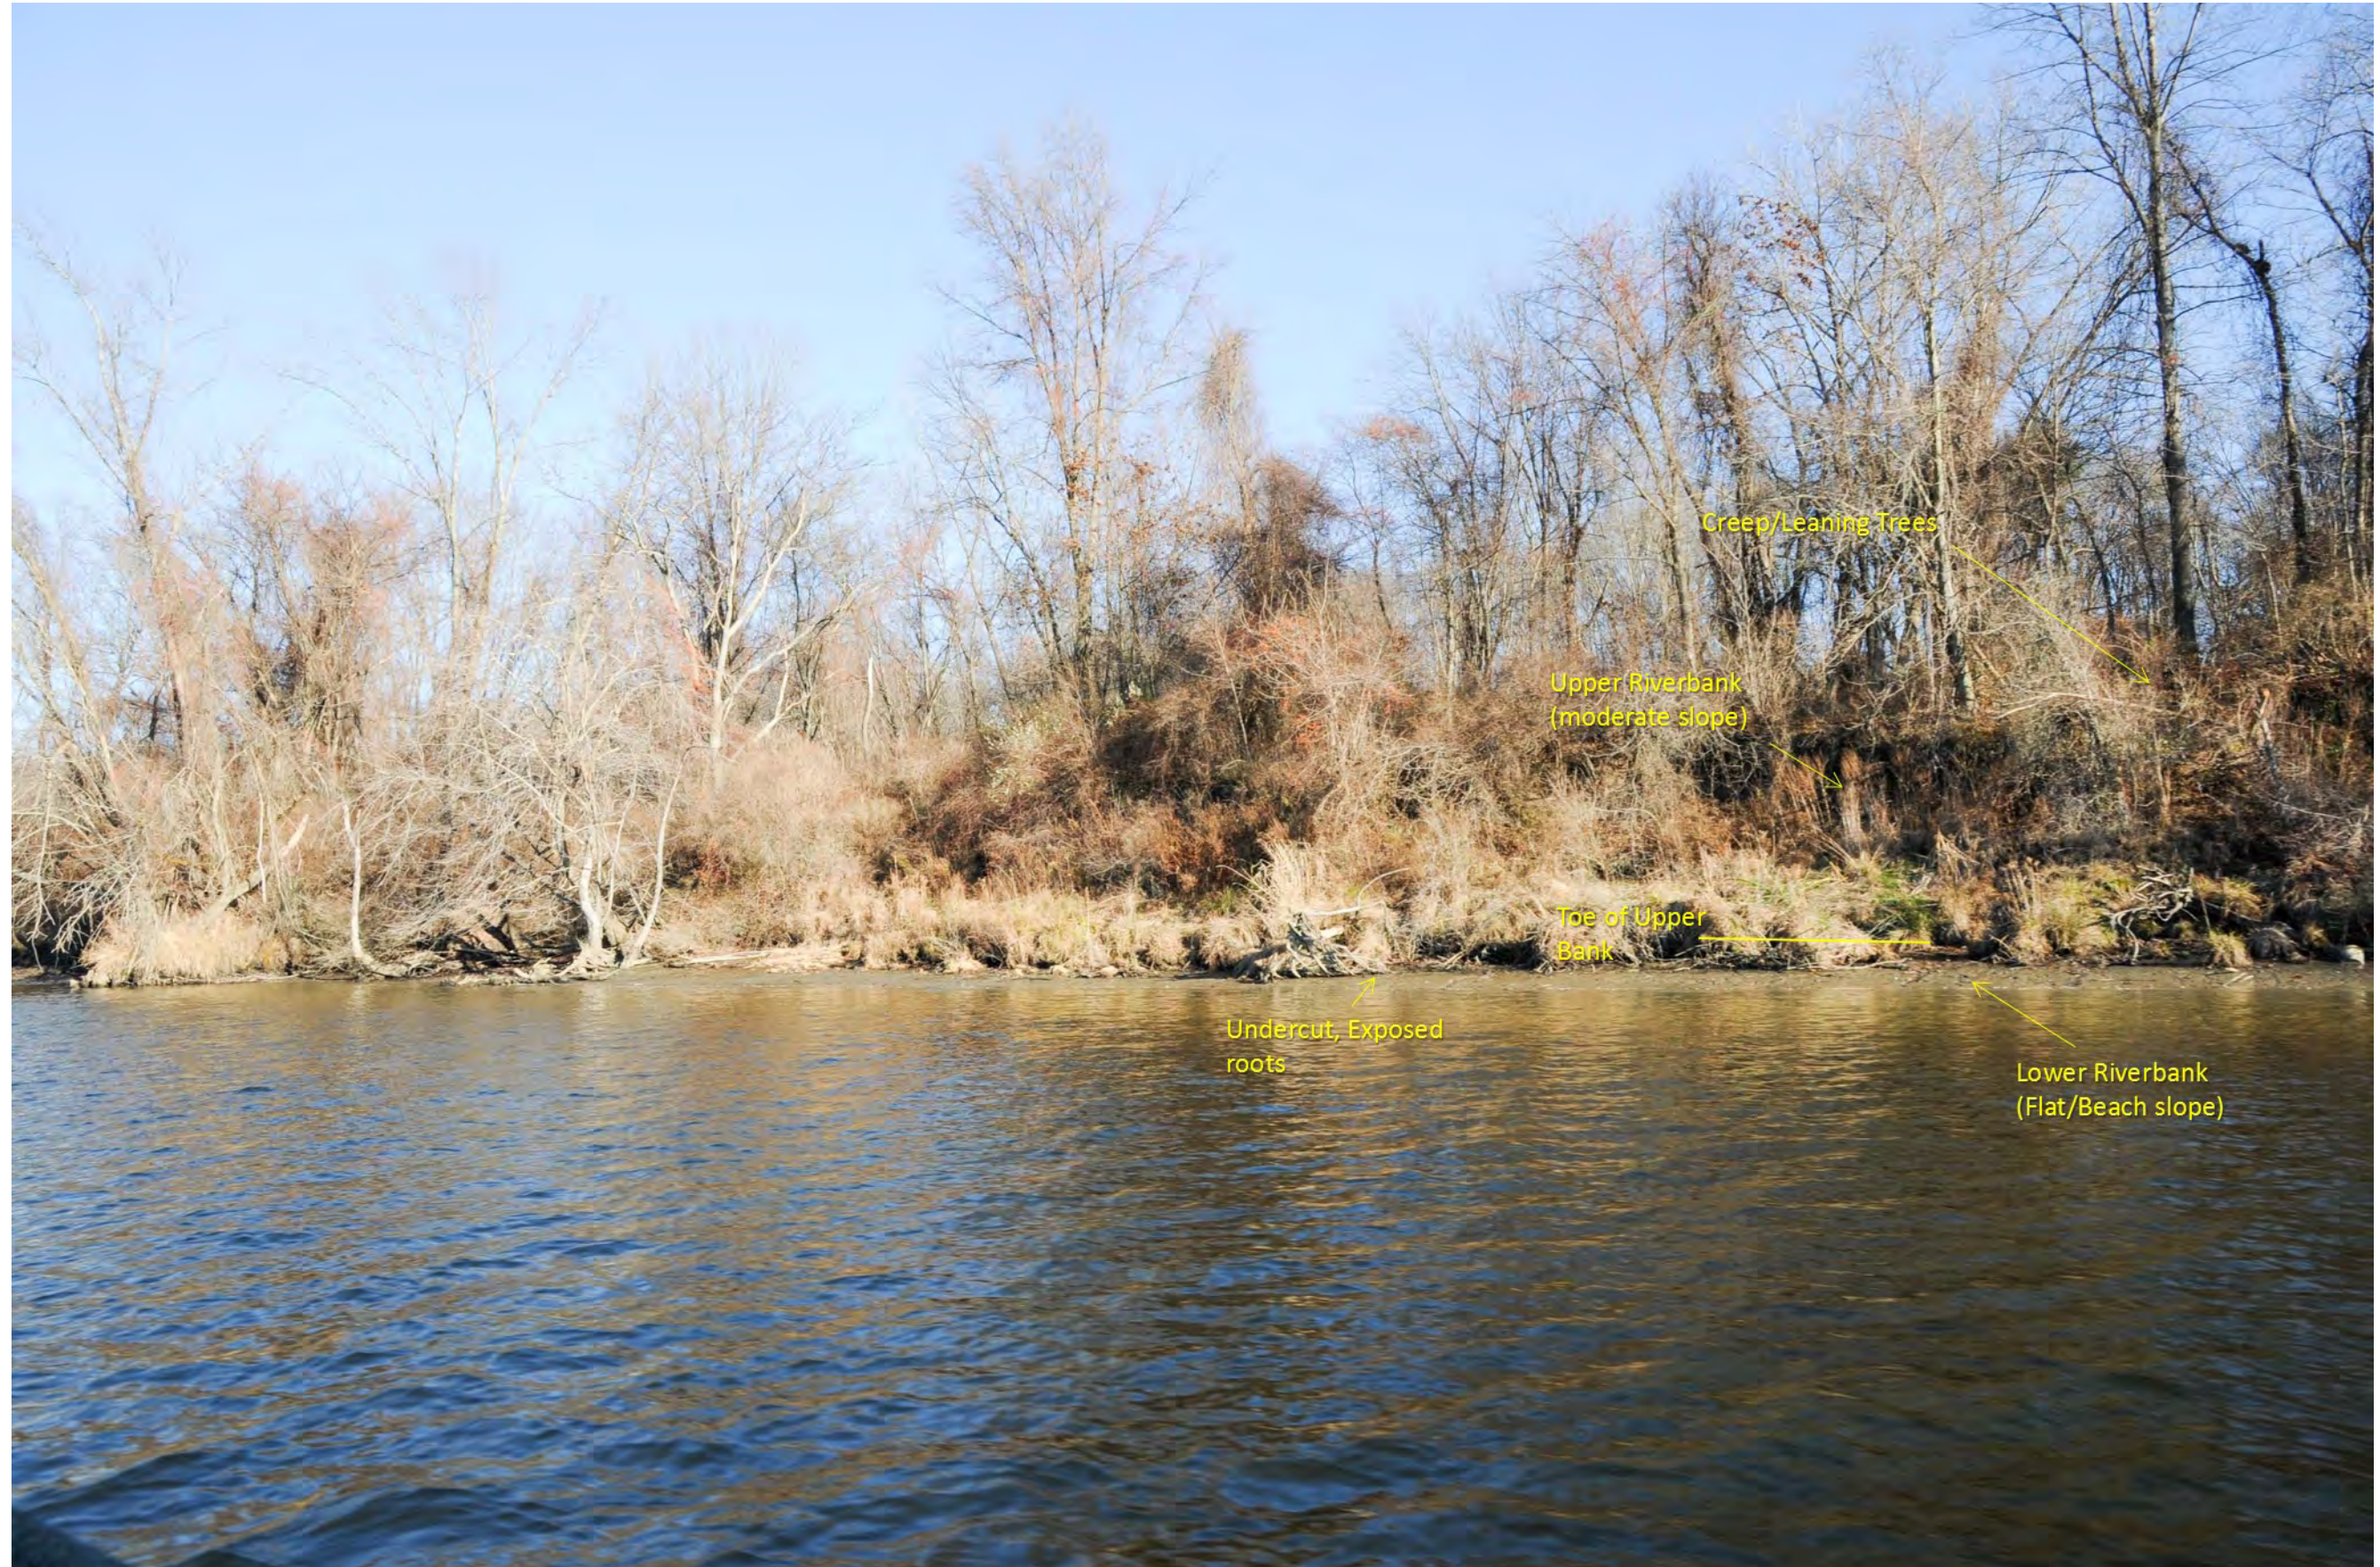
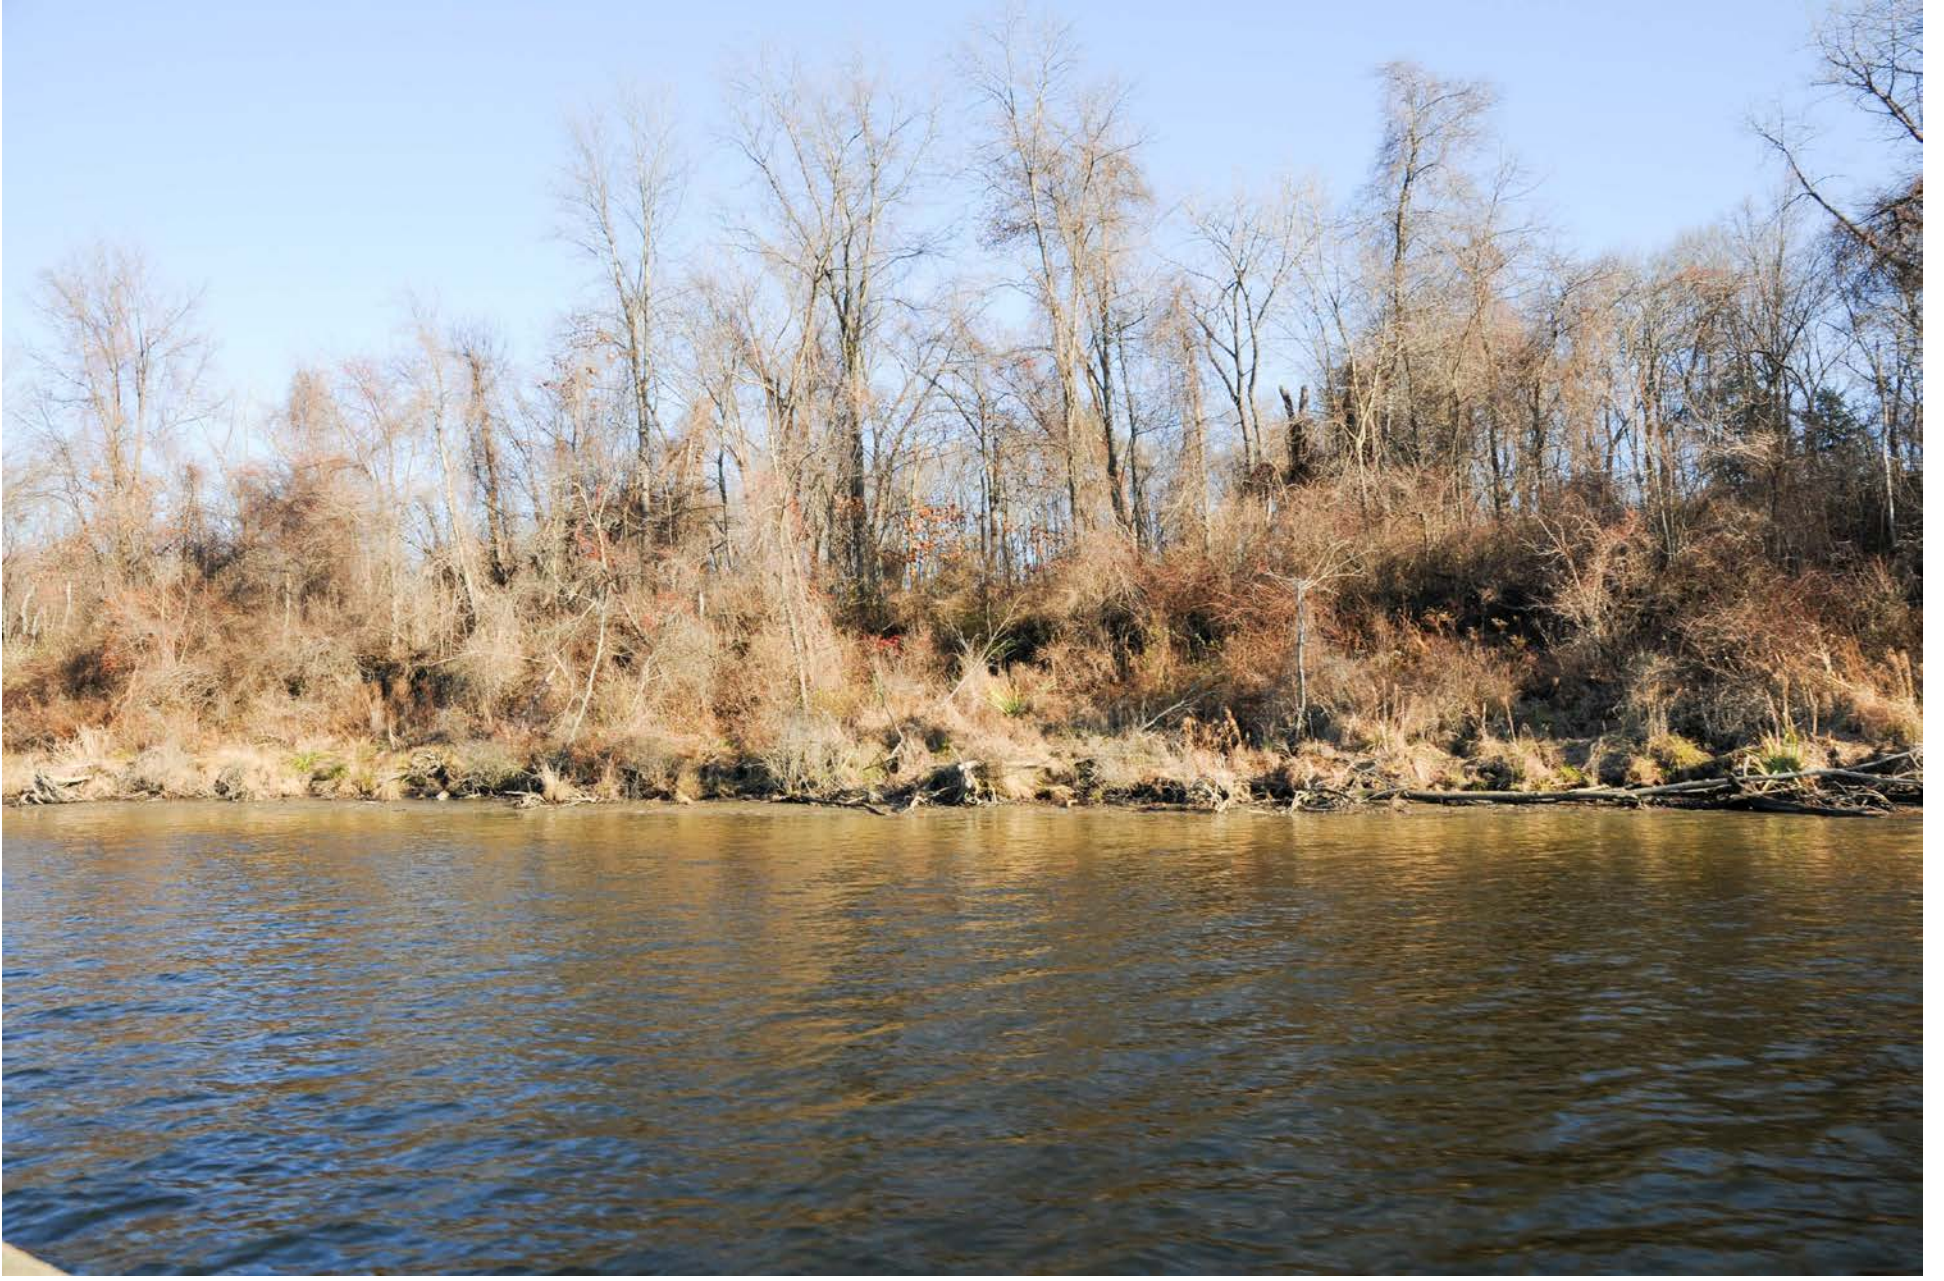
Riverbank Features	Characteristics
Upper Riverbank Slope	Moderate
Upper Riverbank Height	High
Upper Riverbank Sediment	Silt/Sand
Upper Riverbank Vegetation	Heavy
Lower Riverbank Slope	Flat/Beach
Lower Riverbank Sediment	Silt/Sand
Lower Riverbank Vegetation	None to very sparse
Type of Erosion	Undercut
Potential Erosion Indicators	Exposed roots, Creep/leaning trees
Stage of Erosion	Stable
Extent of Erosion	None/Little

QA Observations: Upon review of the photos for this segment, classification made in the field was confirmed and additional indicators of potential future erosion were included.
