Segment 90 – Left Bank

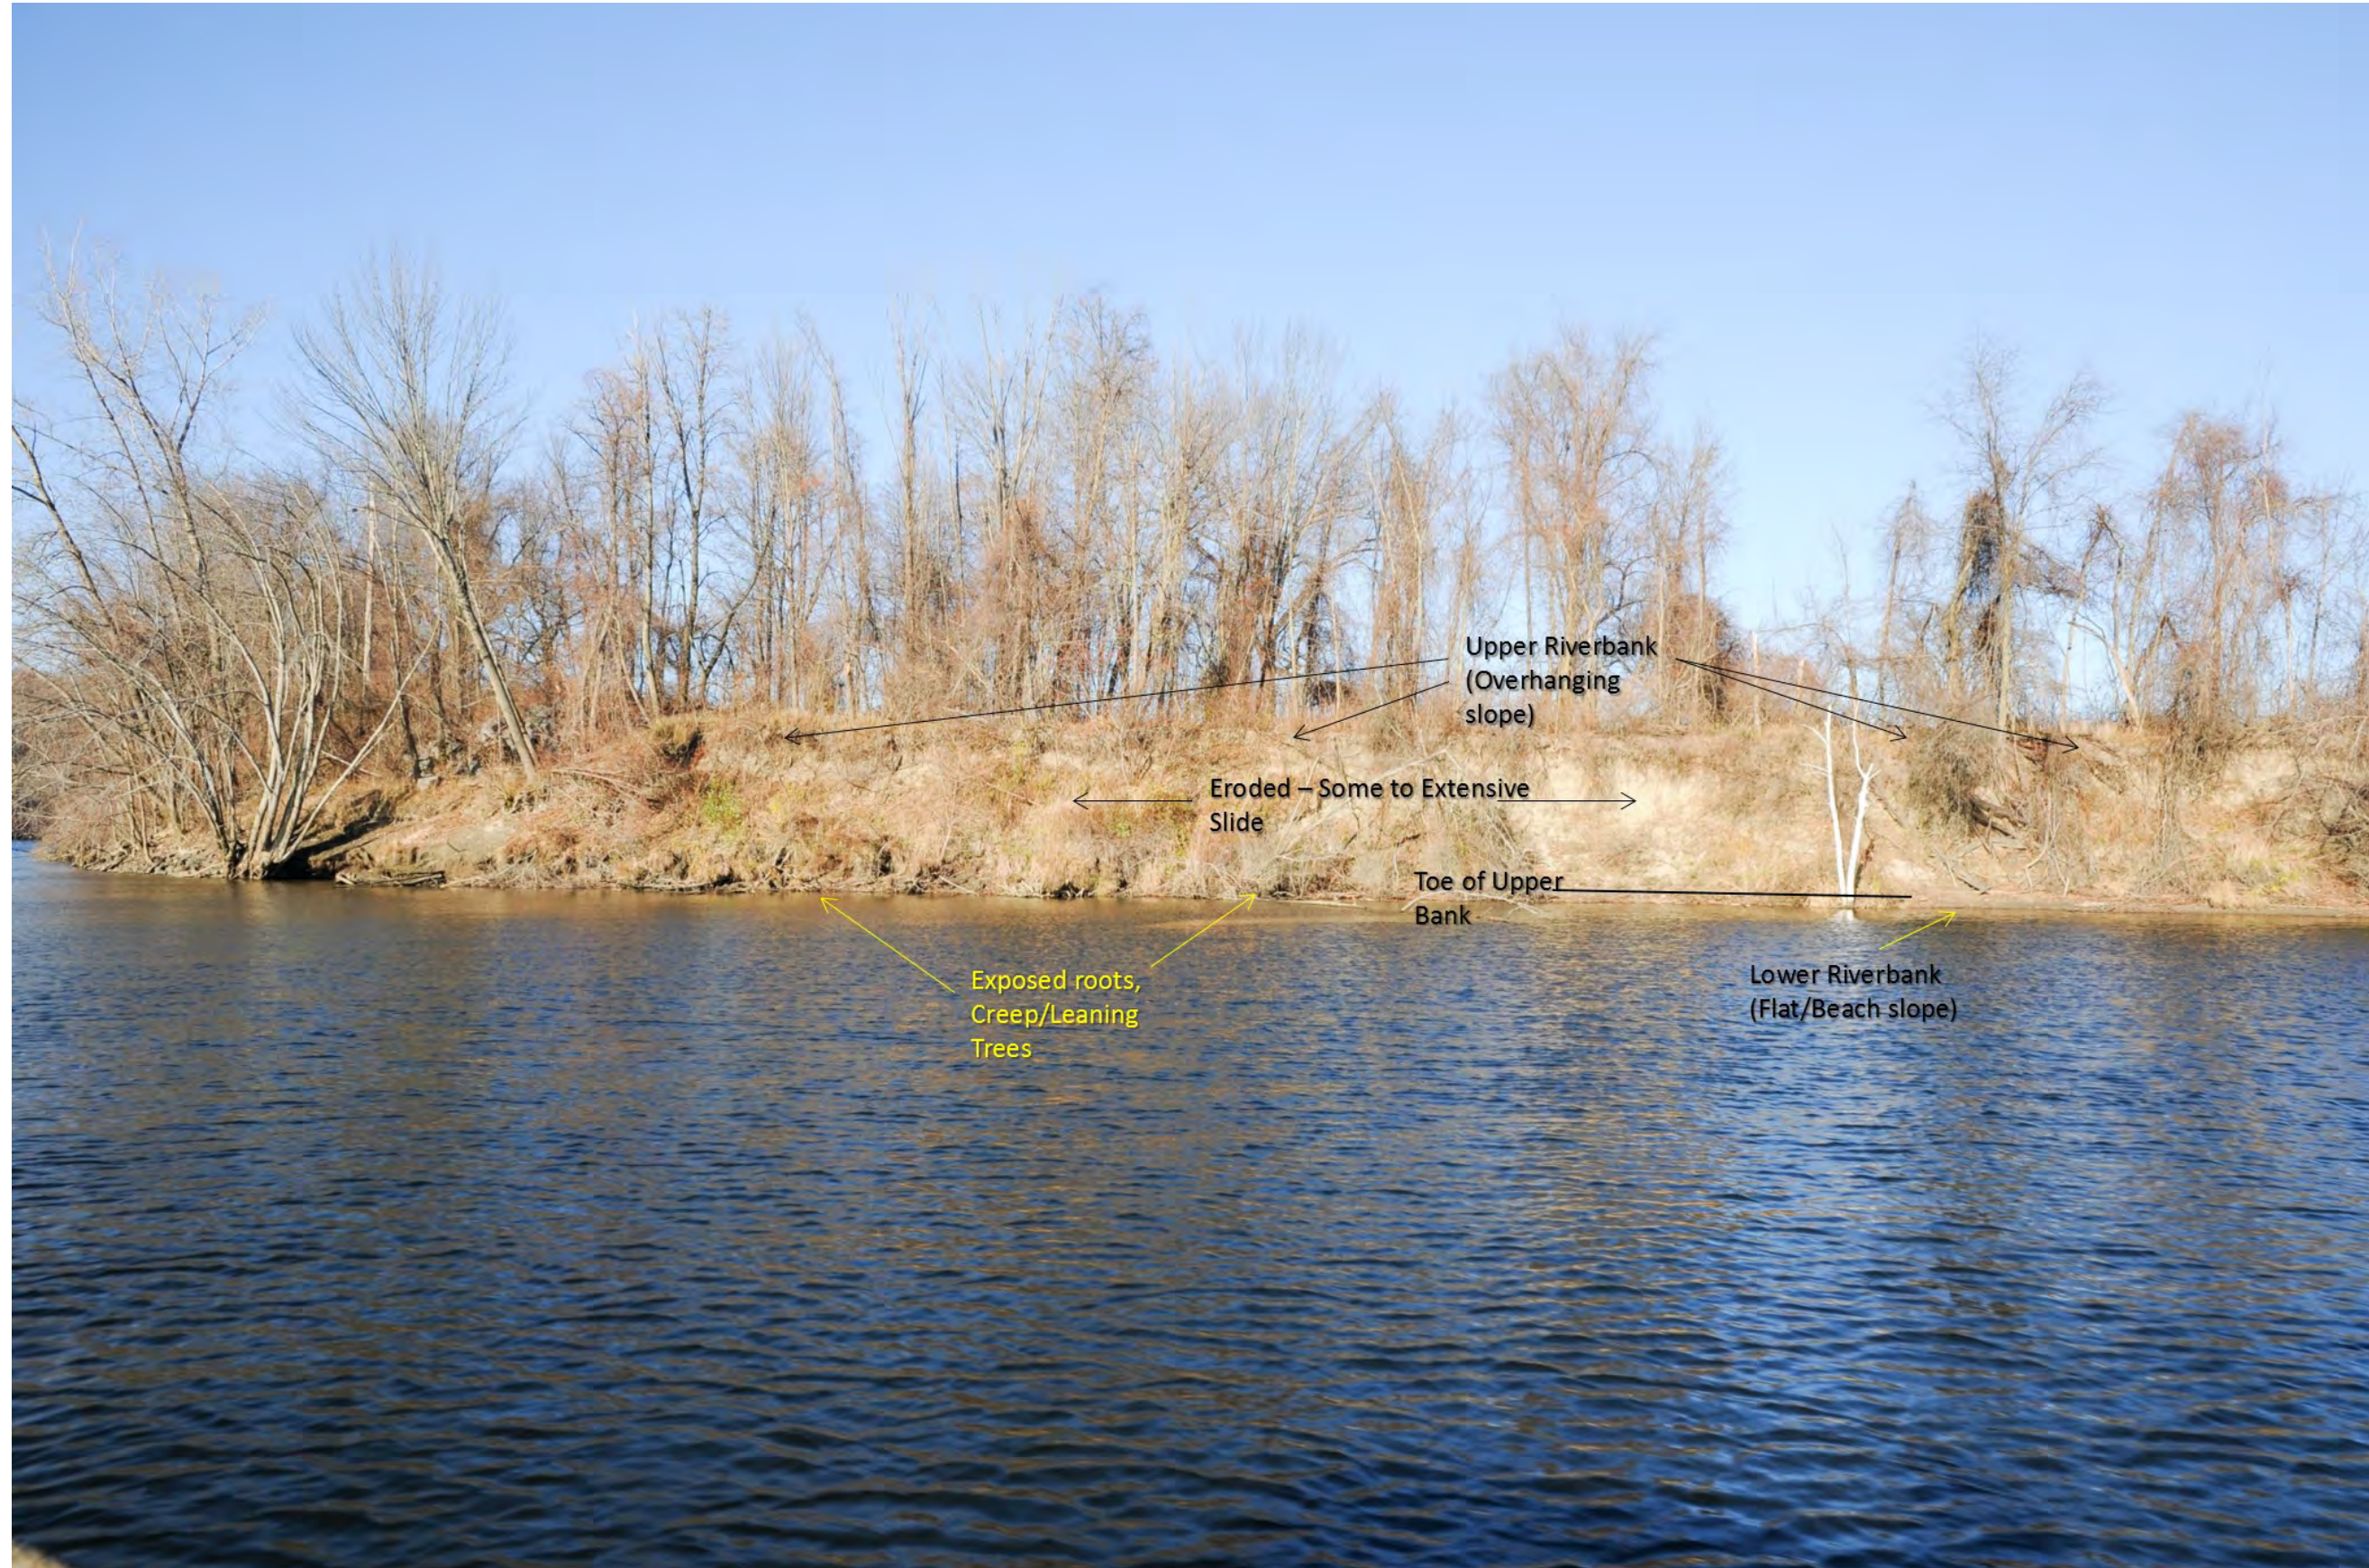
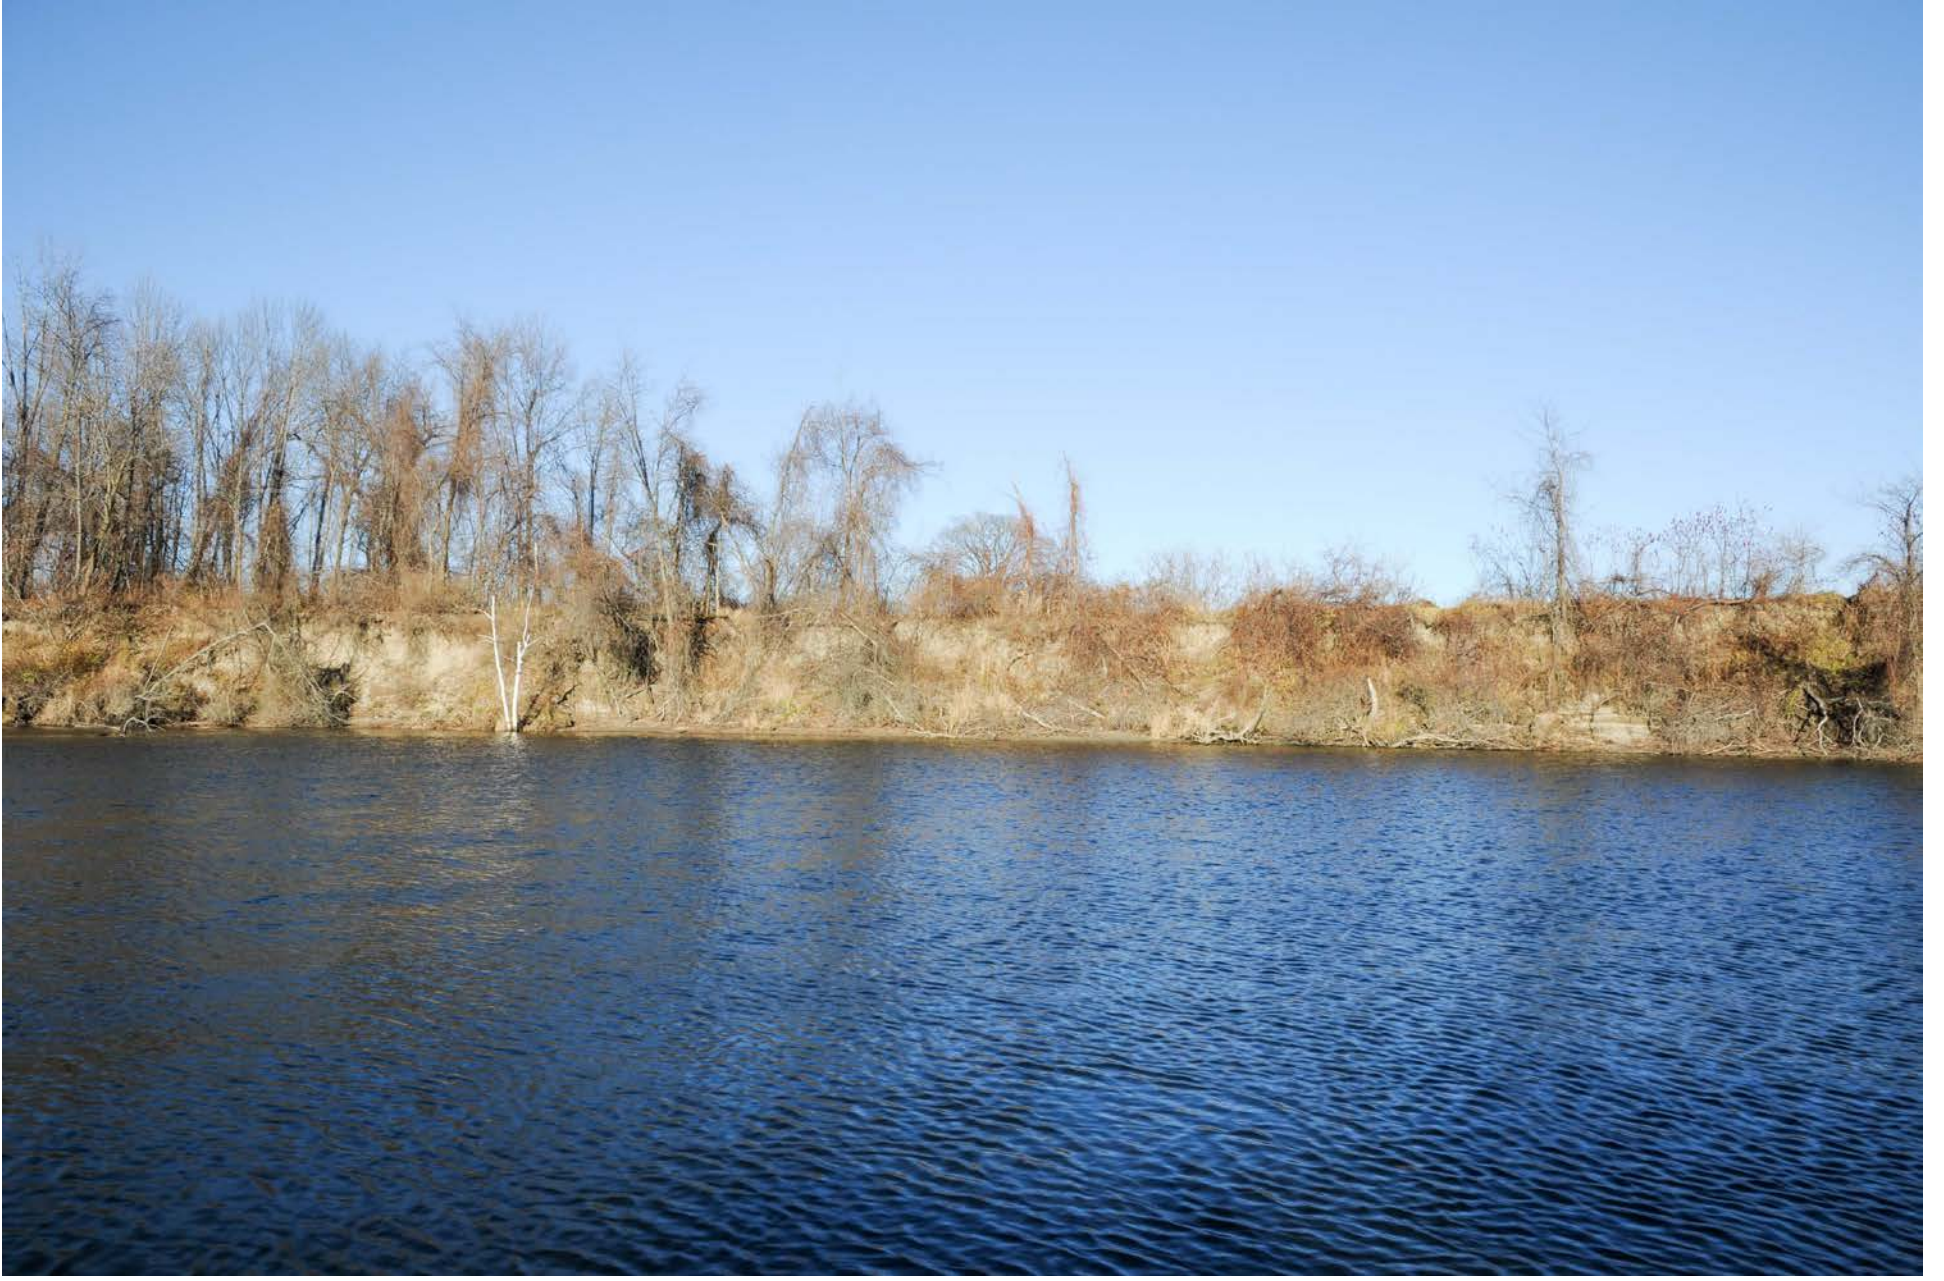
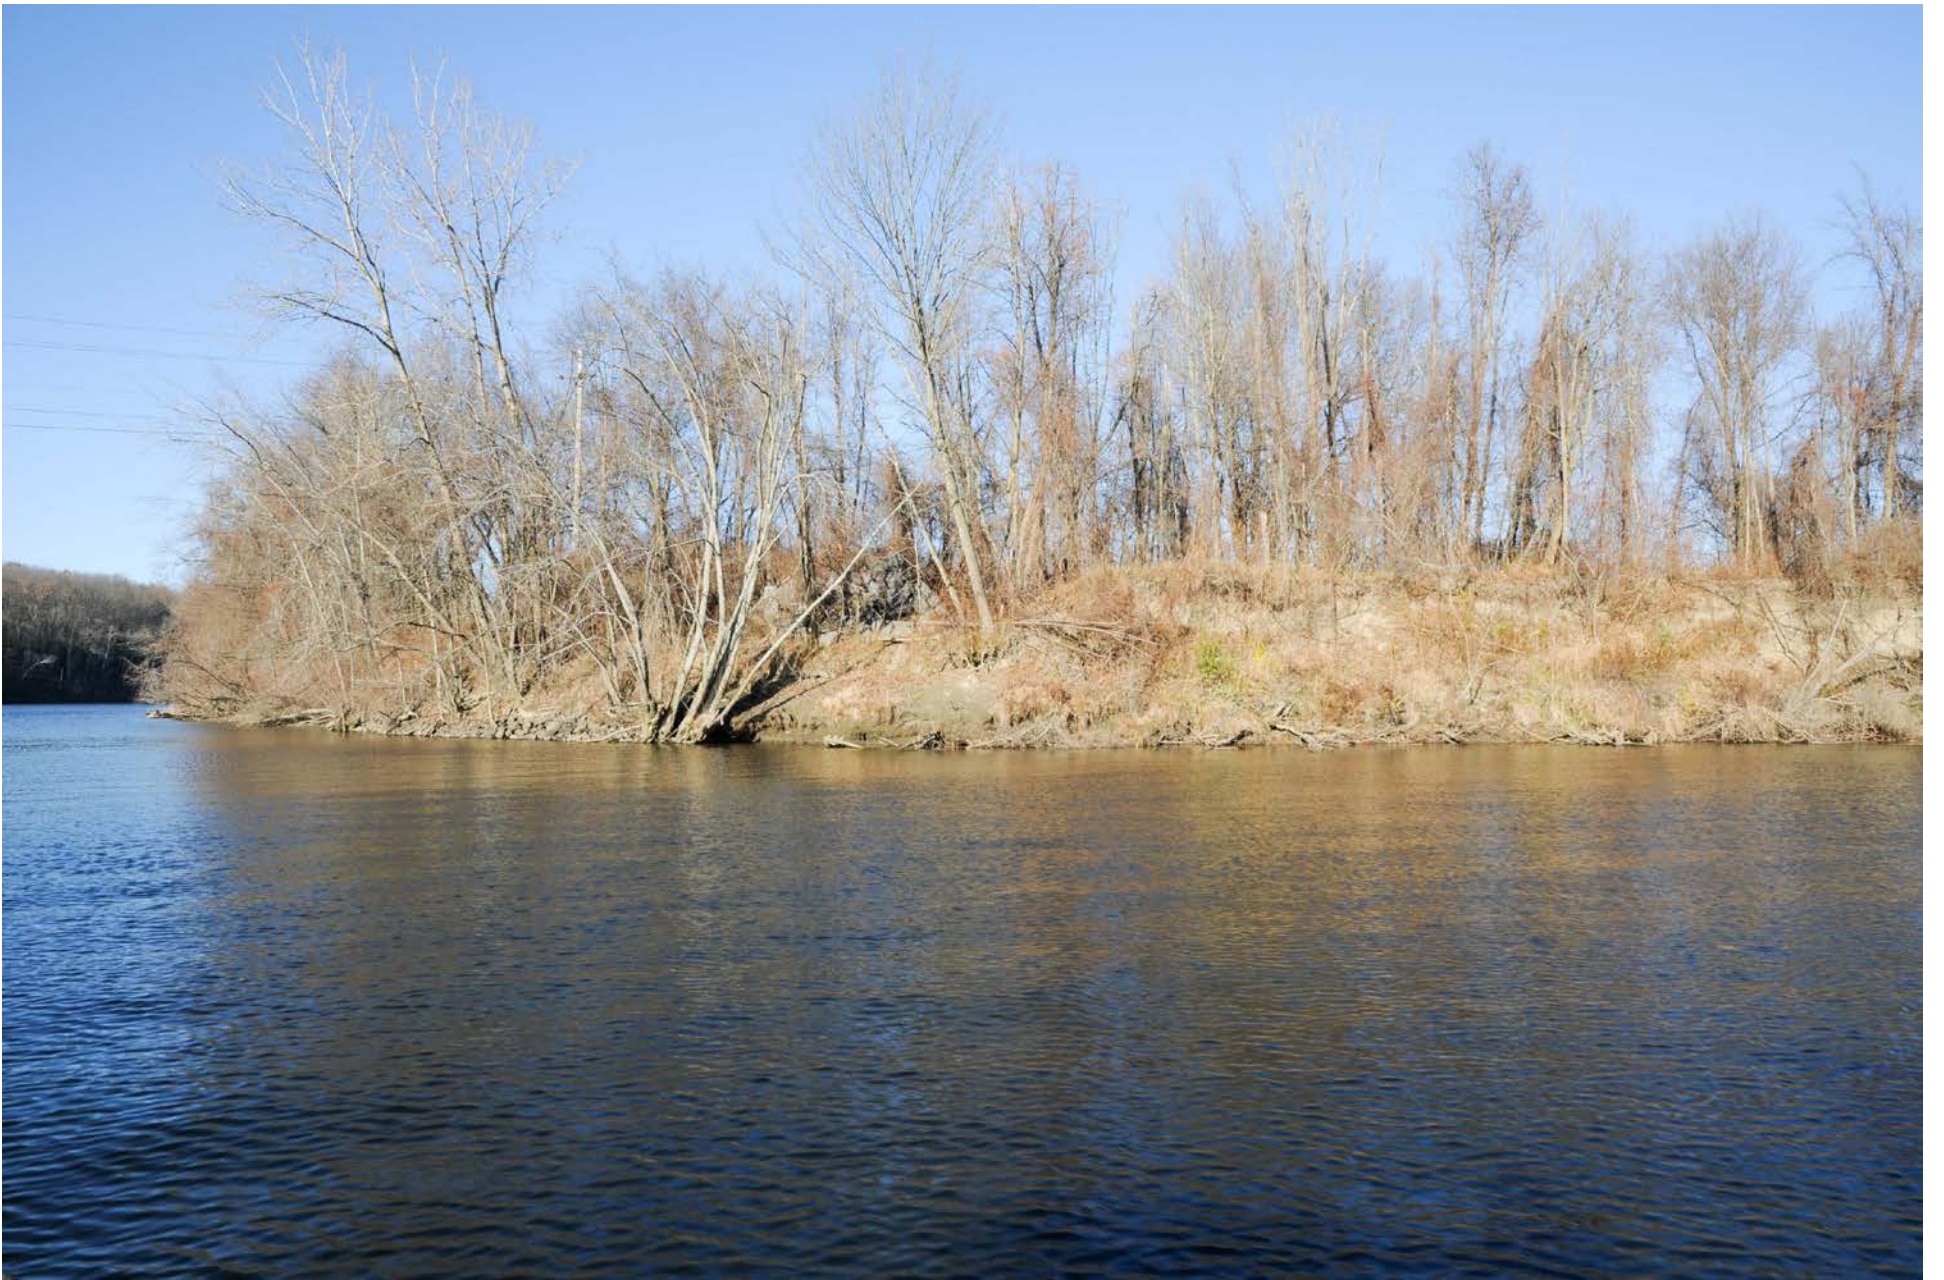
Riverbank Features	Characteristics
Upper Riverbank Slope	Overhanging
Upper Riverbank Height	High
Upper Riverbank Sediment	Silt/Sand
Upper Riverbank Vegetation	Moderate
Lower Riverbank Slope	Flat/Beach
Lower Riverbank Sediment	Silt/Sand
Lower Riverbank Vegetation	None to very sparse
Type of Erosion	Slide
Potential Erosion Indicators	Overhanging bank, Exposed roots, Creep/leaning trees
Stage of Erosion	Eroded
Extent of Erosion	Some to Extensive

QA Observations: Upon review of the photos for this segment, classification made in the field was confirmed and additional indicators of potential future erosion were included.

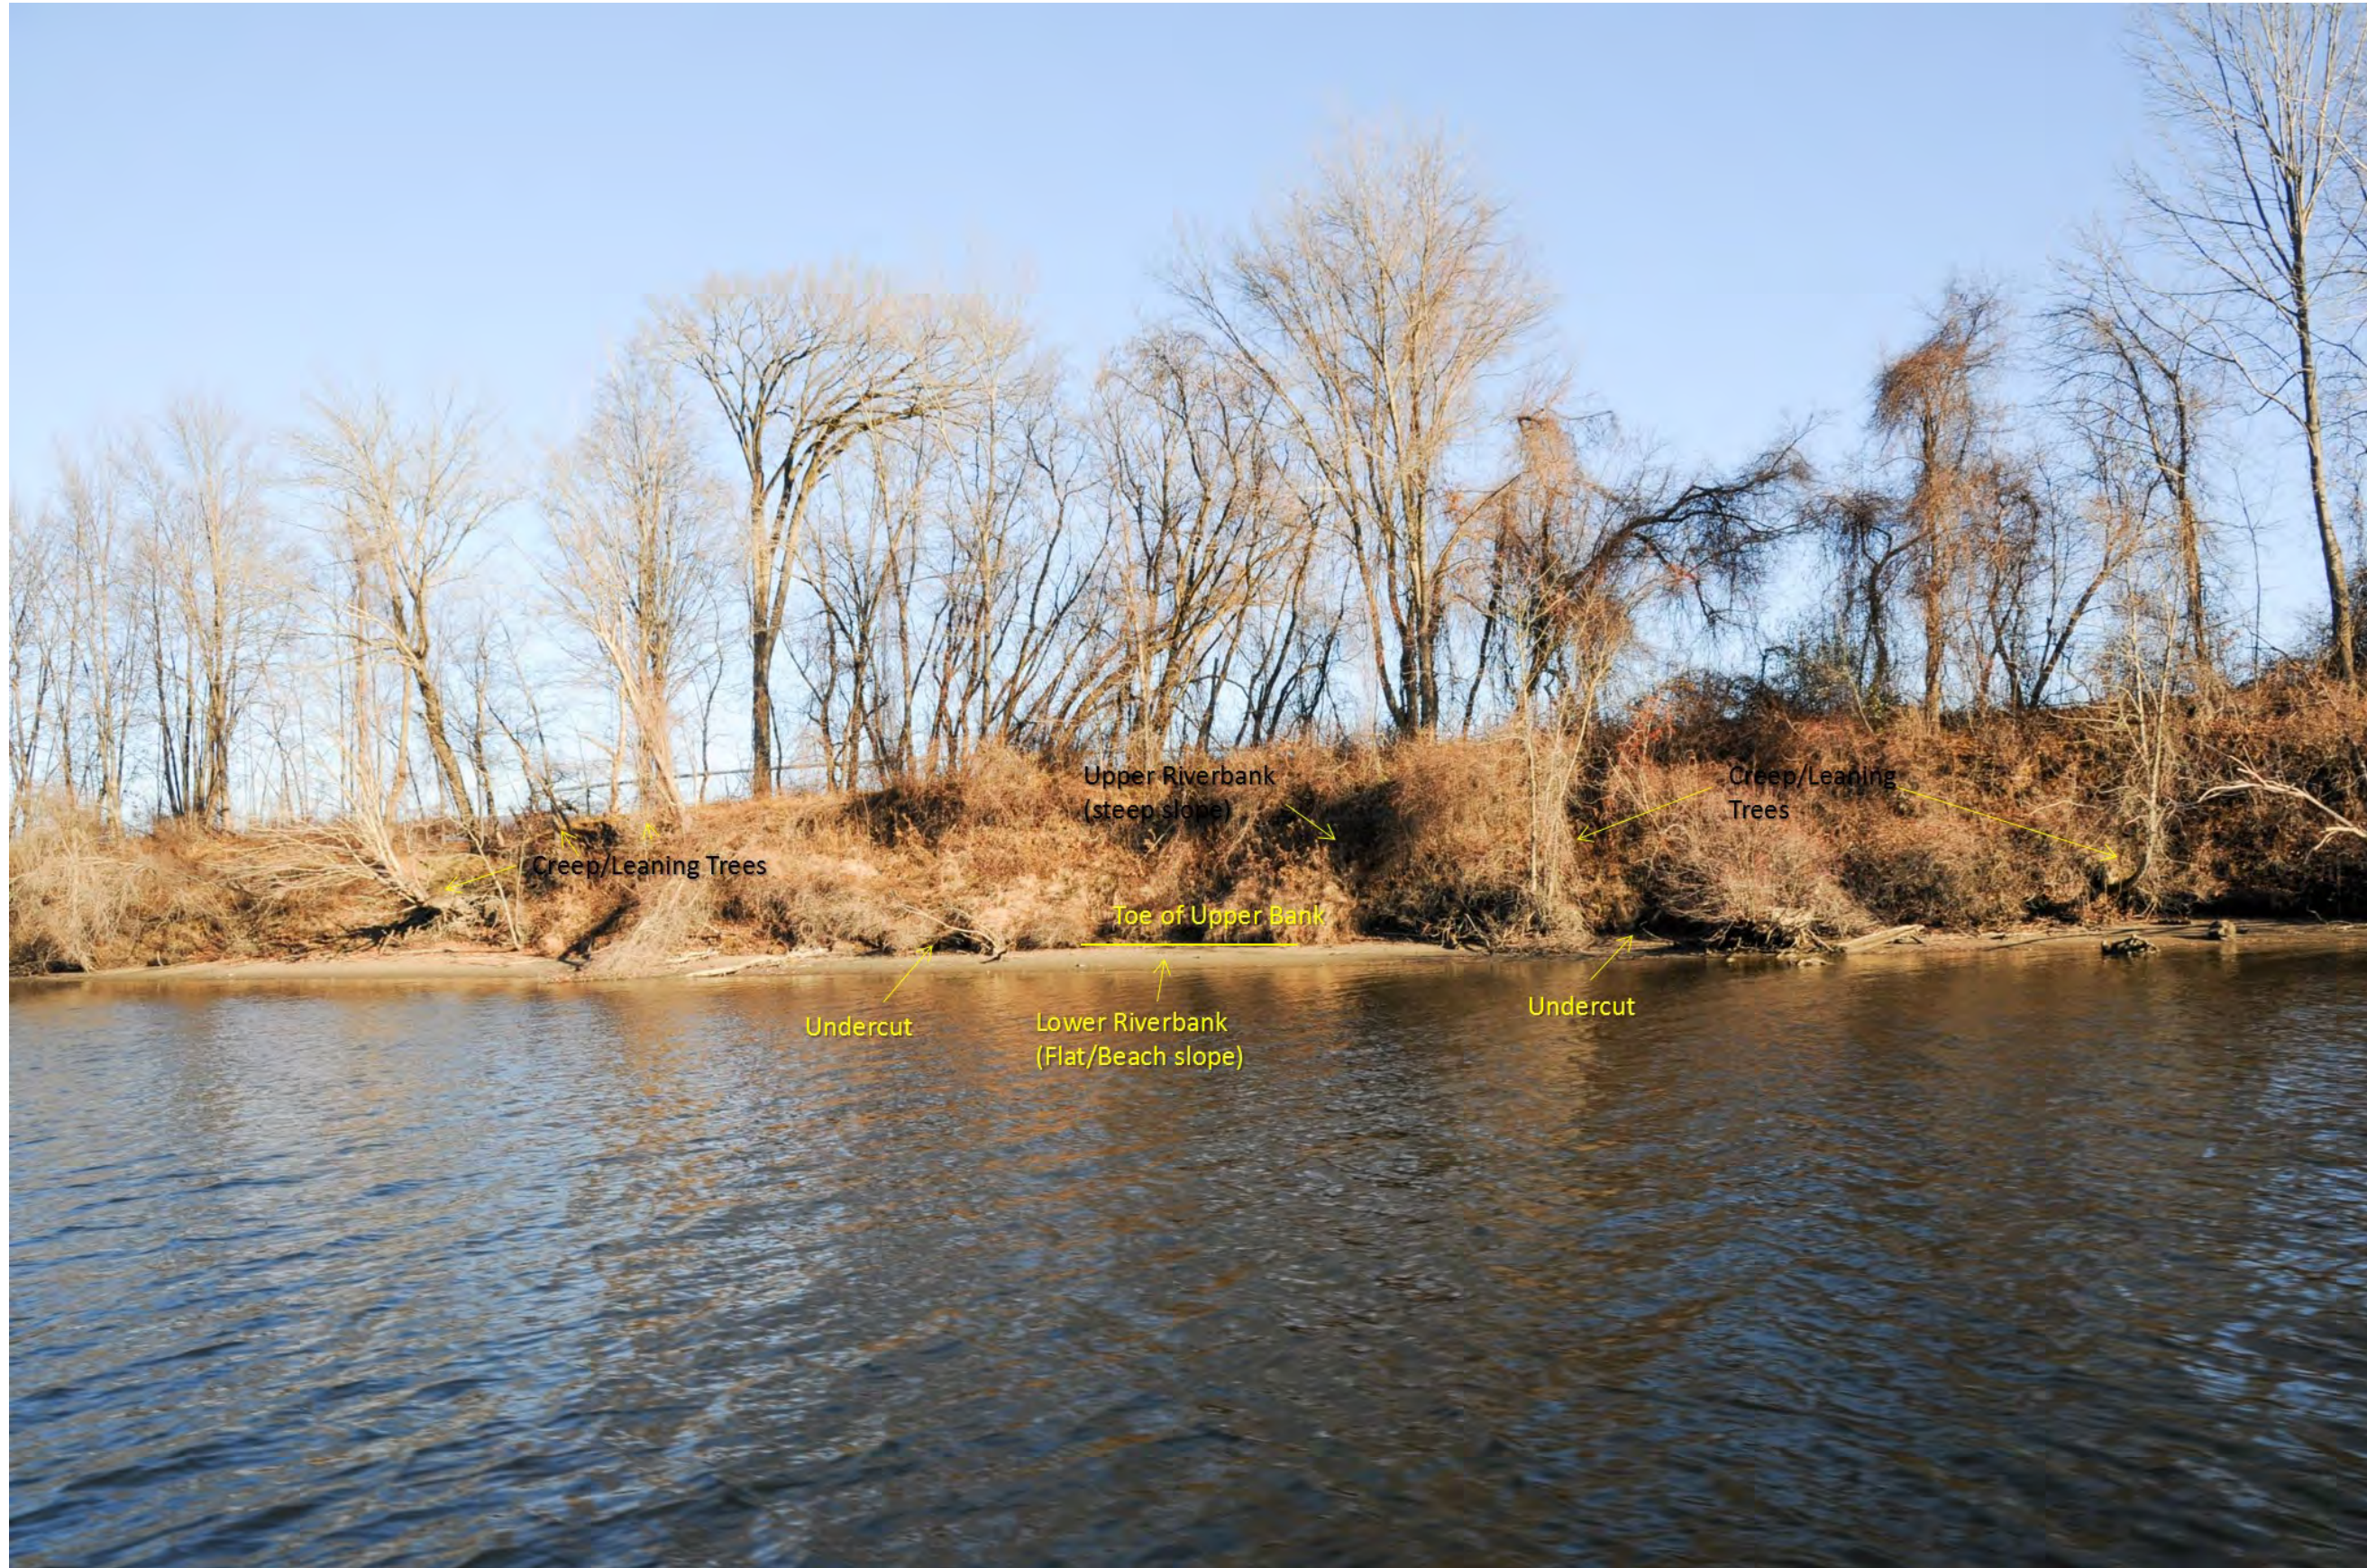
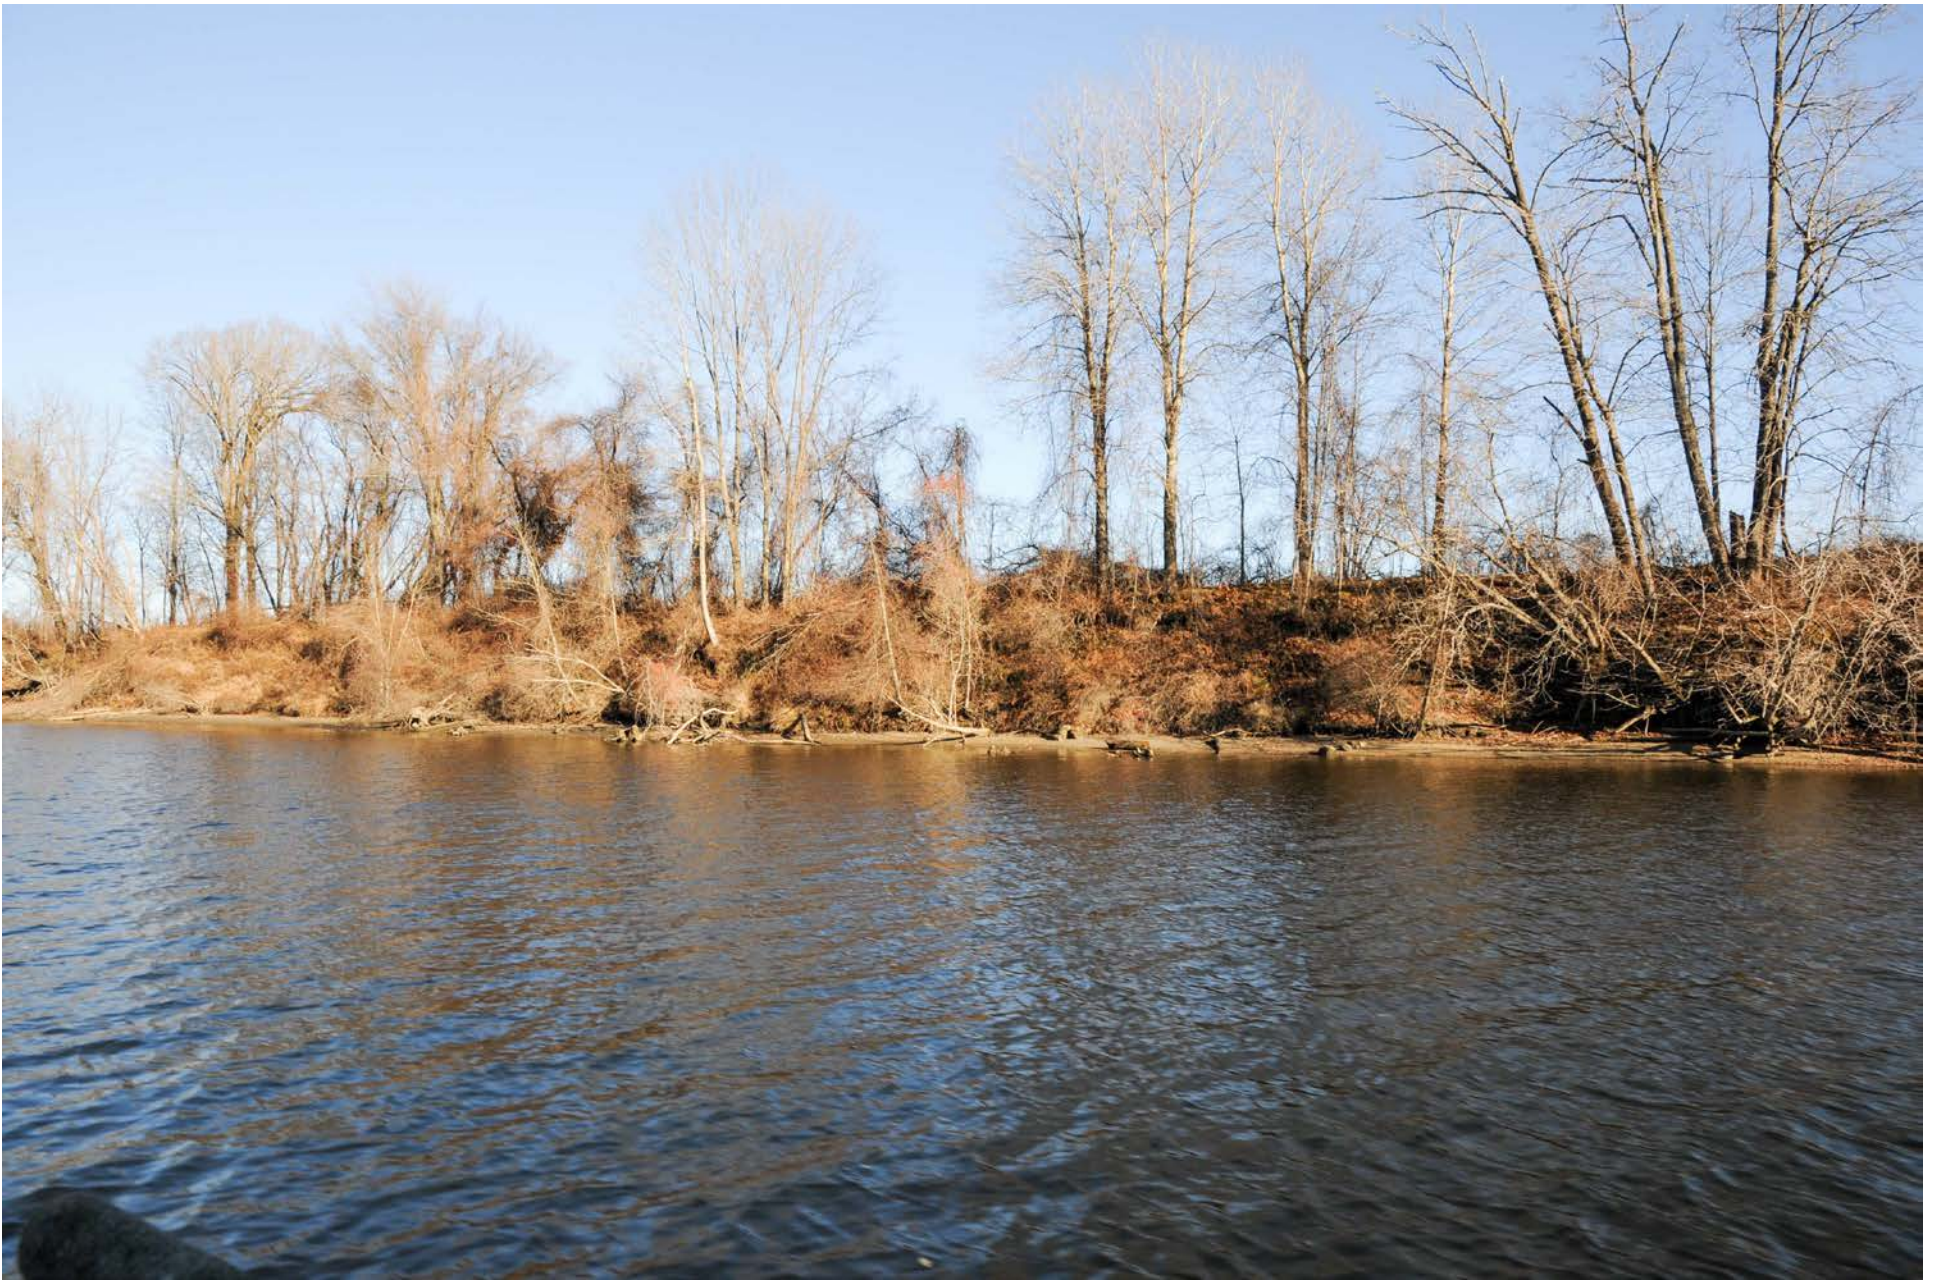
Riverbank Features	Characteristics
Upper Riverbank Slope	Steep
Upper Riverbank Height	High
Upper Riverbank Sediment	Silt/Sand
Upper Riverbank Vegetation	Heavy
Lower Riverbank Slope	Flat/Beach
Lower Riverbank Sediment	Silt/Sand
Lower Riverbank Vegetation	None to very sparse
Type of Erosion	Undercut
Potential Erosion Indicators	Creep/leaning trees, Exposed roots
Stage of Erosion	Stable
Extent of Erosion	None/Little

QA Observations: Upon review of the photos for this segment, classification made in the field was confirmed and additional indicators of potential future erosion were included.

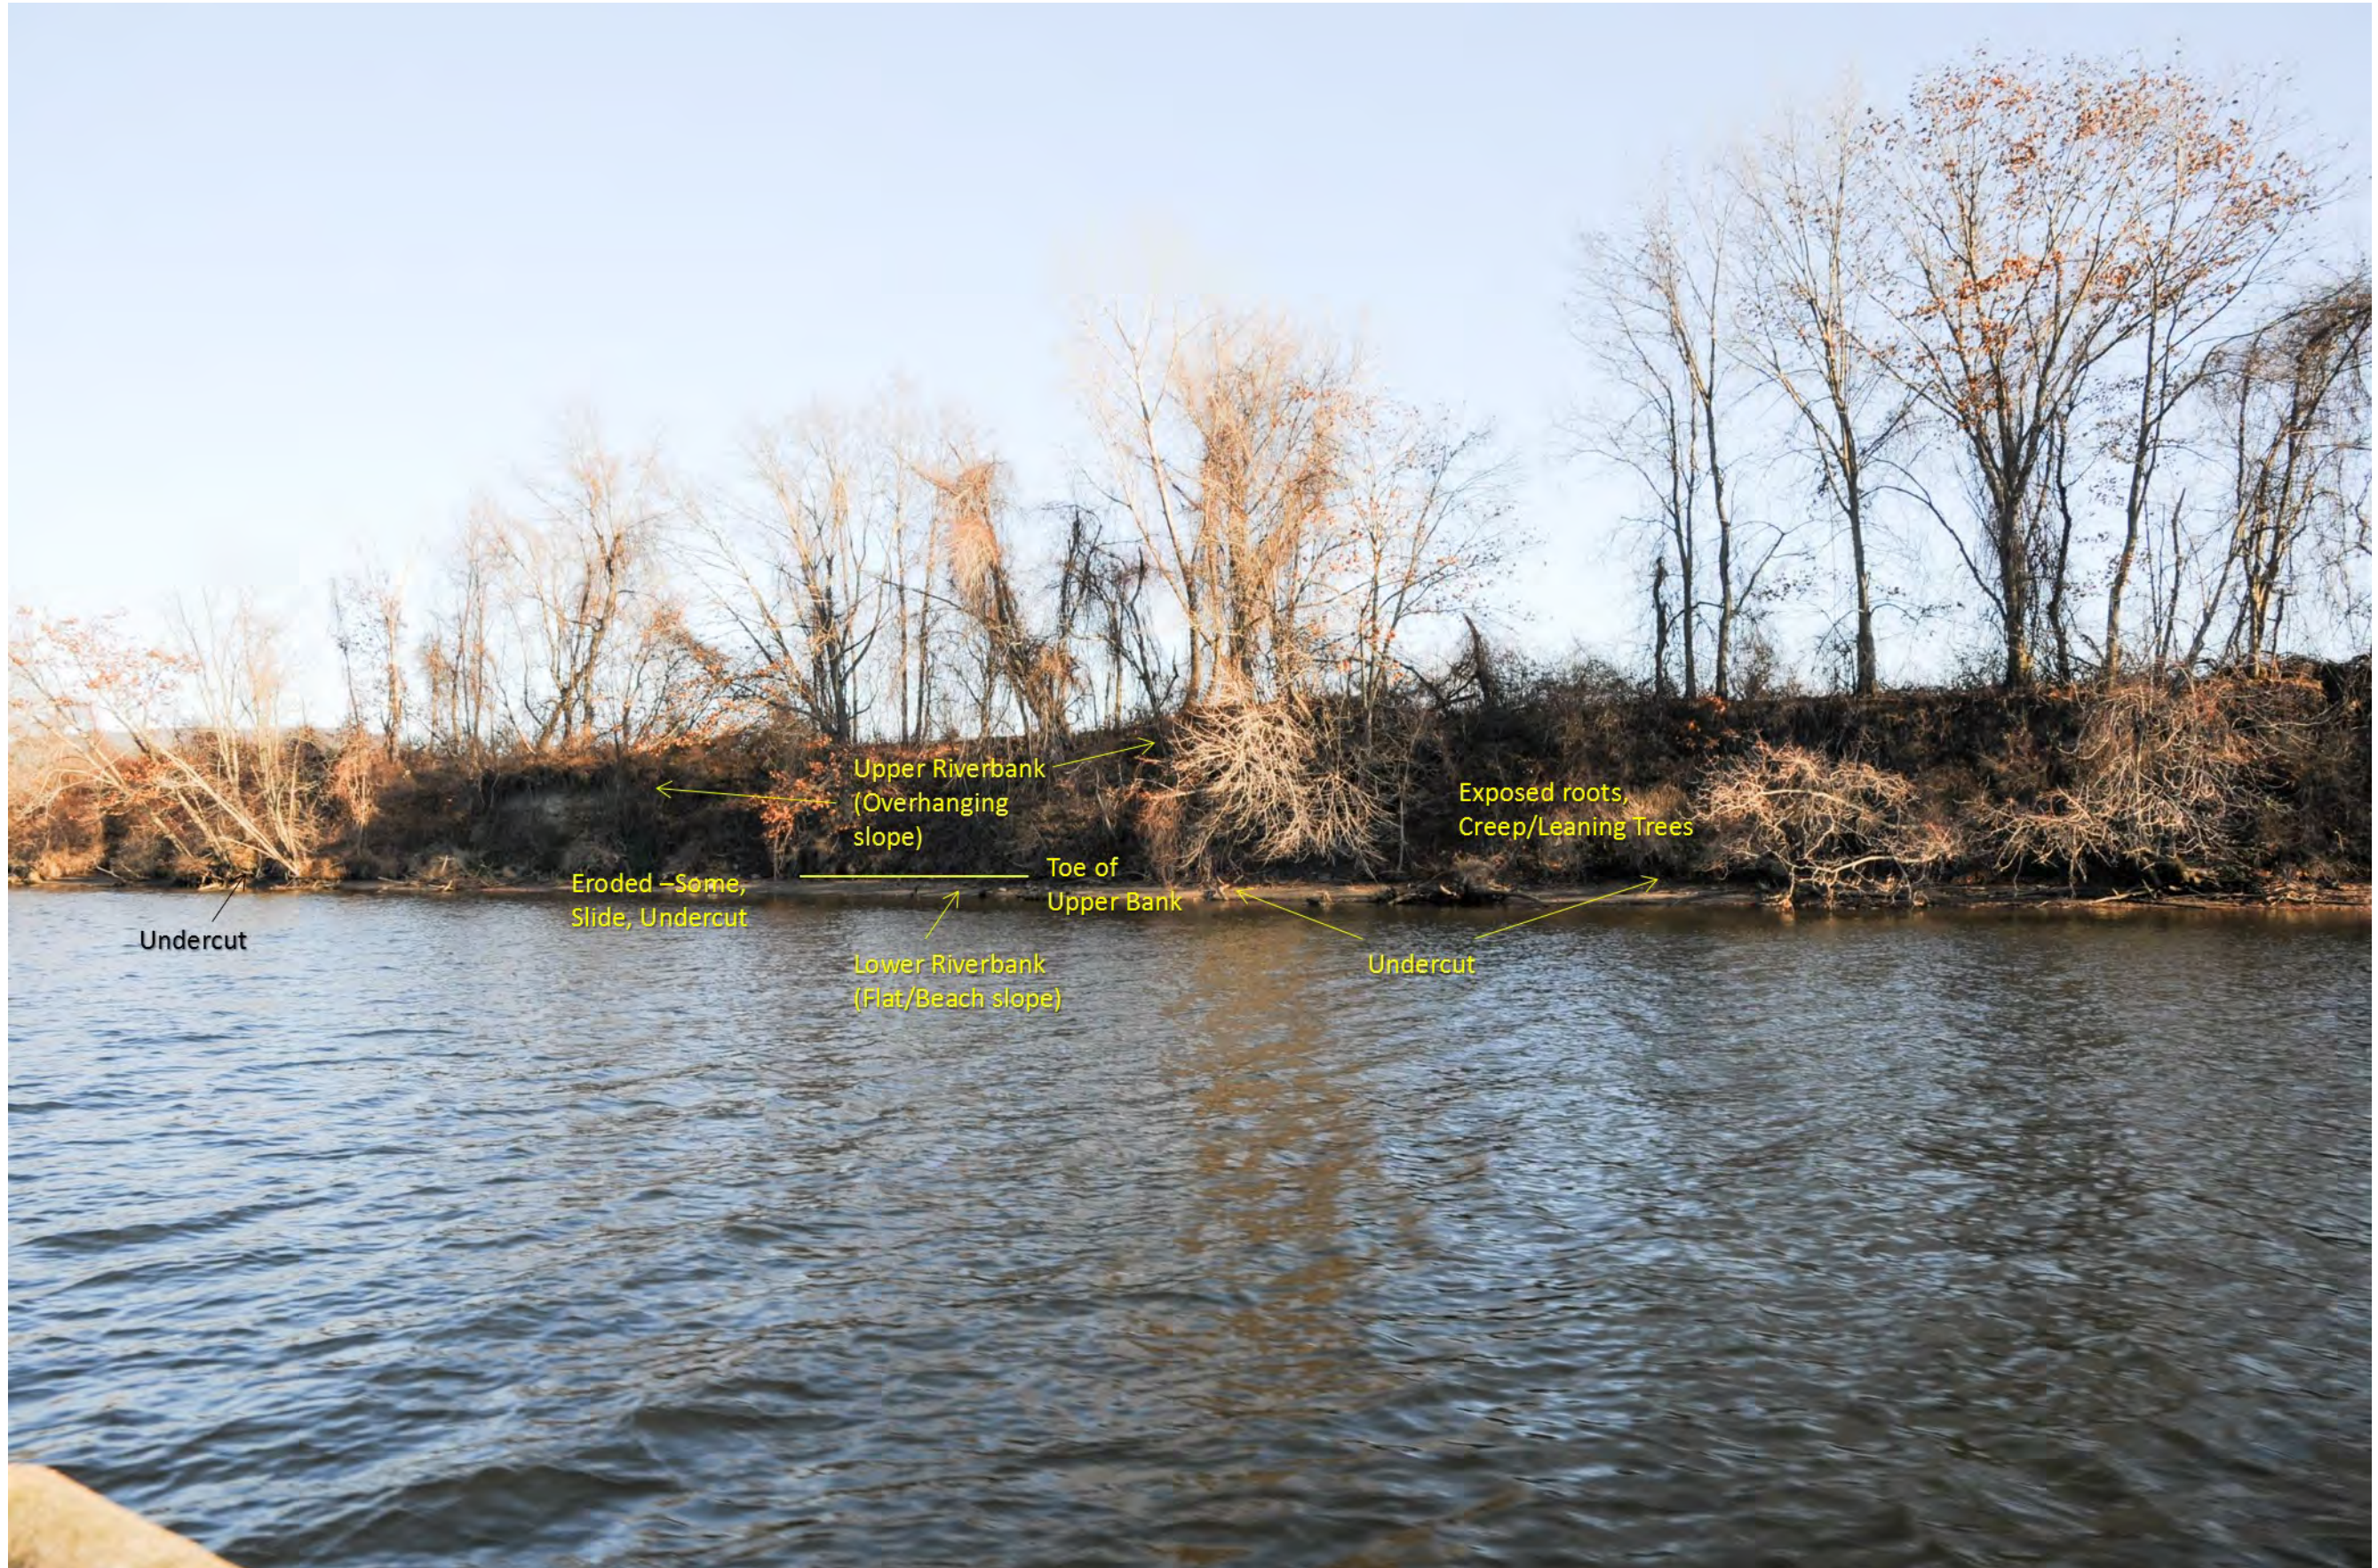
Photo ID 854 (mid-segment)

Riverbank Features	Characteristics
Upper Riverbank Slope	Overhanging
Upper Riverbank Height	High
Upper Riverbank Sediment	Silt/Sand
Upper Riverbank Vegetation	Moderate
Lower Riverbank Slope	Flat/Beach
Lower Riverbank Sediment	Silt/Sand
Lower Riverbank Vegetation	None to very sparse
Type of Erosion	Slide, undercut
Potential Erosion Indicators	Exposed roots, Overhanging bank, Creep/leaning trees
Stage of Erosion	Eroded
Extent of Erosion	Some

QA Observations: Upon review of the photos for this segment, classification made in the field was confirmed and additional indicators of potential future erosion were included.
