Segment 90 – Left Bank

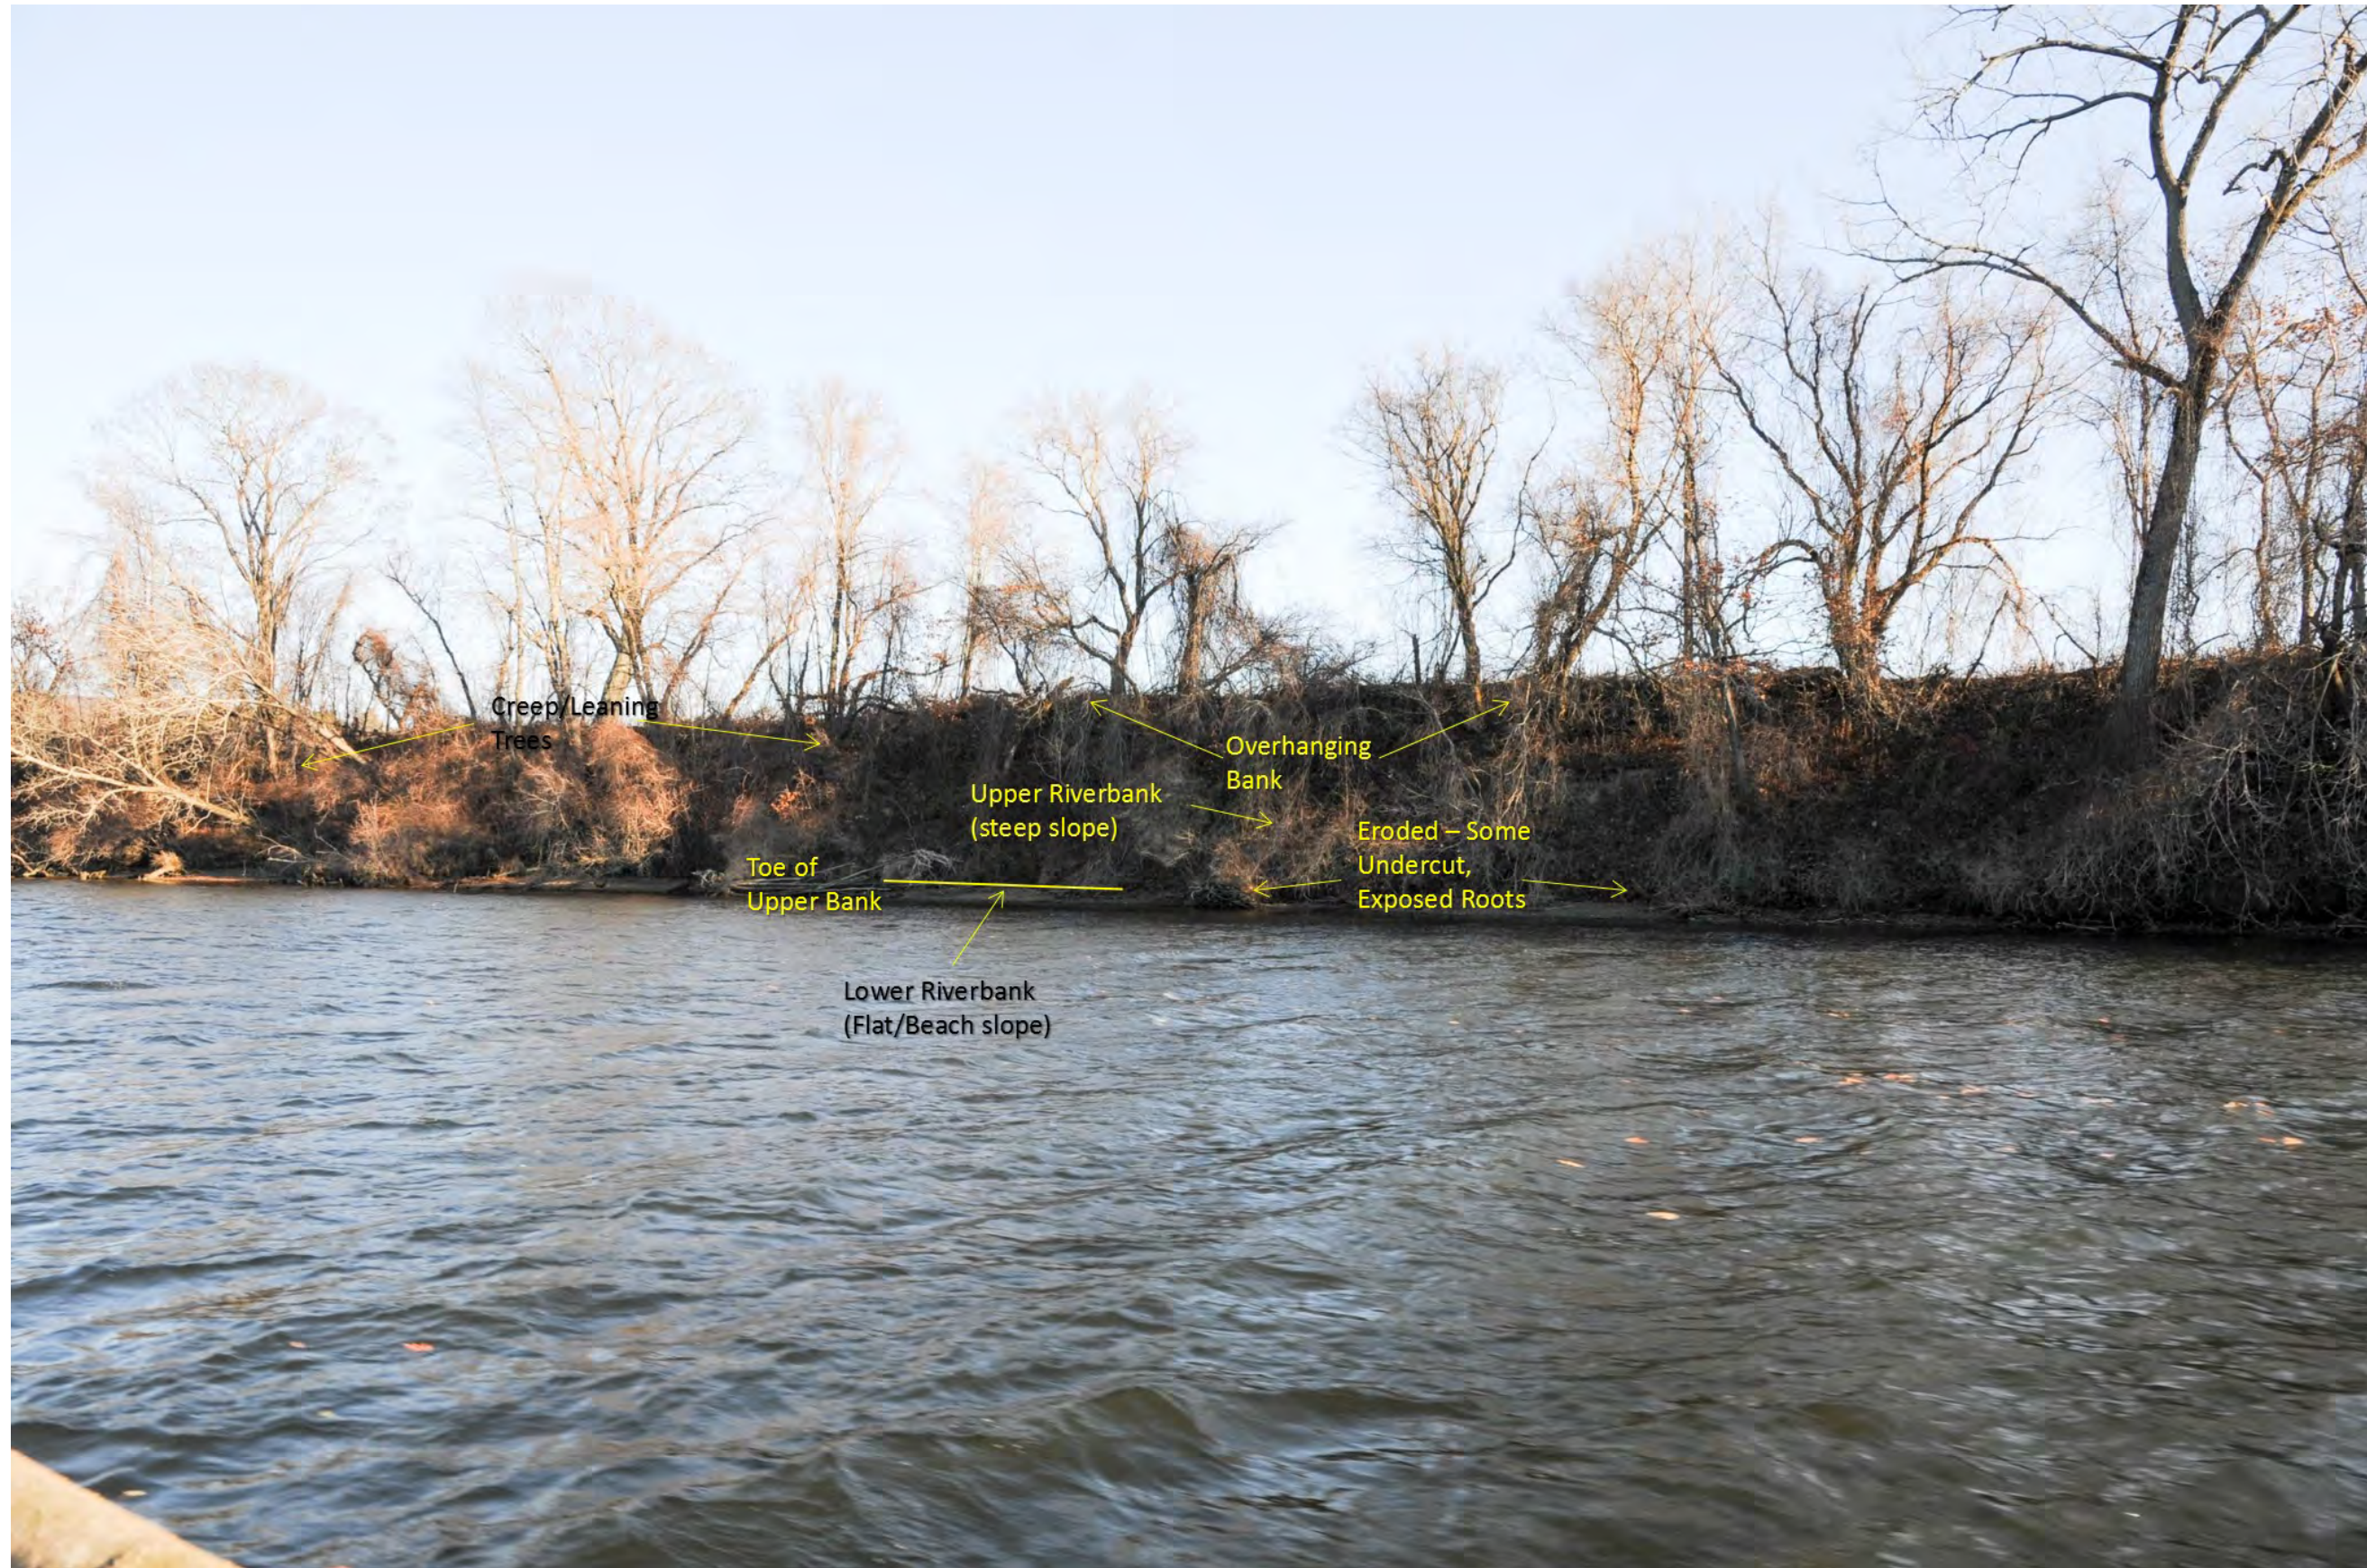
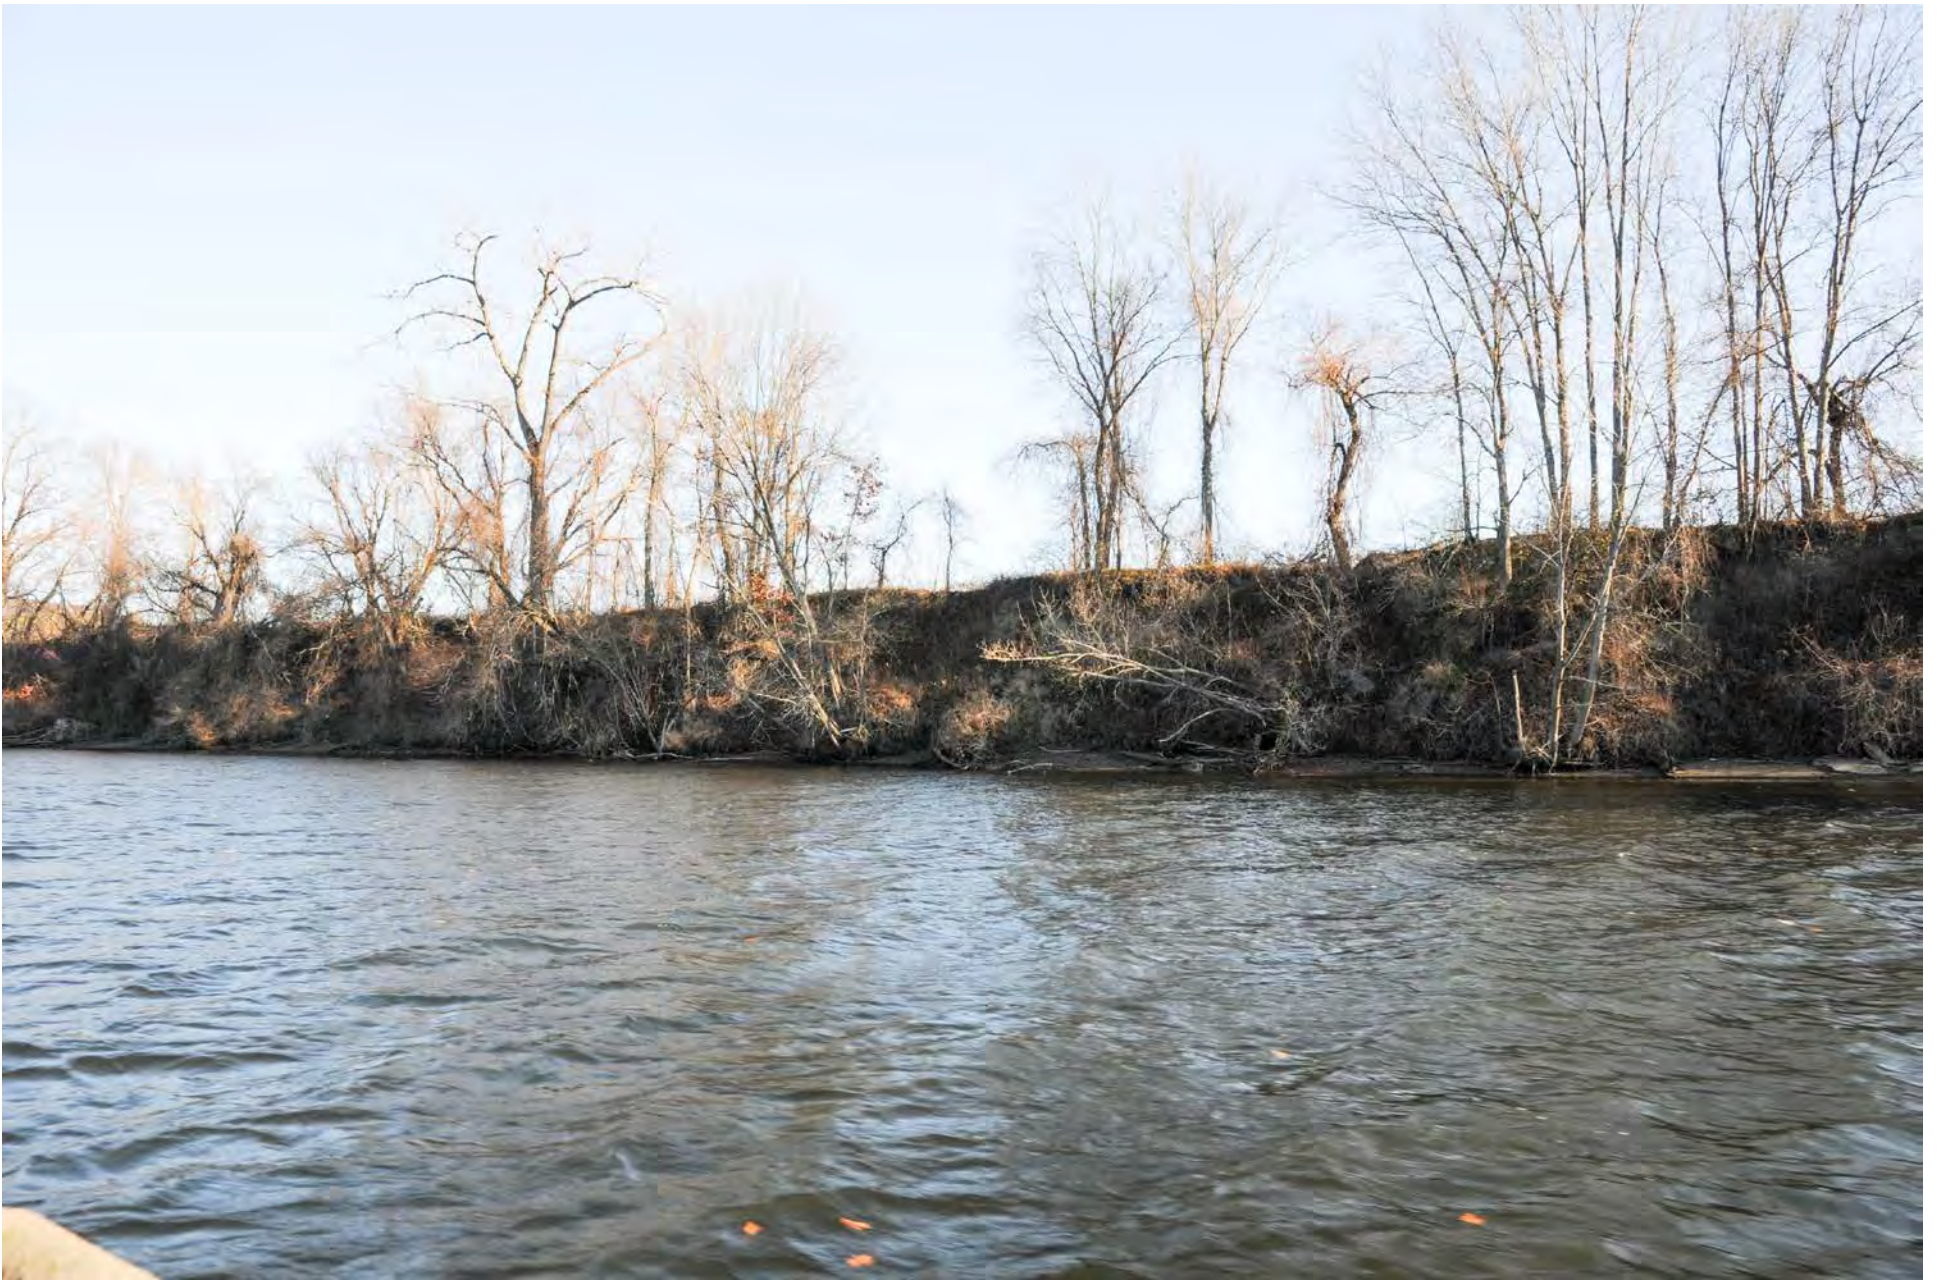
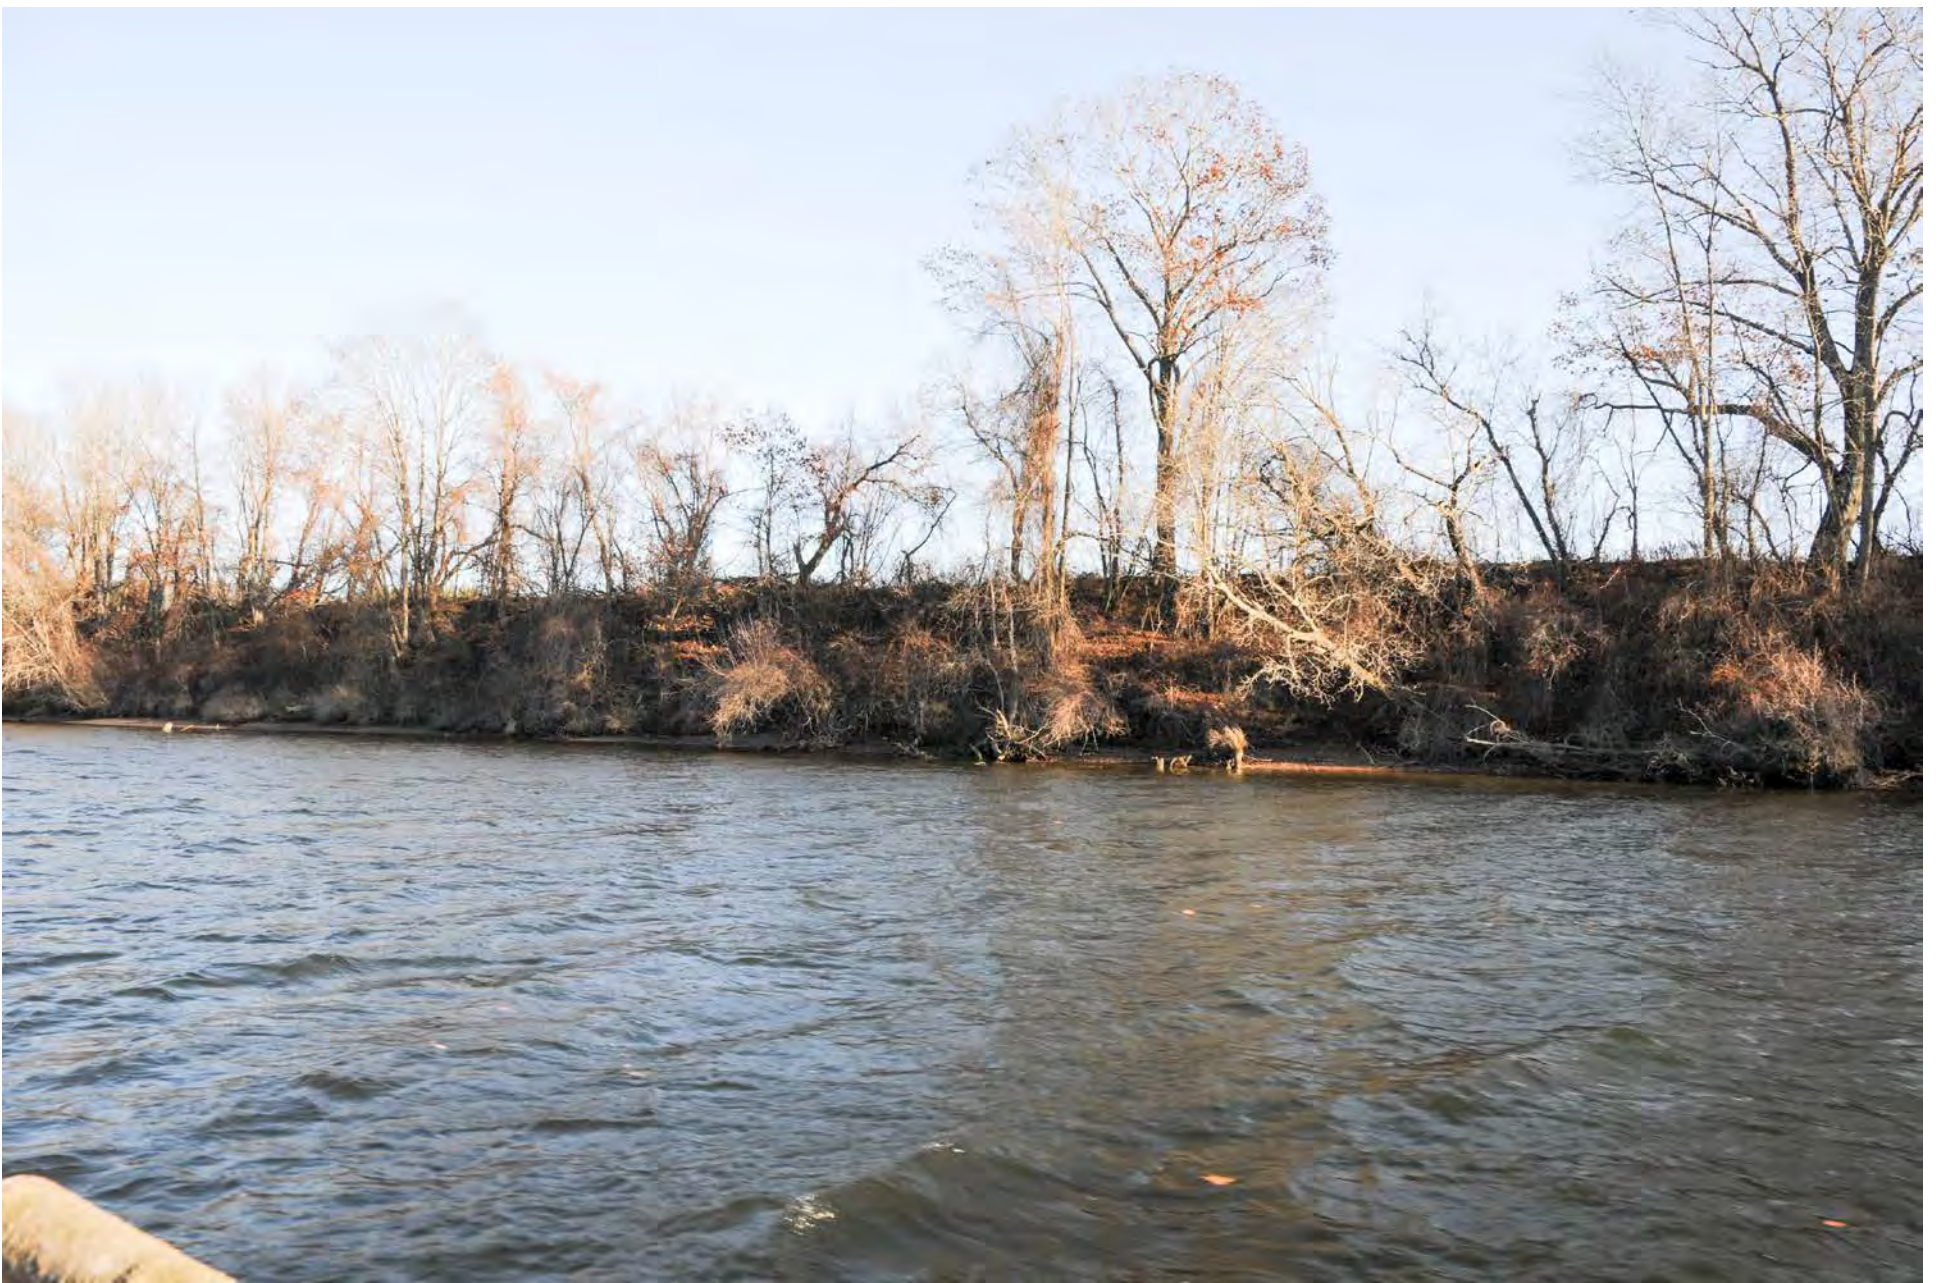
Riverbank Features	Characteristics
Upper Riverbank Slope	Steep
Upper Riverbank Height	High
Upper Riverbank Sediment	Silt/Sand
Upper Riverbank Vegetation	Heavy
Lower Riverbank Slope	Flat/Beach
Lower Riverbank Sediment	Silt/Sand
Lower Riverbank Vegetation	None to very sparse
Type of Erosion	Undercut
Potential Erosion Indicators	Creep/leaning trees, Exposed roots, Overhanging bank
Stage of Erosion	Eroded
Extent of Erosion	Some

QA Observations: Upon review of the photos for this segment, classification made in the field was confirmed and additional indicators of potential future erosion were included.
