Segment 210 – Left Bank

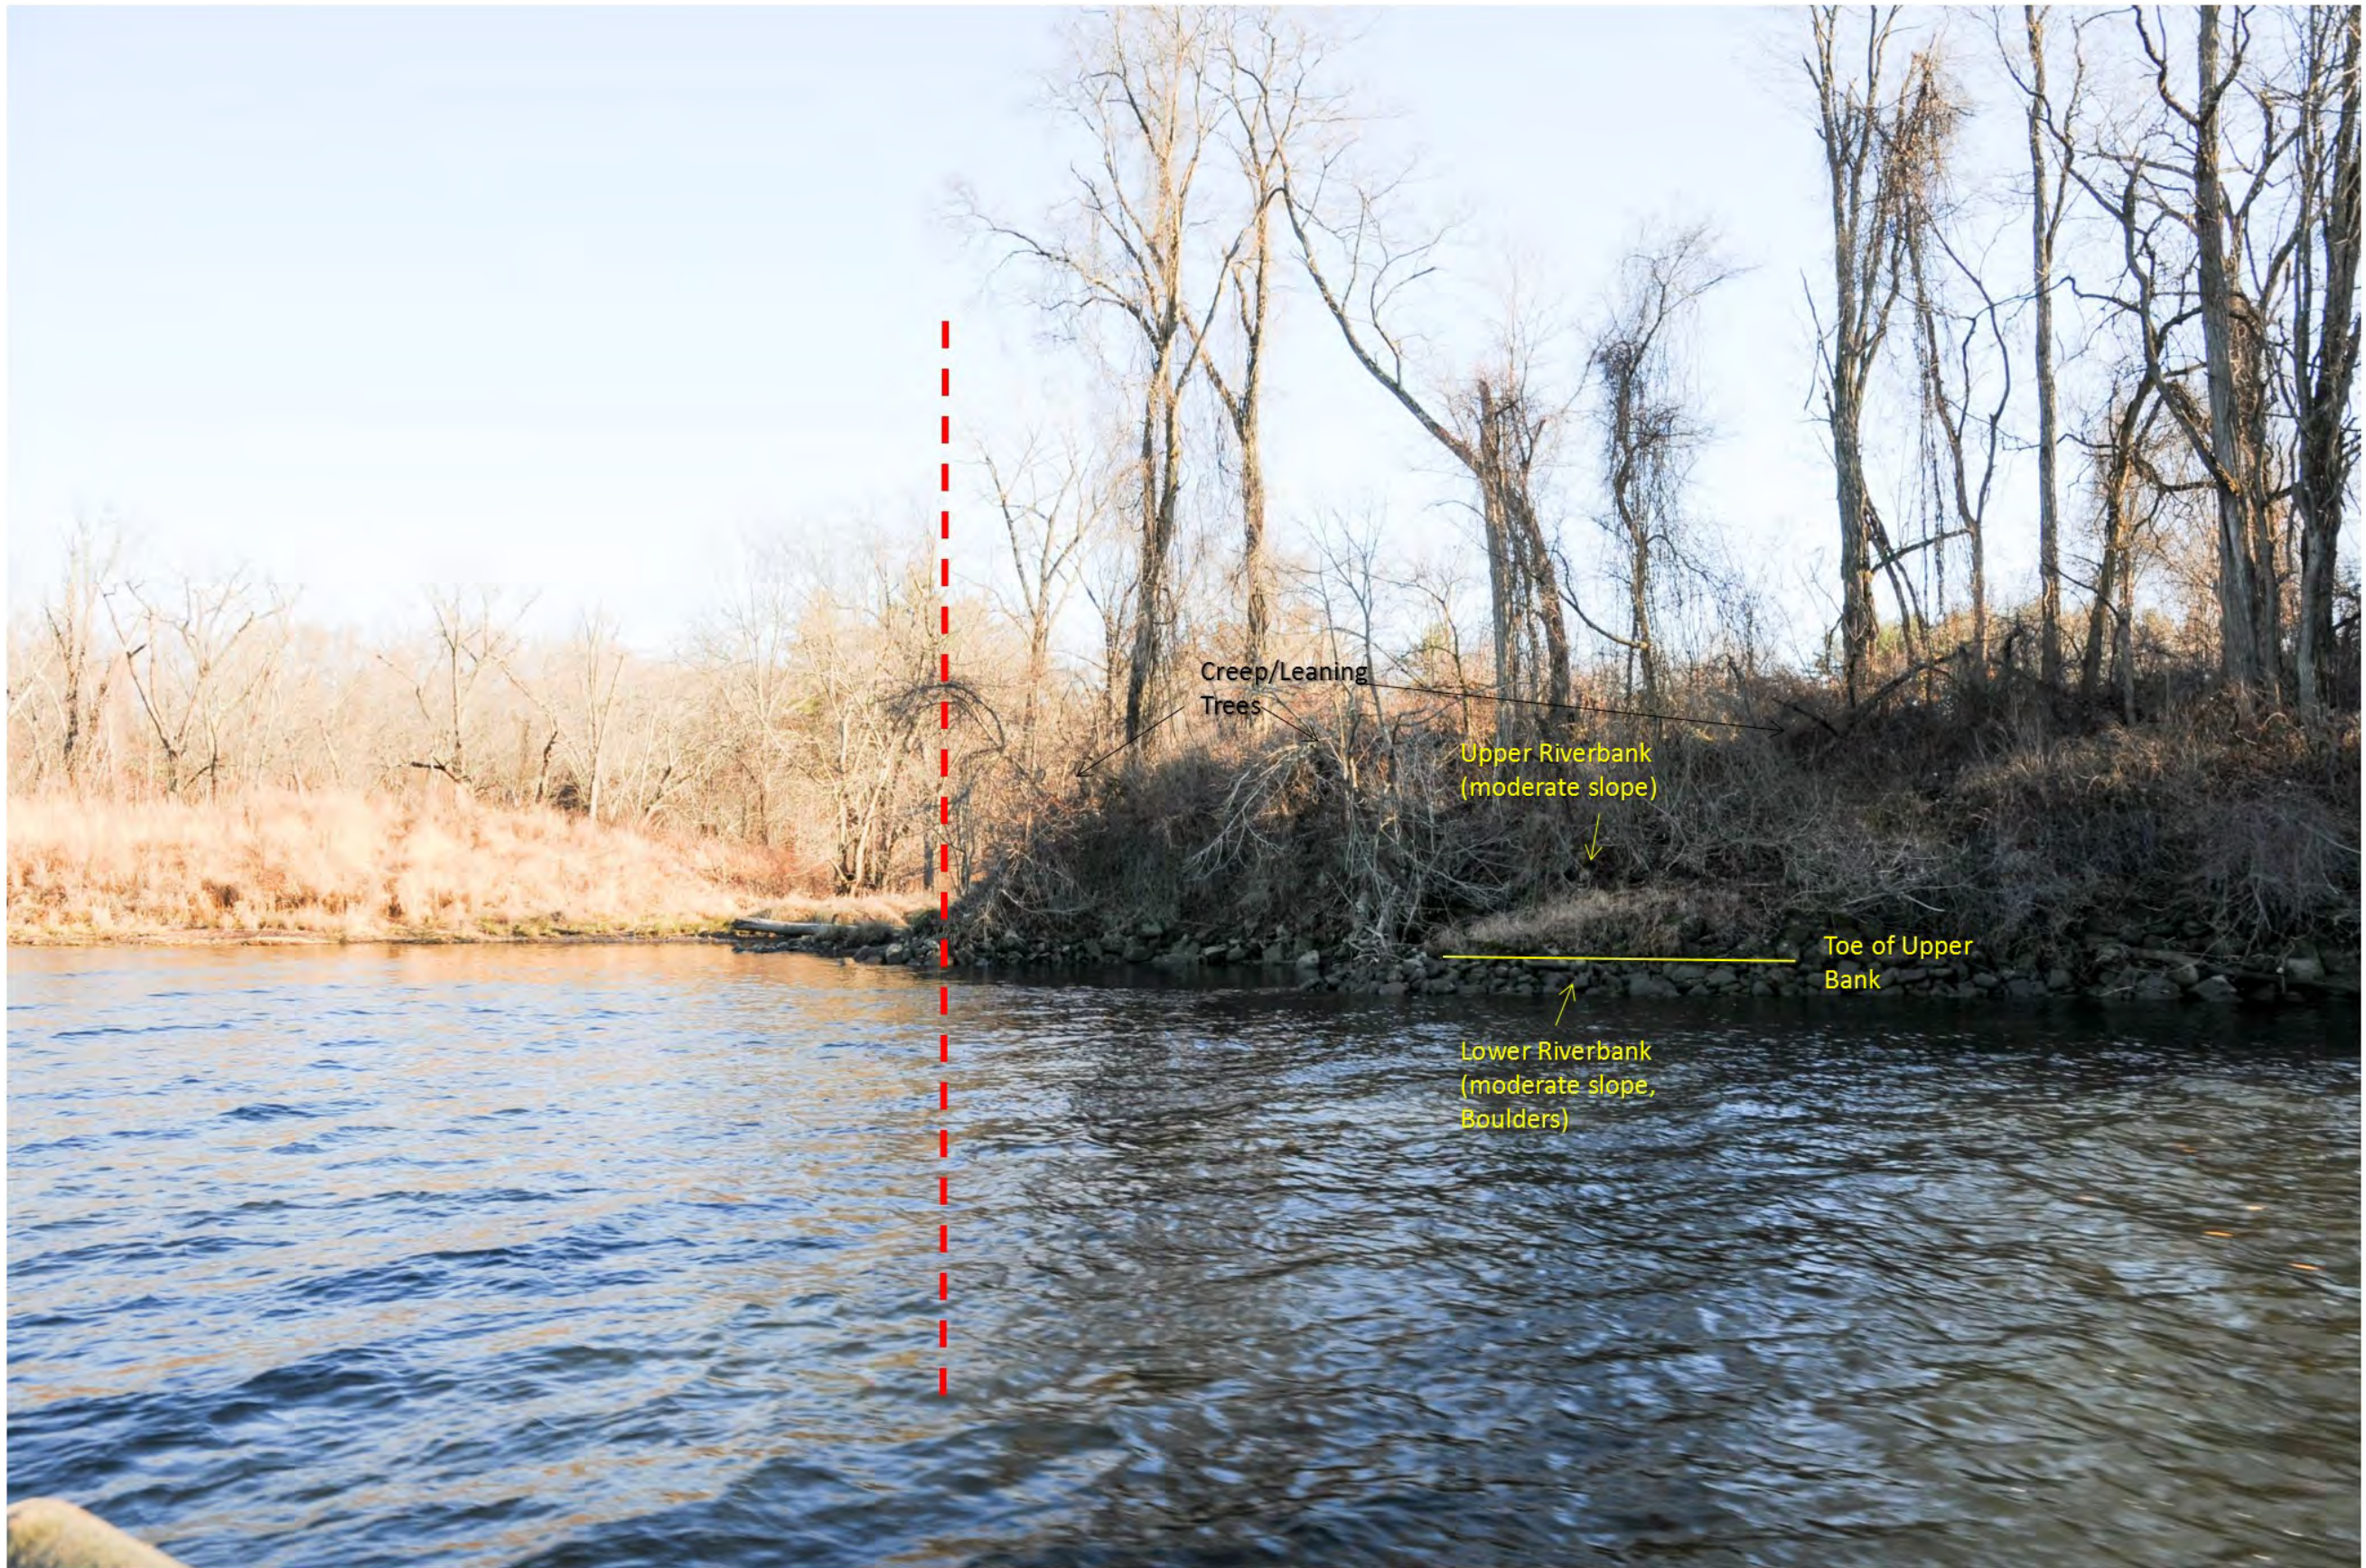
Photo ID 883 (left, U/S portion of segment shown in labeled portion of photo. Dashed line represents approximate end of segment)

Riverbank Features	Characteristics
Upper Riverbank Slope	Moderate
Upper Riverbank Height	Low
Upper Riverbank Sediment	Silt/Sand
Upper Riverbank Vegetation	Heavy
Lower Riverbank Slope	Moderate
Lower Riverbank Sediment	Boulders
Lower Riverbank Vegetation	None to very sparse
Type of Erosion	
Potential Erosion Indicators	Creep/leaning trees
Stage of Erosion	Stable
Extent of Erosion	None/Little

QA Observations: Upon review of the photos for this segment, classification made in the field was confirmed.

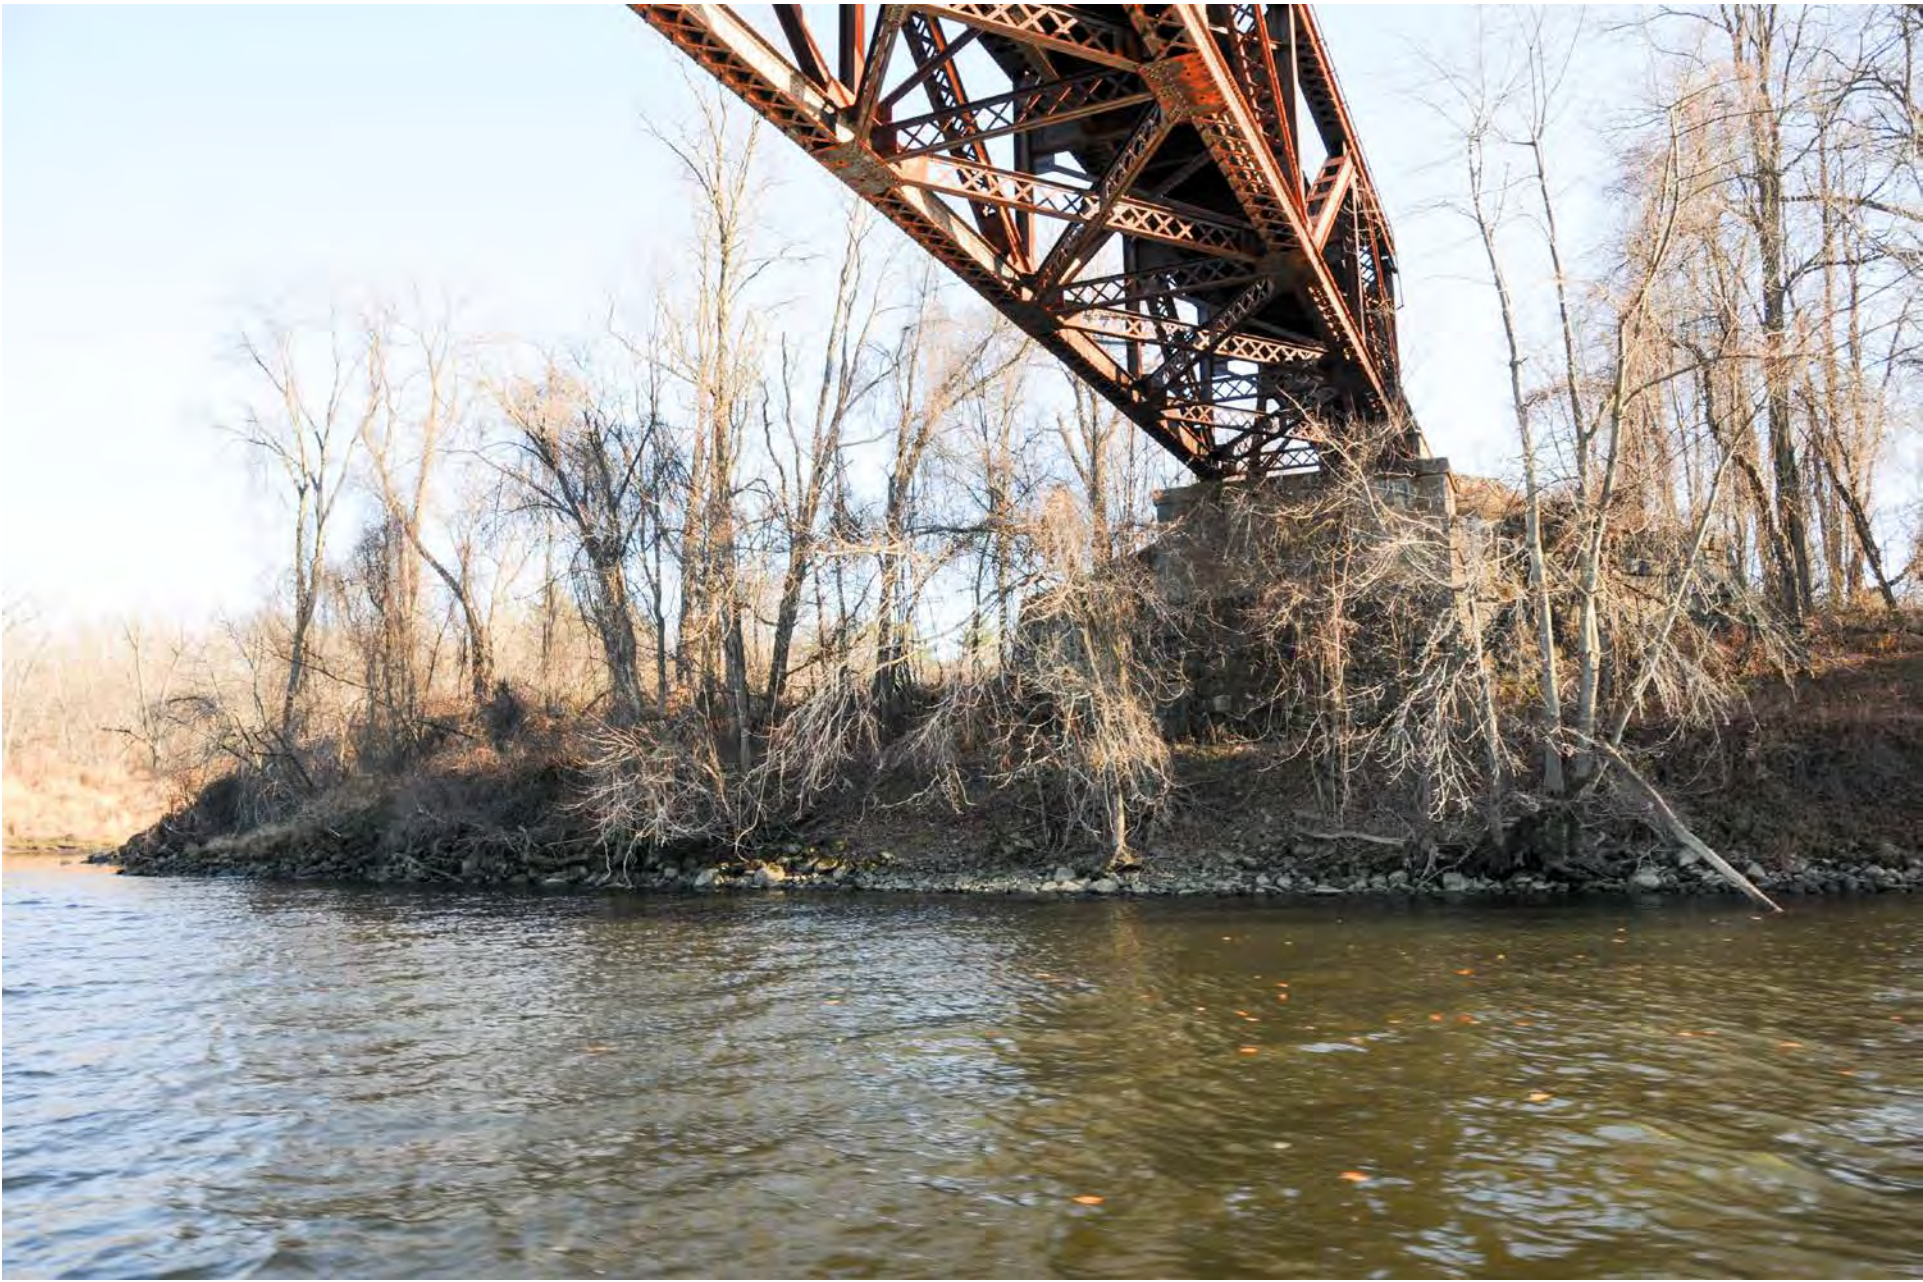
Photo ID 882 (U/S and includes some of next segment)

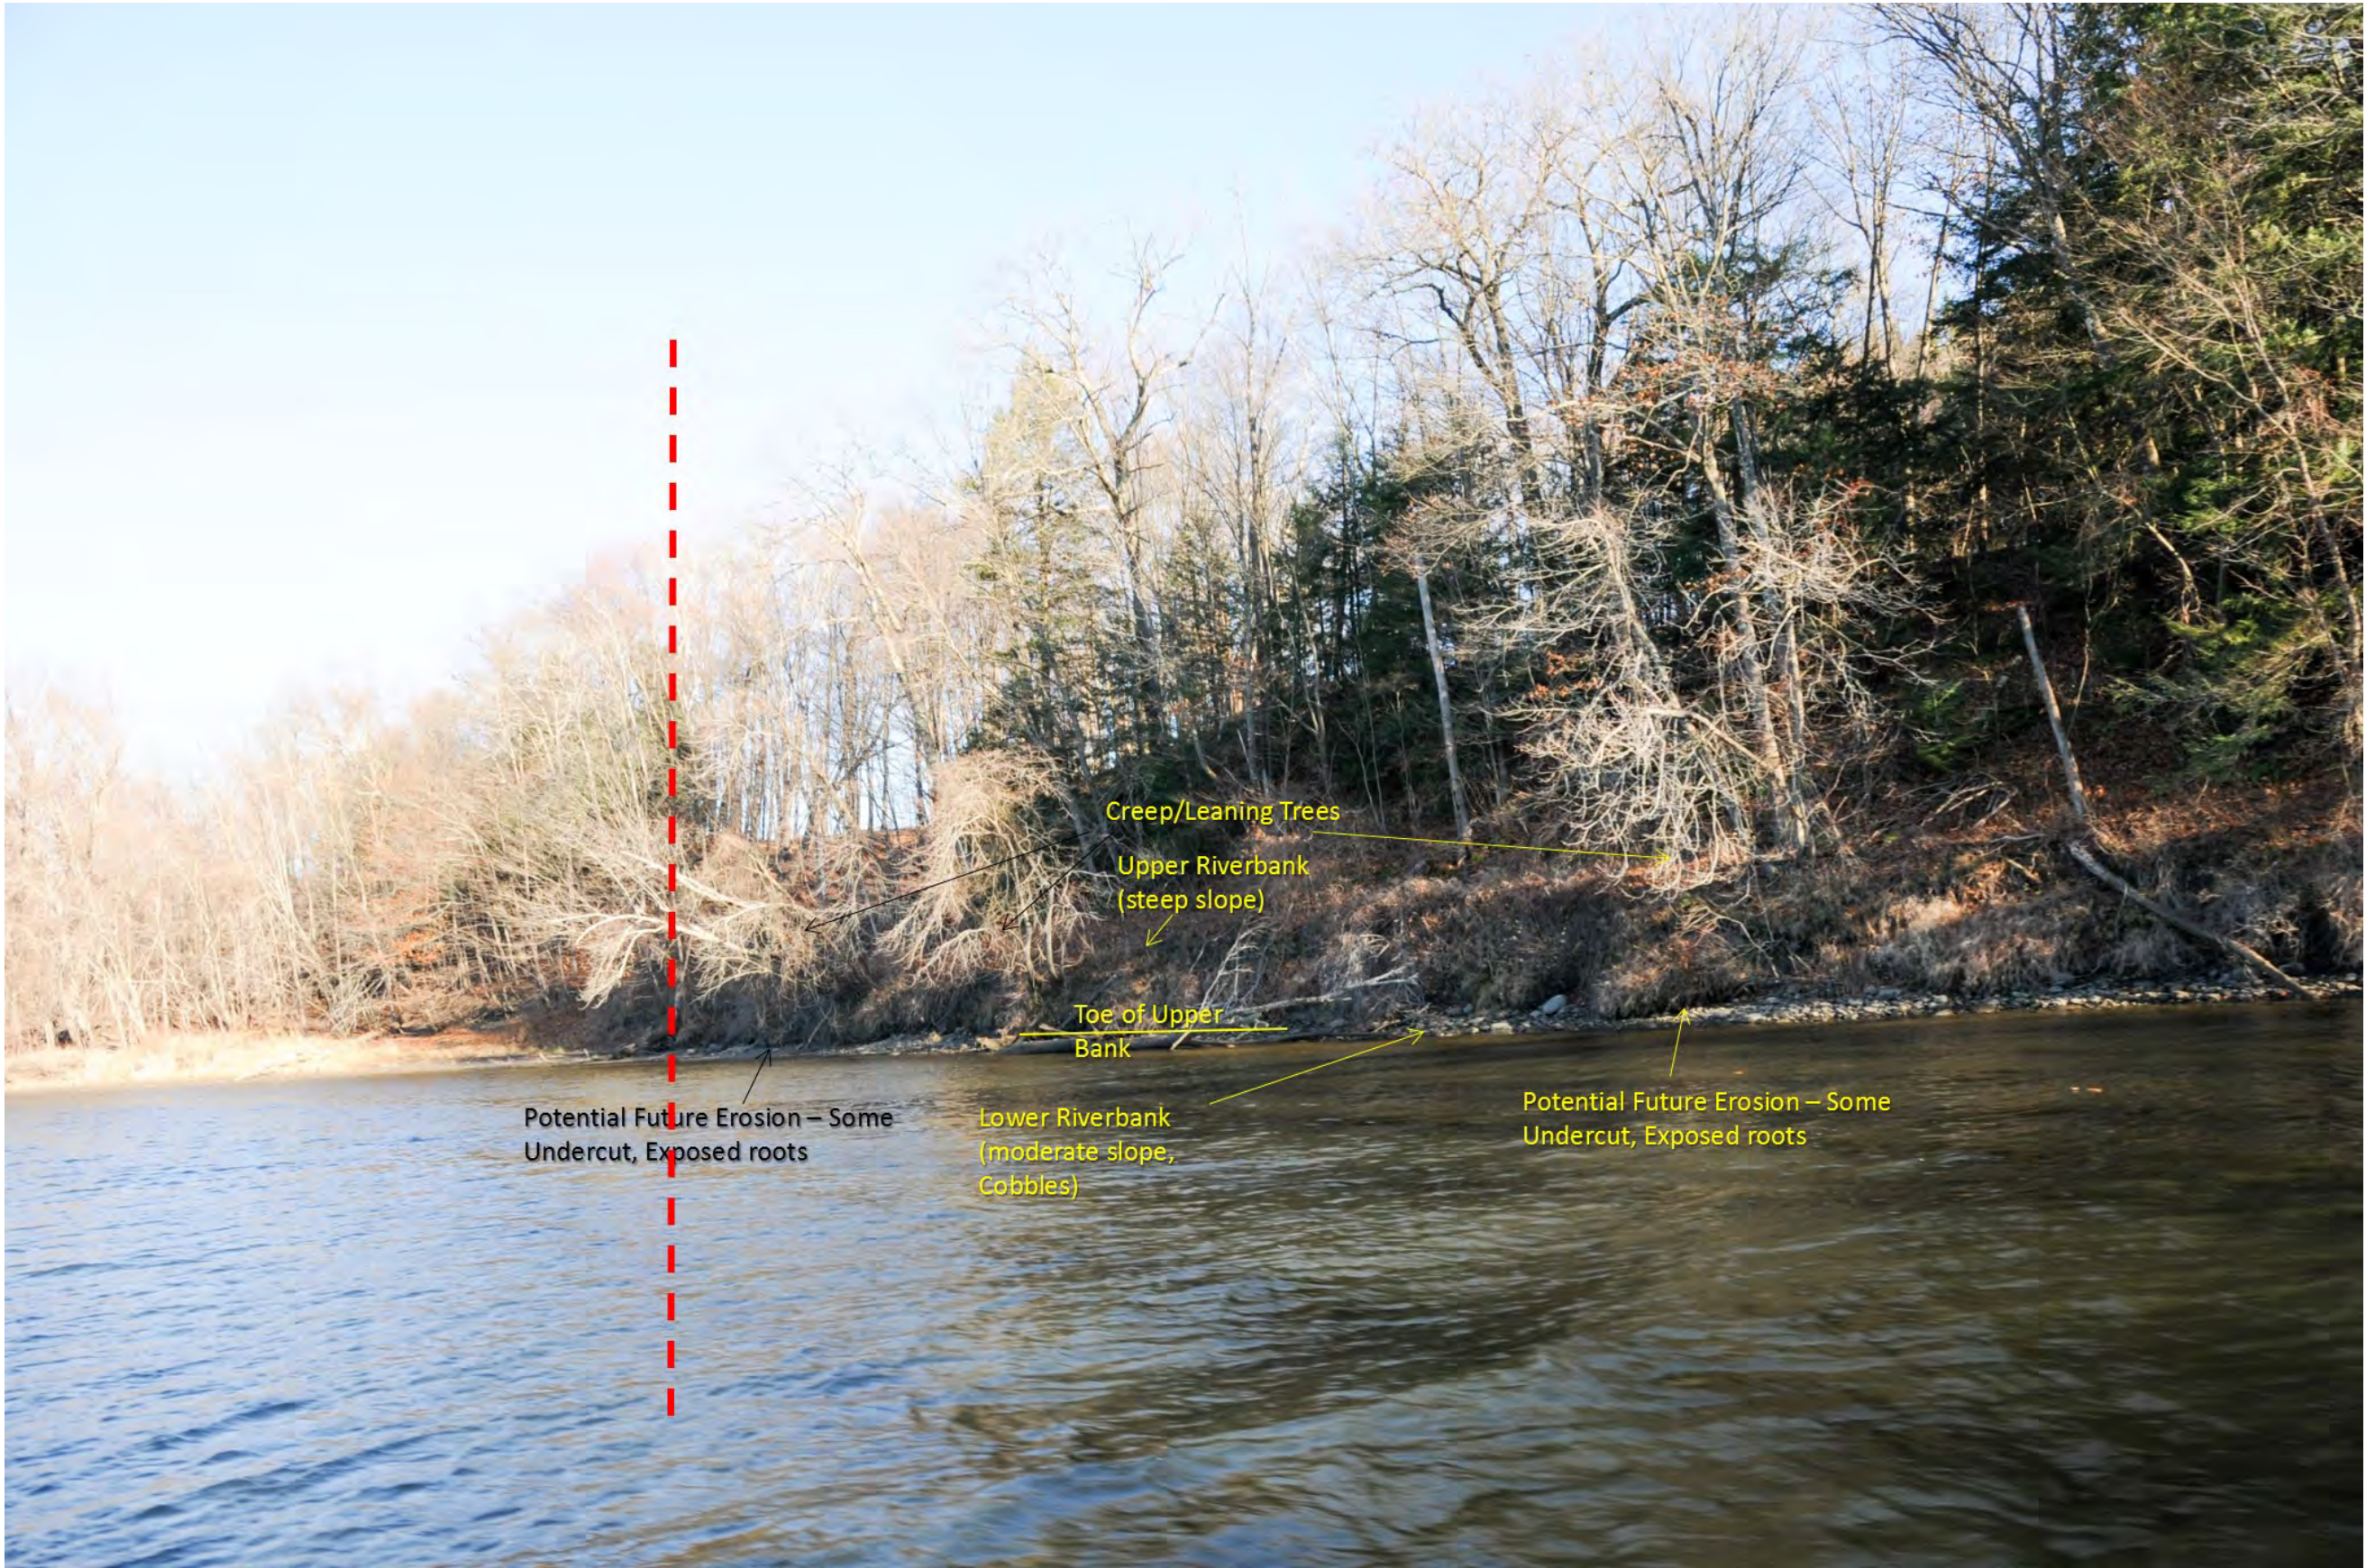
Photo ID 903 (left, U/S portion of segment shown in labeled portion of photo. Dashed line represents approximate end of segment)

Riverbank Features	Characteristics
Upper Riverbank Slope	Steep
Upper Riverbank Height	High
Upper Riverbank Sediment	Silt/Sand
Upper Riverbank Vegetation	Heavy
Lower Riverbank Slope	Moderate
Lower Riverbank Sediment	Cobbles
Lower Riverbank Vegetation	None to very sparse
Type of Erosion	Undercut
Potential Erosion Indicators	Creep/leaning trees, Exposed roots
Stage of Erosion	Potential Future Erosion
Extent of Erosion	Some

QA Observations: Upon review of the photos for this segment, classification made in the field was confirmed and additional indicators of potential future erosion were included.

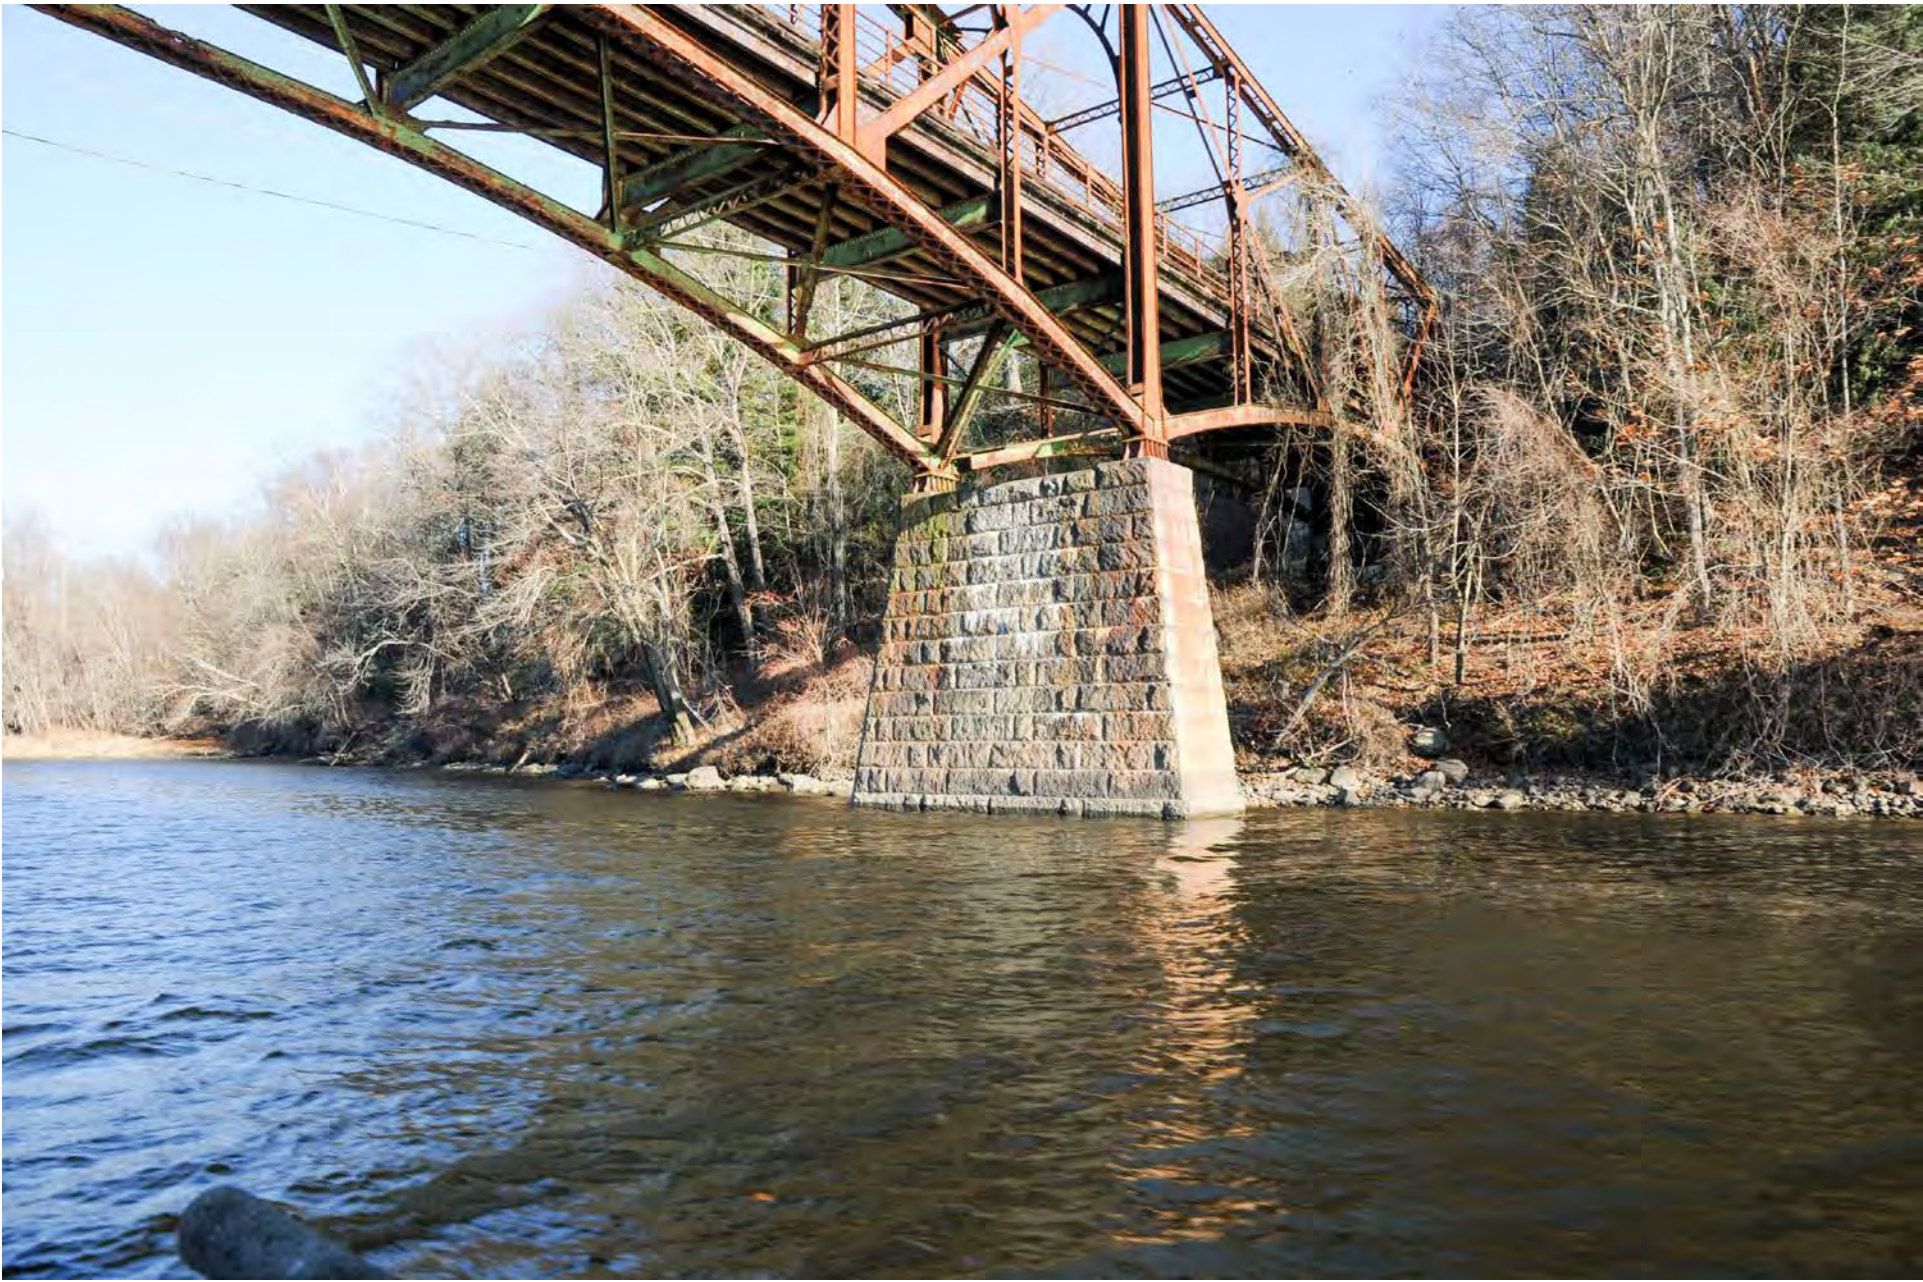
Photo ID 902 (D/S and includes next segments)

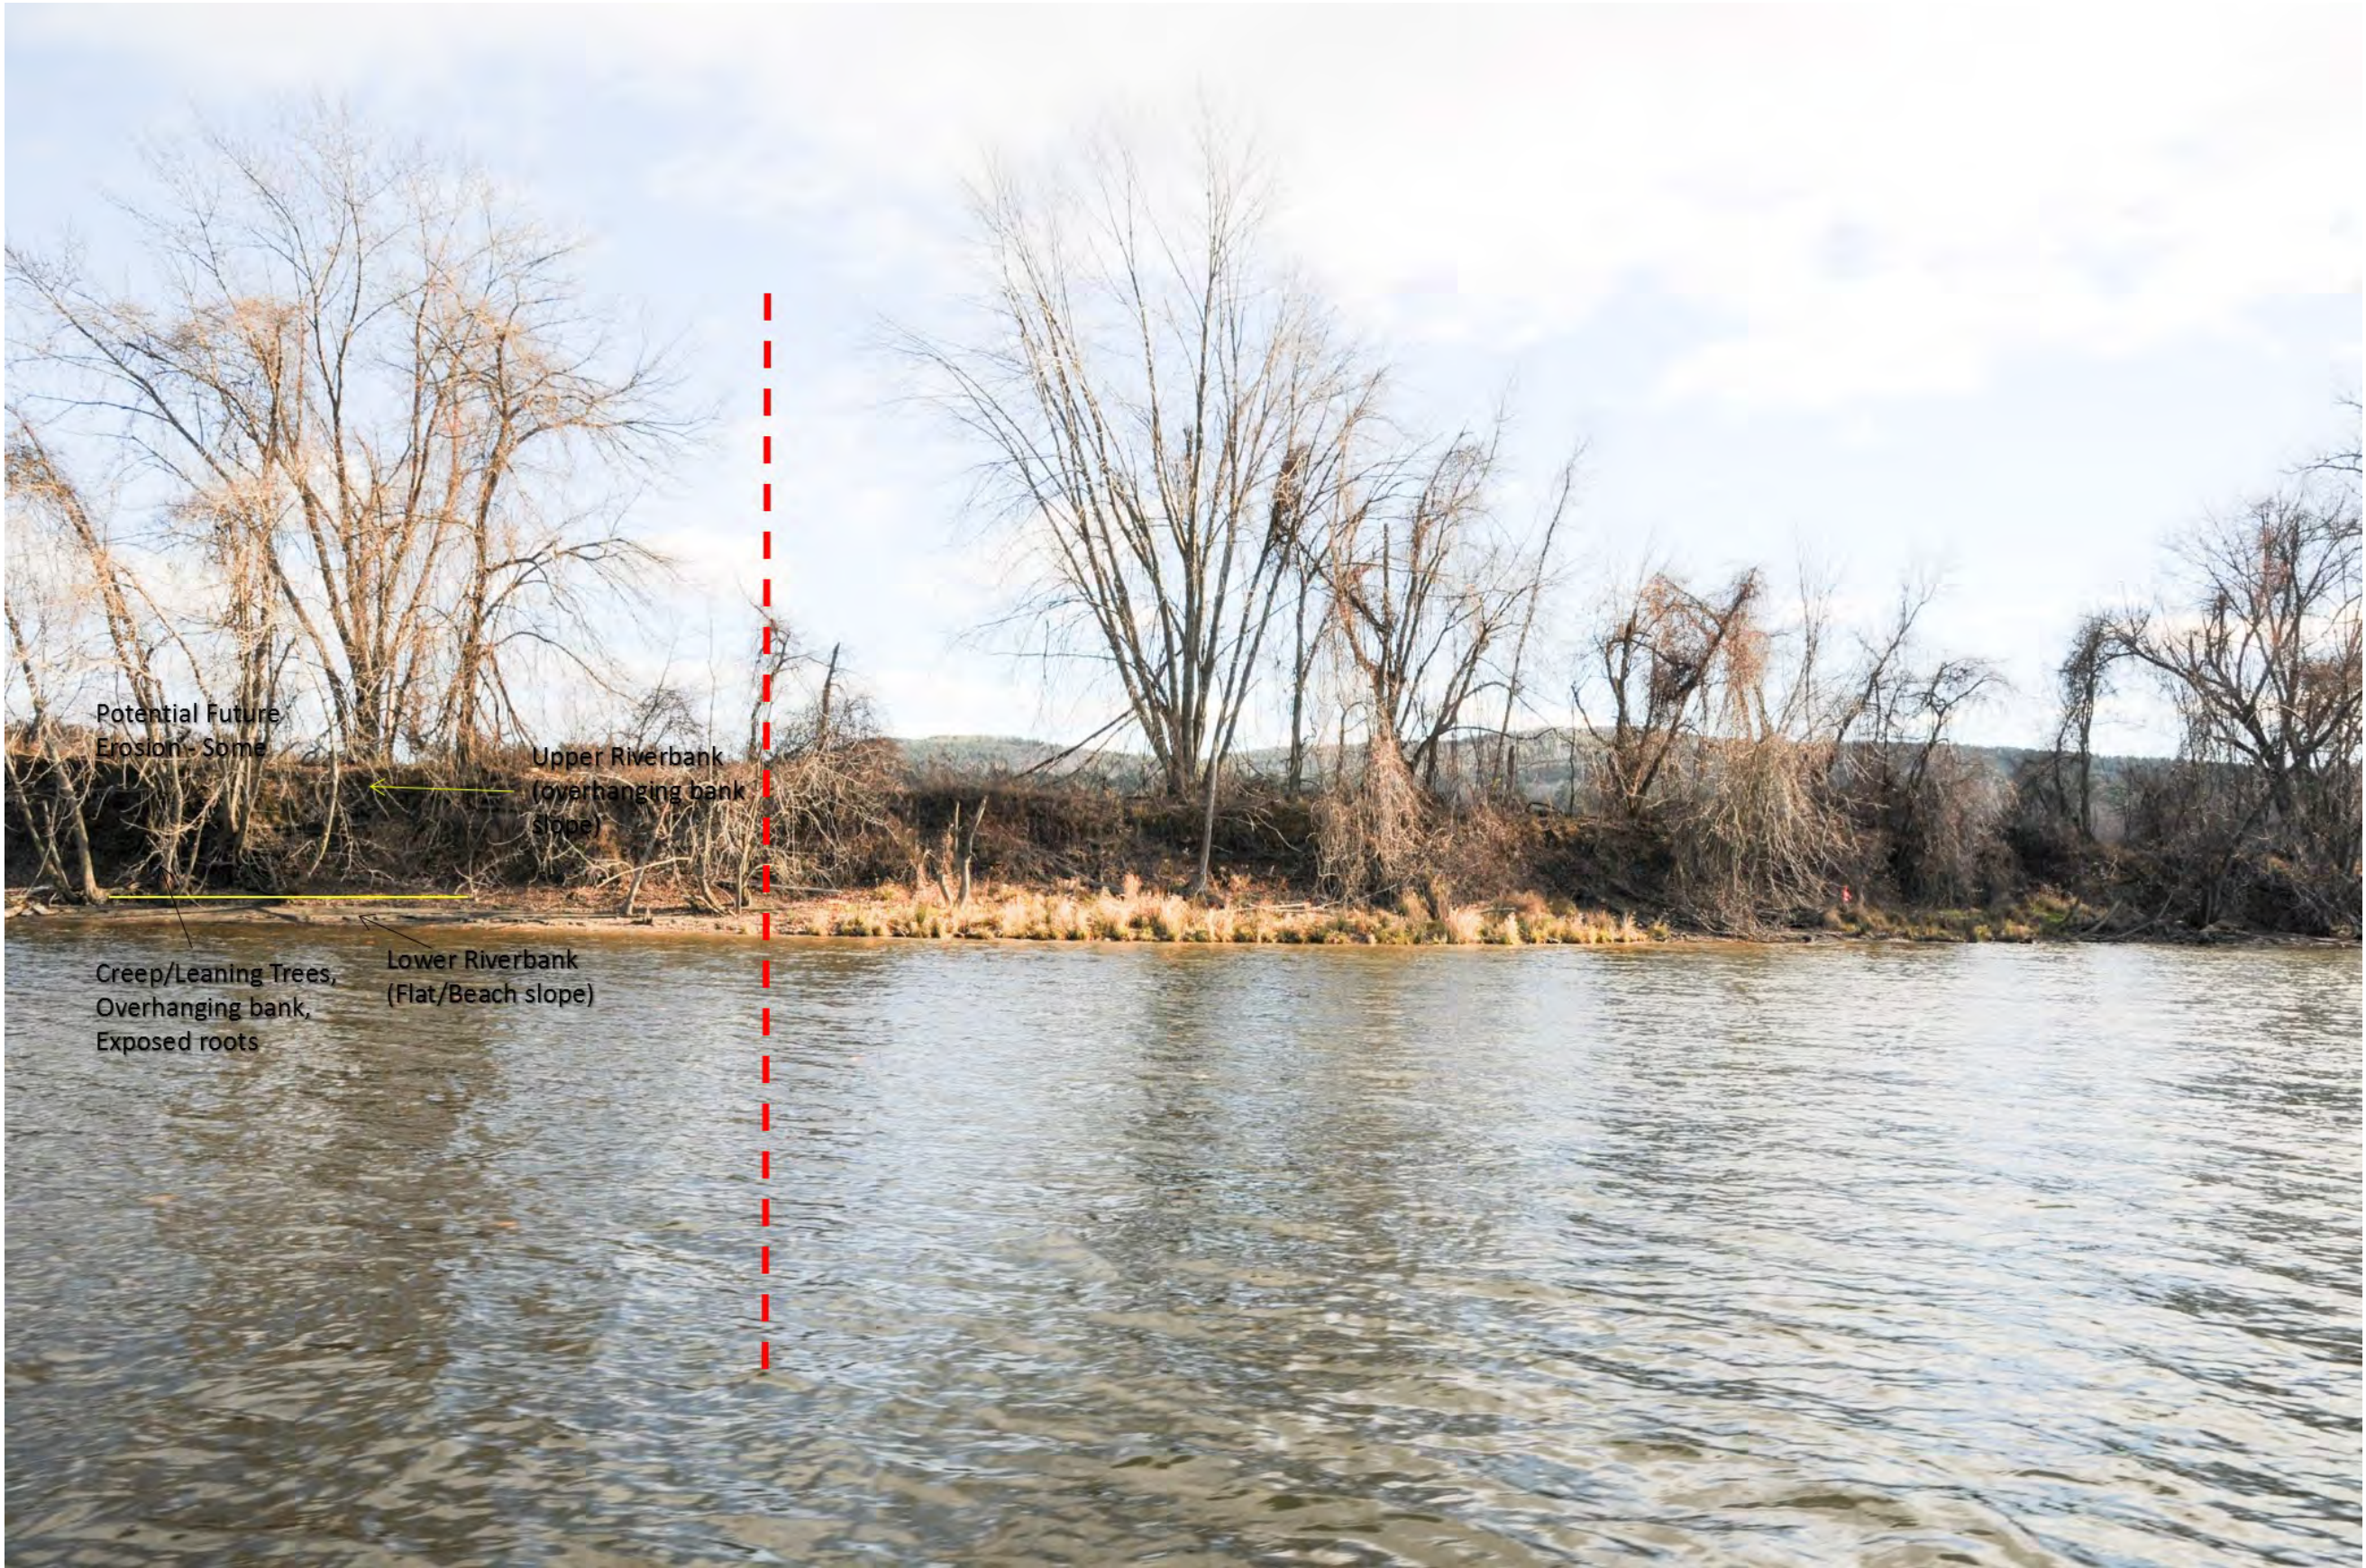
Photo ID 1707 (labeled portion of photo is right, D/S portion of segment. Dashed line represents approximate end of segment)

Riverbank Features	Characteristics
Upper Riverbank Slope	Overhanging
Upper Riverbank Height	Medium
Upper Riverbank Sediment	Silt/Sand
Upper Riverbank Vegetation	Moderate
Lower Riverbank Slope	Flat/Beach
Lower Riverbank Sediment	Silt/Sand
Lower Riverbank Vegetation	None to very sparse
Type of Erosion	
Potential Erosion Indicators	Creep/leaning trees, Overhanging bank, Exposed roots
Stage of Erosion	Potential Future Erosion
Extent of Erosion	Some

QA Observations: Upon review of the photos for this segment, classification made in the field was confirmed and additional indicators of potential future erosion were included.

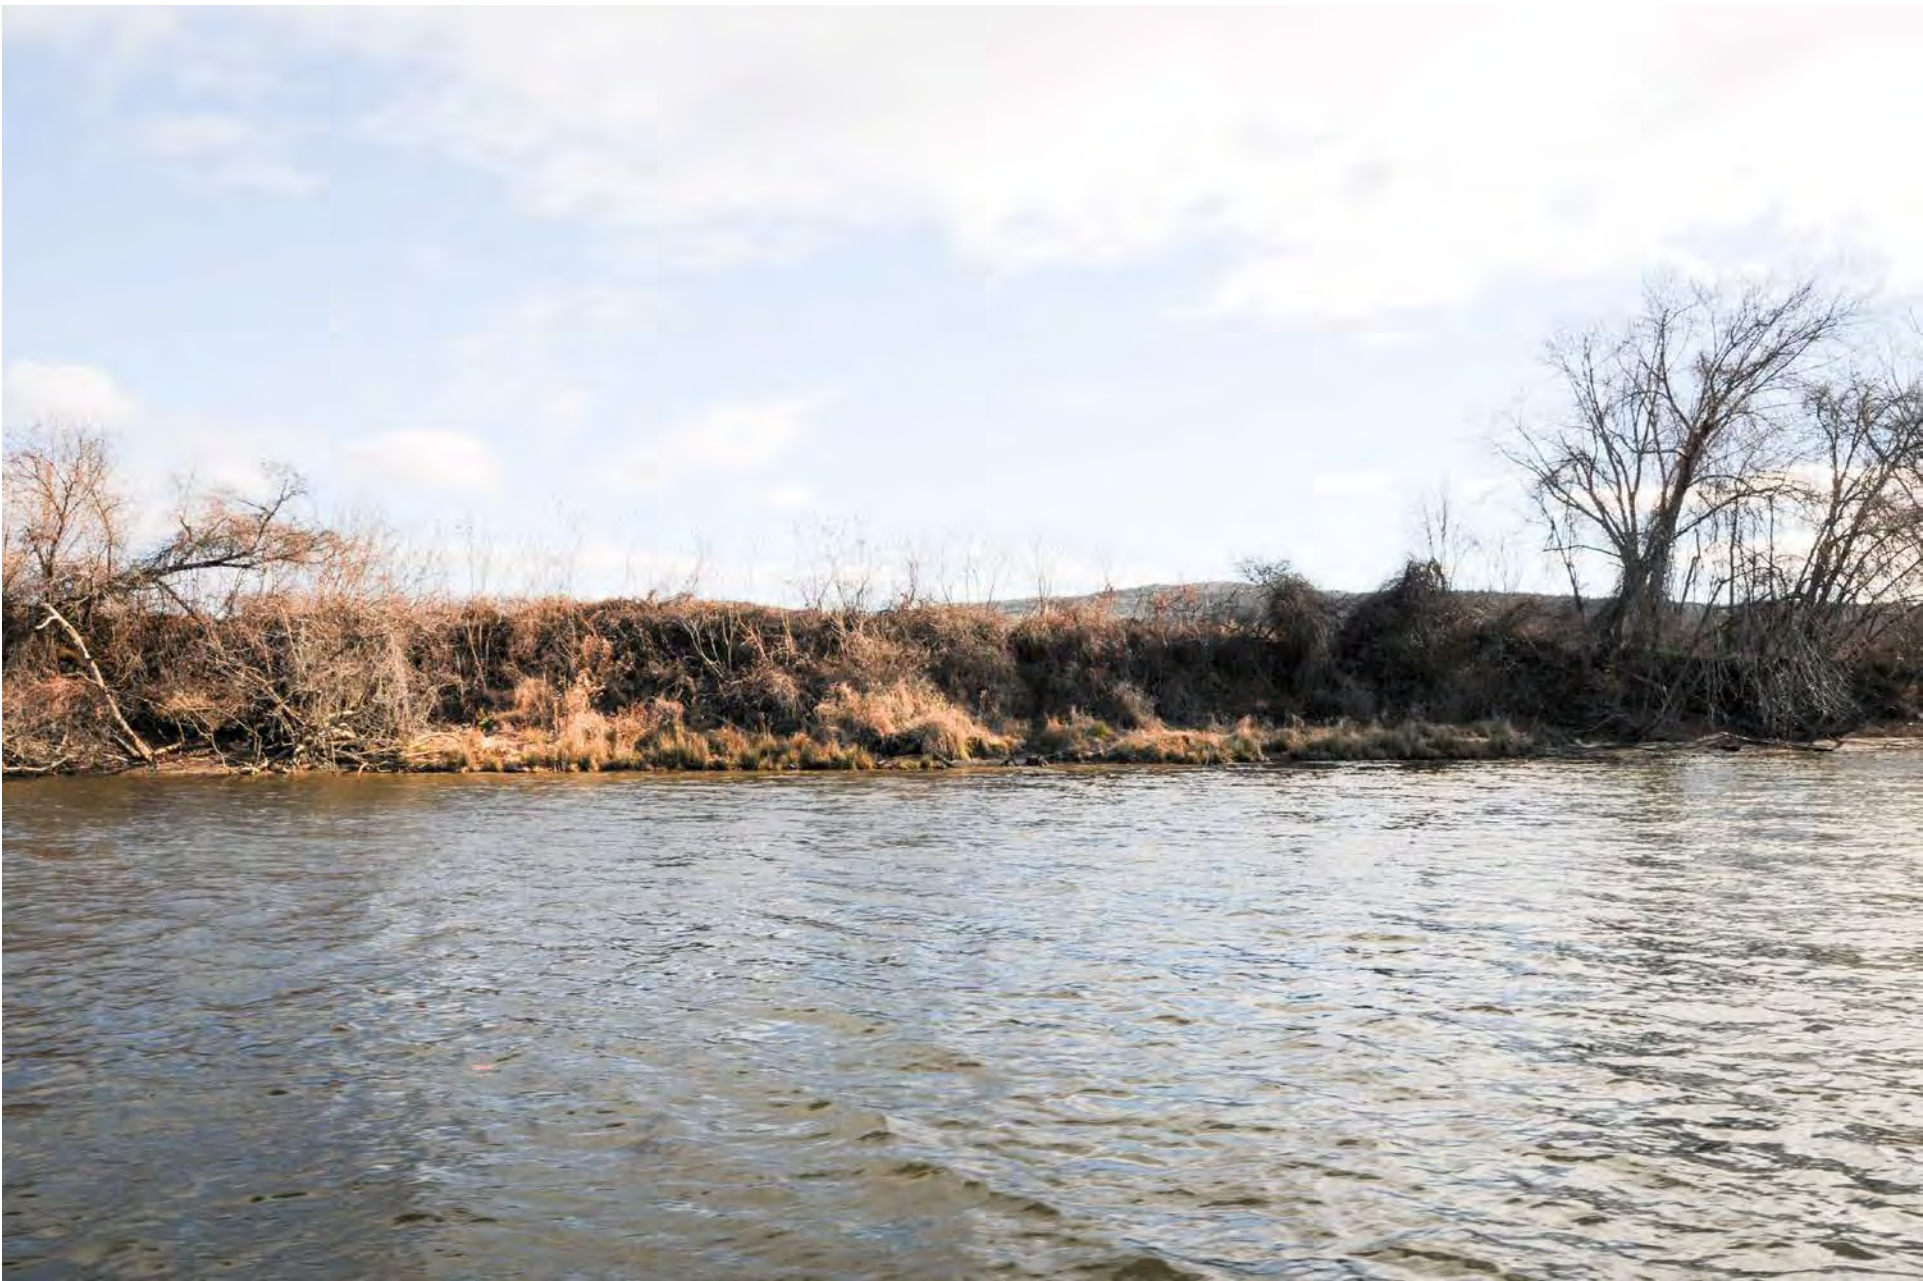
Photo ID 1706 (Right side of photo depicts a portion of Segment 230)

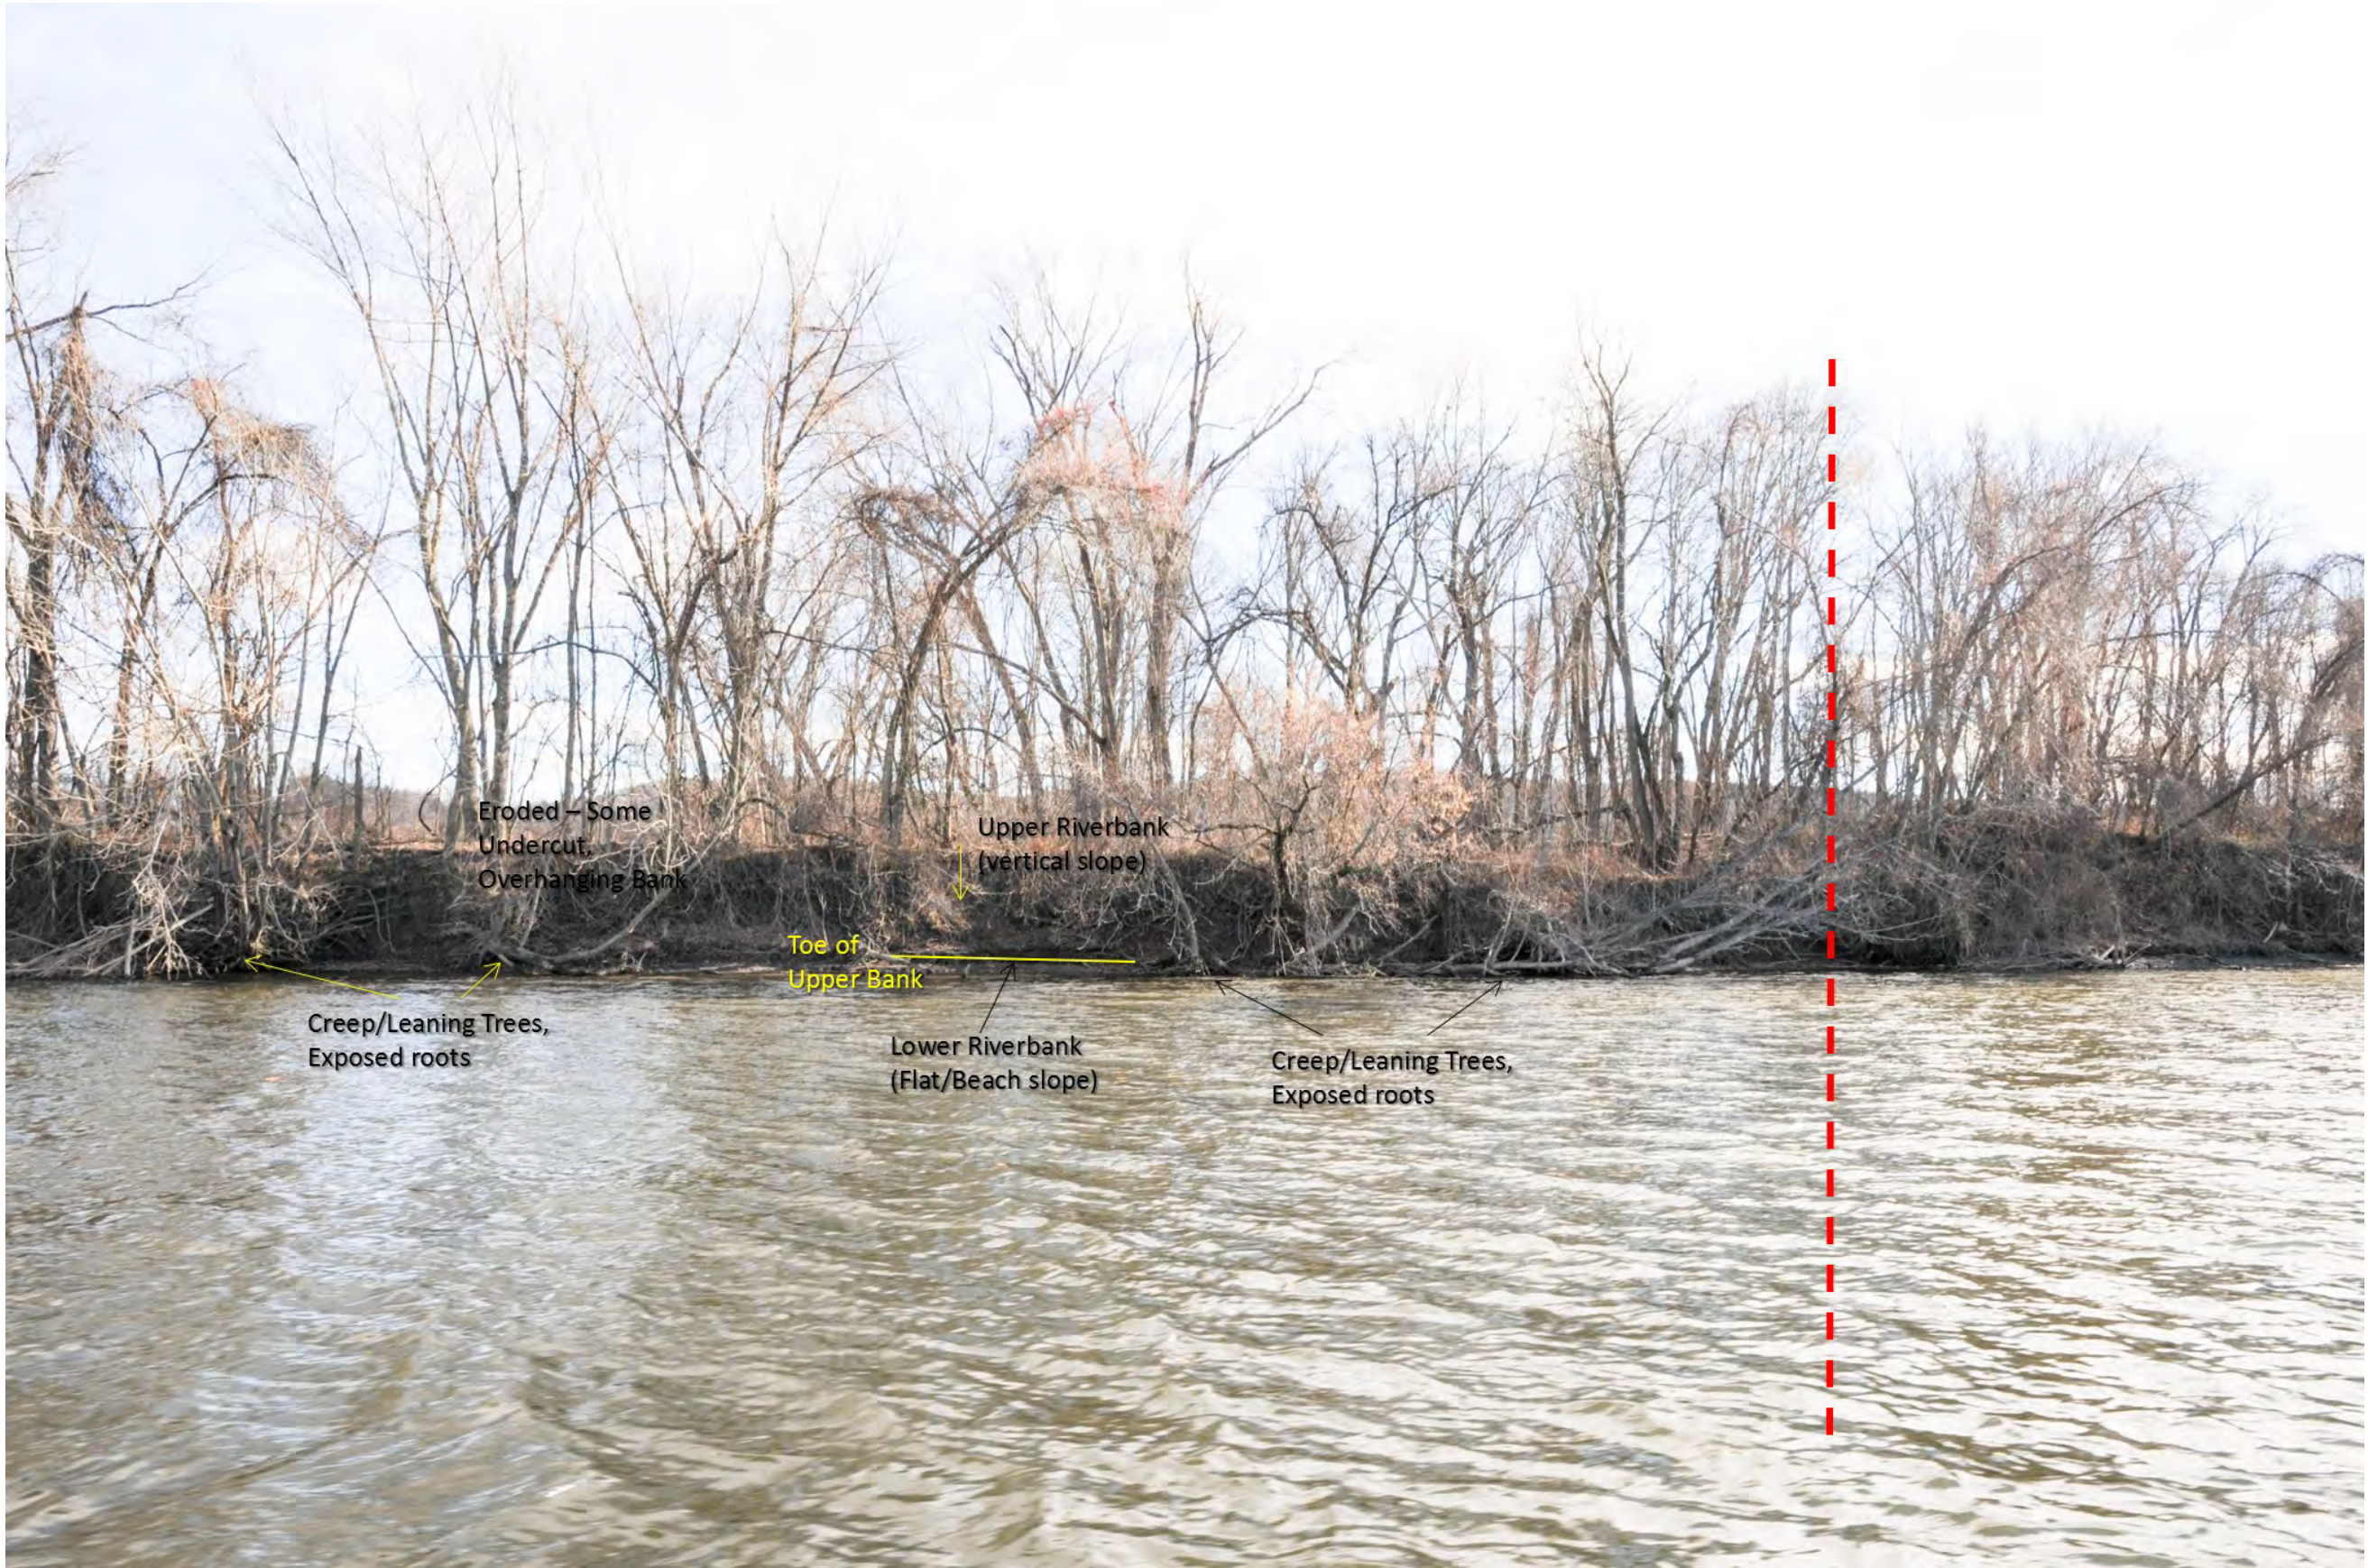
Photo ID 1702 (labeled portion of photo is right, D/S portion of segment. Dashed line represents approximate end of segment)

Riverbank Features	Characteristics
Upper Riverbank Slope	Vertical
Upper Riverbank Height	Low
Upper Riverbank Sediment	Silt/Sand
Upper Riverbank Vegetation	Moderate
Lower Riverbank Slope	Flat/Beach
Lower Riverbank Sediment	Silt/Sand
Lower Riverbank Vegetation	None to very sparse
Type of Erosion	Undercut
Potential Erosion Indicators	Creep/leaning trees, Exposed roots, Overhanging bank
Stage of Erosion	Eroded
Extent of Erosion	Some

QA Observations: Upon review of the photos for this segment, classification made in the field was confirmed and additional indicators of potential future erosion were included.
