Segment 210 – Left Bank

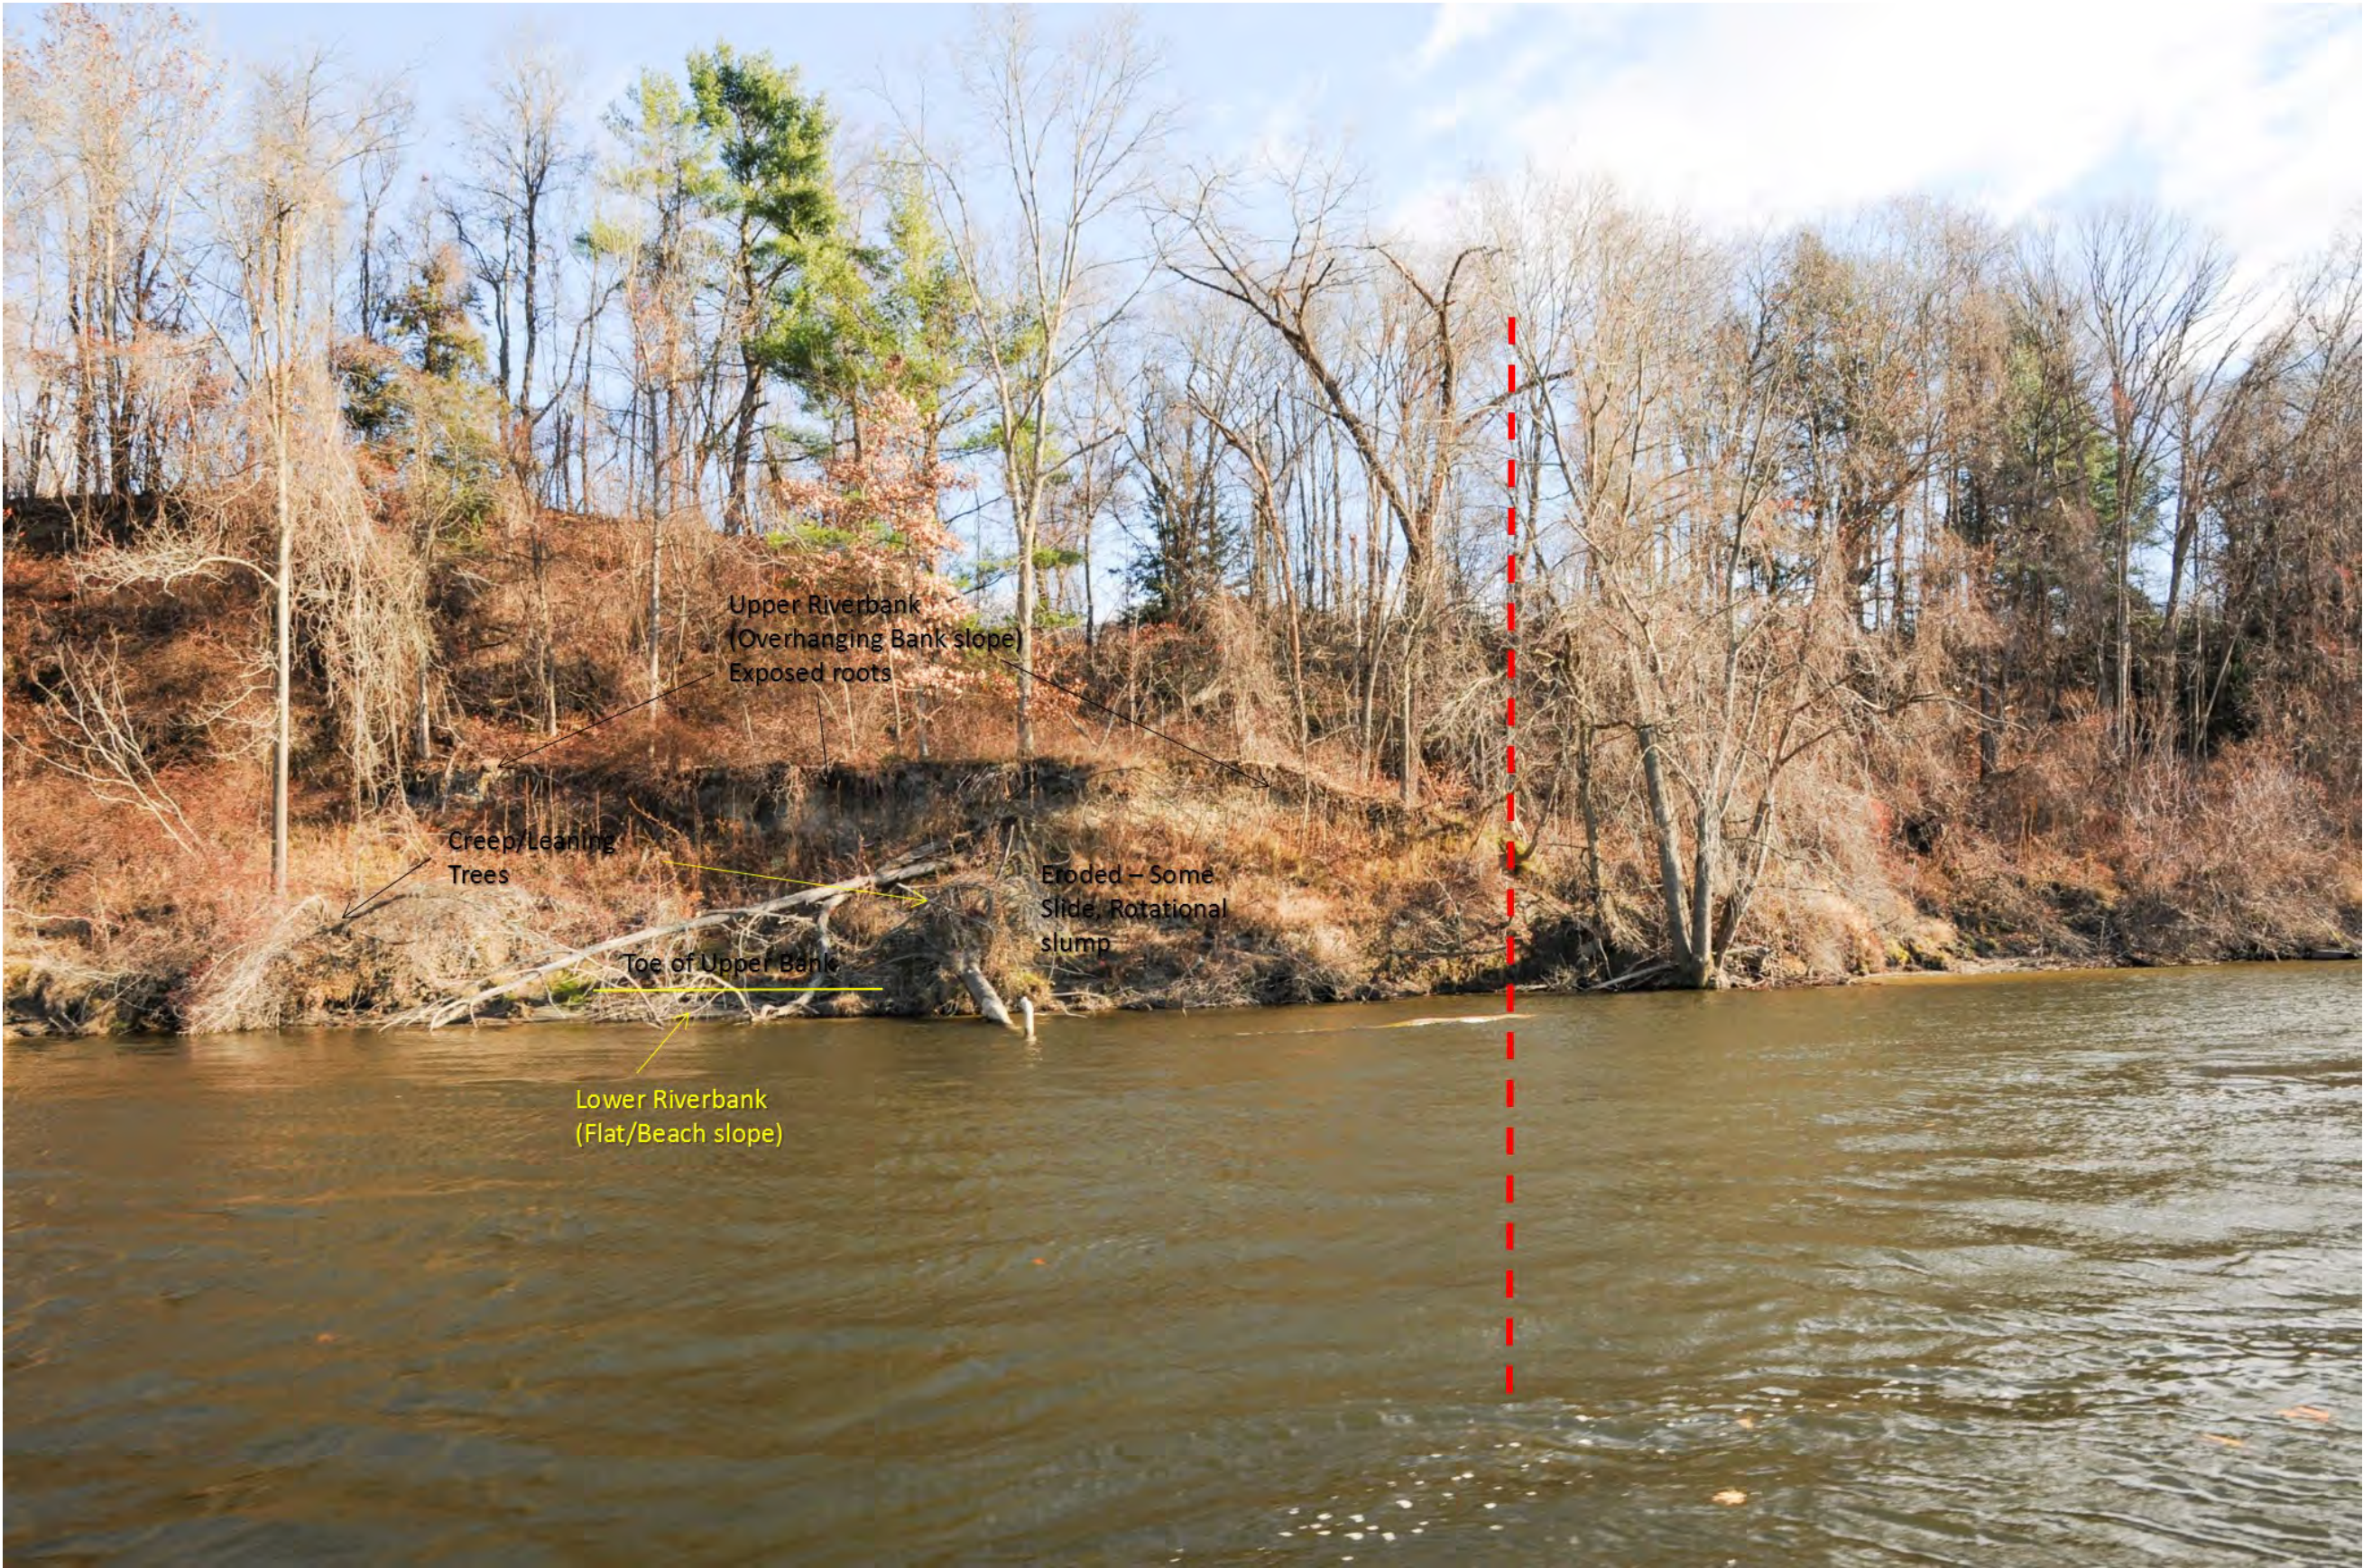
Photo ID 1670 (segment shown in labeled portion of photo. Dashed line represents approximate end of segment)

Riverbank Features	Characteristics
Upper Riverbank Slope	Overhanging
Upper Riverbank Height	High
Upper Riverbank Sediment	Silt/Sand
Upper Riverbank Vegetation	Moderate
Lower Riverbank Slope	Flat/Beach
Lower Riverbank Sediment	Silt/Sand
Lower Riverbank Vegetation	None to very sparse
Type of Erosion	Slide, Rotational Slump
Potential Erosion Indicators	Overhanging bank, Creep/leaning trees, Exposed roots,
Stage of Erosion	Eroded
Extent of Erosion	Some

QA Observations: Upon review of the photos for this segment, classification made in the field was confirmed and additional indicators of potential future erosion were included.

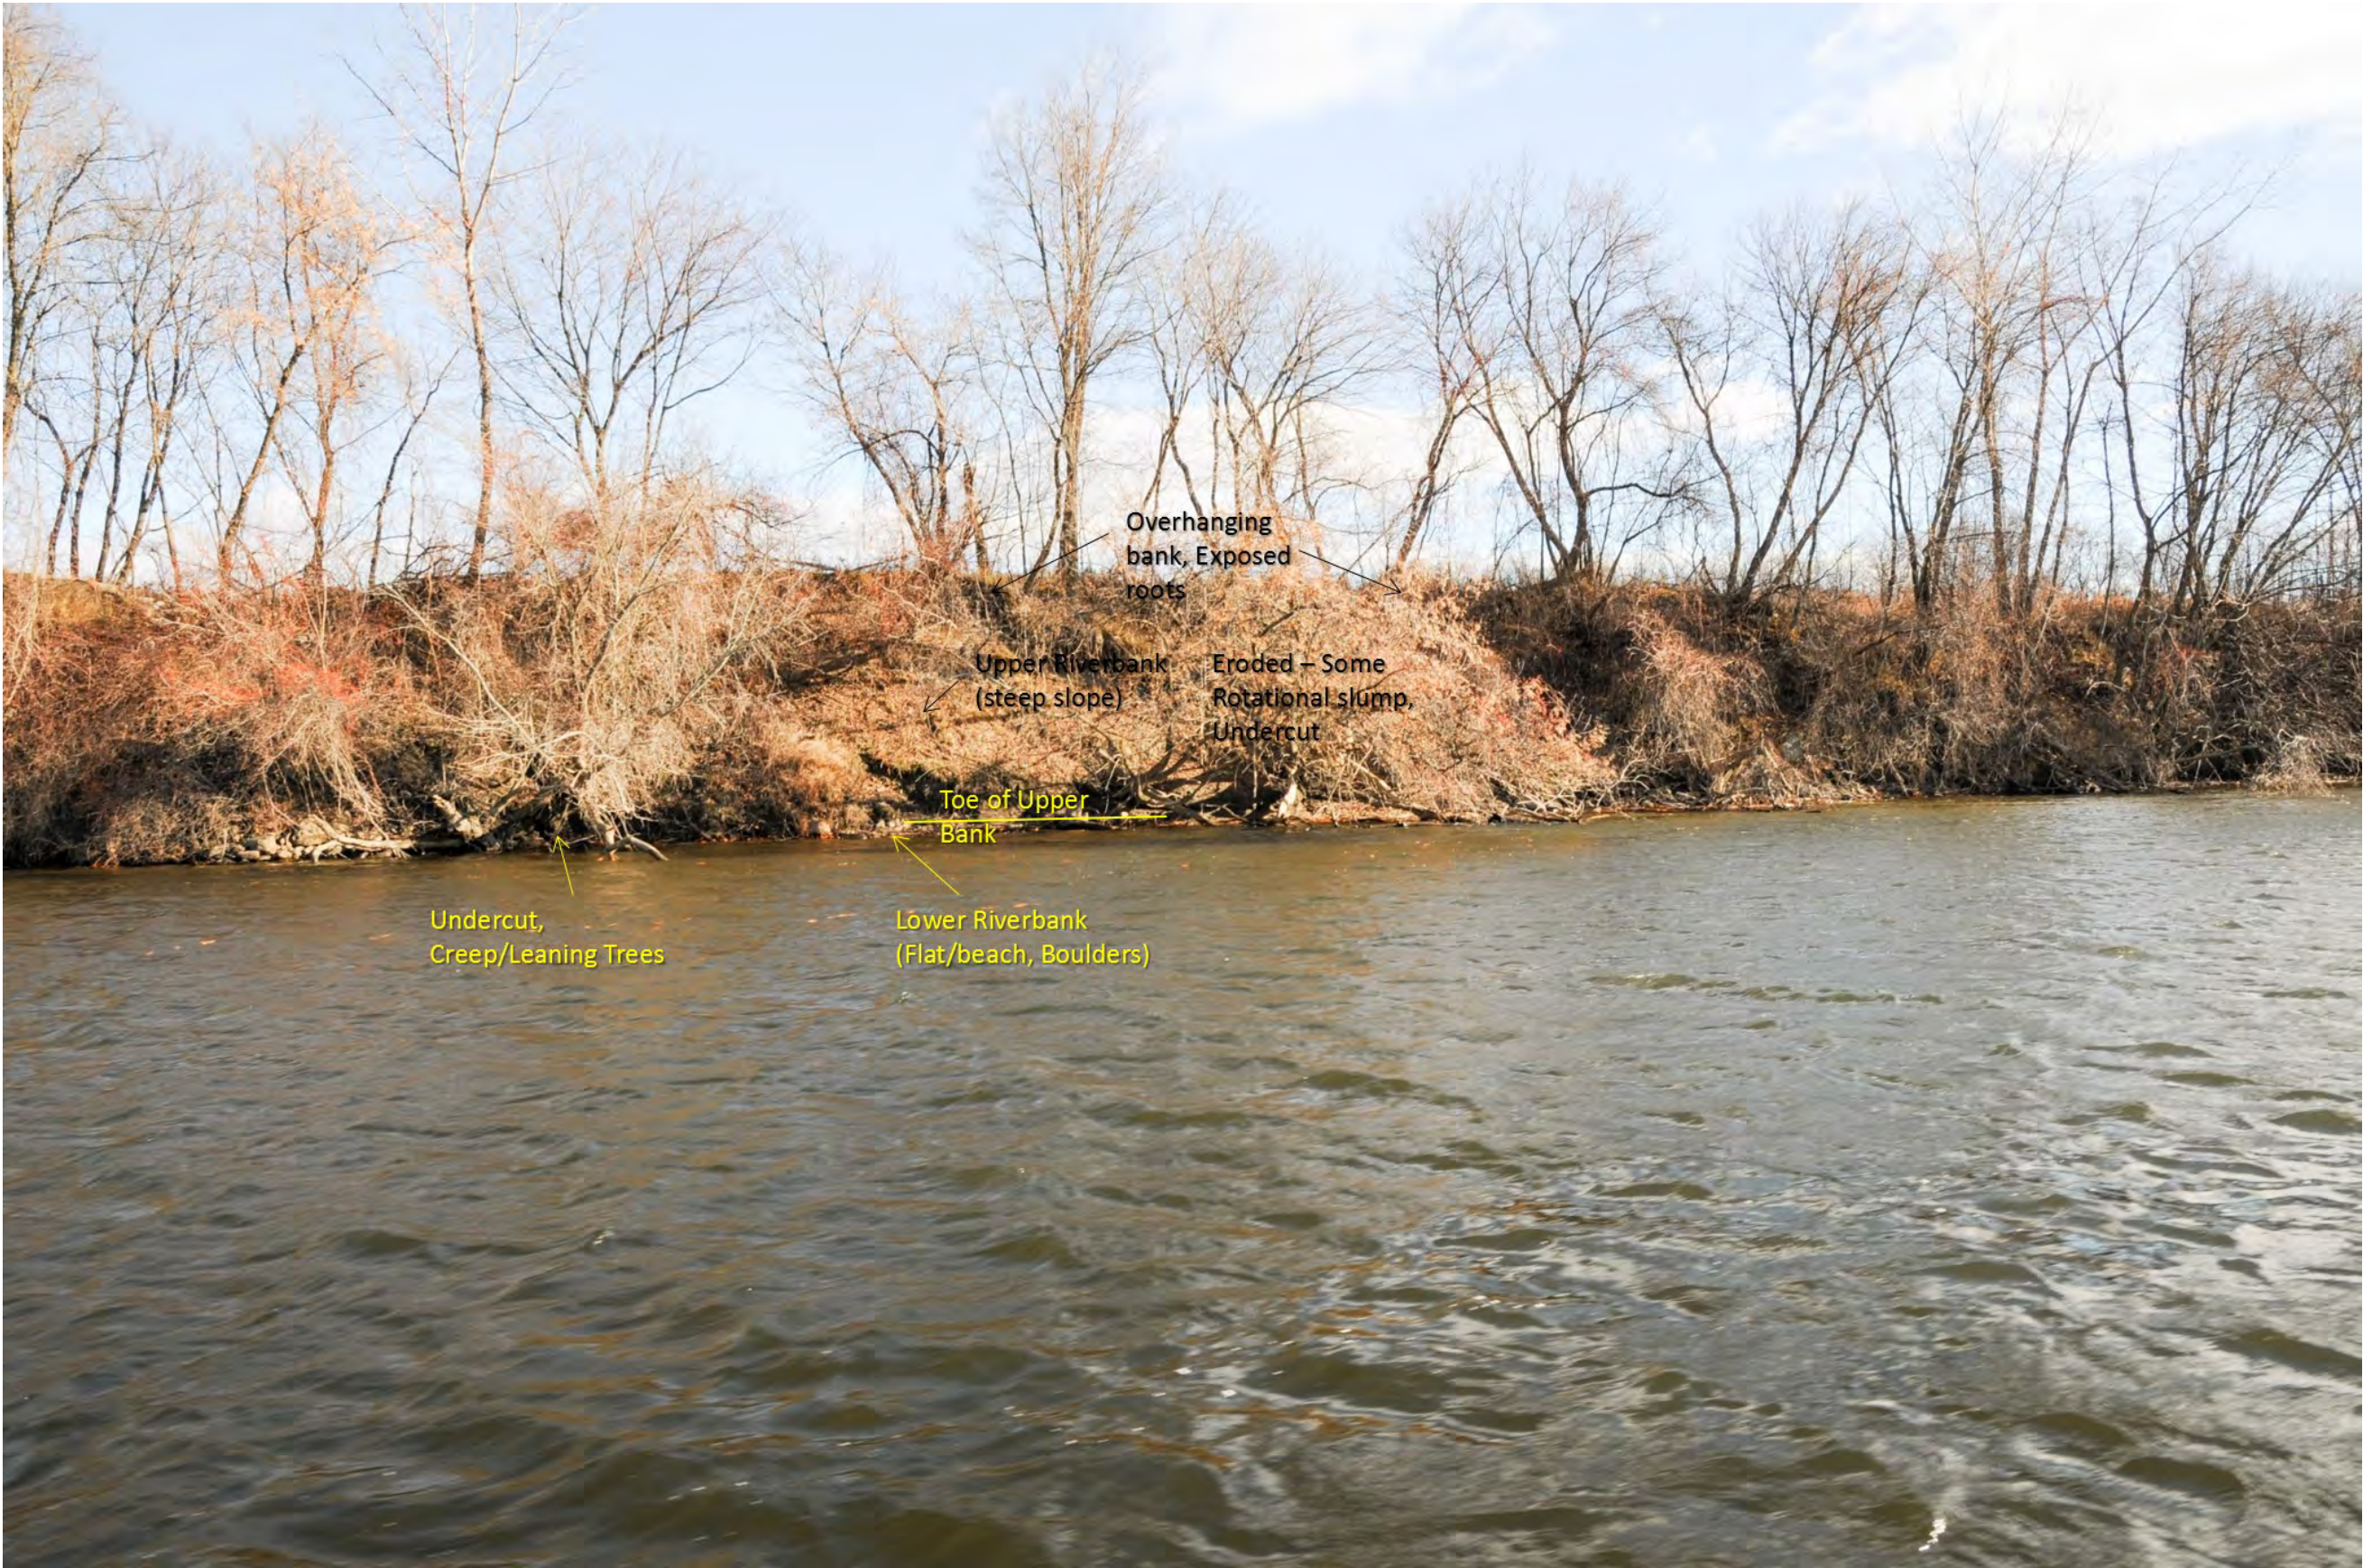
Photo ID 1661 (mid-segment)

Riverbank Features	Characteristics
Upper Riverbank Slope	Steep
Upper Riverbank Height	High
Upper Riverbank Sediment	Silt/Sand
Upper Riverbank Vegetation	Moderate
Lower Riverbank Slope	Flat/Beach
Lower Riverbank Sediment	Boulders
Lower Riverbank Vegetation	None to very sparse
Type of Erosion	Rotational Slump, Undercut
Potential Erosion Indicators	Creep/leaning trees, Overhanging bank, Exposed roots
Stage of Erosion	Eroded
Extent of Erosion	Some

QA Observations: Upon review of the photos for this segment, classification made in the field was confirmed and additional indicators of potential future erosion were included.

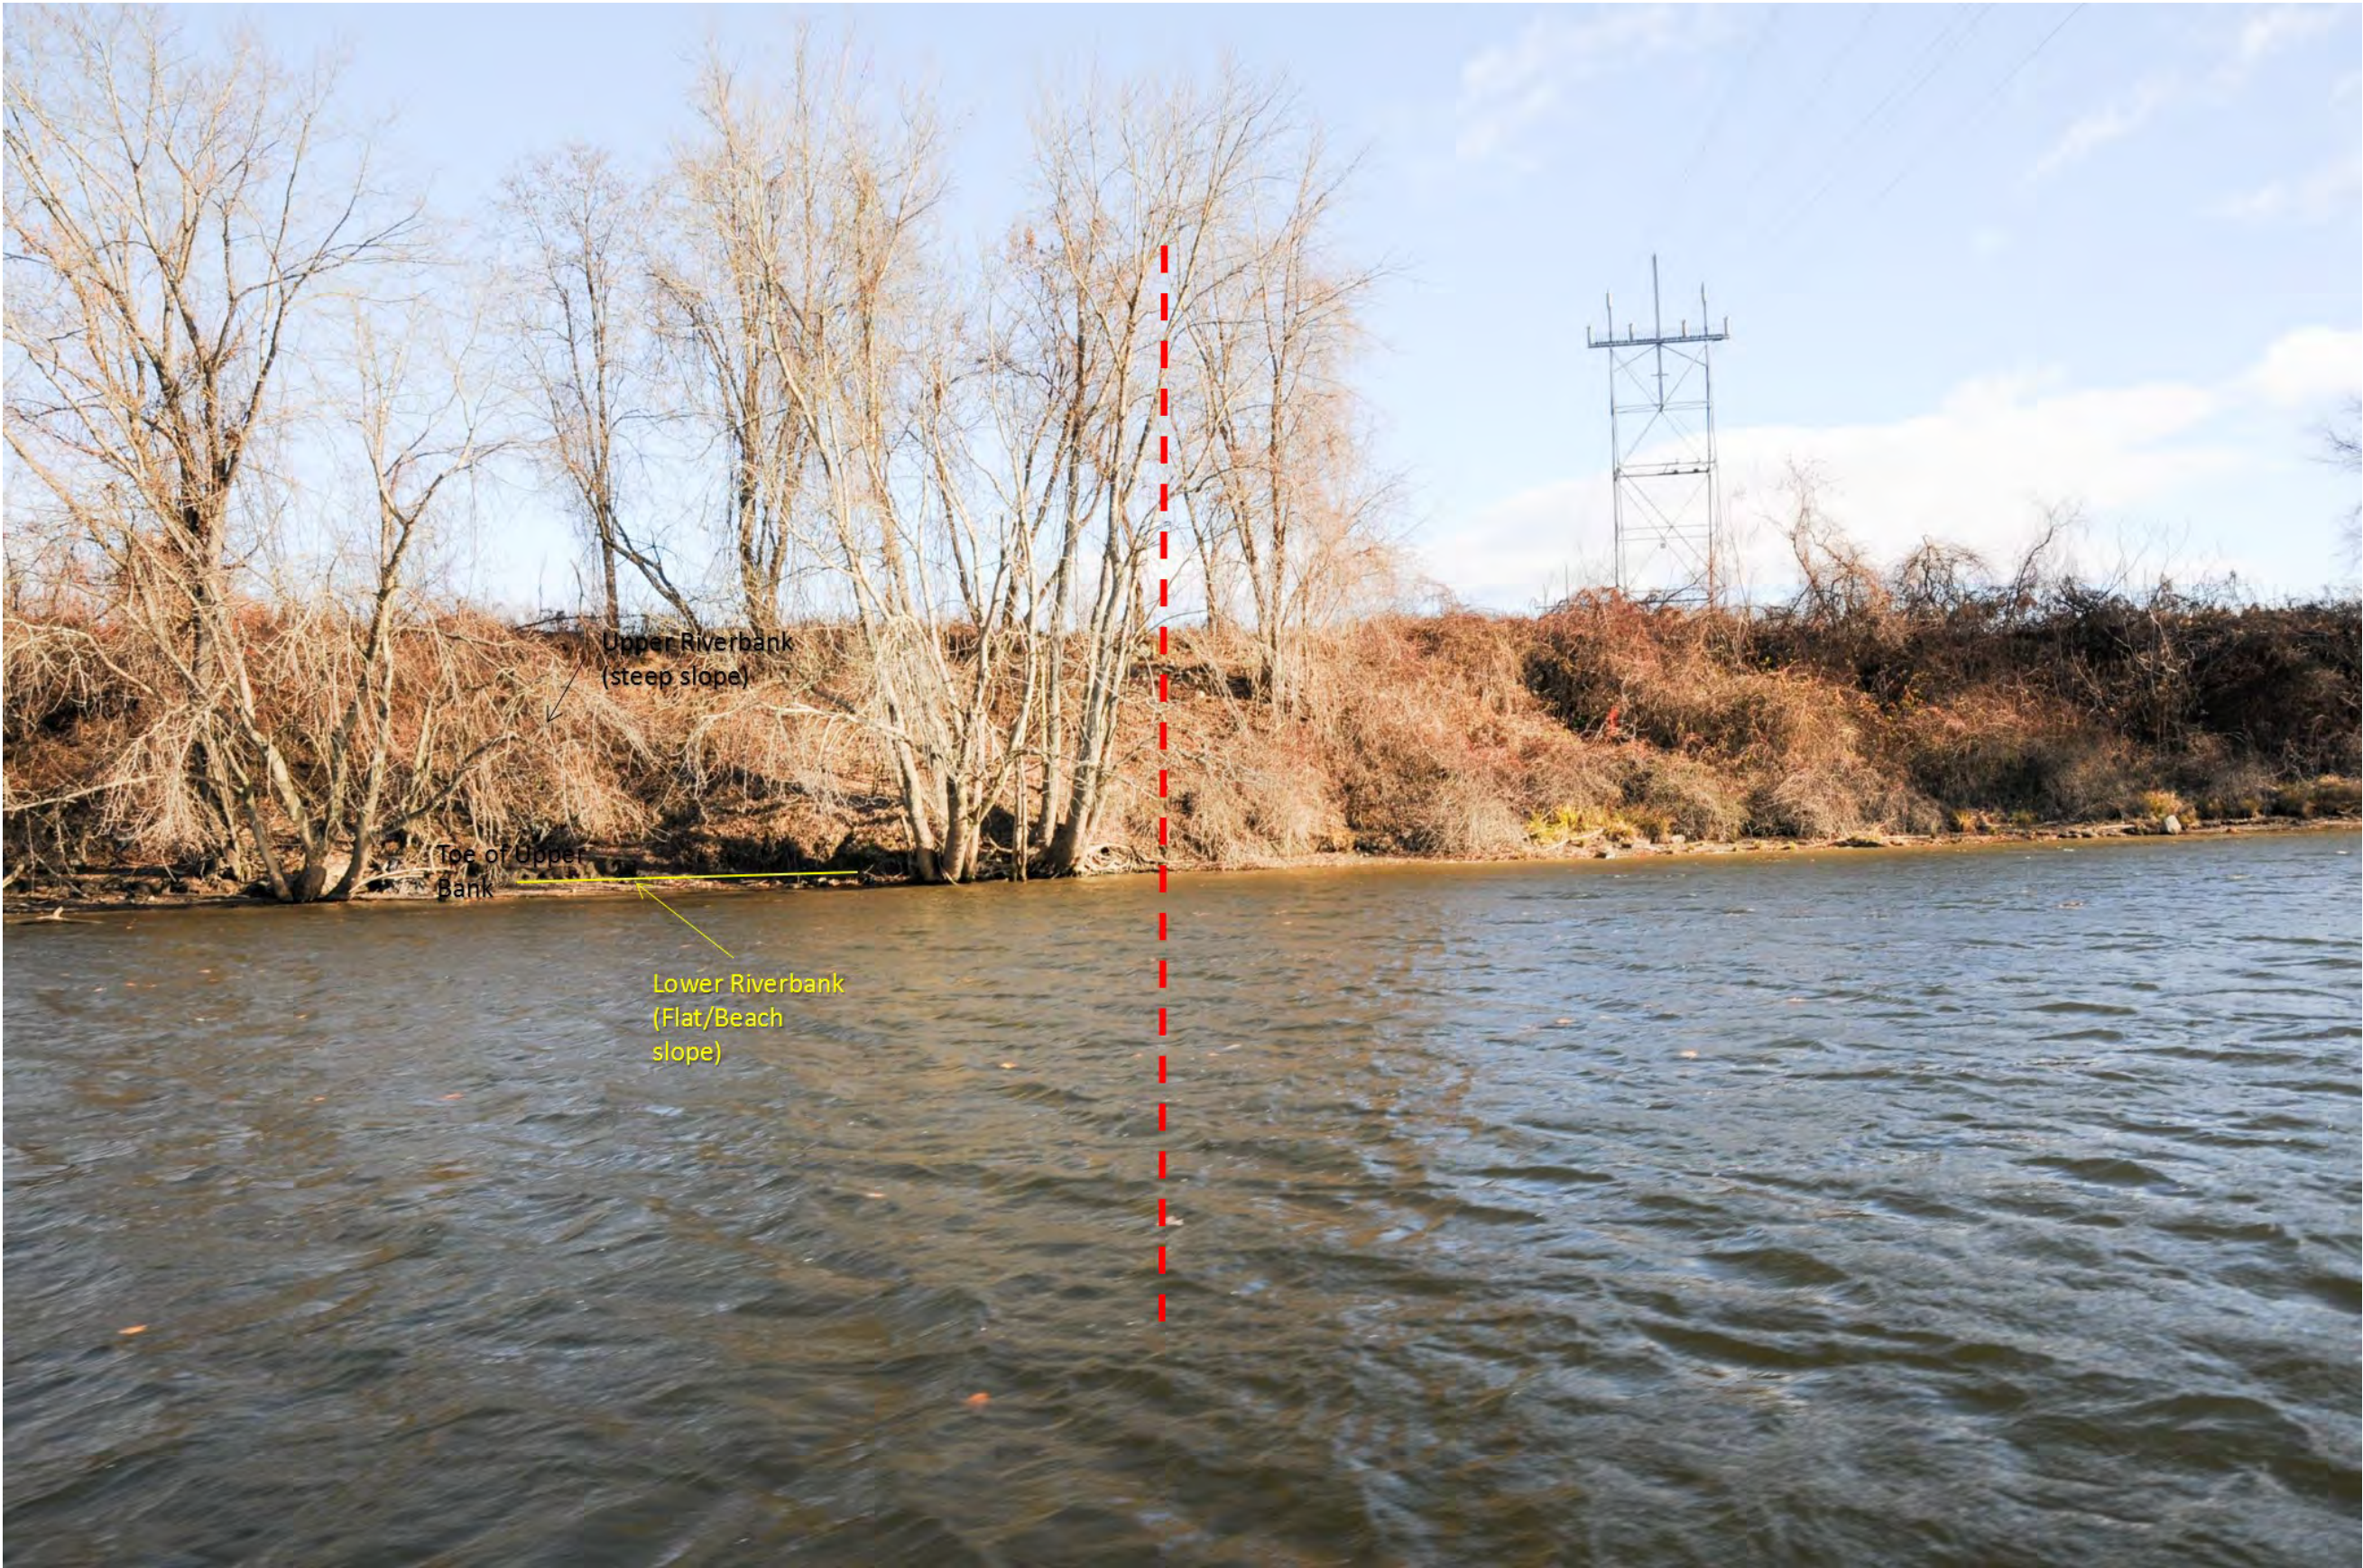
Photo ID 1647 (labeled portion of photo is right, D/S portion of segment. Dashed line represents approximate end of segment)

Riverbank Features	Characteristics
Upper Riverbank Slope	Steep
Upper Riverbank Height	High
Upper Riverbank Sediment	Silt/Sand
Upper Riverbank Vegetation	Heavy
Lower Riverbank Slope	Flat/Beach
Lower Riverbank Sediment	Silt/Sand
Lower Riverbank Vegetation	None to very sparse
Type of Erosion	
Potential Erosion Indicators	None
Stage of Erosion	Stable
Extent of Erosion	None/Little

QA Observations: Upon review of the photos for this segment, classification made in the field was confirmed.

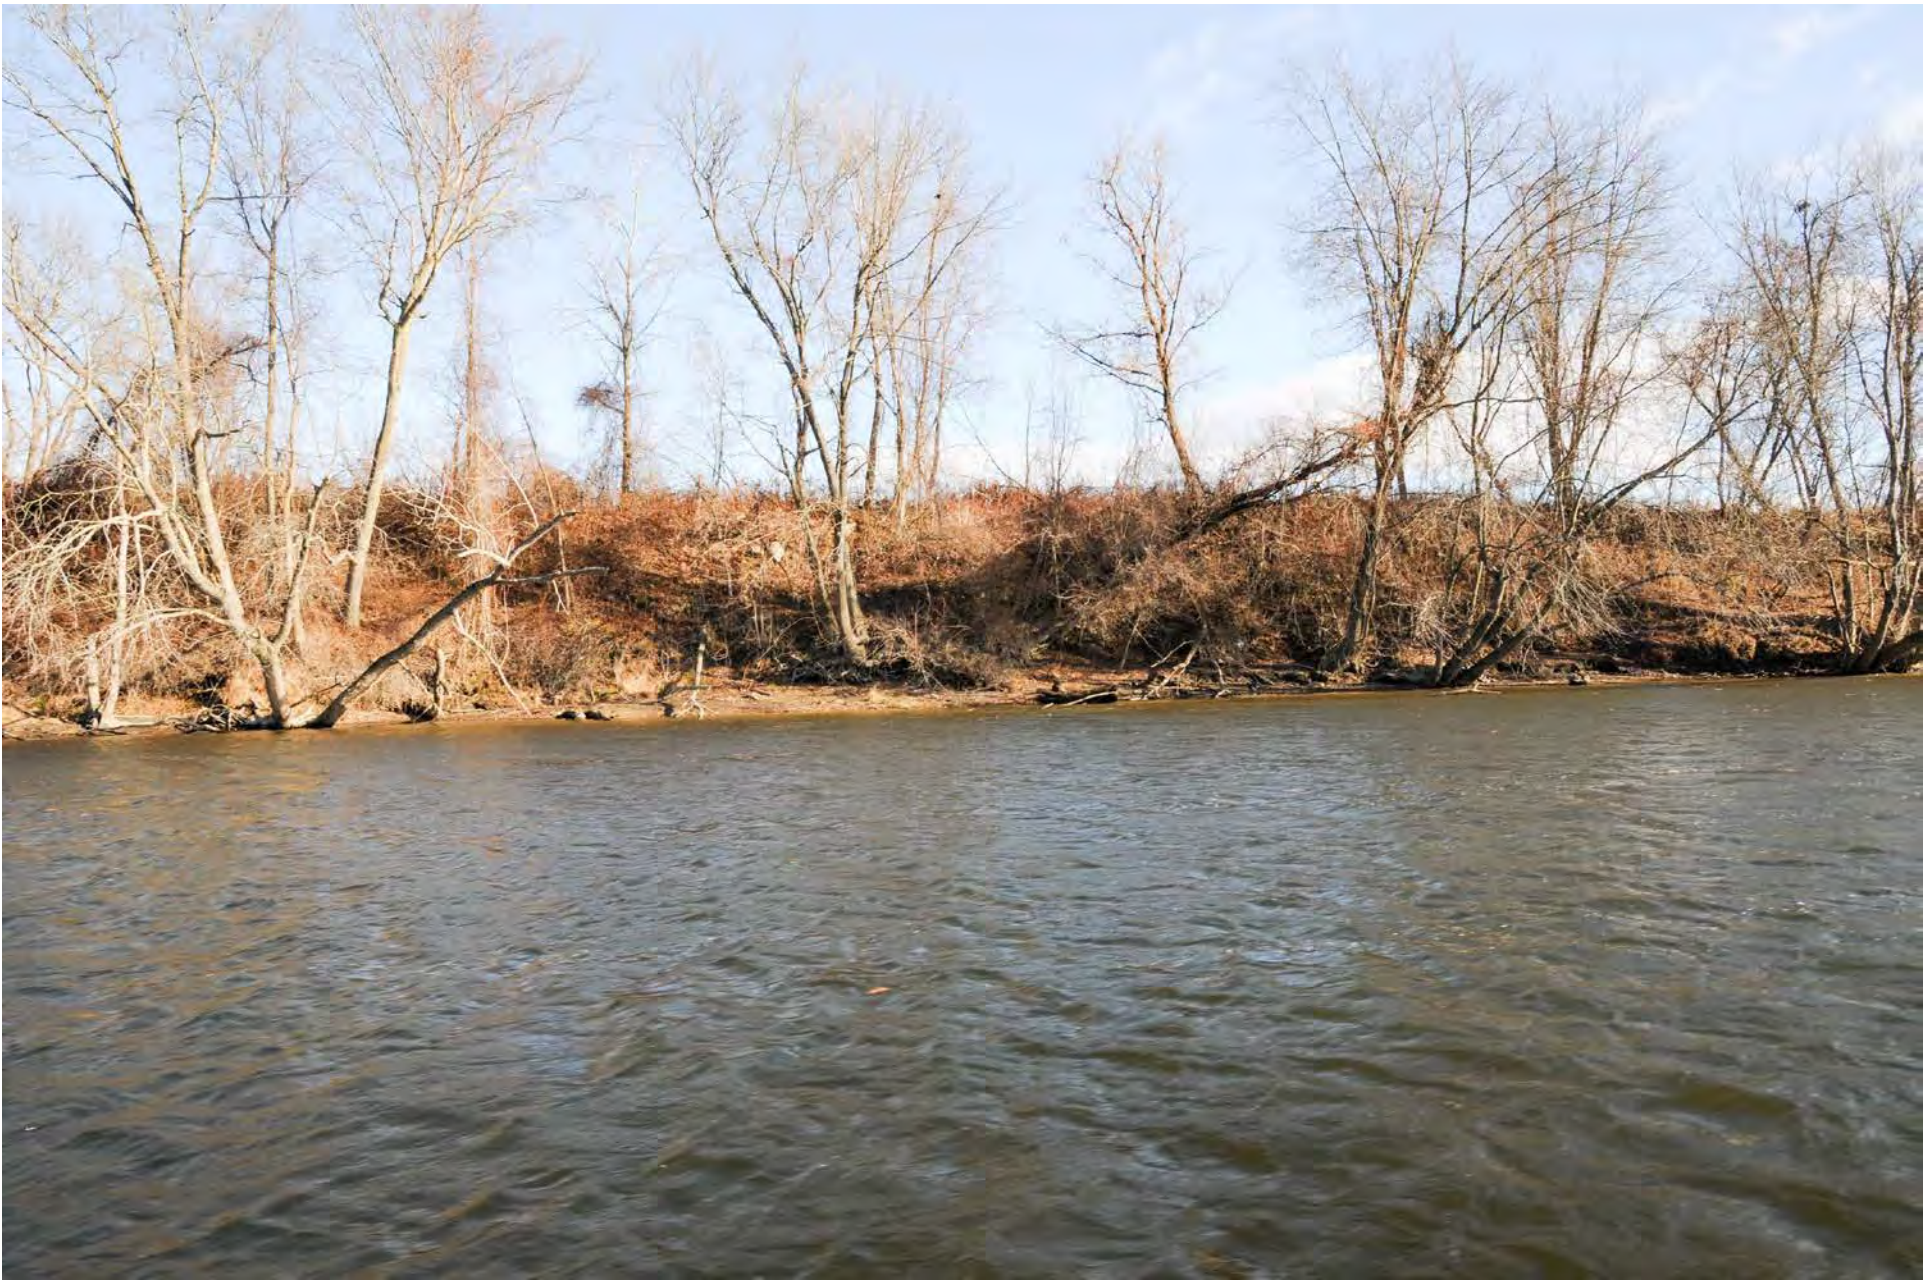
Photo ID 1646 (Right side of photo depicts the U/S portion of the segment)

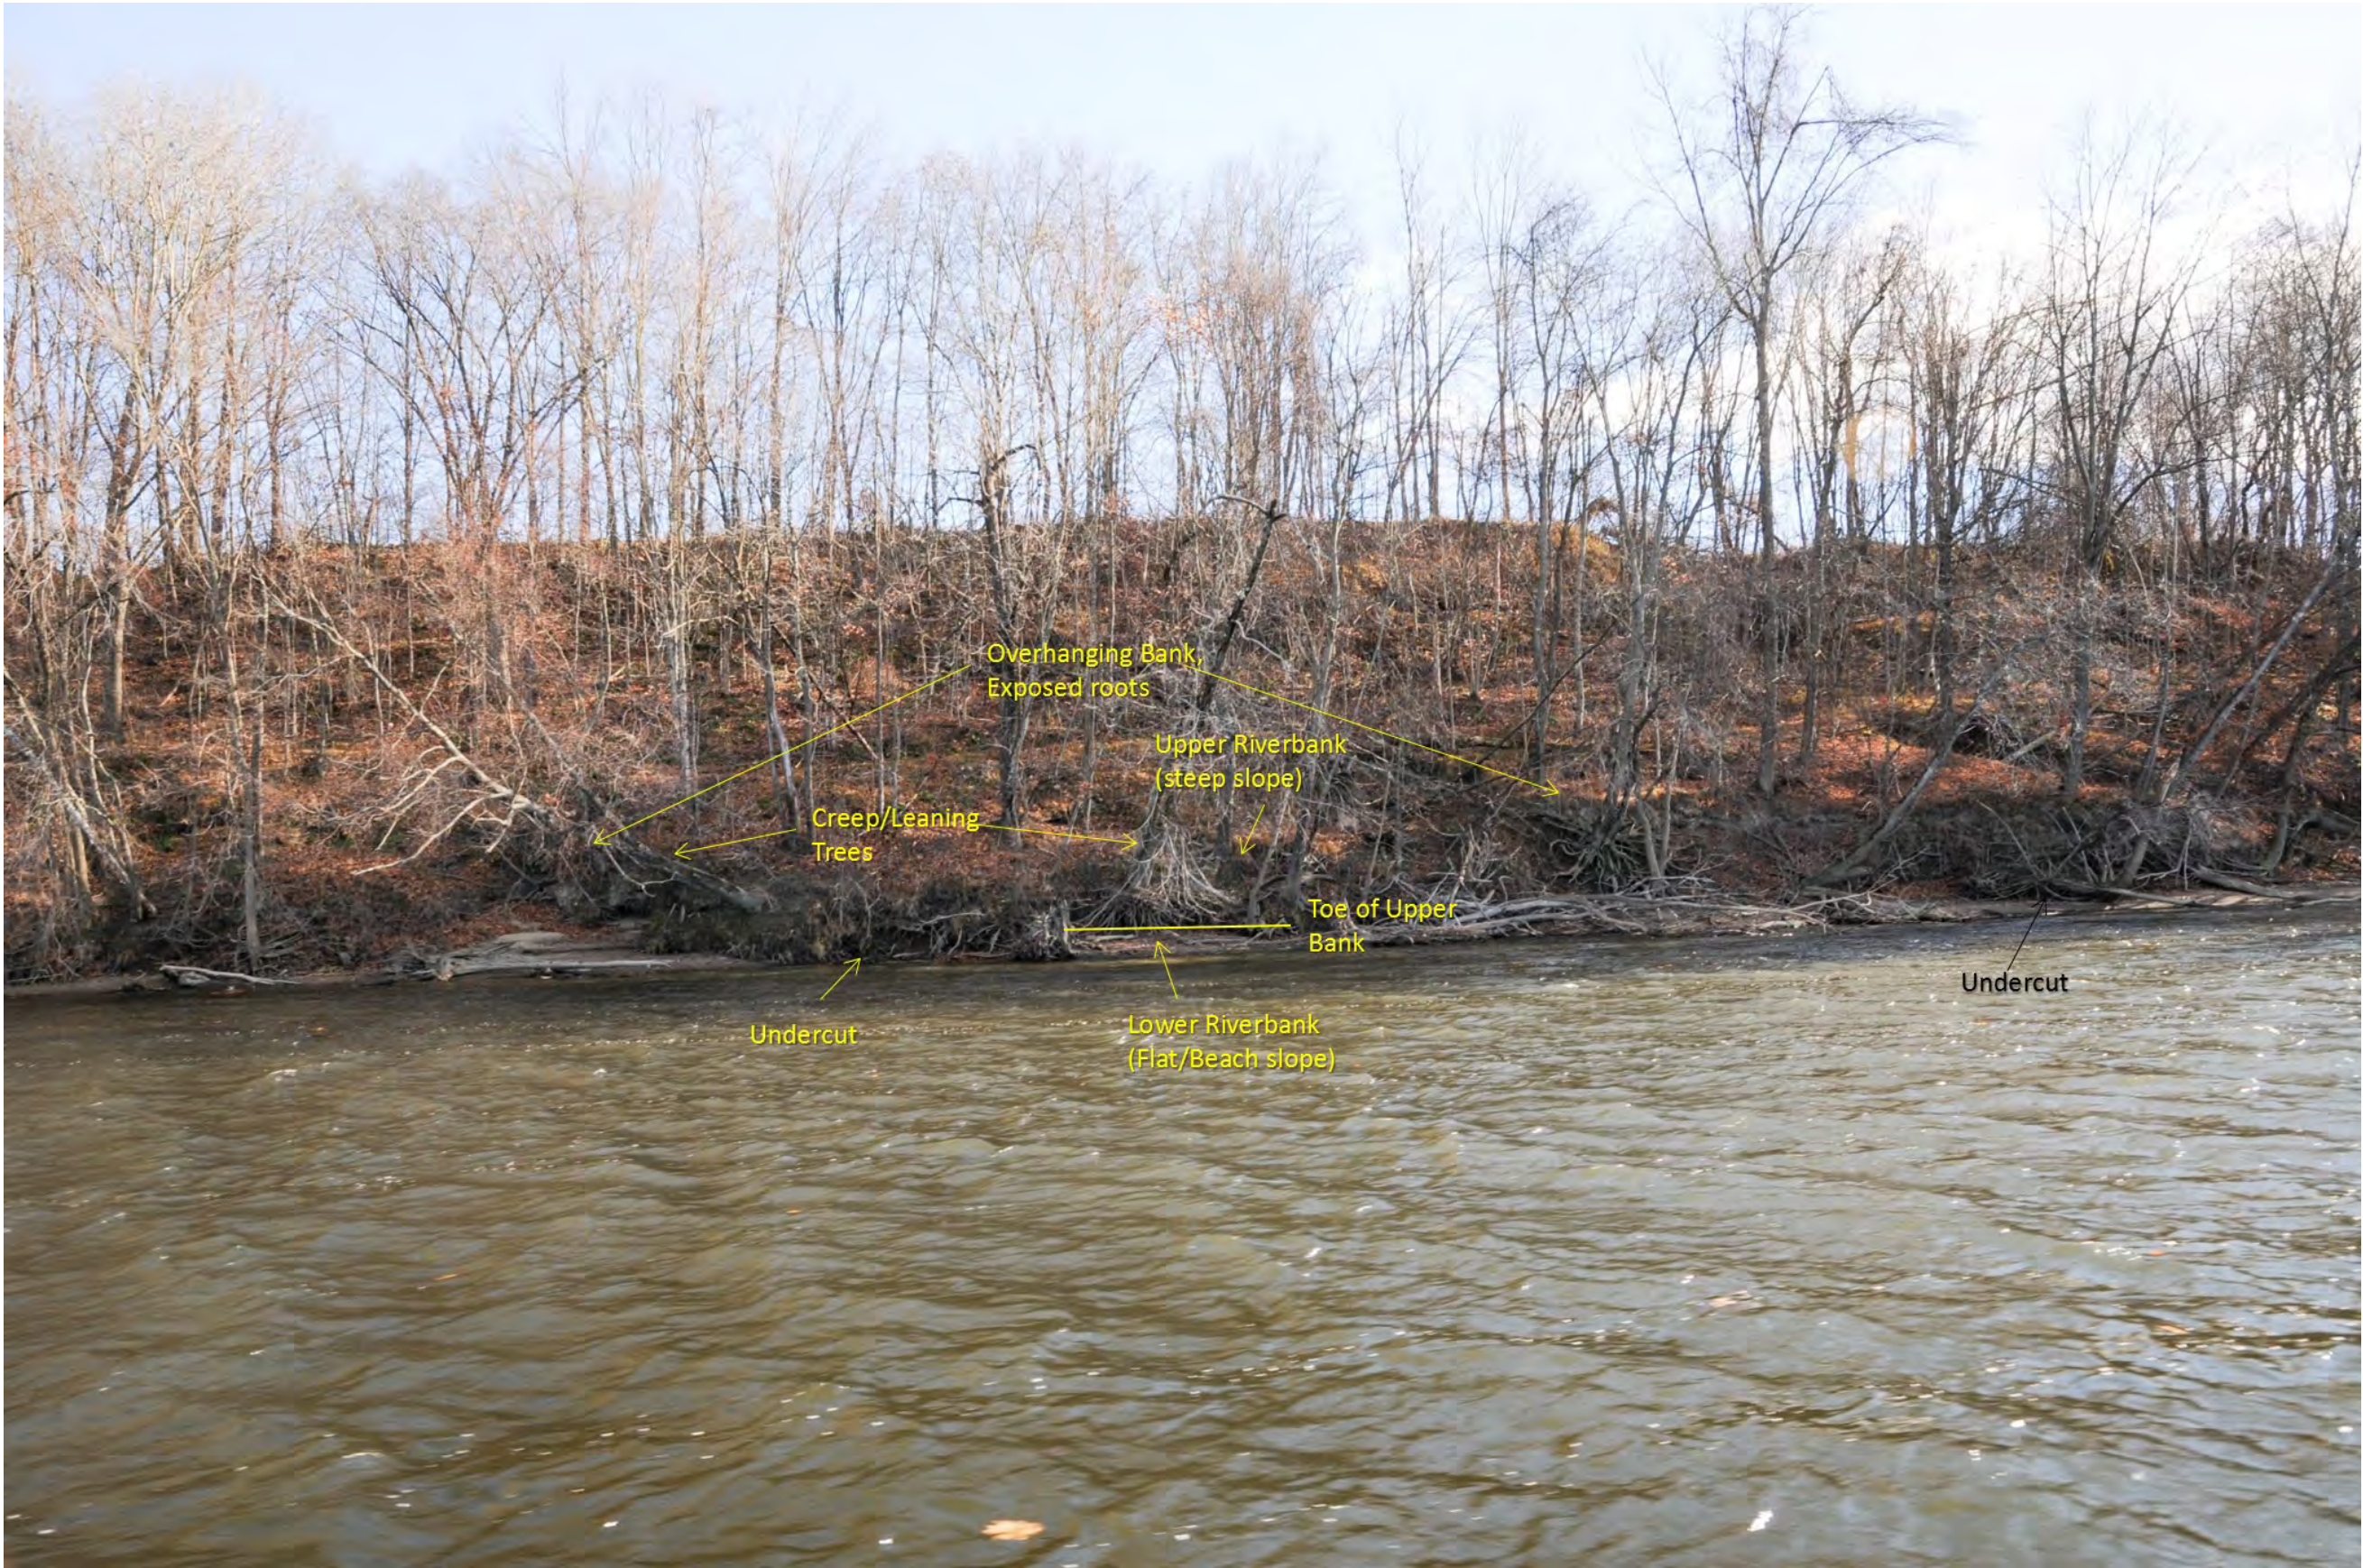
Photo ID 1628 (mid-segment)

Riverbank Features	Characteristics
Upper Riverbank Slope	Steep
Upper Riverbank Height	High
Upper Riverbank Sediment	Silt/Sand
Upper Riverbank Vegetation	Heavy
Lower Riverbank Slope	Flat/Beach
Lower Riverbank Sediment	Silt/Sand
Lower Riverbank Vegetation	None to very sparse
Type of Erosion	Undercut
Potential Erosion Indicators	Creep/leaning trees, Exposed roots, Overhanging bank
Stage of Erosion	Stable
Extent of Erosion	None/Little

QA Observations: Upon review of the photos for this segment, classification made in the field was confirmed and additional indicators of potential future erosion were included.

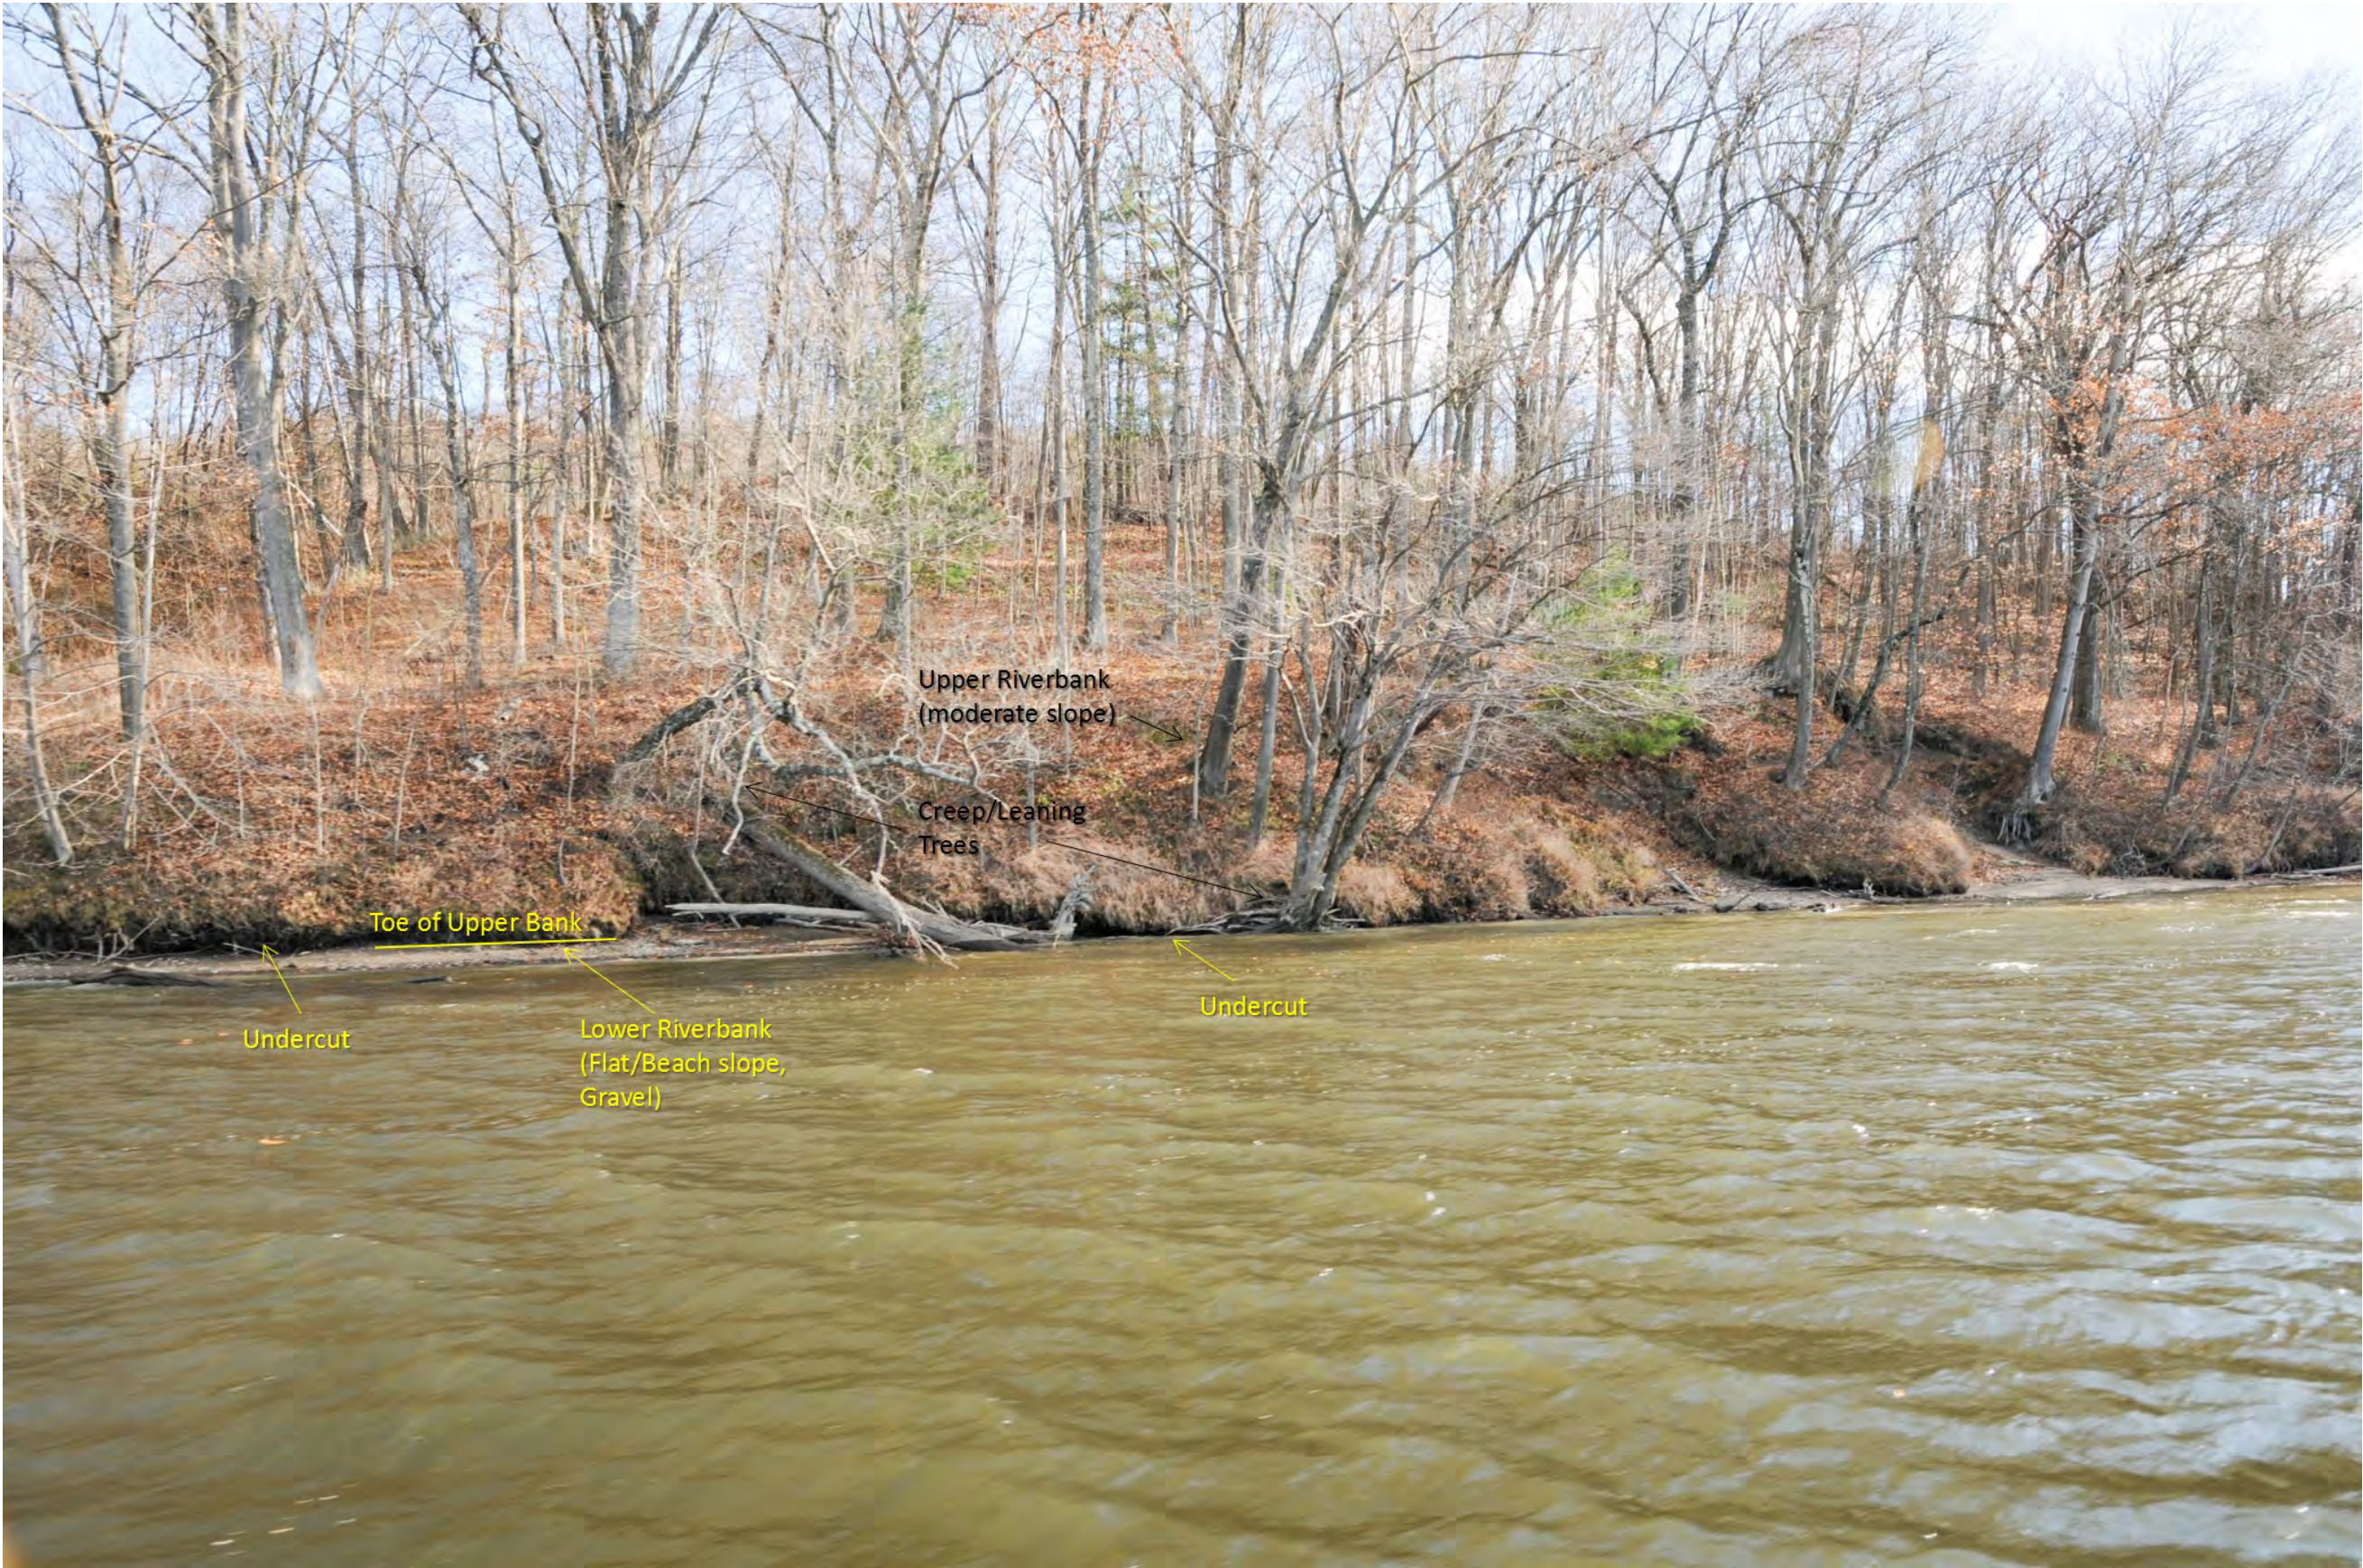
Photo ID 1605 (near left, U/S side of segment)

Riverbank Features	Characteristics
Upper Riverbank Slope	Moderate
Upper Riverbank Height	High
Upper Riverbank Sediment	Silt/Sand
Upper Riverbank Vegetation	Heavy
Lower Riverbank Slope	Flat/Beach
Lower Riverbank Sediment	gravel
Lower Riverbank Vegetation	None to very sparse
Type of Erosion	Undercut
Potential Erosion Indicators	Creep/leaning trees
Stage of Erosion	Stable
Extent of Erosion	None/Little

QA Observations: Upon review of the photos for this segment, classification made in the field was confirmed.
