Segment 210 – Left Bank

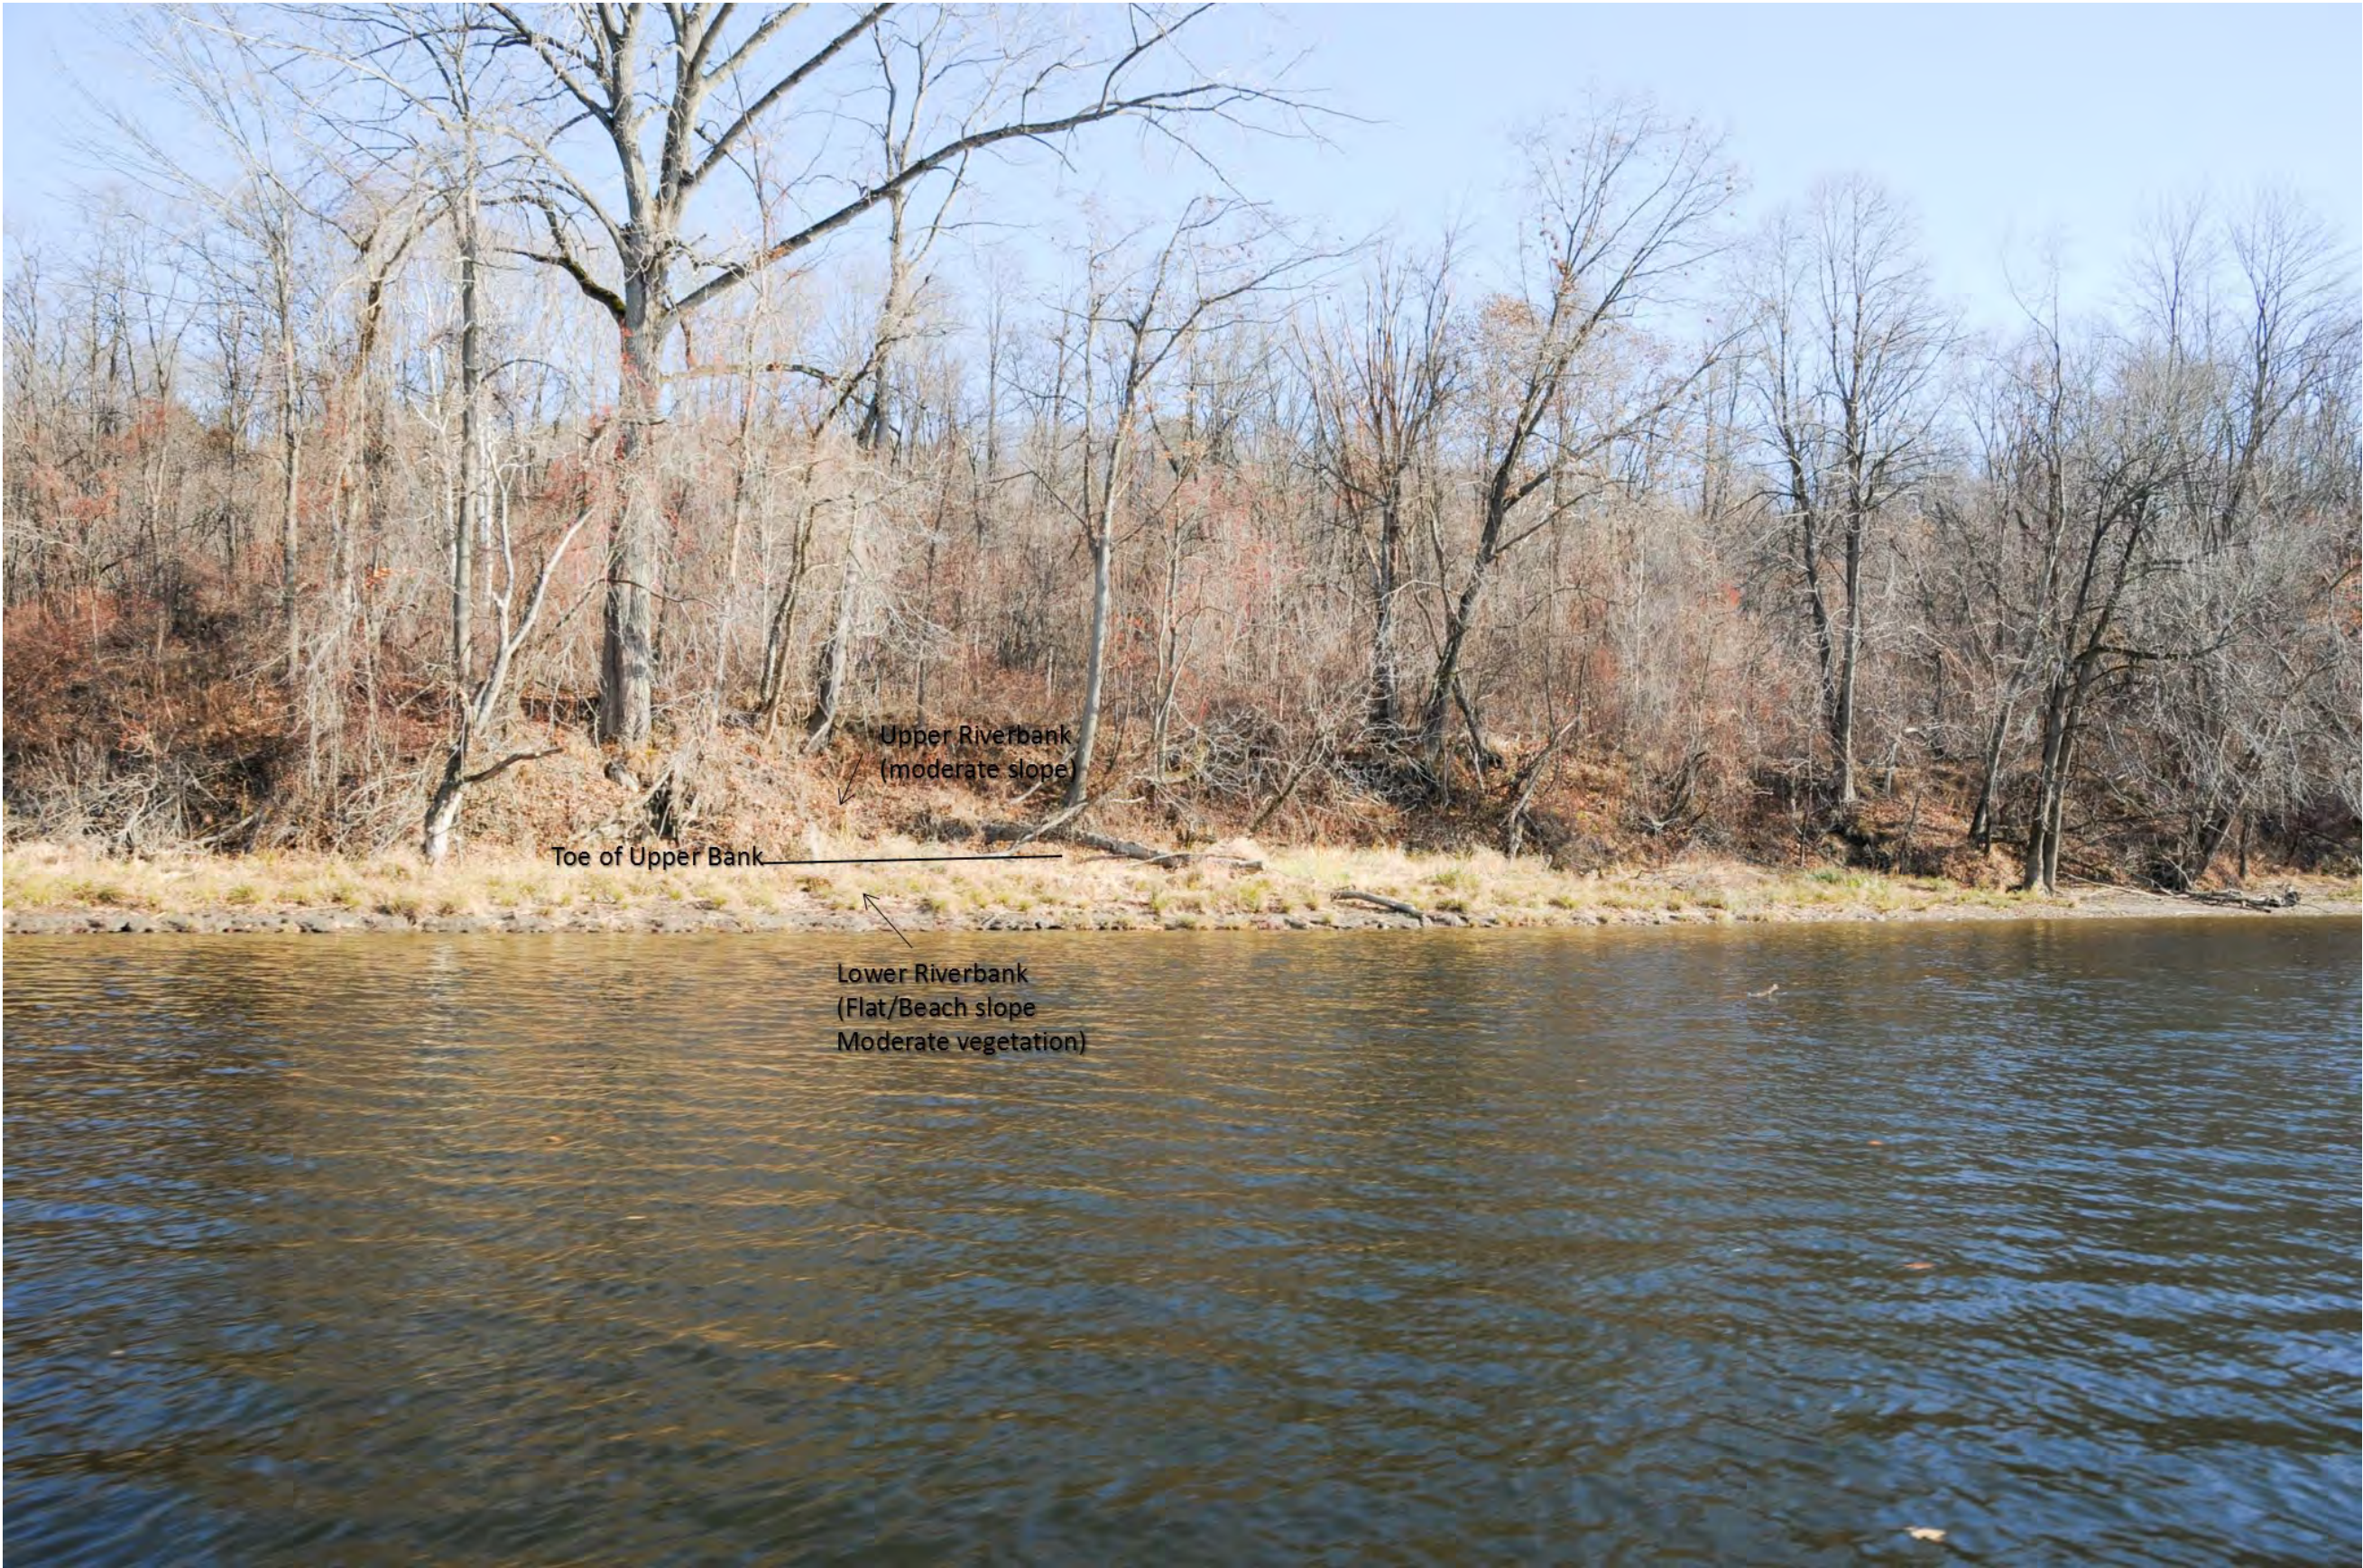
Photo ID 1586 (mid-segment)

Riverbank Features	Characteristics
Upper Riverbank Slope	Moderate
Upper Riverbank Height	High
Upper Riverbank Sediment	Silt/Sand
Upper Riverbank Vegetation	Heavy
Lower Riverbank Slope	Flat/Beach
Lower Riverbank Sediment	Silt/Sand
Lower Riverbank Vegetation	Moderate
Type of Erosion	
Potential Erosion Indicators	None
Stage of Erosion	Stable
Extent of Erosion	None/Little

QA Observations: Upon review of the photos for this segment, classification made in the field was confirmed.

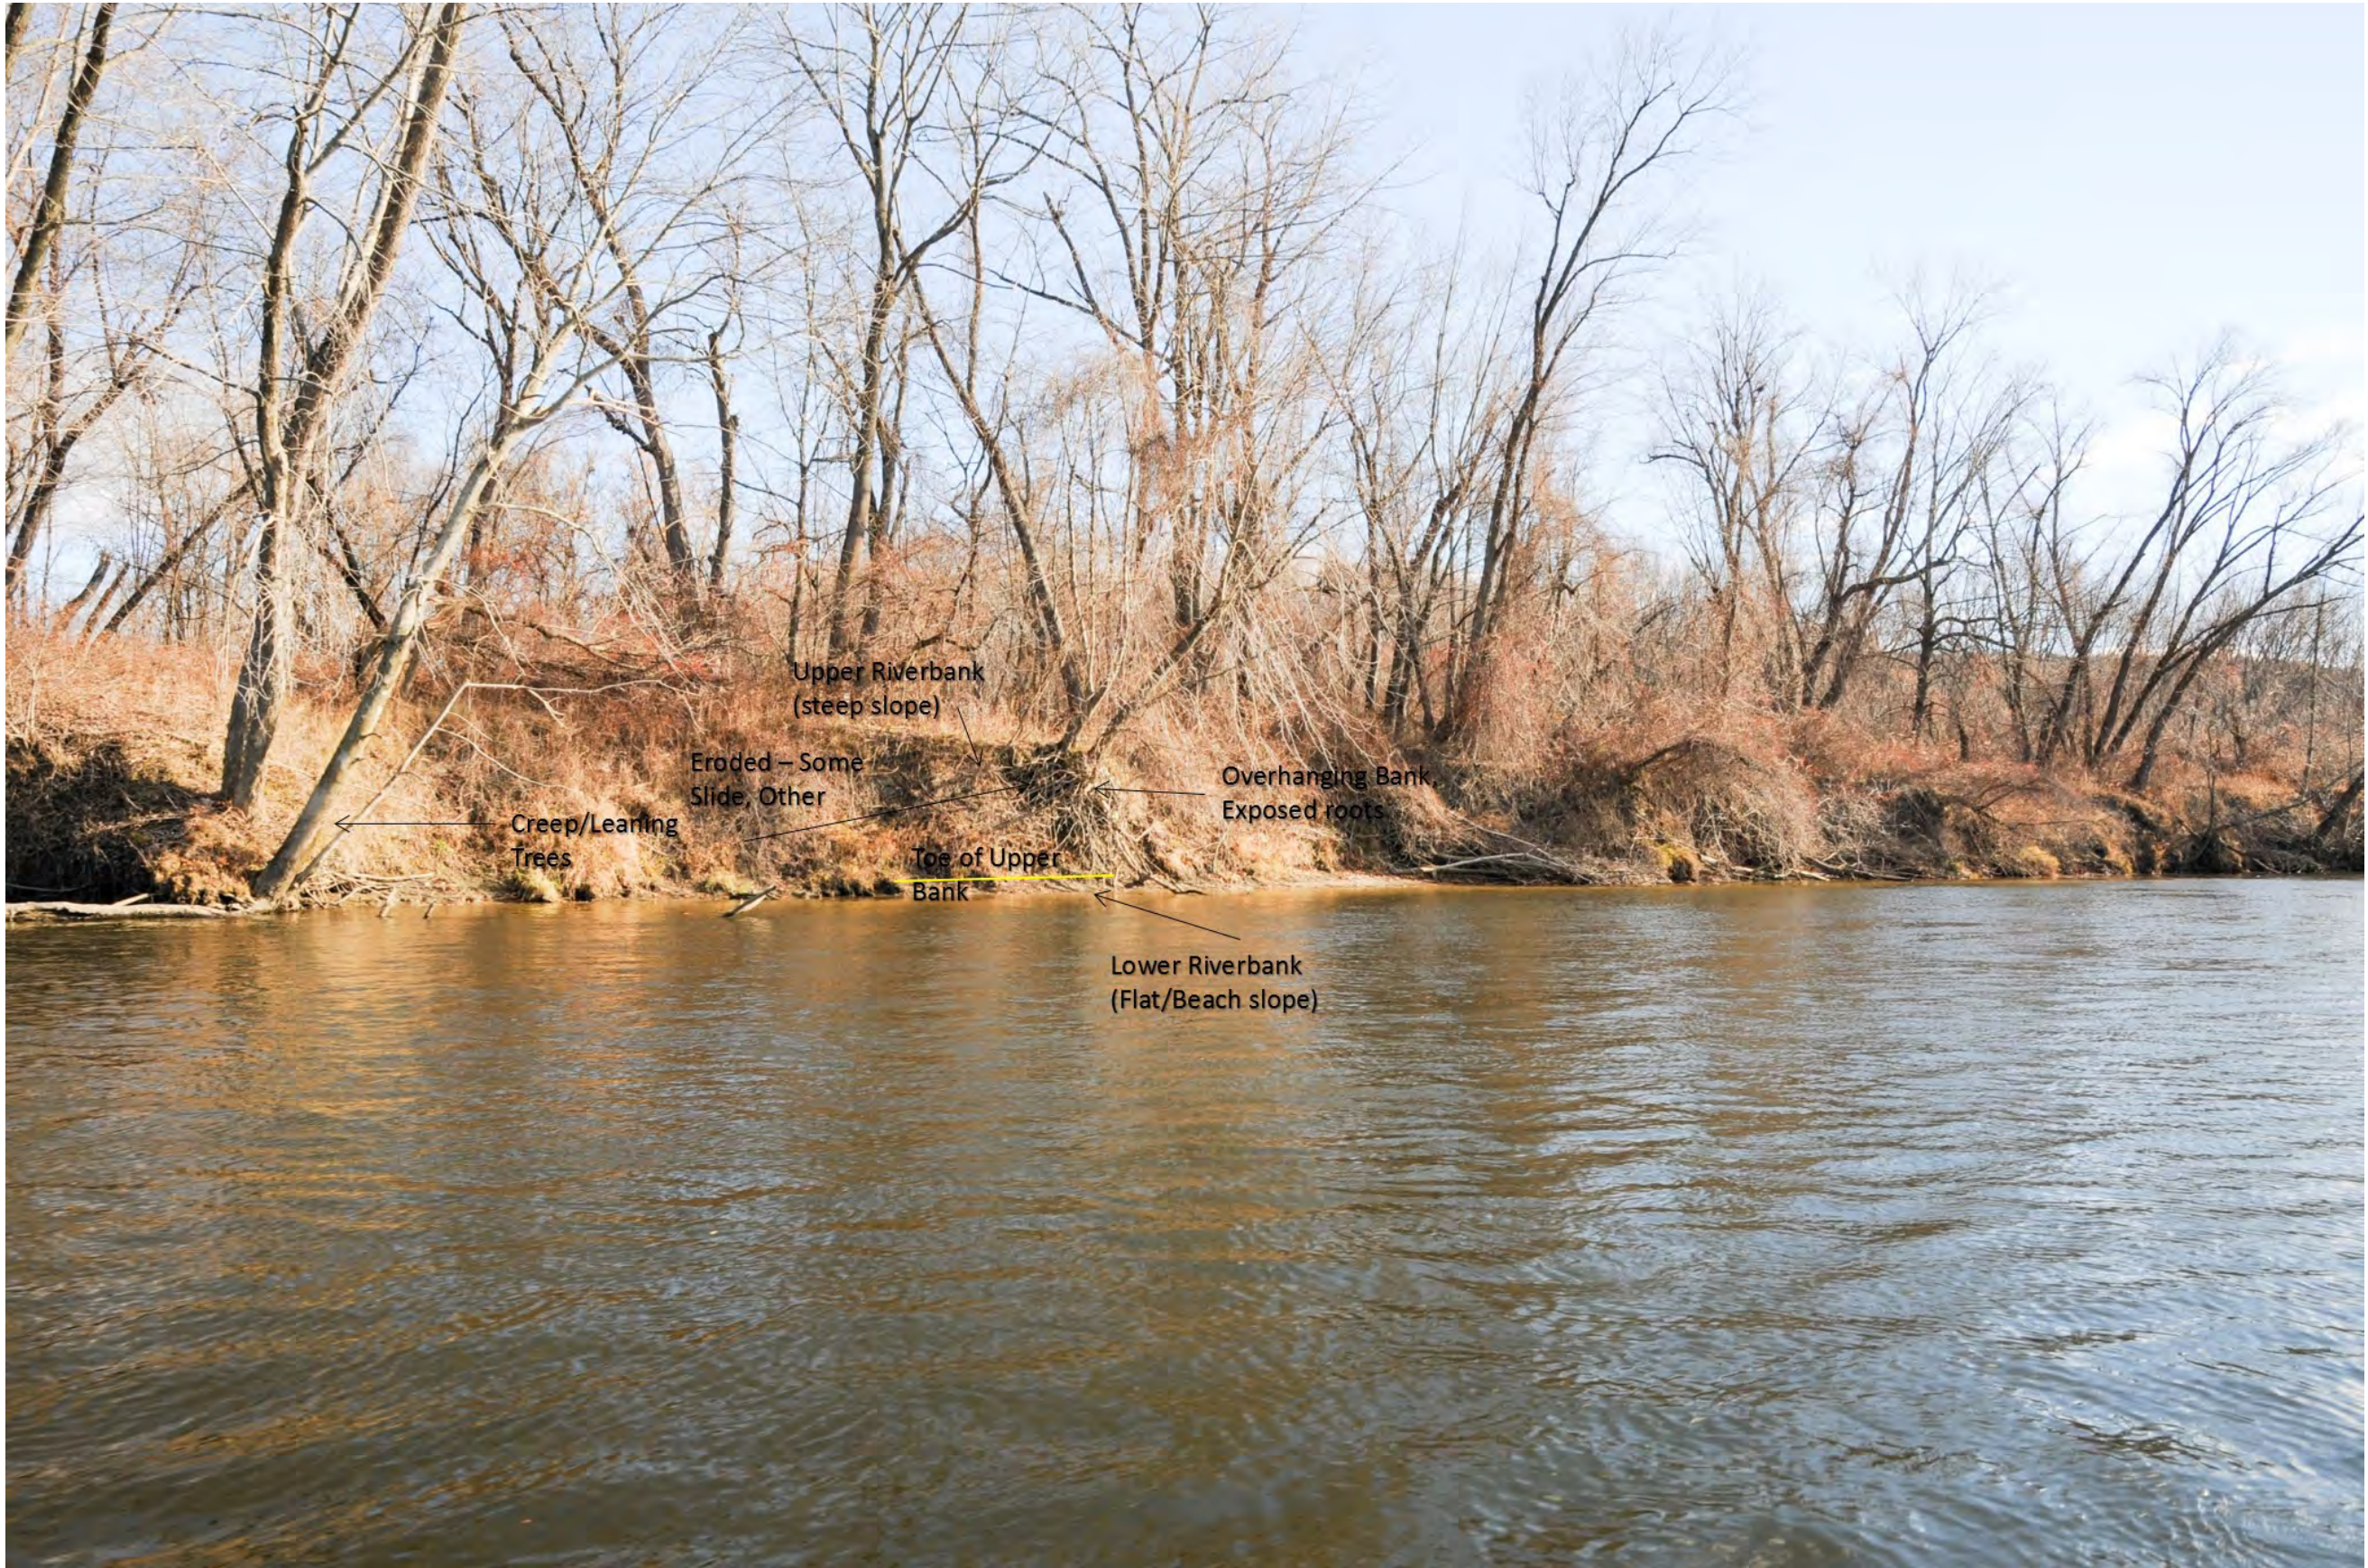
Photo ID 1564 (near right, D/S side of segment)

Riverbank Features	Characteristics
Upper Riverbank Slope	Steep
Upper Riverbank Height	Medium
Upper Riverbank Sediment	Silt/Sand
Upper Riverbank Vegetation	Moderate
Lower Riverbank Slope	Flat/Beach
Lower Riverbank Sediment	Silt/Sand
Lower Riverbank Vegetation	None to very sparse
Type of Erosion	Slide
Potential Erosion Indicators	Other, Creep/leaning trees, Exposed roots, Overhanging bank
Stage of Erosion	Eroded
Extent of Erosion	Some

QA Observations: Upon review of the photos for this segment, classification made in the field was confirmed and additional indicators of potential future erosion were included.
