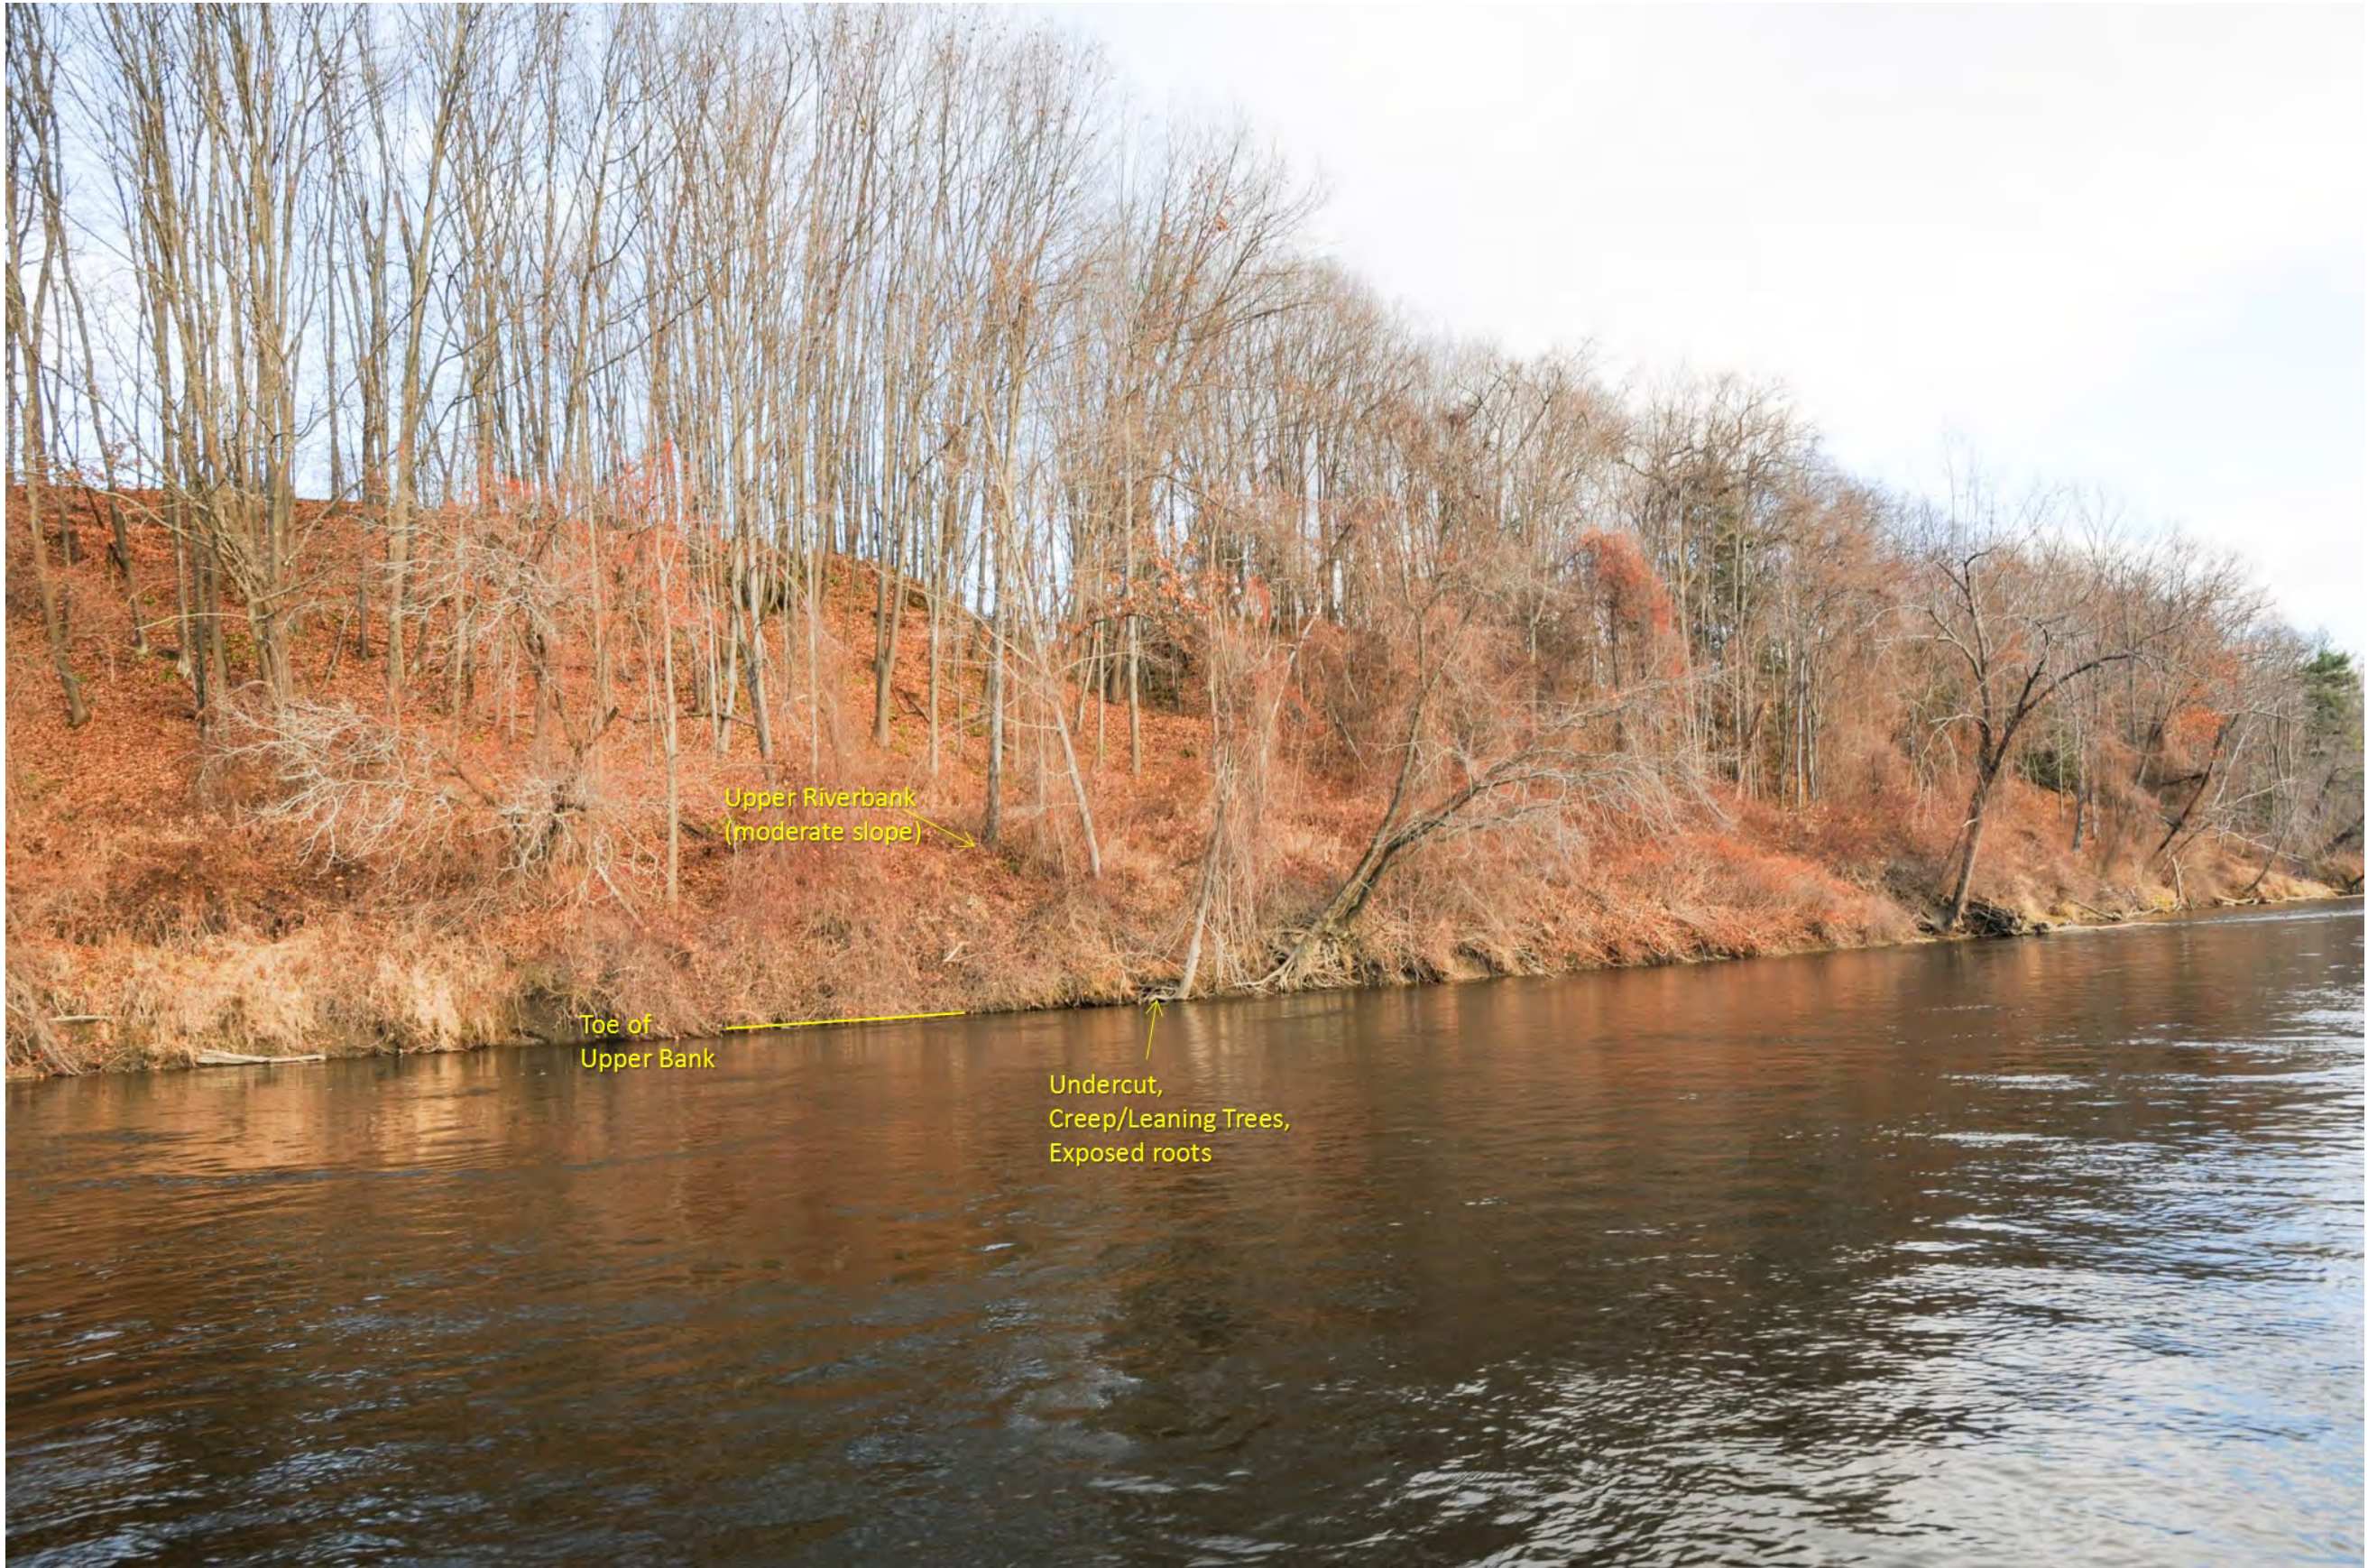
Photo ID 1447 (near mid-segment)

Riverbank Features	Characteristics
Upper Riverbank Slope	Moderate
Upper Riverbank Height	High
Upper Riverbank Sediment	Silt/Sand
Upper Riverbank Vegetation	Heavy
Lower Riverbank Slope	Flat/Beach
Lower Riverbank Sediment	Silt/Sand
Lower Riverbank Vegetation	None to very sparse
Type of Erosion	Undercut
Potential Erosion Indicators	Creep/Leaning trees, Exposed Roots
Stage of Erosion	Stable
Extent of Erosion	None/Little

QA Observations: Upon review of the photos for this segment, classification made in the field was confirmed and additional indicators of potential future erosion were included.

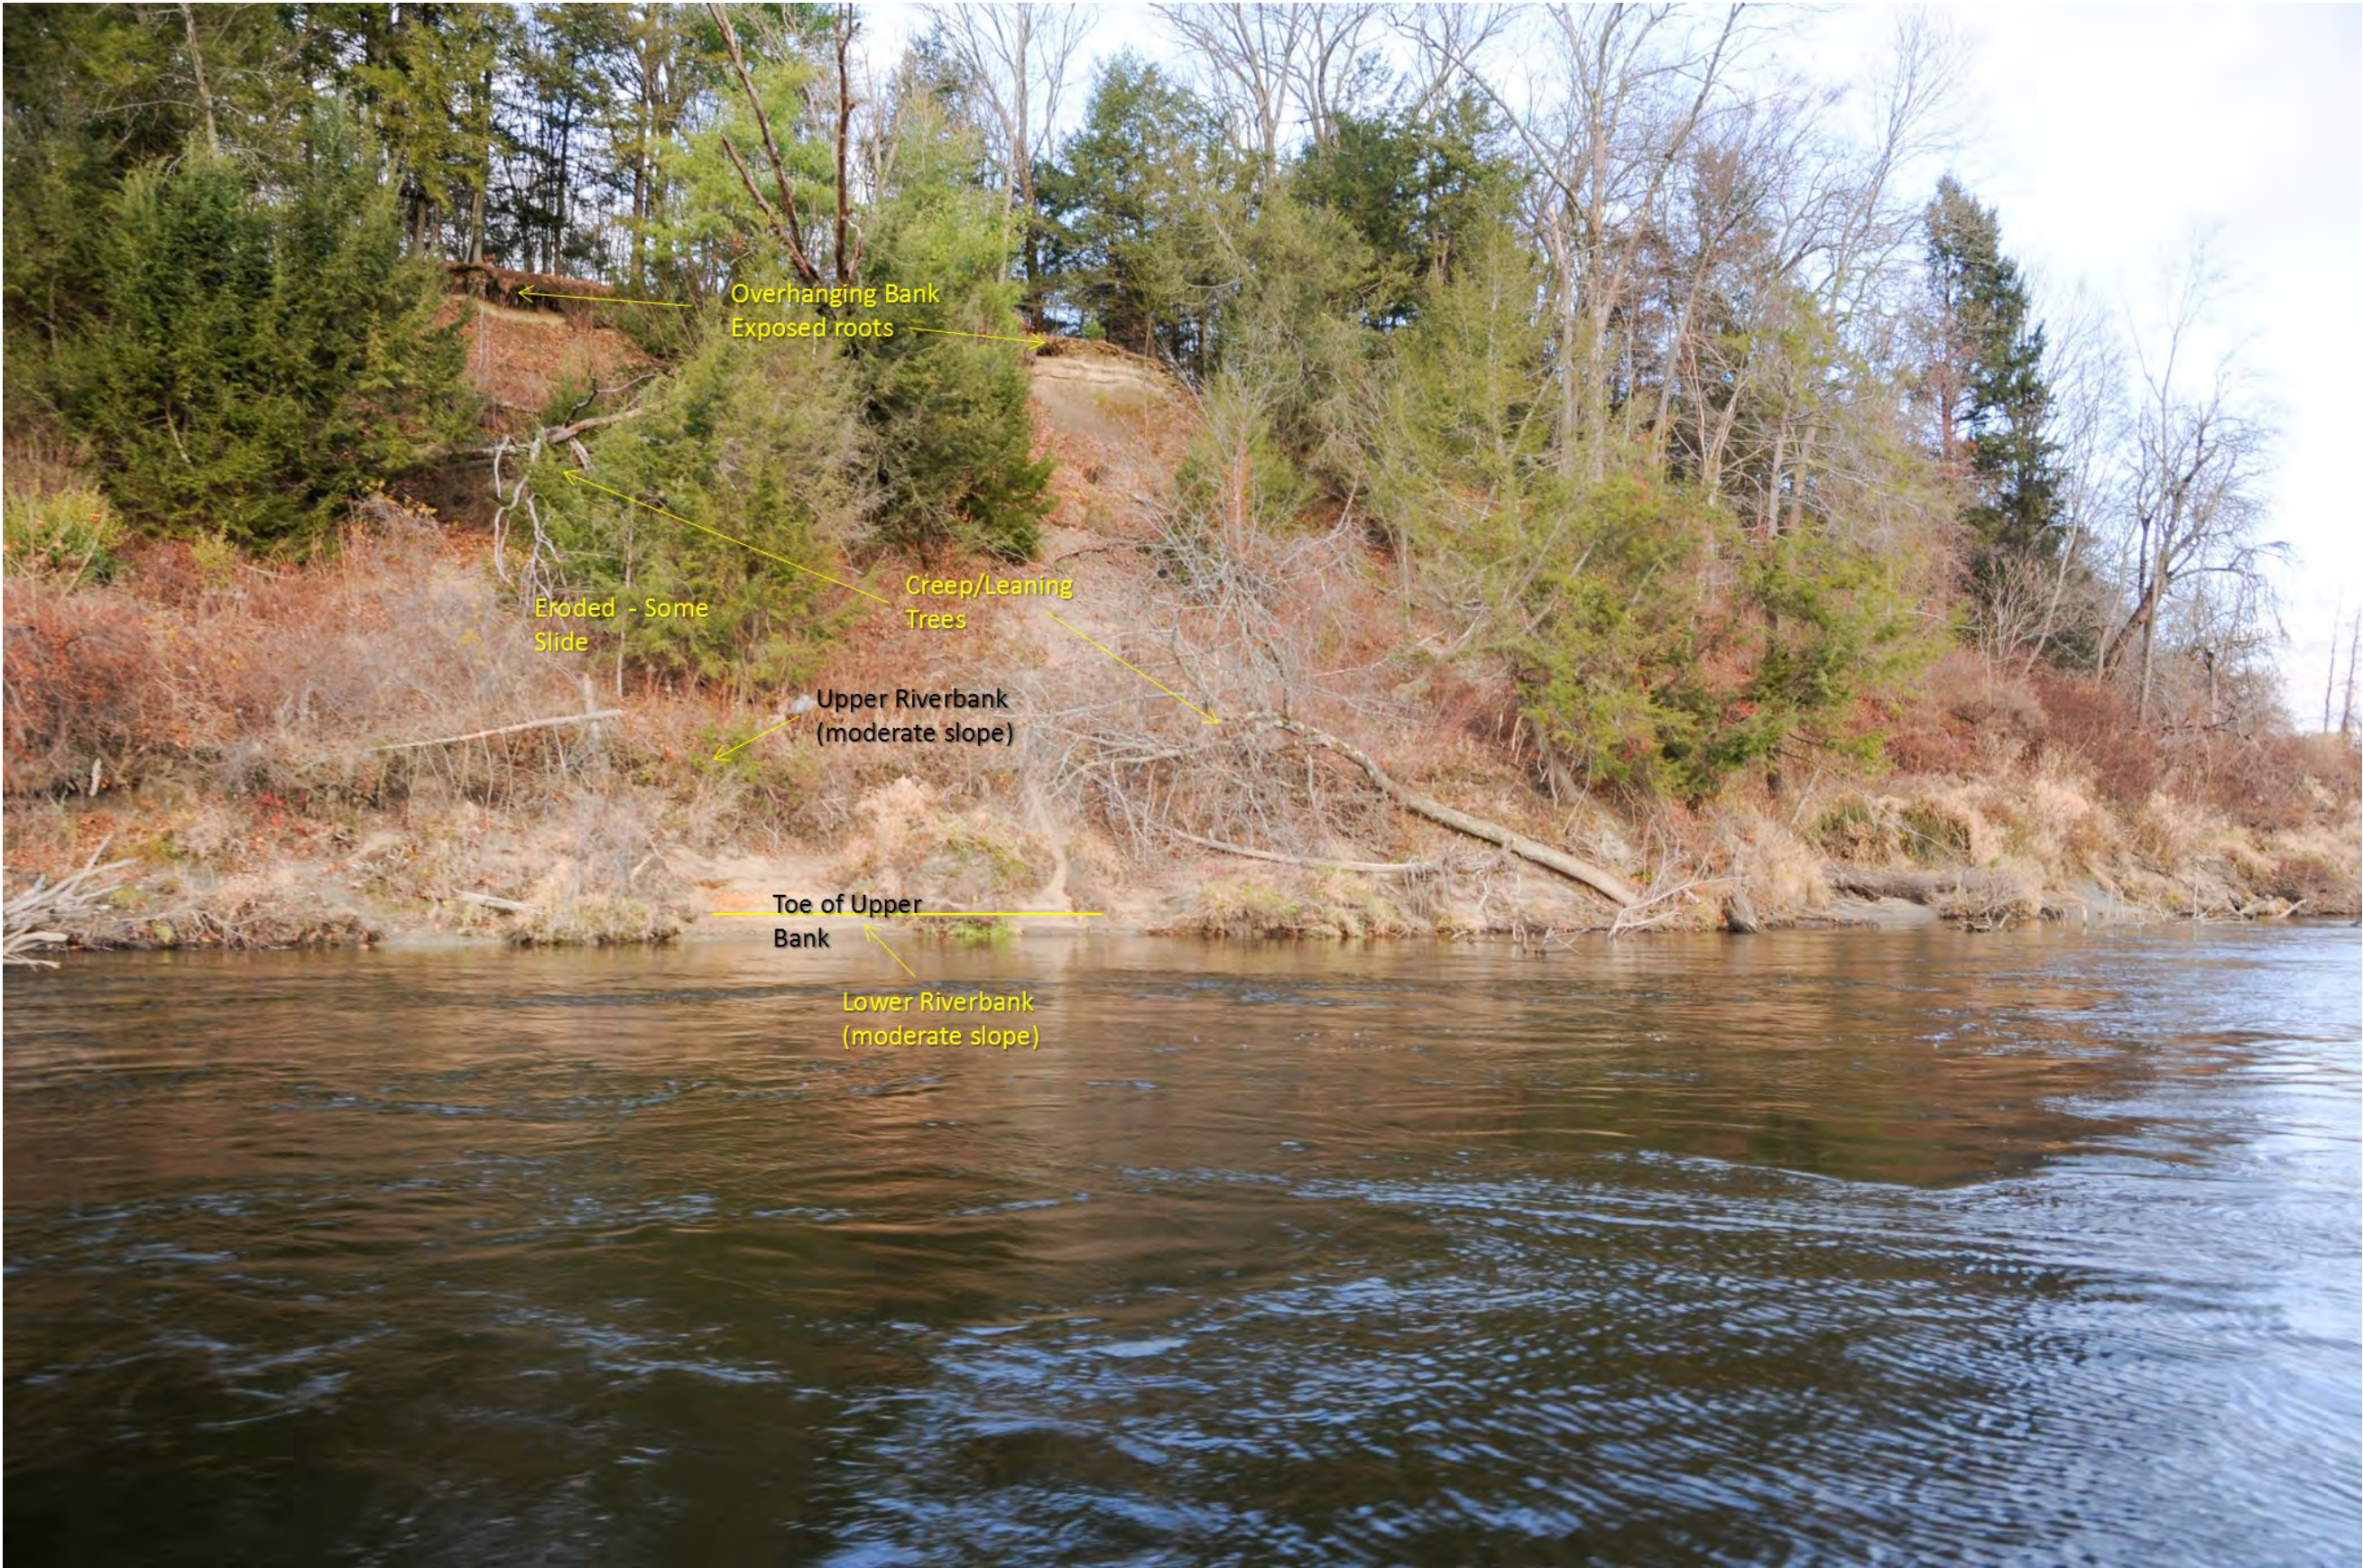
Photo ID 1429 (near mid-segment)

Riverbank Features	Characteristics
Upper Riverbank Slope	Moderate
Upper Riverbank Height	High
Upper Riverbank Sediment	Silt/Sand
Upper Riverbank Vegetation	Heavy
Lower Riverbank Slope	Moderate
Lower Riverbank Sediment	Silt/Sand
Lower Riverbank Vegetation	None to very sparse
Type of Erosion	Slide
Potential Erosion Indicators	Creep/leaning trees, Overhanging bank, Exposed roots
Stage of Erosion	Eroded
Extent of Erosion	Some

QA Observations: Upon review of the photos for this segment, classification made in the field was confirmed and additional indicators of potential future erosion were included.

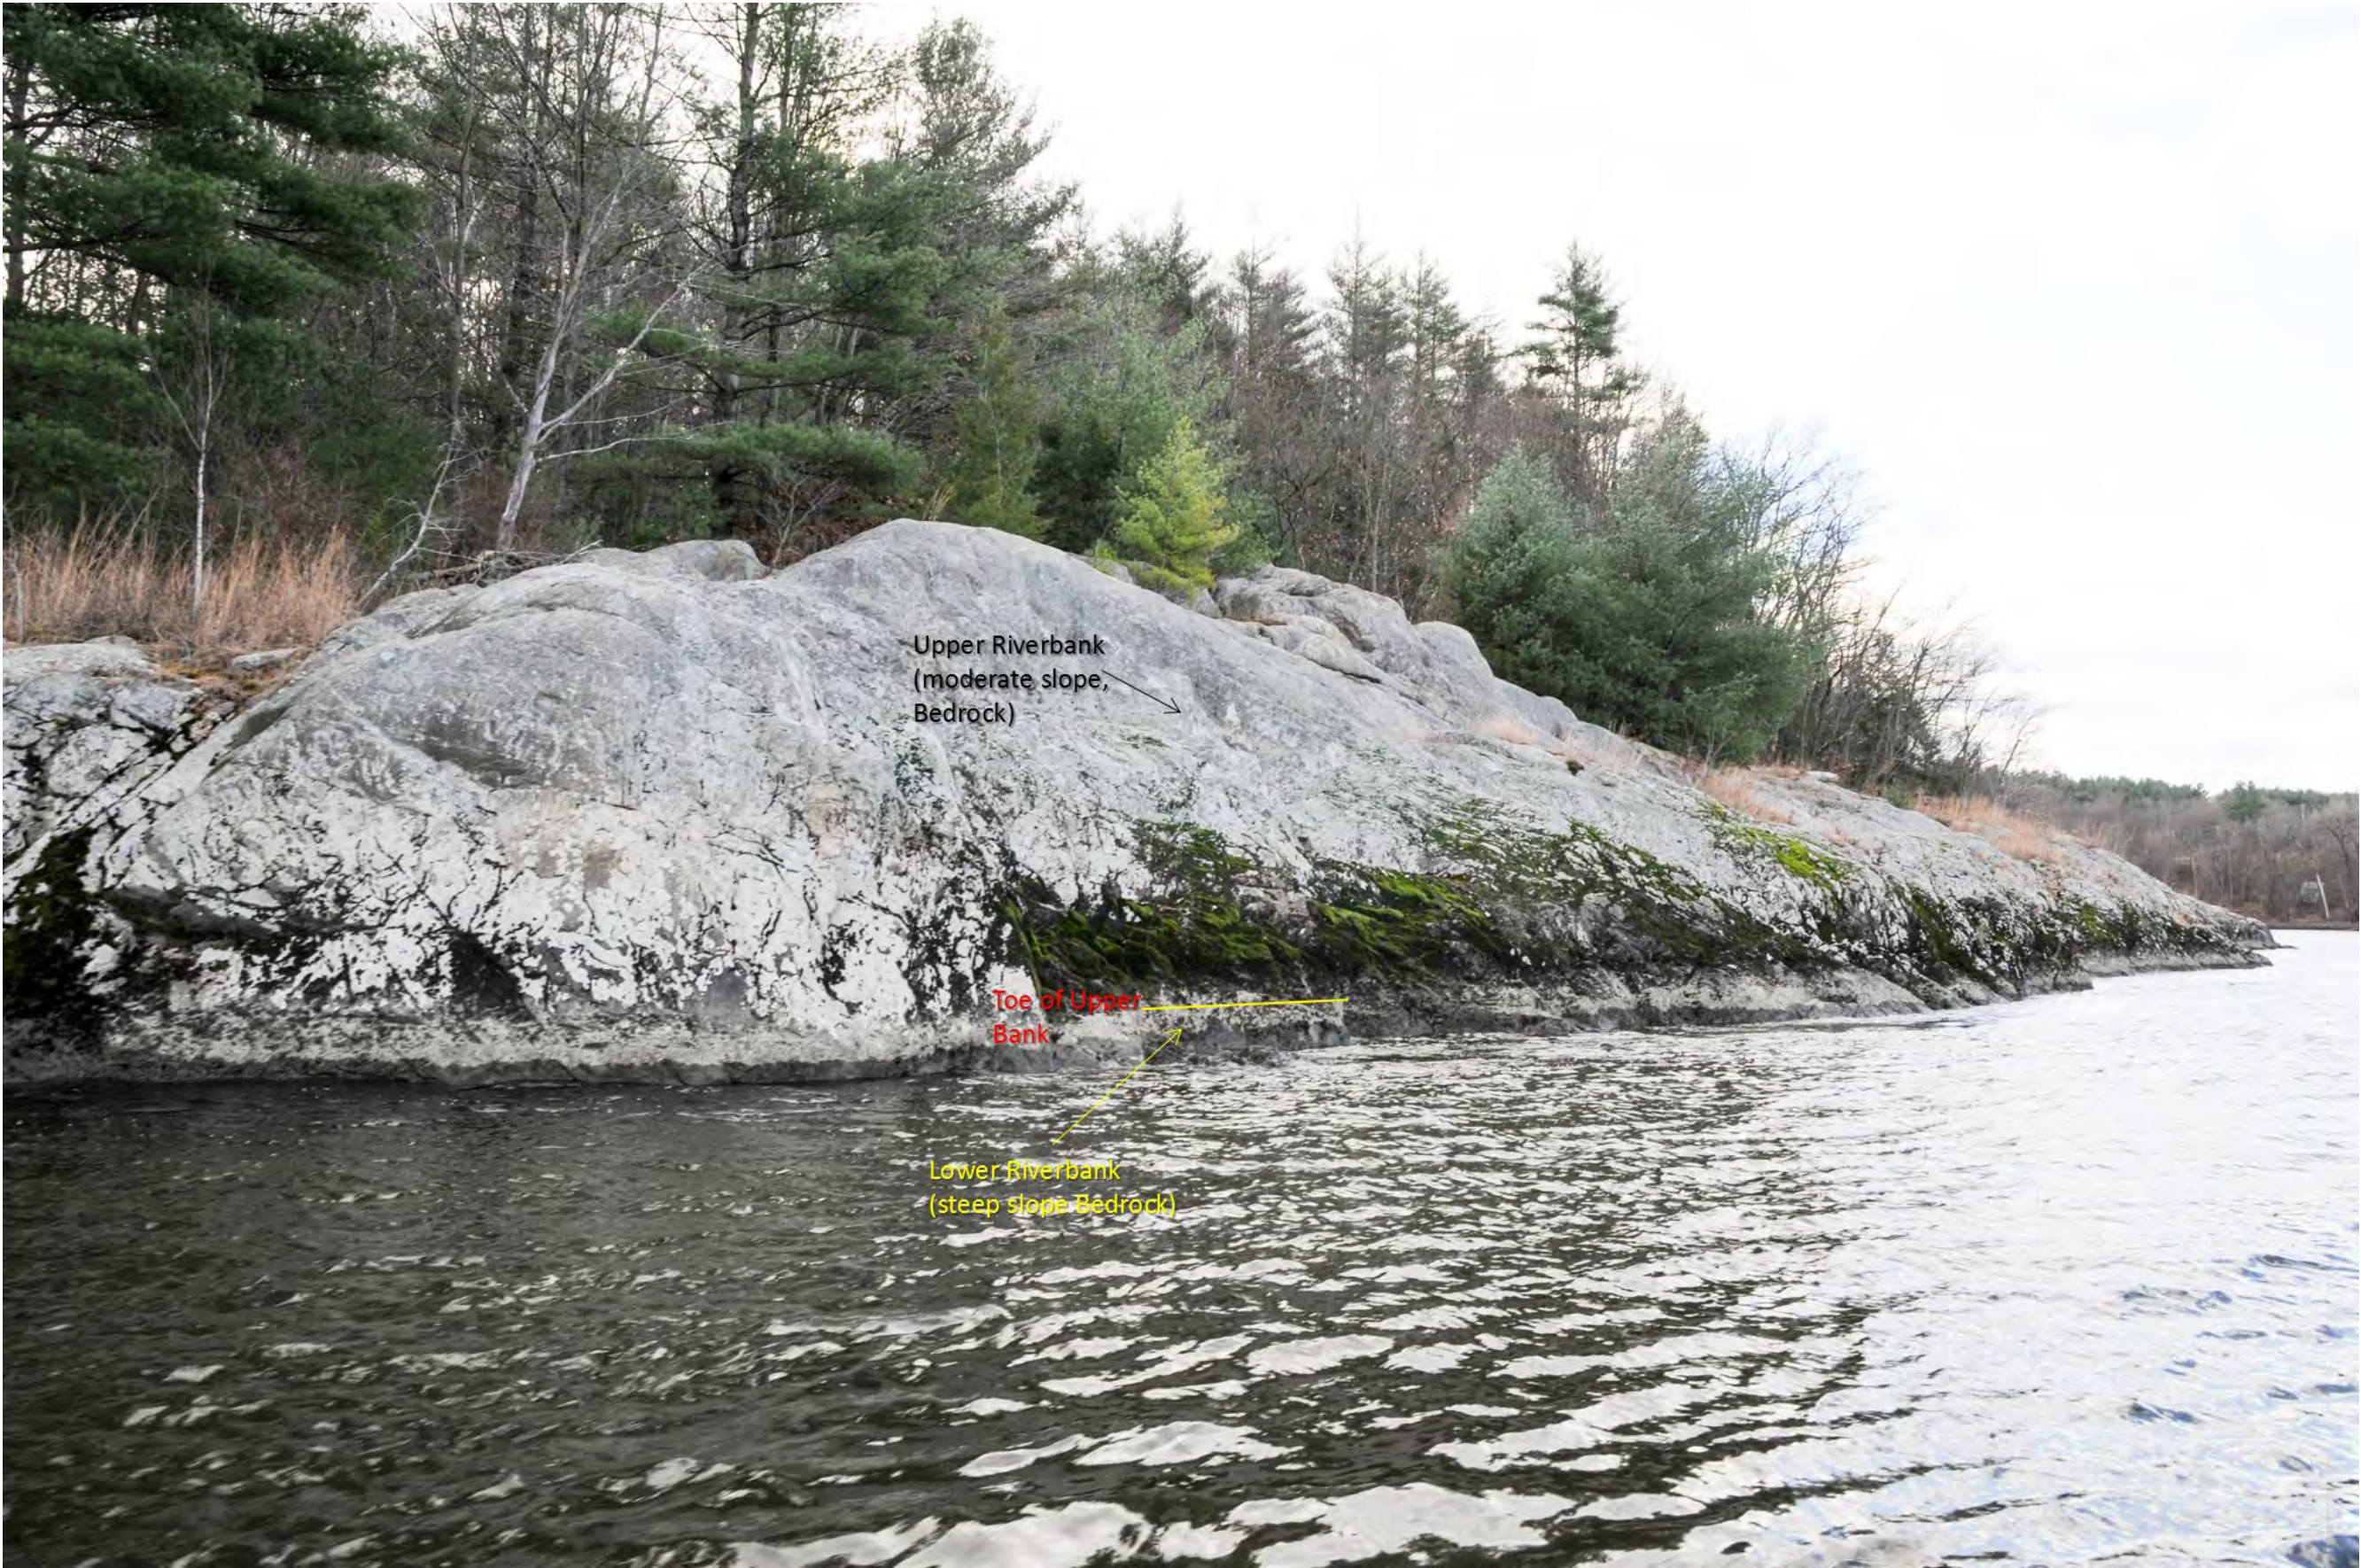
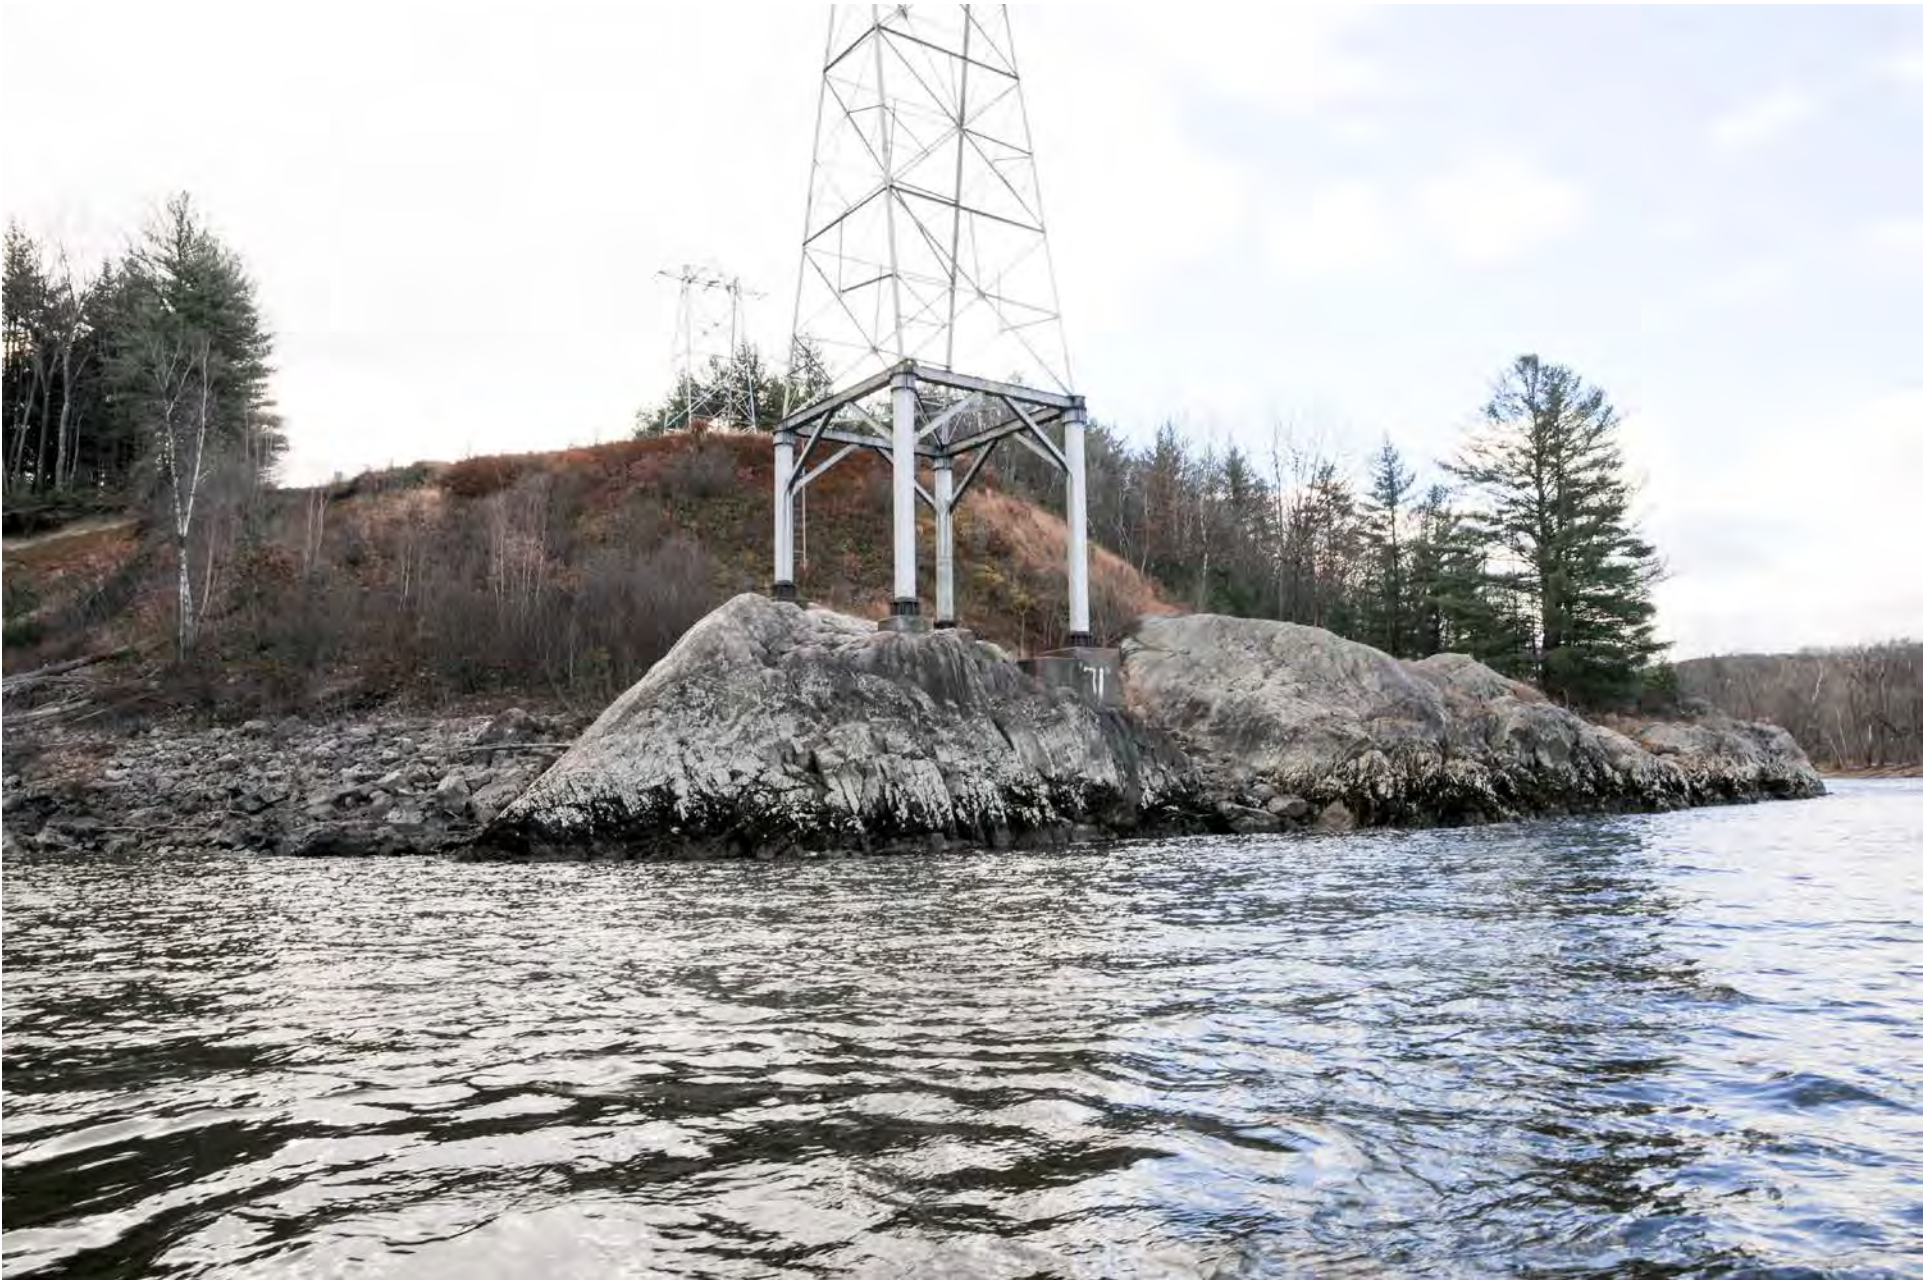
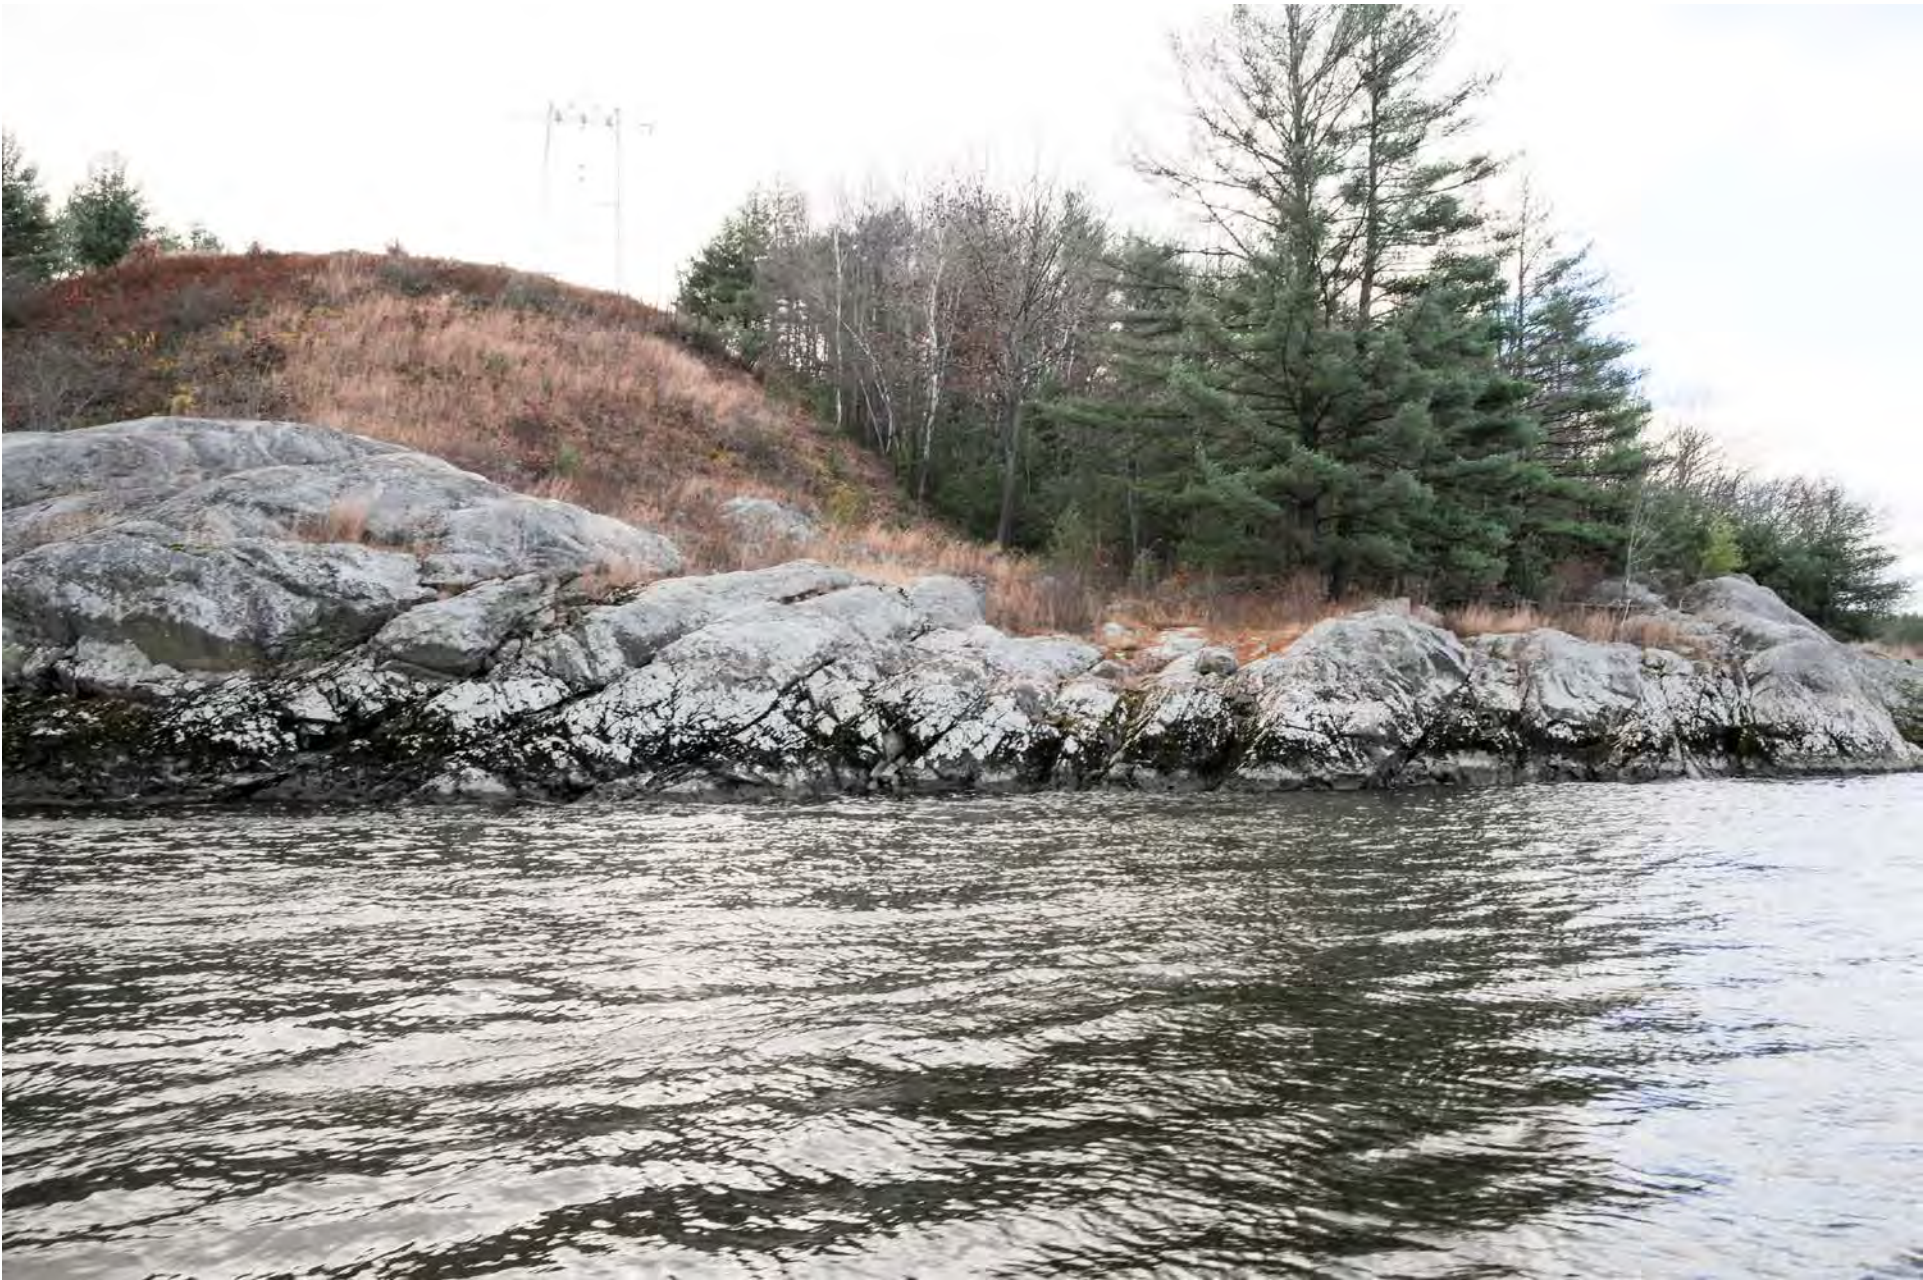
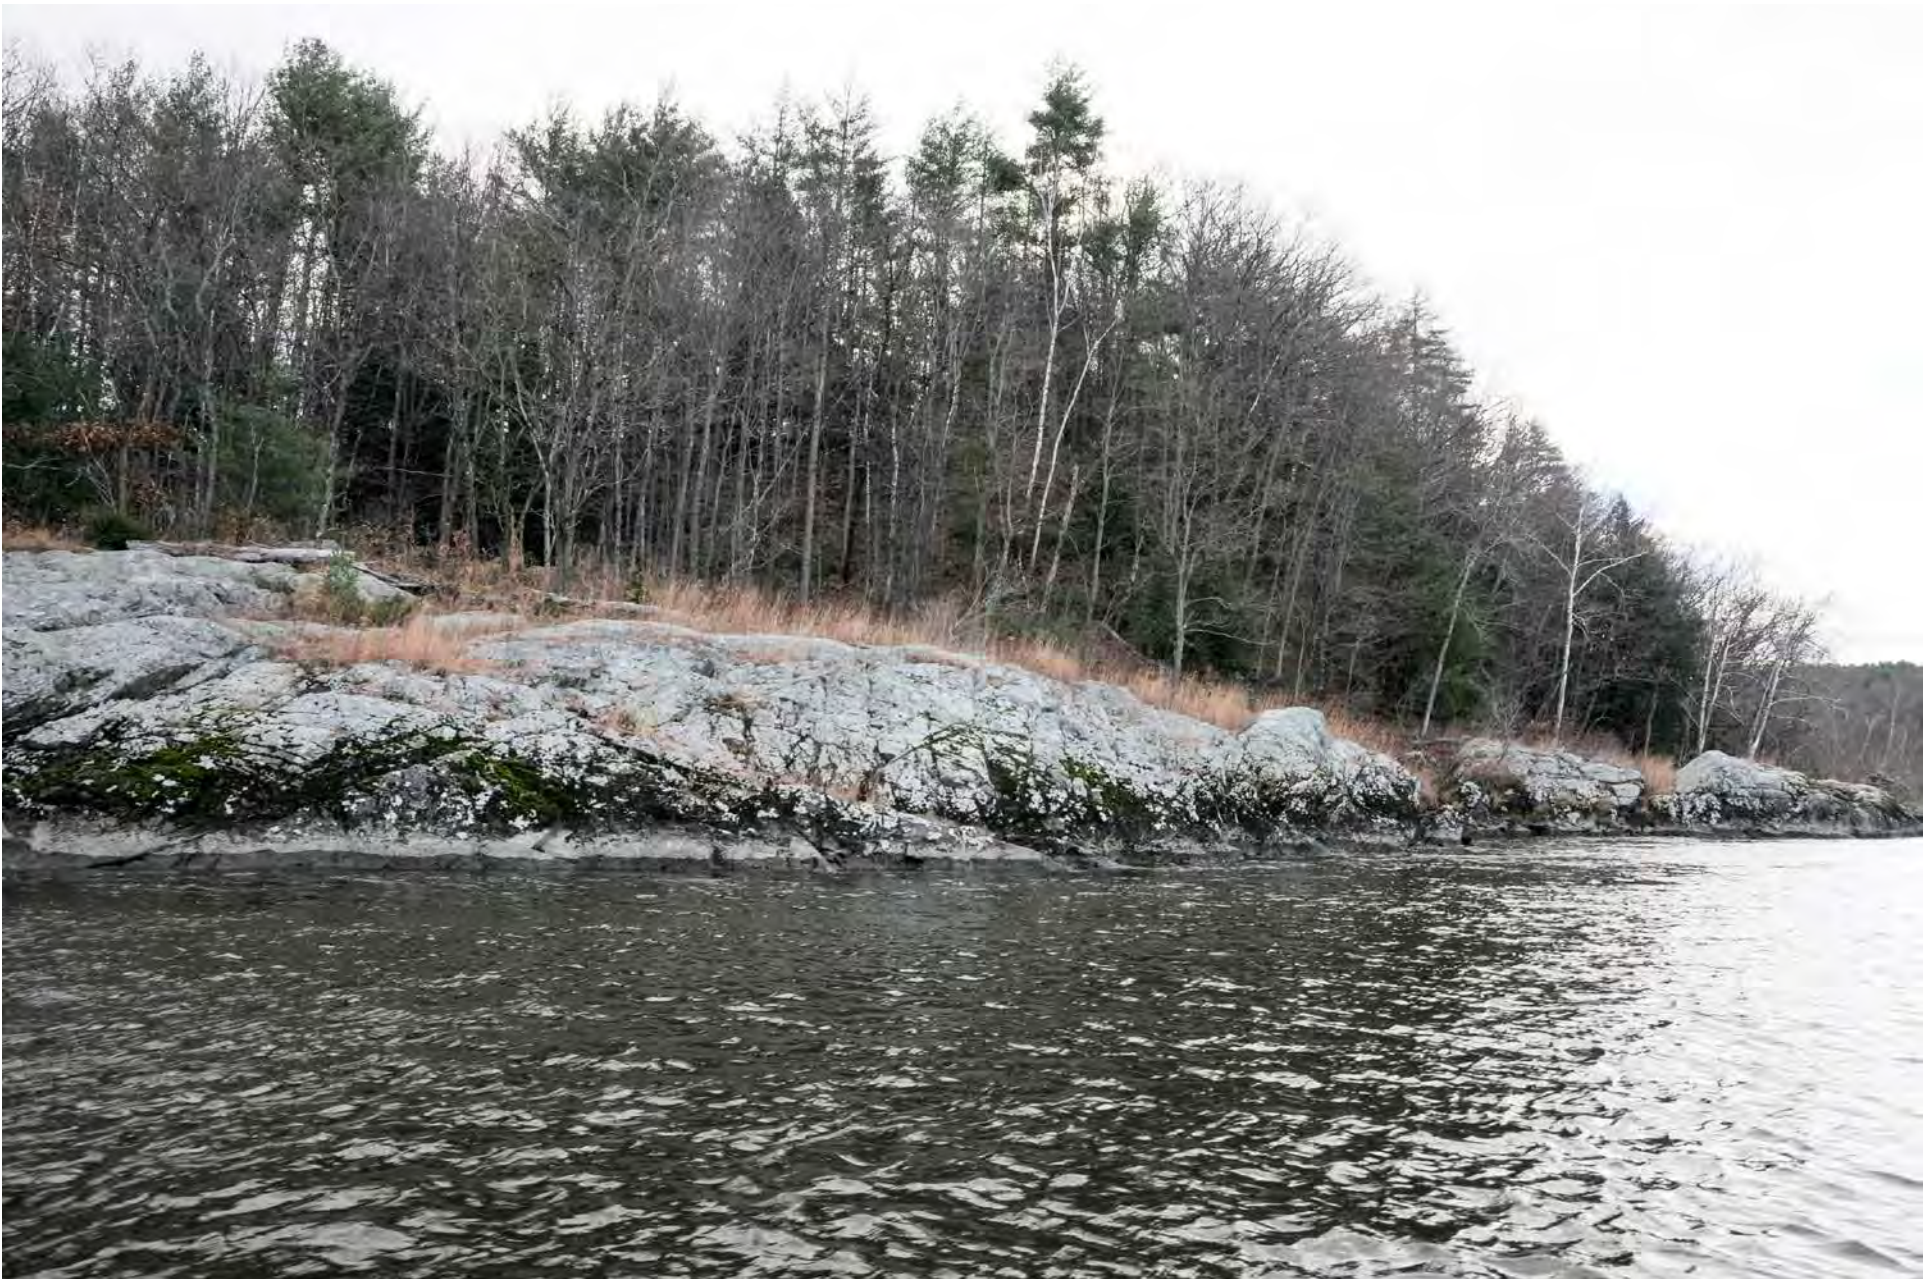
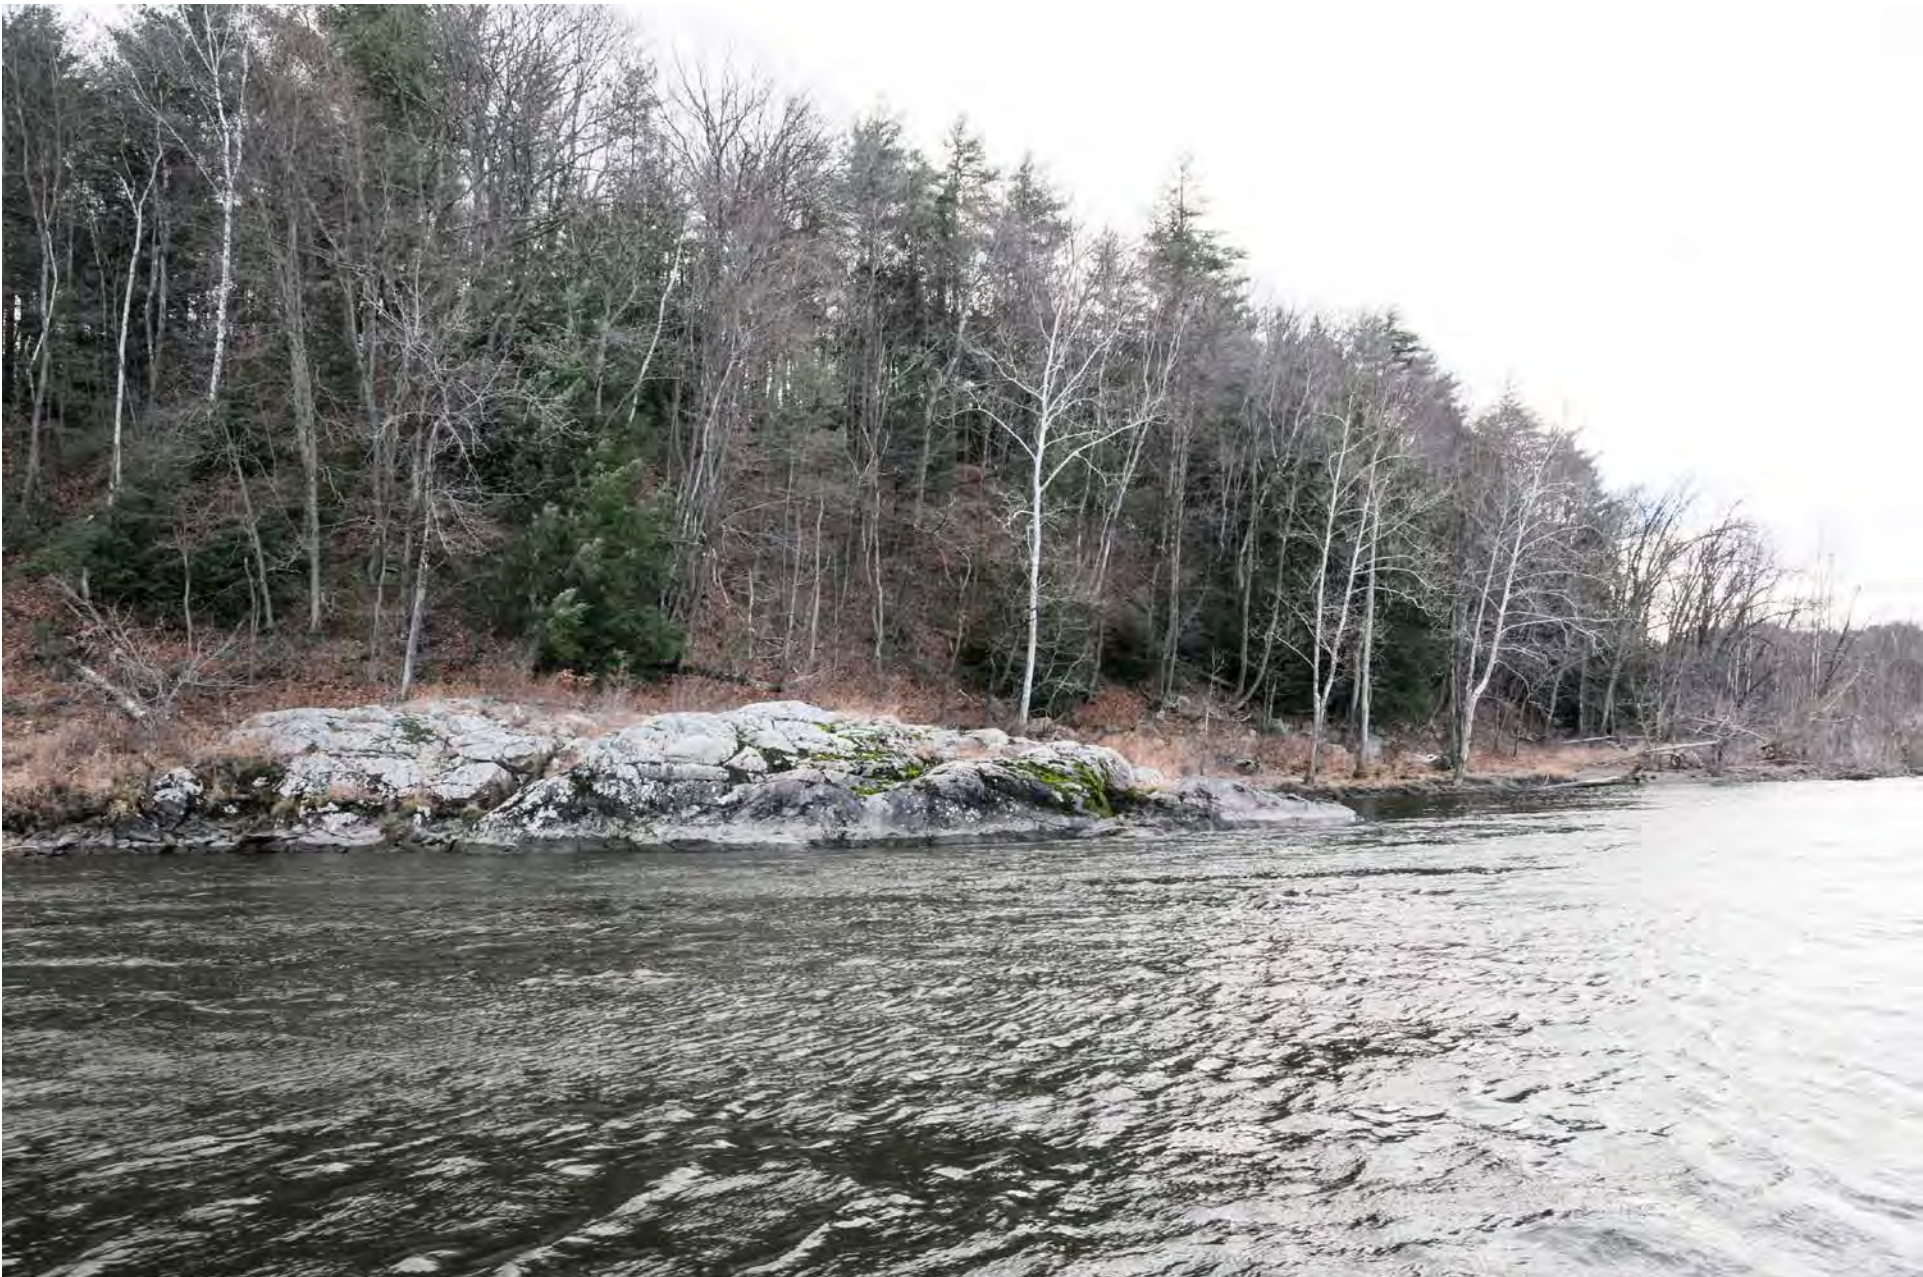
Photo ID 1408 (near mid-segment)

Riverbank Features	Characteristics
Upper Riverbank Slope	Moderate
Upper Riverbank Height	High
Upper Riverbank Sediment	Bedrock
Upper Riverbank Vegetation	None to very sparse
Lower Riverbank Slope	Steep
Lower Riverbank Sediment	Bedrock
Lower Riverbank Vegetation	None to very sparse
Type of Erosion	
Potential Erosion Indicators	None
Stage of Erosion	Stable
Extent of Erosion	None/Little

QA Observations: Upon review of the photos for this segment, classification made in the field was confirmed.
