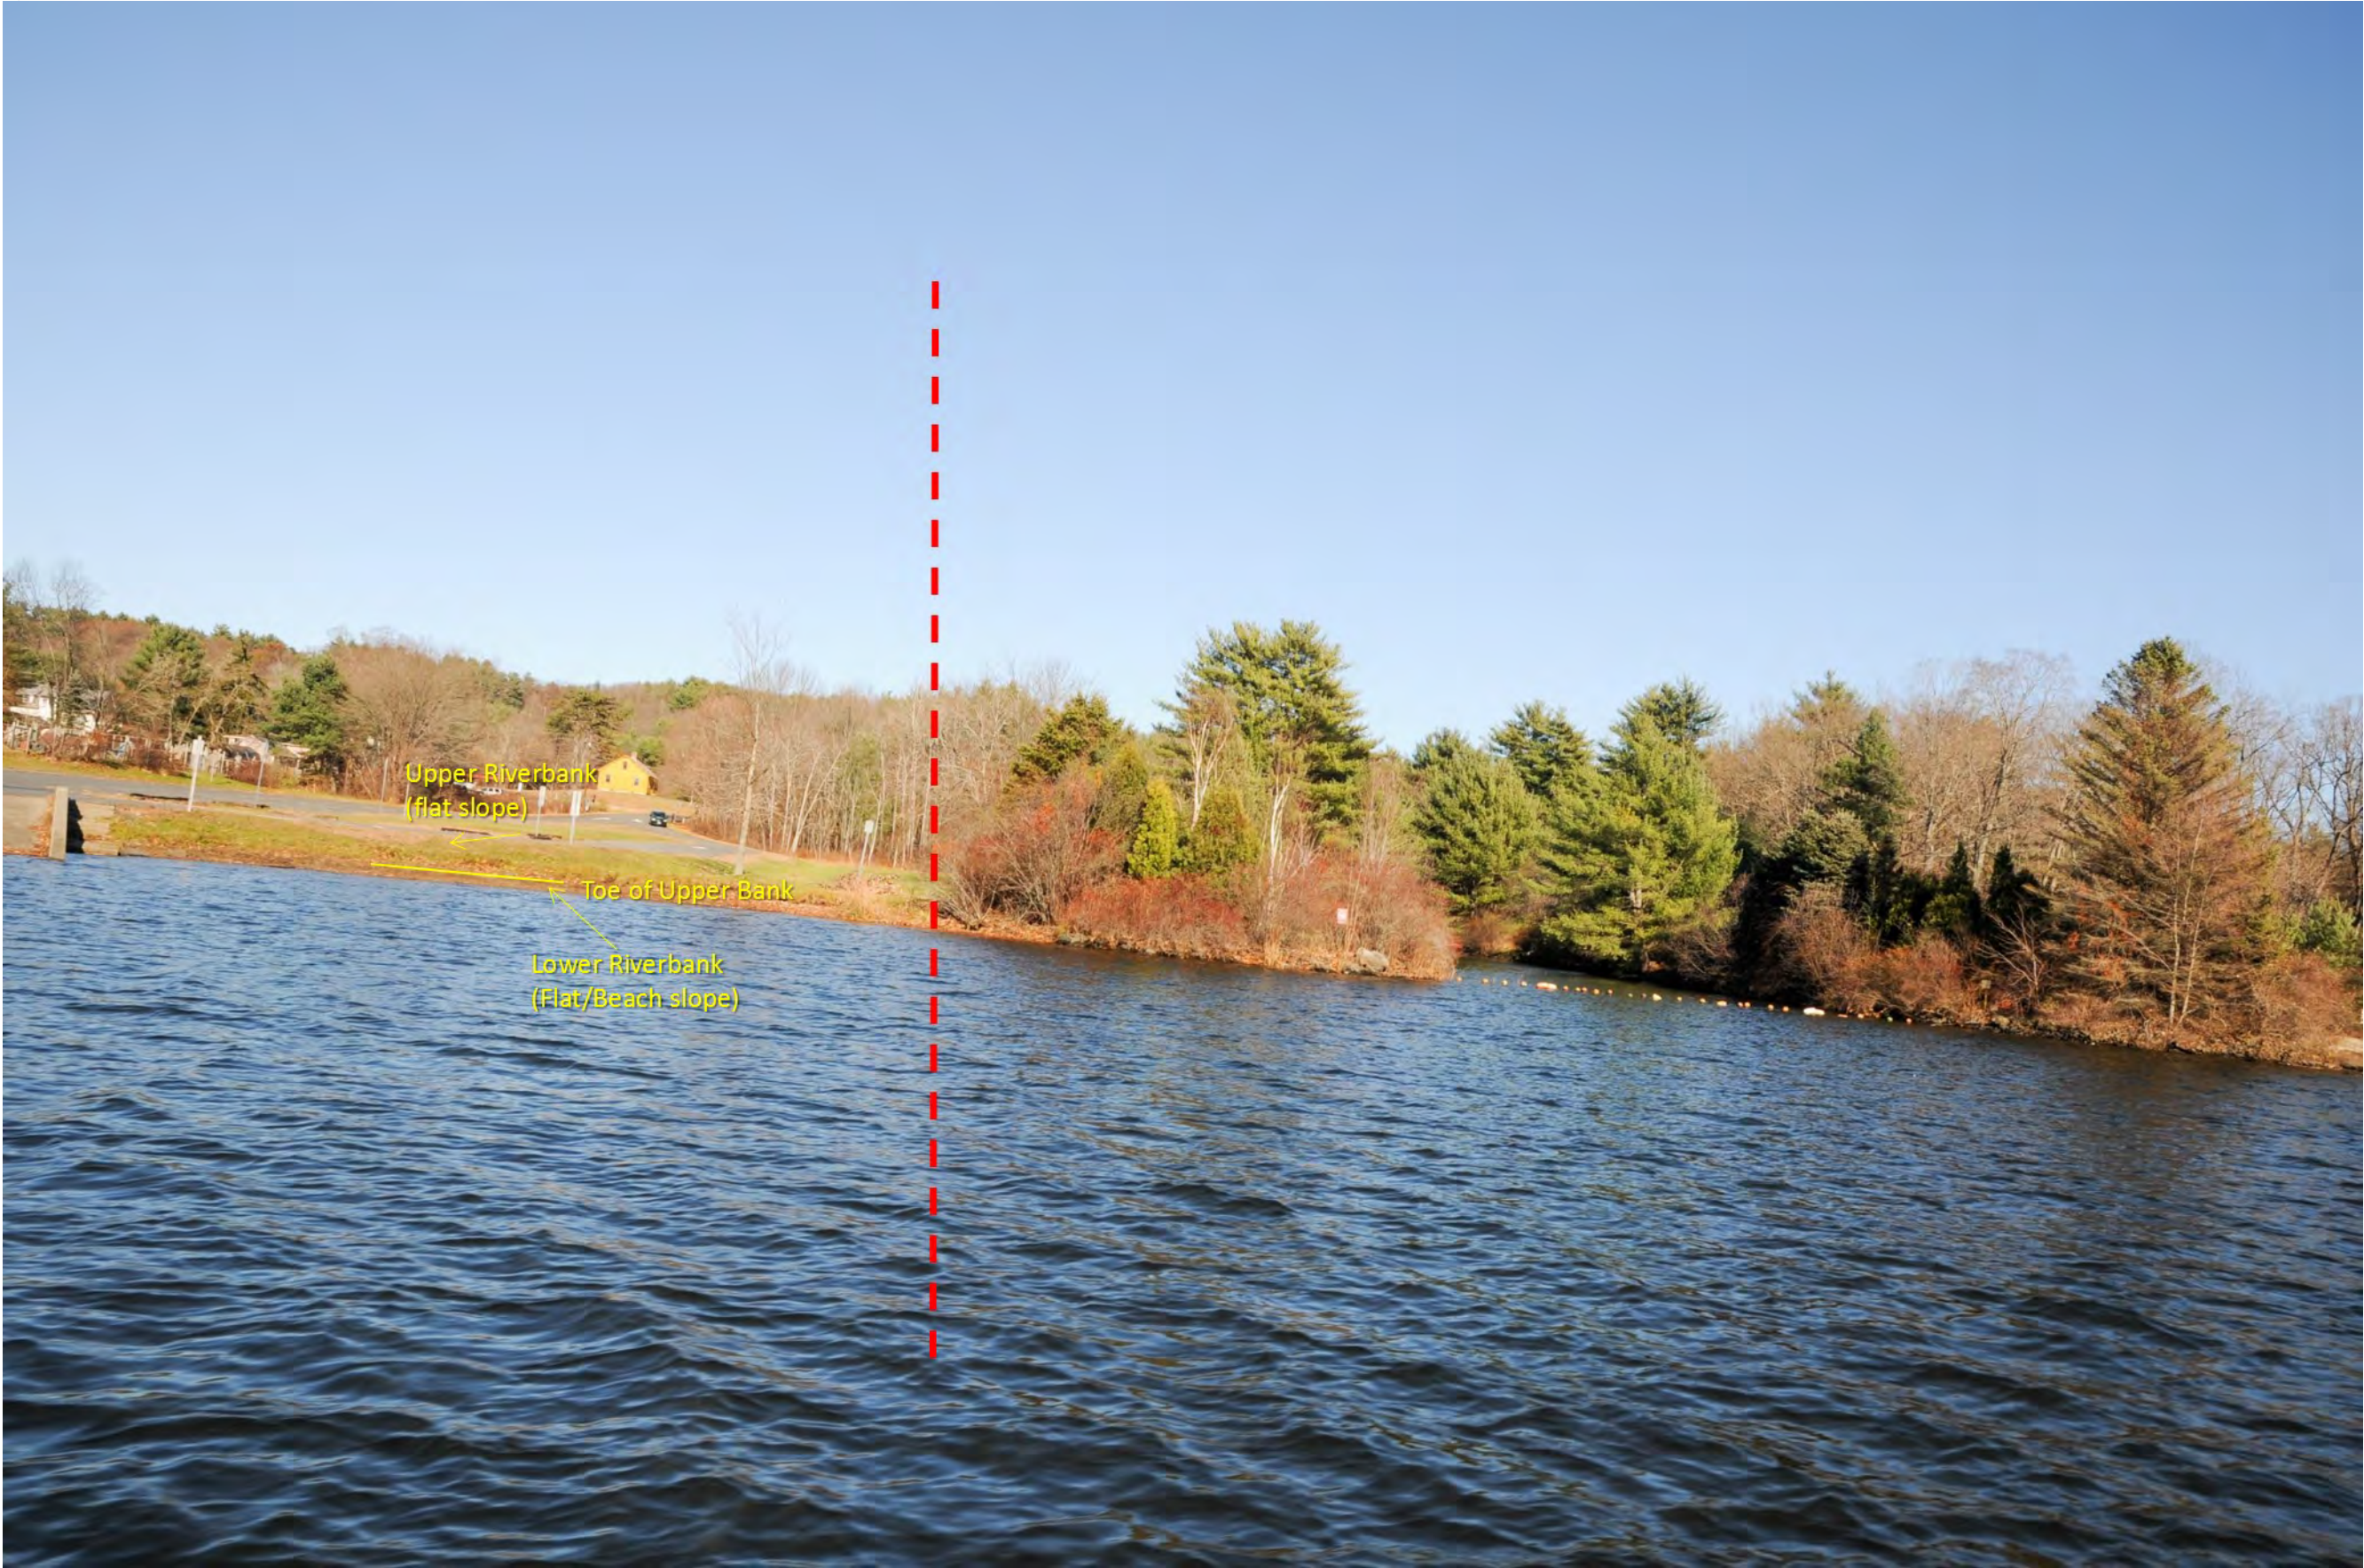
Photo ID 314 (segment is labeled portion of photo. Dashed line represents approximate end of segment)

Riverbank Features	Characteristics
Upper Riverbank Slope	Flat
Upper Riverbank Height	Low
Upper Riverbank Sediment	Silt/Sand
Upper Riverbank Vegetation	Heavy
Lower Riverbank Slope	Flat/Beach
Lower Riverbank Sediment	Silt/Sand
Lower Riverbank Vegetation	None to very sparse
Type of Erosion	
Potential Erosion Indicators	None
Stage of Erosion	Stable
Extent of Erosion	None/Little

QA Observations: Upon review of the photos for this segment, classification made in the field was confirmed.

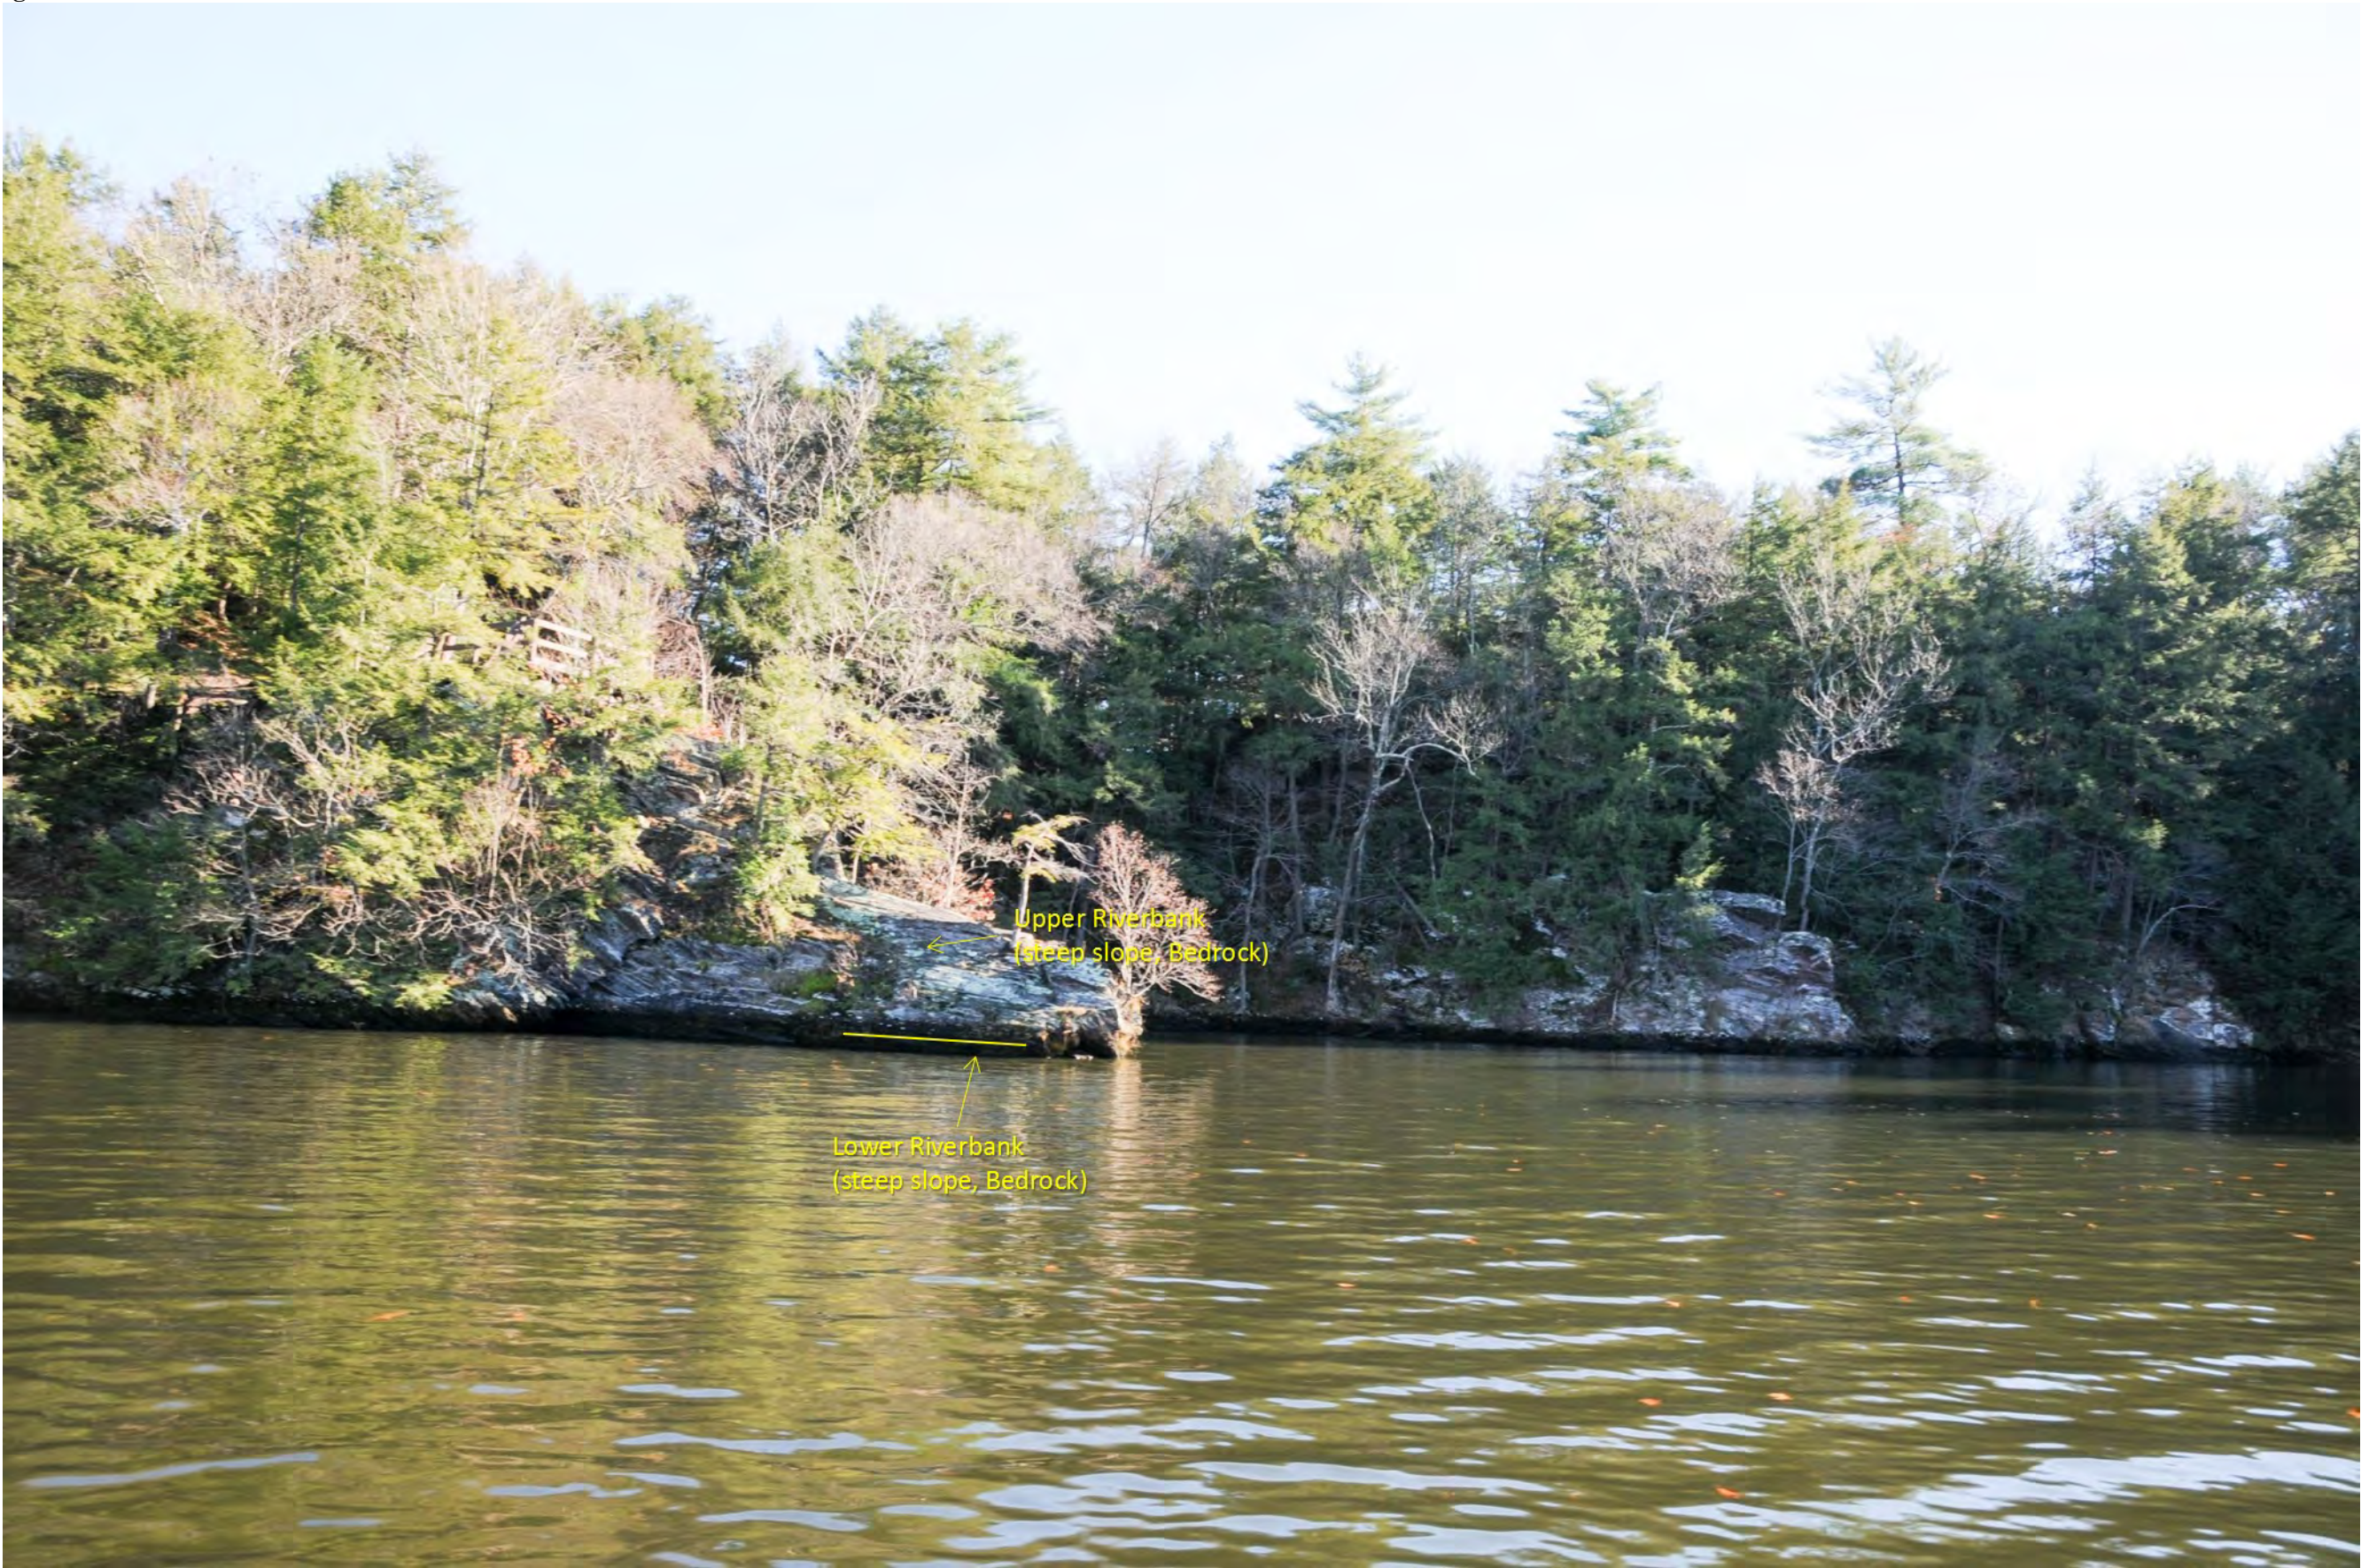
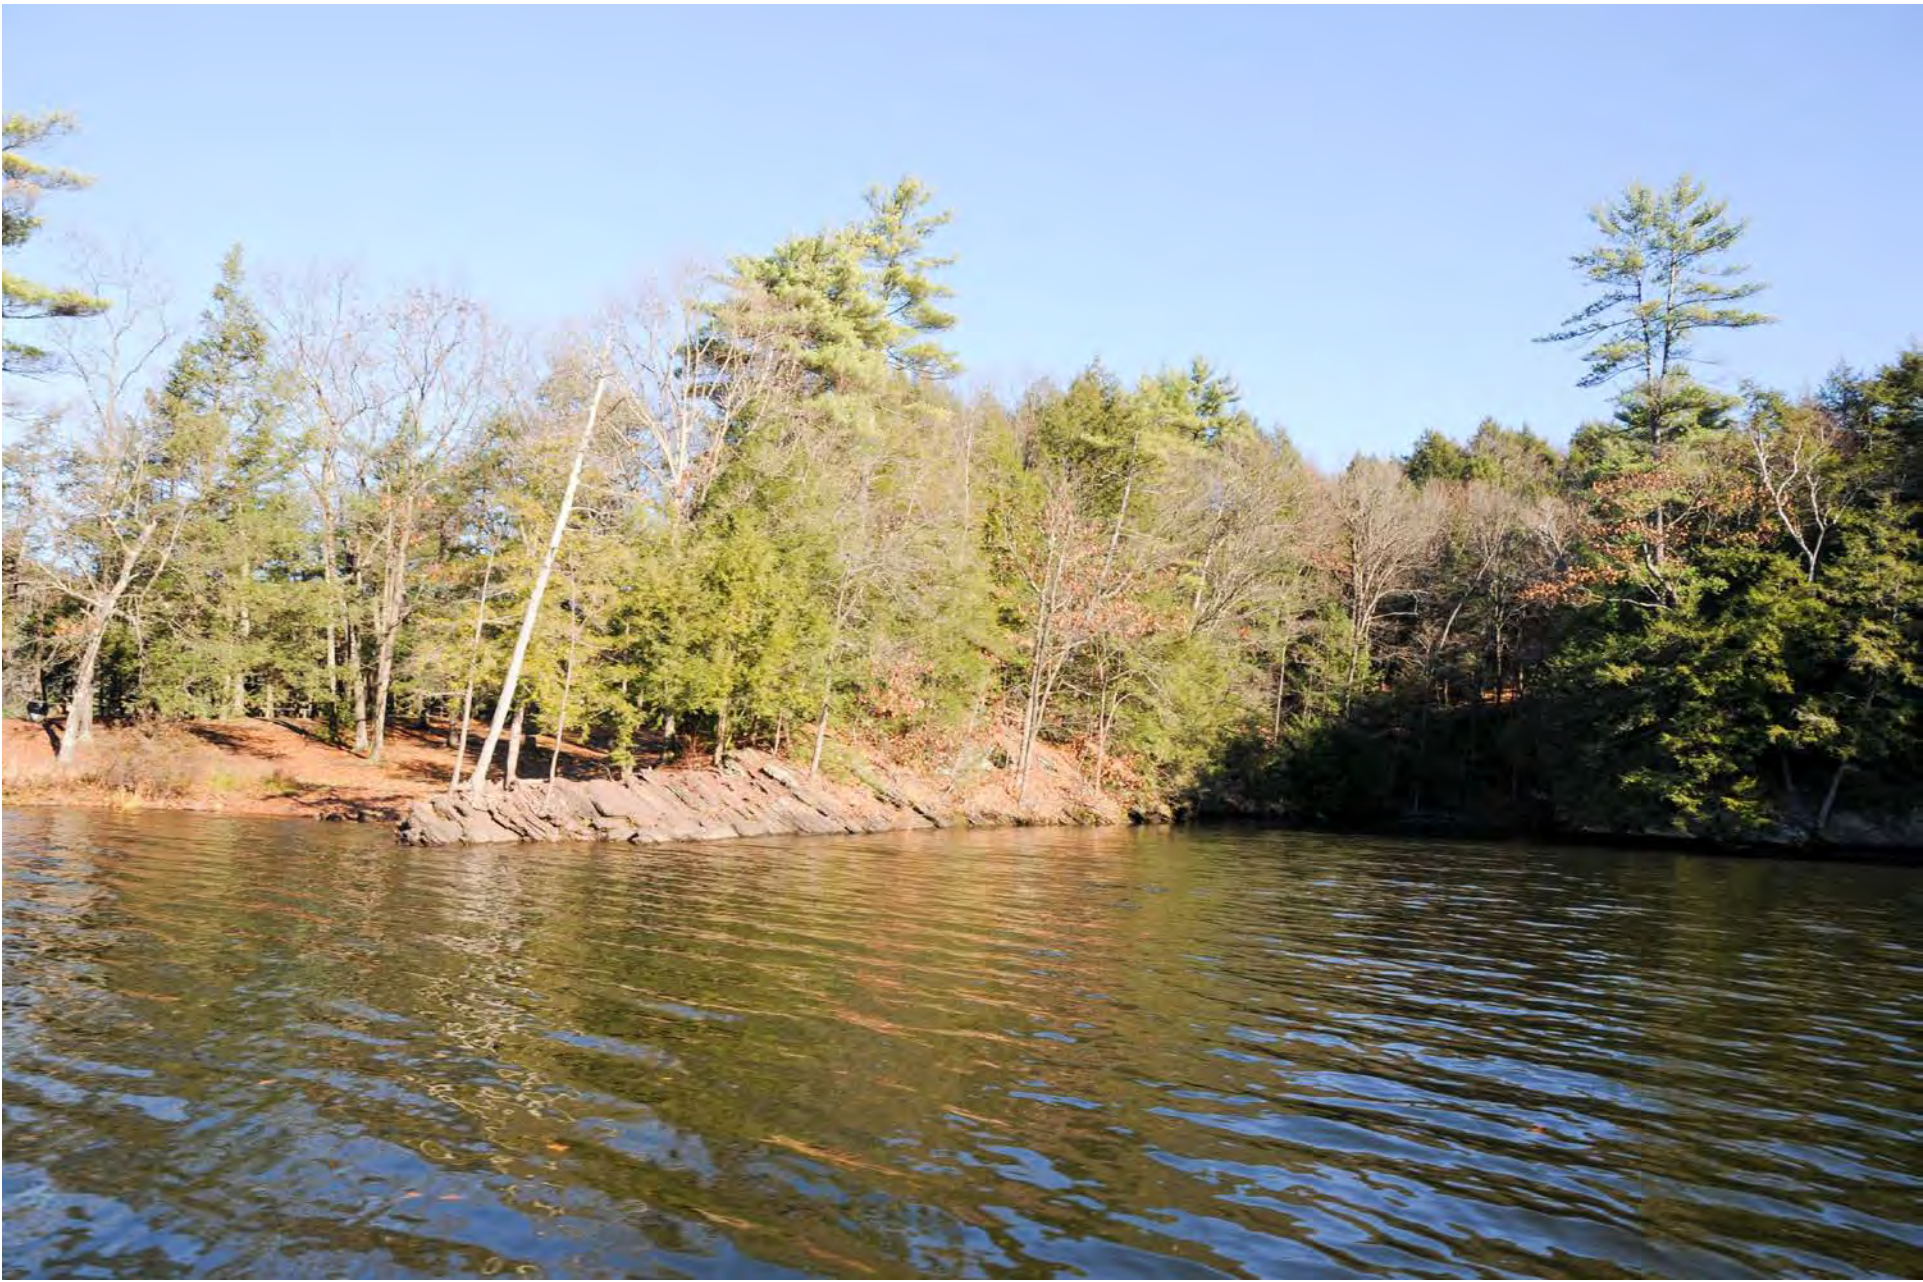
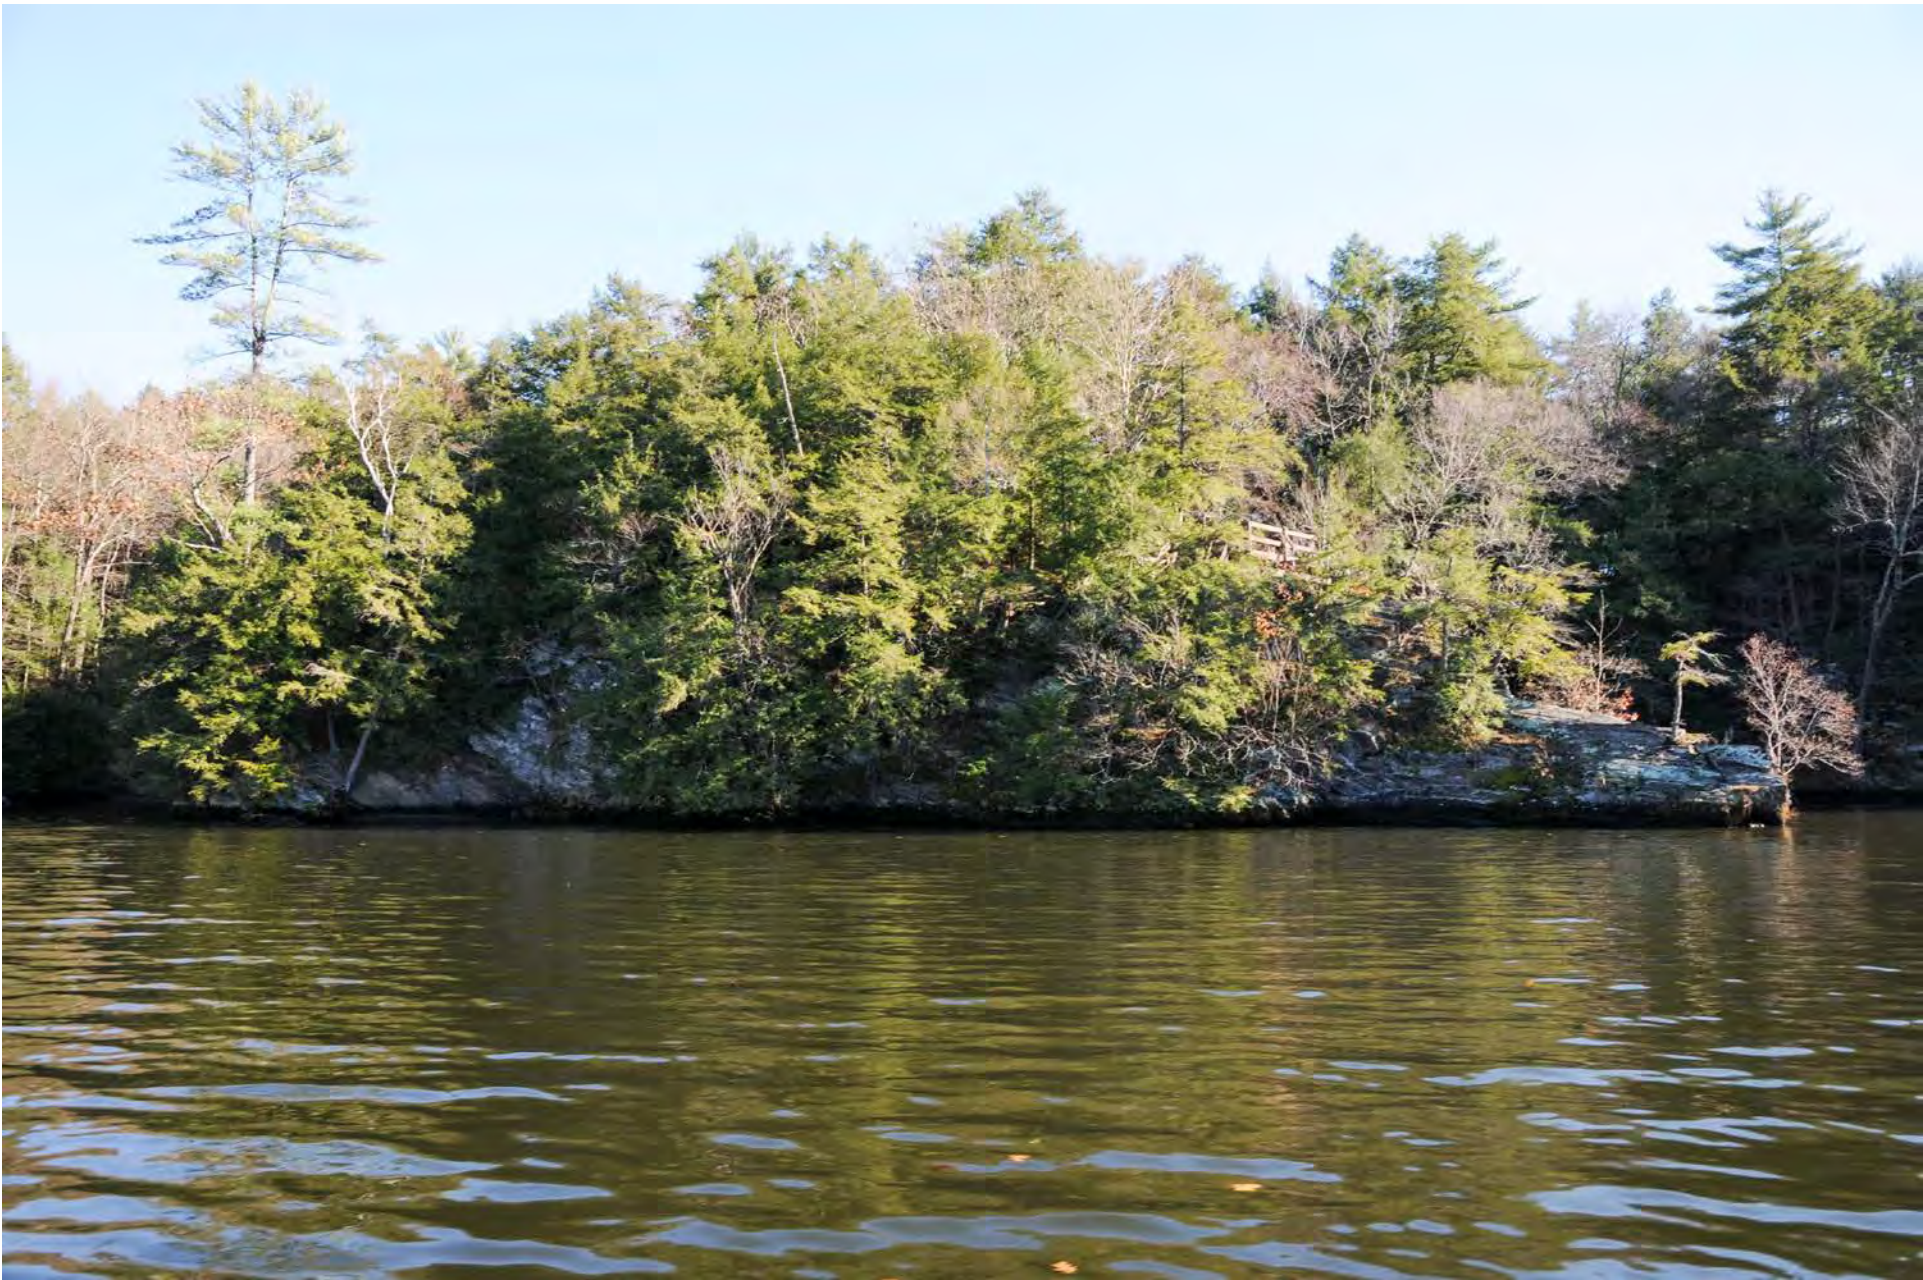
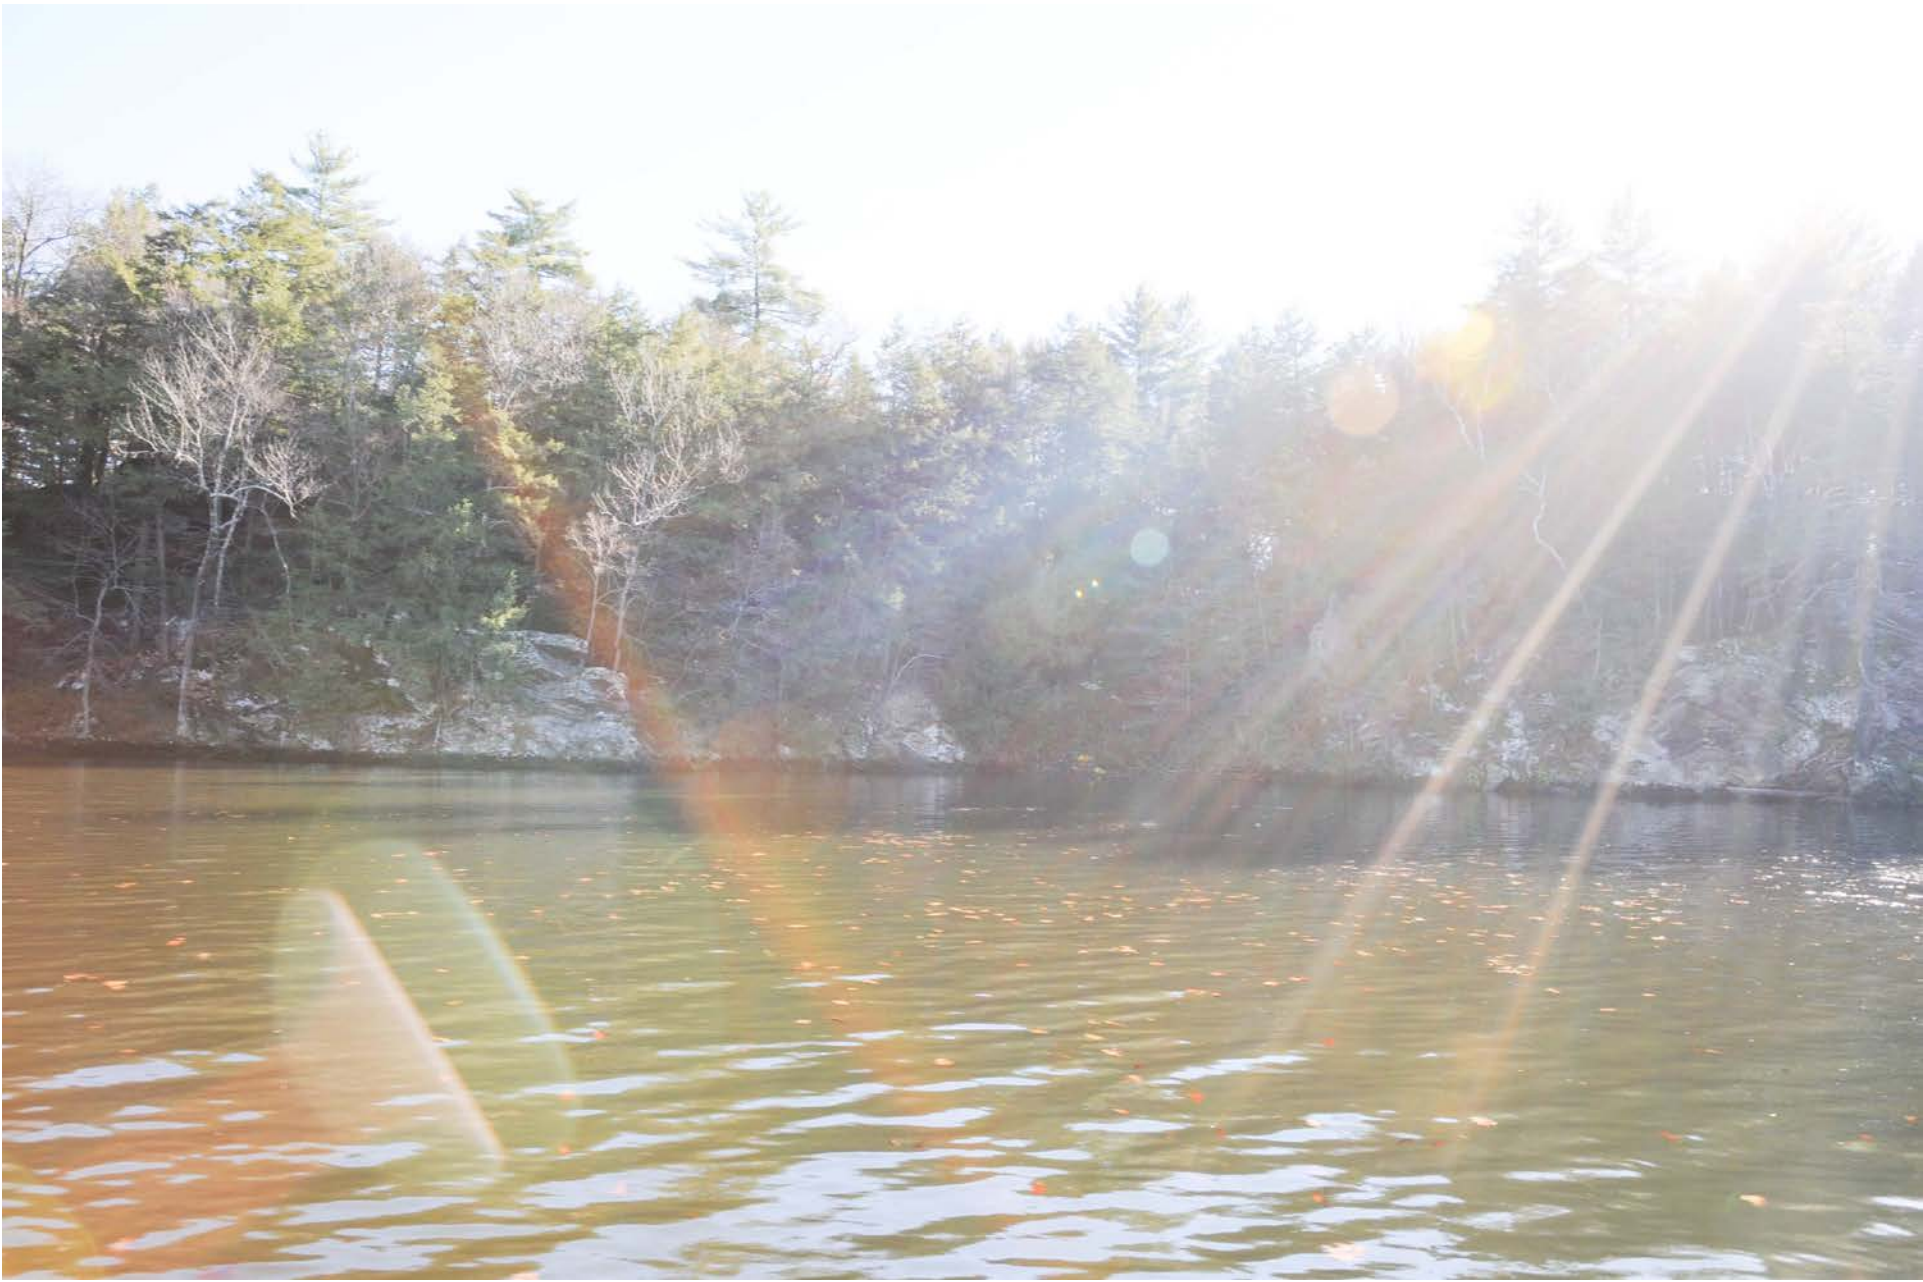
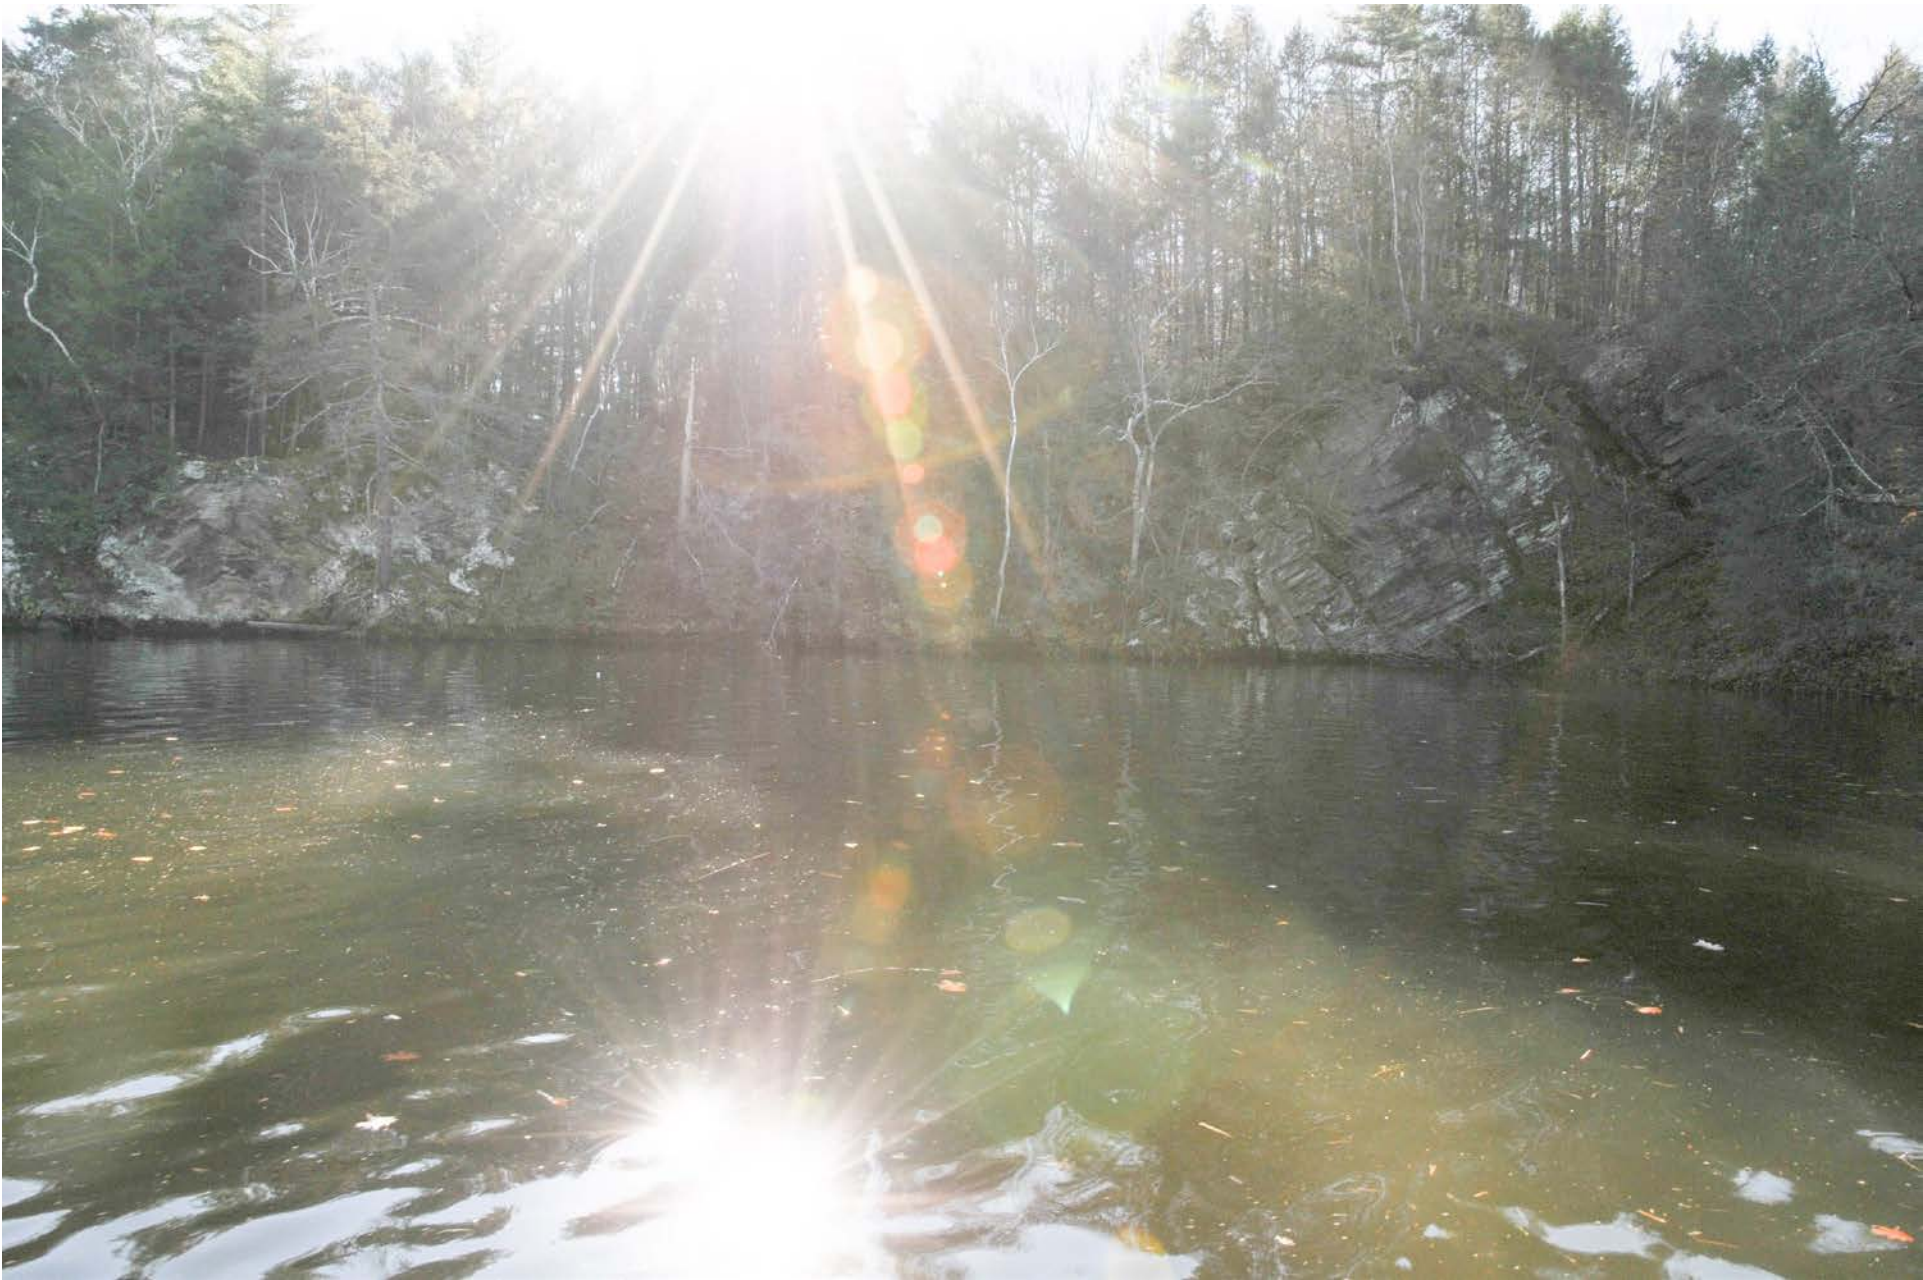
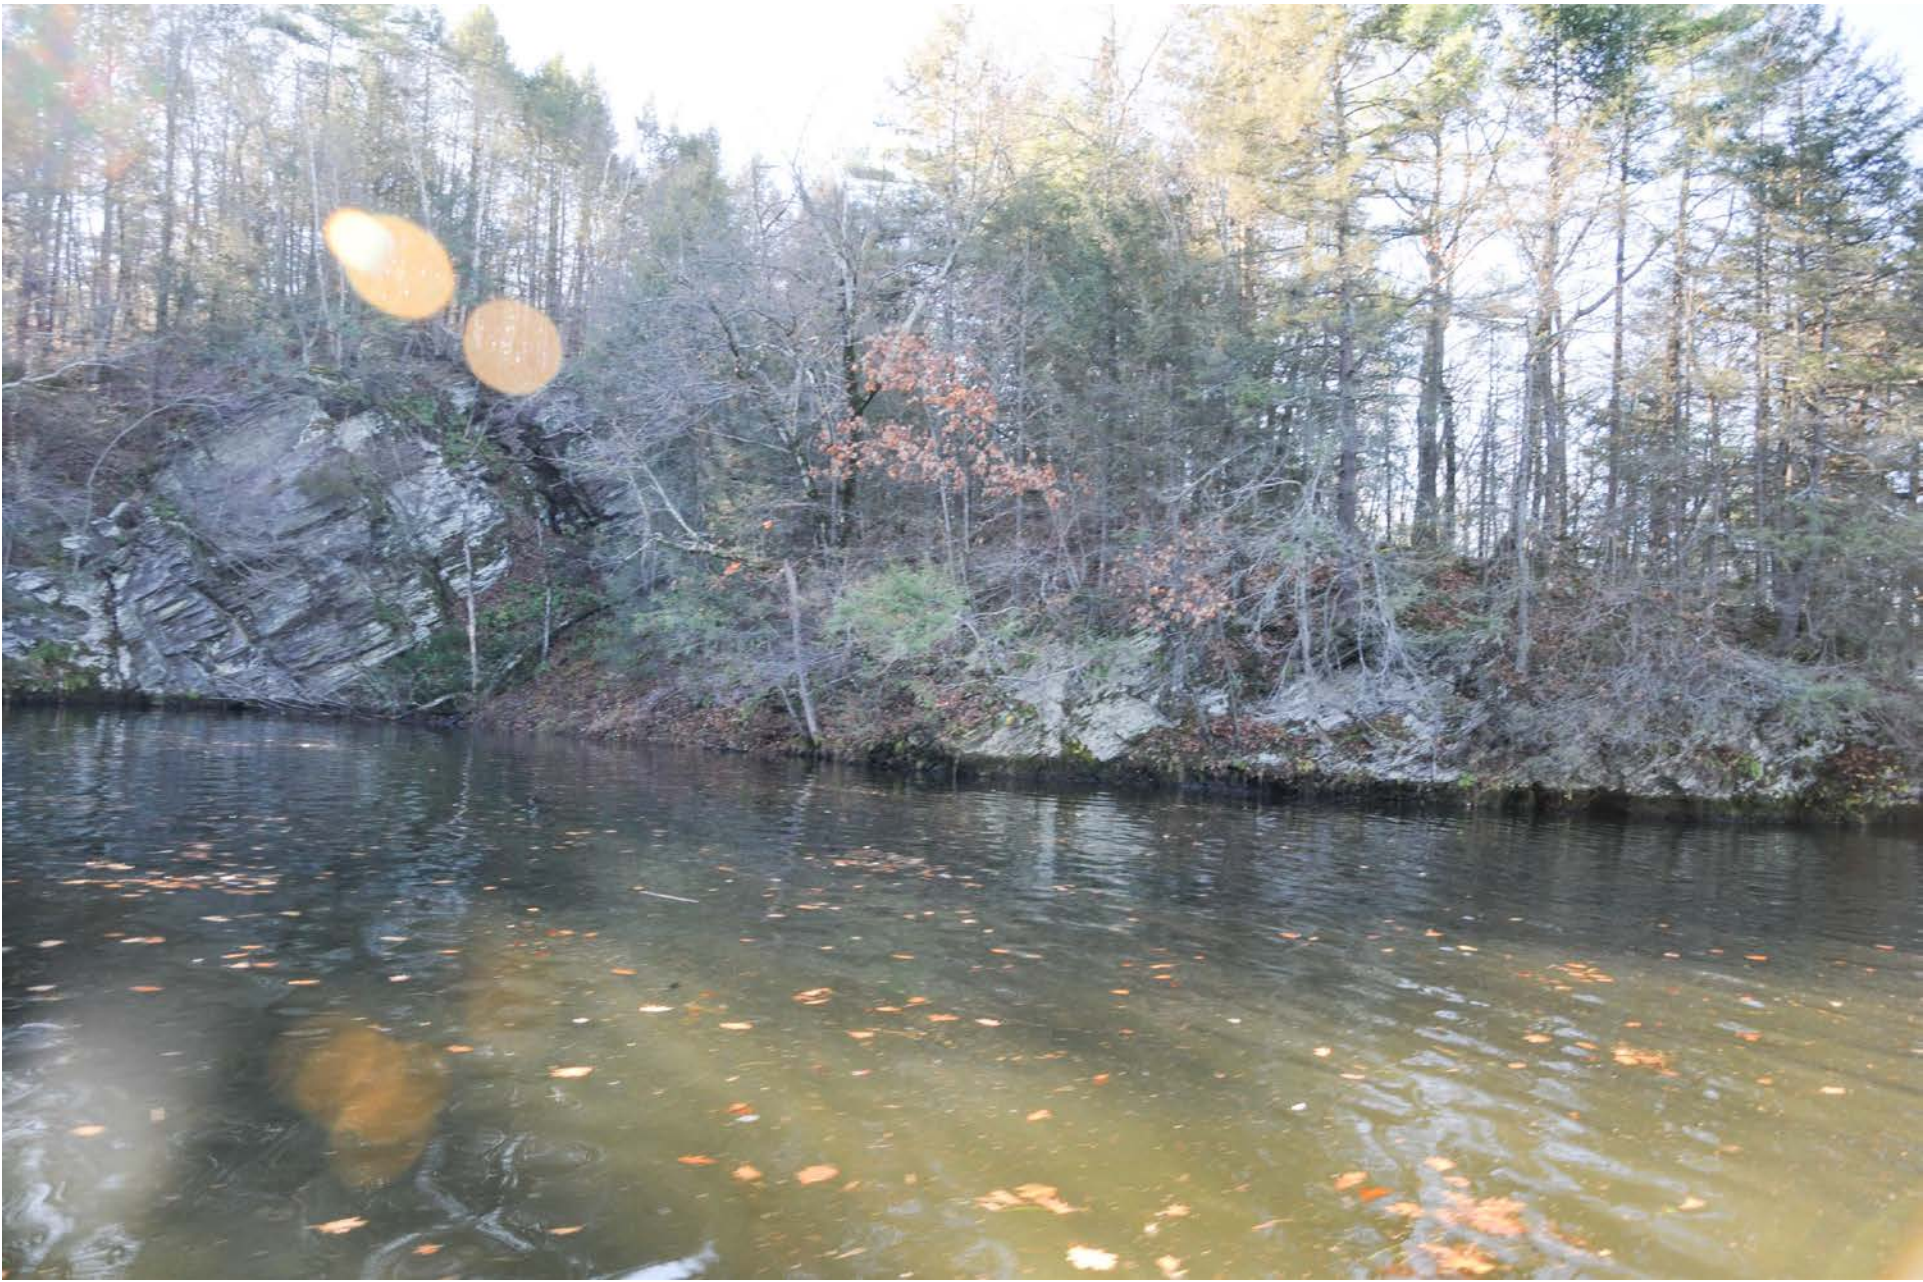
Photo ID 348 (near mid-segment)

Riverbank Features	Characteristics
Upper Riverbank Slope	Steep
Upper Riverbank Height	High
Upper Riverbank Sediment	Bedrock
Upper Riverbank Vegetation	Moderate
Lower Riverbank Slope	Steep
Lower Riverbank Sediment	Bedrock
Lower Riverbank Vegetation	None to very sparse
Type of Erosion	
Potential Erosion Indicators	None
Stage of Erosion	Stable
Extent of Erosion	None/Little

QA Observations: Upon review of the photos for this segment, classification made in the field was confirmed.
