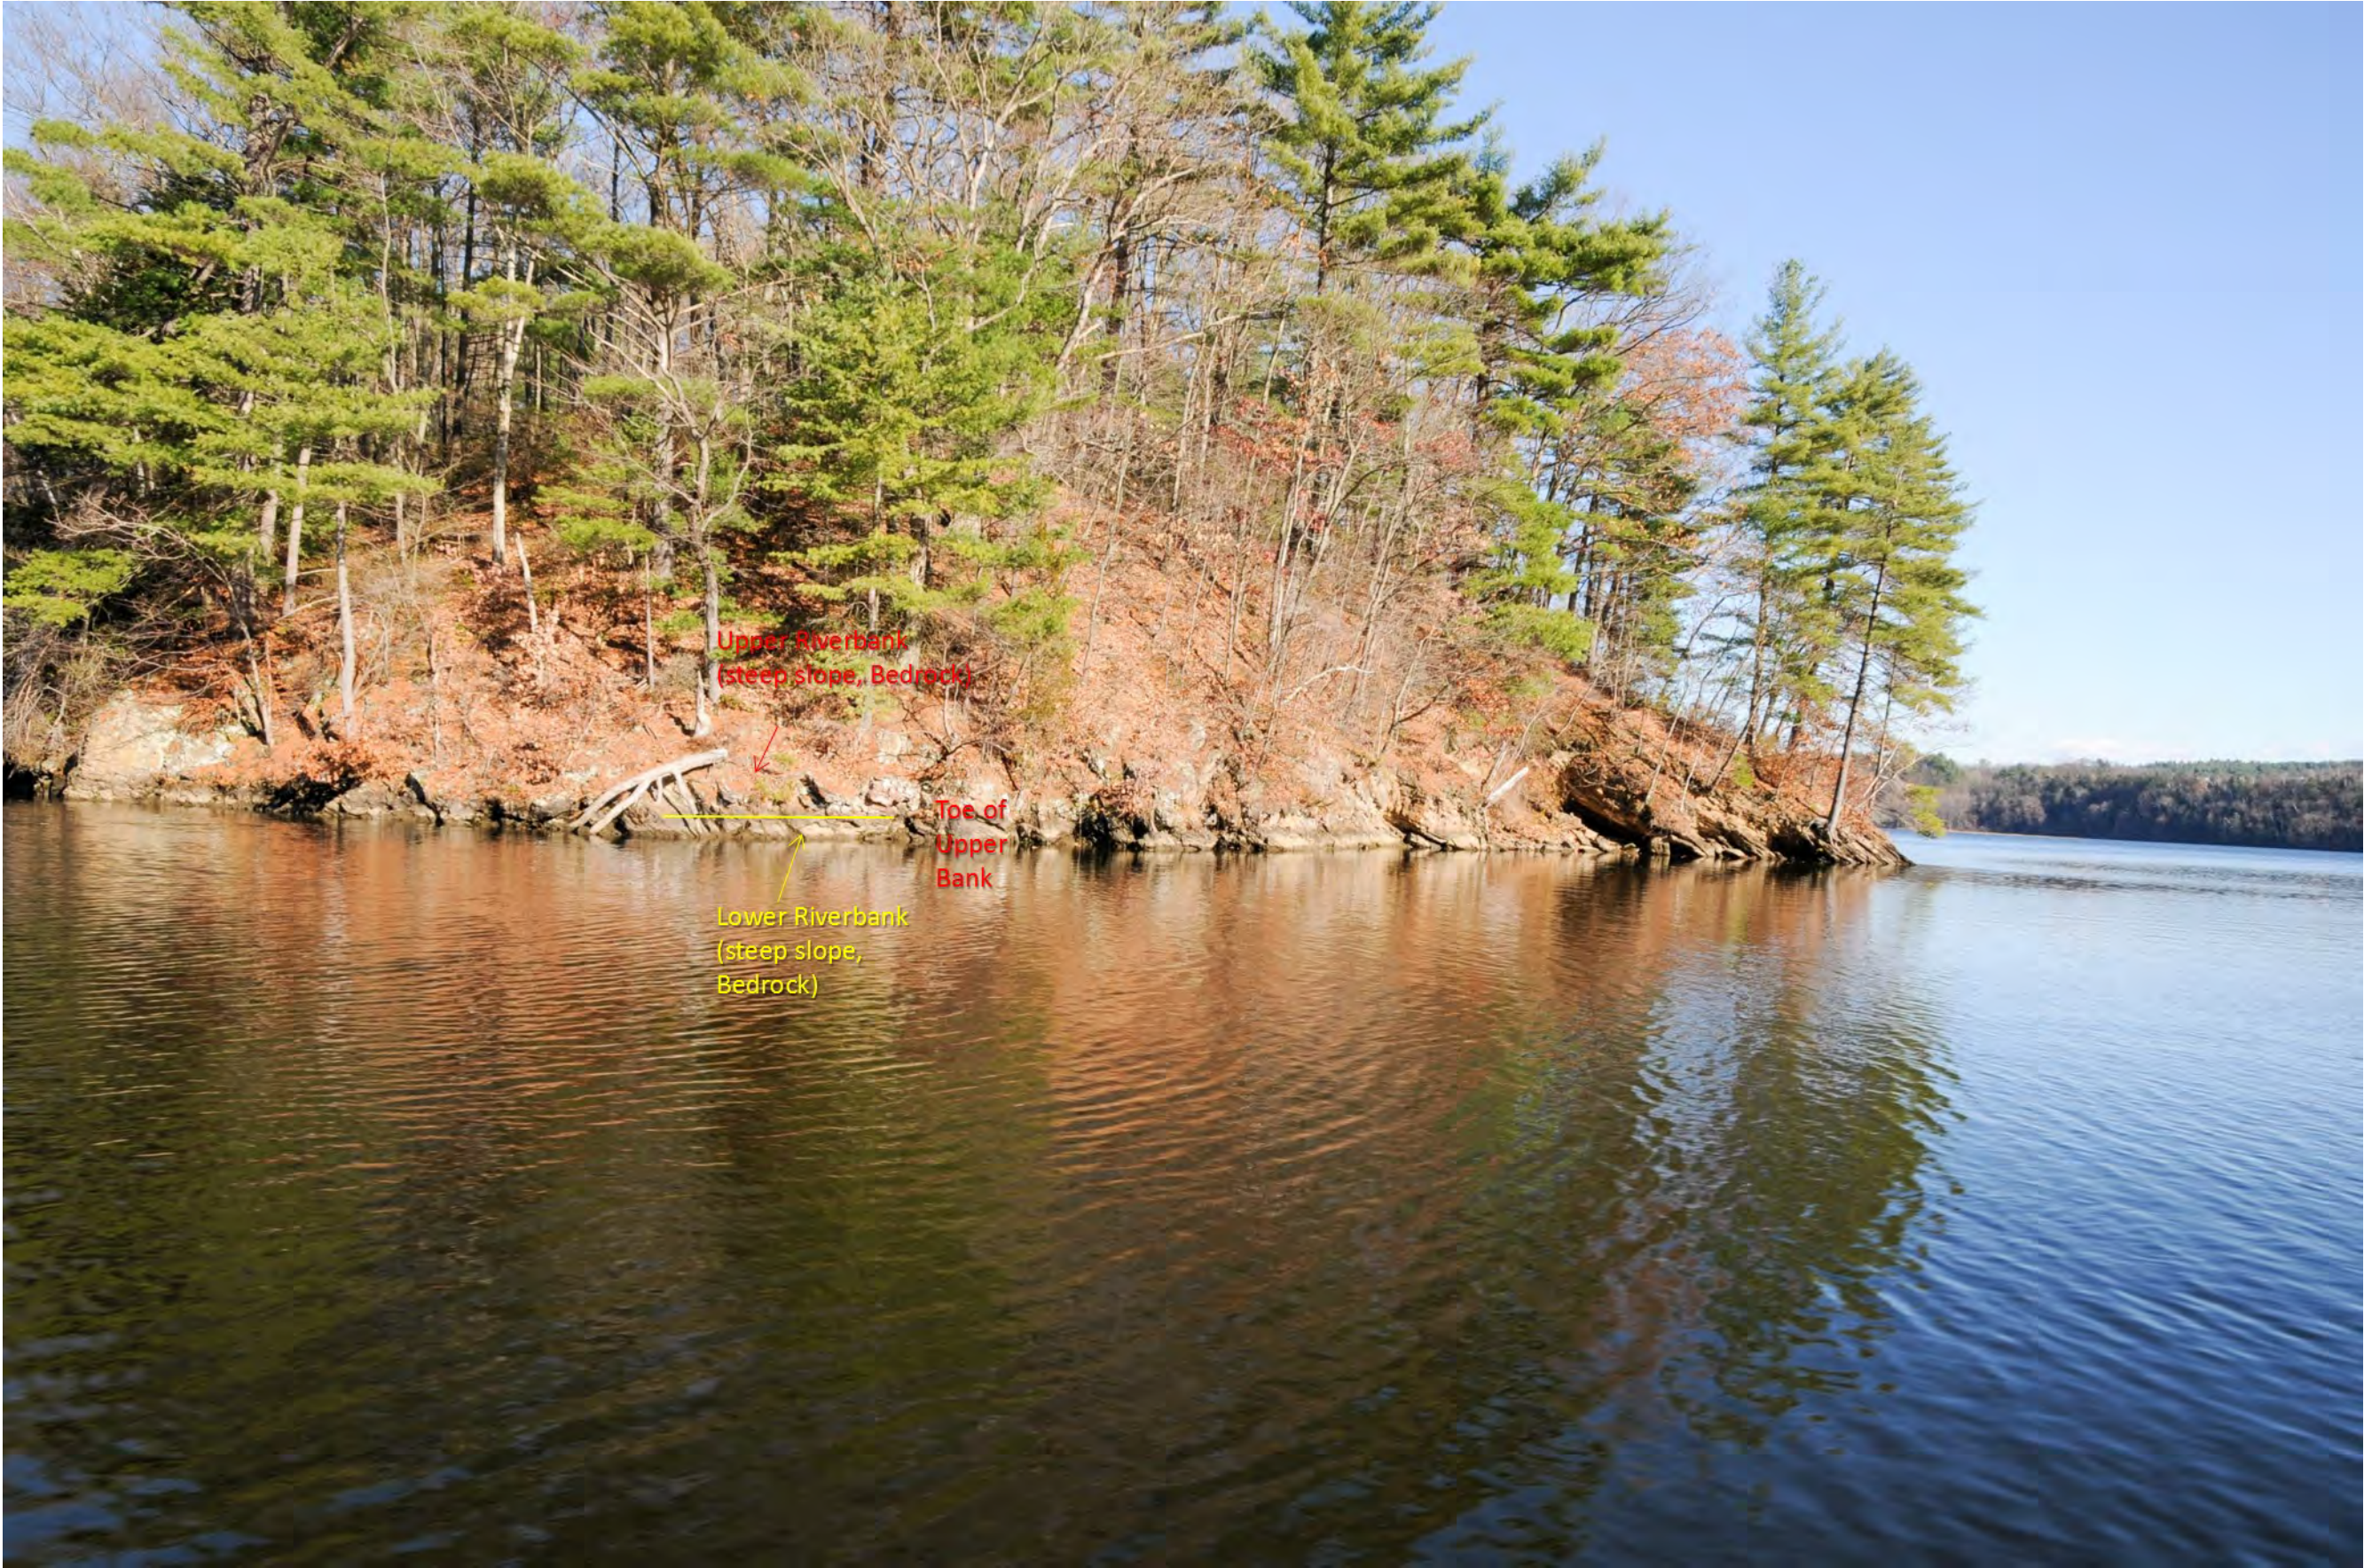
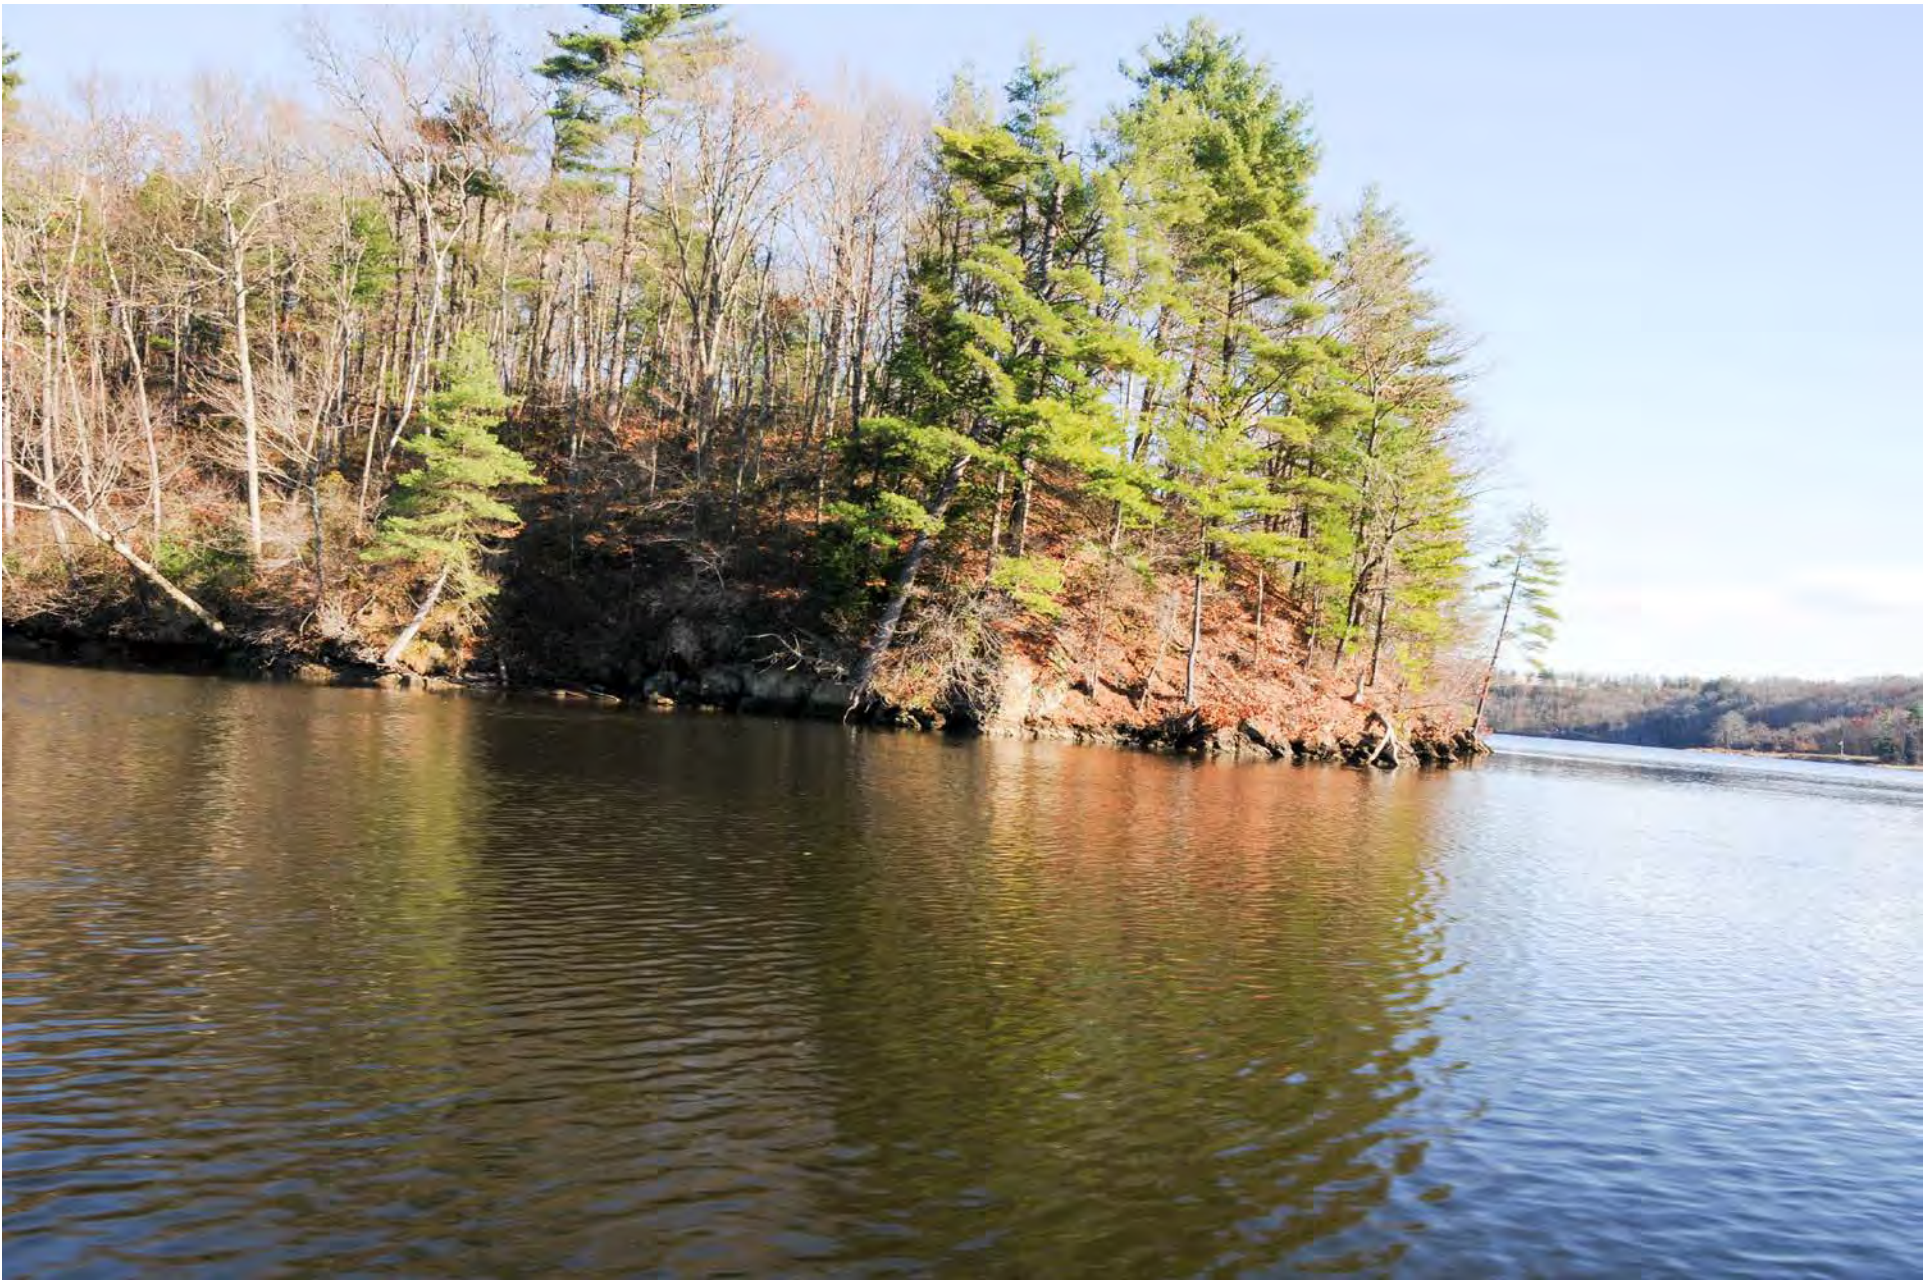
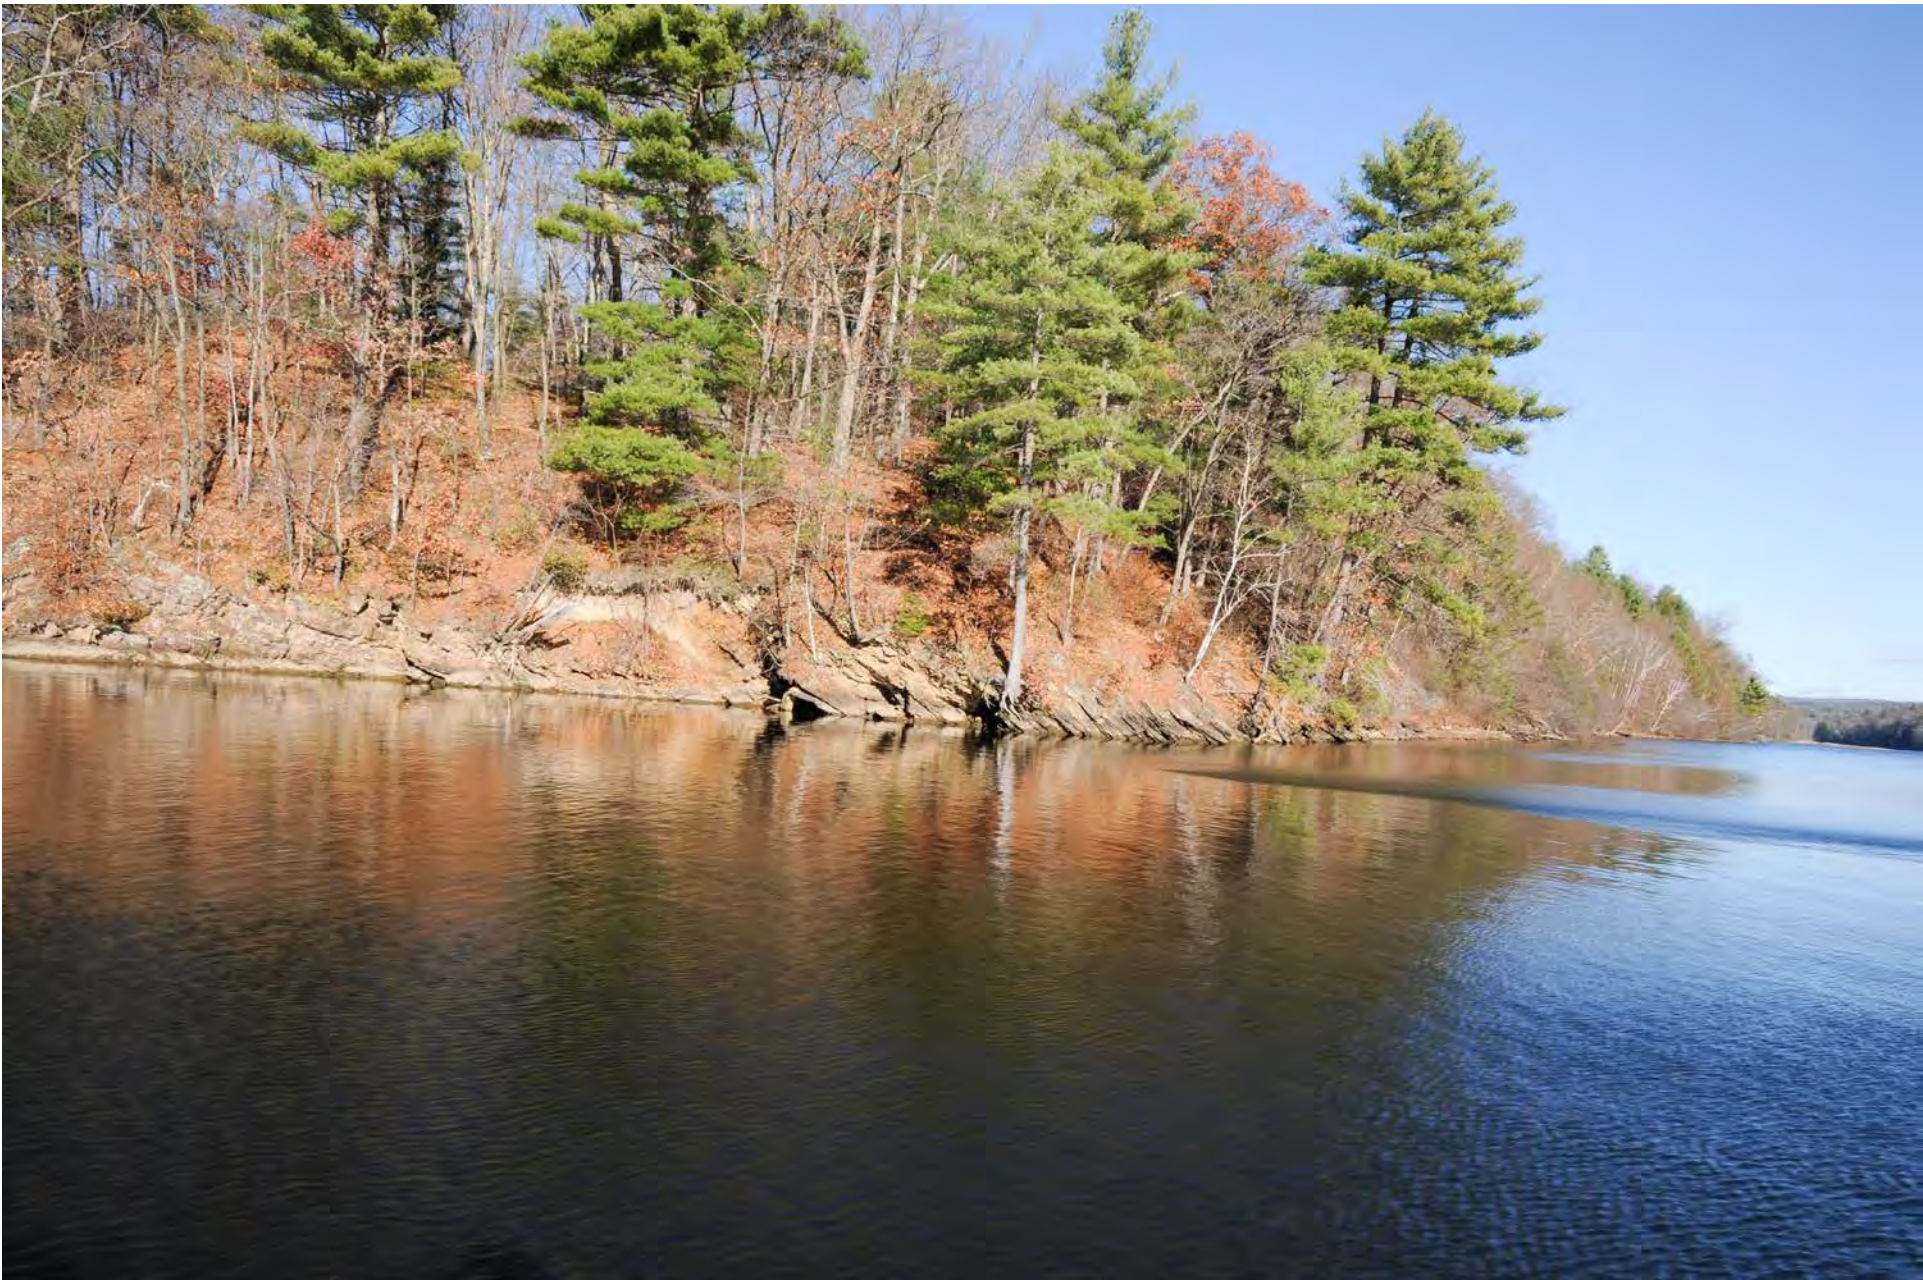
Photo ID 383 (near mid-segment)

Riverbank Features	Characteristics
Upper Riverbank Slope	Steep
Upper Riverbank Height	High
Upper Riverbank Sediment	Bedrock
Upper Riverbank Vegetation	Moderate
Lower Riverbank Slope	Steep
Lower Riverbank Sediment	Bedrock
Lower Riverbank Vegetation	None to very sparse
Type of Erosion	
Potential Erosion Indicators	None
Stage of Erosion	Stable
Extent of Erosion	None/Little

QA Observations: Upon review of the photos for this segment, classification made in the field was confirmed.

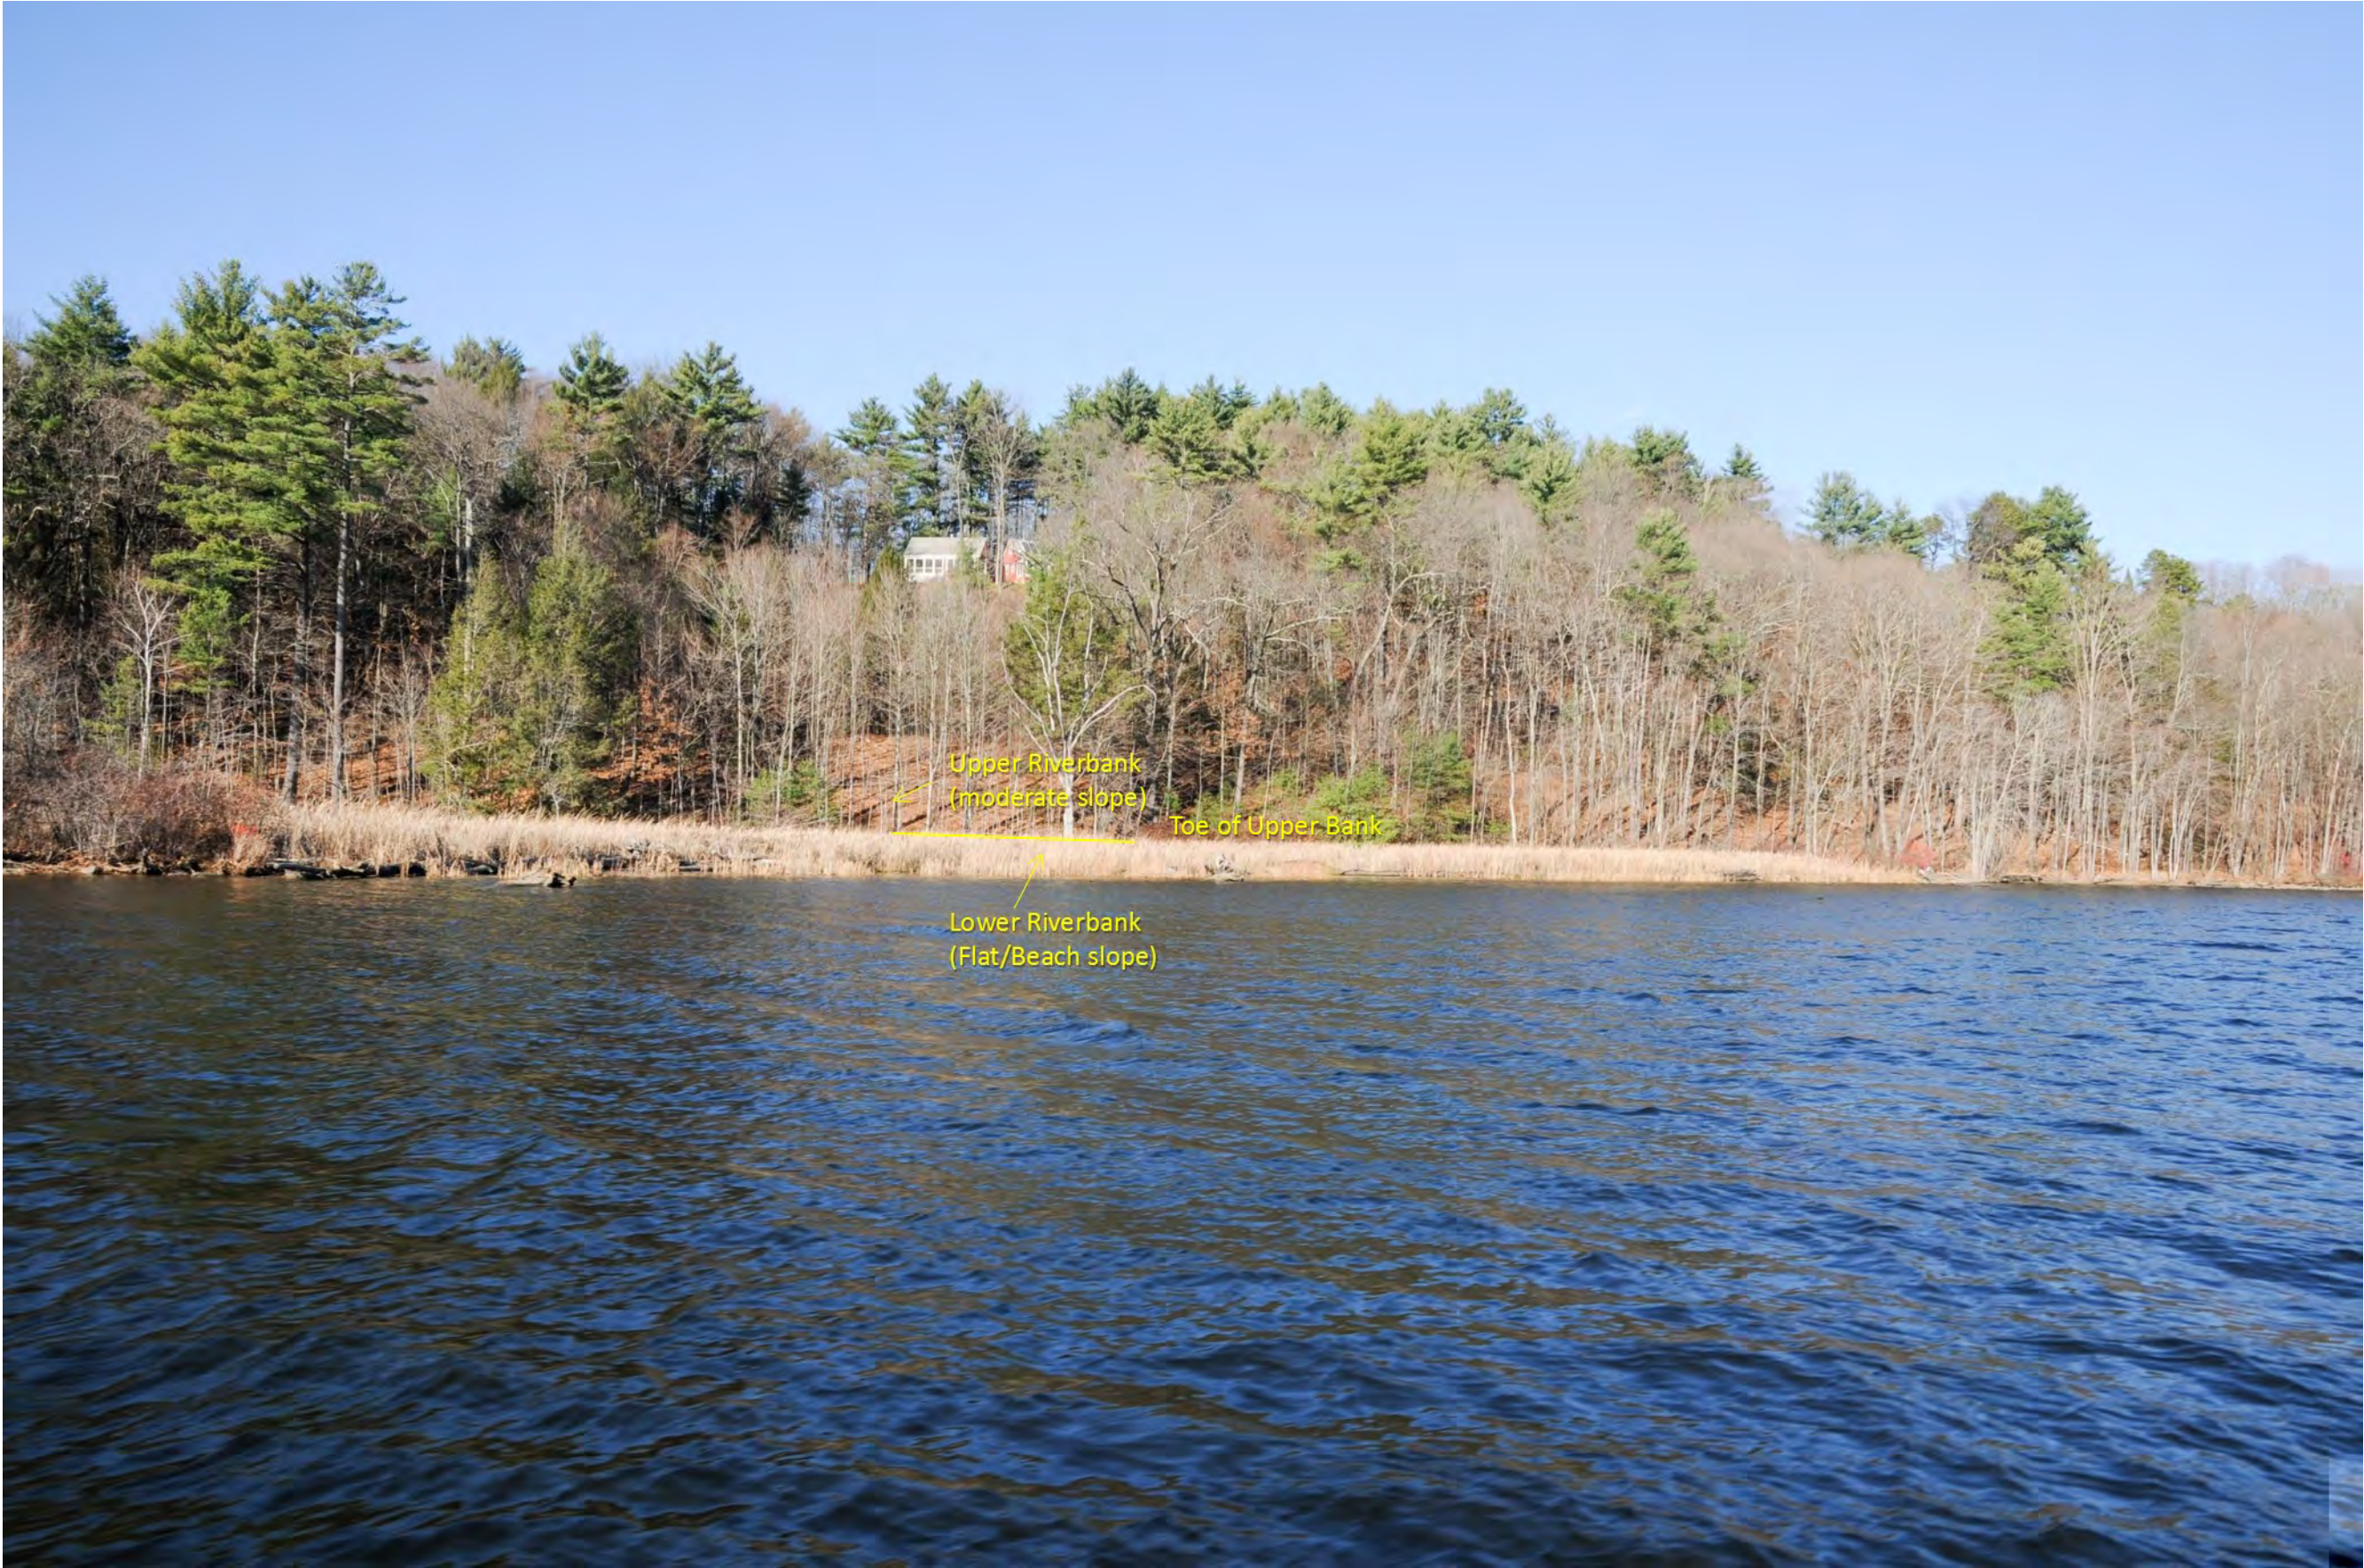
Photo ID 424 (photo includes segment)

Riverbank Features	Characteristics
Upper Riverbank Slope	Moderate
Upper Riverbank Height	High
Upper Riverbank Sediment	Silt/Sand
Upper Riverbank Vegetation	Heavy
Lower Riverbank Slope	Flat/Beach
Lower Riverbank Sediment	Silt/Sand
Lower Riverbank Vegetation	Heavy
Type of Erosion	
Potential Erosion Indicators	None
Stage of Erosion	Stable
Extent of Erosion	None/Little

QA Observations: Upon review of the photos for this segment, classification made in the field was confirmed.

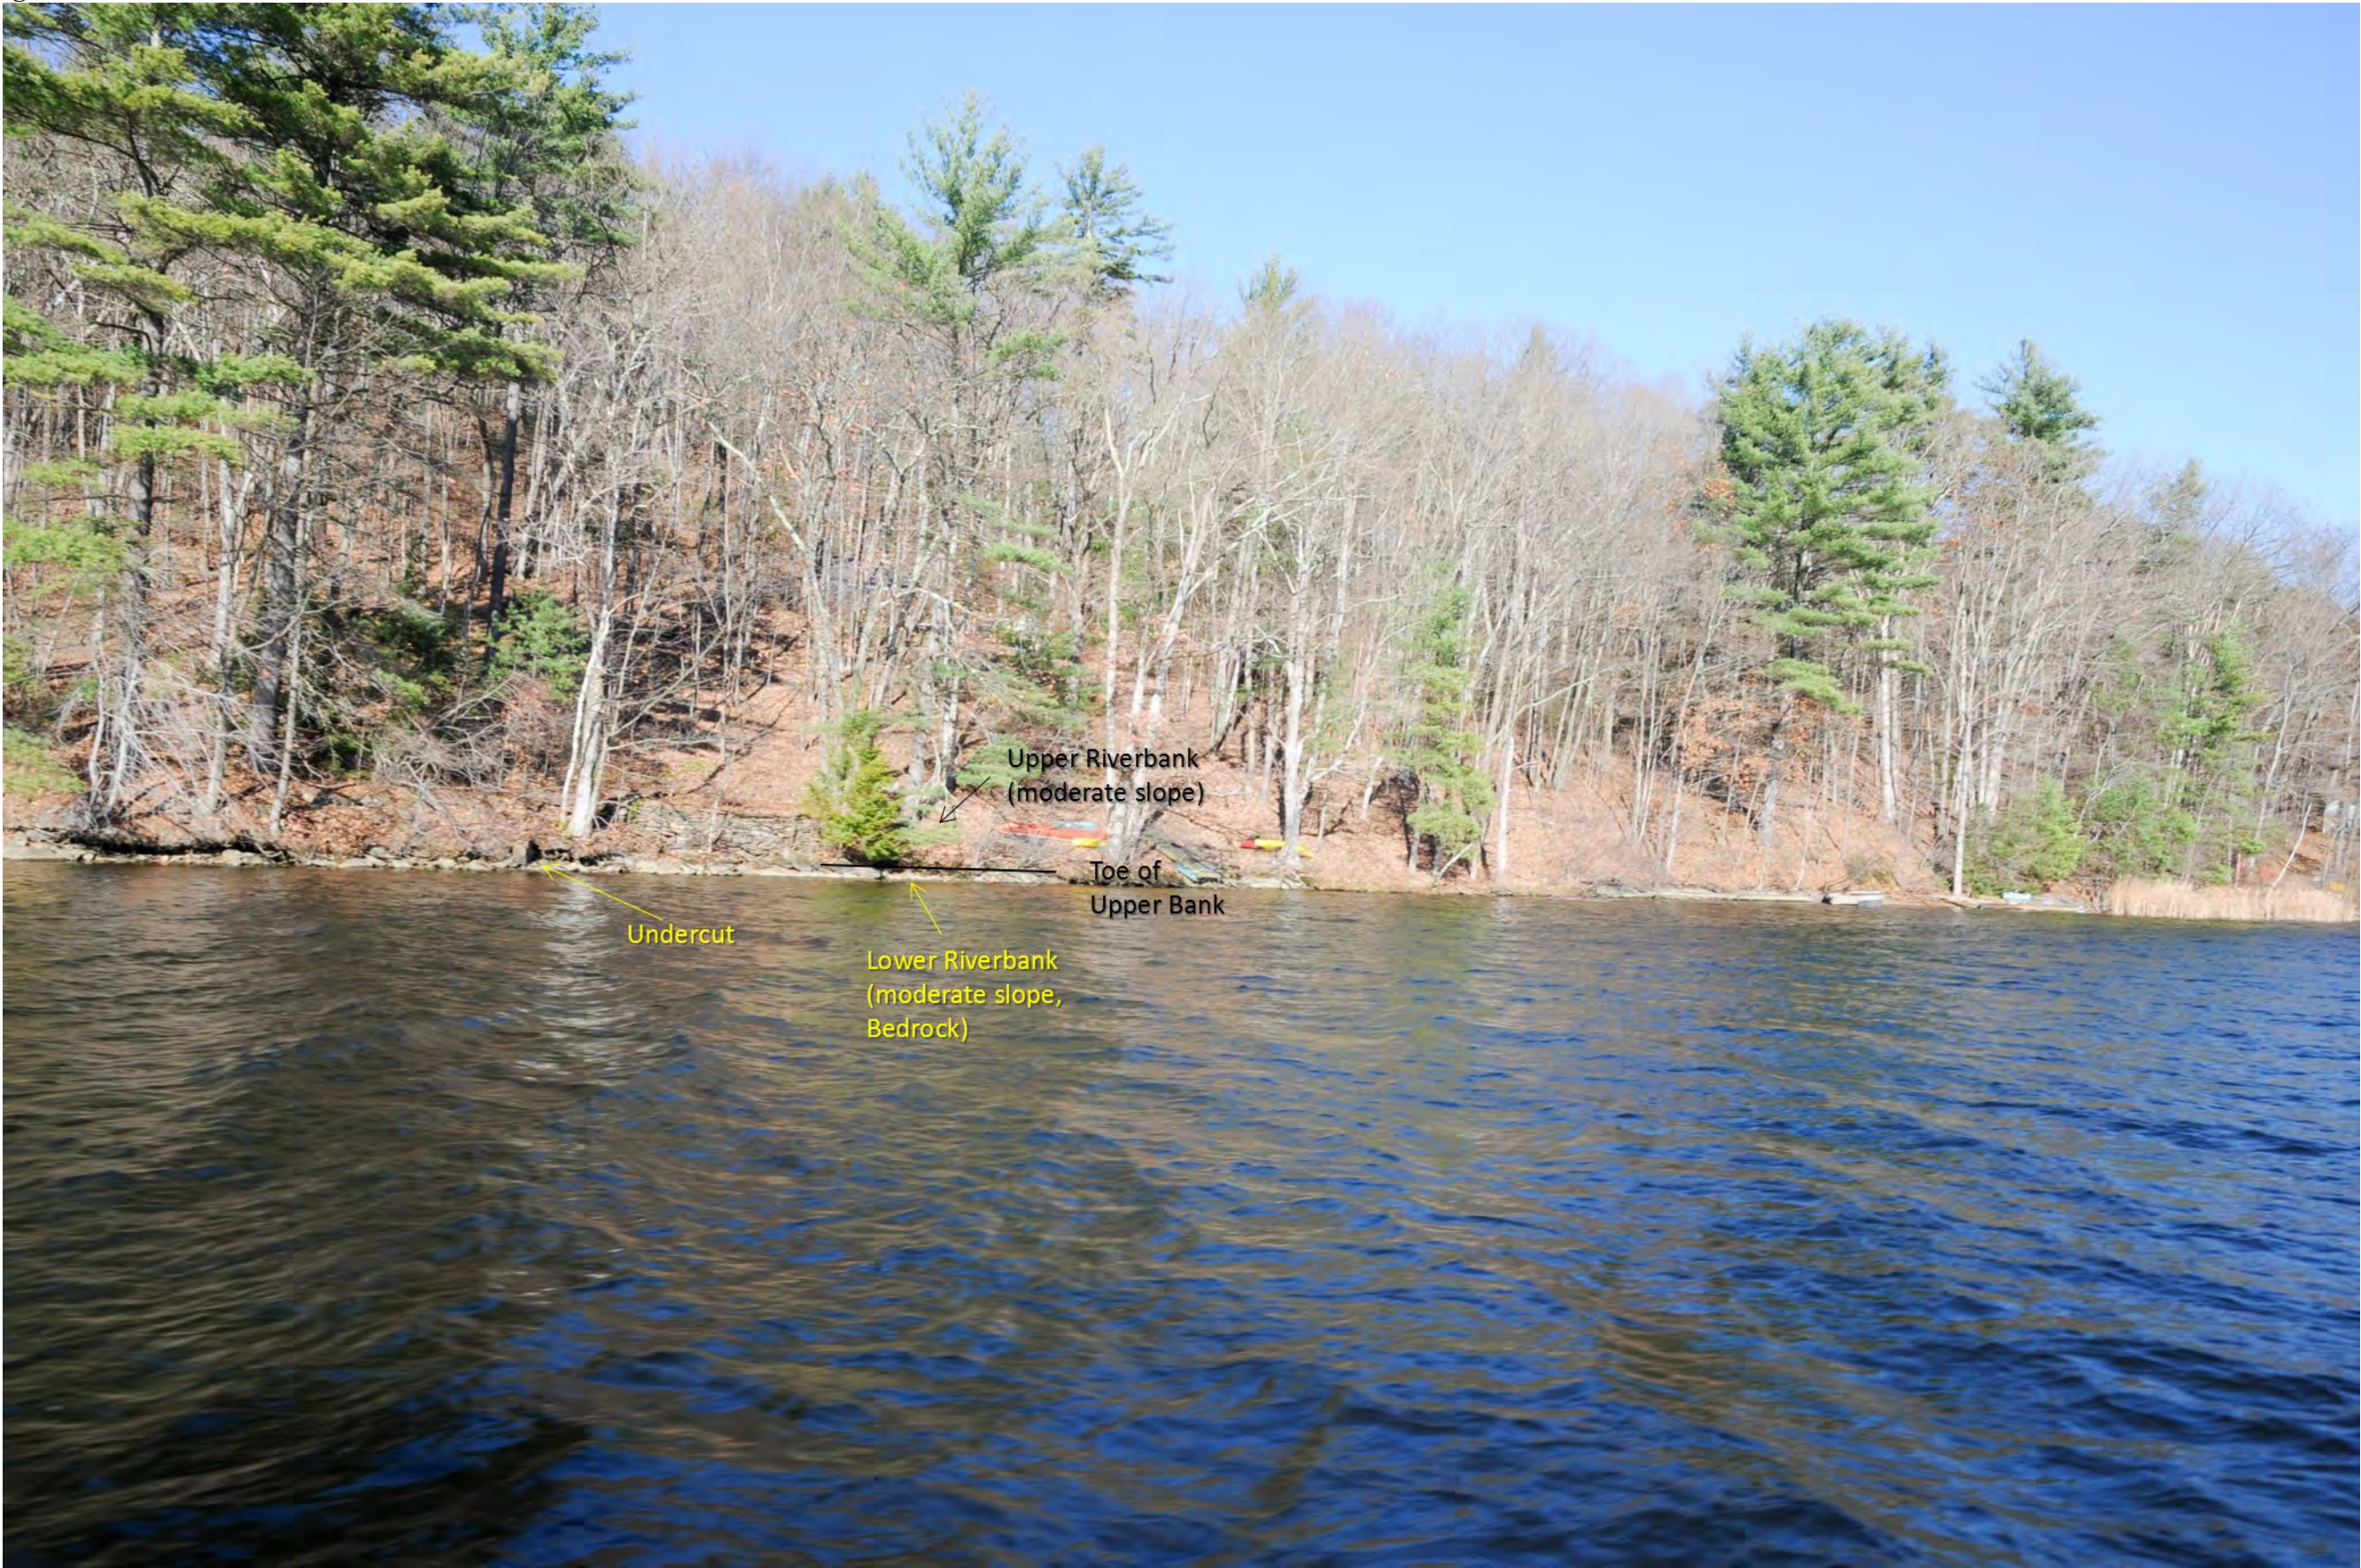
Photo ID 446 (D/S portion of segment)

Riverbank Features	Characteristics
Upper Riverbank Slope	Moderate
Upper Riverbank Height	High
Upper Riverbank Sediment	Silt/Sand
Upper Riverbank Vegetation	Heavy
Lower Riverbank Slope	Moderate
Lower Riverbank Sediment	Bedrock
Lower Riverbank Vegetation	None to very sparse
Type of Erosion	Undercut
Potential Erosion Indicators	None
Stage of Erosion	Stable
Extent of Erosion	None/Little

QA Observations: Upon review of the photos for this segment, classification made in the field was confirmed.

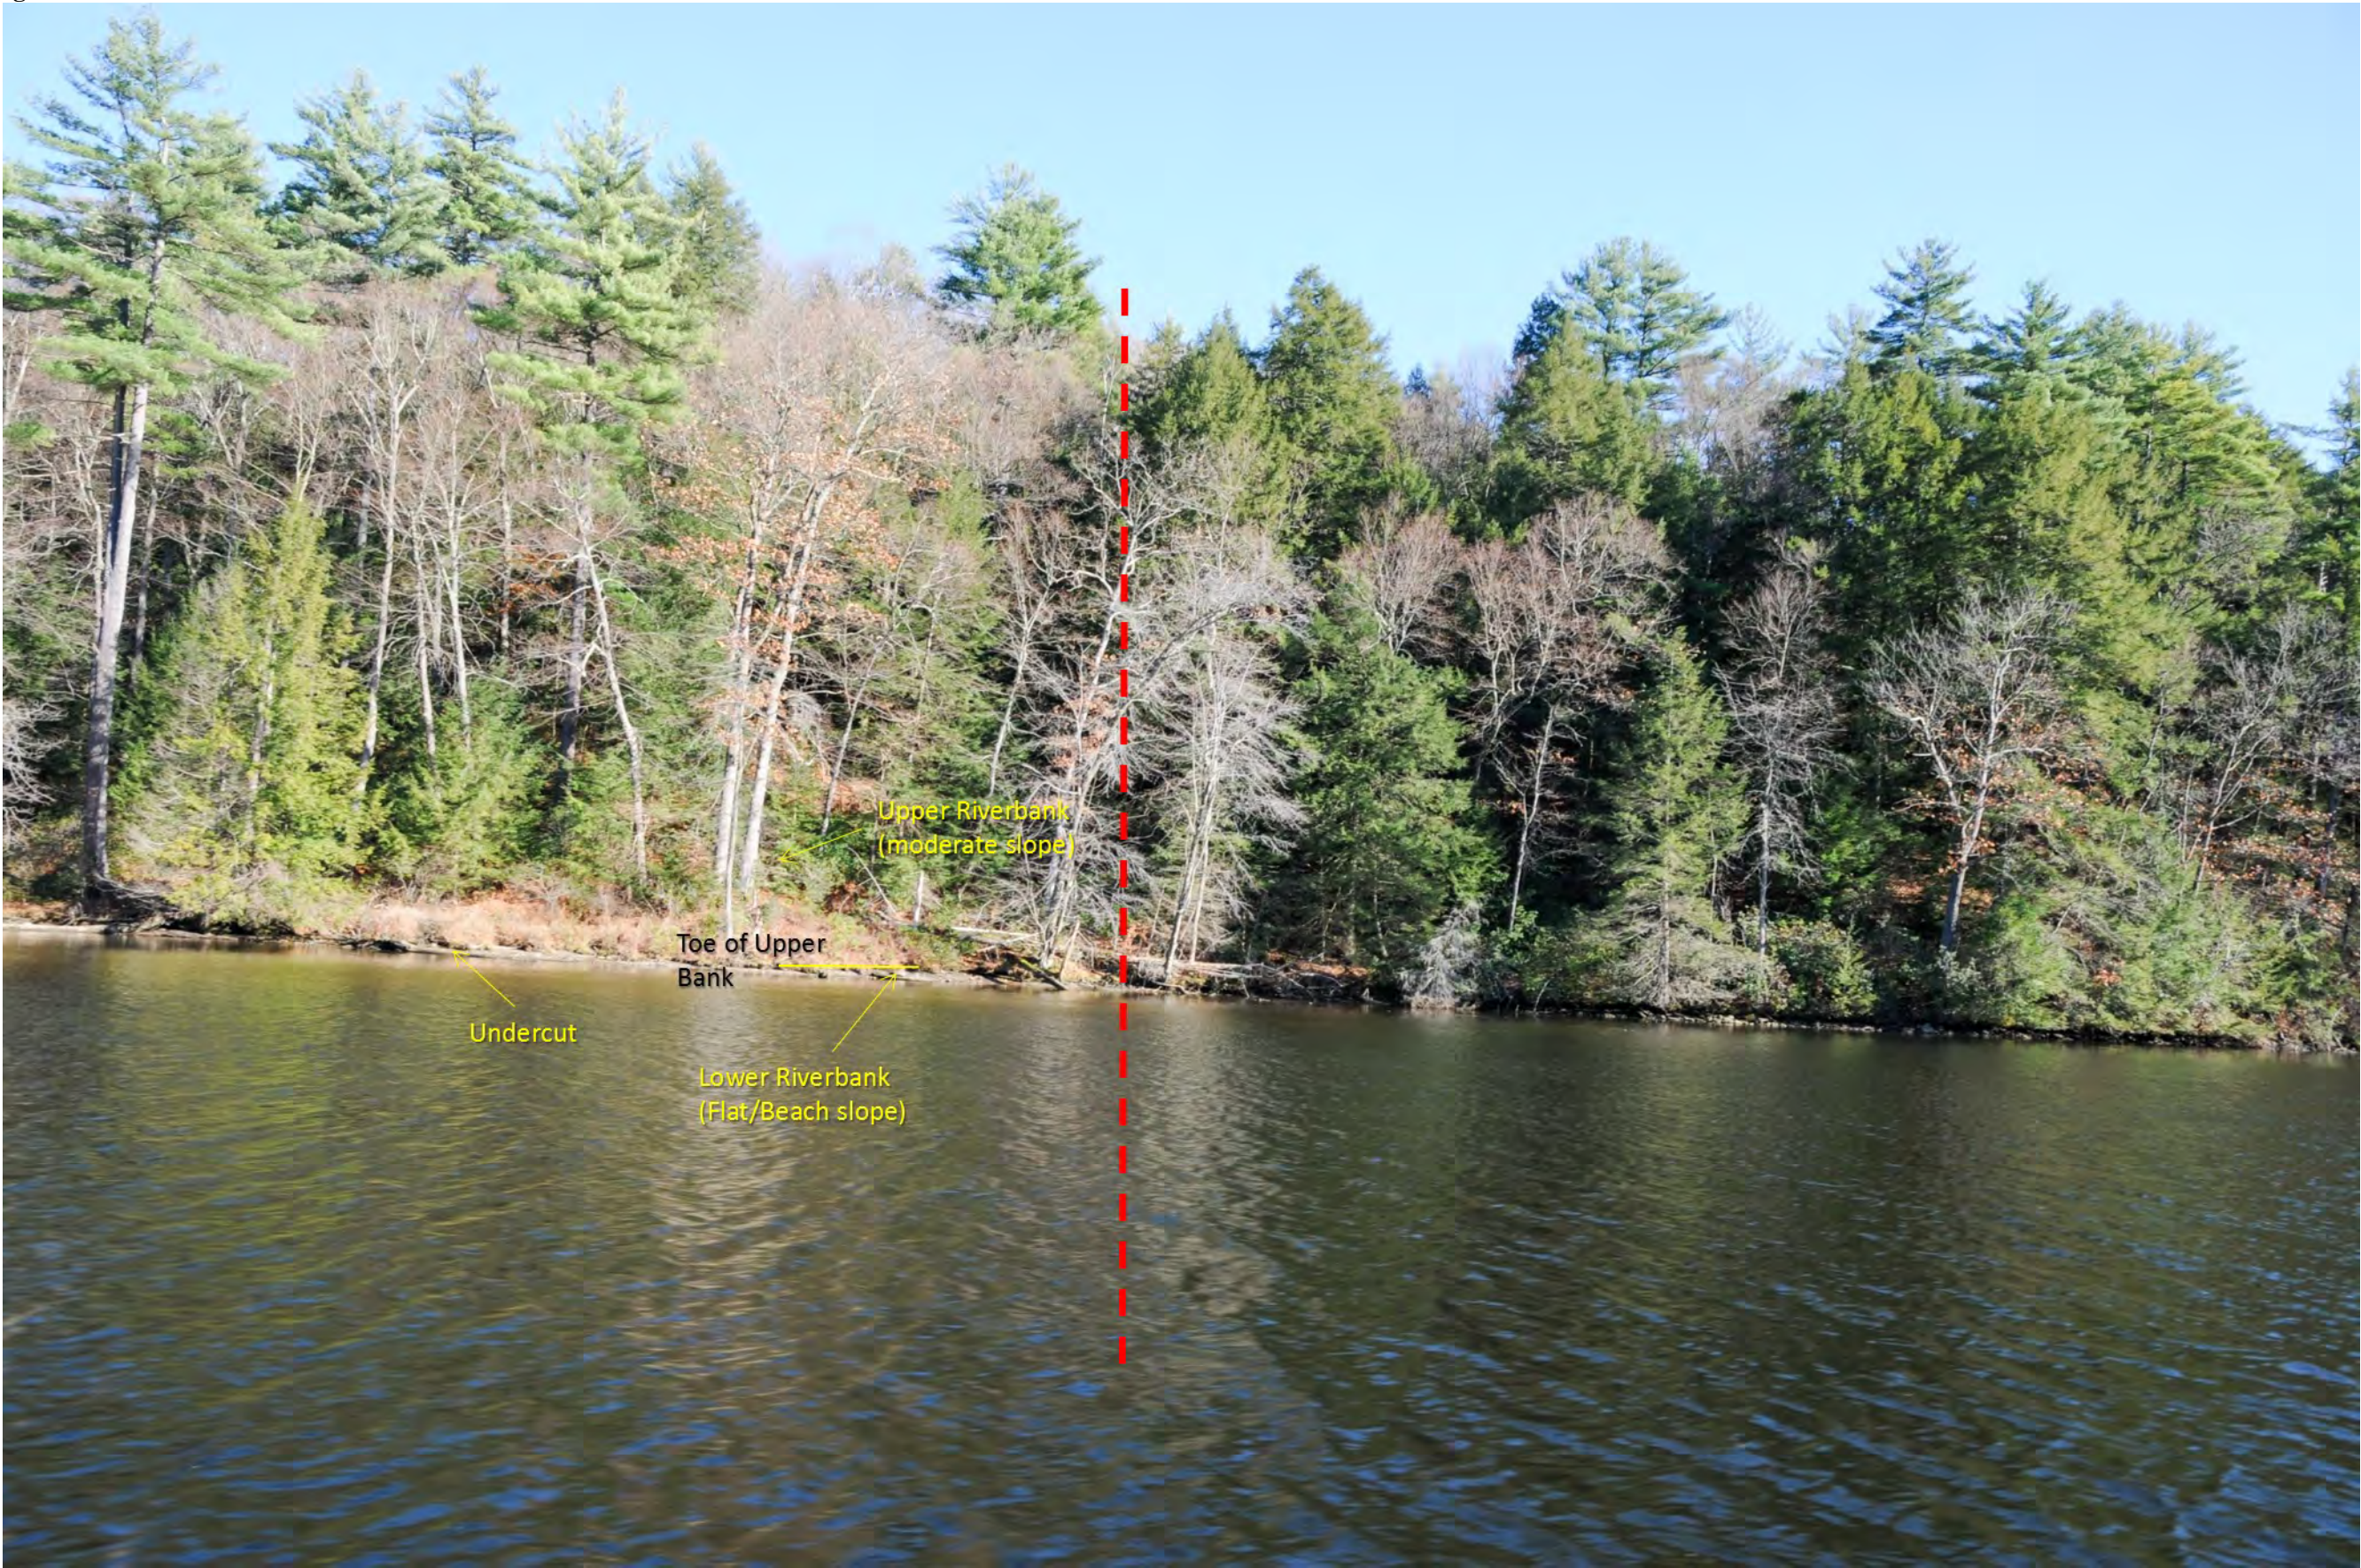
Photo ID 476 (labeled portion of photo is right, D/S portion of segment. Dashed line represents approximate end of segment)

Riverbank Features	Characteristics
Upper Riverbank Slope	Moderate
Upper Riverbank Height	High
Upper Riverbank Sediment	Silt/Sand
Upper Riverbank Vegetation	Heavy
Lower Riverbank Slope	Flat/Beach
Lower Riverbank Sediment	Silt/Sand
Lower Riverbank Vegetation	None to very sparse
Type of Erosion	Undercut
Potential Erosion Indicators	Creep/leaning trees
Stage of Erosion	Stable
Extent of Erosion	None/Little

QA Observations: Upon review of the photos for this segment, classification made in the field was confirmed.
