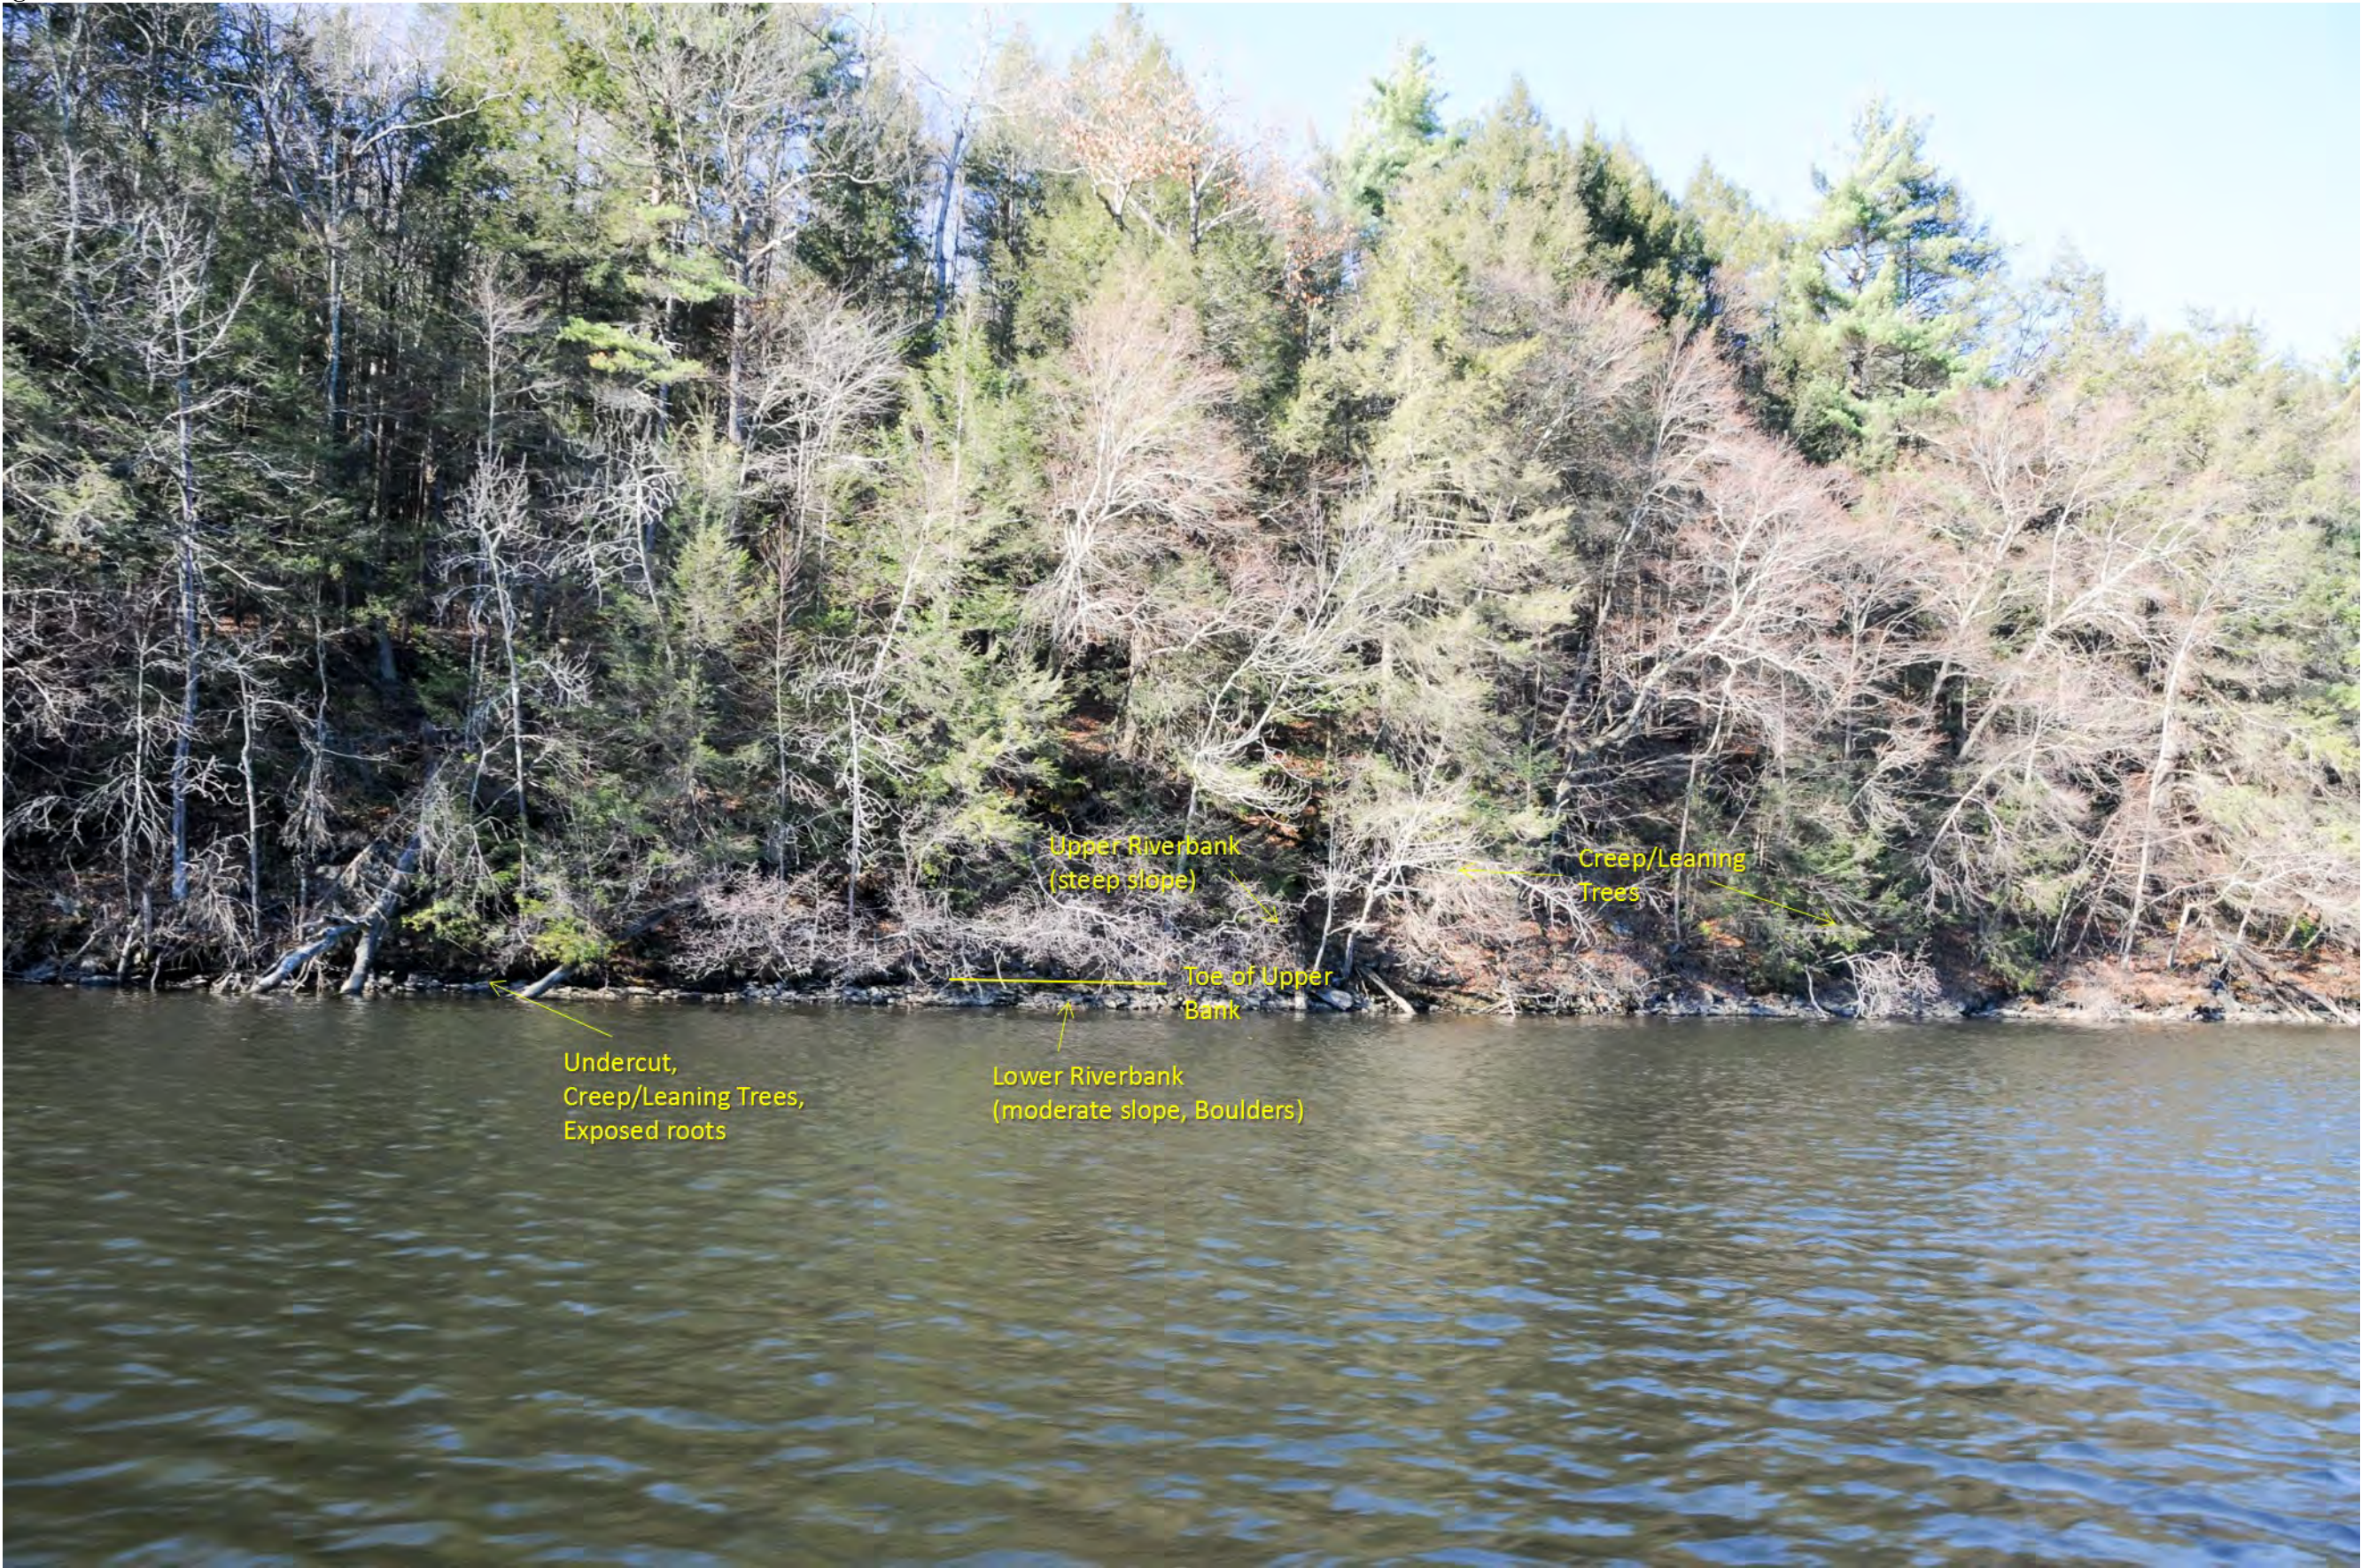
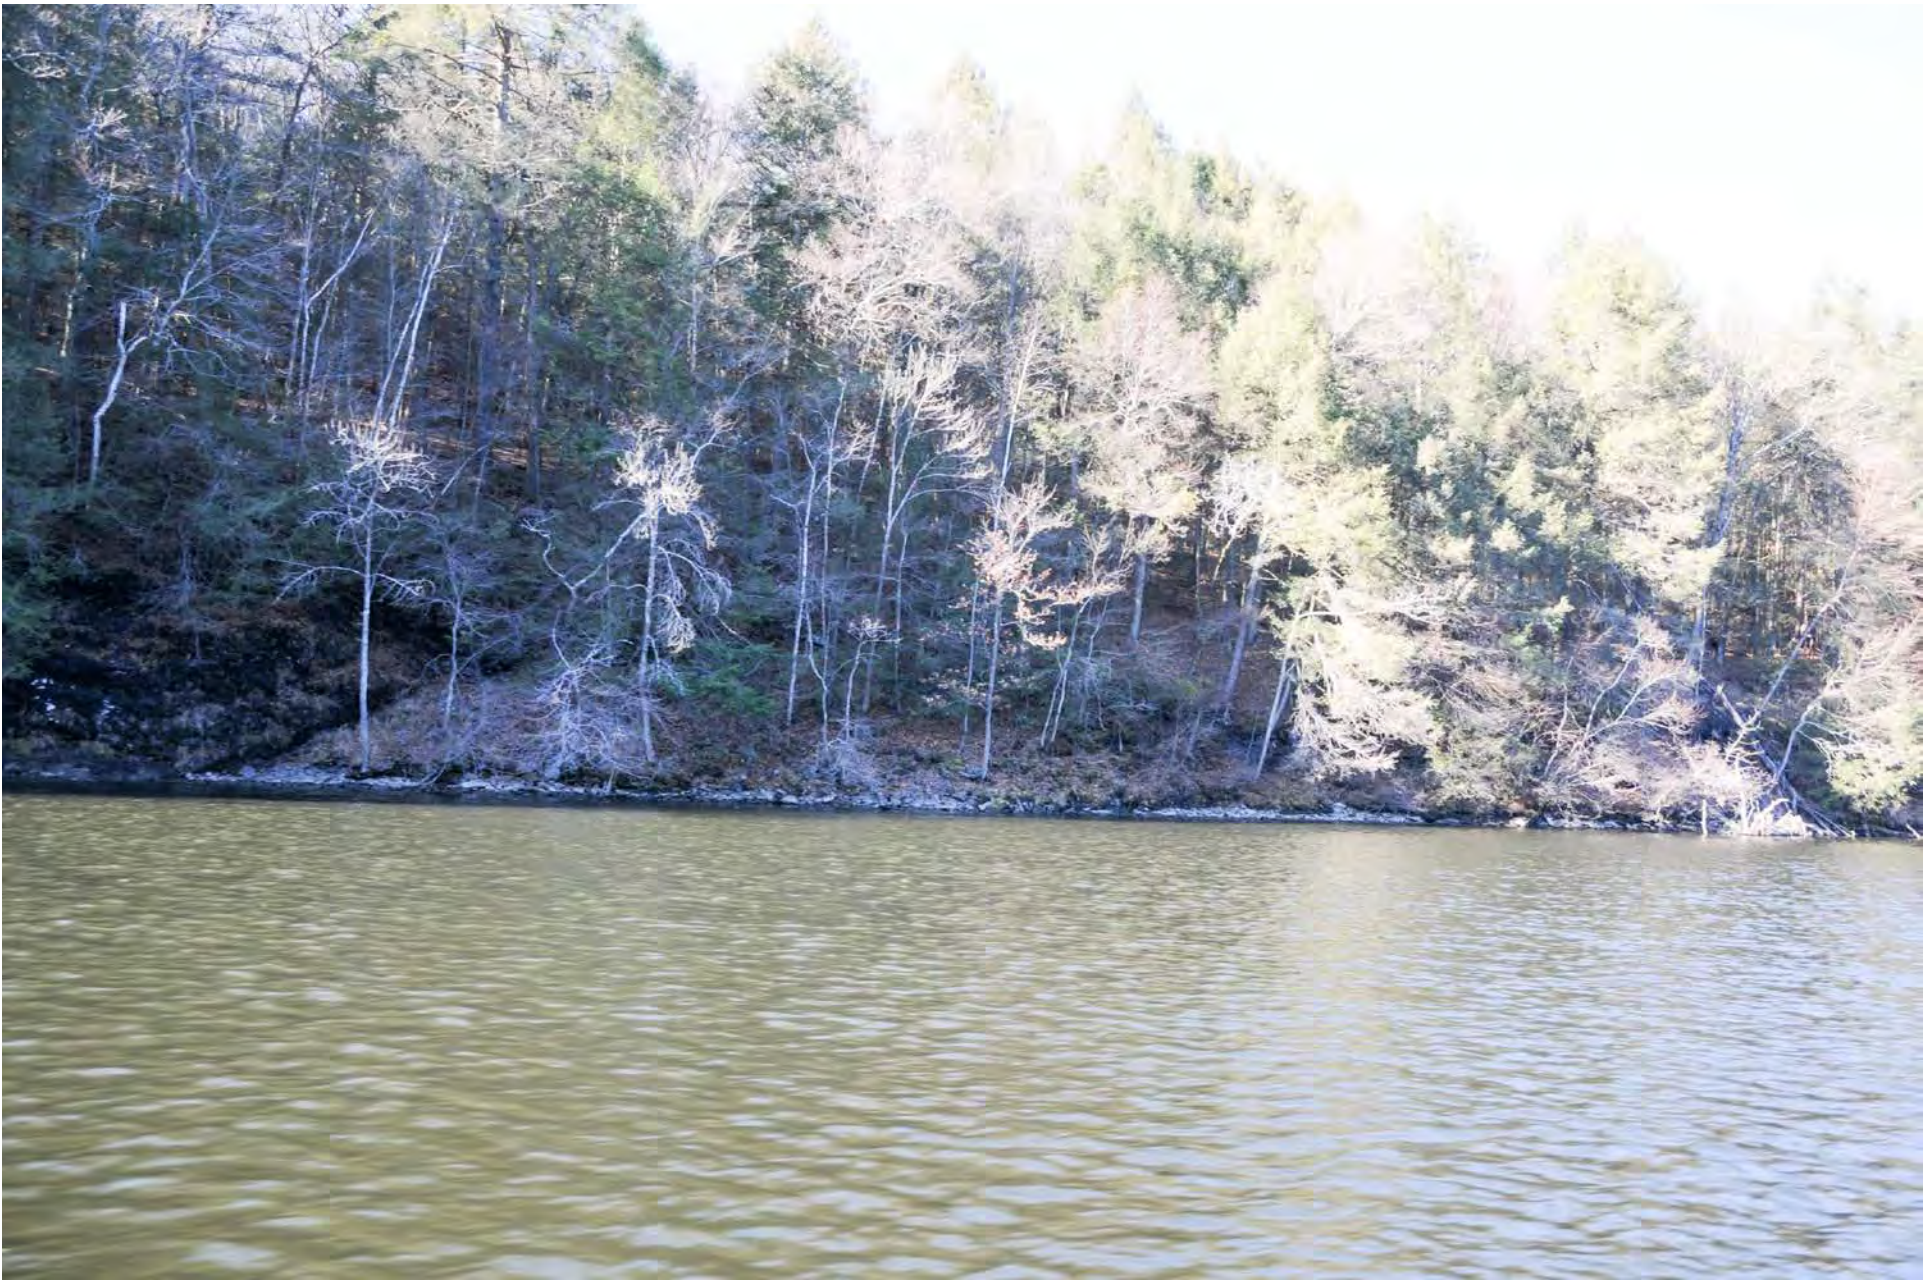
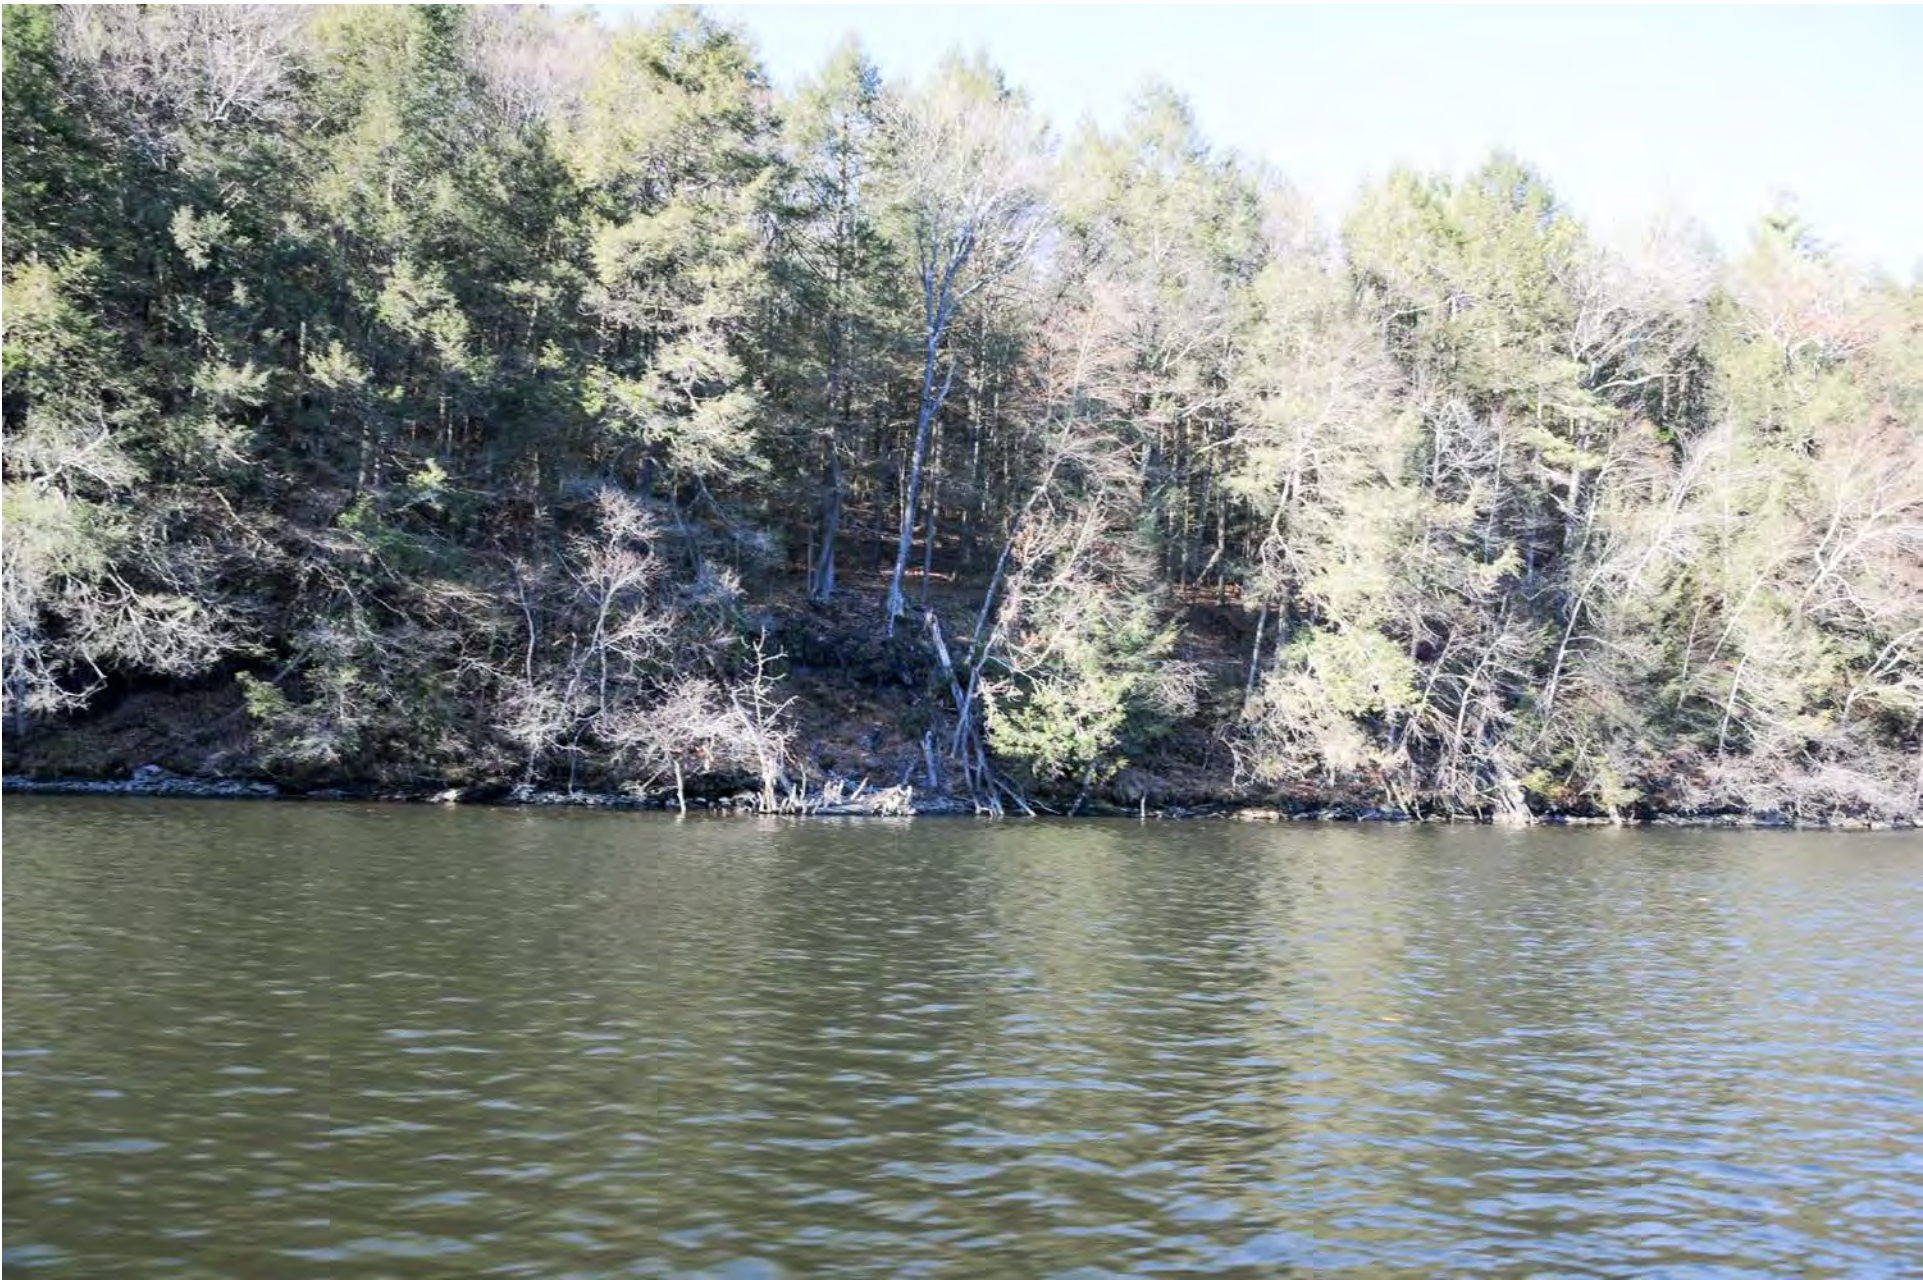
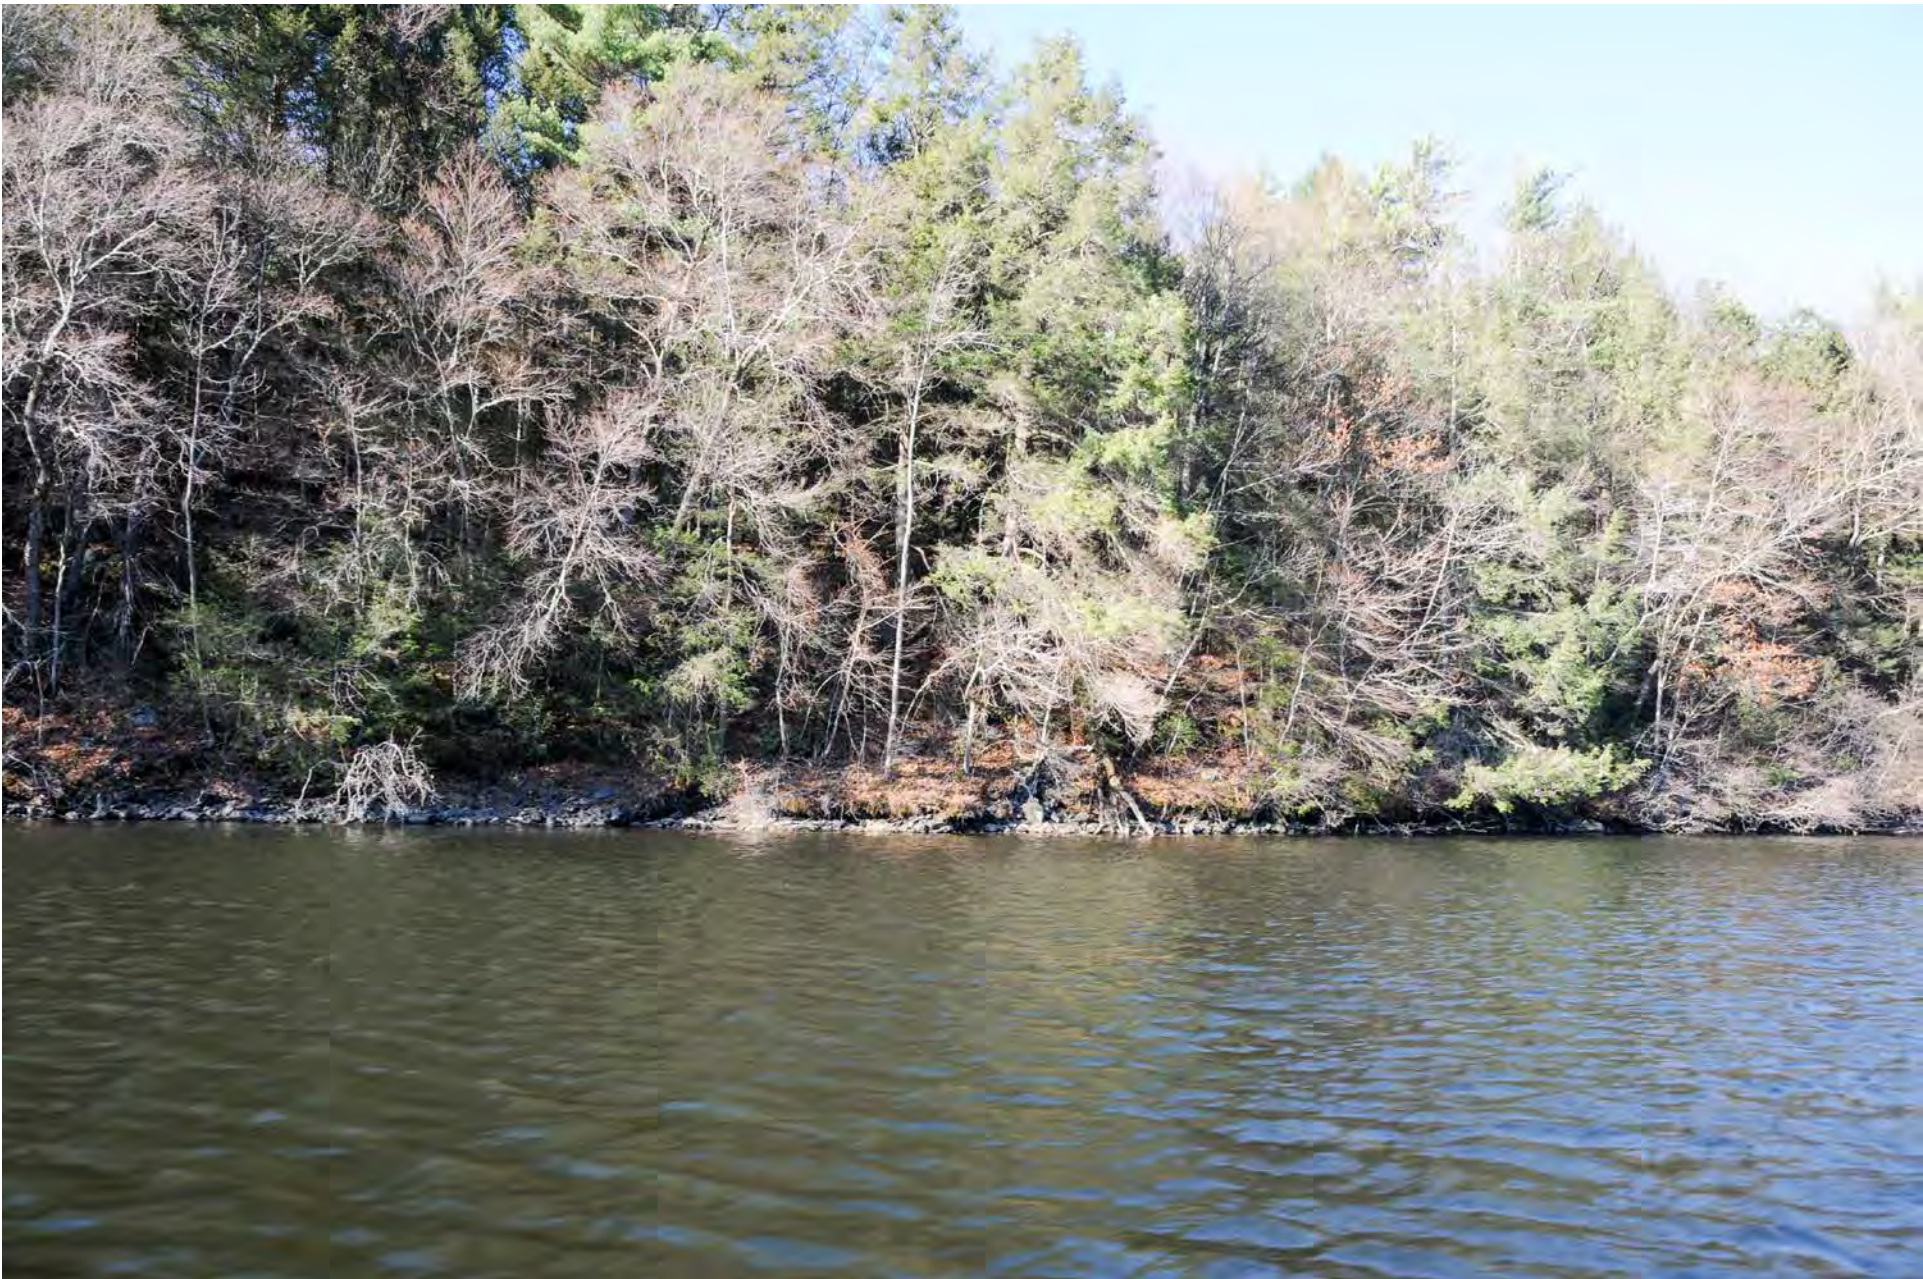
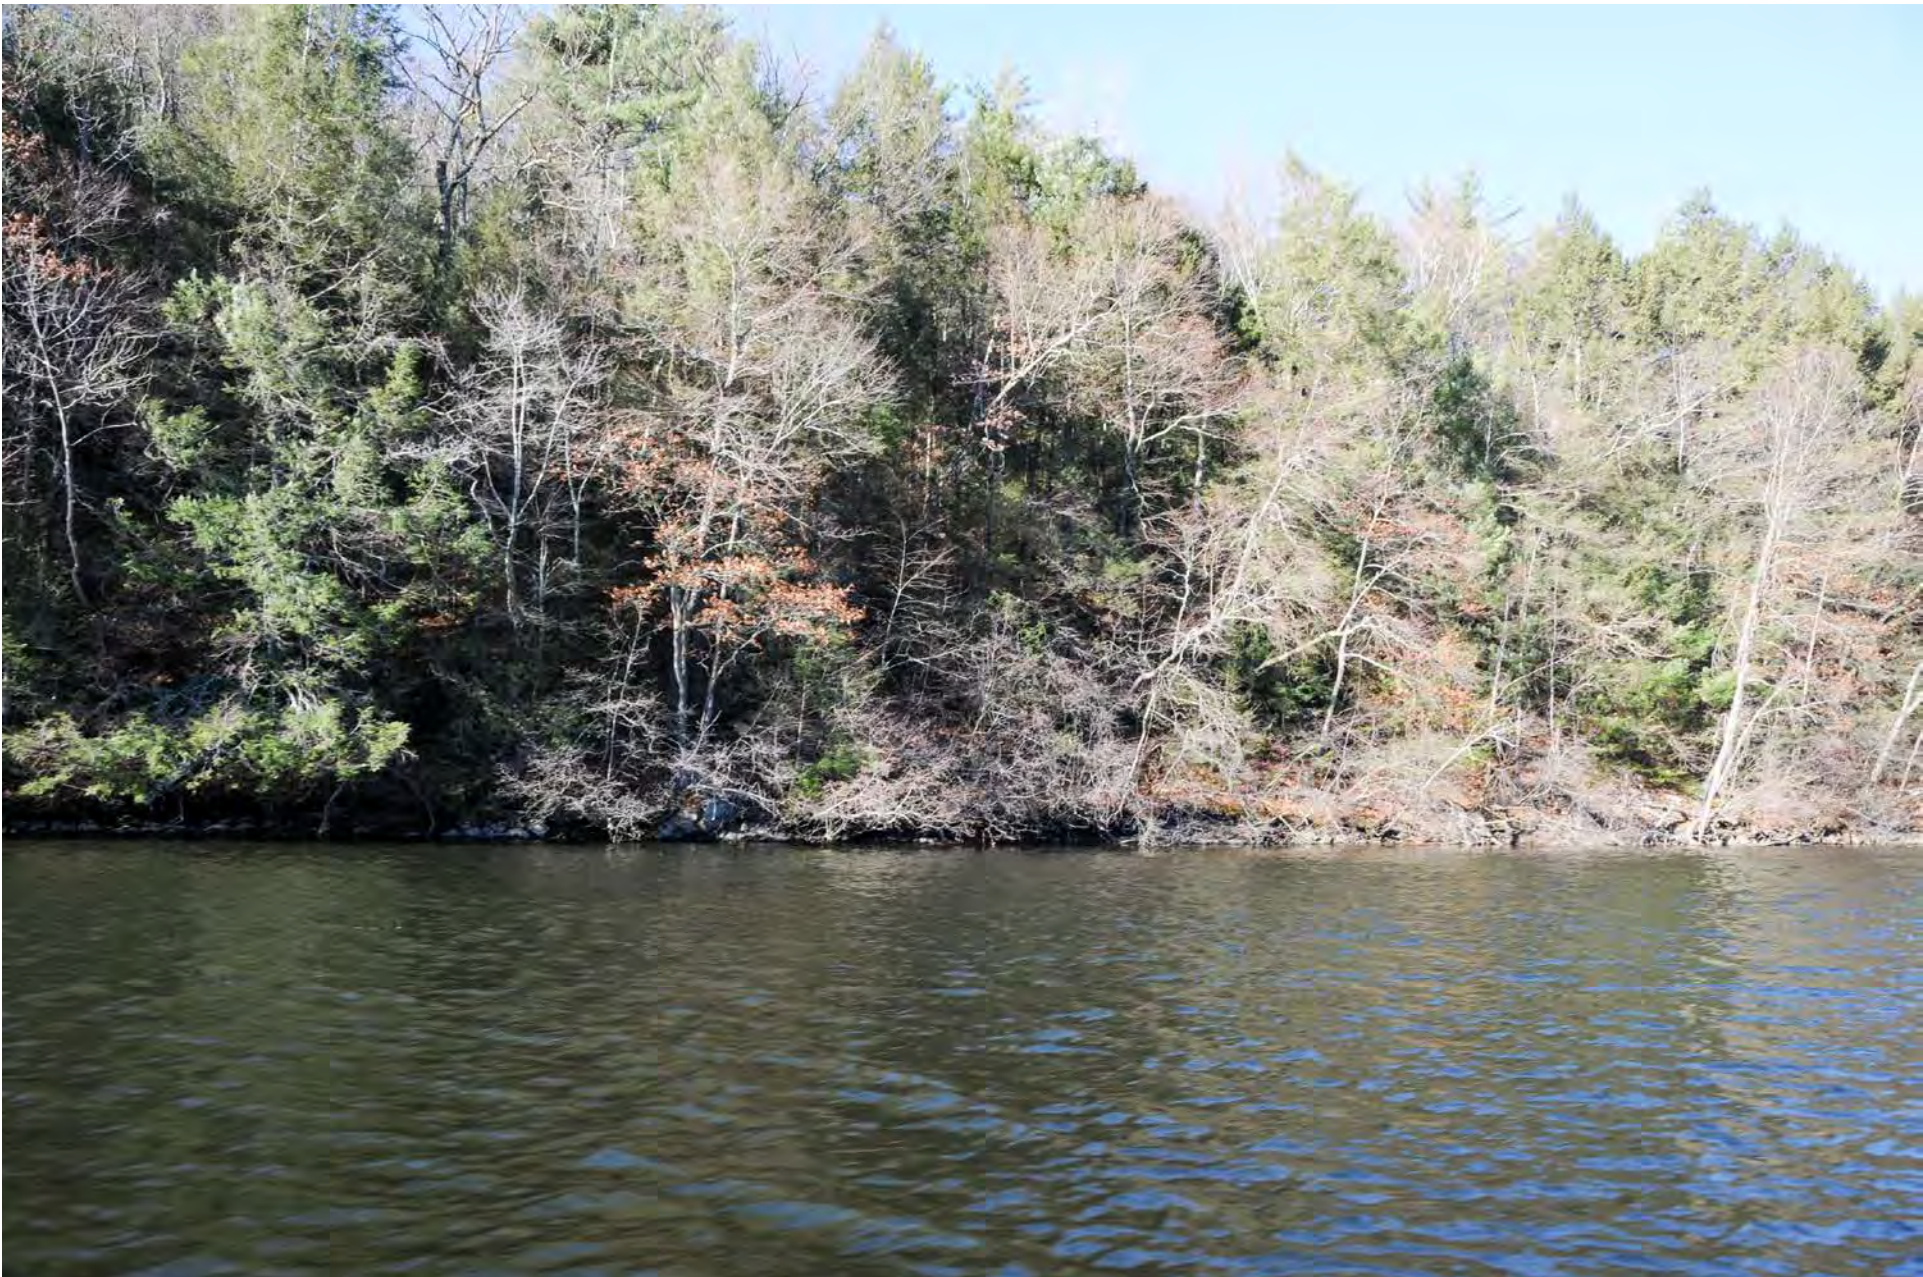
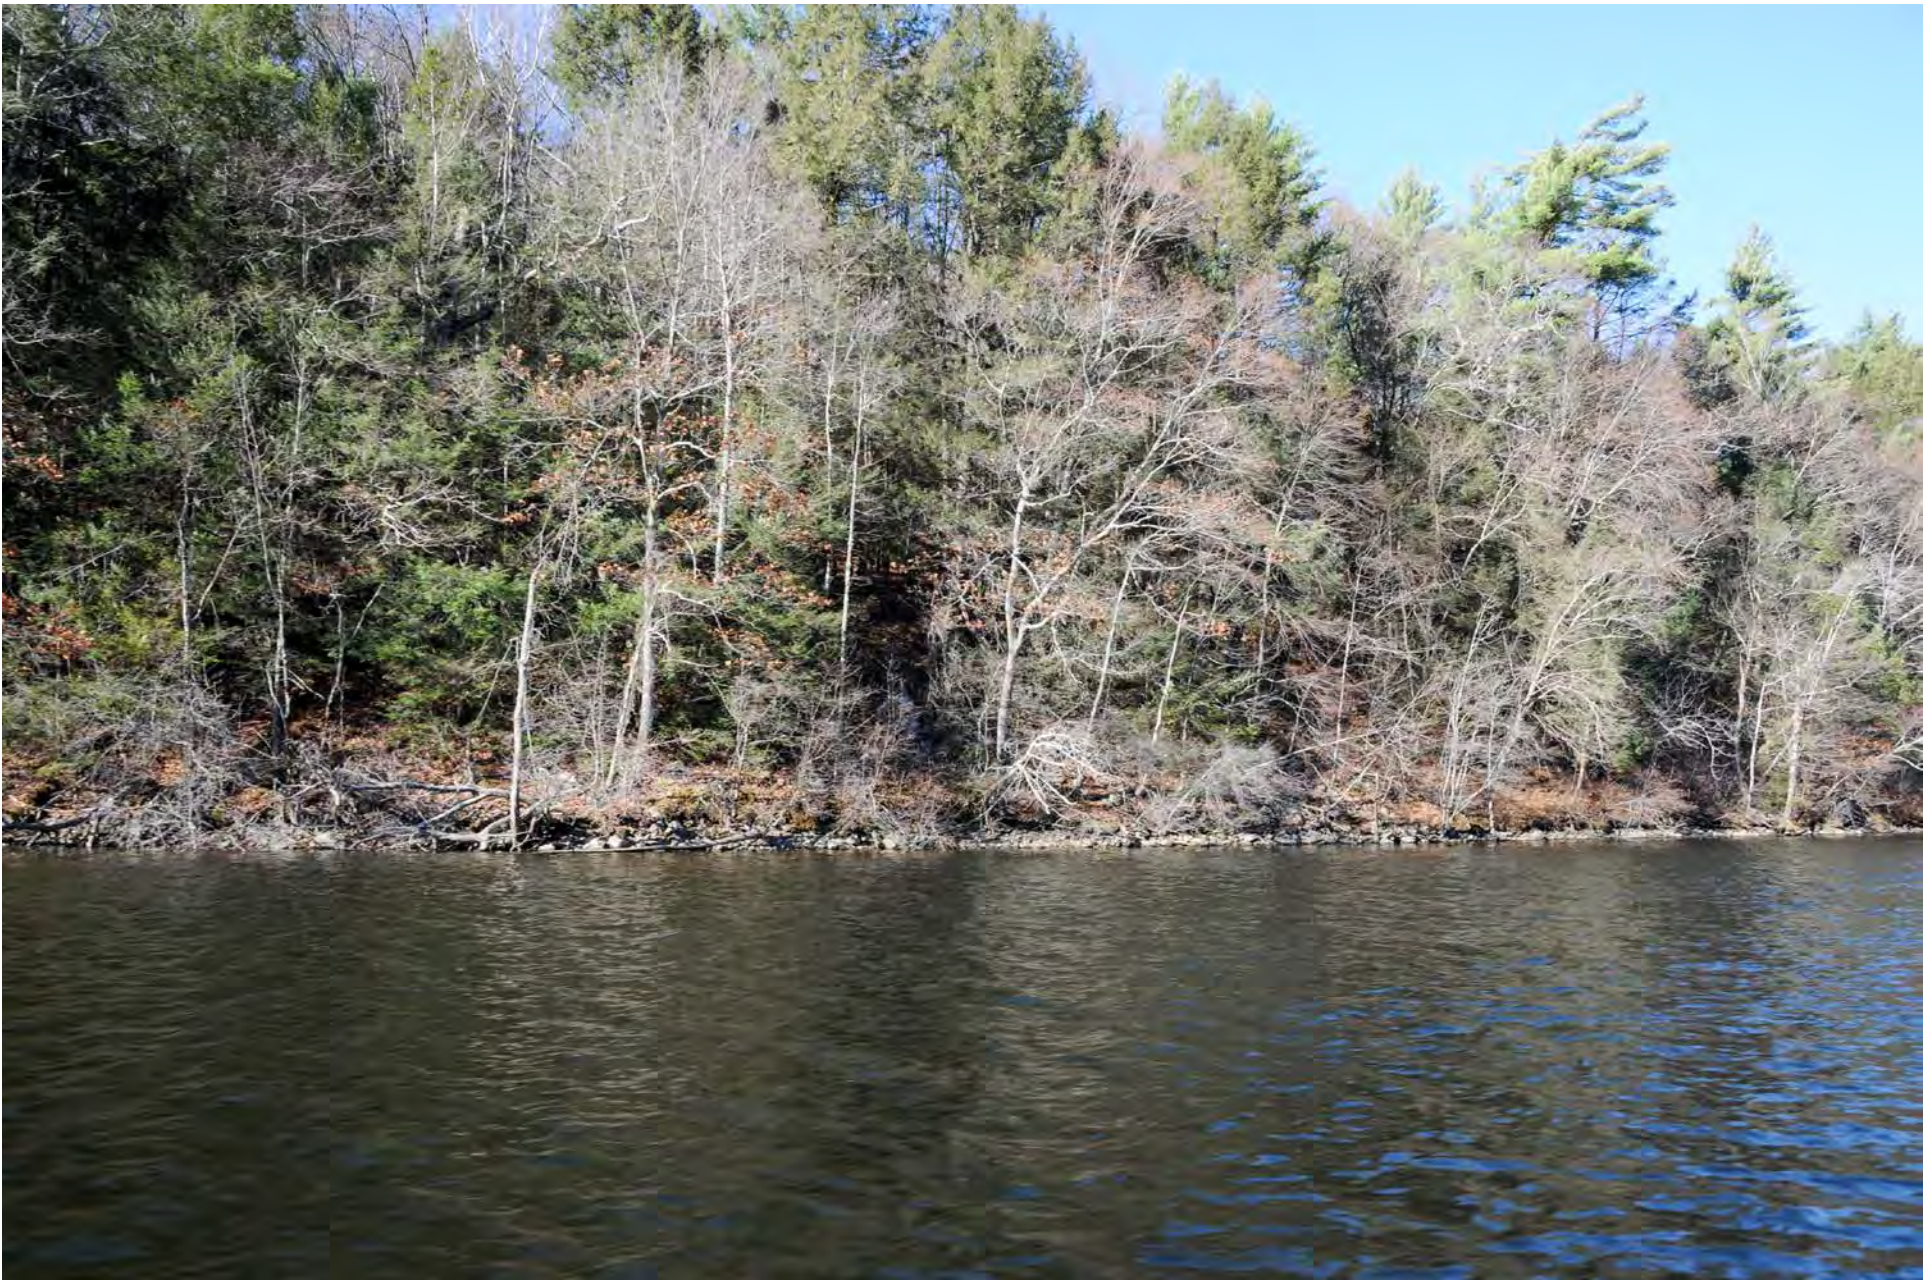
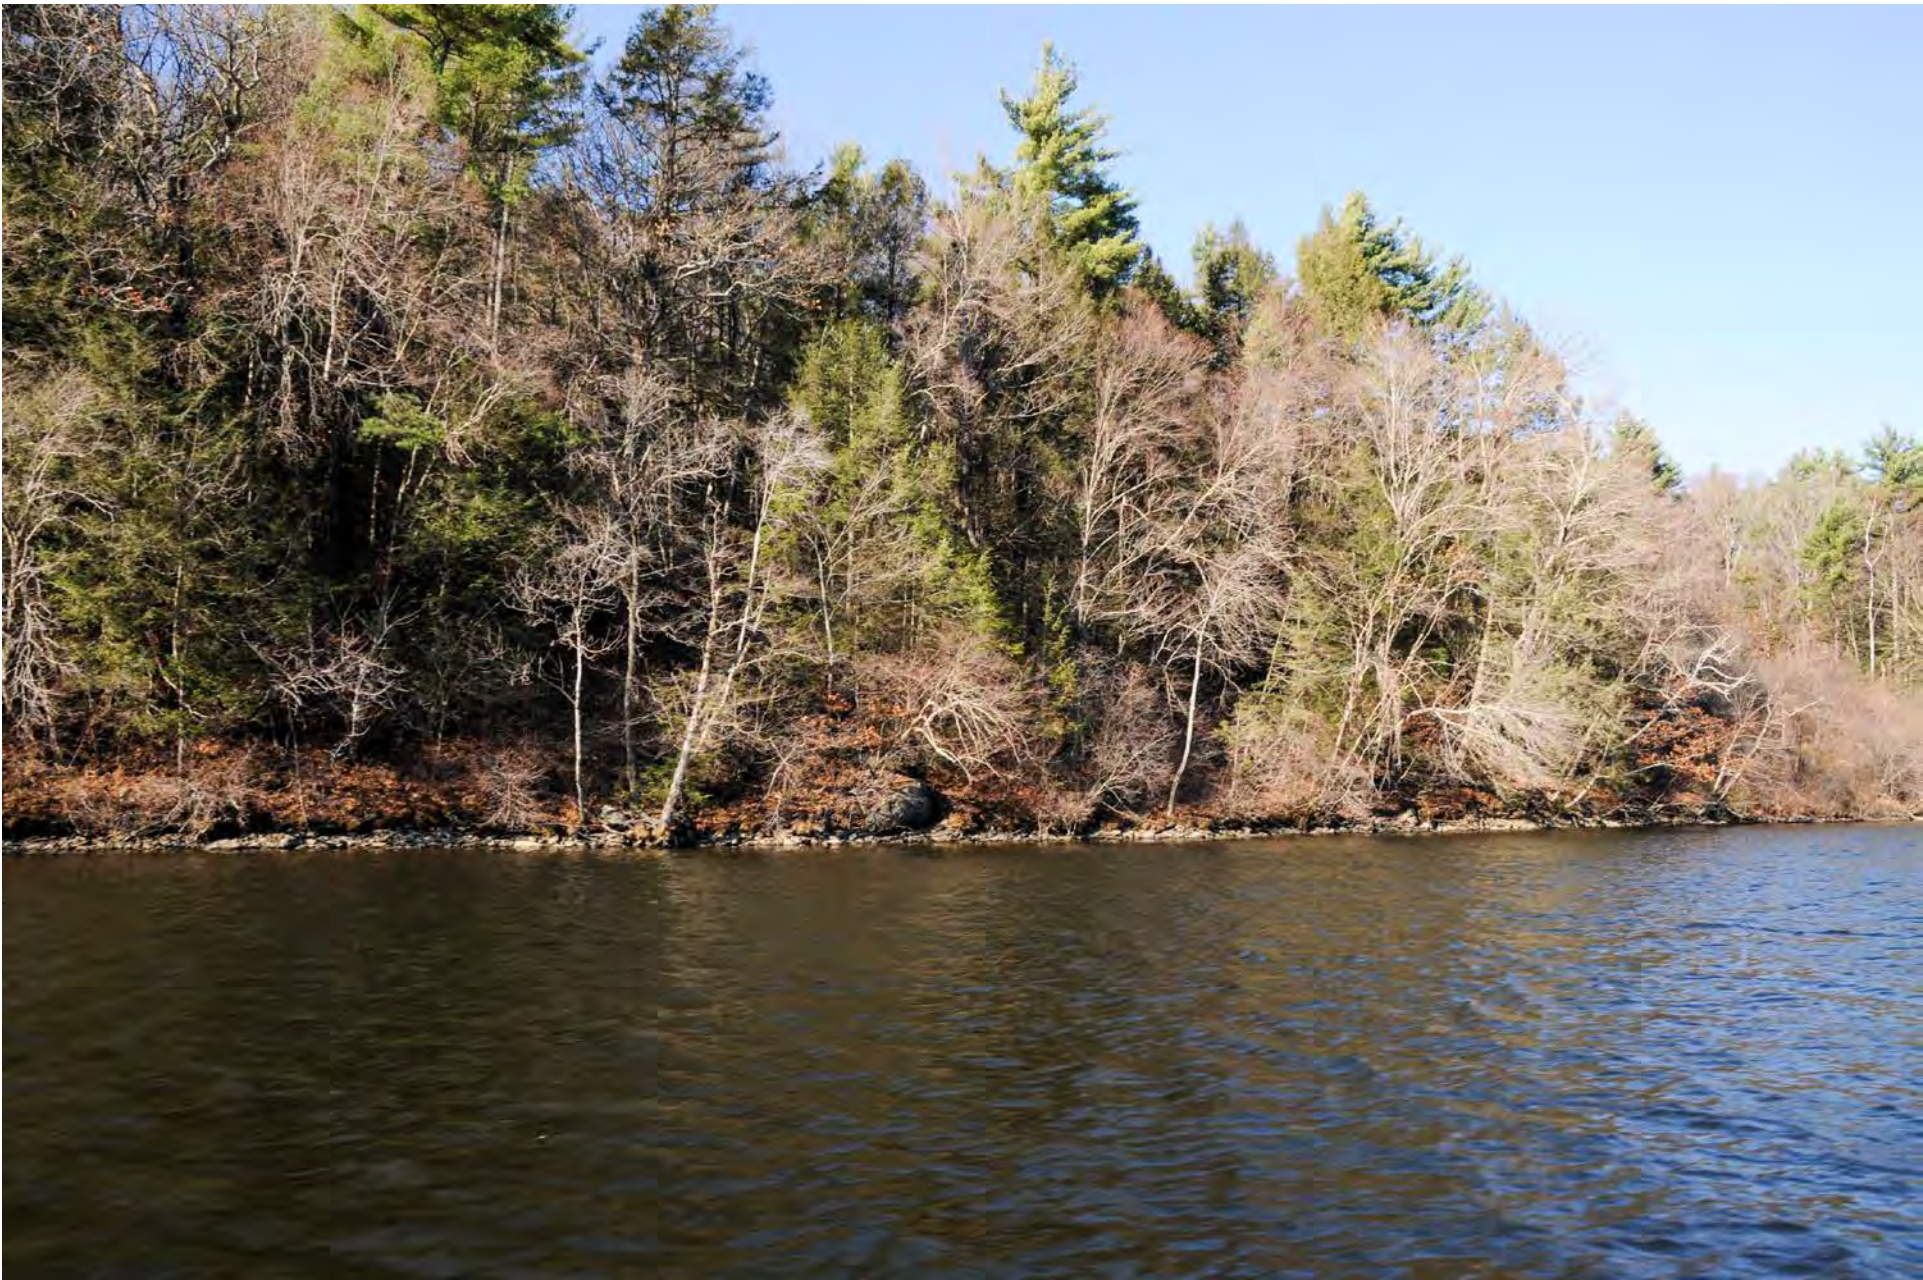
Photo ID 505 (mid-segment)

Riverbank Features	Characteristics
Upper Riverbank Slope	Steep
Upper Riverbank Height	High
Upper Riverbank Sediment	Silt/Sand
Upper Riverbank Vegetation	Heavy
Lower Riverbank Slope	Moderate
Lower Riverbank Sediment	Boulders
Lower Riverbank Vegetation	None to very sparse
Type of Erosion	Undercut
Potential Erosion Indicators	Creep/leaning trees, Exposed roots
Stage of Erosion	Stable
Extent of Erosion	None/Little

QA Observations: Upon review of the photos for this segment, classification made in the field was confirmed and additional indicators of potential future erosion were included.
