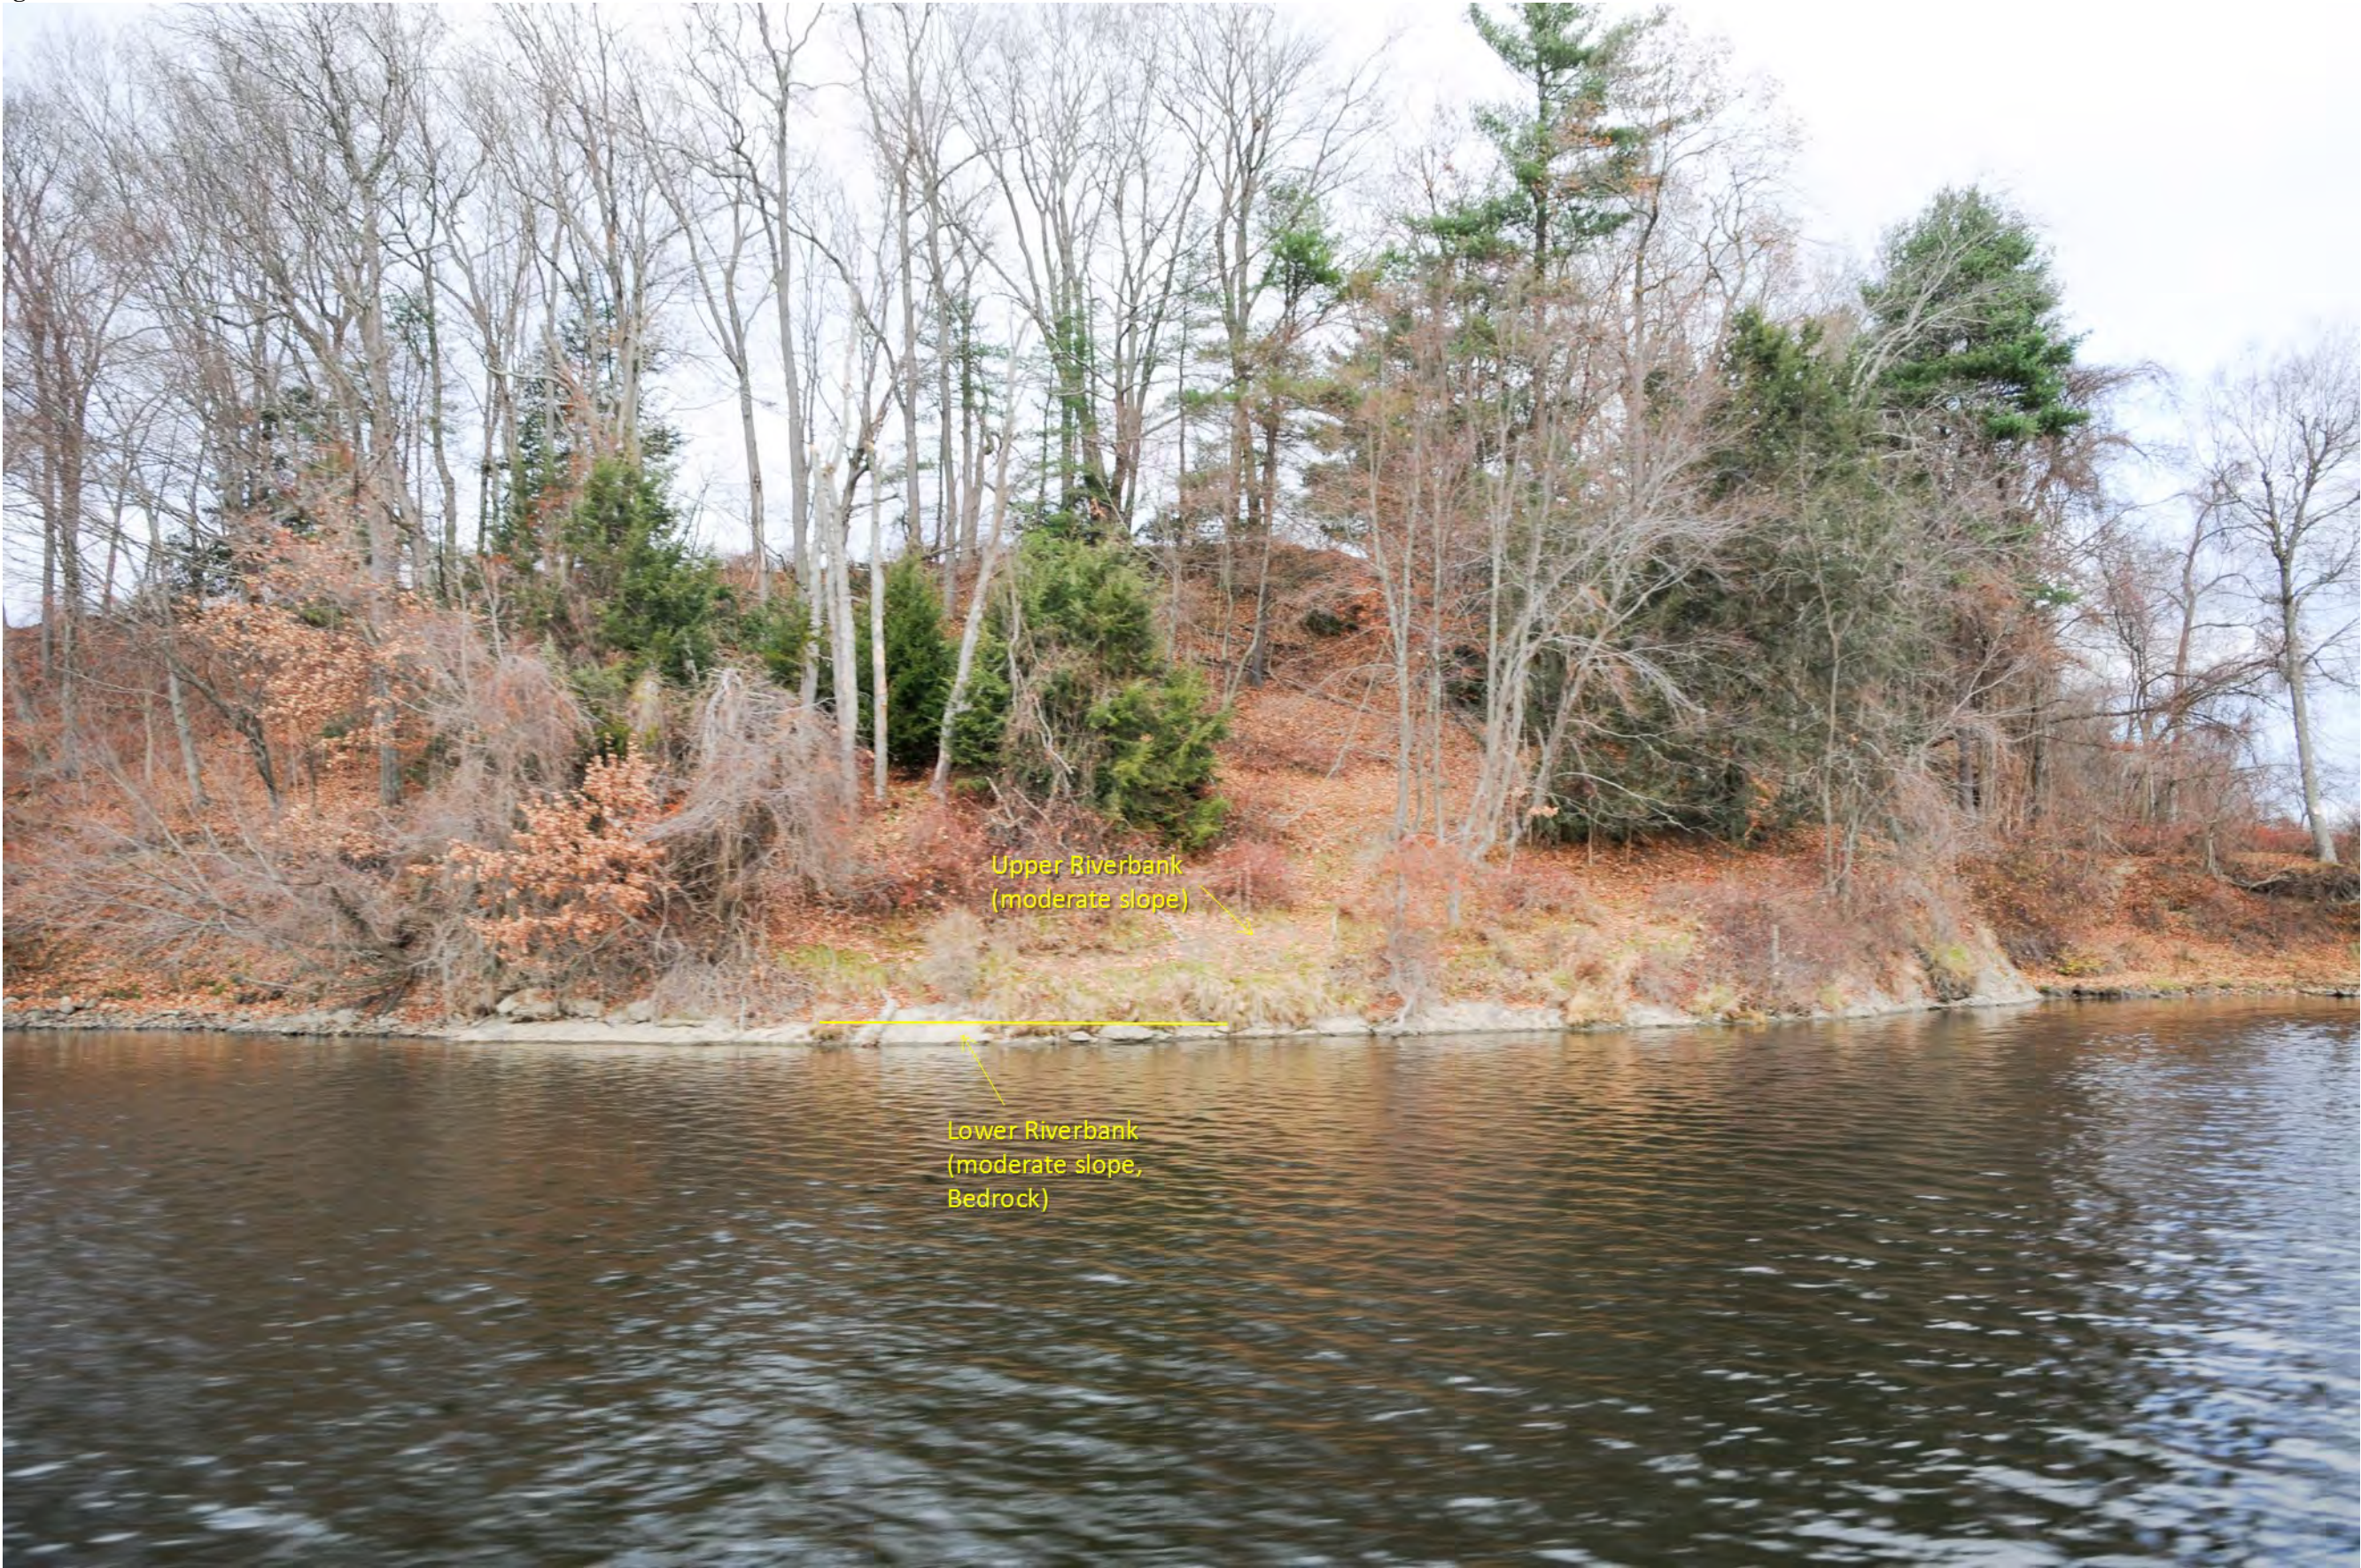
Photo ID 971 (U/S)

Riverbank Features	Characteristics
Upper Riverbank Slope	Moderate
Upper Riverbank Height	High
Upper Riverbank Sediment	Silt/Sand
Upper Riverbank Vegetation	Heavy
Lower Riverbank Slope	Flat/Beach
Lower Riverbank Sediment	Cobbles
Lower Riverbank Vegetation	None to very sparse
Type of Erosion	Undercut
Potential Erosion Indicators	Creep/Leaning trees, Exposed roots
Stage of Erosion	Stable
Extent of Erosion	None/Little

**QA Observations:** Upon review of the photos for this segment, classification made in the field was confirmed and additional indicators of potential future erosion were included.

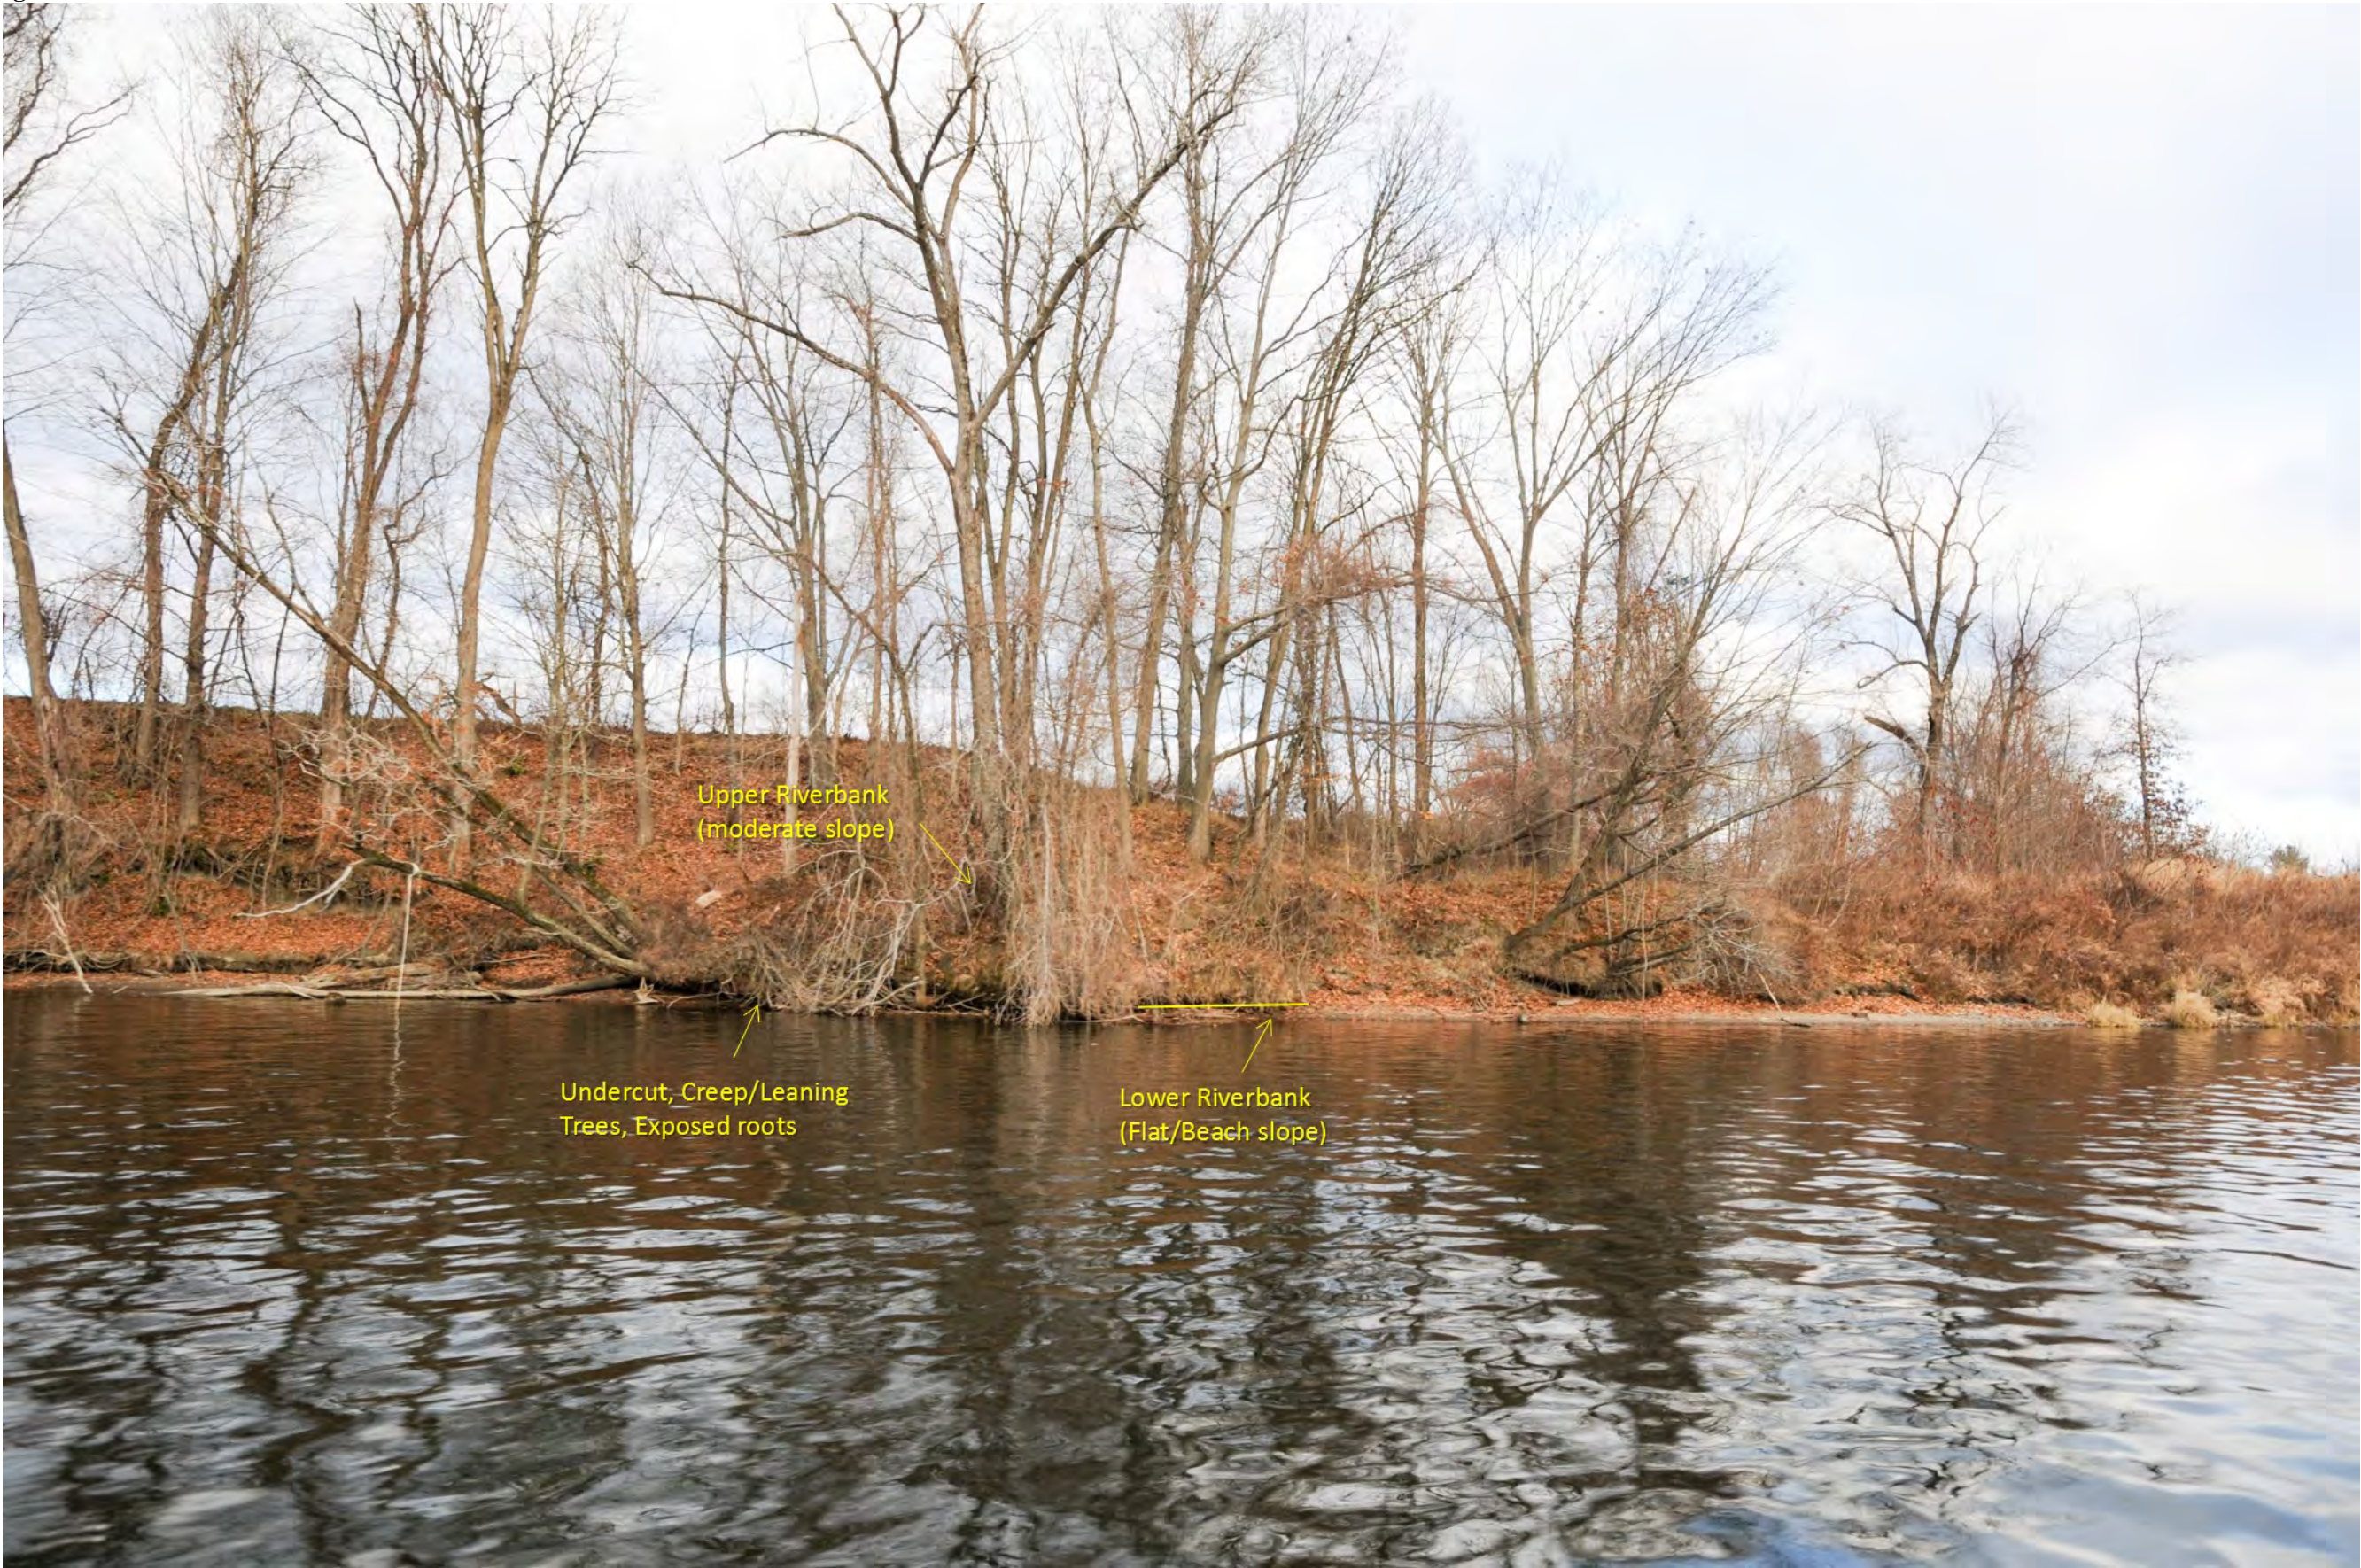
Photo ID 1004 (photo covers most of segment)

Riverbank Features	Characteristics
Upper Riverbank Slope	Moderate
Upper Riverbank Height	High
Upper Riverbank Sediment	Silt/Sand
Upper Riverbank Vegetation	Heavy
Lower Riverbank Slope	Moderate
Lower Riverbank Sediment	Bedrock
Lower Riverbank Vegetation	None to very sparse
Type of Erosion	
Potential Erosion Indicators	None
Stage of Erosion	Stable
Extent of Erosion	None/Little

**QA Observations:** Upon review of the photos for this segment, classification made in the field was confirmed.

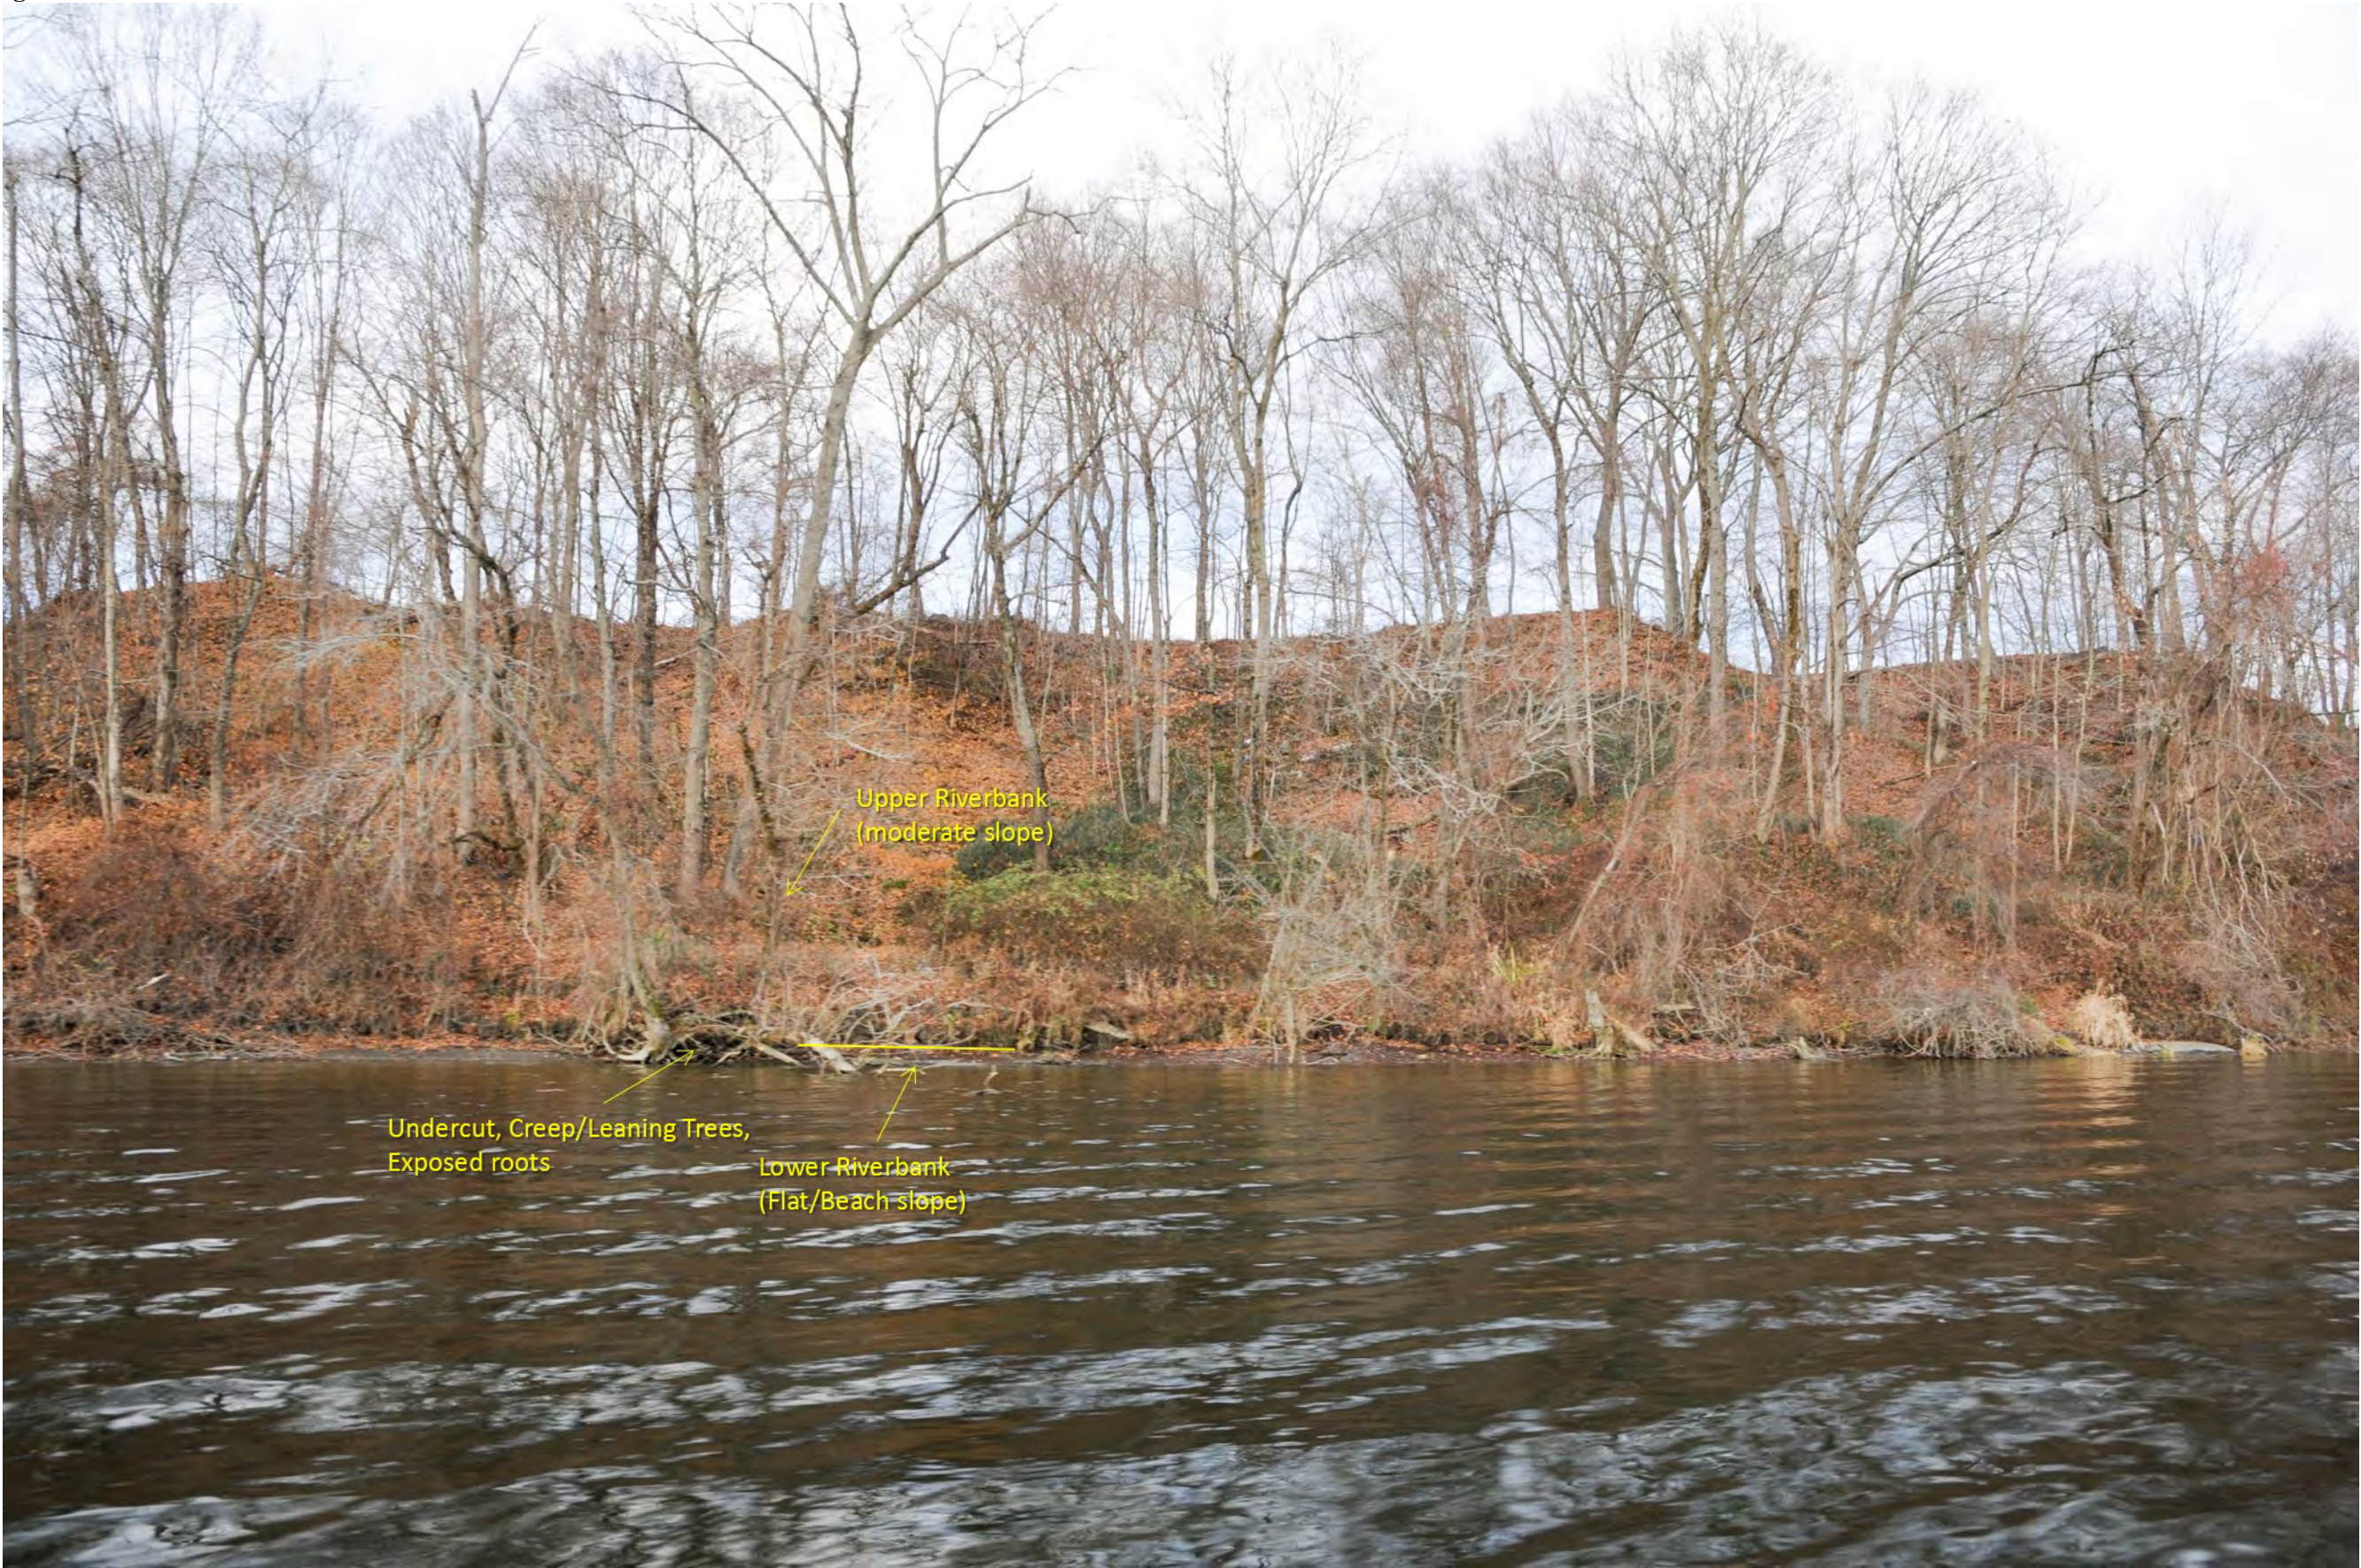
Photo ID 1035 (D/S)

Riverbank Features	Characteristics
Upper Riverbank Slope	Moderate
Upper Riverbank Height	High
Upper Riverbank Sediment	Silt/Sand
Upper Riverbank Vegetation	Heavy
Lower Riverbank Slope	Flat/Beach
Lower Riverbank Sediment	Silt/Sand
Lower Riverbank Vegetation	None to very sparse
Type of Erosion	Undercut
Potential Erosion Indicators	Creep/Leaning trees, Exposed roots
Stage of Erosion	Stable
Extent of Erosion	None/Little

**QA Observations:** Upon review of the photos for this segment, classification made in the field was confirmed and additional indicators of potential future erosion were included.

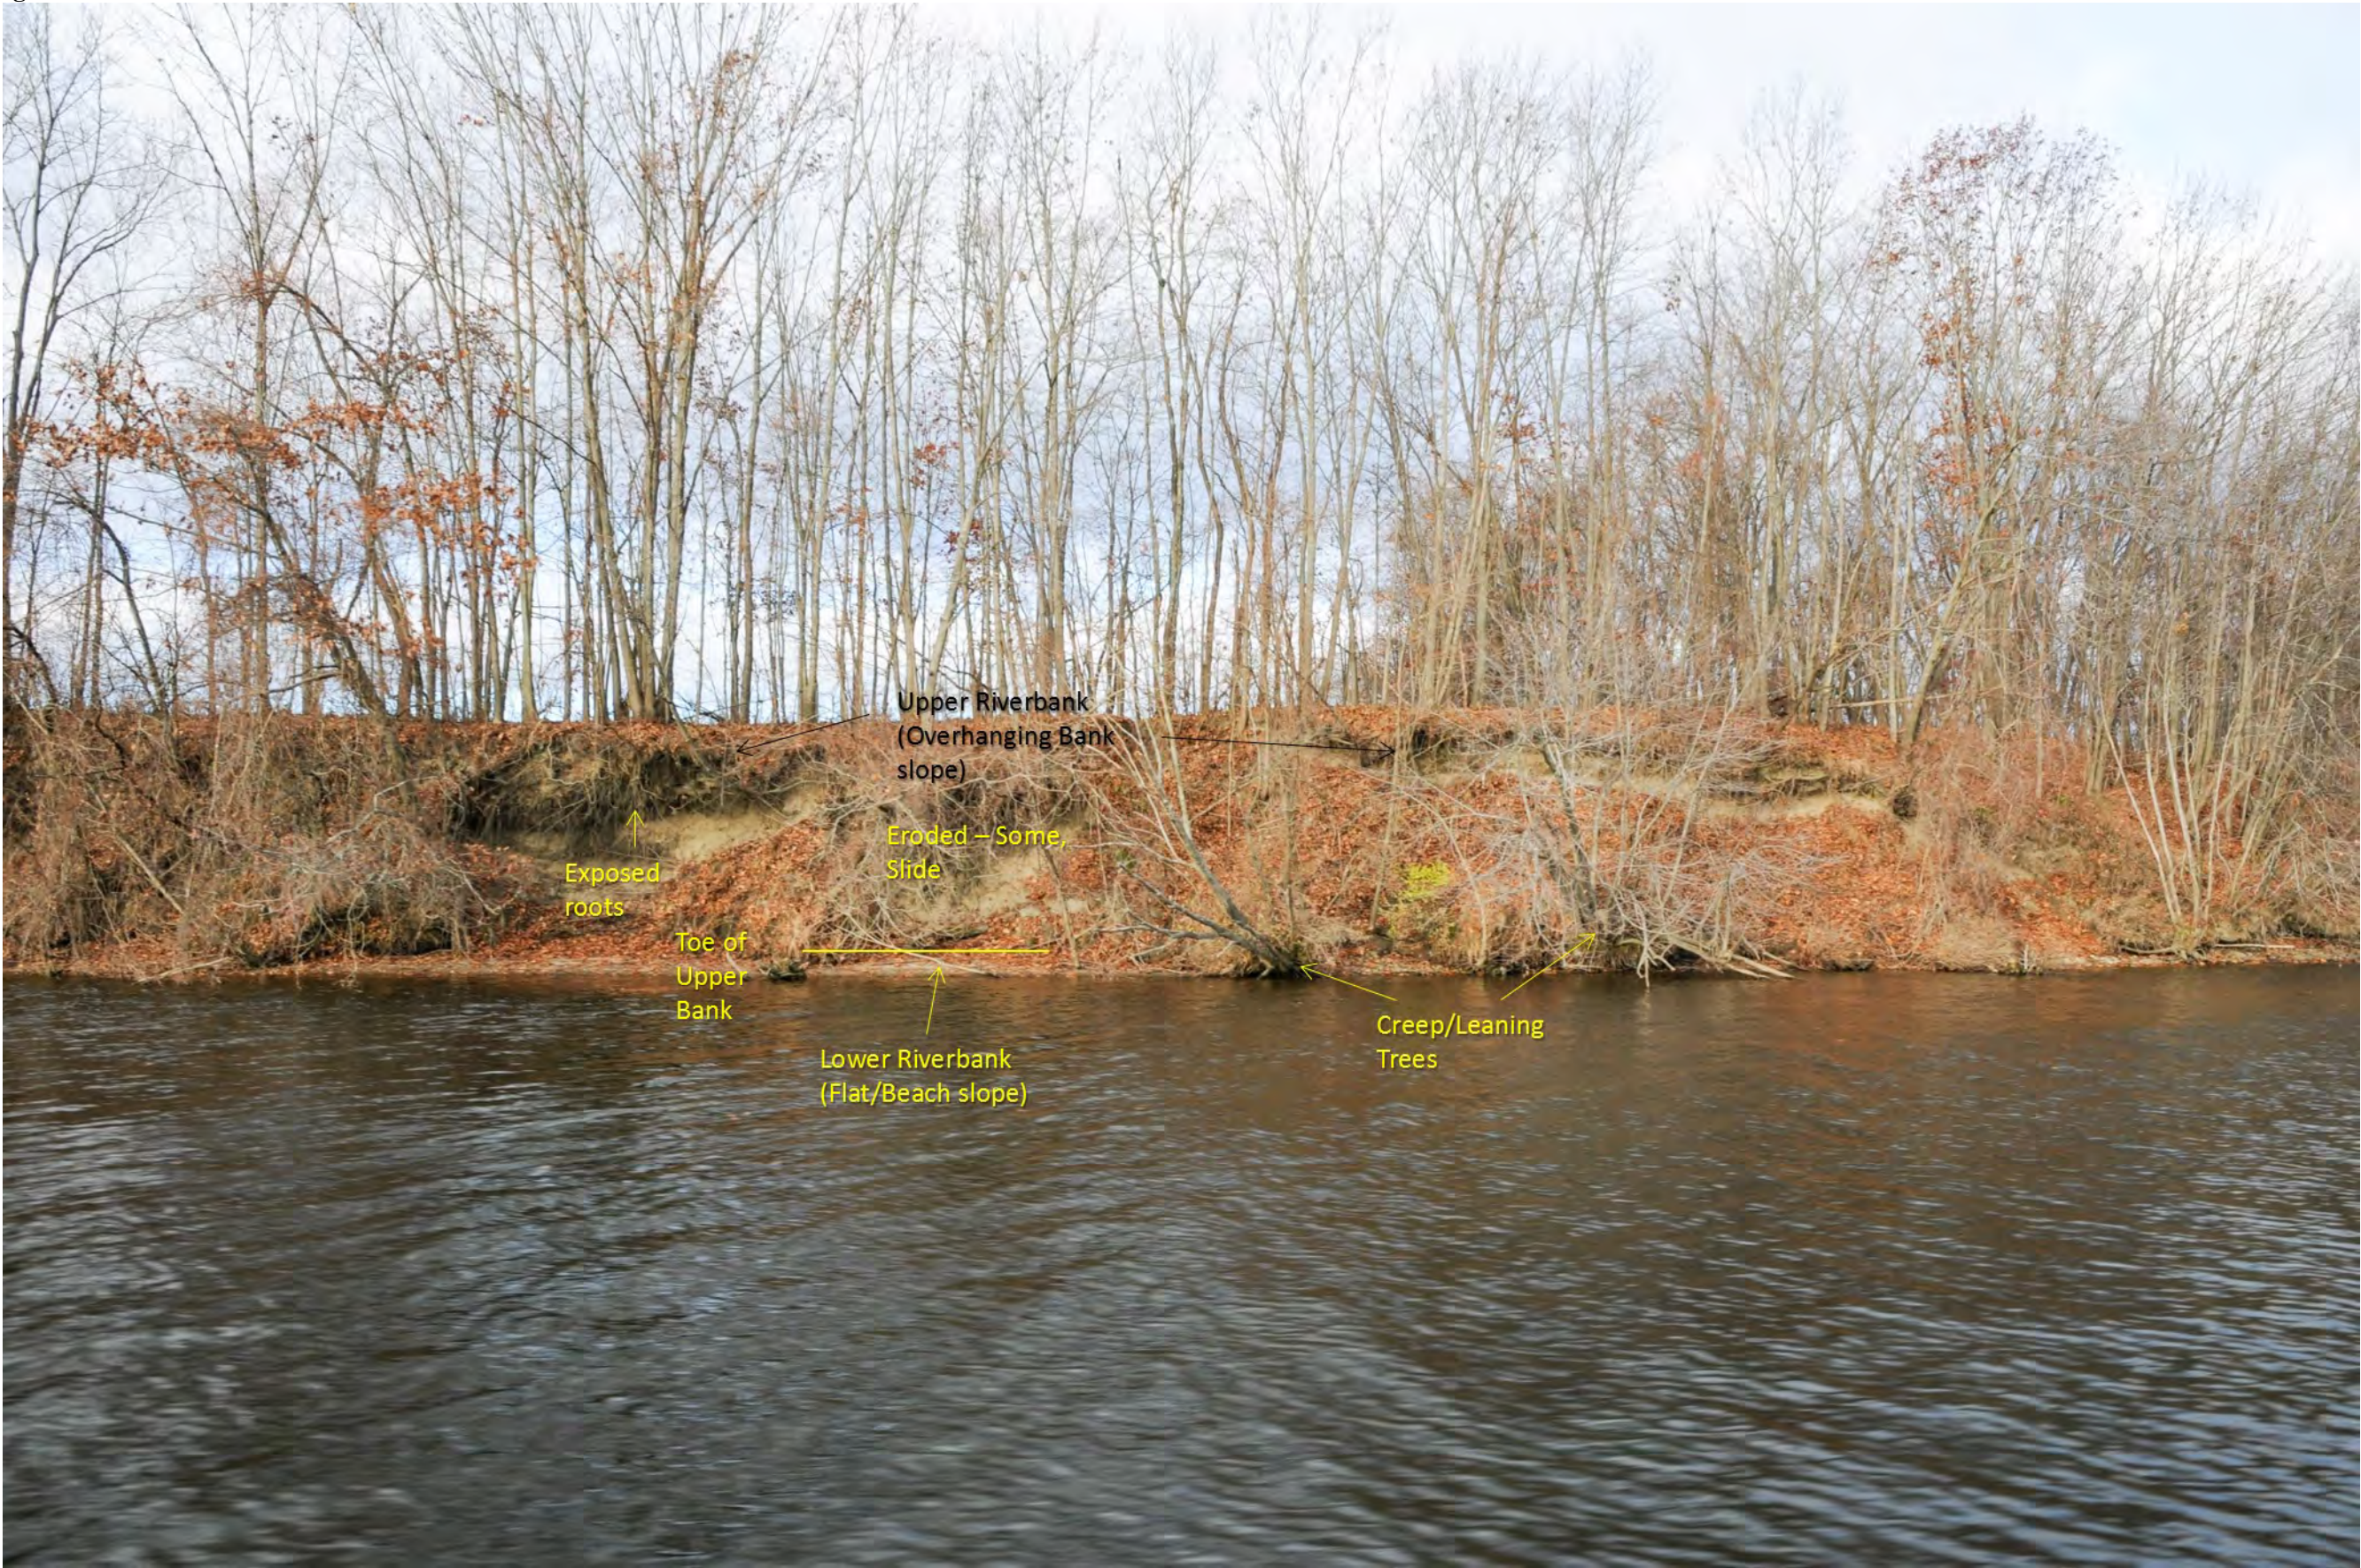
Photo ID 1069 (U/S and includes next segment)

Riverbank Features	Characteristics
Upper Riverbank Slope	Moderate
Upper Riverbank Height	High
Upper Riverbank Sediment	Silt/Sand
Upper Riverbank Vegetation	Heavy
Lower Riverbank Slope	Flat/Beach
Lower Riverbank Sediment	Silt/Sand
Lower Riverbank Vegetation	None to very sparse
Type of Erosion	Undercut
Potential Erosion Indicators	Creep/Leaning trees, Exposed roots
Stage of Erosion	Stable
Extent of Erosion	None/Little

**QA Observations:** Upon review of the photos for this segment, classification made in the field was confirmed and additional indicators of potential future erosion were included.

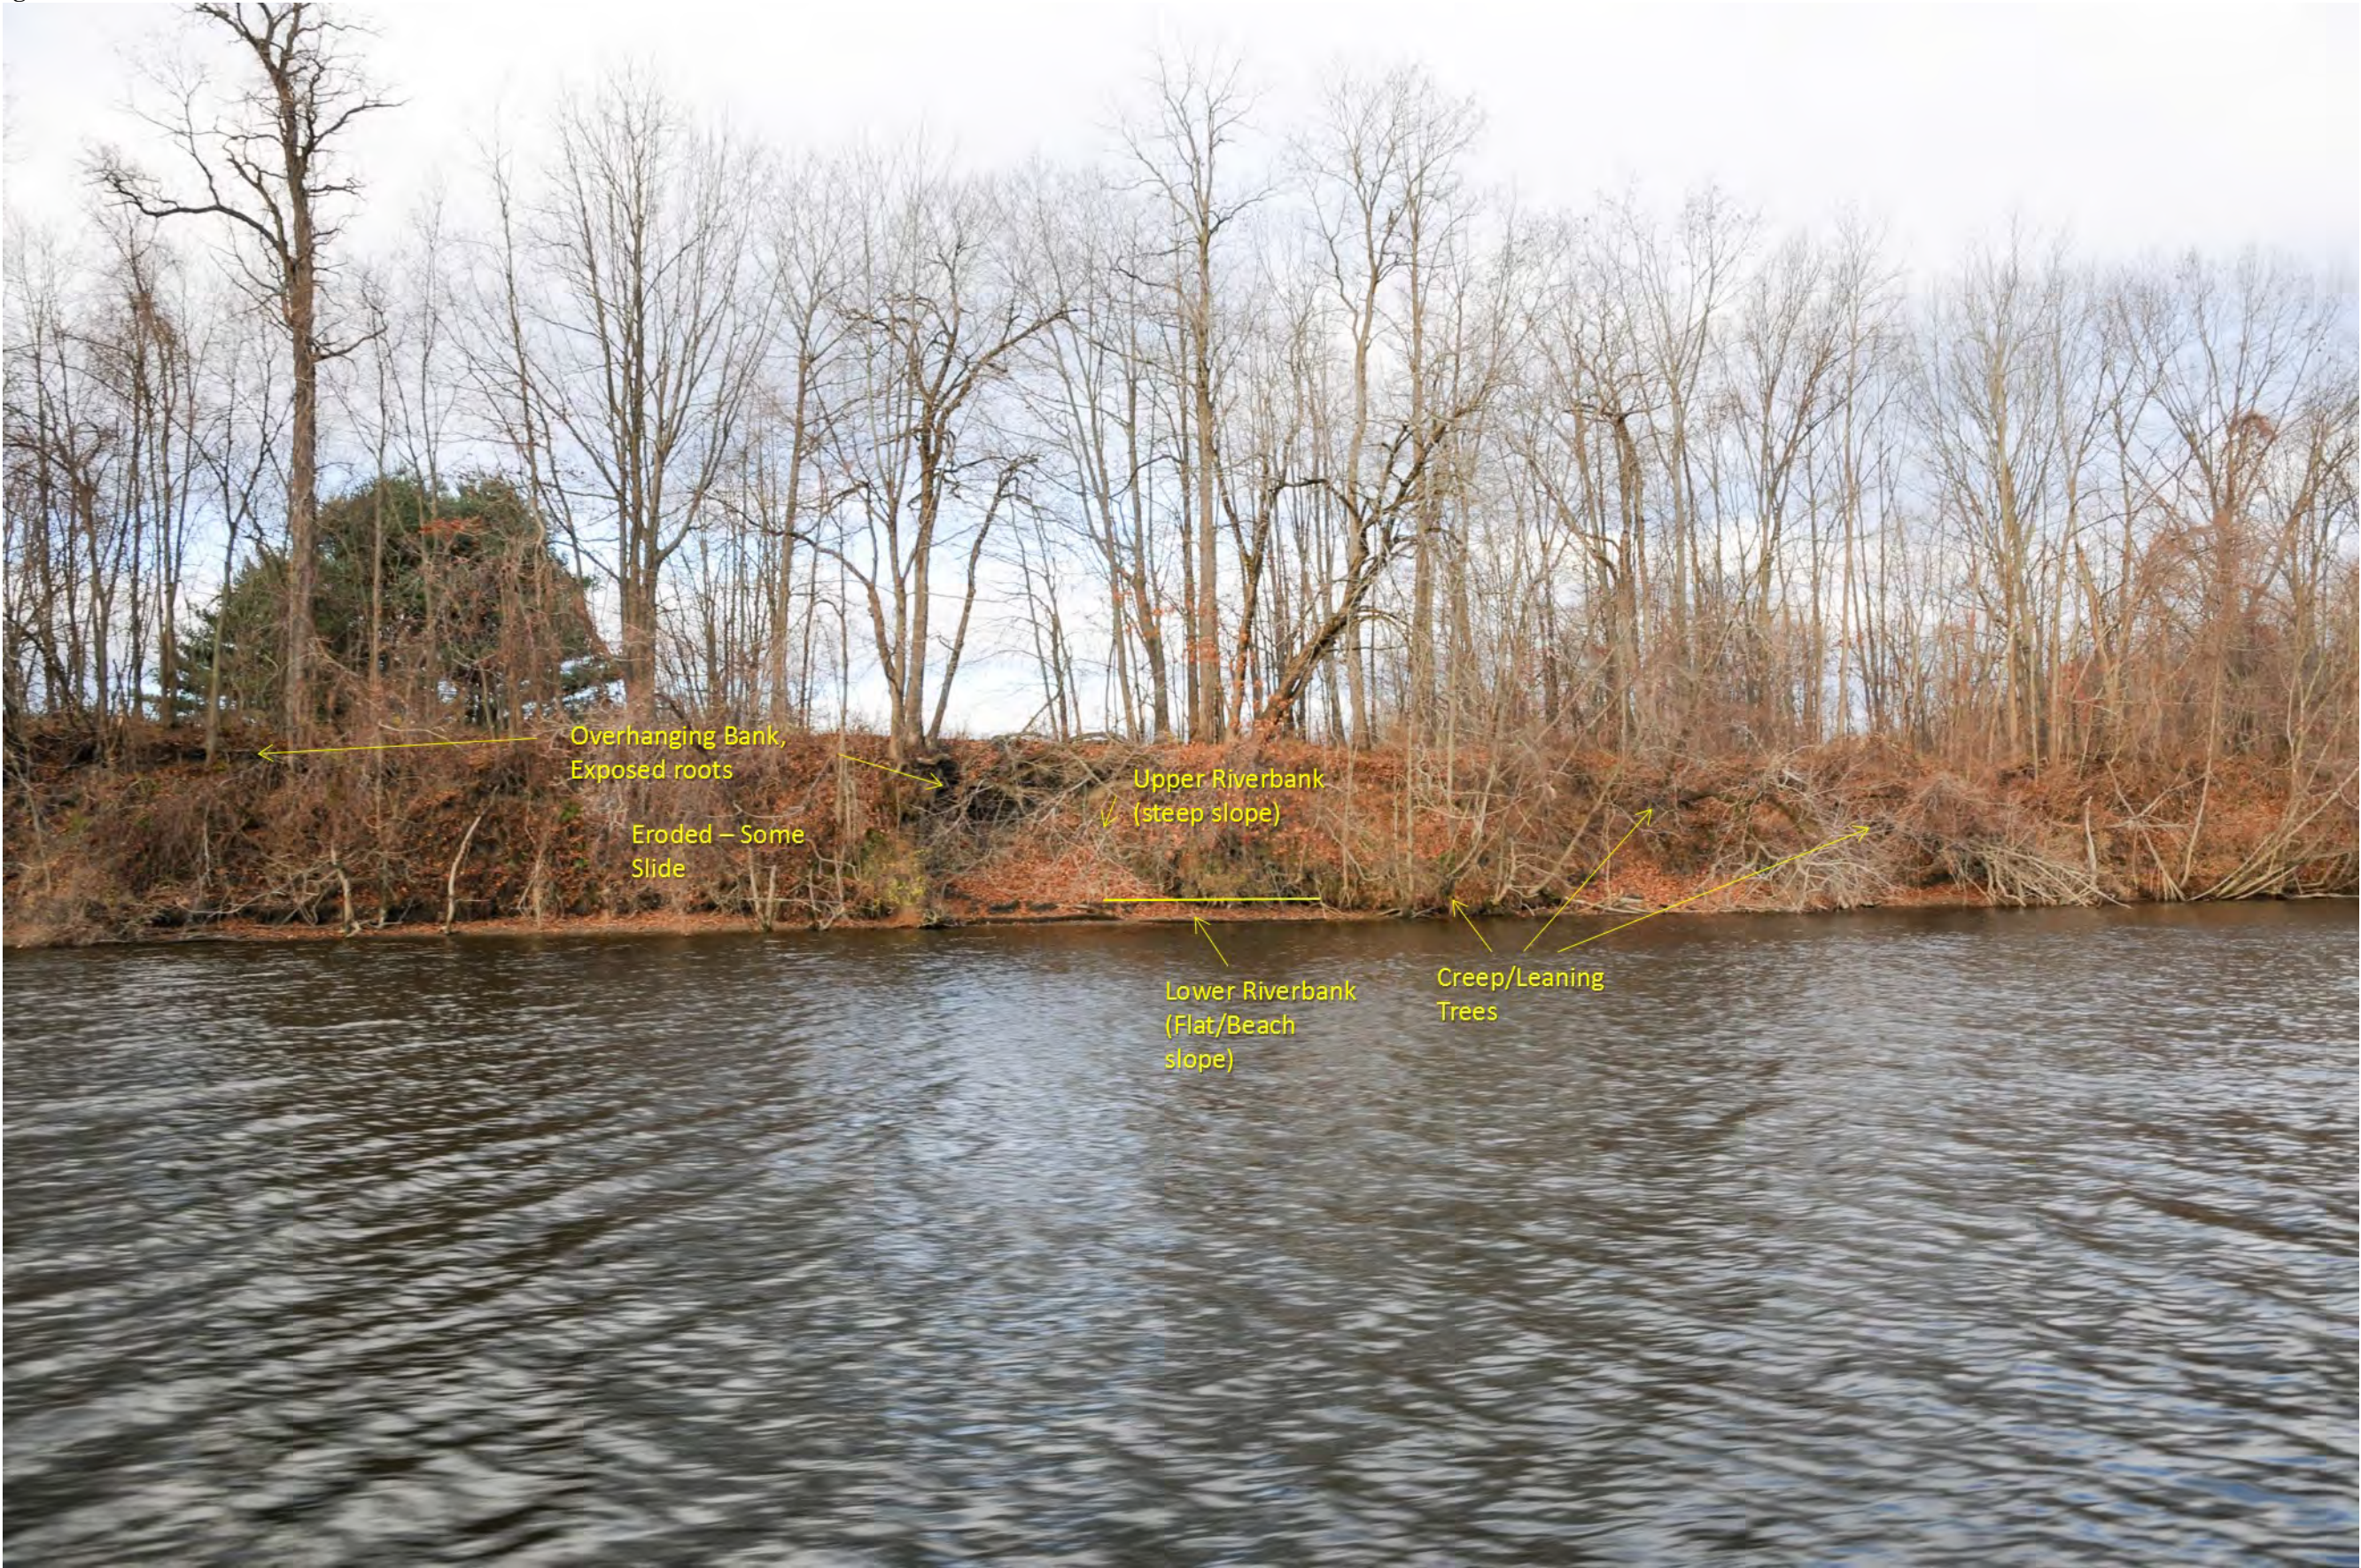
Photo ID 1092 (U/S)

Riverbank Features	Characteristics
Upper Riverbank Slope	Overhanging
Upper Riverbank Height	High
Upper Riverbank Sediment	Silt/Sand
Upper Riverbank Vegetation	Heavy
Lower Riverbank Slope	Flat/Beach
Lower Riverbank Sediment	Silt/Sand
Lower Riverbank Vegetation	None to very sparse
Type of Erosion	Slide
Potential Erosion Indicators	Overhanging bank, Exposed roots, Creep/leaning trees
Stage of Erosion	Eroded
Extent of Erosion	Some

**QA Observations:** Upon review of the photos for this segment, classification made in the field was confirmed and additional indicators of potential future erosion were included.
