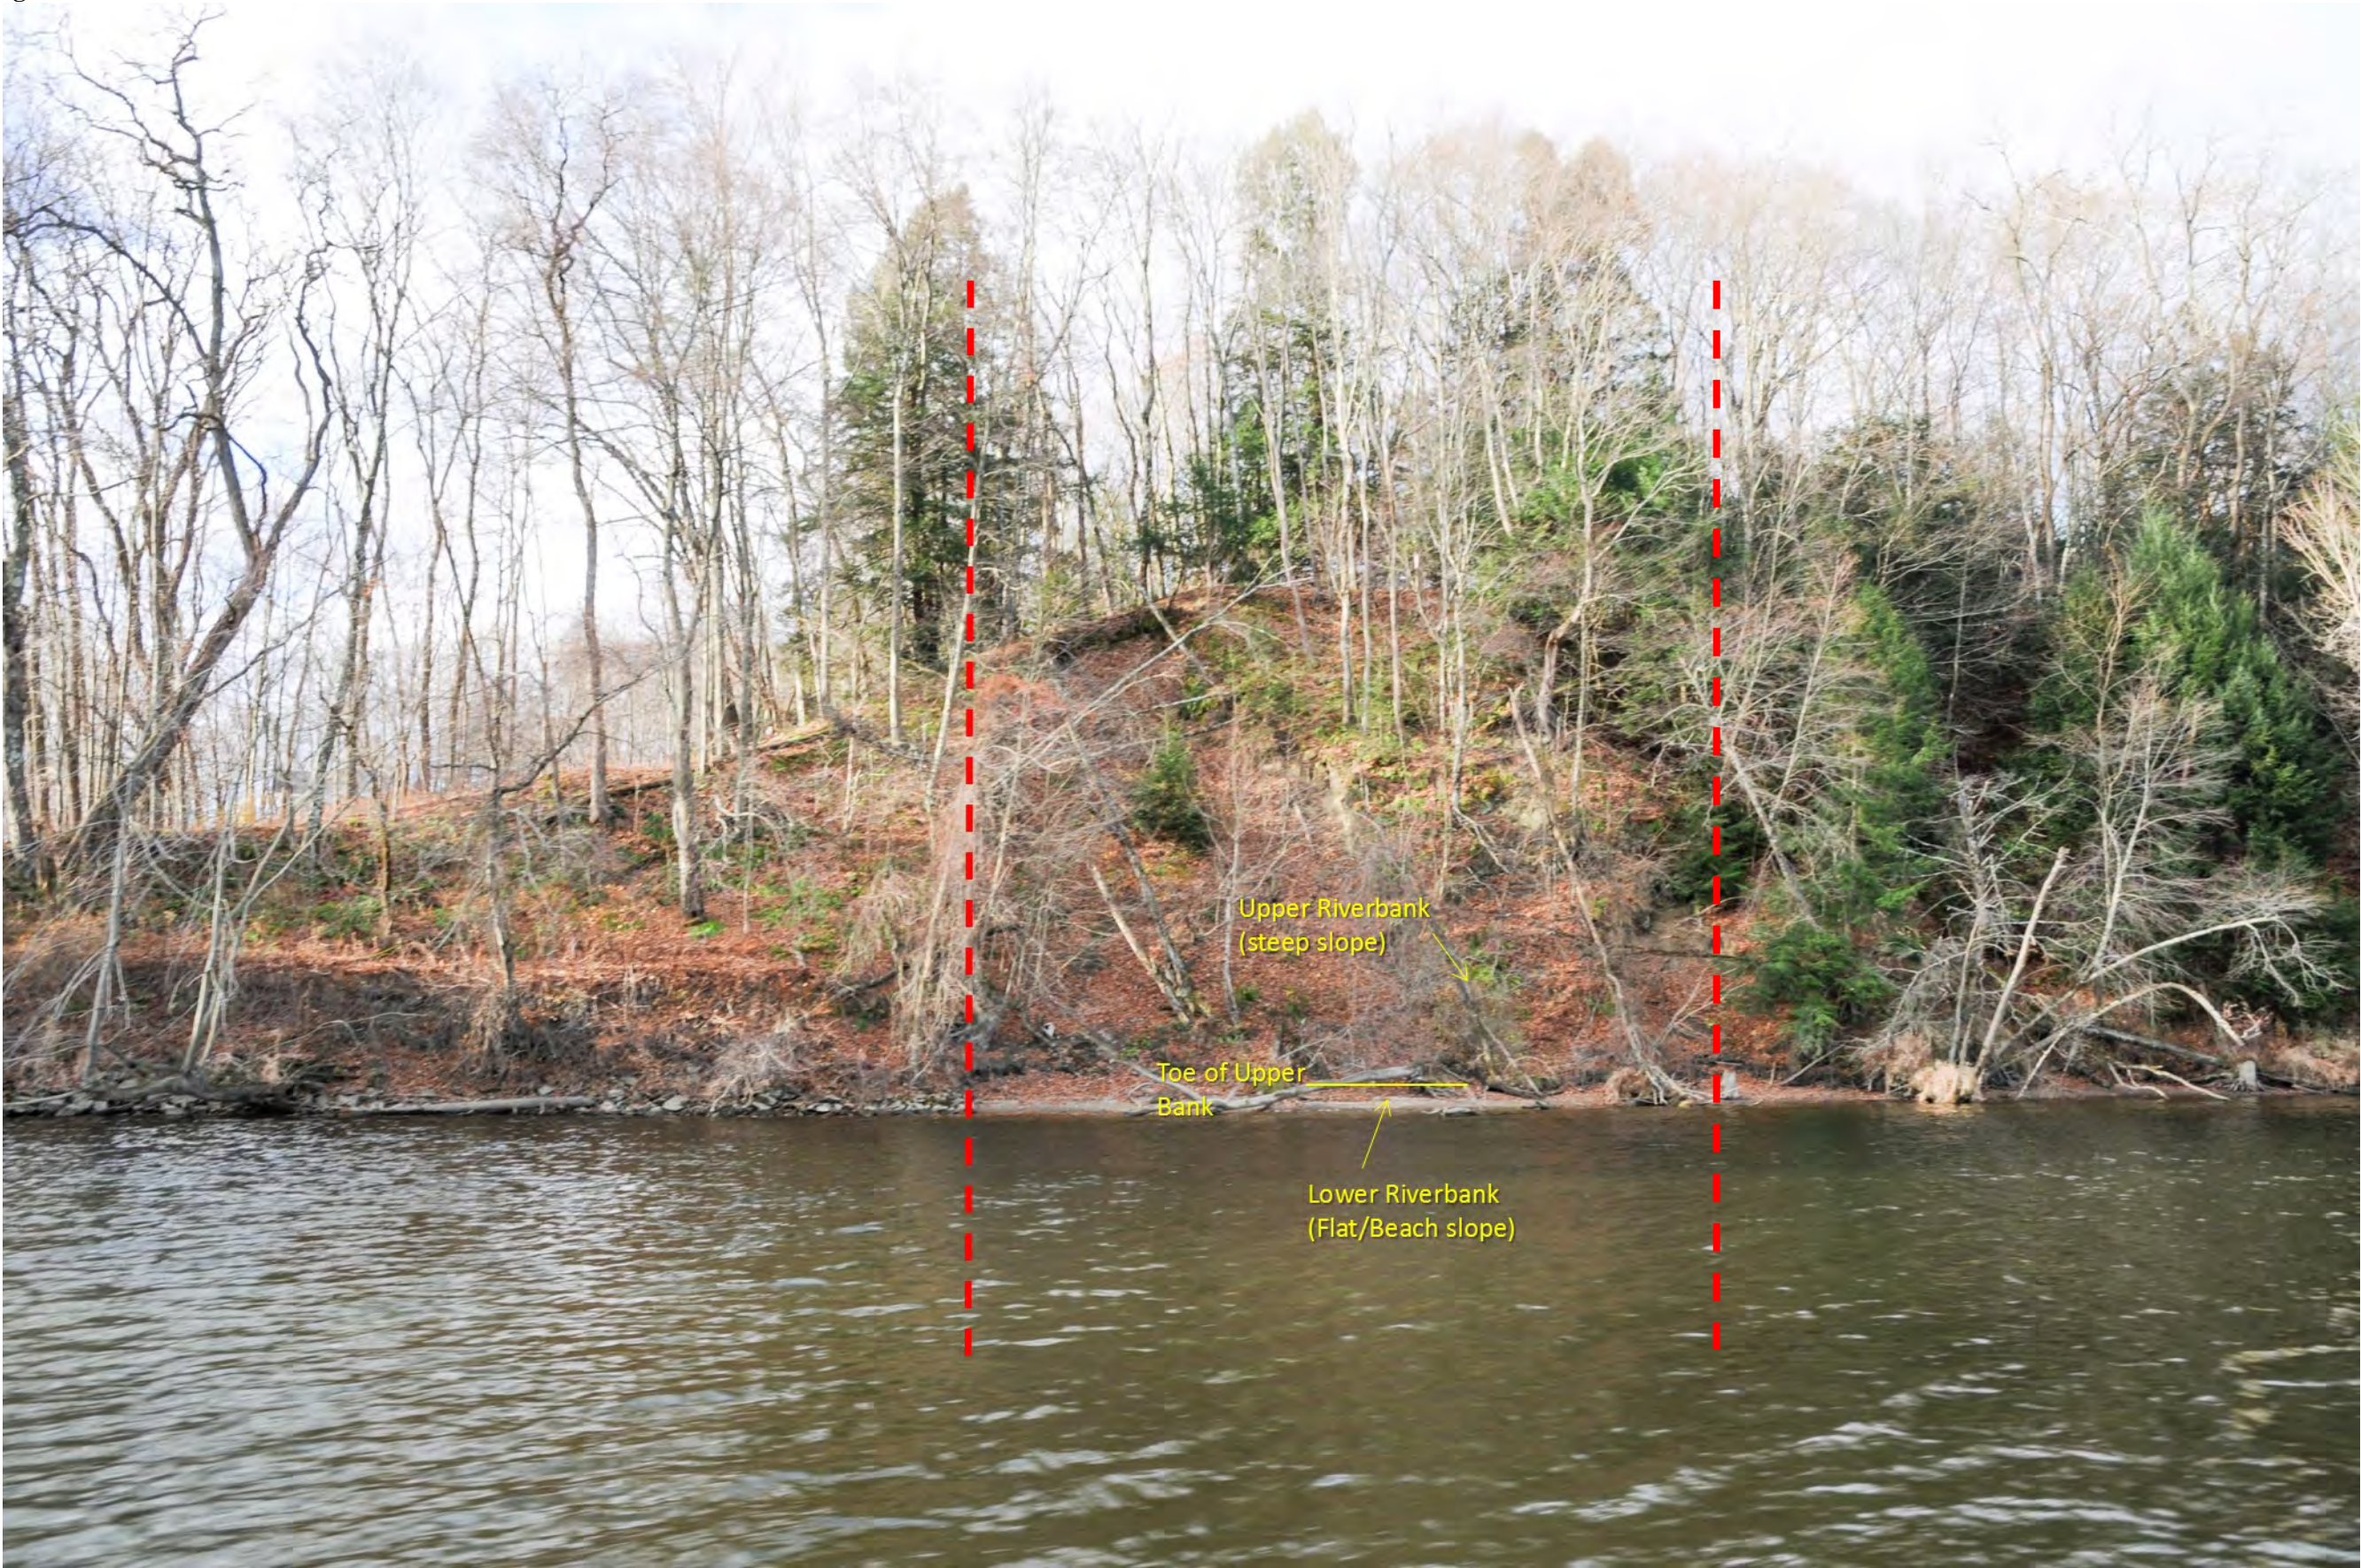
Photo ID 1104 (photo covers most of segment)

Riverbank Features	Characteristics
Upper Riverbank Slope	Steep
Upper Riverbank Height	High
Upper Riverbank Sediment	Silt/Sand
Upper Riverbank Vegetation	Moderate
Lower Riverbank Slope	Flat/Beach
Lower Riverbank Sediment	Silt/Sand
Lower Riverbank Vegetation	None to very sparse
Type of Erosion	Slide
Potential Erosion Indicators	Exposed roots, Overhanging bank, Creep/leaning trees
Stage of Erosion	Eroded
Extent of Erosion	Some

**QA Observations:** Upon review of the photos for this segment, classification made in the field was confirmed and additional indicators of potential future erosion were included.

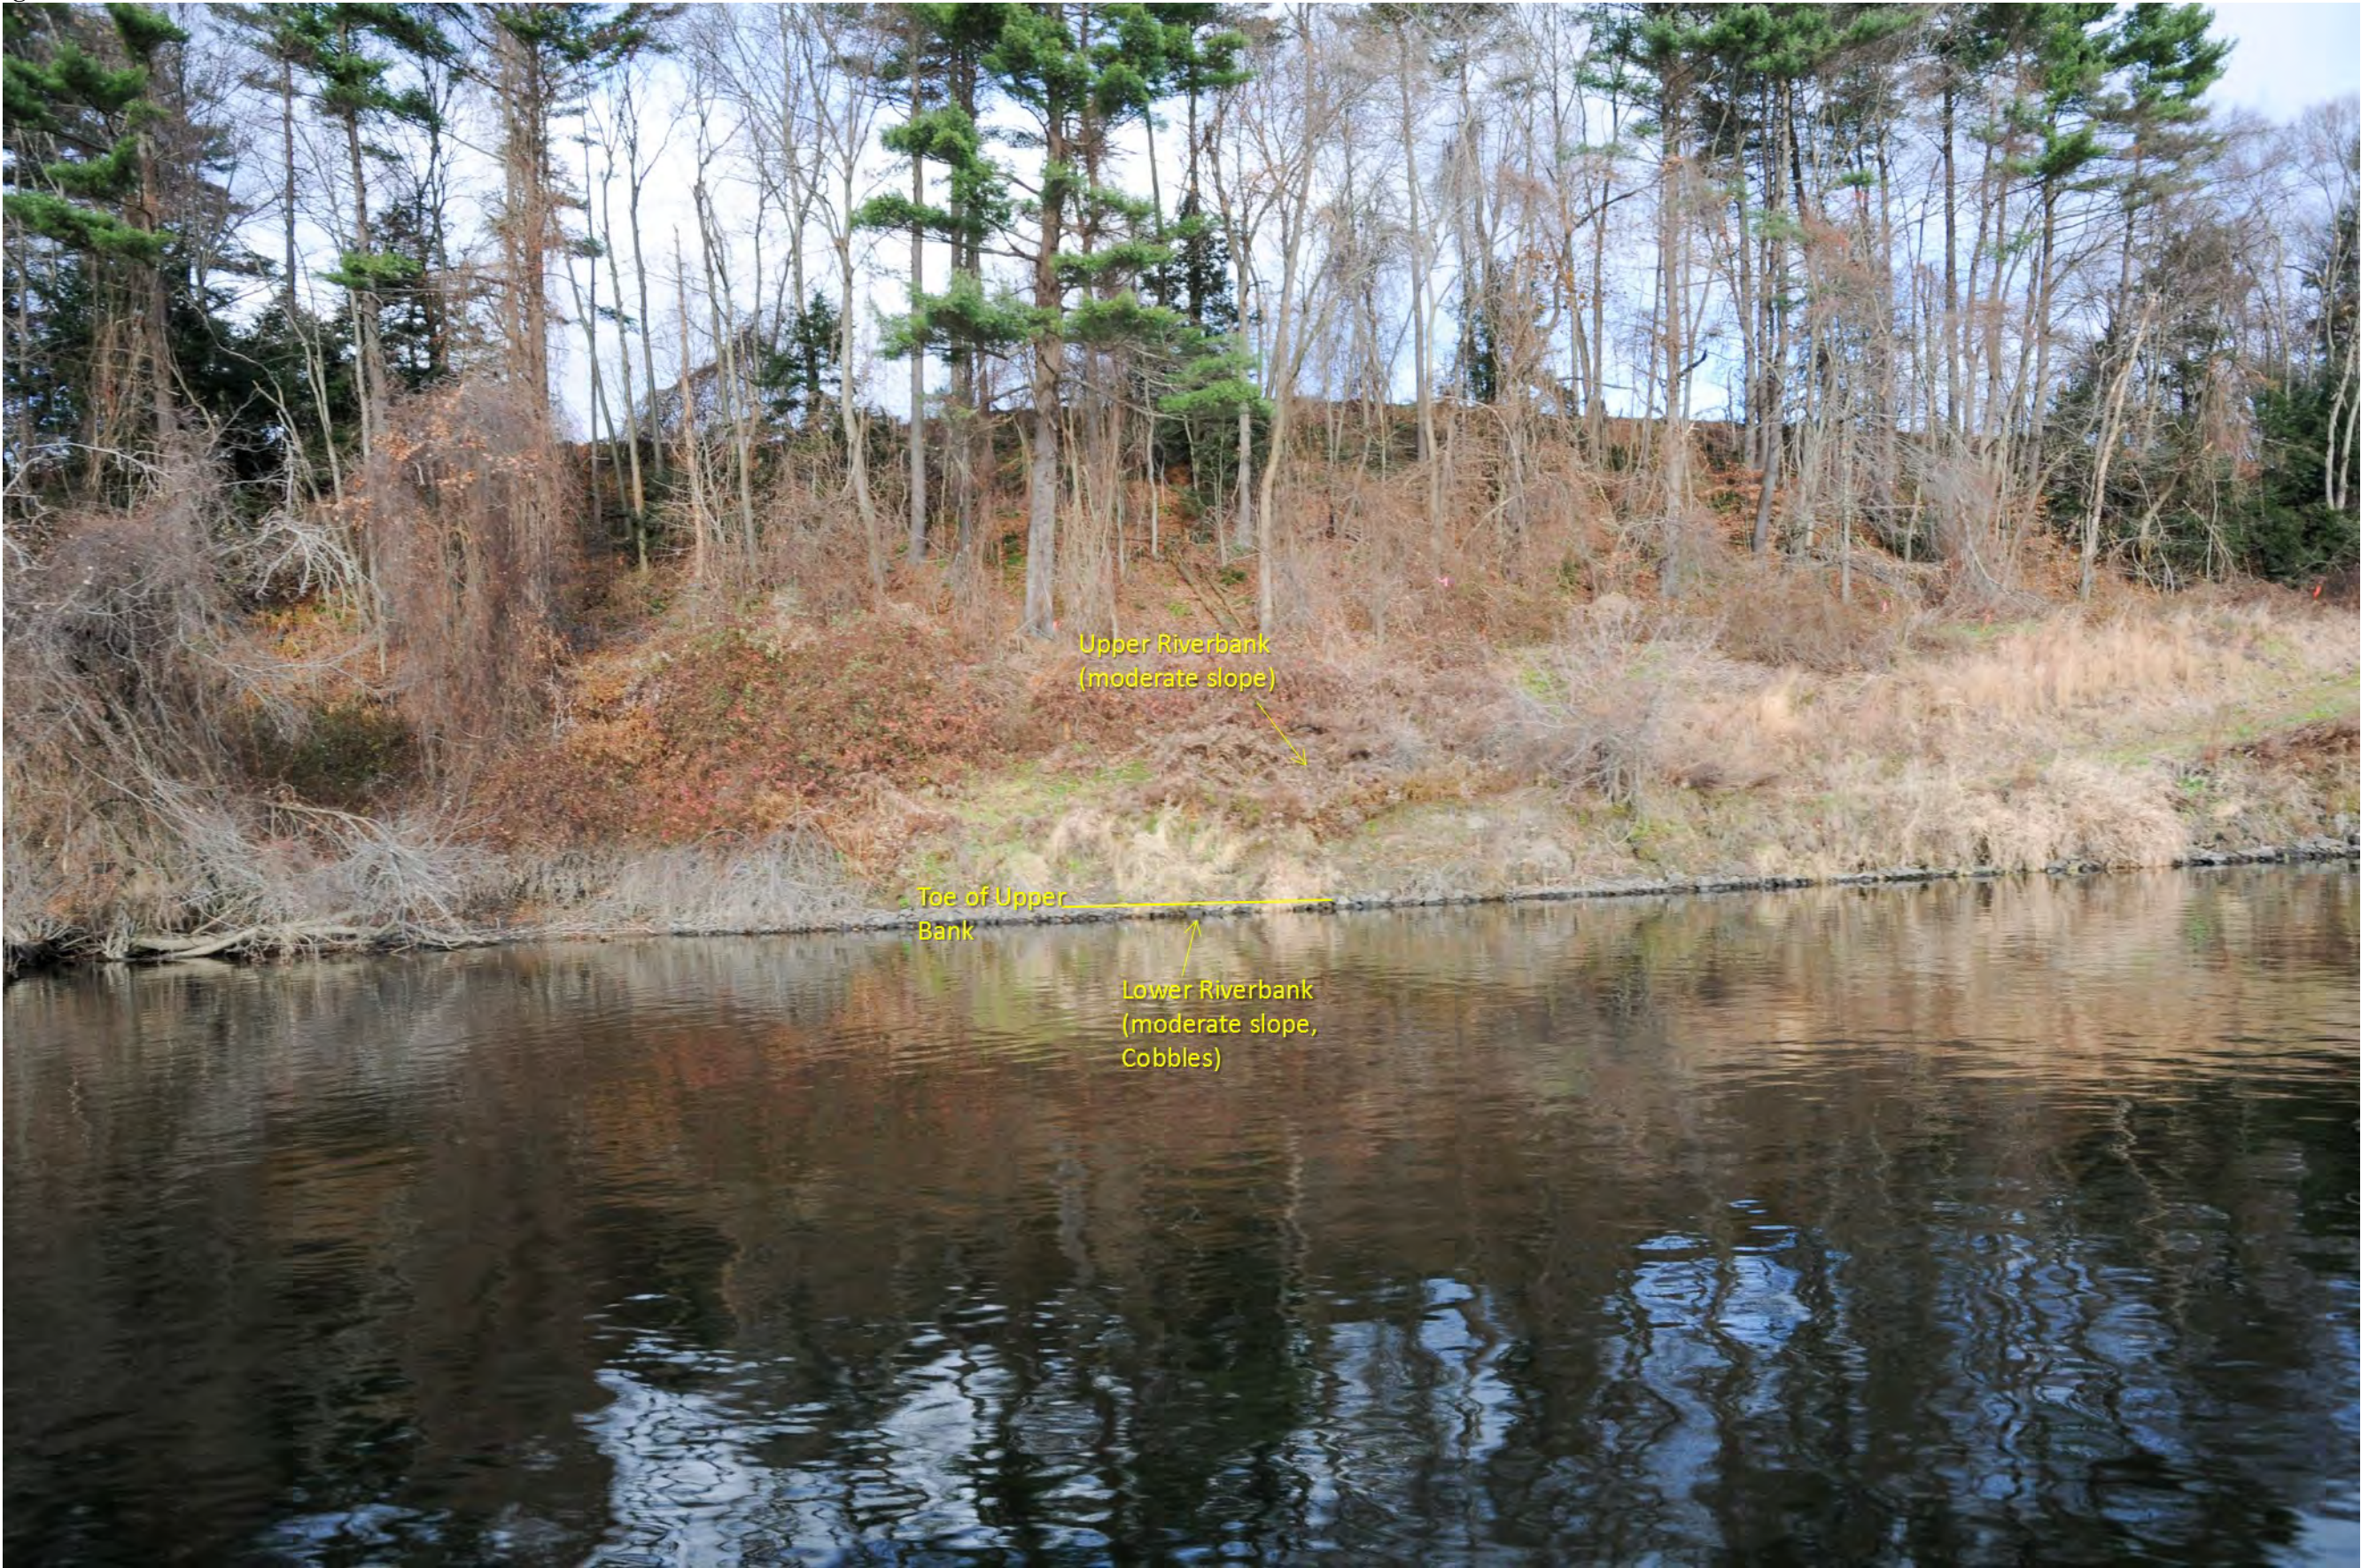
**Photo ID 1114** (segment is labeled portion of photo. Dashed line represents approximate end of segment)

Riverbank Features	Characteristics
Upper Riverbank Slope	Steep
Upper Riverbank Height	High
Upper Riverbank Sediment	Silt/Sand
Upper Riverbank Vegetation	Moderate
Lower Riverbank Slope	Flat/Beach
Lower Riverbank Sediment	Silt/Sand
Lower Riverbank Vegetation	None to very sparse
Type of Erosion	
Potential Erosion Indicators	None
Stage of Erosion	Stable
Extent of Erosion	None/Little

**QA Observations:** Upon review of the photos for this segment, classification made in the field was confirmed.

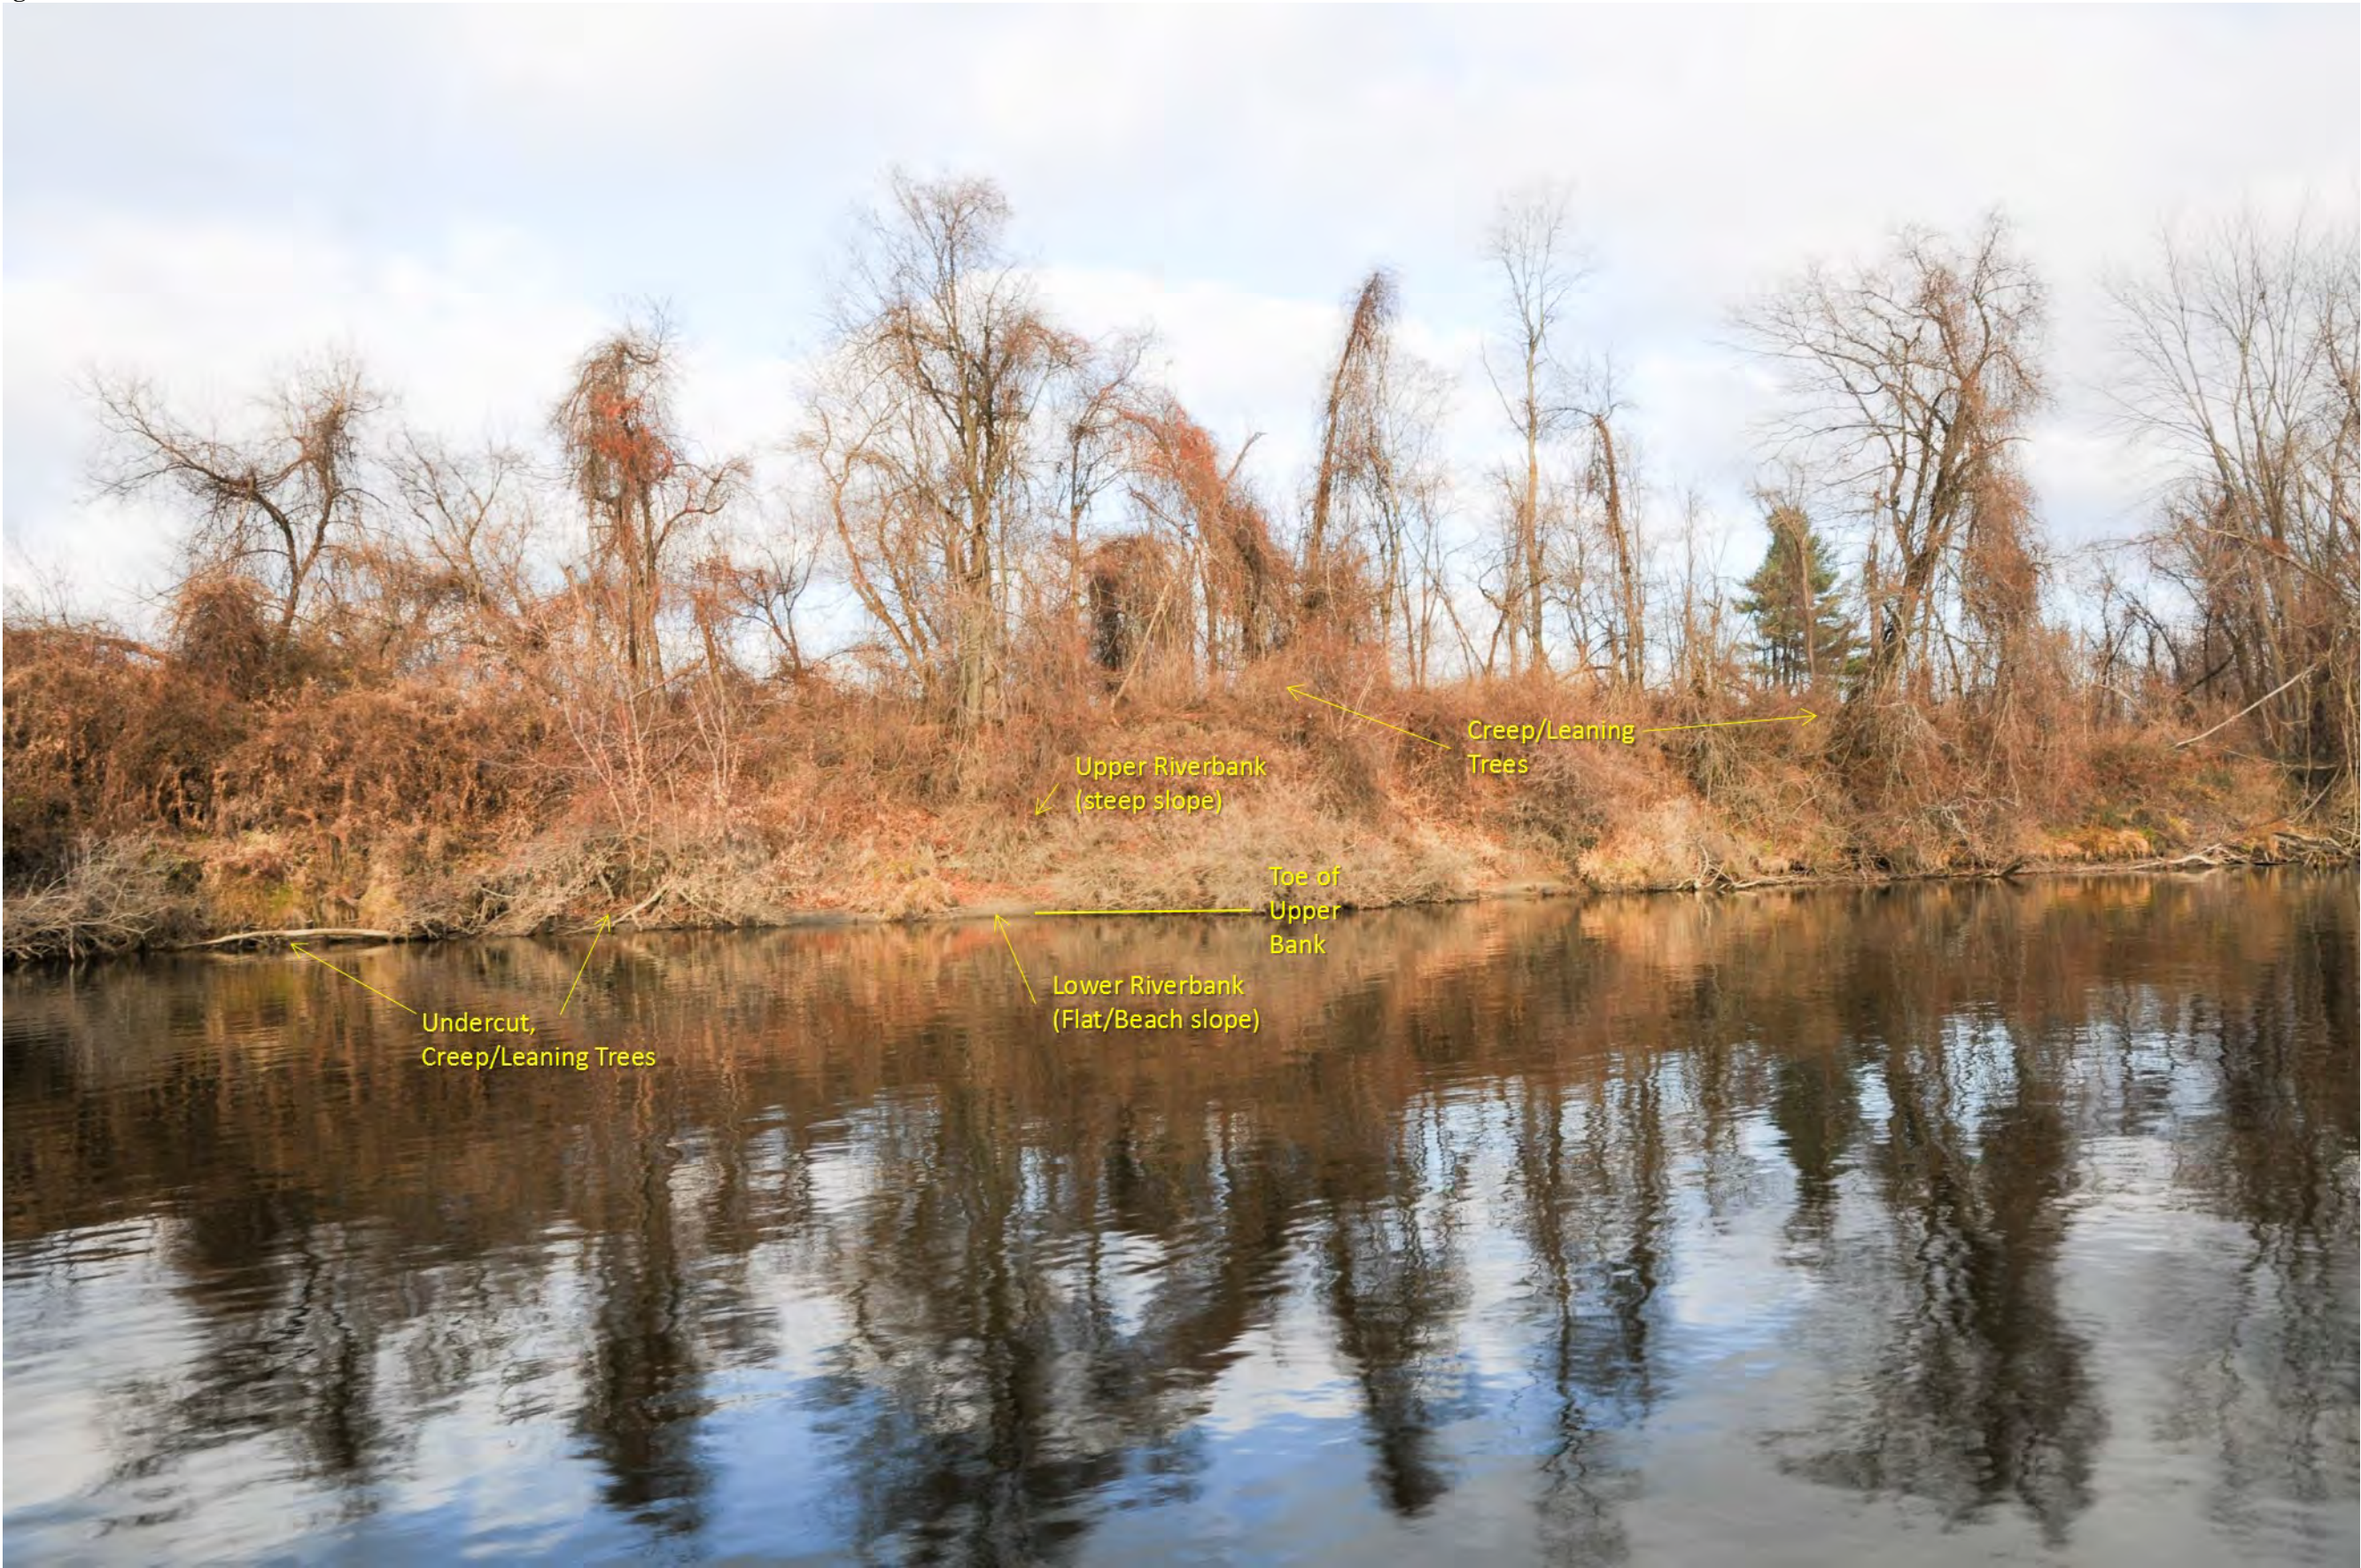
Photo ID 1156 (U/S)

Riverbank Features	Characteristics
Upper Riverbank Slope	Moderate
Upper Riverbank Height	High
Upper Riverbank Sediment	Silt/Sand
Upper Riverbank Vegetation	Heavy
Lower Riverbank Slope	Moderate
Lower Riverbank Sediment	Cobbles
Lower Riverbank Vegetation	None to very sparse
Type of Erosion	
Potential Erosion Indicators	None
Stage of Erosion	Stable
Extent of Erosion	None/Little

**QA Observations:** Upon review of the photos for this segment, classification made in the field was confirmed.

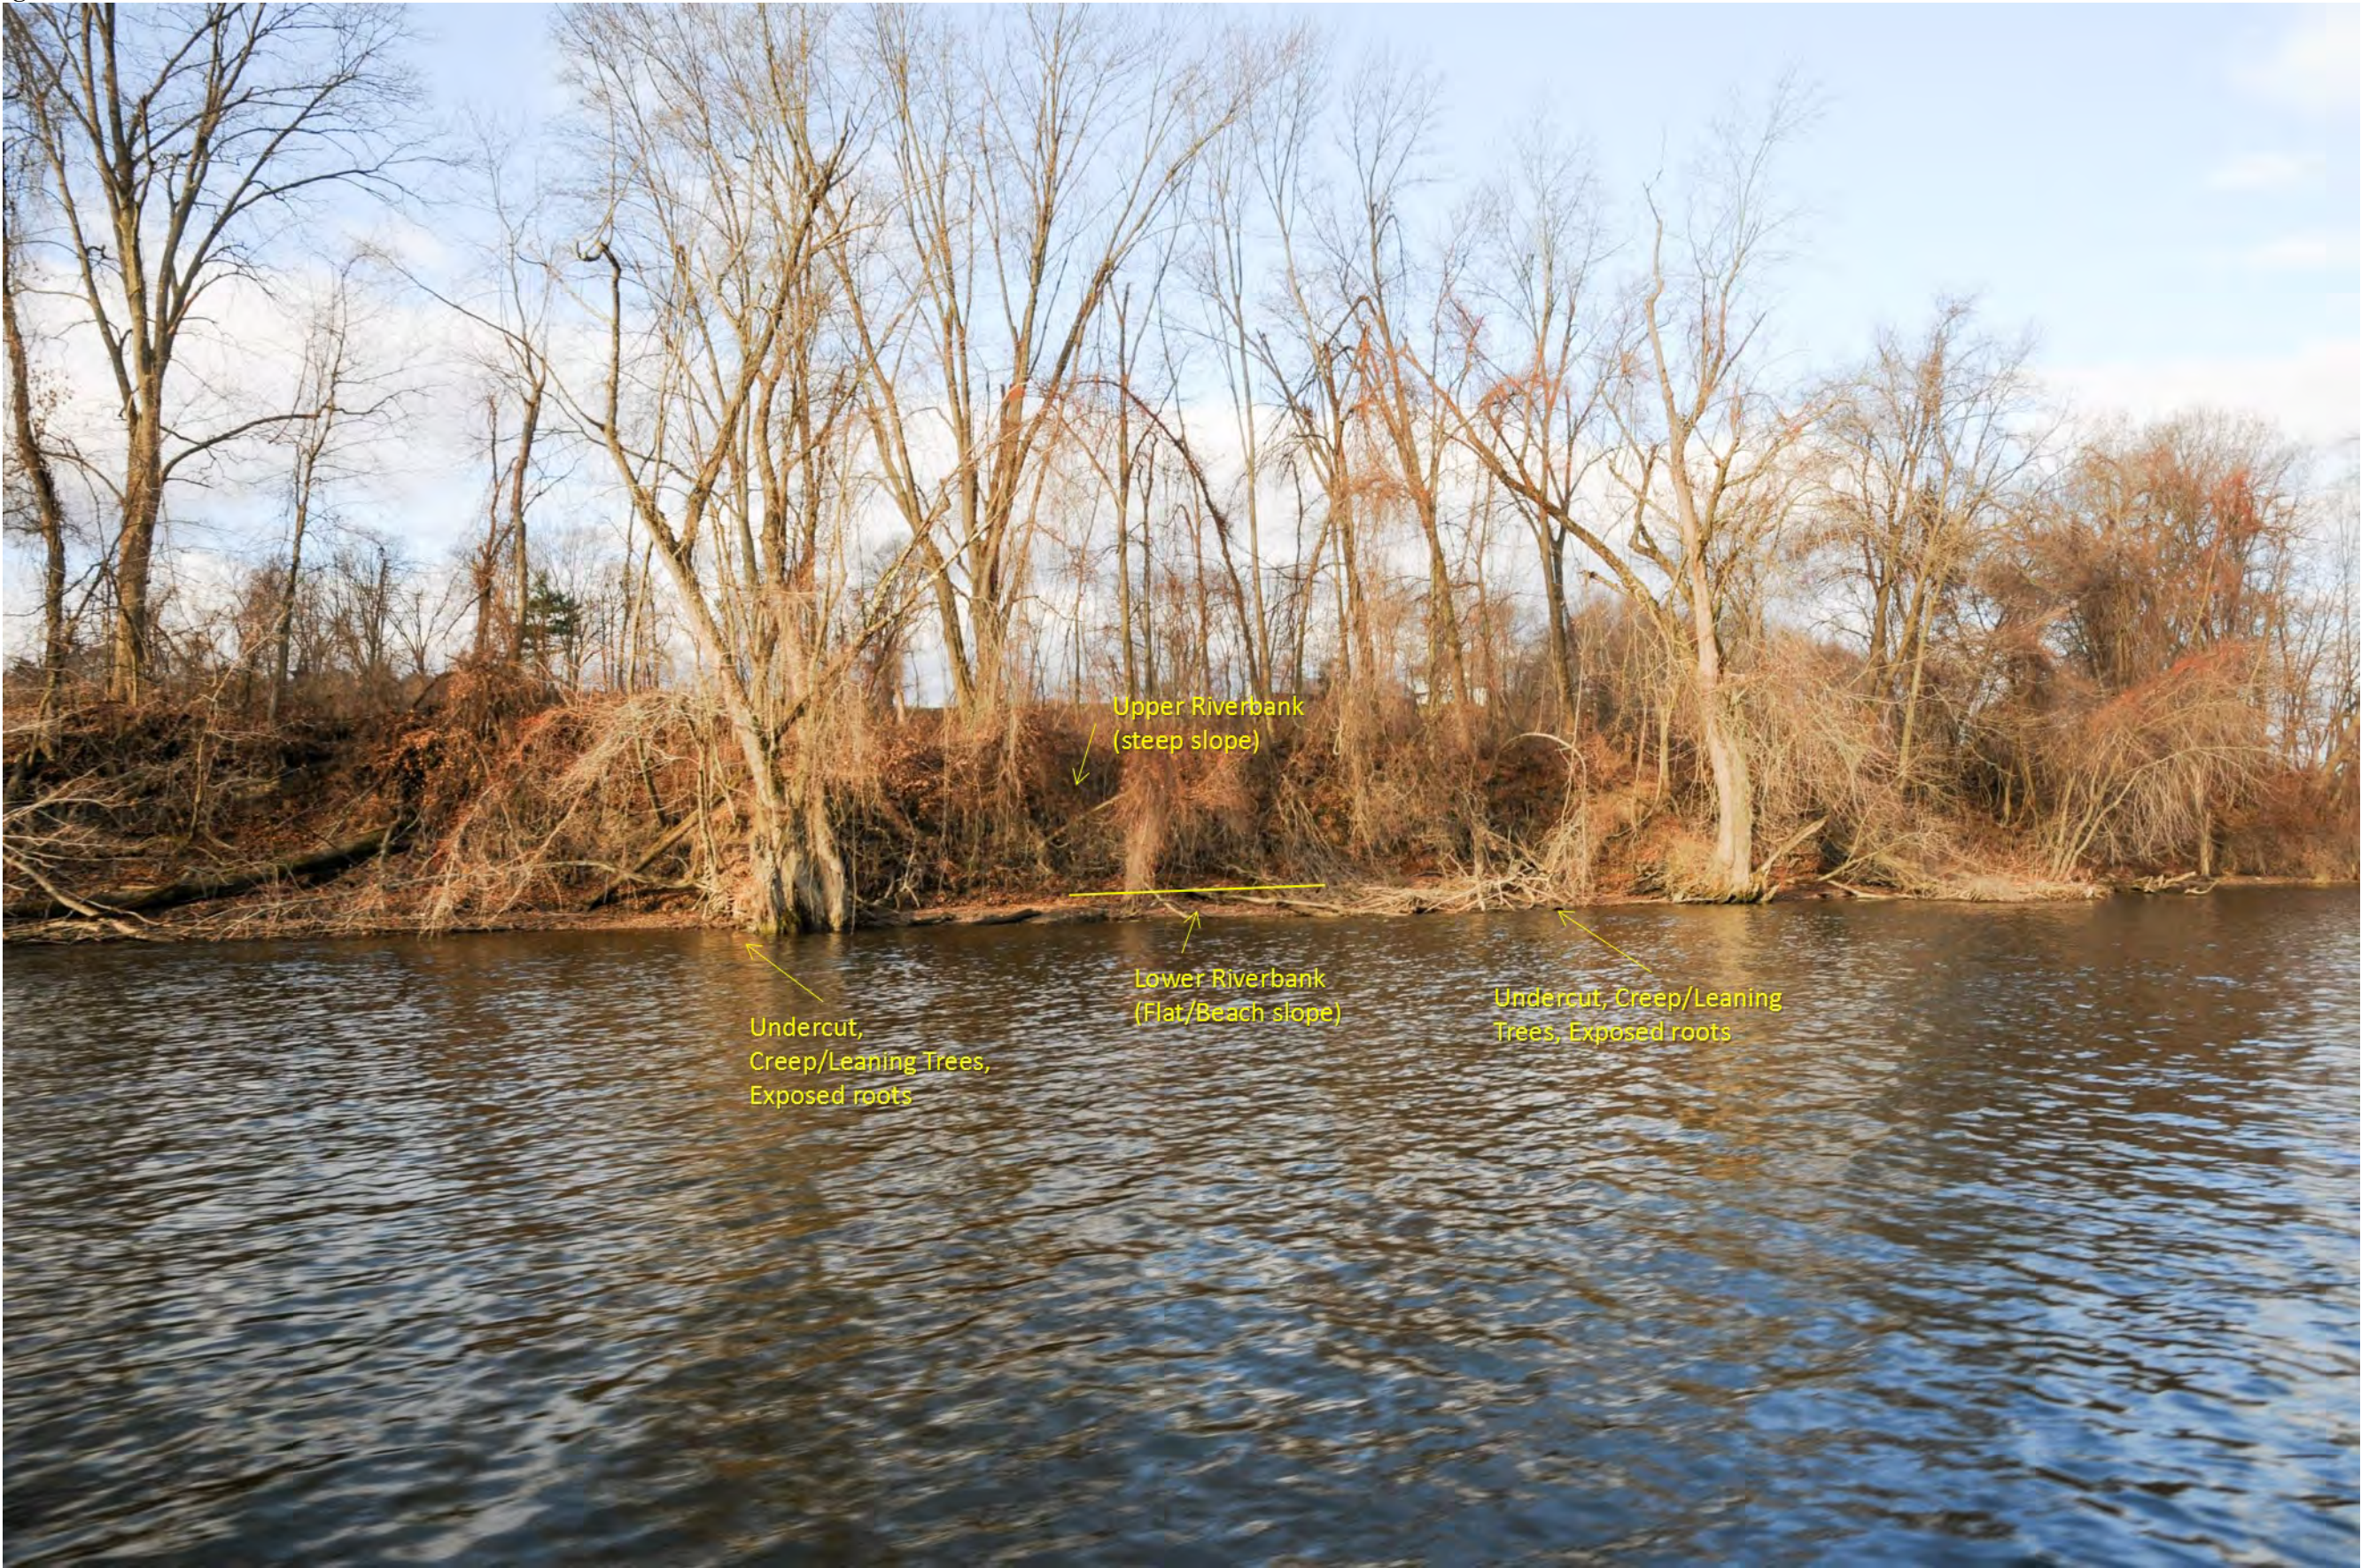
Photo ID 1183 (near mid-segment)

Riverbank Features	Characteristics
Upper Riverbank Slope	Steep
Upper Riverbank Height	Low
Upper Riverbank Sediment	Silt/Sand
Upper Riverbank Vegetation	Heavy
Lower Riverbank Slope	Flat/Beach
Lower Riverbank Sediment	Silt/Sand
Lower Riverbank Vegetation	None to very sparse
Type of Erosion	Undercut
Potential Erosion Indicators	Creep/leaning trees
Stage of Erosion	Stable
Extent of Erosion	None/Little

**QA Observations:** Upon review of the photos for this segment, classification made in the field was confirmed.
