Photo ID 1241 (right, U/S portion of segment with labels)  
2013 Full River Reconnaissance – 2015 Addendum  
Attachment A - **DRAFT**

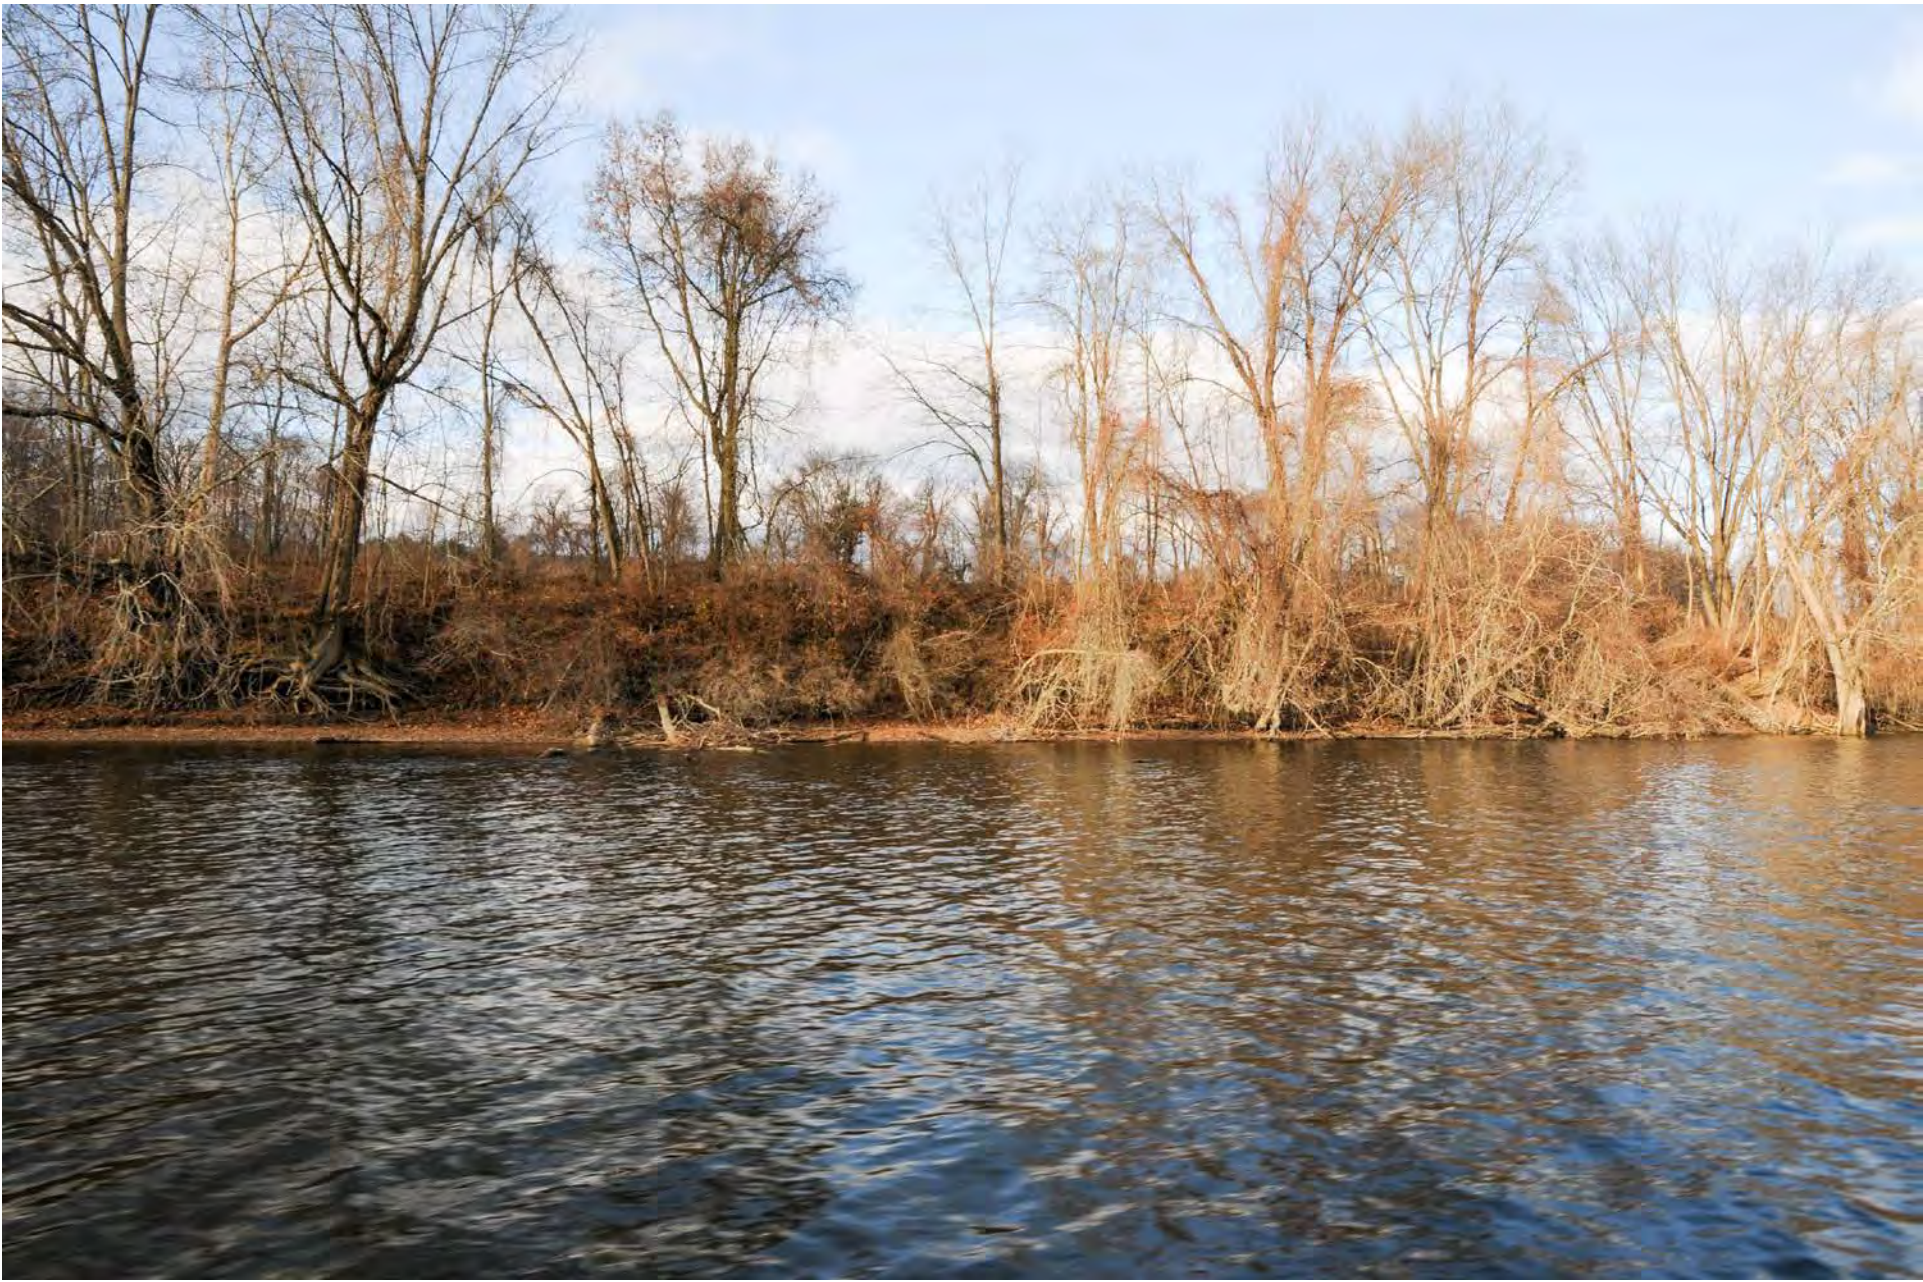
Photo ID 1222 (D/S)

Segment 520 – Right Bank

Riverbank Features	Characteristics
Upper Riverbank Slope	Steep
Upper Riverbank Height	High
Upper Riverbank Sediment	Silt/Sand
Upper Riverbank Vegetation	Heavy
Lower Riverbank Slope	Flat/Beach
Lower Riverbank Sediment	Silt/Sand
Lower Riverbank Vegetation	None to very sparse
Type of Erosion	Undercut
Potential Erosion Indicators	Creep/leaning trees, Exposed roots
Stage of Erosion	Stable
Extent of Erosion	None/Little

**QA Observations:** Upon review of the photos for this segment, classification made in the field was confirmed and additional indicators of potential future erosion were included.

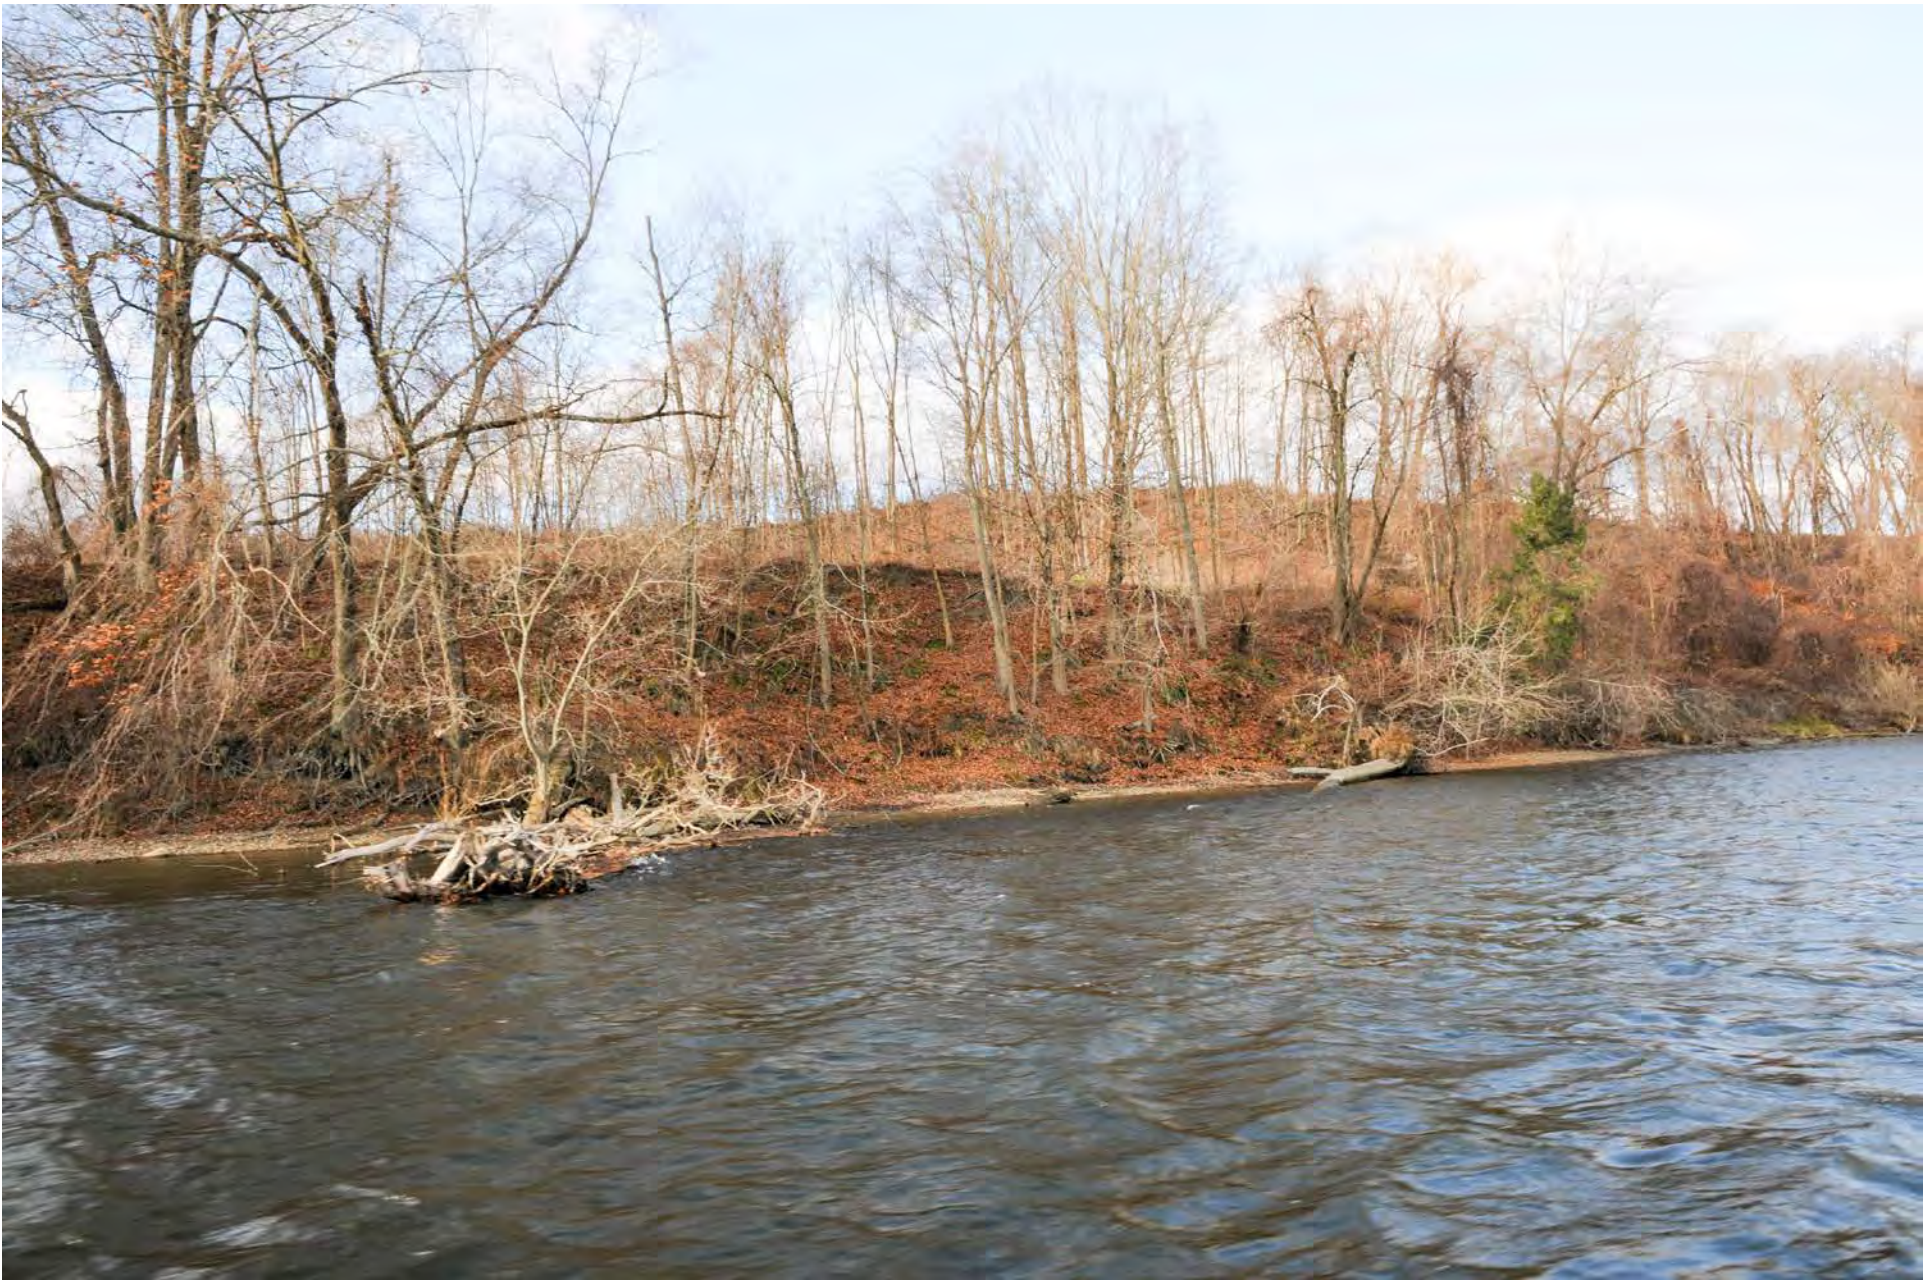
Photo ID 1240 (D/S)

Segment 530 – Right Bank

Riverbank Features	Characteristics
Upper Riverbank Slope	Moderate
Upper Riverbank Height	High
Upper Riverbank Sediment	Silt/Sand
Upper Riverbank Vegetation	Heavy
Lower Riverbank Slope	Flat/Beach
Lower Riverbank Sediment	Gravel
Lower Riverbank Vegetation	None to very sparse
Type of Erosion	Undercut
Potential Erosion Indicators	Creep/leaning trees, Exposed roots
Stage of Erosion	Stable
Extent of Erosion	None/Little

**QA Observations:** Upon review of the photos for this segment, classification made in the field was confirmed and additional indicators of potential future erosion were included.

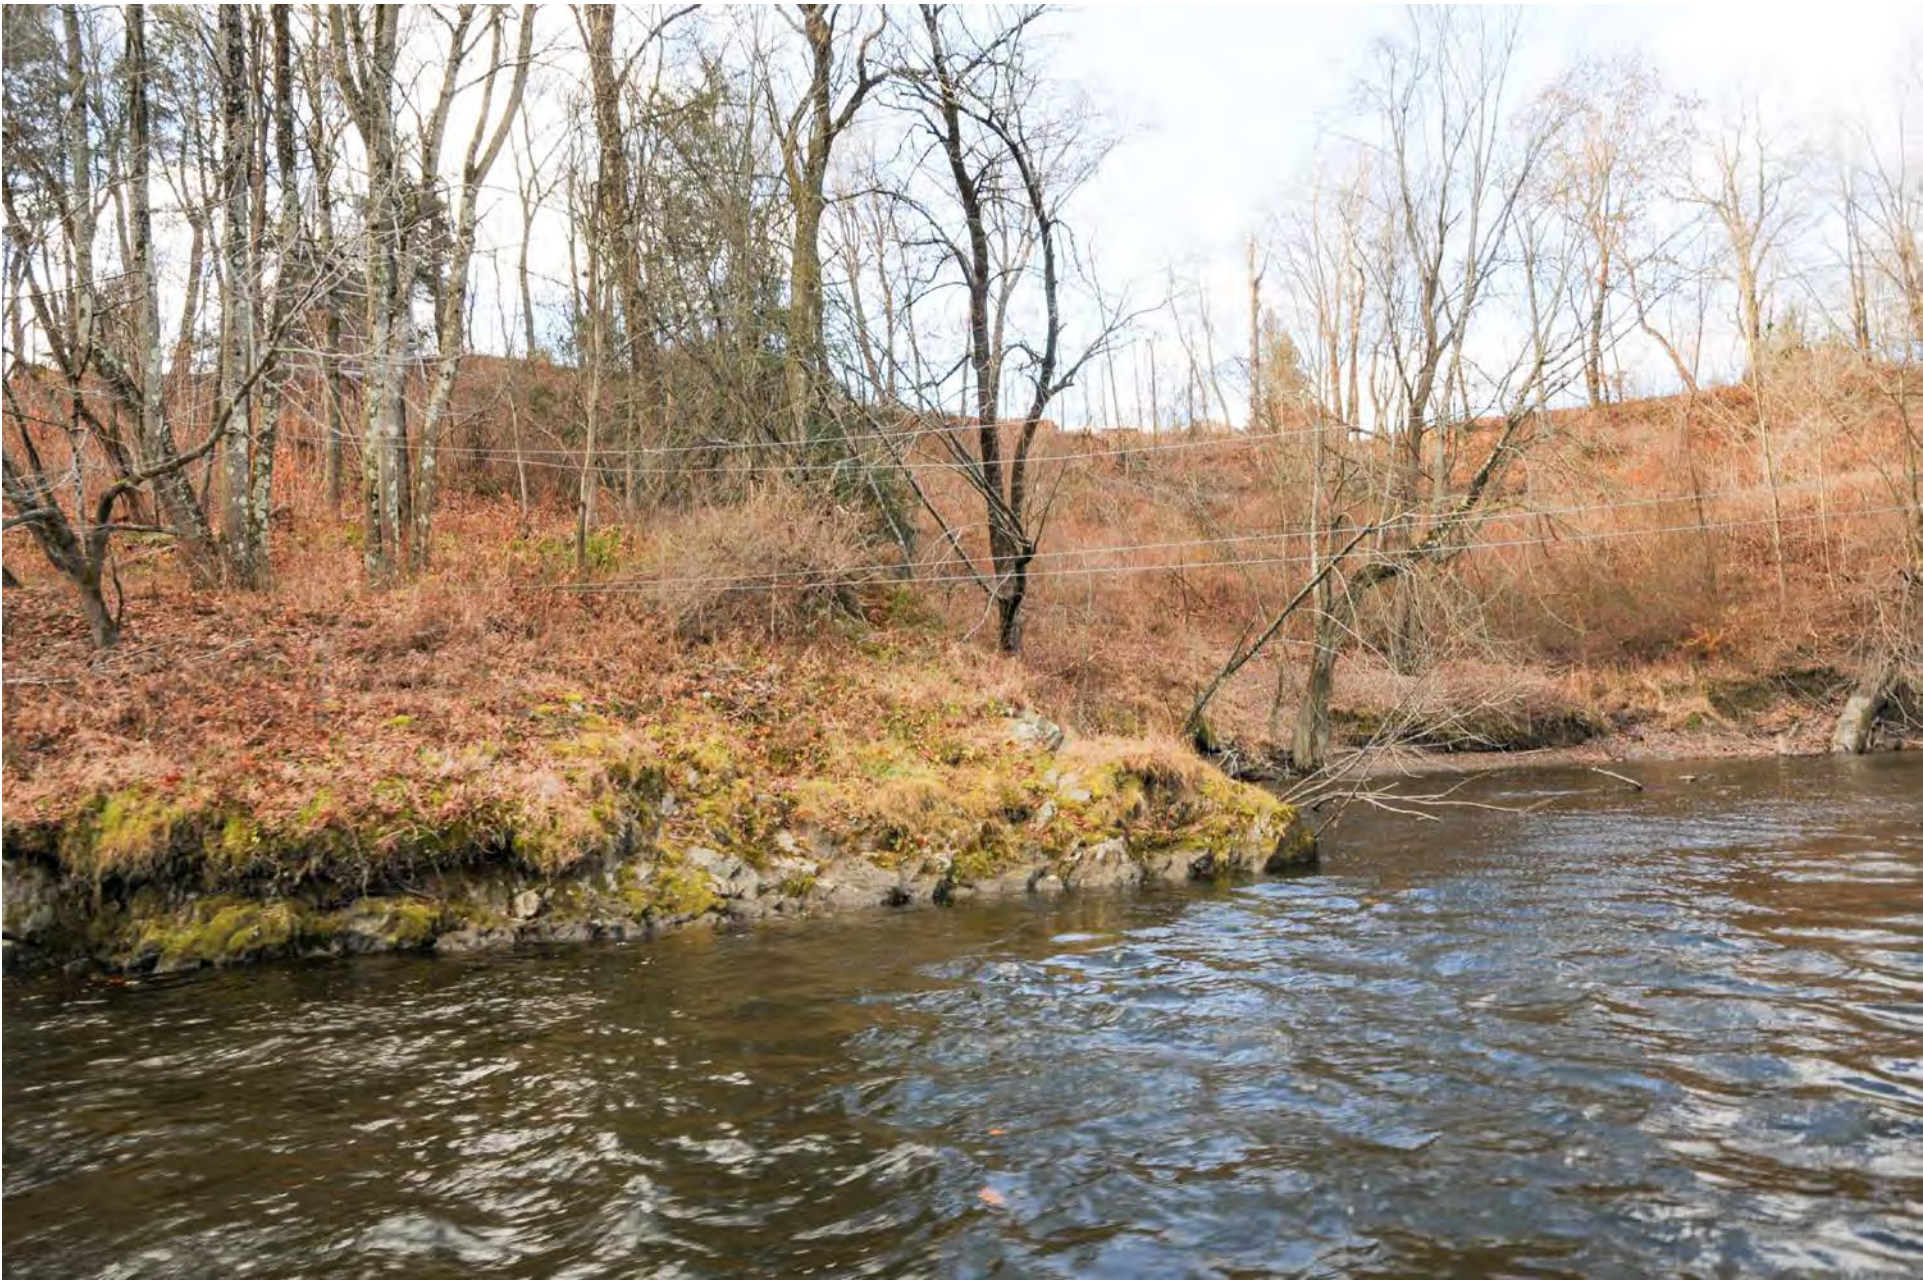
Photo ID 1258 (U/S, includes next segment)

Segment 540 – Right Bank

Riverbank Features	Characteristics
Upper Riverbank Slope	Steep
Upper Riverbank Height	High
Upper Riverbank Sediment	Bedrock
Upper Riverbank Vegetation	Moderate
Lower Riverbank Slope	Steep
Lower Riverbank Sediment	Bedrock
Lower Riverbank Vegetation	None to very sparse
Type of Erosion	
Potential Erosion Indicators	None
Stage of Erosion	Stable
Extent of Erosion	None/Little

**QA Observations:** Upon review of the photos for this segment, classification made in the field was confirmed.

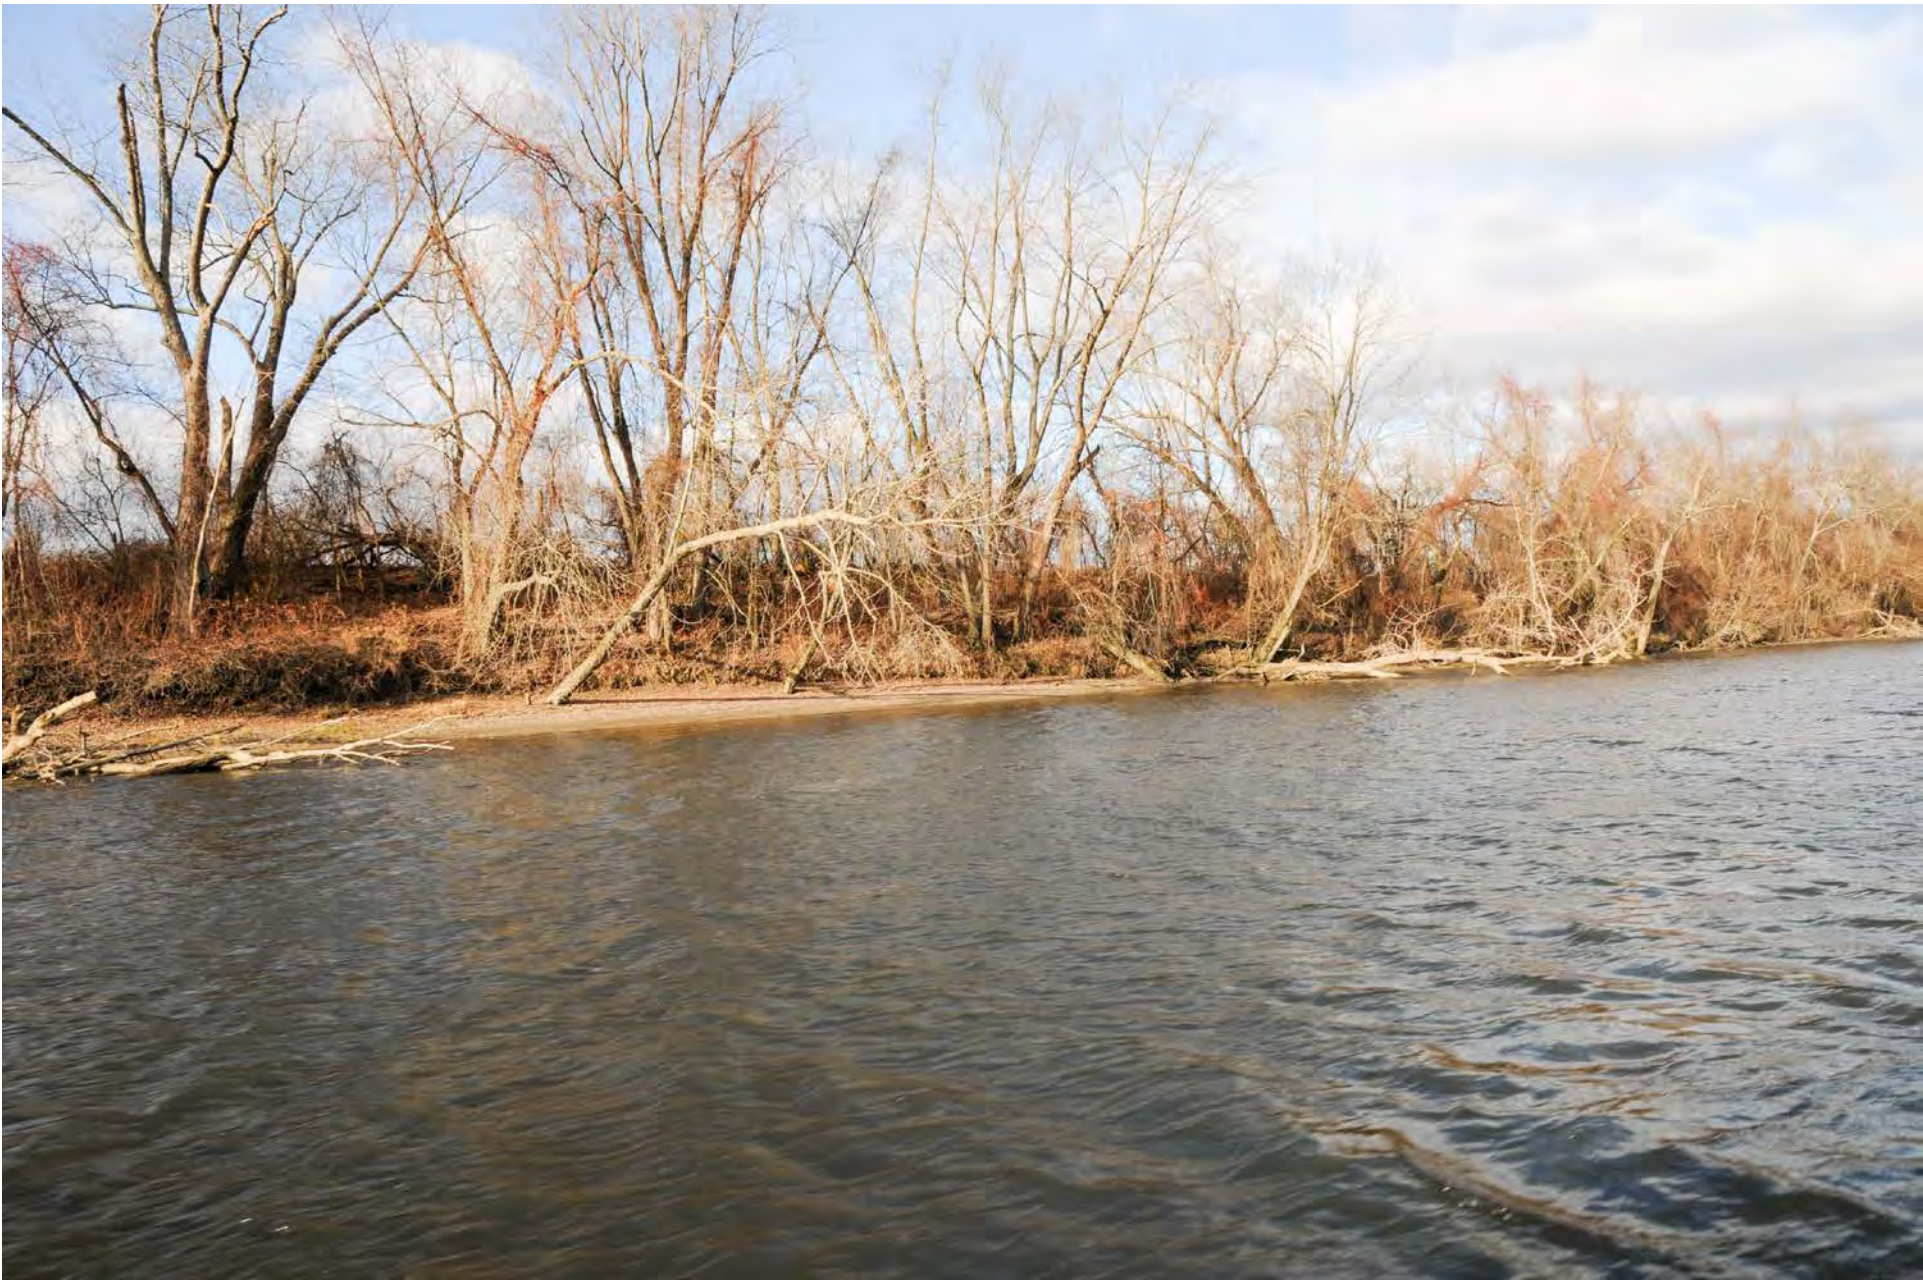
Photo ID 1297 (D/S)

Segment 550 – Right Bank

Riverbank Features	Characteristics
Upper Riverbank Slope	Moderate
Upper Riverbank Height	High
Upper Riverbank Sediment	Silt/Sand
Upper Riverbank Vegetation	Heavy
Lower Riverbank Slope	Flat/Beach
Lower Riverbank Sediment	Silt/Sand
Lower Riverbank Vegetation	None to very sparse
Type of Erosion	
Potential Erosion Indicators	Creep/leaning trees, Notch
Stage of Erosion	Stable
Extent of Erosion	None/Little

**QA Observations:** Upon review of the photos for this segment, classification made in the field was confirmed and additional indicators of potential future erosion were included.

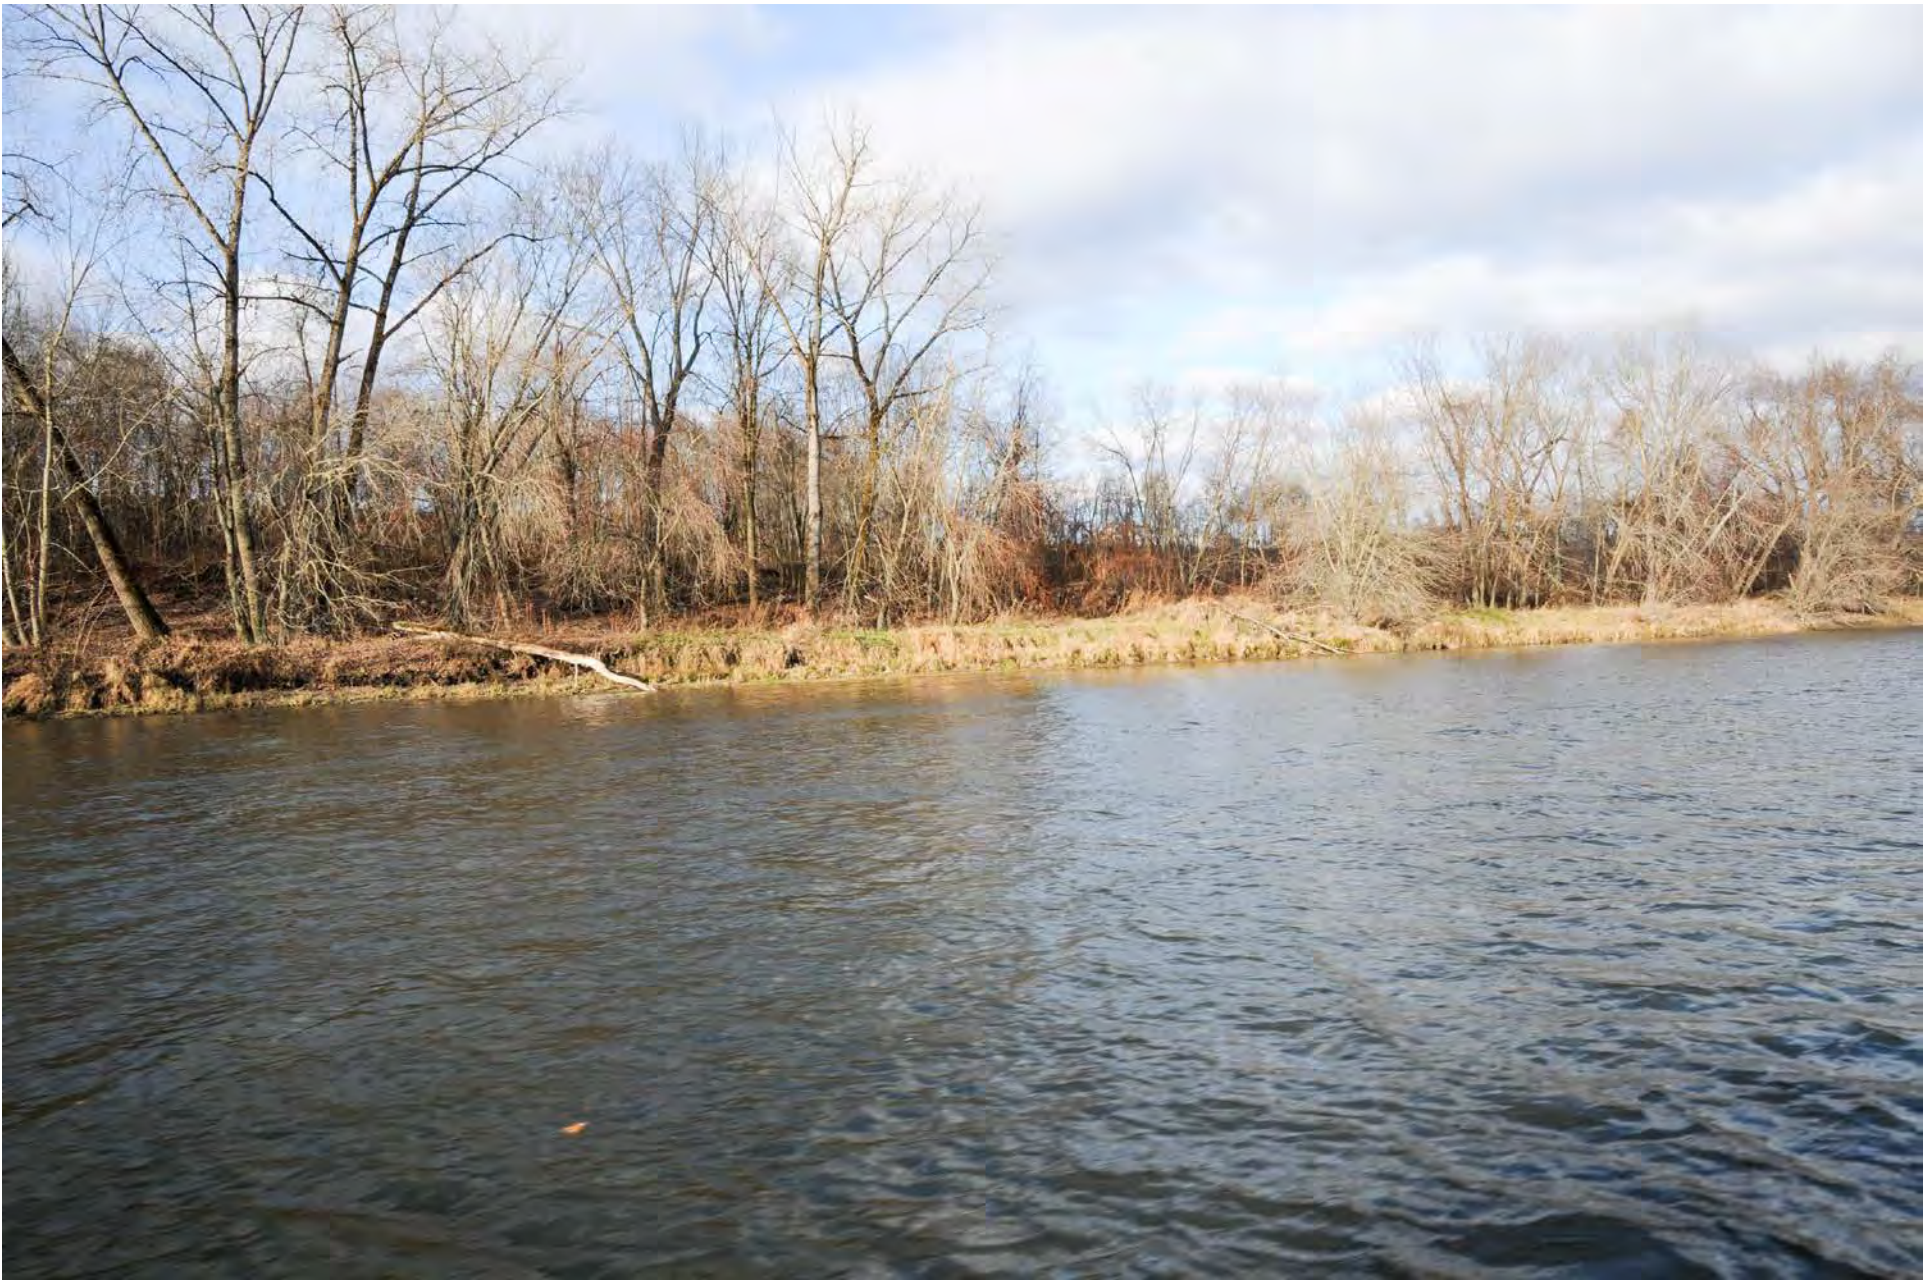
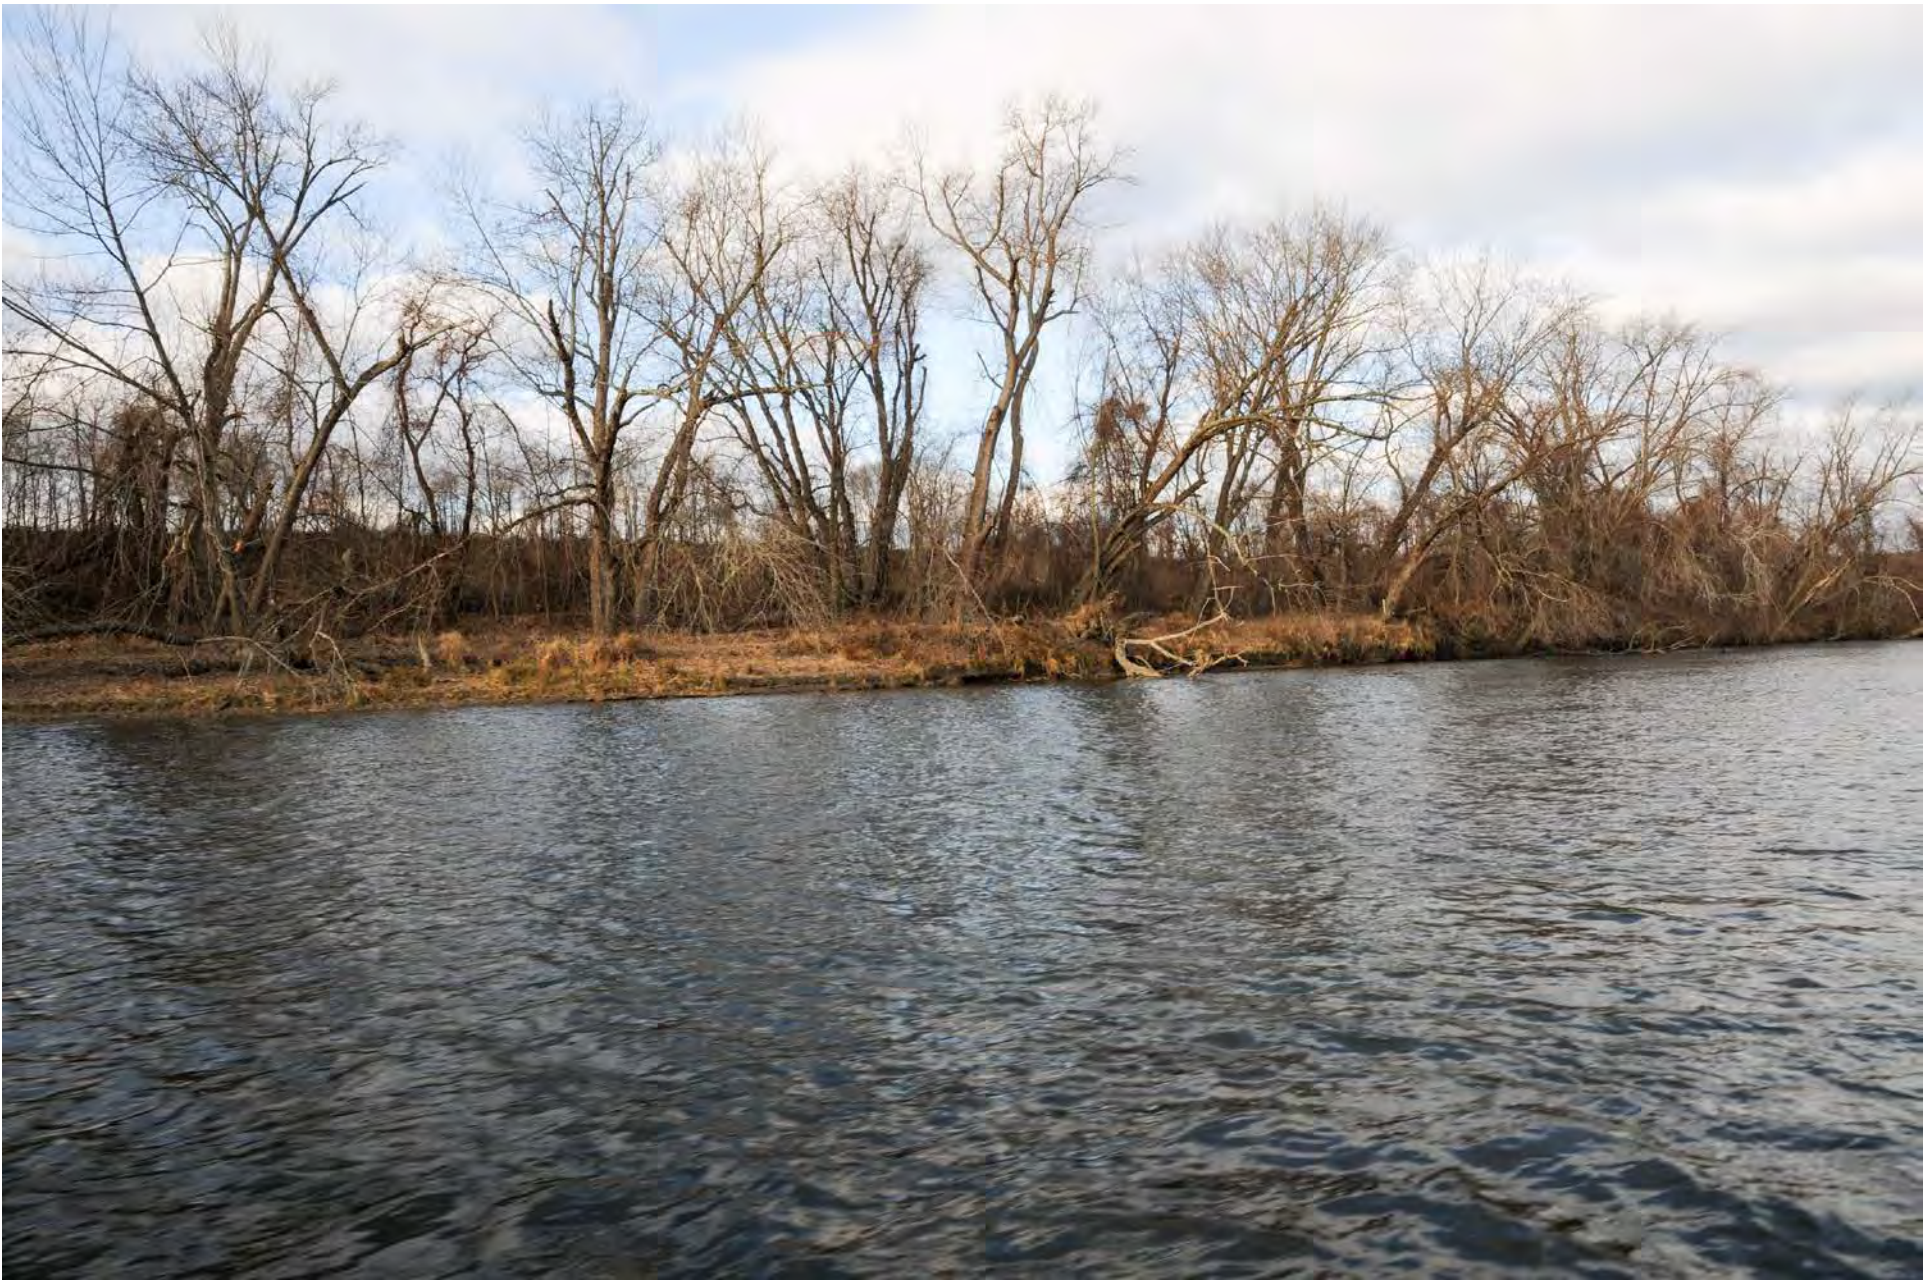
Segment 560 – Right Bank

Riverbank Features	Characteristics
Upper Riverbank Slope	Flat
Upper Riverbank Height	Low
Upper Riverbank Sediment	Silt/Sand
Upper Riverbank Vegetation	Moderate
Lower Riverbank Slope	Flat/Beach
Lower Riverbank Sediment	Silt/Sand
Lower Riverbank Vegetation	Moderate
Type of Erosion	
Potential Erosion Indicators	None
Stage of Erosion	Stable
Extent of Erosion	None/Little

**QA Observations:** Upon review of the photos for this segment, classification made in the field was confirmed.

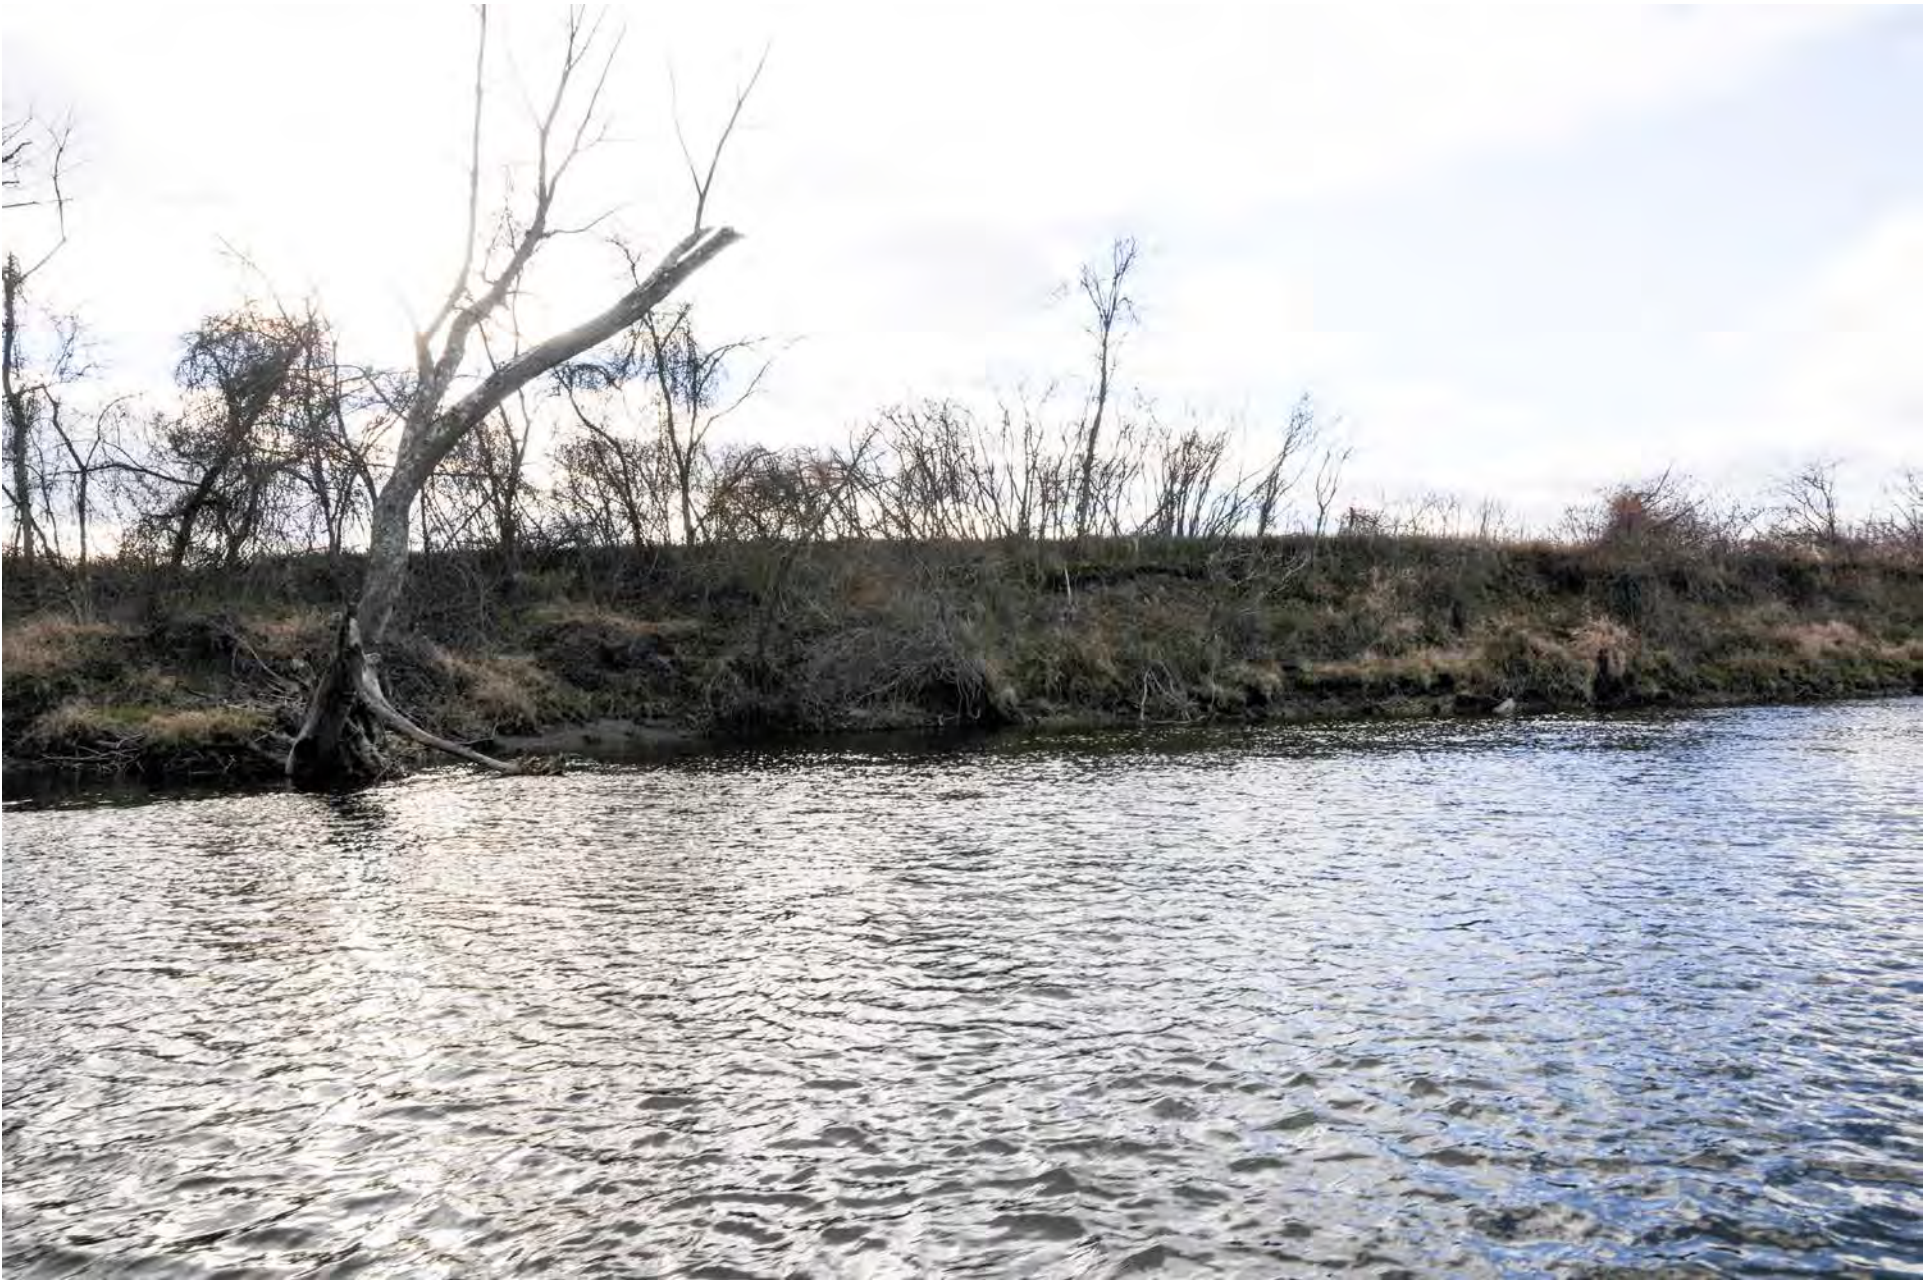
Photo ID 1338 (D/S)

Segment 570 – Right Bank

Riverbank Features	Characteristics
Upper Riverbank Slope	Steep
Upper Riverbank Height	High
Upper Riverbank Sediment	Silt/Sand
Upper Riverbank Vegetation	Heavy
Lower Riverbank Slope	Flat/Beach
Lower Riverbank Sediment	Silt/Sand
Lower Riverbank Vegetation	None to very sparse
Type of Erosion	
Potential Erosion Indicators	None
Stage of Erosion	Stable
Extent of Erosion	None/Little

**QA Observations:** Upon review of the photos for this segment, classification made in the field was confirmed.

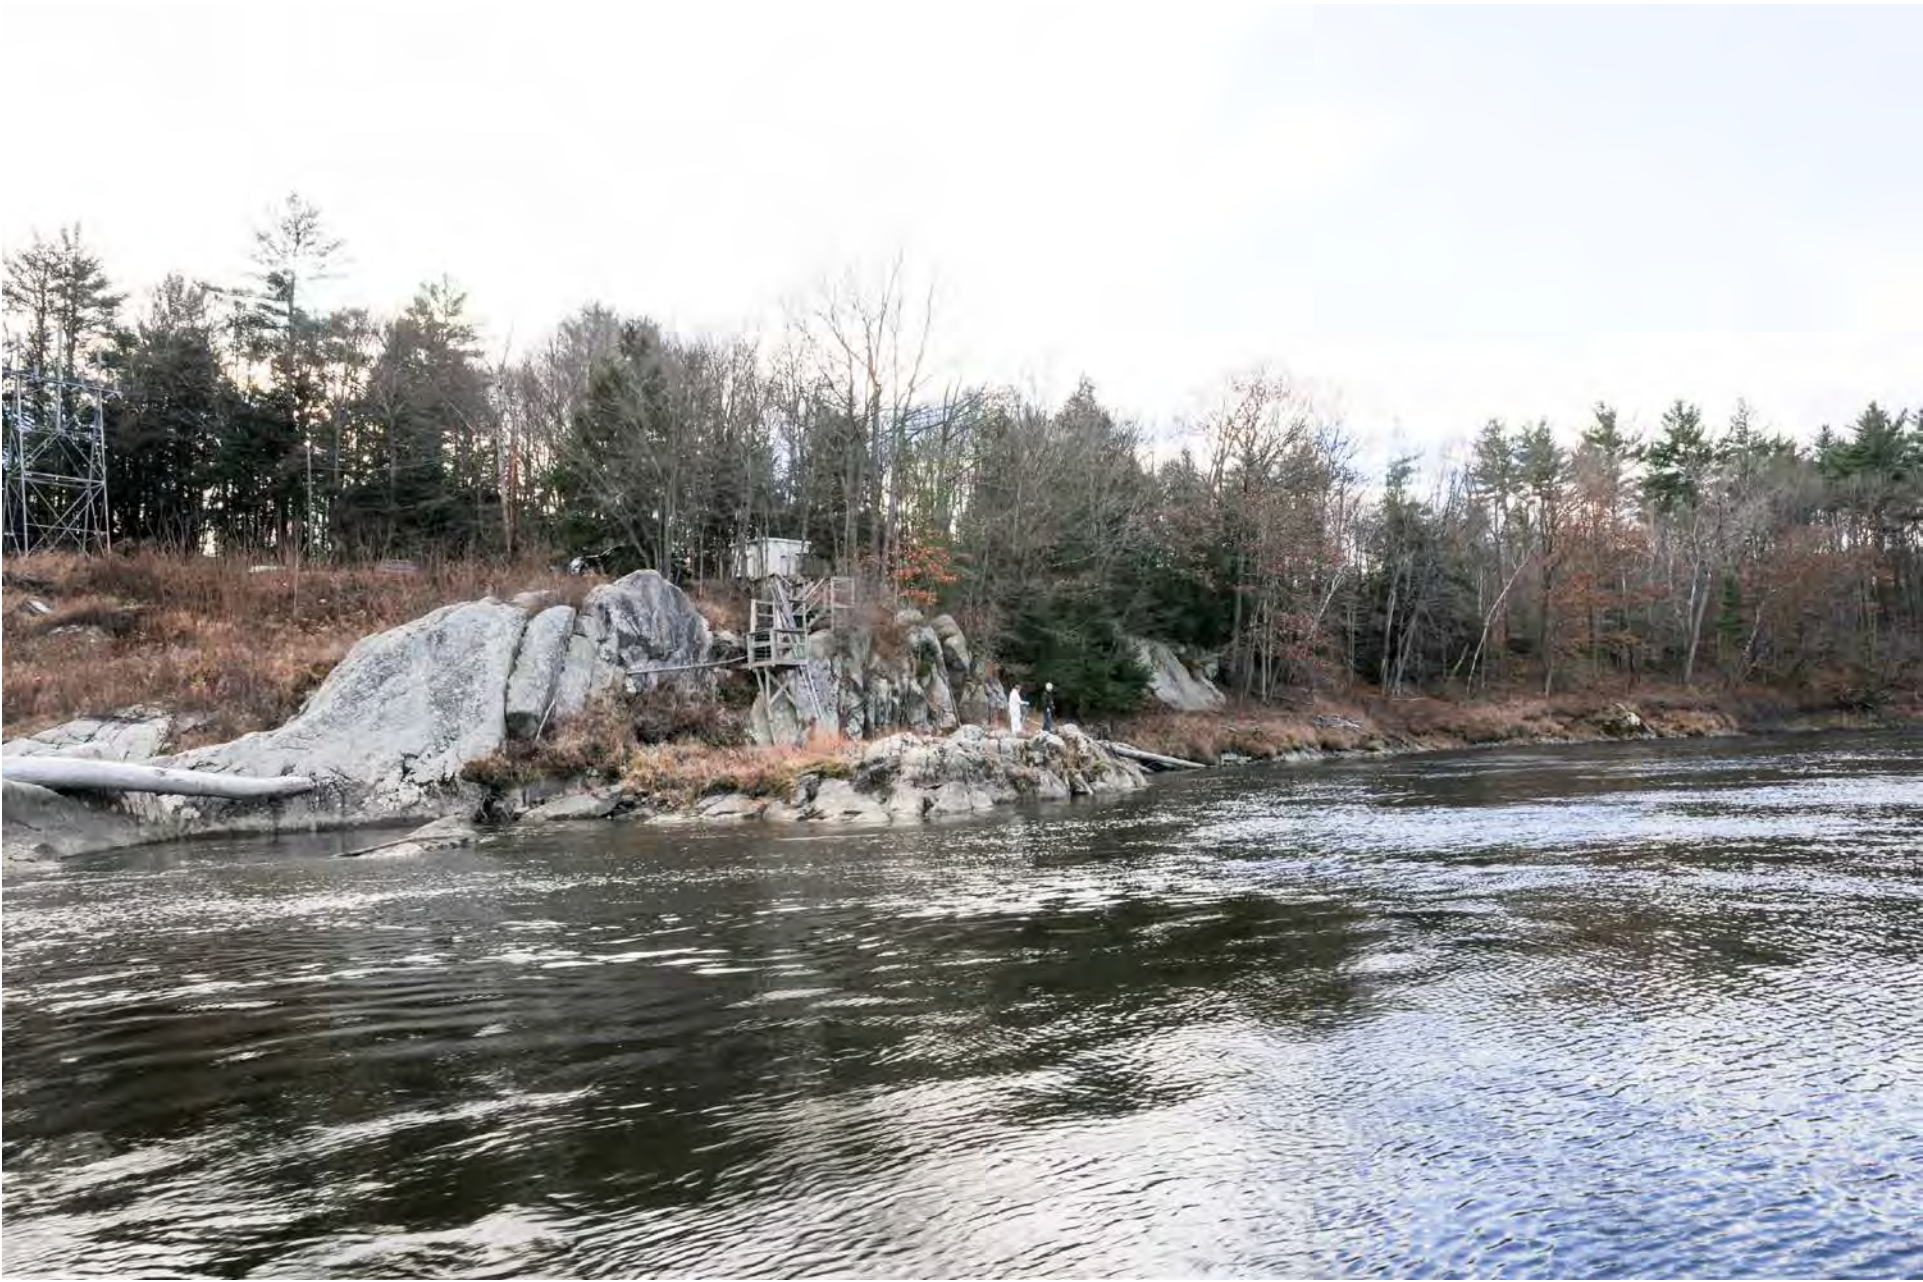
Photo ID 1369 (middle)

Segment 580 – Right Bank

Riverbank Features	Characteristics
Upper Riverbank Slope	Moderate
Upper Riverbank Height	High
Upper Riverbank Sediment	Bedrock
Upper Riverbank Vegetation	Moderate
Lower Riverbank Slope	Moderate
Lower Riverbank Sediment	Bedrock
Lower Riverbank Vegetation	None to very sparse
Type of Erosion	
Potential Erosion Indicators	None
Stage of Erosion	Stable
Extent of Erosion	None/Little

**QA Observations:** Upon review of the photos for this segment, classification made in the field was confirmed.
