Photo ID 1241 (right, U/S portion of segment with labels)  
2013 Full River Reconnaissance – 2015 Addendum  
Attachment A - **DRAFT**

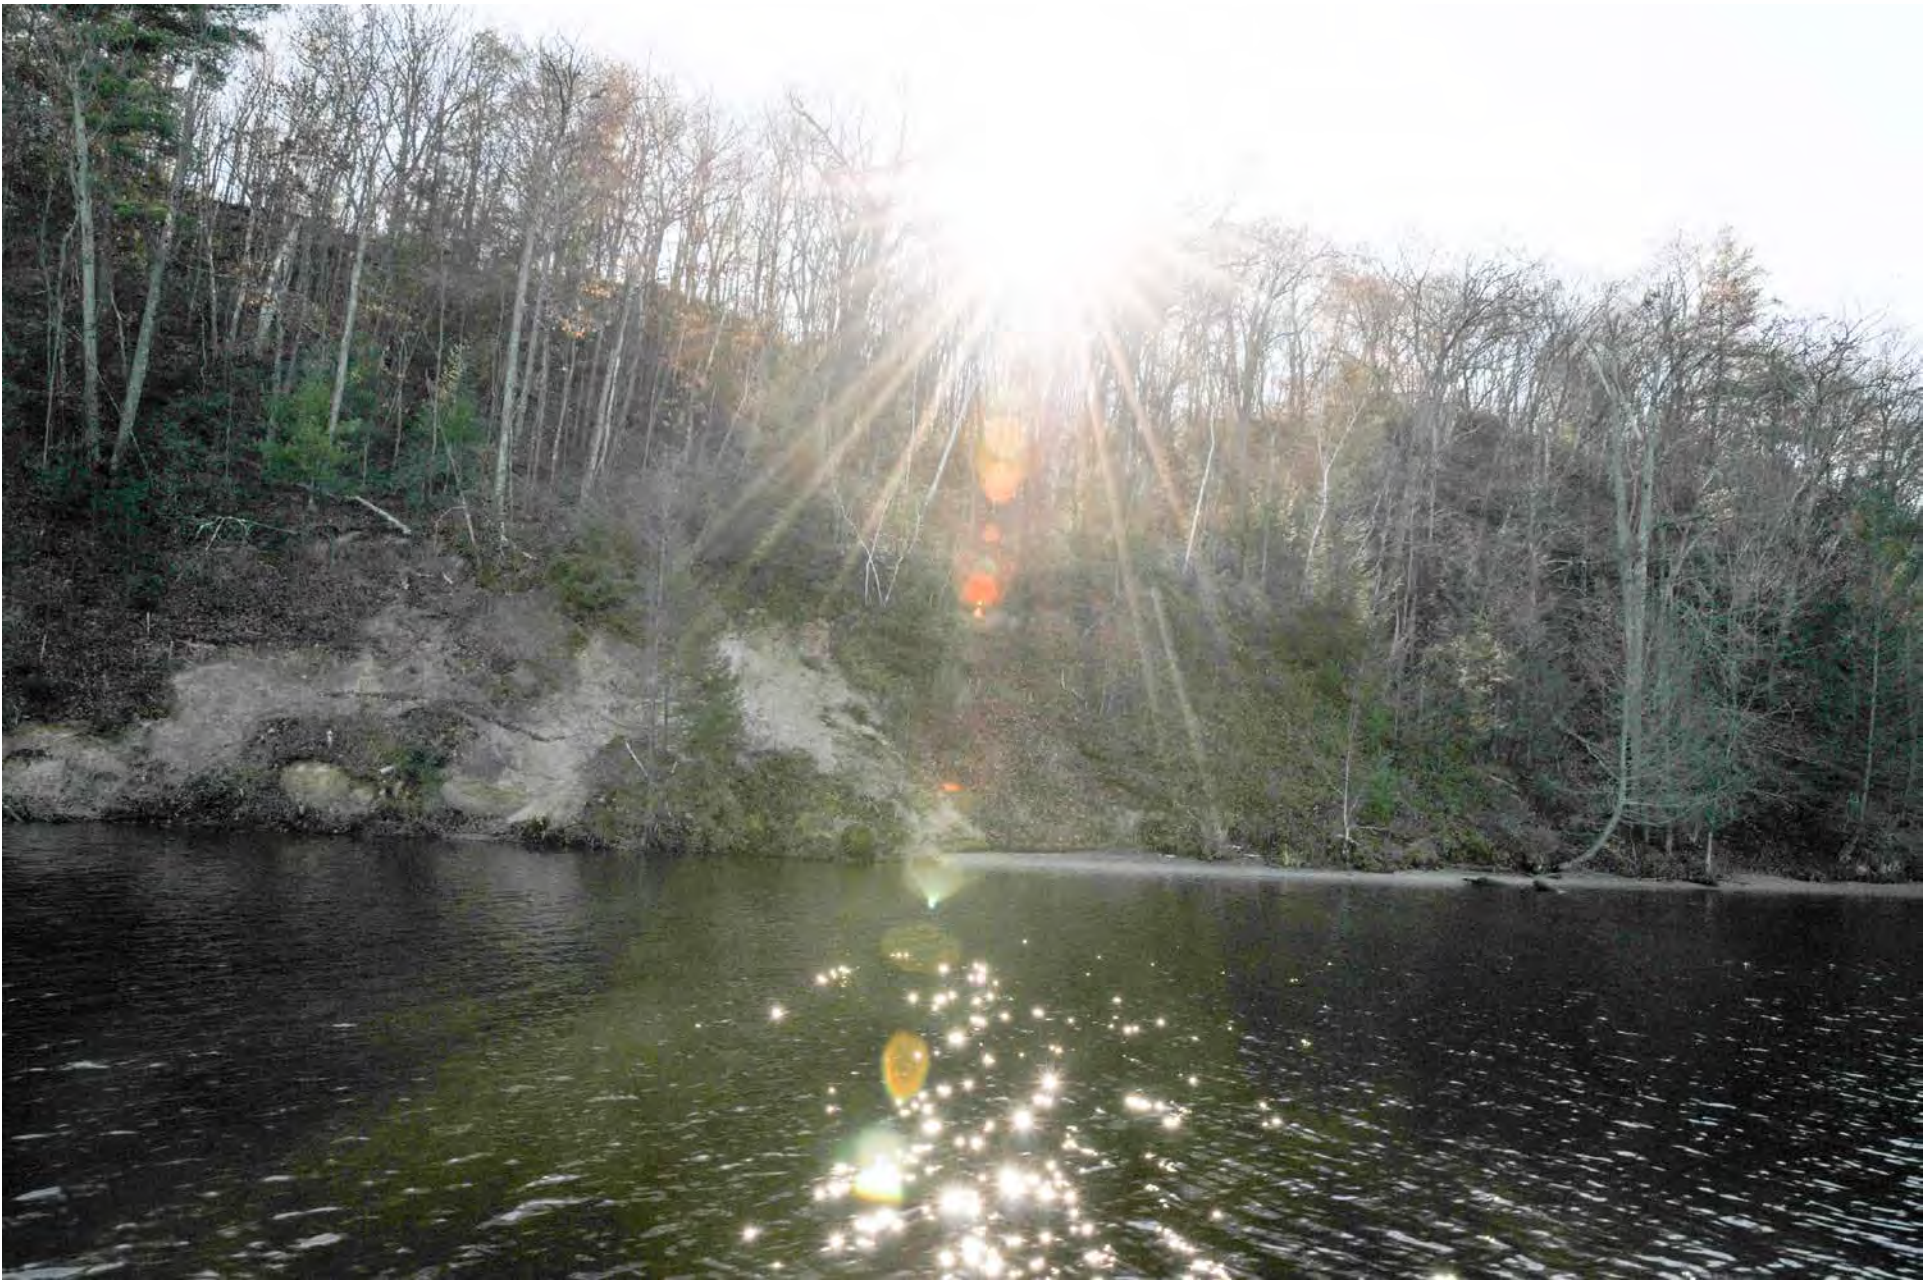
Photo ID 253 (D/S, includes next segment)

Segment 12 – Left Bank

Riverbank Features	Characteristics
Upper Riverbank Slope	Steep
Upper Riverbank Height	High
Upper Riverbank Sediment	Silt/Sand
Upper Riverbank Vegetation	Sparse
Lower Riverbank Slope	Flat/Beach
Lower Riverbank Sediment	Silt/Sand
Lower Riverbank Vegetation	None to very sparse
Type of Erosion	Planar Slip, Overhanging Bank
Potential Erosion Indicators	Overhanging Bank, Creep/leaning trees, Exposed roots, Other
Stage of Erosion	Active Erosion
Extent of Erosion	Extensive

**QA Observations:** Upon review of the photos for this segment, classification made in the field was confirmed and additional indicators of potential future erosion were included.

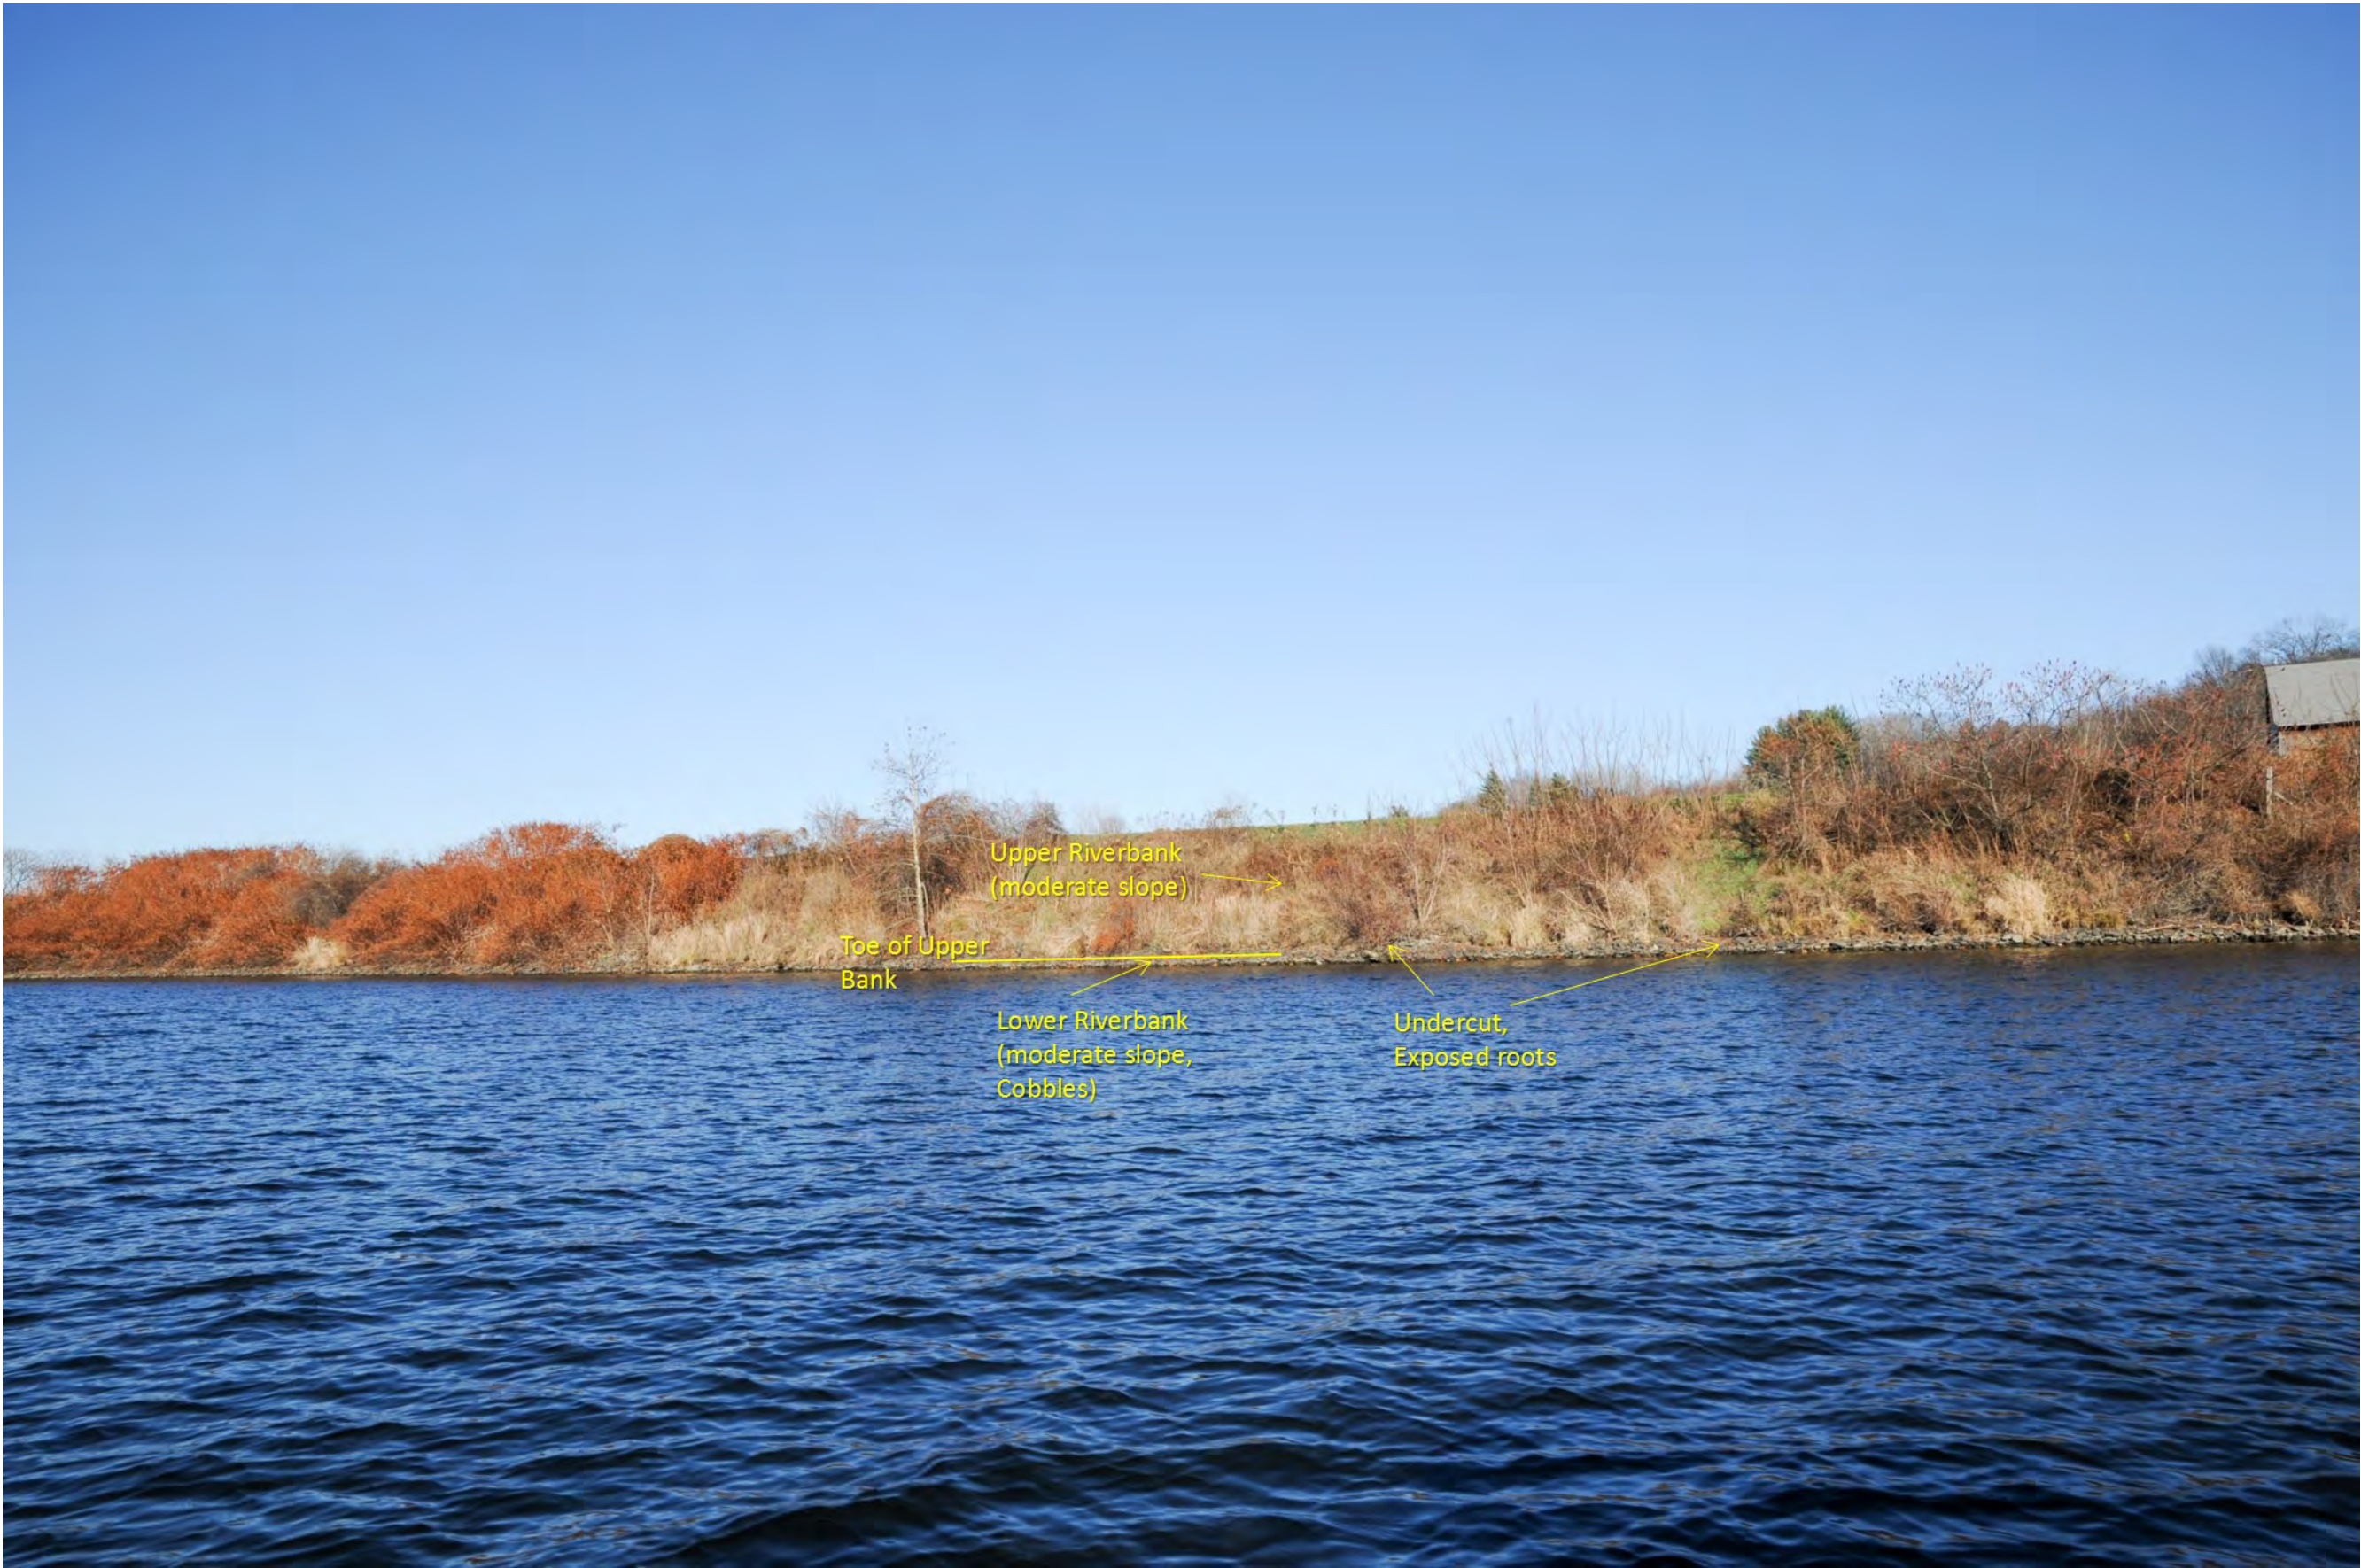
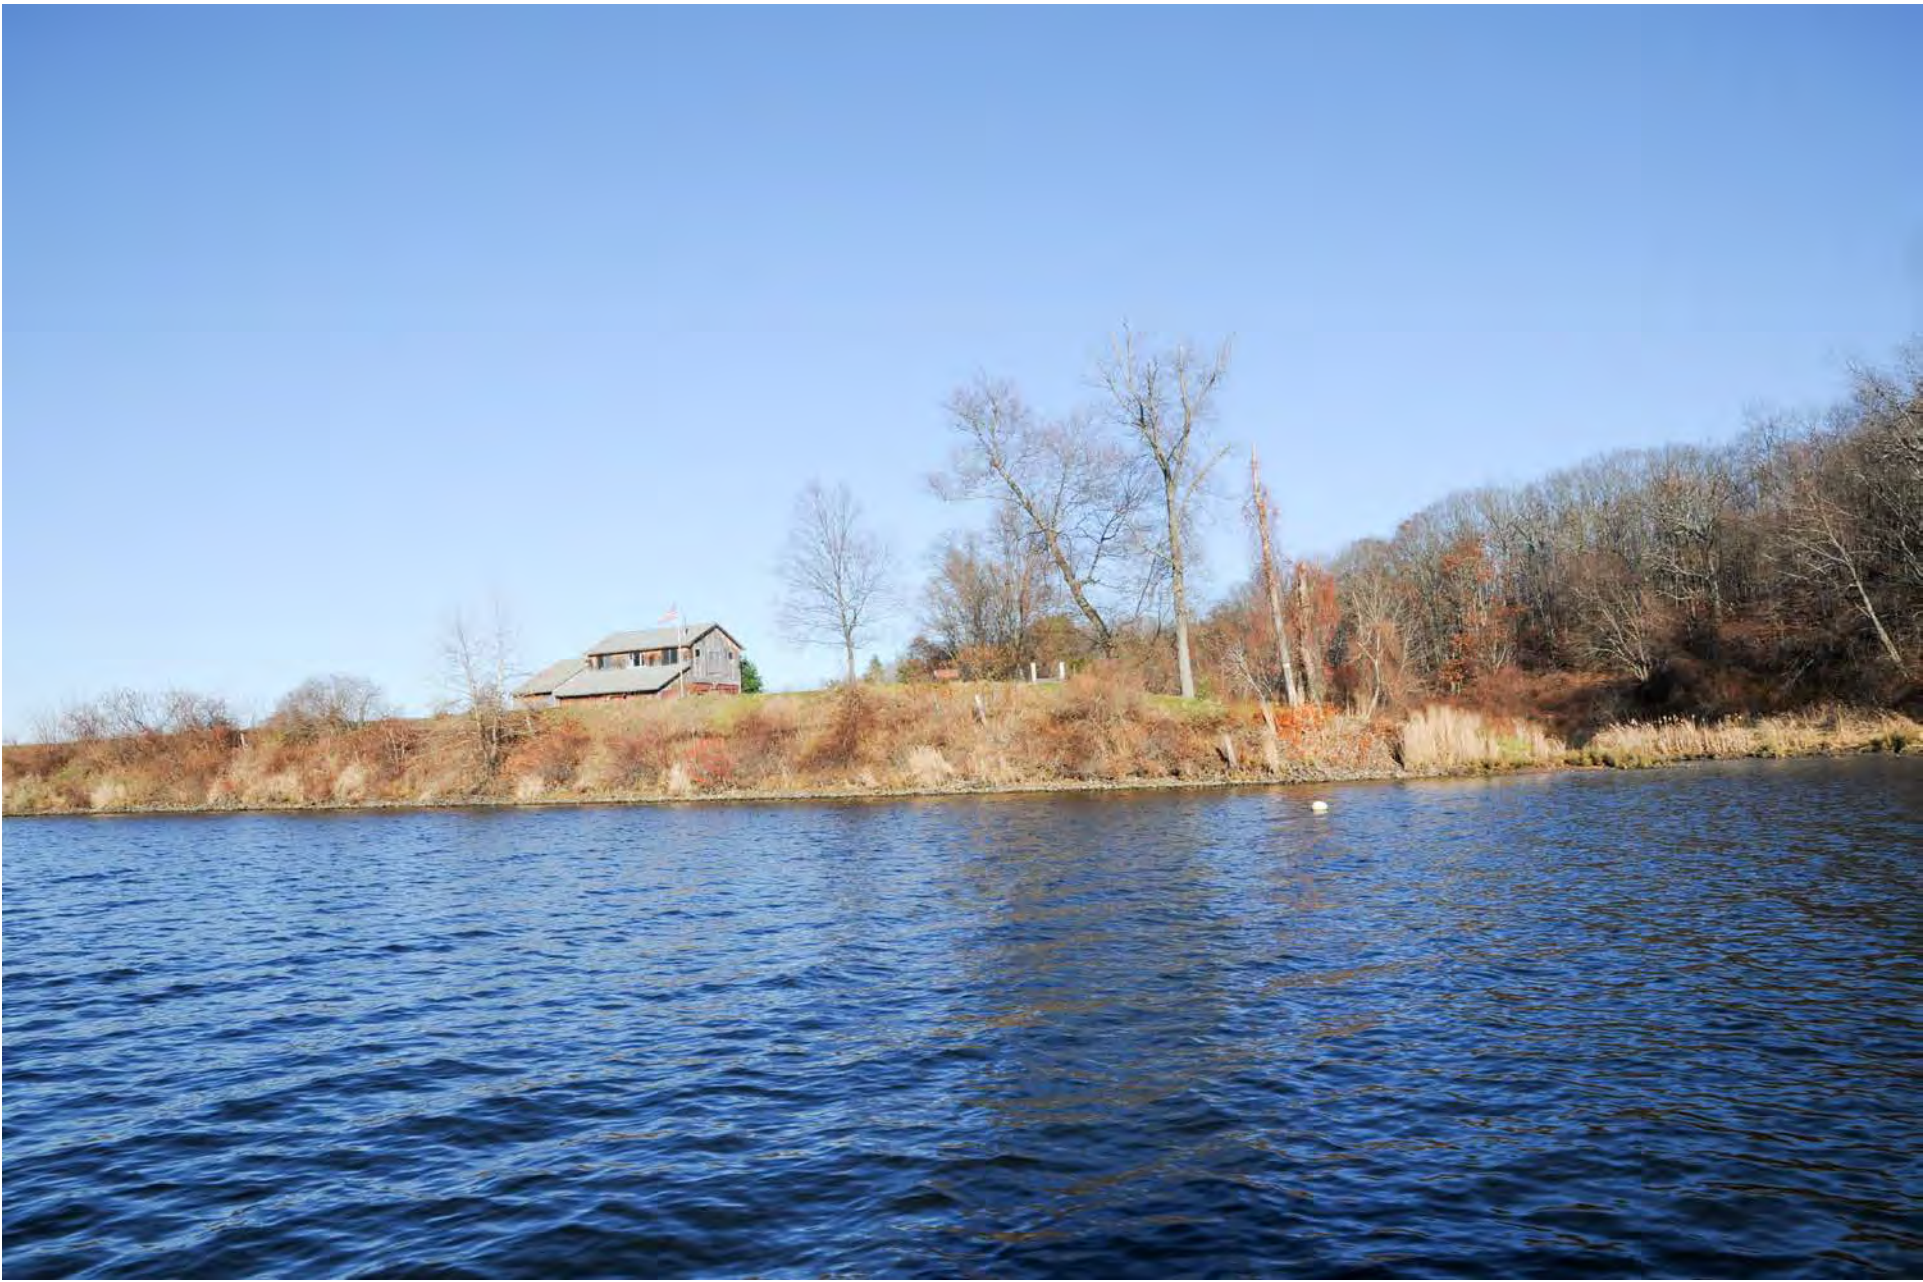
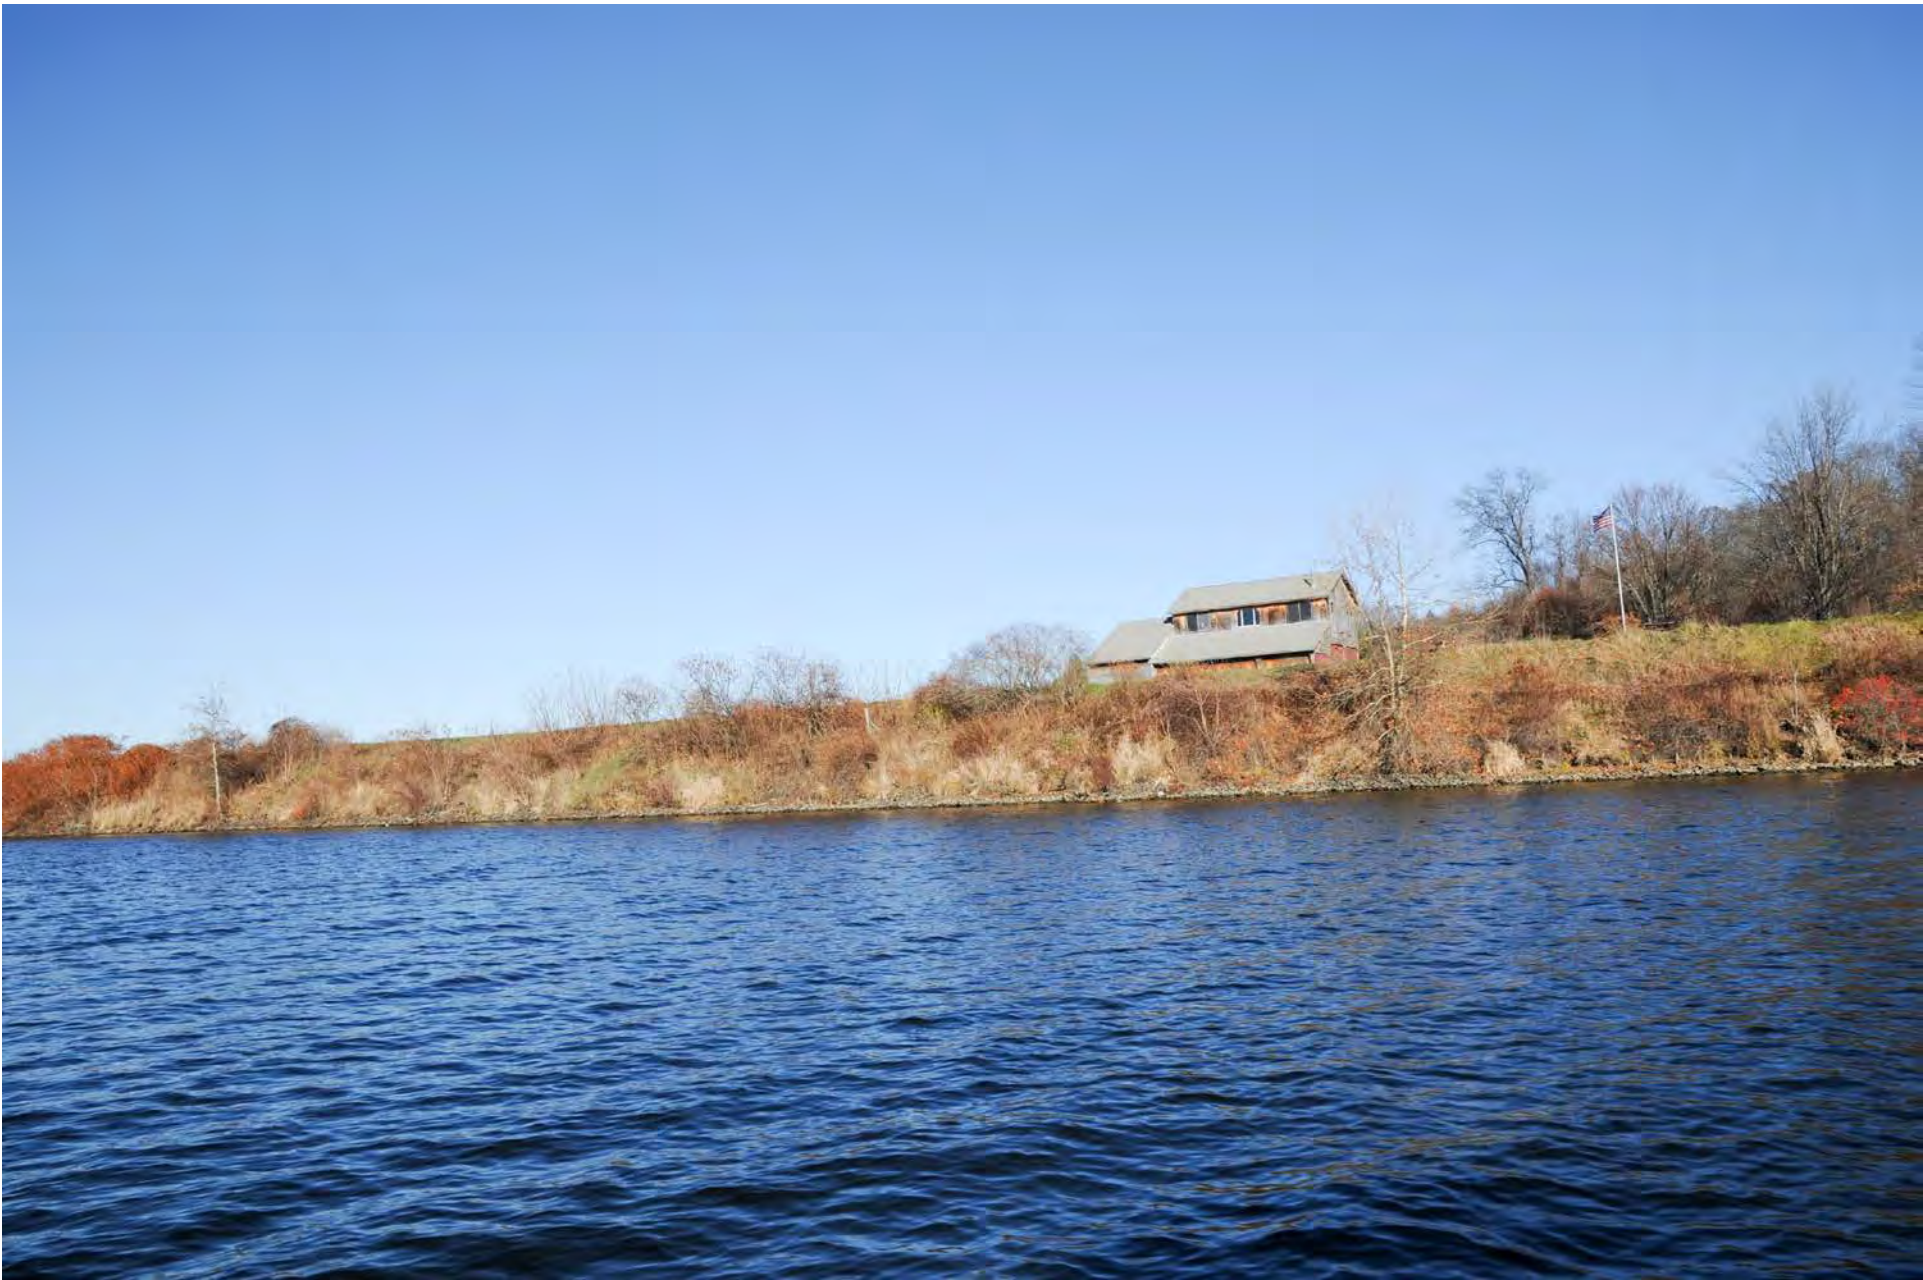
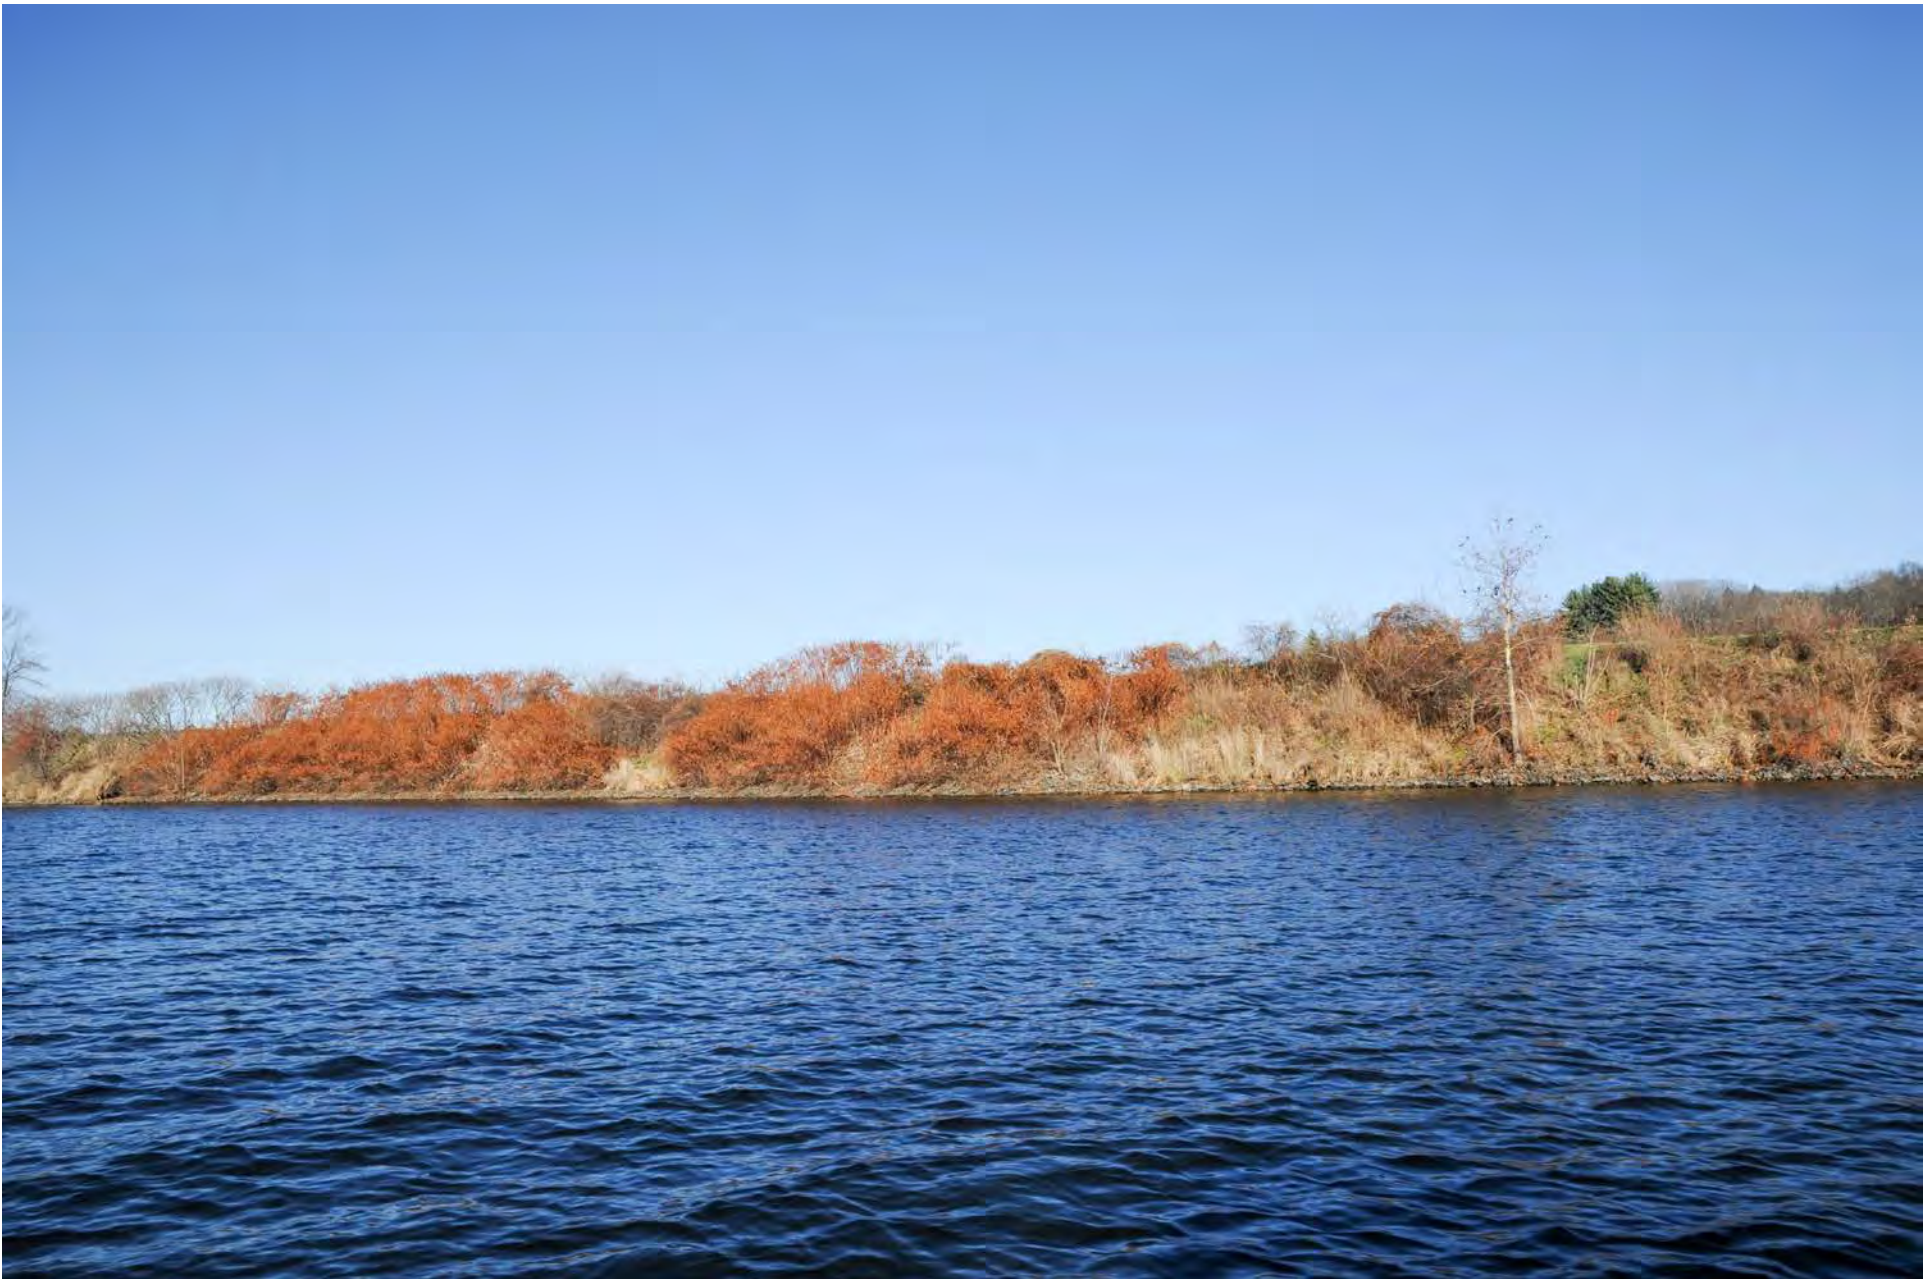
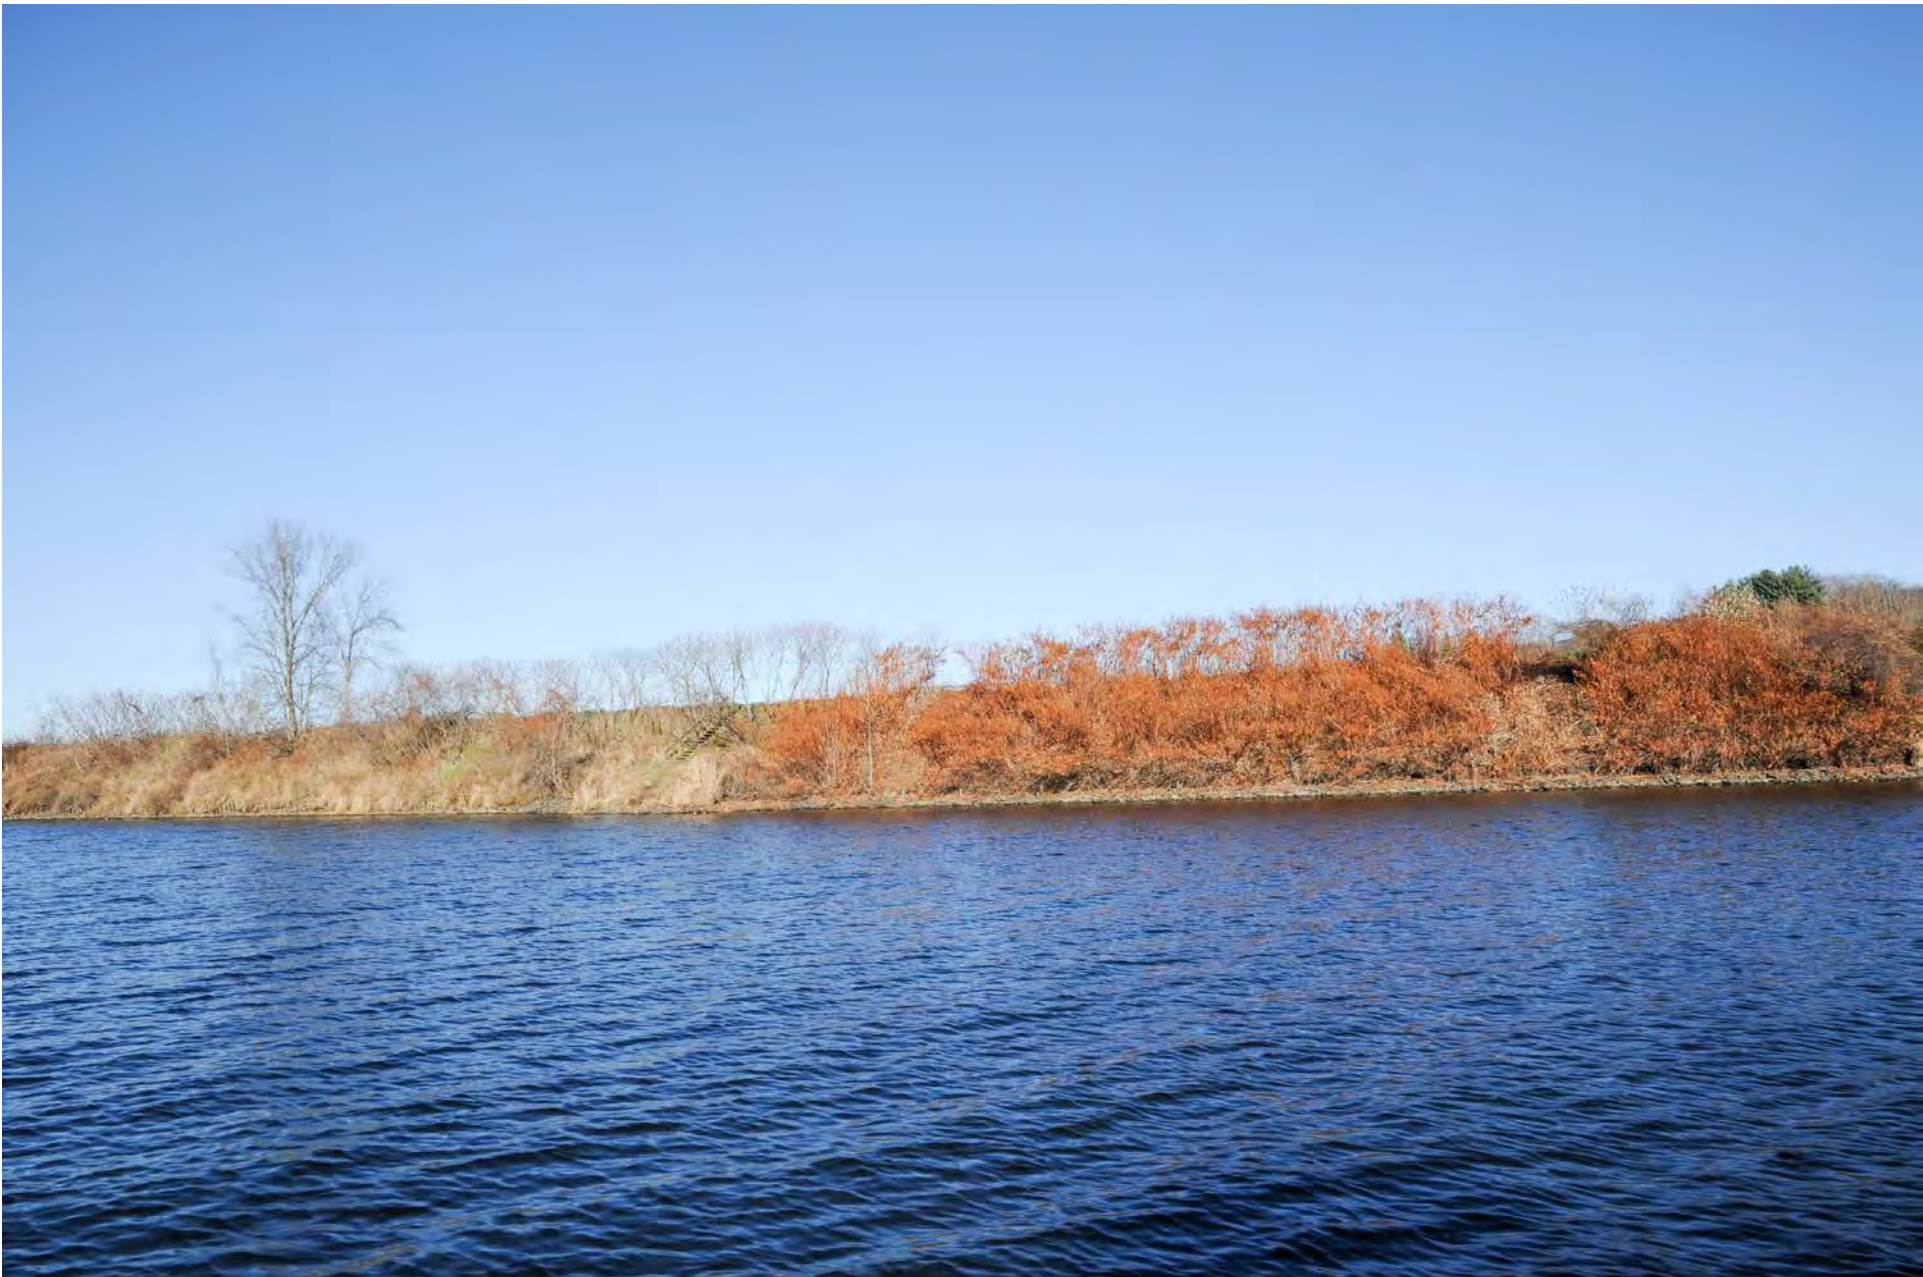
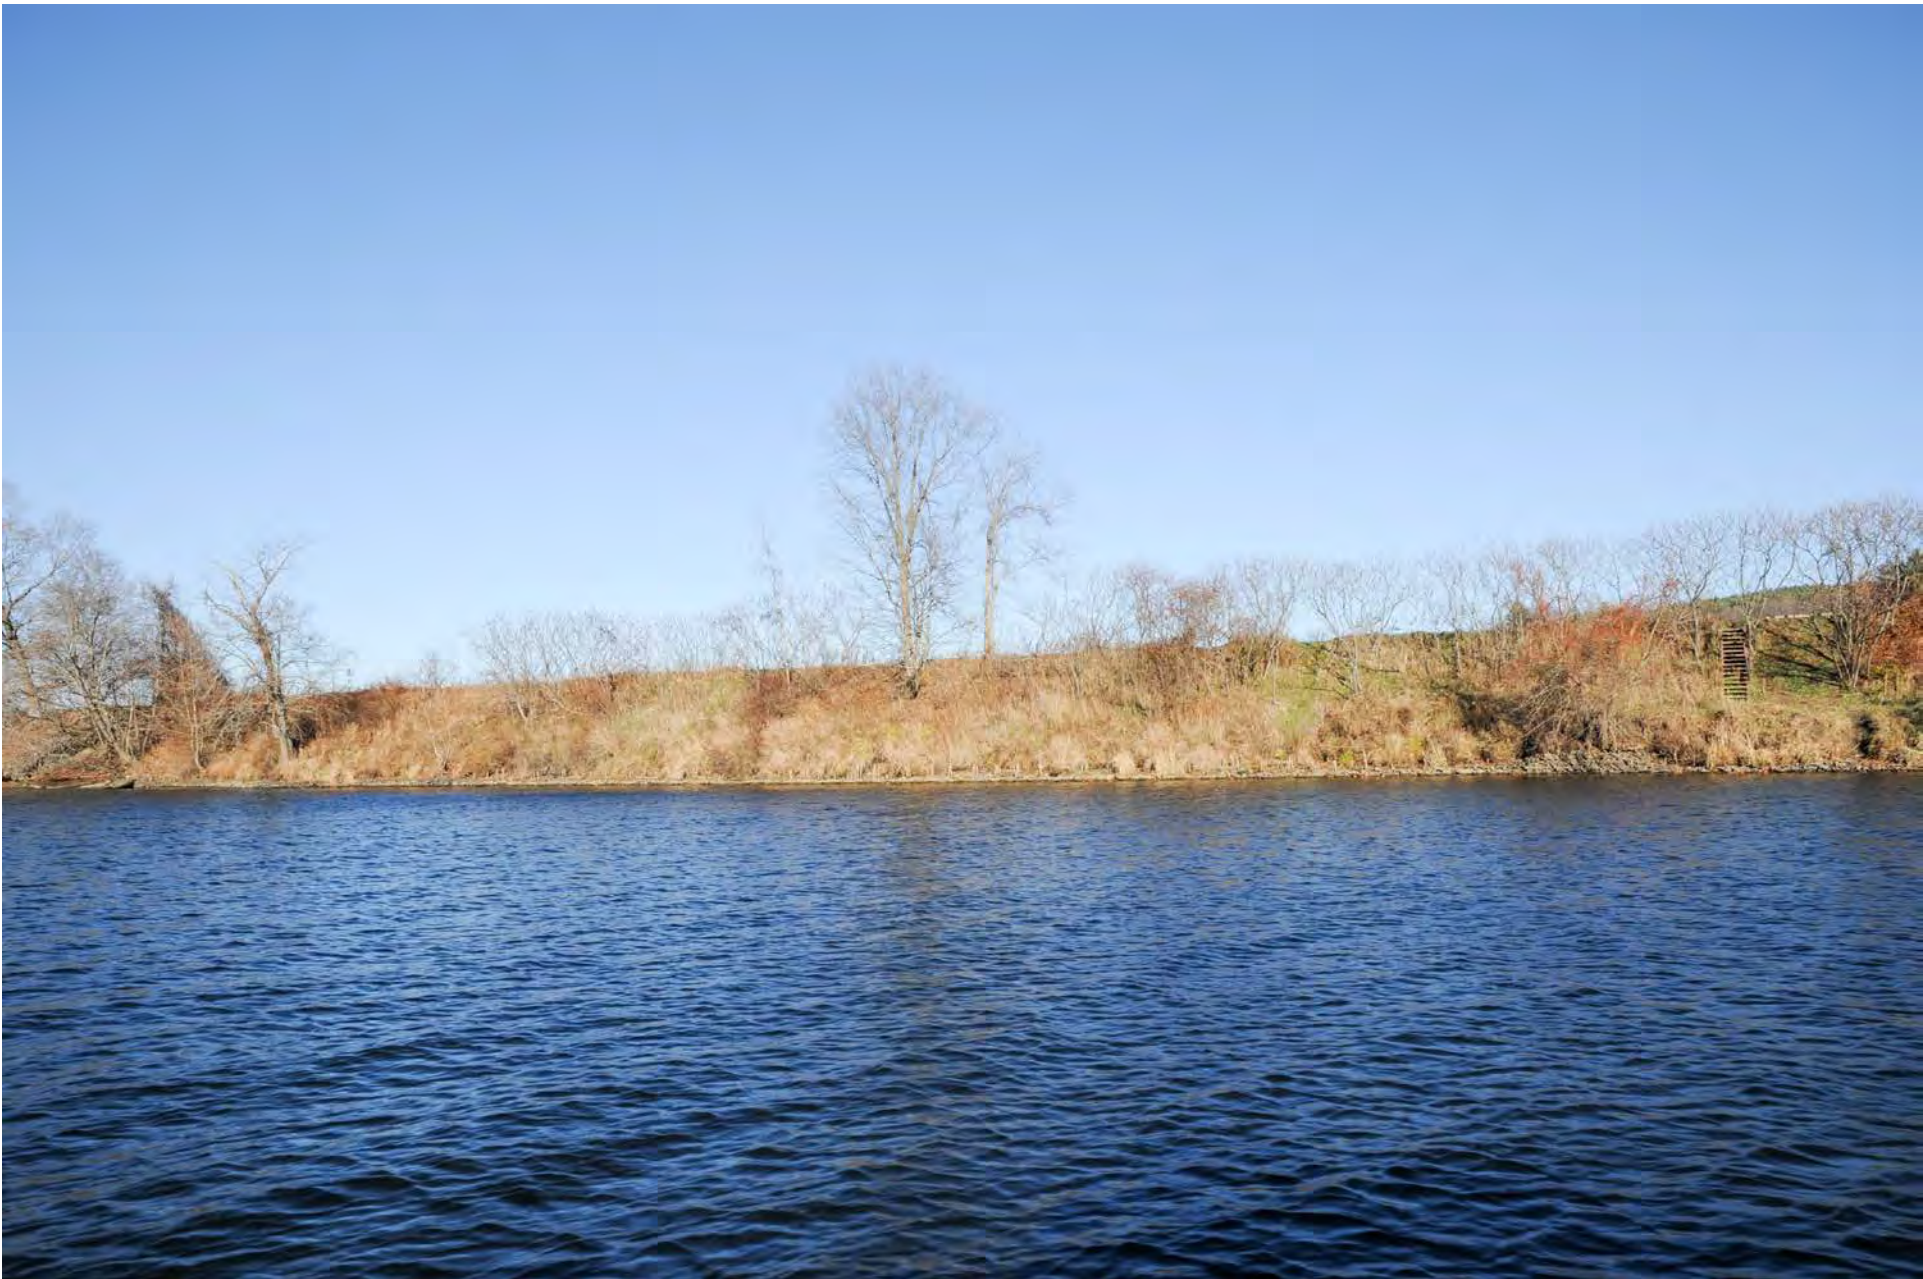
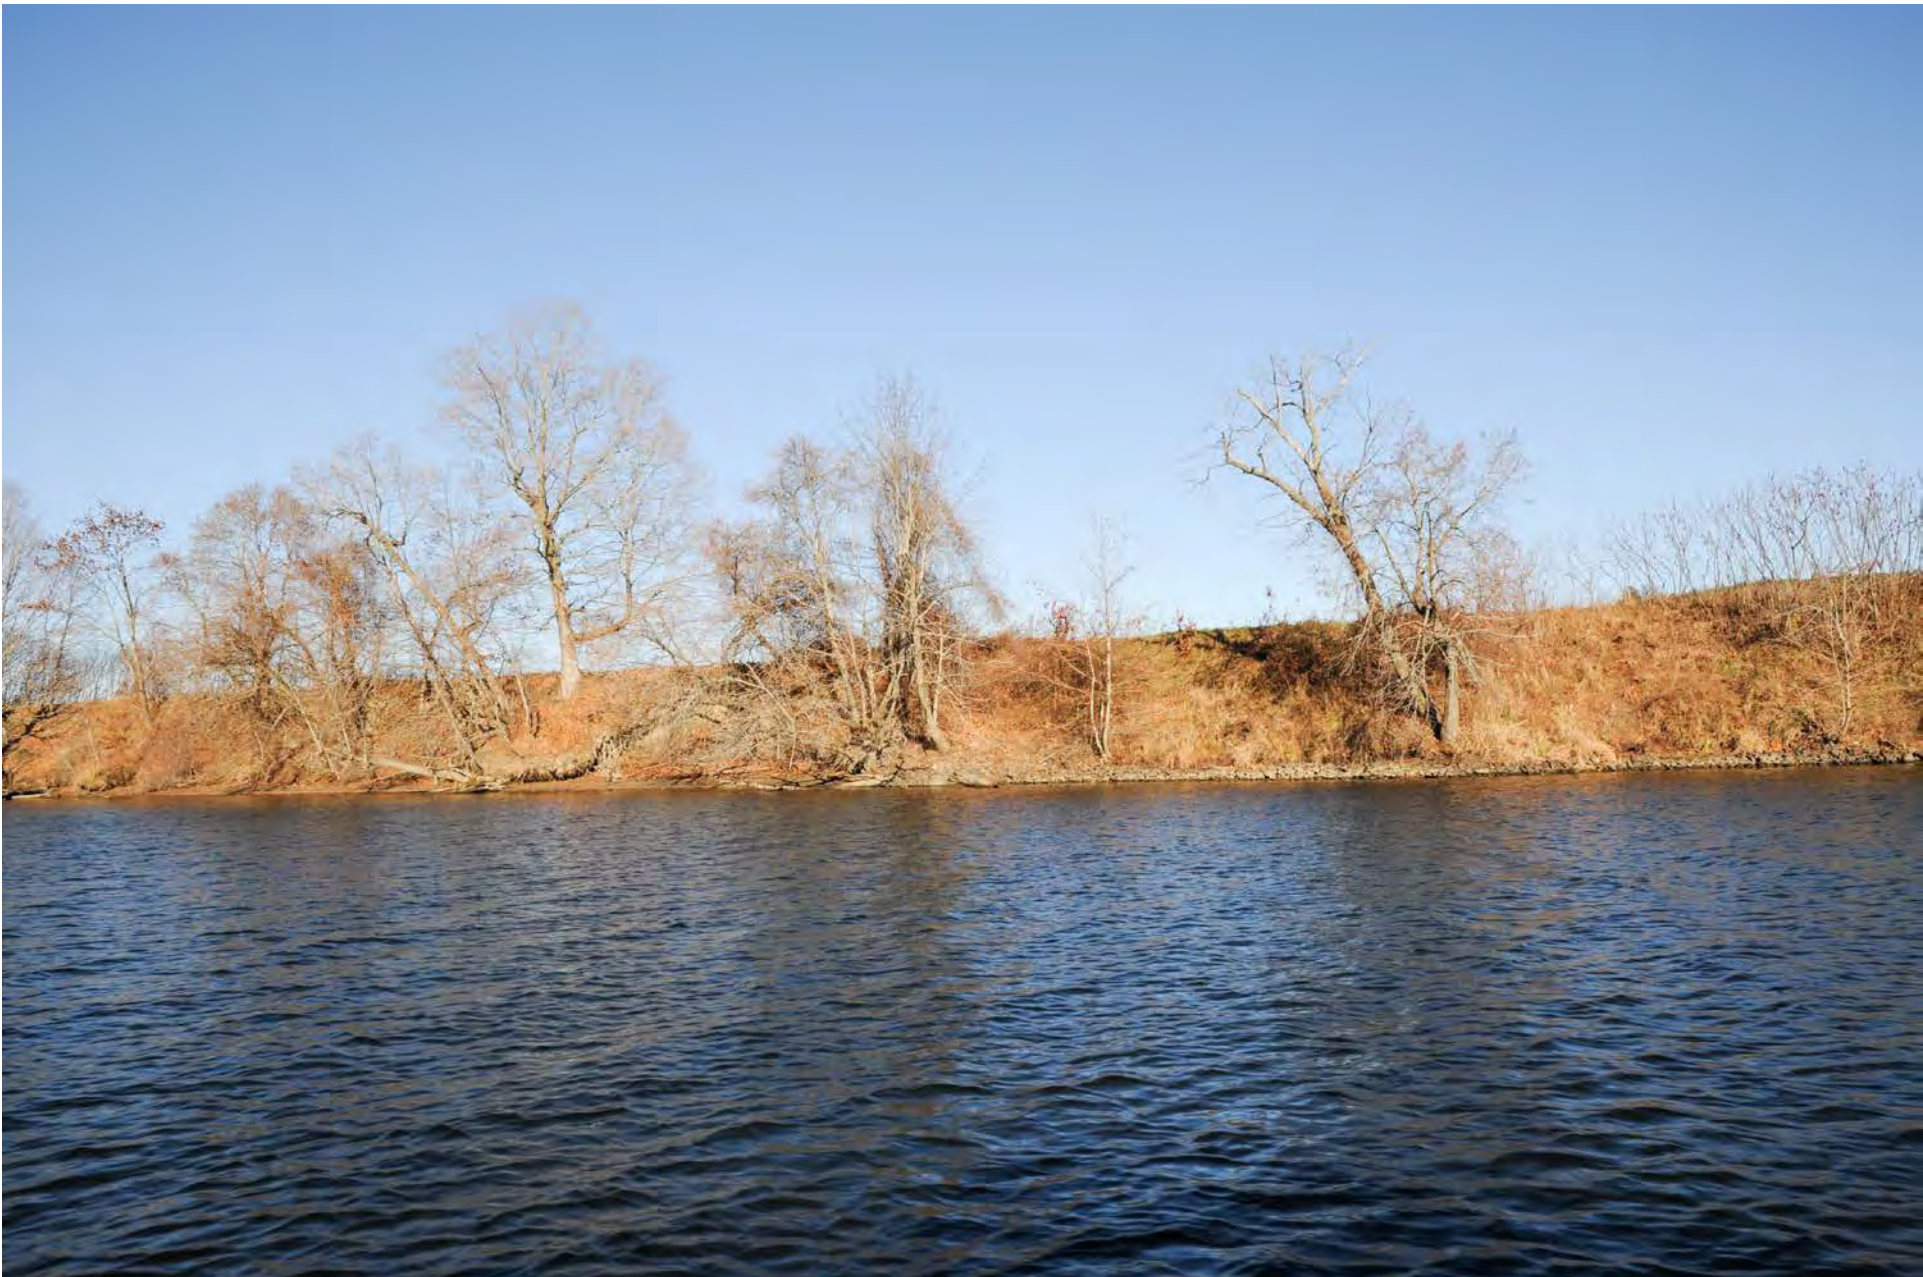
Segment 89 – Left Bank

Riverbank Features	Characteristics
Upper Riverbank Slope	Moderate
Upper Riverbank Height	High
Upper Riverbank Sediment	Silt/Sand
Upper Riverbank Vegetation	Heavy
Lower Riverbank Slope	Moderate
Lower Riverbank Sediment	Cobbles
Lower Riverbank Vegetation	None to very sparse
Type of Erosion	Undercut
Potential Erosion Indicators	Exposed roots
Stage of Erosion	Stable
Extent of Erosion	None/Little

**QA Observations:** Upon review of the photos for this segment, classification made in the field was confirmed. Segment added as a site of interest due to planned repair to existing restoration to deal with undercut and exposed roots.
