Photo ID 1241 (right, U/S portion of segment with labels)  
2013 Full River Reconnaissance – 2015 Addendum  
Attachment A - **DRAFT**

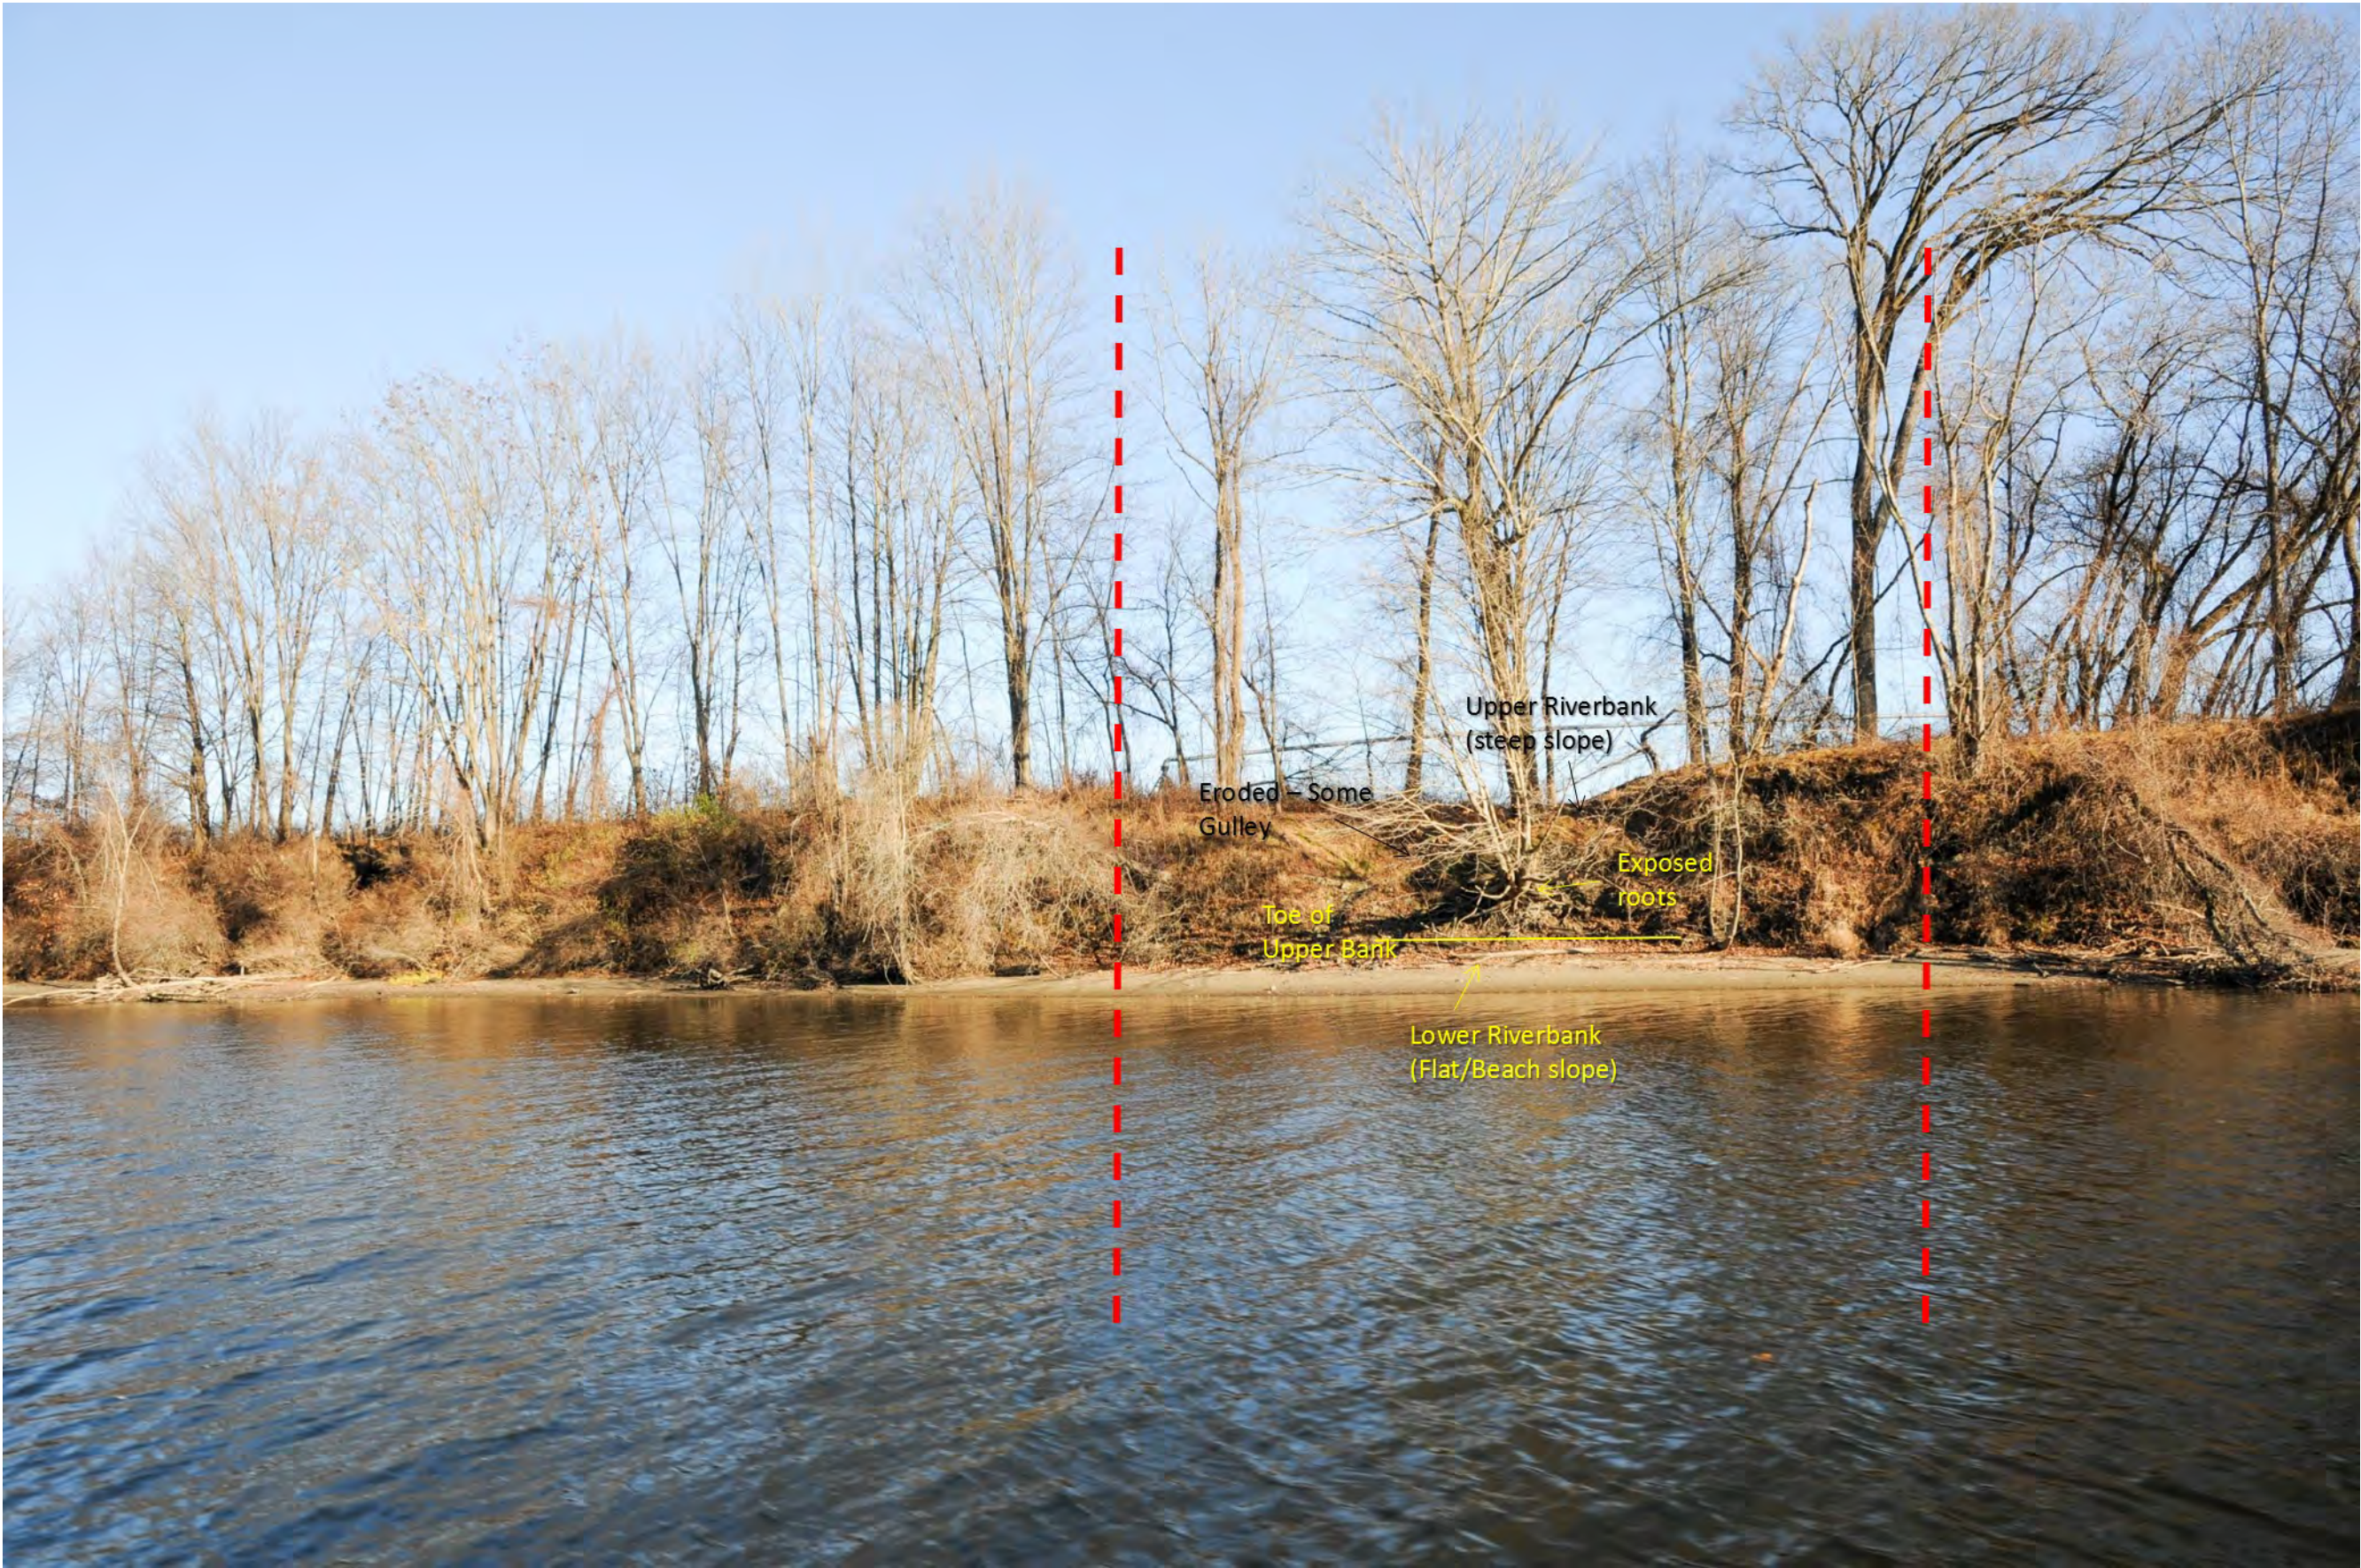
Photo ID 845 (segment is labeled portion of photo. Dashed line represents approximate end of segment)

Segment 182 – Left Bank

Riverbank Features	Characteristics
Upper Riverbank Slope	Steep
Upper Riverbank Height	Low
Upper Riverbank Sediment	Silt/Sand
Upper Riverbank Vegetation	Sparse
Lower Riverbank Slope	Flat/Beach
Lower Riverbank Sediment	Silt/Sand
Lower Riverbank Vegetation	None to very sparse
Type of Erosion	Gully
Potential Erosion Indicators	Exposed roots
Stage of Erosion	Eroded
Extent of Erosion	Some

**QA Observations:** Upon review of the photos for this segment, classification made in the field was confirmed. Segment added to include gully.

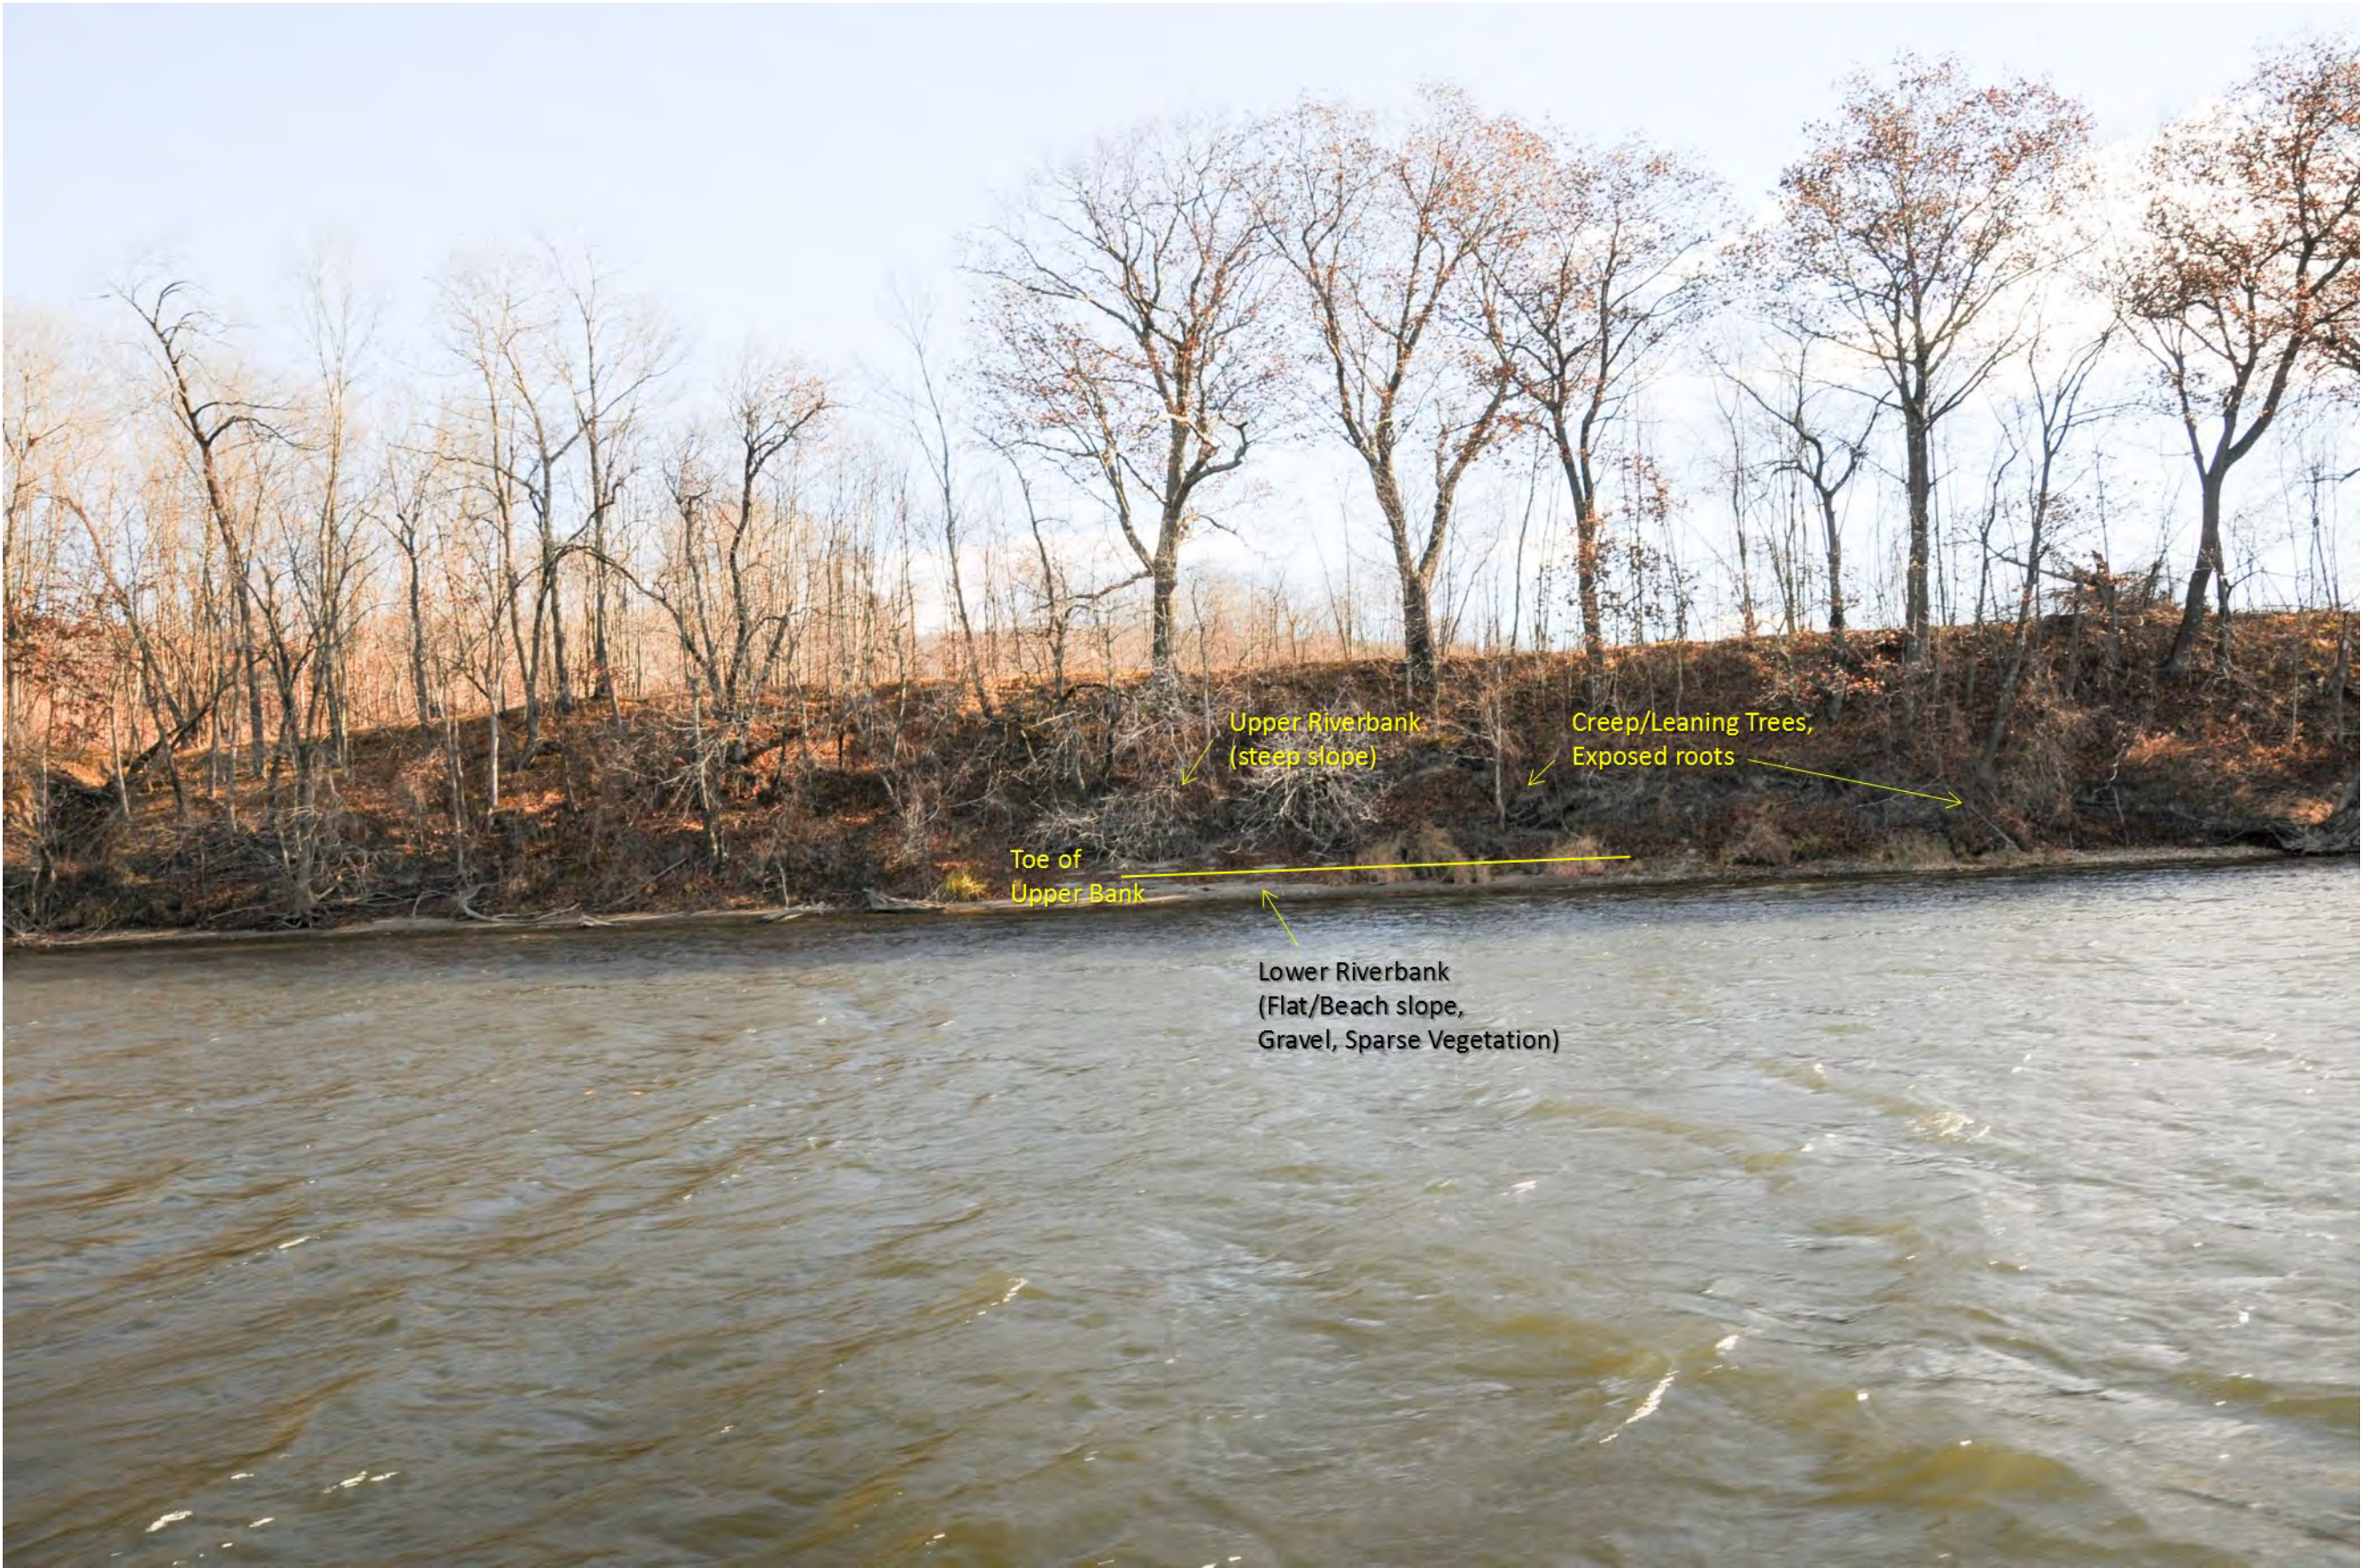
Photo ID 1631 (photo covers most of segment)

Segment 279 – Left Bank

Riverbank Features	Characteristics
Upper Riverbank Slope	Steep
Upper Riverbank Height	High
Upper Riverbank Sediment	Silt/Sand
Upper Riverbank Vegetation	Heavy
Lower Riverbank Slope	Flat/Beach
Lower Riverbank Sediment	Gravel
Lower Riverbank Vegetation	Sparse
Type of Erosion	Undercut
Potential Erosion Indicators	Creep/Leaning Trees, Exposed roots
Stage of Erosion	Stable
Extent of Erosion	None/Little

**QA Observations:** Upon review of the photos for this segment, classification made in the field was confirmed and additional indicators of potential future erosion were included. Segment added to include sparse lower riverbank vegetation.

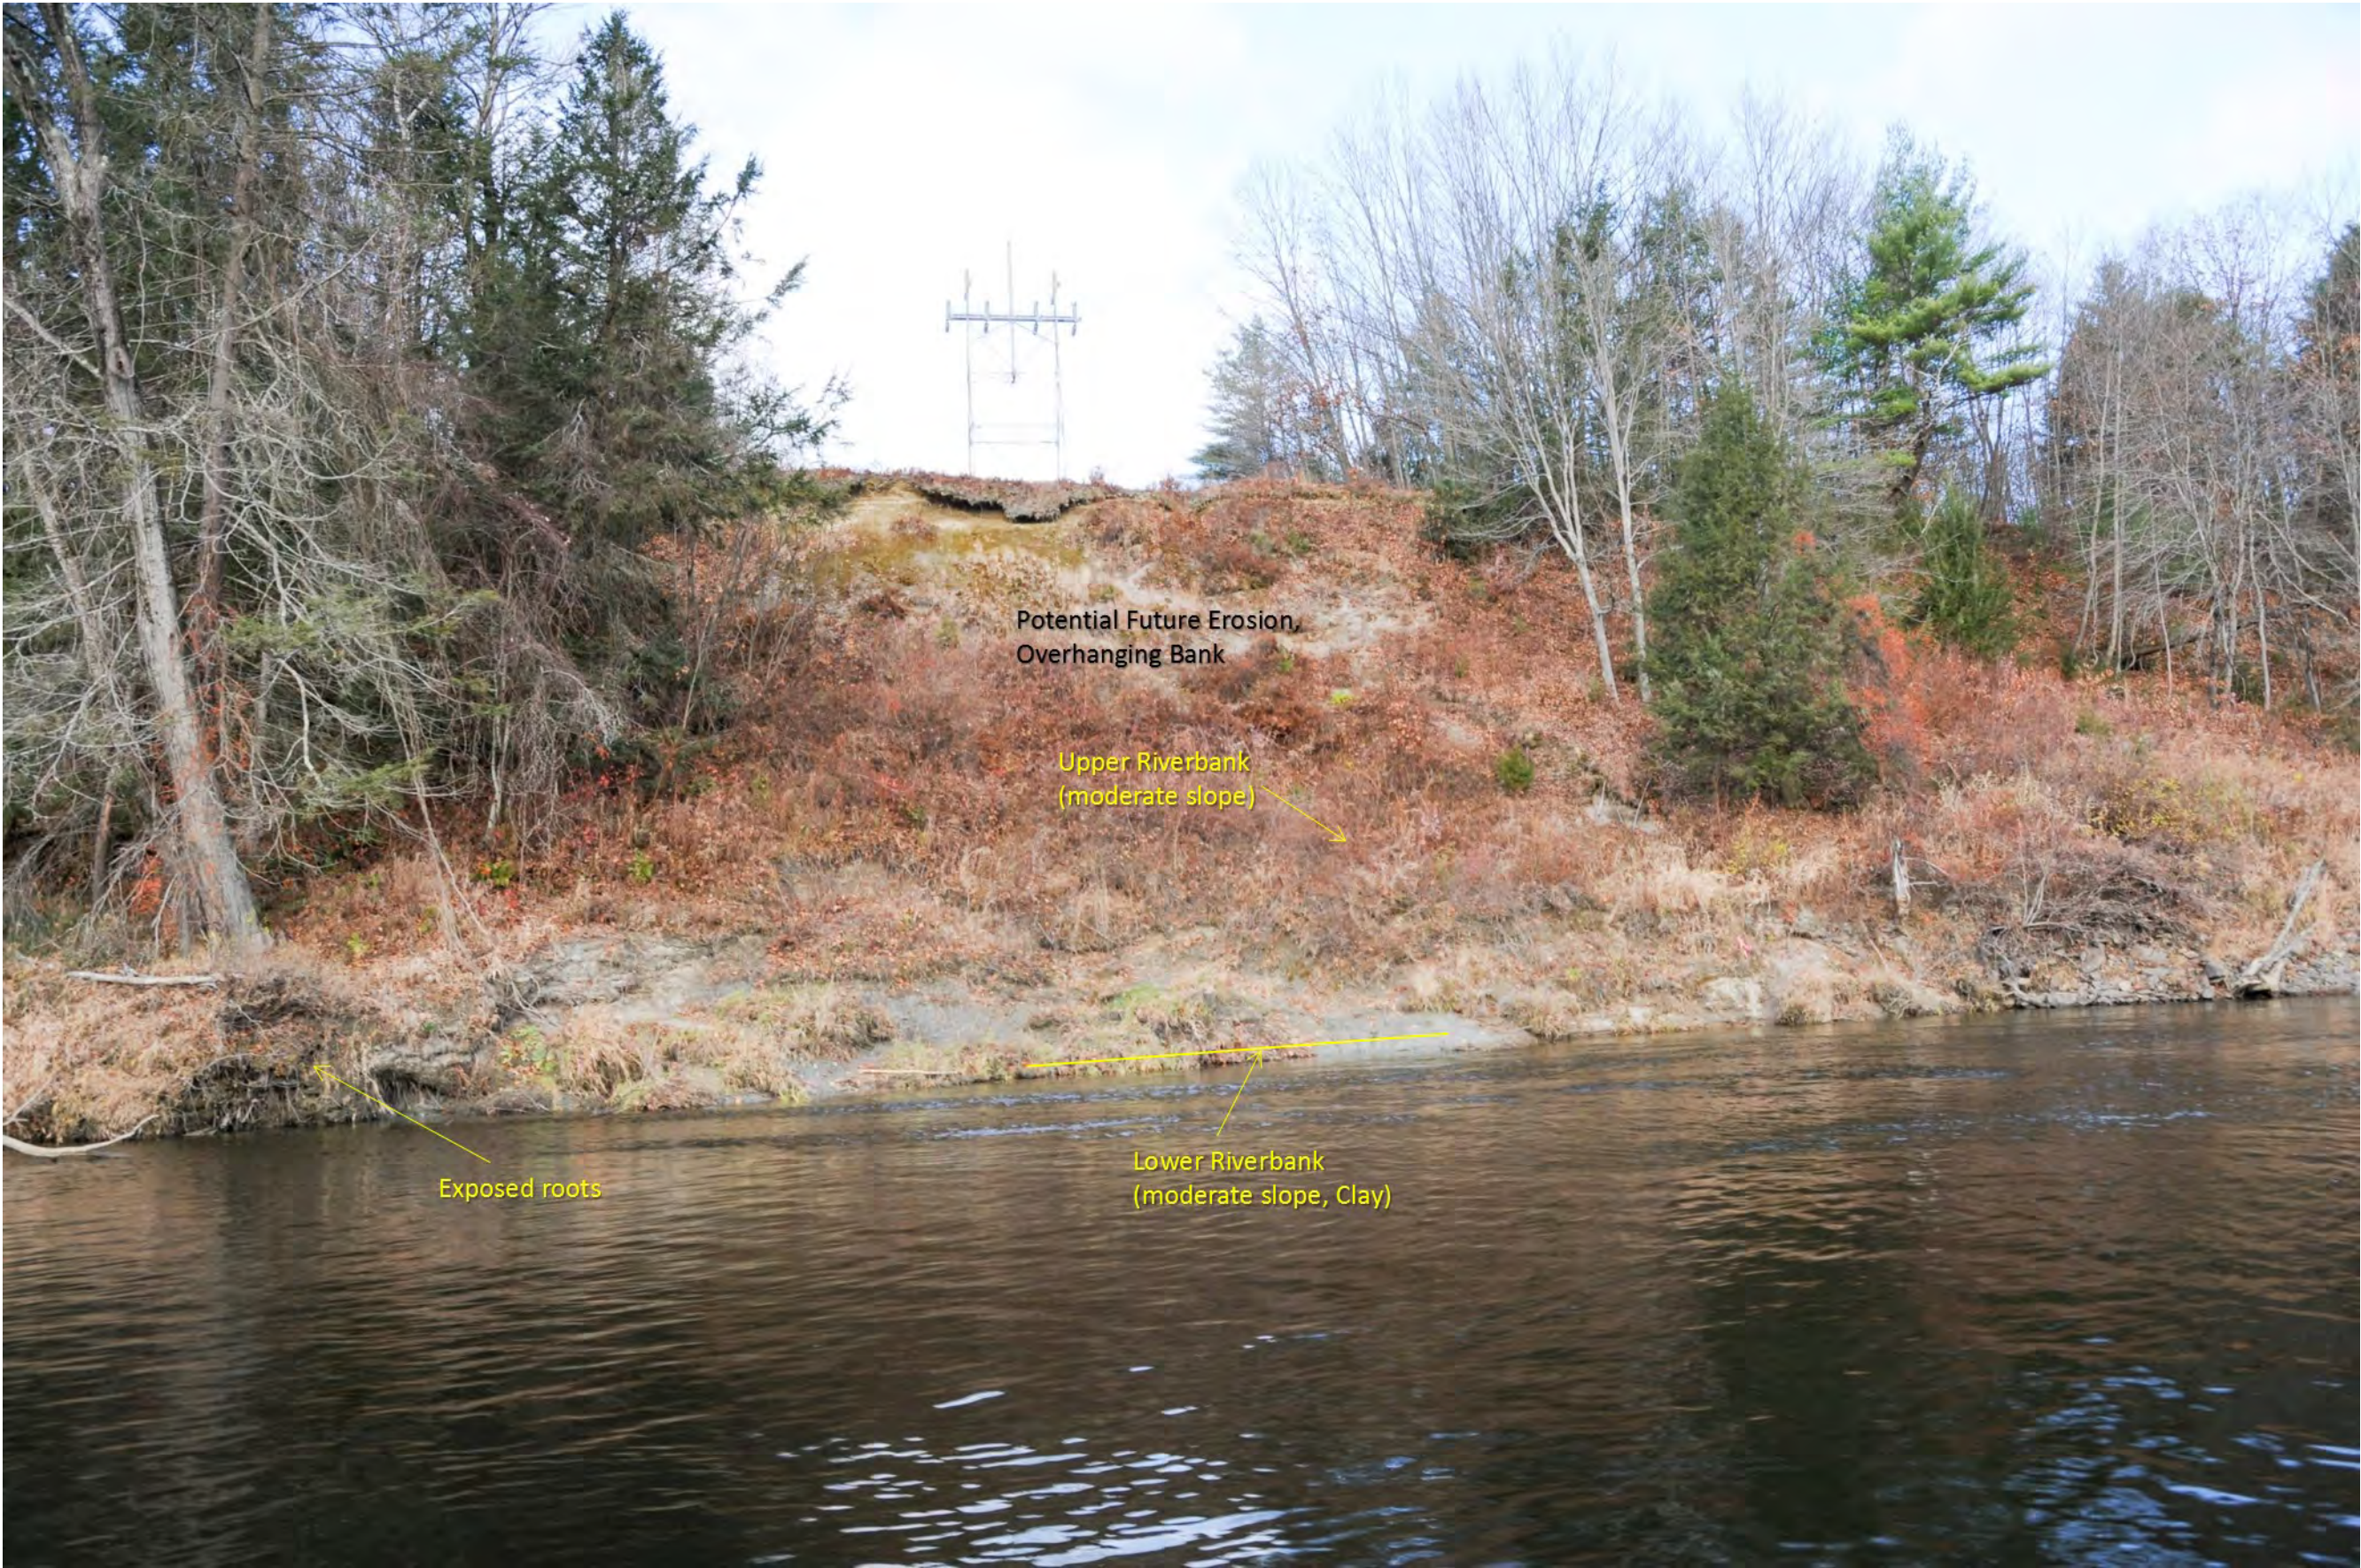
Photo ID 1425 (photo covers segment)

Segment 332 – Left Bank

Riverbank Features	Characteristics
Upper Riverbank Slope	Moderate
Upper Riverbank Height	High
Upper Riverbank Sediment	Silt/Sand
Upper Riverbank Vegetation	Moderate
Lower Riverbank Slope	Moderate
Lower Riverbank Sediment	Clay
Lower Riverbank Vegetation	None to very sparse
Type of Erosion	Slide
Potential Erosion Indicators	Overhanging, Exposed roots
Stage of Erosion	Potential Future Erosion
Extent of Erosion	Some

**QA Observations:** Upon review of the photos for this segment, classification made in the field was confirmed and additional indicators of potential future erosion were included. Segment added to include clay.

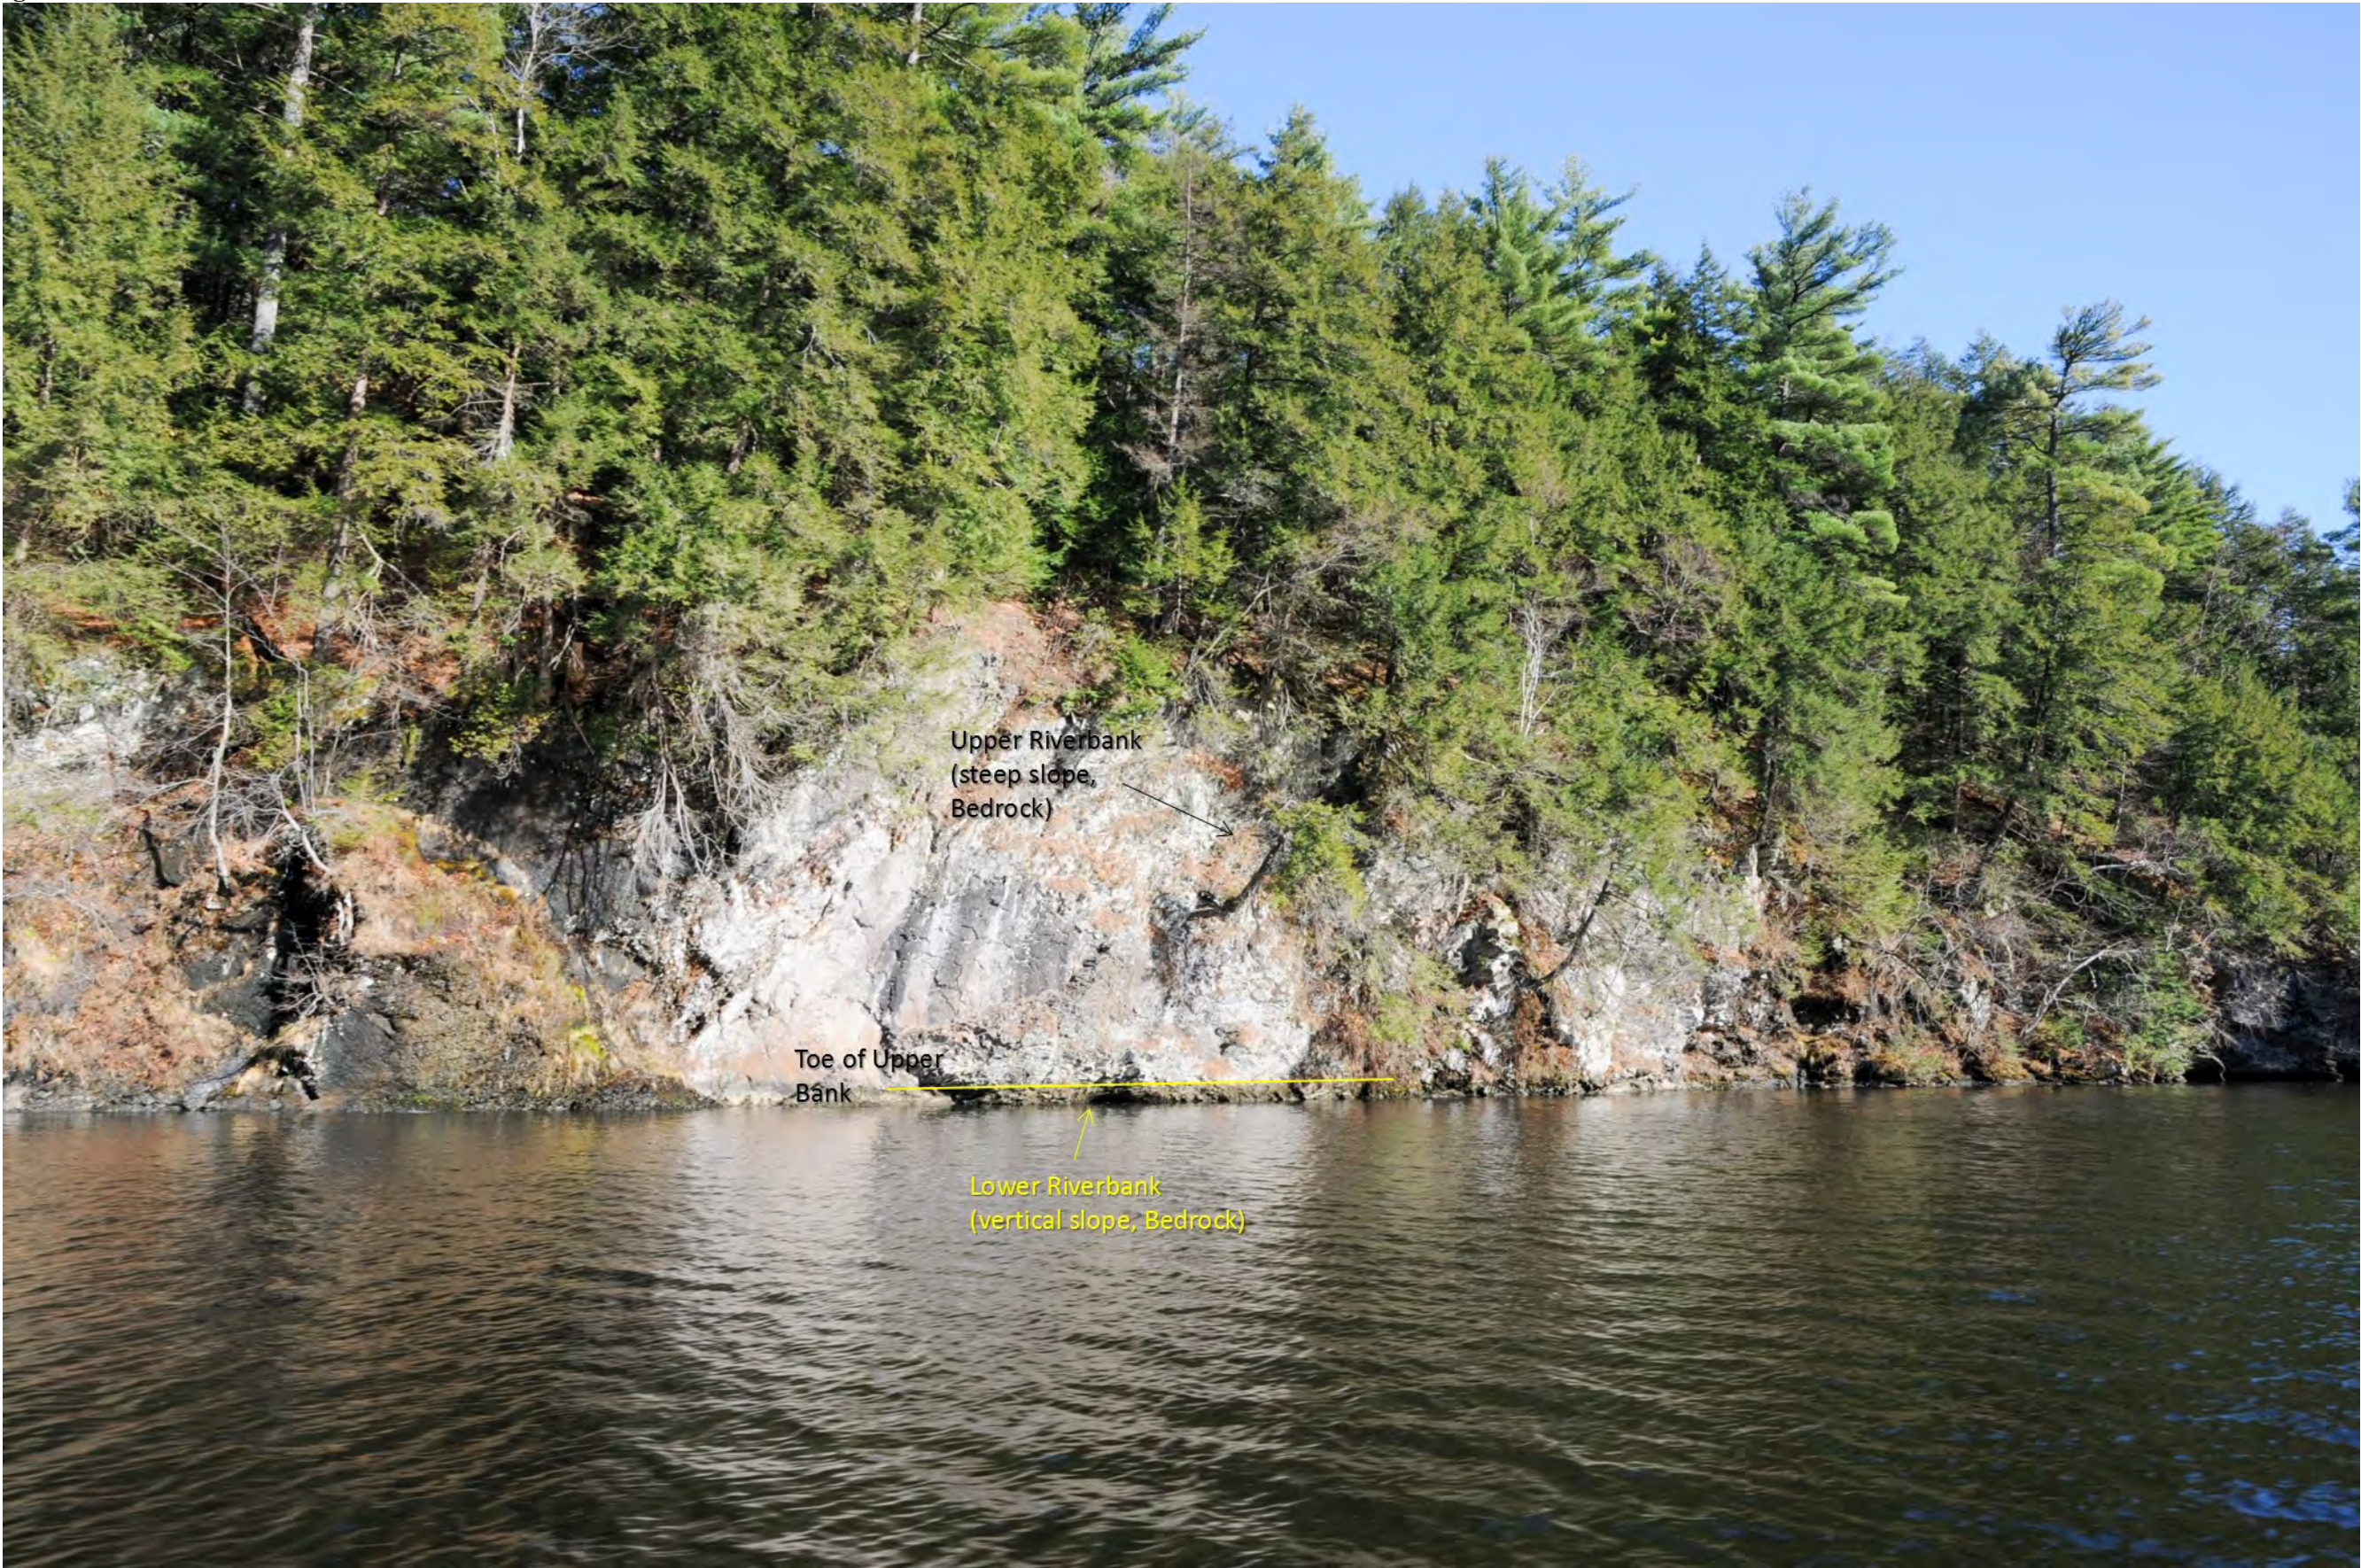
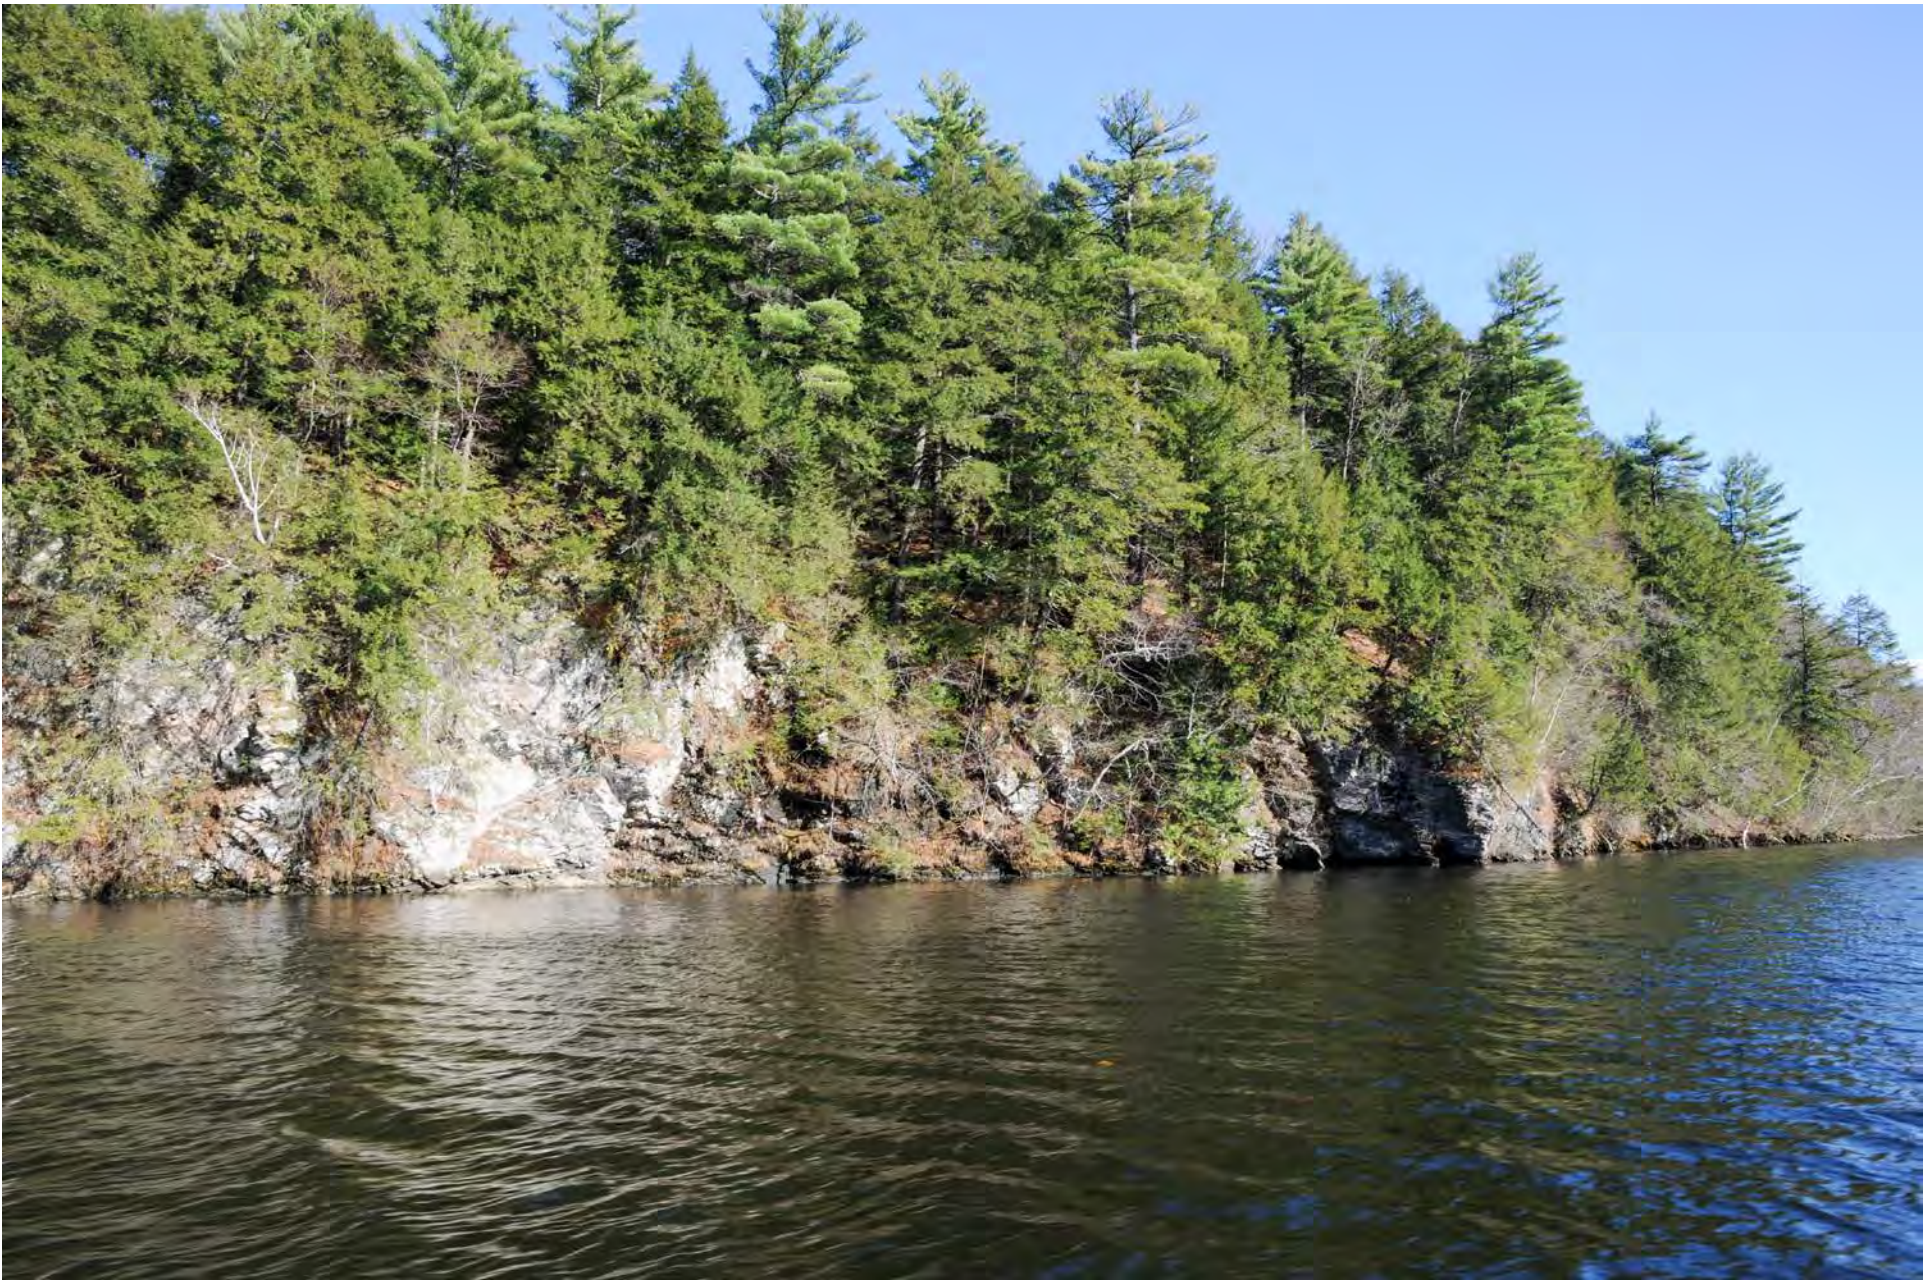
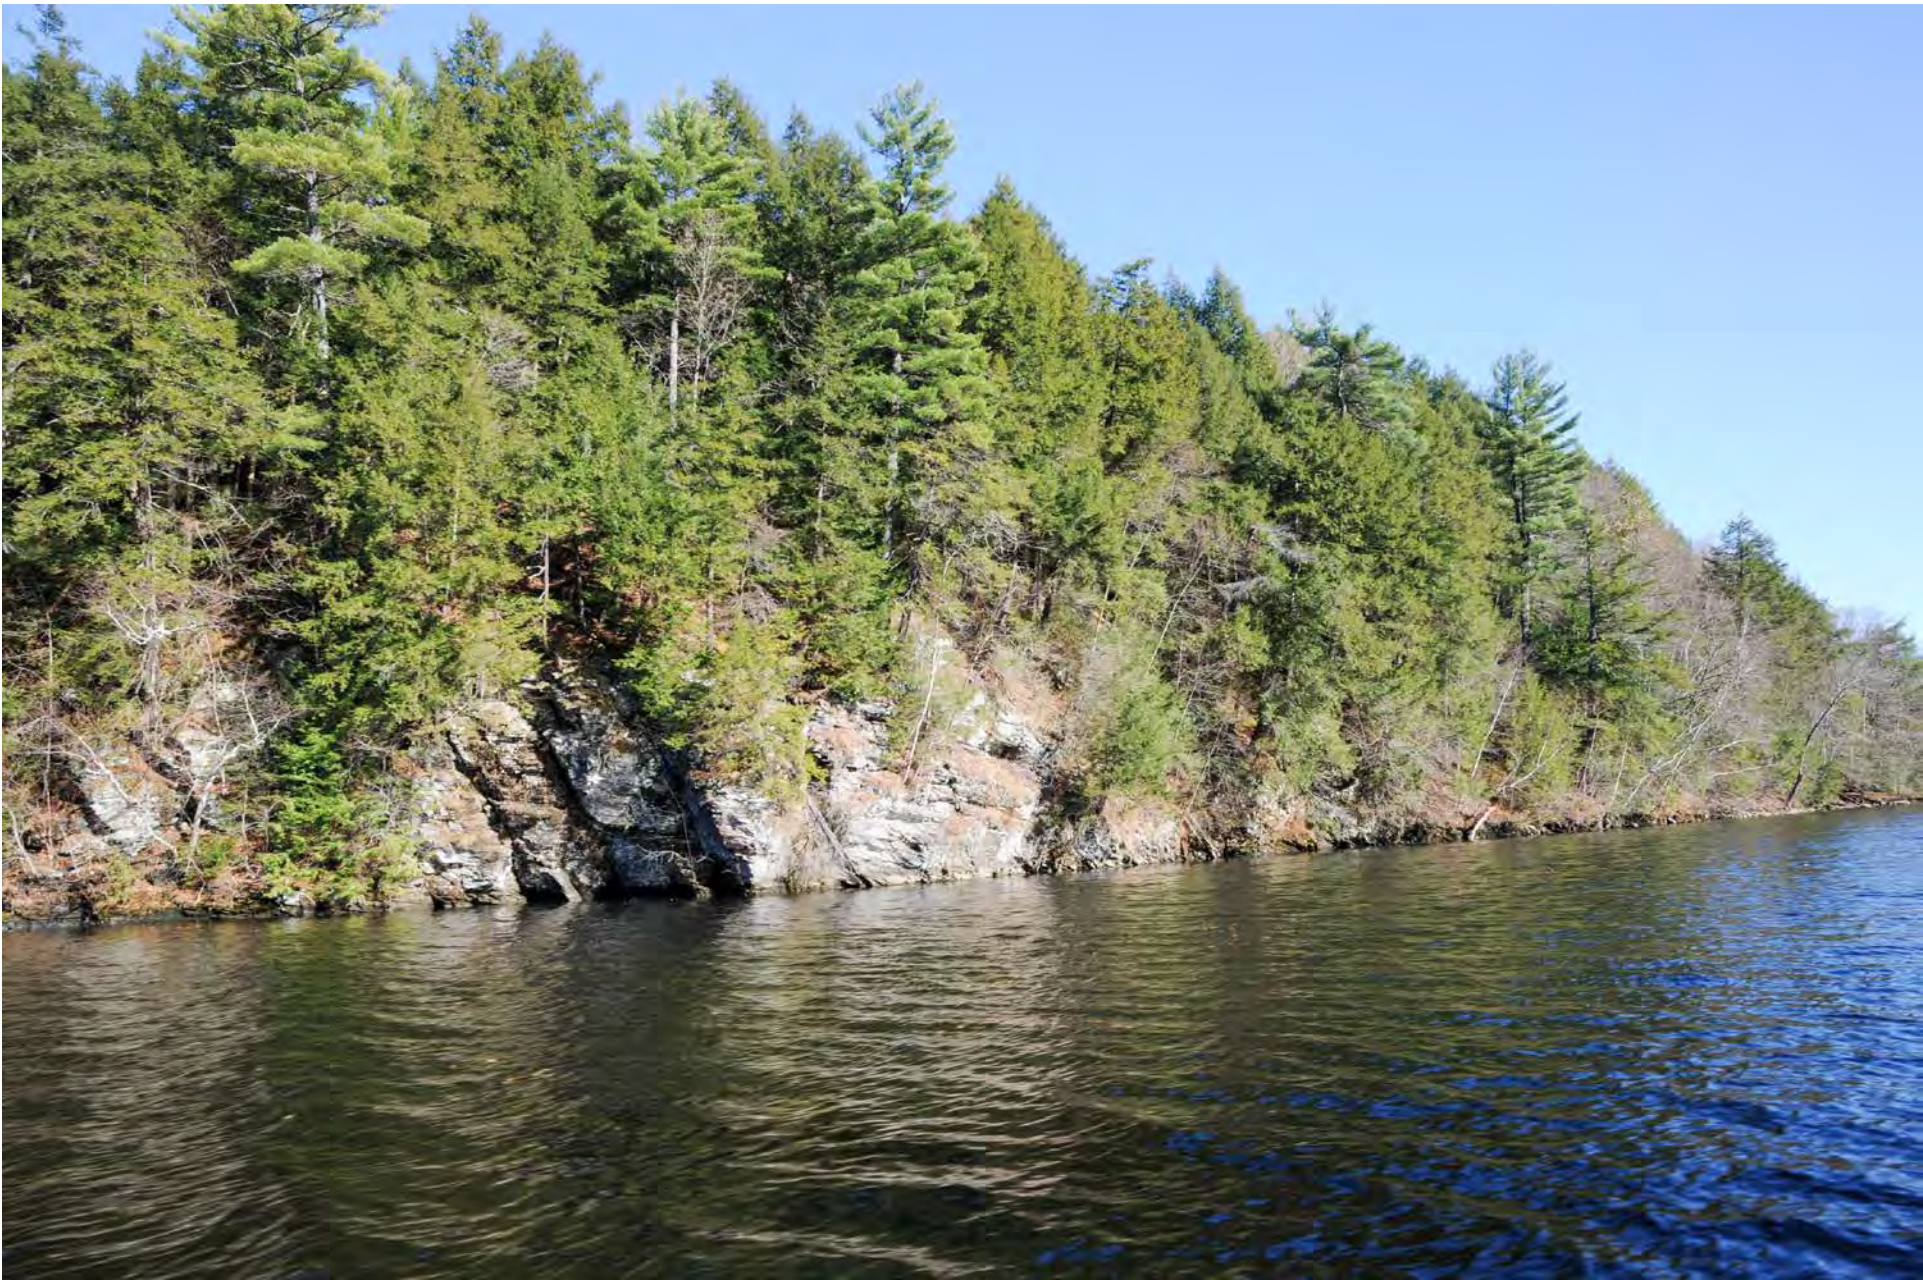
Segment 403 – Right Bank

Riverbank Features	Characteristics
Upper Riverbank Slope	Steep
Upper Riverbank Height	High
Upper Riverbank Sediment	Bedrock
Upper Riverbank Vegetation	Moderate
Lower Riverbank Slope	Vertical
Lower Riverbank Sediment	Bedrock
Lower Riverbank Vegetation	None to very sparse
Type of Erosion	
Potential Erosion Indicators	None
Stage of Erosion	Stable
Extent of Erosion	None/Little

**QA Observations:** Upon review of the photos for this segment, classification made in the field was confirmed. Segment added to include vertical lower riverbank.
