ATTACHMENT B: 2007-2014 Photo Log Comparison

FIRSTLIGHT POWER RESOURCES
RELICENSING STUDY 3.1.1
2013 FULL RIVER RECONNAISSANCE
TURNERS FALLS IMPOUNDMENT

Addendum Figure 1:
Photo Station Locations for Comparison of
2007 Photographs (Field) and
2014 Photographs (NEE)

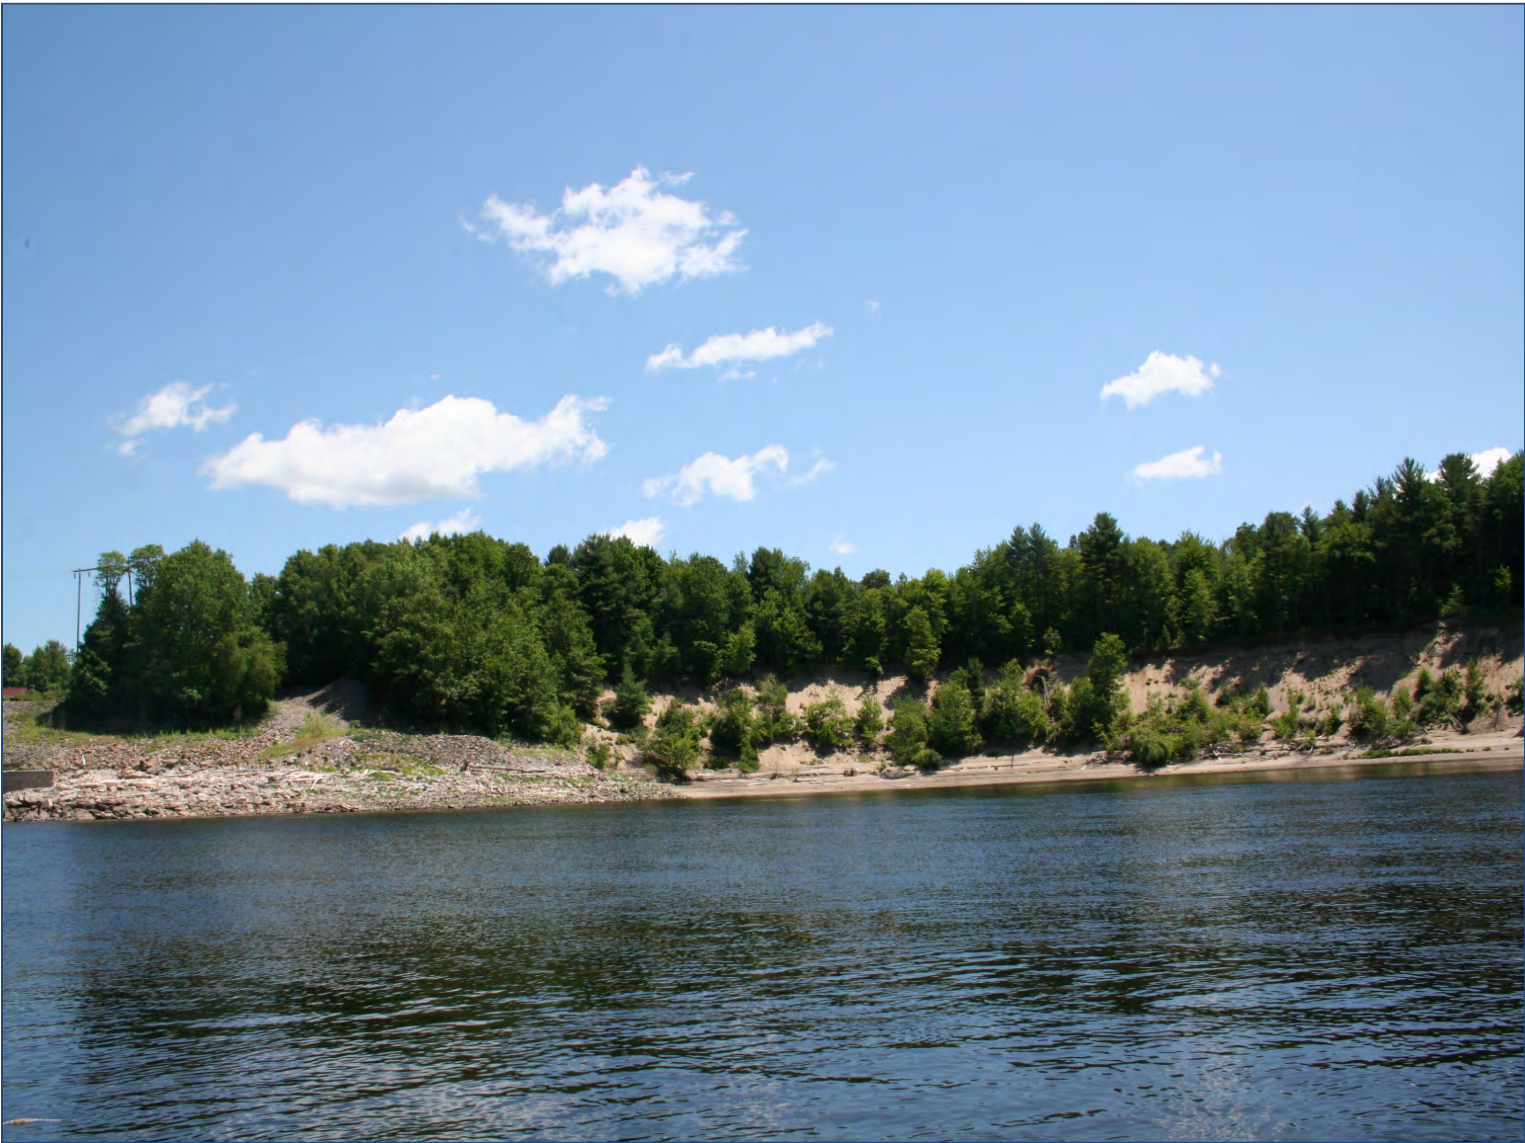
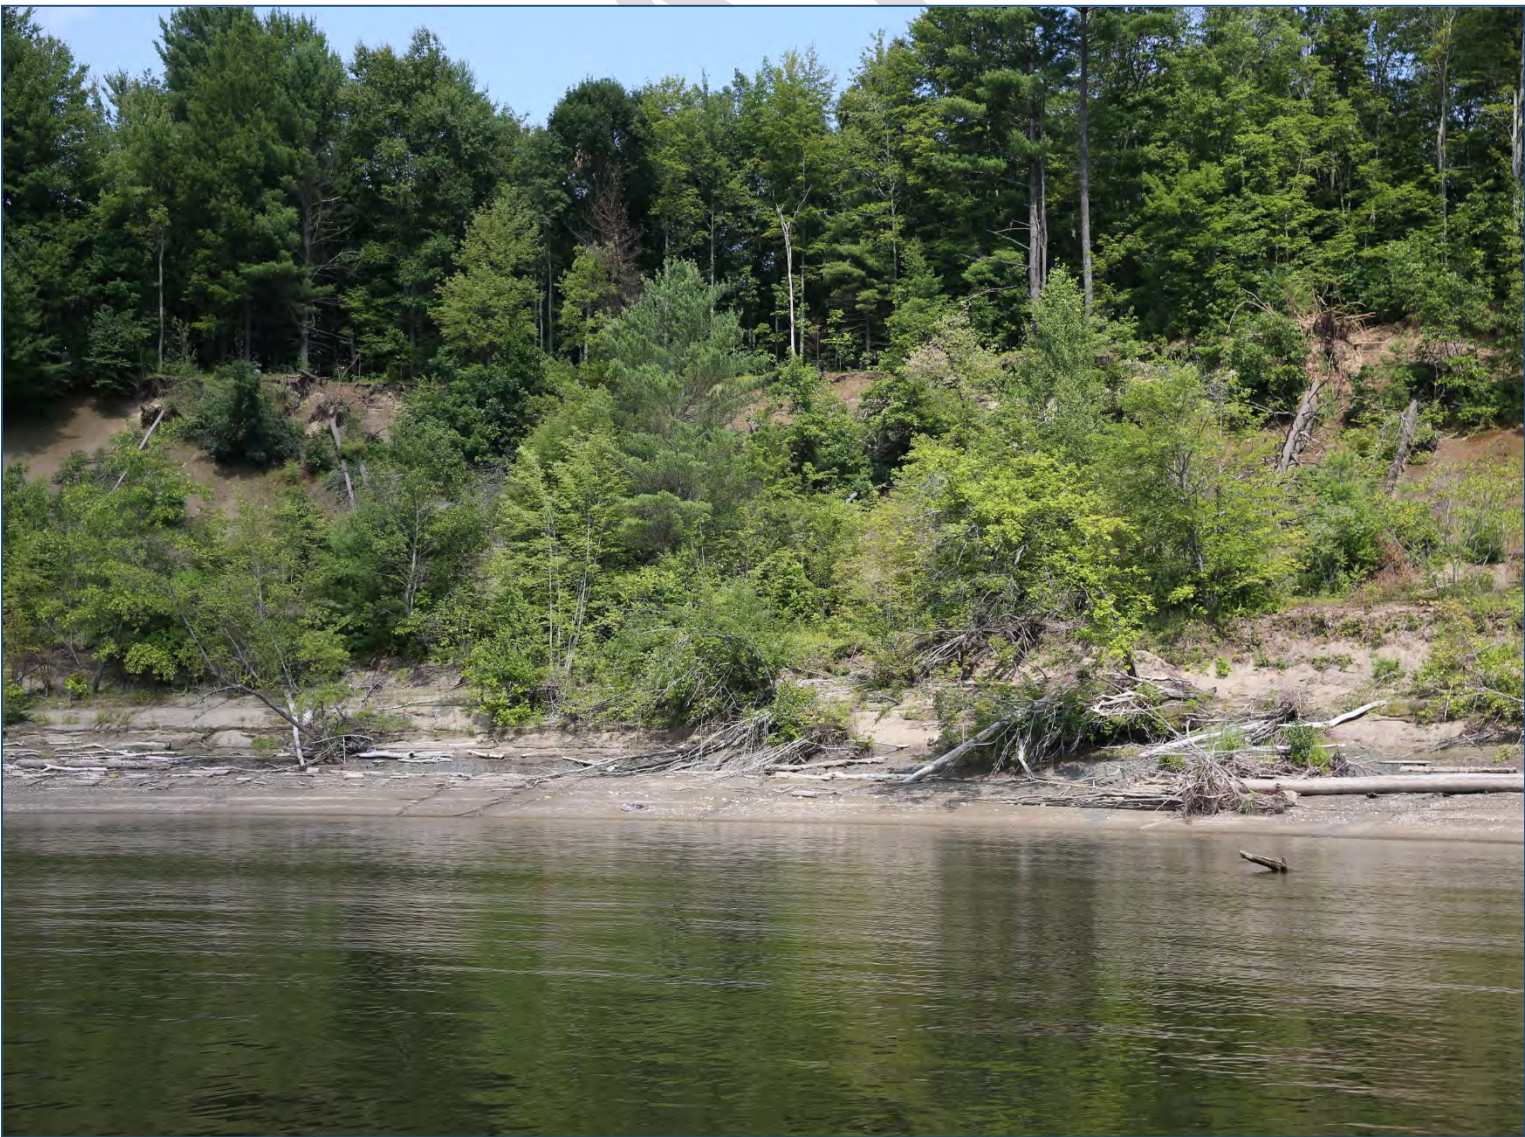
PHOTO SET #1

2007 Photo: Vernon Dam: Located immediately downstream of the Vernon Dam on the left bank.

Observations: The young trees present in the photo from 2007 have grown, additional coarse woody debris has accumulated on the bench since the 2007 photo, and some of the trees fell since the 2007 photograph. The overhang at the top of the bank appears to have receded back indicated by the toppled trees at the top of bank but the lower bank appears to have remained in place allowing increased growth of vegetation.

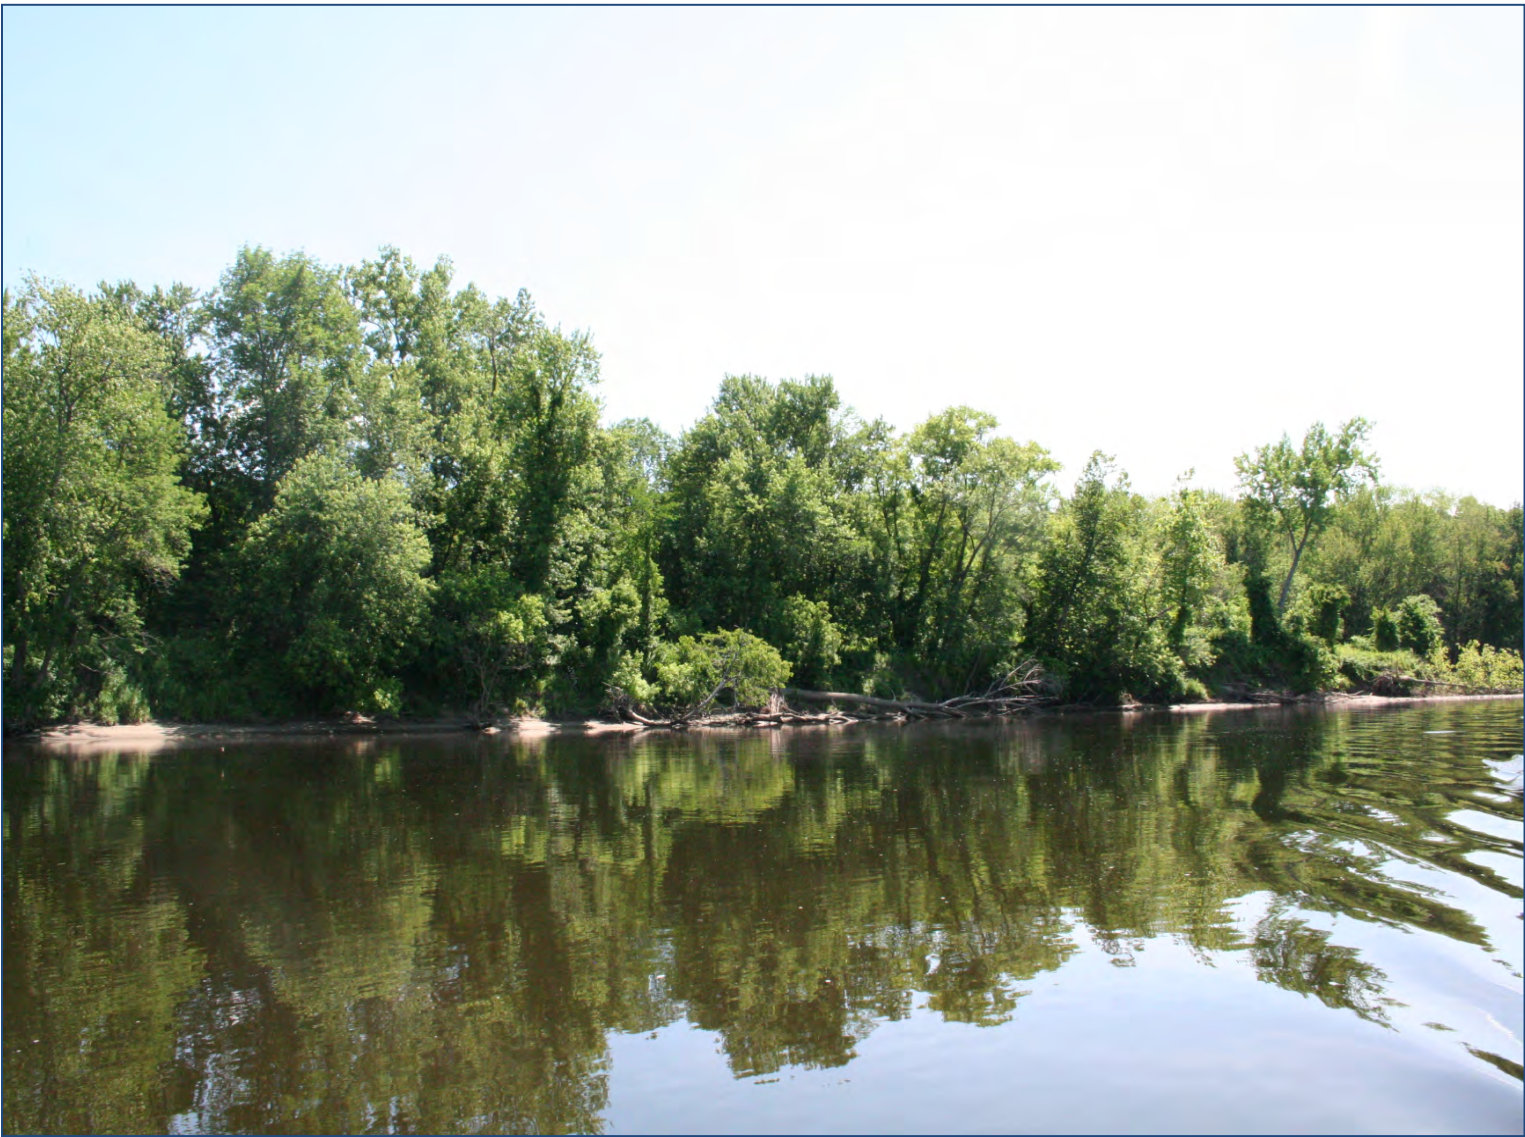
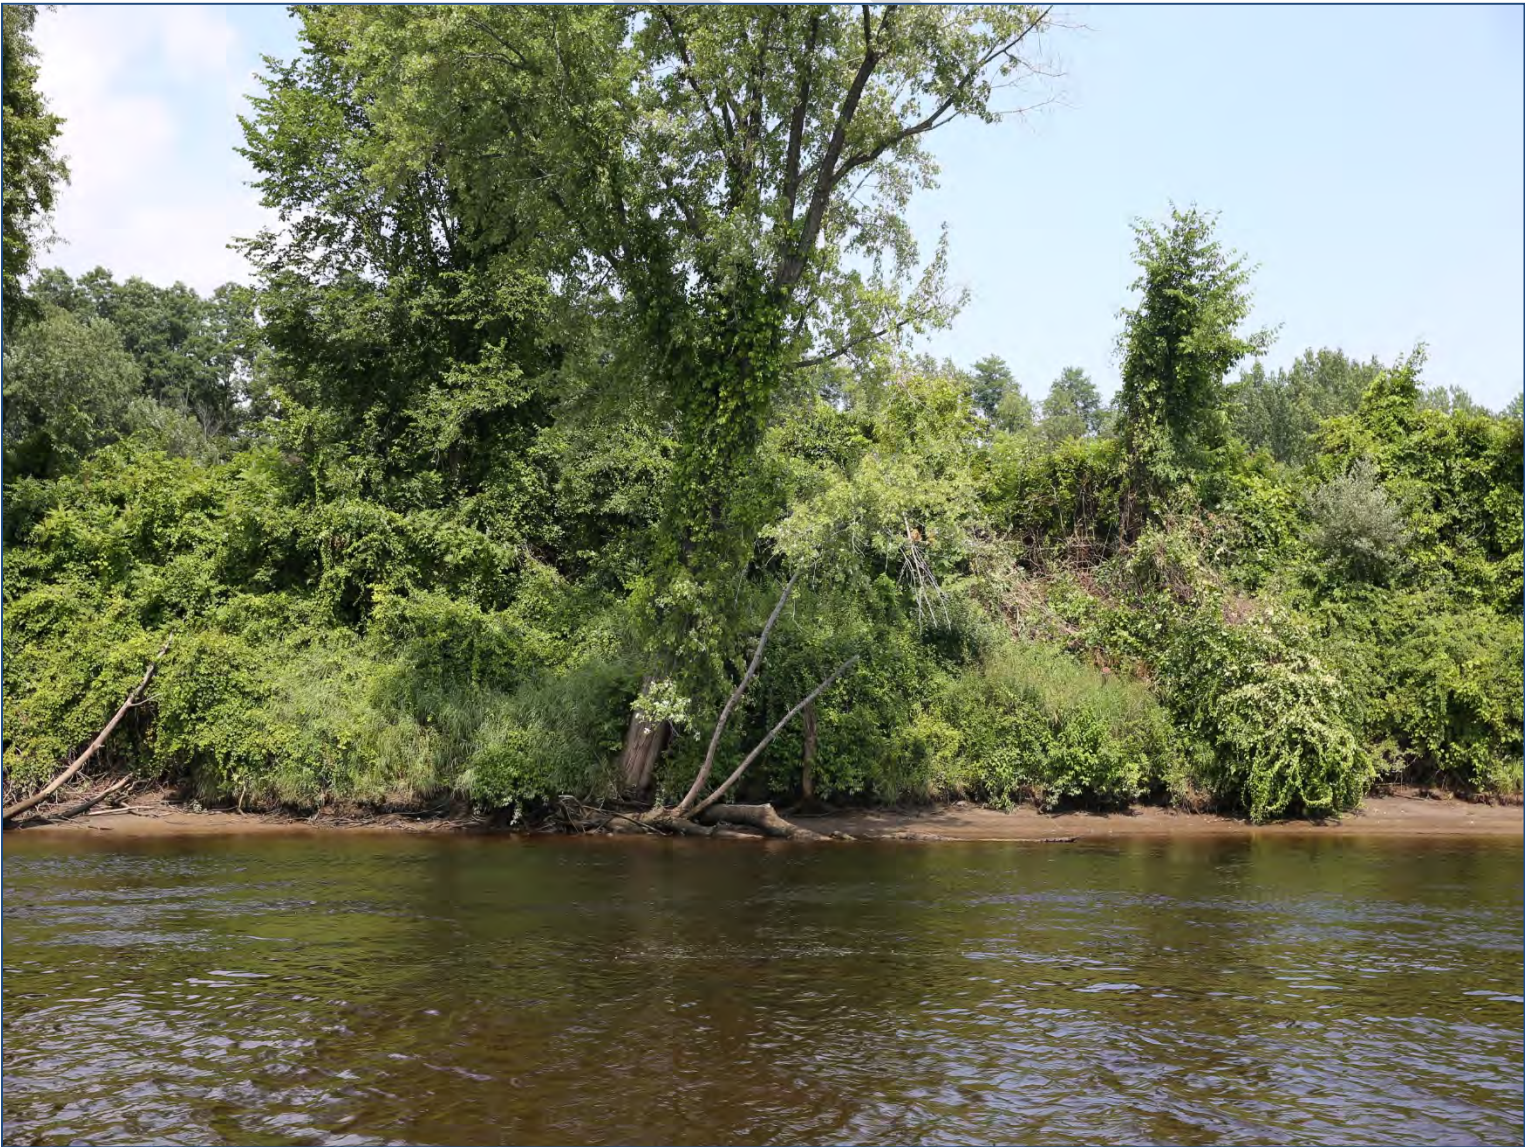
PHOTO SET #2

2007 Photo: Bonnette Farm: Located in New Hampshire on the left bank.

Observations: Dense and well established vegetation are observed in both photographs, indicative of relative stability. Since the 2007 photograph, the bank has become more vegetated, particularly with oriental bittersweet vines. There were sensitive receptor sites (kingfisher next cavity) present in 2007 and in 2014.

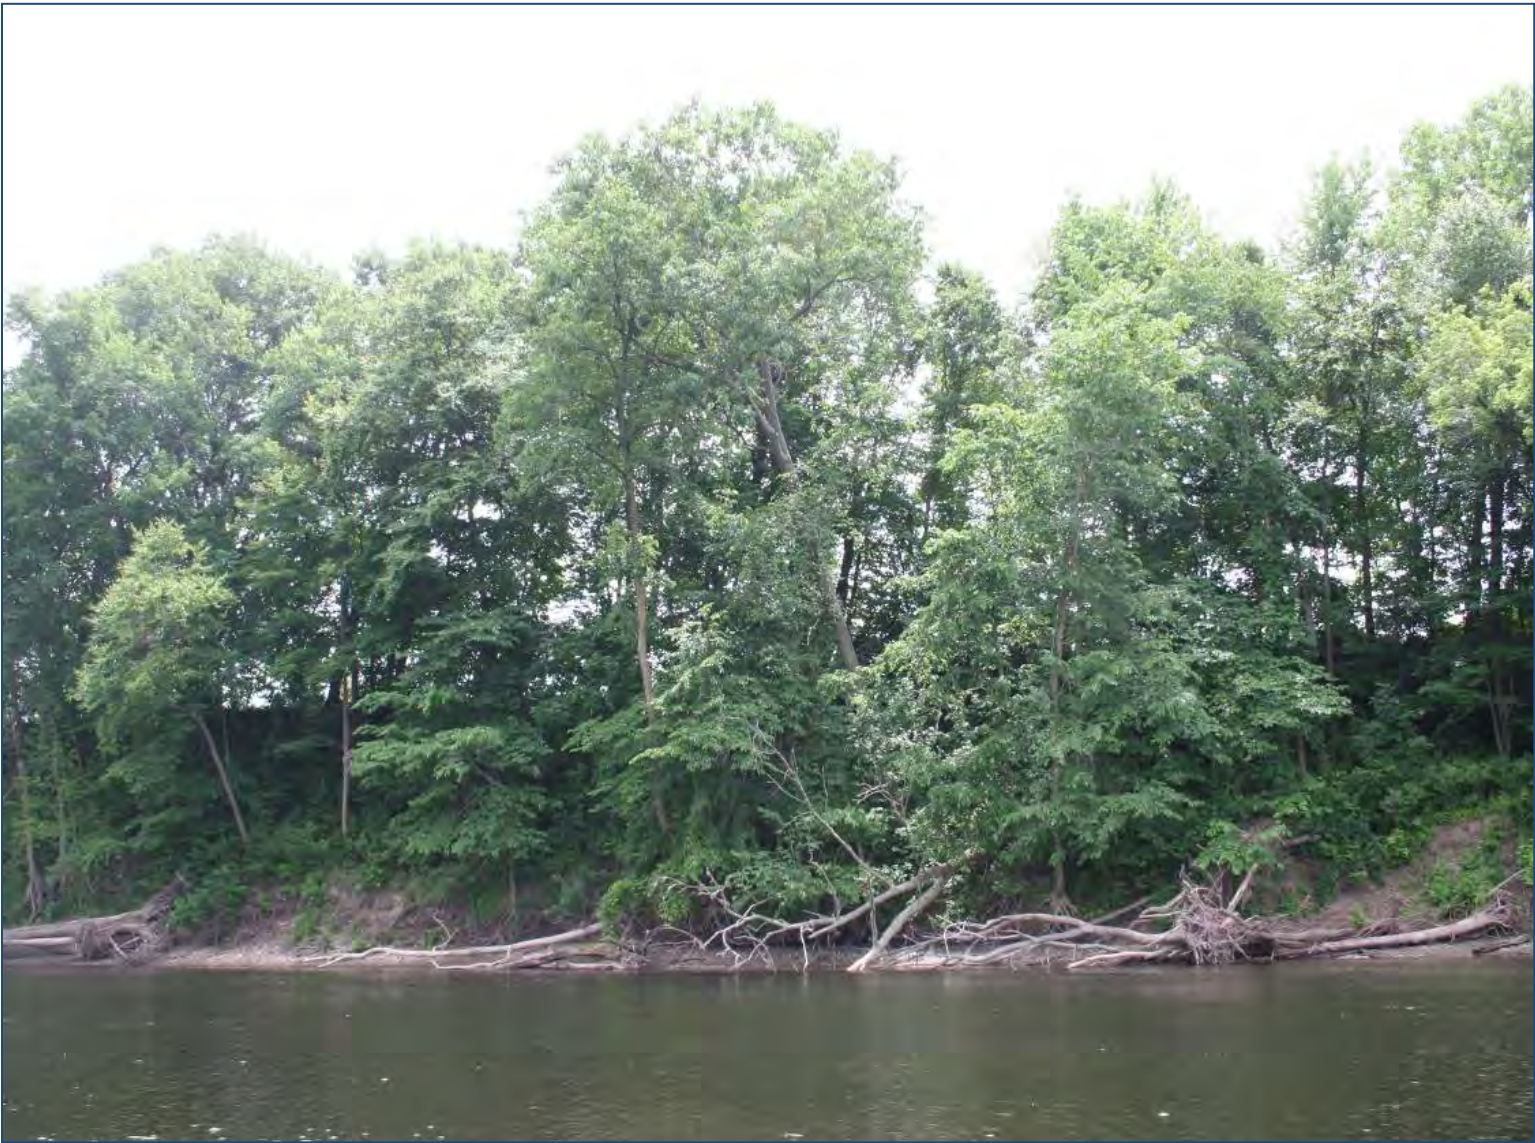
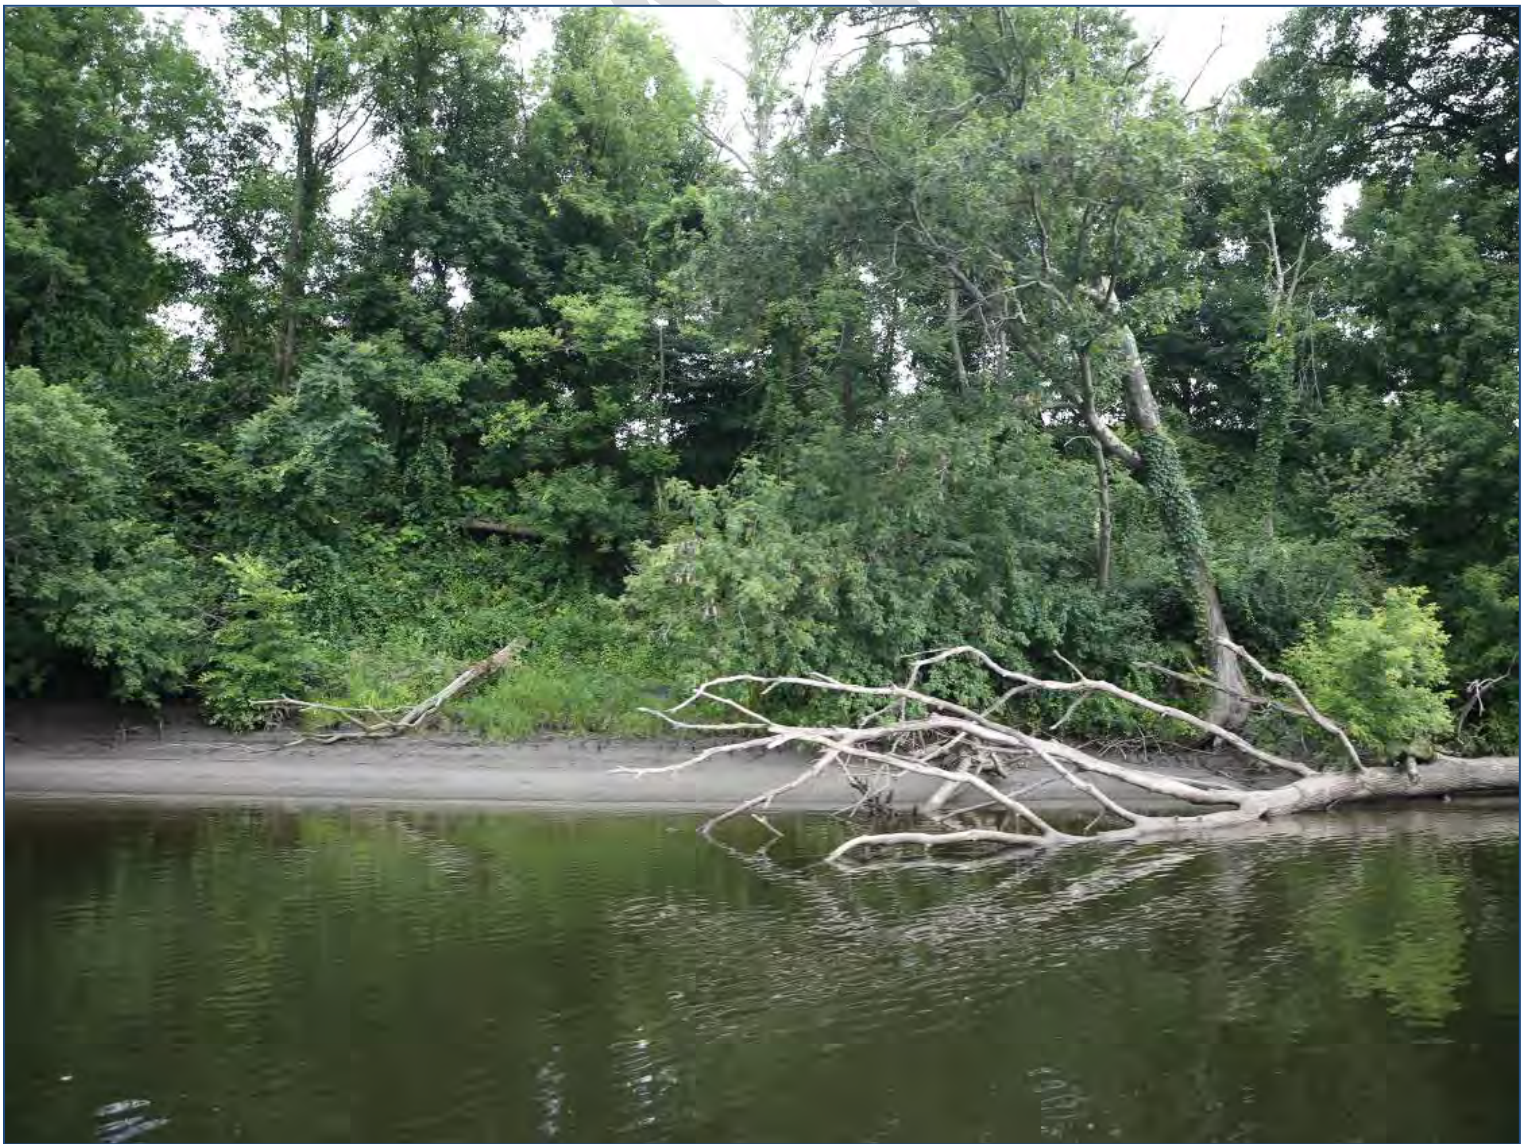
PHOTO SET #3

2007 Photo: Vermont Farm: Located in Vermont on the right bank. Note the bank is steep, and there are exposed roots at the toe.

Observations: Banks in both photos support a significant density of trees. An increase in lower level vegetative growth, including a patch of emergent vegetation on the bench which was not observed in the 2007 photo, can be observed in the 2014 photo.

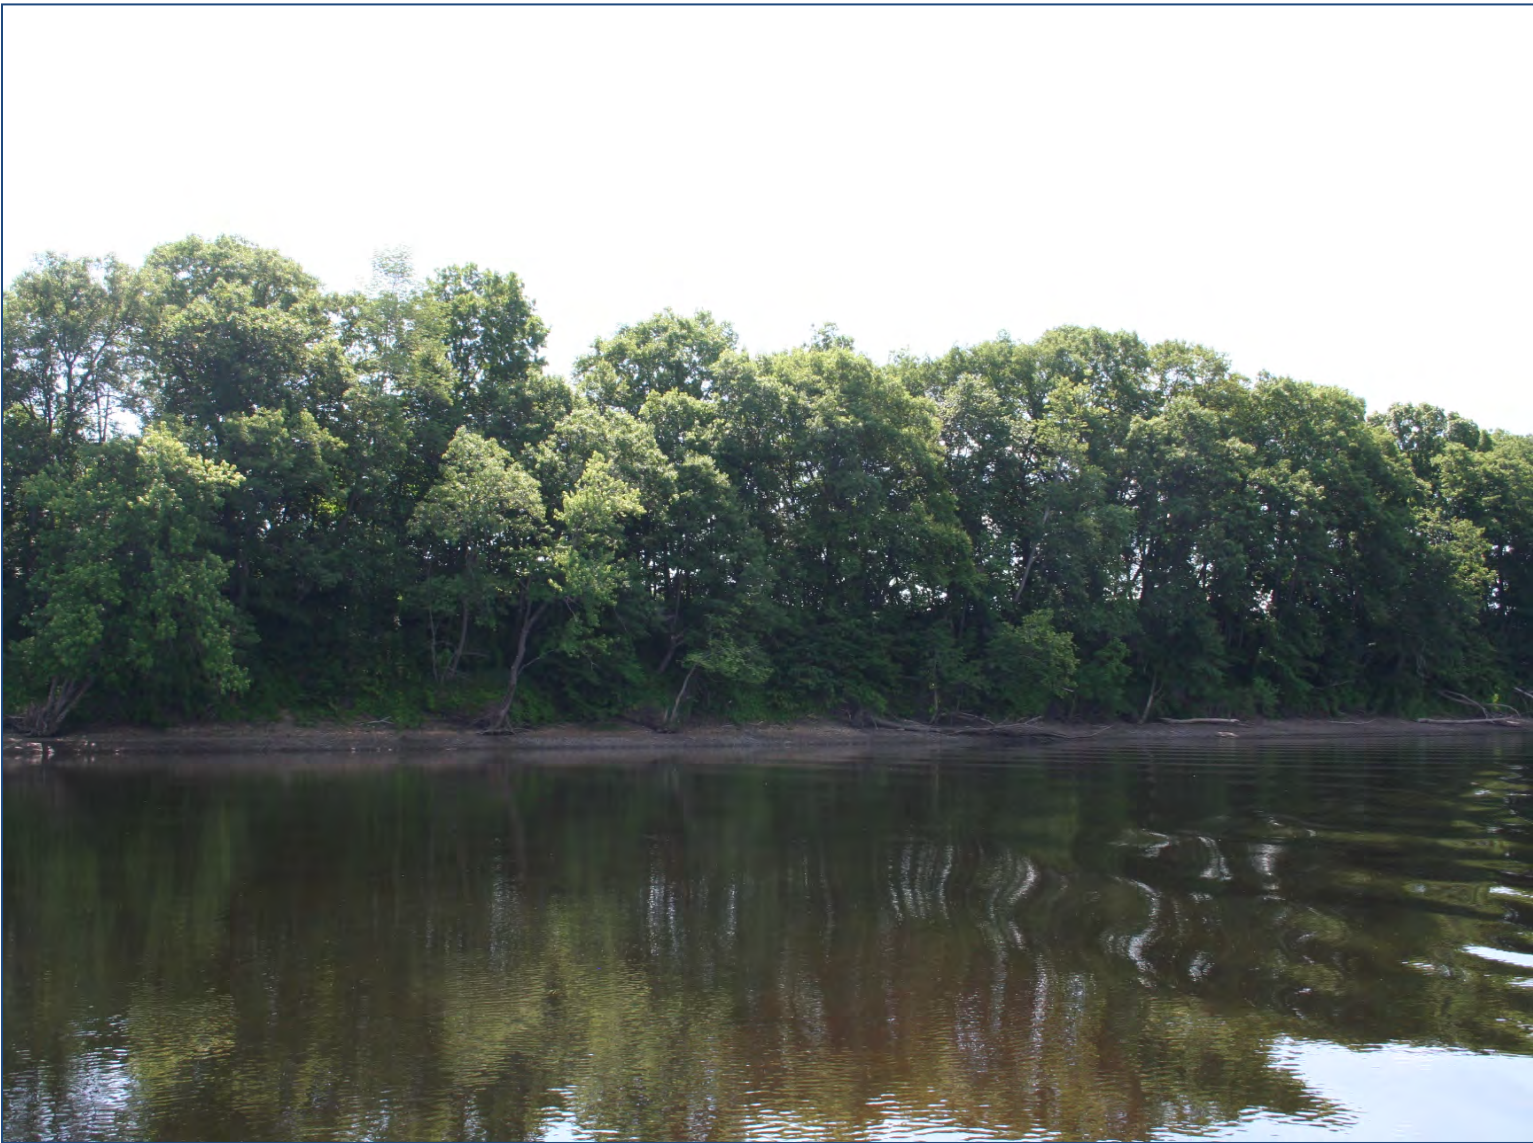
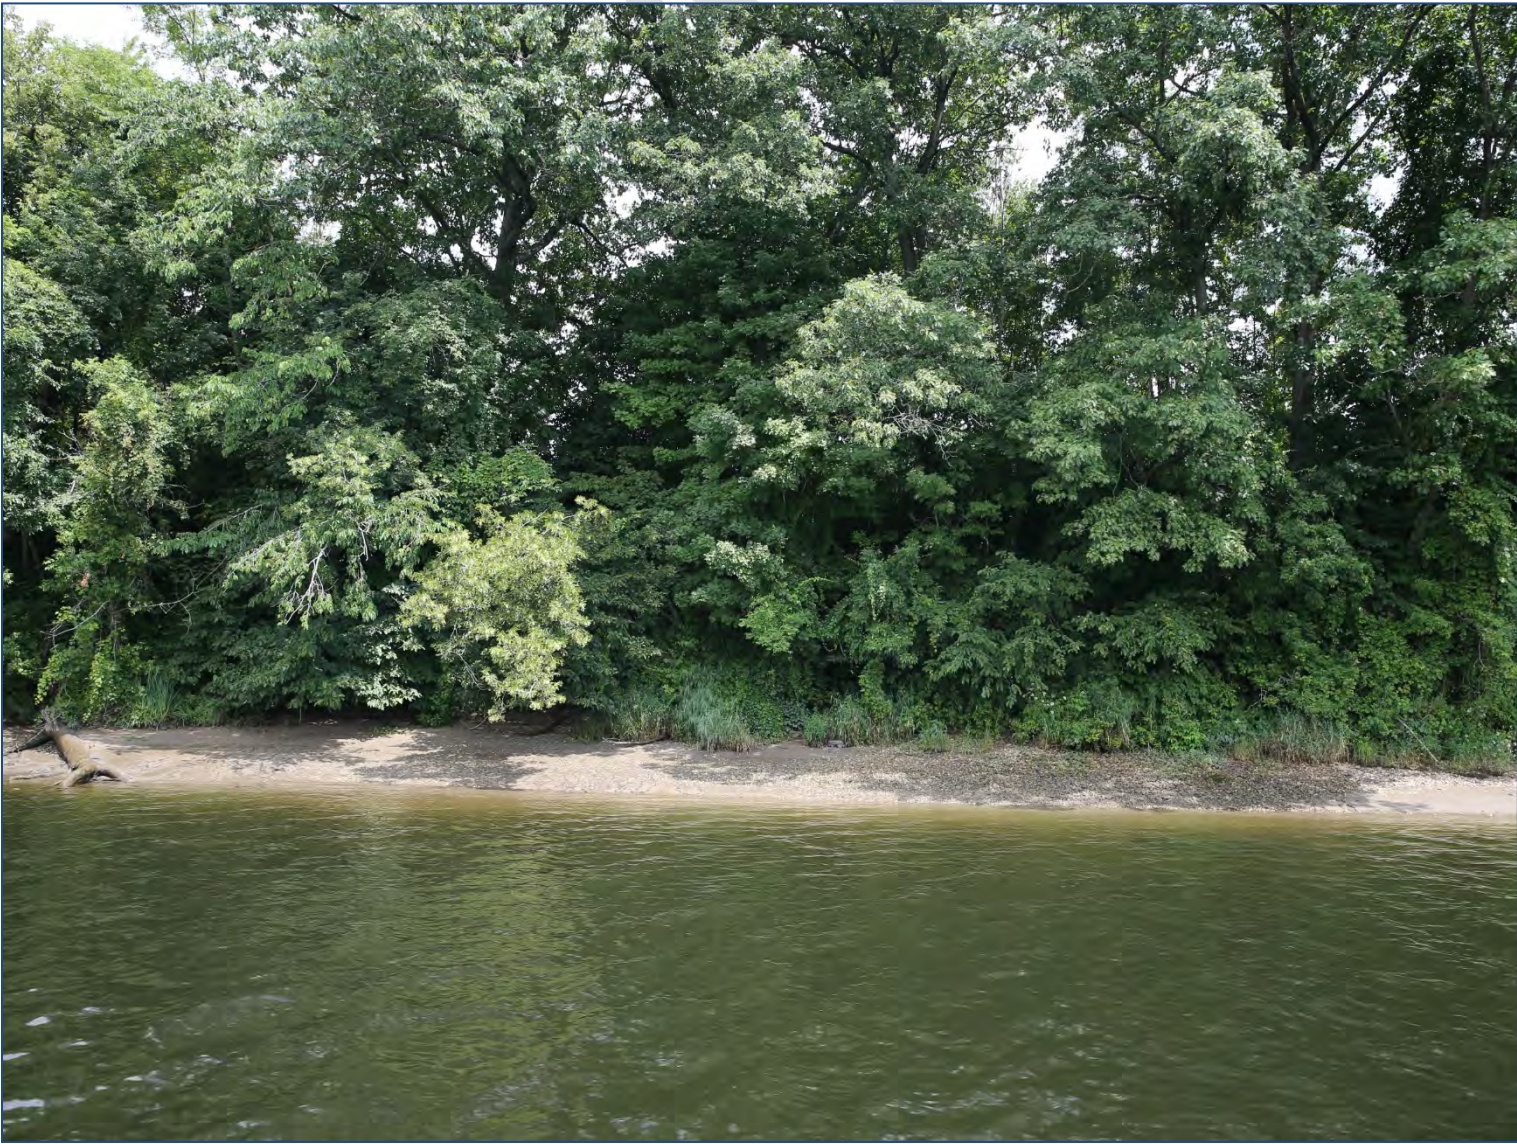
PHOTO SET #4

2007 Photo: Across from Urgiel Upstream: Located in New Hampshire on the left bank. The bench is gravelly at this site, with some areas of exposed bedrock, and some patches of emergent vegetation.

Observations: No significant changes in the bank at this location are observed.

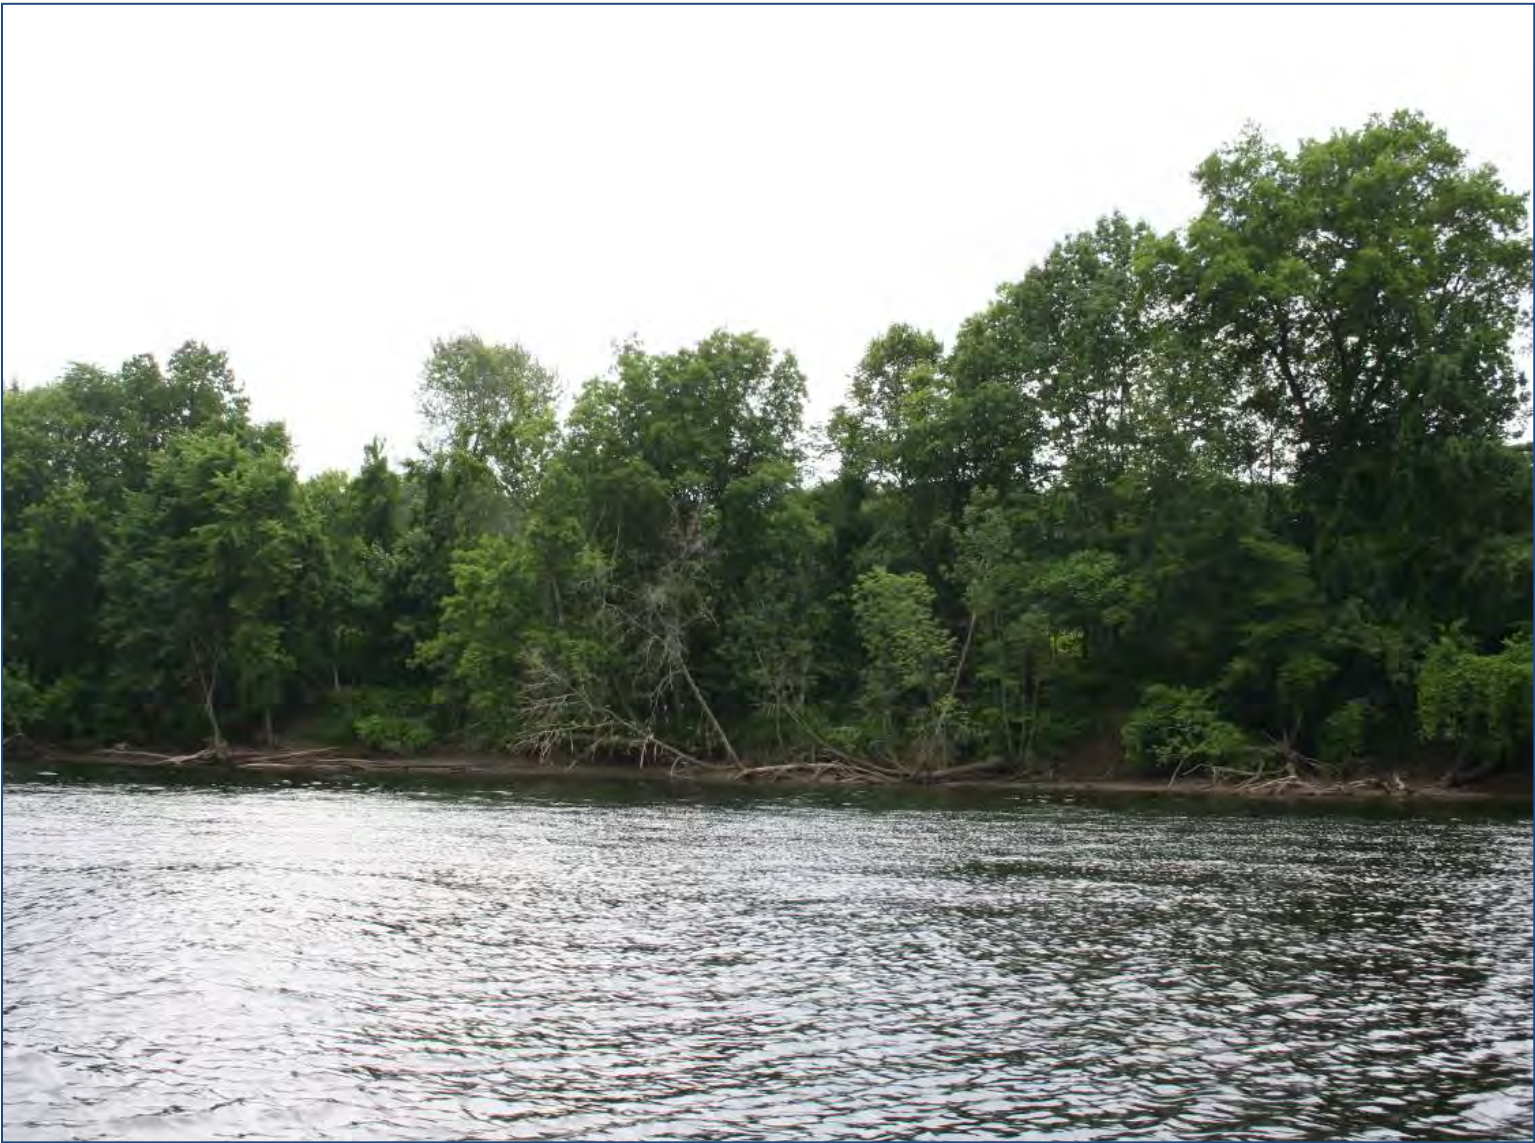
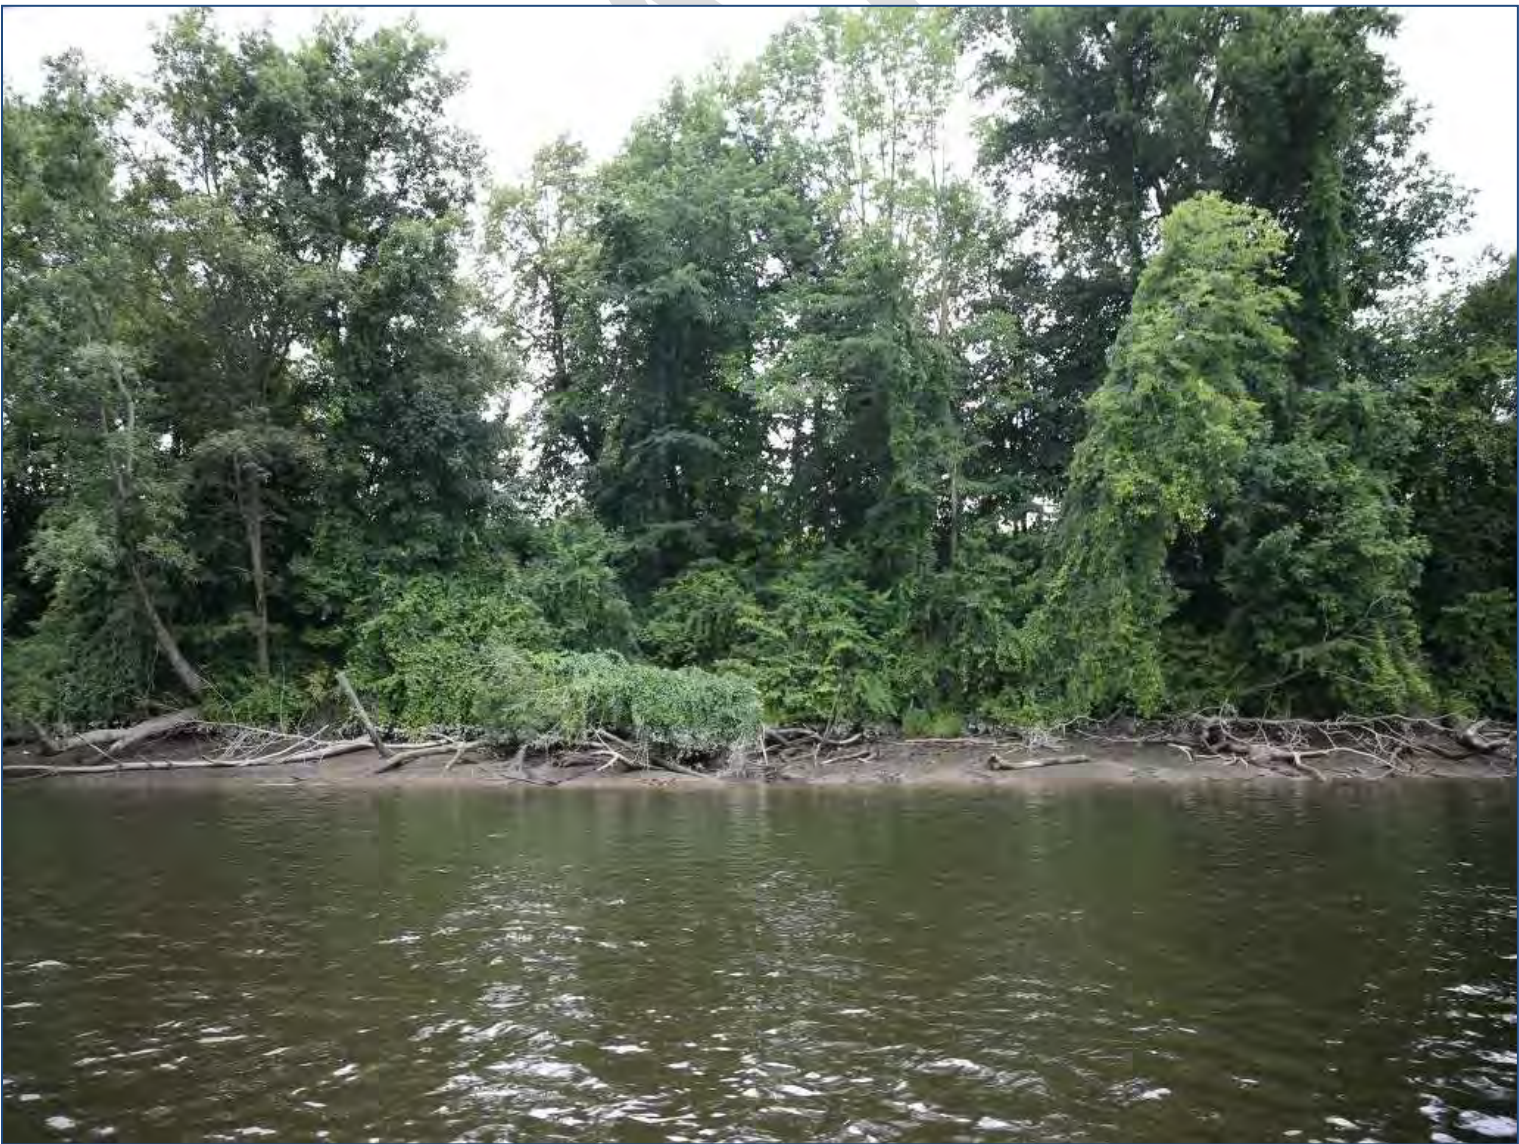
PHOTO SET #5

2007 Photo: Downstream from Kendall, Site 1: Located in Vermont on the right bank, and immediately downstream from the Kendall restoration site.

Observations: Banks in both photos are well-vegetated, however, since the 2007 photograph oriental bittersweet has overgrown many of the trees.

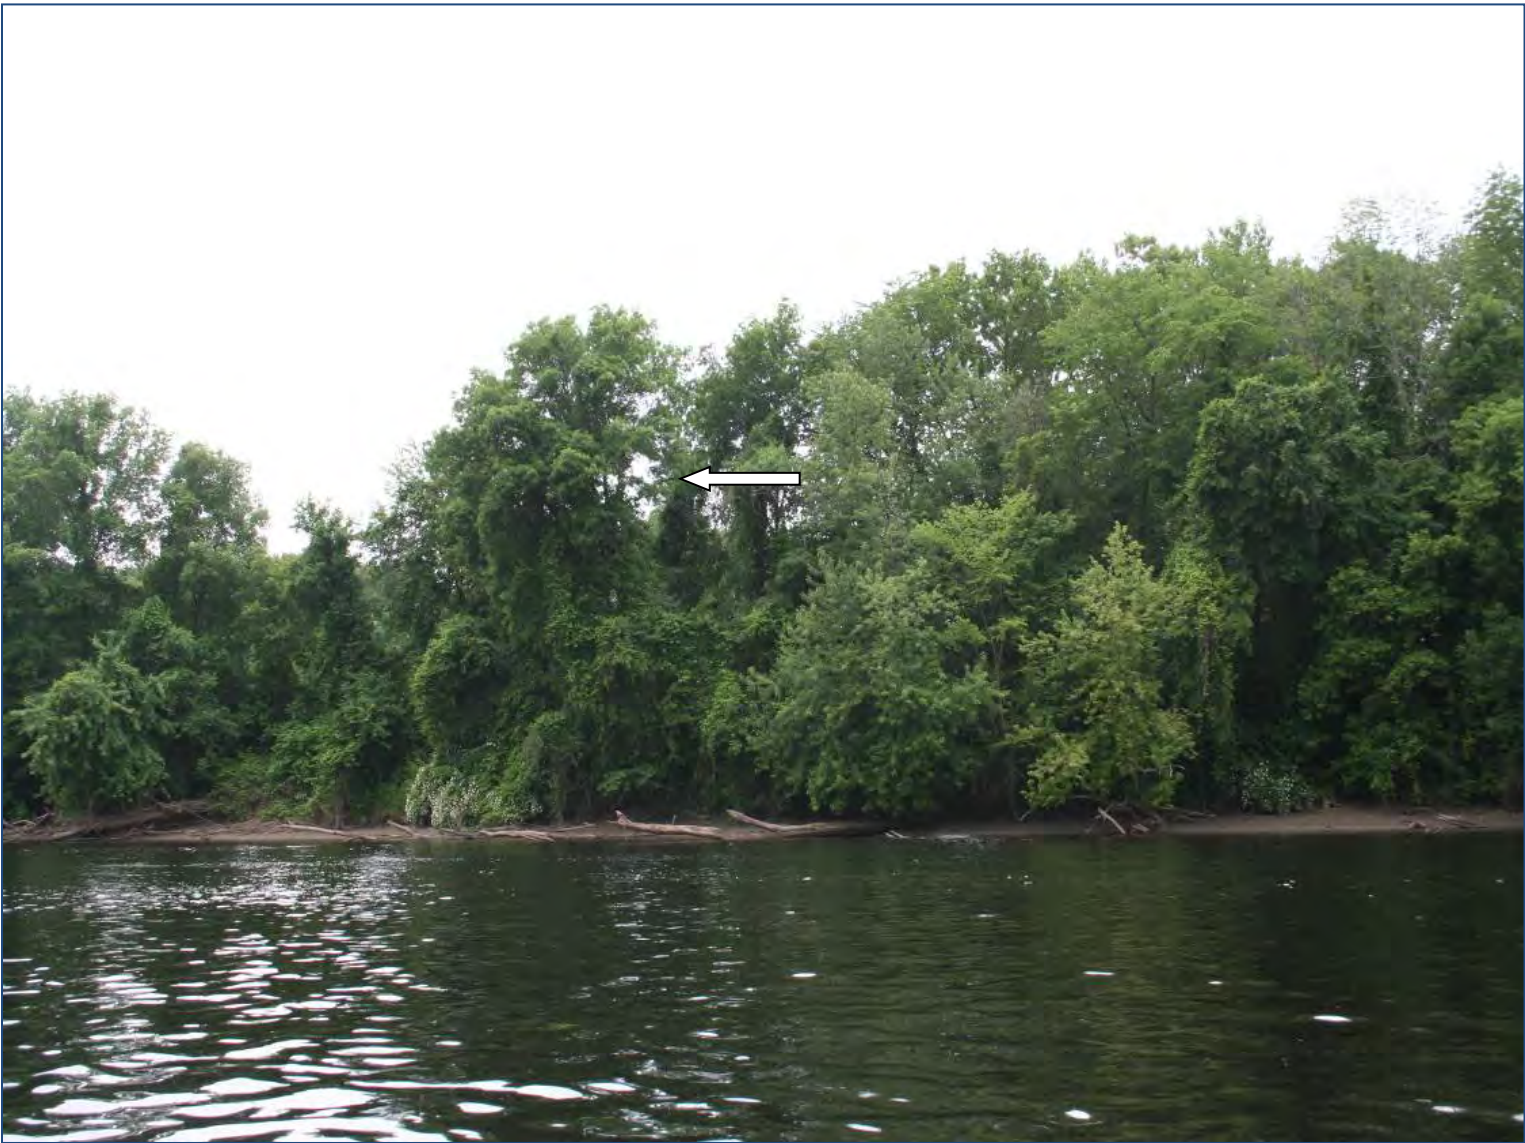
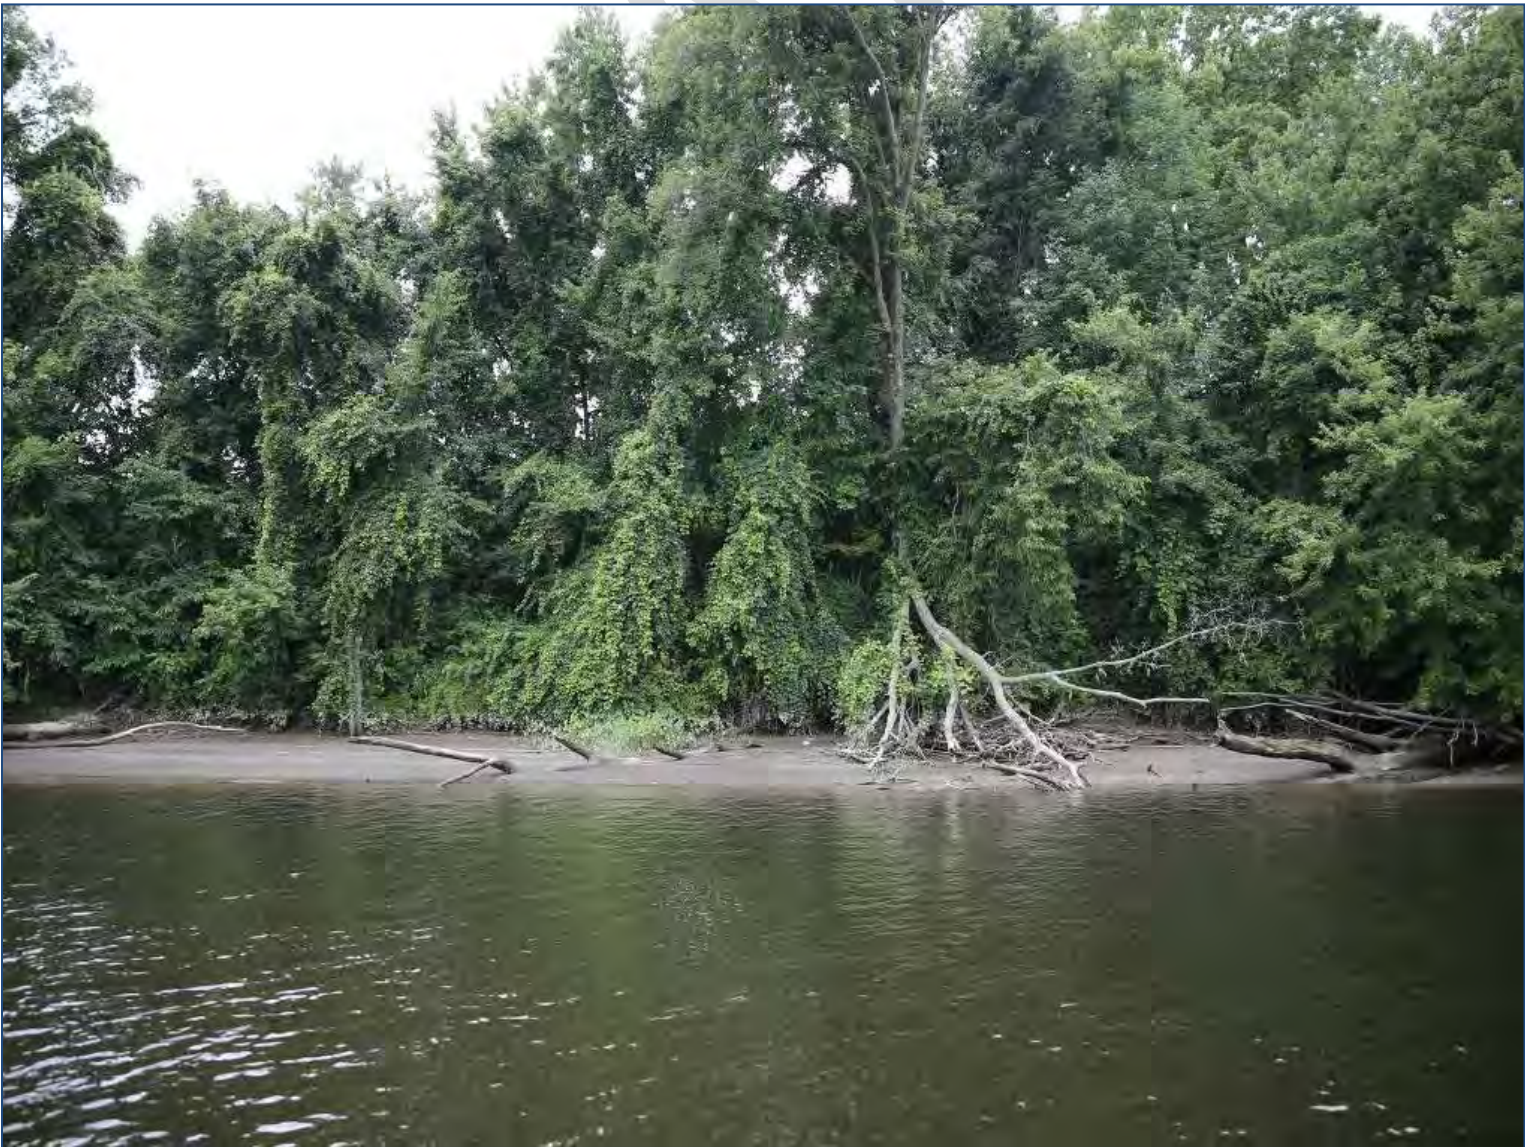
PHOTO SET #6

2007 Photo: Downstream from Kendall, Site 2: Located further downstream from the Kendall restoration site than Photo set 5, this site is located in Vermont on the right bank.

Observations: The banks appear to be similar in both time periods with heavy vegetation. Part of a large oak tree has fallen since 2007 (white arrow), and the oriental bittersweet has become denser.
