ATTACHMENT B: 2007-2014 Photo Log Comparison

FIRSTLIGHT POWER RESOURCES
RELICENSING STUDY 3.1.1
2013 FULL RIVER RECONNAISSANCE
TURNERS FALLS IMPOUNDMENT

Addendum Figure 1:
Photo Station Locations for Comparison of
2007 Photographs (Field) and
2014 Photographs (NEE)

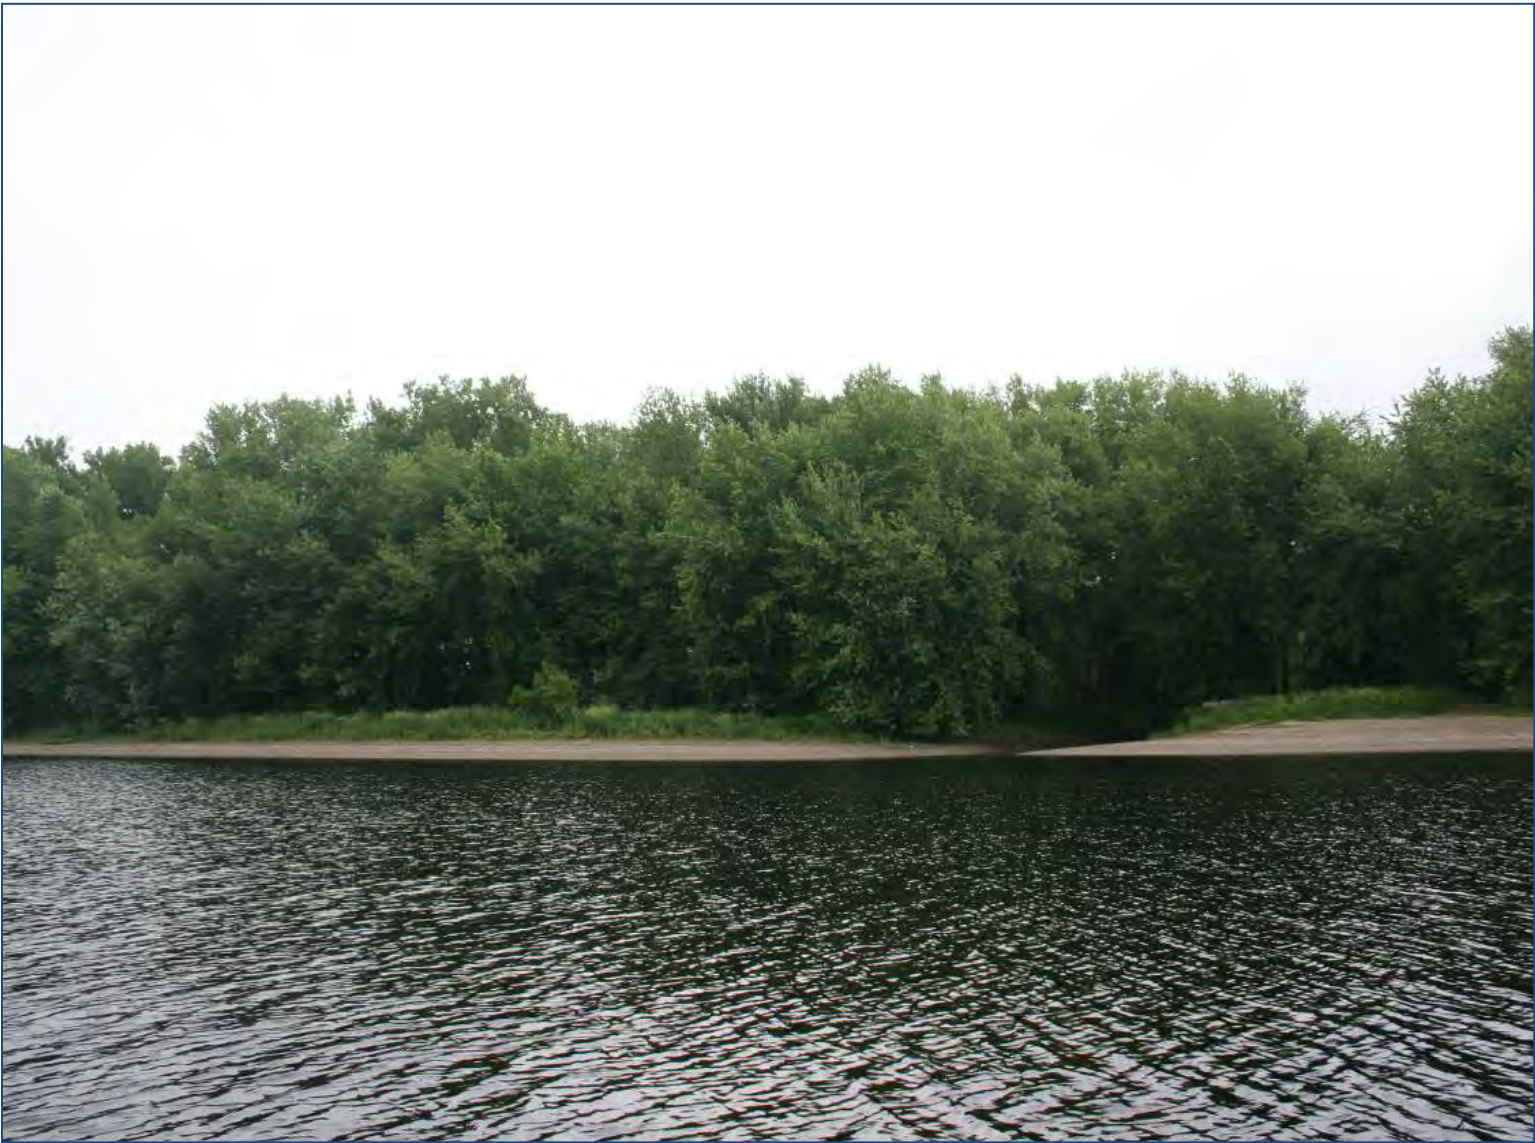
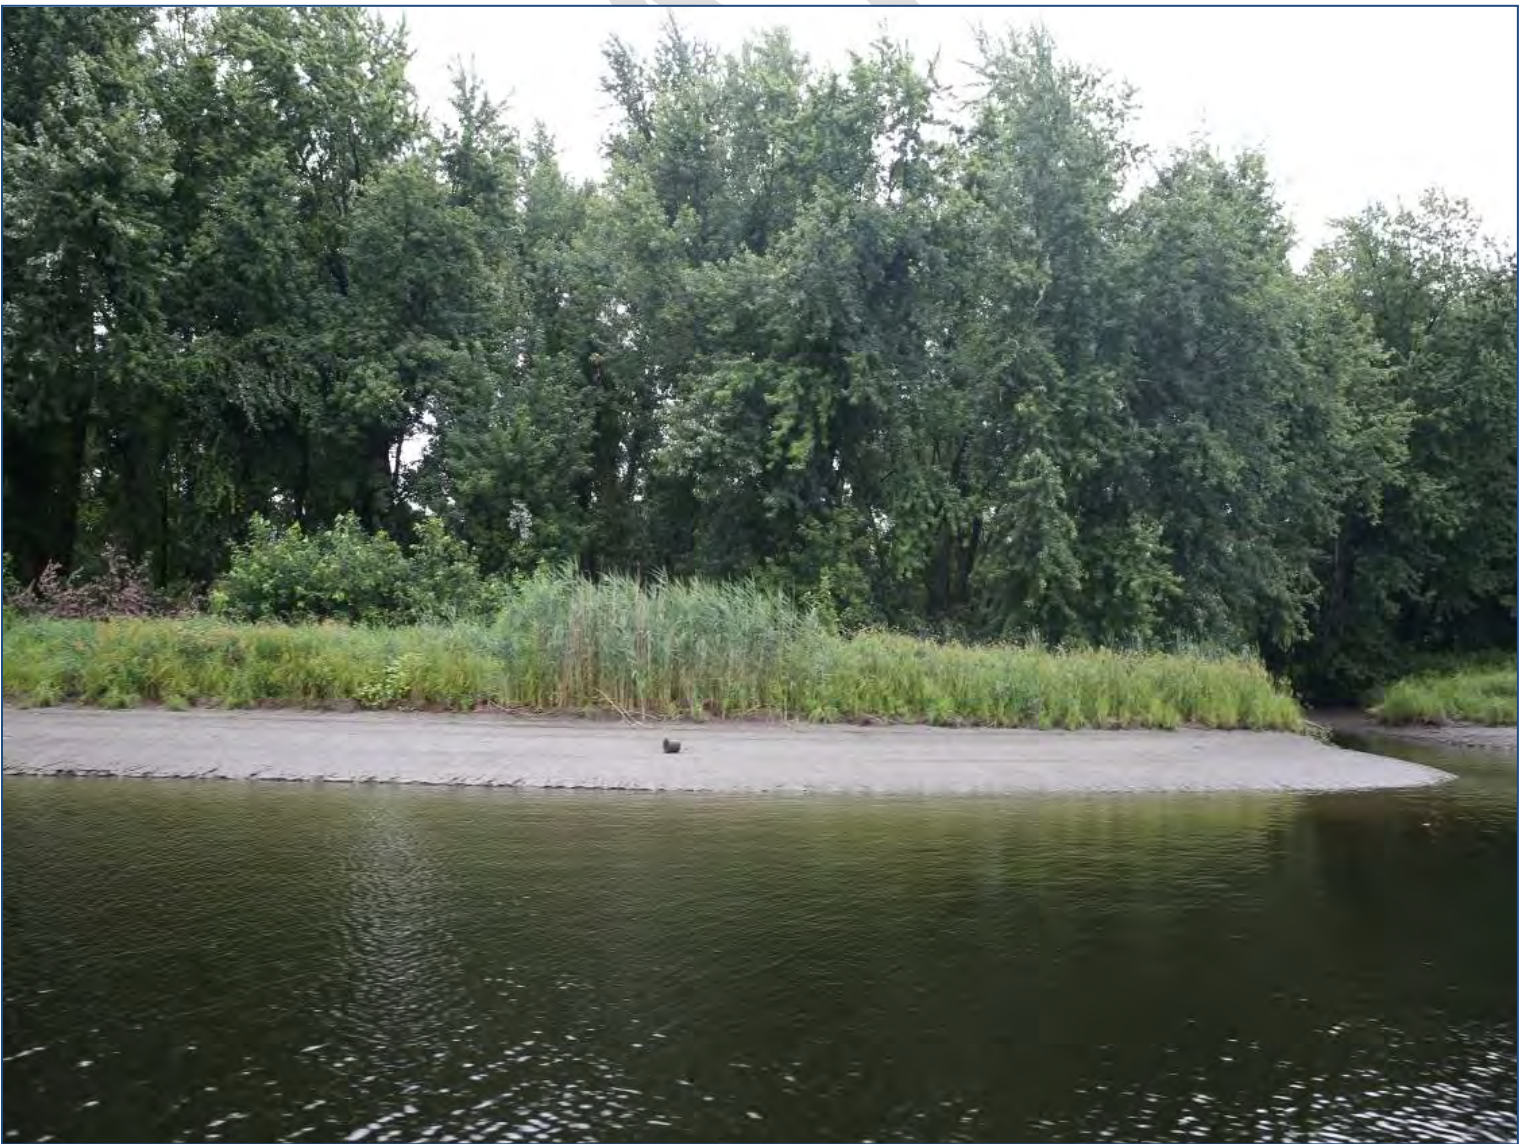
PHOTO SET #7

2007 Photo: Pauchaug: Located upstream of the Pauchaug boat launch site on the left bank of the River, in Northfield, Massachusetts.

Observations: Both photographs indicate dense vegetation on the upper bank as well as dense vegetation on the lower bank/beach area. Since the 2007 photograph, the bench has accumulated sediment and the emergent vegetation has become very well established. The extent of the *Phragmites* colonization has grown since 2007.

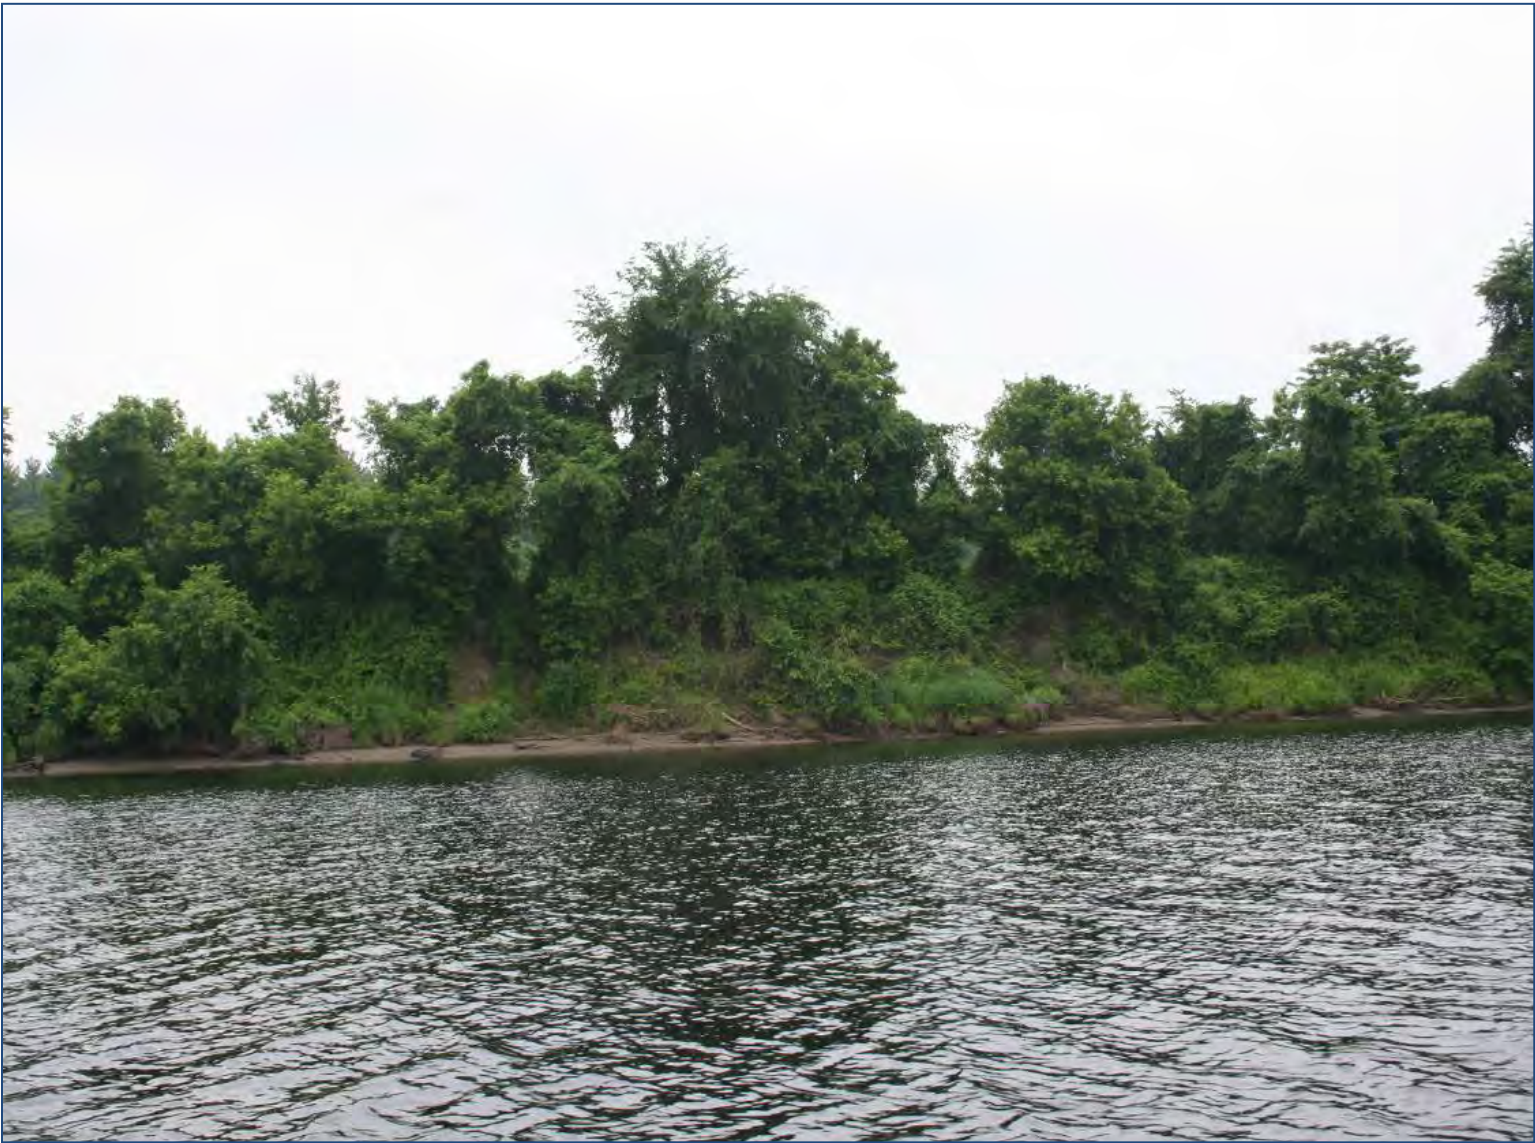
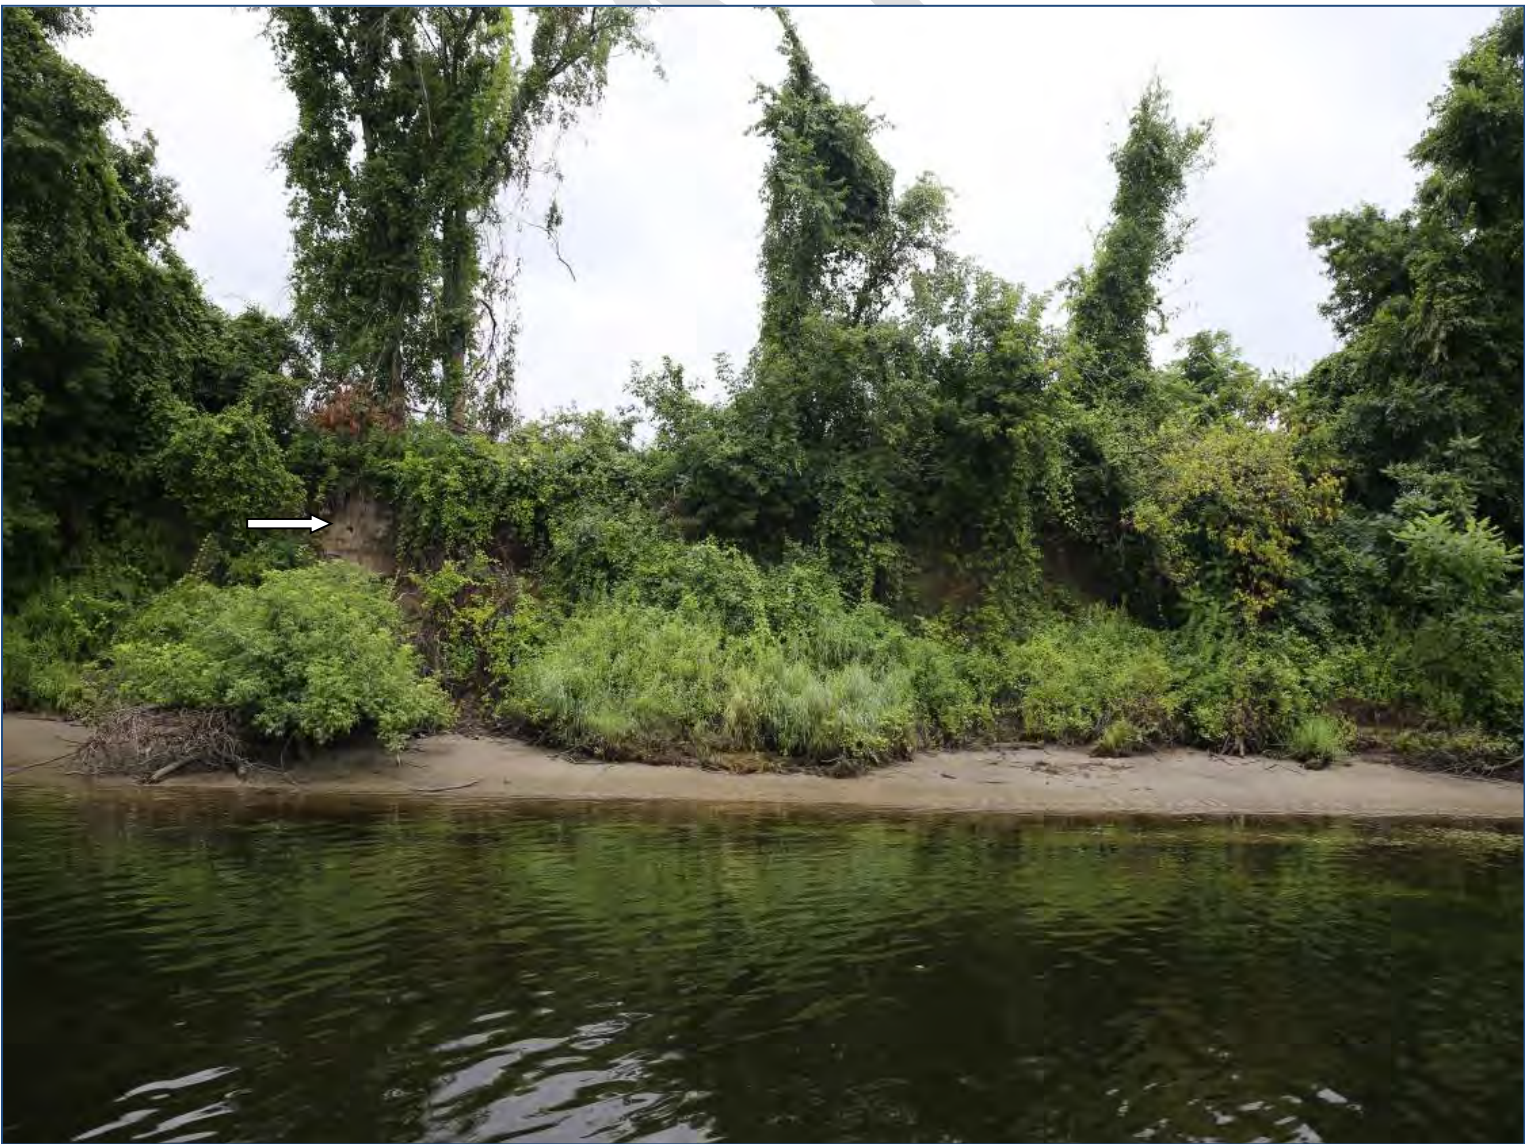
PHOTO SET #8

2007 Photo: Downstream from the old Railroad Bridge: Located on the left bank of the River.

Observations: Bank conditions appear similar in both sets of photographs but oriental bittersweet has become more established since 2007 at this location. There is a kingfisher nest cavity in the 2014 photograph (white arrow).

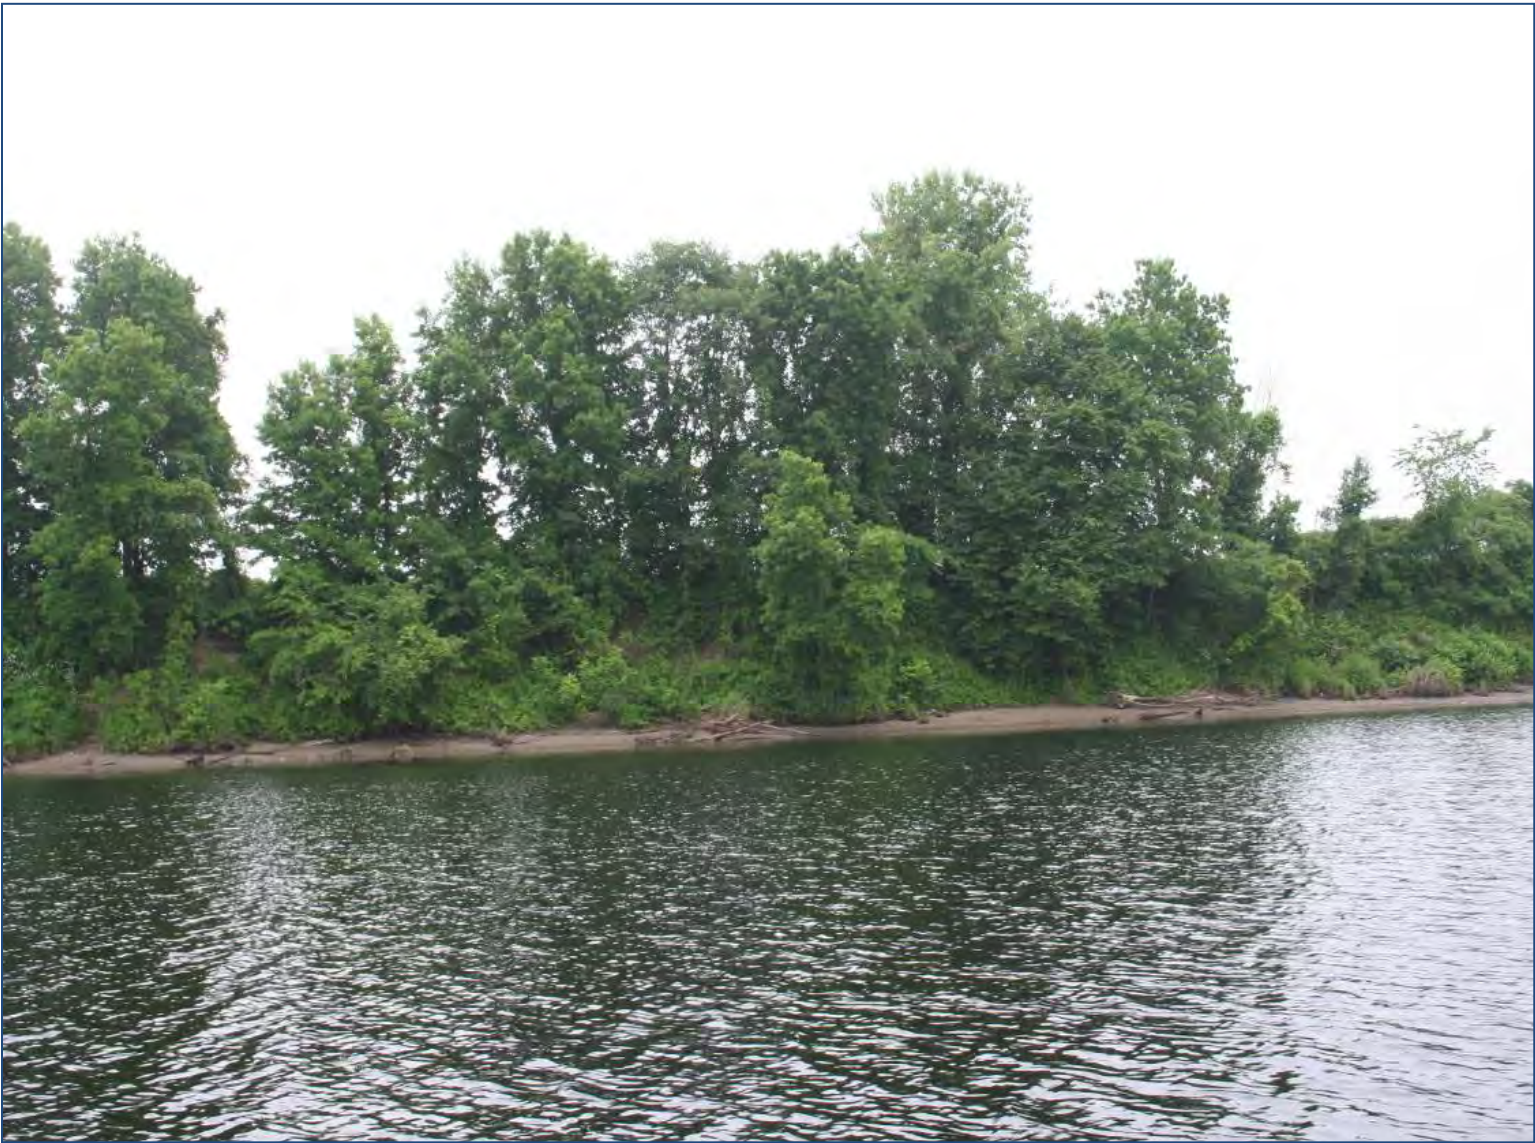
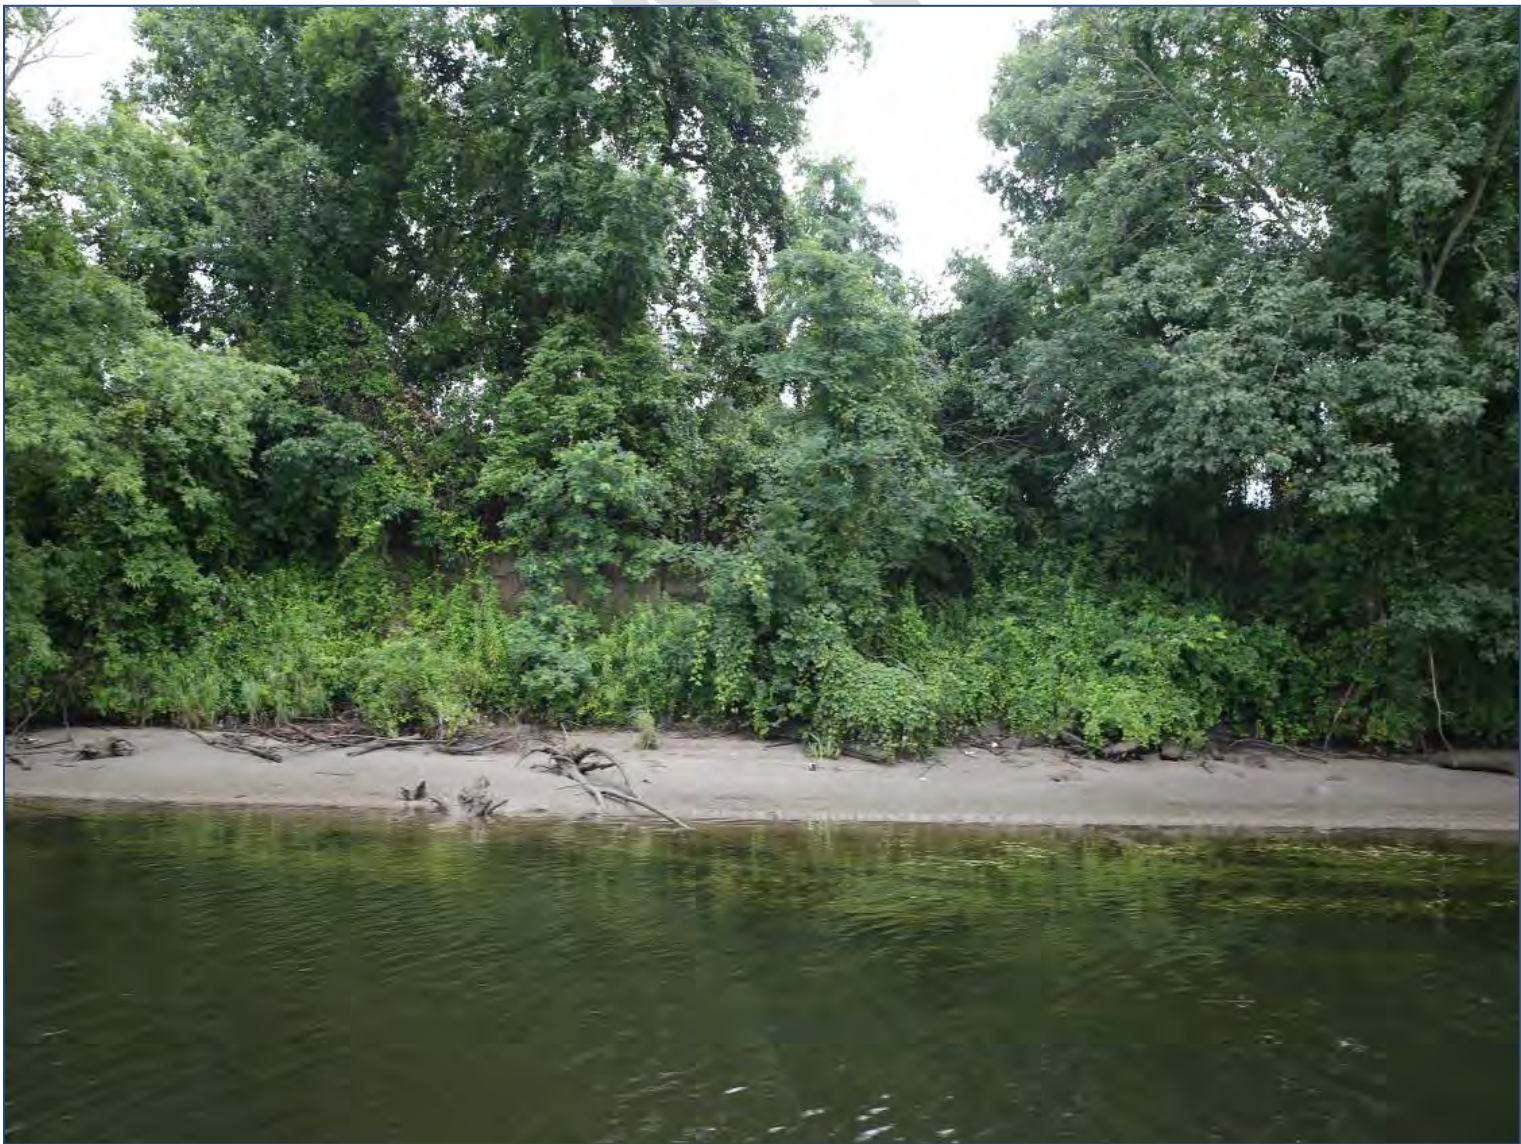
PHOTO SET #9

2007 Photo: Northfield Farm: Located in Northfield, Massachusetts, on the left bank

Observations: Bank conditions do not appear to have changed significantly from 2007 to 2014. The vegetated riparian buffer along this farm field is narrow, and has not changed since 2007.

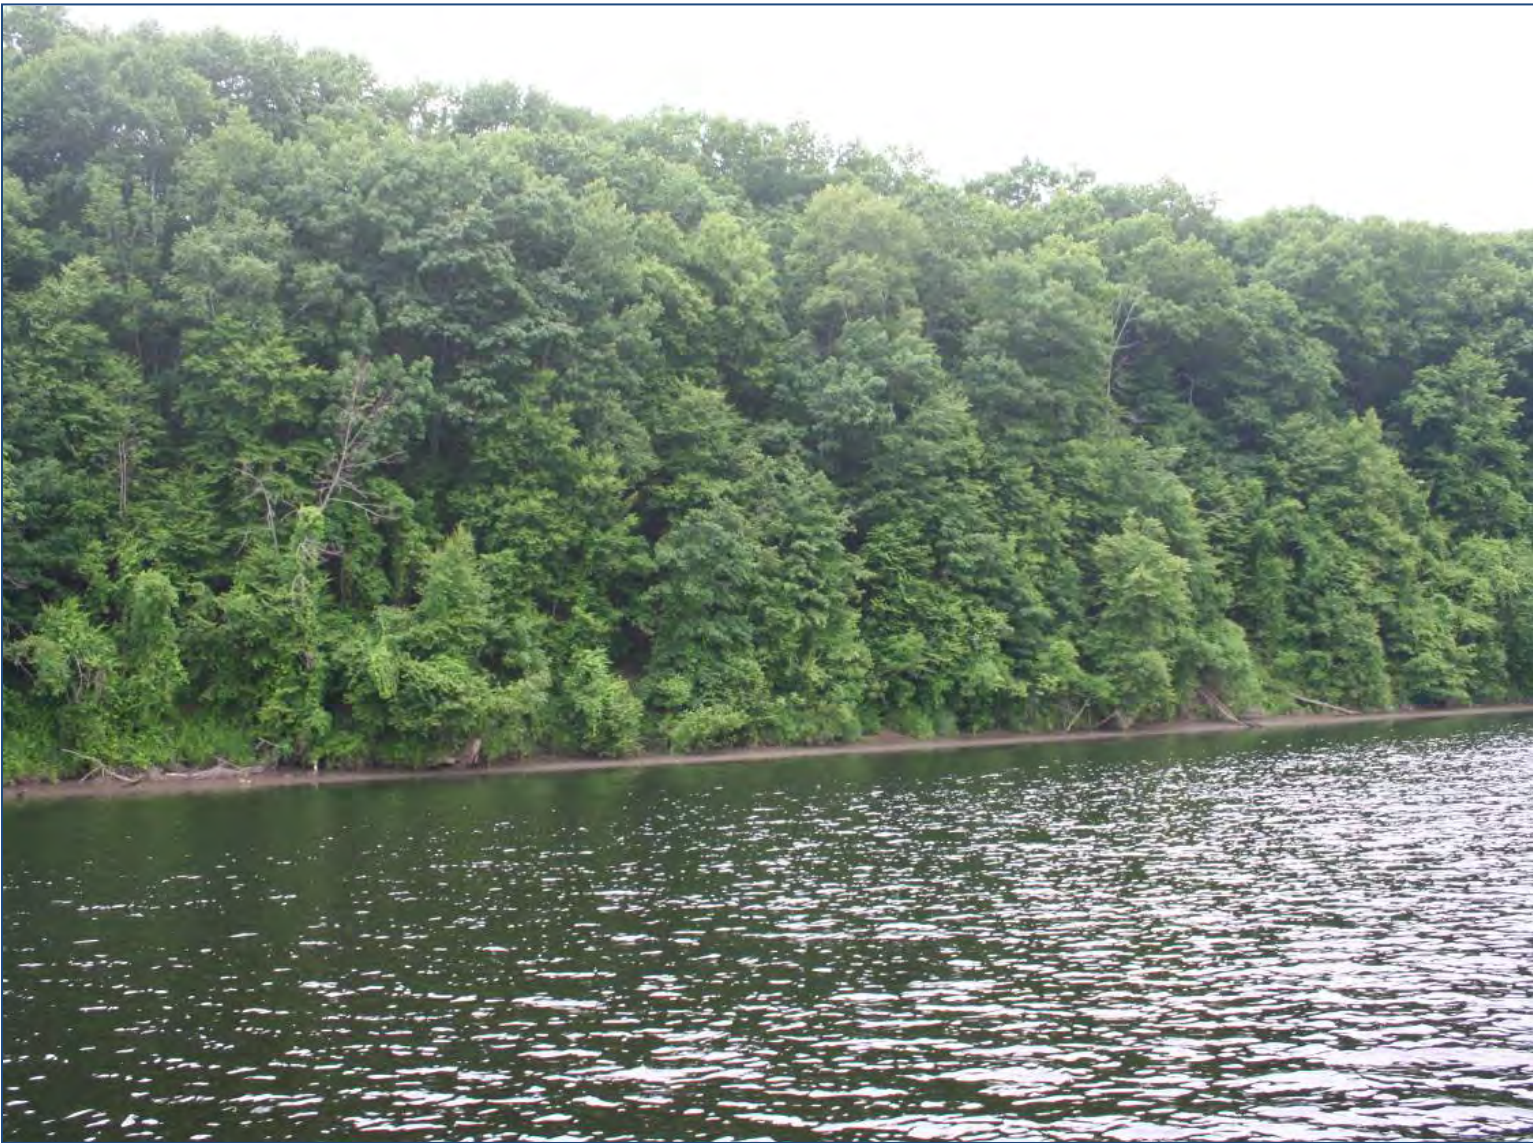
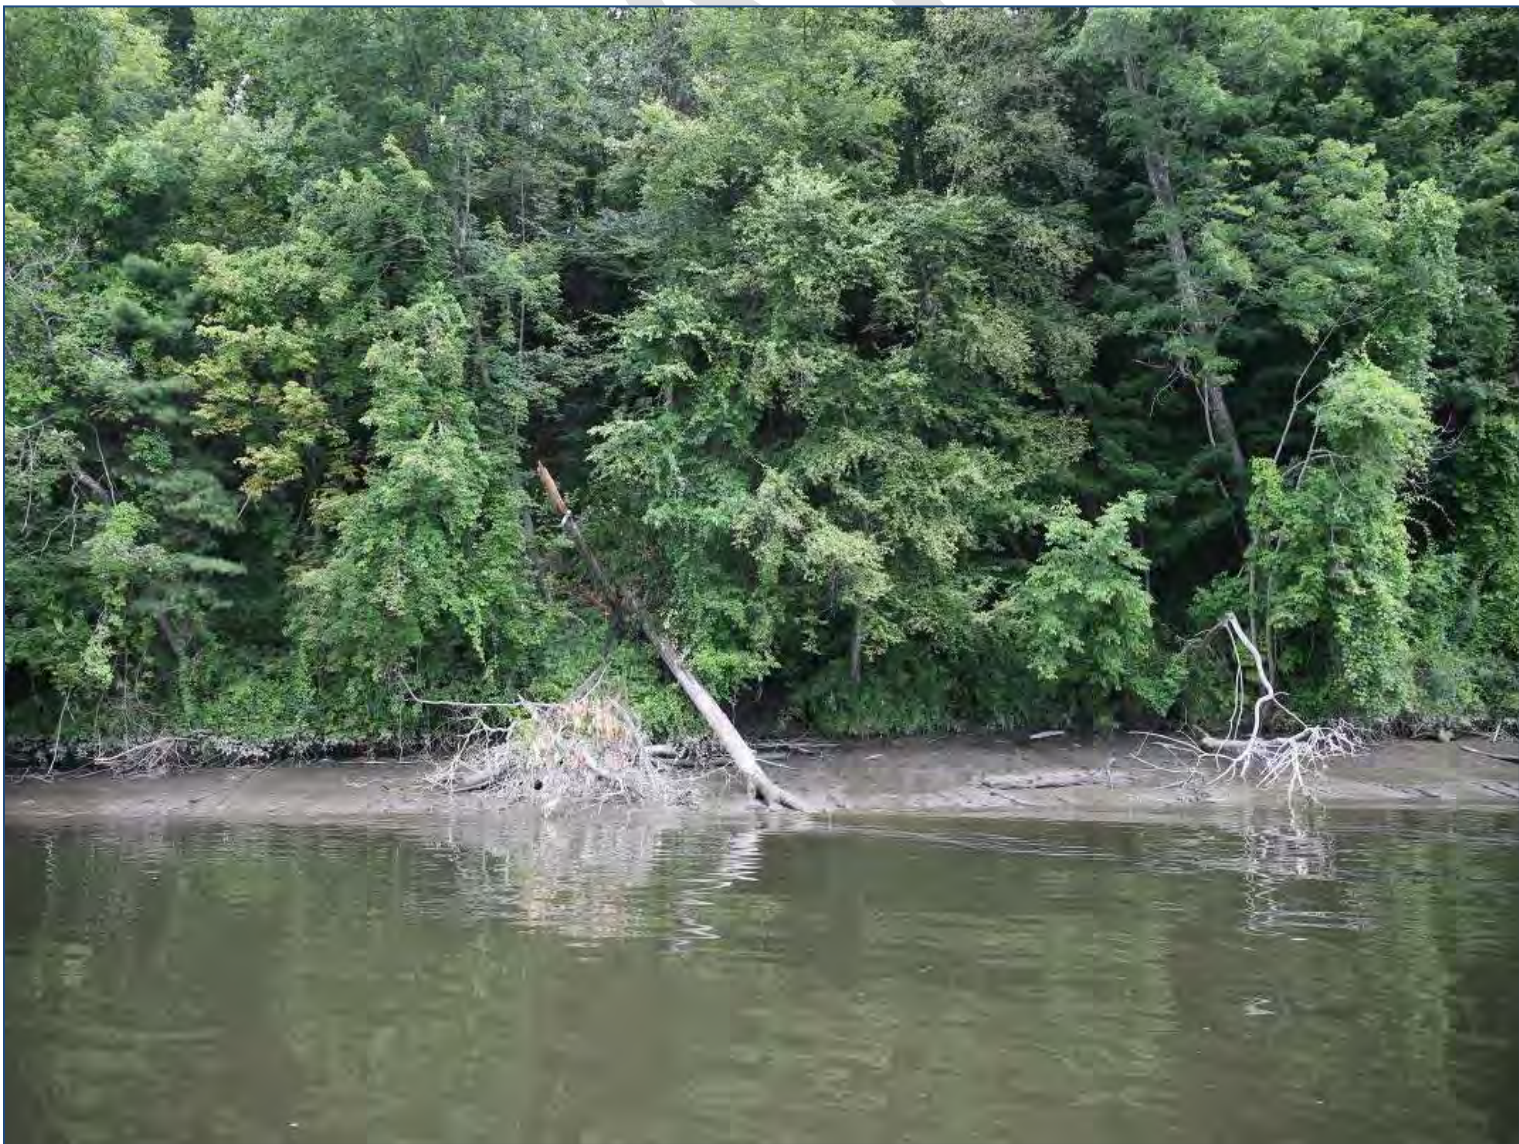
PHOTO SET #10

2007 Photo: Upstream from the Rt. 10 Bridge: Located upstream of the Route 10 Bridge on the right bank in Northfield, this section of Riverbank is very steep, and is heavily forested.

Observations: No observable changes can be seen at this site since 2007.

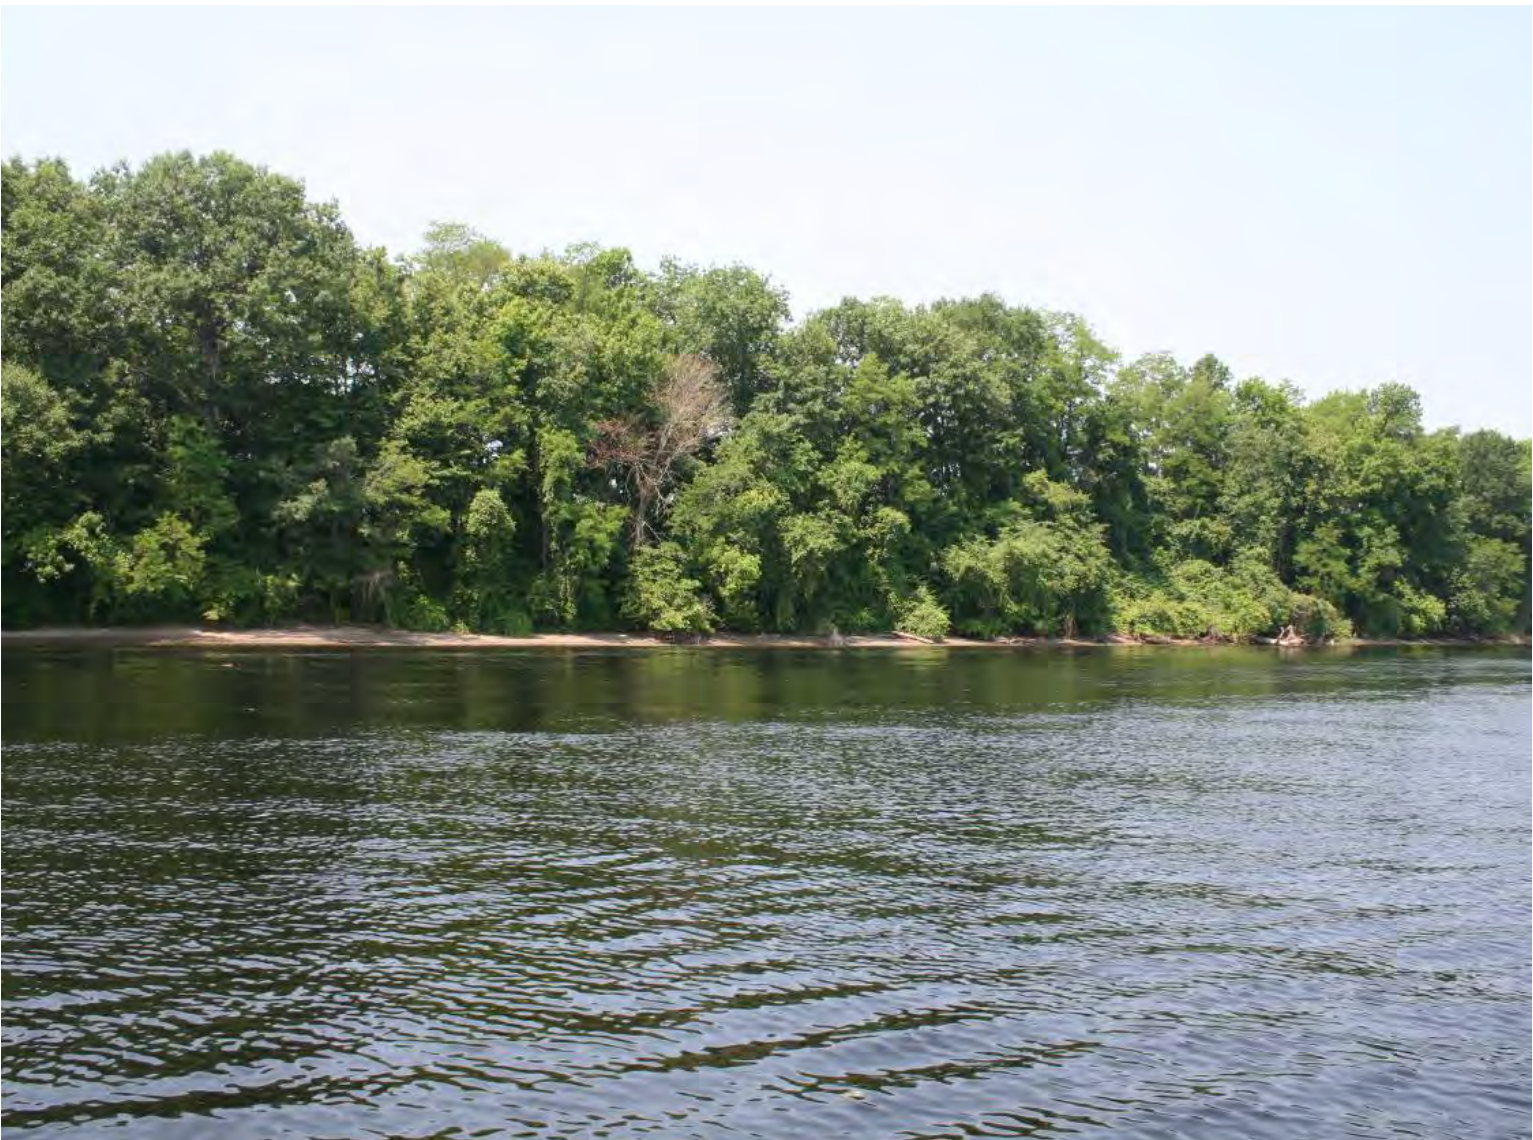
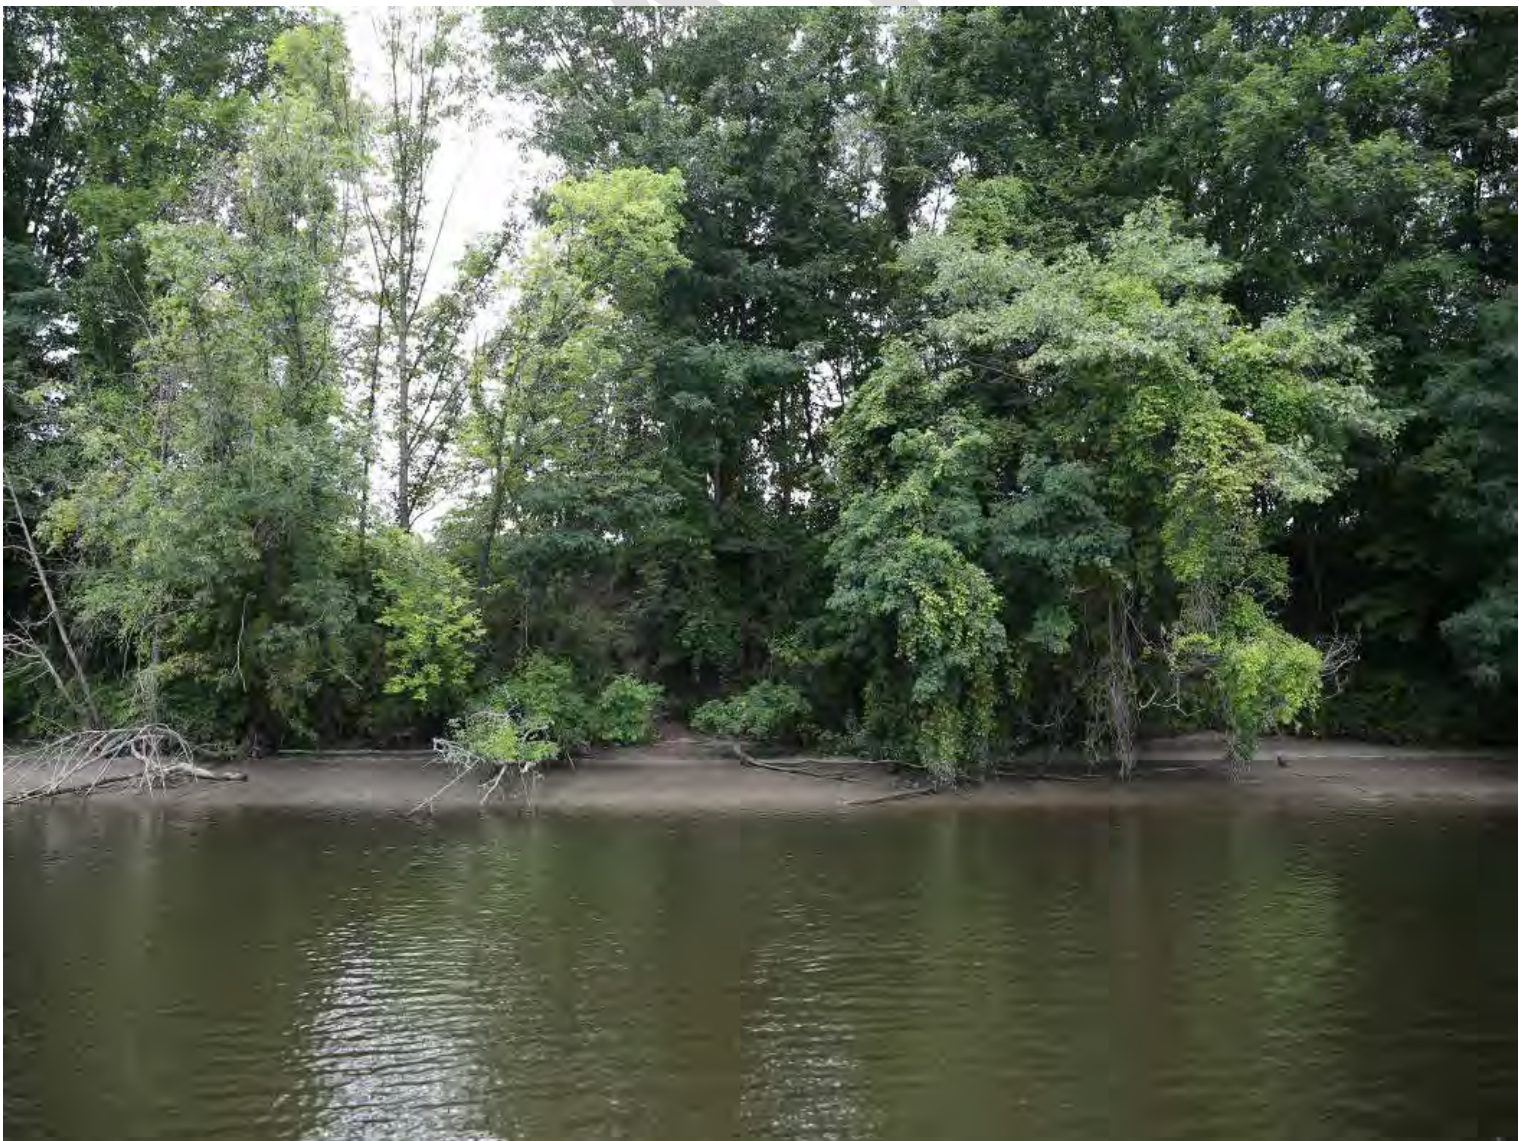
PHOTO SET #11

2007 Photo: Downstream from the Rt. 10 Bridge: Located in Northfield, Massachusetts, on the right bank.

Observations: There are no observable changes at this photo station since 2007.

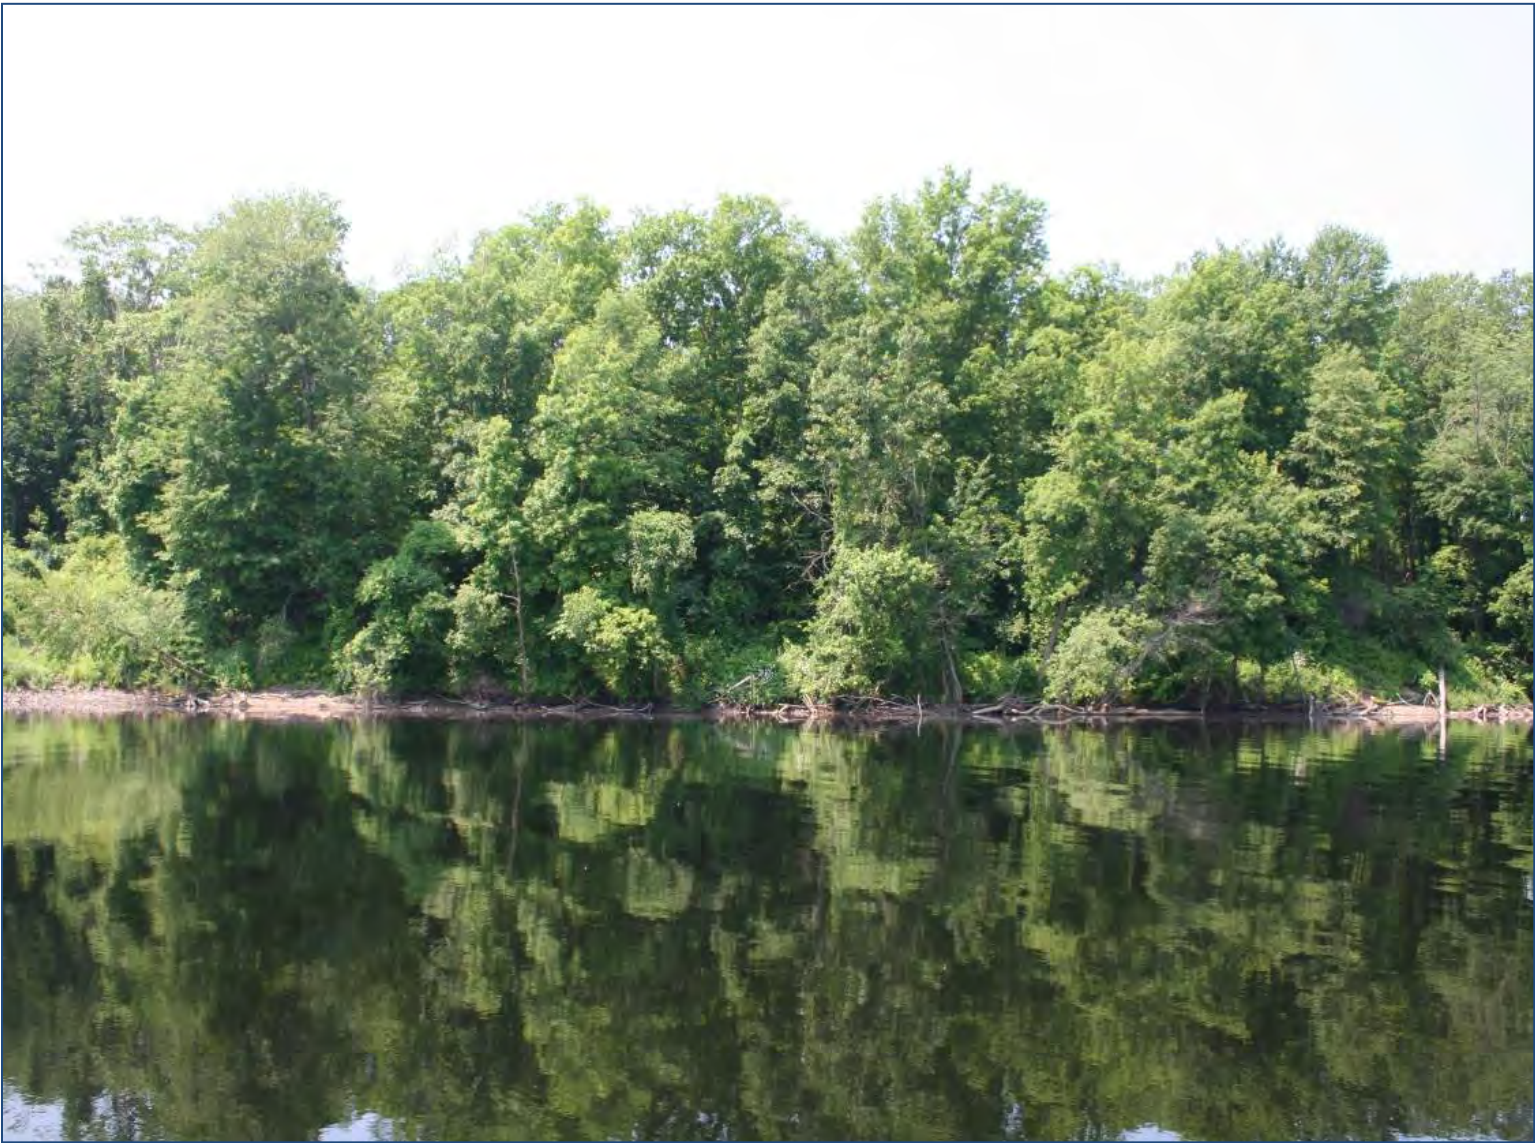
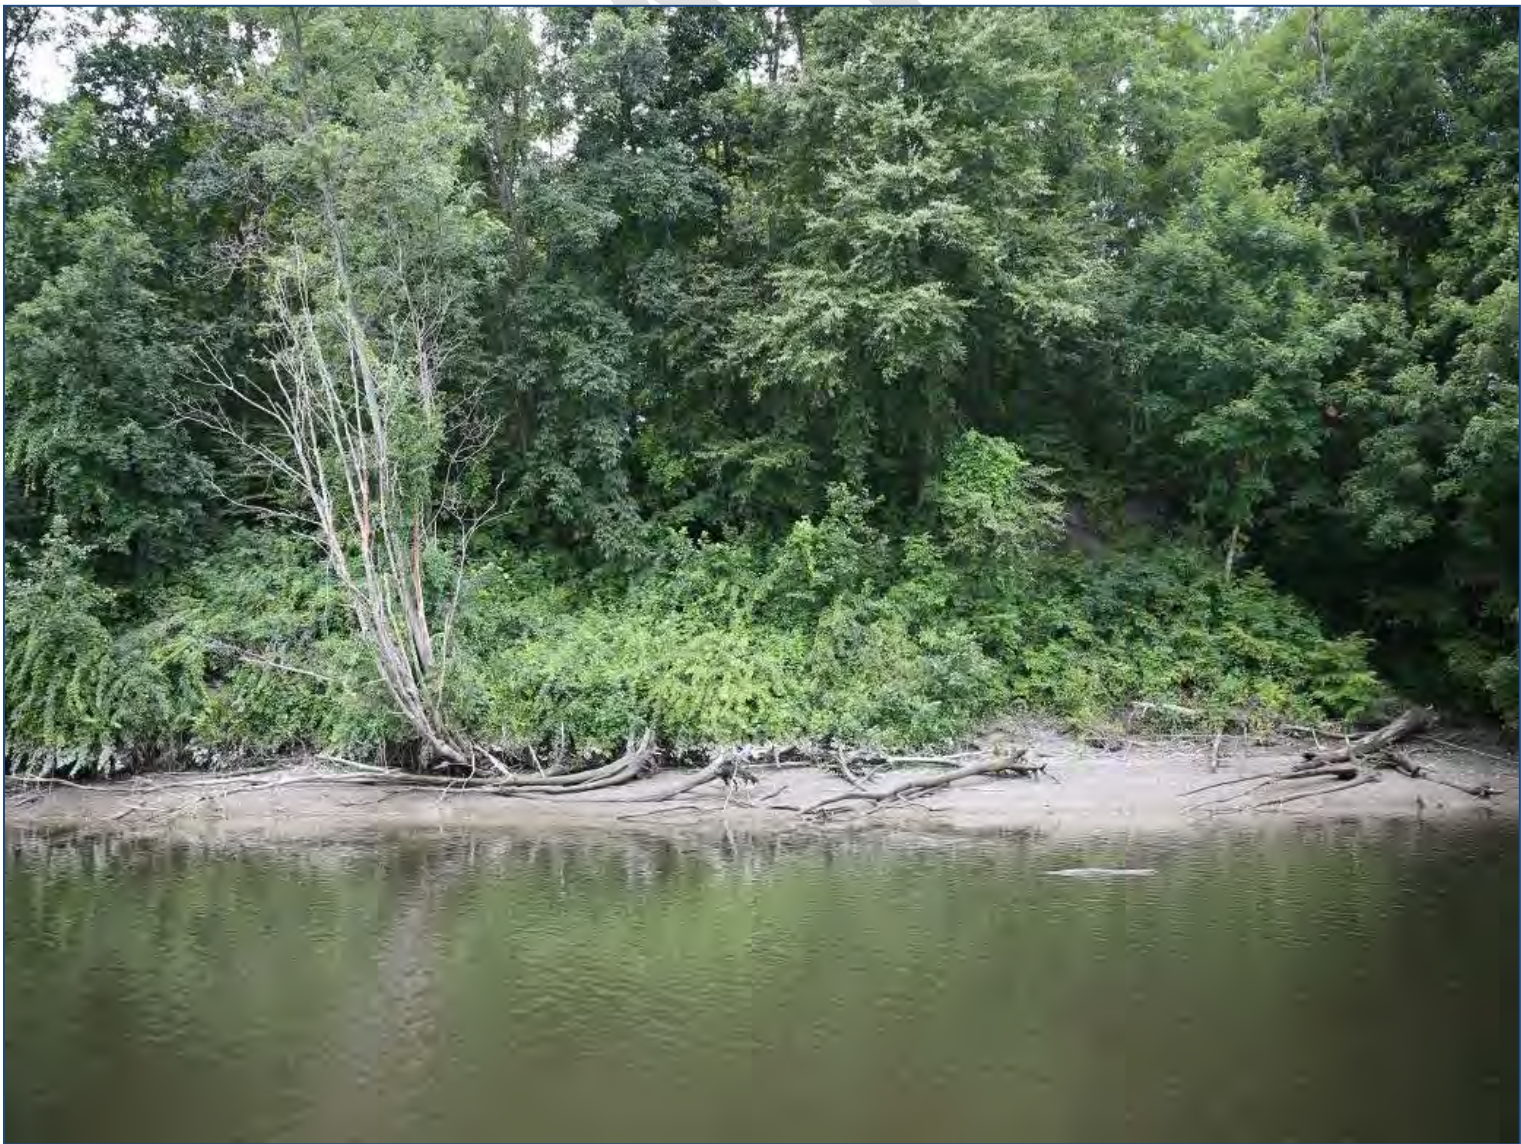
PHOTO SET #12

2007 Photo: Upstream from Urgiel: Located in Gill, Massachusetts, on the right bank.

Observations: Bank conditions appear to be similar in both photographs. This photograph shows the approximate location of a linear erosion feature with a vertical exposed face ranging from 1 to 2 feet high that extends longitudinally through part of the repaired segment (Urgiel) as well as farther upstream even crossing through a small drainage feature.
