ATTACHMENT B: 2007-2014 Photo Log Comparison

FIRSTLIGHT POWER RESOURCES
RELICENSING STUDY 3.1.1
2013 FULL RIVER RECONNAISSANCE
TURNERS FALLS IMPOUNDMENT

Addendum Figure 1:
Photo Station Locations for Comparison of
2007 Photographs (Field) and
2014 Photographs (NEE)

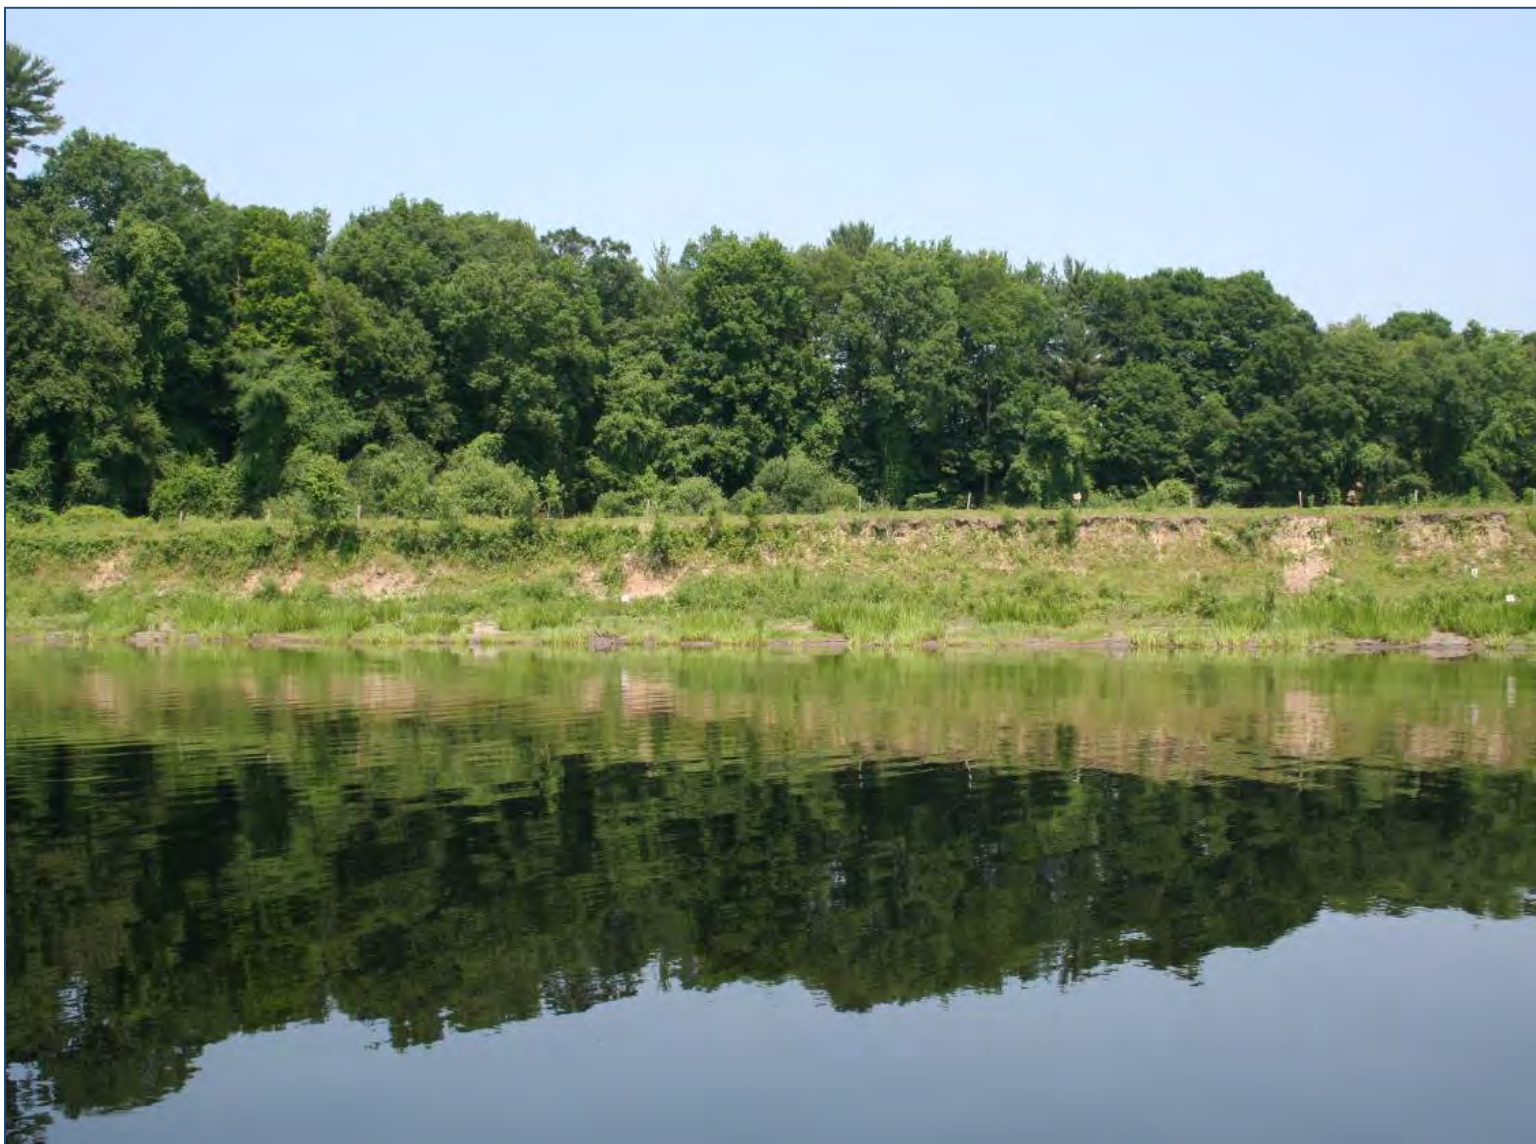
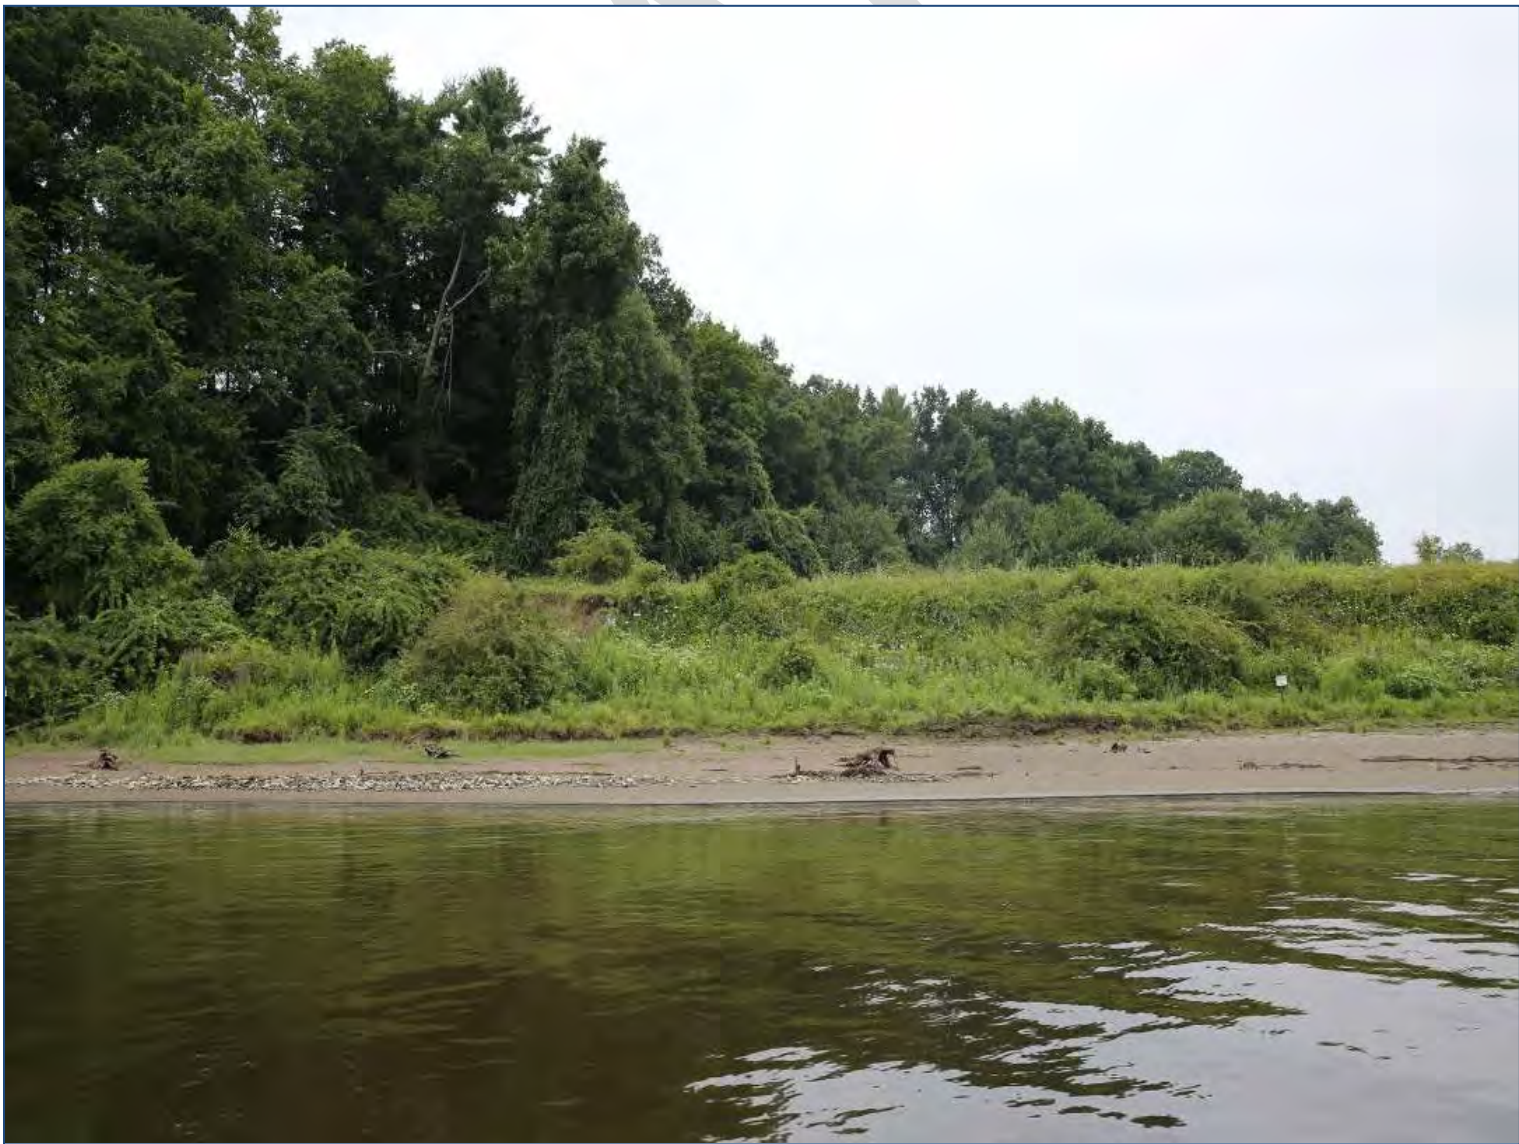
PHOTO SET #13

2007 Photo: Flagg Farm: This site is located at the downstream end of the Flagg restoration site, on the right bank, in Gill, Massachusetts.

Observations: Since the 2007 photograph the bank face has become more vegetated and recovering from past grazing activity by cattle since this site was restored in 1999. Sediment has deposited on the lower bank and emergent vegetation is becoming established and growing. Close observation of this site during field data collection for the erosion causation study showed that a number of cottonwood seedlings have become established on this lower bank. There were several bank swallow nest cavities observed at this site in 2007, but there were none observed in 2014.

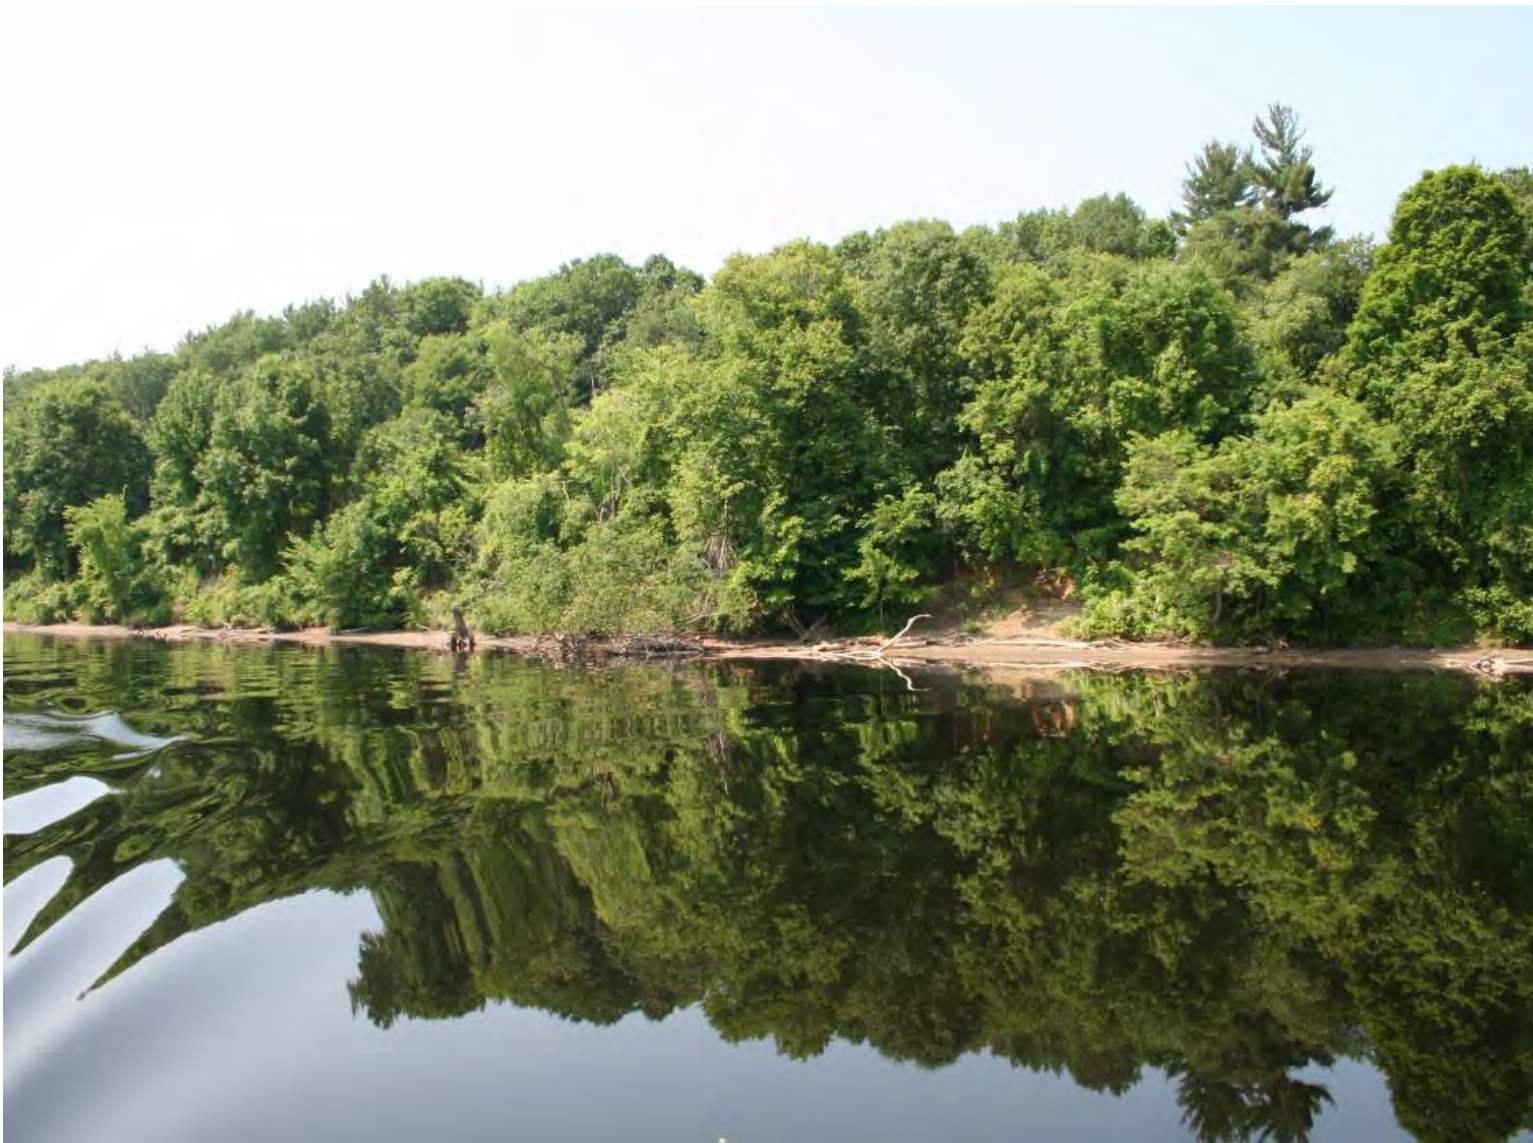
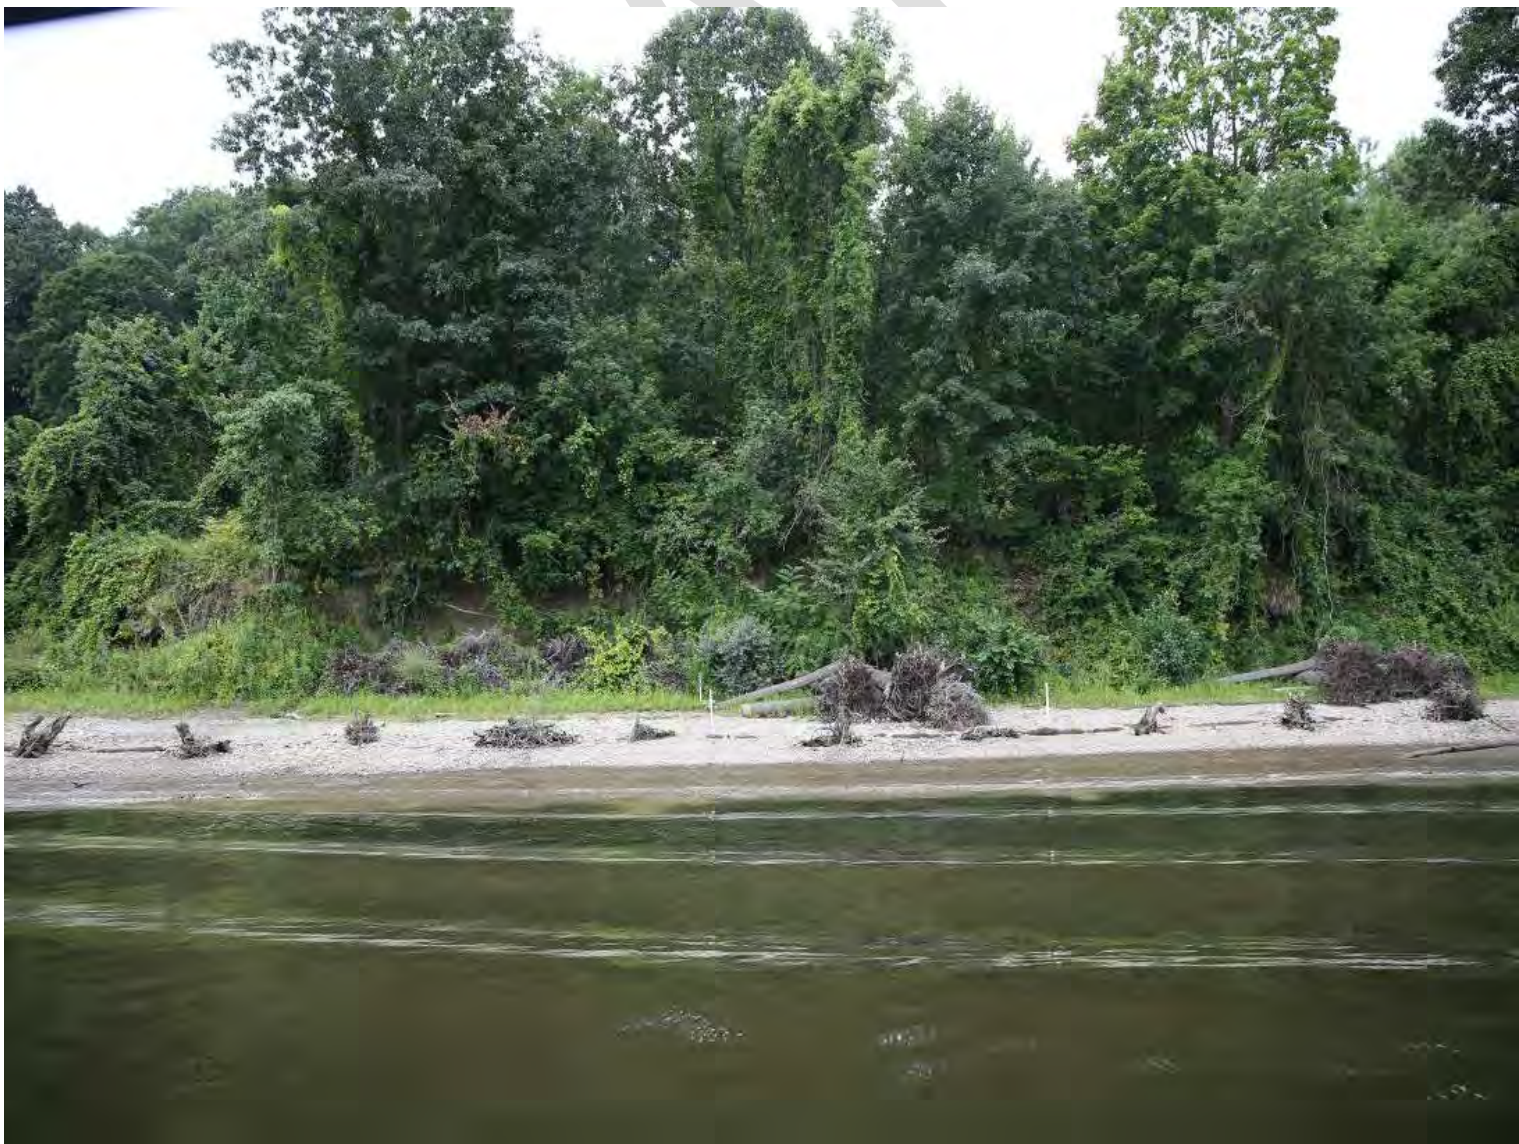
PHOTO SET #14

2007 Photo: Wallace Watson: This photo shows a portion of the Wallace/Watson restoration site prior to restoration efforts. It is located in Gill, Massachusetts, on the right bank.

Observations: This site was restored using bioengineering techniques in 2013. Techniques utilized included, building up the lower bank/beach with gravel and imbedded large woody debris and planting of vegetation. Since the 2007 photo was taken, new vegetation has become established on the bench. There are bank swallow and kingfisher cavities along this section of the riverbank.

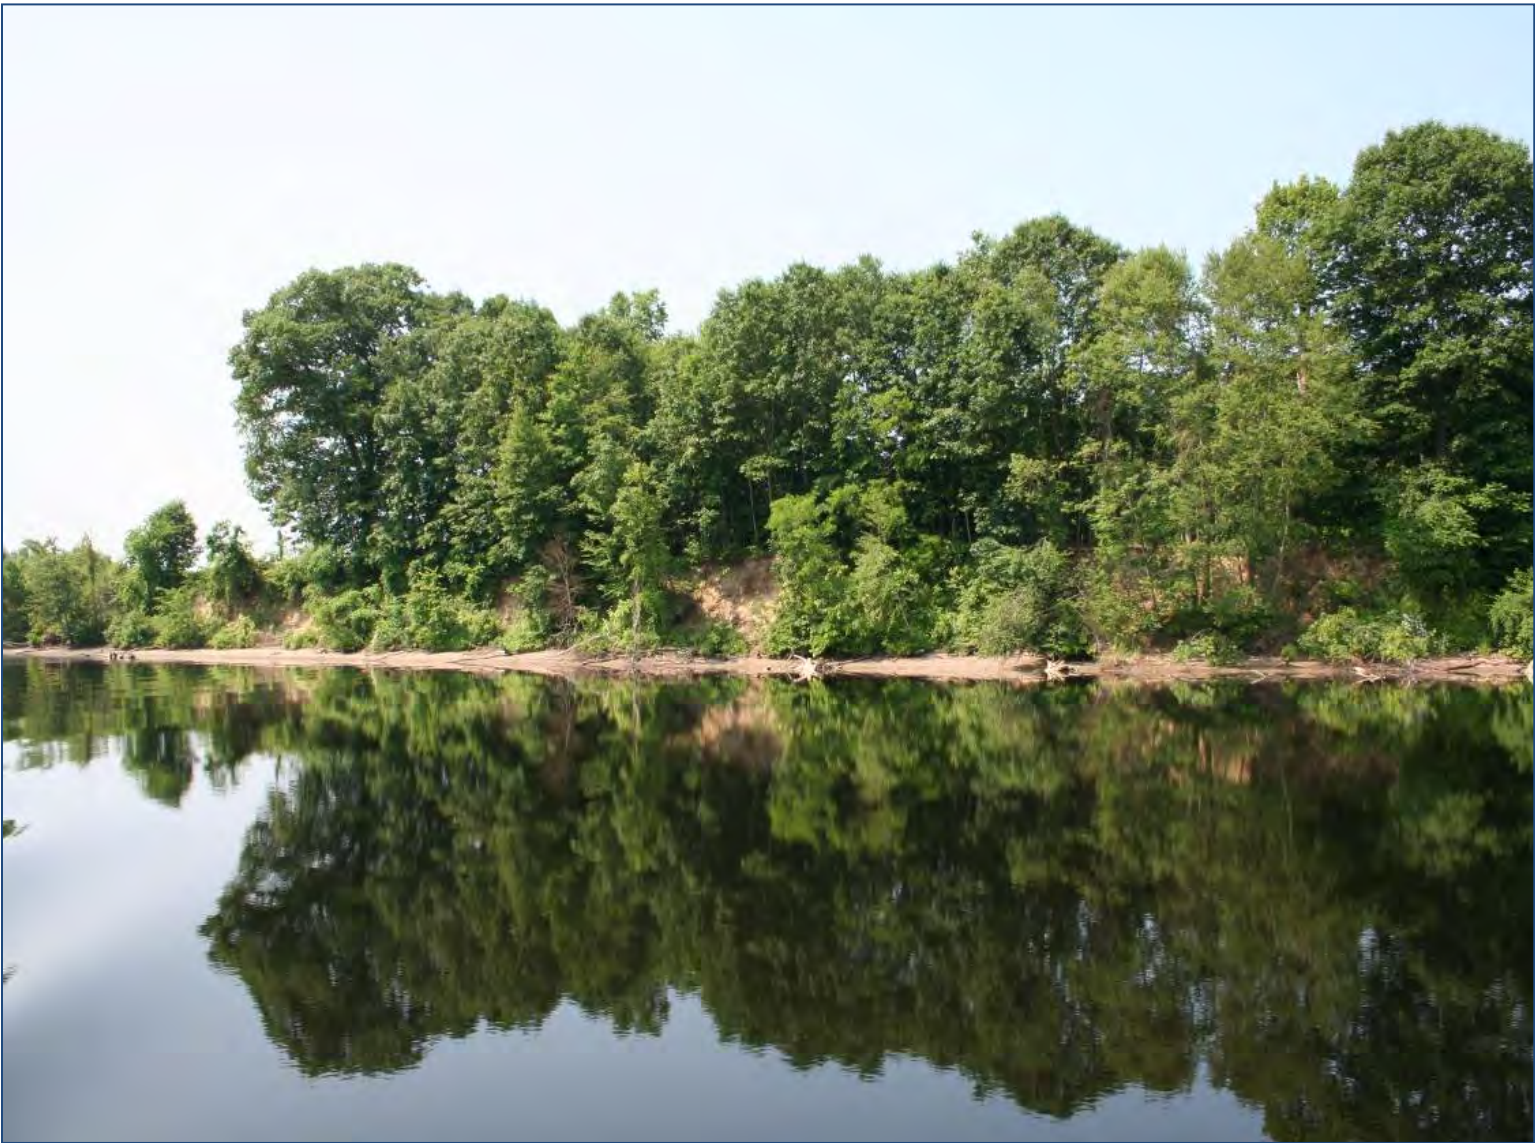
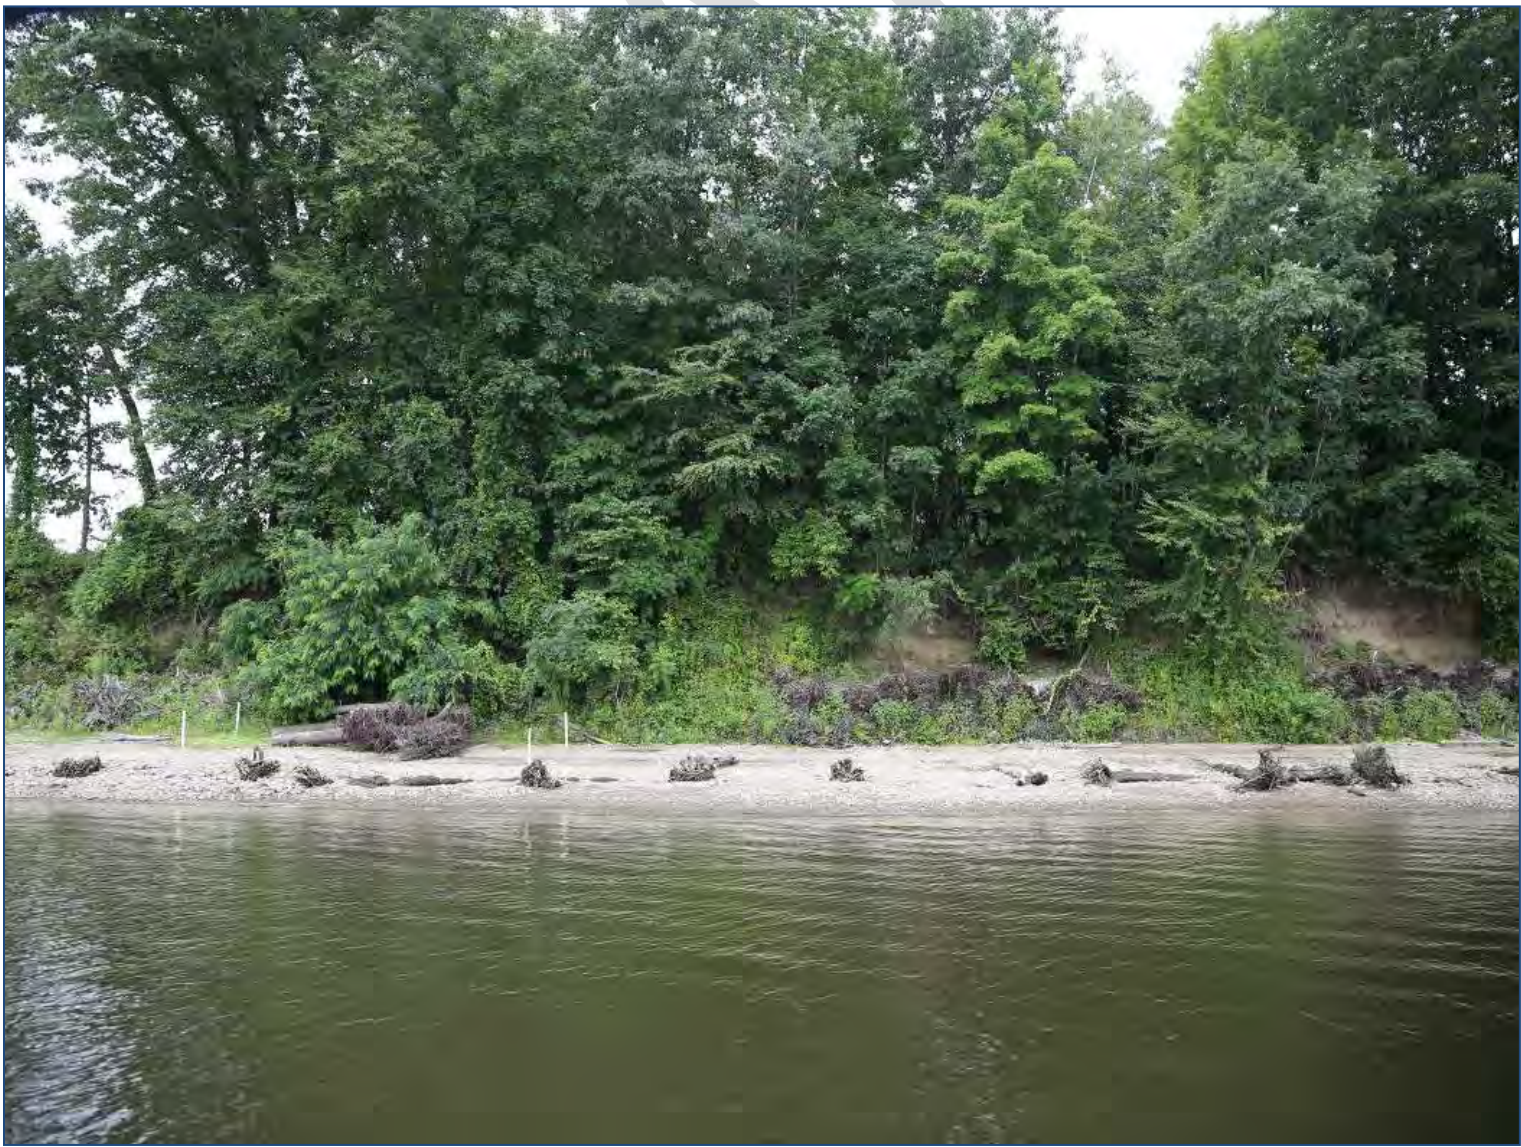
PHOTO SET #15

2007 Photo: Bathory Gallagher Oak Tree: This photo station is at the downstream end of the Bathory/Gallagher restoration site, prior to restoration efforts, in Gill, Massachusetts, on the right bank.

Observations: This site was restored using bioengineering techniques in 2013. Techniques utilized included, building up the lower bank/beach with gravel and imbedded large woody debris and planting of vegetation. Since the 2007 photo was taken, new vegetation has become established on the bench. There are bank swallow and kingfisher cavities along this section of the riverbank.

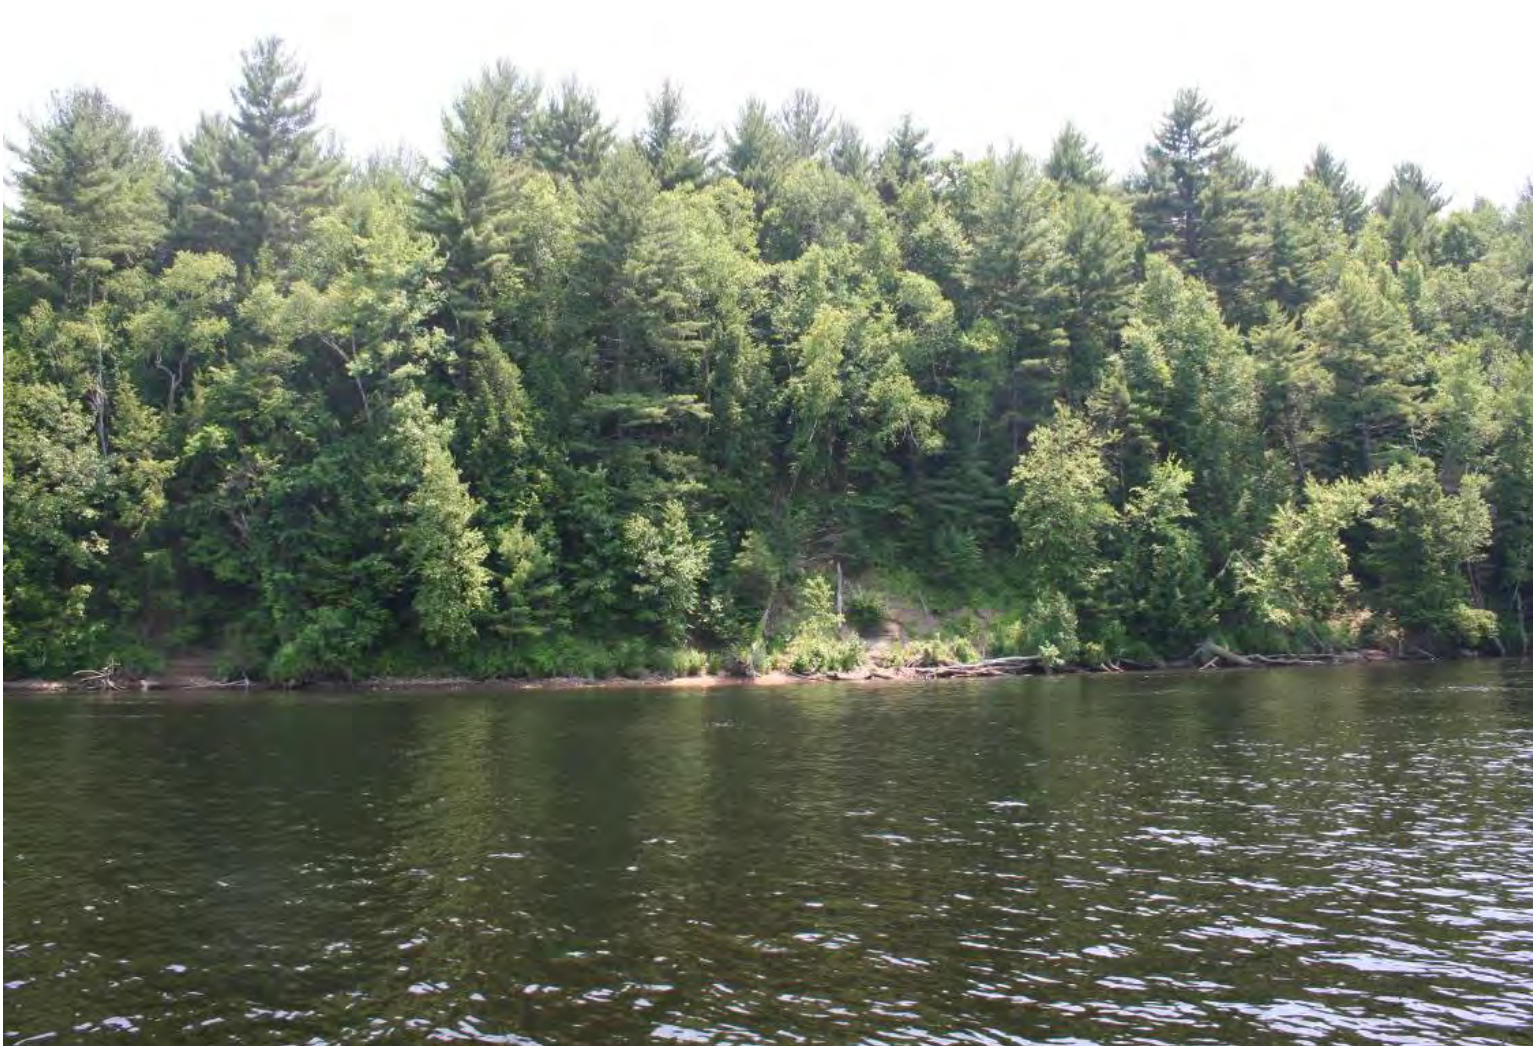
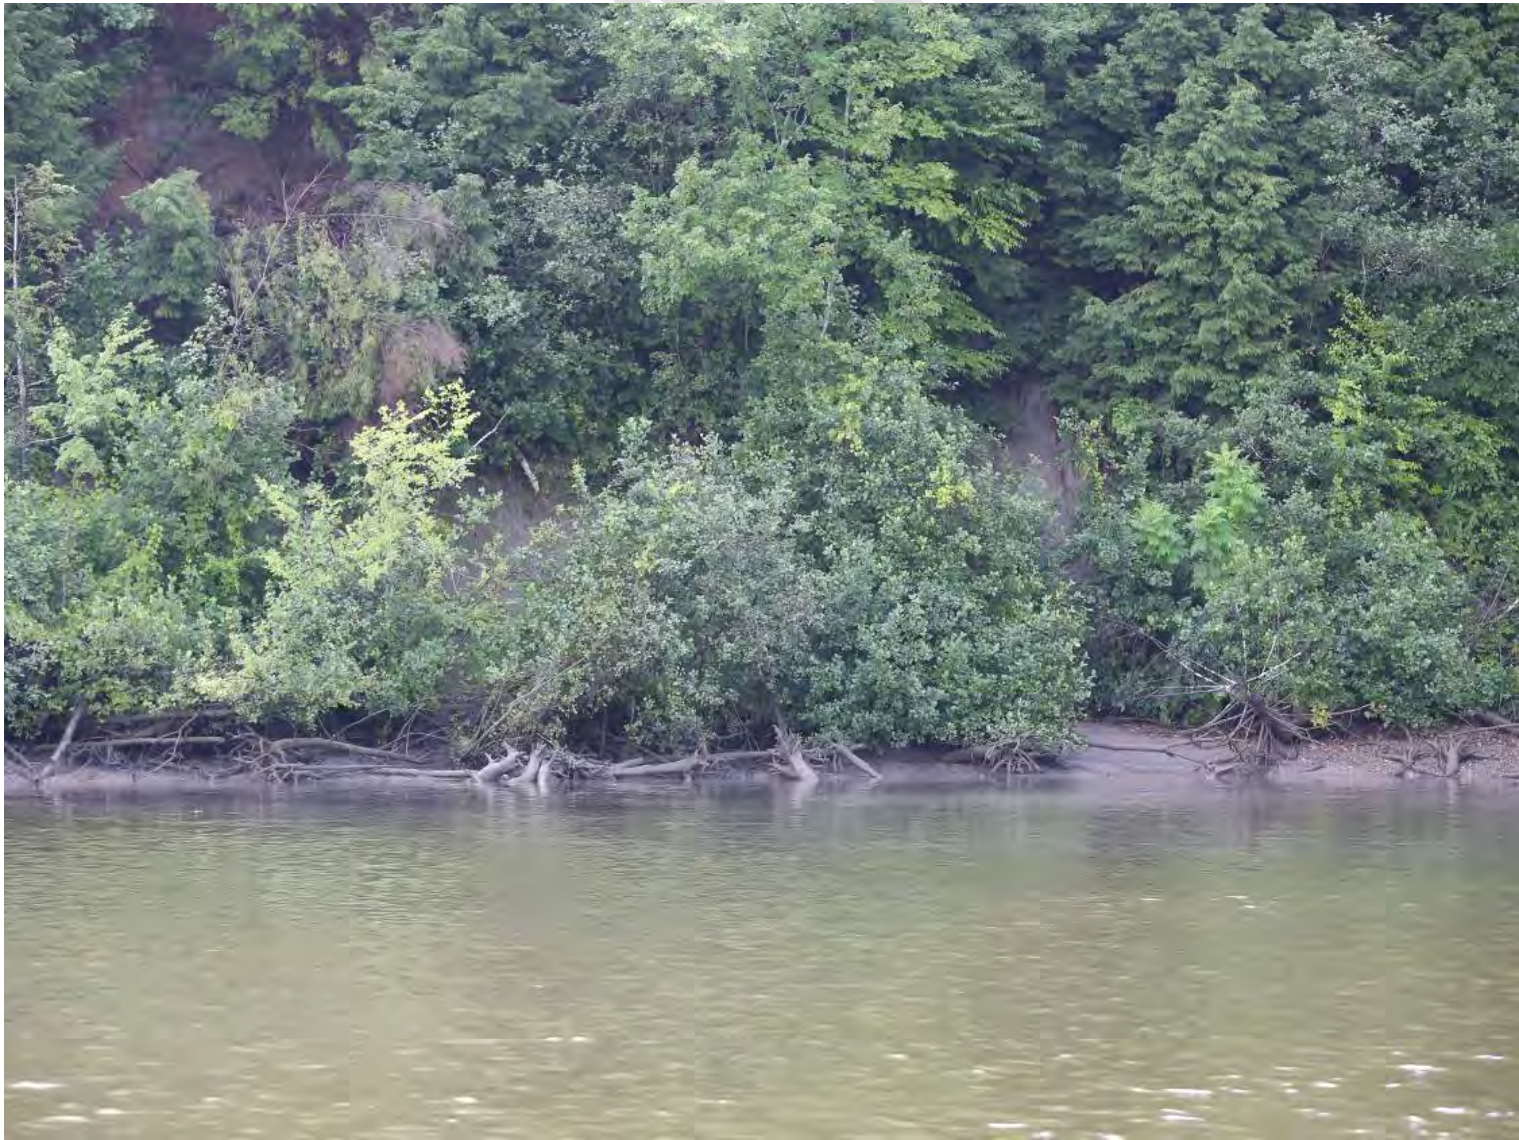
PHOTO SET #16

2007 Photo: Located downstream from the tailrace in Northfield, Massachusetts, on the left bank.

Observations: Erosion is occurring at this site and has been recommended for preventative maintenance and/or bank stabilization work in the 2013 FRR report.

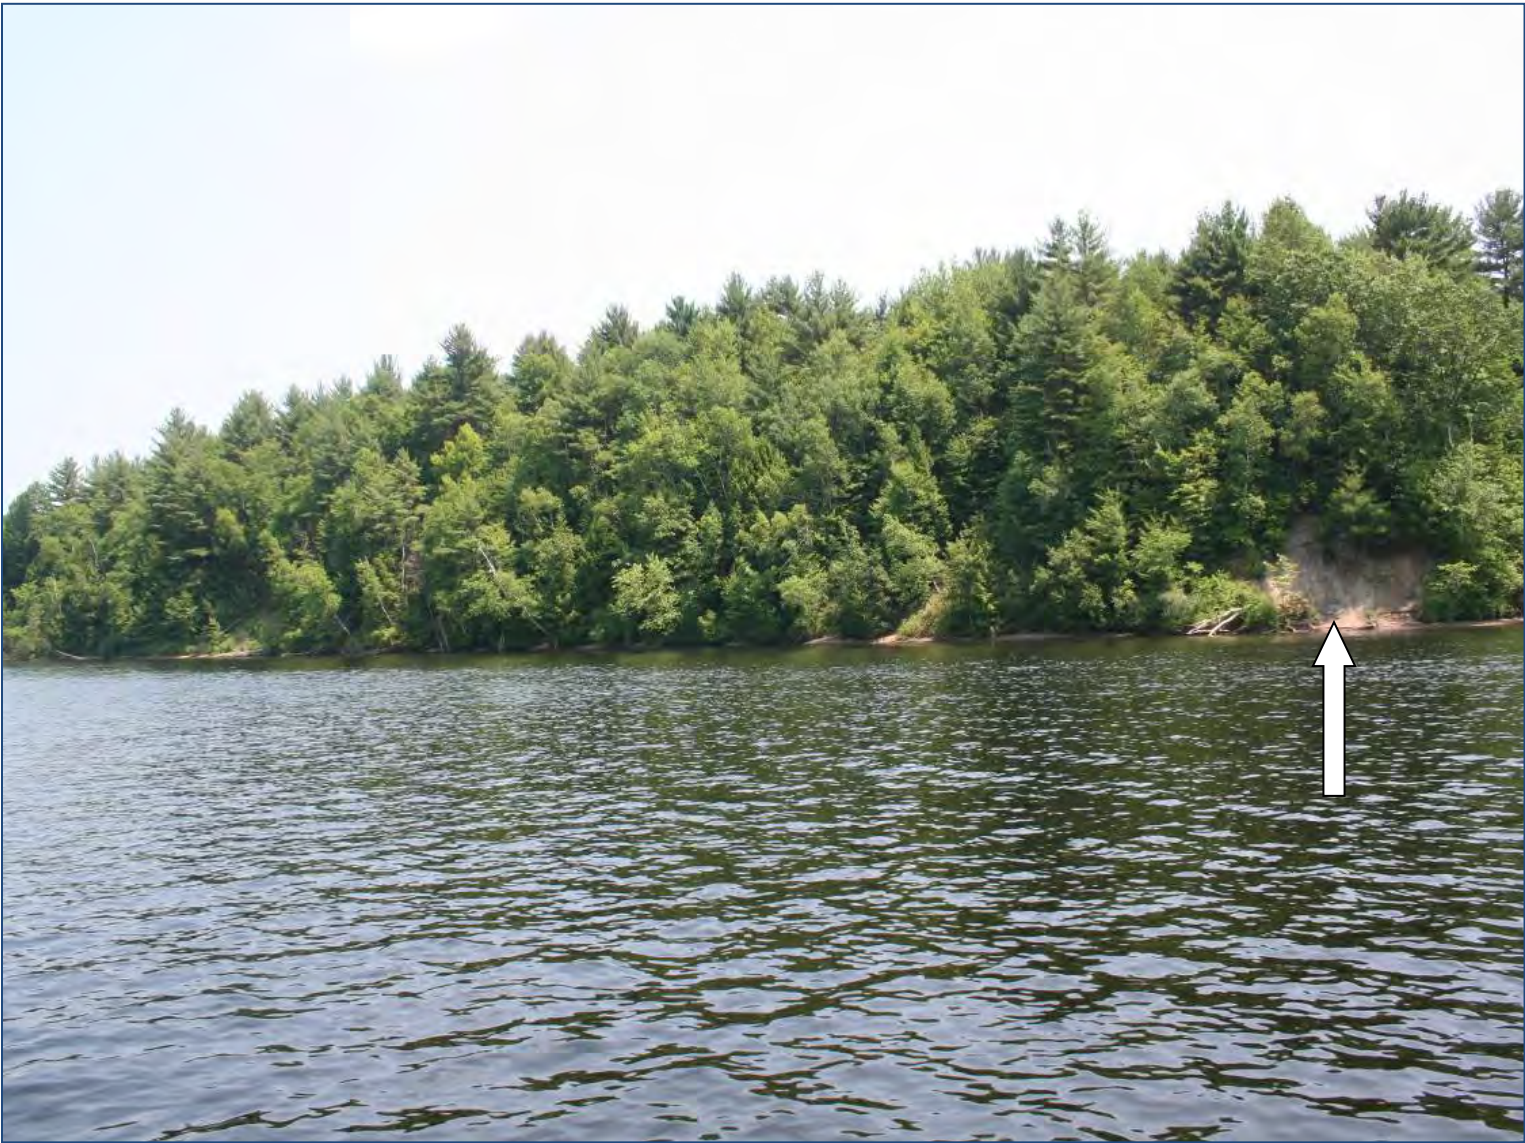
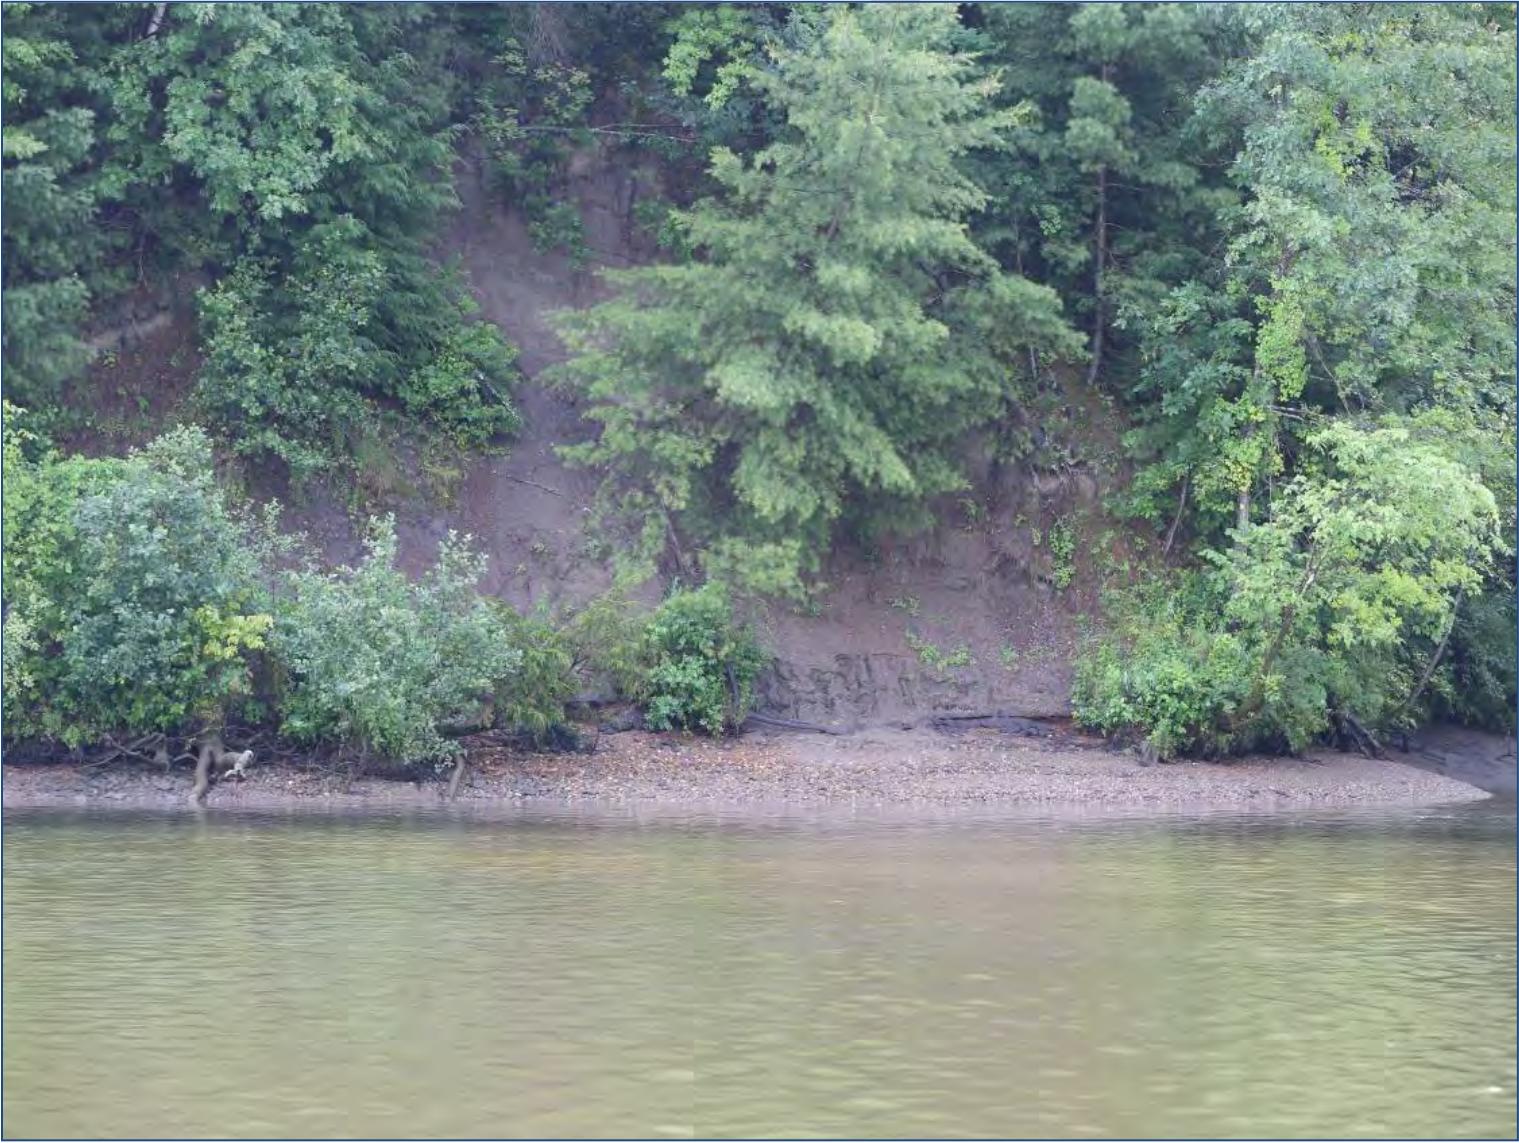
PHOTO SET #17

2007 Photo: Pine Meadow: This site is located at the mouth of Pine Meadow Brook in Northfield, MA, on the left bank.

2014 Photo: Pine Meadow - This photo is a close-up of the area shown in photo 17a (white arrow), which is at the mouth of Pine Meadow Brook.

Observations: This site has been eroded for some time and was recommended for preventative maintenance and/or bank stabilization work in the 2013 FRR report.

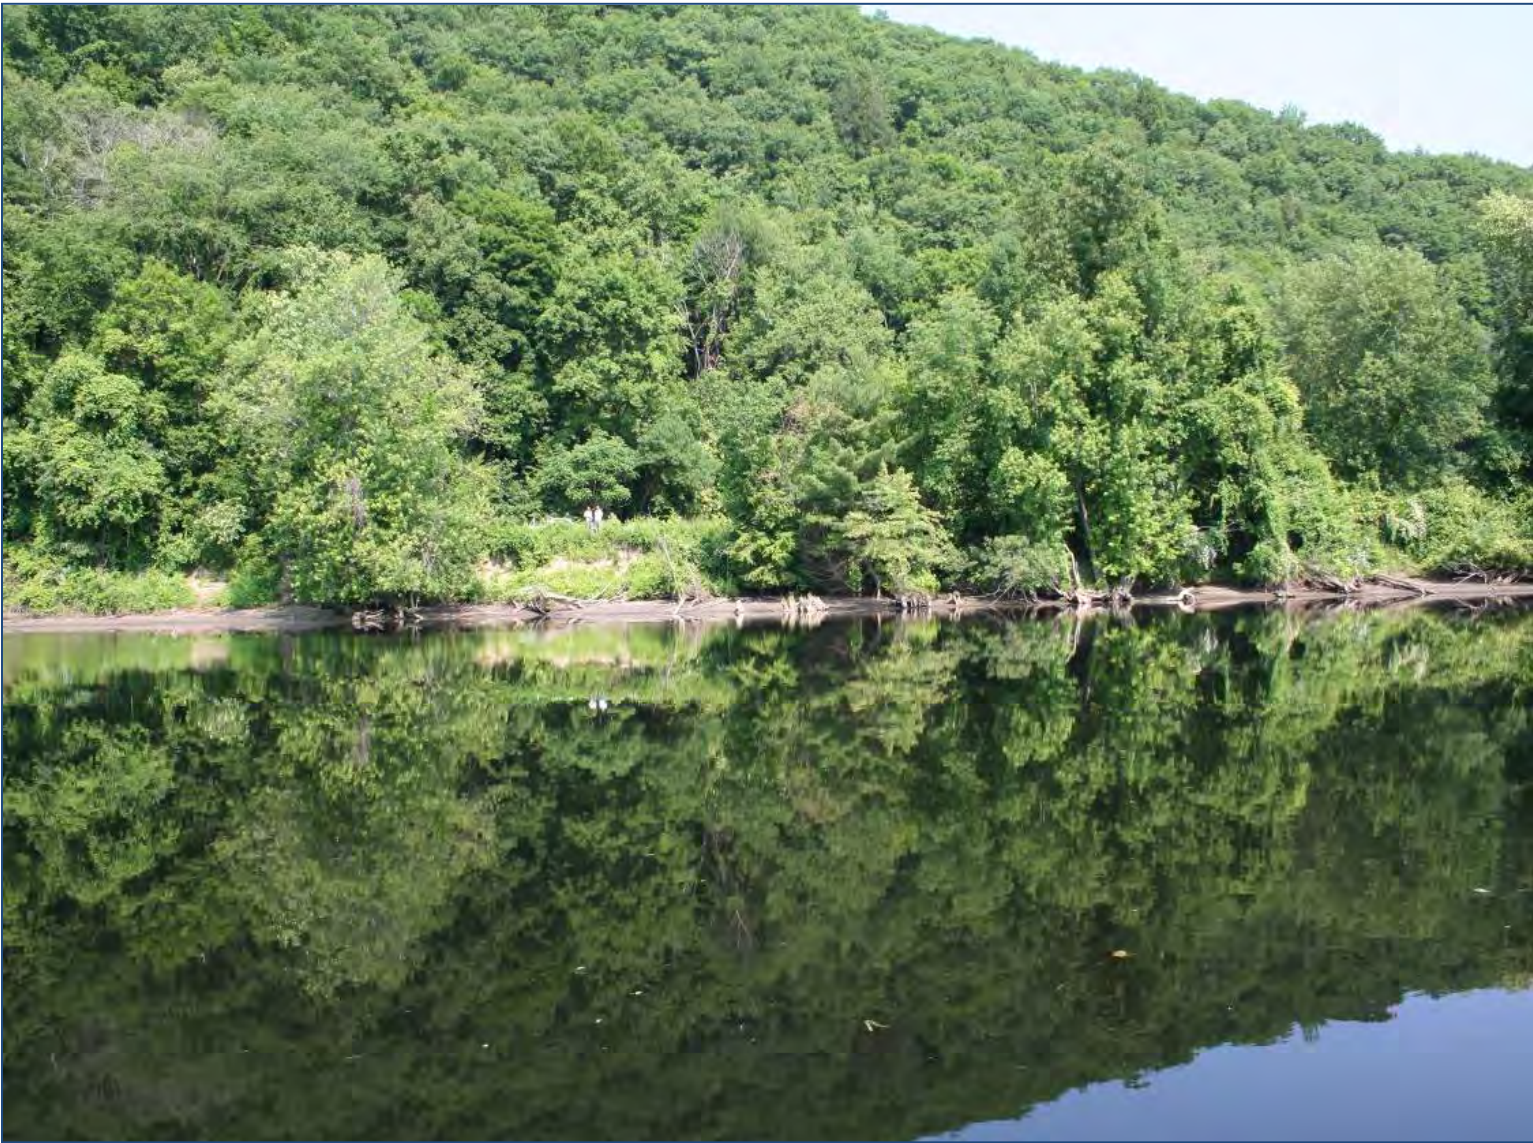
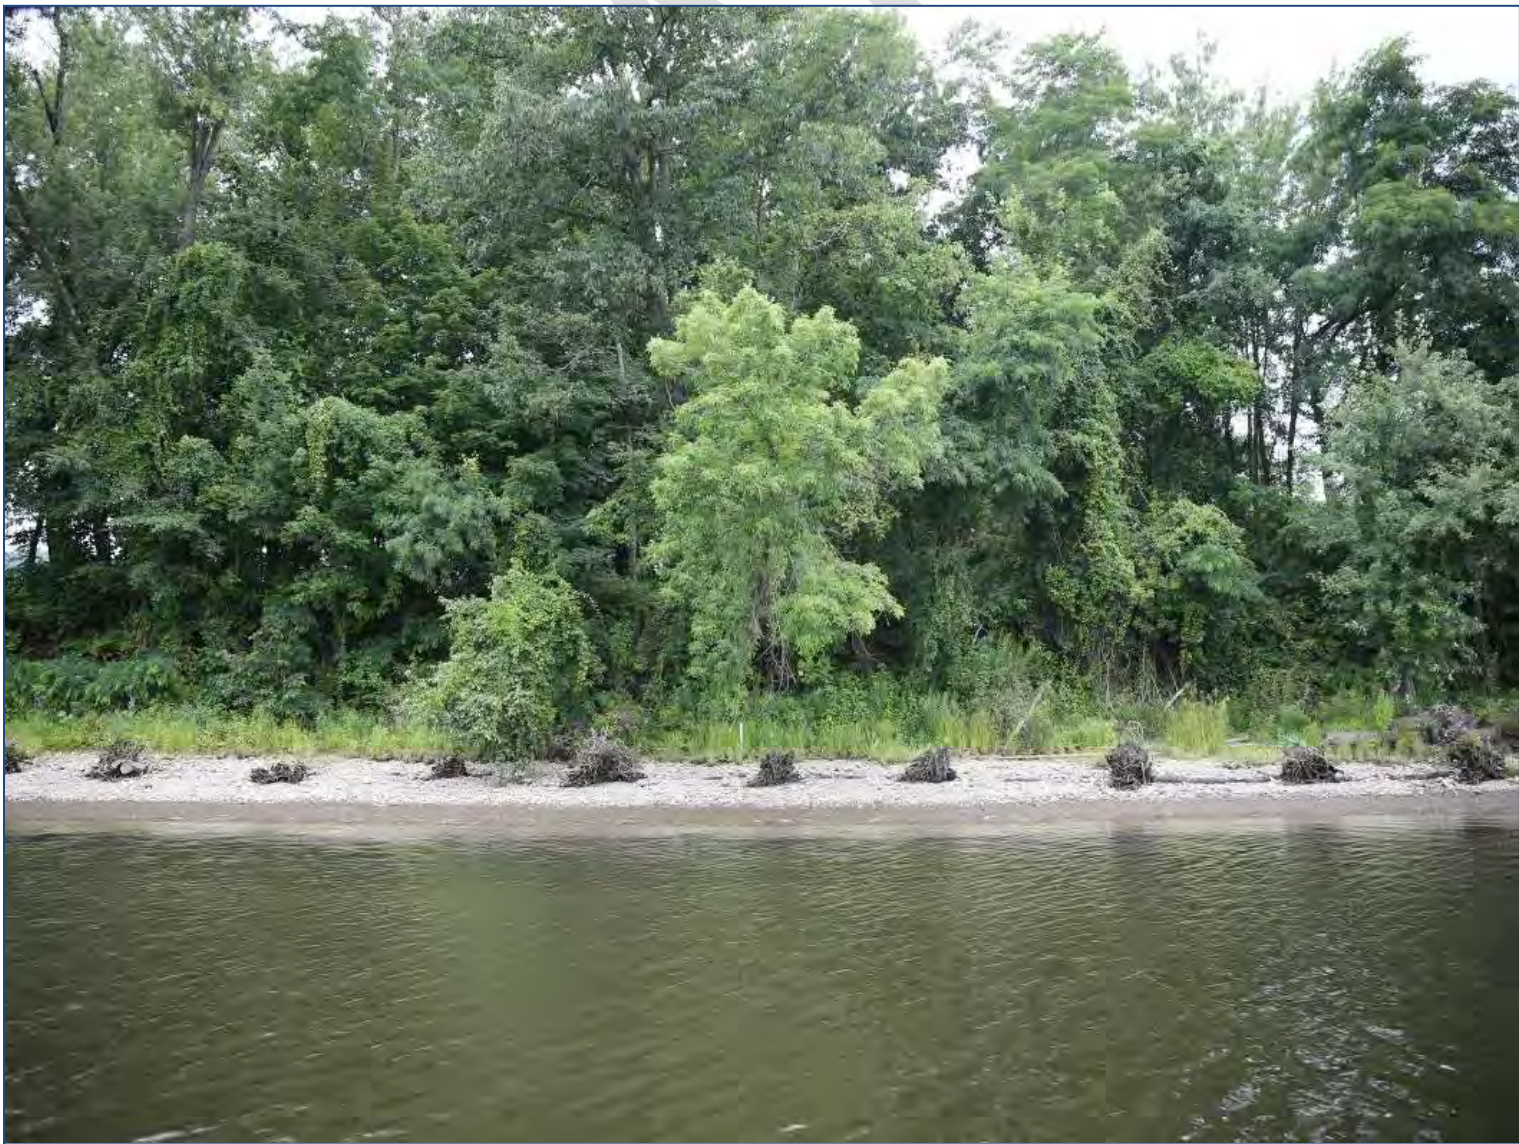
PHOTO SET #18

2007 Photo: Lower Split River Farm: Located at Lower Split River Farm restoration site prior to restoration efforts, in Gill, MA, on the right bank.

Observations: This site was restored using bioengineering techniques in 2009. Techniques utilized included, placement of gravel on the lower bank/beach area along with large woody debris and planting of vegetation. Since the 2007 photo was taken, new vegetation has become established on the bench.
