ATTACHMENT B: 2007-2014 Photo Log Comparison

FIRSTLIGHT POWER RESOURCES
RELICENSING STUDY 3.1.1
2013 FULL RIVER RECONNAISSANCE
TURNERS FALLS IMPOUNDMENT

Addendum Figure 1:
Photo Station Locations for Comparison of
2007 Photographs (Field) and
2014 Photographs (NEE)

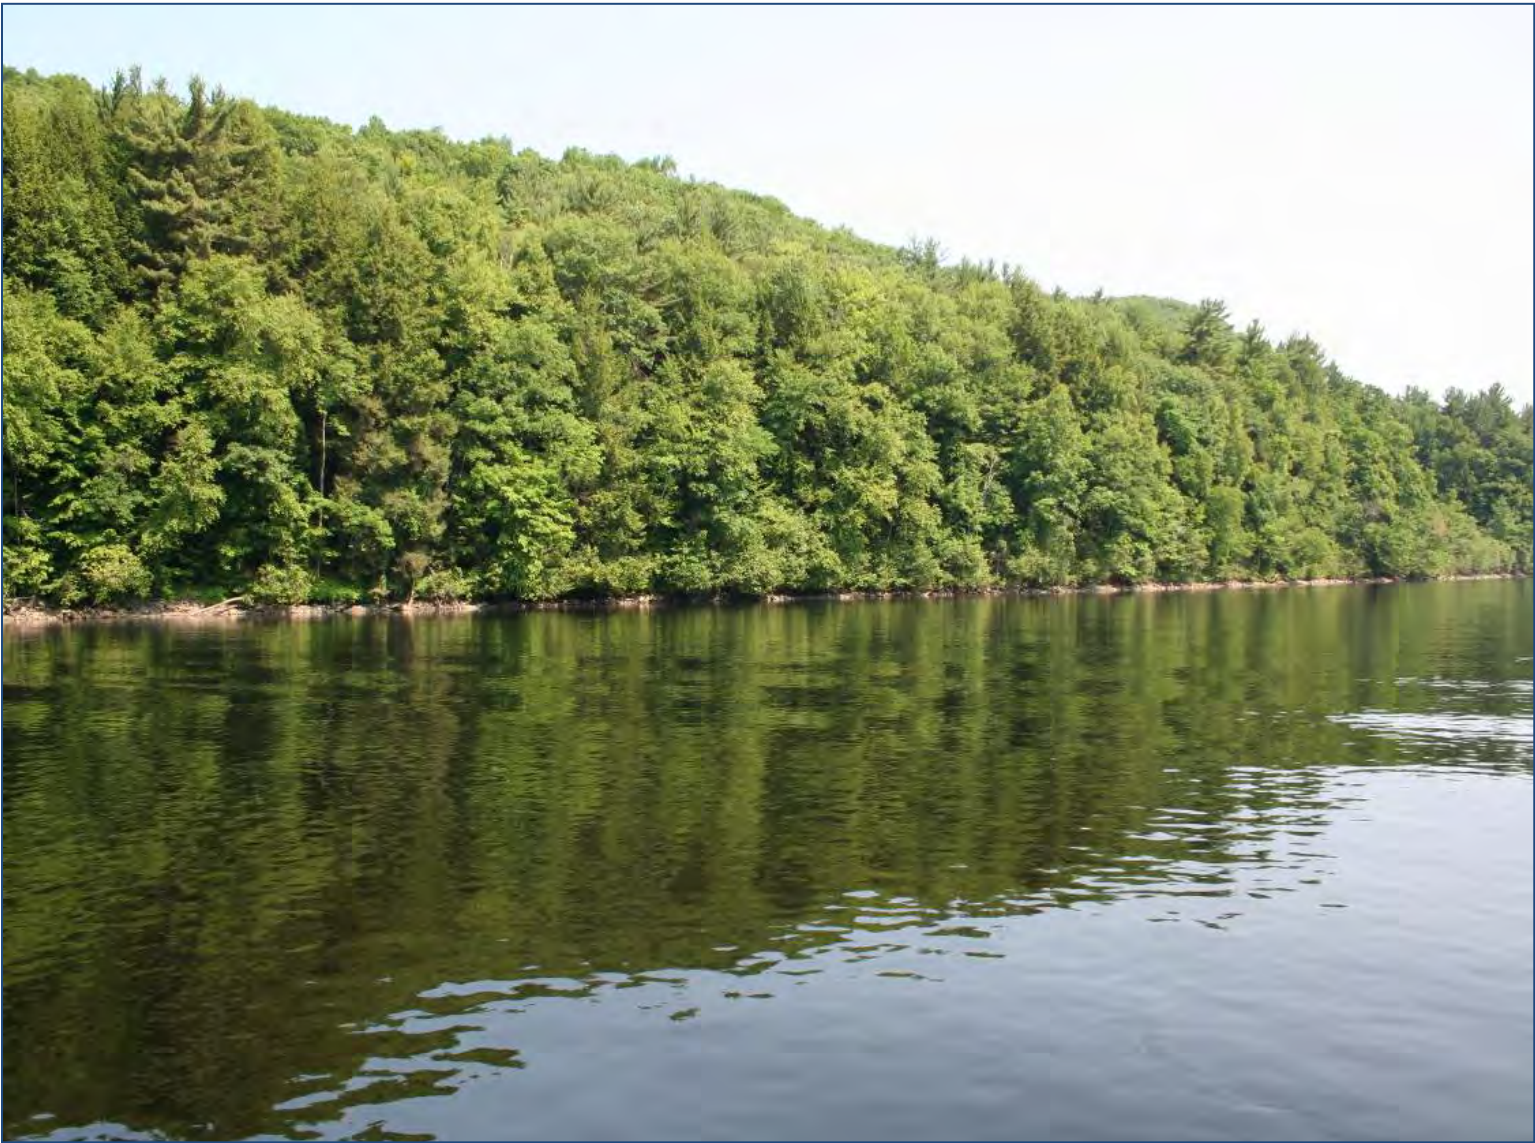
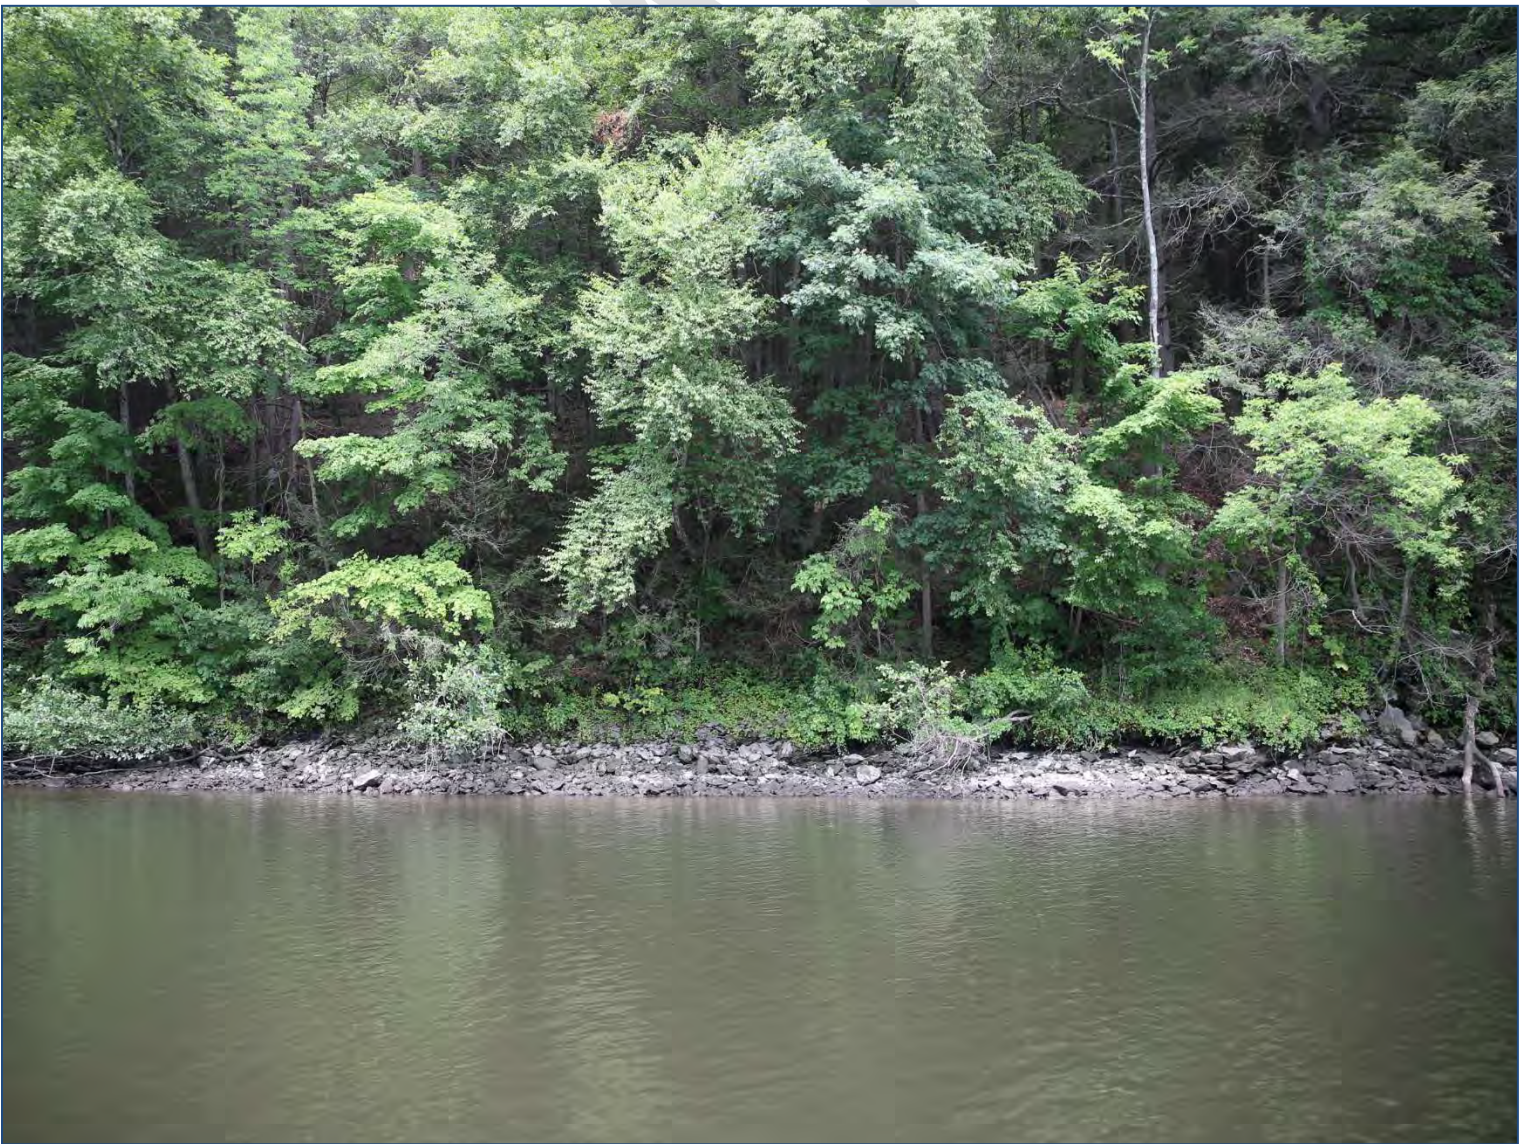
PHOTO SET #19

2007 Photo: Upstream from French King Bridge: This photo station is located upstream from the French King Bridge in Gill, MA, on the right bank.

Observations: This is a stable section of riverbank; no observable changes are noted between these photos.

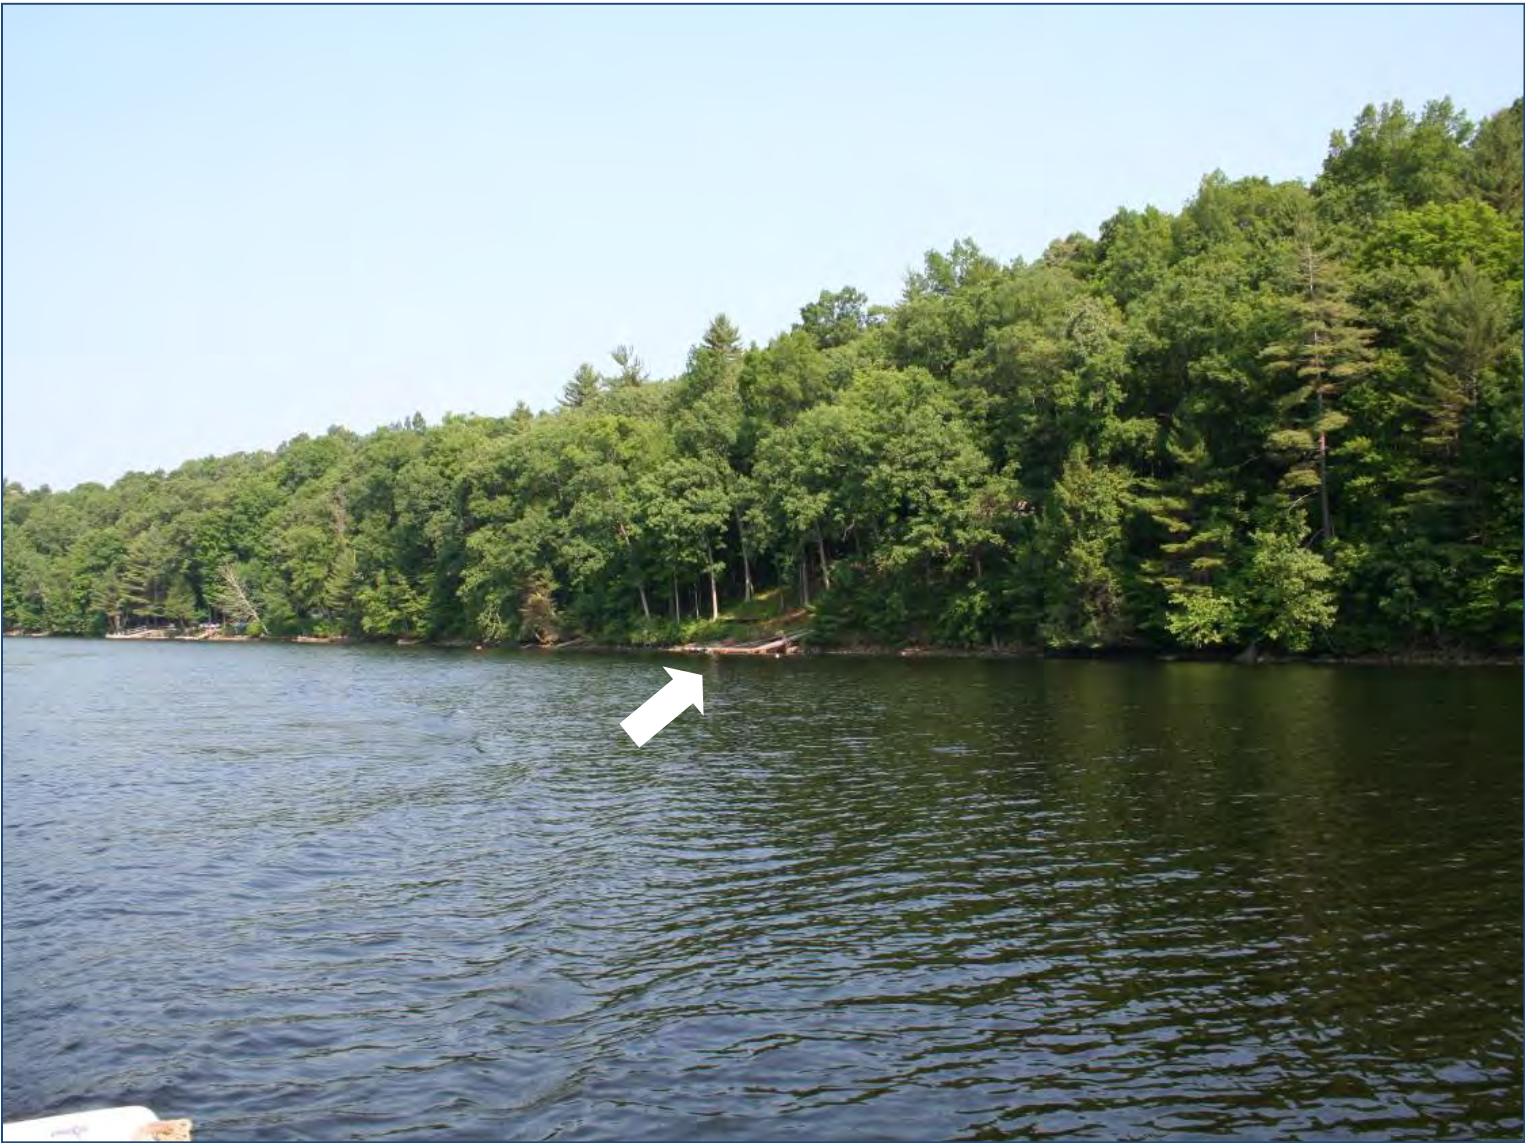
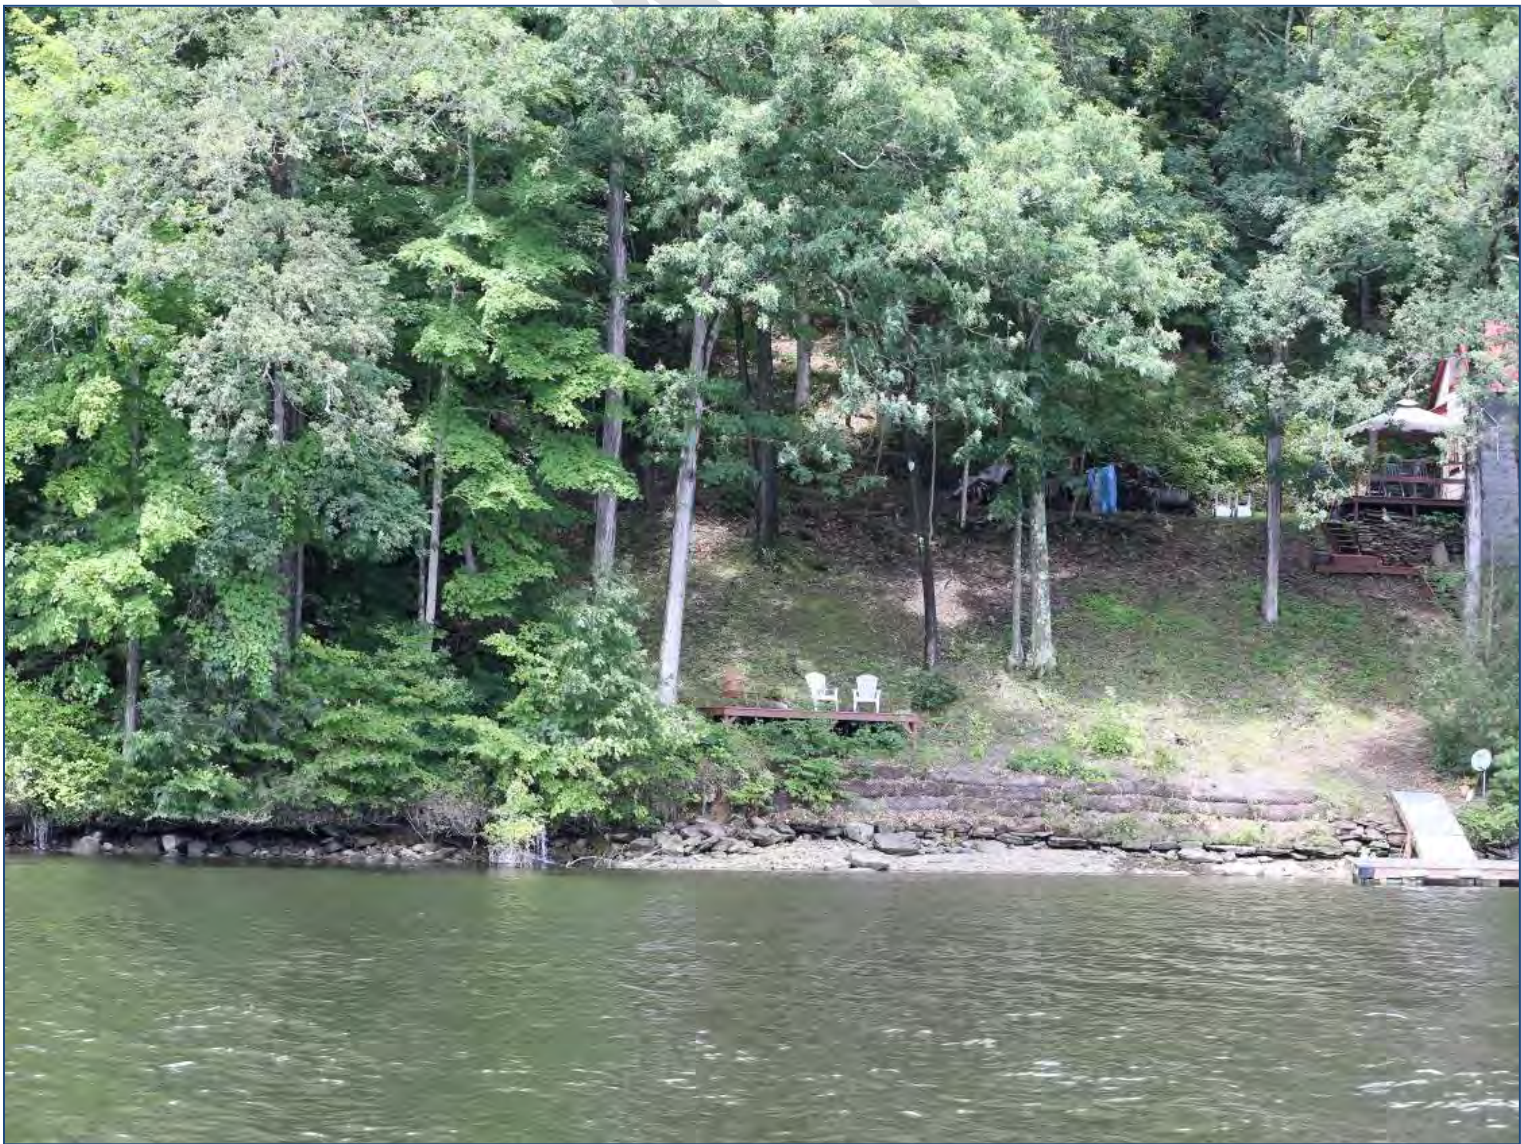
PHOTO SET #20

2007 Photo: Camp 2W: This station is located at Camp Site 2W, on the right bank, in Gill, MA.

Observations: This site (see white arrow location in the 2007 photo) has been recommended for preventative maintenance and/or bank stabilization work in the 2013 FRR report.

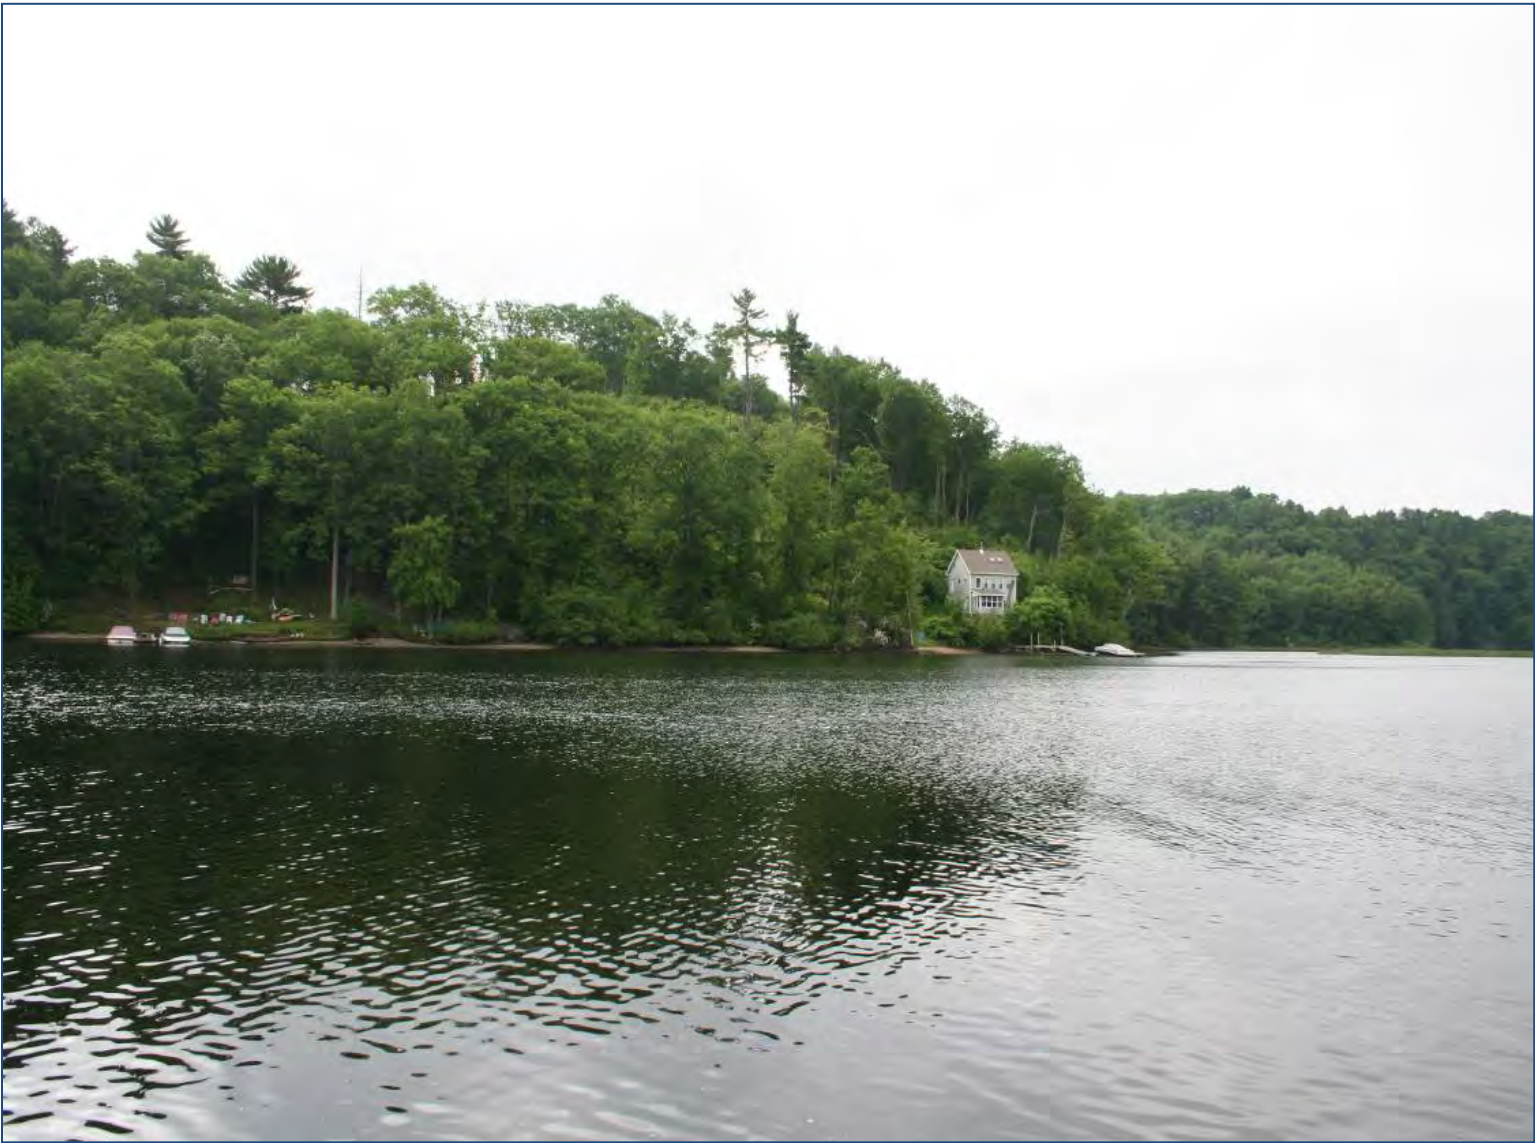
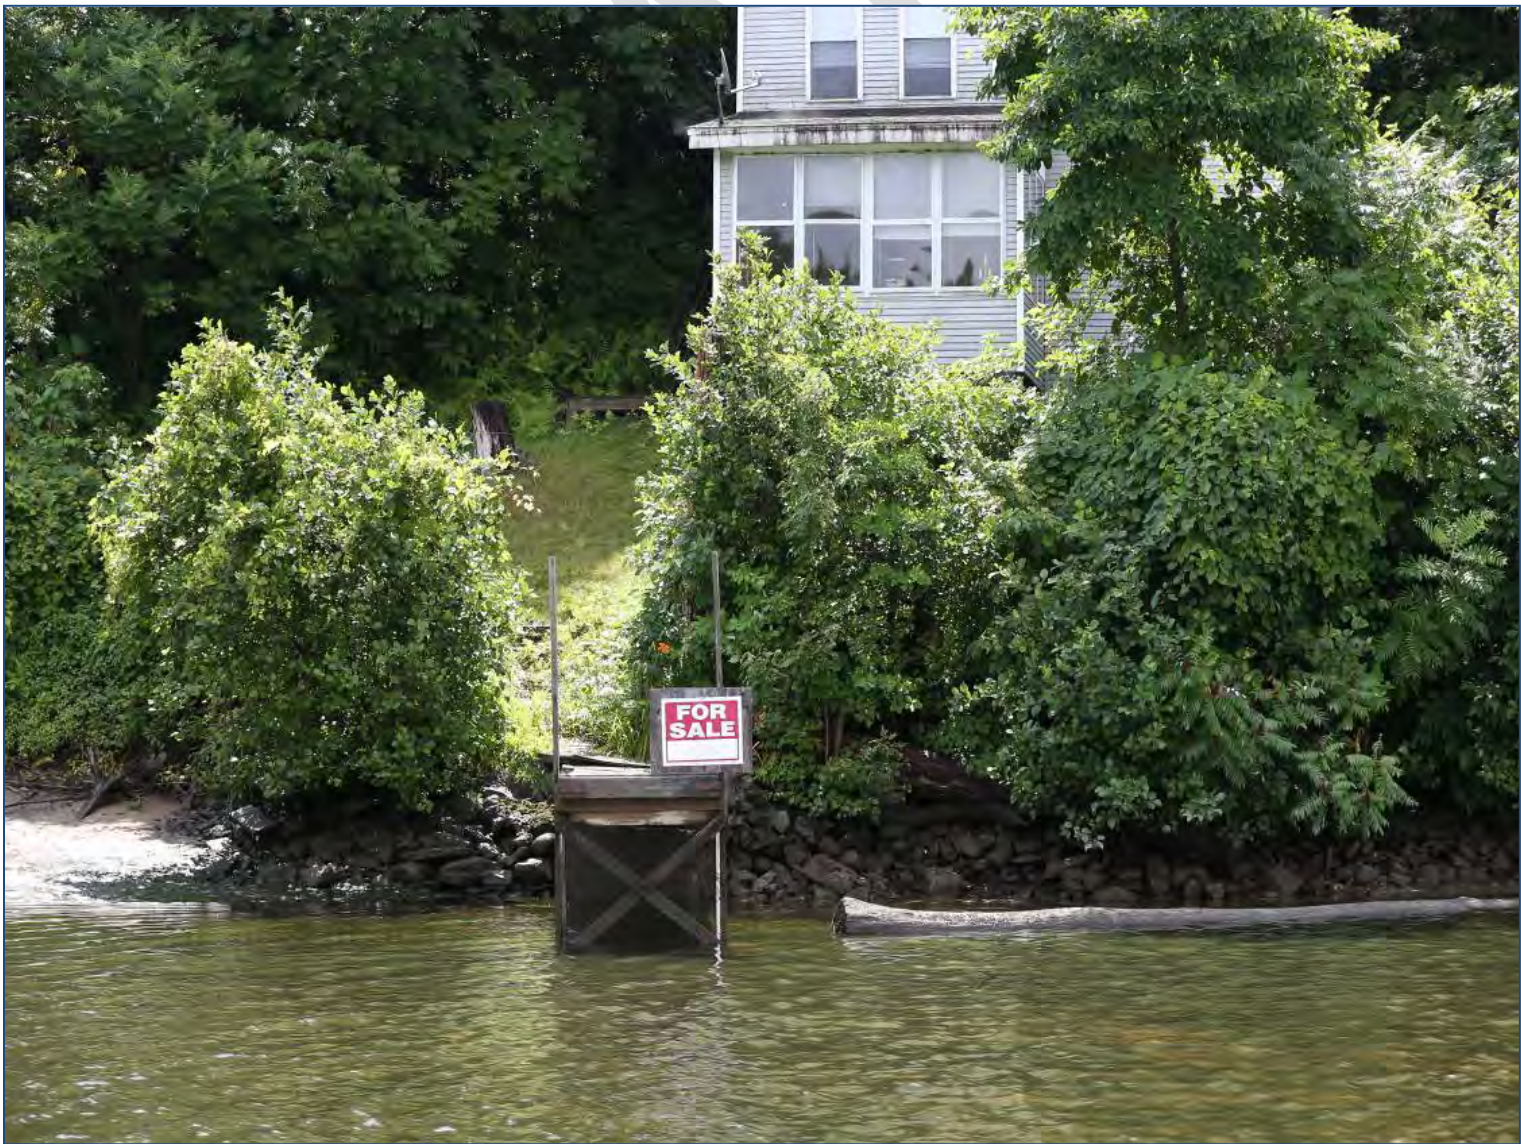
PHOTO SET #21

2007 Photo: Camp 4E: This camp is located in Montague, MA, on the left bank.

Observations: This camp site has been recommended for preventative maintenance and/or bank stabilization work in the 2013 FRR report.

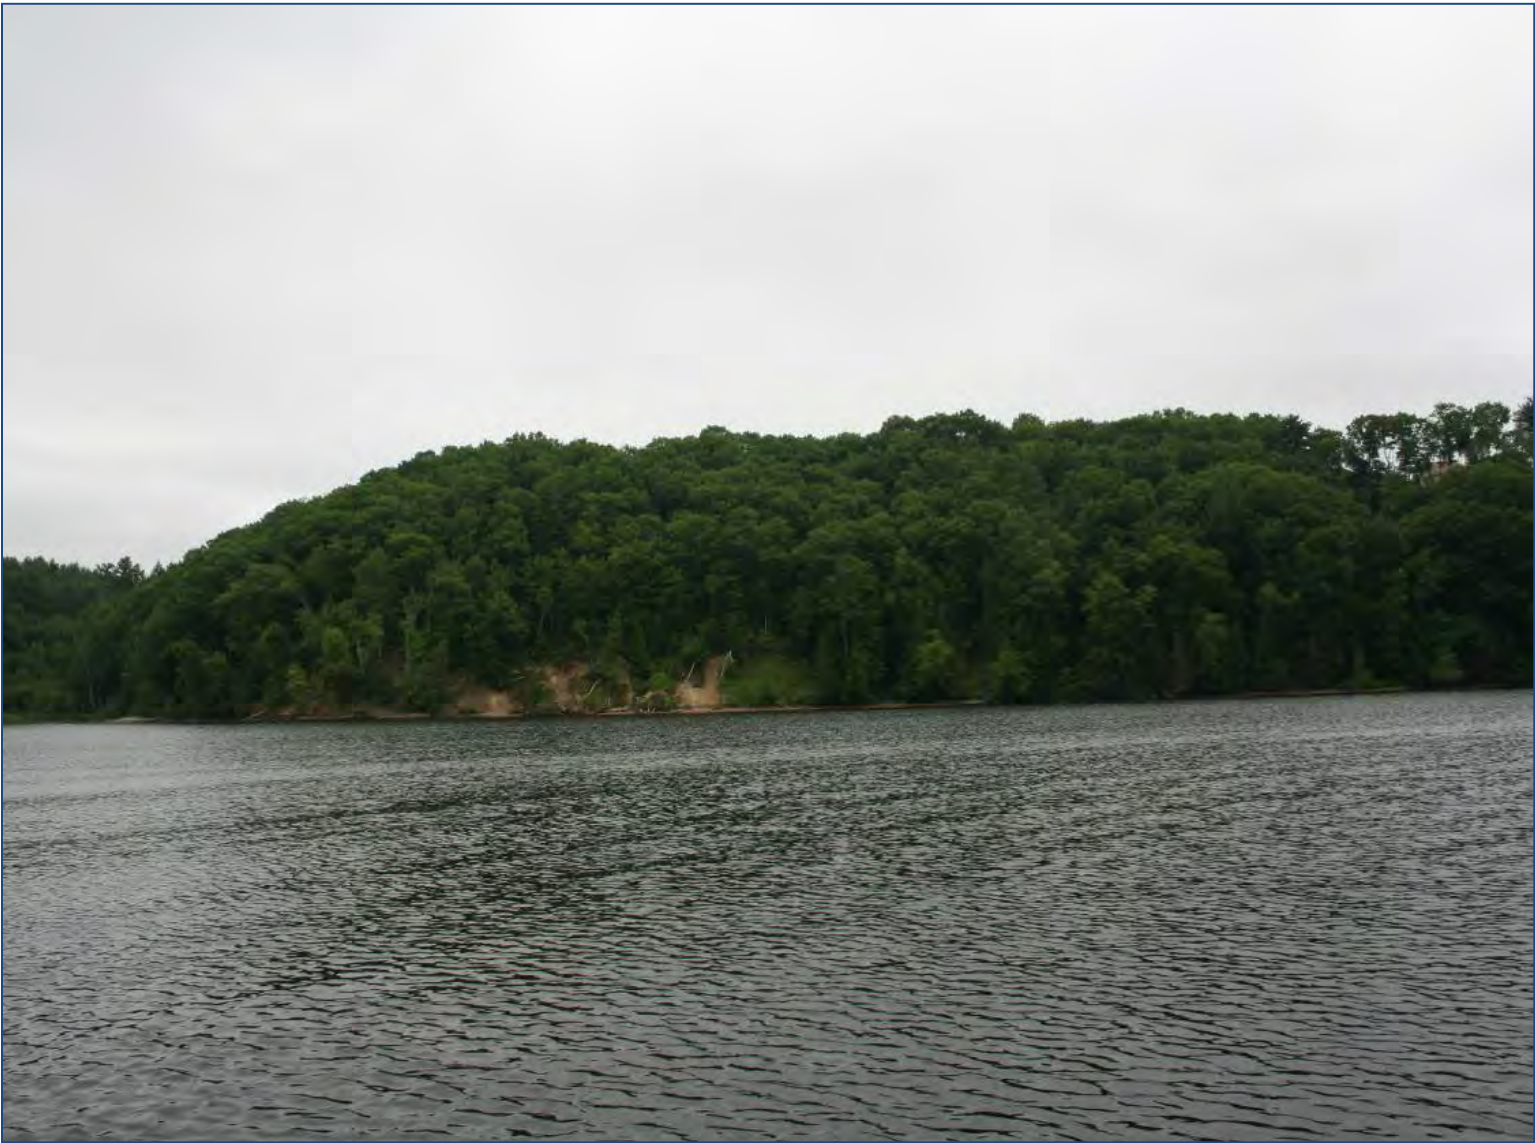
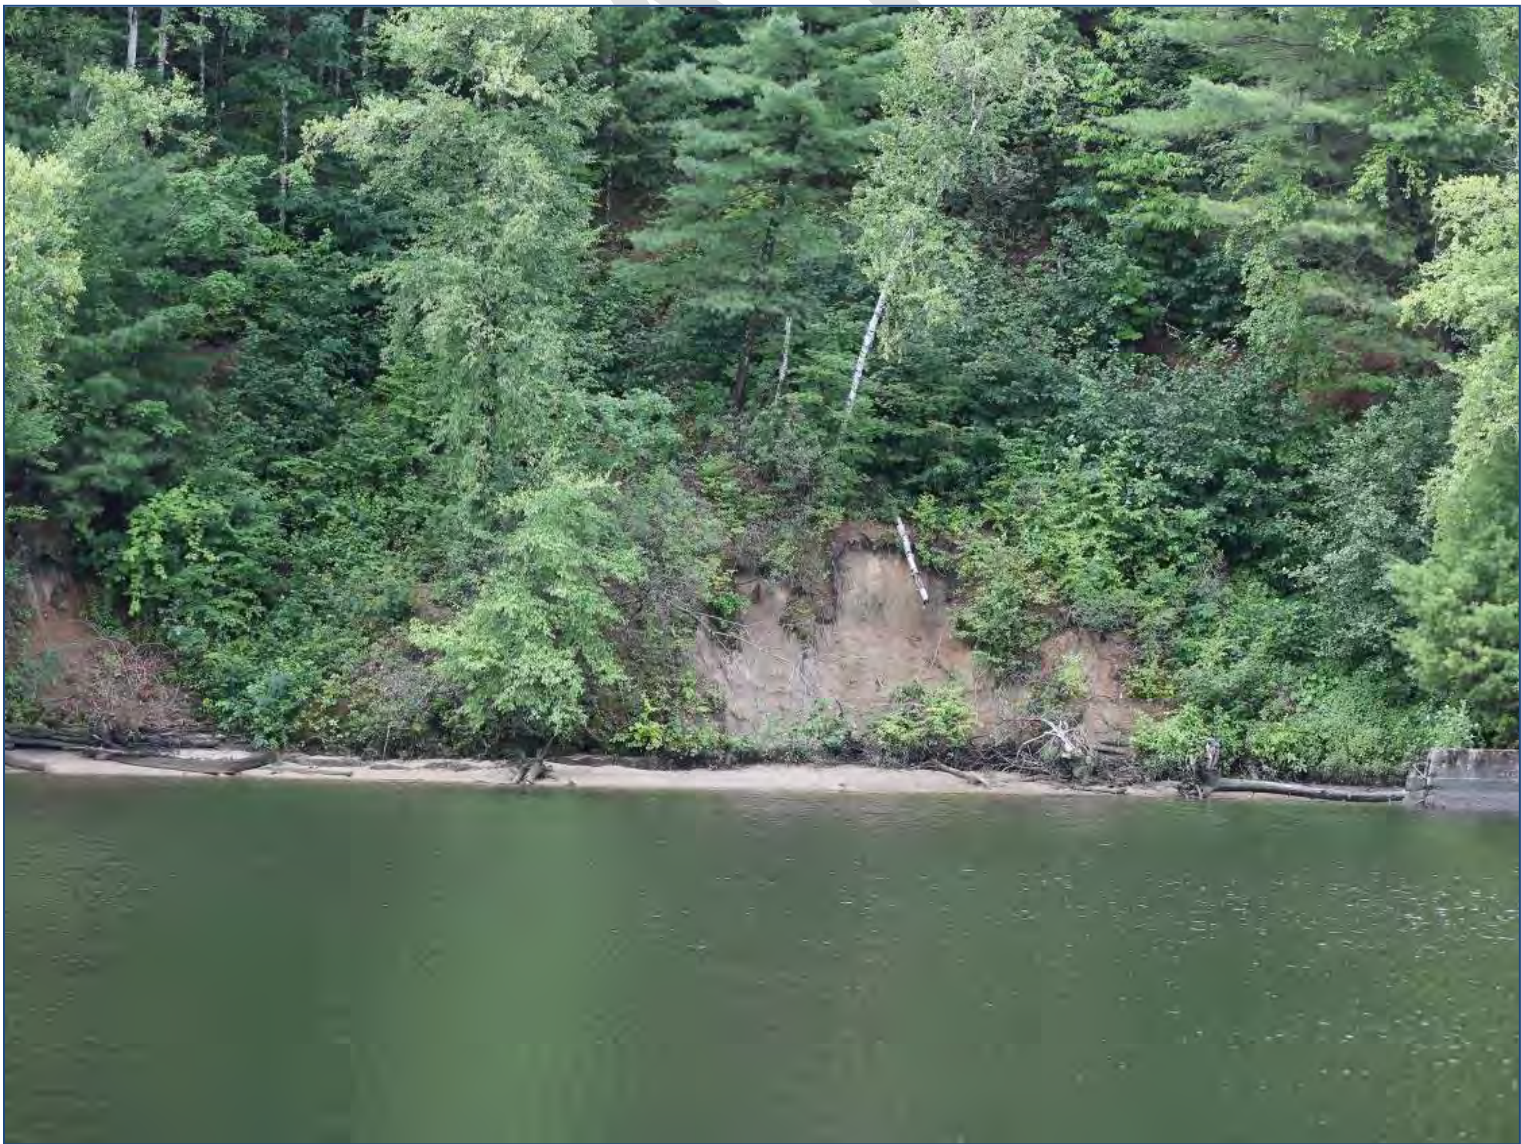
PHOTO SET #22

2007 Photo: Montague: Located downstream from the Montague Rod & Gun Club, in Montague, MA, on the left bank.

Observations: Erosion has been ongoing at this site for quite some time and has been recommended for preventative maintenance and/or bank stabilization work in the 2013 FRR report.
