Riverbank Erosion Comparison along the Connecticut River

October 2012

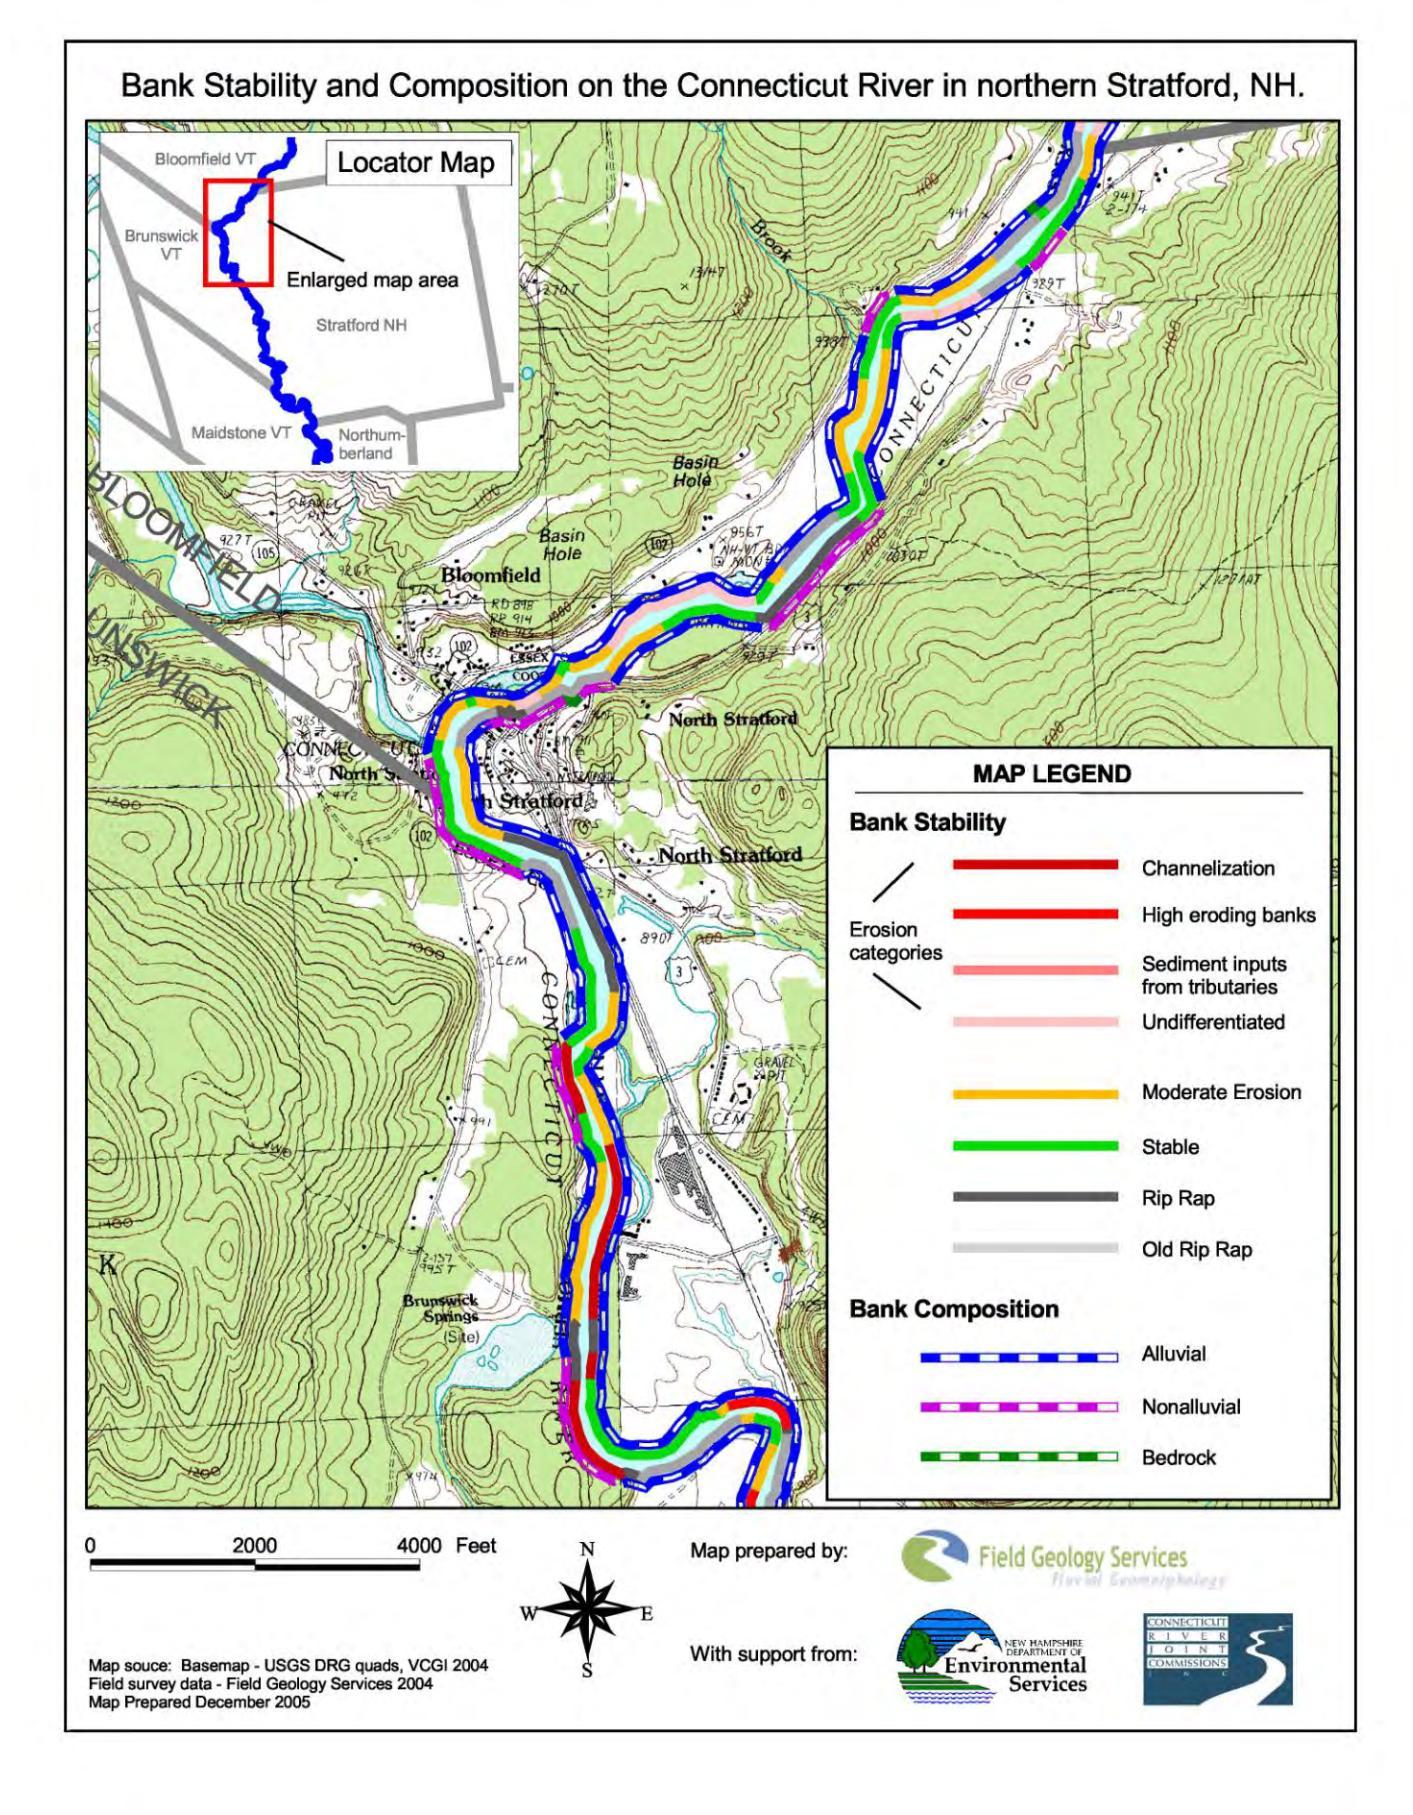
Figure 10. Example of Riverbank Characteristics – Northern, Free-Flowing Reach

Additional maps were prepared by Field in 2005 showing riverbank characteristics and erosion. Figure 10 (after Field Geology Services, 2005) shows a portion of this free-flowing reach with the various aspects related to channel characteristics and stability or erosion. Appendix B presents other maps prepared by Field showing the riverbank conditions in this free-flowing reach.

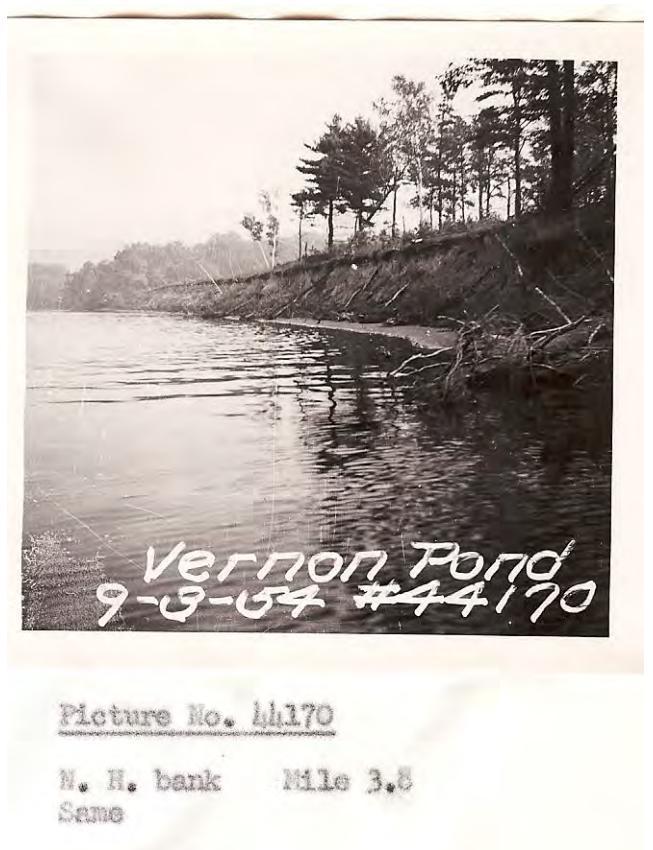
Figure 15. Erosion in Vernon Pool, 1954

As listed in available references, the power company that was operating the Vernon Station during the 1950s documented erosion in the Vernon Impoundment on a periodic basis. The 1954 document discusses and shows about 50 erosion sites that were photographed. Apparently, they were monitoring erosion sites along the Vernon Impoundment over time and documenting them by noting changes and taking photographs. Figure 15 presents an example of an erosion site taken by the Connecticut River Power Company in 1954. Other examples are found in Appendix F. The existence of this document shows that erosion has been an issue of concern for over half a century.
