# CONNECTICUT RIVER RIVERBANK MANAGEMENT MASTER PLAN (DRAFT)

JUNE 1991

**NORTHROP, DEVINE & TARBELL, INC.**

**NORTHEAST UTILITIES SERVICE CO., INC.**

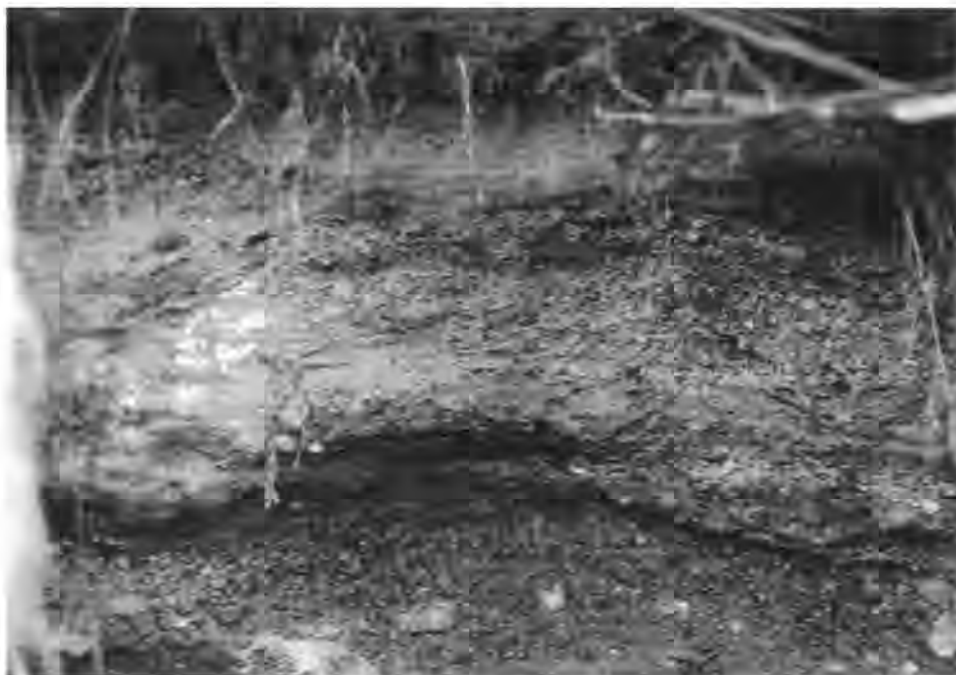
Much of the riverbank stands on steep or near vertical slopes, even in the predominately granular alluvial deposits. These banks are at the point of incipient failure, and would be determined to be unstable using theoretical analyses. The effects of vegetation, apparent cohesion and cementation act temporarily to stabilize the bank. It should be noted that apparent cohesion is due to capillarity, and does not act when soils are submerged, and cementation may be less effective in the submerged state. These banks will be prone to erosion until they are cut back or flattened to less than the theoretical angle of repose.

Kidds Island - East bank approximately 100 ft downstream of the northern end of the island. July 25, 1990.

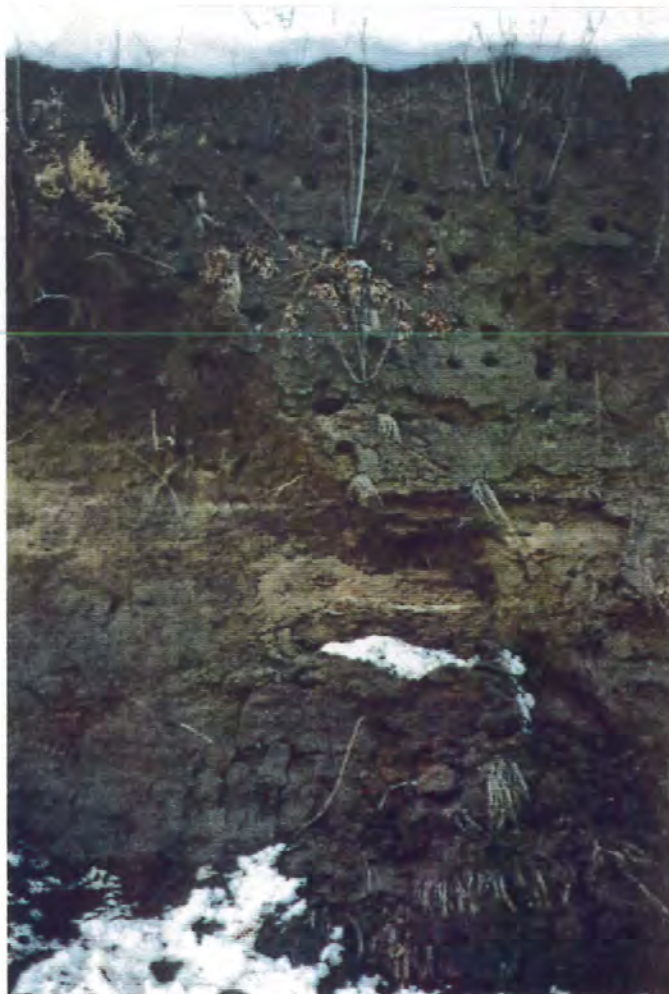
Bank swallow nest holes at erosion site #60, west of Kidds Island - Feb. 6, 1990.
