## <u>Detailed Analysis of the 2008 Full River Reconnaissance of</u> <u>the Turners Falls Pool on the Connecticut River</u>

## Landowners and Concerned Citizens for License Compliance Turners Falls Pool

Dr. John Field Field Geology Services Farmington, ME

July 2011

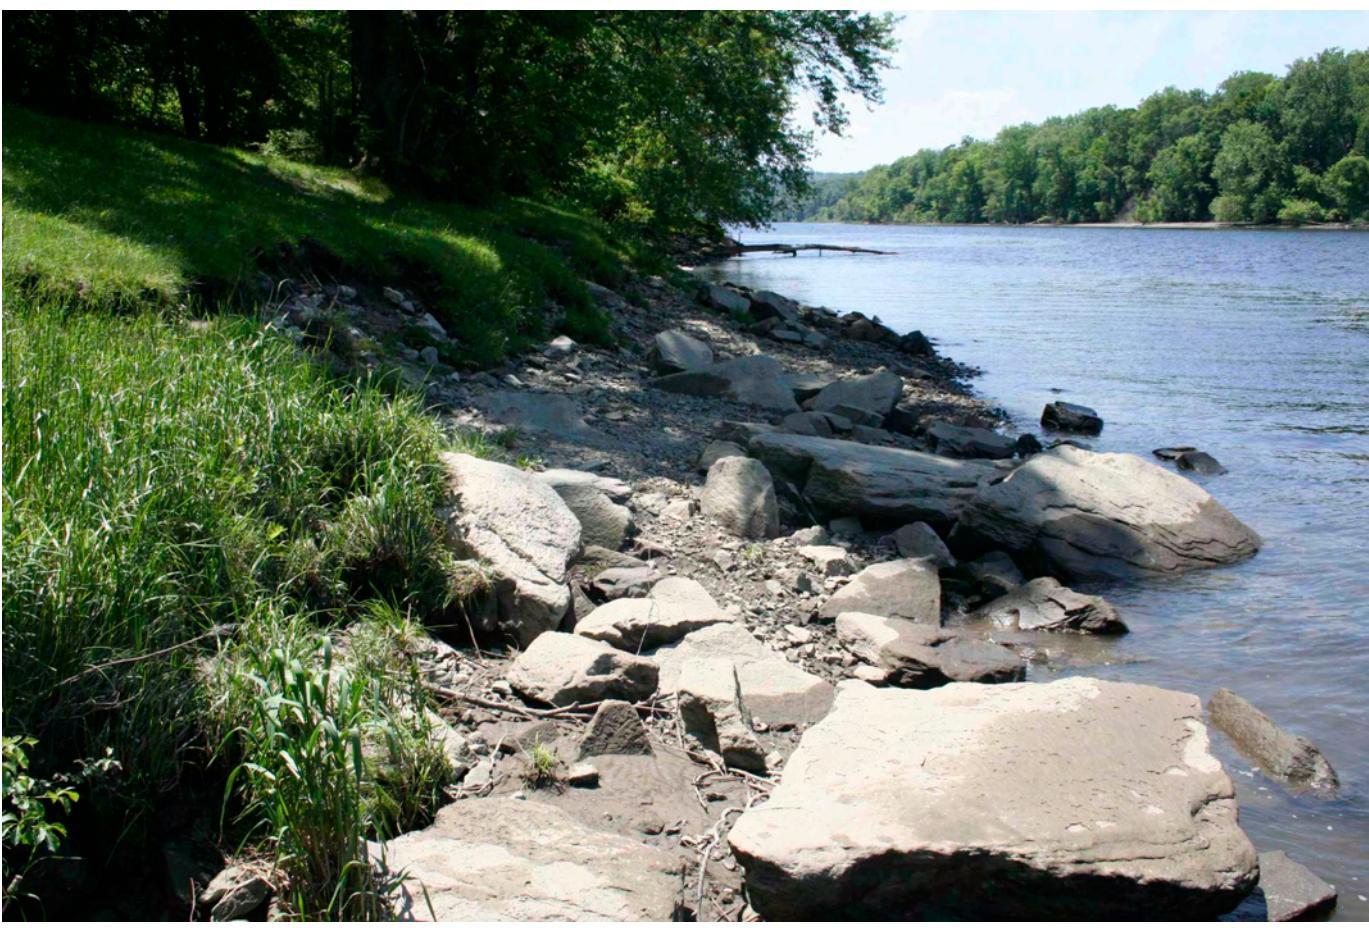
Munn's Ferry picnic area

Cover photo. Erosion has continued behind riprap at the Munn's Ferry picnic area.

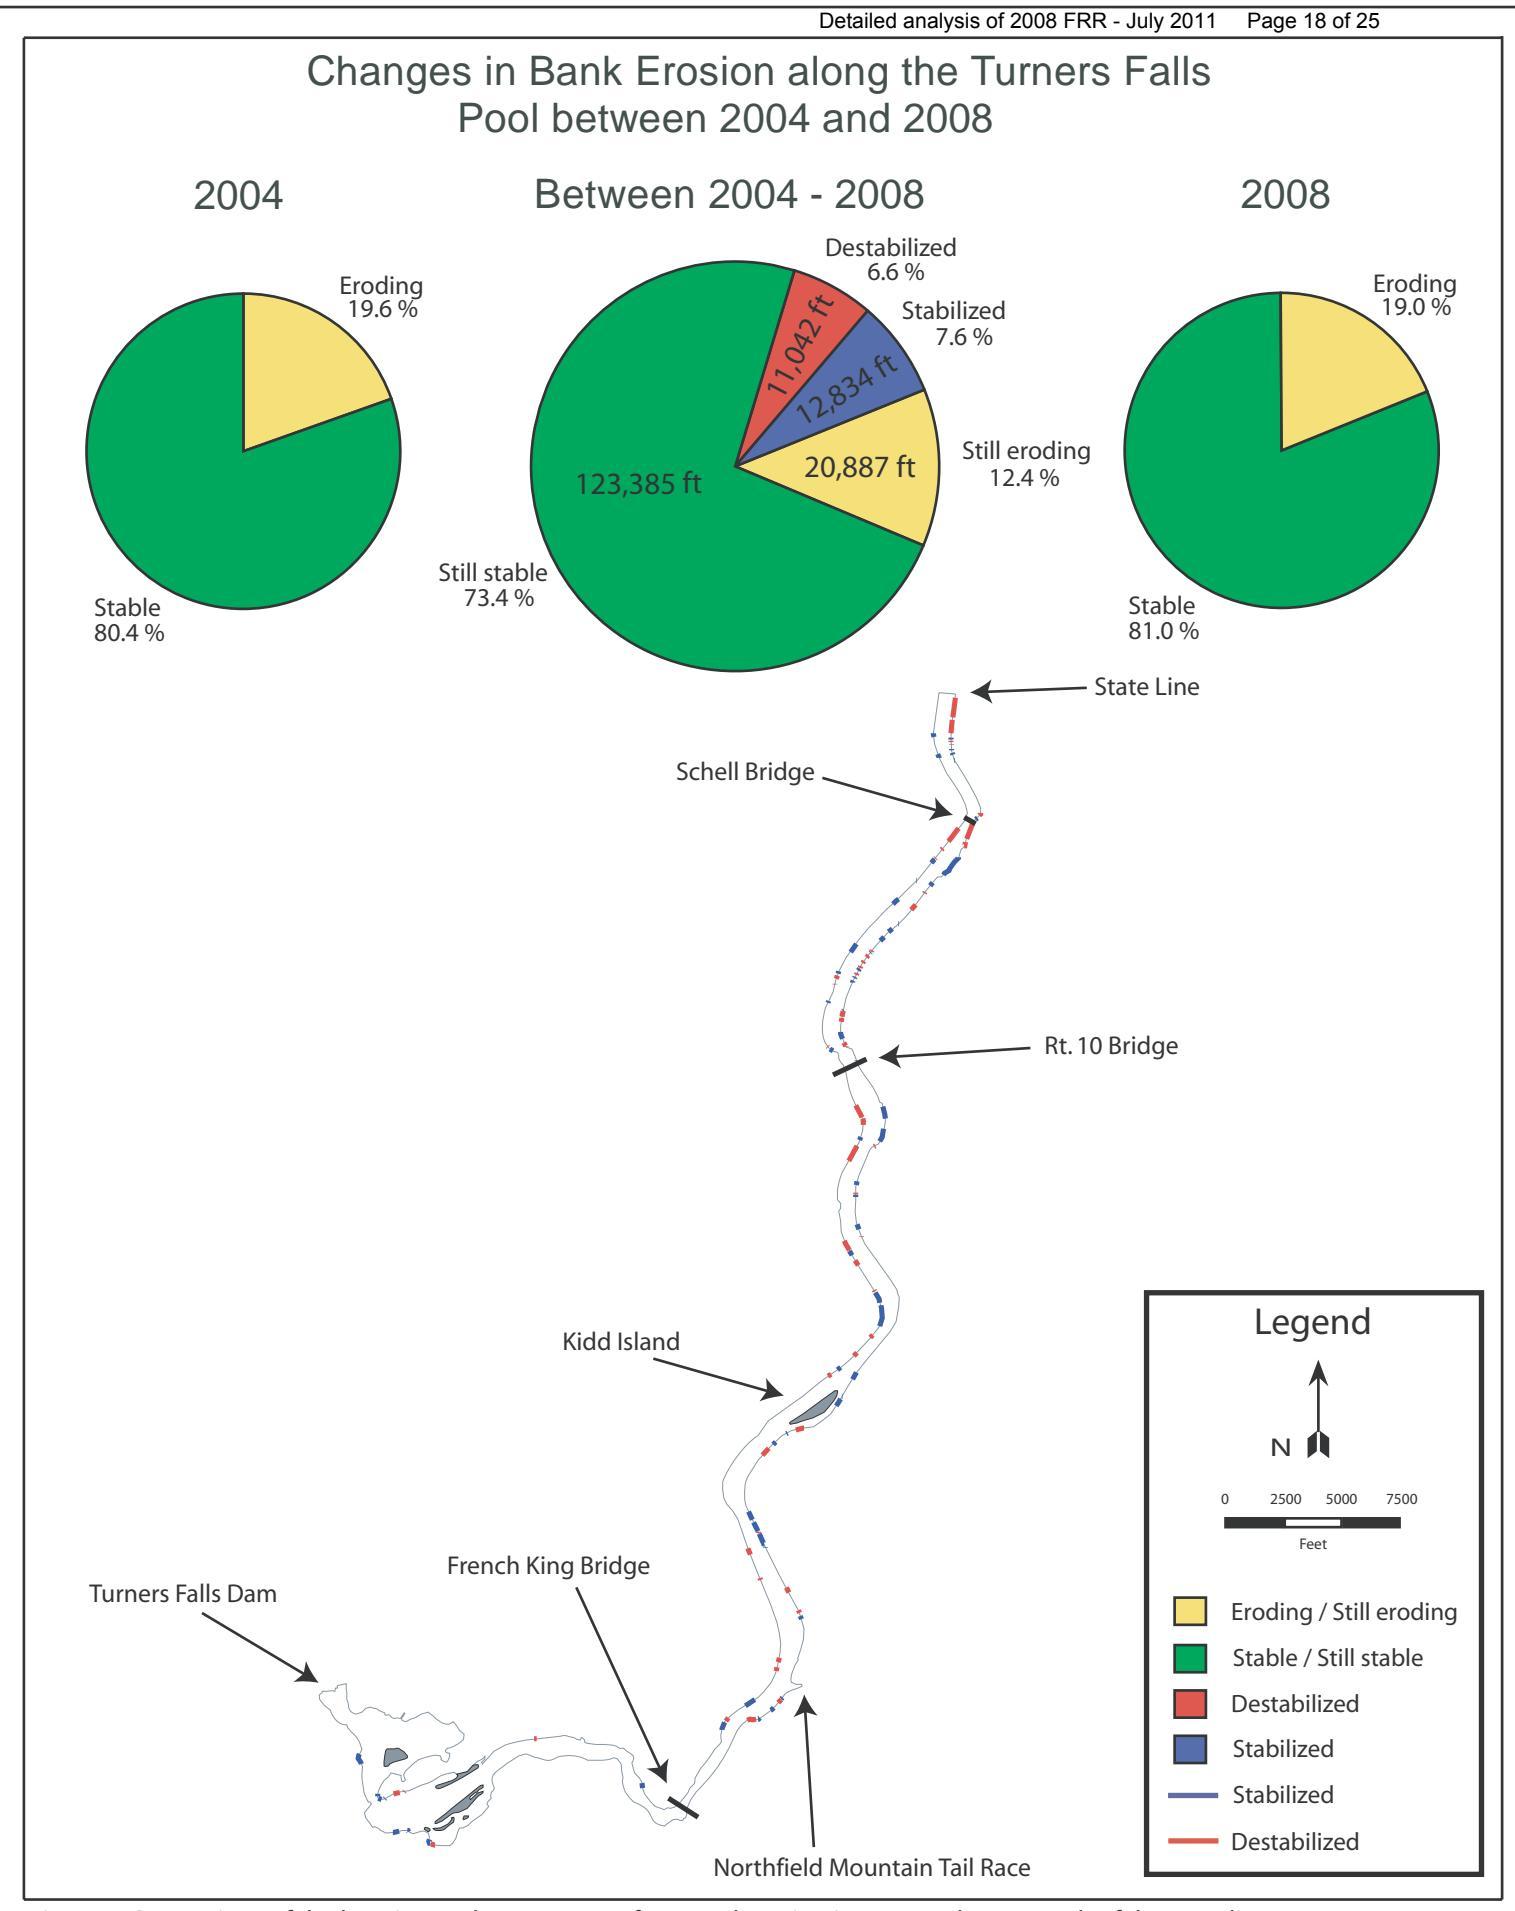
Figure 1. Comparison of the location and percentage of mapped erosion in 2004 and 2008 south of the state line.

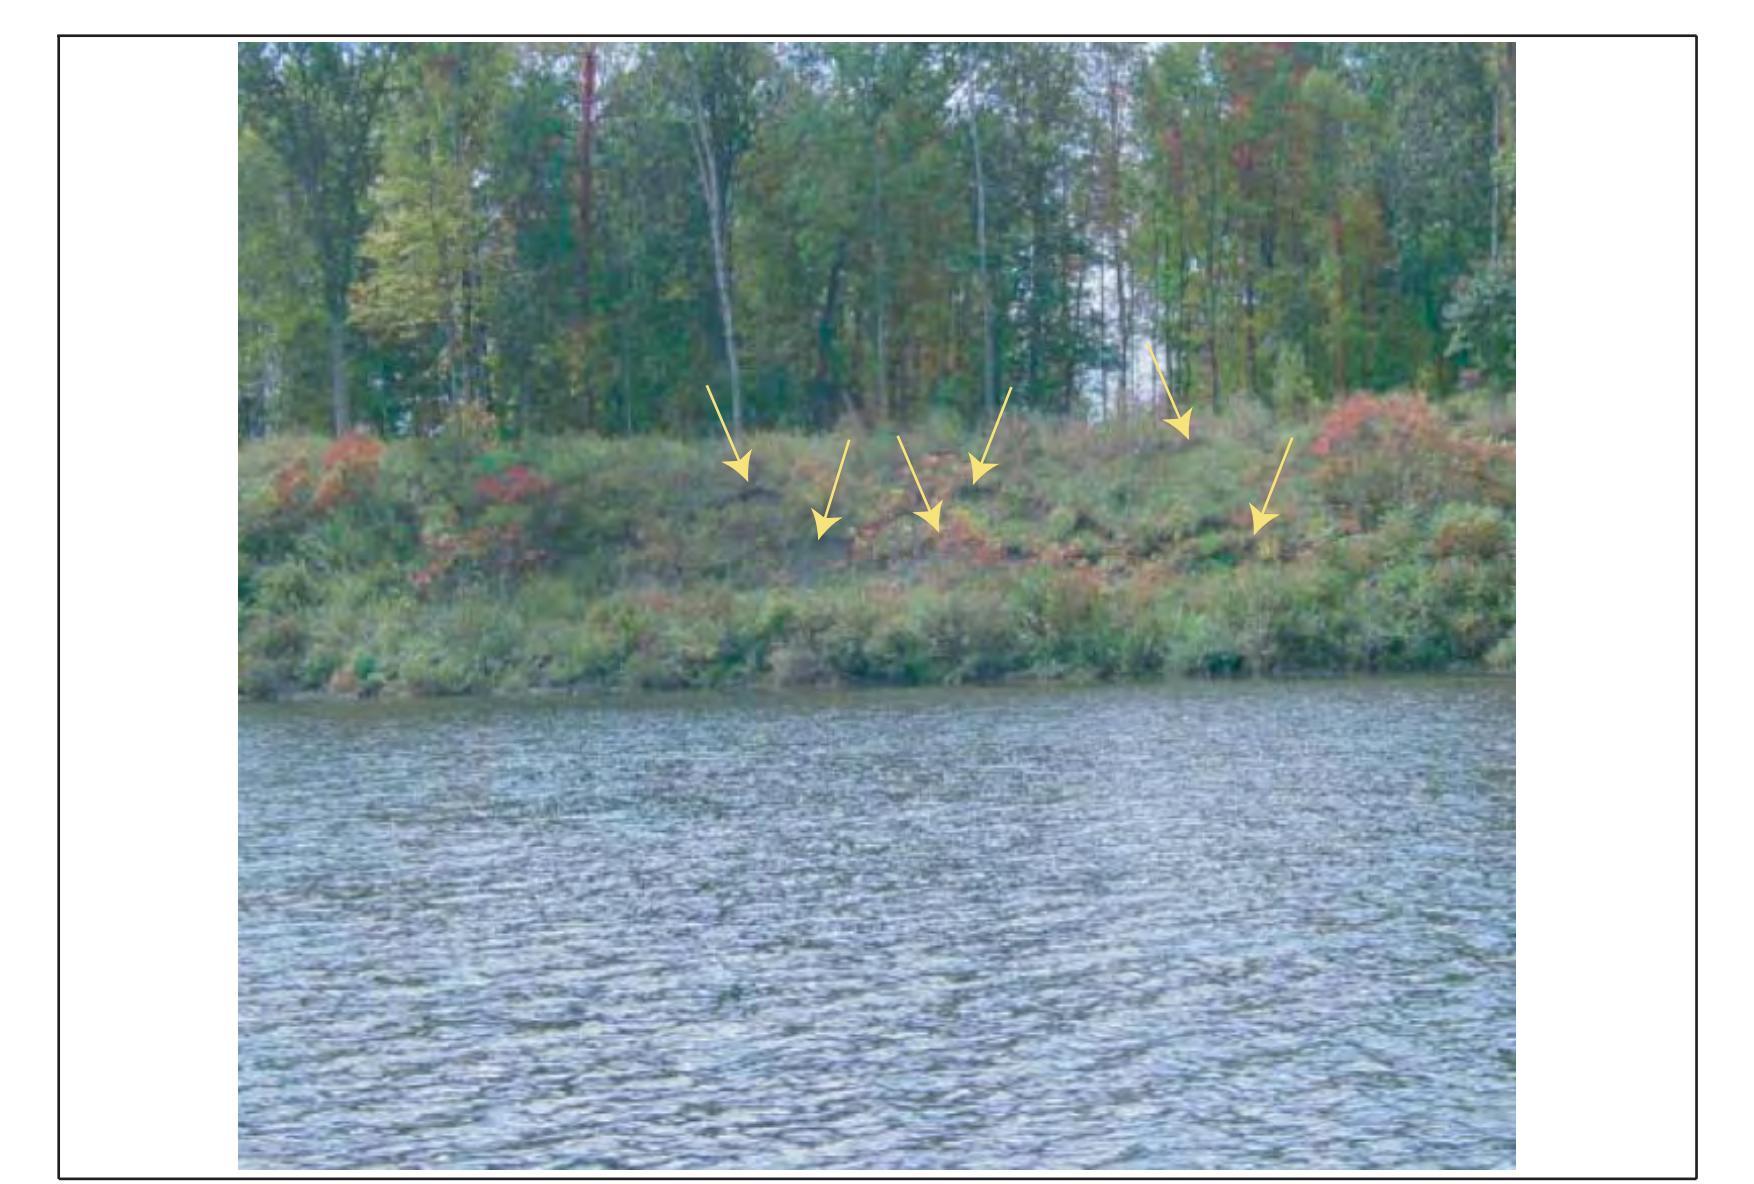
Thousands of feet of bank stabilization has occurred in the Pool since operations began at the Project in 1972. The 2008 FRR deems these previously stabilized areas as still "stable and not eroding" (Simons, 2009, p. 24). At least one of the photographs included in Simons (2009, p. 74) contradicts this claim (included here as Figure 2 for convenience). Although meant to illustrate how the bank has been stabilized by bioengineering, the photograph also shows unmistakable signs of planar slips, a common form of bank erosion observed in the Pool (Field, 2007). Continuing erosion after implementation of this bioengineering project at the Upper Urgiel site is more clearly seen in Figure 3a. Other bioengineering projects have also experienced erosion following implementation (Figure 3b-d), necessitating repairs at several sites to prevent more serious erosion problems (Field, 2007). Some of the older riprap projects completed in the 1970's are eroding more severely with significant bank recession observed behind the former line of armoring stones (Figure 4). The 2004 FRR mapped 758 ft of armored areas as eroding (Field, 2007, Table 3), providing further evidence that areas receiving bank treatments do not always remain stable. The considerable evidence for erosion at previously stabilized sites indicates Simon's (2009, p. 24) presumption that these areas remain "stable and not eroding" is not valid and, as a consequence, the amount of erosion reported in the 2008 FRR underestimates what is actually present in the Pool.

Figure 2. Photo from Simons (2009, p. 74) showing bioengineering at the Upper Urgiel site. Arrows highlight the crest of planar slip scars indicating erosion continues at the site despite stabilization efforts.

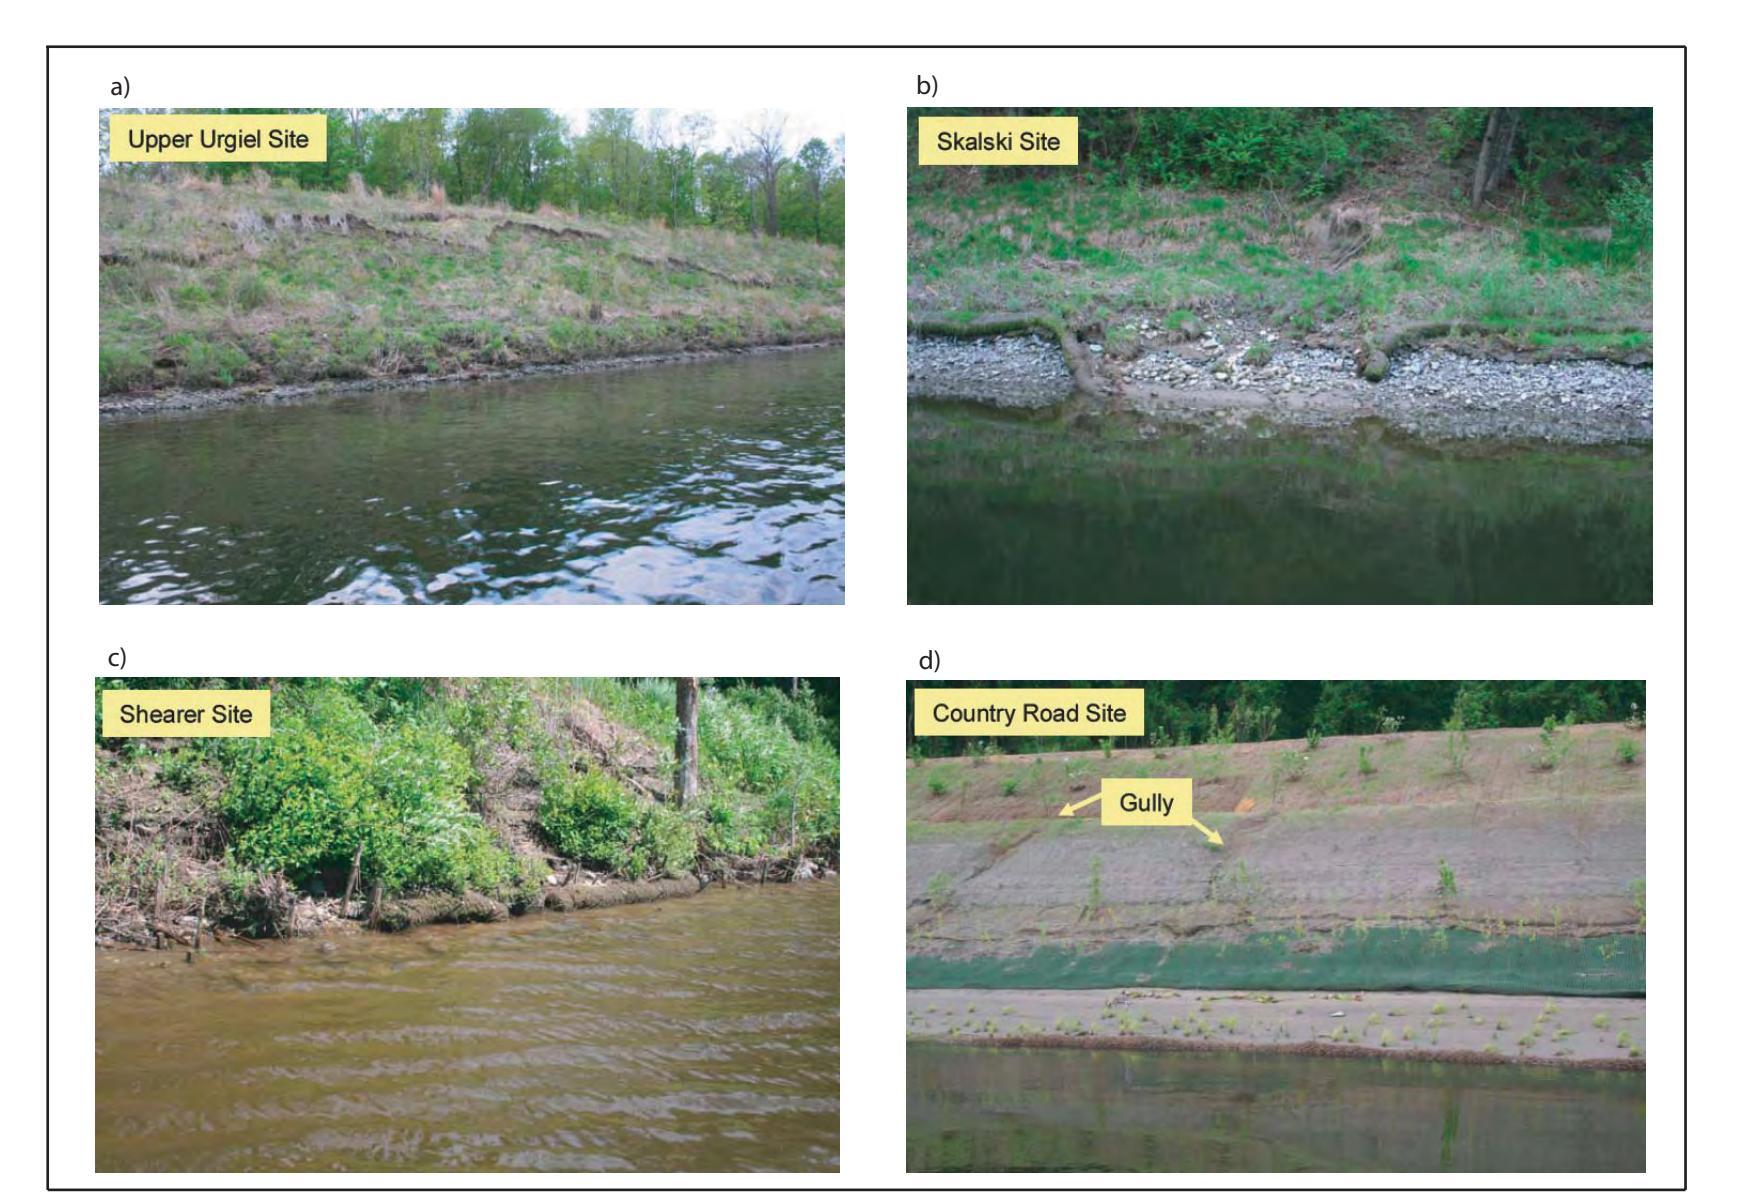
Figure 3. Photos showing instability at bioengineering sites. a) Upper Urgiel site showing planar slip failures at same site as in Figure 2, b) coir logs detached from bank by mass movements at Skalski site, c) coir logs removed by water currents at Shearer Site, and d) gullying on the slope of Country Road site. Modified from Field (2007, Figure 39).

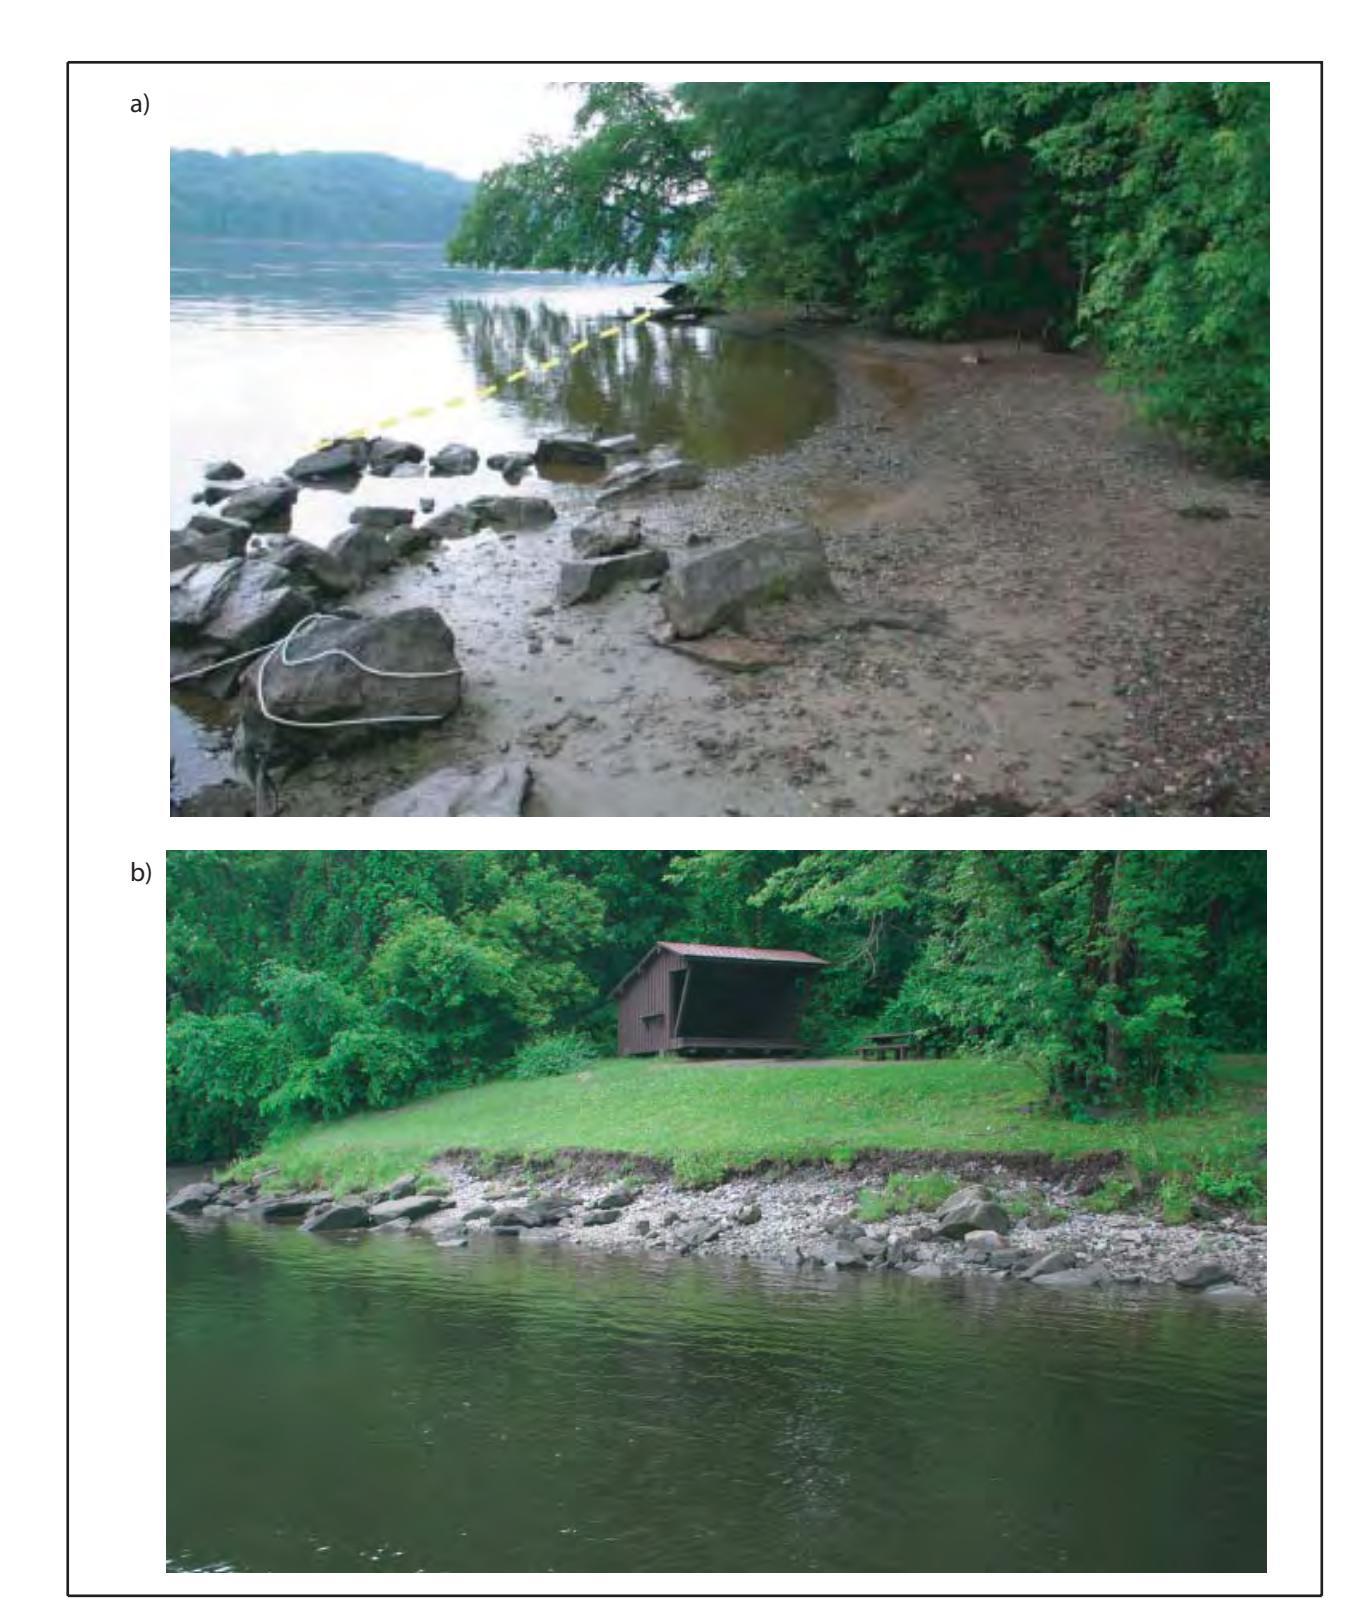
Figure 4. Erosion where bank armoring occurred in the past at a) Barton Cove with dashed line indicating former position of riprap and b) Munn's Ferry picnic area. Modified from Field (2007).

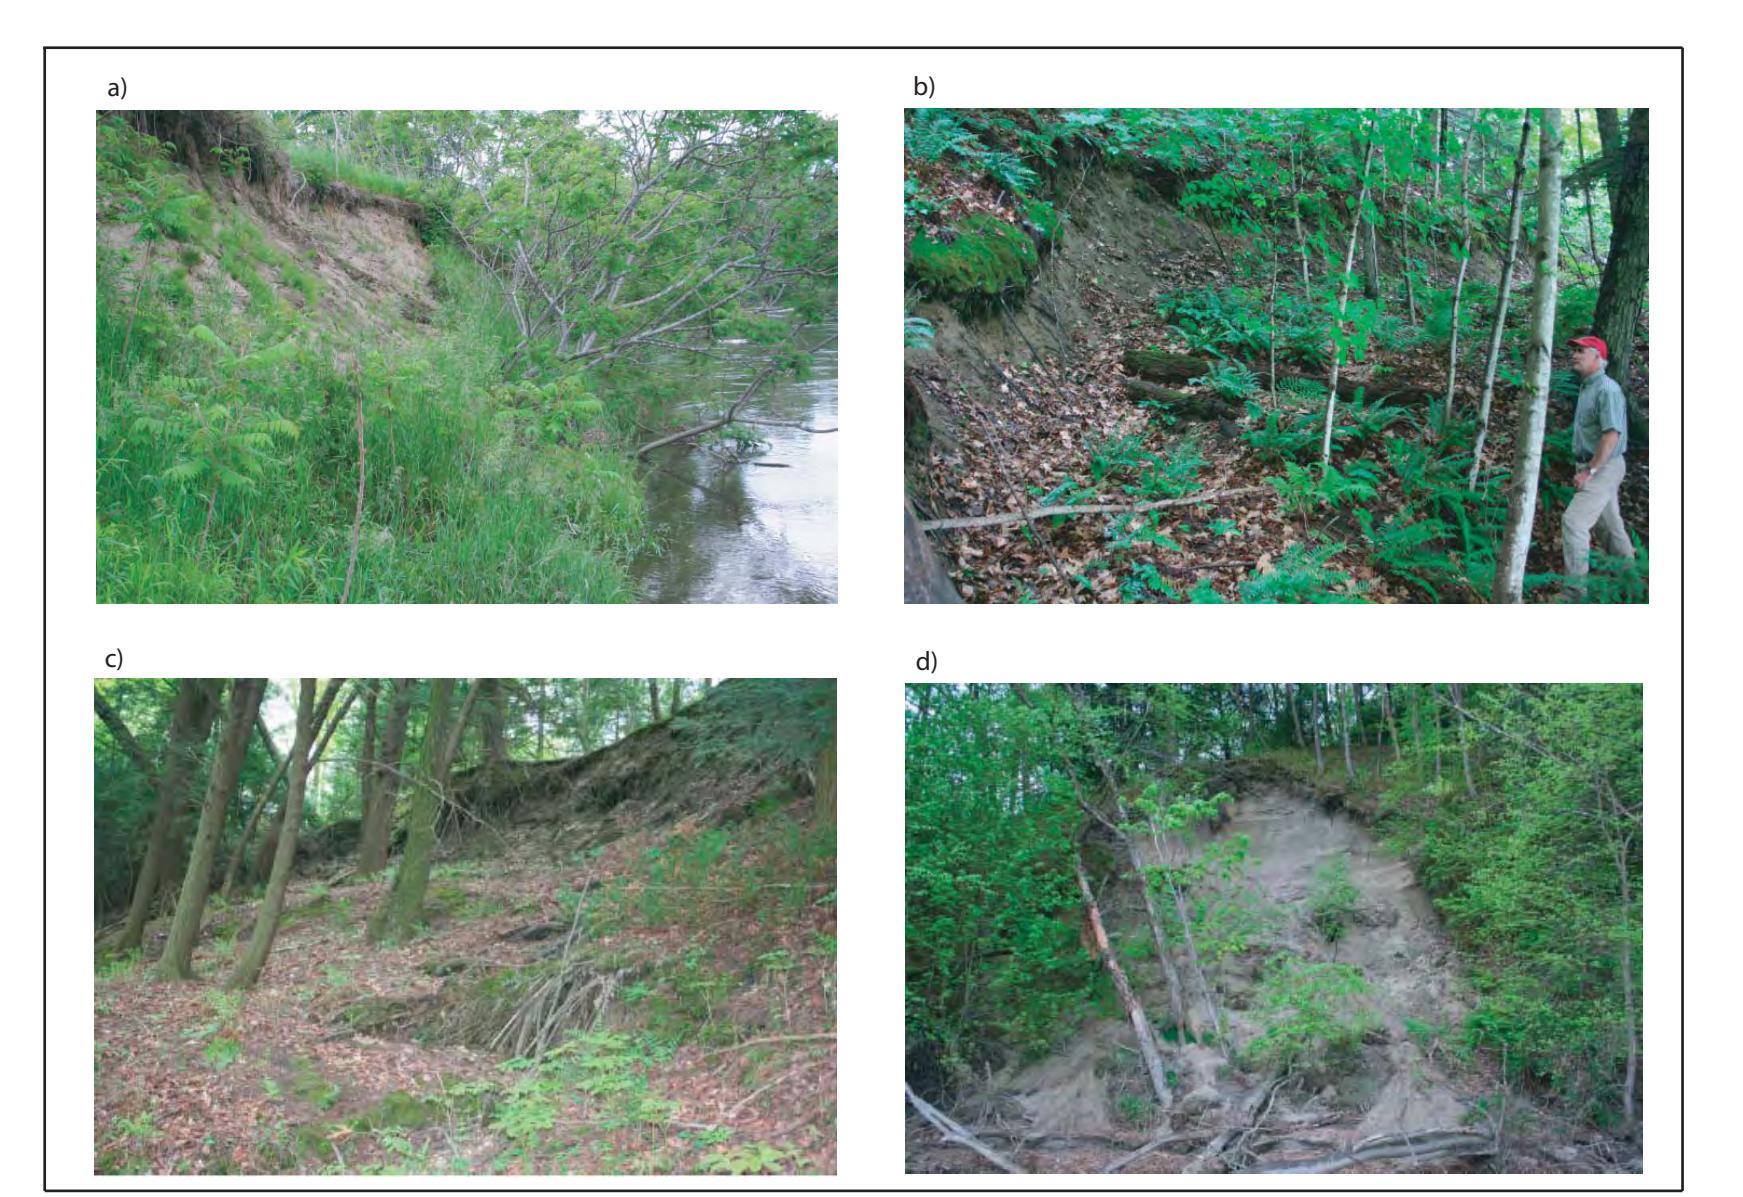
Figure 5. Four examples of bank erosion occurring where vegetation is present on the bank. Modified from Field (2007).

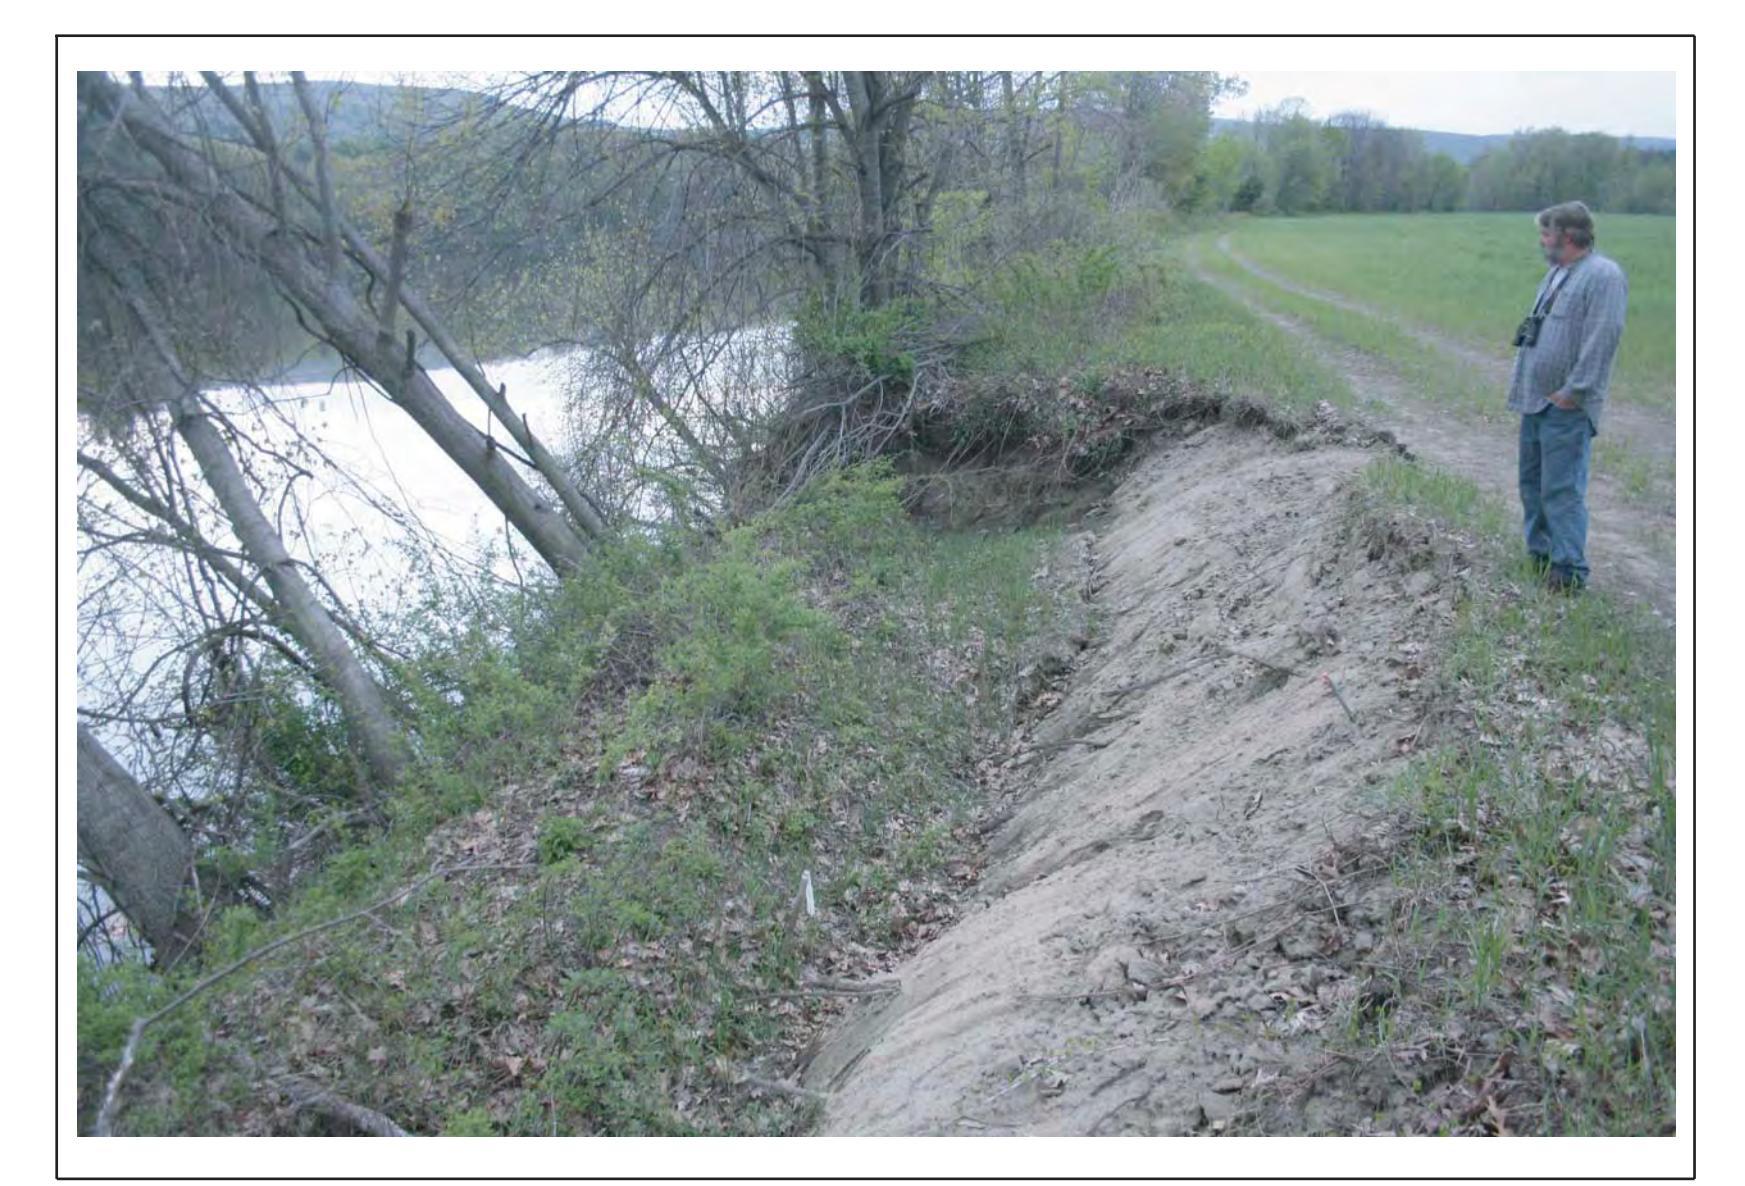
Figure 6. Large active slump block with trees intact at Upper Split River Farm site.

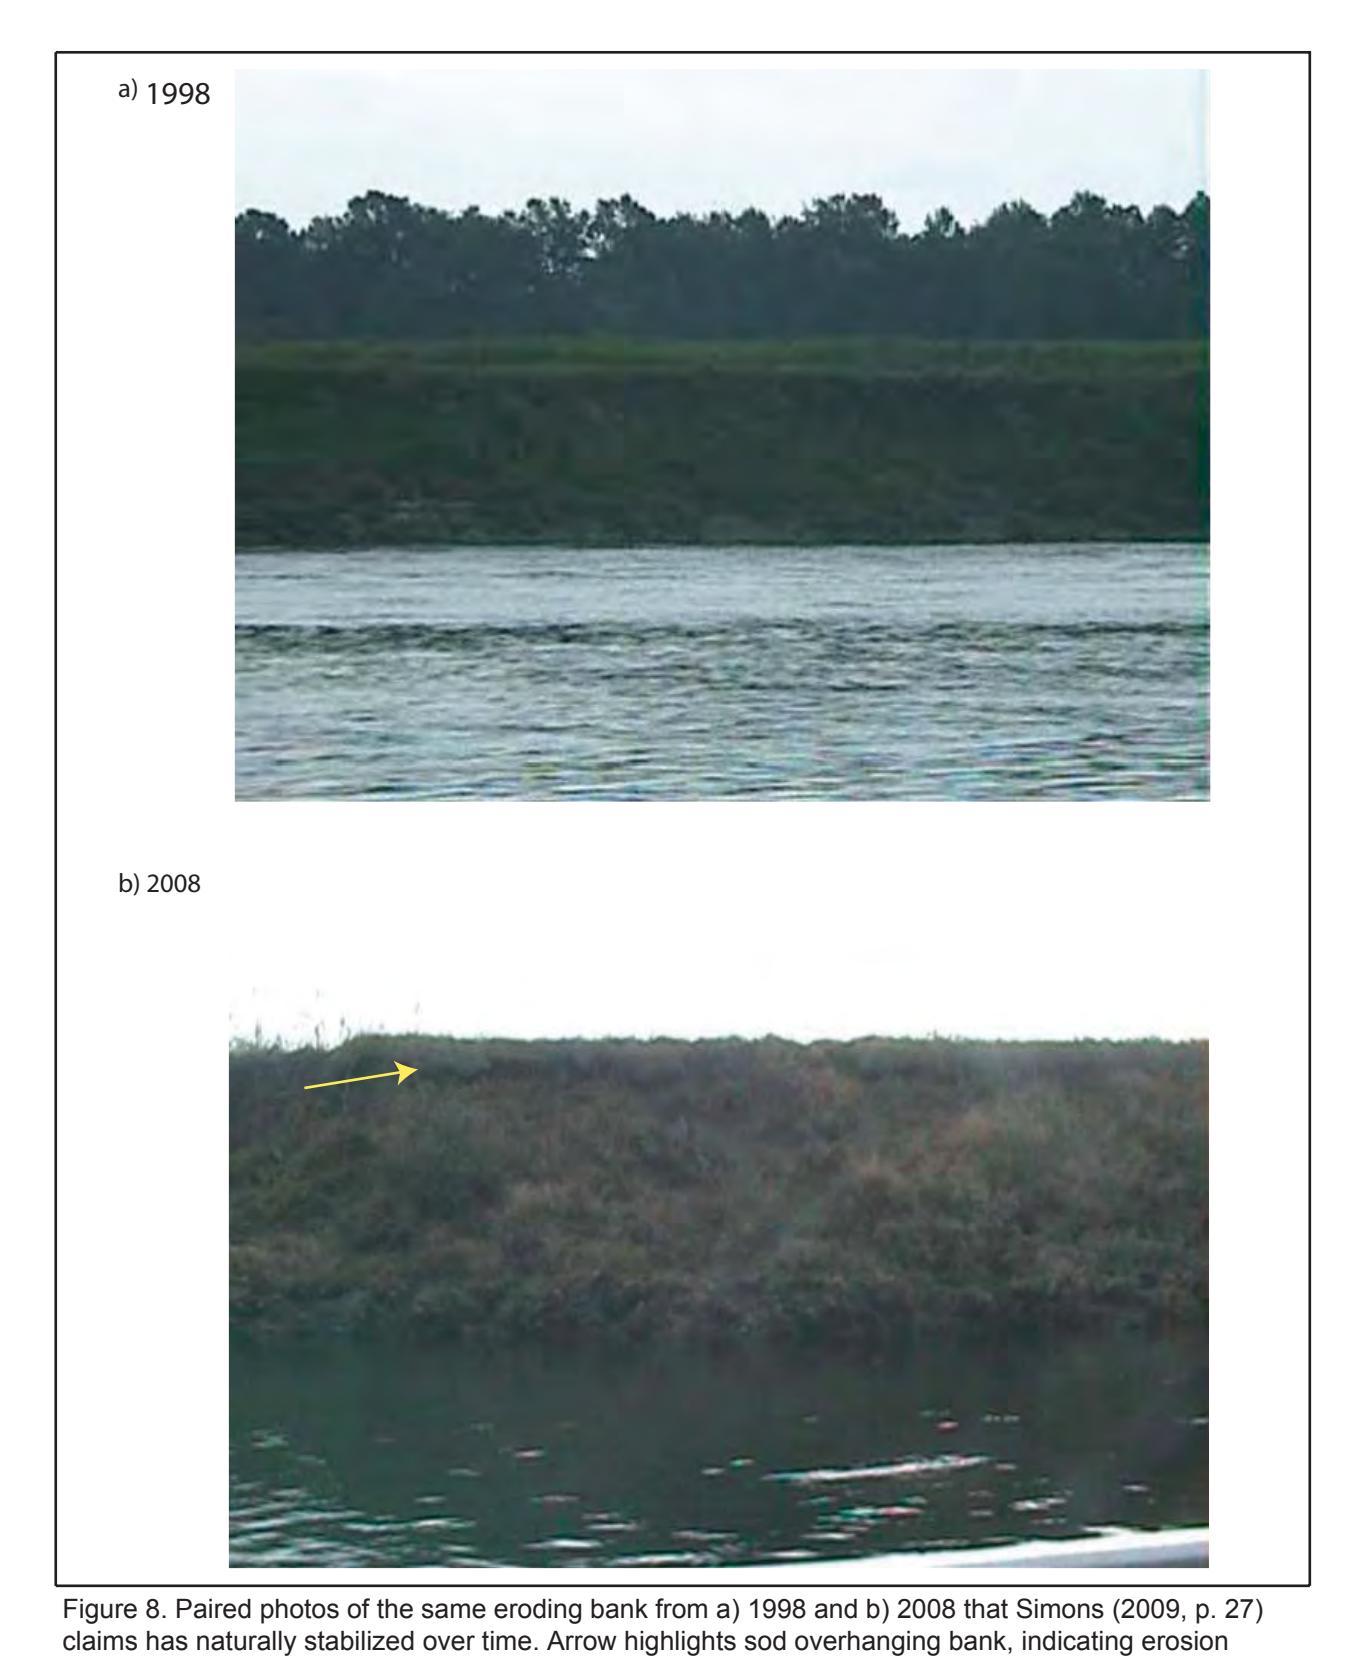
(Simons, 2009, p. 76 - photos provided as Figure 8 here for convenience). First, if natural stabilization is occurring at the site shown, no evidence is provided to demonstrate that the stabilization occurred between 2004 and 2008, as inferred, and not between 1998 and 2004. While the photographs are of too low a quality to definitively support any conclusions, the photographs actually appear to show that the bank is continuing to erode (Figure 8). The 2008 photograph shows the sod on the floodplain draped slightly over the top edge of the bank, indicating the bank material that was supporting the sod has been recently removed by erosion (Figure 8b). The amount of vegetation growing on the bank in both photographs does not necessarily support the contention that vegetation has increased in this area (Simons, 2009, p. 27) nor should the amount of bank vegetation be used as a variable in indentifying the presence or absence of bank erosion (Field, 2007, p. 32). The two photographs are not framed the same (i.e., the 2008 photograph shows no trees in the distance) to determine if exactly the same portion of the eroding bank is shown (Figure 8). While both photographs are of the right bank downstream of Stebbin's Island, the density of vegetation on this 2,000-foot section of eroding bank would vary across its length as different sections of bank collapse at different times. Shrubs, such as shown growing on the bank in Figure 8, can become established on actively eroding banks where the bank remains unchanged for a season or two, but the bank will become bare again as erosion continues (Field, 2007, p. 32). Consequently, the two photographs provided as evidence of natural stabilization through time more likely reflect the natural variation in vegetation density that would be expected at any given time along a 2,000-foot length of bank. If "natural stabilization processes" are occurring in the Pool, they have not been substantiated by the 2008 FRR. Claiming natural stabilization as evidence that "the rate of erosion in the Turners Falls Pool is decreasing" (Simons, 2009, p. 27) is, therefore, misleading, as most of the assumed natural stabilization is, based on spot checking of "naturally stabilized" sites (Figure 7), merely an artifact of differences in mapping methodology.

continues at the site. Modified from Simons (2009, p. 76).
