July 15, 2013

Re: Northfield Mountain Pumped Storage Project, FERC No. 2485-063
Turners Falls Project, FERC No. 1889-081

Comments on the Updated Proposed Study Plan (PSP) submitted by FirstLight June 28, 2013.

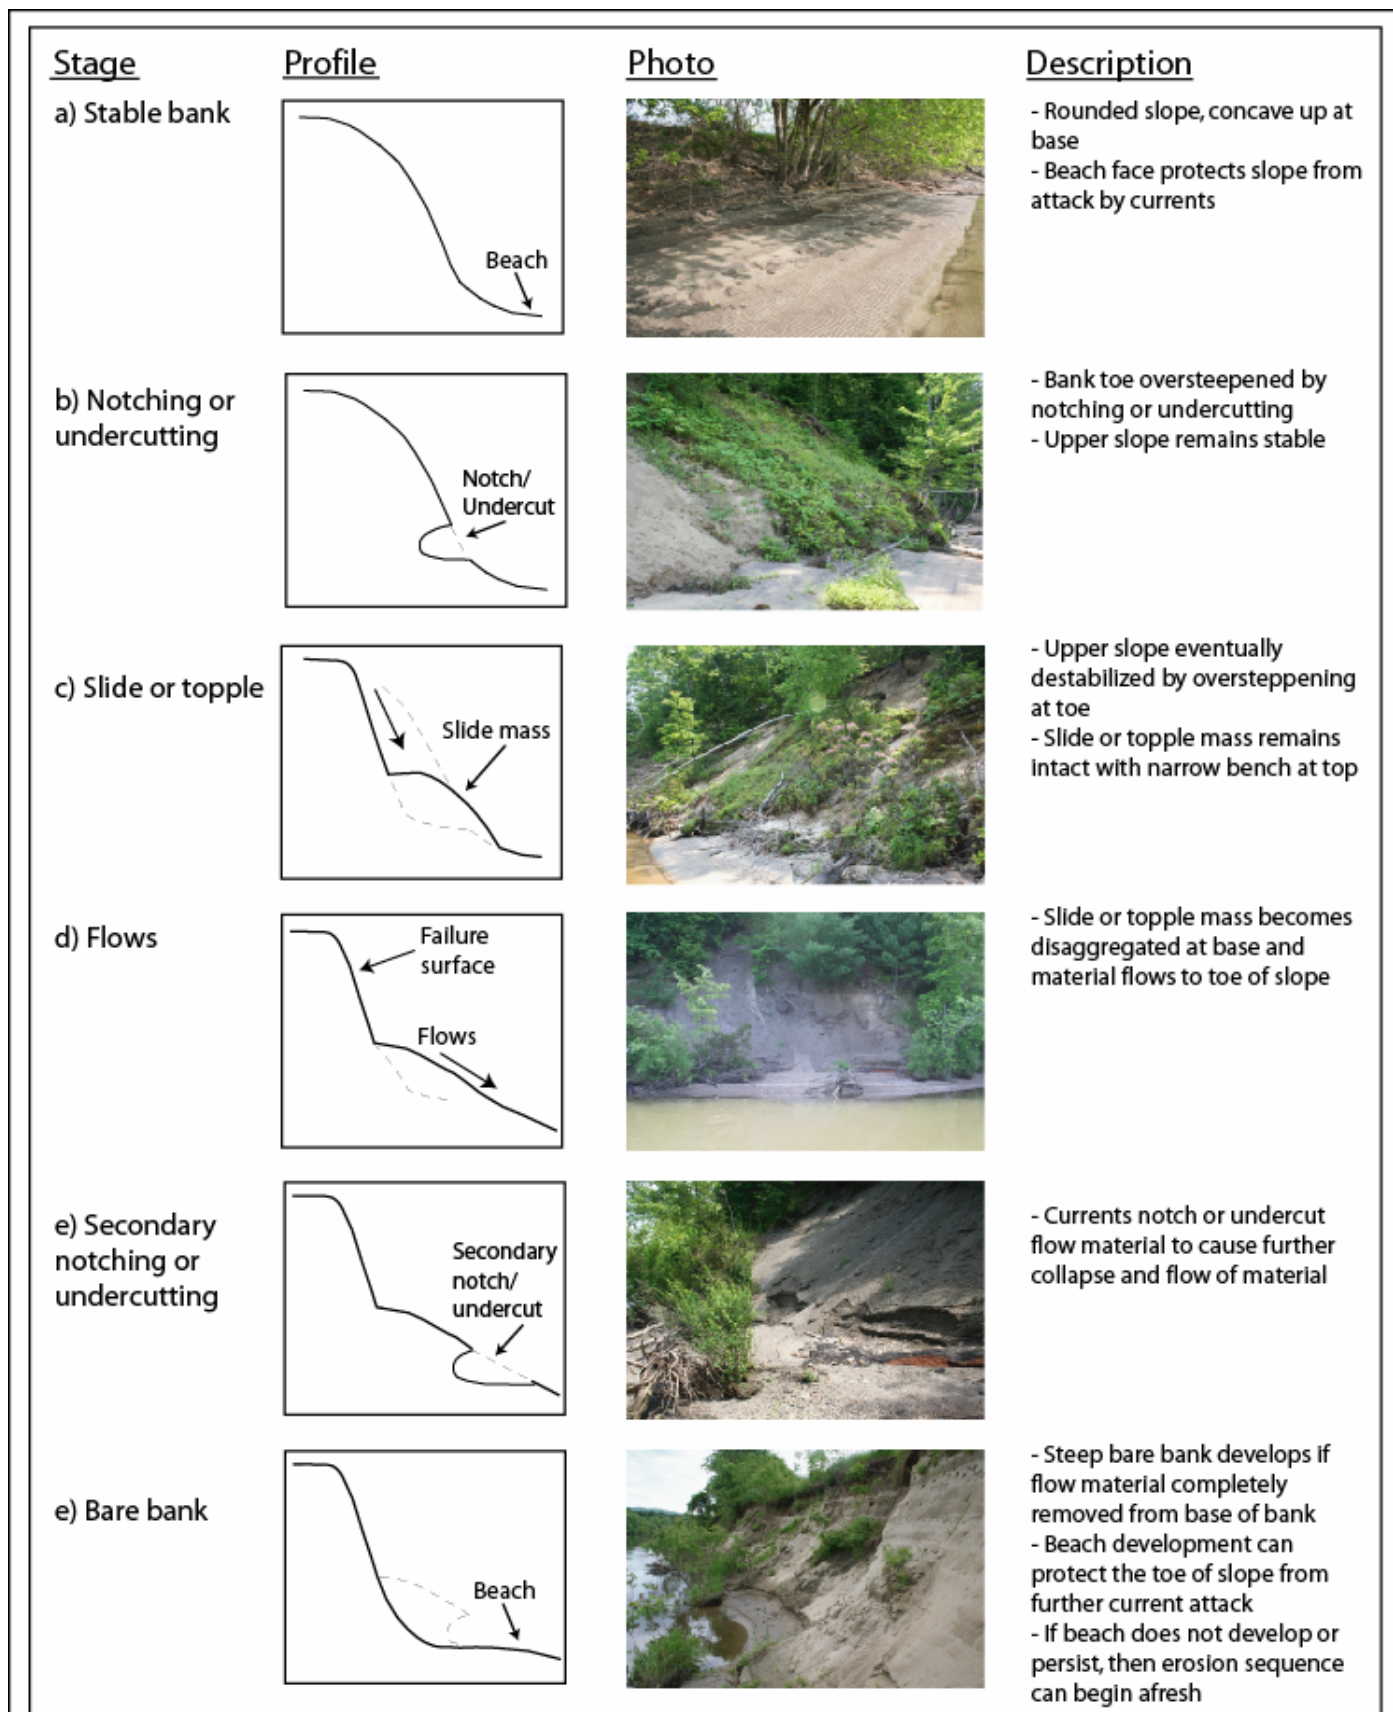
Figure 30: Model illustrating idealized sequence of erosion. Different stages of erosion can be occurring adjacent to each other along a long continuously eroding bank.

Another fatal flaw in these tables is the use of the category “mass wasting” to characterize the extent of erosion. First, mass wasting describes the movement of material downslope under the influence of gravity. The term lumps three types of erosion - flow, slide and fall - and the term doesn’t describe what erosional stage is responsible for the mass movement of the bank material. Mass wasting is a generic term to describe a typically catastrophic event like a landslide or mudslide. It is a term that should be more accurately used (if at all) as a grouping of erosion types. To characterize the spatial extent of erosion, we should be gathering data on the linear and vertical extent of the specific types of erosion as identified by Field (2007), which can be quantified, rather than combining types of erosion into one category and using qualitative terms like “little/none”, “some” or “extensive” to describe the erosion. These qualitative terms are not valid due to their extreme subjectivity and should not be used at all in the relicensing studies to describe the erosion in the Turners Falls Pool. According to Field (2007), four of the erosion types described by Lawson (1985) are widely observed in the Turners Falls Pool: falls, topples, slides, and flows (Field (2007) Tables 1 and 2), which are attached to this letter. Dr. Field noted that these four erosion types rarely occur in isolation, but rather work in concert to remove bank material from the upper and lower slope. According to Dr. Field, visual observations of bank conditions at various places in the Turners Falls Pool permit the development of an idealized model that describes a sequence of events occurring through time at a single point (Field, Figure 30), which is attached.

On page 3-8, it is stated that the 2008 and 2013 FRR methodologies include the six stages of erosion identified by Field (2007). We assert that this is a misrepresentation of what Dr. Field identified in his report. He provides definitions for each stage of erosion, along with a picture of a representative site in the Turners Falls Pool and a profile drawing. What is presented in the 2013 FRR methodology (Table 1 on page 3-8 of the Updated Proposed Study Plan) is not comparable to Field’s Figure 30. Further, these are stages of erosion as identified by Field (2007) not types of erosion as identified in the 2013 FRR methodology. The 2013 methodology does not identify the stages of erosion. In Appendix C of the proposed QAPP for the 2013 FRR, the types of erosion listed include: none, notching, overhanging bank, undercut toe, and slide. A representative picture is provided. No citations, descriptions, or line drawings are given for the source of these types of erosion. This list of the types of erosion includes only one of the four types of erosion listed by Field (2007) – slide. In fact, it appears that the 2013 FRR methodology has confused the type of erosion with the stage of erosion or perhaps lumped the two categories and picked only a few categories to include as representative of the conditions in the Turners Falls Pool.

Field's Figure 30 presents 6 stages of erosion as presented above. These 6 combinations of riverbanks provide useful information on possible combinations of riverbank features and characteristics. The matrix of riverbank features and characteristics utilized in the 2008 FRR and proposed for the 2013 FRR provide a comprehensive set of key features and characteristics, including those outlined by Field, 2007. The use of the matrix allows for a detailed and comprehensive approach in classifying riverbanks and allows development of a detailed and comprehensive understanding of riverbanks. Each of the stages described in Field's Figure 30 is included in the matrix as shown in Table 1. Inclusion of the six descriptions of riverbanks developed by Field and the numerous other possible sets of riverbank features and characteristics in the matrix provides a comprehensive set of riverbank features and characteristics that both describe the riverbank conditions as observed in the field, as well as the stages of erosion as described by Field.

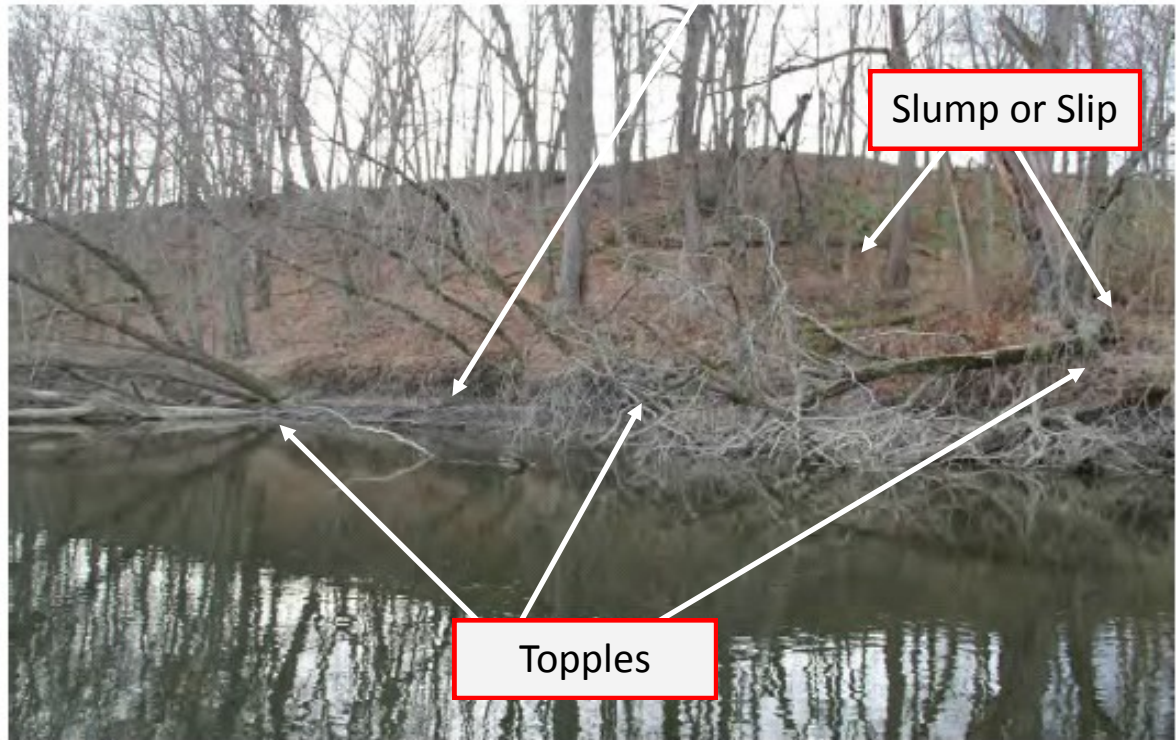
Little/None

Stage of Erosion: b and c
Erosion Type: Falls (undercuts, gullies), Topples, Slides (slump, slip)

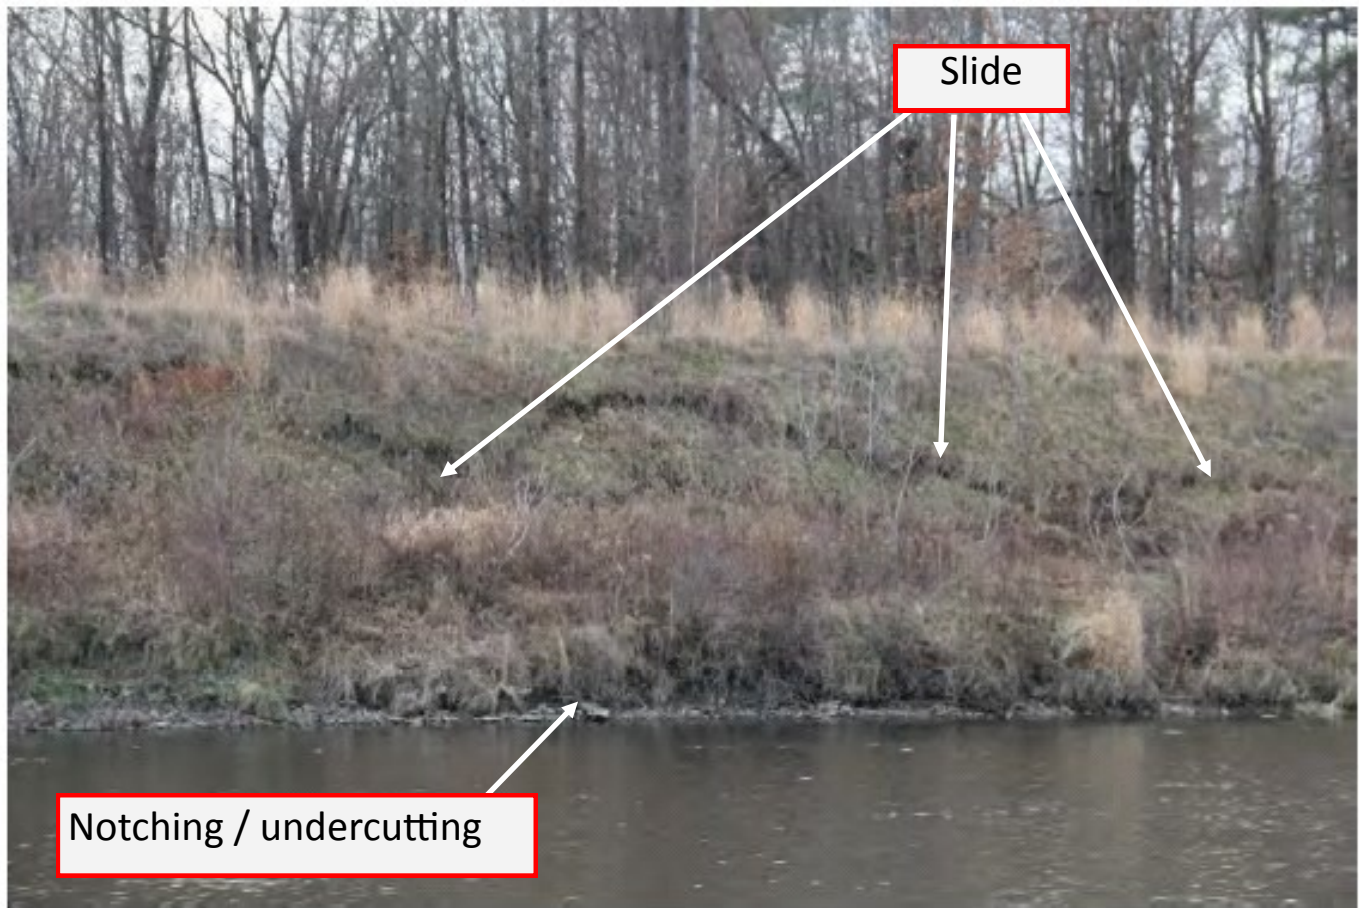
Little/None

Stage of Erosion: b and c
Erosion Type: Falls (notching, undercutting)
Slides (planar slip)

Slide mass remains intact with narrow bench at top

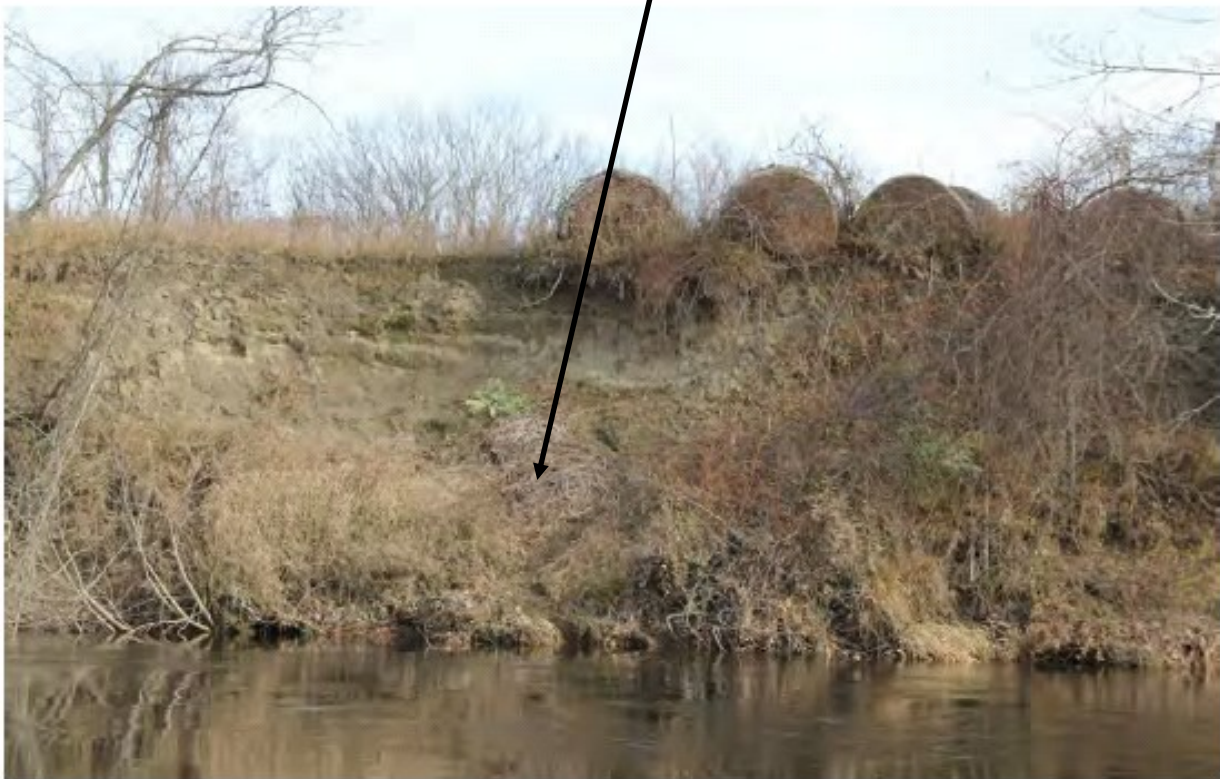
Some

Stage of Erosion: b and c — Slide mass remains intact with narrow bench at top
Erosion Type: Slide

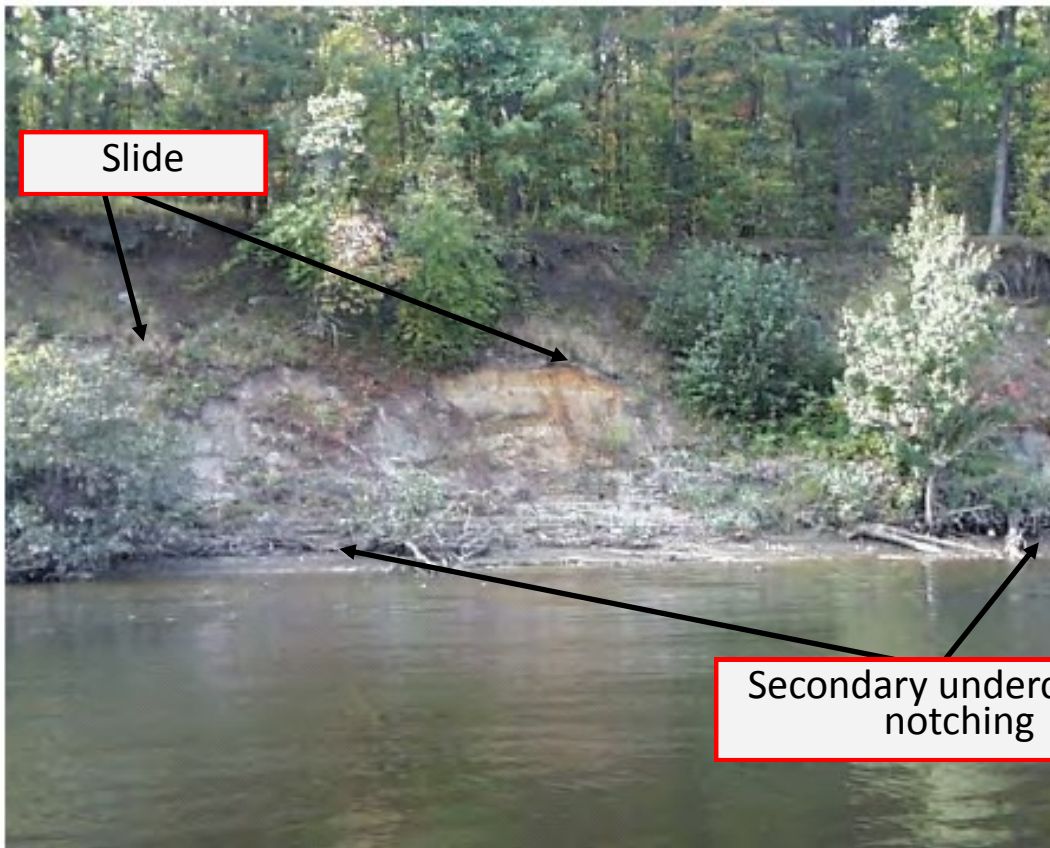
Extensive

Stage of Erosion: b and e

Erosion Type: Slide (planar slip), Falls (undercuts)

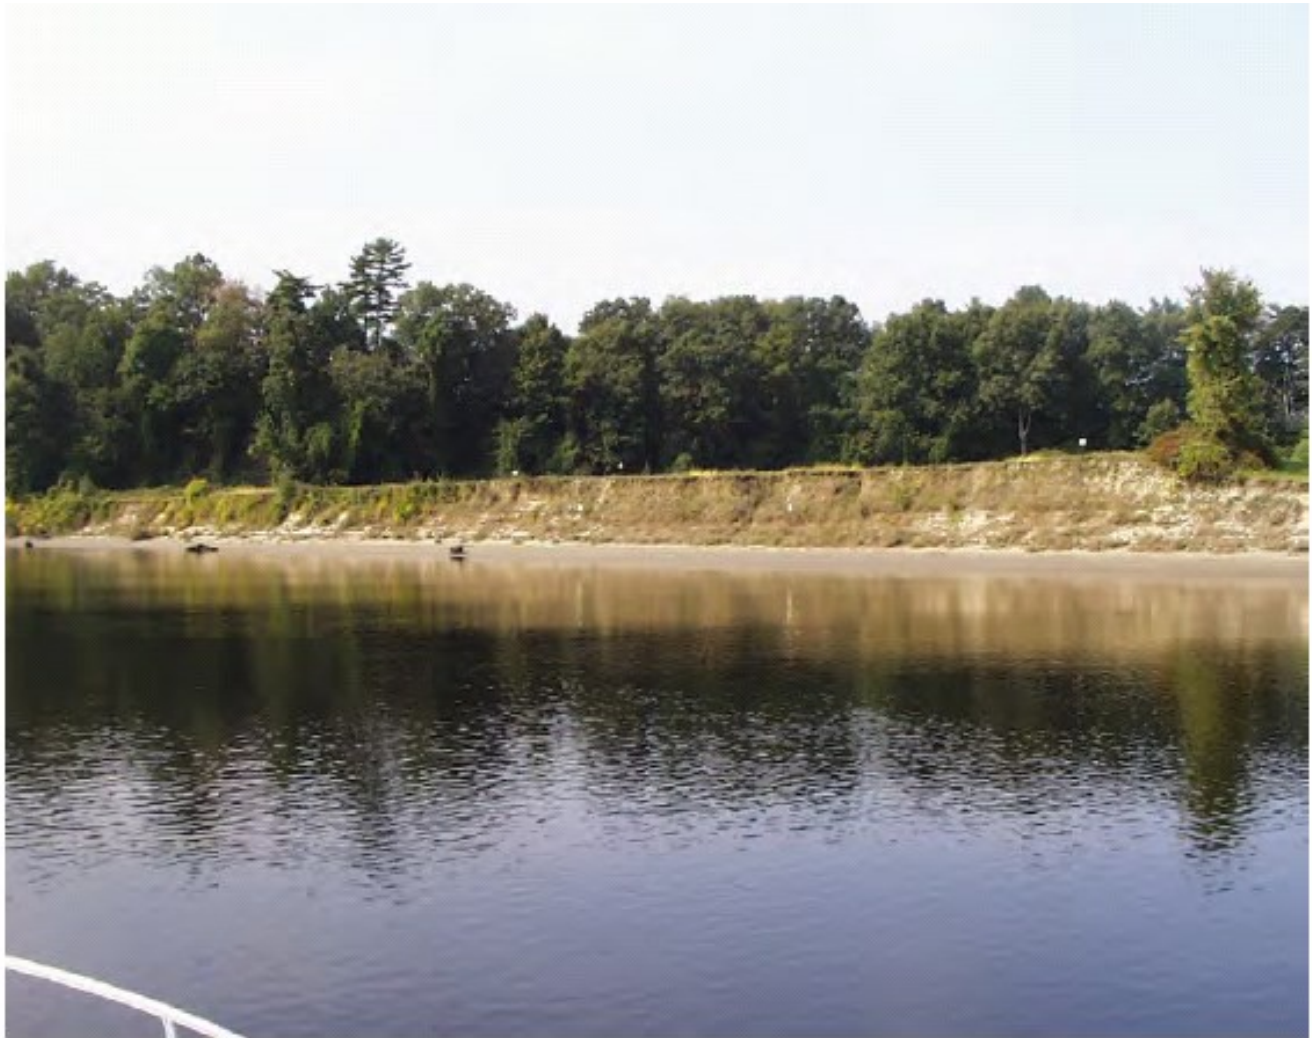
Extensive

Stage of Erosion: e (End stage)

This is a stabilized site. It is the Flagg property.
