Re: Northfield Project No. 2485 and Turners Falls Project No. 1889
Report on Uses and Occupancies of Project Lands

The attached 2013 Mitigation Implementation Report describes the completion status of each mitigation measure in the approved Order that has an identified completion date as well as the implementation status of the proposed buffer and website page.

2013 Mitigation Implementation Report

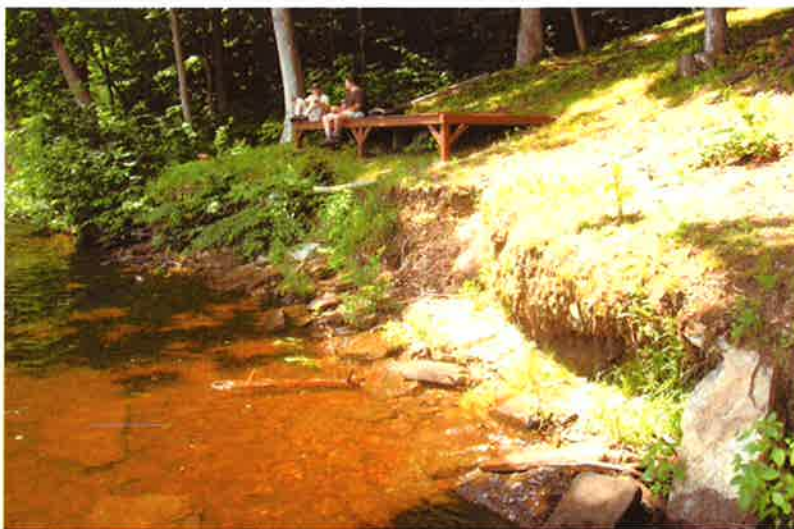
In 2010 the shoreline erosion at Camp 2W consisted of +/- four feet of vertical eroded edge.

Shoreline Mitigation Example

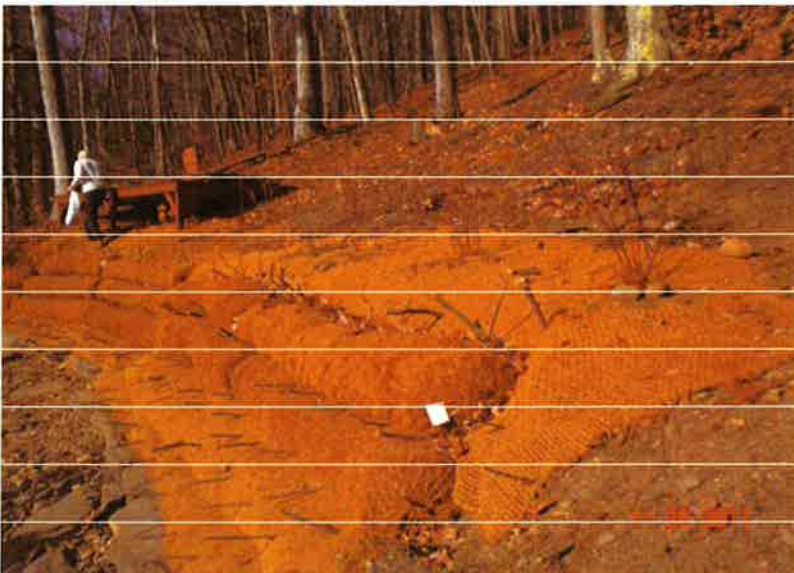
In November 2011 custom built Geolifts were created at the base of the repair, coir logs were layered on top and woody plants and New England Conservation Wildlife Seed Mix were planted.

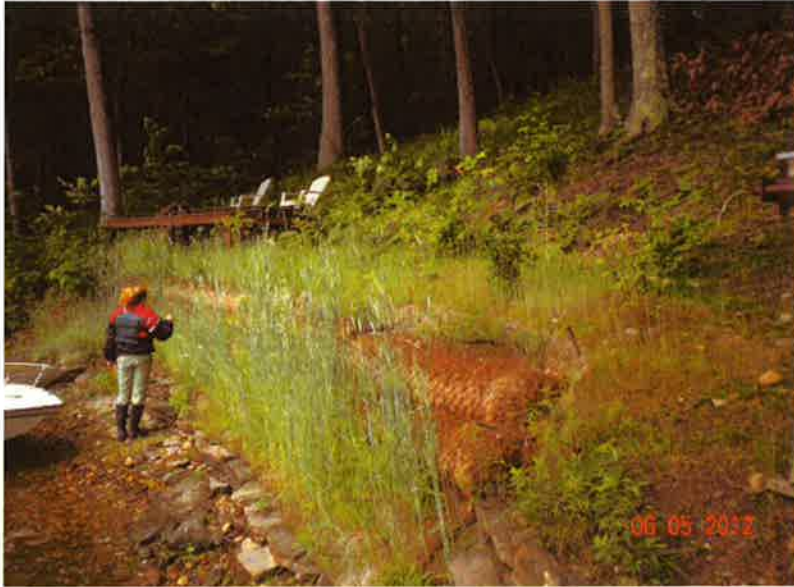
Photos from the 2012 field season show healthy perennials at the top of the mitigation area and wildlife conservation mix growing vigorously from the geolifts.

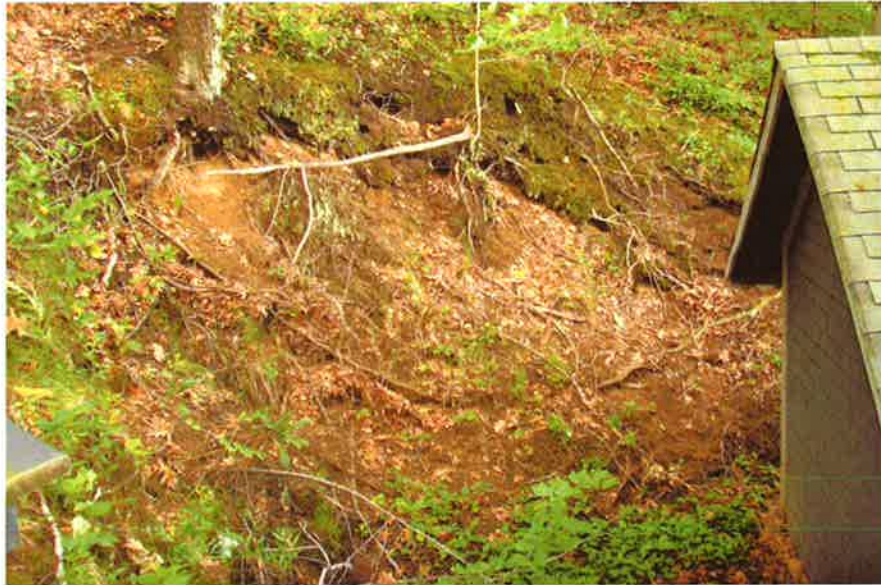
In 2010 Camp 3E had the highest bank erosion around structures of all the camps. The site also had particularly steep slopes shaded by structures.

- **2010 Recommendation:** The erosion around the parking area, main house, and guest house, should be stabilized by re-vegetating. The erosion up-gradient of wooden retaining wall should be filled and stabilized. Continue monitoring the riverbank and wooden retaining wall down slope of the parking area.
- **2011-2013 Field Observations:** Erosion control repairs around parking area, main and guest houses were completed in December 2012. The wooden retaining wall did not appear strong enough to hold recommended fill.
- **2013 Recommendation and completion date:** Currently conducting engineering analysis of multiple site repair options, all of which require additional environmental permitting, project bidding, implementation, and evaluation phases. As a result, the projected completion date is **December 31, 2014**.

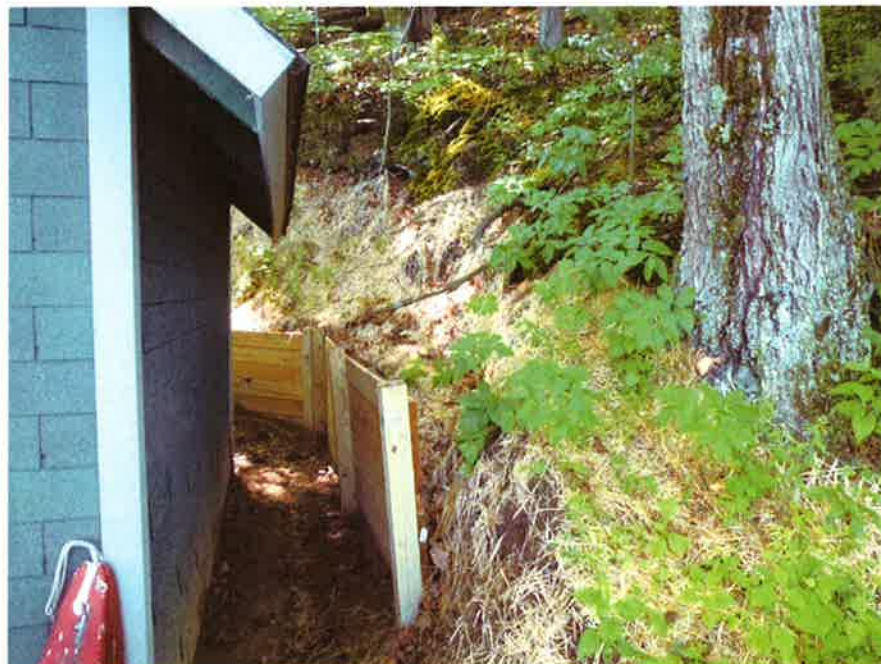
Installation of a 3.75' wooden wall was topped with erosion control mat. The wall decreases the slope on which plant material will grow and covers highly shaded areas.

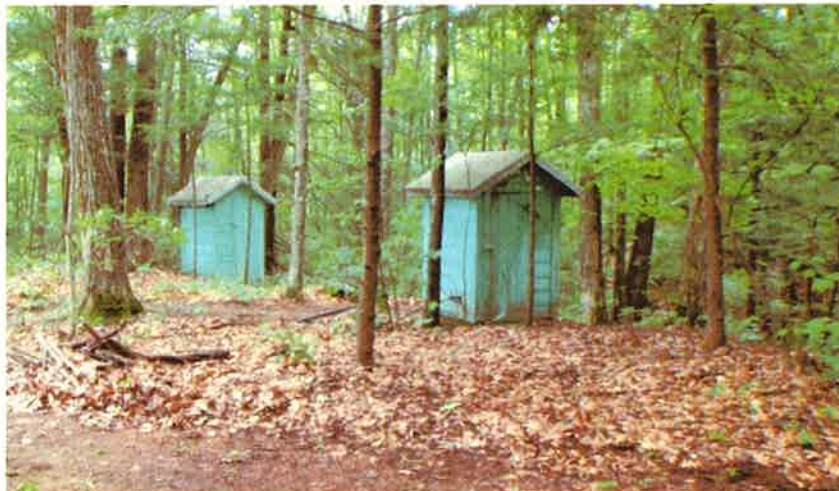
Camp 14E - two outbuildings, no longer in use, targeted for removal in 2010 report.

One unused structure each was removed from sites 7E, 16E, and 17E, two structures were removed around camps 15E, and 8W, and three were removed from camp 14E for a total reduction of ten outbuildings. An unused dock was also removed from Camp 10W and, while most sites have less personal property visible along the river, one striking example of personal property reduction at the shoreline, Camp 6E, is shown below.

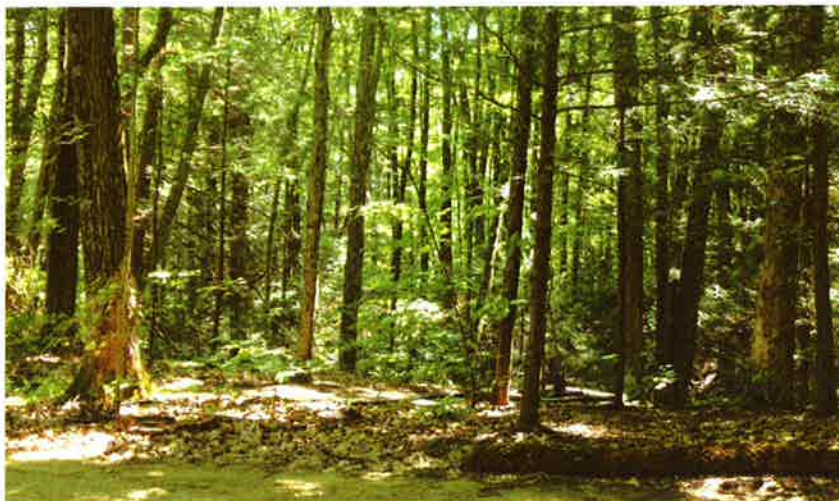
Camp 14E -- same location in 2013.

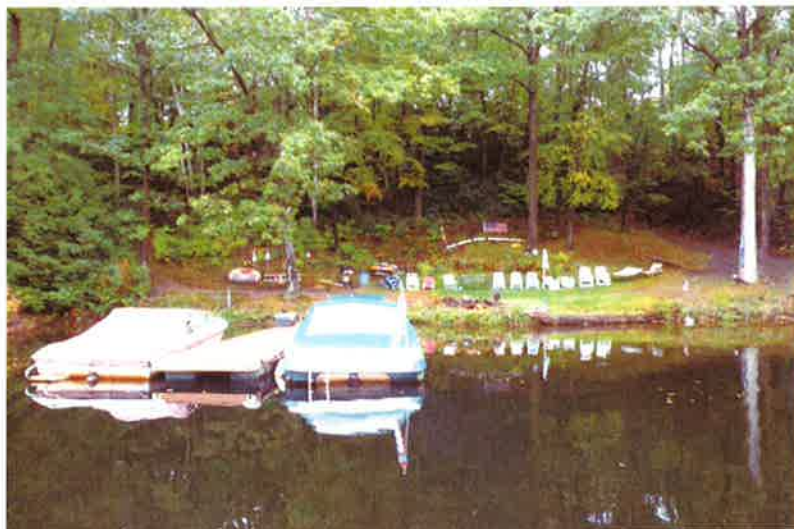
In 2010 Camp 6 E – multiple chairs, water-ski floats, table, etc. routinely left on site.

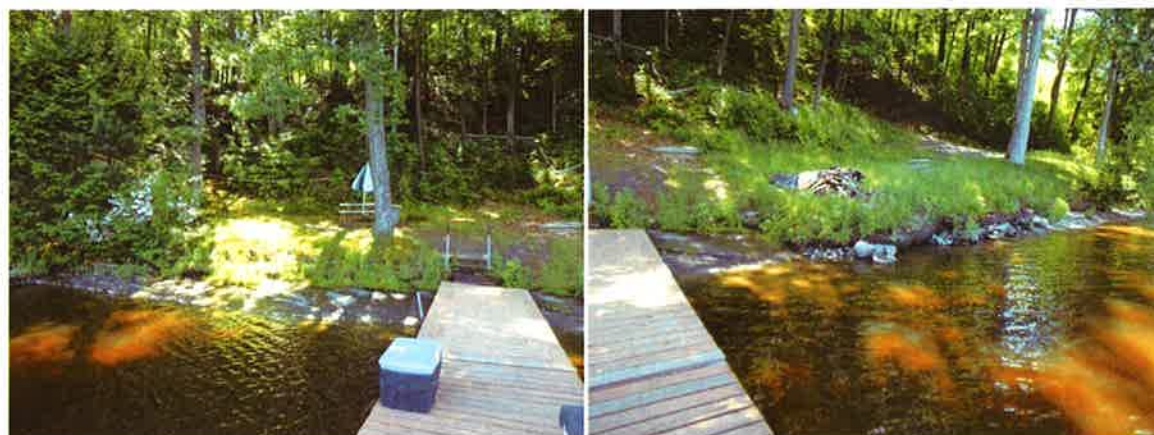
In 2013 only one picnic table, a bench and scrap wood/cloth for burning during the next camp fire is visible

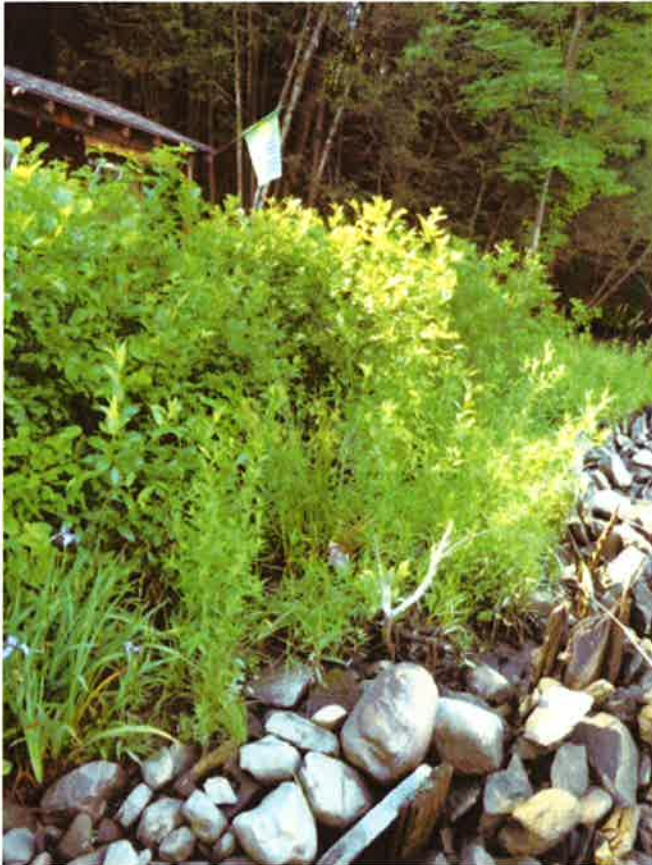
Vegetation at Camp 7E is approximately 4 feet tall in 10' diameter no-mow buffer zone.

This is the second field season that camp owners are modifying mowing practices to leave a ten foot no-mow buffer zone at the edge of the river. There was broad acceptance of the new requirement in 2012 and those that had difficulty understanding the policy in the first field season were observed to be compliant during 2013 site visits. Monitoring and education will continue annually on this requirement to ensure camp owners adhere to standard.
