Relicensing Study 3.6.2

RECREATION FACILITIES INVENTORY AND ASSESSMENT

**Northfield Mountain Pumped Storage Project (No. 2485)
and Turners Falls Hydroelectric Project (No. 1889)**

Initial Study Report Summary

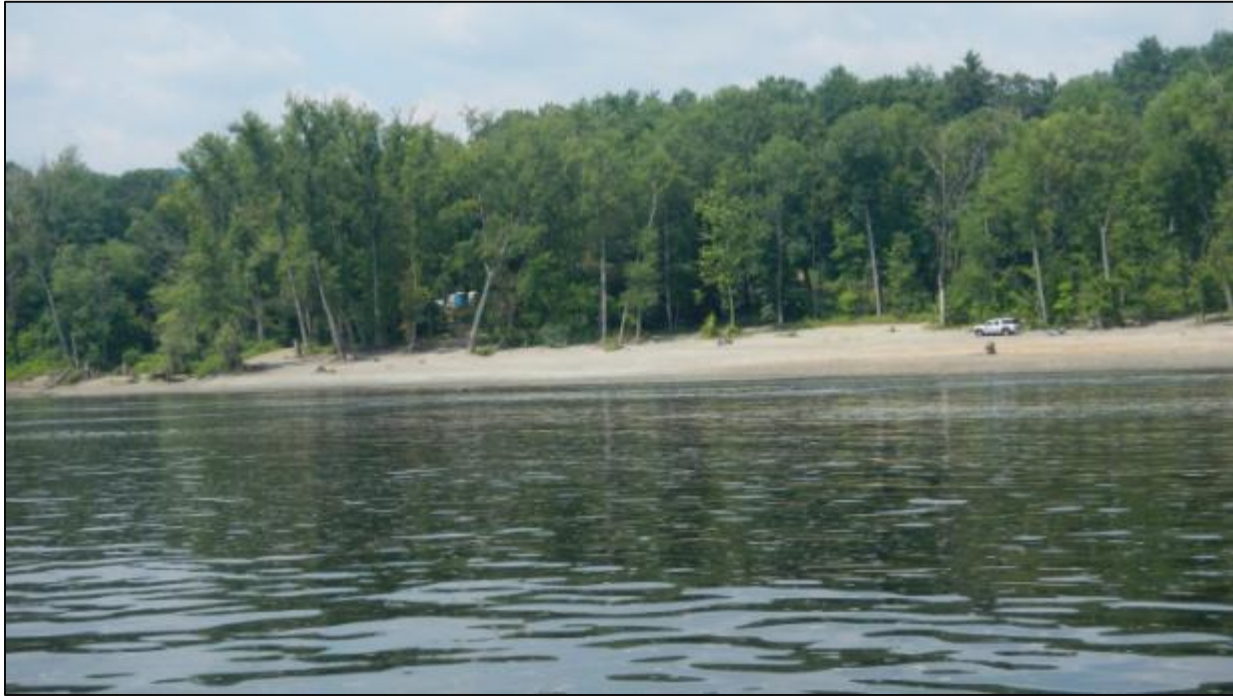
Figure 3. Governor Hunt Boat Launch/Picnic Area

The site appears to see moderate use as evidenced by observed rod rests and a minor amount of litter. No recreation use related compaction or erosion was noted during the site visit. Overall the site is currently functioning as intended. The boat launch condition was rated as a Category 2 during the site visit. The remaining facilities are located outside of the Turners Falls and Northfield Mountain Project boundaries and were not rated.

View of Site from Water: Boat Launch is to the right, picnic area (outside of Project) above on left.

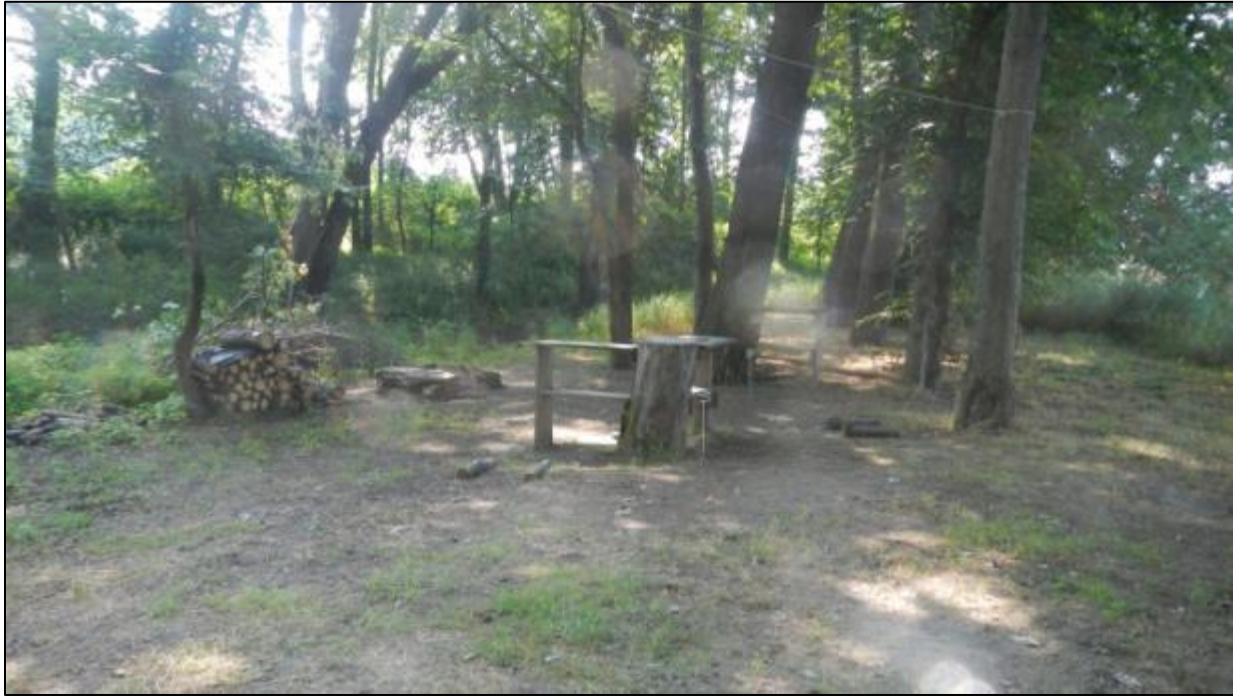
Figure 4. Ashuelot River Informal Campsite

This site was not rated because it is an informal recreation area, located on private property.

Informal Campsite

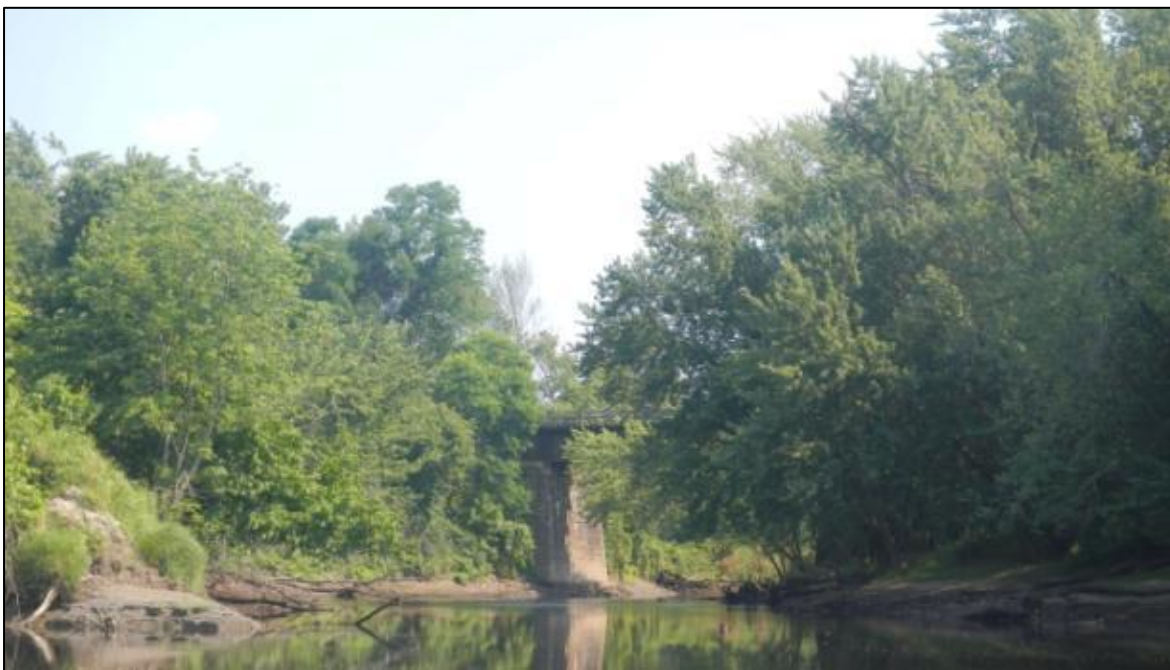
Figure 5. Fort Hill Rail Trail

The Route 63 parking lot and trail are functional for public use. The portion of the trail that lies within the Project boundary was observed to be in good condition and was rated at a Category 4. The trail appears to be receiving some unauthorized use by motorized vehicle use, possibly all-terrain vehicles (ATVs), in the vicinity of the Project boundaries.

Ashuelot River Outlet to the Connecticut River

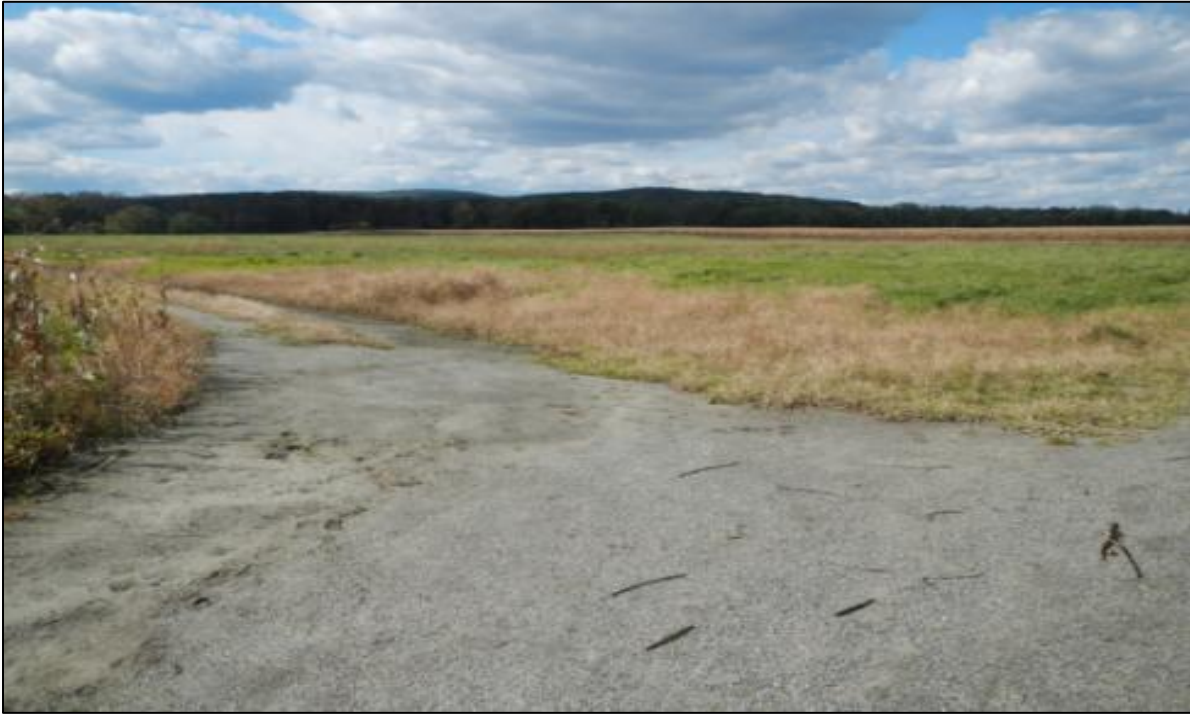
Figure 6. Pauchaug Wildlife Management Area

The site is currently functioning as intended and has no formal facilities or recreation site improvements to rate.

View of WMA

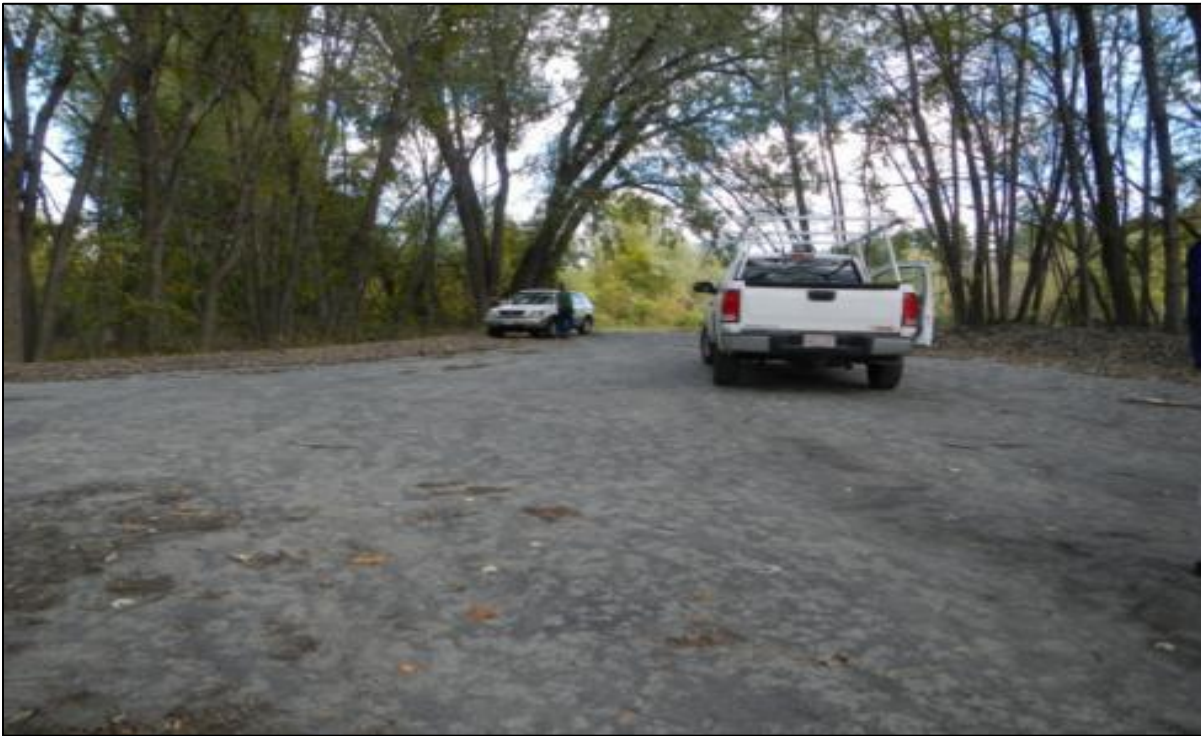
Figure 7. Pauchaug Boat Launch

The boat launch facility at this site is currently functioning as intended. However, during the site visit we were informed that at low Impoundment elevations accumulated silt at the site makes it difficult for large boats to launch. The condition of the boat launch was given a Category rating of 3 due to the need for removal of siltation on the ramp. The parking area was found to be functional and was given a Category rating of 4. While the site may be open in the winter, the portable sanitation is seasonal. There was no recreation related erosion or compaction noted at the time of the site visit.

View looking up launch from the edge of the water

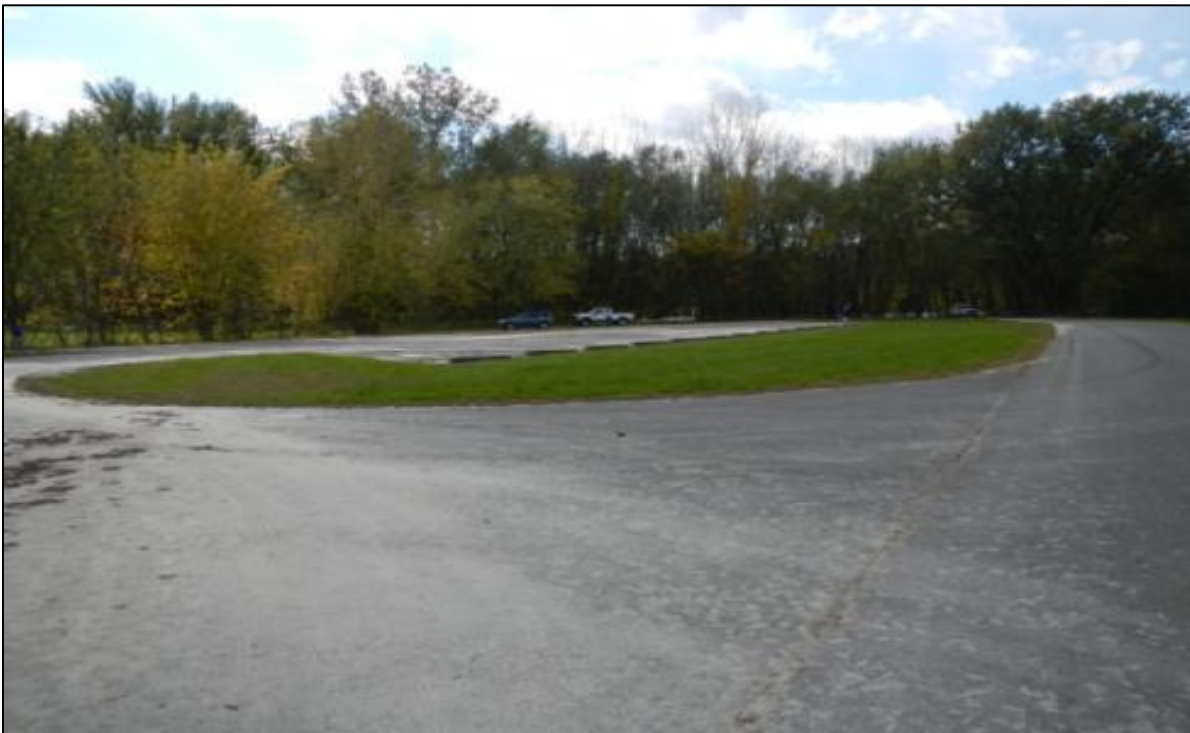
Figure 8. Pauchaug Boat Launch

Facilities at this site include a hard surface boat launch with two launching lanes, parking, informational signage, and portable sanitation. The parking lot is delineated by curbing and can accommodate 32 vehicles with trailers. No ADA signs for parking spaces were observed at this site.

Parking Area

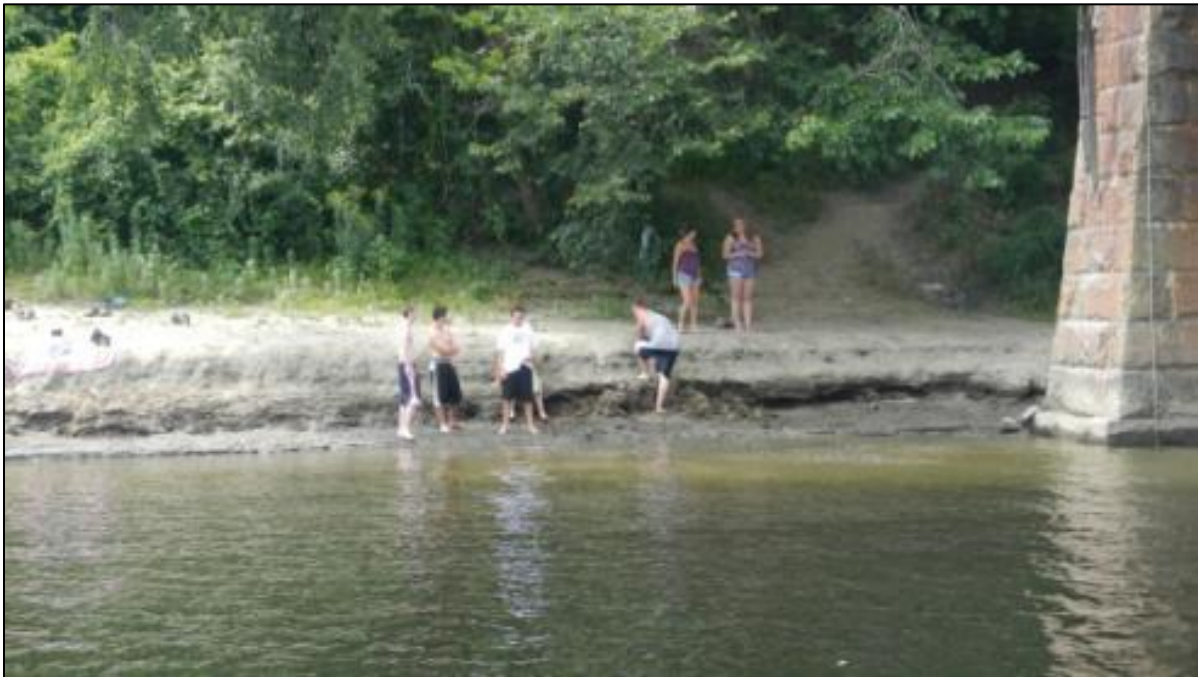
Figure 9. Schell Bridge Informal Site

Compaction and litter were observed during the site visit, but the condition of this site was not rated because it is an informal recreation area, located on private property.

View of Site from Water

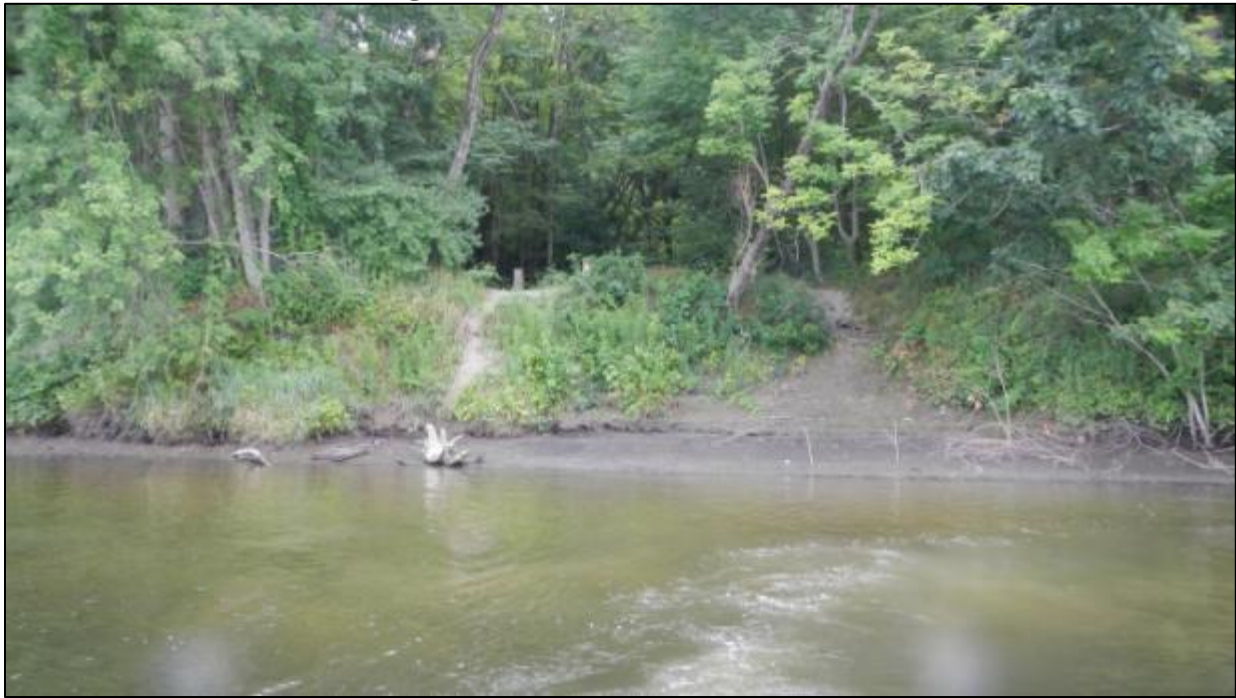
Figure 10. Informal Multi-Use Site

Compaction was observed during the site visit, but the condition of this site was not rated because it is an informal recreation area,.

View of Informal Site from Water.

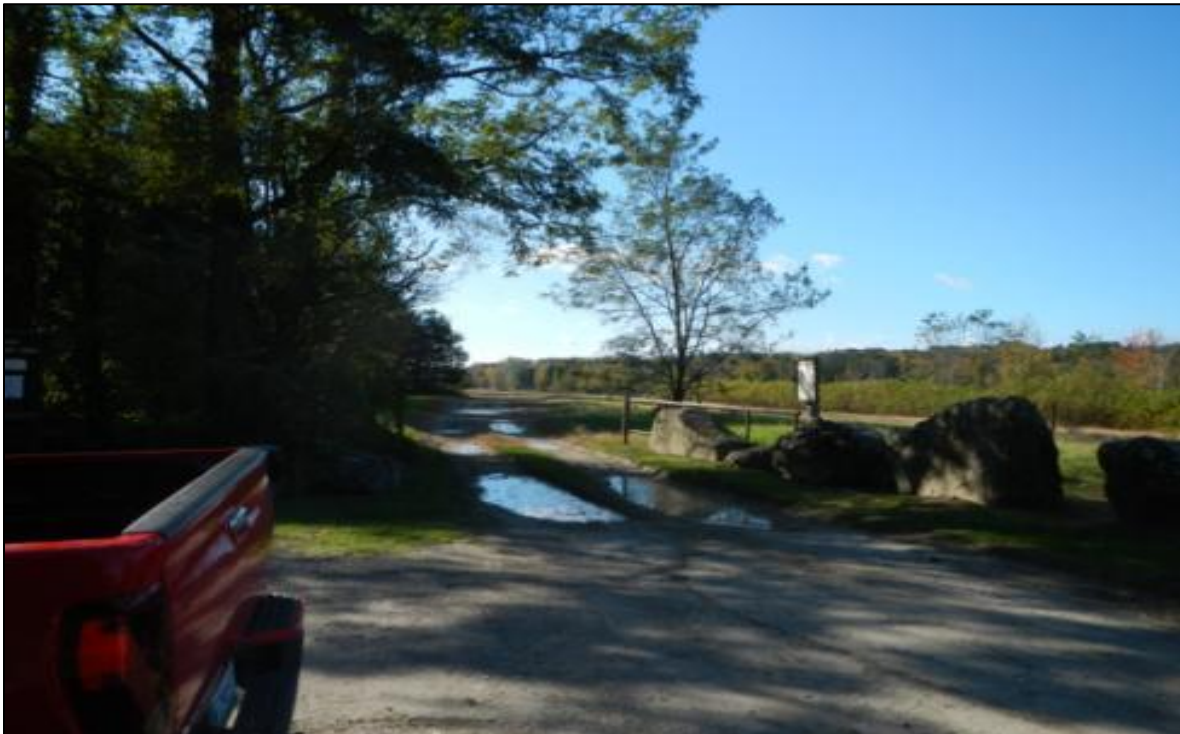
Figure 11. Bennett Meadow Wildlife Management Area

There was no recreation related erosion or compaction noted at the time of the site visit. The site is currently functioning as intended and received a Category rating of 4 at the time of the site visit.

Access Road into the WMA

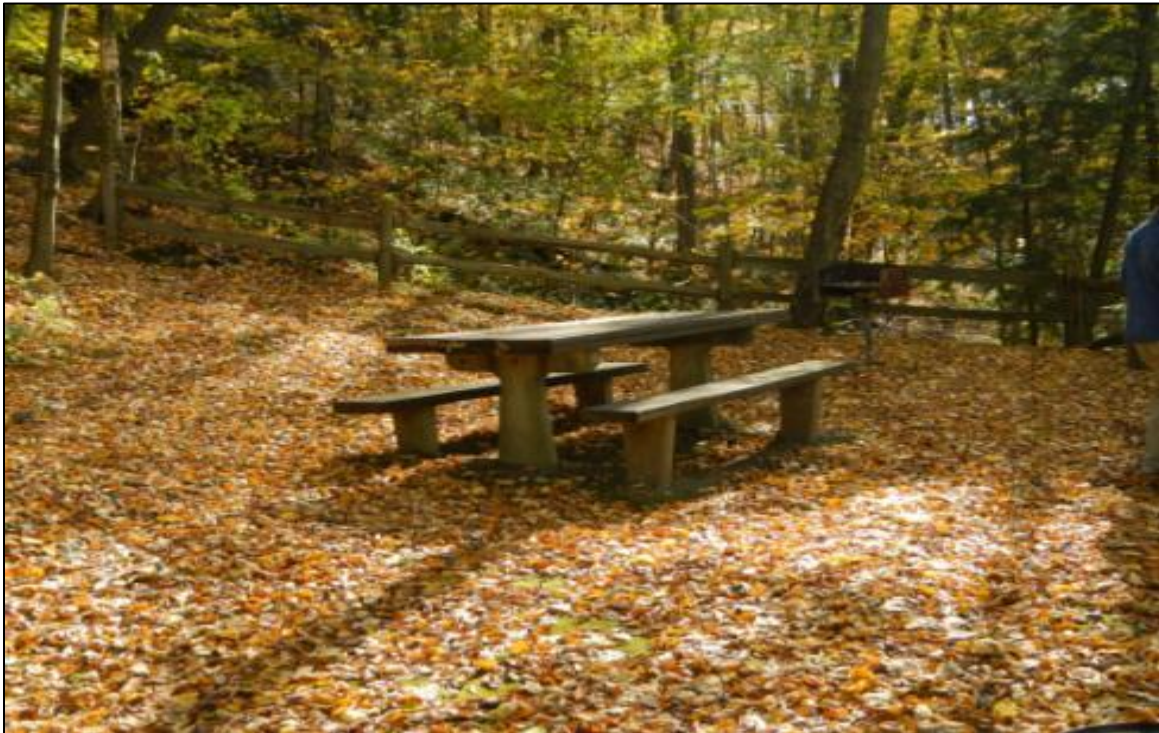
Figure 12. Munn's Ferry Boat Camping Recreation Area

There was a minor amount of recreation related compaction and shore erosion noted while on site. The site and associated amenities are in good condition and functioning as intended. Overall the amenities at the site were rated a Category 4.

Typical Picnic Table and Grill

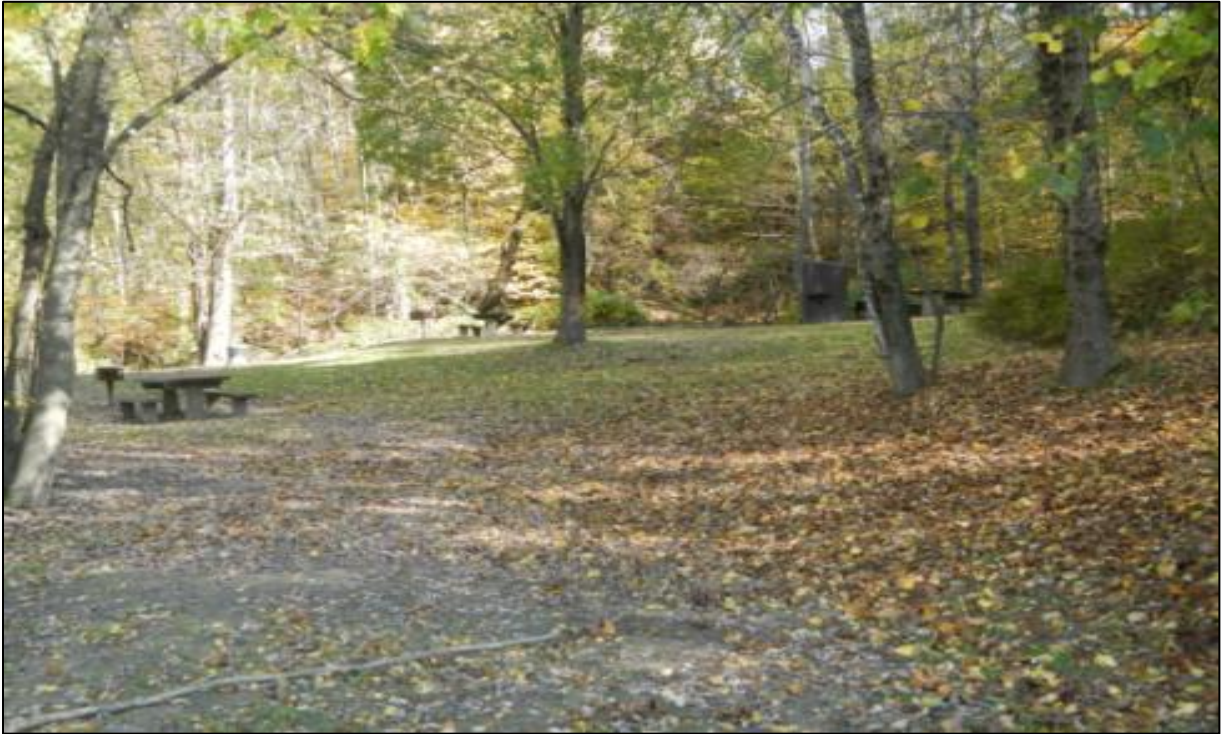
Figure 13. Munn's Ferry Boat Camping Recreation Area

Camping Area

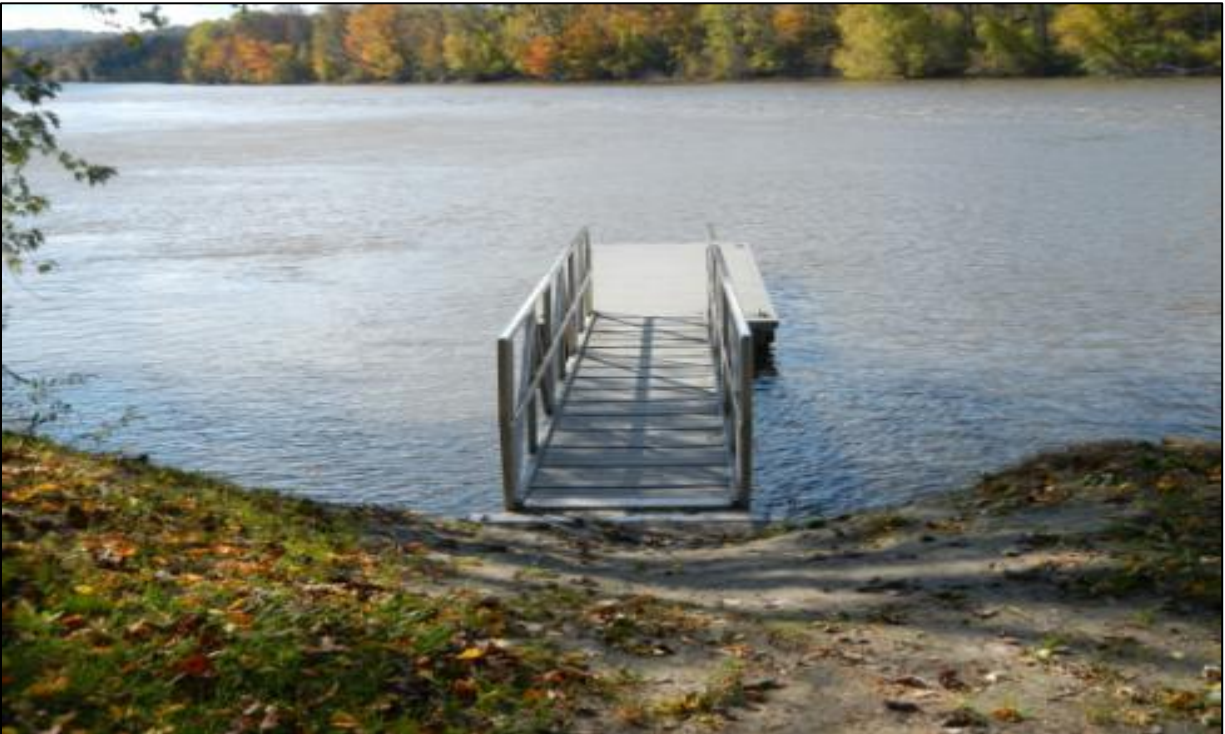
Figure 14. Munn's Ferry Boat Camping Recreation Area

Dock

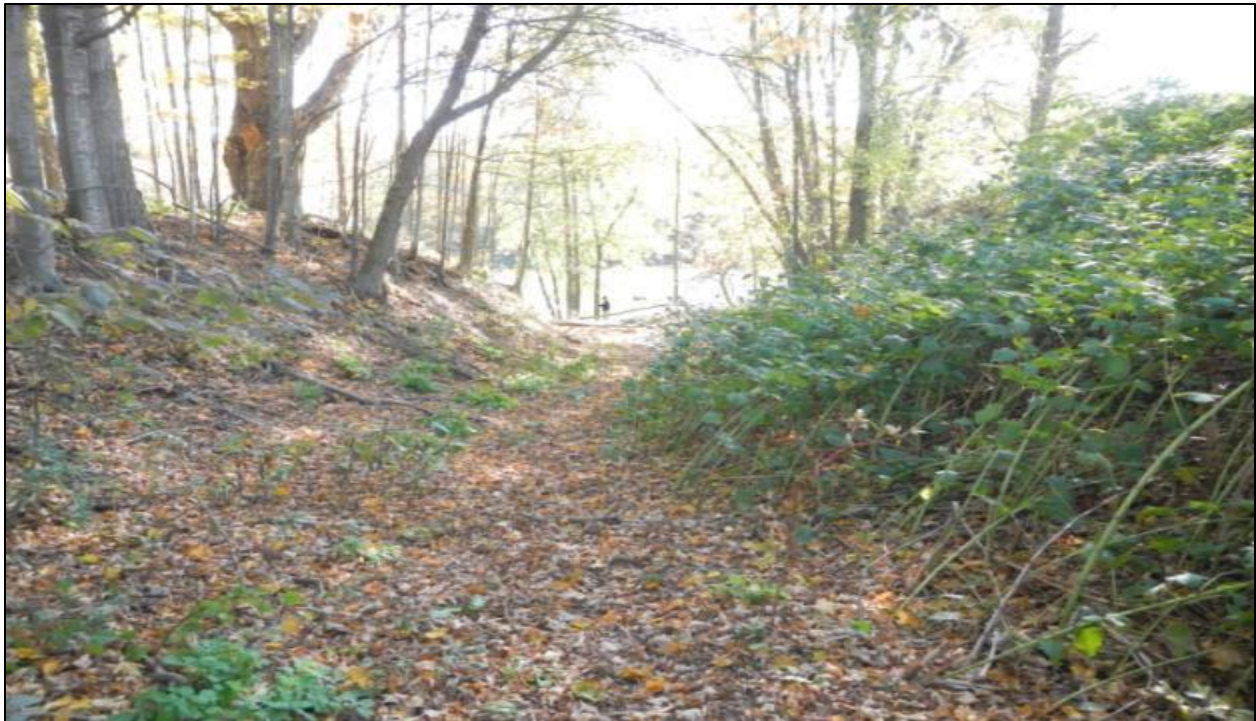
Figure 15. Informal Munn's Ferry Access Site

Signs of use, including minor compaction on a trail to the water and along the shoreline, were observed during the site visit. However, the condition of this site was not rated because it is an informal recreation site on private property.

View of the Access Trail from Parking Area

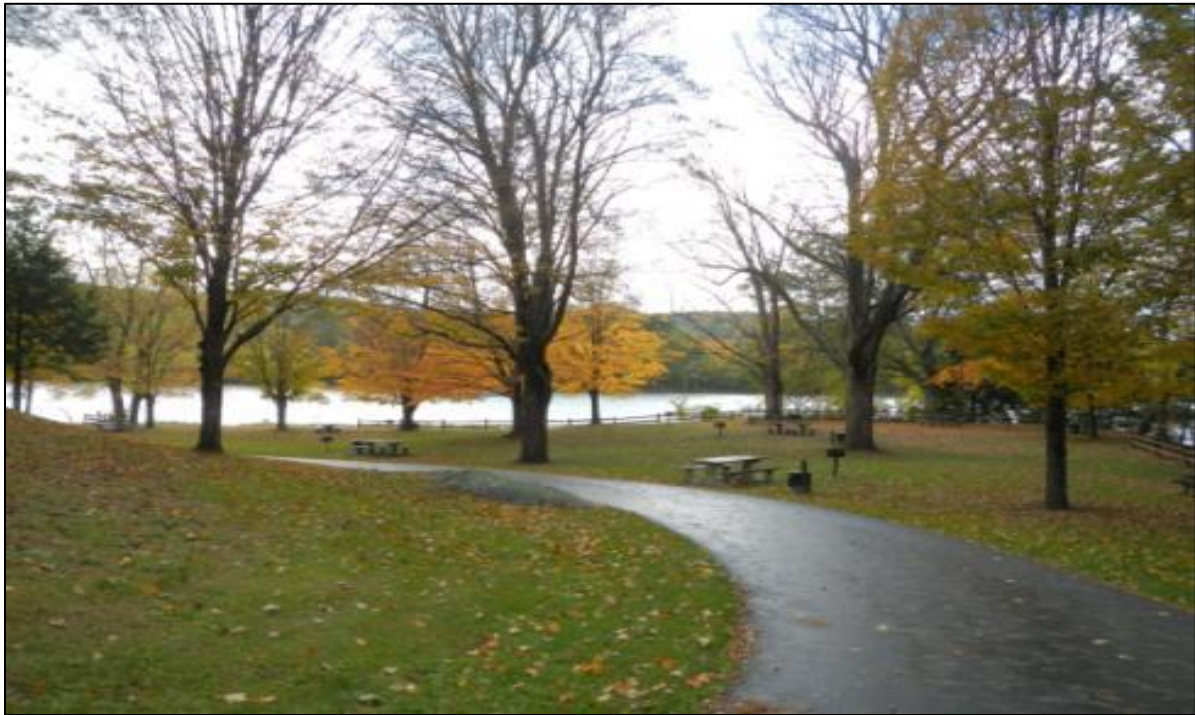
Figure 16. Boat Tour and Riverview Picnic Area

The site was in good overall condition and functioning as intended at the time of the site visit. The amenities at the site received a Category rating of 4. There was a very minor amount of shoreline erosion that may have occurred from recreation users.

Overview of Picnic Area

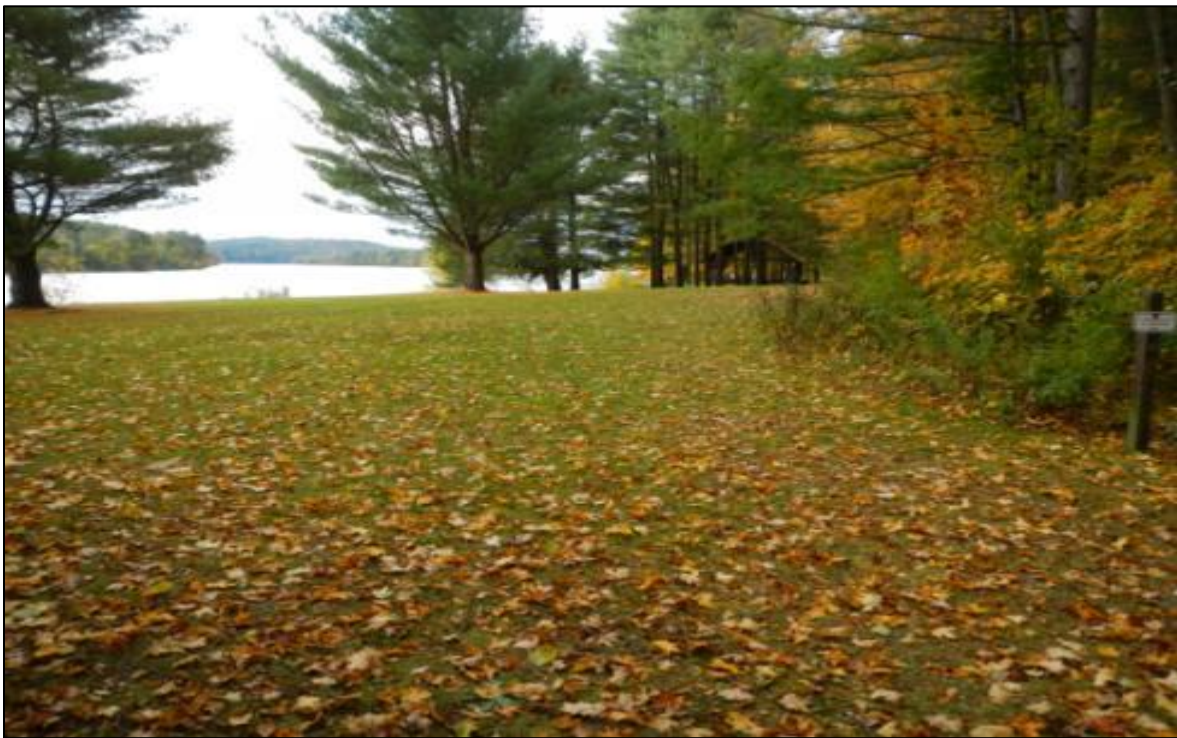
Figure 17. Boat Tour and Riverview Picnic Area

Open Area and Rental Pavilion

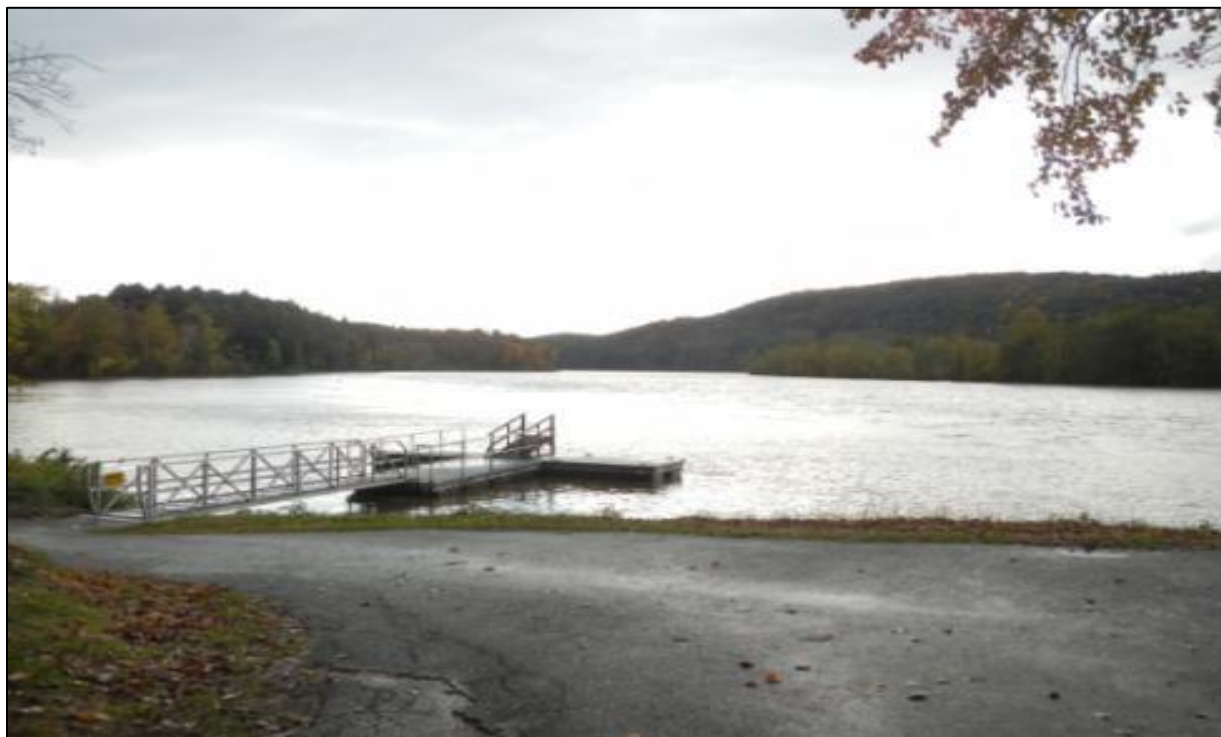
Figure 18. Boat Tour and Riverview Picnic Area

Boat Tour Dock

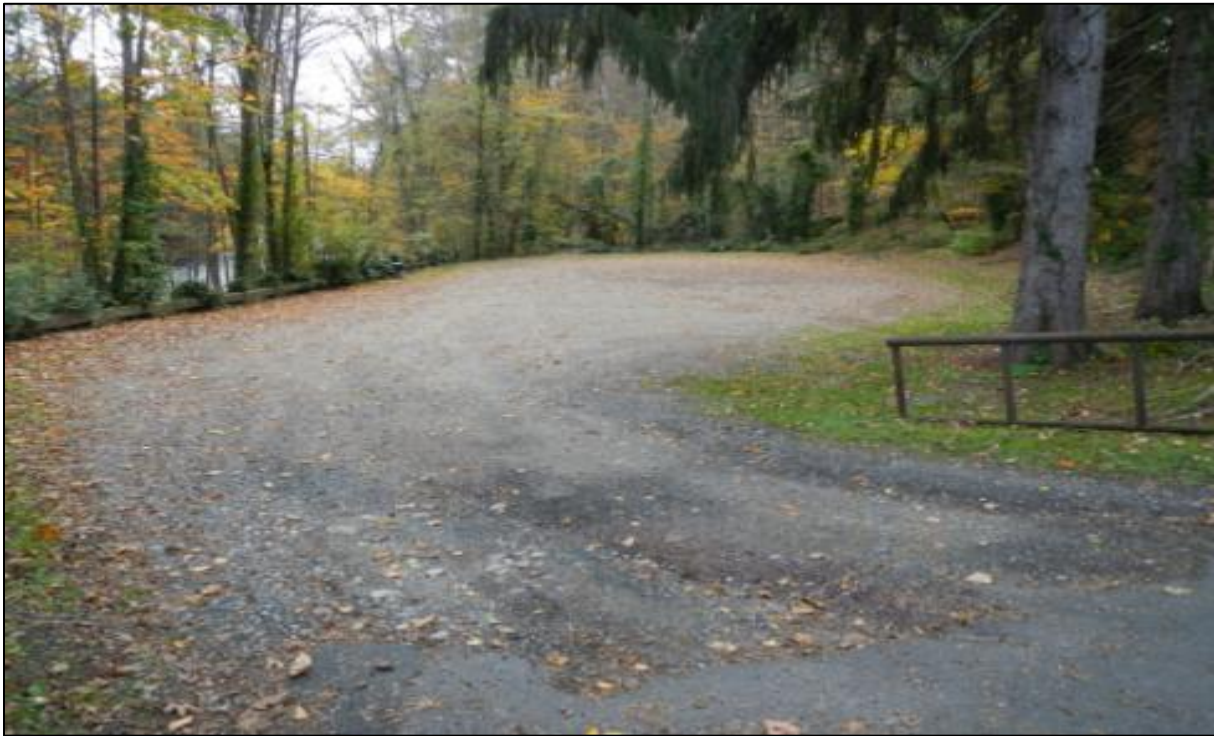
Figure 24. Cabot Camp Access Area

The parking lot was functioning as intended and received a Category rating of 4. There was some minor soil compaction noted along the shoreline during the site visit.

Cabot Camp Parking Area

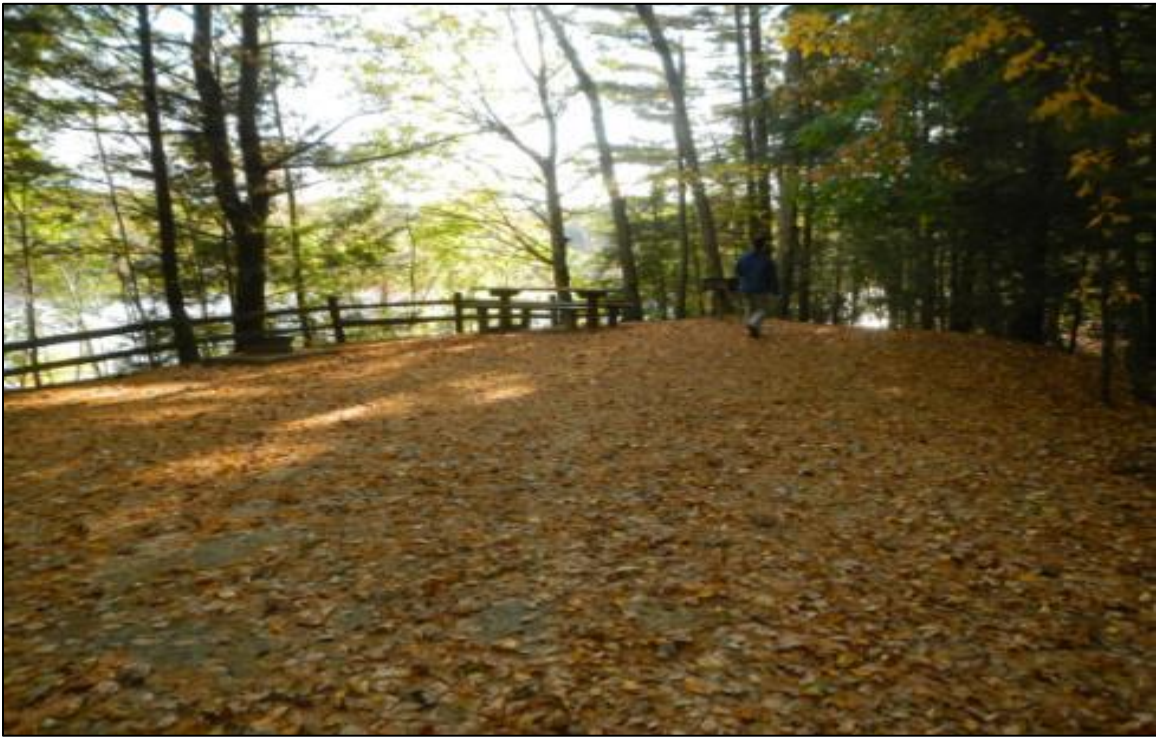
Figure 27. Barton Cove Nature Area and Campground

Overall the campground was functioning as intended and was well maintained. At the time of the site visit the campground facilities were in good repair and functioning as intended. There were some areas of compaction and minor erosion outside of some campsites, where individuals have accessed the water. The facilities for the campground site received a Category rating of 4 during the site visit.

Typical Campsite within the Barton Cove Campground

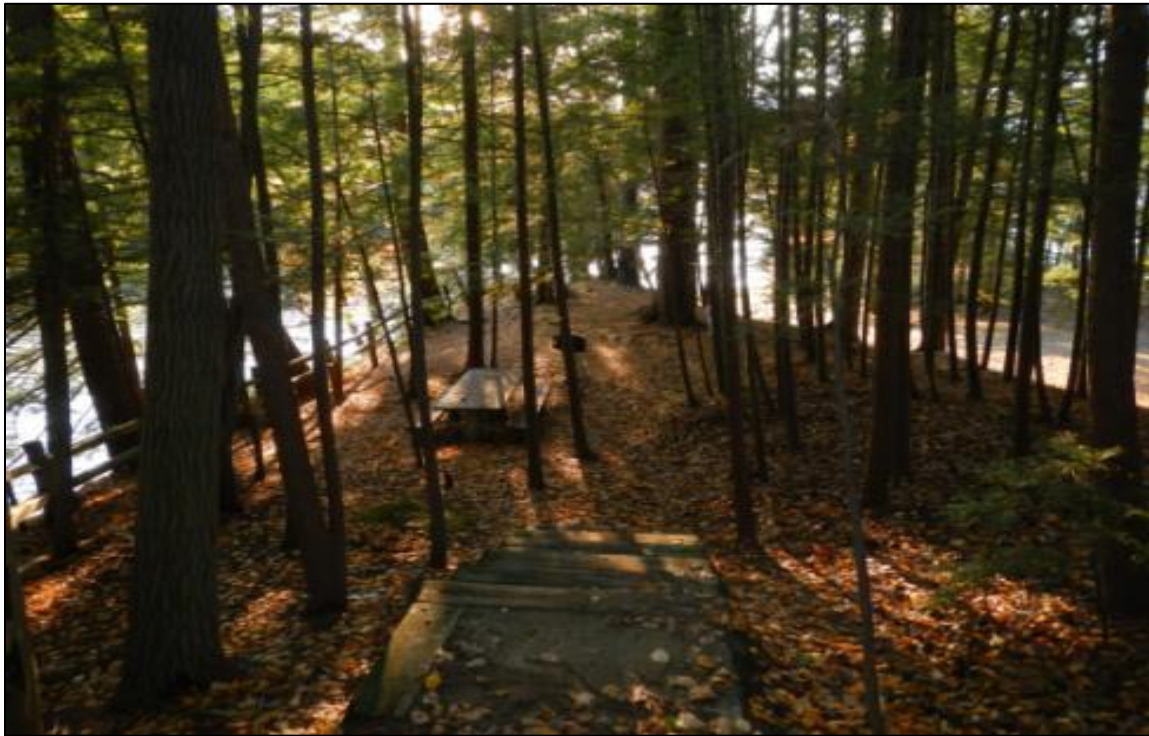
Figure 28. Barton Cove Nature Area and Campground

Overall, the Nature Area facilities were functioning as intended and received a Category rating of 4. There was a minor amount of litter noted during the site visit. Soil compaction was noted in the area of the picnic tables and along well used footpaths. The walkway to the overlook, including some sets of stairs, were currently functioning as intended; however, the condition of some structures were starting to show exposure to the elements and may require future replacement of some boards. Therefore this amenity received a Category rating of 2 at the time of the site visit.

Picnic Area within the Barton Cove Nature Area

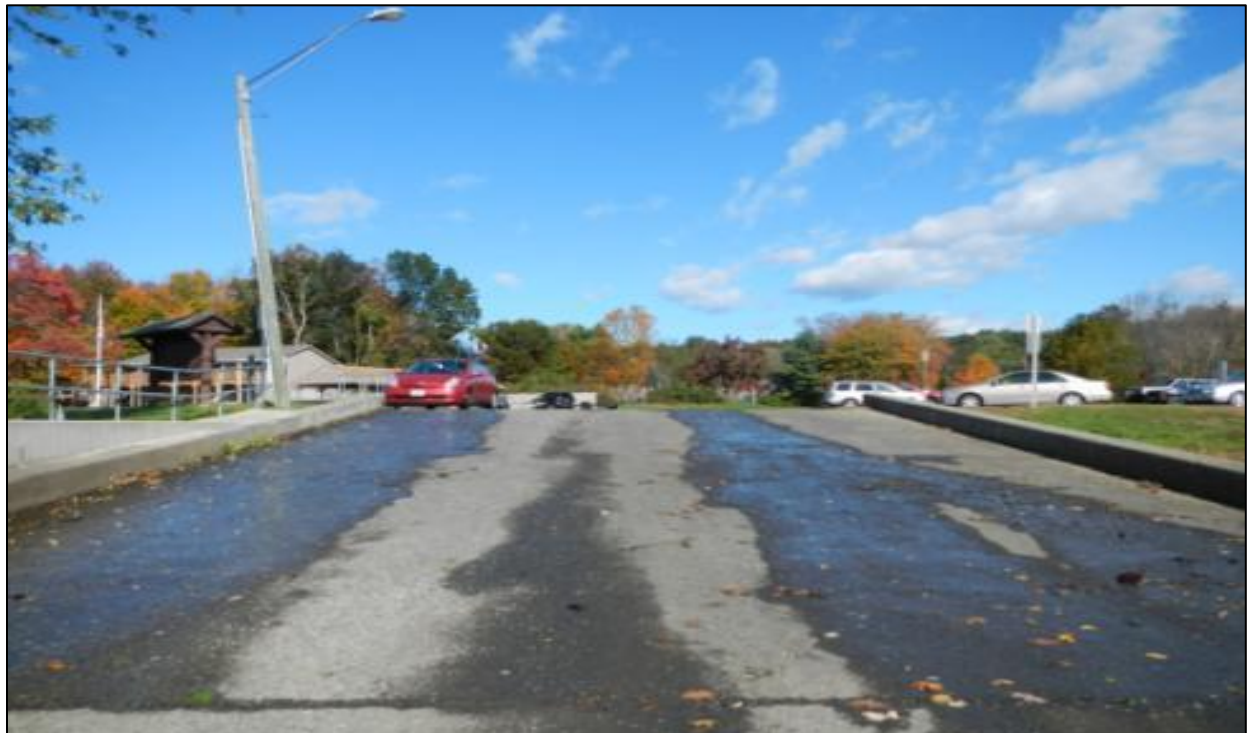
Figure 35. State Boat Launch

The site offers boat launching and bank fishing opportunities. There is a hard surface boat ramp with two launching lanes, a dock, and portable sanitation facility (seasonal) at the site. There is a parking lot, which is delineated to handle 44 vehicles with trailers. There was a single ADA parking space for a vehicle and trailer, along with a single vehicle ADA parking space noted during the site visit.

Launch Ramp

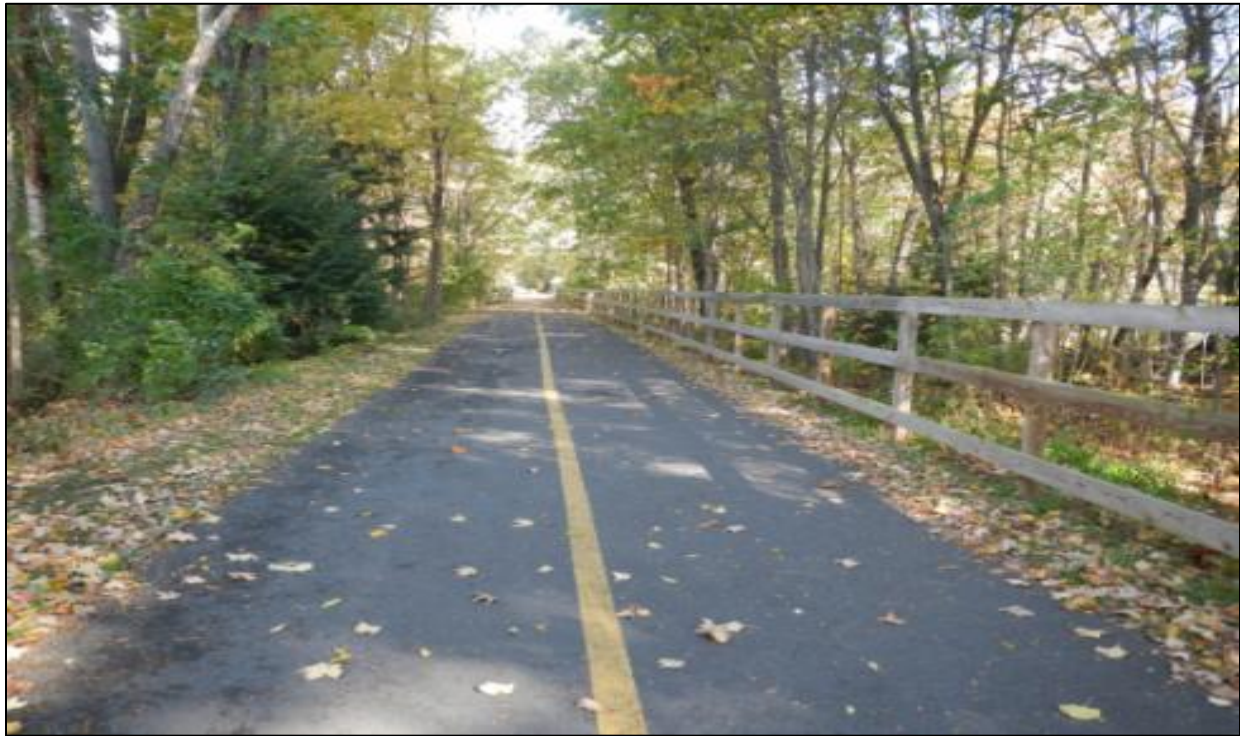
Figure 37. Canalside Trail Bike Path

No user impacts were noted during the site visit. The trail is currently functioning as intended and received a Category rating of 4 at the time of the site visit.

Typical Photo of Bike Trail

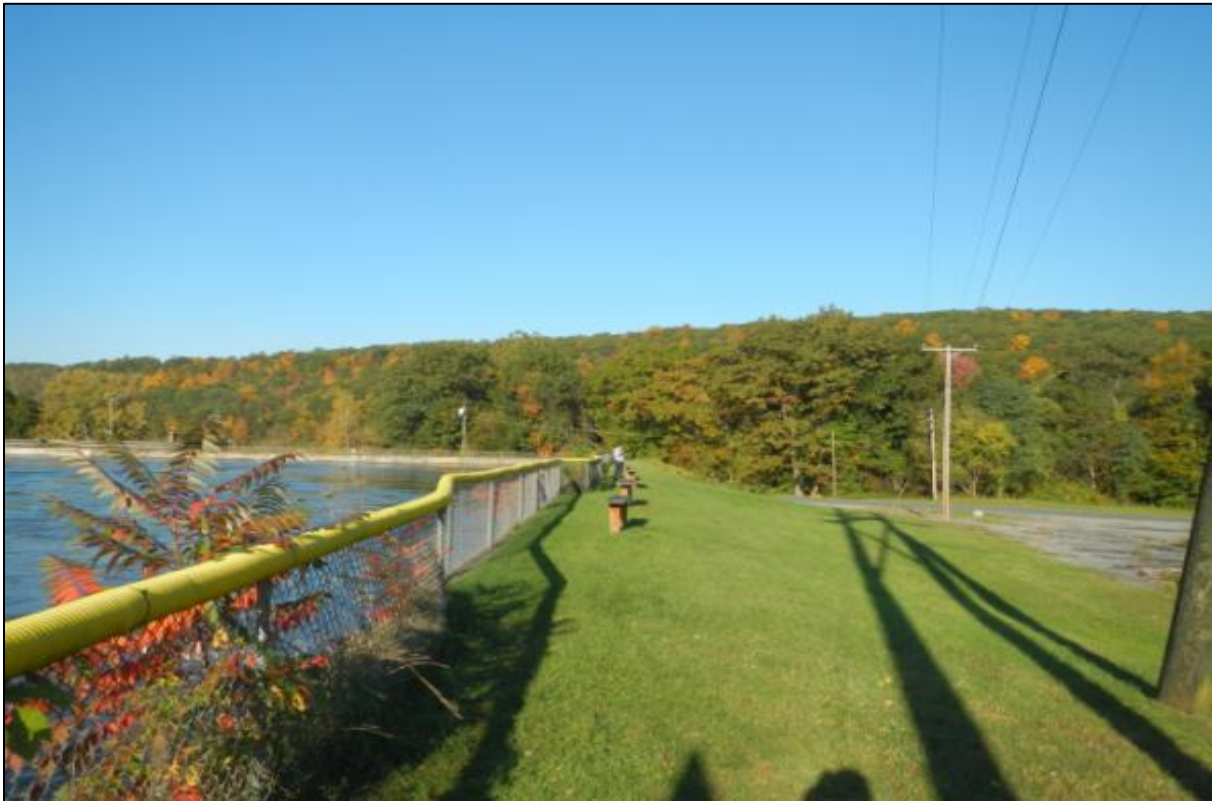
Figure 40. Turners Falls Branch Canal Area

The site appears to be functioning as intended and the amenities appeared to be in functional condition. The site therefore received a Category rating of 4.

Branch Canal Benches

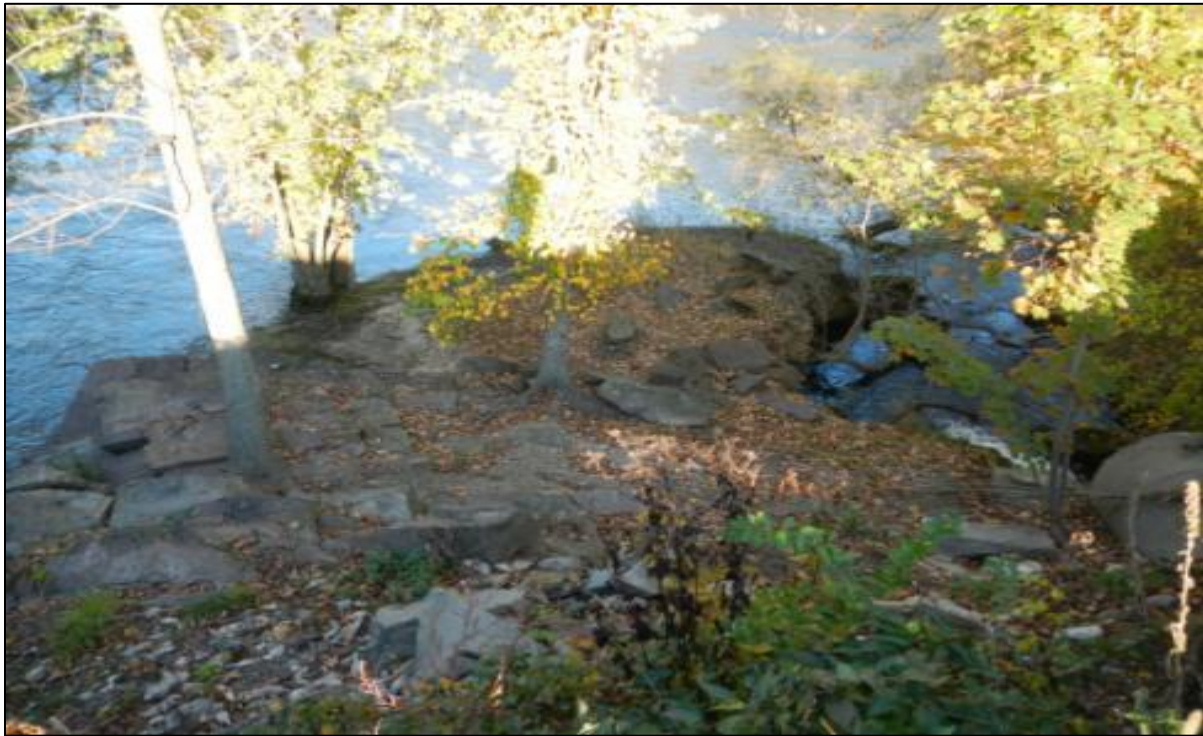
Figure 41. Turners Falls Station No. 1 Fishing Access

Site use was determined by compacted trails and shoreline areas, along with a minor amount of erosion which was observed. The condition of this site was not rated because it is an informal recreation site.

Informal Fishing Location

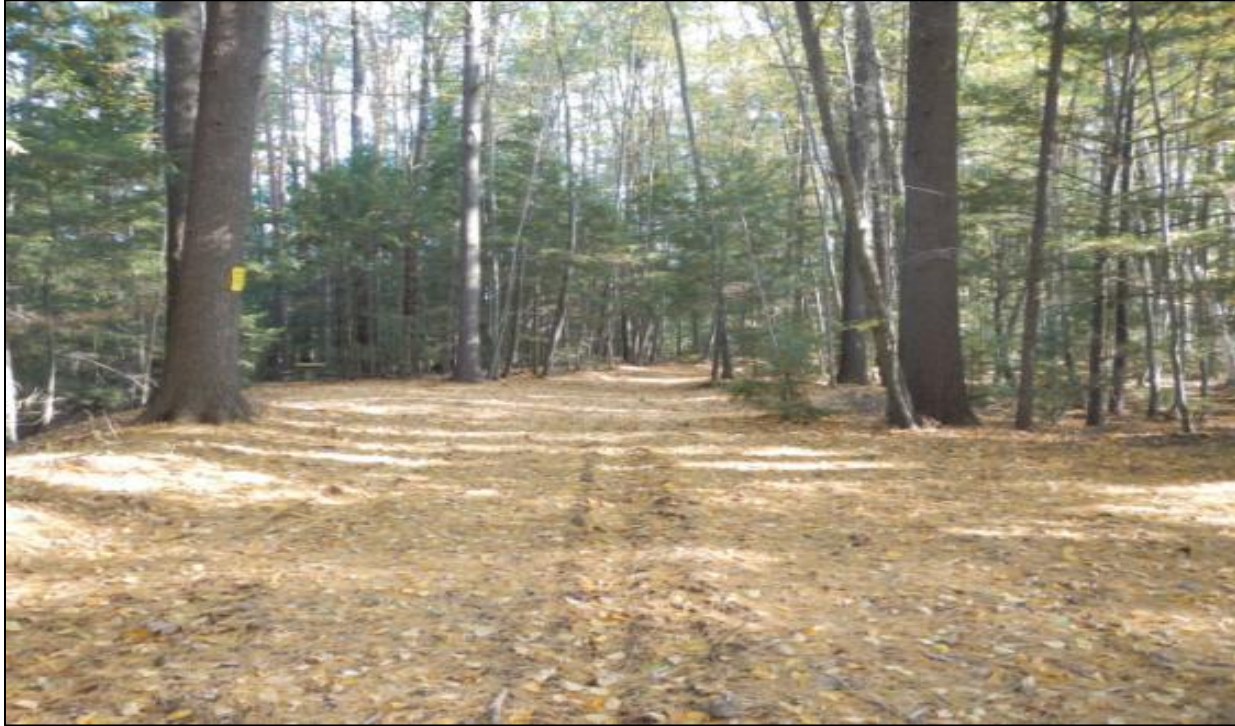
Figure 43. Cabot Woods Fishing Access

There was compaction of the soils in the vicinity of well used trails to the shoreline of the bypass reach and minor erosion noted at the time of the site visit. The erosion observed during the site visit conducted in October, 2011 may not have been a result of recreation use but from Hurricane Irene that had passed

through the area six weeks before the site visit. Amenities at the site were in good, functioning condition and received a Category rating of 4.

Cabot Woods Trail and Picnic Area
