Relicensing Study 3.6.2

RECREATION FACILITIES INVENTORY AND ASSESSMENT

**Northfield Mountain Pumped Storage Project (No. 2485)
and Turners Falls Hydroelectric Project (No. 1889)**

Initial Study Report Summary

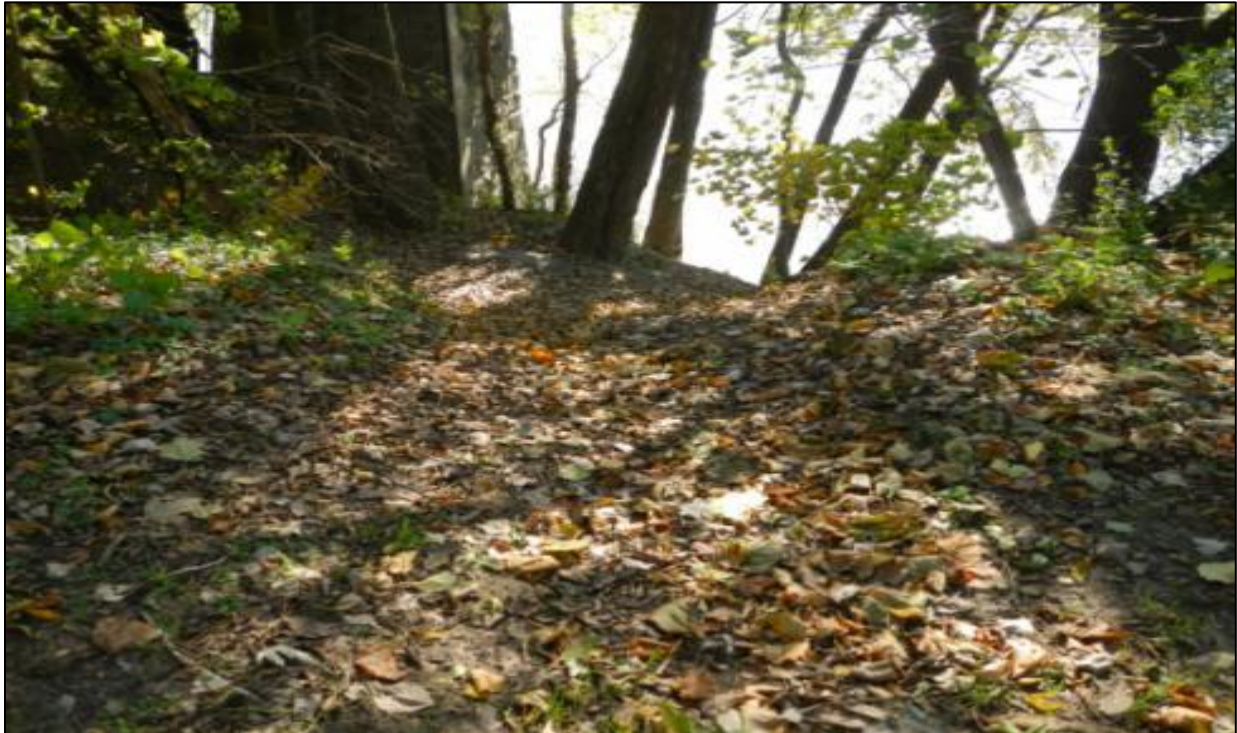
Figure 44. Turners Falls Canoe Portage

The condition of the take-out site was assessed as part of the assessment of the Barton Cove Canoe and Kayak Rental Area (Site 16). The improved parking area at the put-in location was determined to be in functional condition. The portage trail at the put-in site is currently functional, but as there have been no improvements to the put-in, no condition assessment was made of this area.

View of Shoreline Approach from Top of Slope of Portage Put-In
