**Turners Falls Hydroelectric Project (FERC No. 1889)  
Northfield Mountain Pumped Storage Project (FERC No.  
2485)**

**2015 Updated Study Report**

September 29-30, 2015

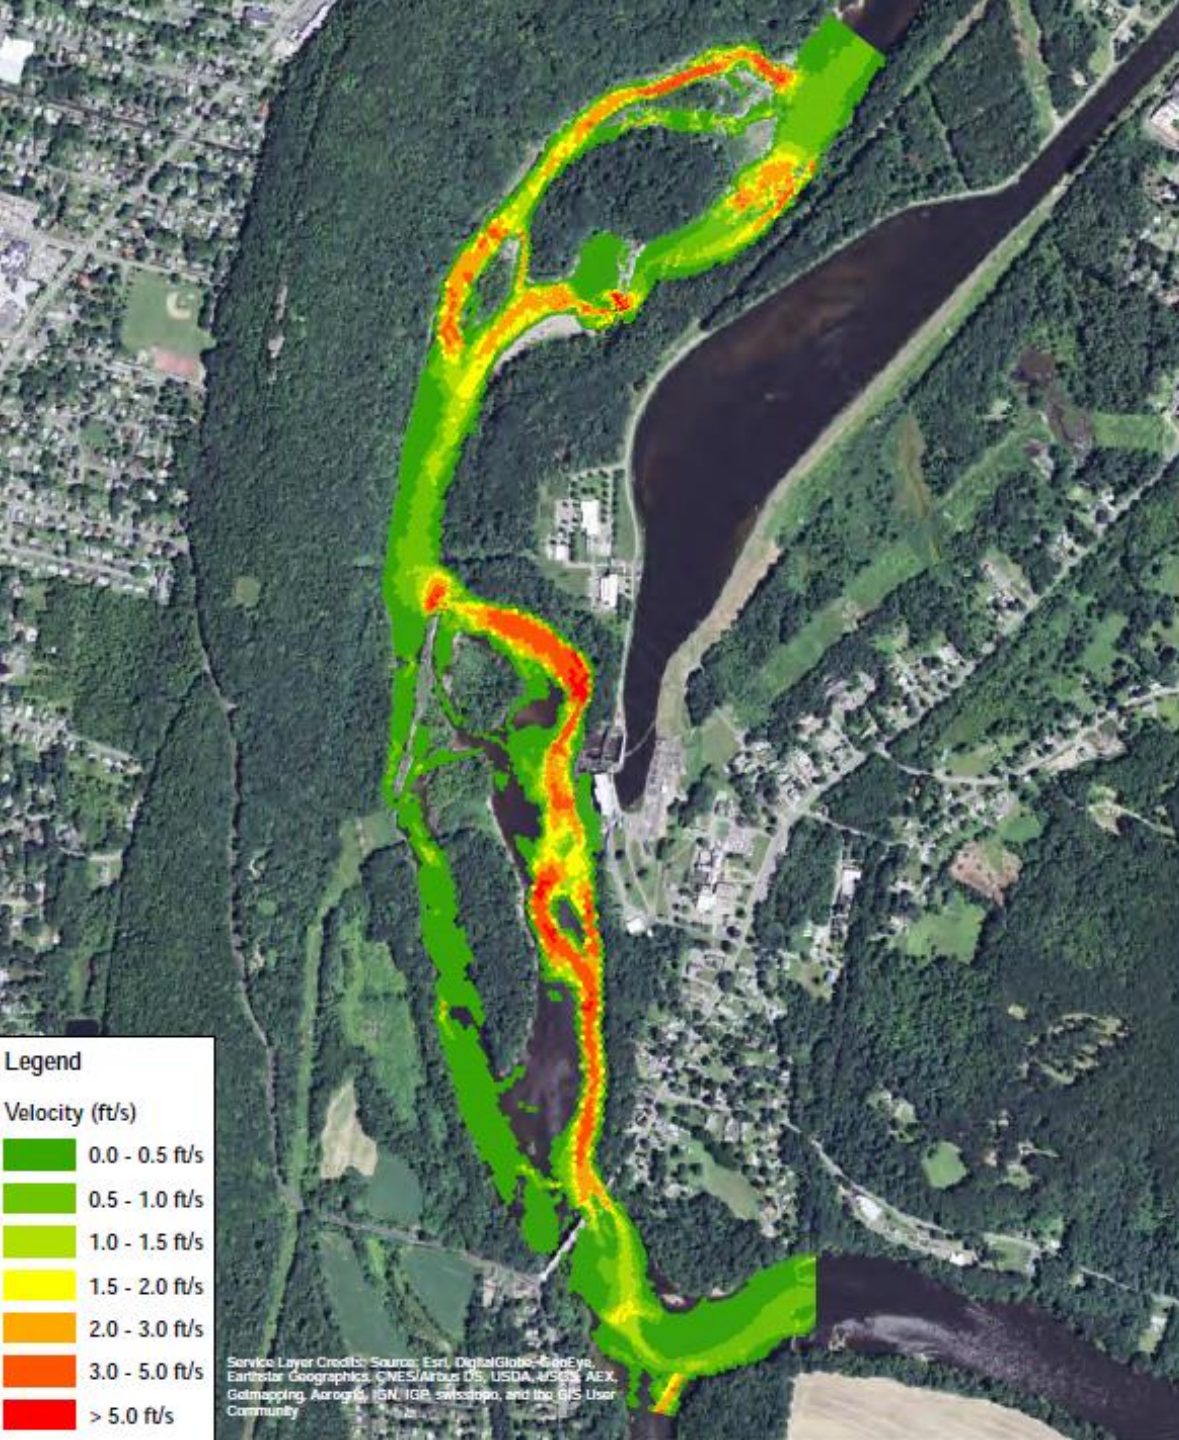
#### Velocity Map Reach 3

Bypass:	1,600 cfs
Cabot:	0 cfs
Deerfield:	200 cfs

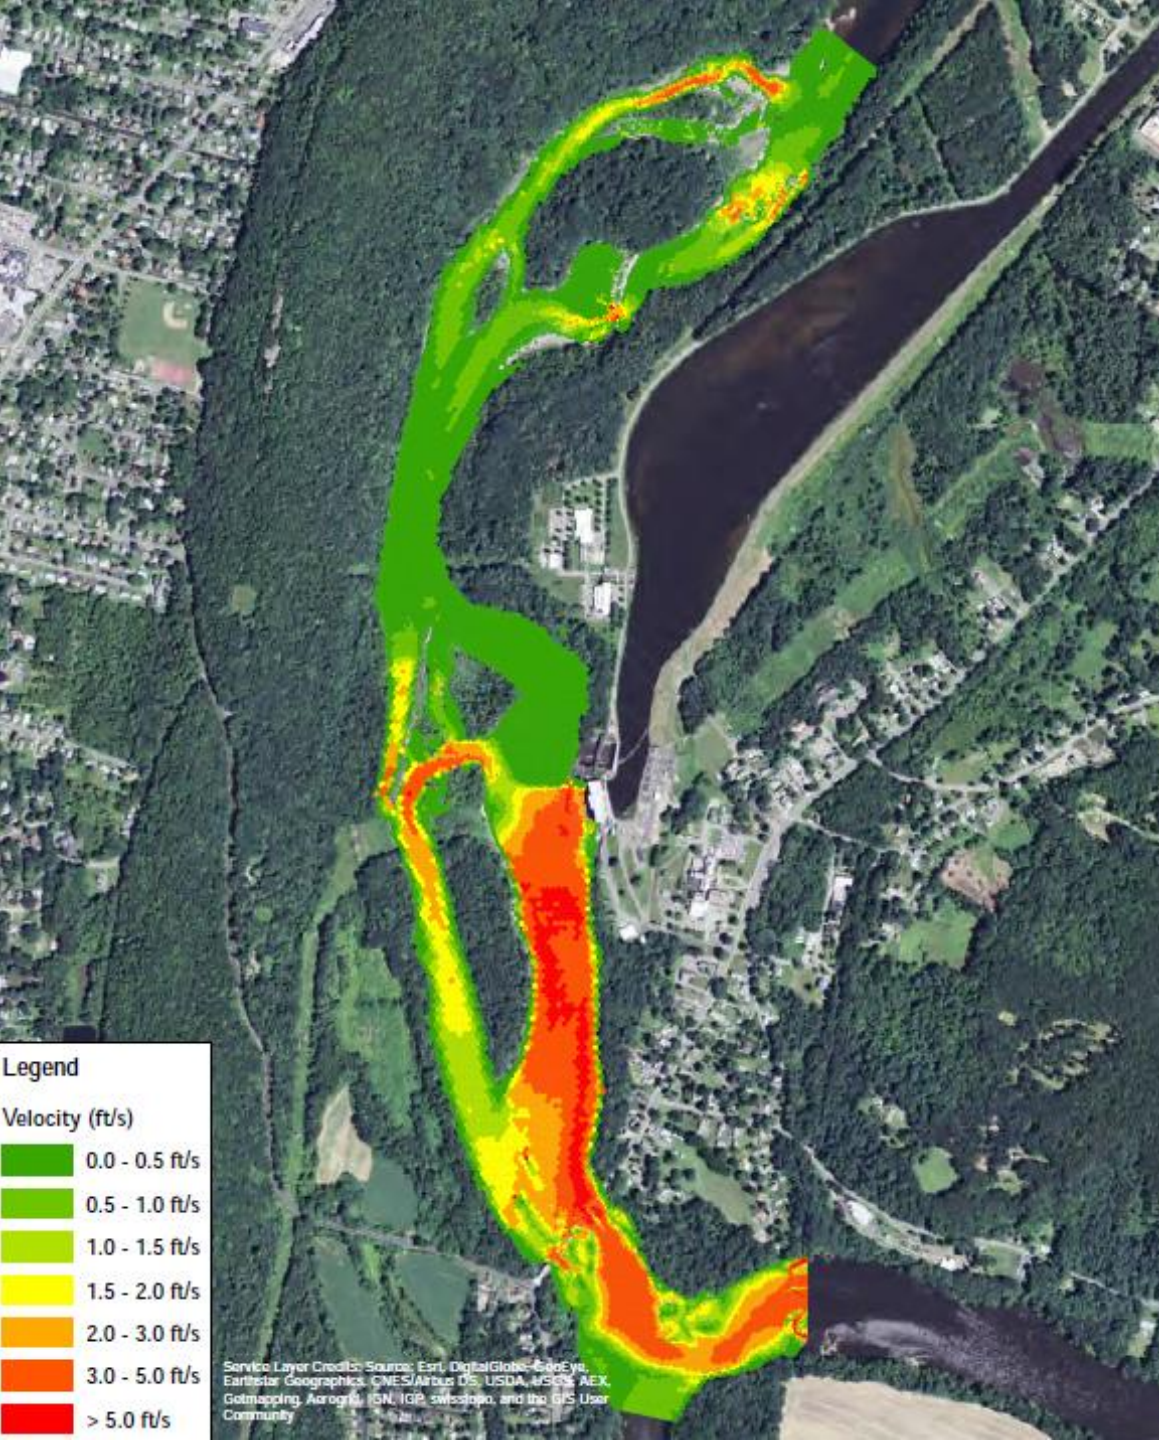
#### Velocity Map Reach 3

Bypass:	2,000 cfs
Cabot:	13,728 cfs
Deerfield:	1,445 cfs

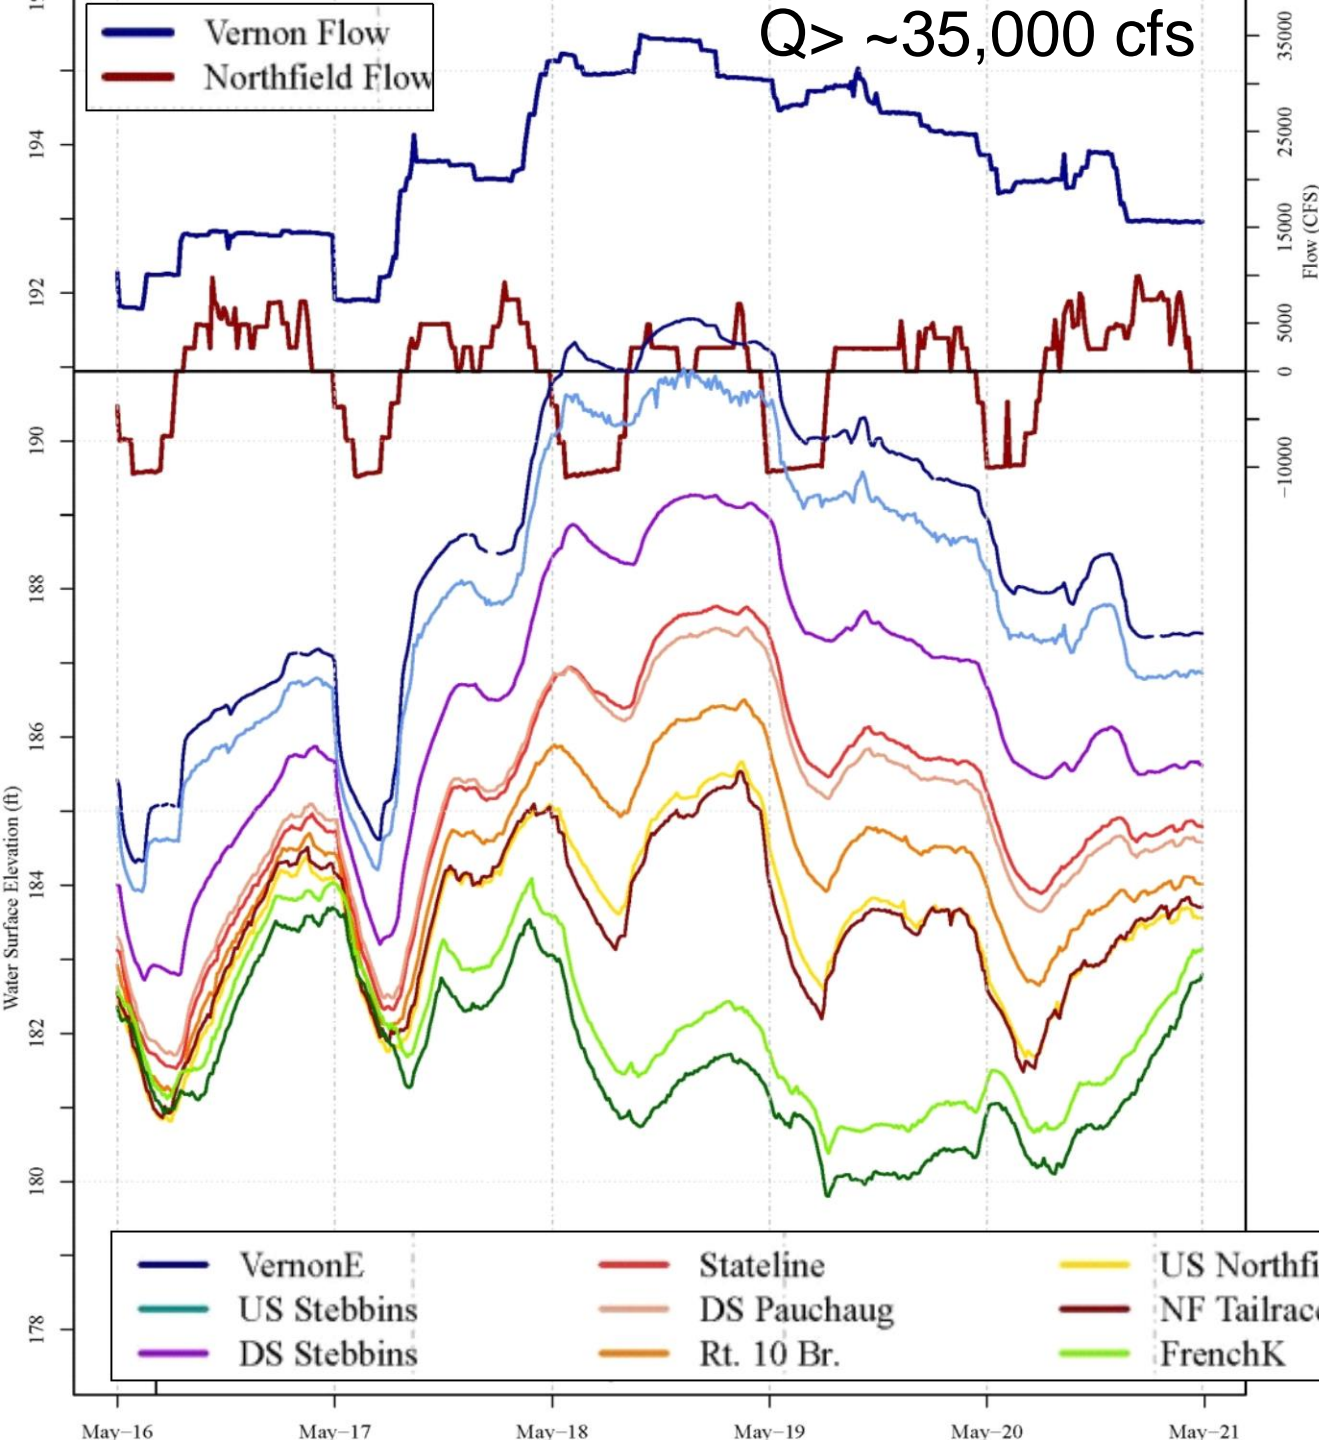
Example Low Flow  
Event- Plots developed  
For Entire Period  
Water Level Loggers  
Operated

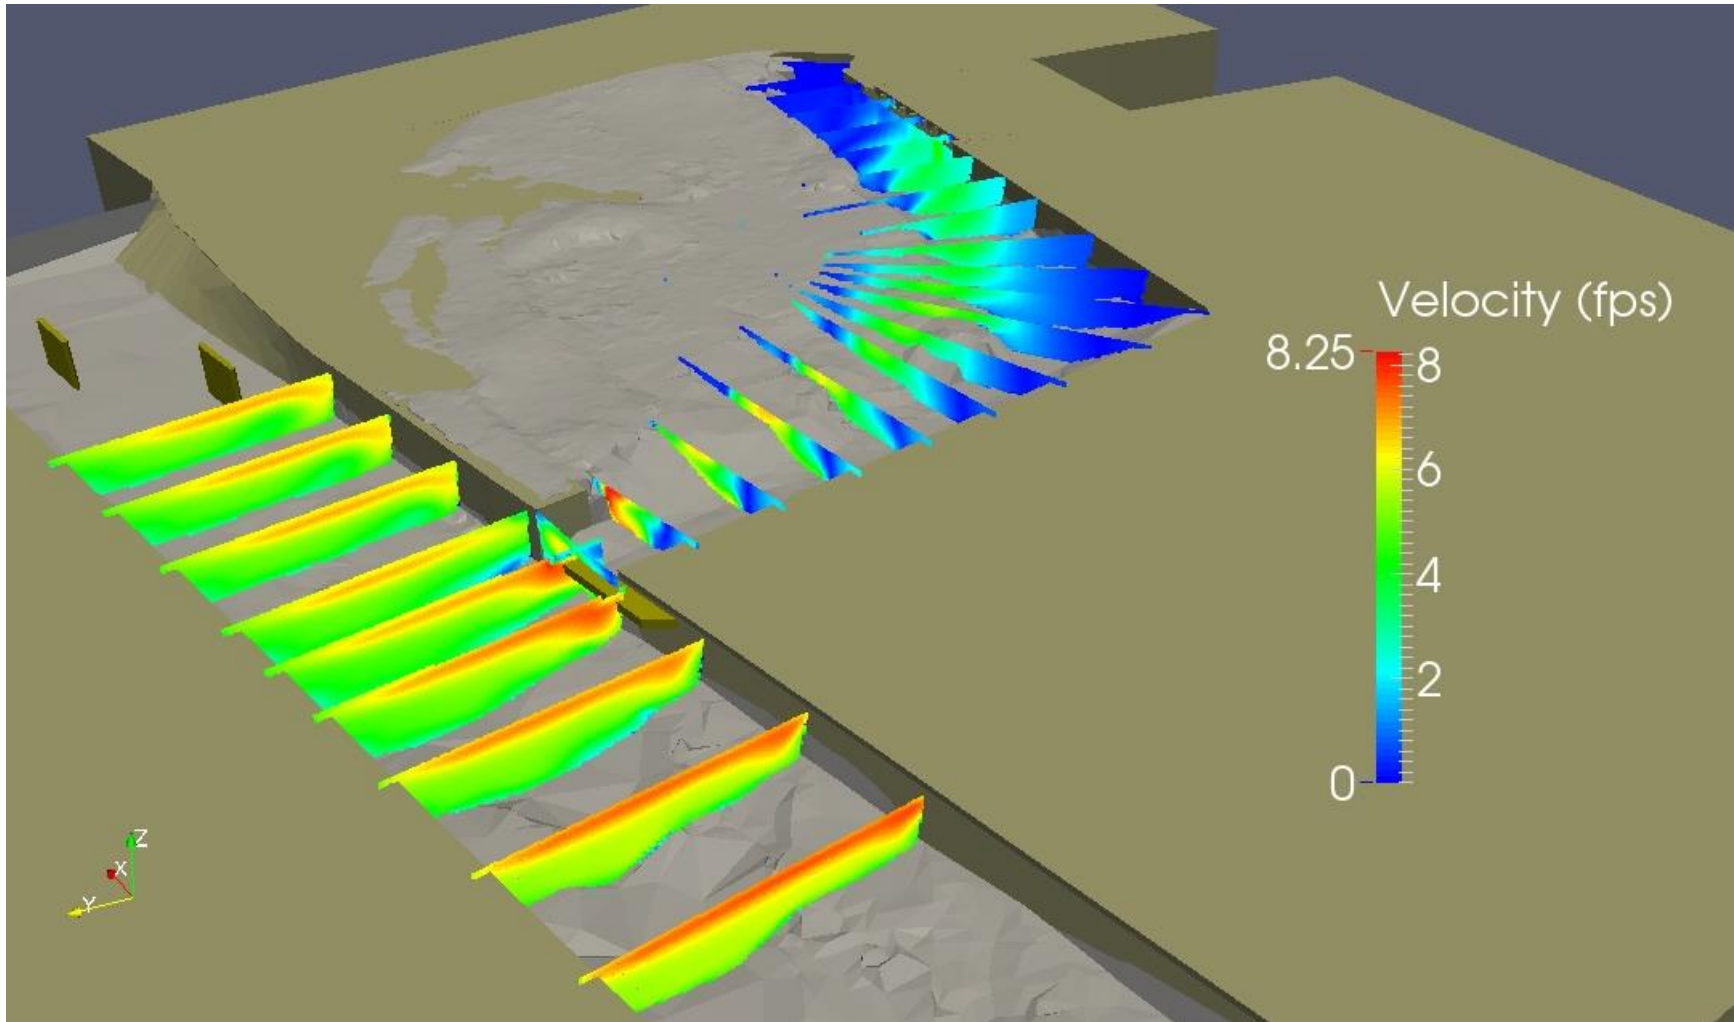
Preliminary results for Station No. 1 forebay CFD model, production run number 1-3.

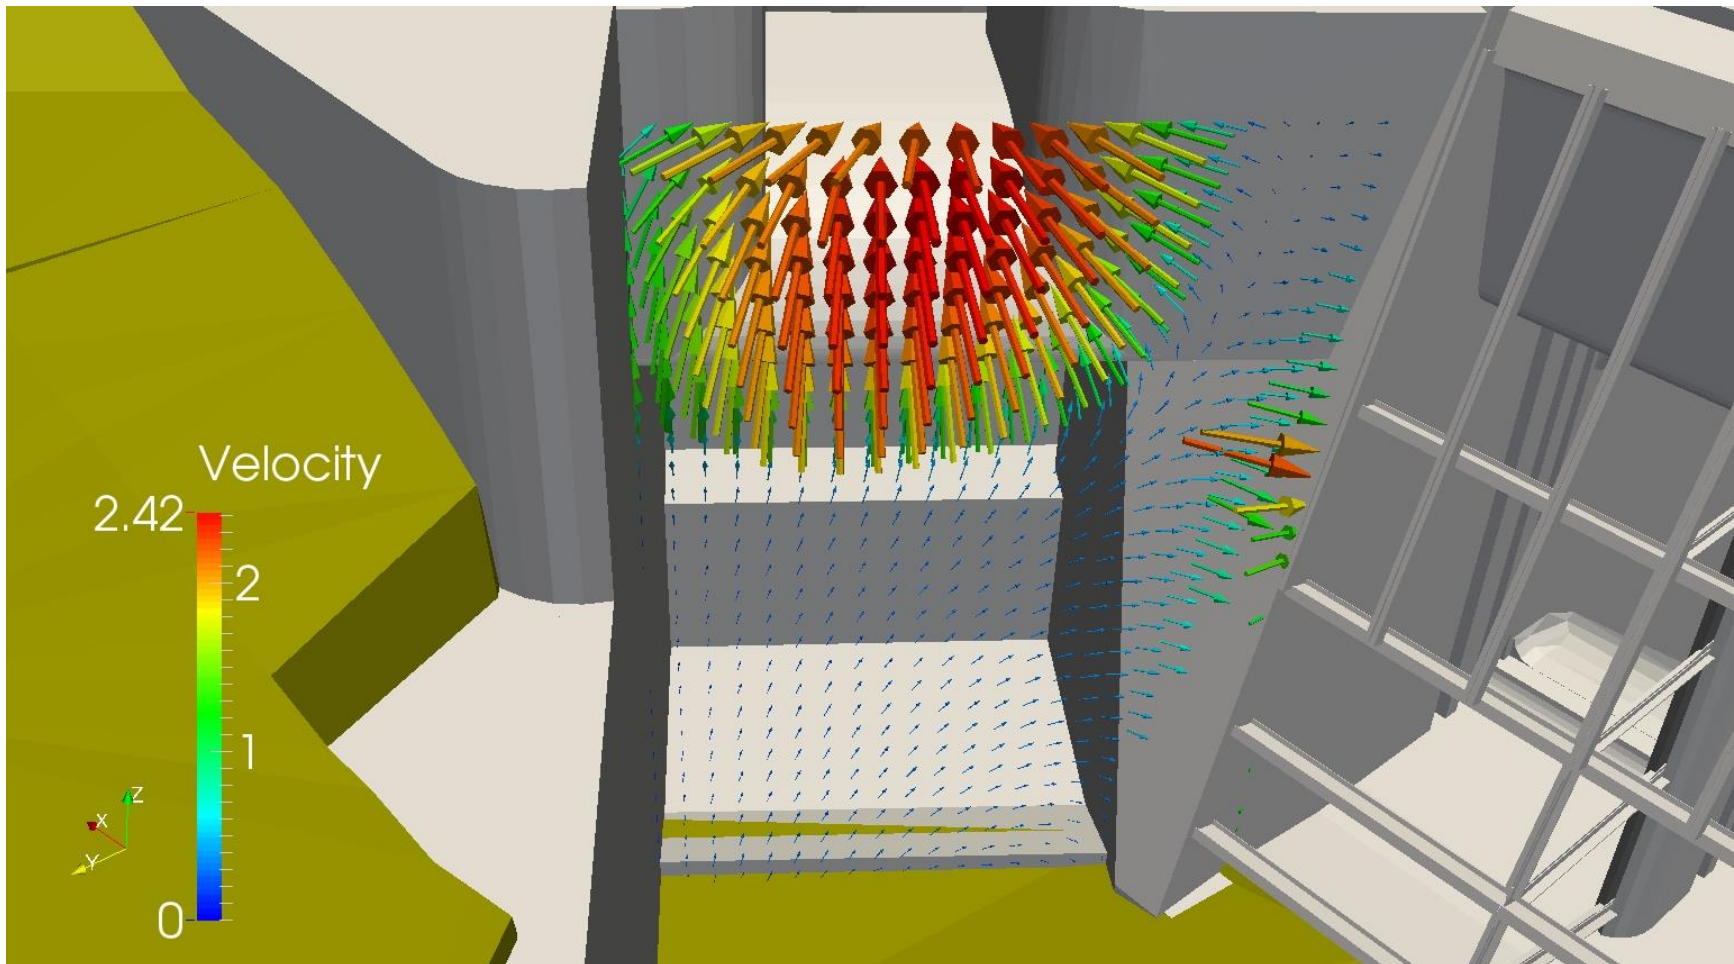
Preliminary results for Cabot forebay, production run number 3-1 at the log sluice entrance.

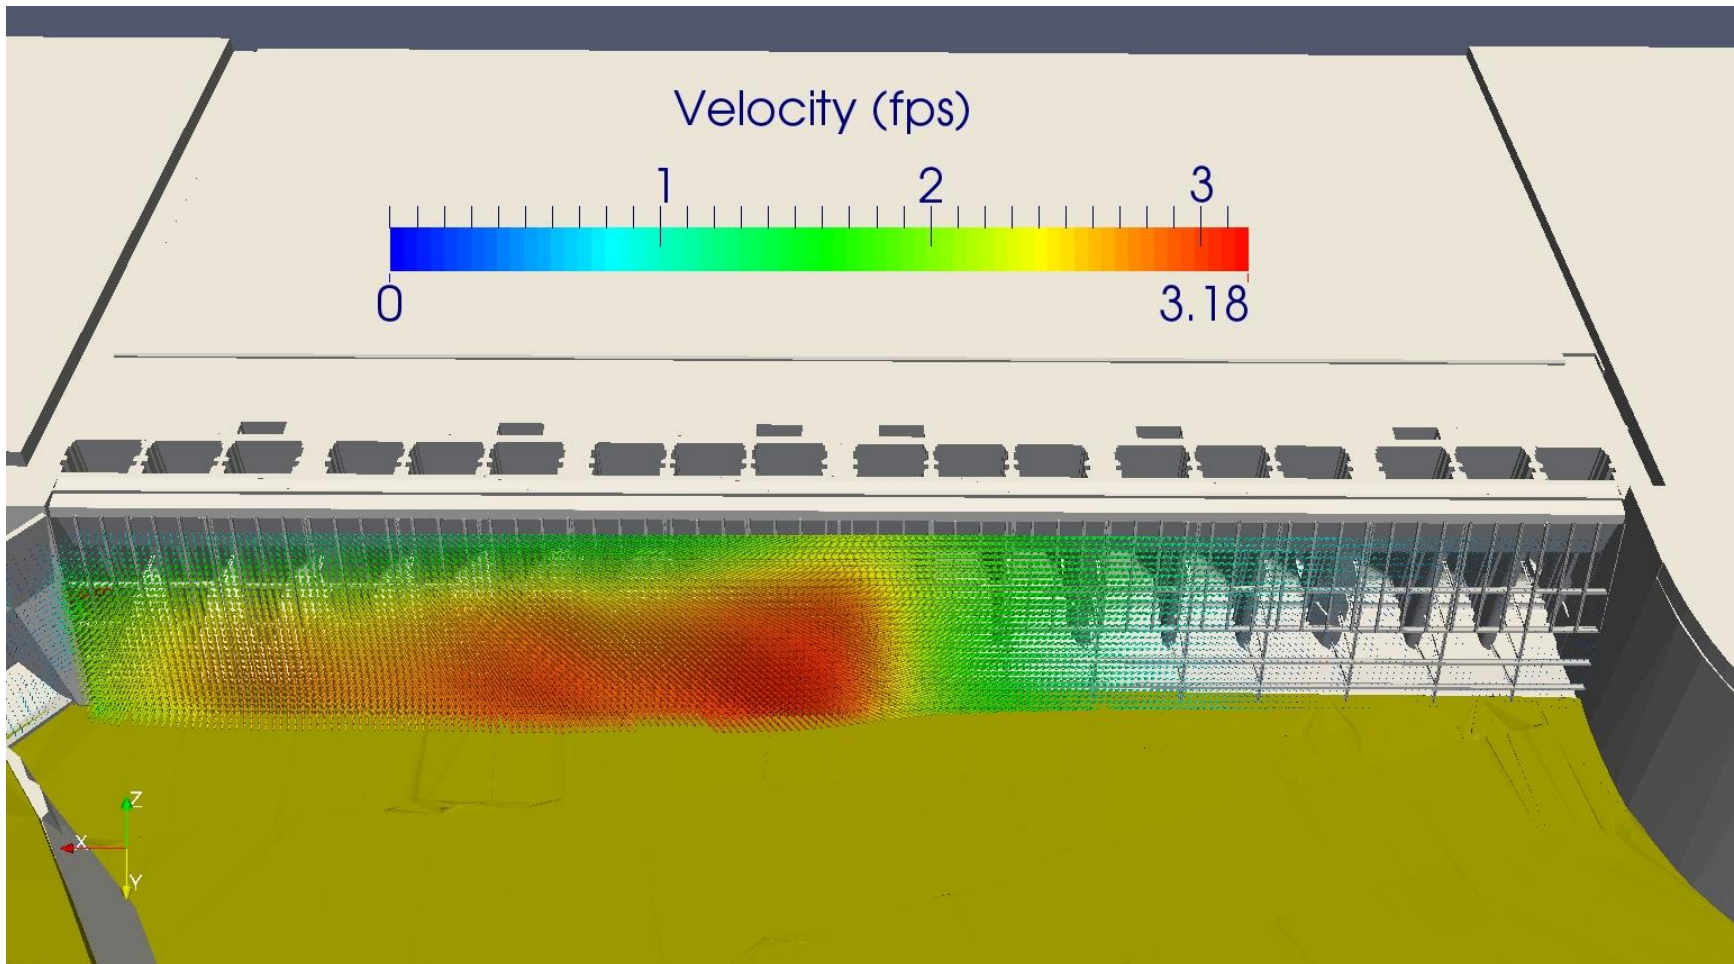
Preliminary results for Cabot forebay, production run number 3-2 near the Cabot Station intake racks.

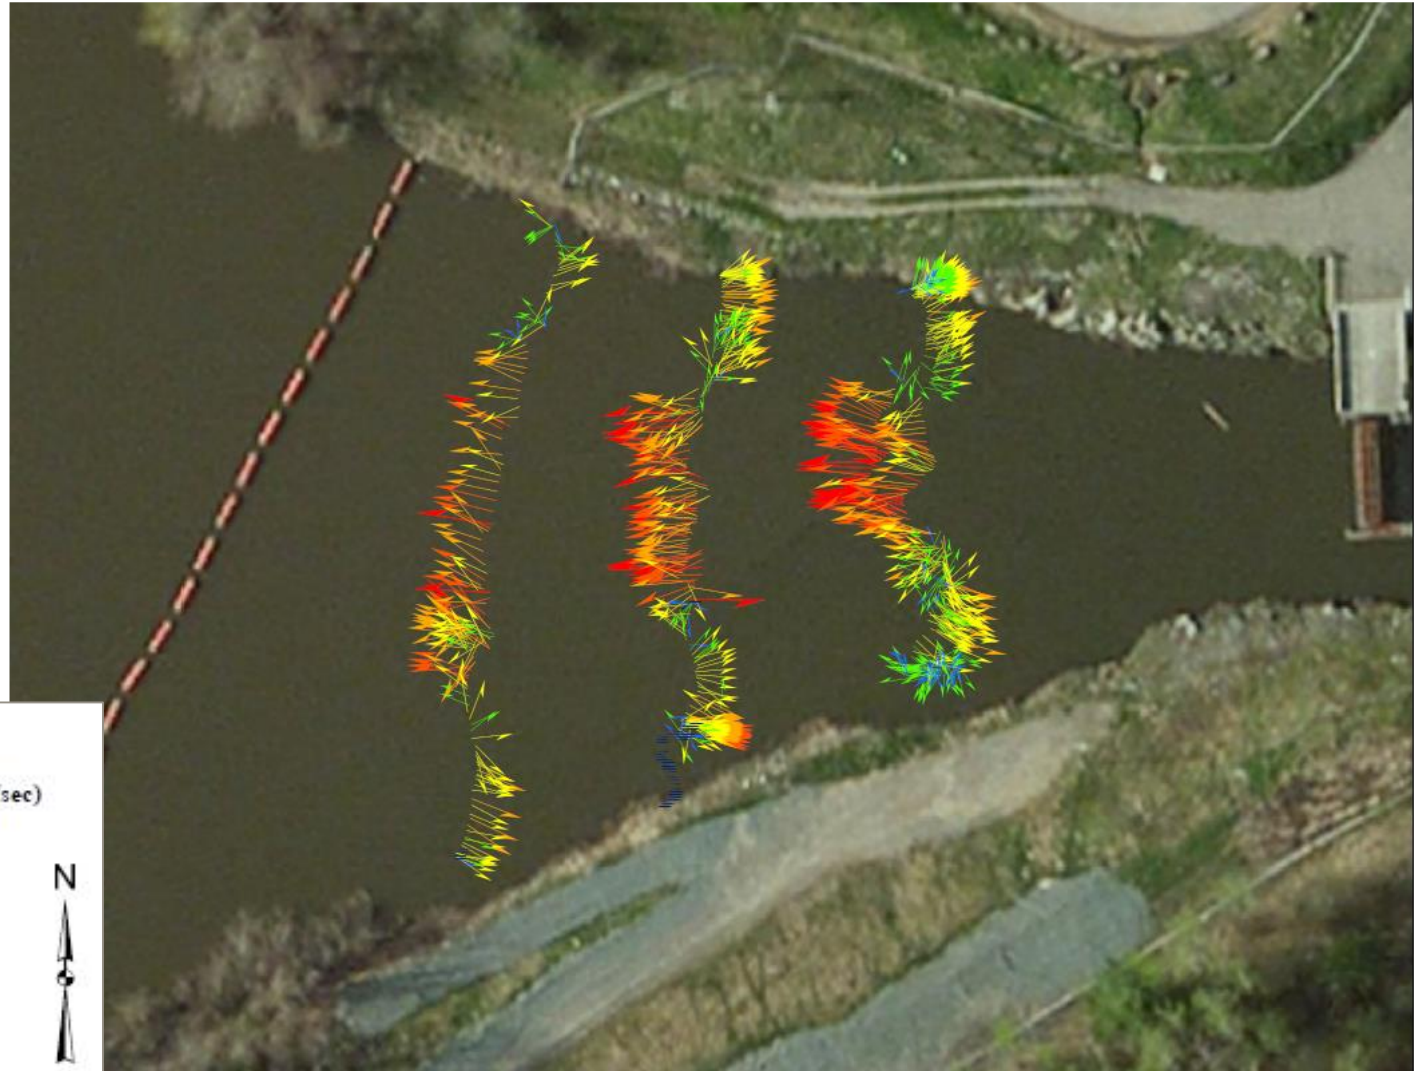
## Velocity Vector Map for Scenario 18

- 50% Exceedence Flow (8,440 cfs)
- 2 Units Generating (10,000 cfs)
- WSEL at Dam= 185 ft

- 4 Units Generating (20,000 cfs)

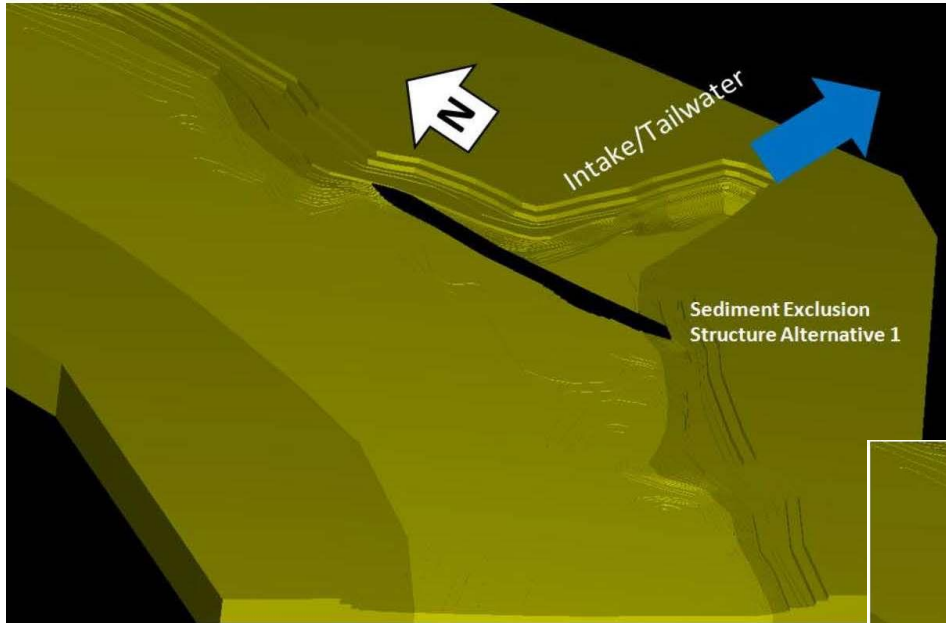
**Convex Sediment Structure (Alternative 1)**

- Model extended 500 ft. upstream and downstream of the tailrace, including the tailrace intake area.
  - Three CFD simulations were run: 1) existing conditions; 2) installing a convex sediment exclusion structure; and 3) installing a concave sediment exclusion structure.

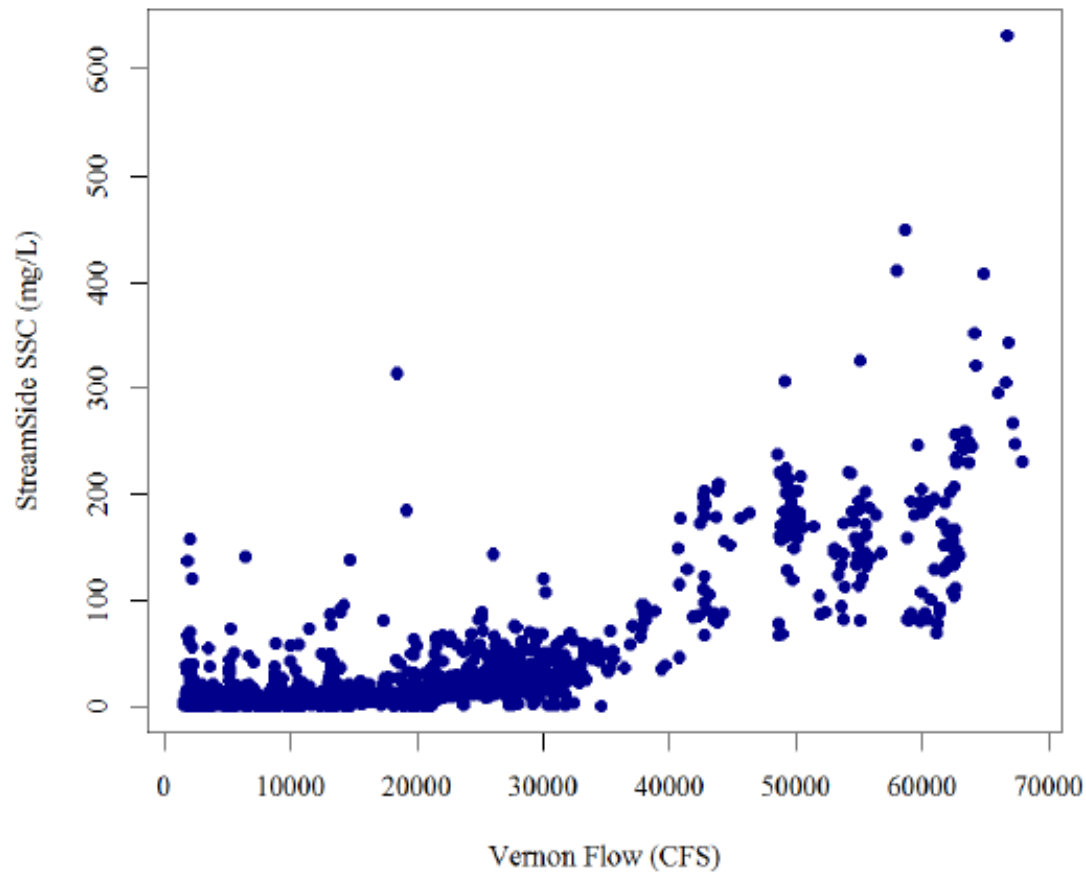
Connecticut River SSC vs. Vernon Discharge (2013-2015)

- Mainstem SSC values are directly proportional to flow (i.e., the higher the flow, the higher the SSC values).
- Three flow thresholds were observed in regard to SSC values - <12,000 cfs, 12,000-35,000 cfs, and >35,000 cfs. Median values for each threshold were 2.9 mg/L (<12,000 cfs), 12.45 mg/L (12,000-35,000 cfs), and 144.61 mg/L (>35,000 cfs).
