## **Relicensing Study 3.4.2**

# **EFFECTS OF NORTHFIELD MOUNTAIN PUMPED STORAGE DEVELOPMENT-RELATED LAND MANAGEMENT PRACTICES AND RECREATIONAL USE ON TERRESTRIAL HABITATS**

## **Study Report**

**Northfield Mountain Pumped Storage Project (No. 2485)  
and Turners Falls Hydroelectric Project (No. 1889)**

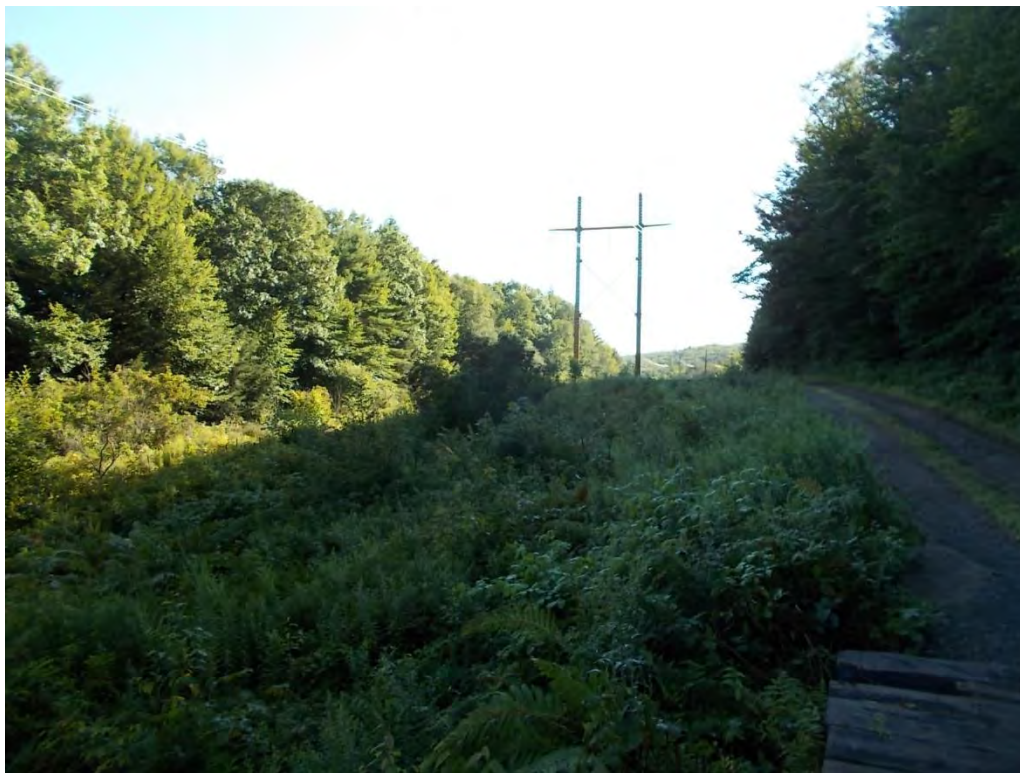
**Figure 4.2.7-1. Representative view of the right-of-way community.**

This community, which is not identified by the NHESP, was identified within the portion of the study area which is crossed by the Eversource transmission right-of-way. This area is maintained by period vegetation management which limits the growth of large woody vegetation. The dominant communities are shrub and herbaceous communities. Shrub layer vegetation is dominated by white pine saplings, glossy buckthorn, red cedar (*Juniperus virginiana*), and meadowsweet (*Spiraea alba* var. *latifolia*). The herbaceous community is extensive and includes several weedy species such as chicory (*Cichorium intybus*), mullein (*Verbascum Thapsus*), and pearly everlasting (*Anaphalis* sp.). Additional herbaceous vegetation includes bracken fern (*Pteridium aquilinum*), sensitive fern (*Onoclea sensibilis*), Joe pye weed (*Eutrochium maculatum*), and milkweed (*Asclepias* sp.). Portions of this area include a gravel access road ([Figure 4.2.7-1](#)).

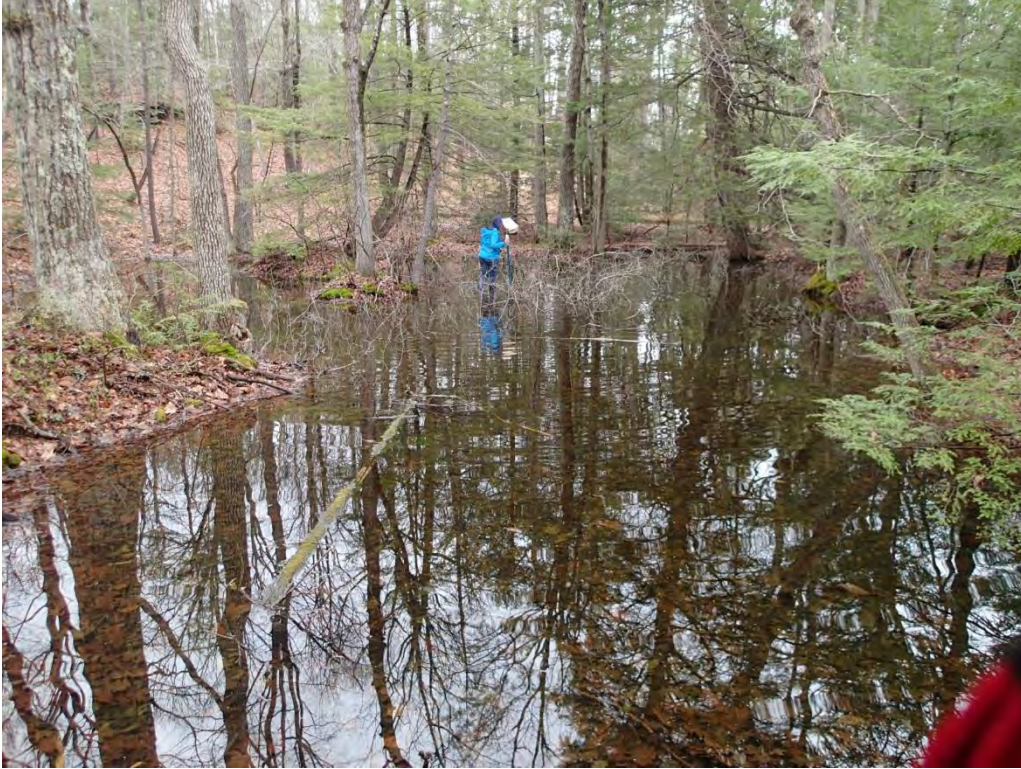
**Figure 4.3.3-1: Example of Woodland Vernal Pool - Vernal Pool #3 - Biologist Dip Net Sampling**

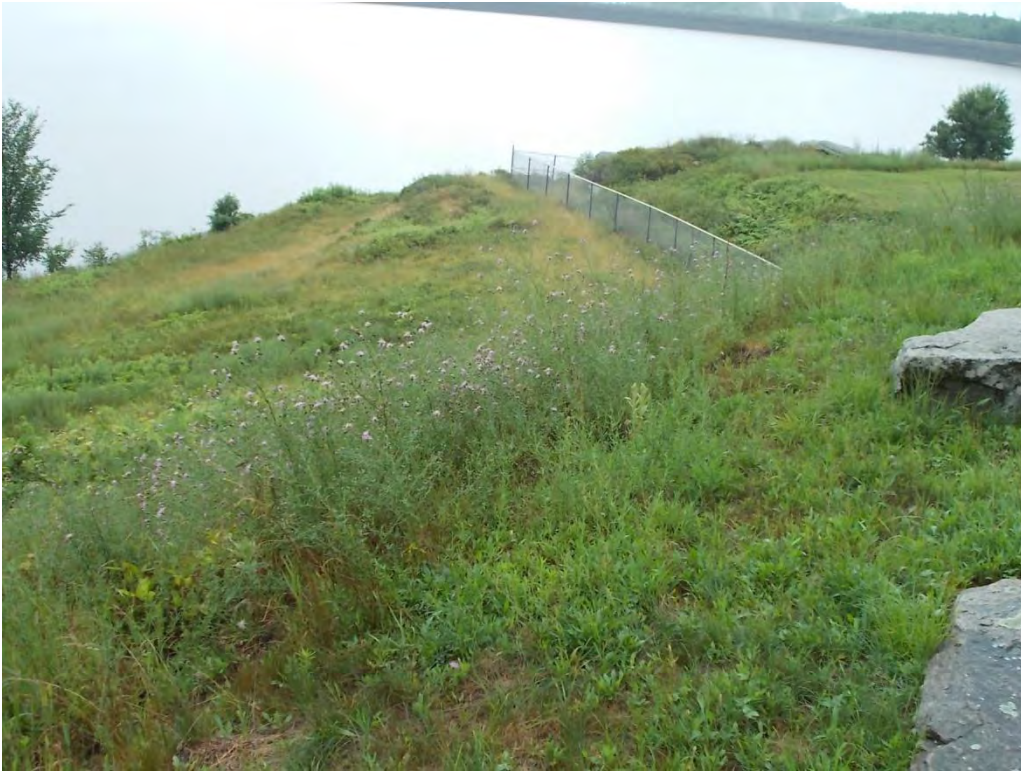
**Figure 4.4-1: Example of Vegetation Management Zone Along Western Side of Upper Reservoir**

Land management practices related to Project-related activities are limited to maintaining a strip of land that encompasses the Upper Reservoir envelope. This includes some mowed sections of land immediately outside of the Protected Fenced Zone surrounding the Upper Reservoir. The vegetation management area around the Upper Reservoir is maintained for safety and surveillance as part of Northfield Mountain Project Dam Safety Surveillance and Monitoring Program. Generally, this vegetation management area provides lower quality wildlife habitat compared to the undeveloped portions of the study area. It is around these managed zones and edge habitats that invasive species are more prevalent, and there is less diversity in the habitat. It should be noted that Eversource also maintains a transmission line right-of-way in the western portion of the study area.

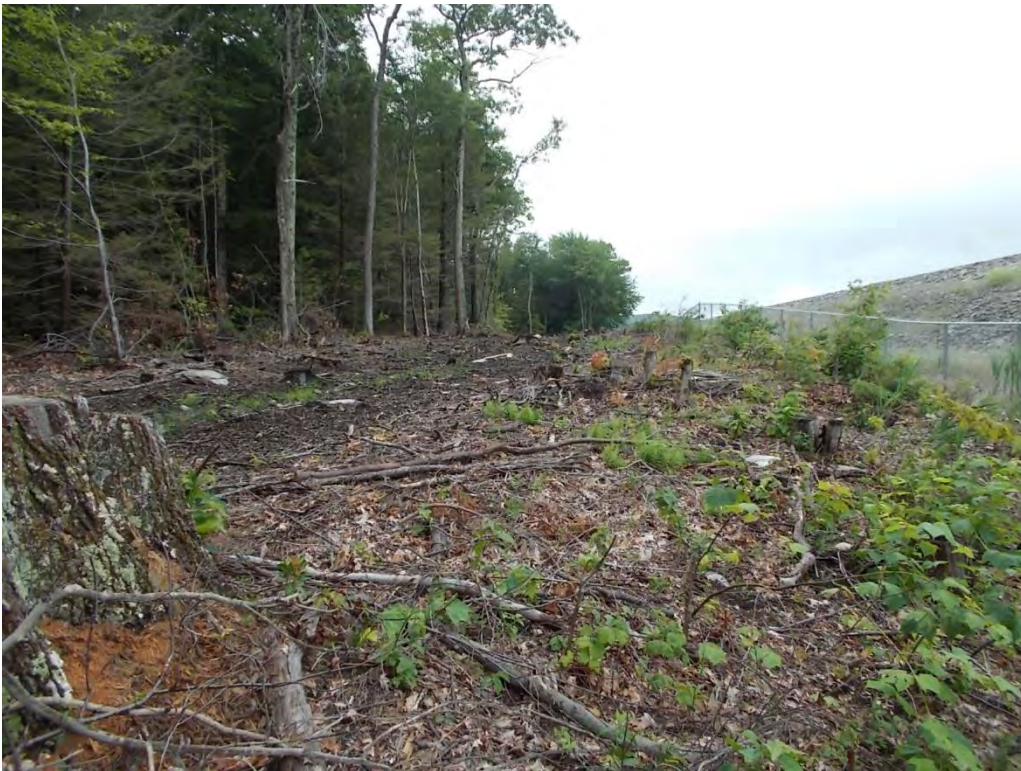
**Figure 4.4-2: Example of Vegetation Management Zone Along Eastern Side of Upper Reservoir**

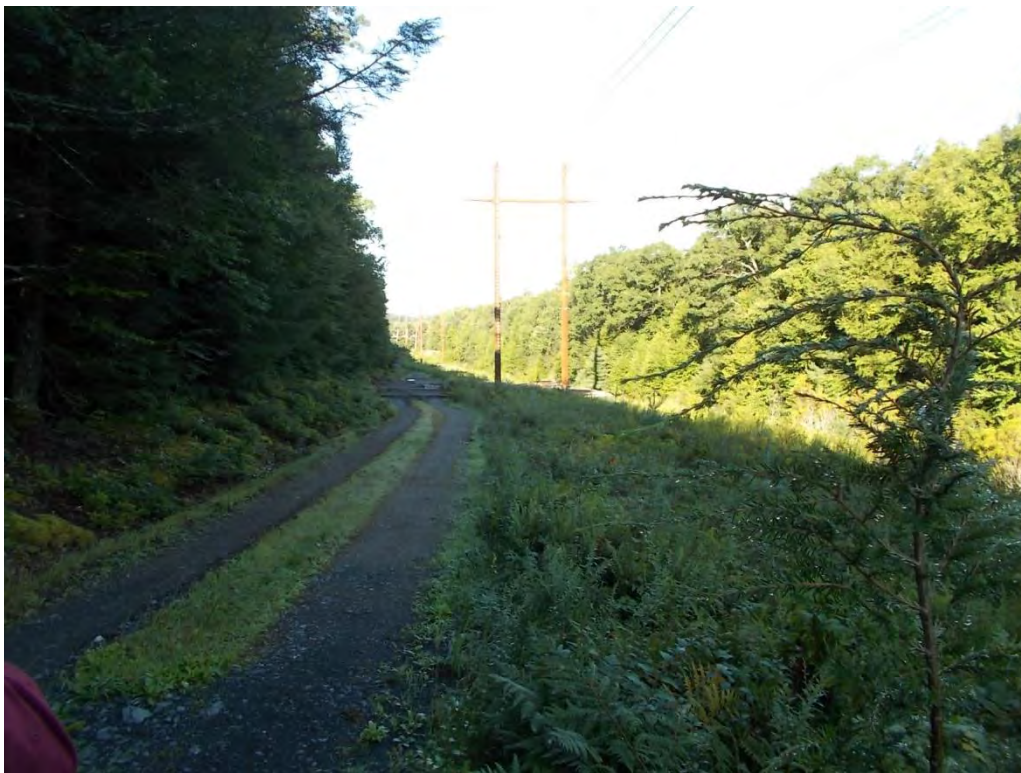
**Figure 4.4-3: Example of Habitat Along Eversource Transmission Right-of-Way**

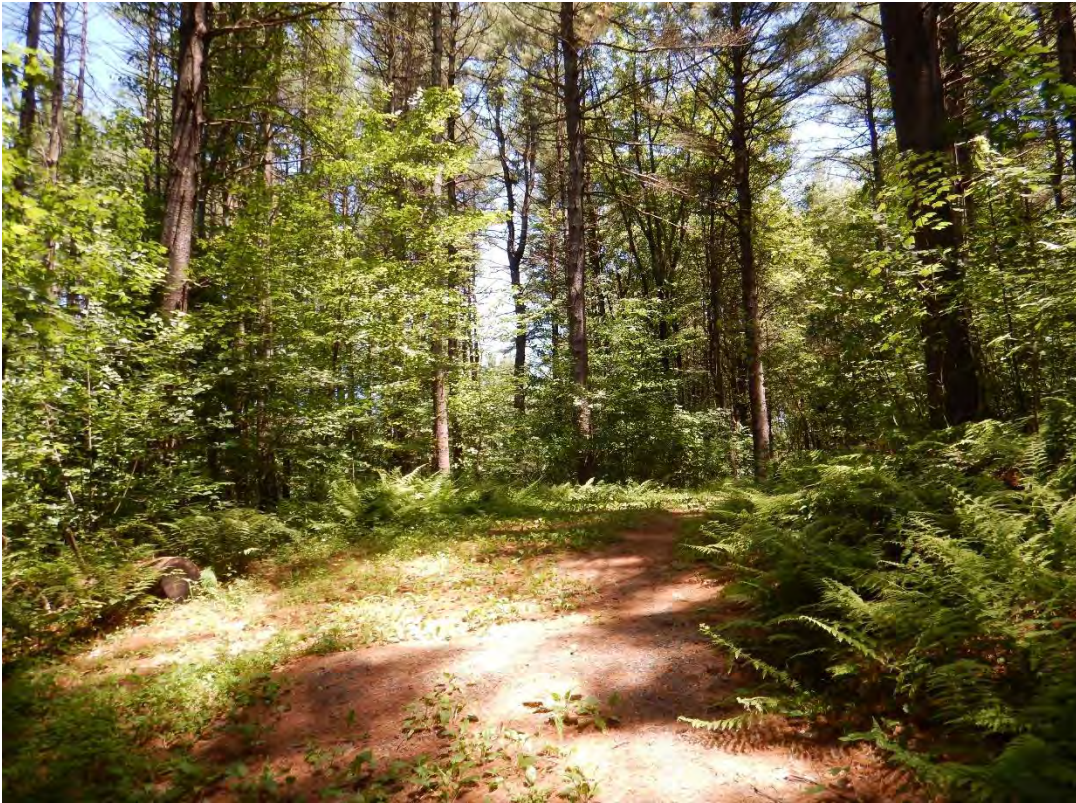
**Figure 4.4-4: Example of Typical Wide Trail on Northfield Mountain**

Recreation at the Northfield Mountain Project centrally revolves around the Northfield Mountain trail system. The Northfield Mountain trail system includes over 25 miles of trail, which are available for hiking, biking, horseback riding, snowshoeing, and cross-country skiing. The trail system begins at FirstLight's Northfield Mountain Tour and Trail Center (NMTTC). Most of the trails are located within the Northfield Mountain Project boundary, and the trails can be used to access the mountaintop observation area offering views of the Upper Reservoir. There are two different trail types within the system. One type is wide and can be used for double track cross-country skiing or skating in the winter and hiking, horseback riding, and mountain biking in the summer. During the winter these trails are typically groomed. The second type of trail is narrow and can be used for snowshoeing in the winter or hiking and mountain biking in the summer. The narrow trails are not typically groomed in the winter. Trail systems are kept naturalized, but are typically kept clear of hazards such as fallen trees and limbs. Most trails have erosion protection structures including water bars, and culvert crossings for ephemeral streams, keeping erosion issues to a minimum. While trail systems can be potential vectors for introducing invasive species within the study area, there were only noted incidental to trace occurrences of invasive plants along the trail system.
